**Cell 1 Regional Coastal Monitoring Programme  
Analytical Report 4: 'Full Measures' Survey 2011**

North Tyneside Council

**North Tyneside Council  
Final Report**

**October 2012**

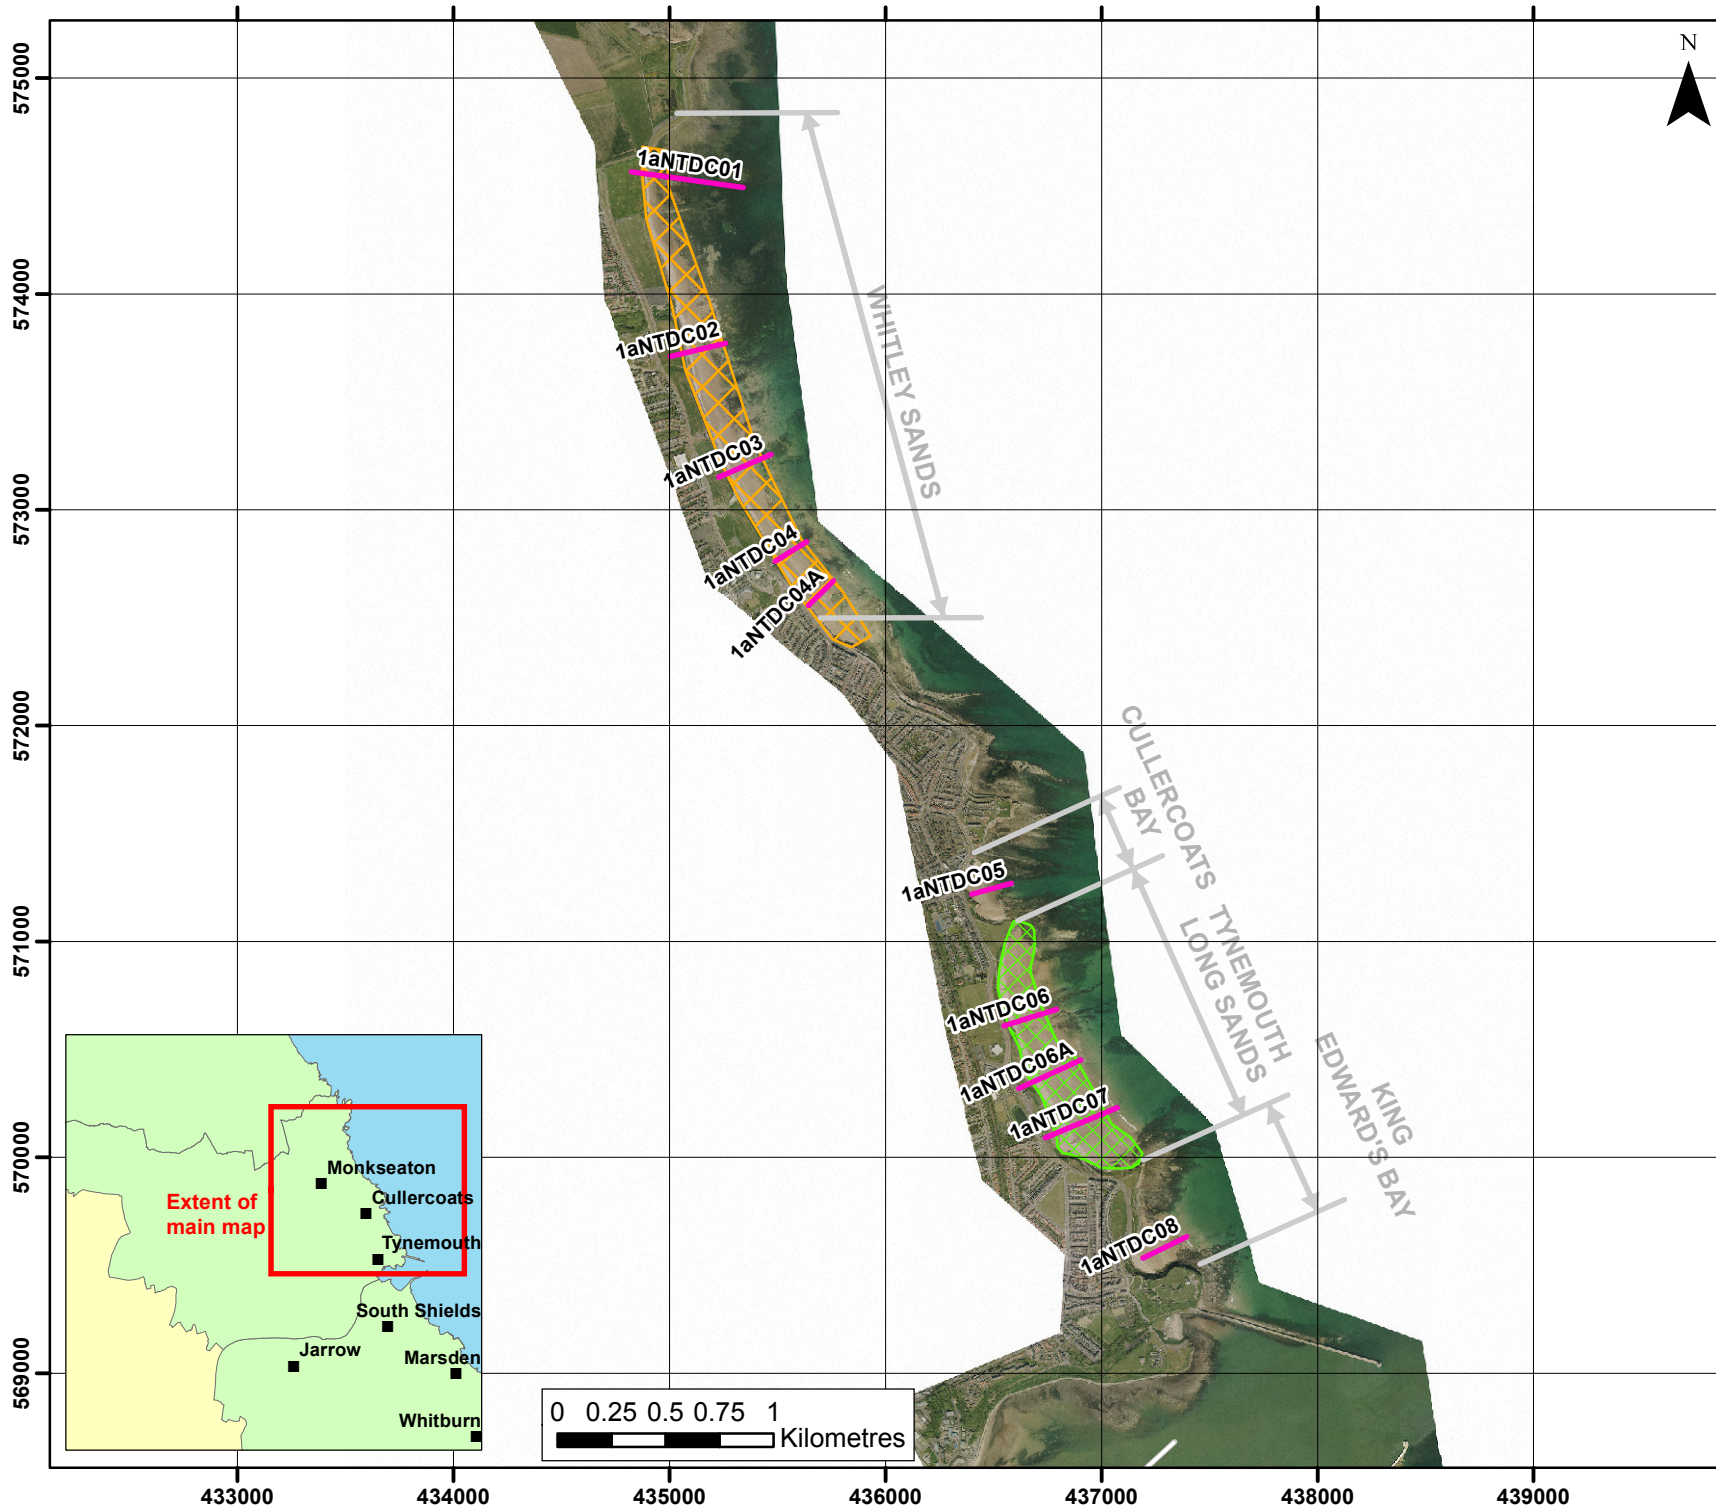
**Figure 2 - Map 1**  
**Survey Locations**  
**Whitley Sands**  
**to Tynemouth**  
**North Tyneside Council**

The location of these surveys is shown in Figure 2. The baseline Full Measures survey was undertaken along this frontage on the 11<sup>th</sup> (Tynemouth Long Sands topographic survey) and 27<sup>th</sup> October 2011. During this time weather conditions varied considerably; refer to the survey reports for details of the weather conditions over this survey period.

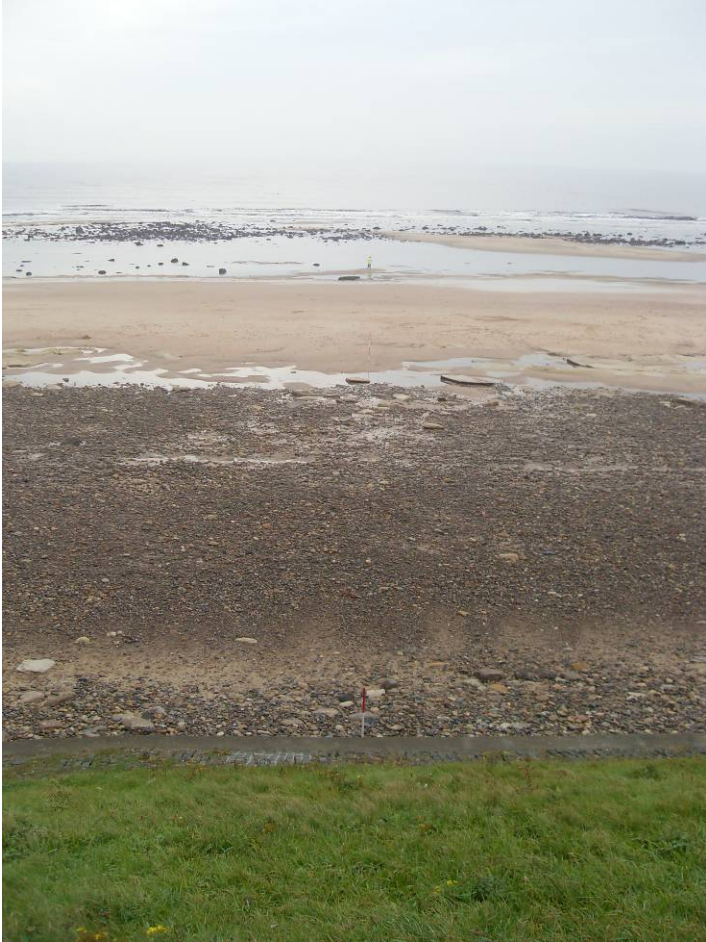
Plate 1 – Survey photograph 1aNTDC04\_20111027\_Dwn.JPG

Survey Date	Description of Changes Since Last Survey	Interpretation
	<p>1m. Here the berm has been flattened to formed a more gently sloping and concave profile. The survey photograph (Plate 1) shows an upper beach comprised of shingle and a lower beach comprised of sand. The position of the berm shown by the previous profile (4<sup>th</sup> March 2011) corresponds with the transition zone from one sediment type into another. The flattening of the berm and smoother profiles indicating some cross-shore transport of beach material and with that some sorting of the sediment since the last survey.</p> <p>Profile <b>1aNTDC04a</b> is located to the south of Whitley Sands. Since the last survey (partial measures, spring 2011), beach levels at the toe of seawall, immediately below MHWS and between a chainage of 0m and 15m, have increased up to 0.6m. Conversely, adjacent to this between a chainage of 15m and 40m, beach levels have fallen by up to 0.4m. Between 0m and 40m chainage, the beach profile has flattened. It is likely that beach material has been redistributed across the profile. From a chainage of 40m, out to the exposed rock at a chainage of 80m beach levels have increased by up to 0.5m.</p>

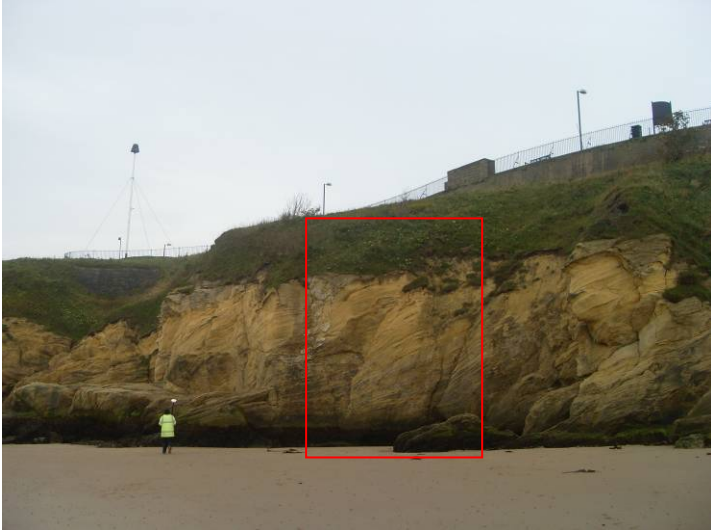
**Plate 2 – Survey photograph, cliff face at profile 1aNTDC05 (1aNTDC05\_20111027\_S1.JPG)**

At profile 1aNTDC05 the cliff was not measured due to dangerous access. The plot of the profile shows movement of the toe seawards by 0.25m. Overall this creates a profile that is of a shallower gradient. This suggests that cliff may have destabilised with some slumping of the cliff face. However as the survey report notes that '*cliff not measured at section 5 due to dangerous access*'. It is more likely that the changes observed are related to the survey technique used rather than actual change.

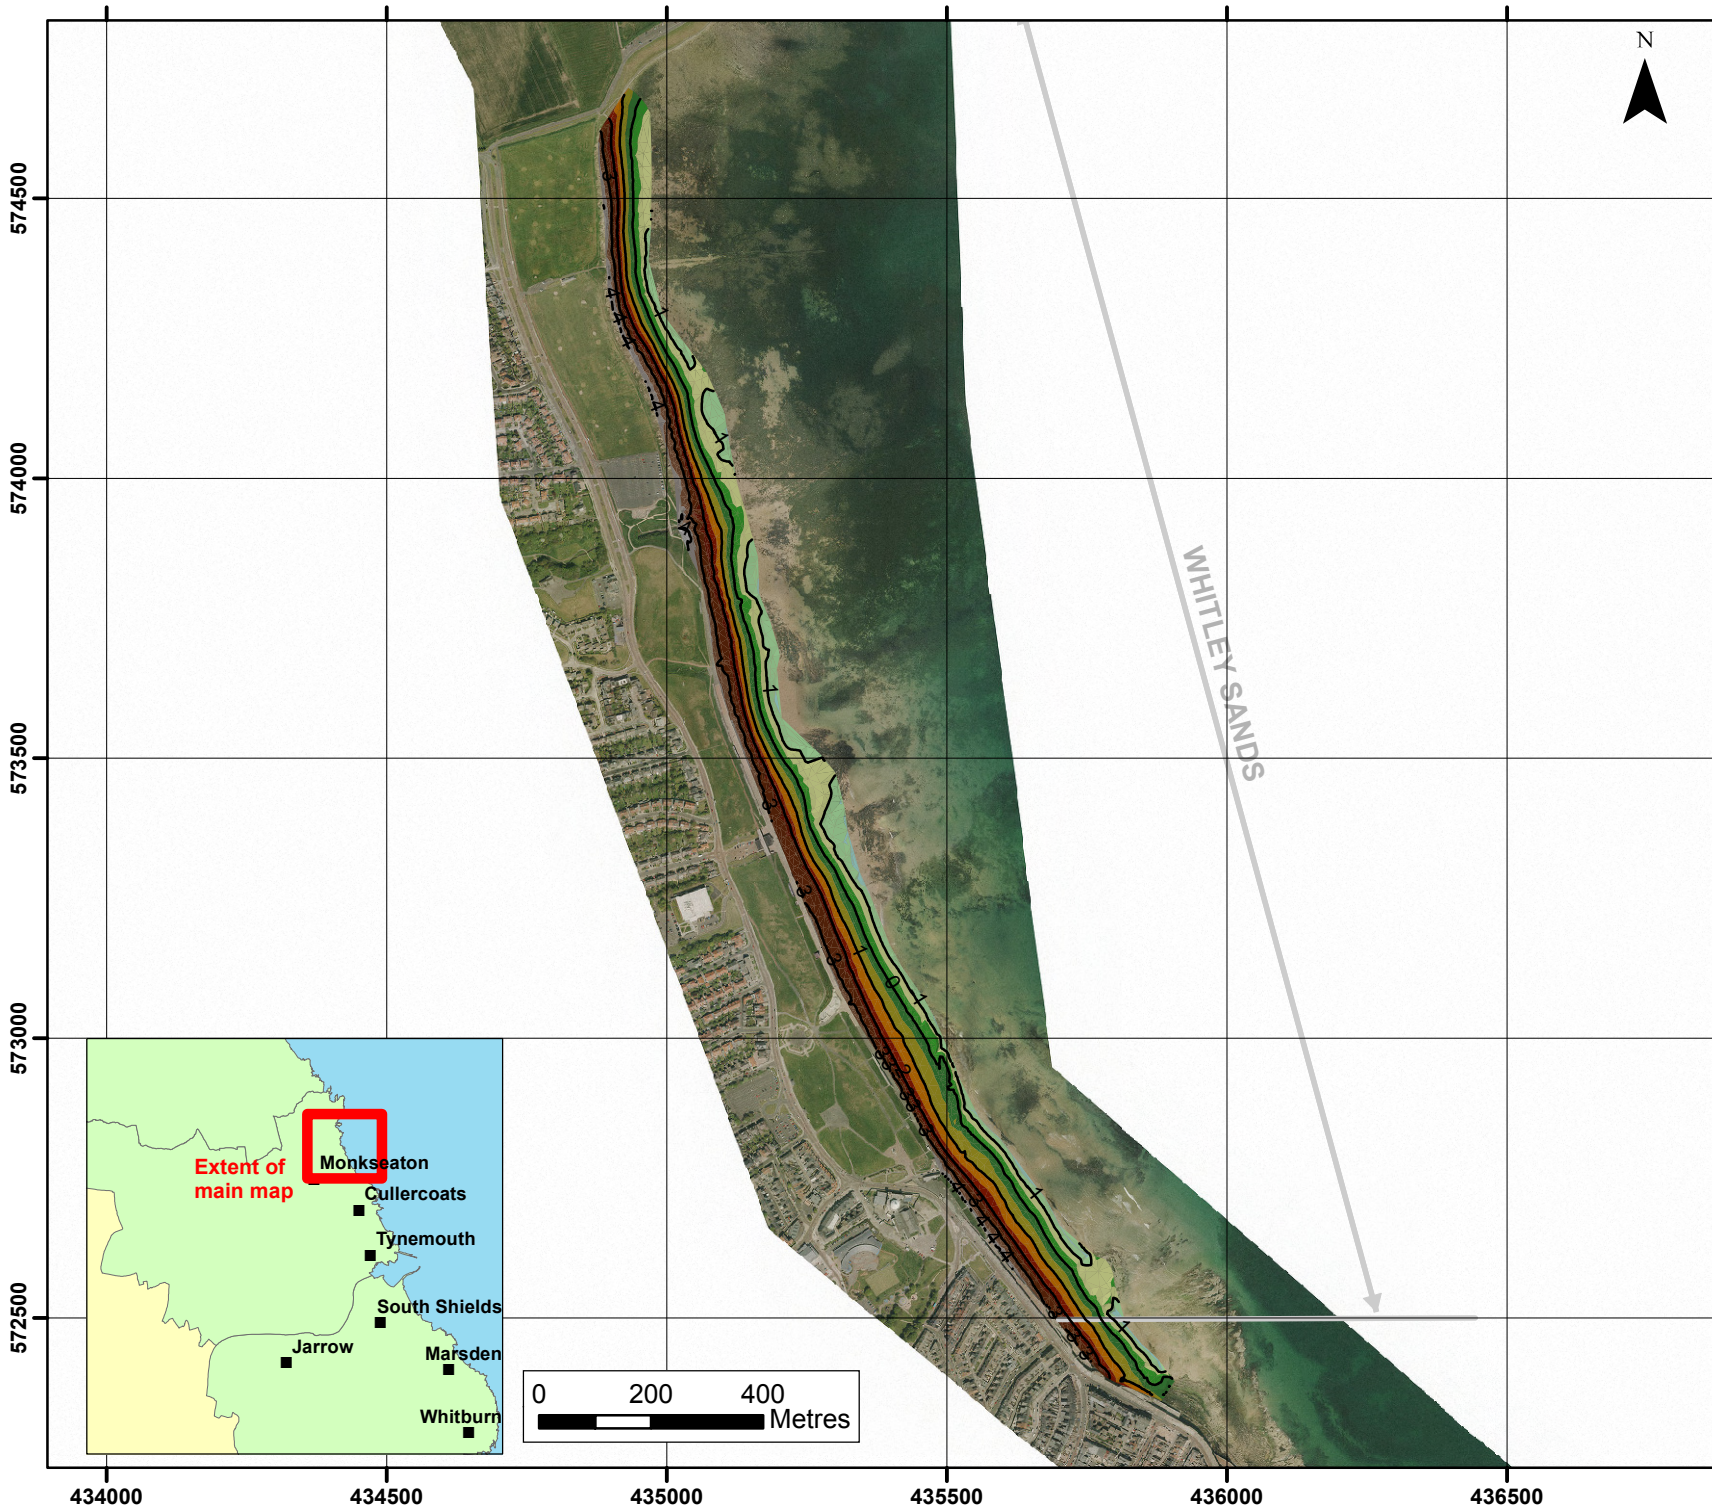
**Appendix B- Map 1a**  
**Topographic Survey**  
**Whitley Bay**  
**North Tyneside Council**

Oct 2011	<p><b>Topographic Survey:</b></p> <p>Whitley Sands is covered by an annual topographic survey, which commenced in October 2010.</p> <p>Data from the most recent topographic survey (full measures, winter 2011)) have been used to create a DGM (Appendix B – Map 1a) using a Geographical Information System (GIS). A difference plot has also been produced using the DGM (Appendix B – Map 1b) produced from the previous topographic survey (partial measures, spring 2011) and the present survey.</p> <p>In particular, the difference plot shows: (i) a liner zone of an increase in elevation along the entire length of the backshore and upper beach of Whitley Bay; and (ii) a linear zone of reduced beach elevation that runs parallel to that described in (i).</p>	<p>The trends observed from the beach profiles are replicated in the topographic survey. Given the two zones of erosion and accretion run parallel, there is a clear suggestion that beach material has been transported by cross-shore process from the middle beach to the upper beach by the migration of large shore-parallel sand bars. In addition, the survey report for Whitley Sands notes that the walled bay at south end of survey has filled in with sand and large amounts of seaweed have been deposited on the beach in front of Boardwalk Café. As suggested above this is likely to be post-storm recovery and the opposite is expected to occur between the present survey and the next partial measures survey (spring 2012).</p>
