Cell 1 Regional Coastal Monitoring Programme Analytical Report 9: 'Full Measures' Survey 2016

North Tyneside Council

March 2017

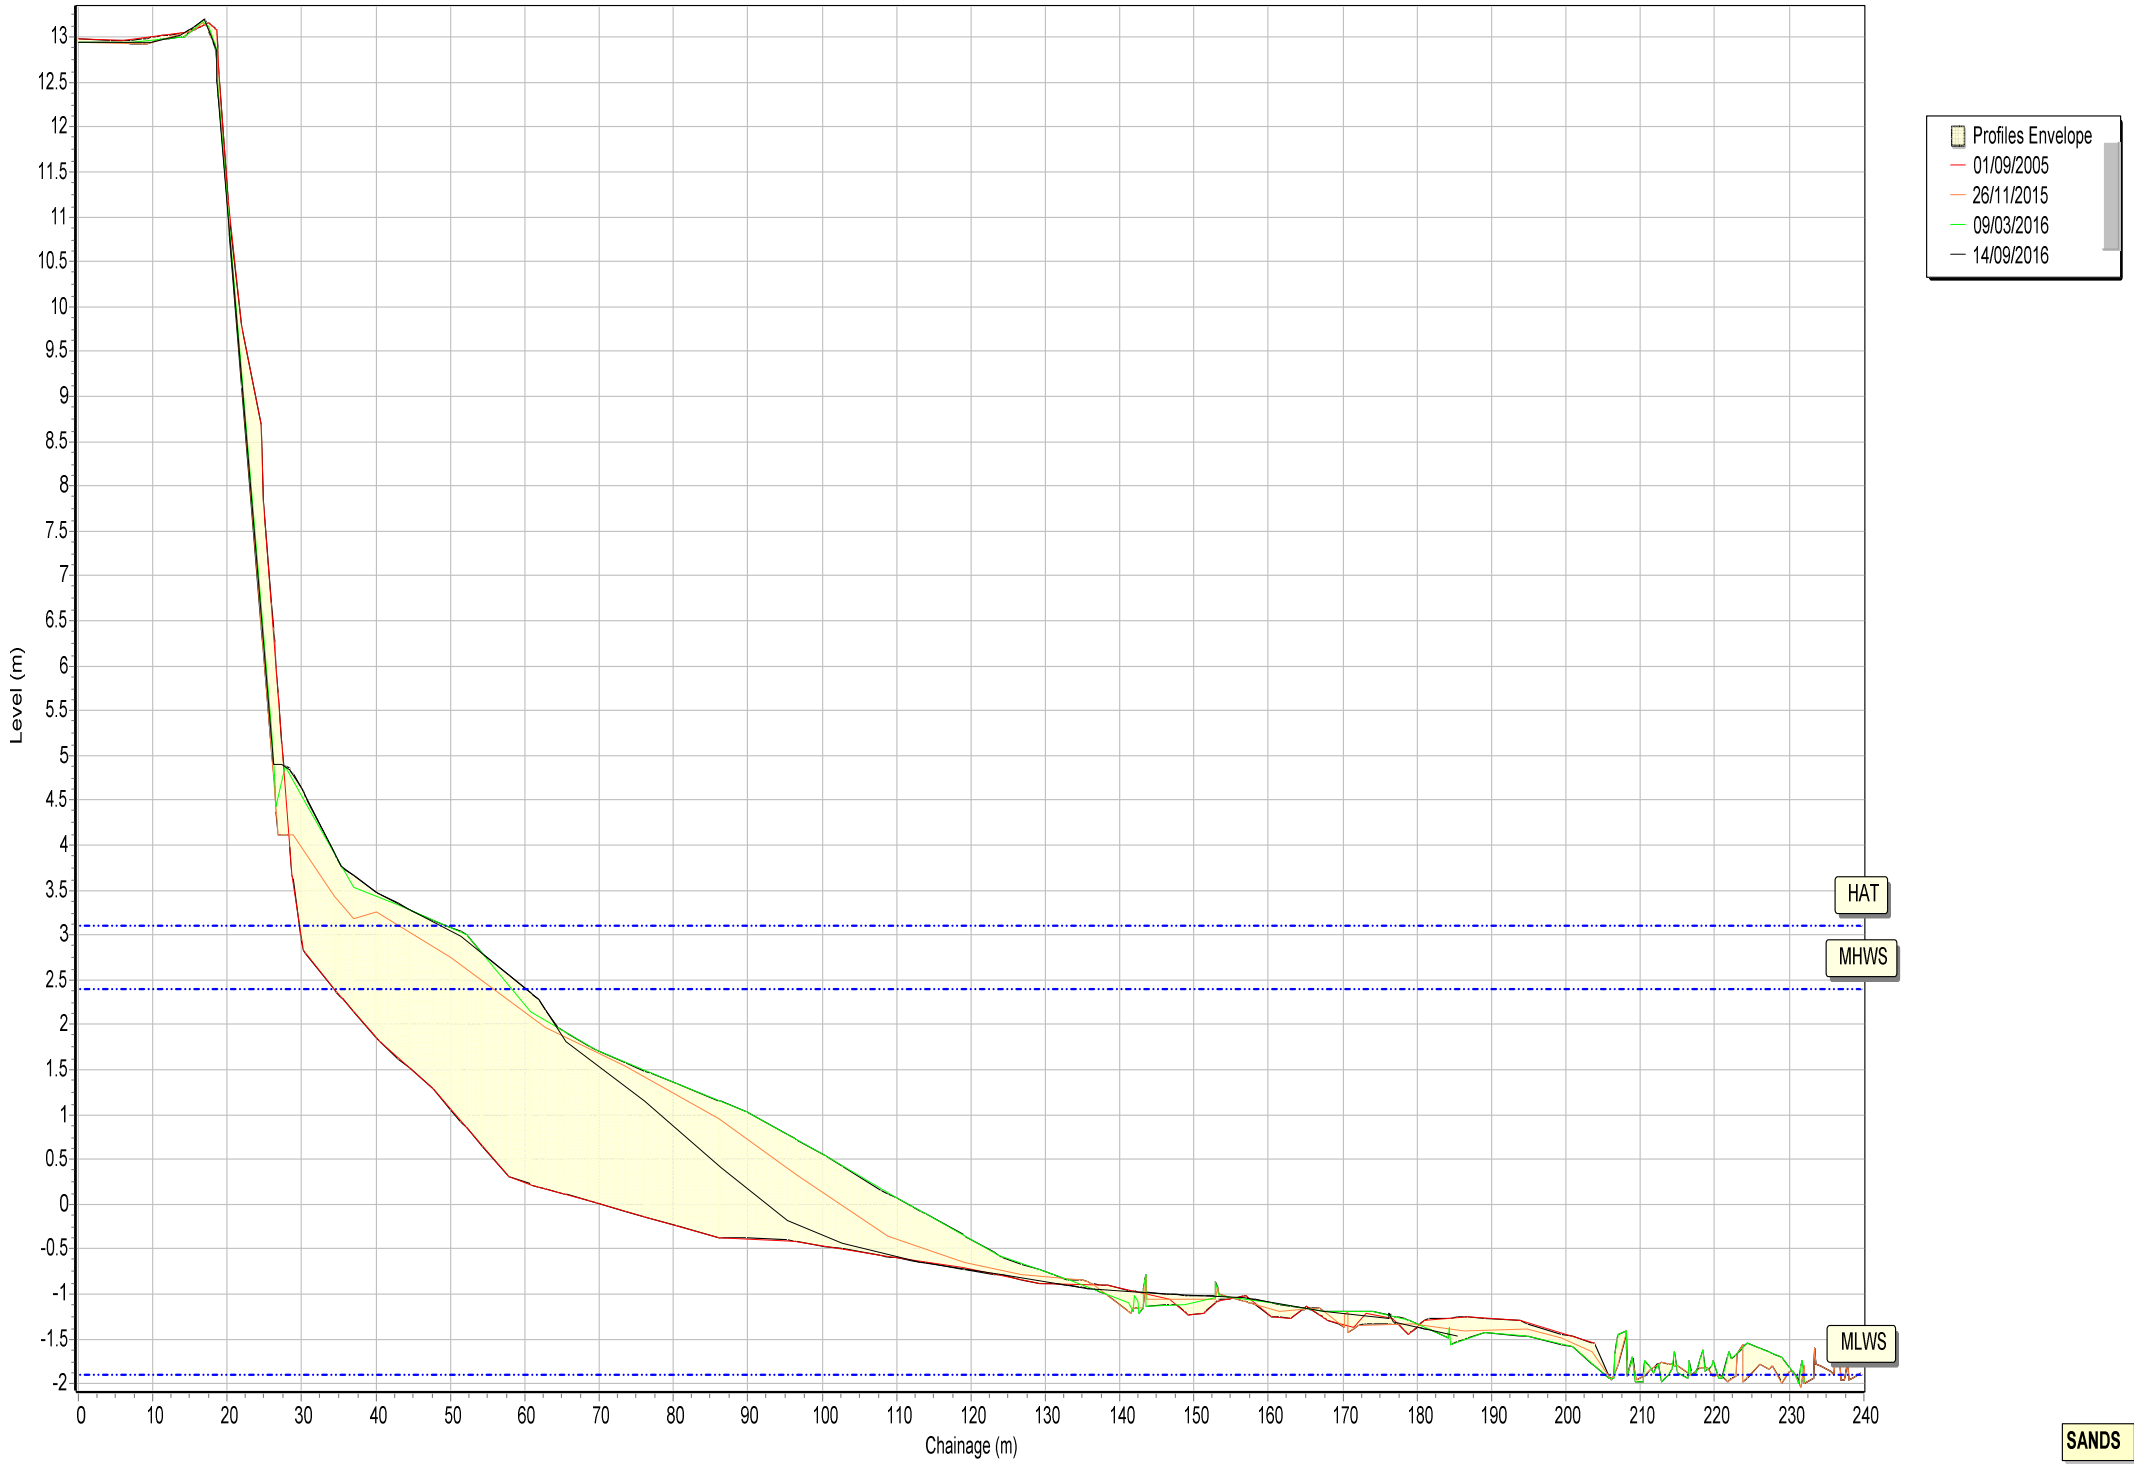
Beach Profiles: 1aNTDC01

Profiles Envelope
01/09/2005
26/11/2015
09/03/2016
14/09/2016

Survey Date	Description of Changes Since Last Survey	Interpretation
September 2016	<p>Beach Profiles:</p> <p>Whitley Sands is covered by five beach profile lines for the Full Measures survey (Appendix A). Four of these (1aNTDC01 to 1aNTDC04) were initially surveyed in April 2002 and were surveyed annually to 2009 (Full Measures, autumn 2009) and bi-annually thereafter. From March 2010 (Partial Measures, spring 2010) onwards, an additional beach profile line (NTDC04A) has been surveyed at the southern end of the frontage. All profiles were last surveyed in March 2016 for the Partial Measures survey.</p> <p>1aNTDC01 is located in the north of Whitley Sands, along the undefended cliffs immediately south of Trinity Road car park. There has been little change in the position of the cliff or beach levels at the toe of cliff to chainage 65m since the March 2016 survey. Between chainage 65m and 135m there has been erosion of up to 0.9m. Seawards of 135m chainage there has been little change. Overall, the profile is relatively high on the upper and lower beach compared to the range recorded from previous surveys but medium-low through the middle beach.</p> <p>Profile 1aNTDC02 is located in the northern part of Whitley Sands. A seawall is present at the back of the beach. There has been significant accretion at the base of the seawall, forming a large berm up to 1.5m higher than the March 2016 beach levels. Accretion has occurred between the seawall (chainage 50m) and chainage 105m. There has been erosion of 0.4m between chainage 105m and 145m, and the rock is exposed from 145m seawards. The profile is relatively high on the upper beach and low on the lower beach compared with the range recorded from previous surveys, resulting in a relatively steep profile.</p> <p>Profile 1aNTDC03 is located at the centre of Whitley Sands. There has been accretion of up to 0.4m across the whole beach profile since the March 2016 survey, though the gains in the middle beach are <0.2m. A berm up to 0.8m high has formed at the base of the seawall (chainage 15m to 25m). Overall, the October 2016 profile is in the middle of the range recorded from previous surveys.</p> <p>Profile 1aNDC04 is located in the southern part of Whitley Sands. There has been a small amount of accretion on the upper beach between the seawall (15m) and chainage 45m of up to 0.2m. The middle</p>	<p>Since the last survey, there has been accretion across the beach in the southern part of the bay. In the northern part of the bay there has been erosion in the middle beach.</p> <p>Longer term trends: Beach levels are within the range seen in earlier surveys.</p>

Survey Date	Description of Changes Since Last Survey	Interpretation
	<p>beach shows more significant accretion of up to 0.5m between chainage 45m and 90m, covering the rock platform which was previously exposed in the March 2016 and November 2015 surveys. Seaward of 90m chainage there has been very little change since March 2016. Overall, the profile is in the middle of the range recorded from previous surveys.</p> <p>Profile 1aNTDC04a is located towards the southern end of Whitley Sands. There has been accretion across the whole of the beach profile since March 2016 of up to 0.6m. The rock platform at chainage 80m remains exposed. Overall, the profile is a medium level compared to the range recorded from previous surveys, though it is relatively low towards the toe of the beach and at the base of the seawall.</p>	
September 2016	<p>Topographic Survey:</p> <p>Whitley Sands is covered by an annual topographic survey, which commenced in October 2010.</p> <p>Data from the most recent topographic survey (Full Measures, autumn 2016) have been used to create a digital ground model (DGM) (Appendix B – Map 1) using a GIS. A difference plot has also been produced using the DGM (Appendix B – Map 3) produced from the last produced topographic survey (Full Measures, autumn 2015) and the present survey.</p> <p>The difference plot shows generally shore parallel changes. Accretion has occurred on the upper beach around the whole bay, with the accretion spreading across the middle and lower beach at the southern end of the bay. The middle beach is dominated by erosion in the centre and north of the bay, with some areas of erosion on the upper and lower beach in the centre of the bay. The lower beach at the northern end of the bay shows very little change. Overall accretion dominates the southern end of the bay, with erosion being slightly more predominant in the centre of the bay.</p> <p>Whilst this is a comparison of annual surveys, rather than a biannual comparison like the beach profiles, the changes observed in the detailed profiles support this pattern of change in the bay as whole, indicating that much of this change is likely to have happened in the last six months.</p>	<p>The topographic survey indicates there to have been a movement of sediment towards the southern end of the bay. This is similar to the pattern recorded in the Autumn 2015 survey. In the autumn 2014 Full Measures survey there was a northerly movement of sediment recorded, suggesting the beach responds to storm directions that dominate over the monitoring period.</p>

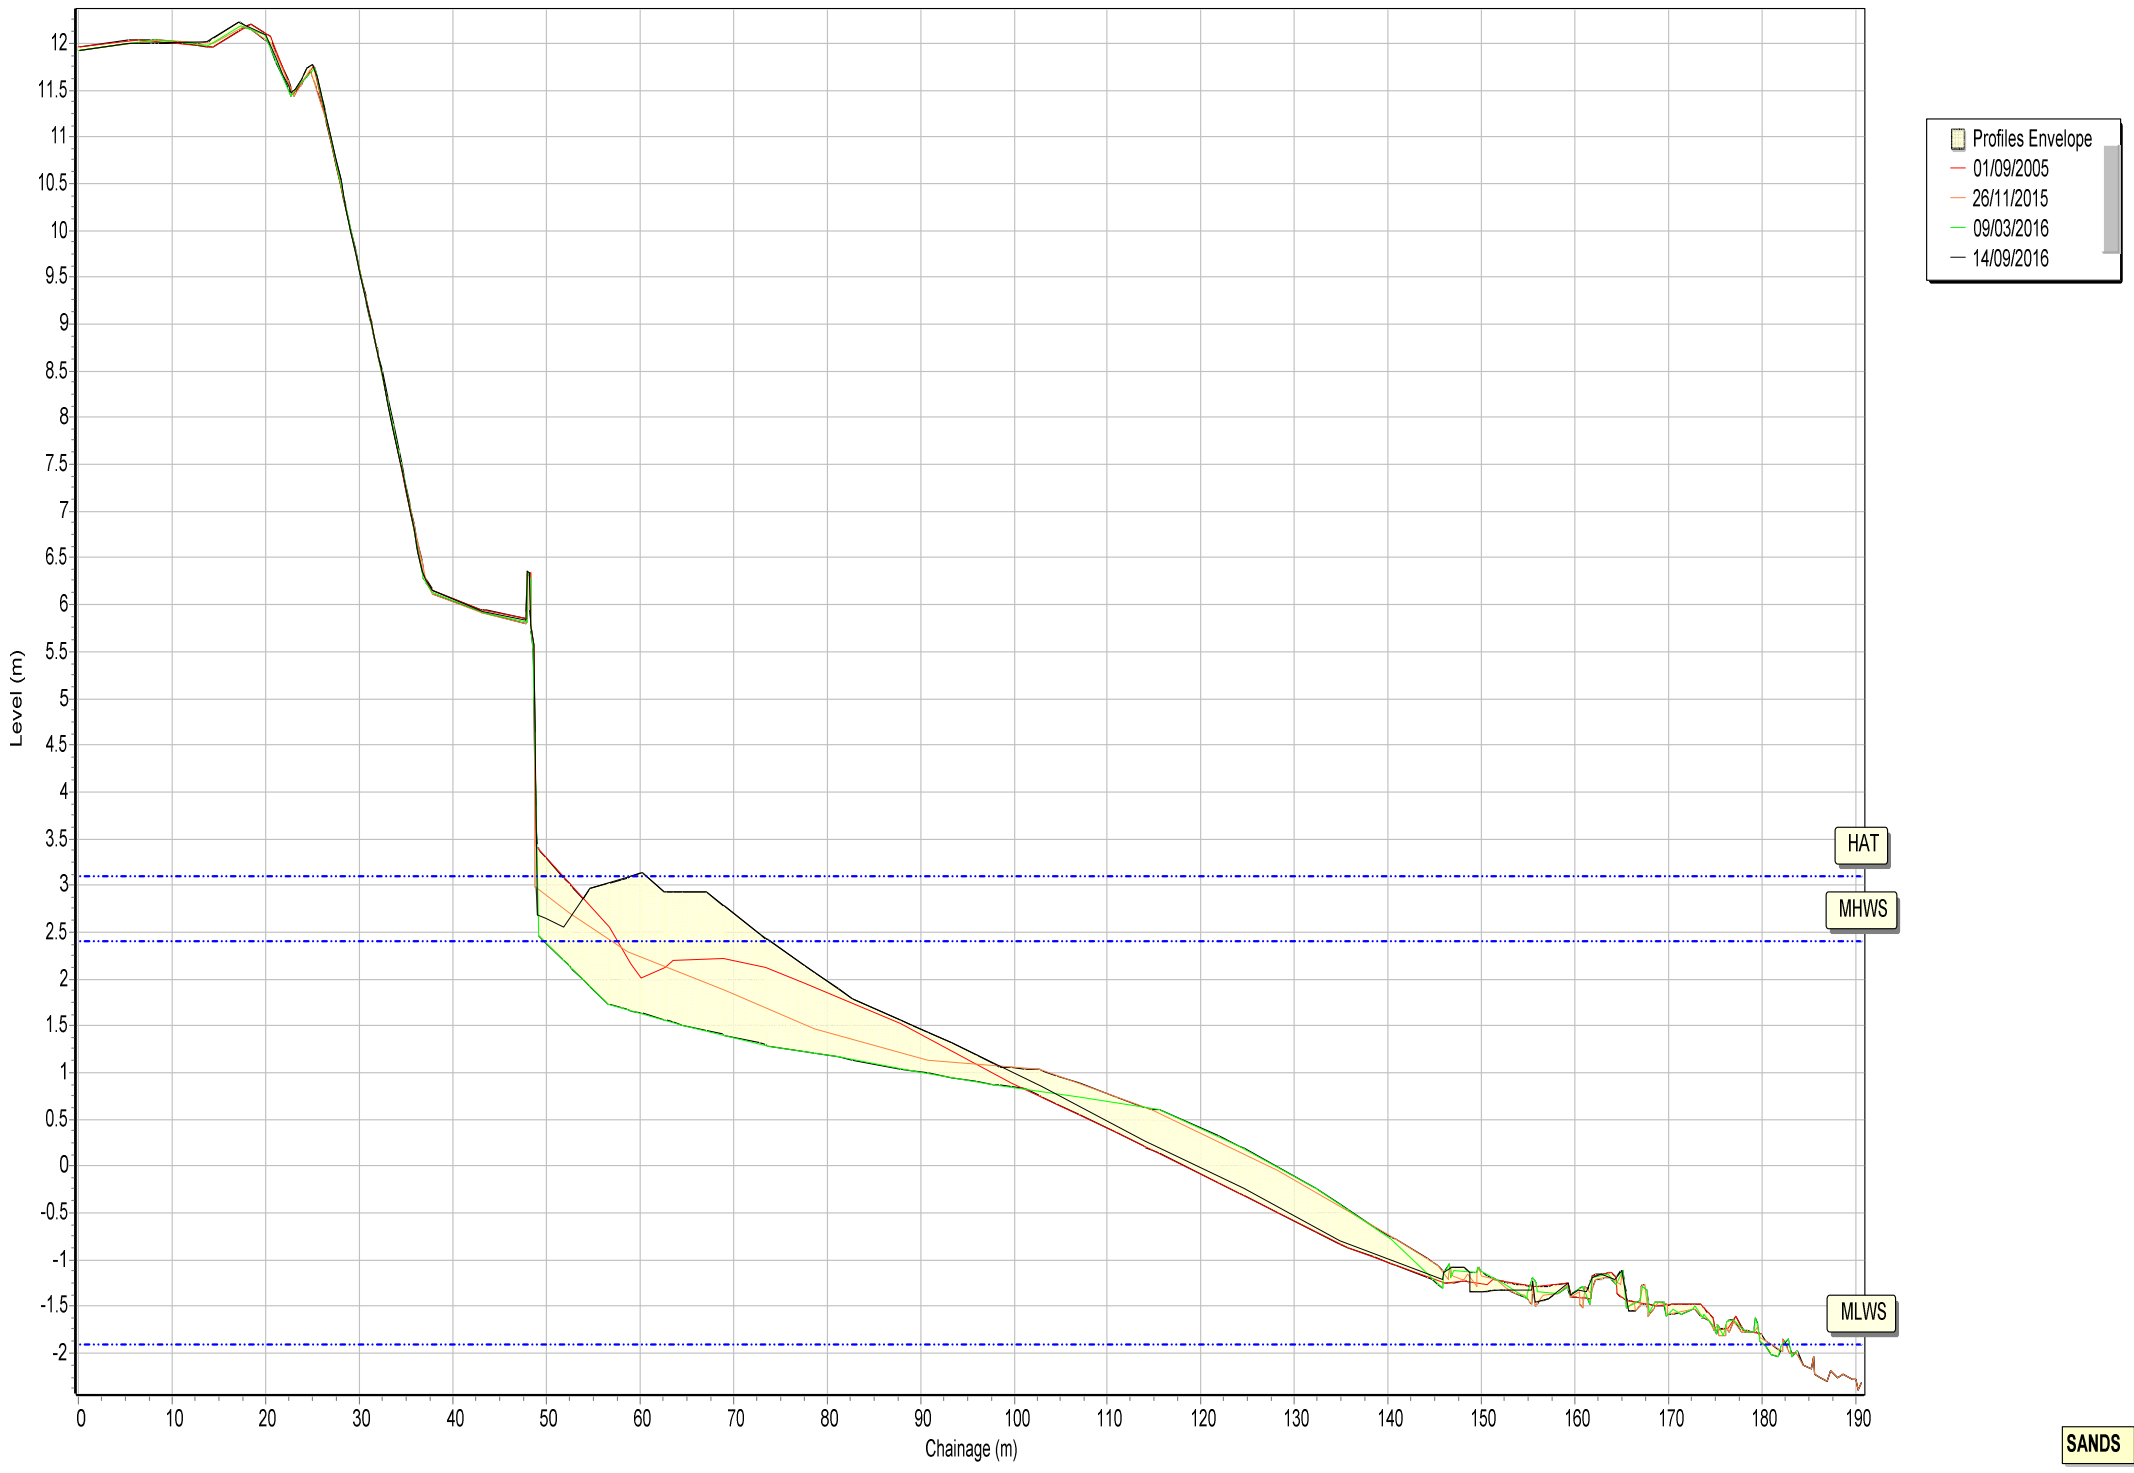
Beach Profiles: 1aNTDC02

Profiles Envelope
01/09/2005
26/11/2015
09/03/2016
14/09/2016

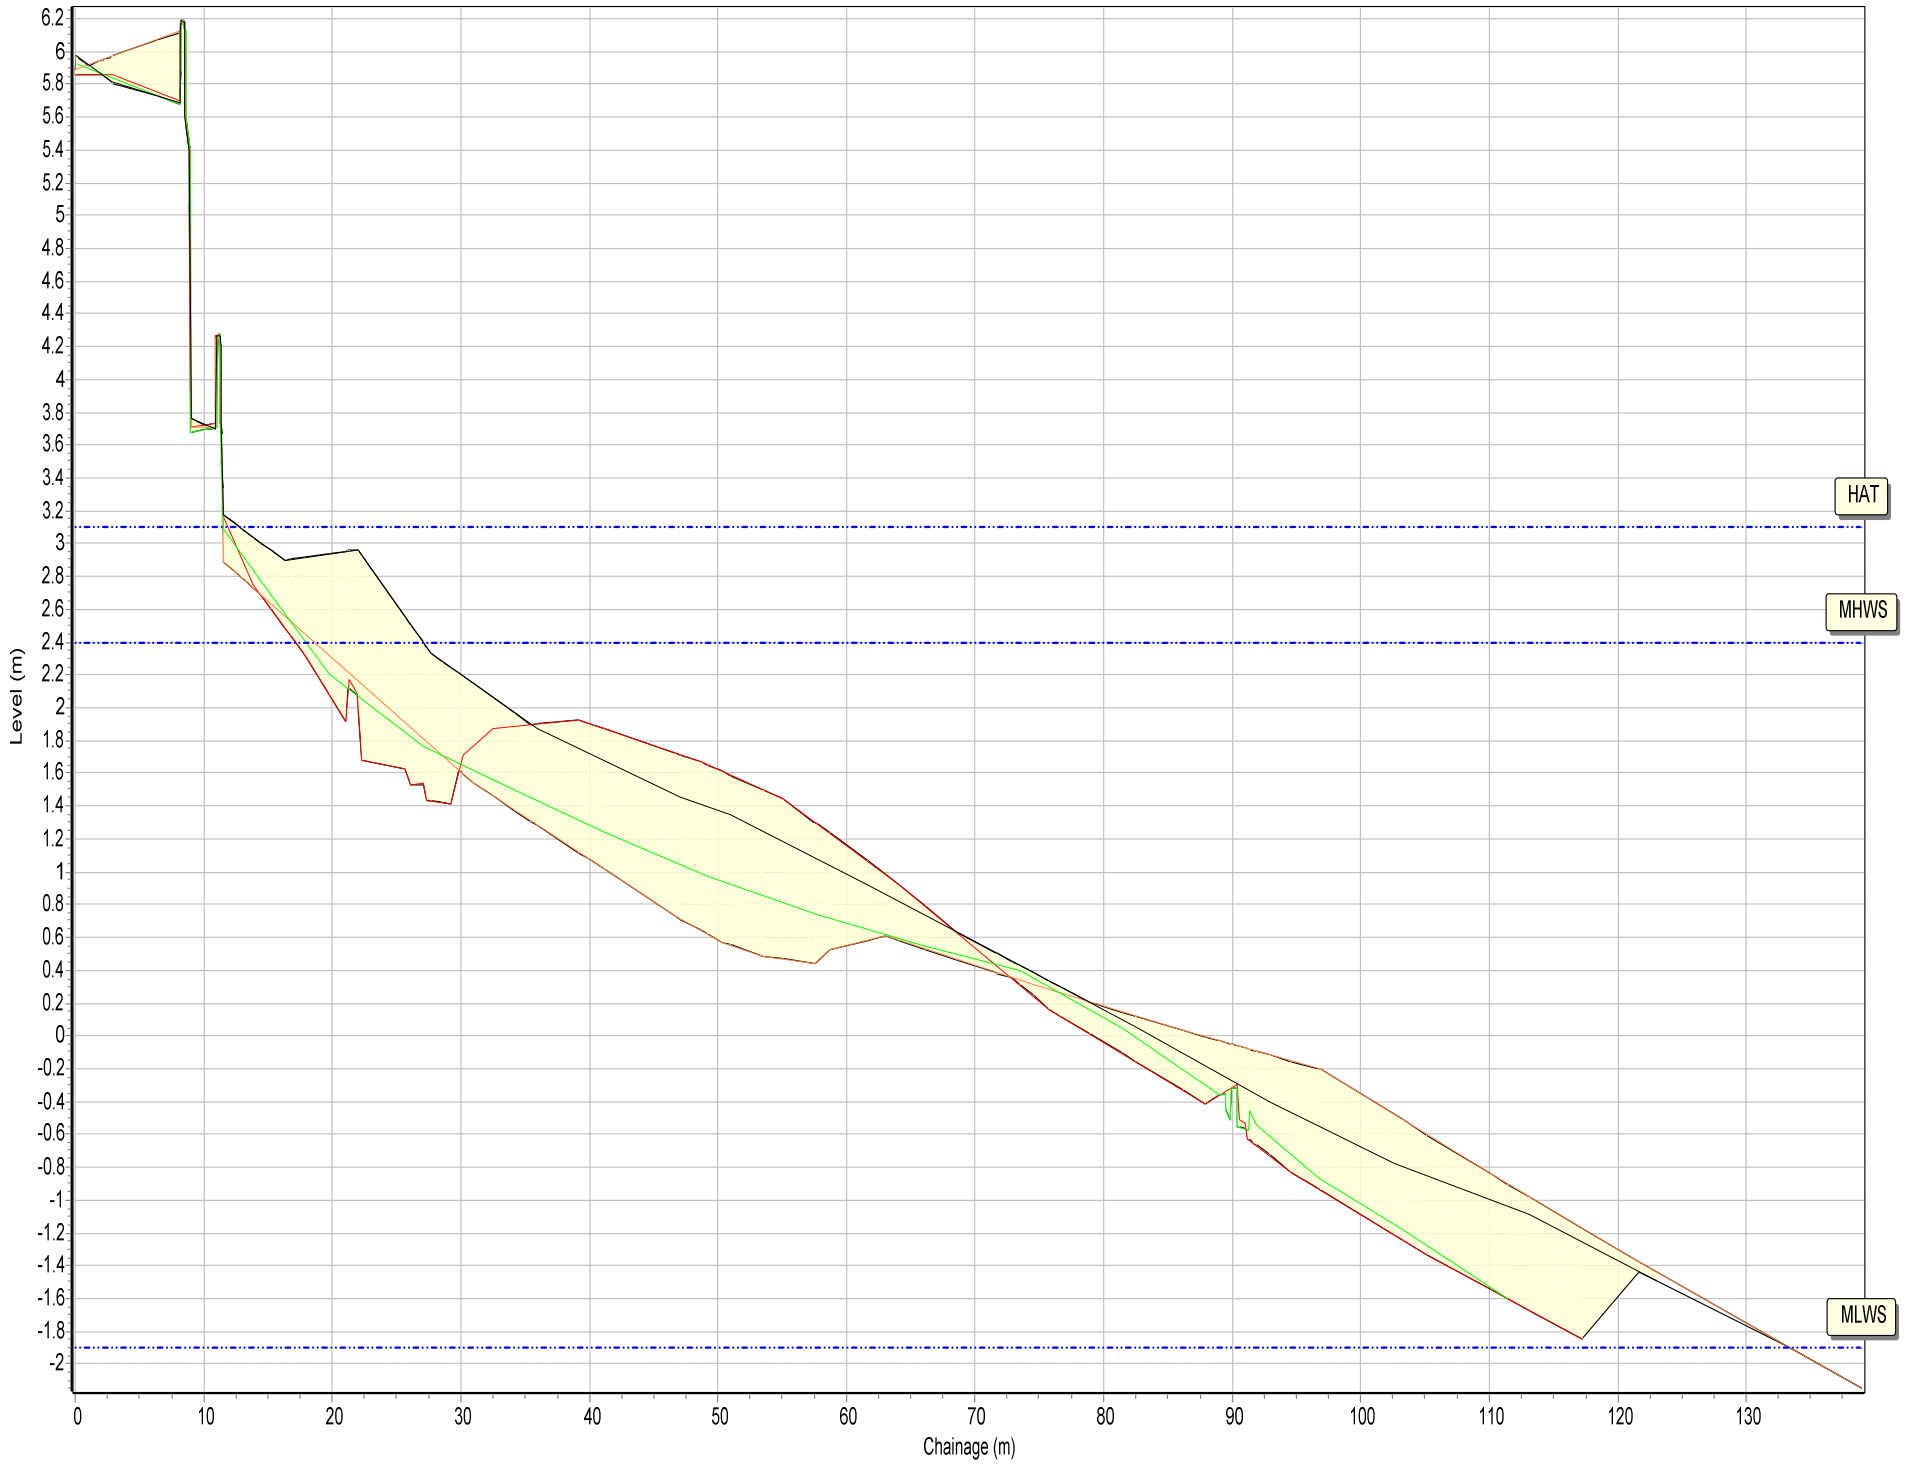
Beach Profiles: 1aNTDC03

Profiles Envelope
01/09/2005
26/11/2015
09/03/2016
14/09/2016

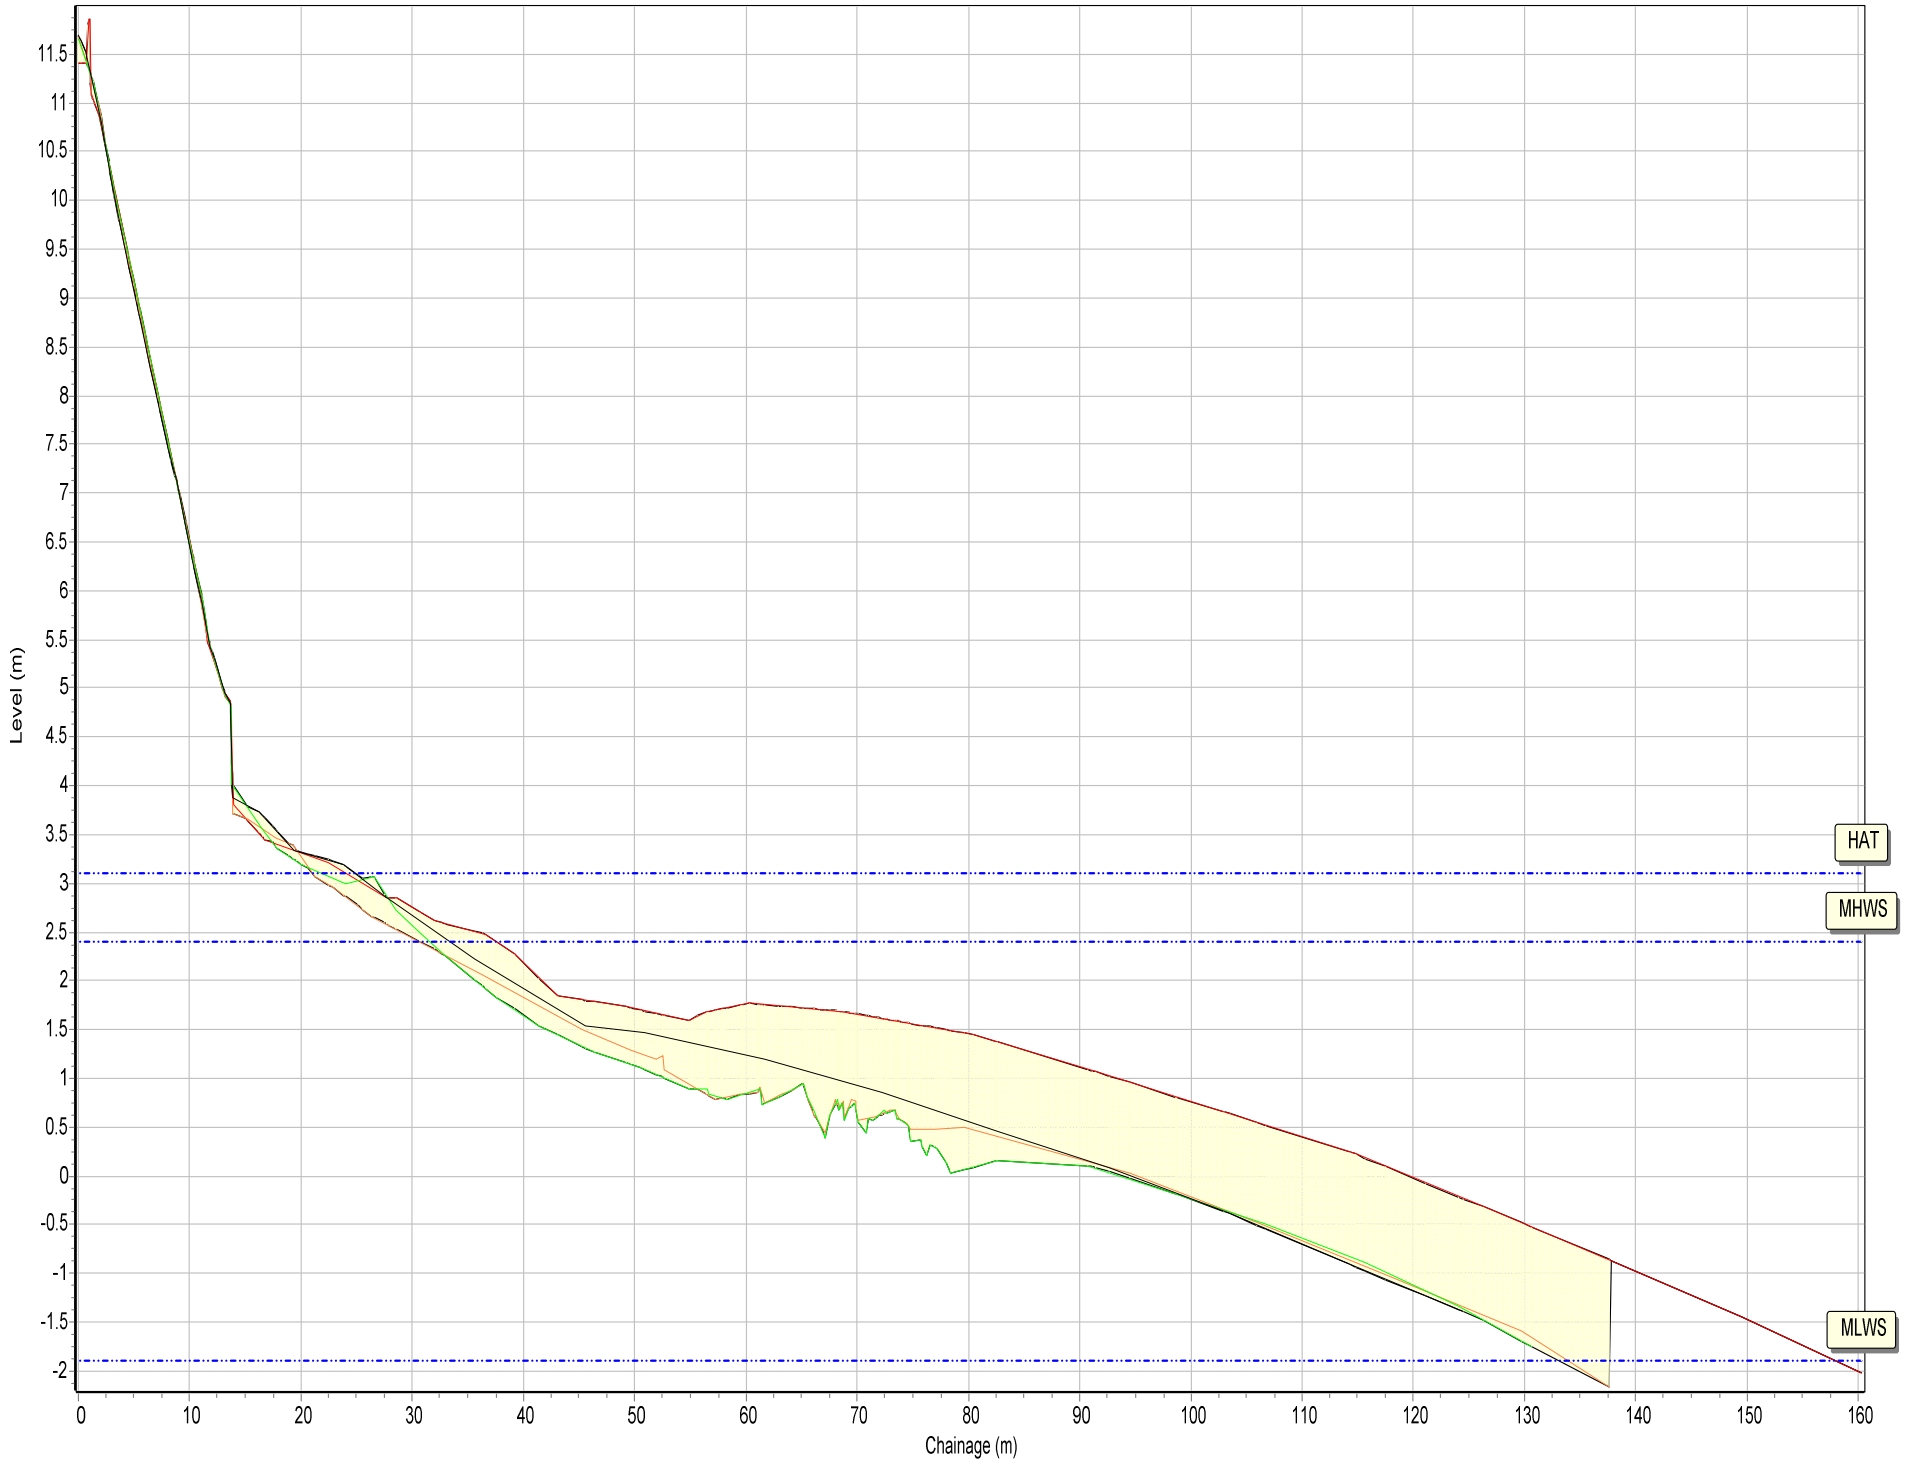
Beach Profiles: 1aNTDC04

Profiles Envelope
01/09/2005
26/11/2015
09/03/2016
14/09/2016

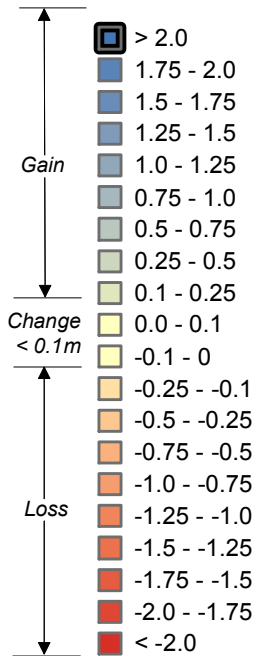
Appendix B - Map 3

DIFFERENCE BETWEEN TOPOGRAPHIC SURVEYS

Nov 2015 to Sept 2016

Change in Elevation (mOD)

WHITLEY SANDS

- The topographic survey indicates that sediment movements in Whitley Bay have, in general terms, 'reverted to type' with apparent sediment movement being towards the southern end of the bay.
