## **Cell 1 Regional Coastal Monitoring Programme Analytical Report 12: 'Full Measures' Survey 2019**

**North Tyneside Council**

**December 2019**

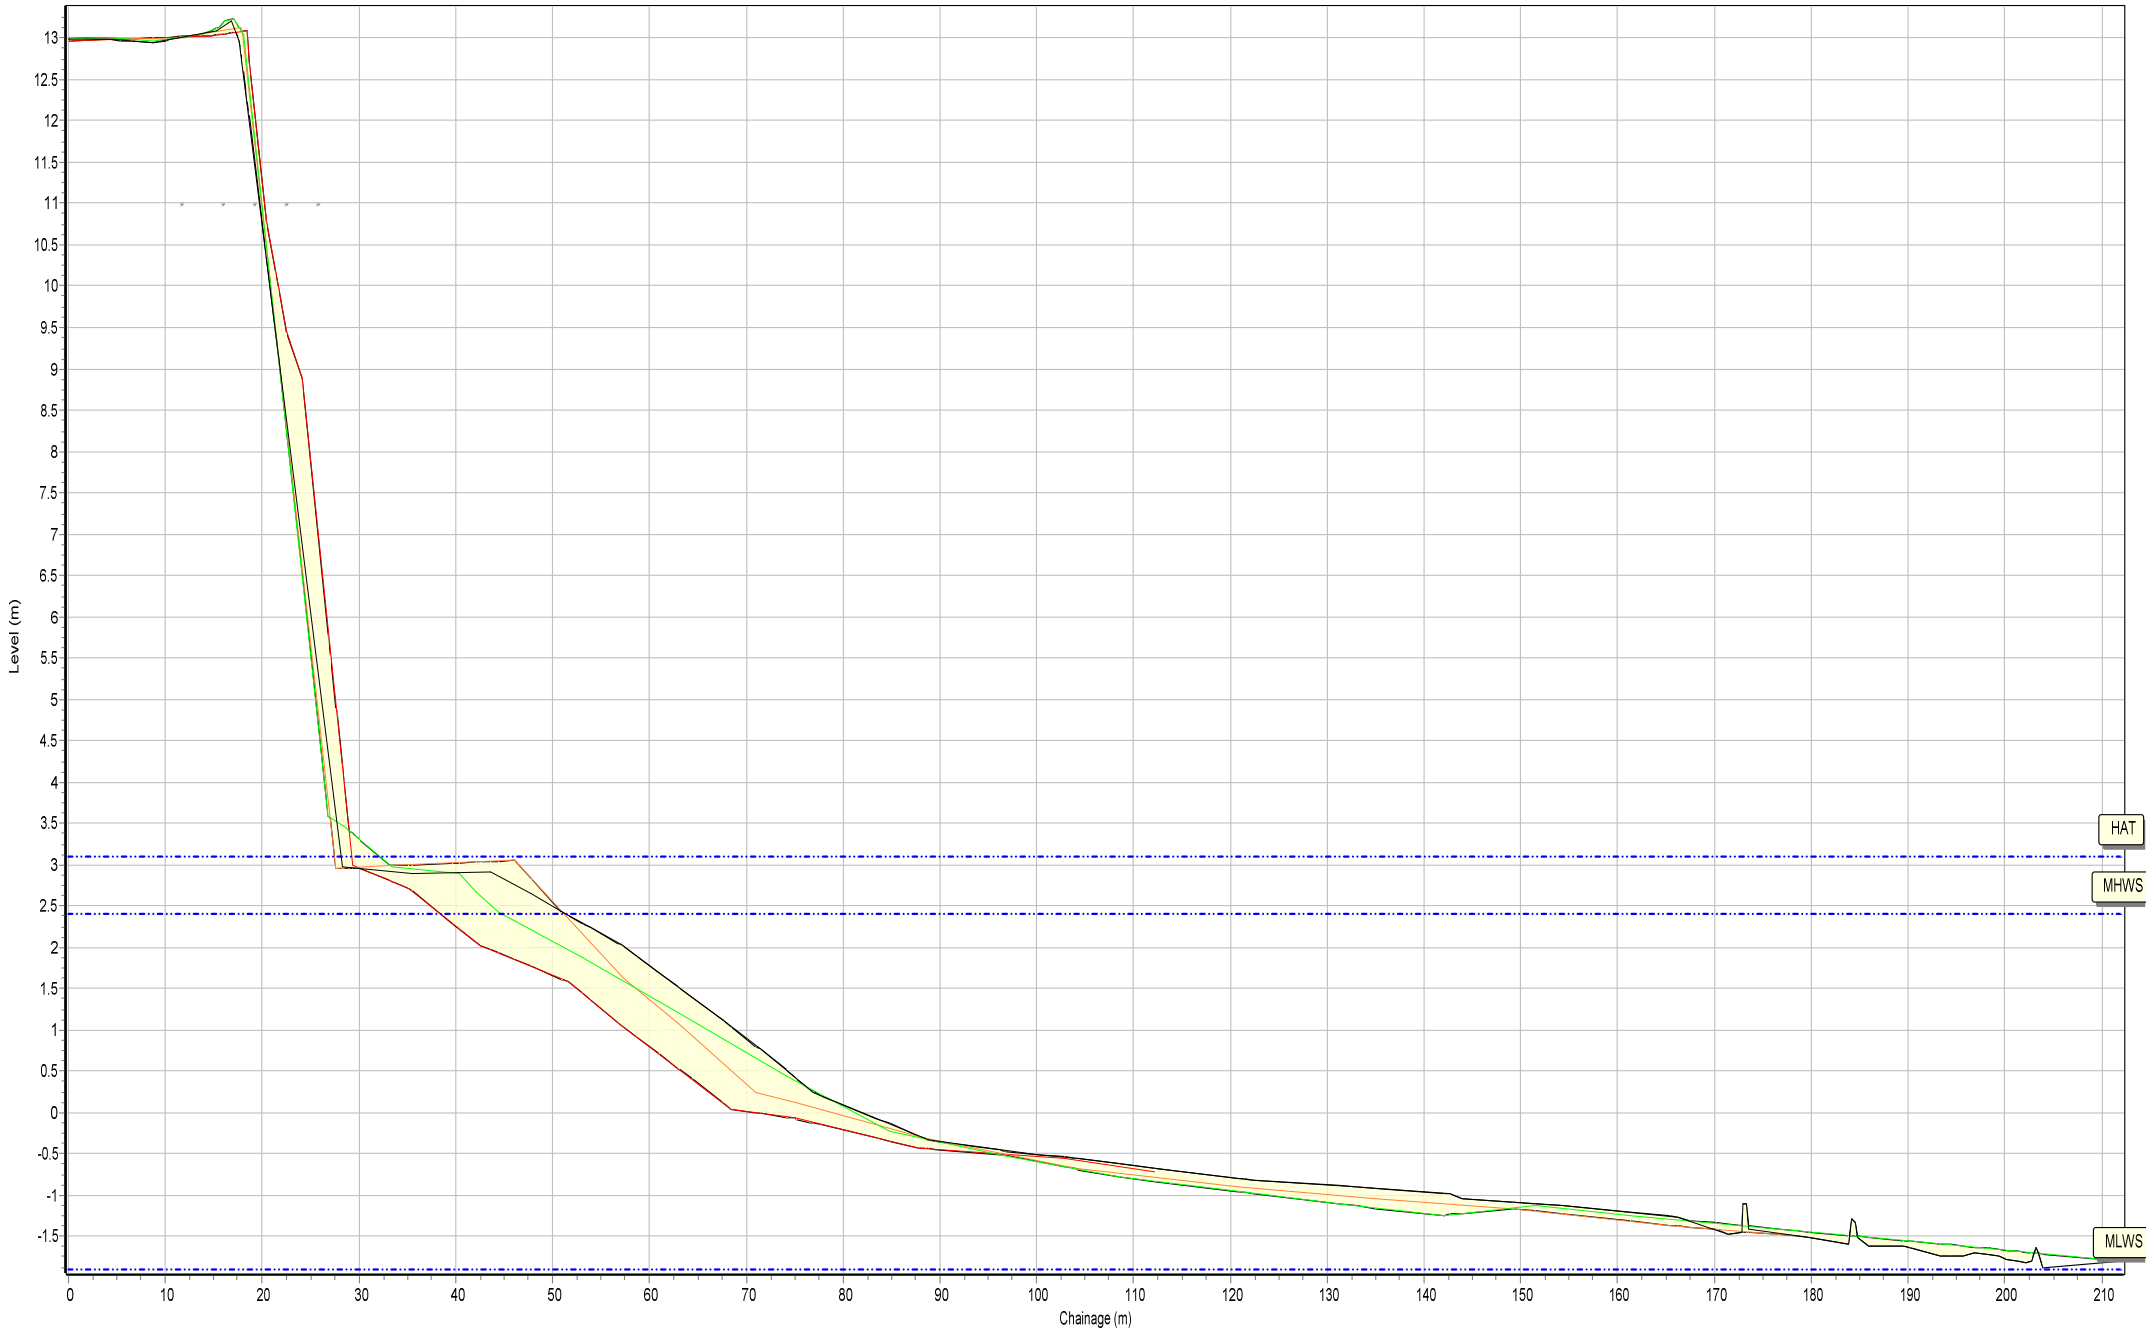
Beach Profiles: 1aNTDC01

Profiles Envelope 01/10/2006 11/09/2018 19/02/2019 27/09/2019

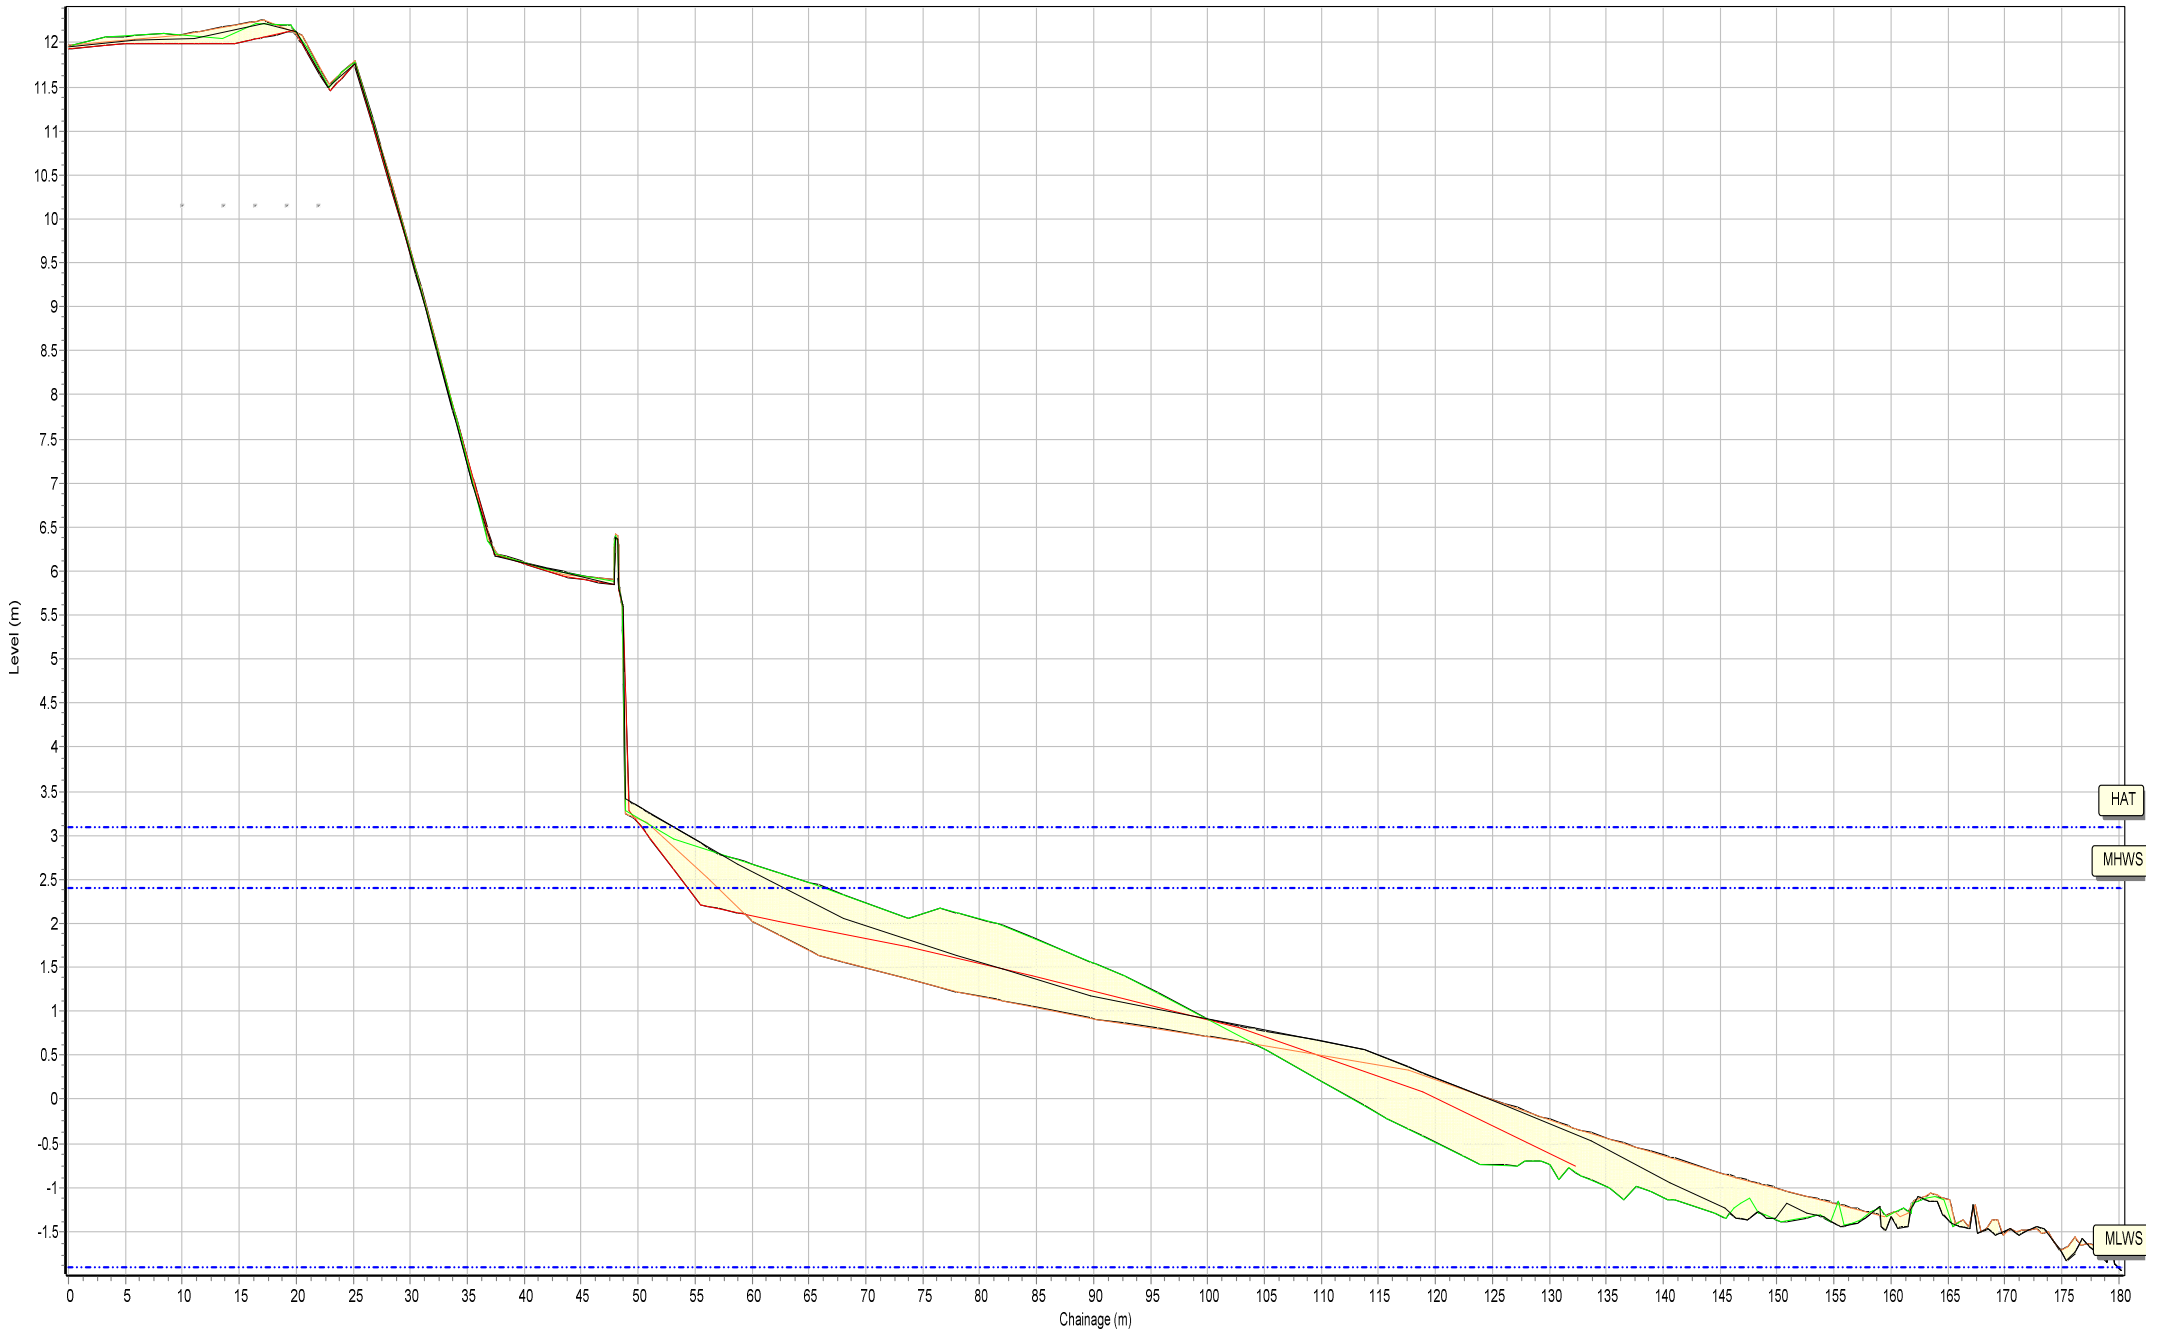
# Beach Profiles: 1aNTDC02

Survey Date	Description of Changes Since Last Survey	Interpretation
<p>27<sup>th</sup> September – 30<sup>th</sup> September 2019</p>	<p><b>Beach Profiles:</b></p> <p>Whitley Sands is covered by five beach profile lines for the Full Measures survey (Appendix A). Four of these (1aNTDC01 to 1aNTDC04) were initially surveyed in April 2002 and were surveyed annually to 2009 (Full Measures, autumn 2009) and bi-annually thereafter. From March 2010 (Partial Measures, spring 2010) onwards, an additional beach profile line (NTDC04A) has been surveyed at the southern end of the frontage. All profiles were last surveyed in February 2019 for the Partial Measures survey.</p> <p><b>1aNTDC01</b> is located in the north of Whitley Sands, along the undefended cliffs immediately south of Trinity Road car park. The cliff was not measured due to dangerous access. Beach levels at the toe of cliff to chainage 40m have decreased by 0.5m since the February 2019 survey. The majority of the profile shows an accretion by up to 0.4m on the upper beach, and 0.2m on the middle beach. Seawards of 167m chainage, beach levels have decreased by up to 0.2m, exposing some rocks at the beach toe. Overall the profile is at a relatively medium level compared to the range recorded from previous surveys.</p> <p>Profile <b>1aNTDC02</b> is located in the northern part of Whitley Sands. A seawall is present at the back of the beach. A small amount of accretion up to 0.15m has occurred between the seawall (chainage 50m) and chainage 57m. There has been erosion of up to 0.5m between chainage 57m and 100m. Seaward of chainage 100m there has been an accretion of 0.4m to the rocks, where the profile is similar to the February 2019 survey. The profile is relatively medium across the beach compared with the range recorded from previous surveys.</p> <p>Profile <b>1aNTDC03</b> is located at the centre of Whitley Sands. The survey report notes that construction is complete on the promenade. Accretion of up to 0.4m has occurred between the bottom of the seawall up to chainage 25m. From chainage 25m to 43m there has been erosion of up to 0.2m, switching to accretion seaward of chainage 43m by up to 0.7m, covering up a previously exposed</p>	<p>Since the last survey, there has generally been accretion across the beach profile at all profiles, with the upper beach between chainages 14m and 29m at profile 1aNTDC04 being the highest level recorded.</p> <p><b>Longer term trends:</b> Beach levels are generally within the middle of the range seen in earlier surveys. At profile <b>1aNTDC04</b>, the berm present on the upper beach has migrated further landward over time.</p>

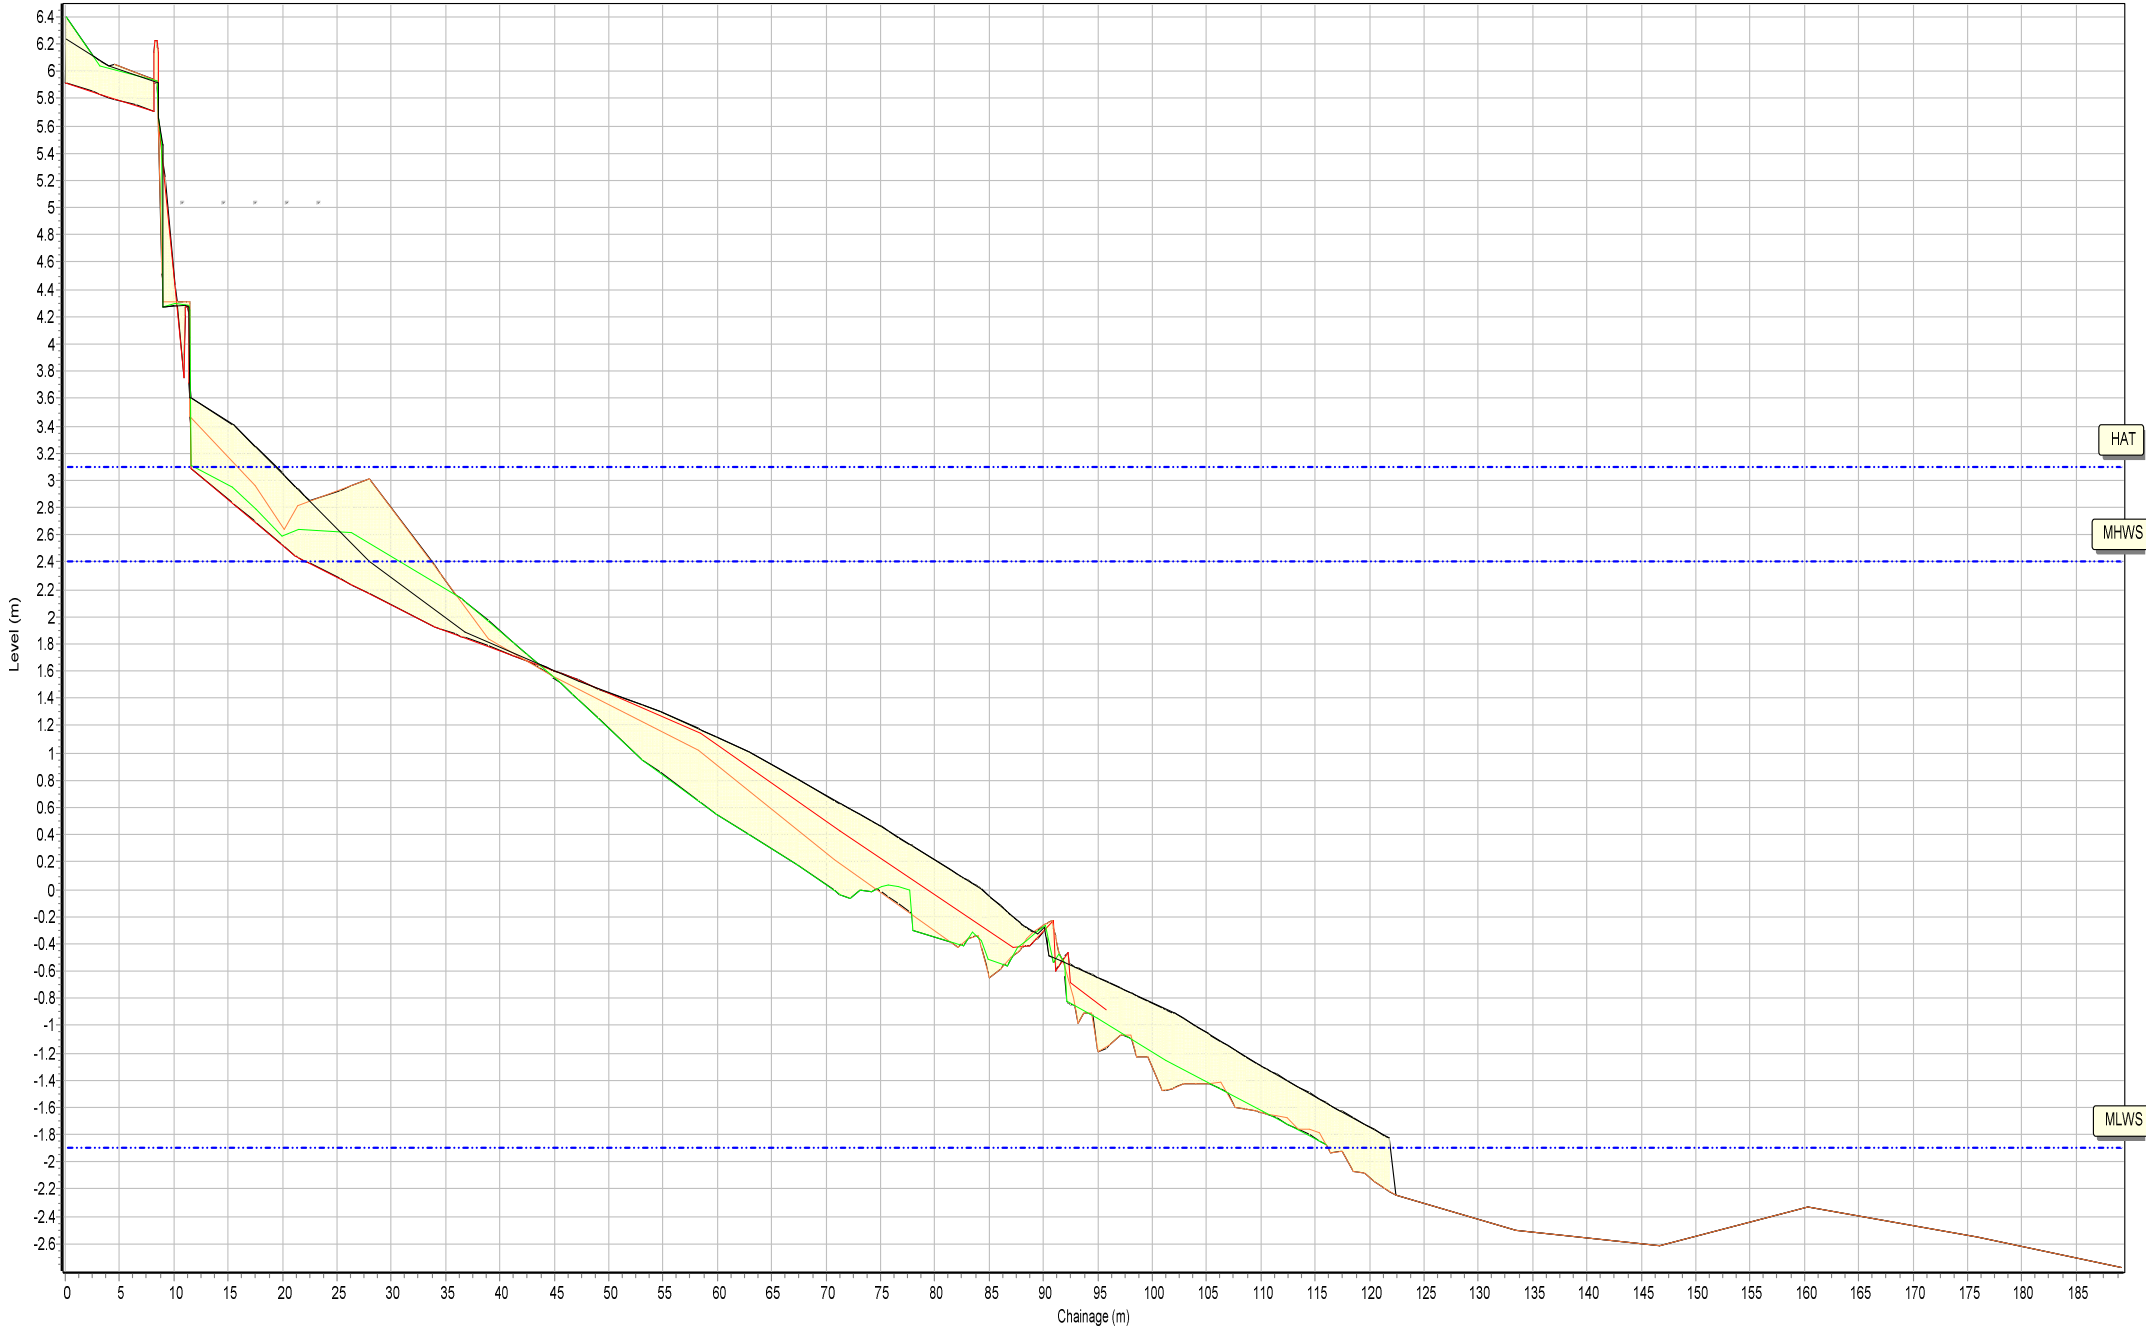
Beach Profiles: 1aNTDC03

- The surveyor noted that construction on the promenade was complete at profiles 1aNTDC03 and 1aNTDC04A.
- At profile 1aNTDC05 the cliff was not measured due to access problems. Access to this profile is noted to have been dangerous in previous Partial Measures and Full Measures reports, and it is recommended that the beach profile should start at the cliff toe and that the cliff be monitored using the aerial survey data.
- At Whitley Sands (profile 1aNTDC01) the cliff was not measured due to access problems.
- At Tynemouth Long Sands (profiles 1aNTDC06, 1aNTDC06A and 1aNTDC07) there was no access to the dunes in the middle of the profile due to seed protection fences. This means it has not yet been possible to monitor the effectiveness of the dune stabilisation scheme.

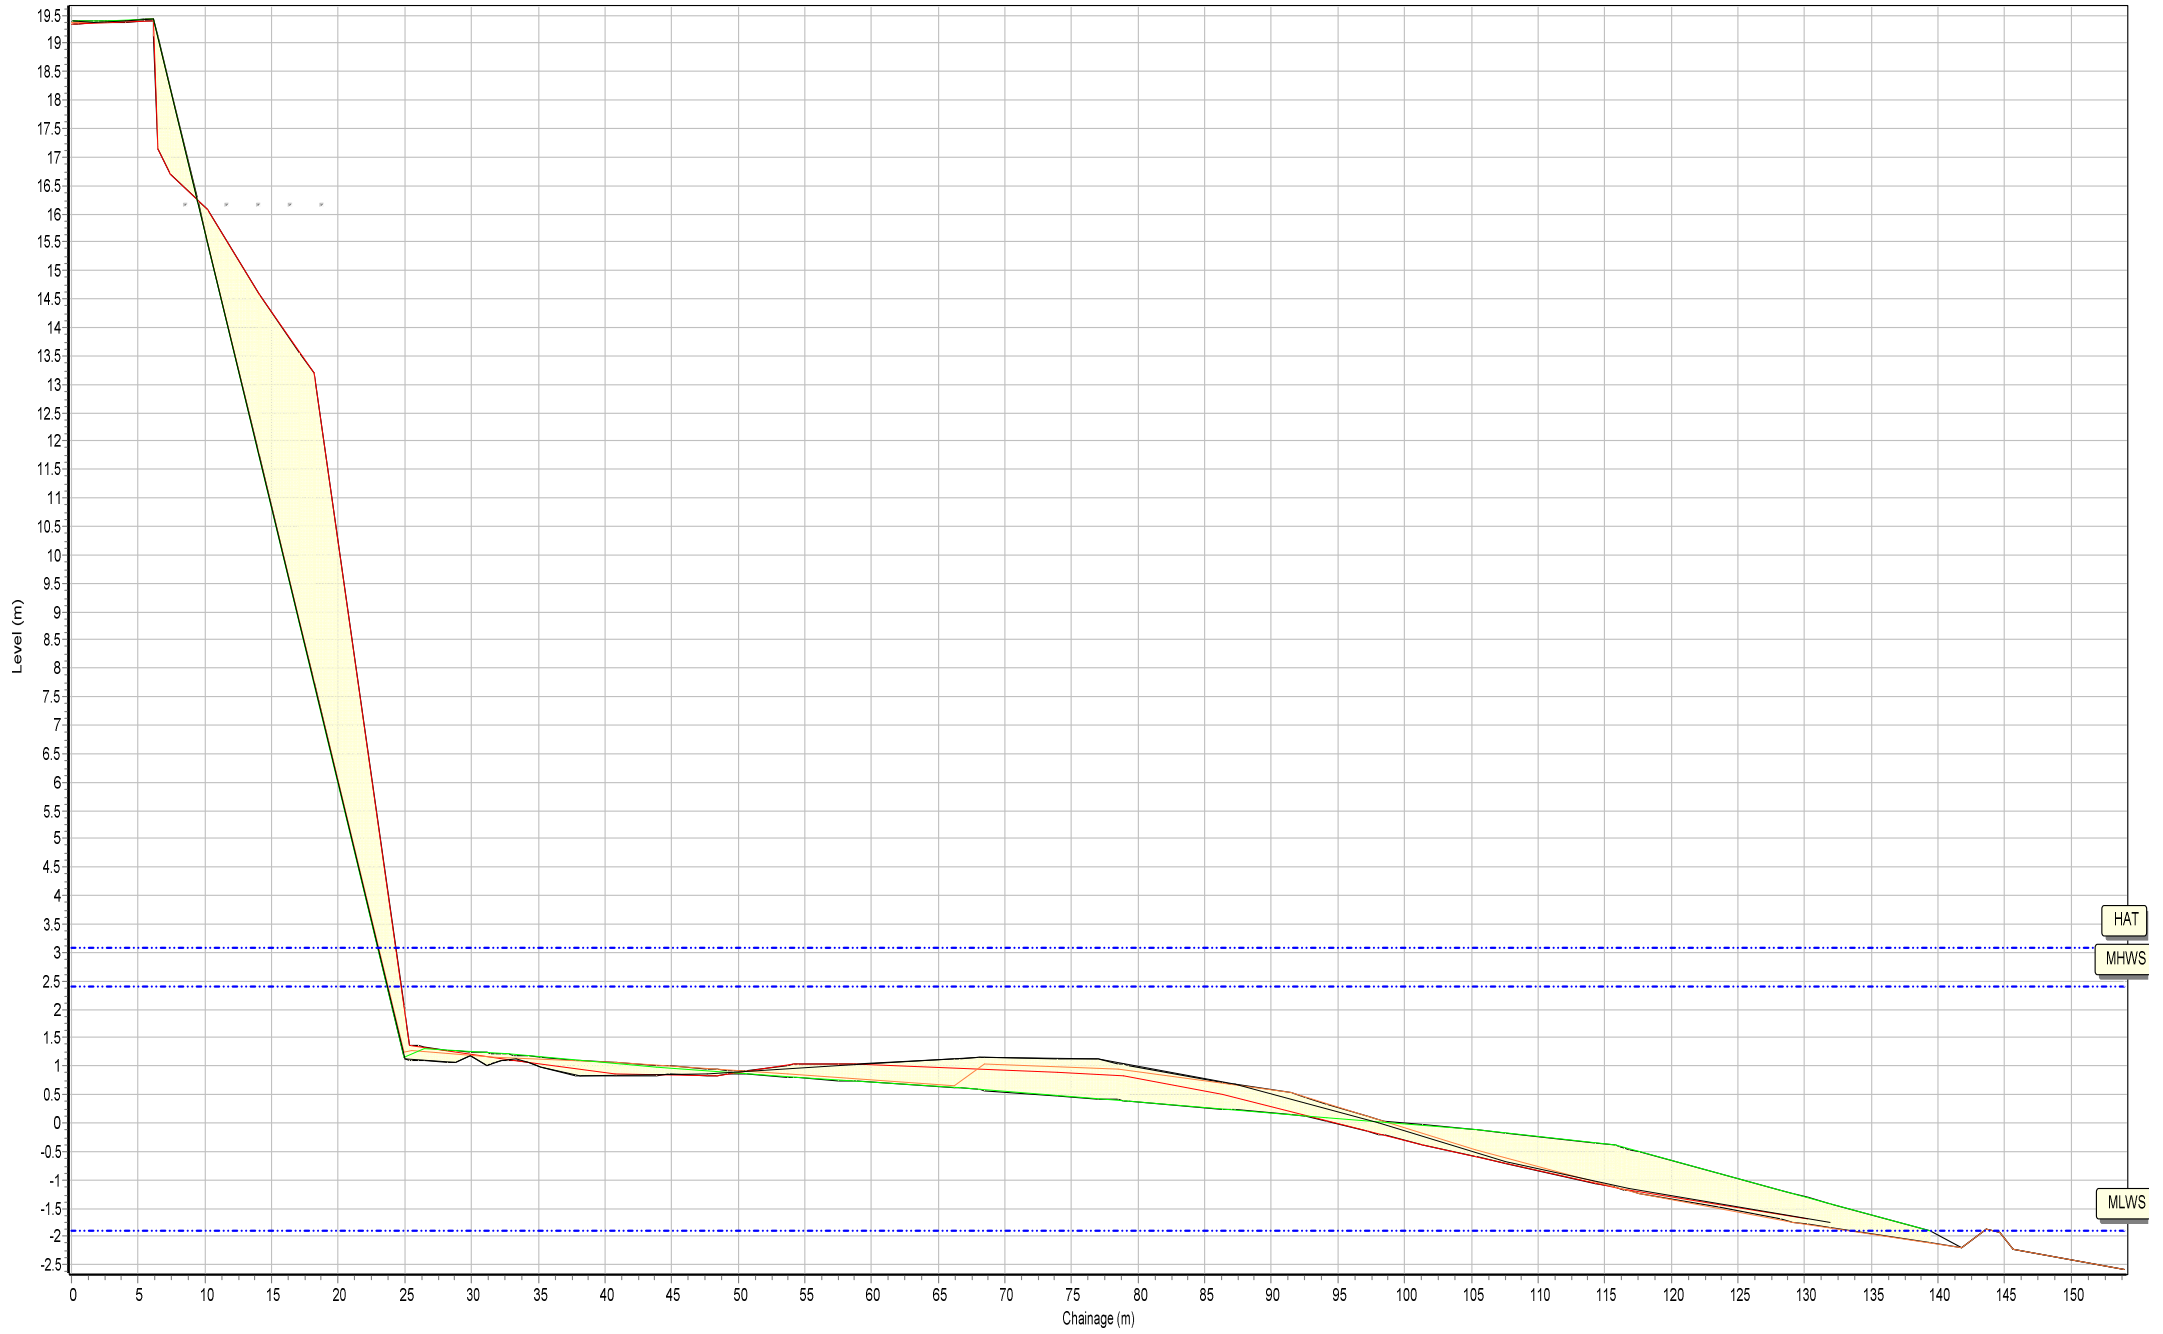
# Beach Profiles: 1aNTDC05

Survey Date	Description of Changes Since Last Survey	Interpretation
<p>27<sup>th</sup> September – 30<sup>th</sup> September 2019</p>	<p><b>Beach Profiles:</b></p> <p>Cullercoats Bay is covered by one beach profile line for the Full Measures survey (Appendix A). This was surveyed annually each autumn between 2002 and 2009. From spring 2010 onwards, it has been surveyed bi-annually.</p> <p>At profile 1aNTDC05 the survey report notes that the cliff was not measured due to dangerous access. There has been erosion from chainage 25m to 49m of up to 0.3m. A shallow berm has formed across the middle beach between chainages 49m and 97m, with an accretion of up to 0.5m. Seaward of chainage 0.6m there has been an erosion of up to 0.5m. The September 2019 profile is at a low level on the upper beach compared to the range recorded from previous surveys, the highest on record in the middle beach (chainage 62m to 86m) and at a relatively medium level at the toe of the beach.</p>	<p>As in previous surveys access to the cliff has not been possible.</p> <p>The data shows only limited change related to short-term patterns of sediment movement.</p> <p><b>Longer term trends:</b> The amount of change is within the past range, except between chainage 49m to 97m where the berm has reached its highest recorded level on the middle beach. The upper beach is at a low level and the lower beach is at a medium range.</p>

It is recommended that the beach profile at 1aNTDC05 in Cullercoats Bay should start at the cliff toe and that the cliff be monitored using the aerial survey data.
