**Cell 1 Regional Coastal Monitoring Programme
Update Report 5: 'Partial Measures' Survey 2013**

**North Tyneside Council
Final Report**

June 2013

Update Report 5
 Partial Measures Survey
 Spring 2013

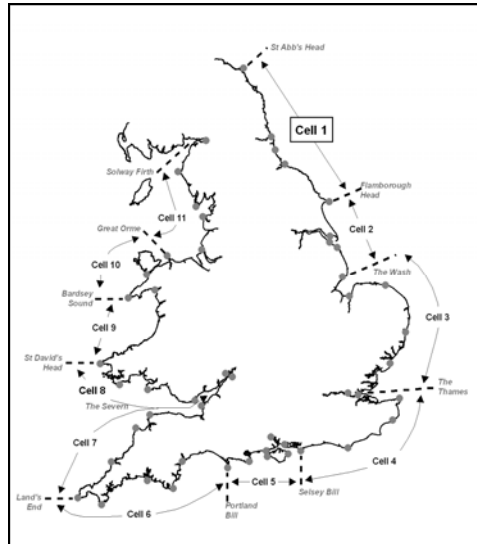
Figure 1 Sediment Cells in England and Wales

The Cell 1 Regional Coastal Monitoring Programme covers approximately 300km of the north east coastline, from the Scottish Border (just south of St. Abb's Head) to Flamborough Head in East Yorkshire. This coastline is often referred to as 'Coastal Sediment Cell 1' in England and Wales (Figure 1).

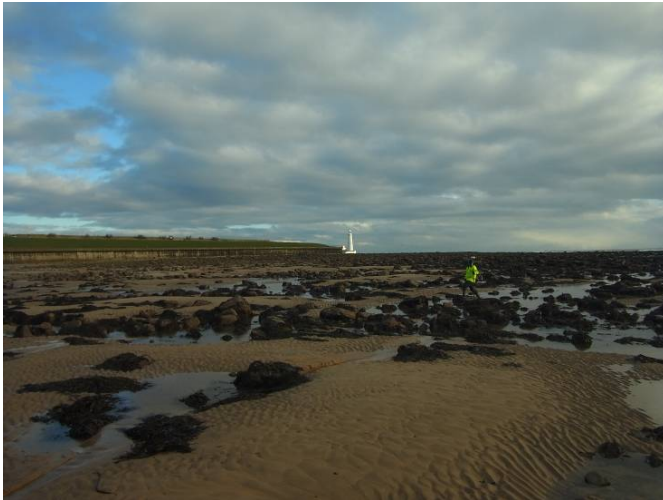
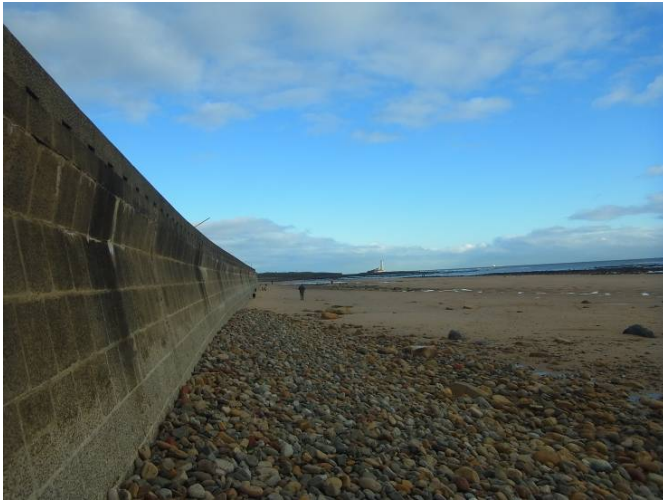
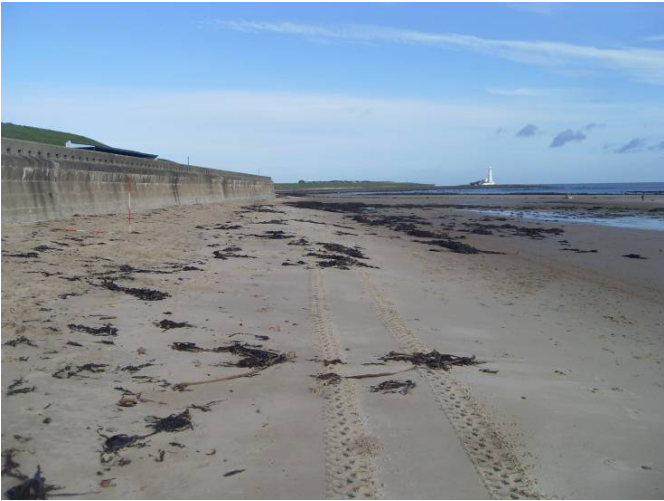
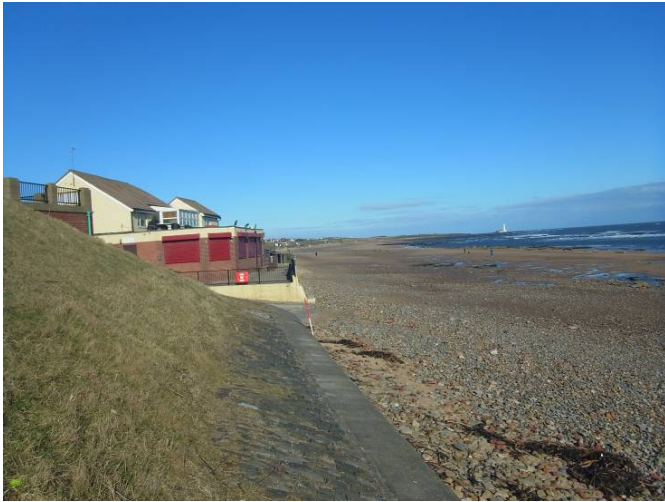
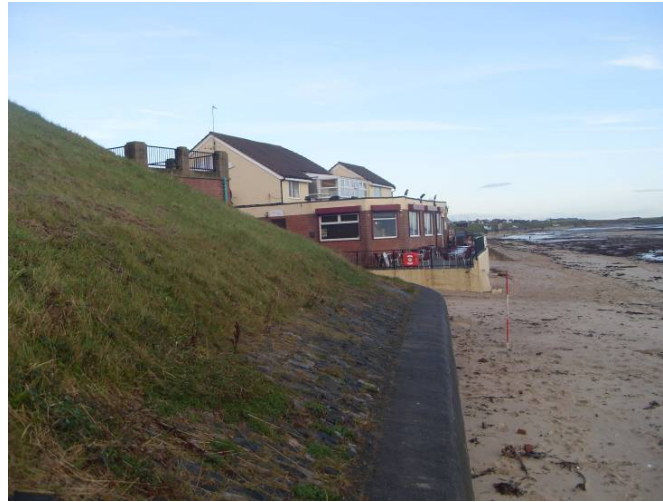
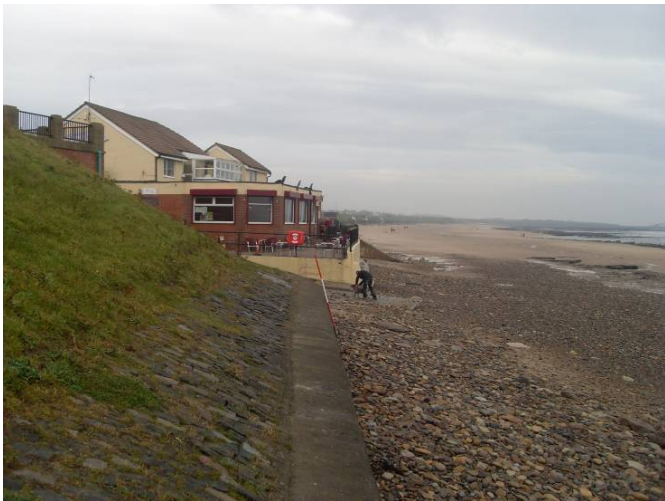
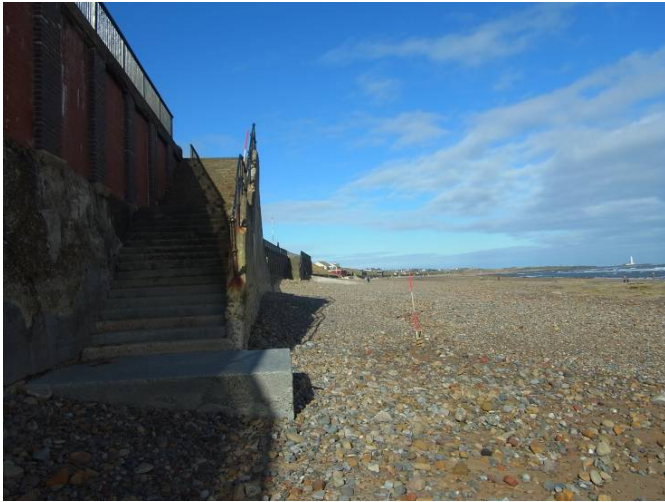
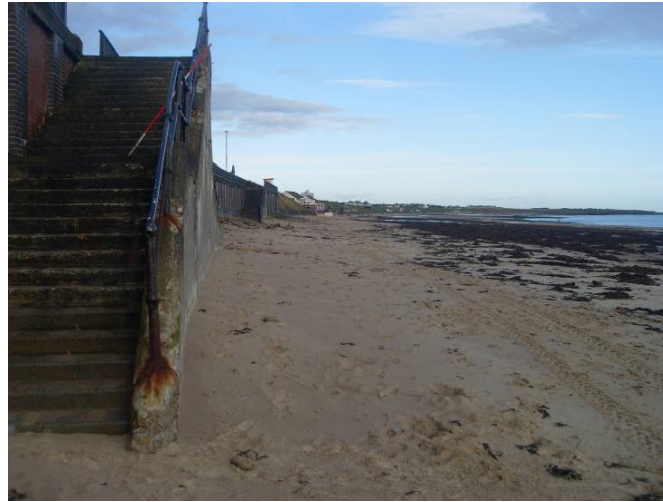
Survey Date	Description of Changes Since Last Survey	Interpretation
Mar 2013	<p>Beach Profiles:</p> <p>Whitley Sands is covered by five beach profile lines for the Partial Measures survey (Appendix A). Four of these (1aNTDC01 to 1aNTDC04) were initially surveyed in April 2002 and re-surveyed annually to 2009 (Full Measures, autumn 2009). Since then, they have been surveyed bi-annually. From March 2010 (Partial Measures, spring 2010) onwards, an additional beach profile line (NTDC04A) has been surveyed at the southern end of the frontage for the same time periods listed above. All profiles were last surveyed in autumn 2012 for the Full Measures survey.</p> <p>1aNTDC01 is located in the north of Whitley Sands, along the undefended cliffs immediately south of Trinity Road car park. From the toe of the cliff to a chainage of 45m (just below MHWS), beach levels have fallen by 0.2m, however, seawards of this beach levels have increased along the length of the profile by up to 1m, so that in places the rocky foreshore is overlain by sand (as shown by the survey photograph in Plate 1).</p> <p>Profile 1aNTDC02 is located to the north of Whitley Sands opposite the seawall. Beach levels from the toe of the seawall to a chainage of 155m have dropped considerably since the last survey. This is by over 2m at the seawall toe, where coarse shingle has been exposed beneath the sand (the difference is shown in the survey photographs in Plates 2 and 3 respectively). Seaward of a chainage of 155m (and a level of -1m), beach levels have increased to form a berm, which may be the material drawn-down from the upper/middle beach during winter storms.</p> <p>Profile 1aNTDC03 is located at the centre of Whitley Sands. Beach levels have generally reduced across the length of this profile by approximately 0.3m, the exception being a short-length of beach between a chainage of 45m and 75m (a level of 0.5m and 1.2m) where beach levels have increased by 0.3m.</p> <p>Profile 1aNTDC04 is located to the south of Whitley Sands. The beach at 1aNTDC04 has behaved similarly to 1aNTDC03, with a general drop in beach levels across the length of this profile by</p>	<p>Since the last survey, along the length of Whitley Sands, beach levels have fallen quite considerably, which is a typical, if extreme, response to winter storms. At profiles 1aNTDC02, 1aNTDC04 and 1aNTDC04A, sand has been eroded to expose the underlying coarse shingle on the foreshore 1aNTDC04A, the rocky foreshore. A berm is present on the lower shore of profile 1aNTDC01. These changes suggest the occurrence of significant storms over the winter months, which have resulted in draw-down of the overlying sand (and a lowering of beach levels) with storage on the lower beach, as observed to the north of the Whitley Sands, or, further offshore as seen on the beaches to the centre and south of Whitley Sands.</p> <p>Longer term trends: At most locations, beach levels are within the bounds of previous changes and beach levels have historically been higher and lower when compared to present levels. The exceptions are 1aNTDC02 and 1aNTDC04A:</p> <ul style="list-style-type: none"> At profile 1aNTDC02, between a chainage of 70m and 105m, beach levels are the lowest observed to date (*April 2002, when monitoring began), and seaward of a chainage of 155m (where the berm has formed), the highest observed to date (*).

Survey Date	Description of Changes Since Last Survey	Interpretation
	<p>approximately 0.3m, the exception being a short-length of beach between a chainage of 60m and 95m (a level of 1m and 0m) where beach levels have increased by 0.3m. There has been a notable change in sediment type on the beach, with a switch from sand to coarse shingle, as shown by the survey photographs in Plates 4 and 5). The survey photograph from the Full Measures 2011 survey (see Plate 6), also shows the presence of the coarse shingle beach. This suggests that this material is likely to have been exposed from beneath the overlying sand rather than the deposition of a new supply of material since the last survey</p> <p>Profile 1aNTDC04a is located to the south of Whitley Sands. Beach levels have fallen considerably, by approximately 1.25m, across the length of the profile. The toe of the revetment steps has been exposed (shown by the survey photographs in Plates 7 and 8) and further seaward, the underlying rocky foreshore around a level of 0m (seaward of a chainage of 50m) has also become exposed.</p>	<ul style="list-style-type: none"> • At profile 1aNTDC04A, beach levels are the lowest observed to date (*March 2010, when monitoring began) by up to 0.8m.

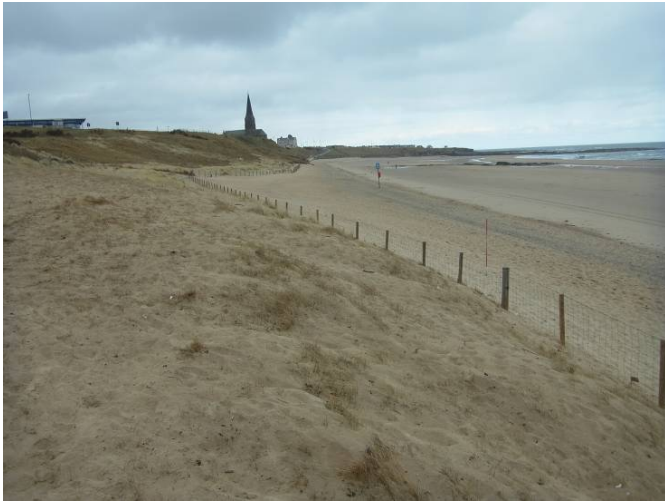
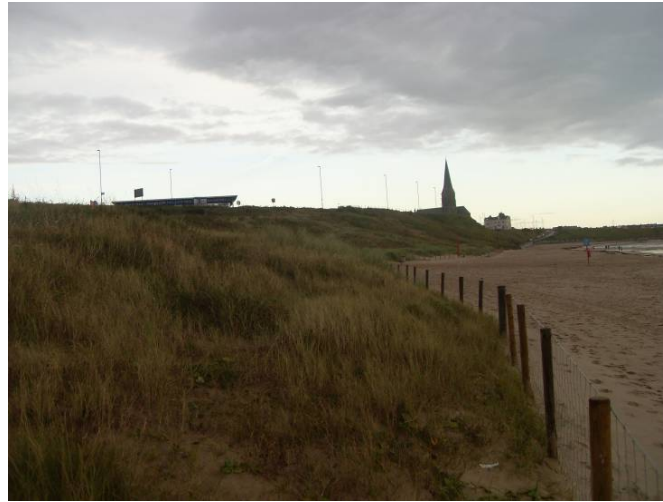
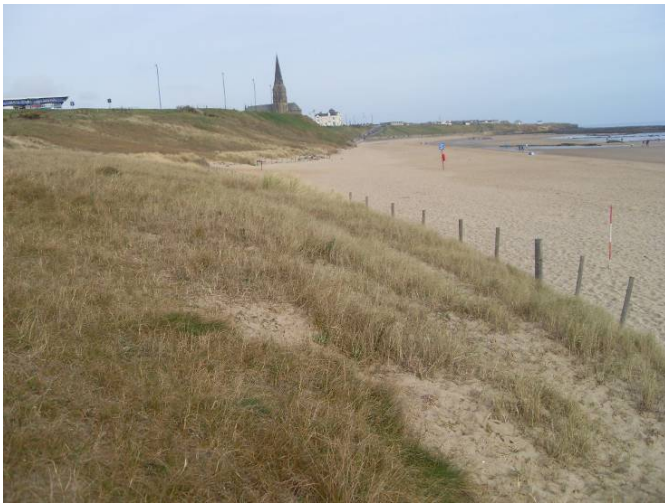
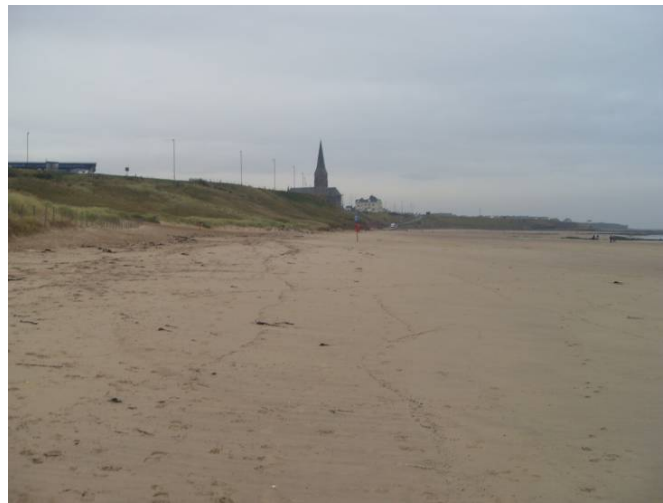
Survey Date	Description of Changes Since Last Survey	Interpretation
<p>Apr 2013</p>	<p>Beach Profiles:</p> <p>Tynemouth Long Sands is covered by three beach profile lines for the Partial Measures survey (Appendix A). Profiles 1aNTDC06 and 1aNTDC07 were initially surveyed annually each autumn between 2002 and 2009. A third profile, 1aNTDC06A, has been added in the centre of the frontage after that. From spring 2010 (Partial Measures) onwards, they have been surveyed bi-annually. The last survey was the autumn 2012 Full Measures survey.</p> <p>1aNTDC06 is located approximately 150m south of the access road/ramp towards the north of the bay. The dune-cliff face has not changed in form or position, although the survey report notes '<i>mud slips showing on section 6, sand encroaching up the dunes</i>'. Beach levels have fluctuated along the length of this profile, with a reduction at the toe of the dune-cliff to a chainage of 80m and between a chainage of 115m and 150m. Between a chainage of 80m and seawards of 150m, beach levels have increased. The magnitude of chainage is in the order of. 0.5m across the profile, suggesting a cross-shore movement of material.</p> <p>At profile 1aNTDC06A, the profile for the dune-cliff face is a straight line; a result of a lack of data points in the profile plot. This is explained by the note in the survey report; which states '<i>no access to middle of section 6A due to seed protection fences</i>'. Review of the survey photographs for the past four surveys (refer to Plates 9, 10, 11 and 12), show how the vegetation cover on the dunes has changed from well-vegetated, to the present survey, where the dune-cliff face is bare and devoid of vegetation. This may be a result of increased aridity, string winds, or human activities. Beach levels have fallen across the profile, with greatest change (1m) occurring at the toe of the dune-cliff face, around MHWS.</p> <p>Profile 1aNTDC07 is located approximately 50m south of the access route through the dunes towards the southern end of the bay. The profile for the dune-cliff face is a straight line; a result of a lack of data points in the profile plot. This is explained by the note in the survey report; which states '<i>no access to middle of section 7 due to seed protection fences</i>'. Beach levels have fallen across the profile, by approximately 0.5m. As with profile 1aNTDC06A, the change is greatest around MHWS, where beach levels have fallen by up to 1m.</p>	<p>At Tynemouth Long Sands, the dune-cliff face has been subject to change, although the profile plots suggest that it has not changed in from or position since the last survey. At profile 1aNTDC06, the survey report notes that mud slips have occurred and are encroaching up the dunes and at profile 1aNTDC06A, the survey photographs for the past four surveys show that the dune-cliff face has changed from well-vegetated to the present survey, where the dune-cliff face is devoid of vegetation. This may be a result of increased aridity, string winds, or human activities. The survey report notes for both 1aNTDC06A and 1aNTDC07 that access to the dunes was not possible due to seed protection fences, which suggests that efforts are being made to help stabilise the dunes.</p> <p>Beach levels along the length of coastline here have fallen between 0.5m and 1m. To the north, at profile 1aNTDC06, the beach is a little more dynamic, with alternating change in beach levels (fall and increase) in a cross-shore direction.</p> <p>Longer term trends: Overall, the beaches have retained a similar form, however, particularly at profiles 1aNTD06A and 1aNTDC0, beach levels are the lowest recorded to date (2010 and 2002 respectively, when monitoring began).</p>

Survey Date	Description of Changes Since Last Survey	Interpretation
Apr 2013	<p>Topographic Survey:</p> <p>Tynemouth Long Sands is a new survey area. The first survey was undertaken for the Full Measures survey in October 2010.</p> <p>Data from the current topographic survey have been used to create a digital ground model (DGM) (Appendix B – Map 1a) using a Geographical Information System (GIS). A difference plot has also been produced by comparing the current DGM (Appendix B – Map 1b) with that produced from the last topographic survey.</p> <p>In particular the difference plot shows (i) a general reduction in beach levels to the south of Tynemouth Long Sands between 0m and 1m; and (ii) a dynamic beach to the north, with alternating parallel strips of beach elevation reduction and increase, in the order of 1m, indicating migration of sand bars. These findings correspond well to the each profile surveys, which show alternating changes in beach levels (fall and increase) in a cross-shore direction.</p>	<p>Since the last survey, the beach to the north of Tynemouth Long Sands has been more dynamic, with alternating parallel bars of beach elevation reduction and increase. To the south, beach elevation has generally reduced across the beach in the order of 0m to 1m.</p> <p>Longer term trends: The longer term trends are covered by the long term topographic trends autumn 2010 to autumn 2013 (see next report, Full Measures 2013).</p>

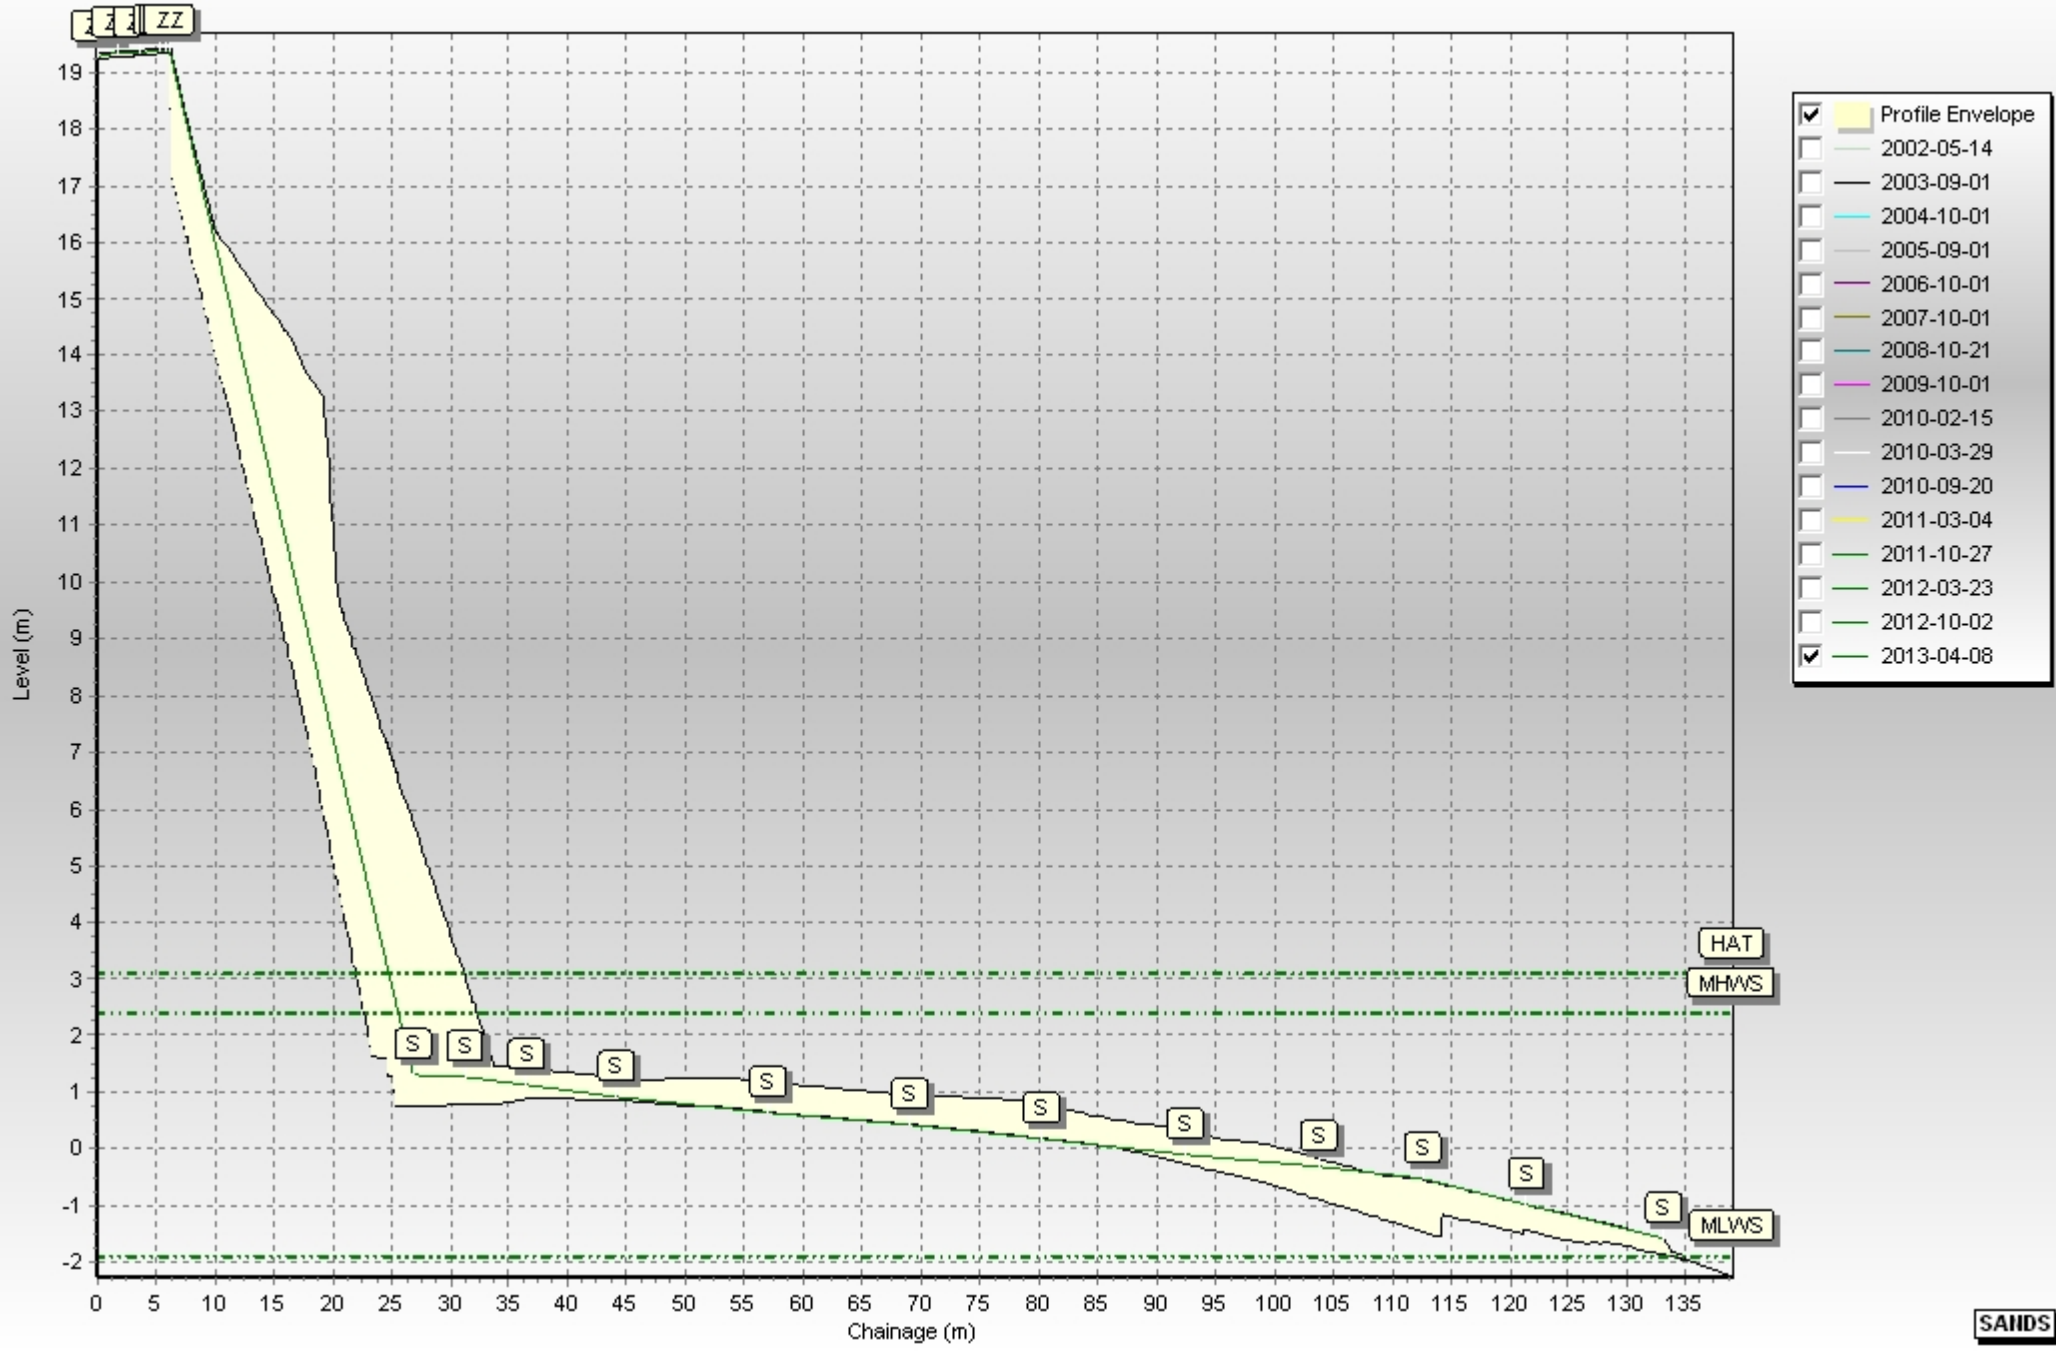
Profiles: 1aNTDC05

At profile 1aNTDC05 the cliff was not measured due to dangerous access. The plot of the Profile therefore shows movement of the cliff toe seawards by 0.5m to 1m, which is misleading. Access to this profile is noted to have been dangerous in the previous partial measures and full measures reports, and therefore consideration should be given to changing the location of this survey.

- At Whitley Sands, the recorded profiles present no causes for concern.
- At Cullercoats Bay, at profile 1aNTDC05, the cliff was not measured due to dangerous access. Access to this profile is noted to have been dangerous in the previous Partial Measures and Full Measures reports, and therefore consideration should be given to changing the location of this survey.
- At Tynemouth Long Sands, at profile 1aNTDC06A, survey photographs show a reduction in vegetation cover on the dunes, which may be due to increased aridity, strong winds, drying of sand or human activities. Protection fences have been installed and their effectiveness in stabilising the dunes can be monitored by future surveys.
- Elsewhere along Tynemouth Long Sands, the recorded profiles and topographic survey present no causes for concern.
- At King Edward's Bay, the recorded profiles present no causes for concern.

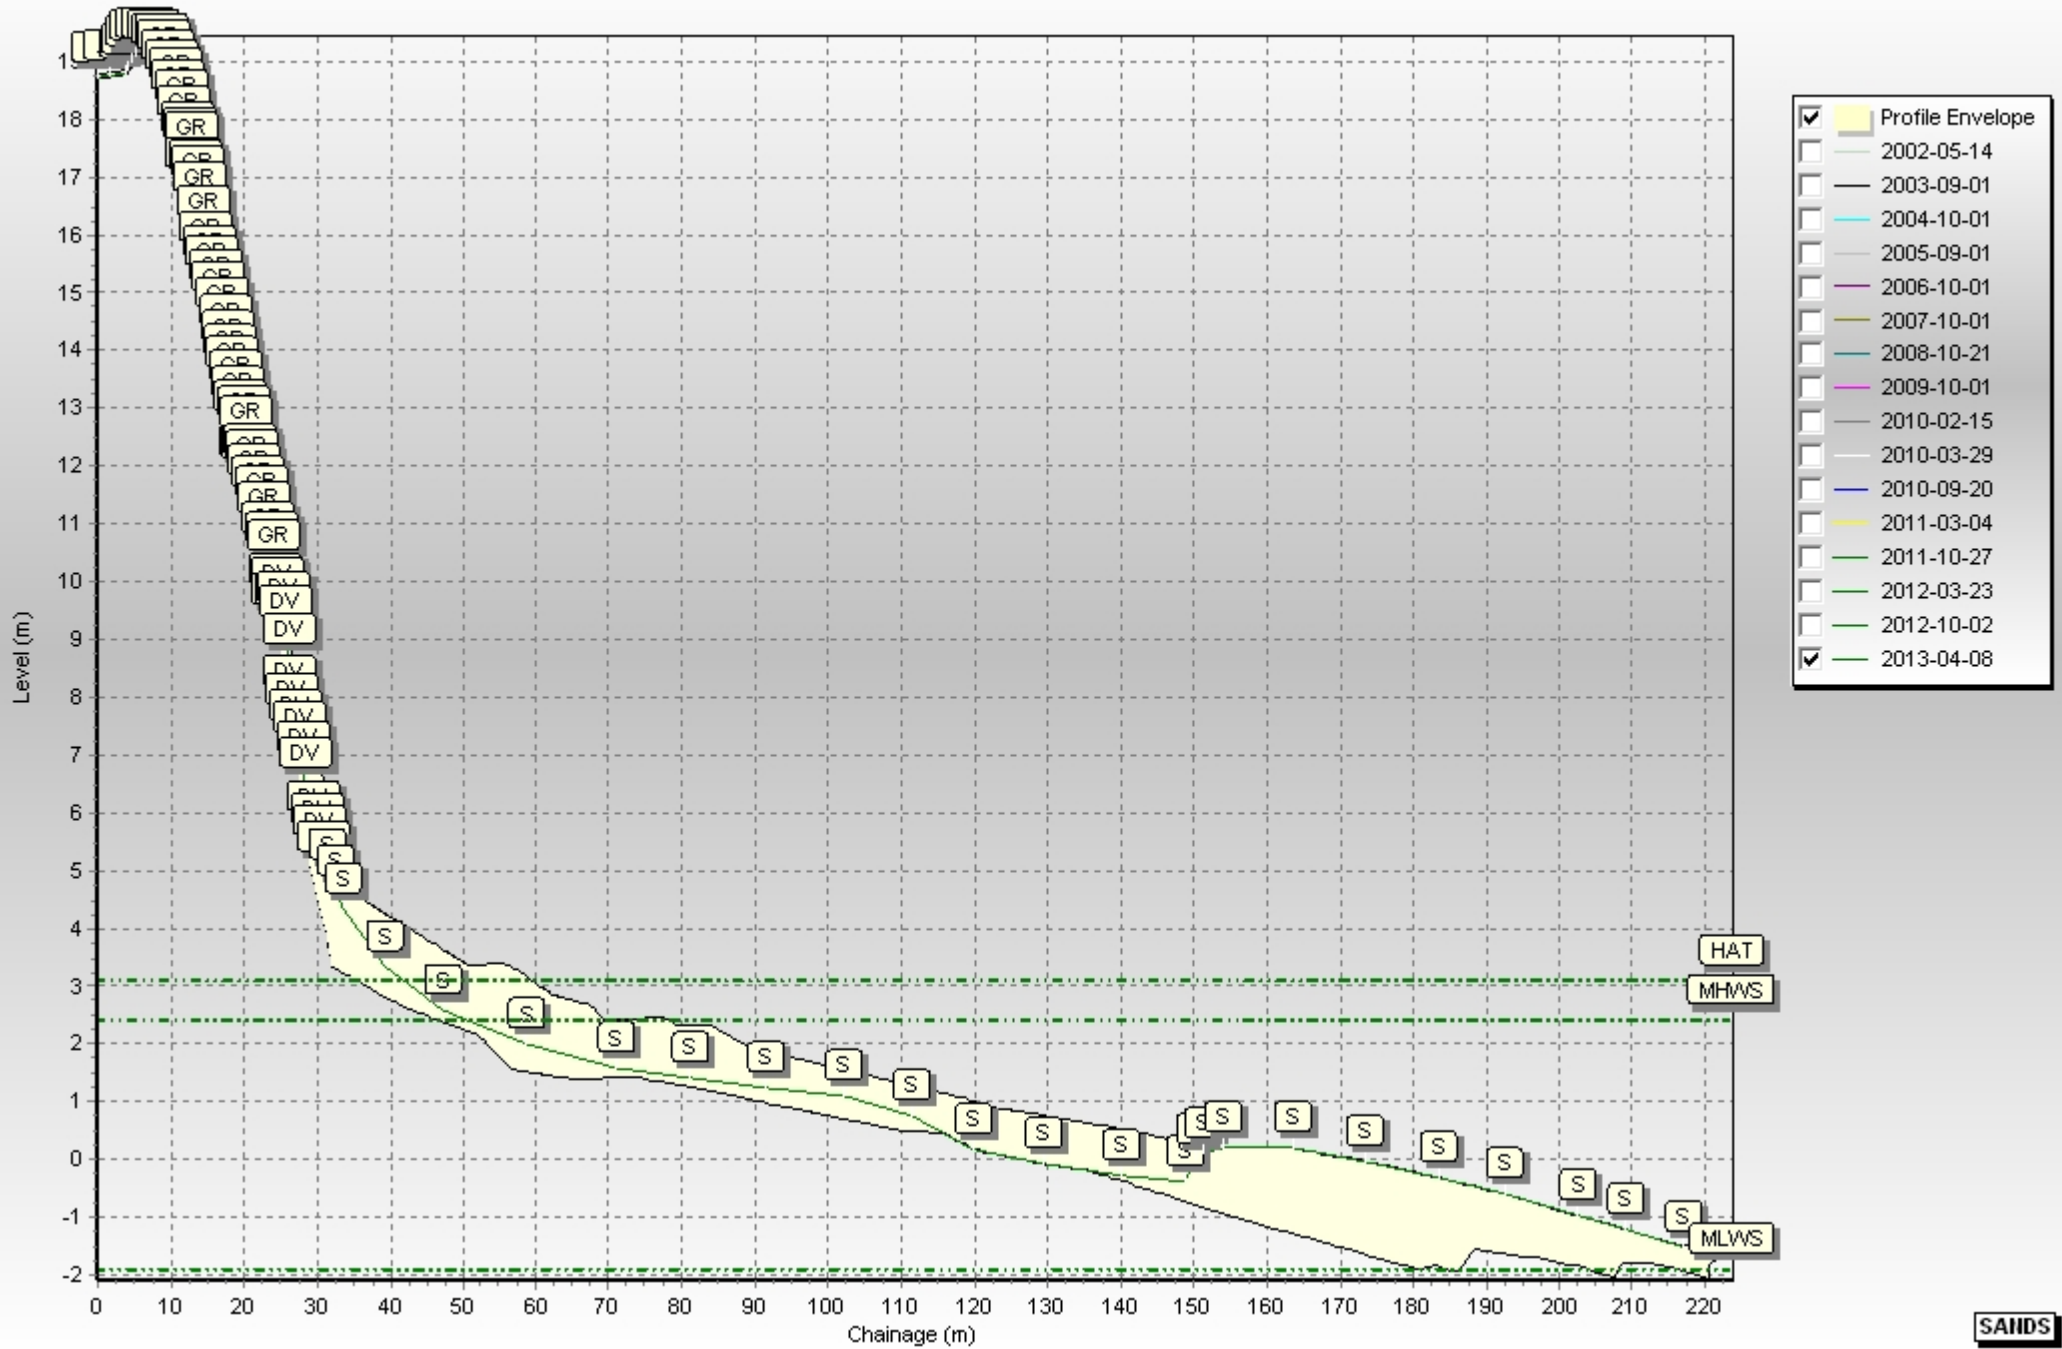
Profiles: 1aNTDC06

At profile 1aNTDC06, mud slips were observed and sand was encroaching up the dunes.

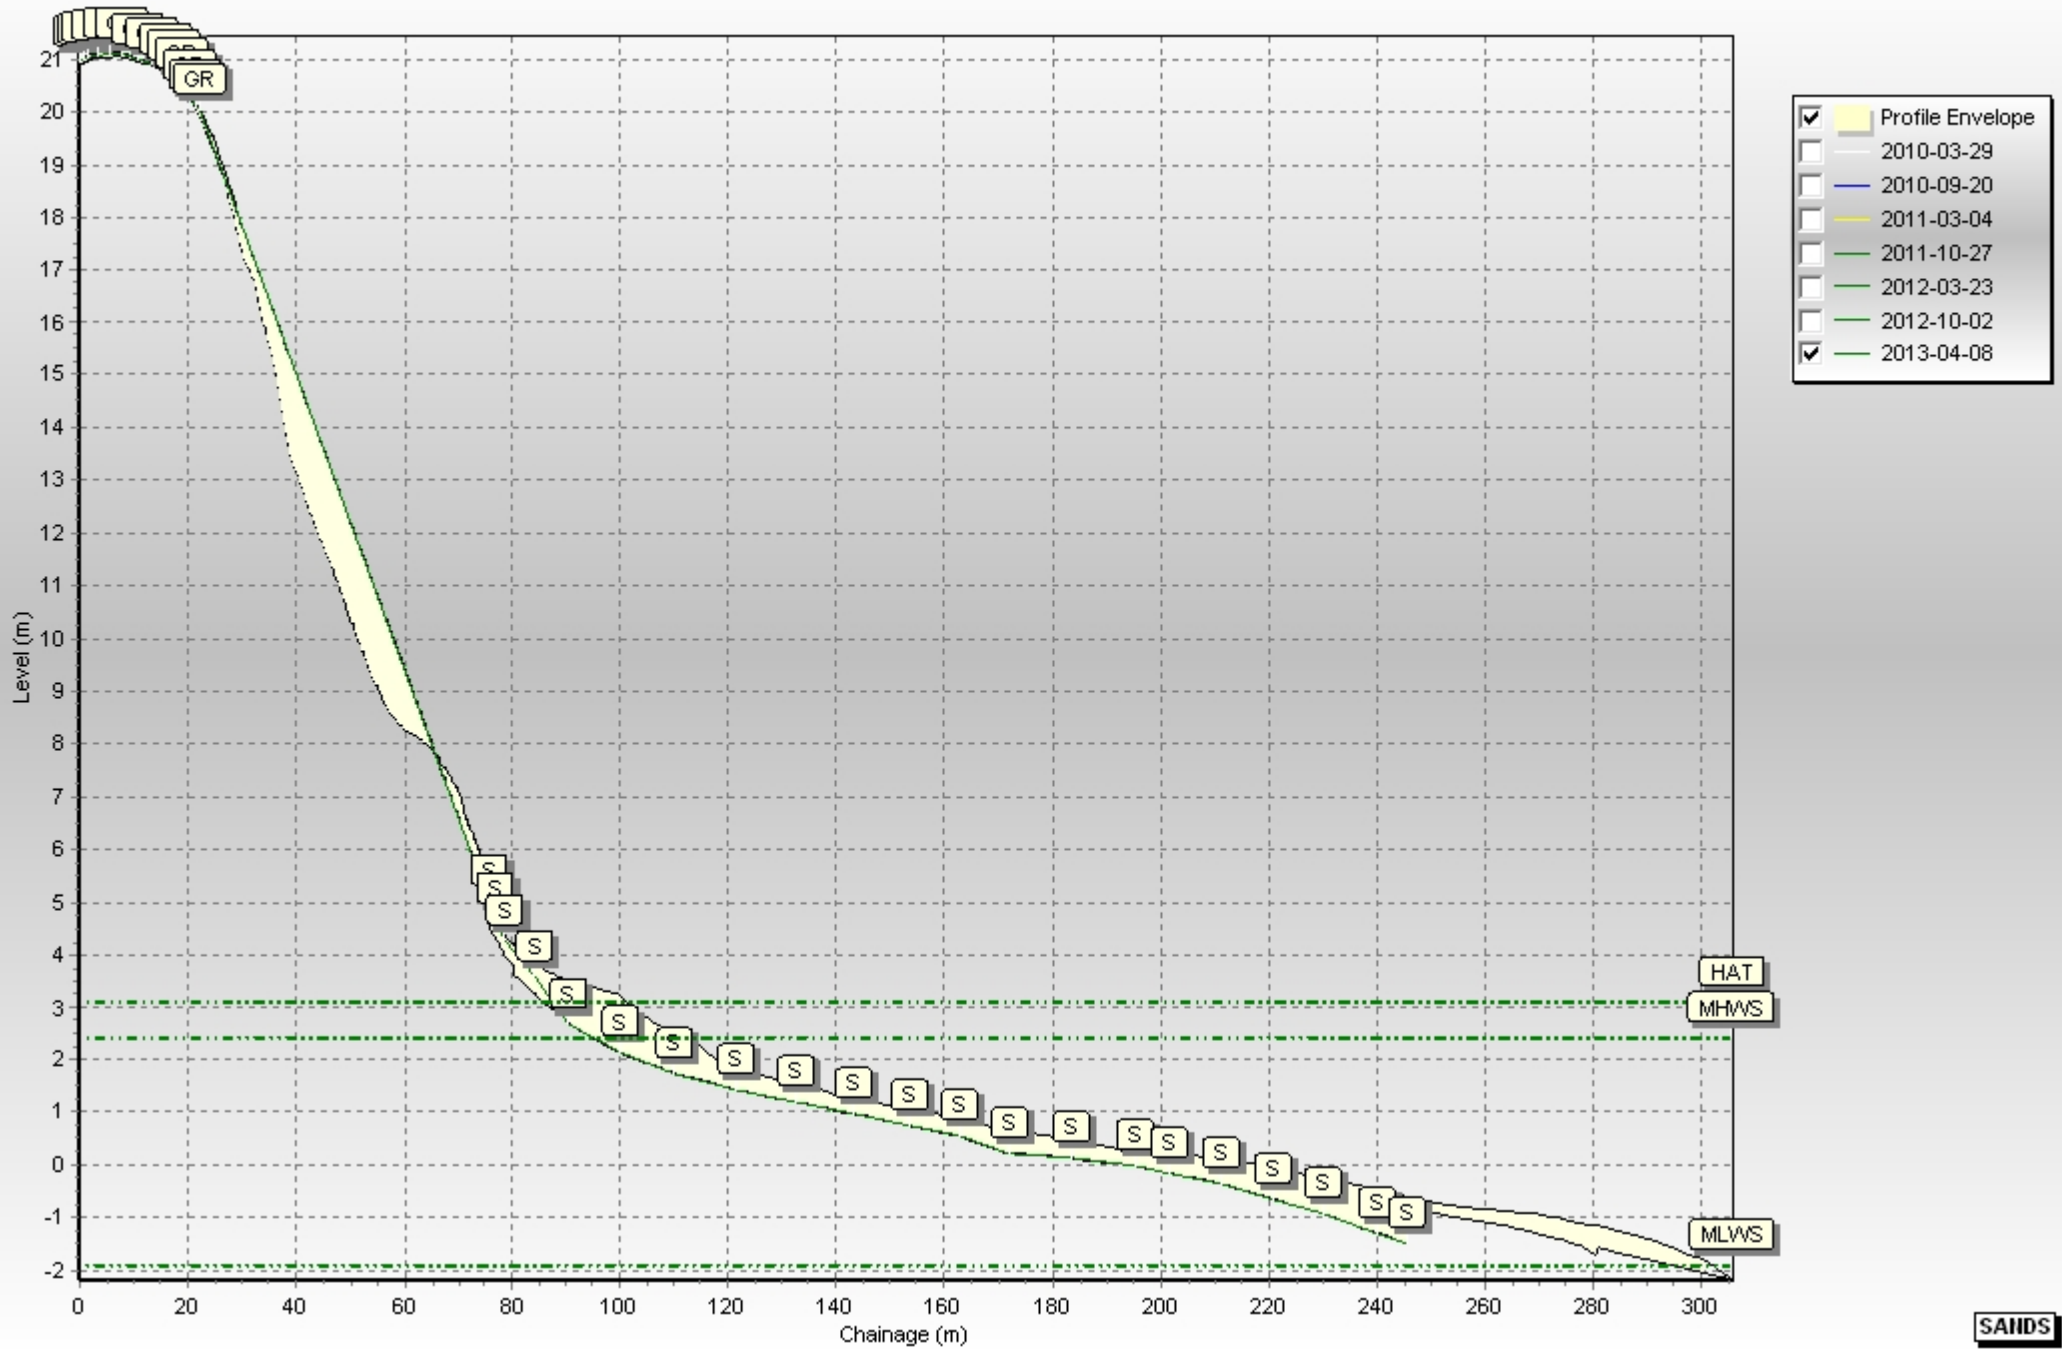
Profiles: 1aNTDC06A

At profile 1aNTDC06A, there was no access to the middle of the profile due to seedling protection fences.

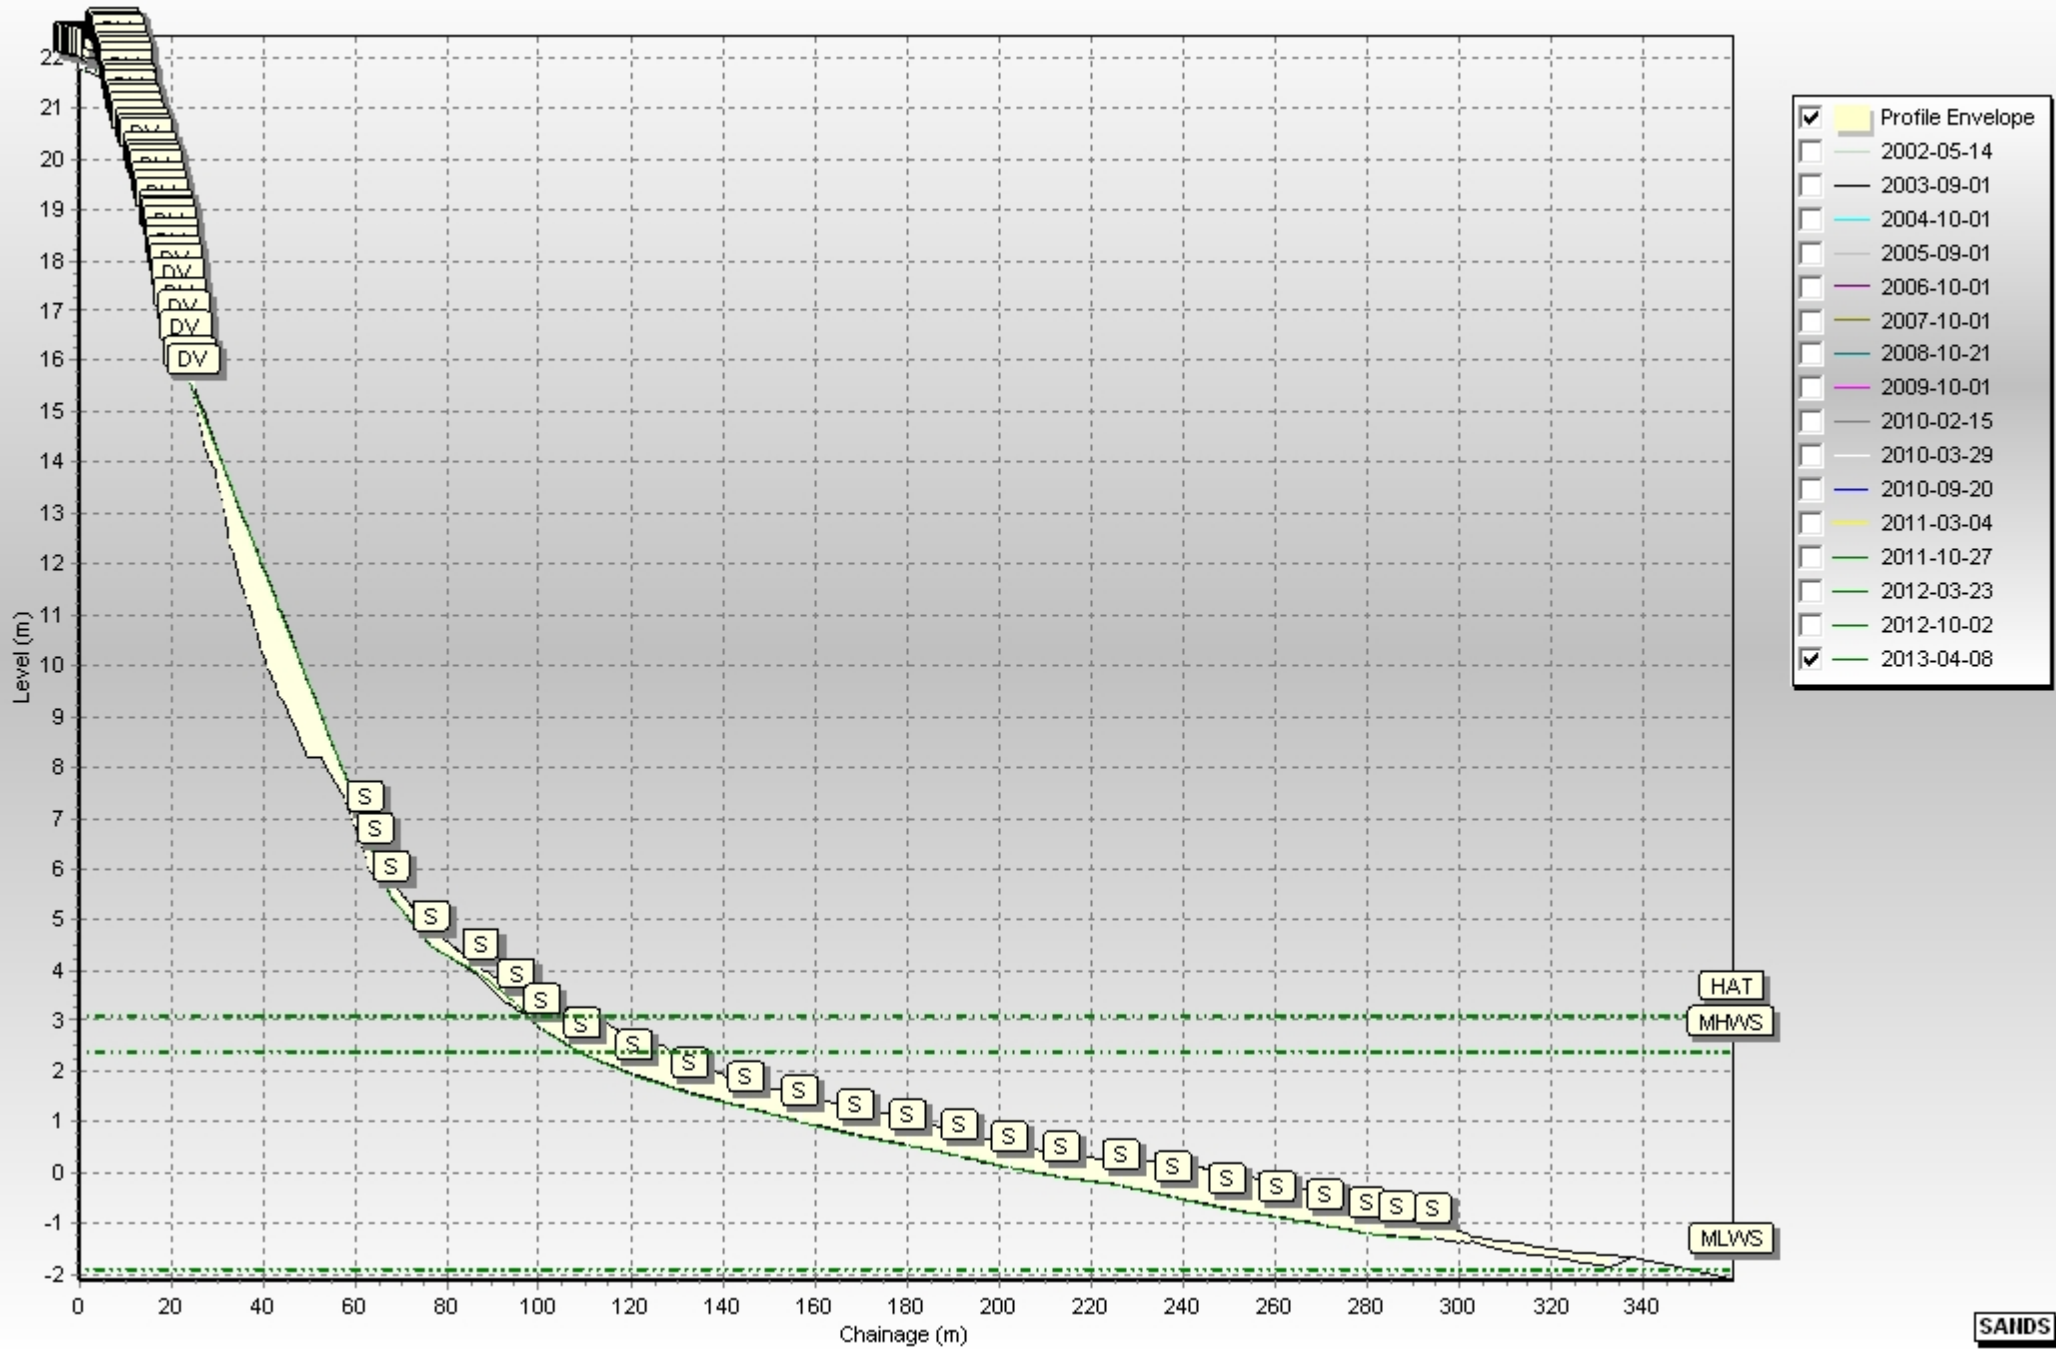
Profiles: 1aNTDC07

At profile 1aNTDC07, there was no access to the middle of the profile due to seedling protection fences.

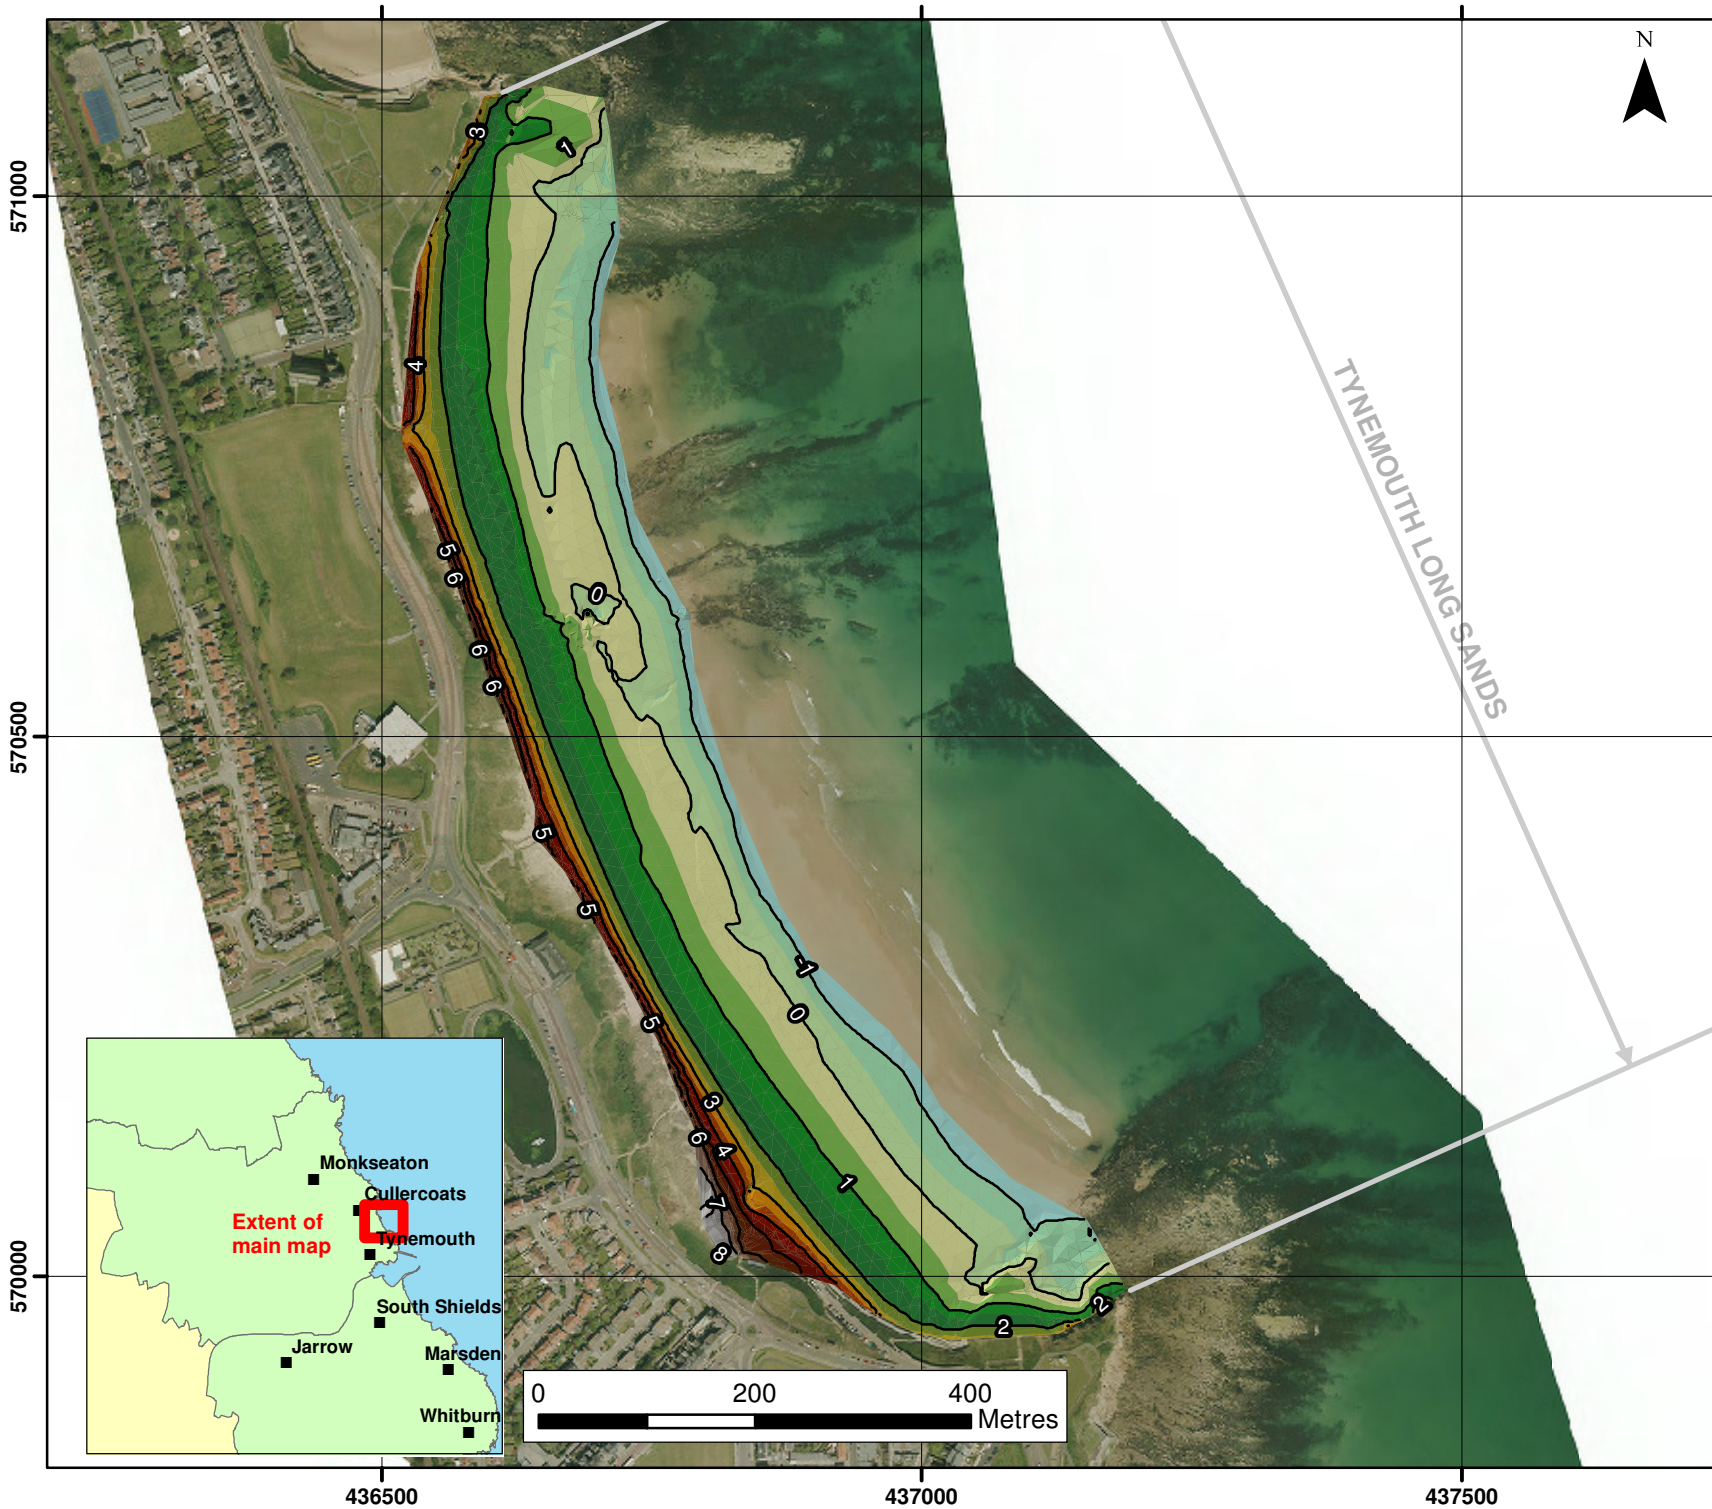
Appendix B - Map 1a
Topographic Survey
Tynemouth Long Sands
North Tyneside Council

- 'slips evident on face of dunes'.
- 'spring at south end of beach in deep channel'.
