**Cell 1 Regional Coastal Monitoring Programme
Update Report 5: 'Partial Measures' Survey 2013**

**North Tyneside Council
Final Report**

June 2013

Update Report 5
 Partial Measures Survey
 Spring 2013

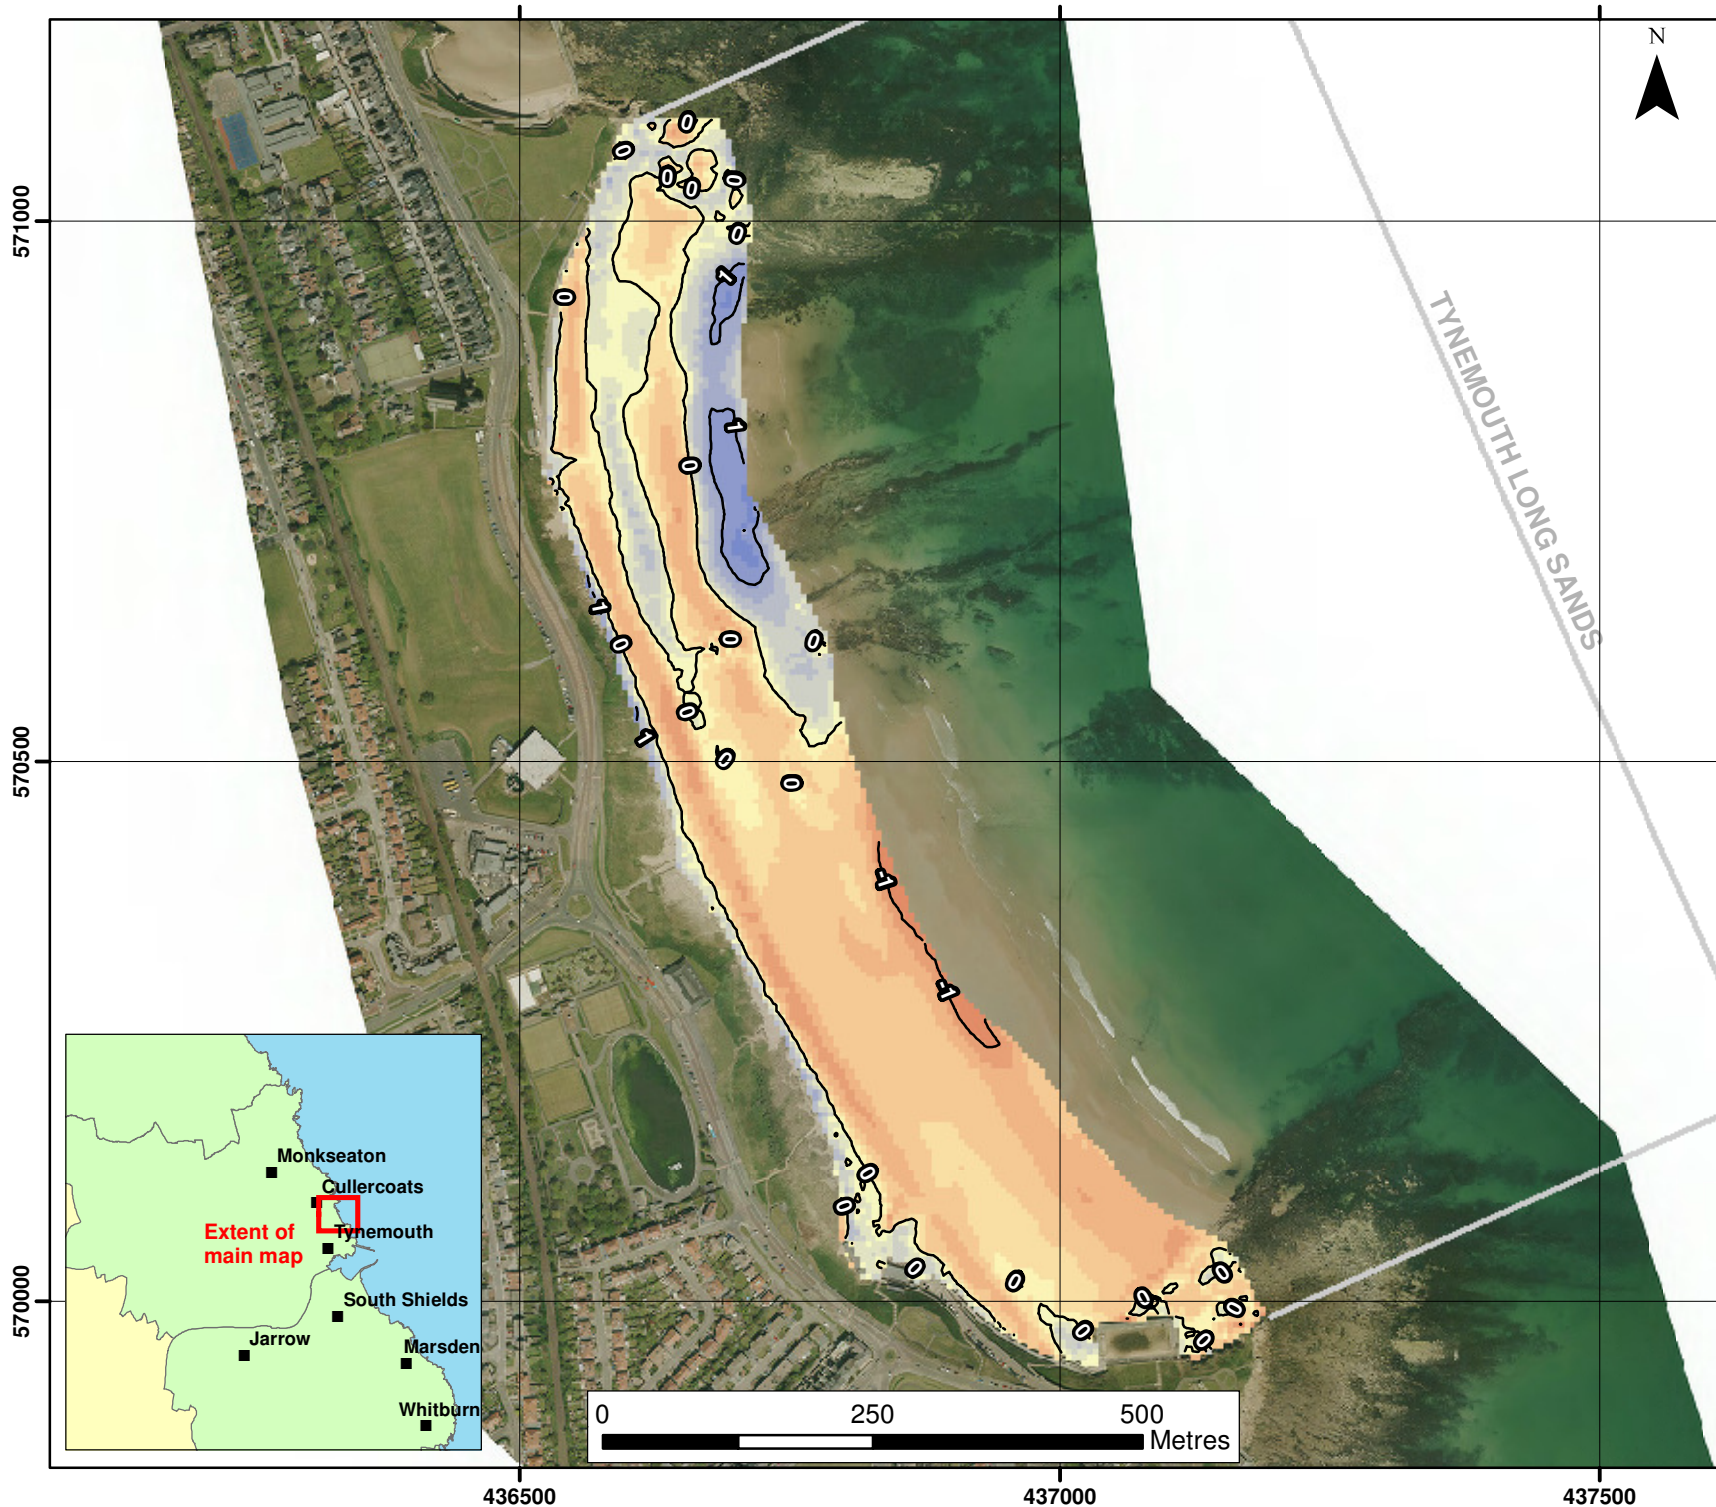
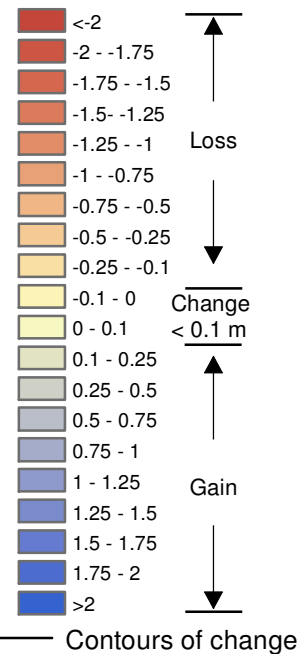
Appendix B - Map1b
Short-term
Elevation Change
Tynemouth Long Sands
North Tyneside Council

Survey Date	Description of Changes Since Last Survey	Interpretation
Apr 2013	<p>Topographic Survey:</p> <p>Tynemouth Long Sands is a new survey area. The first survey was undertaken for the Full Measures survey in October 2010.</p> <p>Data from the current topographic survey have been used to create a digital ground model (DGM) (Appendix B – Map 1a) using a Geographical Information System (GIS). A difference plot has also been produced by comparing the current DGM (Appendix B – Map 1b) with that produced from the last topographic survey.</p> <p>In particular the difference plot shows (i) a general reduction in beach levels to the south of Tynemouth Long Sands between 0m and 1m; and (ii) a dynamic beach to the north, with alternating parallel strips of beach elevation reduction and increase, in the order of 1m, indicating migration of sand bars. These findings correspond well to the each profile surveys, which show alternating changes in beach levels (fall and increase) in a cross-shore direction.</p>	<p>Since the last survey, the beach to the north of Tynemouth Long Sands has been more dynamic, with alternating parallel bars of beach elevation reduction and increase. To the south, beach elevation has generally reduced across the beach in the order of 0m to 1m.</p> <p>Longer term trends: The longer term trends are covered by the long term topographic trends autumn 2010 to autumn 2013 (see next report, Full Measures 2013).</p>

KEY Autumn 2012 and Spring 2013
Change in elevation (m)
