**Cell 1 Regional Coastal Monitoring Programme  
Update Report 7: 'Partial Measures' Survey 2015**

**North Tyneside Council  
Final Report**

**July 2015**

(\*) The present report is **Update Report 7** and provides an analysis of the 2015 Partial Measures survey for North Tyneside Council's frontage.

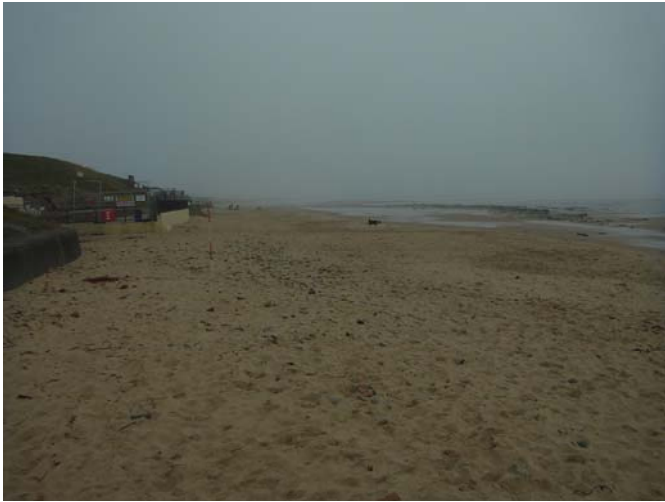
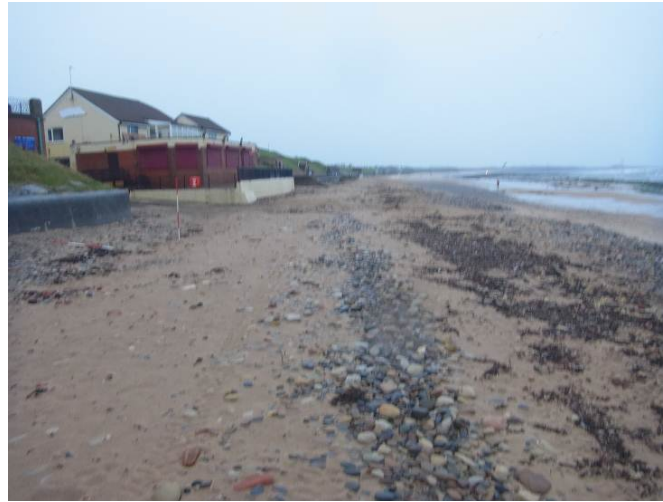
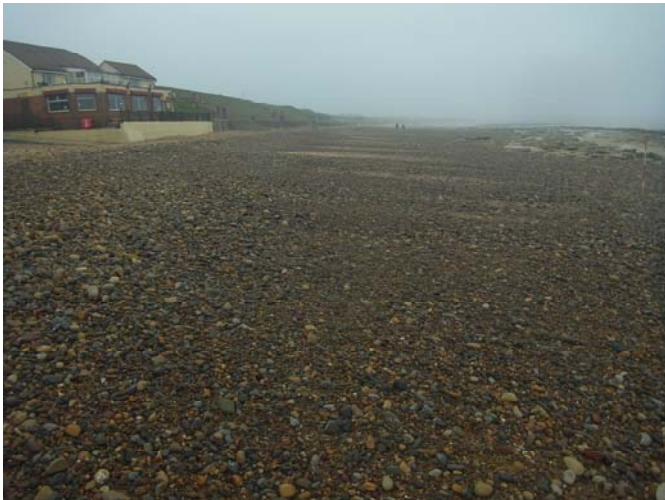
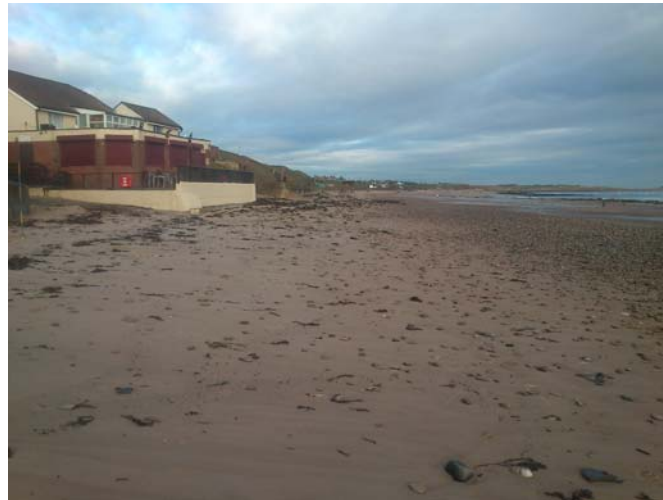
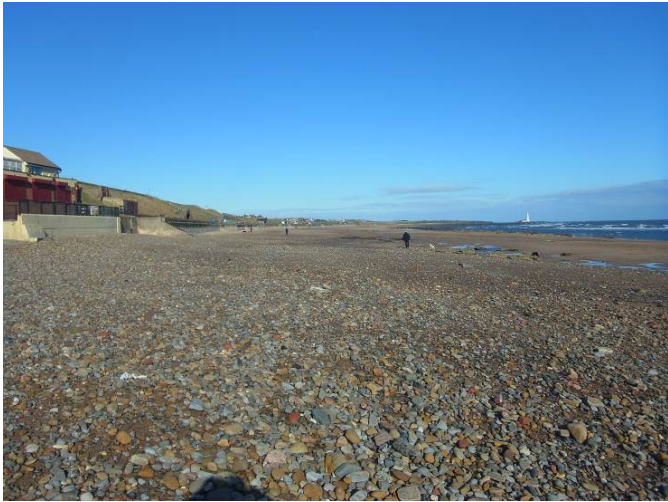
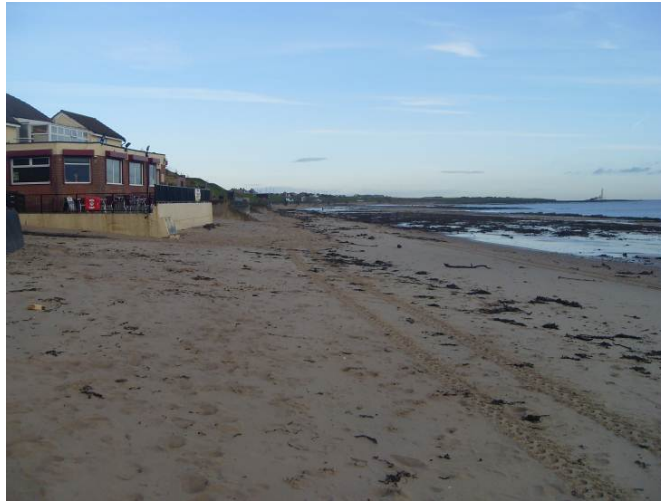
Survey Date	Description of Changes Since Last Survey	Interpretation
	<p>been taken down. As observed in previous reports, the sediment type on the beach is subject to change, and since the last survey, has changed again; this time from a combination of sand and shingle to sand. The photographs in Plates 2 to 6 show how the sediment type on the beach has changed; the last time the beach was sandy was in the autumn of 2013. The beach profile has changed in level by small and different amounts across the profile length, but the key trend is an overall decrease between 20m and 60m chainage by up to 0.5m and an increase in beach level seaward of 80m chainage by approximately 0.5m, indicating a cross-shore transfer of material seaward over the winter/spring months.</p> <p>Profile <b>1aNTDC04a</b> is located to the south of Whitley Sands. Beach levels have increased across the profile by up to 0.7m, although the beach has retained the same form. As at profile 1aNTDC04, there has been a change in the sediment type on the beach (refer to Plates 7 to 12) from a combination of sand and shingle to sand. The sand is on the beach is now similar to the content last observed during the September 2012 (Full Measures) survey, suggesting recovery.</p>	<p>sand by spring 2015. This suggests that the beach at these locations have recovered and sand that was removed from the beach by significant storms during the winter of 2013 and 2014 has now been returned.</p>

- At Whitley Sands, beach levels have remained mostly stable with discrete sections of beach level change associated with the cross-shore movement of material during winter/spring storms. There has been a change in sediment type from shingle/sand to sand, which is evident from the survey photographs for profiles 1aNTDC04 and 1aNTDC04A.

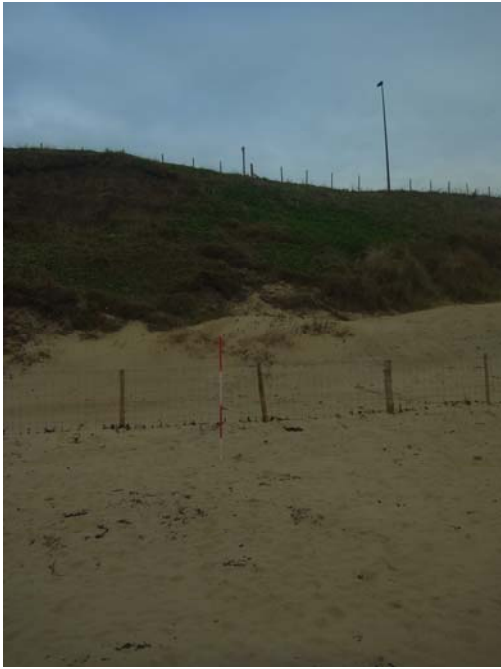
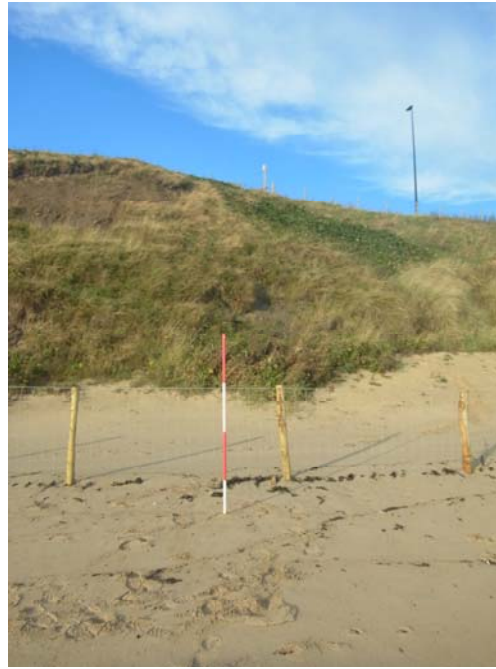
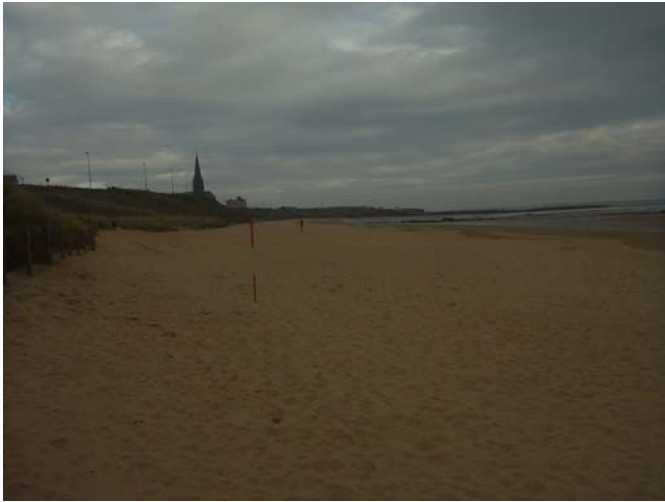
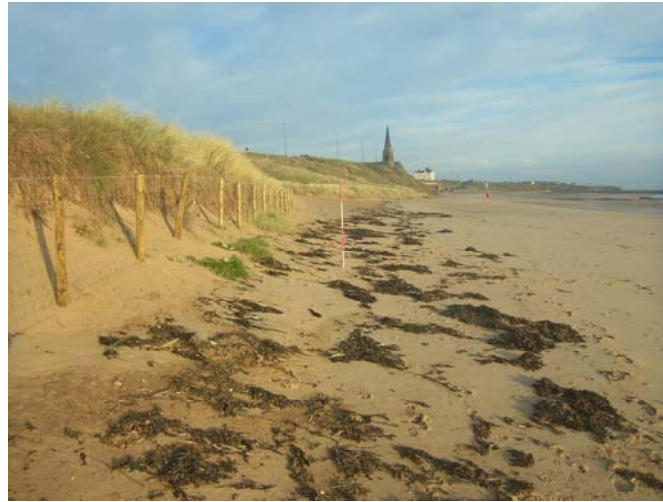
Survey Date	Description of Changes Since Last Survey	Interpretation
	during the winter/spring months.	
Mar 2015	<p><b>Topographic Survey:</b></p> <p>Tynemouth Long Sands is a new survey area. The first survey was undertaken for the Full Measures survey in October 2010.</p> <p>Data from the current topographic survey have been used to create a digital ground model (DGM) (Appendix B – Map 1a) using a Geographical Information System (GIS). A difference plot has also been produced by comparing the current DGM (Appendix B – Map 1b) with that produced from the last topographic survey.</p> <p>In particular the difference plot shows (i) a general increase in beach elevation of between 0.0m and 1.0m along the upper beach; (ii) a general decrease in beach elevation of between 0.0m and 1.0m along lower beach at the centre of the bay, and towards the middle and lower beach to the north and south of the bay. These trends are the reverse of those observed during the previous survey (Full Measures, autumn 2014). These findings correspond well to the beach profile surveys, which show alternating changes in beach levels in a cross-shore direction.</p>	<p>Since the last survey, the beach at Tynemouth Long Sands has been dynamic, with formation of a band of accretion on the upper beach and a more distinct zone of beach elevation reduction on the middle and lower beach. The last survey identified an area of beach elevation reduction to the north, but this is now spread out over the beach.</p>

- Elsewhere at Cullercoats Bay, beach level change since the last survey are minimal and the recorded profiles and present no causes for concern.
- At Tynemouth Long Sands, the dune-cliff face was not surveyed due to access constraints, but survey photographs suggest that there has been a build-up of wind-blown sand material in the lee of the defences and along the upper beach.

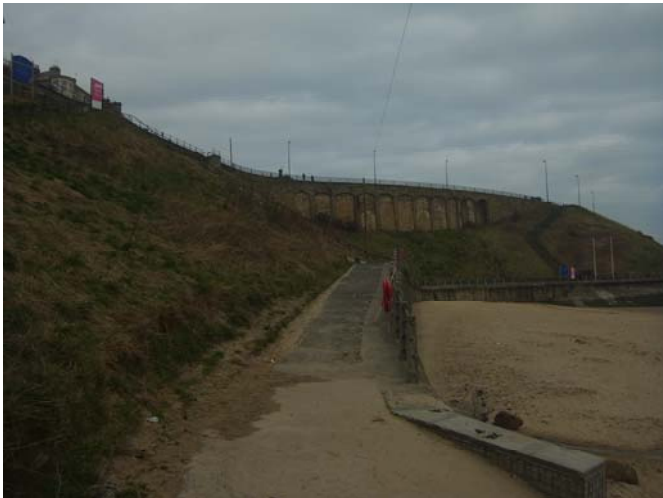
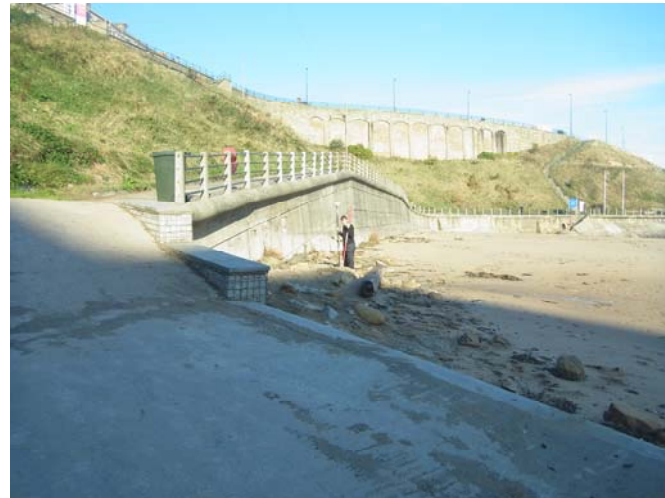
Survey Date	Description of Changes Since Last Survey	Interpretation
Mar 2015	<p><b>Beach Profiles:</b></p> <p>King Edward's Bay is covered by one beach profile line for the Full Measures survey (Appendix A). This was surveyed annually each autumn between 2002 and 2009. From spring 2010 onwards, it has been surveyed bi-annually. The last survey was the autumn 2014 Full Measures survey.</p> <p>At profile <b>1aNTDC08</b> beach levels have changed quite considerably across the profile, with an increase in beach levels on the upper beach (chainage 0-50m) by approximately 0.5m (see Plates 17 and 18); a decrease along the centre of the beach between a chainage of 50m and 100m by approximately 0.5m, and an increase in beach level of up to 1.5m on the lower beach, between a chainage of 100m and 190m. The overall effect is the formation of a more undulating profile. The survey photograph in Plate 17 shows evidence of the accumulation of wind-blown on the access slipway.</p>	<p>Since the last survey, the beach at King Edward's Bay beach has been subject to some considerable change over the winter/spring months with the cross-shore movement of material across the beach, but notably accumulation of sand against the seawall and deposition of wind-blown sand on the slipway. The beach profile is now, as a result, more undulating.</p> <p><b>Longer term trends:</b> Although the changes observed since the last survey appear to be considerable, they are within the realms of previous change where a berm on the upper beach is not uncommon.</p>

- At King Edward's Bay, the beach has been subject to some considerable change over the winter/spring months with the cross-shore movement of material across the beach, but notably accumulation of sand against the seawall and deposition of wind-blown sand on the slipway. Otherwise, the recorded profiles present no causes for concern.

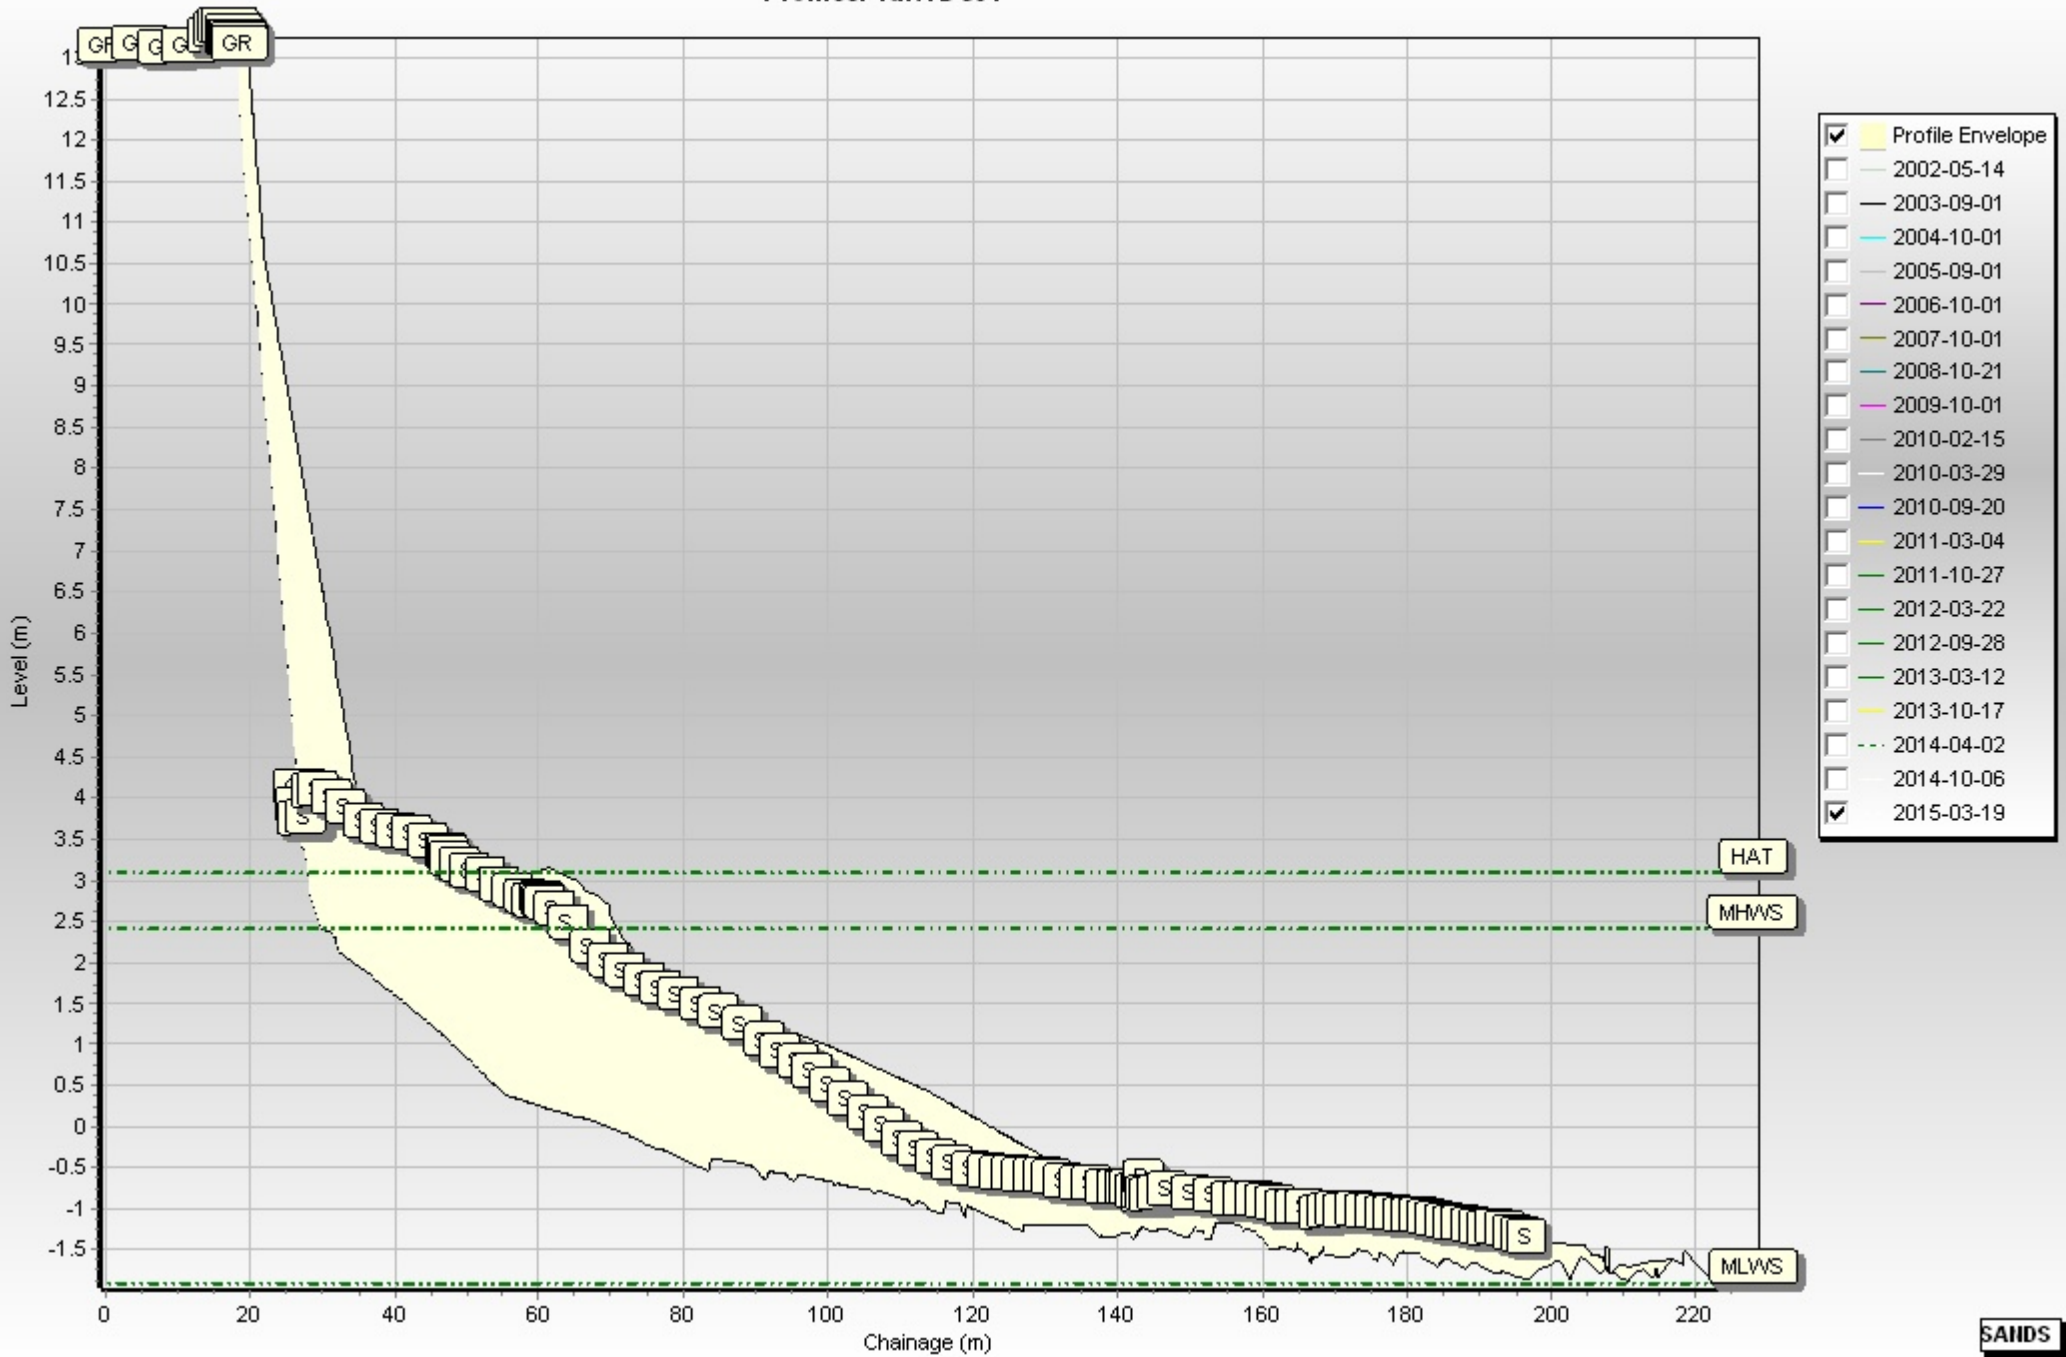
# Profiles: 1aNTDC01

Survey Date	Description of Changes Since Last Survey	Interpretation
Mar 2015	<p><b>Beach Profiles:</b></p> <p>Whitley Sands is covered by five beach profile lines for the Partial Measures survey (Appendix A). Four of these (1aNTDC01 to 1aNTDC04) were initially surveyed in April 2002 and were then re-surveyed annually to 2009 (Full Measures, autumn 2009) after which time they have been surveyed bi-annually. From March 2010 (Partial Measures, spring 2010) onwards, an additional beach profile line (NTDC04A) has been surveyed at the southern end of the frontage for the same time periods listed above. All profiles were last surveyed in autumn 2014 for the Full Measures survey.</p> <p><b>1aNTDC01</b> is located in the north of Whitley Sands, along the undefended cliffs immediately south of Trinity Road car park. The cliff profile shows the cliff to have retreated since the last survey, but comparison with previous surveys shows it in the same position as those, so the cliff is assumed to have remained stable and the change is a result of interpolation. Beach levels at the toe of the cliff have increased by 0.5m, but seaward of a chainage of 50m have generally decreased to leave a smoother profile.</p> <p>Profile <b>1aNTDC02</b> is located to the north of Whitley Sands opposite the seawall. Along this profile, there have been some fluctuations in profile height along the profile length, from the seawall to the lower rocky beach, to form a slightly more undulating profile. These changes are in the region of 0.2m, showing that the profile has generally remained stable since the last survey (Full Measures, autumn 2014).</p> <p>Profile <b>1aNTDC03</b> is located at the centre of Whitley Sands. Beach levels have increased by approximately 0.2m at the toe of the seawall, seaward to a chainage of 20m, and by approximately 0.5m seaward of the exposed rocky foreshore (seaward of a chainage of 90m). In between beach levels have fallen by approximately 0.2m, but the profile form has remained the same since the last survey (Full Measures, autumn 2014).</p> <p>Profile <b>1aNTDC04</b> is located to the south of Whitley Sands. The survey photograph taken during the most recent survey (see Plate 1) shows that the café and buildings that once existed on the promenade have</p>	<p>Since the last survey, beach levels at Whitley Sands have carried by approximately 0.5m, with relatively small changes in form as material has been moved across the beach. The largest change is observed at profile 1aNTCD04A, where beach level change was in the order of 0.7m.</p> <p>These changes indicate the occurrence of cross-shore transport occurring under winter/spring storms, and possibly the southerly movement of drawdown material to the southern end of the frontage.</p> <p>The construction of a new seawall to the north of 1aNTDC01 and the removal of the café and buildings at the site of profile 1aNTDC04A does not appear to have affected beach behaviour.</p> <p><b>Longer term trends:</b></p> <p>The data show that profiles are within the bounds of previous surveys, indicating generic behaviour with no clear trend.</p> <p>Aerial photographs show that the beach at the southern end of the White Sands (specifically profiles 1aNTDC04 and 1aNTDC04A) have been subject to a change in beach material; type, from sandy in the autumn of 2012 to a combination of shingle and sand, between autumn 2012 and autumn 2014, and back to</p>

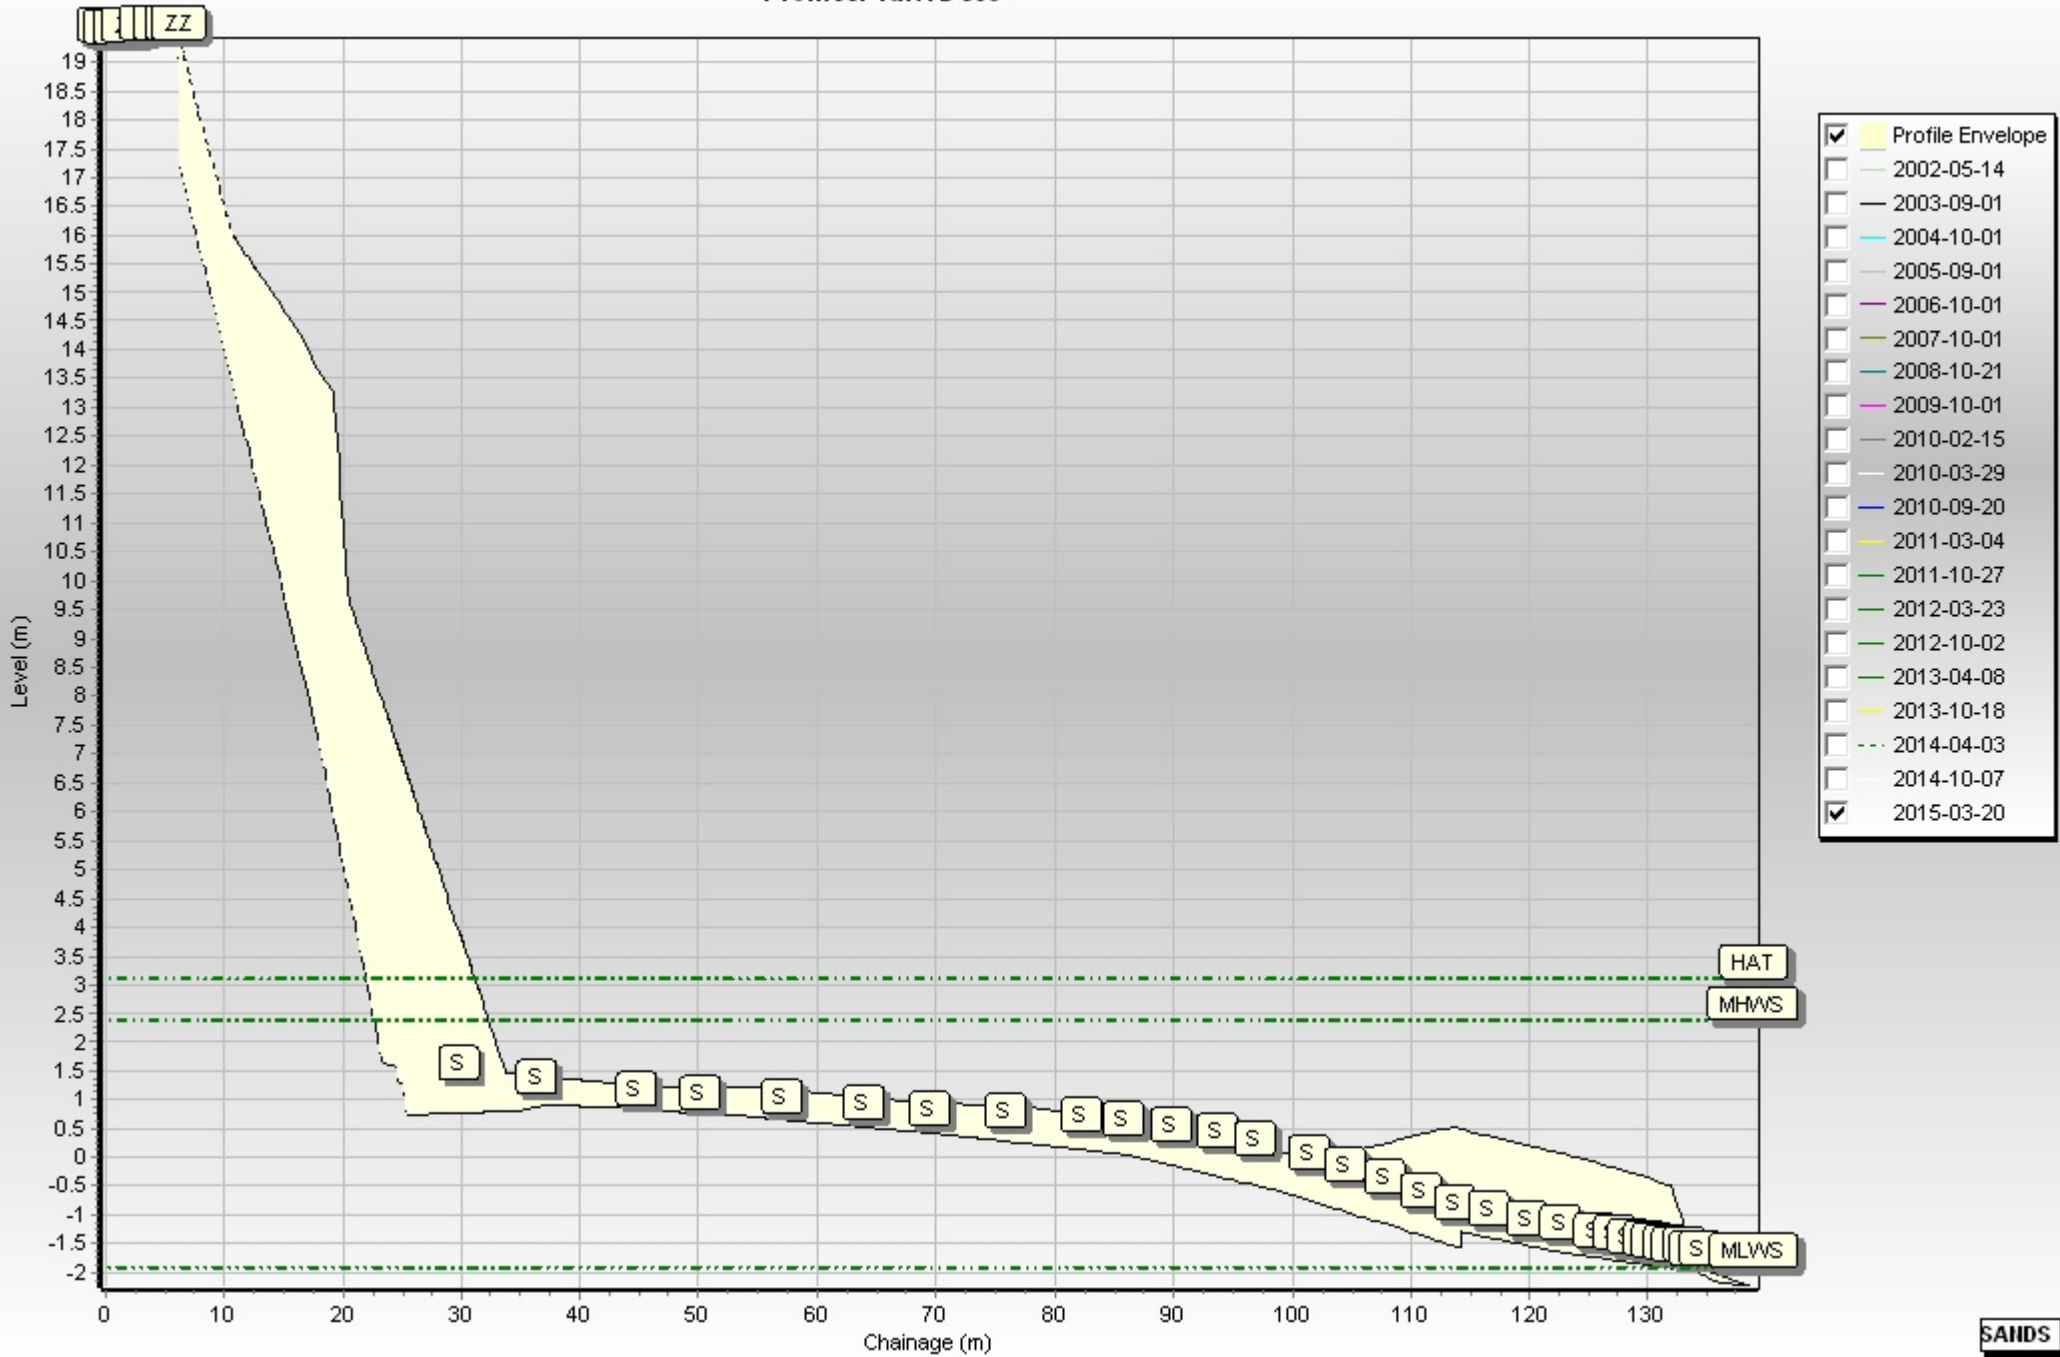
Profiles: 1aNTDC05

Survey Date	Description of Changes Since Last Survey	Interpretation
<p><b>Mar 2015</b></p>	<p><b>Beach Profiles:</b></p> <p>Cullercoats Bay is covered by one beach profile line for the Partial Measures survey (Appendix A). This was surveyed annually each autumn between 2002 and 2009. From spring 2010 onwards, it has been surveyed bi-annually. The last survey was the autumn 2014 Full Measures survey.</p> <p>The cliff top position along <b>1aNTDC05</b> has remained constant since surveys began in April 2002, but there have been apparent changes along the cliff face. The profile shows the cliff face to have advanced. However, this result is a function of interpolation between limited data points. Seaward of a chainage of 30m, the beach has been subject to change, with a reduction of beach level by approximately 0.2 on the upper flatter beach (chainage 30m to 85m) and an increase in beach levels by approximately 0.2m along the downward sloping middle/lower beach (chainage 85m to 130m).</p>	<p>Changes in beach level since the last survey are minimal, with a drop in beach levels on the upper beach are matched by an increased in beach levels on the middle/lower beach suggesting some movement of material across the beach in response to winter/spring storms.</p> <p><b>Longer term trends:</b> The beach levels observed are within the bounds of previous surveys, indicating generic behaviour with no clear trend.</p>

- At profile 1aNTDC05 the cliff was not measured due to dangerous access. Access to this profile is noted to have been dangerous in the previous partial measures and full measures reports, and therefore consideration should be given to changing the location of this survey.
- At Tynemouth Long Sands (profiles 1aNTDC06, 1aNTDC06A and 1aNTDC07) there was no access to the dunes in the middle of the profile due to seedling protection fences. This means it has not been possible to directly monitor the effectiveness of the dune stabilisation scheme, although observations made from the survey photographs do show the accumulation of sand in the lee of the dune fencing.

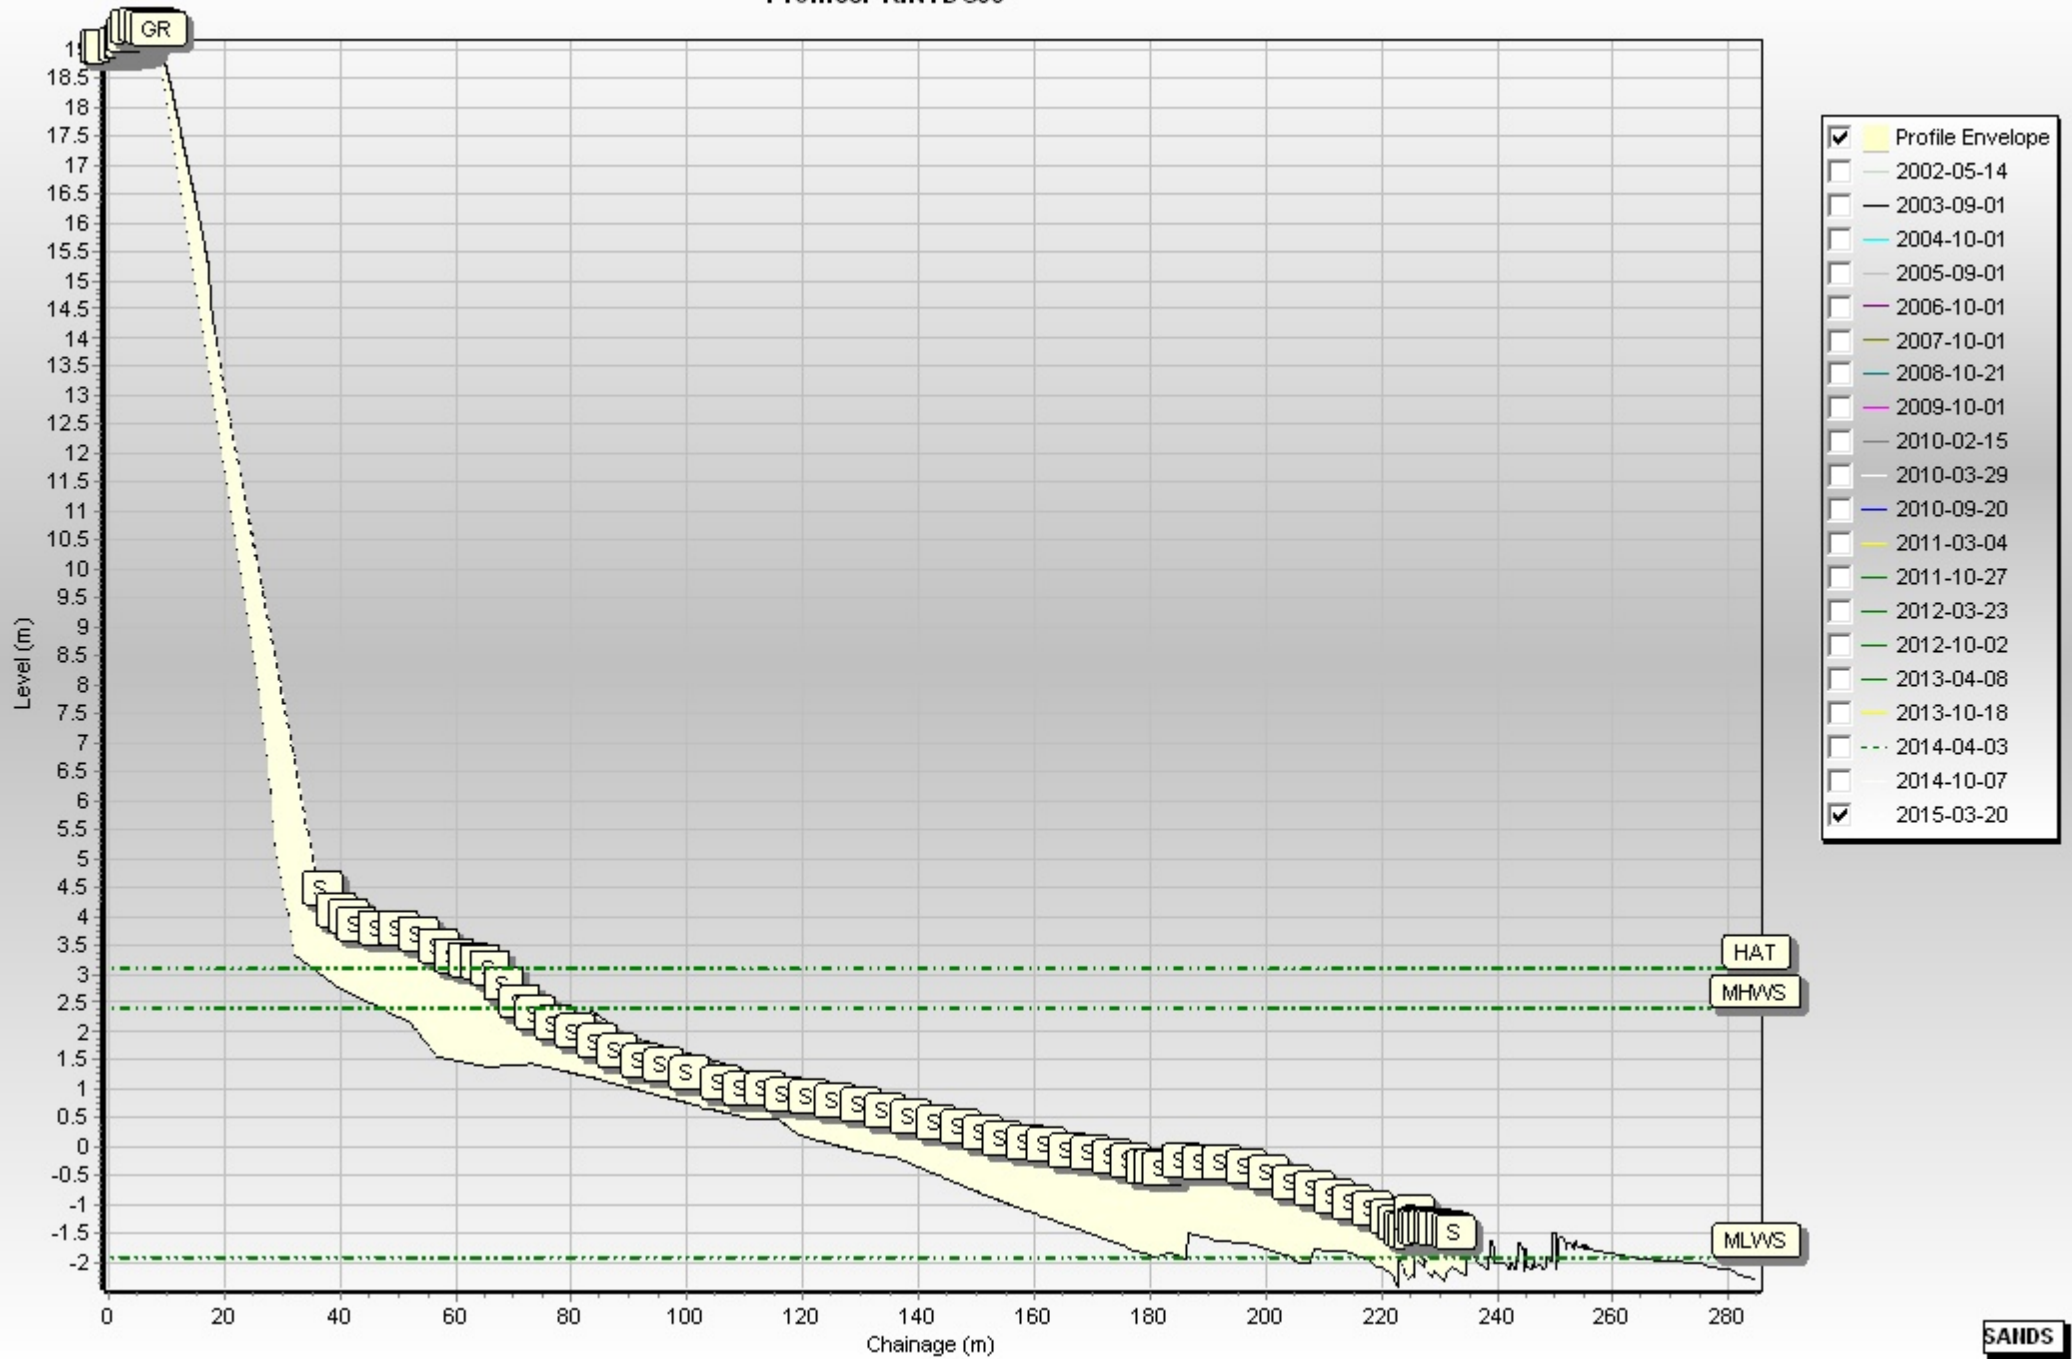
Profiles: 1aNTDC06

Survey Date	Description of Changes Since Last Survey	Interpretation
Apr 2015	<p><b>Beach Profiles:</b></p> <p>Tynemouth Long Sands is covered by three beach profile lines for the Partial Measures survey (Appendix A). Profiles 1aNTDC06 and 1aNTDC07 were initially surveyed annually each autumn between 2002 and 2009. A third profile, 1aNTDC06A, was later added in the centre of the frontage. From spring 2010 (Partial Measures) onwards, they have been surveyed bi-annually. The last survey was the autumn 2014 Full Measures survey.</p> <p><b>1aNTDC06</b> is located approximately 150m south of the access road/ramp towards the north of the bay. The profile for the dune-cliff face is limited due to a lack of data points in the profile plot; previous survey reports have noted "<i>no access to middle of section 6 due to seed protection fences</i>" and it is assumed that the same applies to the present survey. The survey photographs in Plates 13 and 14 show the dune face during the present and previous survey. Although there appears to be less vegetation, there is a clear build-up of sand behind the dune fencing and at the toe of the dune cliff. Beach levels have remained relatively stable, with movement anywhere between 0.1m and 0.2m across the beach with no clear trend.</p> <p>At profile <b>1aNTDC06A</b>, the profile for the dune-cliff face is a straight line; a result of a lack of data points in the profile plot. Previous survey reports have noted '<i>no access to middle of section 6A due to seed protection fences</i>' and it is assumed that the same applies to the present survey. The upper beach has accreted by approximately 0.7m since the previous survey, with build-up of sand against the dune fencing (see Plates 15 and 16). Beach levels seaward of a chainage of 180m have reduced by up to 0.7m. It is possible that material has been from the lower to the upper beach during the winter/spring months.</p> <p>Profile <b>1aNTDC07</b> is located approximately 50m south of the access route through the dunes towards the southern end of the bay. As with the other profiles the dune-cliff face is a straight line; a result of a lack of data points in the profile plot. Previous survey reports have noted '<i>no access to middle of section 7 due to seed protection fences</i>' and it is assumed that the same applies to the present survey. Beach levels have generally remained stable with discrete and adjacent sections of decrease/increase in the order of 0.2m at a chainage of around 80m and 250m. This suggests material has been moved seaward</p>	<p>At Tynemouth Long Sands, the dune-cliff face was not surveyed due to access constraints, but survey photographs suggest that there has been a build-up of wind-blown sand material in the lee of the defences and along the upper beach.</p> <p>Beach profile change has been relatively small over the winter/spring months since the last survey, with beach level change in the order of 0.2m to 0.7m, and generally showing a cross-shore movement of material both seaward and landward in response to winter/spring storms and wind-blown activity.</p> <p><b>Longer term trends:</b> Overall, the beaches have retained a similar form and are within the bounds of previous surveys.</p>

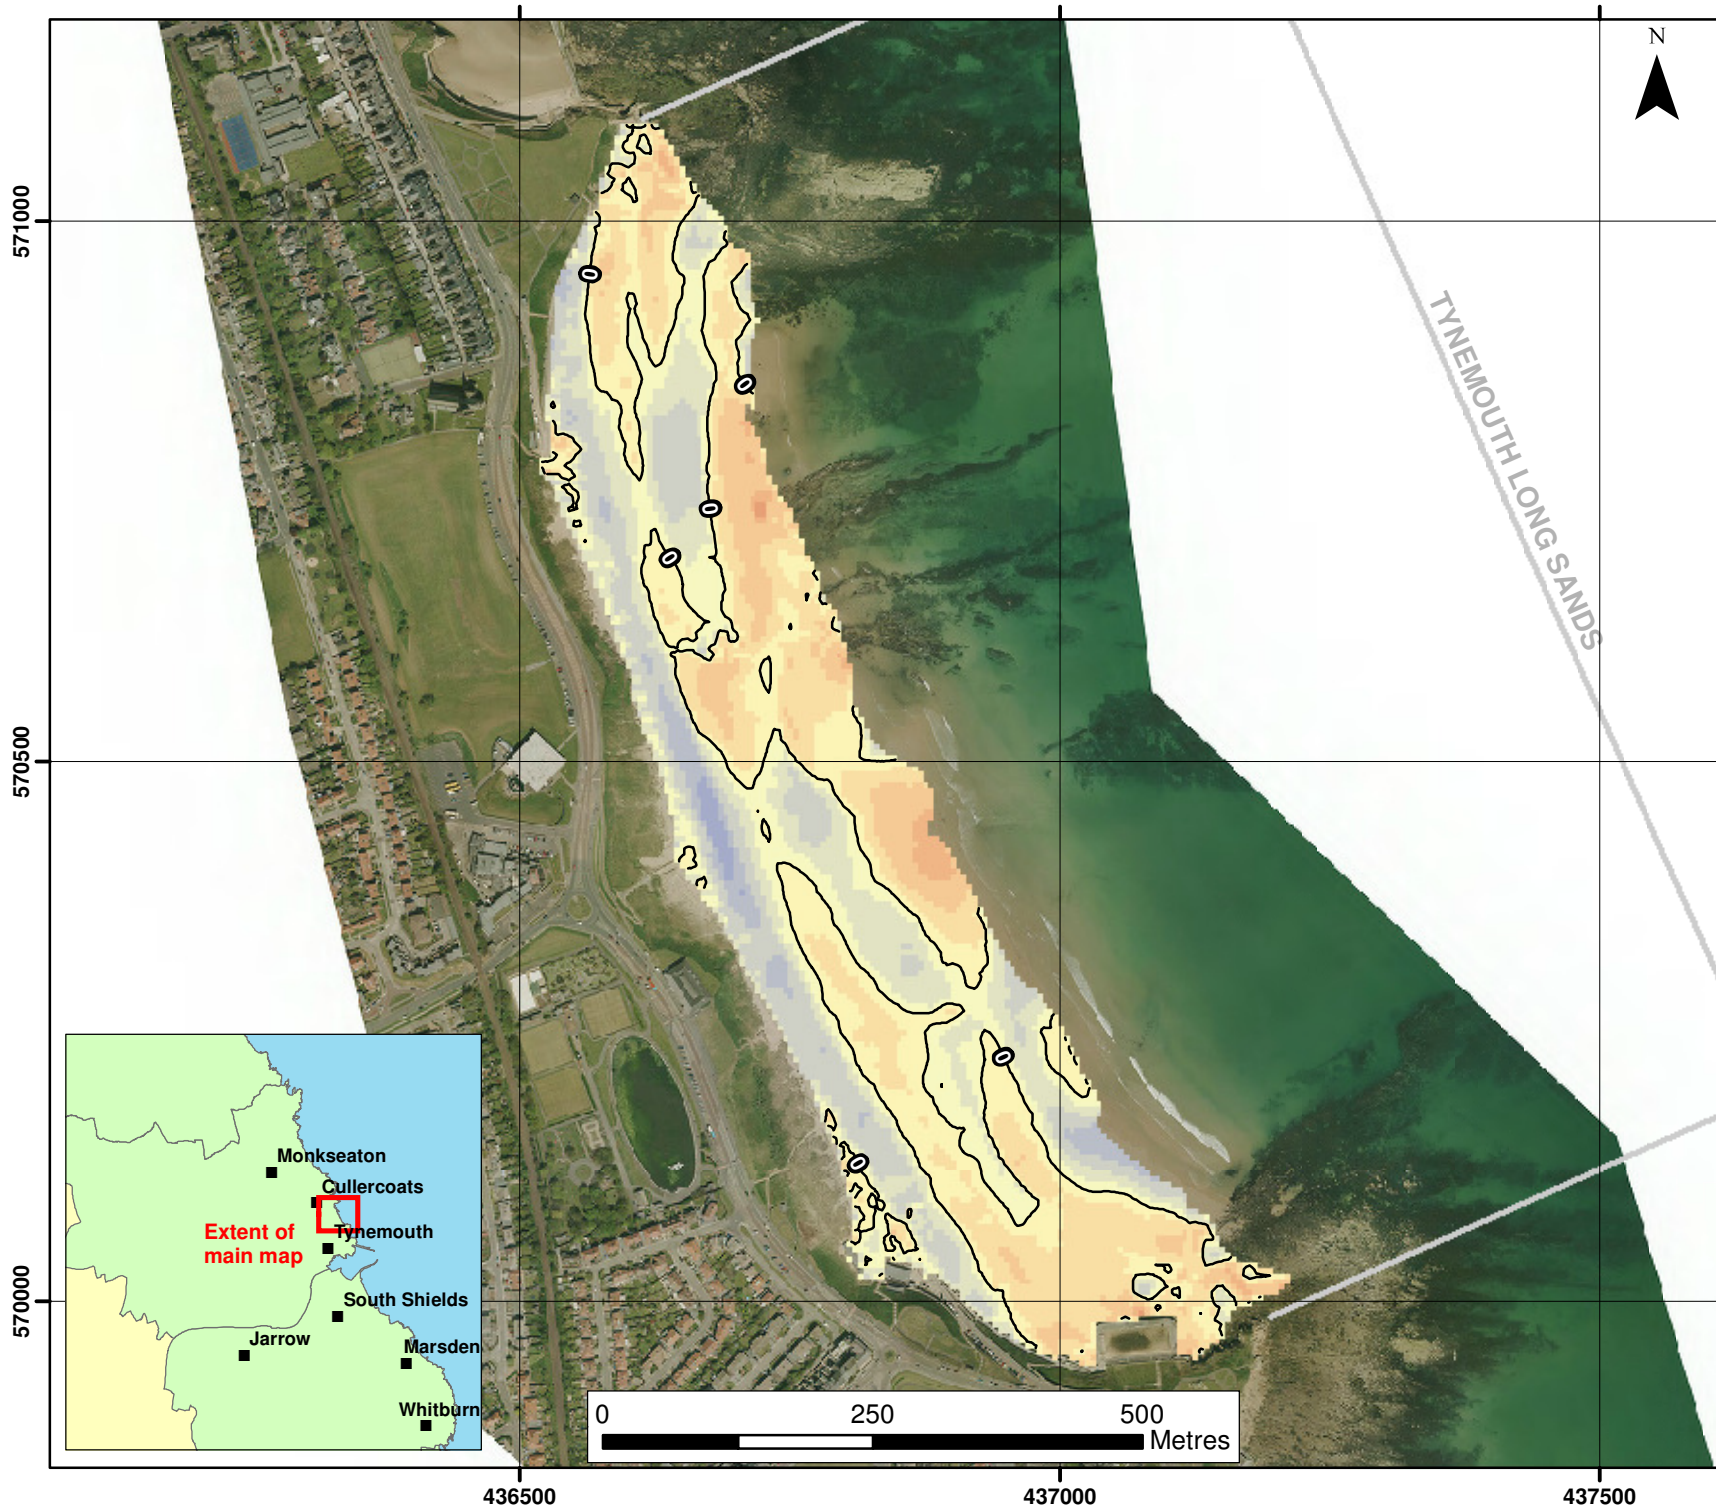
**Appendix B - Map 1b**  
**Short-term**  
**Elevation Change**  
**Tynemouth Long Sands**  
**North Tyneside Council**

**KEY** Autumn 2014 and Spring 2015  
Change in elevation (m)
