**Cell 1 Regional Coastal Monitoring Programme
Analytical Report 1: 'Full Measures' Survey 2008**

**South Tyneside Council
Final Report**

May 2009

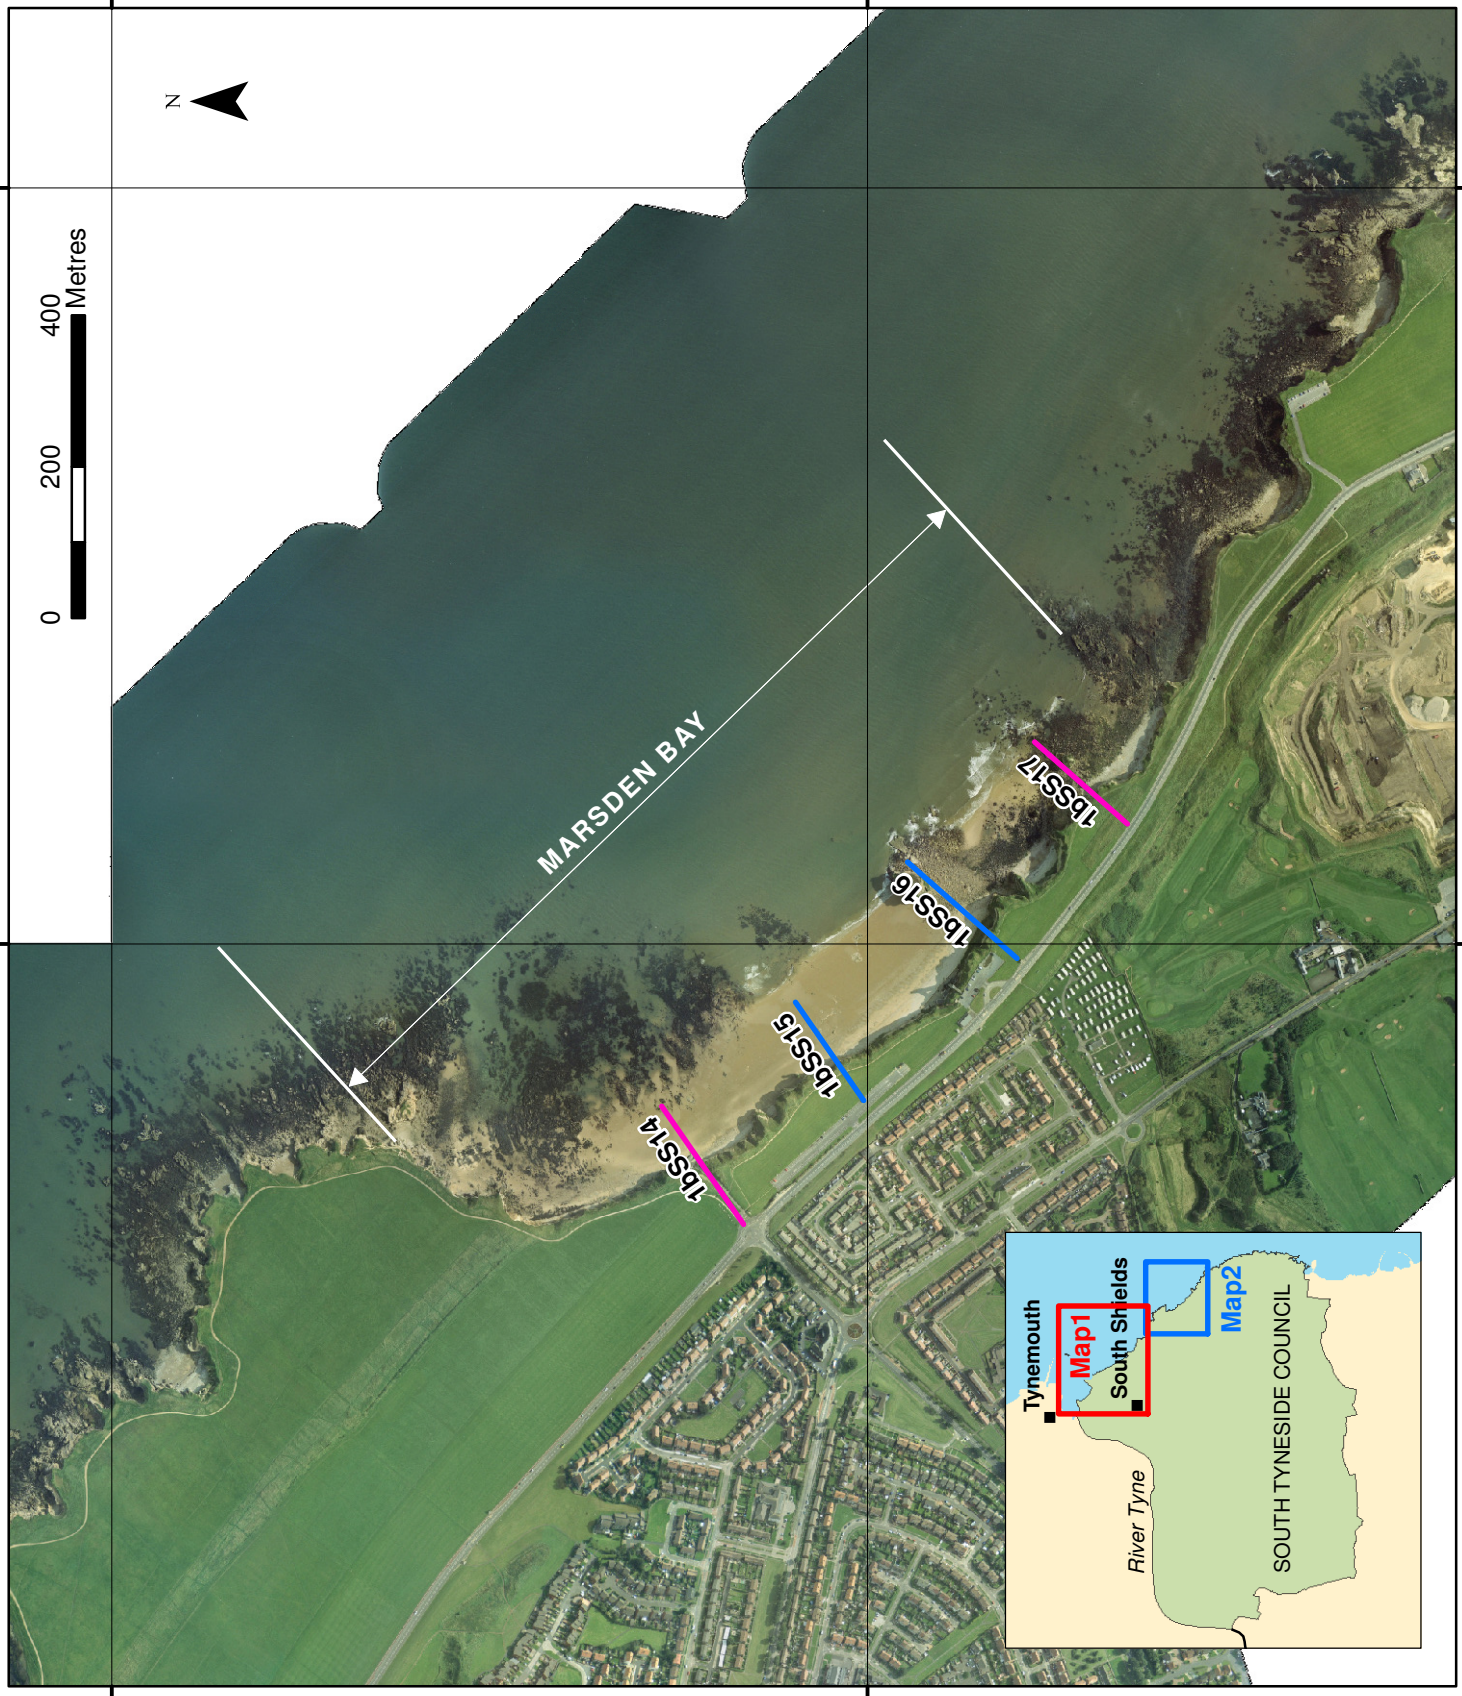
Figure 2 - Map 2 South Tyneside Council Frontage

SURVEY LOCATIONS

Topographic Profiles

- Annual
- Bi-Annual

Topographic Surveys

- 6 monthly
- yearly
- 5 yearly

Cliff Top Monitoring Pegs

- @ 50 centres
- @ 100 centres
- @ 300 centres

The location of these surveys is shown in Figure 2. Also enclosed on the accompanying CD-ROM is a file which can be opened in Google Earth showing the locations of the surveys.

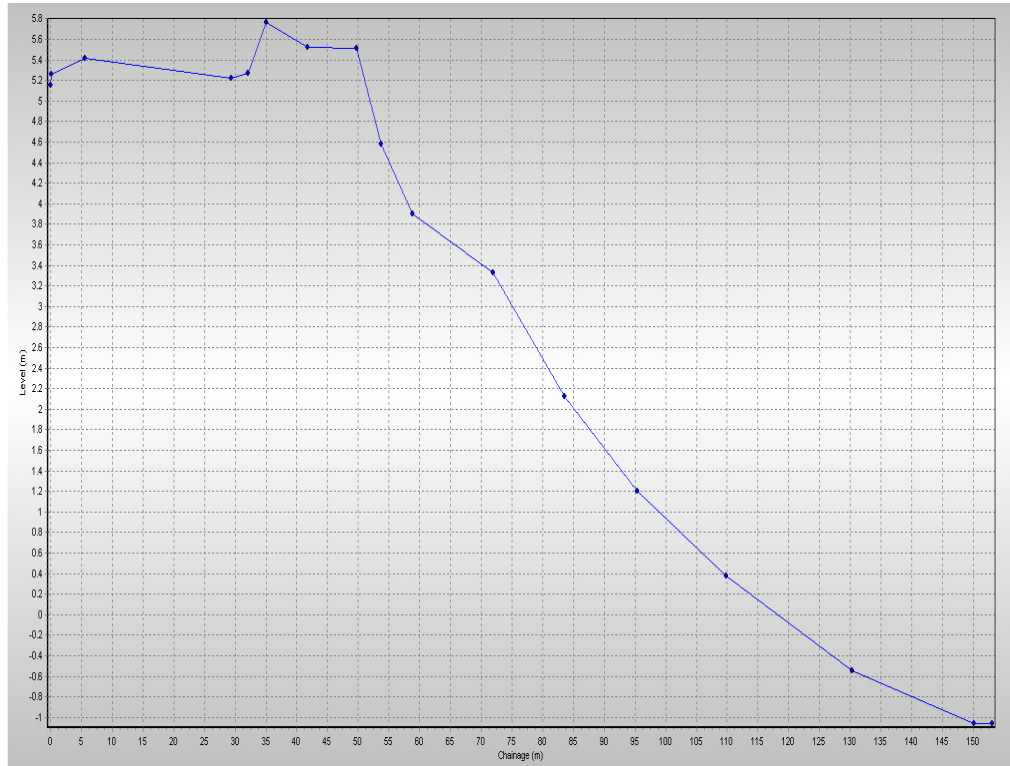
1bSS1

Easting 436810.000 **Northing** 568148.060 **Bearing** 45

Chainage	Level
0.000	5.154
0.124	5.257
5.546	5.418
29.331	5.226
32.084	5.272
35.067	5.766
41.722	5.522
49.698	5.514
53.681	4.582
58.886	3.906
71.885	3.326
83.487	2.129
95.436	1.199
109.882	0.374
130.277	-0.544
150.080	-1.061
153.087	-1.058

Survey Date	Description of Changes Since Last Survey	Interpretation
<p>11-2008 (Baseline)</p>	<p>Beach Profiles:</p> <p>Littlehaven Beach is covered by four beach profile lines, spaced between South Groyne and South Pier (Appendix A).</p> <p>SS1 is at the northern end, close to the Little Haven Hotel. The profile line starts across some of the hotel grounds before crossing the dunes and extending across the foreshore to low water. The dune crest level peaks at around 5.8mODN, with the backing land varying between 5.2mODN and 5.4mODN. The dunes and backing land are located well above the levels of MHWS, HAT and the 1 in 200 year extreme water level event.</p> <p>Profiles SS2 and SS3 are located in front of the Littlehaven Sea Wall – an area of present ongoing investigation into options for re-alignment. SS2 is about 75m south of the <i>Conversation Piece</i> art feature and the profile starts across open amenity land before crossing the seawall and then extending down the beach to around MLWS level. The seawall crest is recorded as peaking at about 4.5mODN, with sand levels at the toe of the wall at around 4.1mODN. Both of these levels are well above levels of MHWS and HAT, but the 1 in 200 year extreme sea level would interact with beach material (as presently recorded) only around 7m away from the face of the wall.</p> <p>SS3 shows a very different profile, with low beach levels at the toe of the wall. This profile line is located close to where the seawall protrudes seaward. It starts across the car park and then crosses the seawall crest, which peaks at around 4.4mODN. There is then a drop of some 1.8m down to beach levels. From the toe of the seawall, the beach profile extends down to around MHWS.</p> <p>SS4 is at the southern end of the beach, where the seawall is set further landward. The profile line starts across the dune/scrubland seaward of the B1334 road and extends across the seawall to the beach. There is a substantial width of beach, of around 60m, where levels are at or around a very healthy value of 3.9mODN before the profile levels drop down to MLWS.</p>	<p>The dunes in the north of Littlehaven Beach along SS1 are expected to be relatively stable as long as the sheltering effect of the South Groyne and both the North and South Piers at the entrance to the River Tyne estuary remains.</p> <p>If beach levels along SS2 were to drop, it could be envisaged that the toe of the seawall may be exposed and subject to attack. If high water levels combined with storm wave conditions, upper beach material could readily be removed.</p> <p>Low beach levels along SS3 give rise to some concern since it could lead to undermining of the wall toe, or overtopping by waves of the wall crest. The low beach levels at the seawall also offer only limited protection to the wall itself against direct wave attack.</p> <p>Beach width and levels along SS4 are relatively healthy, helped by the groyne-effect of the South Pier which acts to retain sand within Littlehaven Beach.</p>

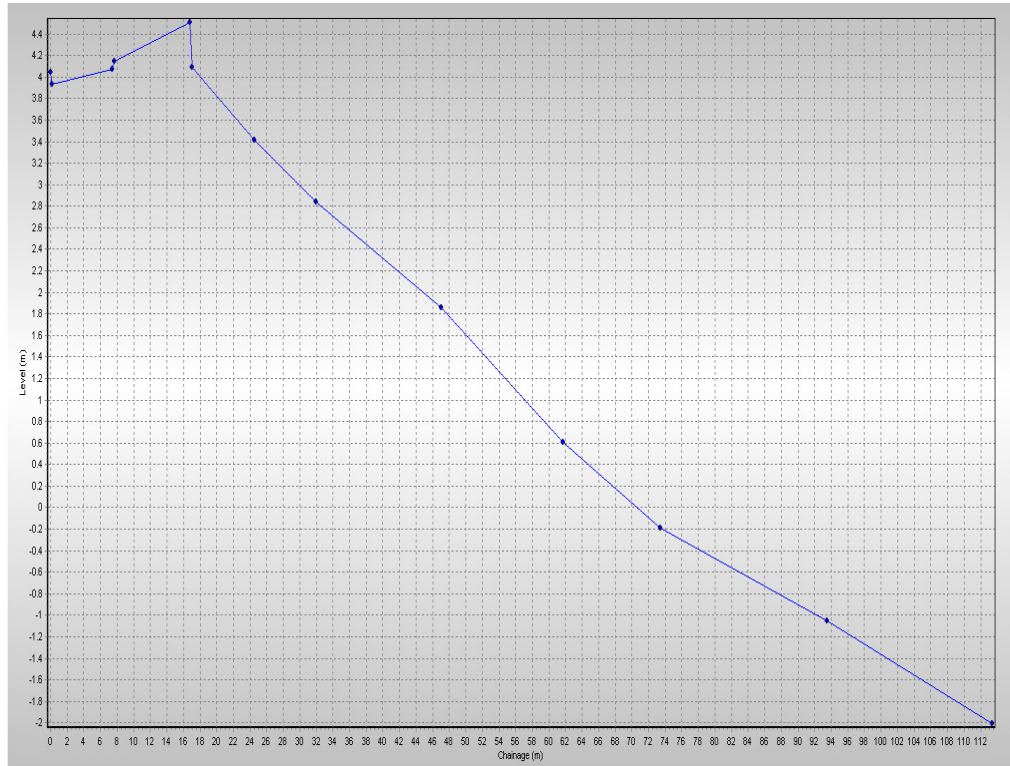
1bSS2

Easting 436919.710 **Northing** 568022.390 **Bearing** 45

Chainage	Level
0.000	4.040
0.160	3.935
7.460	4.070
7.640	4.143
16.810	4.508
17.050	4.091
24.520	3.415
31.970	2.836
47.040	1.857
61.740	0.604
73.420	-0.188
93.530	-1.050
113.390	-2.007

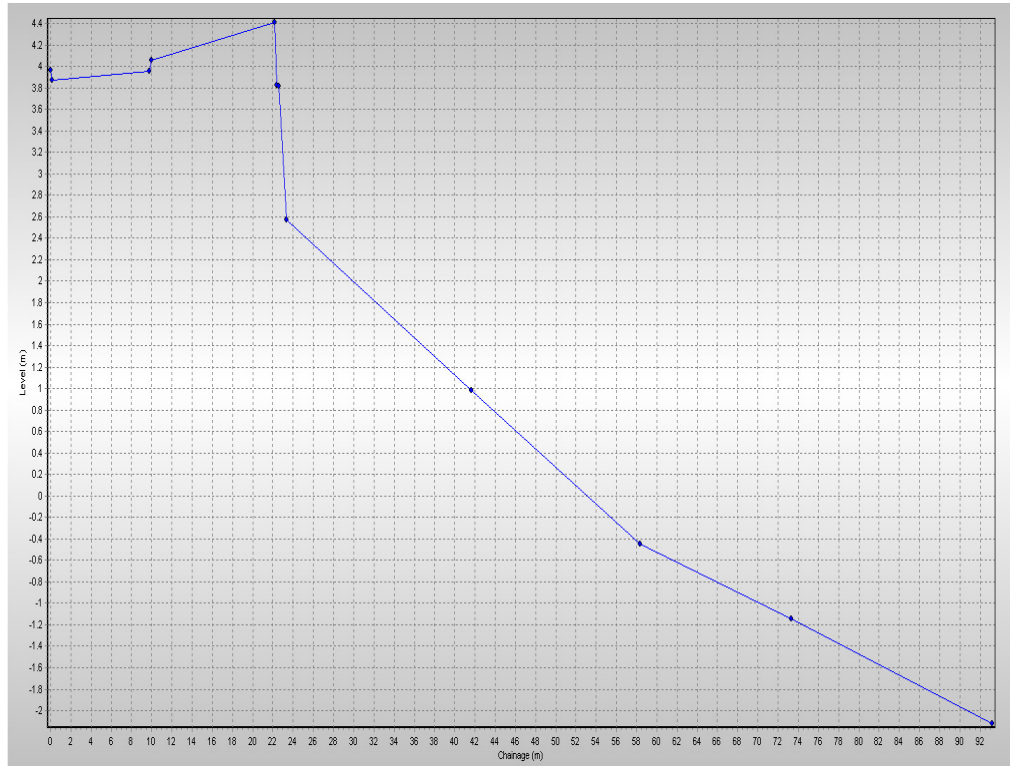
1bSS3

Easting 437034.010 **Northing** 567902.480 **Bearing** 45

Chainage	Level
0.000	3.961
0.170	3.873
9.790	3.959
9.980	4.058
22.140	4.410
22.380	3.828
22.610	3.813
23.350	2.575
41.660	0.986
58.370	-0.446
73.280	-1.146
93.200	-2.120

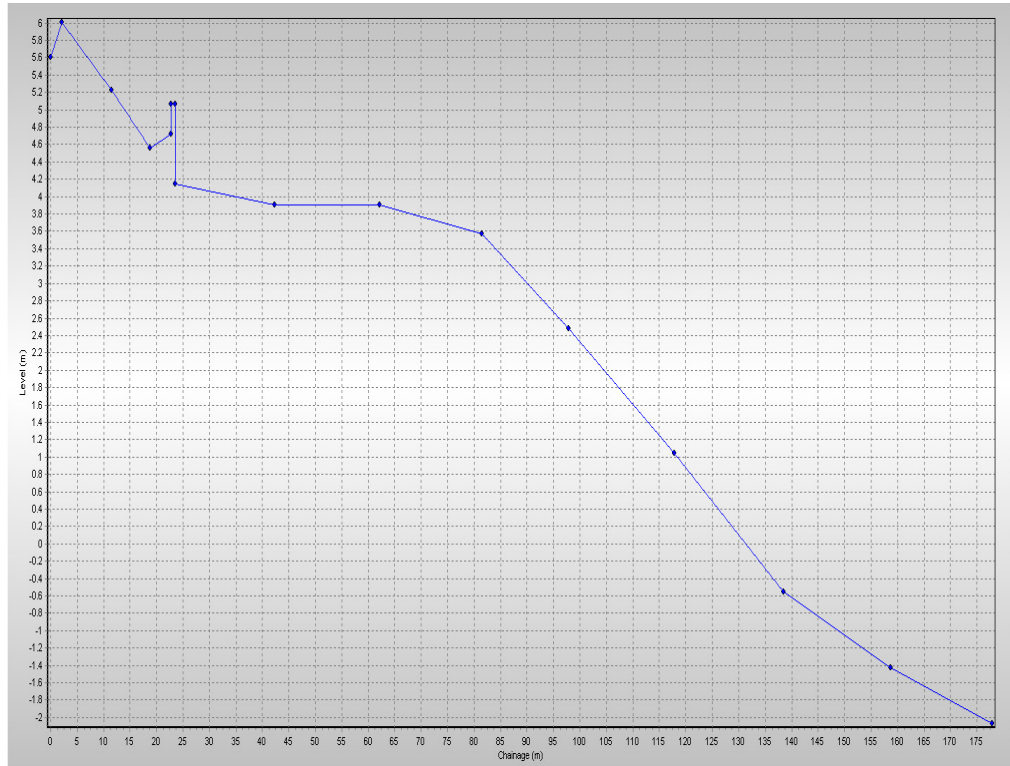
1bSS4

Easting 437113.940 **Northing** 567736.450 **Bearing** 45

Chainage	Level
0.000	5.603
2.160	6.007
11.530	5.227
18.800	4.560
22.770	4.715
22.780	5.064
23.530	5.060
23.540	4.143
42.350	3.907
62.100	3.904
81.520	3.573
97.810	2.485
117.870	1.042
138.490	-0.559
158.710	-1.432
177.890	-2.070

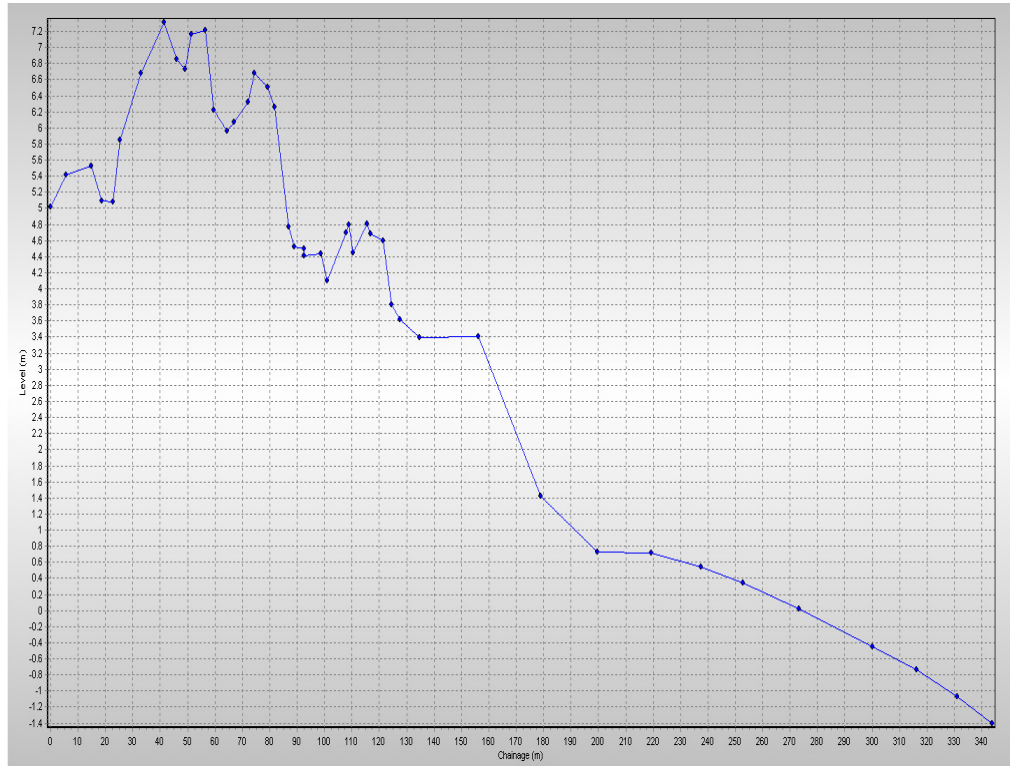
1bSS5

Easting 437448.700 **Northing** 567670.000 **Bearing** 55

Chainage	Level
0.000	5.016
5.715	5.420
14.717	5.531
18.554	5.092
22.763	5.080
25.301	5.843
32.863	6.676
41.535	7.312
46.096	6.858
49.017	6.726
51.379	7.164
56.616	7.219
59.475	6.223
64.499	5.964
67.013	6.067
72.176	6.314
74.328	6.674
79.340	6.511
81.713	6.260
86.790	4.776
89.063	4.528
92.561	4.496
92.615	4.407
98.584	4.431
100.851	4.100
107.873	4.696
108.820	4.794
110.530	4.448
115.604	4.810
116.923	4.688
121.340	4.596
124.474	3.806
127.633	3.616
134.611	3.389
156.152	3.406
178.817	1.420
199.548	0.726
219.422	0.721
237.430	0.544
252.841	0.349
273.175	0.016
300.009	-0.447
316.137	-0.740
331.008	-1.066
343.810	-1.405

Survey Date	Description of Changes Since Last Survey	Interpretation
<p>11-2008 (Baseline)</p>	<p>Beach Profiles:</p> <p>Herd Sands is covered by five beach profile lines, spaced between South Pier and the rock headland of Trow Point (Appendix A).</p> <p>SS5, at the northern end, starts across the dunes that have built up immediately adjacent to the South Pier. These dunes are around 150m in width and contain several ridges. The landward dune crest peaks at a maximum crest level of 7.2mODN. The seaward face of the dunes exhibits a relatively steep and very distinct slope, leading down to the foreshore. MHWS acts mid-way up this distinct slope. Beach levels in front of the toe of this slope are relatively low, being around 0.7mODN and shelve steeply down to low water.</p> <p>There is a slightly narrower width of dunes, around 100m, along SS6. Here there are only two distinct dune crests, both quite narrow and steep. The seaward crest is the highest, reaching a crest level of around 7.7mODN. The toe of this fronting ridge is well above HAT, being at around 4mODN, but upper beach levels just 10m or so in front of the toe are within a zone located between the levels of MHWS and the 1 in 200 year storm event.</p> <p>Along SS7, the profile line starts at the promenade in front of the amphitheatre, at a level of around 4.9mODN, and extends seaward across the foreshore. Beach levels at the toe of the promenade were healthy and reached almost up to promenade level.</p> <p>SS8 is located near to Gypsies' Green and extends from the promenade seaward across the foreshore. This promenade severs the backing dune/scrubland from the fronting beach. The promenade reaches a crest level of just under 5.4mODN, but there is a sudden drop of some 0.8m down to beach levels. From the toe of the defence, a narrow width of around only 20m exists before the beach levels drop, initially very steeply and then more gradually, down to low water.</p> <p>At the southern end of Herd Sands, SS9 shows that a narrow but high (around 9.8mODN) dune ridge has developed in the lee of Trow Point. The toe of these dunes and upper beach levels are relatively healthy, with the profile exhibiting a classic concave morphology down to low water.</p>	<p>It appears that MHWS would act part-way up the slope on the seaward face of the dunes along SS5. This suggests that covered by the wind-blown sand may be an underlying structure of some form which is helping to stabilise the dunes.</p> <p>SS6 could be subject to erosion at the toe of the dunes during storm events, especially if coinciding with high spring tides. Due to the steep and narrow morphology of the seaward dune crest, this could lead to step-back of the shoreline during a major event.</p> <p>SS7 presently has healthy beach levels in front of the promenade.</p> <p>SS8 has low and relatively narrow beach levels in front of the promenade, with a relatively rapidly shelving profile to seaward. It will be important to continue to monitor this section for changes in beach levels that could lead to increased exposure for the promenade. It is the frontage between the amphitheatre and Gypsies' Green that appears the most vulnerable, based on the DGM that has been created from the topographic survey.</p> <p>From SS9 it appears that Trow Point provides an important anchoring effect on Herd Sands, by stabilising beach levels, leading to dune development, in the southern part of the frontage.</p>

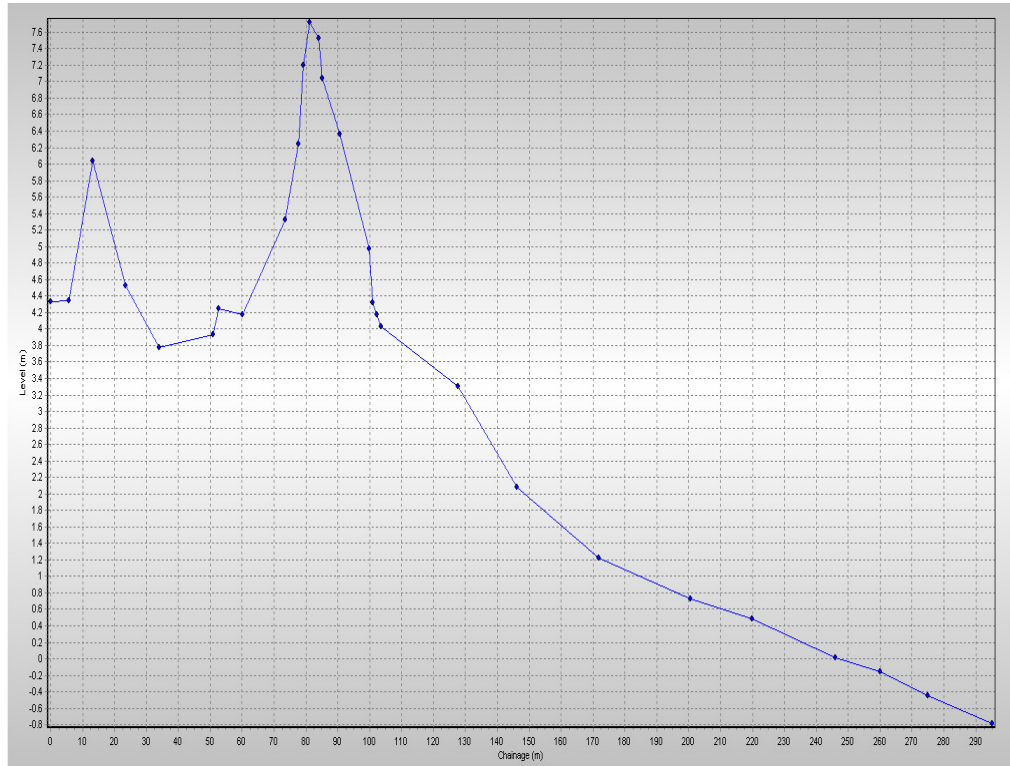
1bSS6

Easting 437573.880 Northing 567388.820 Bearing 53

Chainage	Level
0.000	4.336
5.727	4.346
13.110	6.040
23.422	4.523
34.045	3.773
50.821	3.937
52.611	4.245
60.018	4.175
73.537	5.324
77.655	6.239
79.158	7.193
81.181	7.718
84.068	7.527
85.128	7.042
90.687	6.365
99.844	4.970
101.042	4.316
102.210	4.176
103.626	4.033
127.609	3.303
146.049	2.087
171.850	1.224
200.512	0.722
219.879	0.479
245.916	0.015
260.039	-0.155
274.970	-0.446
295.129	-0.785

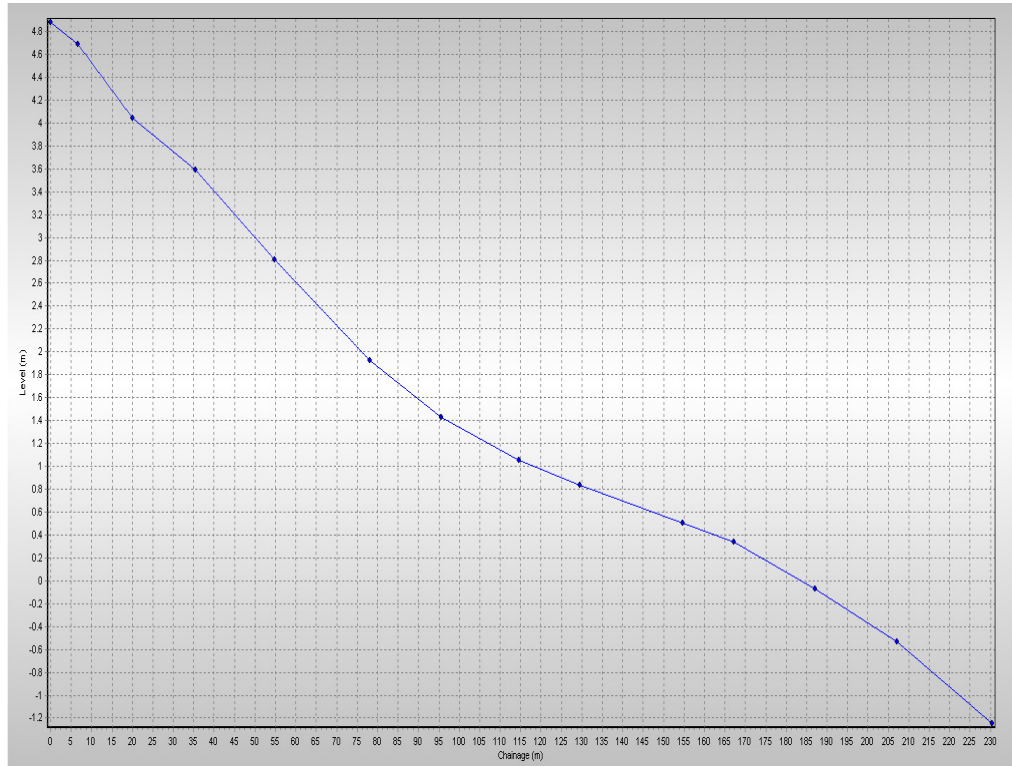
1bSS7

Easting 437793.070 **Northing** 567153.710 **Bearing** 52

Chainage	Level
0.000	4.879
6.739	4.684
19.958	4.045
35.406	3.586
54.879	2.804
78.108	1.927
95.543	1.429
114.520	1.050
129.519	0.835
154.628	0.508
167.153	0.334
186.990	-0.071
207.059	-0.531
230.407	-1.248

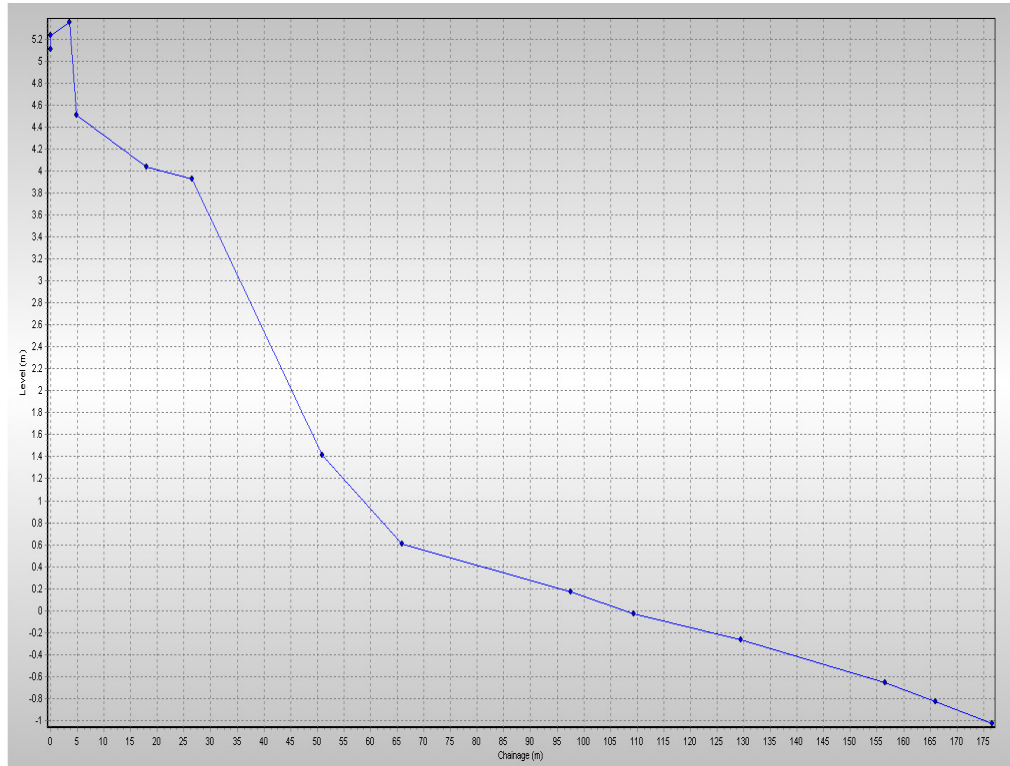
1bSS8

Easting 437996.550 **Northing** 566926.500 **Bearing** 48

Chainage	Level
0.000	5.109
0.065	5.235
3.563	5.351
4.795	4.510
17.926	4.031
26.462	3.928
50.957	1.411
65.900	0.603
97.619	0.166
109.346	-0.026
129.402	-0.262
156.575	-0.658
166.005	-0.827
176.599	-1.028

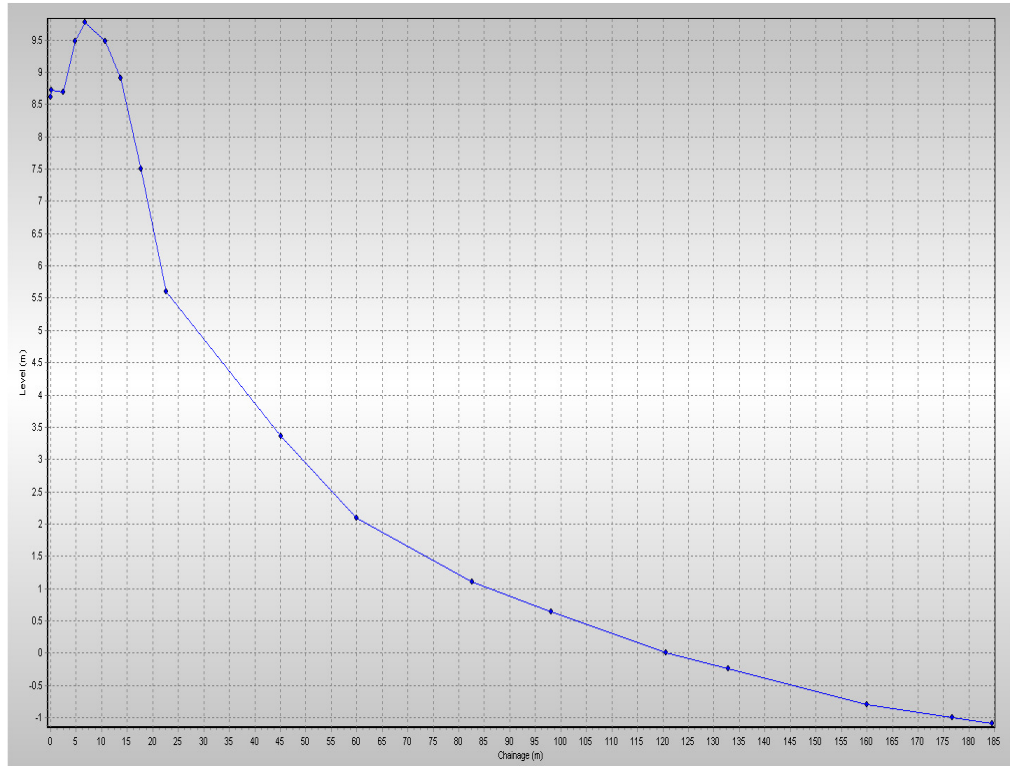
1bSS9

Easting 438183.430 **Northing** 566678.820 **Bearing** 46

Chainage	Level
0.000	8.606
0.081	8.728
2.472	8.695
4.777	9.478
6.784	9.771
10.644	9.477
13.678	8.907
17.634	7.500
22.574	5.605
45.182	3.357
59.979	2.092
82.599	1.105
98.102	0.643
120.548	0.009
132.820	-0.234
159.942	-0.799
176.693	-0.992
184.546	-1.091

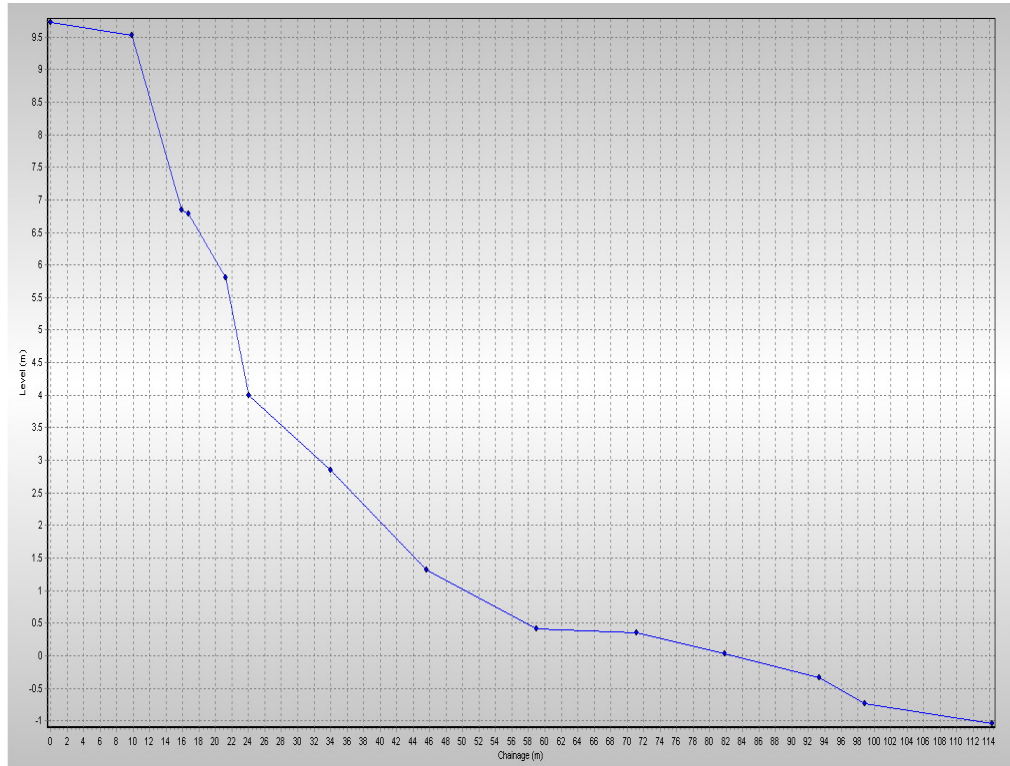
1bSS10

Easting 438408.760 **Northing** 566539.730 **Bearing** 47

Chainage	Level
0.000	9.724
9.883	9.519
15.864	6.842
16.753	6.780
21.205	5.798
24.046	3.997
33.966	2.843
45.668	1.324
59.020	0.412
71.173	0.347
81.864	0.033
93.345	-0.341
98.801	-0.741
114.310	-1.041

Survey Date	Description of Changes Since Last Survey	Interpretation
<p>11-2008 (Baseline)</p>	<p>Beach Profiles:</p> <p>Trow Quarry is covered by four profile lines (Appendix A).</p> <p>SS10 is in the northern end of Graham's Sand and was surveyed following completion of the rock armour revetment in this bay in November 2008. The profile line starts on the amenity grassland at Trow Lea (around 9.7mODN) and then extends across the re-graded coastal slope, the revetment structure, and the foreshore. The undulation in foreshore level between around 60m and 90m chainage is where some rock outcrops exist.</p> <p>SS11 is at the very southern end of Graham's Sand and extends from the coastal slope (around 9.6mODN) across the temporary construction haul road. Where the profile increases dramatically in level, between 34m and 39m chainage, it is clipping the western edge of Target Rock. Just seaward of here, the profile runs across rocky foreshore, as indicated by the sharp variations in level, before reaching more uniform levels.</p> <p>SS12 is located towards the southern end of Southern Bay and extends from the amenity grassland (around 14.7mODN) down the re-graded coastal slope and across the rock armour revetment to the foreshore, from where levels gradually drop down to low water.</p> <p>SS13 is located just to the east of Frenchman's Point and extends from the cliff top amenity grassland (21.2mODN) to the near vertical cliff edge. There is then a rocky foreshore located at the toe of the cliffs.</p>	<p>SS10 shows that the rock armour revetment, completed in 2008, was maintaining its 'as built' gradient and foreshore levels at the toe were unaffected by the scheme.</p> <p>SS11 is presently located along an area of coastline that is not envisaged to change in position or level due to the nature of the underlying geology. Whilst the 2008 survey provides a useful characterisation of this section of coast, it is considered more advantageous to move the profile slightly further north to a new location with Graham's Sand.</p> <p>SS12 shows that the rock armour revetment, completed in 2008, was maintaining its 'as built' gradient and foreshore levels at the toe were unaffected by the scheme.</p>

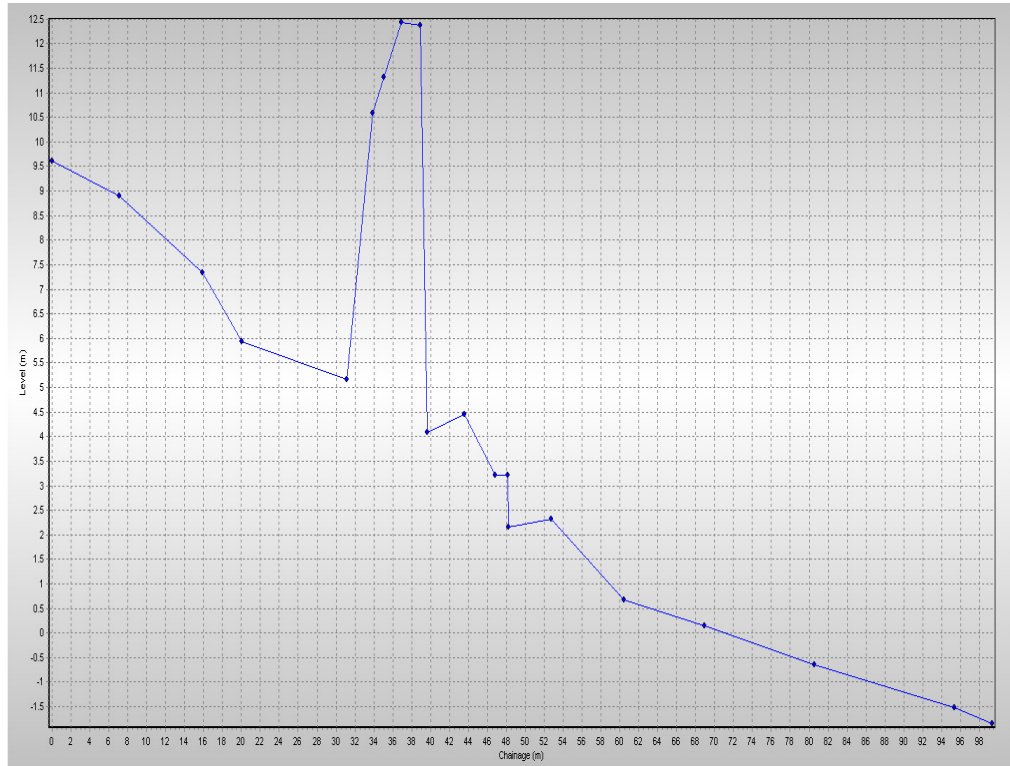
1bSS11

Easting 438561.550 **Northing** 566477.430 **Bearing** 48

Chainage	Level
0.000	9.620
7.099	8.894
15.906	7.332
20.014	5.930
31.143	5.154
33.913	10.593
35.035	11.320
36.938	12.434
38.907	12.371
39.657	4.096
43.535	4.443
46.802	3.216
48.120	3.223
48.257	2.151
52.718	2.317
60.400	0.675
68.941	0.143
80.555	-0.645
95.324	-1.511
99.342	-1.843

As discussed in Section 2.3, whilst profile lines SS11, SS12 and SS13 provide useful data in their present locations, it is considered that they would provide enhanced benefit if SS11 was relocated within Graham's Sand to better complement the location of SS10, and if both SS12 and SS13 were relocated to within Southern Bay. Suggested revised locations are shown in Figure 3.

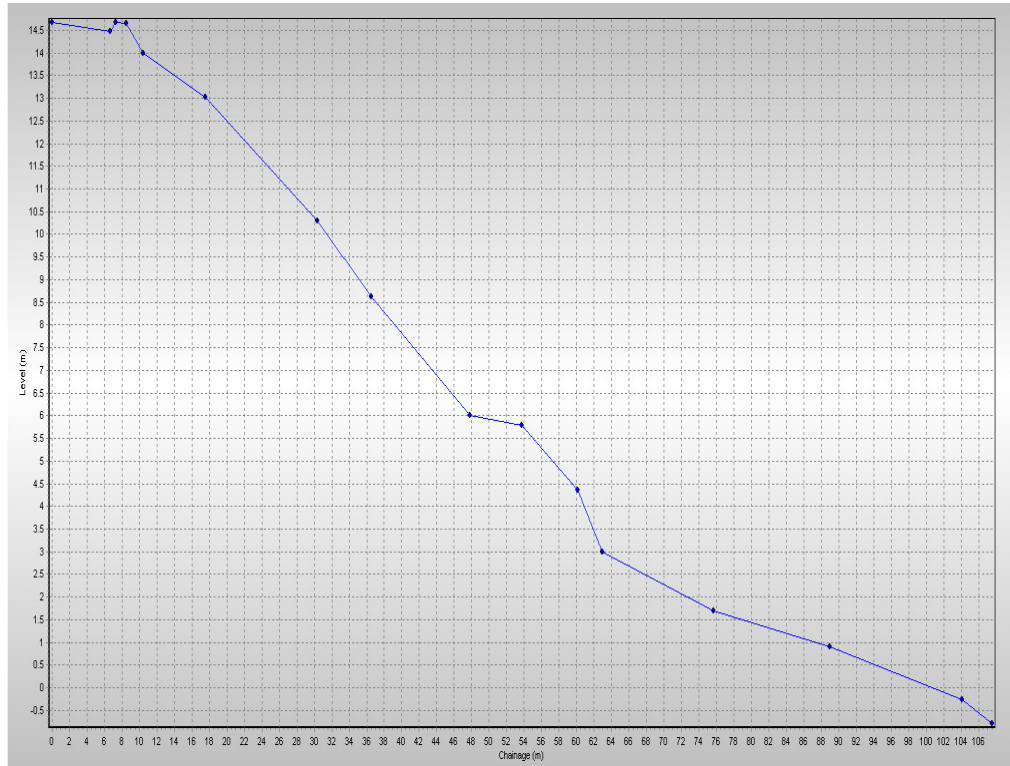
1bSS12

Easting 438759.410 **Northing** 566377.730 **Bearing** 48

Chainage	Level
0.000	14.666
6.656	14.470
7.322	14.673
8.506	14.660
10.407	13.993
17.558	13.026
30.322	10.301
36.542	8.633
47.782	6.001
53.753	5.794
60.111	4.361
62.972	2.996
75.708	1.693
88.956	0.916
104.072	-0.268
107.555	-0.788

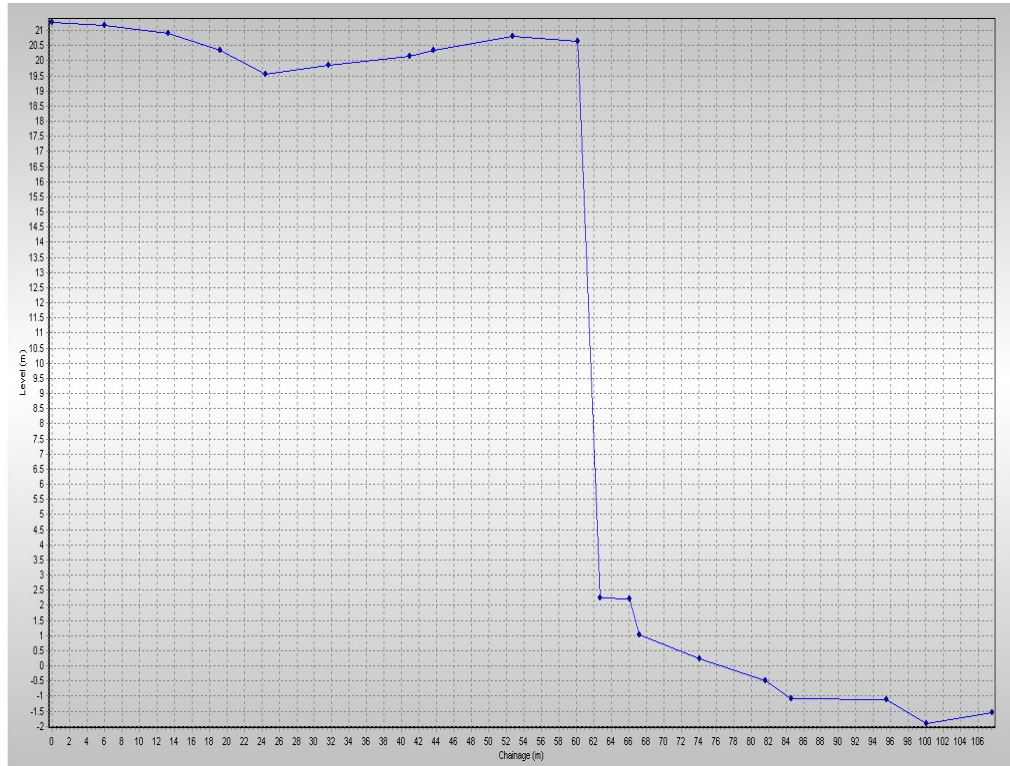
1bSS13

Easting 438847.300 Northing 566202.960 Bearing 47

Chainage	Level
0.000	21.269
5.991	21.167
13.263	20.912
19.249	20.341
24.446	19.566
31.626	19.862
40.927	20.140
43.620	20.334
52.731	20.812
60.160	20.658
62.743	2.239
66.086	2.218
67.185	1.035
74.132	0.220
81.615	-0.487
84.631	-1.072
95.505	-1.114
100.080	-1.907
107.587	-1.533

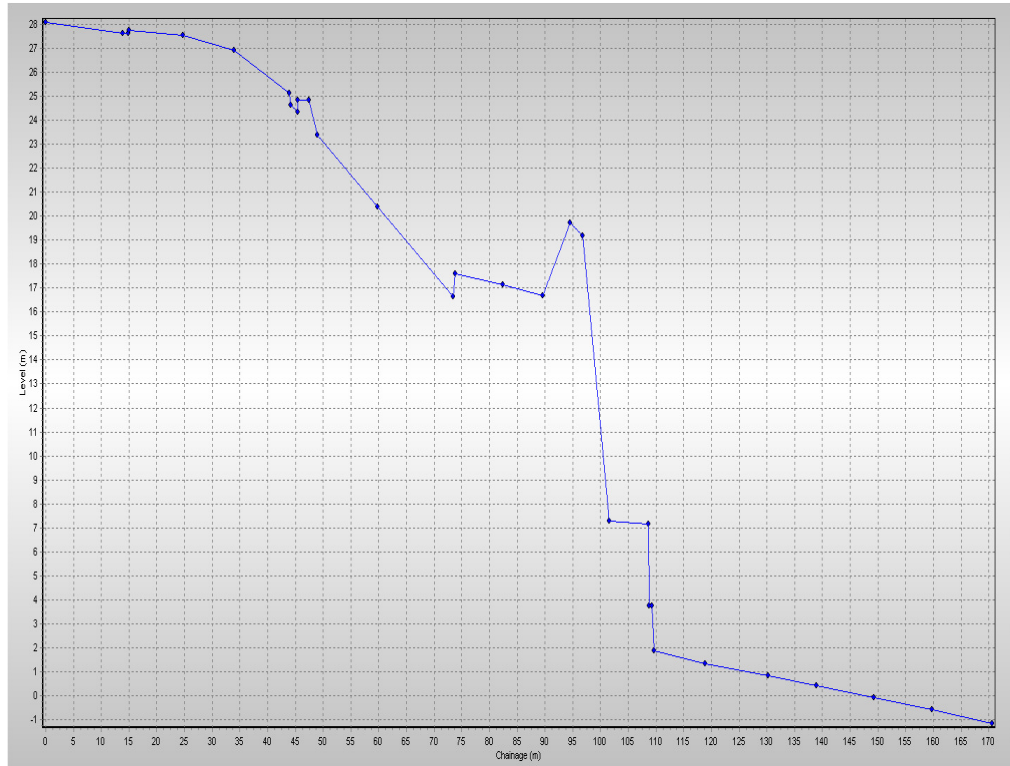
1bSS14

Easting 439630.450 **Northing** 565163.520 **Bearing** 55

Chainage	Level
0.000	28.068
13.839	27.619
14.864	27.613
15.062	27.750
24.737	27.531
33.955	26.918
43.968	25.105
44.179	24.626
45.410	24.346
45.465	24.832
47.483	24.815
48.900	23.355
59.811	20.368
73.445	16.633
73.879	17.597
82.380	17.137
89.643	16.695
94.530	19.701
96.750	19.179
101.537	7.268
108.706	7.140
108.712	3.753
109.258	3.744
109.656	1.893
118.907	1.324
130.182	0.855
138.908	0.417
149.269	-0.074
159.813	-0.554
170.603	-1.156

Survey Date	Description of Changes Since Last Survey	Interpretation
<p>11-2008 (Baseline)</p>	<p>Beach Profiles:</p> <p>Marsden Bay is covered by four profile lines (Appendix A).</p> <p>SS14 is located towards the northern end of Marsden Bay, at the northern-most access point. The profile extends across the coastal cliff, which has a bevelled shape, to the concrete platform at the cliff toe. Beach levels at the toe of this structure are relatively low, at around only 2mODN, which means that MHWS will be intercepted by the wall. Beach levels drop from here at a uniform gradient to low water at the time of the survey.</p> <p>SS15 extends from the public car park (at over 30mODN) across the cliff top grassland to the cliff edge. A near-vertical drop then occurs to the cliff toe, where a small amount of scree is deposited. Beach levels then gradually drop off to low water.</p> <p>SS16, which extends out to Marsden Rock, shows a very similar profile, although there is a near-horizontal ledge at the cliff toe.</p> <p>SS17 exhibits a very similar form to SS15 and SS16, although foreshore levels are lower than along SS16.</p>	<p>Low beach levels in the north of the Bay may affect the condition of the wall at the toe of the concrete wall at northern-most access point (SS14).</p> <p>Elsewhere within the Bay (SS15, SS16 and SS17), the behaviour tends to be linked to small and localised rock falls releasing debris to the toe of the cliff, where it accumulates as scree.</p> <p>SS15, which extends out to Marsden Rock, runs across a slightly elevated platform of boulders and scree which has accumulated in the lee of the rock stack, forming a tombolo feature.</p>

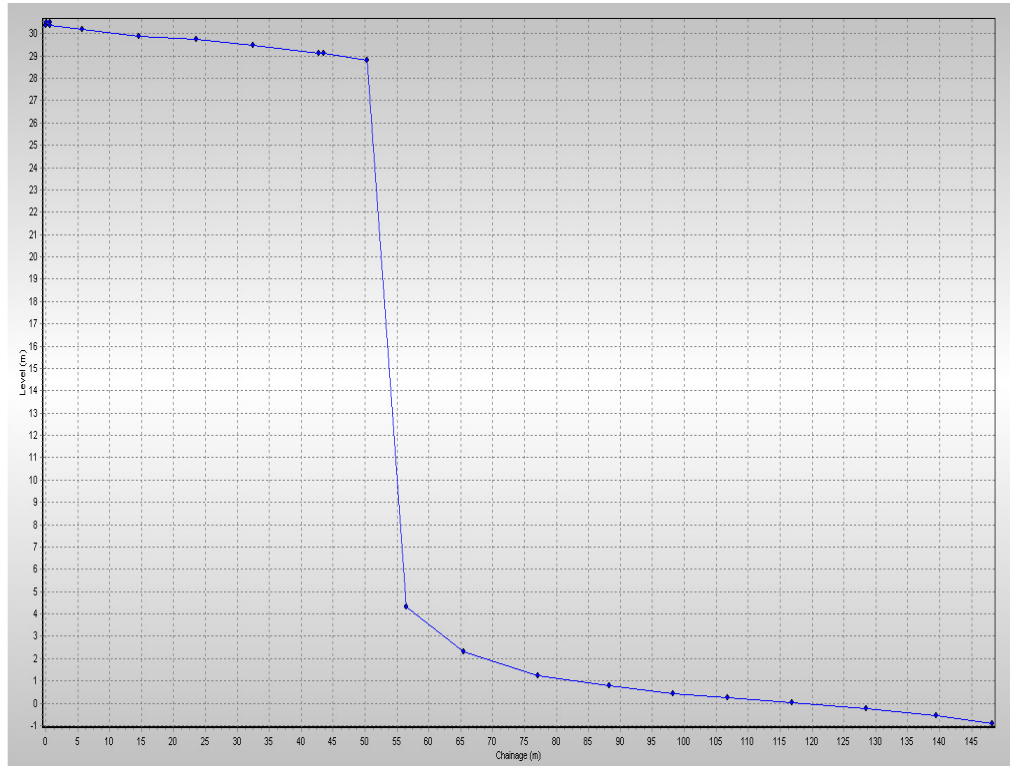
1bSS15

Easting 439795.290 **Northing** 565005.900 **Bearing** 55

Chainage	Level
0.000	30.374
0.078	30.506
0.608	30.504
0.622	30.355
5.671	30.171
14.593	29.878
23.557	29.752
32.451	29.472
42.777	29.100
43.508	29.108
50.341	28.813
56.473	4.318
65.424	2.321
77.067	1.226
88.227	0.774
98.250	0.442
106.748	0.230
116.922	0.020
128.470	-0.237
139.453	-0.562
148.232	-0.916

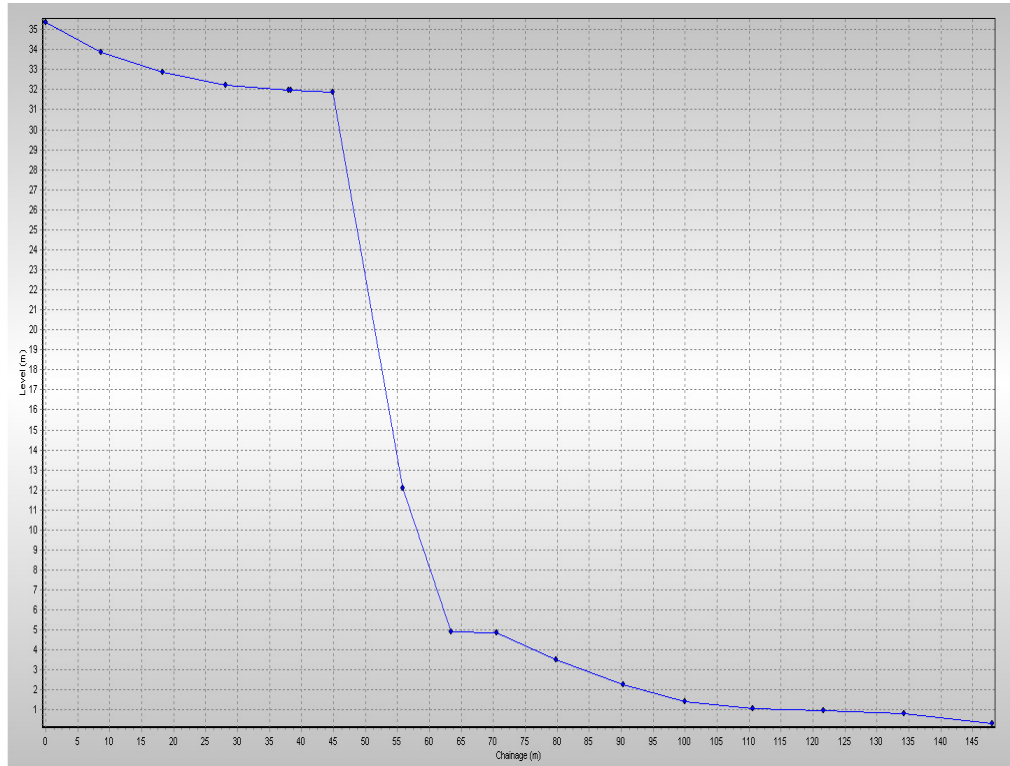
1bSS16

Easting 439981.410 **Northing** 564802.710 **Bearing** 42

Chainage	Level
0.000	35.358
8.662	33.856
18.276	32.847
28.146	32.223
37.973	31.974
38.286	31.983
44.917	31.858
55.825	12.093
63.411	4.885
70.492	4.868
79.867	3.502
90.294	2.278
99.981	1.434
110.607	1.084
121.682	0.987
134.285	0.836
148.029	0.324

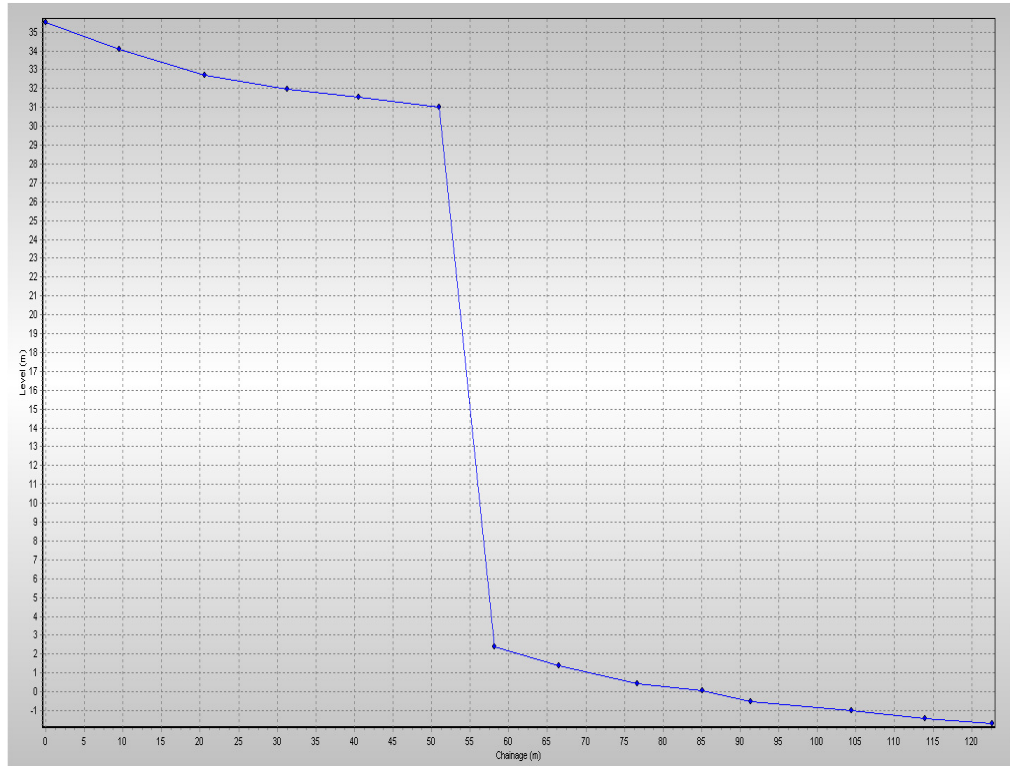
1bSS17

Easting 440161.830 **Northing** 564656.790 **Bearing** 41

Chainage	Level
0.000	35.511
9.516	34.106
20.566	32.699
31.257	31.965
40.590	31.567
50.970	31.014
58.112	2.375
66.533	1.372
76.673	0.412
85.087	0.042
91.358	-0.526
104.469	-0.977
113.926	-1.429
122.662	-1.687

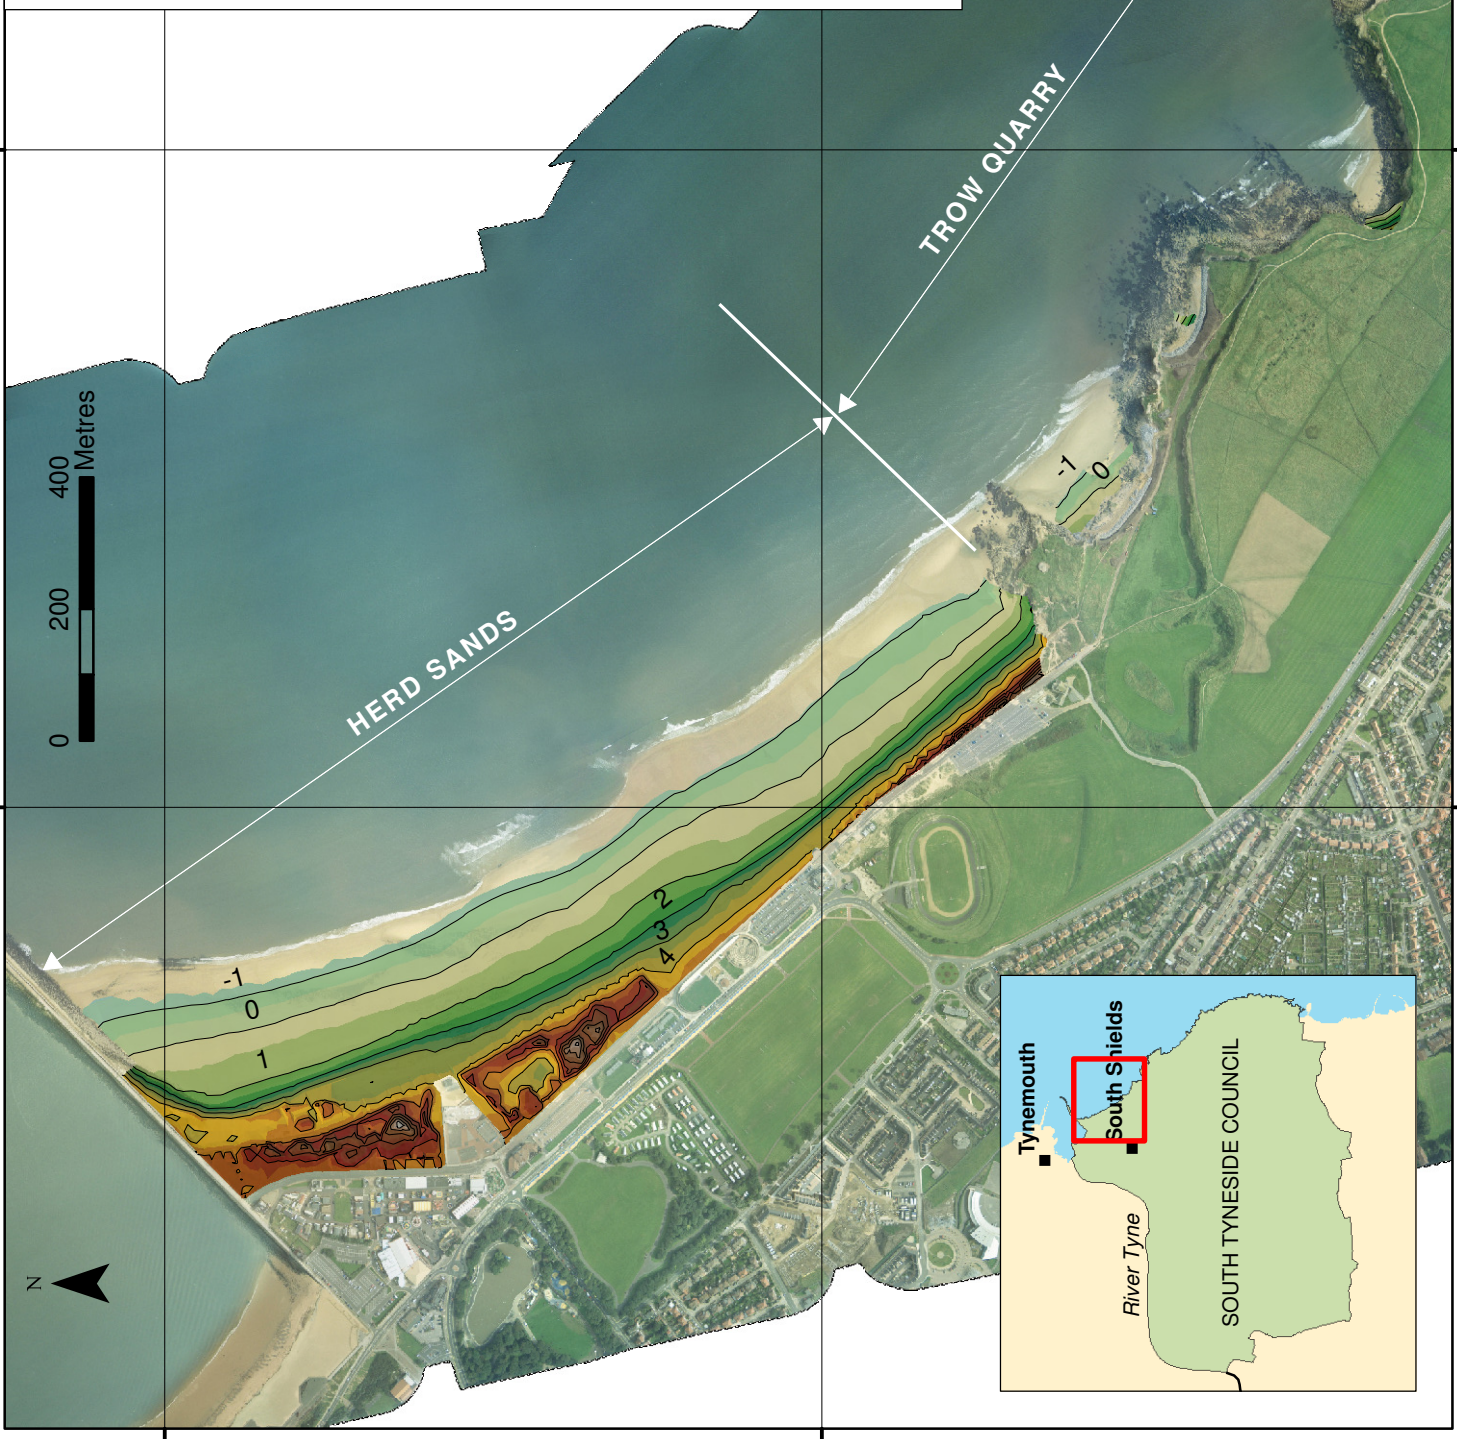
— Topographic Contours
at 1 metre interval

Survey Date	Description of Changes Since Last Survey	Interpretation
	<p>Topographic Survey:</p> <p>Herd Sands is covered by an annual topographic survey between the South Pier and Trow Point. Data have been used to create a DGM (Appendix B – Map 1).</p> <p>This DGM shows the high topographic level contours in the north of the frontage and along a thin narrow strip to the south of the bay, where the dunes are present in both areas. Also notable is how the levels drop in the area between the amphitheatre and Gypsies' Green.</p> <p>This DGM will be used as a baseline against which future topographic surveys will be compared on an annual basis to identify areas of accretion and erosion.</p>
