**Cell 1 Regional Coastal Monitoring Programme
Analytical Report 1: 'Full Measures' Survey 2008**

**South Tyneside Council
Final Report**

May 2009

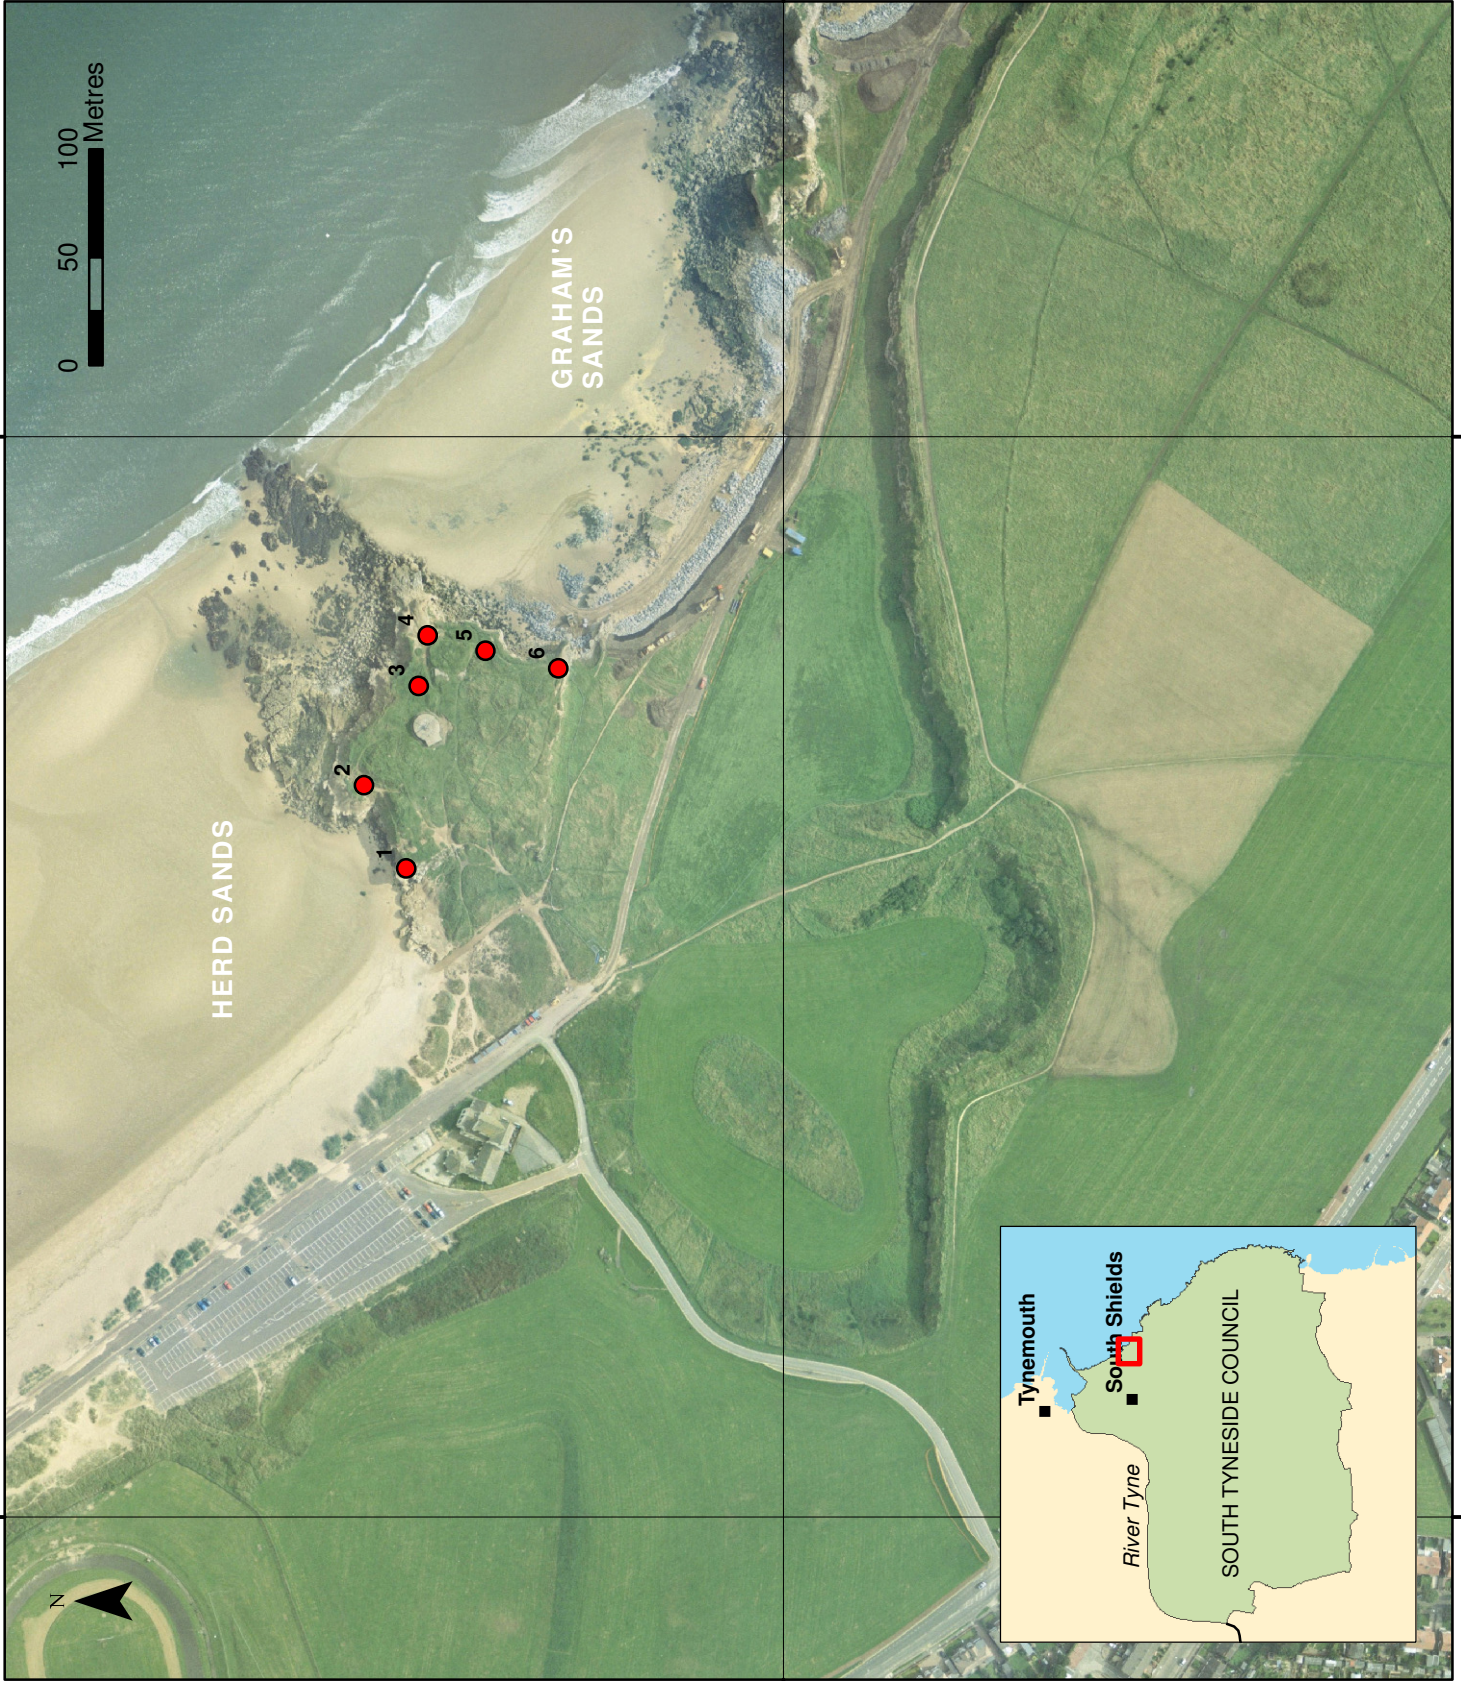
● Cliff Top Monitoring Points

Survey Date	Description of Changes Since Last Survey	Interpretation
	Appendix C provides results from the 2008 (baseline) survey showing the position from the ground control point to the edge of the cliff top along the defined bearing. Future reports will show results from subsequent surveys and provide a means of assessing erosion since the baseline survey.
