**Cell 1 Regional Coastal Monitoring Programme
Analytical Report 3: 'Full Measures' Survey 2010**

South Tyneside Council

**South Tyneside Council
Final Report**

November 2010

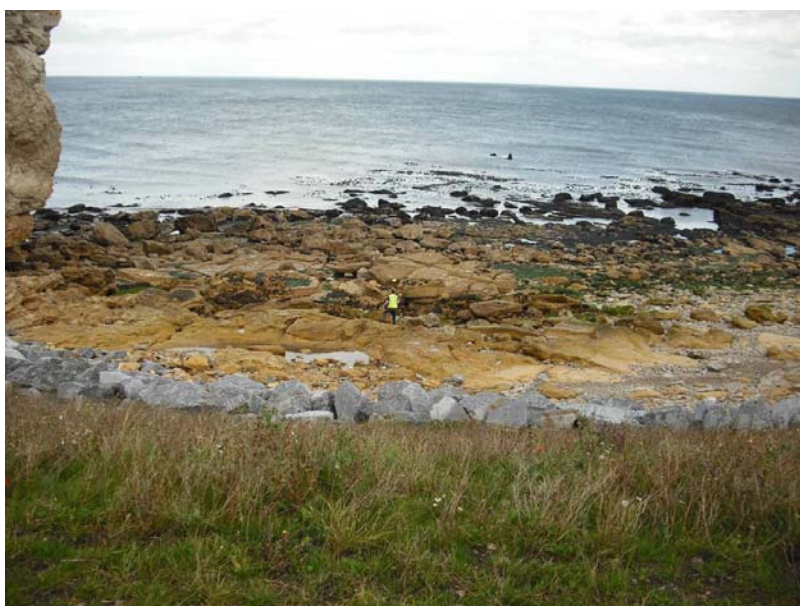
Plate 1 Survey of Rock Foreshore

Surveys of foreshore areas that are covered by inter-tidal rock outcrops present some problems to our surveyors (Plate 1). It is logistically difficult for staff to access across the foreshore but more importantly it is very difficult to ensure that identical rock features are re-surveyed on each occasion. Due to the fragmented, creviced and 'rocky' nature of the foreshore it is extremely likely that different features will be recorded on successive surveys due to this. We would expect that the rock foreshore would not experience significant down-weathering over short timescales and therefore any apparent changes between successive surveys are likely to be due to surveying different features rather than erosion. Notwithstanding this, the rock foreshore areas are periodically covered with a thin veneer of beach sand, which due to its mobility, can be absent on subsequent surveys. Such changes are identified through inspection of the photographs that are taken by the surveyors along each transect line and analysis of the sediment coding that is included in the raw data file, depicting areas of 'sand' or 'rock'.

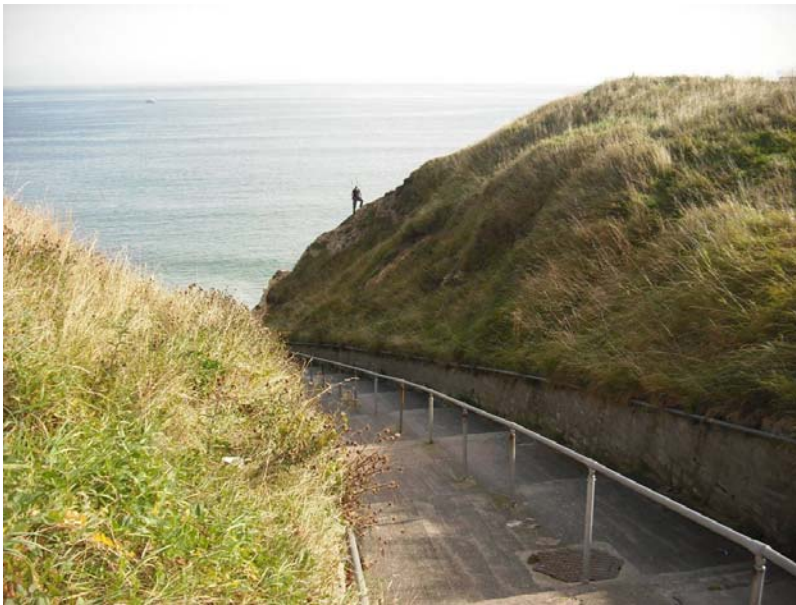
Plate 2 – Survey of Cliff along Beach Profile SS14

Beach Profile SS14 is located at the northern end of Marsden Bay, close to the Redwell Steps. Surveys of the beach and the concrete platform and steps at the base of the cliffs are accurately undertaken on each survey. Due to this, it has become clear that the changes in the cliff form above the structure are 'apparent' changes caused by survey difficulties on this steeply bevelled cliff face (Plate 2). In particular, the rock that outcrops at the seaward face of the cliff is showing apparent signs of change (see Appendix A - Beach Profile 1bSS14). A slight change in alignment of the profile across the cliff section can result in an apparently large change in form simply due to different rock features being picked up on each survey.

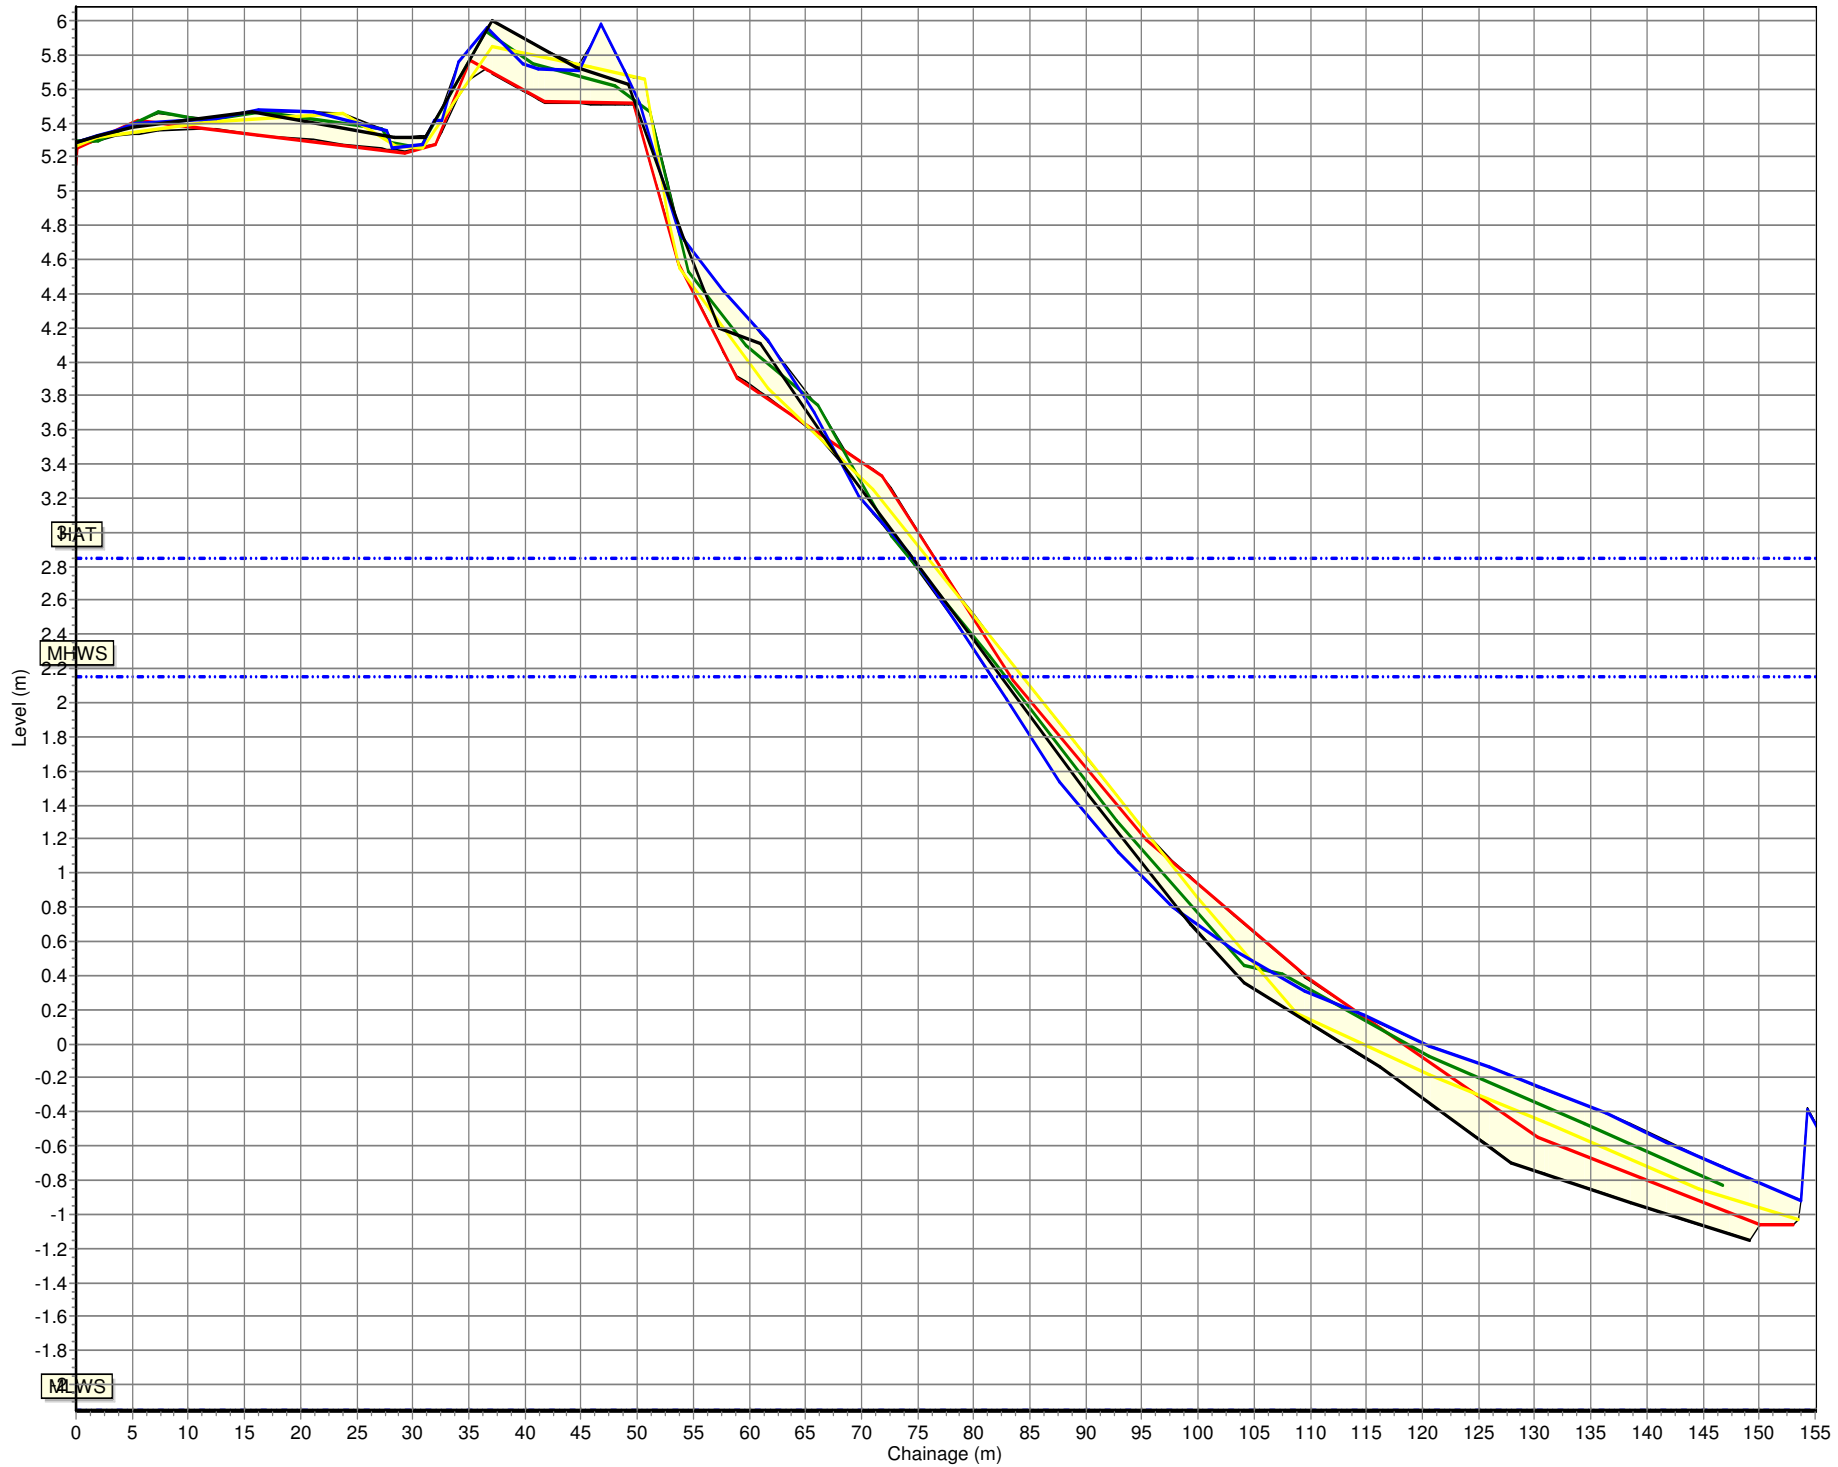
Beach Profiles: 1bSS1

- Profiles Envelope
- 02/11/2008
- 23/03/2009
- 08/09/2009
- 16/03/2010
- 14/09/2010

Survey Date	Description of Changes Since Last Survey	Interpretation
09-2010	<p>Beach Profiles:</p> <p>Littlehaven Beach is covered by four beach profile lines, spaced between South Groyne and South Pier (Appendix A).</p> <p>Whilst profile SS1 remained relatively healthy landward of HAT, including an increase in dune crest level to 6mODN, the mid profile recovered only slightly since the March 2010 survey and the lower profile, seaward of 100m chainage, reduced to new record low levels.</p> <p>Profile SS2 experienced notable redistribution of sediment, with the berm previously recorded around MHWS in September 2009 being flattened resulting in recovery of levels at the toe of the sea wall. Similar to SS1, the lower profile recorded the lowest levels since surveys began in November 2008.</p> <p>Profile SS3 experienced the lowest beach levels recorded to date at the toe of the sea wall in March 2010, leading to significant overtopping and flooding of the backing car park, which was reported in the previous Update Report 2010. Since that time, beach levels at the toe have recovered by some 0.25m to September 2010, with the general beach profile to a chainage of around 62m experiencing notable accretion.</p> <p>Along profile SS4, the previously recorded berm around HAT had slightly flattened but was still pronounced, just above MHWS. Elsewhere along the profile, both landward and seaward of the berm re-adjustment, the profile experienced accretion, in many places to new record high levels.</p>	<p>Despite the lowest levels recorded to date along the seaward end of profile SS1, the dune face remained healthy and the crest increased in height due to wind-blown sand.</p> <p>Beach levels at the toe of the sea wall remain highly variable, as exemplified by SS2 and SS3. Both profiles experienced accretion at the toe of the sea wall. Along SS3, where the sea wall protrudes out across the upper foreshore, beach levels have varied by up to 0.85m since monitoring began in November 2008.</p> <p>The southern section of the frontage remains healthy and experienced general accretion.</p> <p>Overall, Littlehaven Beach experienced a general net increase in sediment, causing beach levels, especially in the centre and south of the bay, to increase. The lower sections of the profile along SS1 and SS2, however, reduced to new record low levels, suggesting a partial re-distribution of sediment from the lower beach to the mid and upper beach.</p>

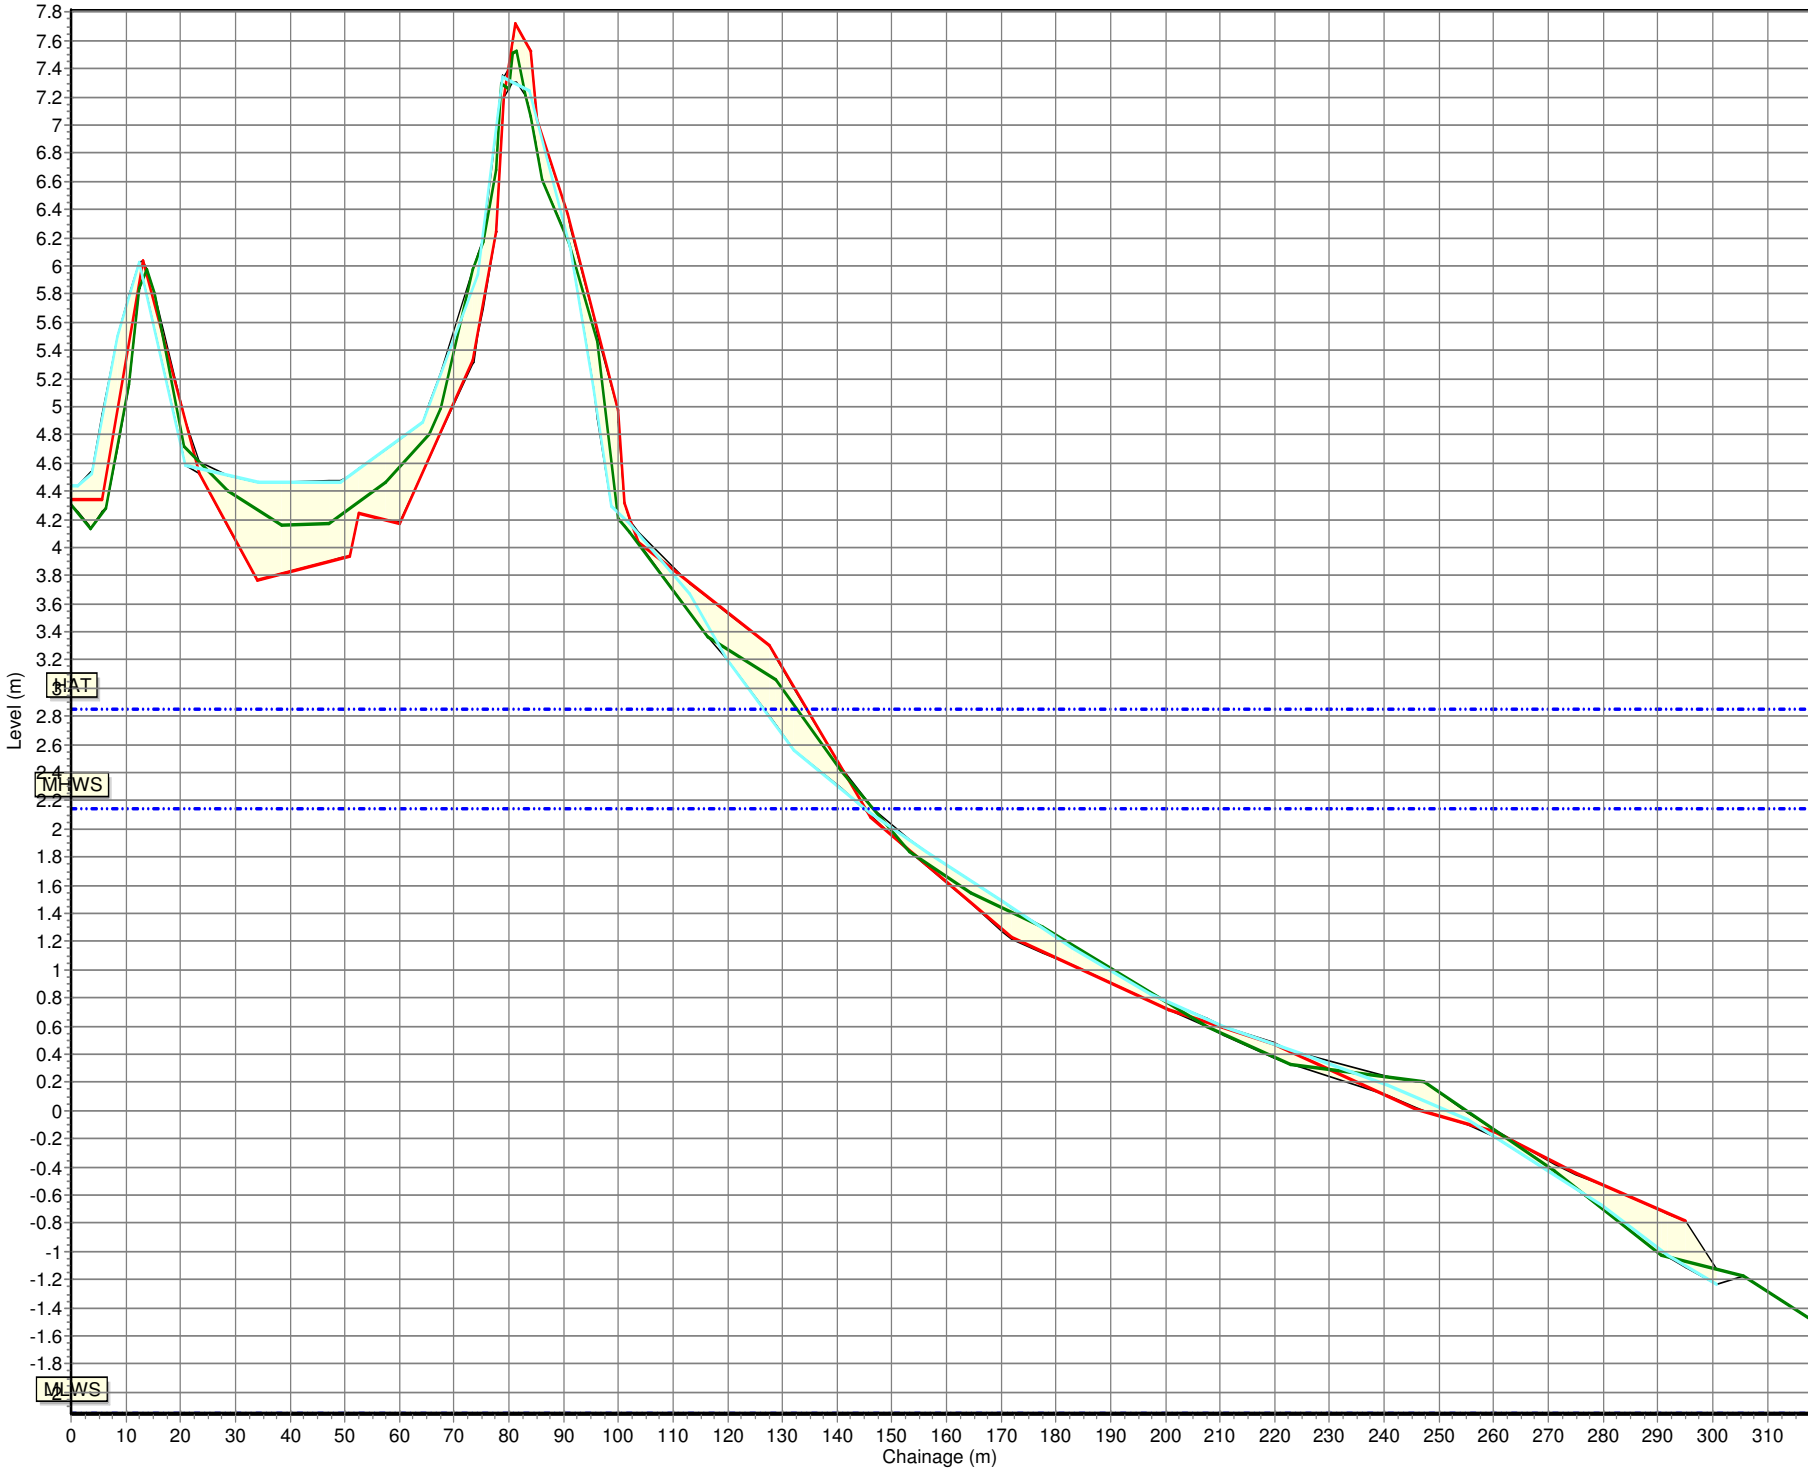
Beach Profiles: 1bSS6

- Profiles Envelope
- 02/11/2008
- 08/09/2009
- 14/09/2010

Survey Date	Description of Changes Since Last Survey	Interpretation
09-2010	<p>Beach Profiles:</p> <p>Herd Sands is covered by five beach profile lines, spaced between South Pier and the rock headland of Trow Point (Appendix A).</p> <p>SS5 shows signs of accretion in the hollows between successive dune crests and apparent deposition of sand across the donkey track at the seaward edge of the dunes. The berm identified on the lower profile in March 2010 has migrated slightly landwards.</p> <p>SS6 experienced accretion of sand in the hollow between the primary and secondary dune fields. The primary dunes decreased slightly in crest level, but remain at a substantial height of 7.35mODN. The berm previously recorded in September 2009 around HAT had become flattened, whilst the foreshore seaward of MHWS level remained very stable.</p> <p>The very large berm and trough feature recorded in the September 2009 survey along SS7 had been flattened by September 2010, with the profile form resembling that recorded during the first survey in November 2008 although with a slight berm and trough recorded along the lower profile.</p> <p>SS8, near Gypsies' Green, recovered somewhat from the notable cut back suffered along the mid to upper profile between September 2009 and March 2010, but beach levels directly at the toe of the sea wall and promenade were some 1m lower than in March 2010. Along the lower beach, beach levels dropped marginally since March 2010, but remain relatively high compared with earlier surveys.</p> <p>At the southern end of the beach, profile SS9 has generally shown marginal recovery in level seaward to a chainage of around 130m, and modest beach lowering further seaward.</p>	<p>The dunes in Herd Sands appeared to have accreted in the hollows between successive dune crest, due to wind-blown sand. Previous (March 2010) low beach levels along some sections of the bay had recovered somewhat by September 2010.</p>
