**Cell 1 Regional Coastal Monitoring Programme  
Analytical Report 4: 'Full Measures' Survey 2011**

**South Tyneside Council  
Final Report**

**October 2012**

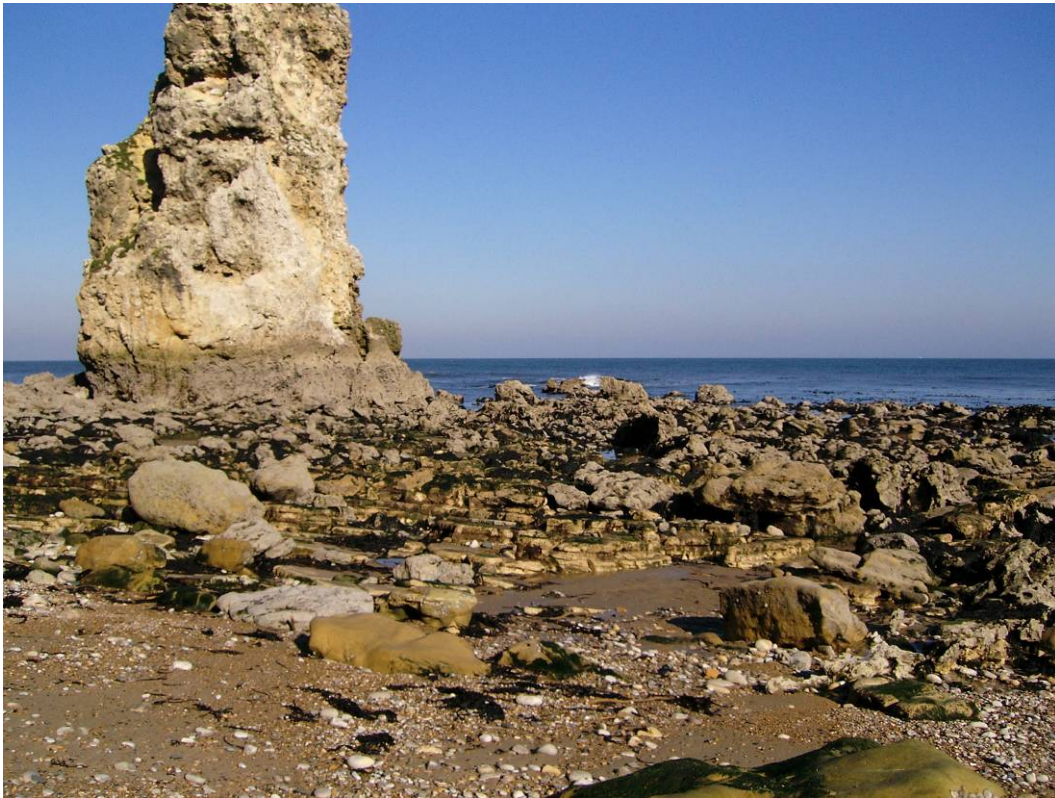
**Figure 1 Sediment Cells in England and Wales**

The Cell 1 Regional Coastal Monitoring Programme covers approximately 300km of the north east coastline, from the Scottish Border (just south of St. Abb's Head) to Flamborough Head in East Yorkshire. This coastline is often referred to as 'Coastal Sediment Cell 1' in England and Wales (Figure 1). Within this frontage the coastal landforms vary considerably, comprising low-lying tidal flats with fringing salt marshes, hard rock cliffs that are mantled with glacial sediment to varying thicknesses, softer rock cliffs and extensive landslide complexes.

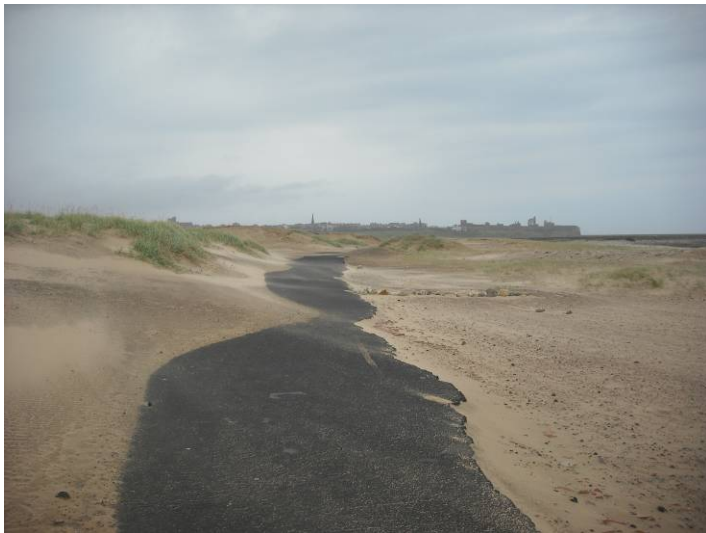
**Plate 2 – Survey photograph 1bSS5\_20110916\_N6.JPG**

Survey Date	Description of Changes Since Last Survey	Interpretation
Sept 2011	<p><b>Beach Profiles:</b></p> <p>Herd Sands is covered by five beach profile lines for the Full Measures survey (Appendix A).</p> <p>Profile <b>1bSS5</b> is located to the north of Herd Sands and is located in the lee of the South Pier breakwater. With the exception of a loss of material from the dune top around a height of 7.2m (chainage 250m), the dunes have largely retained a similar form since the last survey (partial measures, spring 2011). Beach levels have increased around HAT and reduced around MHWS to a level of 0.6m (chainage 210m). The form of the profile shows the landward movement of a berm from MHWS to HAT. From a chainage of 220m beach levels have increased. The survey photograph (Plate 2) shows the exposure of the tarmac Donkey Track beneath the dunes and sand being blow across it.</p> <p>Since the last survey (full measures, winter 2010) the beach at profile <b>1bSS6</b> has been very active. Beach levels between the primary and secondary dune ridge increased by up to 0.7m. This is continuation of the trends observed since winter 2008. The survey photograph (Plate 3 and Plate 4) shows that the dune fencing present at this location is now buried, indicating that this management measure has contributed to the accretionary patterns observed and have therefore been successful. Beach levels have increased substantially (in the region of 1m) between HAT and MHWS. Given the magnitude of change and the profile form, this is likely to be a new dune forming. Between a chainage of 190m and 260m, beach levels have fallen in the region of 0.2m.</p> <p>Profile <b>1bSS7</b> is located at the centre of Herd Sands. At <b>1bSS7</b> beach levels between 0m to 40m and 80m to 200m chainage have fallen. From a height of 3.4m to MHWS, beach levels have increased and the profile is convex. It is therefore likely that this is a berm or dune formed from material eroded and redistributed from the middle and lower beach to the upper beach by cross-shore transport.</p> <p>At <b>1bSS8</b> beach levels at the toe of the promenade revetment have reduced. From HAT to a level of 0.6m, beach levels have increased by 0.4m, however seaward of this they have reduced to form a flatter beach but of a similar gradient. Similarly to 1bSS7, this change is likely to be caused by redistribution of beach material from the middle/lower beach to the upper beach by cross-shore transport processes (i.e. wind and waves).</p>	<p>The beach at Herd Sands is very dynamic. Since the last survey, the dunes have accreted, whilst the beaches have demonstrated a significant redistribution of material across the beach. Wind blown transport is a dominant mechanism behind this movement, evident from the patterns of dune growth and the survey photographs.</p> <p>The northern section of the bay is accreting quite substantially, evident by the on-shore migration of the beach berm and a reduction in beach levels across the middle/lower beach and new dune formation.</p> <p>At the centre of the beach at profile 1bSS7, the beach and dunes have demonstrated a phase of berm/dune building at HAT (full measures (September), 2009), flattening (full measures (September), 2009) and now, building with the formation of the berm/dune at HAT. The survey photograph shows the seawall, fronted by an area of sand with tyre tracks and seaward of that dune fencing. It is possible that the fall in beach levels in front of the promenade is caused by vehicular erosion, or works in the area associated with the promenade regeneration, whilst the berm has been formed as result of trapping by the dune fencing.</p> <p>At the southern section of the bay, beach levels have reduced on the middle/lower beach but increased on the upper as material has been transported across the beach by wind and wave activity.</p>

- At Herd Sand, the recorded profiles, topographic survey and survey photographs suggest that the dunes are accreting and rolling back onto the promenade behind. The survey photographs show that the previously installed dune fencing is now buried and therefore shows that this technique has been successful. However, once the fences are buried, unless vegetation can become established on the dunes there is nothing to intercept the movement of sand across the beach and the dunes are likely to migrate landwards at a faster rate. Ongoing beach management is required in this area in order to build dunes and control sand blow. It is assumed that this material is cleared or will need to be cleared in the future. An increased rate of dune migration may require more frequent clearing or a larger volume of material to be moved. It is important that this material is recycled and

returned back to the beach, rather than being removed permanently from the system to ensure that a natural sediment balance is maintained into the future.

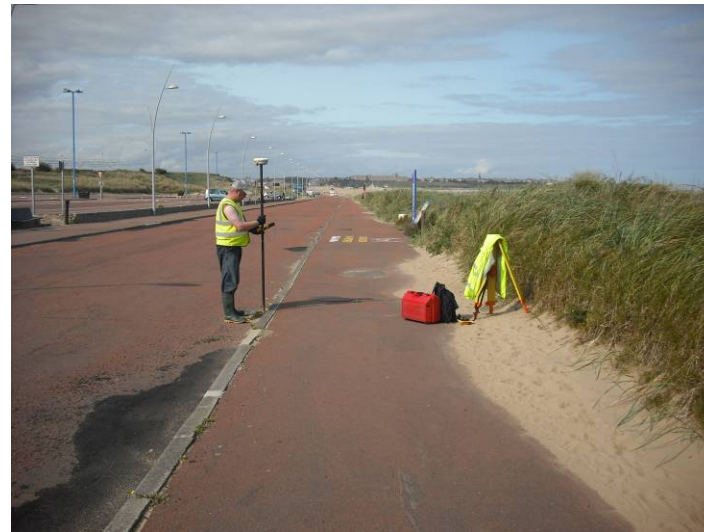
**Plate 5 – Survey photograph 1bSS9\_20110916\_N1.JPG**

Survey Date	Description of Changes Since Last Survey	Interpretation
	<p>Profile <b>1bSS9</b> is located to south of Herd Sands. The dune face has retained the same form and position since the last survey (partial measures, spring 2011). From the dune toe to a height of 0.5m, beach levels have increased and the beach has grown upwards and outwards indicating some progradation and accretion. Between 90m and 150m beach levels have reduced. This redistribution of this material is likely to have been transported by cross-shore transport to the upper beach. From chainage 155m beach levels have increased. The survey photograph (Plate 5) shows the encroachment of sand from the back of the dunes onto the promenade indicating that the dunes are migrating landwards (i.e. rolling back).</p>	
<p><b>Sept 2011</b></p>	<p><b>Topographic Survey:</b></p> <p>Herd Sands is covered by an annual topographic survey between the South Pier and Trow Point, which commenced in November 2008. Data from the most recent topographic survey (full measures, winter 2011) have been used to create a DGM (Appendix B – Map 2a) using a Geographical Information System (GIS). A difference plot has also been produced using the DGM (Appendix B – Map 2b) produced from the last topographic survey (full measures, winter 2011) and the present survey.</p> <p>In particular, the difference plot shows an overall reduction in elevation across the beach with a defined band of increased elevation that follows the planform of the beach. The previous survey (full measures, winter 2010) shows a band of beach elevation increase within the lower beach. Landwards of this is a band of beach elevation reduction. The material that formed the increase could be that which now forms the linear band observed in the present survey, indicating its onshore migration.</p>	<p>The topographic survey shows a distinct pattern, with a general reduction in beach levels across the lower and middle beach and a band of accretion along the upper beach. These findings support those of the beach profile analysis. The linearity of the band of accretion suggests that cross-shore transport is consistent along the length of the beach. In addition, the magnitude of the increase in elevation suggests this band is a significant feature and could represent the formation of a dune ridge. Survey photographs provide evidence that the dunes are dynamic, migrating landwards (via roll back) and also continually building with ongoing dune management.</p>

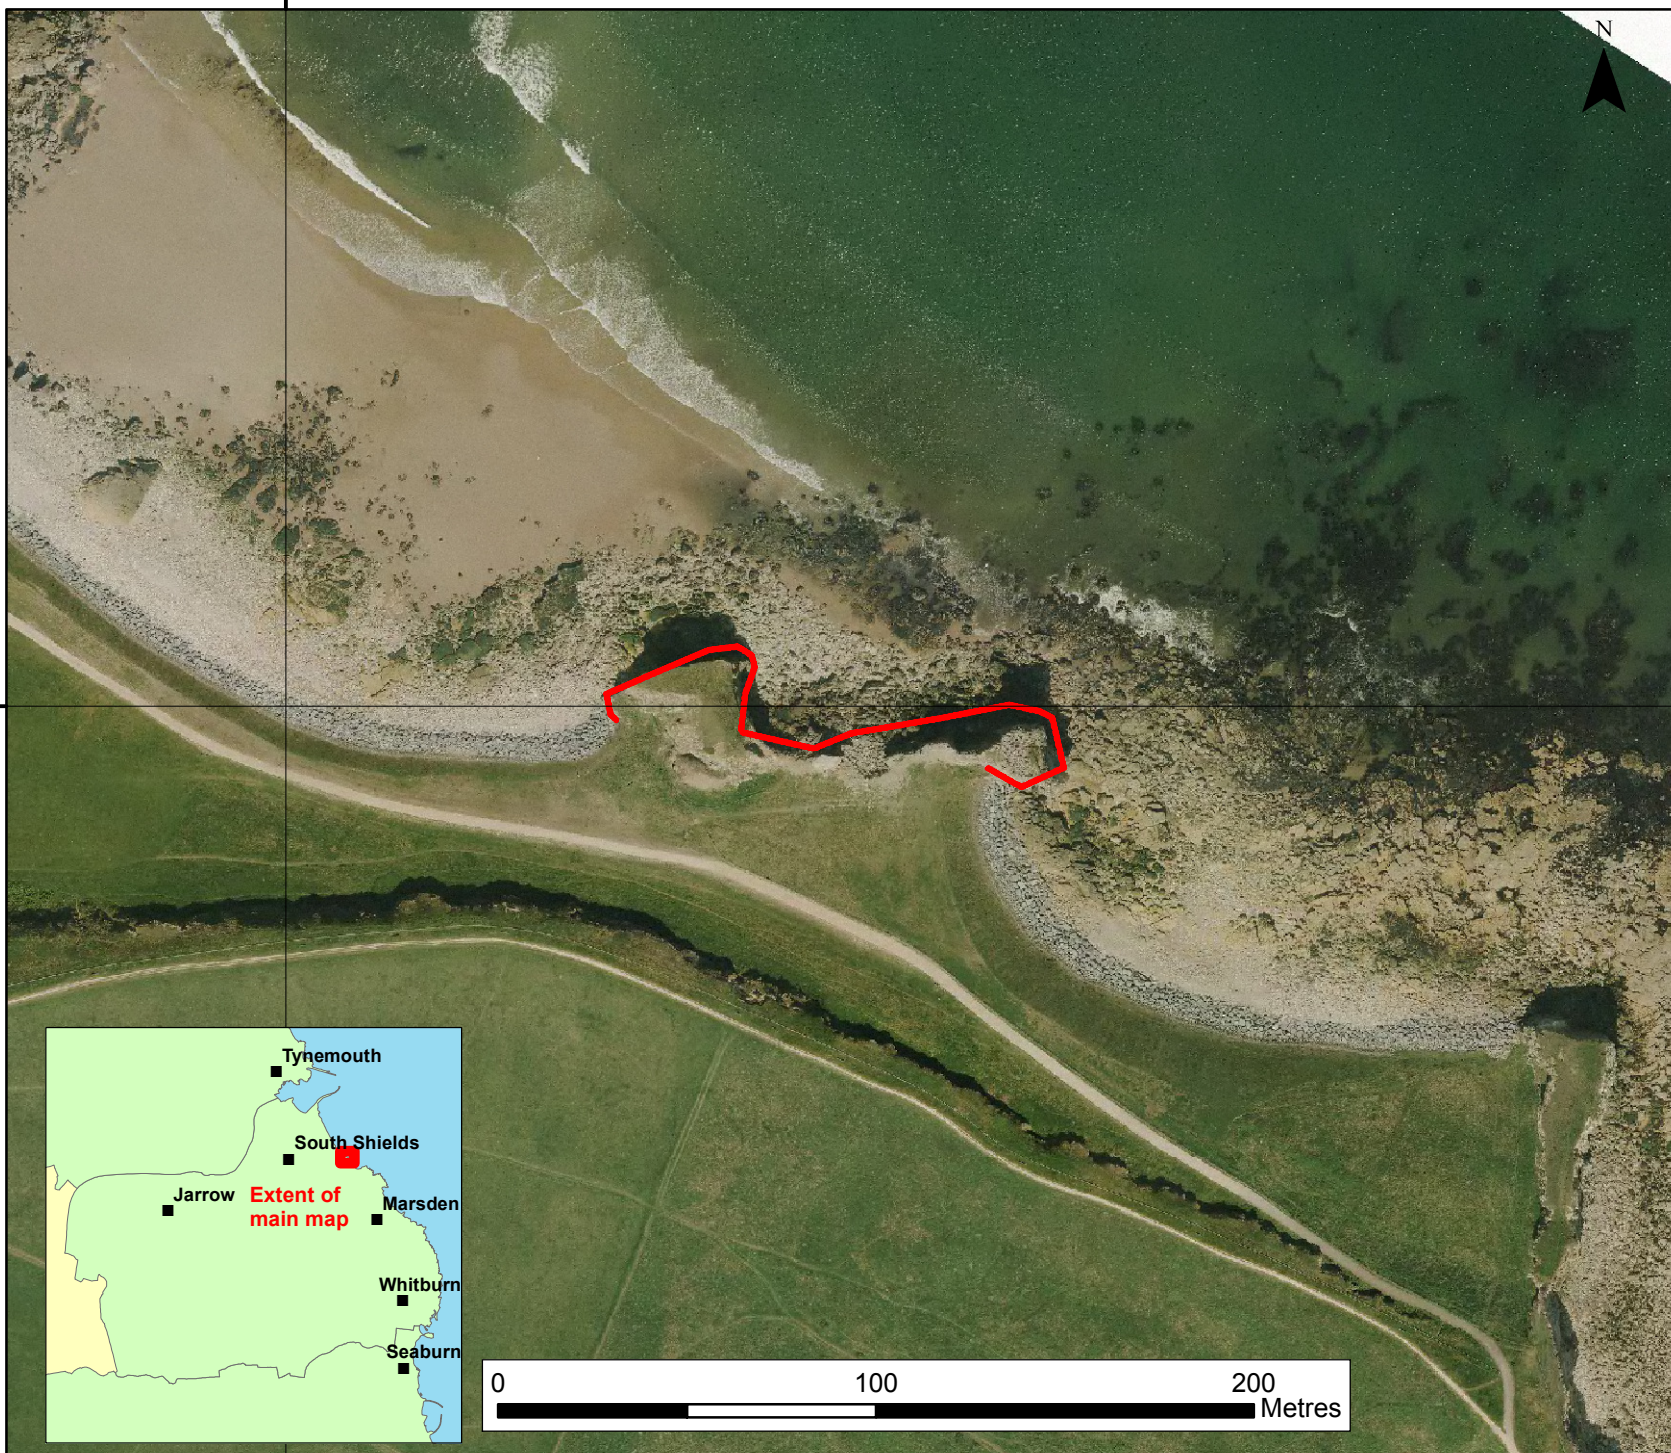
**Appendix C-Map 1  
Cliff Top Survey  
Trow Quarry  
SouthTyneside Council**

Survey Date	Description of Changes Since Last Survey	Interpretation
Sept 2011	<p><b>Cliff-top Survey:</b></p> <p>This is the first year that the cliff top survey data has been plotted as a line on the 2010 aerial map, so a comparison with equivalent previous data has not been completed.</p> <p>Data from the most recent cliff top survey (full measures, winter 2011) has been plotted onto aerial imagery (refer to Appendix C – Map 1). A review of this data shows that the data accuracy is too low to allow meaningful interpretations of coastal change to be made for a number of reasons: (i) the surveyed 'cliff line' is in many places a vegetation limit and not a geomorphological feature that indicates erosion; (ii) in many cases the resolution of the line is too low to allow meaningful comparison to the cliff features visible in the aerial photograph; and (iii) the accuracy of all the data is low, meaning that in many places the cliff top is indicated to have advanced when compared to the 2010 aerial photography.</p>	<p>This is the first year that the cliff top survey data has been plotted as a line on an aerial map, so a comparison with previous data has not been completed.</p>

For all cliff-top surveys prior to Full Measures 2011, data was reported separately in Trow Quarry Coastal Defence Scheme - Monitoring Plan Year 2 (available from South Tyneside Council). Although cliff top data is available for surveys prior to the Full Measures 2011, the accuracy of the data is such that no reliable interpretation can be made. For this reason, the 'kmz' files are not presented or analysed as part of the present report. For the present Full Measures 2011 survey, the cliff top survey data has been plotted as a line on the 2010 aerial photograph which revealed that accuracy is too low to allow meaningful interpretations of coastal change to be made: the surveyed 'cliff line' is in many places a vegetation limit and not a geomorphological feature that indicates erosion; in many cases the resolution of the line is too low to allow meaningful comparison to the cliff features visible in the aerial photograph; and the accuracy of all the data is low, meaning that in many places the cliff top is indicated to have advanced when compared to the 2010 aerial photography.

Consideration needs to be given to the benefit of continuing with cliff top surveys in their current format, particularly if features with no geomorphological significance are being surveyed mistakenly. If the quality of the surveys can be improved, it is possible that a more reliable pattern of change will be determined over the longer term, when the impact of other survey errors will be minimised.

However, in the short term, more reliable assessments of cliff recession will be derived from analysis of time-series remote sensing data. A high quality baseline survey, comprising LiDAR and aerial photography, was collected in 2010, a repeat survey was completed in Sept/Oct 2012 and a second repeat survey is planned for 2014. These data will be analysed to give more accurate information on the behaviour of the cliffs in a separate report.
