**Cell 1 Regional Coastal Monitoring Programme  
Analytical Report 6: 'Full Measures' Survey 2013**

**South Tyneside Council  
Final Report**

**February 2014**

(\*) The present report is **Analytical Report 6** and provides an analysis of the 2013 Full Measures survey for South Tyneside Council's frontage.

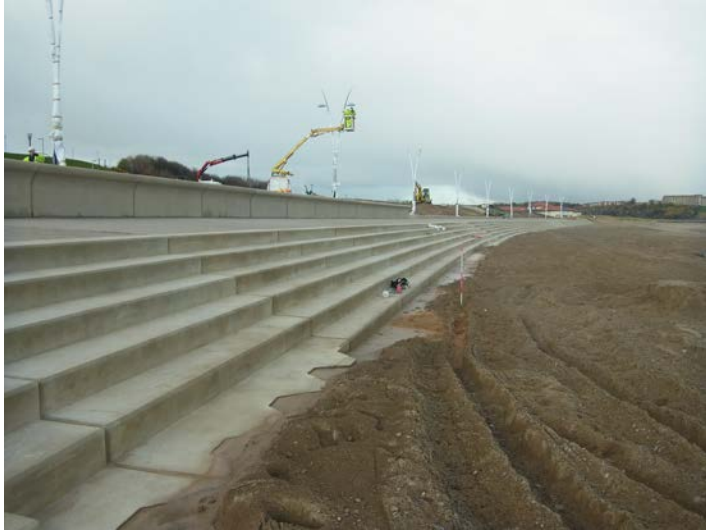
**Plate 1 – Survey photograph 1bSS3\_20131119\_N1.JPG  
(Shows new and realigned Littlehaven seawall)**

- At Littlehaven Beach, the recorded profiles and topographic survey present no causes for concern. This survey was restricted by construction works and the beach profiles had been impacted by artificial movement of sand as part of the works. Future monitoring will identify impacts of the new sea defences on the beach profiles.

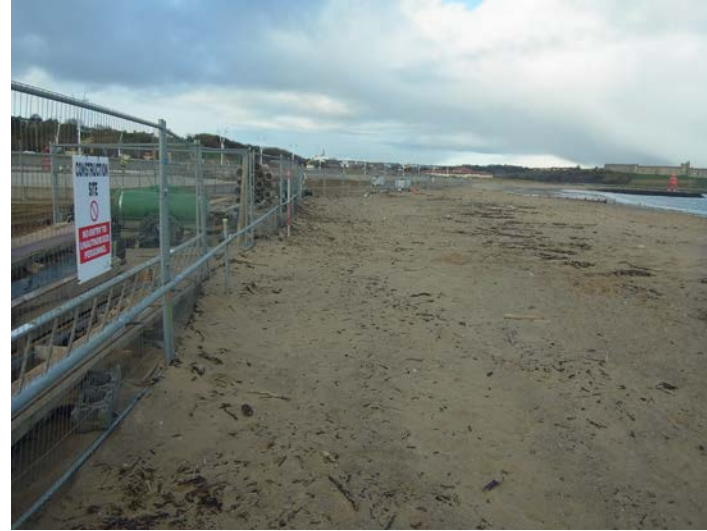
**Plate 2 – Survey photograph 1bSS4\_20131119\_N1.JPG  
(Works underway to Littlehaven seawall)**
