**Cell 1 Regional Coastal Monitoring Programme  
Analytical Report 7: 'Full Measures' Survey 2014**

**South Tyneside Council  
Final Report**

**February 2015**

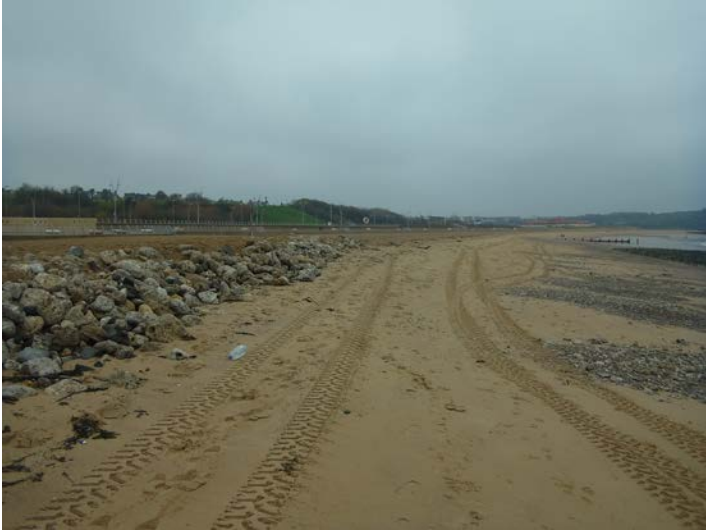
**Plate 1 – Survey photograph 1bSS4\_20140428\_N7**

Survey Date	Description of Changes Since Last Survey	Interpretation
Nov 2014	<p><b>Beach Profiles:</b></p> <p>Littlehaven Beach is covered by four beach profile lines for the Full Measures survey, spaced between South Groyne and South Pier (Appendix A). The previous survey was the Partial Measures survey undertaken in April 2014 and the previous Full Measures survey was undertaken in November 2013. Profiles 1bSS1 and 1bSS3 were last surveyed during the Partial Measures spring survey, 2014. Profiles 1bSS2 and 1bSS4 were last surveyed during the Full Measures autumn survey, 2013.</p> <p>Profile <b>1bSS1</b> is located to the north of Littlehaven beach, in the lee of a rocky outcrop and South Groyne. The dunes have remained stable since the last survey. Beach levels have increased by up to 0.2m across the beach.</p> <p>Profiles <b>1bSS2 to 1bSS4</b> extend seawards from the new sea wall that was completed since the Full Measures survey in Autumn 2013. At profile <b>1bSS2</b>, beach levels from the seawall to a chainage of 65m have fallen by 0.1m to 0.2m, but seaward of there, they have increased by 0.2m. Beach material is likely to have been redistributed from the upper beach during the winter/autumn months of the past year. At profile <b>1bSS3</b>, the beach profile shows a general increase in beach levels, particularly above HAT where the beach berm is approximately 0.5m higher than in the previous survey. Elsewhere across the profile, levels have increased by approximately 0.2m. At profile <b>1bSS4</b>, beach levels between the seawall and a chainage of 110m have fallen to form a rounder berm, but exposing more of the underlying rock (refer to Plates 1 and 2). Seaward of a chainage of 110m, beach levels have increased by approximately 0.3m. Material is likely to have been redistributed from the upper to lower beach during the winter/autumn months of the past year.</p>	<p>The beach at Littlehaven has had some time to adjust since since construction of the new seawall. The beach to the north, at profile <b>1bSS1</b>, has remained stable over the summer months. The beaches to the south have experienced a trend of upper beach lowering and lower beach accretion, which is likely to represent typical seasonal changes occurring in the winter/autumn months of the past year.</p> <p><b>Longer term trends:</b> Generally, the beach profiles are within the bounds of previous surveys, showing no discernible trend and no clear evidence that the beach has been affected by the construction works. Some locations have beach levels at the highest since records began in November 2008:</p> <ol style="list-style-type: none"> <li>1) Profile 1bSS2 – Seward of a chainage of 80m.</li> <li>2) Profile 1bSS3 – the beach berm.</li> </ol> <p>At profile 1bSS4, the beach levels are the lowest recorded on the upper beach at a chainage of 80m, and in line with HAT. It is likely that this is a result of wave action on the beach, which is comprised of sand and rock.</p>

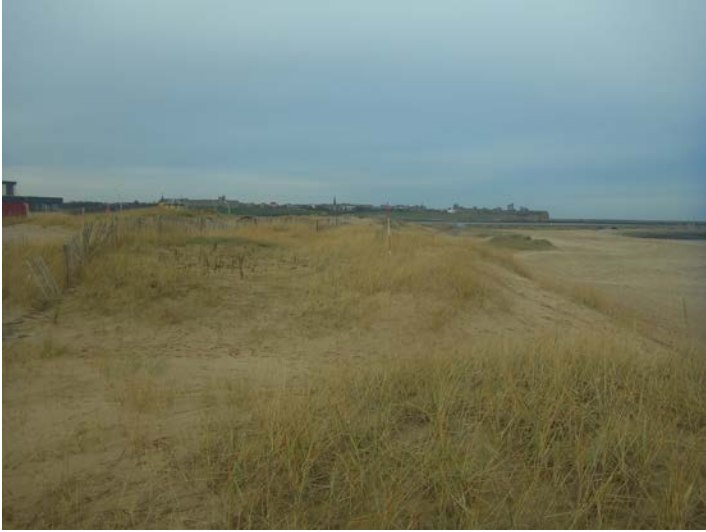
**Plate 3 – Survey photograph 1bSS5\_20141124\_N6**

Survey Date	Description of Changes Since Last Survey	Interpretation
Nov 2014	<p><b>Beach Profiles:</b></p> <p>Herd Sands is covered by five beach profile lines for the Full Measures survey (Appendix A). The previous survey was the Partial Measures survey in March 2013 and previous to that the Full Measures survey was completed in November 2012. Profiles 1bSS5, 1bSS8 to 1bSS9 were last surveyed during the Partial Measures spring survey, 2014. Profiles 1bSS6 and 1bSS7 were last surveyed during the Full Measures autumn survey 2013.</p> <p>Profile <b>1bSS5</b> is located to the north of Herd Sands and is in the lee of the breakwater. Sand fences were constructed on these dunes in 2012 to encourage accretion. The dunes have largely retained a similar form to the previous survey, showing that the defences are helping to stabilise the dunes although as observed from the survey photograph in Plate 3, they have in places fallen down. Beach levels have increased across most of the profile by approximately 0.2m, and this is reflected by the survey photographs from the current survey and the previous survey (Plates 4 and 5) which show the previously exposed tarmac and path fencing is now buried, as well as the formation of a small berm on the lower beach around a chainage of 180m. However, on the middle beach between a chainage of 200m and 280m beach levels have fallen by approximately 0.2m. It is likely that redistribution of material from the middle to lower beach occurred in the autumn months.</p> <p>At profile <b>1bSS6</b>, the most seaward dune ridge has increased in width and height since the last survey. Above MHWS, the upper beach has translated landwards, resulting in a narrower but wider profile. The survey photographs show accretion around the dune fencing. Seaward of MHWS, beach levels have increased (by over 1m in places) to form a flatter and smoother profile.</p> <p>Profile <b>1bSS7</b> is located at the centre of Herd Sands. At profile <b>1bSS7</b>, the beach profile shows substantial accretion of beach levels of 2m with the formation of two large berms, one just above HAT and one seaward of a chainage of 160m. The survey photographs were reviewed but there is no clear evidence of this increase.</p> <p>At profile <b>1bSS8</b>, beach levels immediately in front of the seawall have fallen by approximately 0.5m, but the beach has built upwards and outwards to form a wider profile (see Plates 6 and 7, which show photos from the previous and present survey). Further, beach levels between a chainage of 70m and</p>	<p>To the northern and southern ends of Herd Sands, the beach profiles have remained stable, with a redistribution of material towards the upper and lower beach. At the centre of Herd Sands, the beach profiles show the beaches to have significantly accreted, particularly on the upper and lower beach.</p> <p>Beach levels were particularly low at 1bSS5 in the previous Full Measures and a ship wreck was partially revealed. The current surveys indicates slight recovery from this historic low.</p> <p><b>Longer term trends:</b> The beach to the north at profile 1bSS5 shows little change from previous surveys. However, at profiles 1bSS6, 1bSS7 and 1bSS9, beach levels are on the upper beach the highest recorded since surveys began in November 2008. Conversely, beach levels to the south of Herd Sands at profile 1bSS9, beach levels on the middle beach are the lowest observed since surveys began in November 2008.</p>

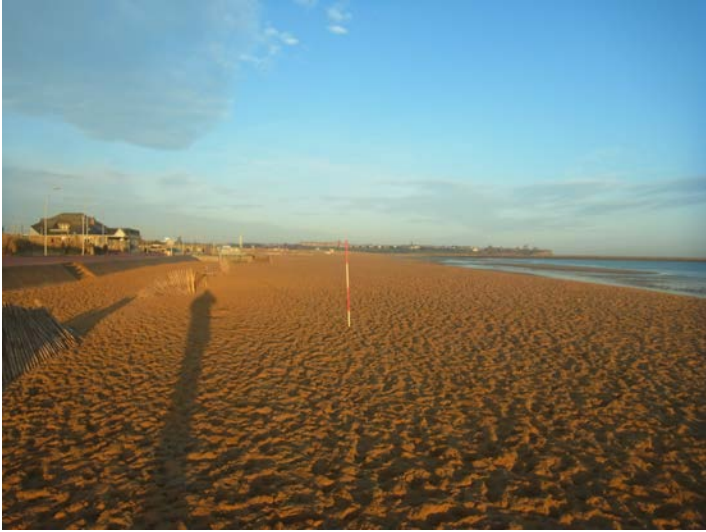
**Plate 6 – Survey photograph 1bSS8\_20141124\_N3**

Survey Date	Description of Changes Since Last Survey	Interpretation
	<p>170m have also increased by up to 0.5m to form a convex profile.</p> <p>Profile <b>1bSS9</b> is located to the south of Herd Sands. Beach levels have increased at the toe of the dune above MHWS by approximately 0.5m. Seaward of MHWS, across most of the profile, beach levels have decreased by 0.5m making a more concave shape. A small berm has formed around 130m chainage. Material has likely to have been redistributed from the middle of the beach to the upper and lower parts during the summer and autumn months.</p>	
Nov 2014	<p><b>Topographic Survey:</b></p> <p>Herd Sands is covered by an annual topographic survey between the South Pier and Trow Point, which commenced in November 2008.</p> <p>Data from the most recent topographic survey (Full Measures, autumn 2013) have been used to create a DGM (Appendix B – Map 2a) using GIS. A difference plot has also been produced using the DGM (Appendix B – Map 2b) produced from the last topographic survey (Full Measures, autumn 2011) and the present survey.</p> <p>The difference plot shows a general increase in beach elevation across Herd Sand particularly to the north, with pockets of beach elevation decrease concentrated along the backshore, northern and southern extents of the bay and the lower beach.</p> <p><b>Longer Term Topographic Trends Autumn 2010 to Autumn 2014:</b></p> <p>The long term difference plot (Appendix B – Map 2c) shows overall accretion in the most northern third of the bay, with a band of beach elevation increase greater than 2m along the middle beach. Beach elevation decrease is concentrated at the southern end of the bay and to the lower beach, with changes in the order of 1m.</p>	<p>Comparison of the present topographic survey with the previous Full Measures (autumn, 2013) shows an overall pattern of accretion with pockets of beach elevation decrease concentrated along the backshore, northern and southern extents of the bay and the lower beach.</p> <p><b>Longer term topographic trends Autumn 2010 to Autumn 2014:</b> shows overall accretion in the most northern third of the bay, with a particularly clear band of beach elevation increase of greater than 2m along the middle beach, which relates to a berm. Beach elevation decrease is concentrated at the southern end of the bay and to the lower beach, with changes in the order of 1m. It is possible that eroded material is being redistributed to form a sand bar along the beach.</p>

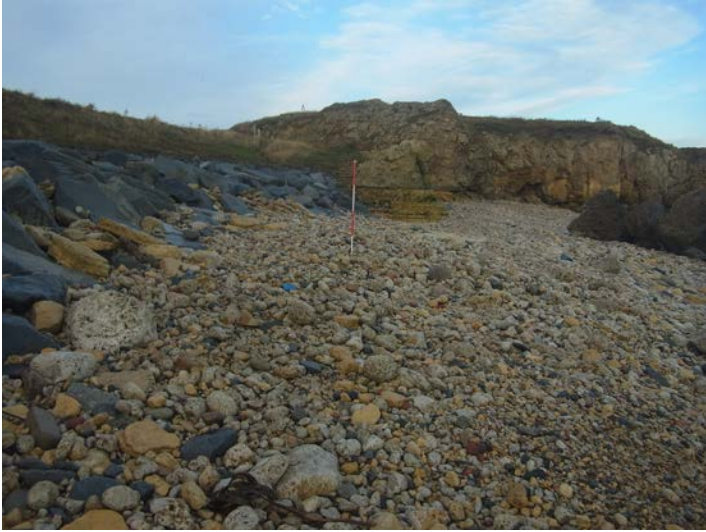
**Plate 8 – Survey photograph 1bSS10\_20141124\_N4**

Survey Date	Description of Changes Since Last Survey	Interpretation
	<p>errors.</p> <p><b>Longer Term Topographic Trends Autumn 2010 to Autumn 2014:</b></p> <p>The long term difference plot (Appendix B – Map 2c) shows the net change in beach levels between autumn 2010 and autumn 2014. The pattern and magnitude of change is very similar to that seen over the short term, with are pockets of beach elevation reduction and increase across the beach. The increase in elevation on and around the headlands that separate Graham’s Sand and Southern Bay, and Herd Sands from Trow Quarry can be attributed to the data interpolation method used. The plot for Frenchman’s Bay shows beach elevation decrease along the upper beach and beach elevation increase across the middle and lower beach suggesting a redistribution of sediment across the beach.</p>	<p>to create the difference grids. The plot for Frenchman’s Bay shows beach elevation decrease along the upper beach and beach elevation increase across the middle and lower beach suggesting a redistribution of sediment across the beach. This may be an ongoing trend or a seasonal change, ongoing analysis of the survey data will clarify this.</p>

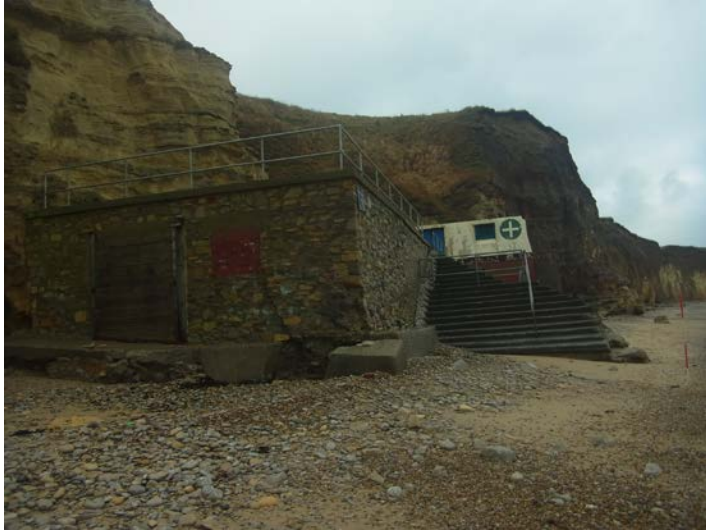
Plate 10 – Survey photograph 1bSS14\_20141127\_N7

Survey Date	Description of Changes Since Last Survey	Interpretation
Nov 2014	<p><b>Beach Profiles:</b></p> <p>Marsden Sands is covered by four beach profile lines for the Full Measures survey (Appendix A). The previous survey was the Partial Measures survey in April 2014 and previous to that the Full Measures survey was completed in November 2013. Profiles 1bSS14 and 1bSS17 were last surveyed during the Partial Measures spring survey, 2014. Profiles 1bSS15 and 1bSS16 were last surveyed during the Full Measures autumn survey, 2013.</p> <p>Profile <b>1bSS14</b> is located to the north of the bay and covers the cliff and the former lifeguard station adjacent to the Redwell Steps. The cliff has retained the same form and position since the last survey. Beach levels on the upper beach have fallen by 0.5m to 1m since the last survey exposing the step at the toe of the seawall (see plates 10 and 11). The material on the beach at this location has changed as sand on the beach has been removed to leave a veneer of coarse shingle and cobbles; a trend that has continued since the last Full Measures survey in 2013. Beach levels seaward of a chainage of 140m have increased by approximately 0.5m to 1m and is likely that material draw-down from the upper beach in the recent autumn months.</p> <p>At profile <b>1bSS15</b> the profile suggests that the cliff has advanced seawards, however the survey photographs do not reflect this change. Beach levels have fallen across the profile by approximately 1m, resulting in exposure of the underlying rock.</p> <p>At Profile <b>1bSS16</b> the profile suggests that the cliff has advanced seawards, however the survey photographs do not reflect this change. The profile shows beach levels at the toe of the cliff to have increased but seaward of a chainage of 75m, beach levels have fallen to form a narrower upper beach and lower middle and lower beach. The survey photographs show that the rocky beach at the toe of the cliff has narrowed and the sandy veneer across the middle beach has disappeared to expose the underlying rock (refer to Plates 12 and 13),</p> <p>Profile <b>1bSS17</b> is located to the south of the bay. The profile suggests that the cliff has advanced seawards, however the survey photographs do not reflect this change and it is likely to be due to survey methods employed and access issues. Beach levels have remained stable since the last survey.</p>	<p>To the north of Marsden Bay, the cliff has retained the same form and position as the previous surveys.</p> <p>Along the north and central section of Marsden Bay beach levels have either fallen across the profile or there has been redistribution of material from the upper to the middle/lower beach. This is typical of autumn/winter behaviour.</p> <p>To the south of Marsden Bay, the beach has remained stable since the last survey.</p> <p><b>Longer term trends: To the north and south of Marsden Bay,</b> the overall changes are within the bounds of changes observed since the first survey in November 2008. The exception is at profile 1bSS14, where beach levels seaward of chainage 135m are the highest since surveys began. At the centre of the bay, around a chainage of 90m (approximately middle/lower beach) levels are the lowest since surveys began.</p>

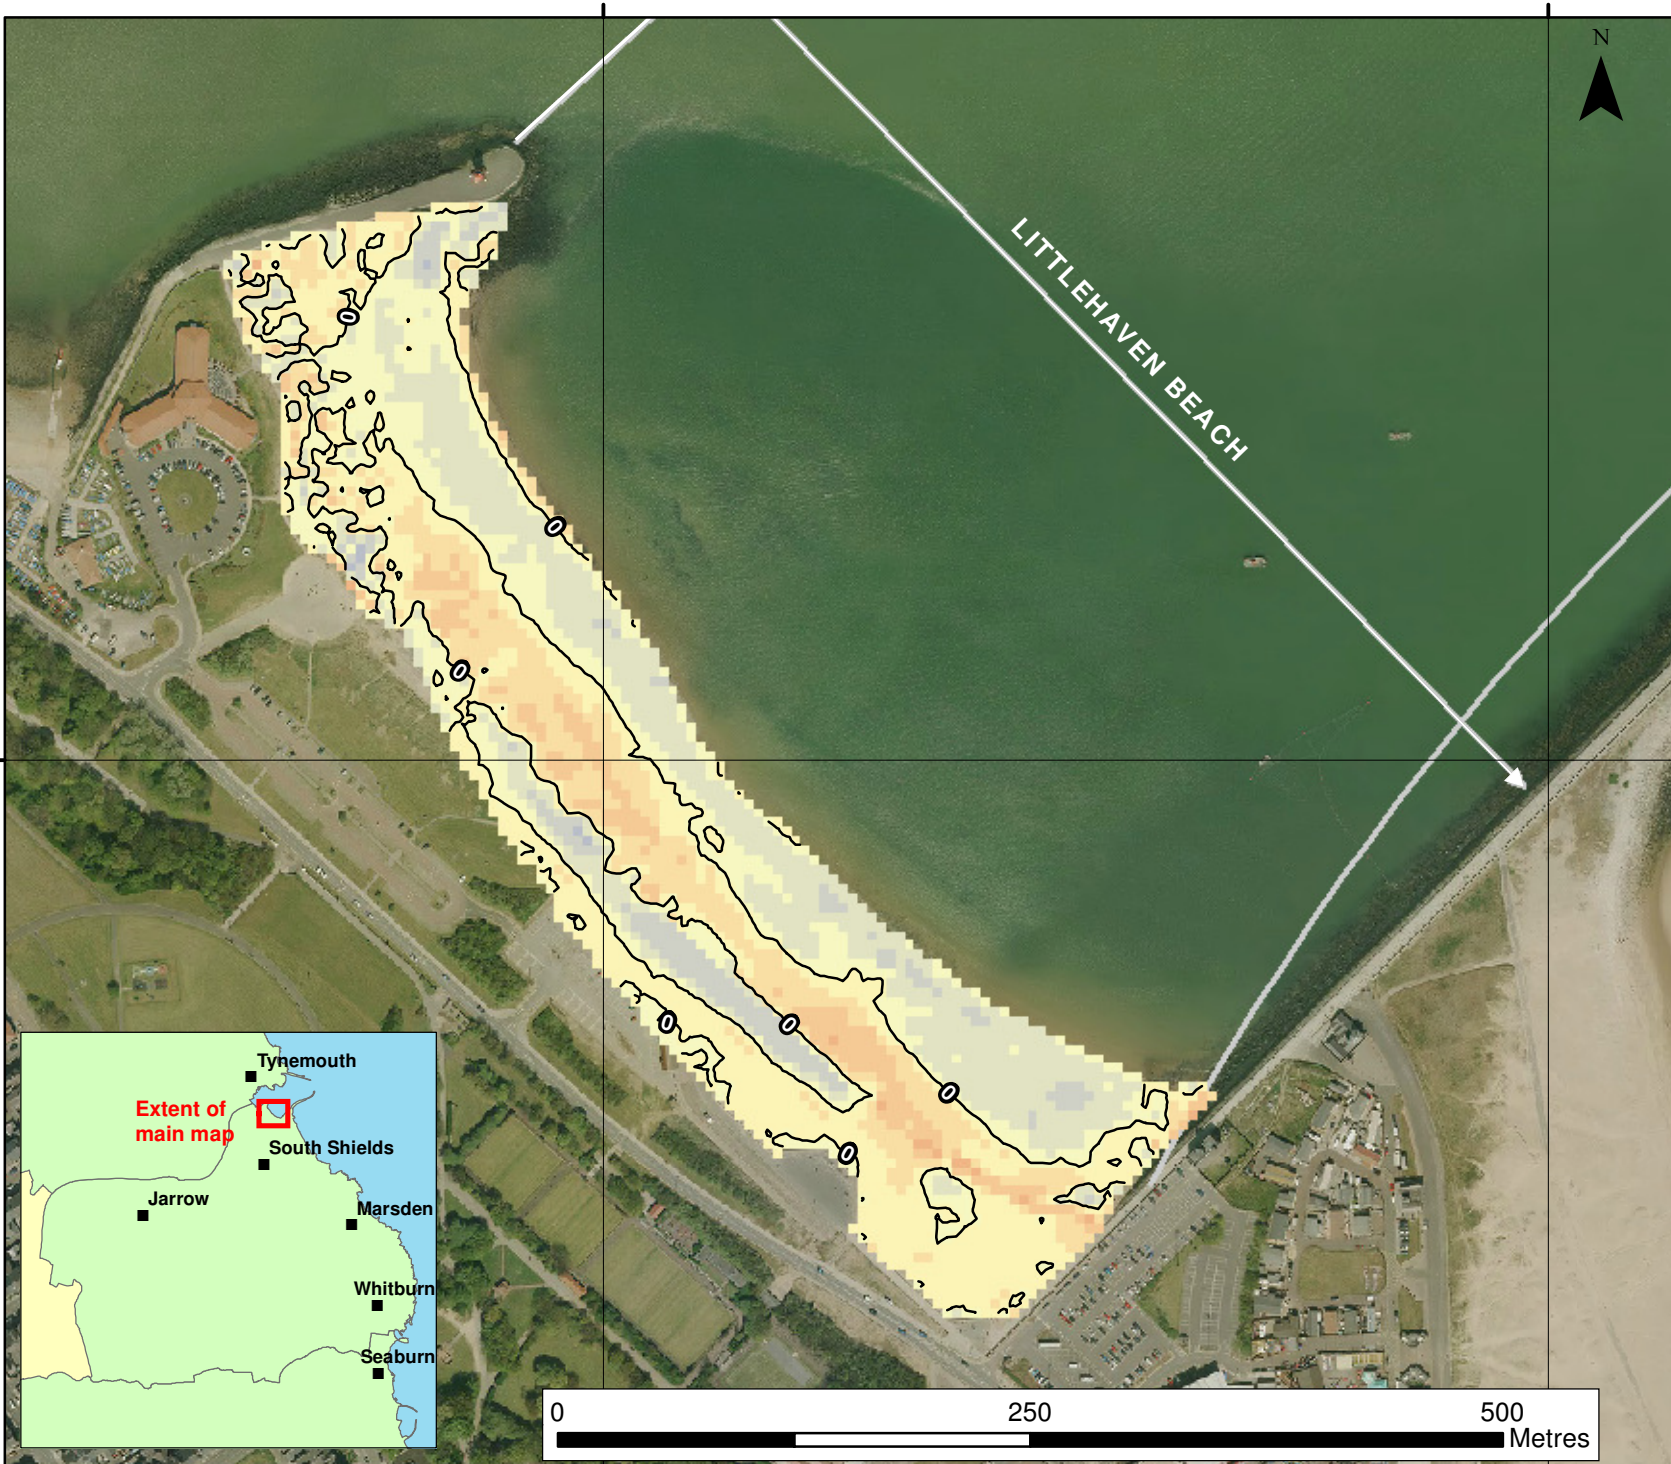
**Appendix B- Map 1b**  
**Short-term**  
**Elevation Change**  
**Littlehaven**  
**SouthTyneside Council**

Survey Date	Description of Changes Since Last Survey	Interpretation
Nov 2014	<p><b>Topographic Survey:</b></p> <p>Littlehaven Beach is covered by bi-annual topographic survey between the South Groyne and the South Pier, which commenced in March 2010.</p> <p>Data from the most recent topographic survey (Full Measures, autumn 2014) have been used to create a DGM (Appendix B – Map 1a) using GIS. A difference plot has also been produced using the DGM (Appendix B – Map 1b) produced from the last produced topographic survey (partial measures, spring 2013) and the present survey.</p> <p>In particular, the difference plot shows: (i) general stability, with elevation increase and decrease being less than 0.2m across the beach (ii) a wide band of small elevation increase along the very upper beach, beach elevation decrease along the middle beach and beach elevation decreased along the lower beach; (iii) a tendency for beach elevation decrease at the very northern and southern corners of the bay.</p> <p><b>Longer Term Topographic Trends Autumn 2010 to Autumn 2013:</b></p> <p>The long term difference plot (Appendix B – Map 1c) shows a general pattern for beach accretion at the very north end of the bay. Along the remaining length of the bay, there is a distinct band of beach erosion along the middle beach and accretion along the lower beach. The southern end of the bay is dominated by erosion.</p>	<p>Comparison of the present topographic survey with the previous Partial Measures (spring, 2014) shows that the beach is generally stable with bands of elevation along the very upper beach, beach elevation decrease along the middle beach and beach elevation decreased along the lower beach. This is likely to be reflecting an ongoing redistribution of material from the upper to lower beach.</p> <p><b>Long term topographic trends Autumn 2010 to Autumn 2013:</b> The plot shows a general pattern for beach accretion at the very north end of the bay and erosion at the southern end of the bay. There is a distinct band of erosion along the middle beach and accretion along the lower beach. This could reflect an ongoing redistribution of material from the upper to lower beach as well as a net drift movement of material from south to north.</p>
