# **Cell 1 Regional Coastal Monitoring Programme Analytical Report 9: 'Full Measures' Survey 2016**

**South Tyneside Council**

**March 2017**

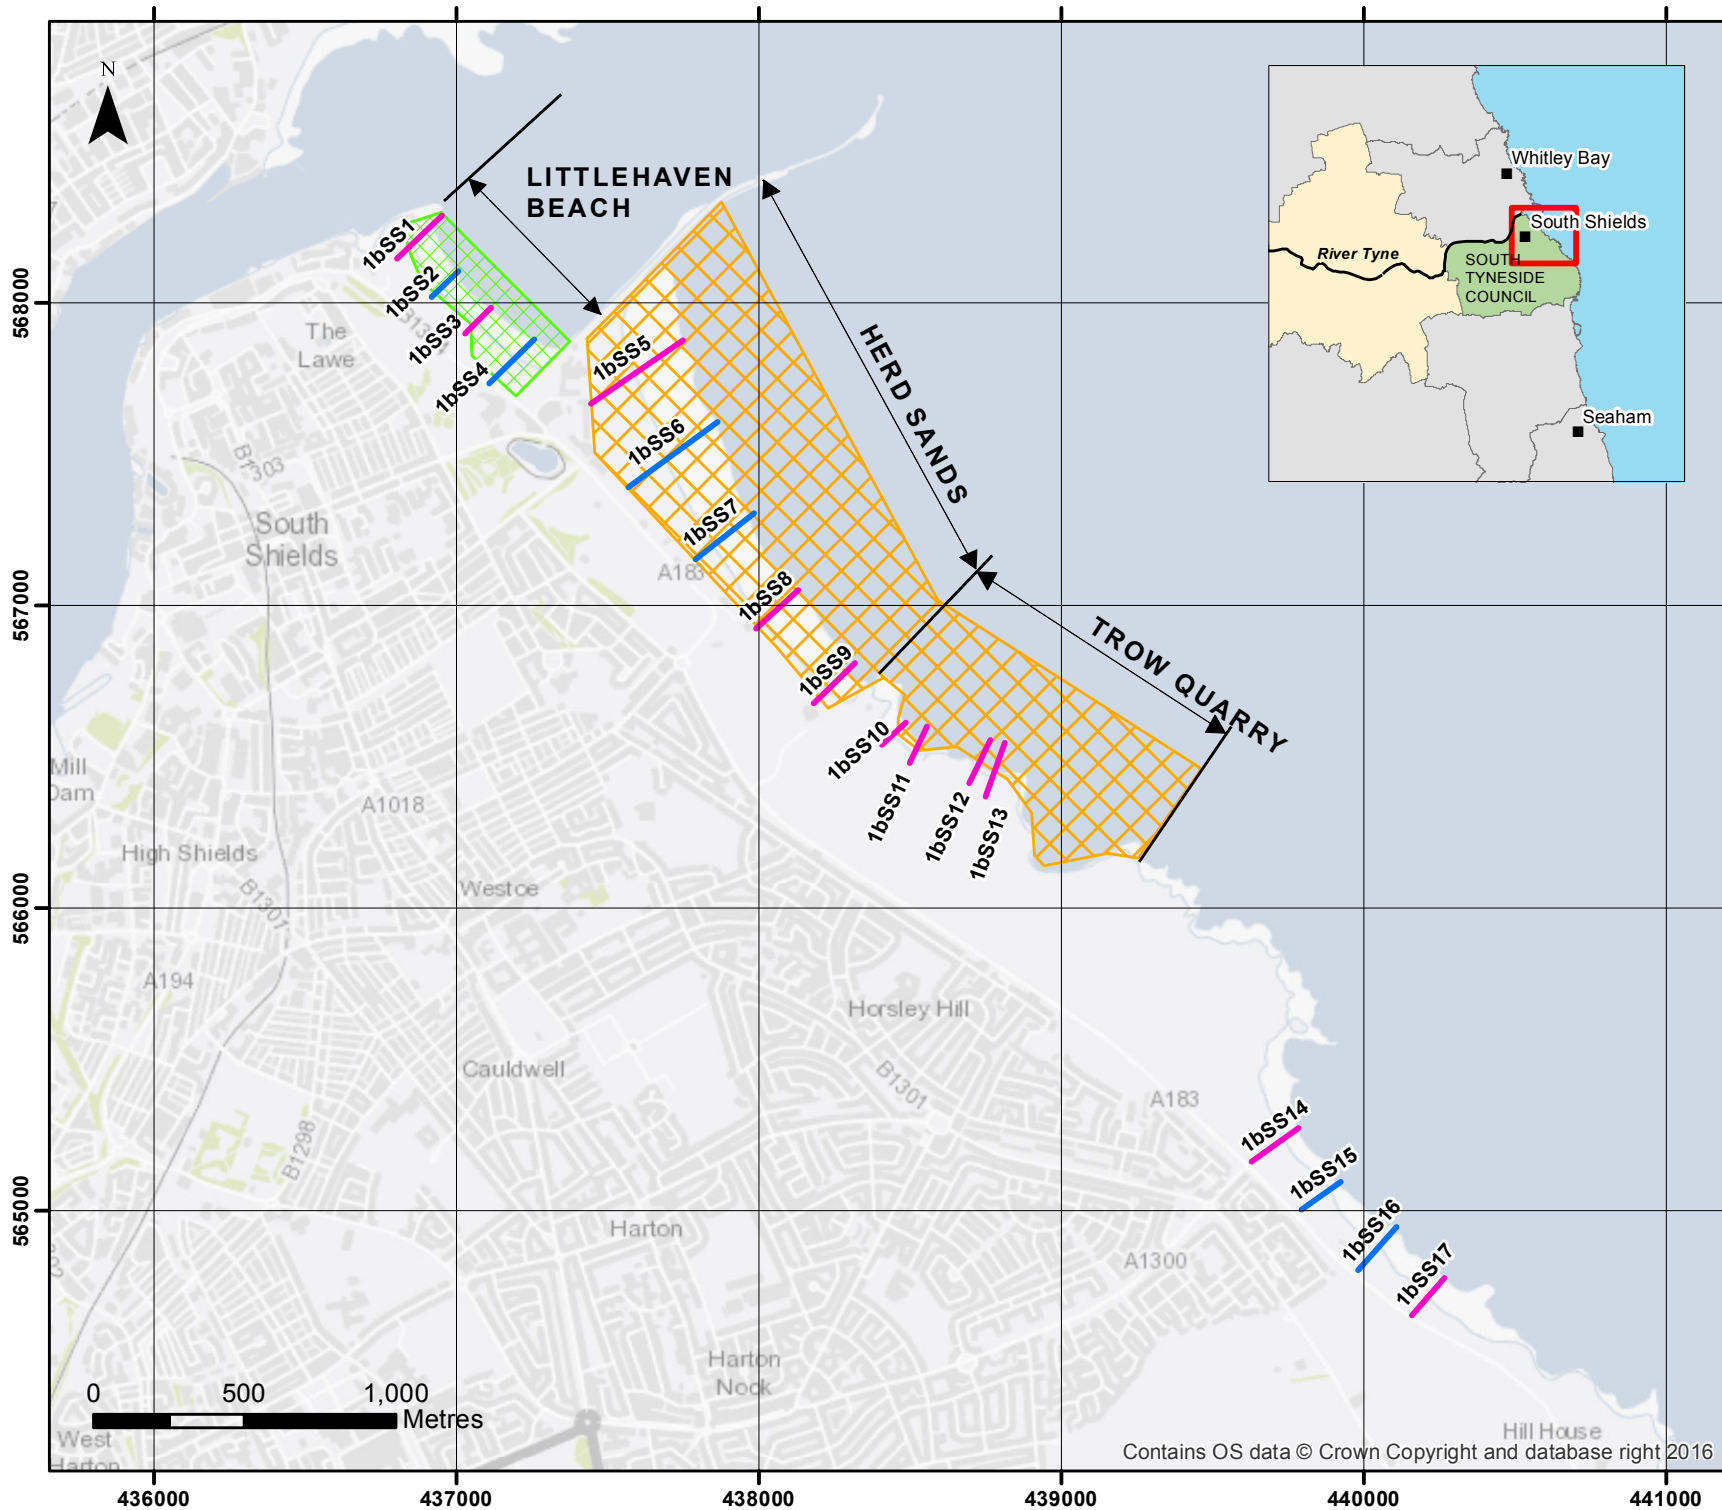
**Figure 2 - Map 1**

The location of these surveys is shown in Figure 2. The Full Measures survey was undertaken along this frontage between 27<sup>th</sup> October and 3<sup>rd</sup> November 2016. During this time, the weather conditions ranged from overcast to sunny but remained dry. Wind speeds ranged from Force 2 to Force 5 and the sea state varied from calm to rough.

**SURVEY LOCATIONS**

**Topographic Profiles**

- Annual
- Bi-Annual

**Topographic Surveys**

- 6 monthly
- yearly
- 5 yearly

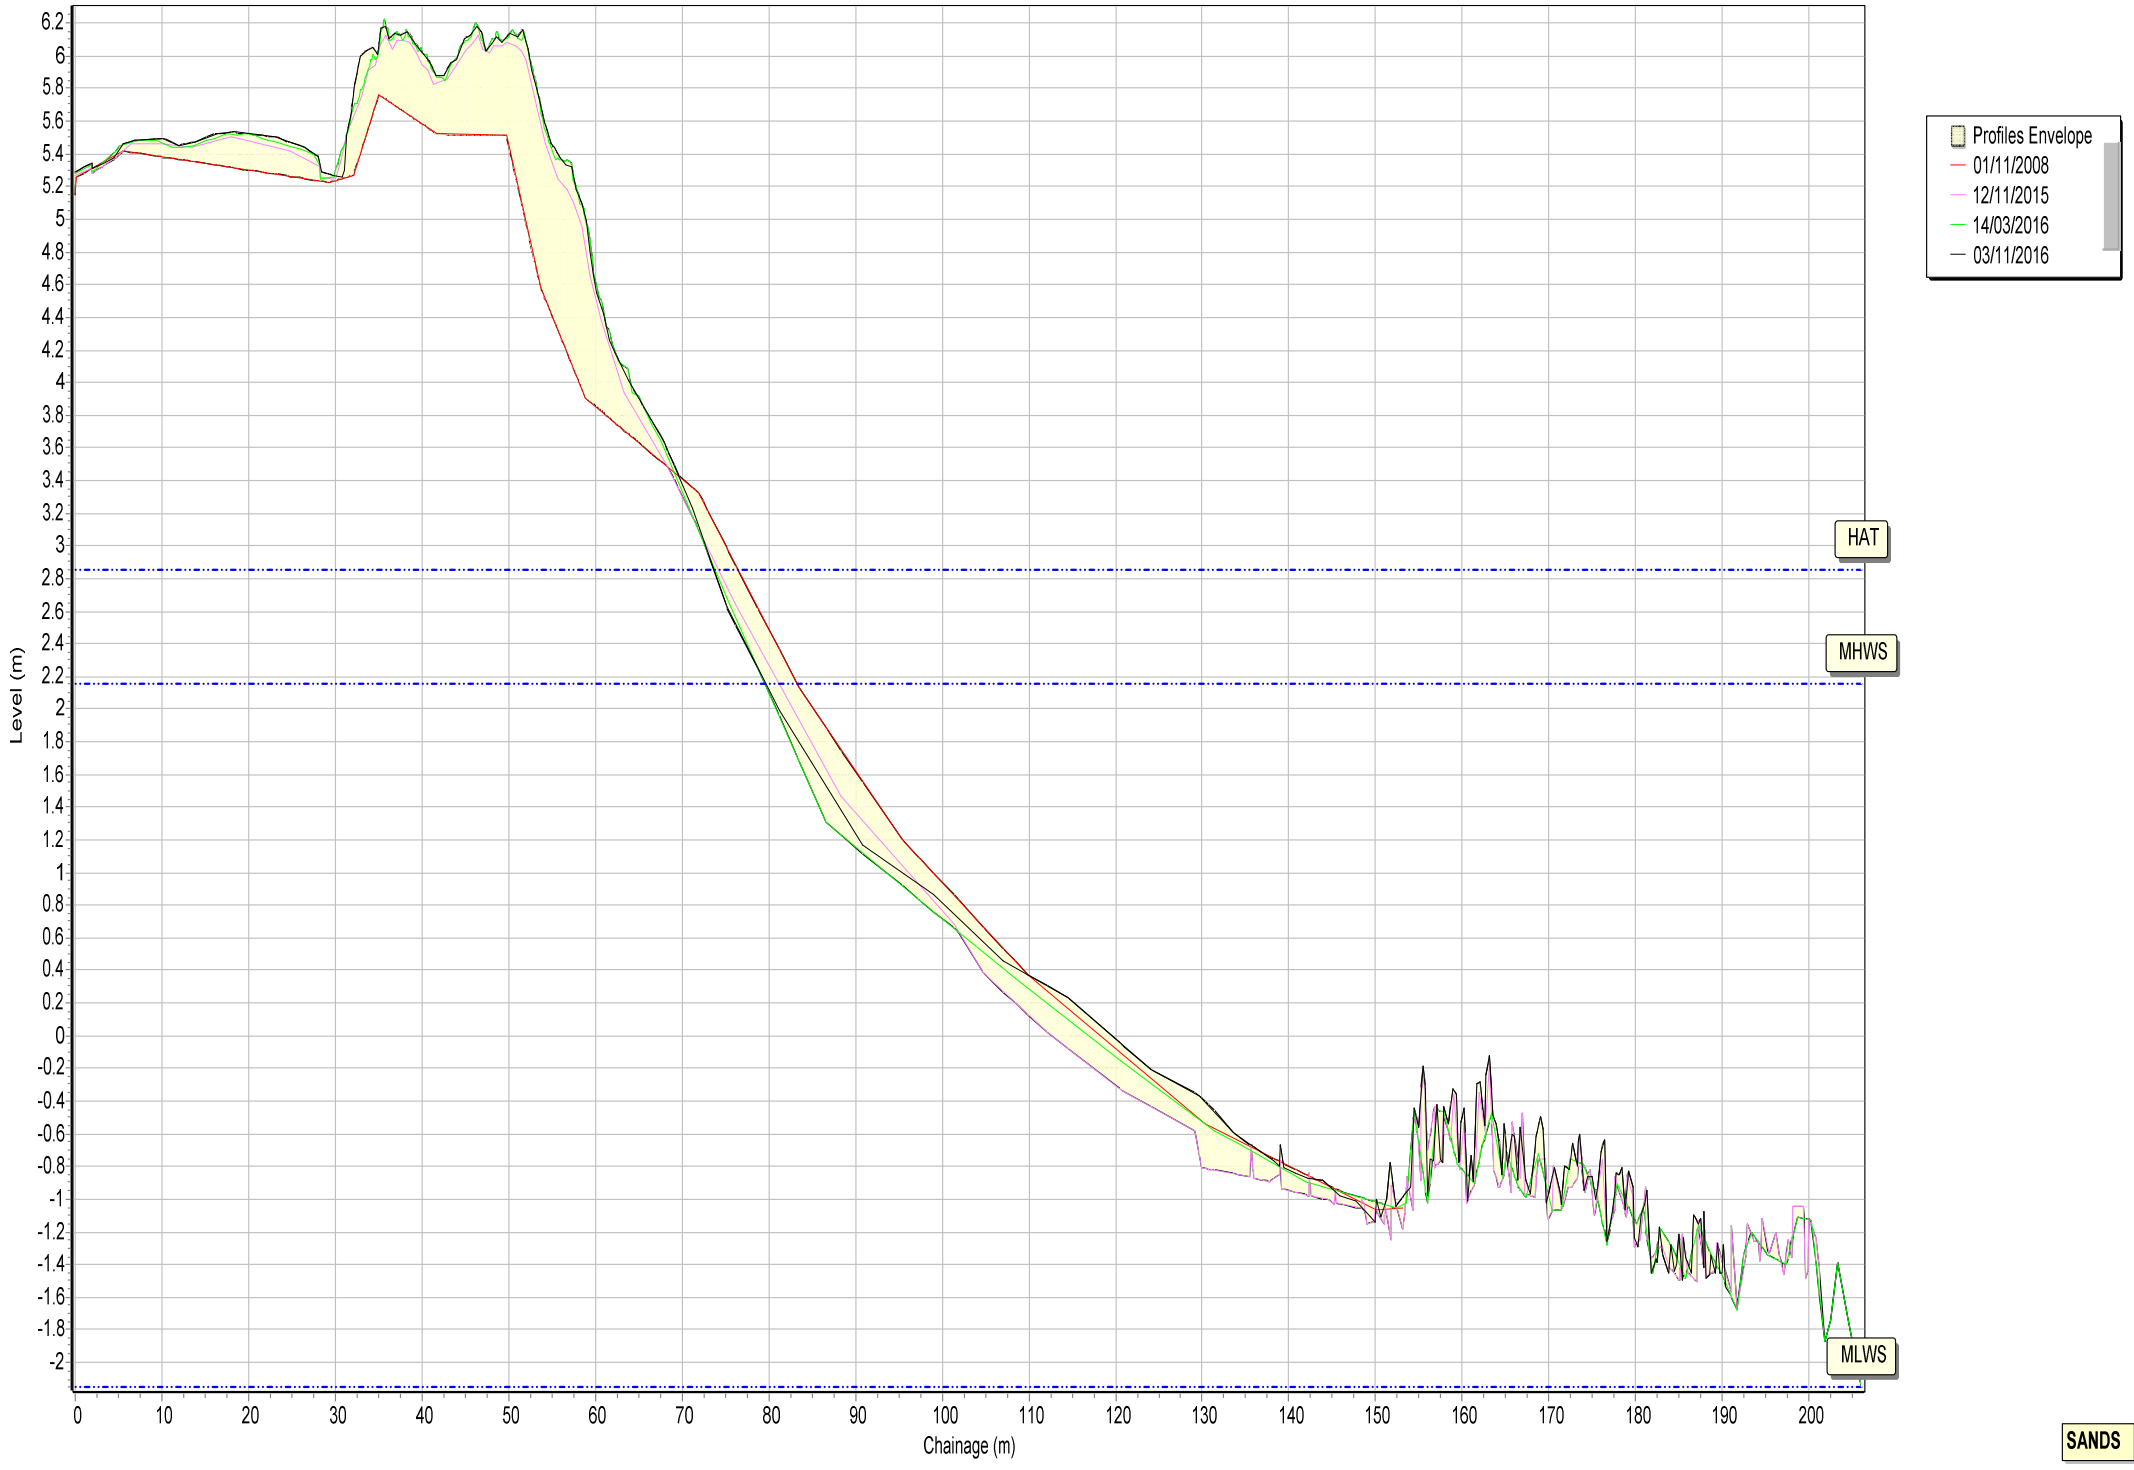
Beach Profiles: 1bSS1

Survey Date	Description of Changes Since Last Survey	Interpretation
<p><b>October-November 2016</b></p>	<p><b>Beach Profiles:</b></p> <p>Littlehaven Beach is covered by four beach profile lines for the Full Measures survey, spaced between South Groyne and South Pier (Appendix A). The previous survey was the Partial Measures survey undertaken in March 2016 and the previous Full Measures survey was undertaken in November 2015. Profiles 1bSS1 and 1bSS3 were last surveyed during the Partial Measures spring survey, 2016. Profiles 1bSS2 and 1bSS4 were last surveyed during the Full Measures autumn survey, 2015.</p> <p>Profile <b>1bSS1</b> is located to the north of Littlehaven beach, in the lee of a rocky outcrop and South Groyne. The dunes have remained stable since the last survey. Beach levels have changed very little since the March 2016 survey, with small amounts of accretion &lt;0.2m along the whole beach profile. The profile is at a medium level through the middle and lower beach compared to the range recorded from previous surveys, but at a relatively low level on the upper beach.</p> <p>Profiles <b>1bSS2 to 1bSS4</b> extend seawards from the new sea wall that was completed since the Full Measures survey in April 2014.</p> <p>At profile <b>1bSS2</b>, beach levels have fallen by 0.2m at the toe of the seawall with a corresponding increase of 0.2m between 0 and 15m chainage forming a small berm. There is little change in the profile between 15m and 90m with changes limited to less than ±0.1m. Between 90m and 110m, chainage there has been accretion of up to 0.3m forming a berm on the lower beach. The profile is at a medium-low level through the upper and middle beach compared to the range recorded from previous surveys, but is the highest on record on the lower beach.</p> <p>At profile <b>1bSS3</b>, there has been accretion along the whole beach profile, though it is generally less than 0.2m. The berm crest at 5m chainage has increased slightly by 0.1m. The largest increase is on the lower beach between chainage 60m and 85m of up to 0.3m. Overall, the profile is at a medium level compared to the range recorded from previous surveys, though at its highest recorded level on the</p>	<p>The beach at Littlehaven has had some time to adjust since construction of the new seawall in April 2014. All of the profiles show little change since March 2016, with small amounts of accretion being typical. All of the profiles are generally at medium-low level compared to the range recorded from previous surveys.</p> <p><b>Longer term trends:</b> The beach profiles are at variable positions relative to past levels. In general they are within the boundaries of previous surveys indicating the new seawall has not adversely affected sediment movements. Profile 1bSS1 shows signs of progressive steepening, but is not currently a cause for concern.</p>

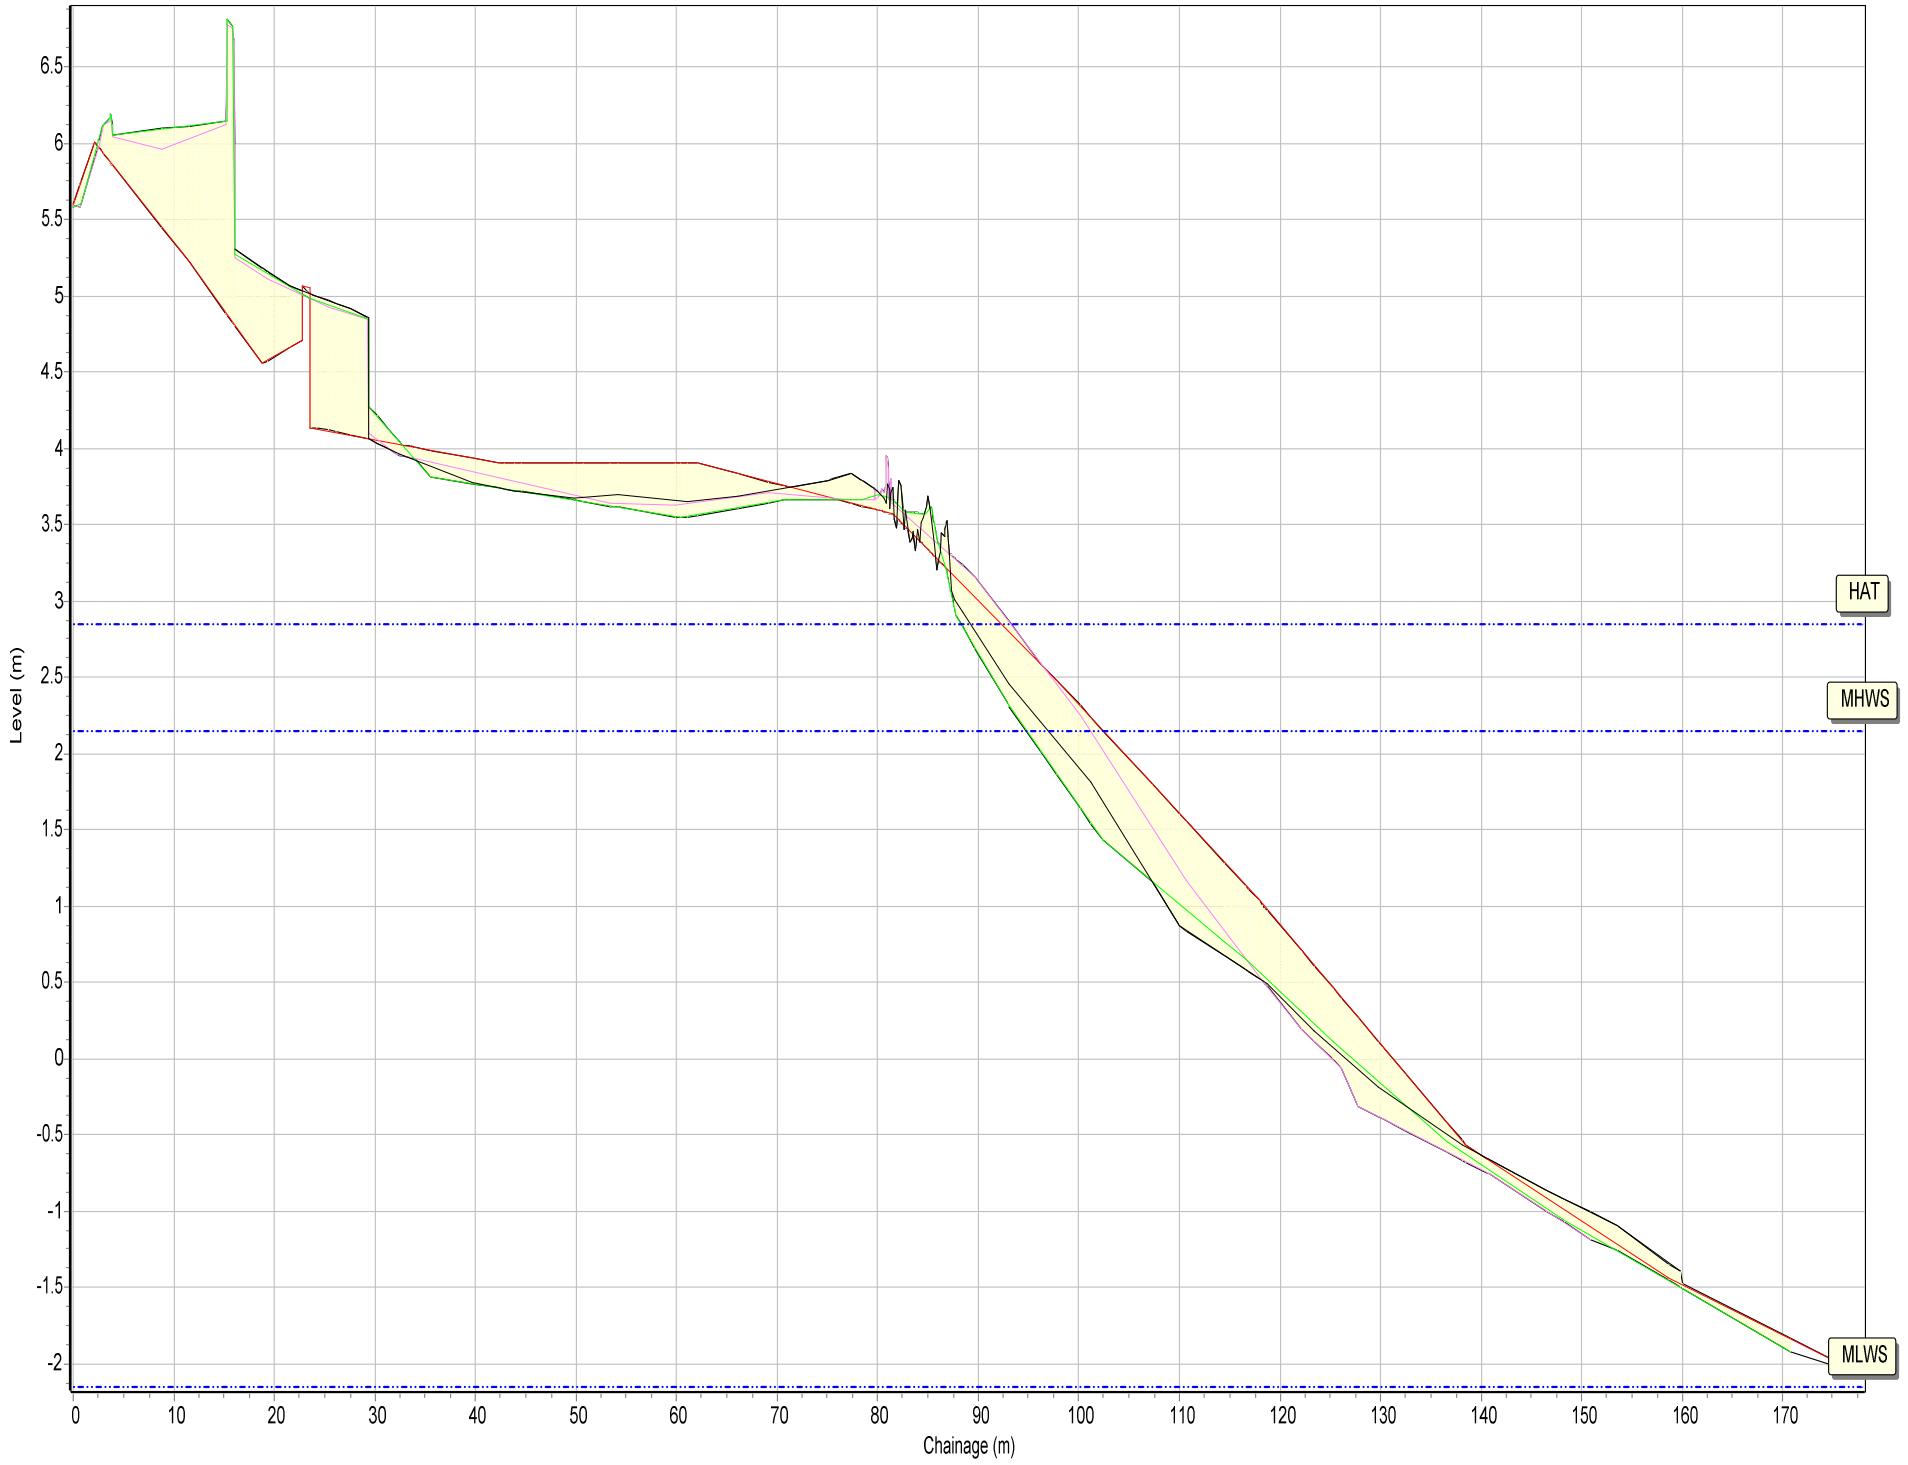
Beach Profiles: 1bSS4

Survey Date	Description of Changes Since Last Survey	Interpretation
	<p>upper beach above the berm.</p> <p>At profile <b>1bSS4</b>, there has been little change to beach levels, with changes limited to less than <math>\pm 0.2\text{m}</math> across the whole beach profile. The bank of cobble-small boulders present at chainage 80-90m remains exposed. Overall, the beach is at a medium-low level compared to the range recorded from previous surveys, and is particularly low in the upper beach and immediately seaward of the cobble-small boulder bank.</p>	
<p><b>October – November 2016</b></p>	<p><b>Topographic Survey:</b></p> <p>Littlehaven Beach is covered by bi-annual topographic survey between the South Groyne and the South Pier, which commenced in March 2010.</p> <p>Data from the most recent topographic survey (Full Measures, autumn 2016) have been used to create a DGM (Appendix B – Map 1) using GIS. A difference plot has also been produced using the DGM (Appendix B – Map 3) produced from the last produced topographic survey (Partial Measures, spring 2016) and the present survey.</p> <p>The topographic survey is patchy and generally shows little change across the beach. In general the lower foreshore shows accretion with the southern half of the bay also showing some accretion on the upper/mid beach. There are small areas of erosion in the mid beach in the centre of the bay and on the upper beach at the northern end of the bay.</p>	<p>Comparison of the present topographic survey with the previous Partial Measures (spring, 2016) shows that the beach is generally stable with shore-parallel bands of elevation change which reflect seasonal redistributions of material throughout across the beach as bars.</p>

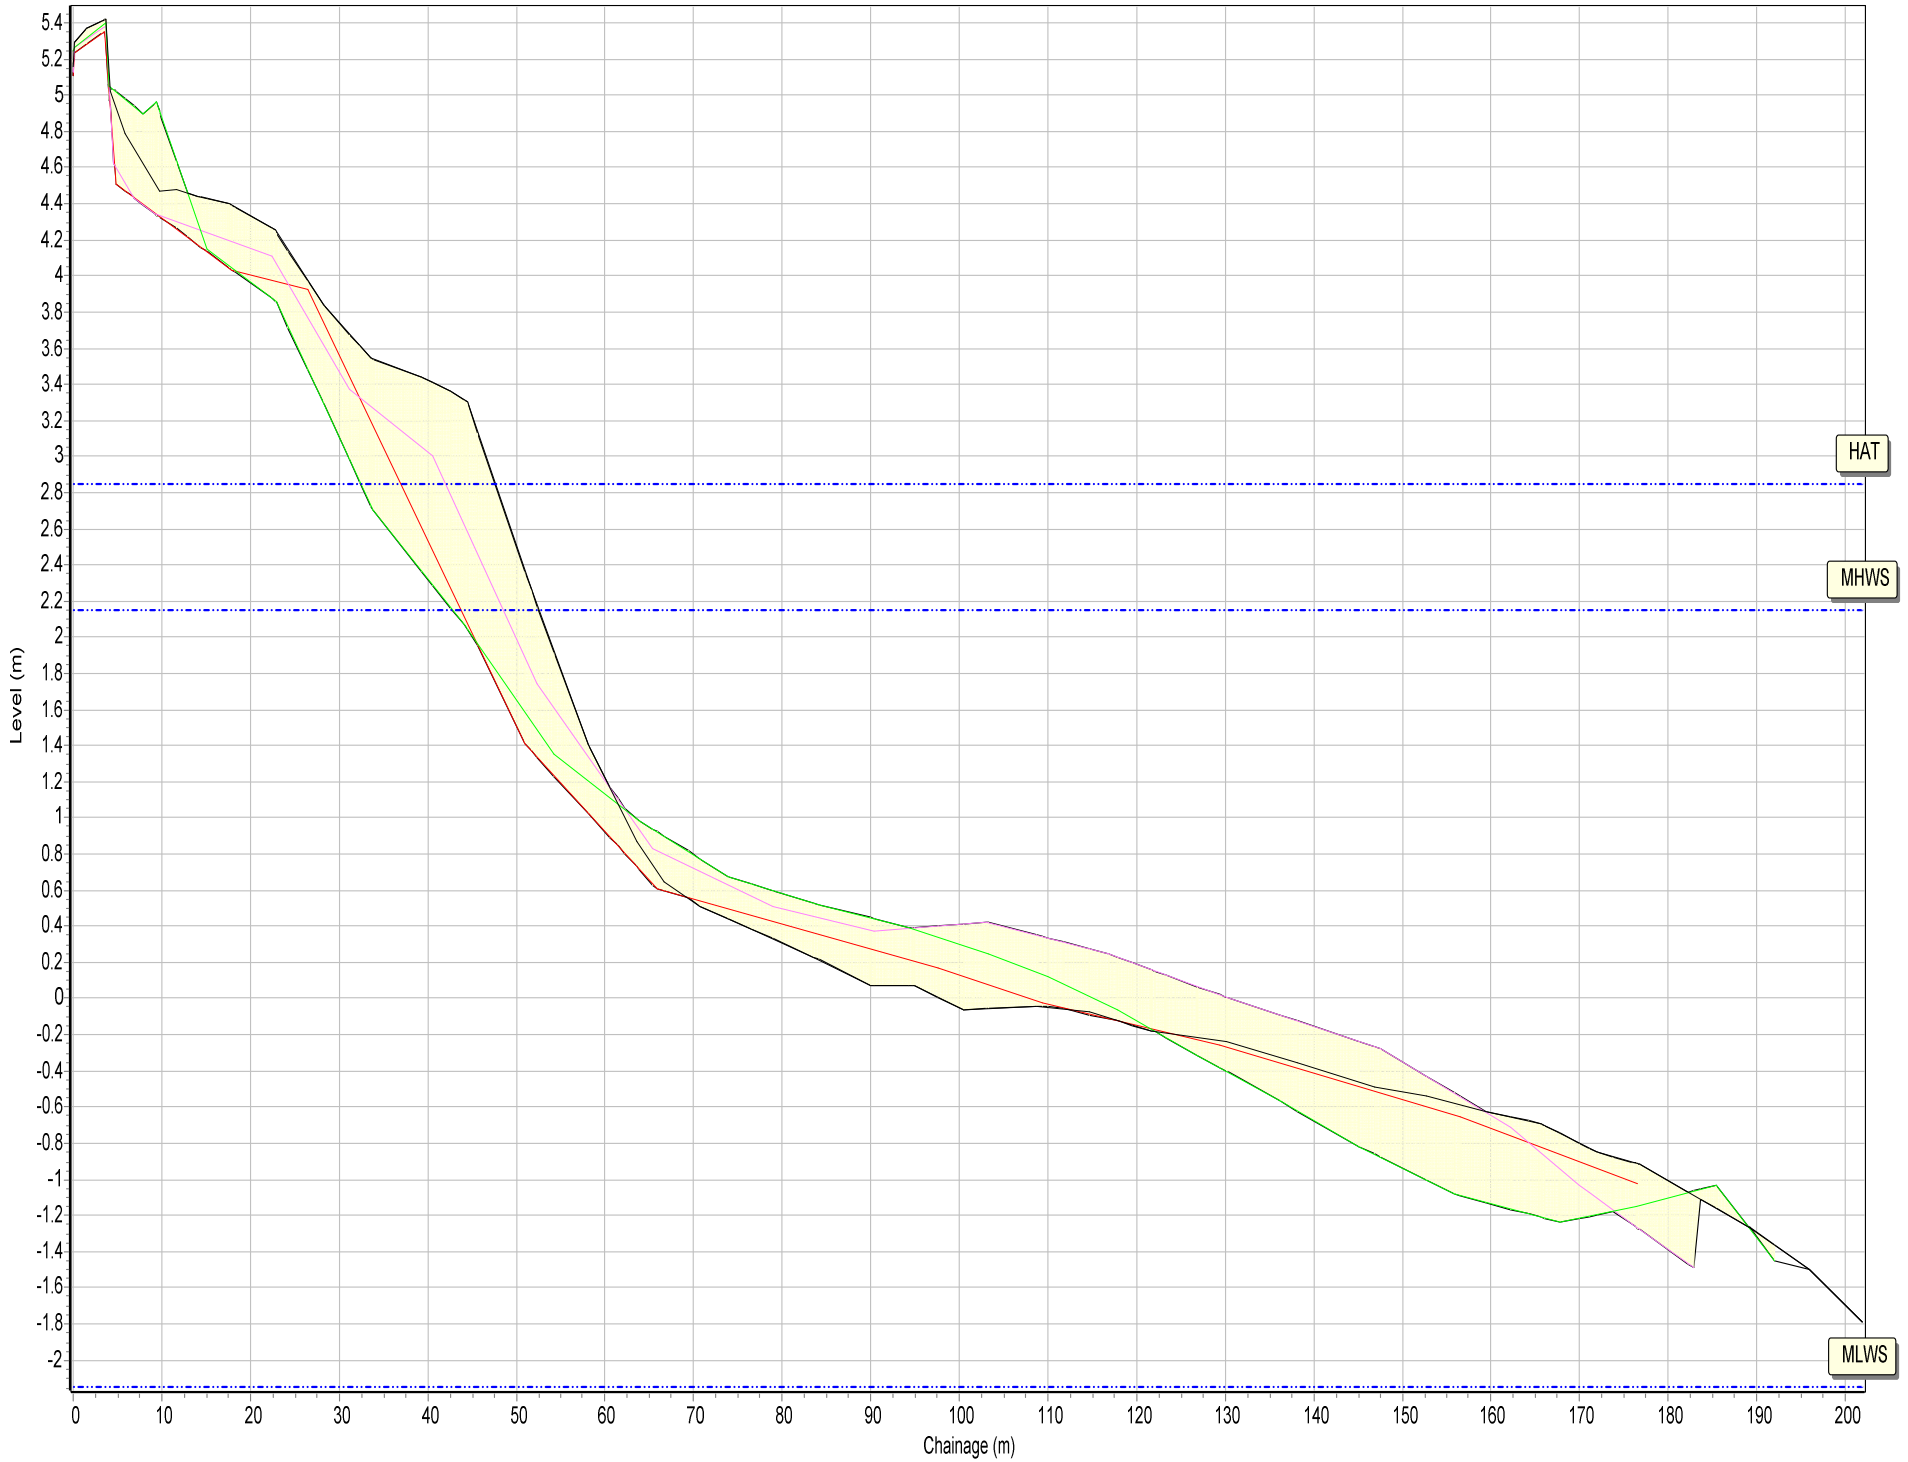
Beach Profiles: 1bSS8

Survey Date	Description of Changes Since Last Survey	Interpretation
	<p>At profile <b>1bSS8</b>, there has been variable erosion and accretion across the profile creating a steeper upper beach and flatter lower/mid beach. At the toe of the seawall there has been erosion of 0.5m. Between chainage 10m and 60m there has been accretion of up to 1m forming a berm at chainage 40m. Between 60m and 120m there has been erosion of up to 0.3m, with erosion of up to 0.5m from 120m to 180m chainage. Overall, the beach is at a medium-high level compared to the range recorded from previous surveys, apart from the middle beach around chainage 70m, which is relatively low.</p> <p>Profile <b>1bSS9</b> is located at the southern end of Herd Sands. The dune profile fronting the car park remains unchanged. The beach profile changes follow a very similar pattern to those at profile 1bSS8, with the formation of a berm on the upper beach at chainage 50m. The middle beach between chainage 65m and 150m has dropped in level by up to 0.3m, whilst the lower beach from 150m seawards has accreted by 0.2m except between chainage 180m and 200m where the berm present on the previous survey has disappeared. Overall the beach is at a medium-high level compared to the range recorded from previous surveys, apart from the toe of the beach which shows the lowest recorded level between chainage 190m and 200m.</p>

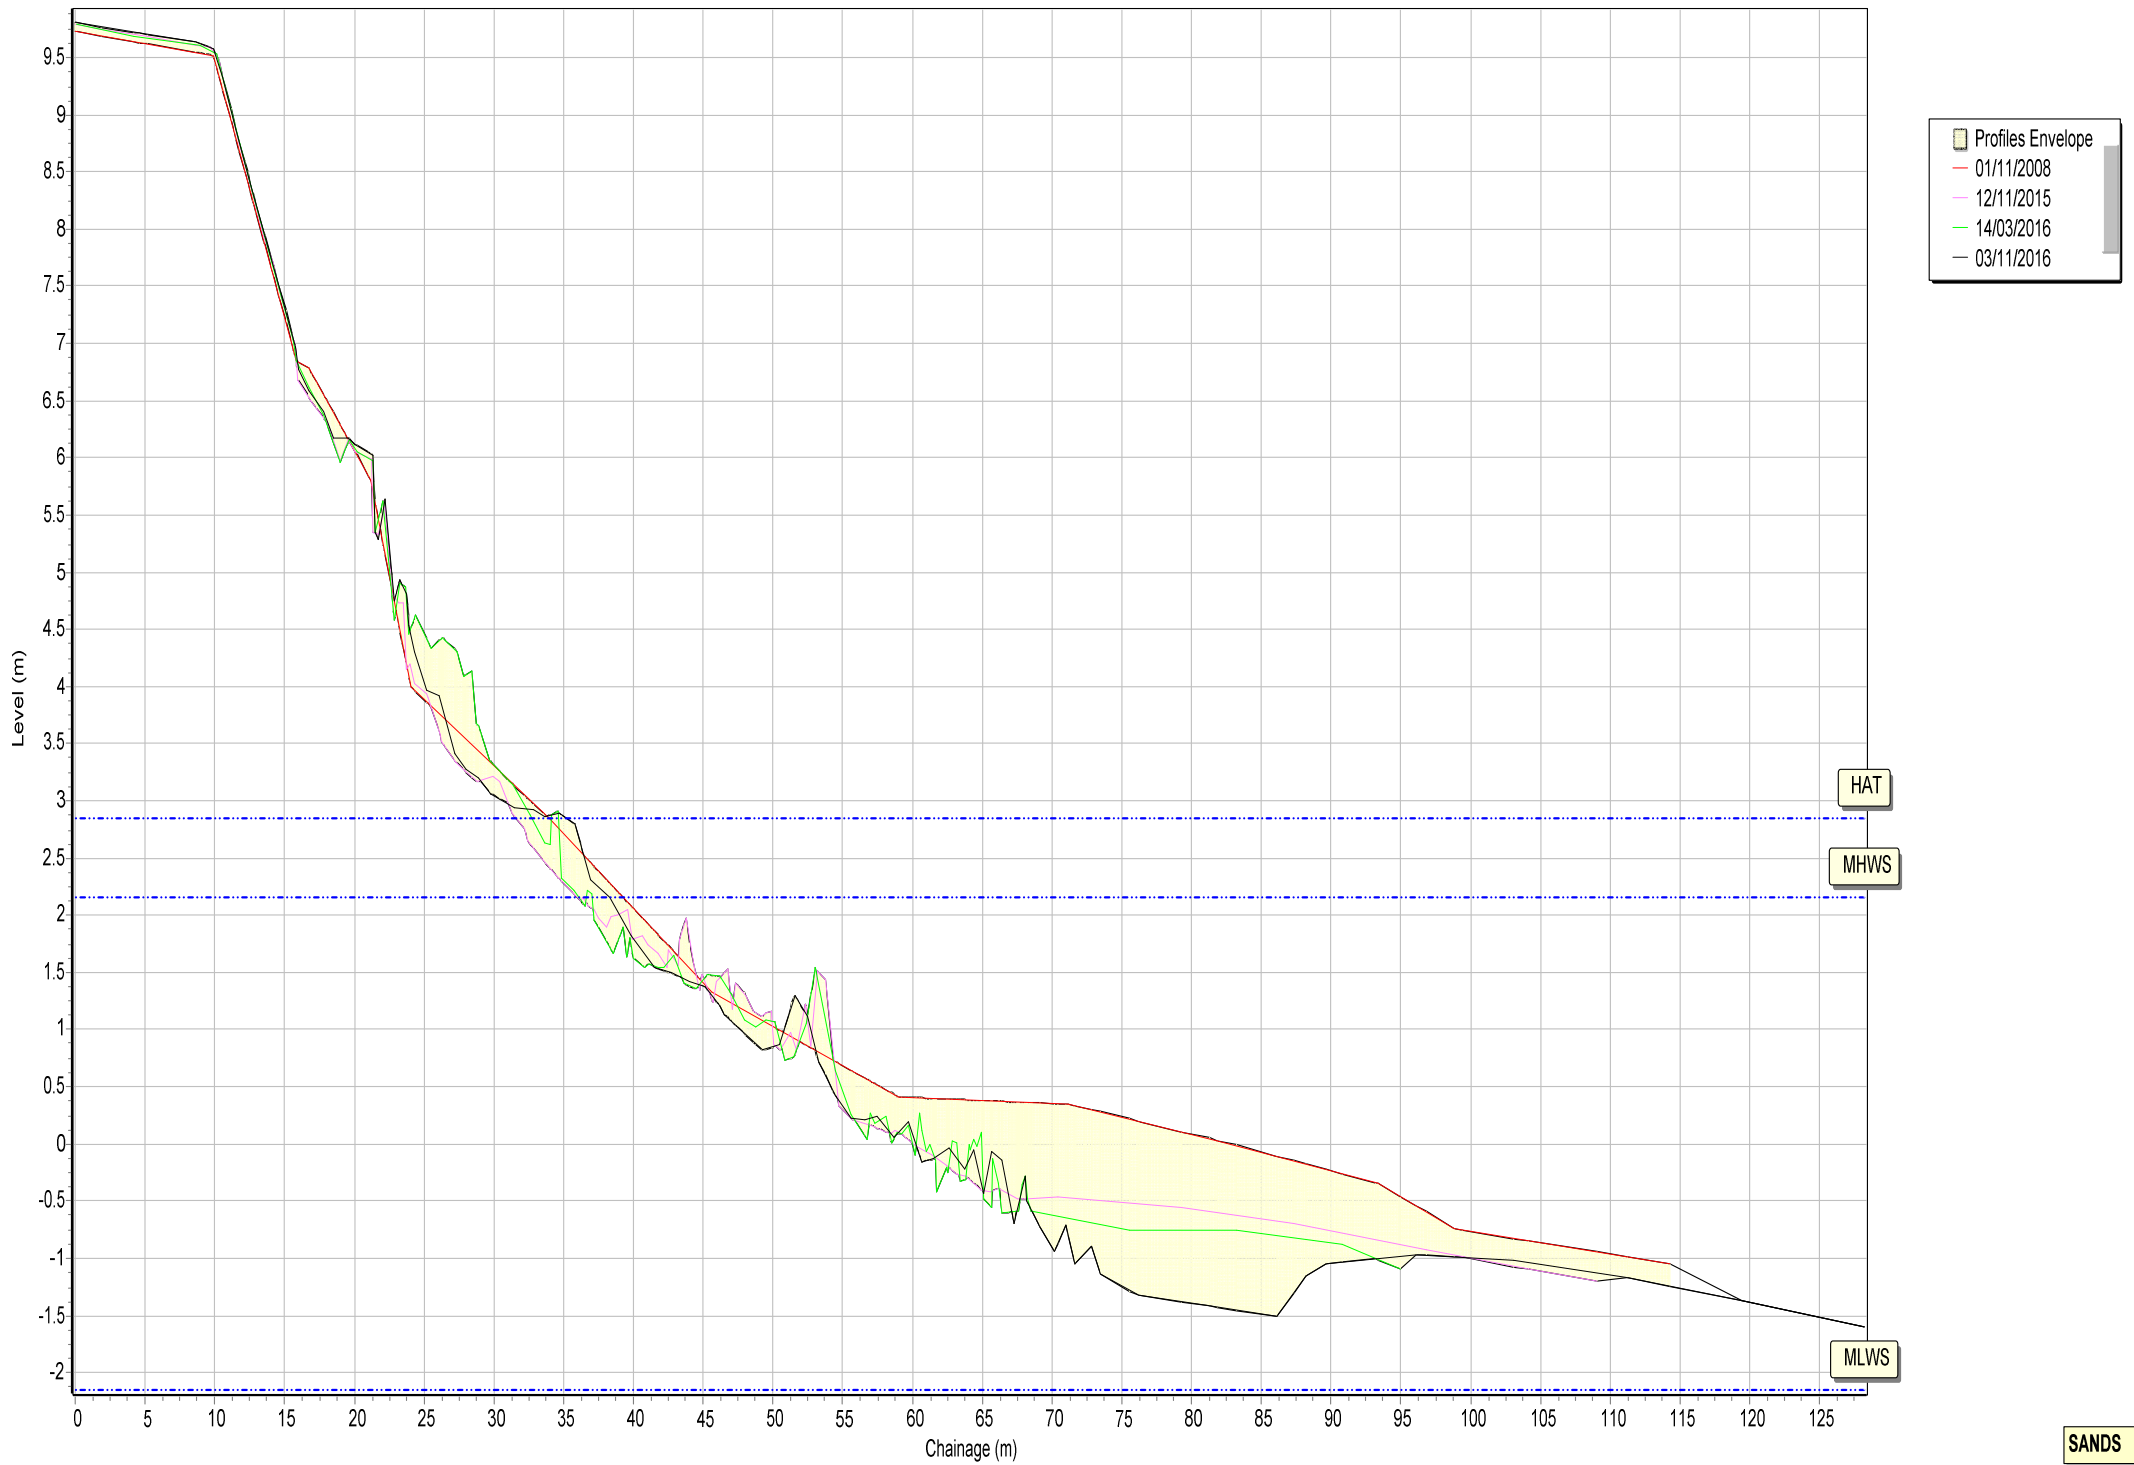
Beach Profiles: 1bSS10

Survey Date	Description of Changes Since Last Survey	Interpretation
<p><b>October – November 2016</b></p>	<p><b>Beach Profiles:</b></p> <p>Trow Quarry is covered by four beach profile lines for the Full Measures survey (Appendix A), two in Graham's Sand and two in Southern Bay. The previous survey was the Partial Measures survey undertaken in March 2016.</p> <p>Profiles <b>1bSS10</b> and <b>1bSS11</b> are located in Graham's Bay.</p> <p>At profile <b>1bSS10</b> the backshore has remained stable. The gravel deposit noted on the March 2016 survey between chainage 24m and 30m has been eroded by up to 1m, although there has been some accretion of gravel between 30m and 50m of up to 0.6m. There has also been erosion of sand between chainage 70m and 85m uncovering c.10m more of rocks. From chainage 85m seawards a broad berm has formed. Overall, the profile is at a relatively low-medium level compared with the range recorded from previous surveys.</p> <p>At profile <b>1bSS11</b>, the profile has remained stable.</p> <p>Profile <b>1bSS12</b> and <b>1bSS13</b> are located in Southern Bay. At both locations the beach profile has remained stable since the previous survey. Apparent changes in the profile likely derive from minor movement of cobbles or differences in the exact placement of survey points.</p>	<p>At both Graham's Bay and Southern Bay, the cliff and rock revetment have remained stable.</p> <p>At Graham's Bay, the northern part of the beach has dropped, with draw-down of material to the lower foreshore, but to the south, the beach has remained fairly stable.</p> <p>At Southern Bay, the rocky foreshore has generally retained the same form and position.</p> <p><b>Longer term trends:</b> Overall, the beach at Graham's Bay and Southern Bay has retained the same form and position since November 2008/March 2009 when surveys began. Movement in the north of Grahams Bay at profile 1bSS10 is within the bounds of previous surveys.</p>

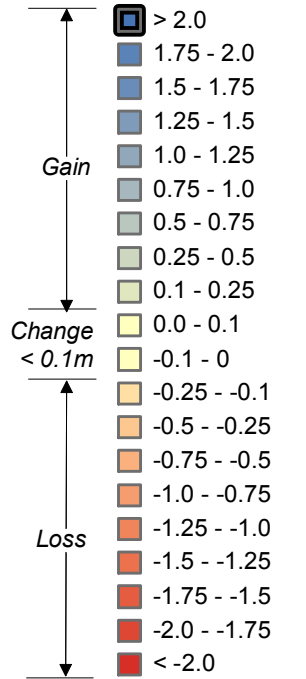
**DIFFERENCE BETWEEN TOPOGRAPHIC SURVEYS**  
March to Nov 2016

Nov 2015	<p><b>Topographic Survey:</b></p> <p>Herd Sands is covered by an annual topographic survey between the South Pier and Trow Point, which commenced in November 2008.</p> <p>Data from the most recent topographic survey (Full Measures, autumn 2016) have been used to create a DGM (Appendix B – Map 1) using GIS. A difference plot has also been produced using the DGM (Appendix B – Map 2) produced from the last topographic survey (Full Measures, autumn 2015) and the present survey.</p> <p>The difference plot shows that change across the dunes is patchy but generally showing accretion. The beach itself is dominated by erosion particularly in the centre and south of Herd Sands, and immediately adjacent to the breakwater. Both the upper and lower beach show narrow strips of accretion in the north and south of the bay but not in the centre. The most intense area of change is in the middle of the beach in the centre of the bay with erosion of up to 2m (where profile 1bSS7 shows the berm has moved landwards).</p>	<p>Comparison of the present topographic survey with the previous Full Measures (autumn, 2015) shows widespread accretion of limited intensity in the dunes and at the dune front, the seaward edge of the upper beach and the lower foreshore. This is mirrored by erosion in the upper and mid foreshore.</p>

<p><b>October – November 2016</b></p>	<p><b>Topographic Survey:</b></p> <p>Trow Quarry is covered by an annual topographic survey within Graham's Sand, Southern Bay and Frenchman's Bay, which commenced in November 2008.</p> <p>Data from the most recent topographic survey (Full Measures, autumn 2015) have been used to create a DGM (Appendix B – Map 2a) using GIS. A difference plot has also been produced using the DGM (Appendix B – Map 2b) produced from the last topographic survey (Full Measures, autumn 2014) and the present survey.</p> <p>The difference plot shows that up to 1m of change has occurred with the dominant pattern being one of</p>	<p><b>Topographic Survey:</b></p> <p>The difference plot indicates a movement of sediment from the back of the beach to the foreshore, which is most evident at Graham Sands. This is likely a process of drawdown, which moves sediment from the upper beach to form berms or bars on the foreshore.</p>
