Cell 1 Regional Coastal Monitoring Programme Analytical Report 10: 'Full Measures' Survey 2017

South Tyneside Council

February 2018

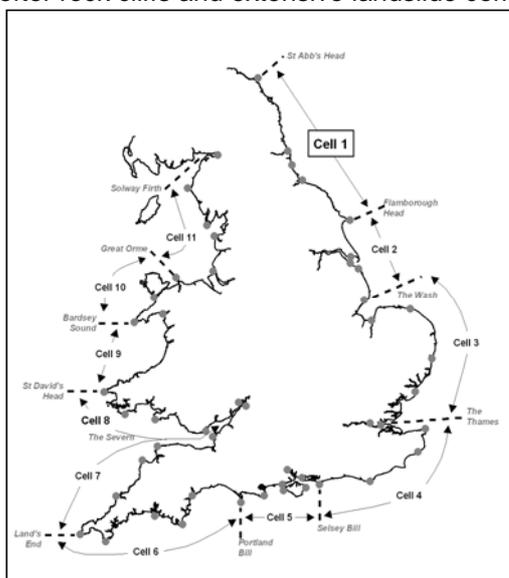
Figure 1 Sediment Cells in England and Wales

The Cell 1 Regional Coastal Monitoring Programme covers approximately 300km of the north east coastline, from the Scottish Border (just south of St. Abb's Head) to Flamborough Head in East Yorkshire. This coastline is often referred to as 'Coastal Sediment Cell 1' in England and Wales (Figure 1). Within this frontage the coastal landforms vary considerably, comprising low-lying tidal flats with fringing salt marshes, hard rock cliffs that are mantled with glacial sediment to varying thicknesses, softer rock cliffs and extensive landslide complexes.

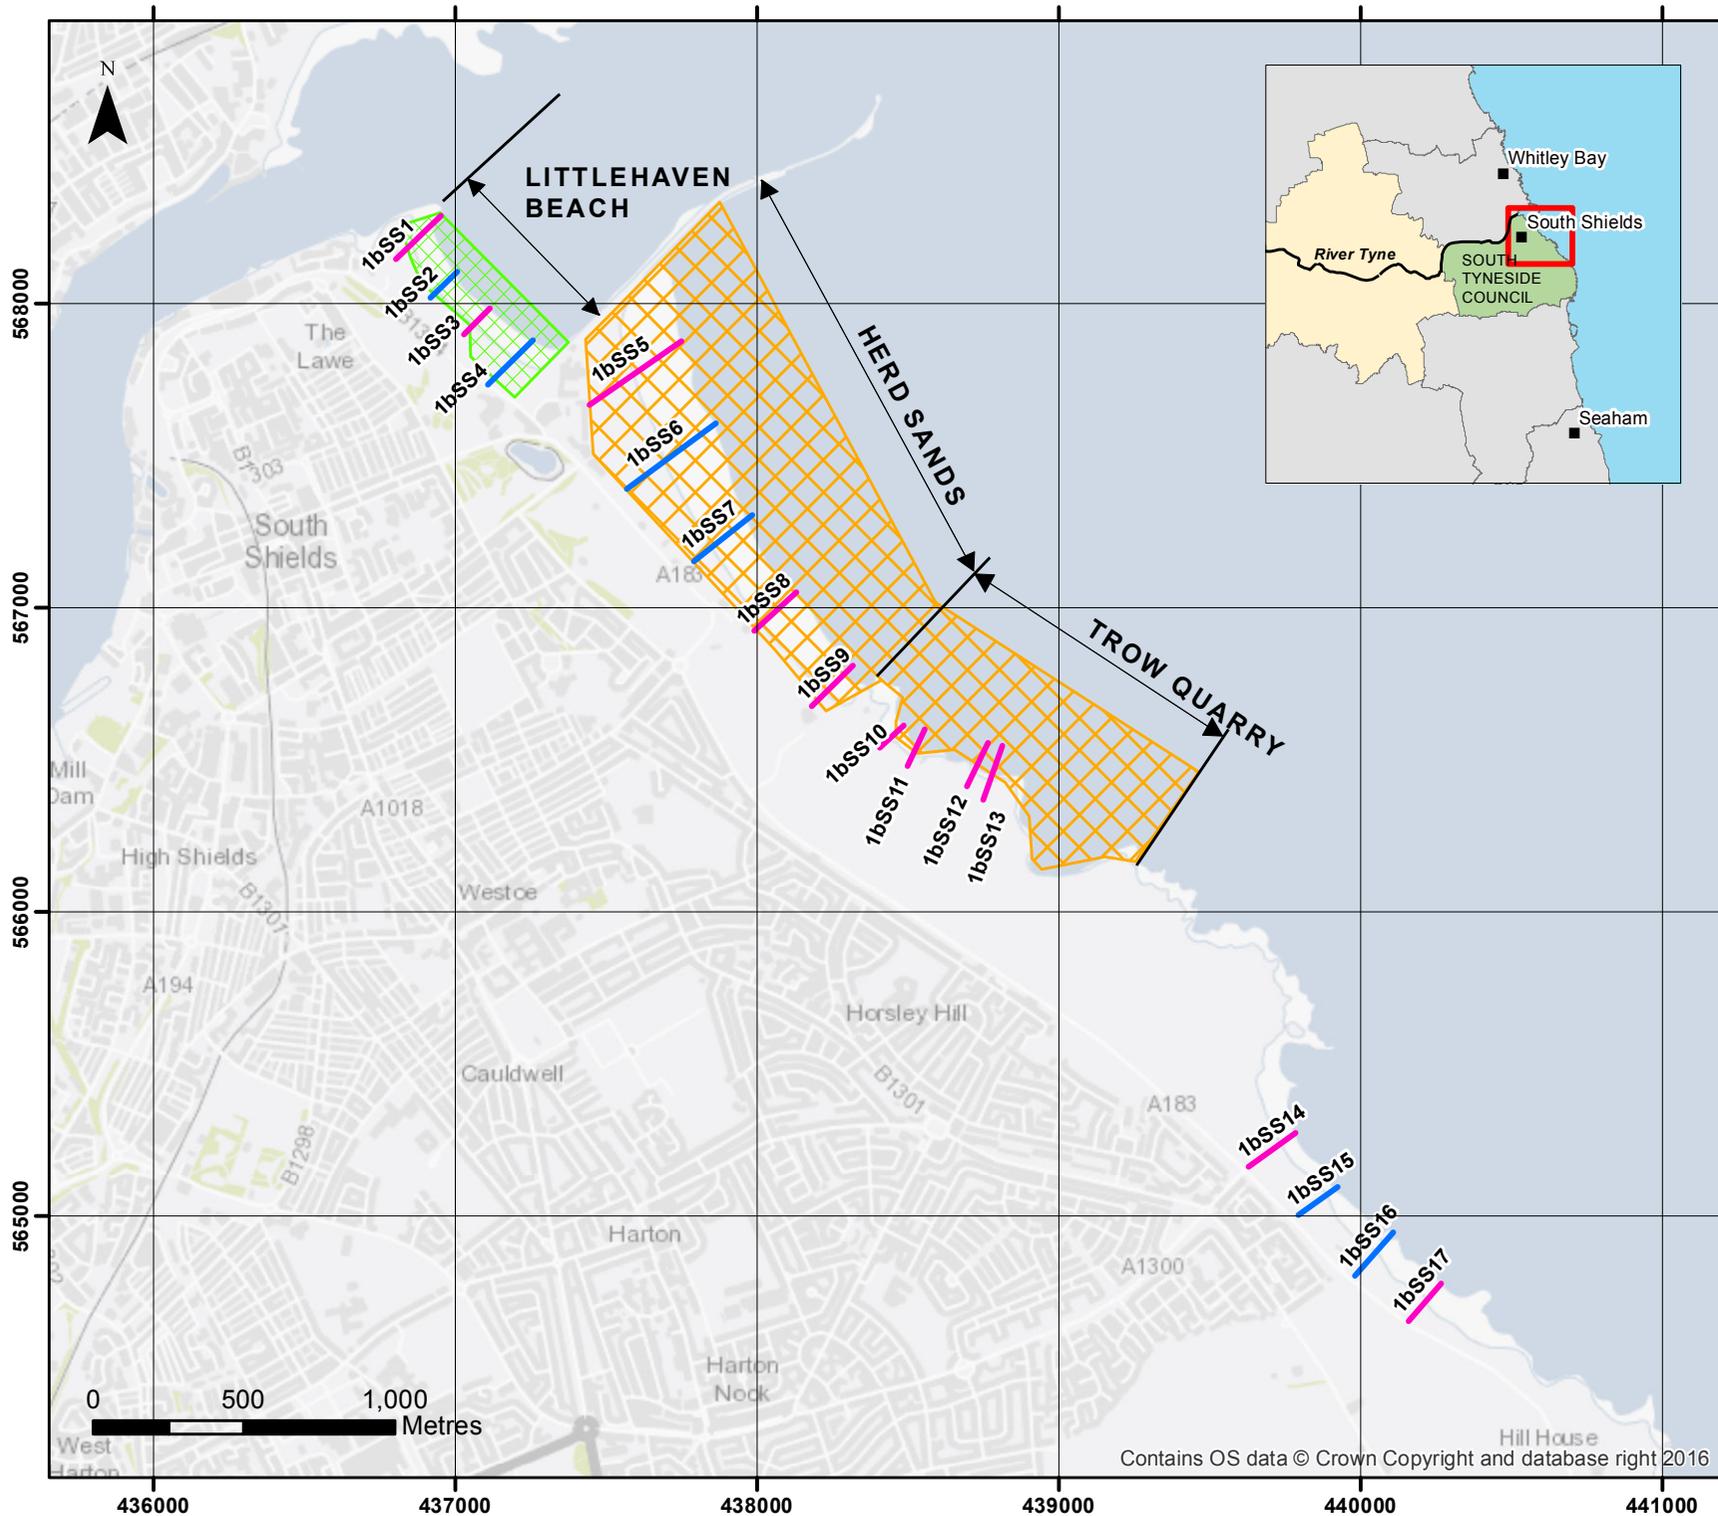
Figure 2 - Map 1

The location of these surveys is shown in Figure 2. The Full Measures survey was undertaken along this frontage between 28th September and 5th October 2017. During this time, the weather and sea state varied greatly, for details of the survey conditions refer to the Academy Geomatics survey report.

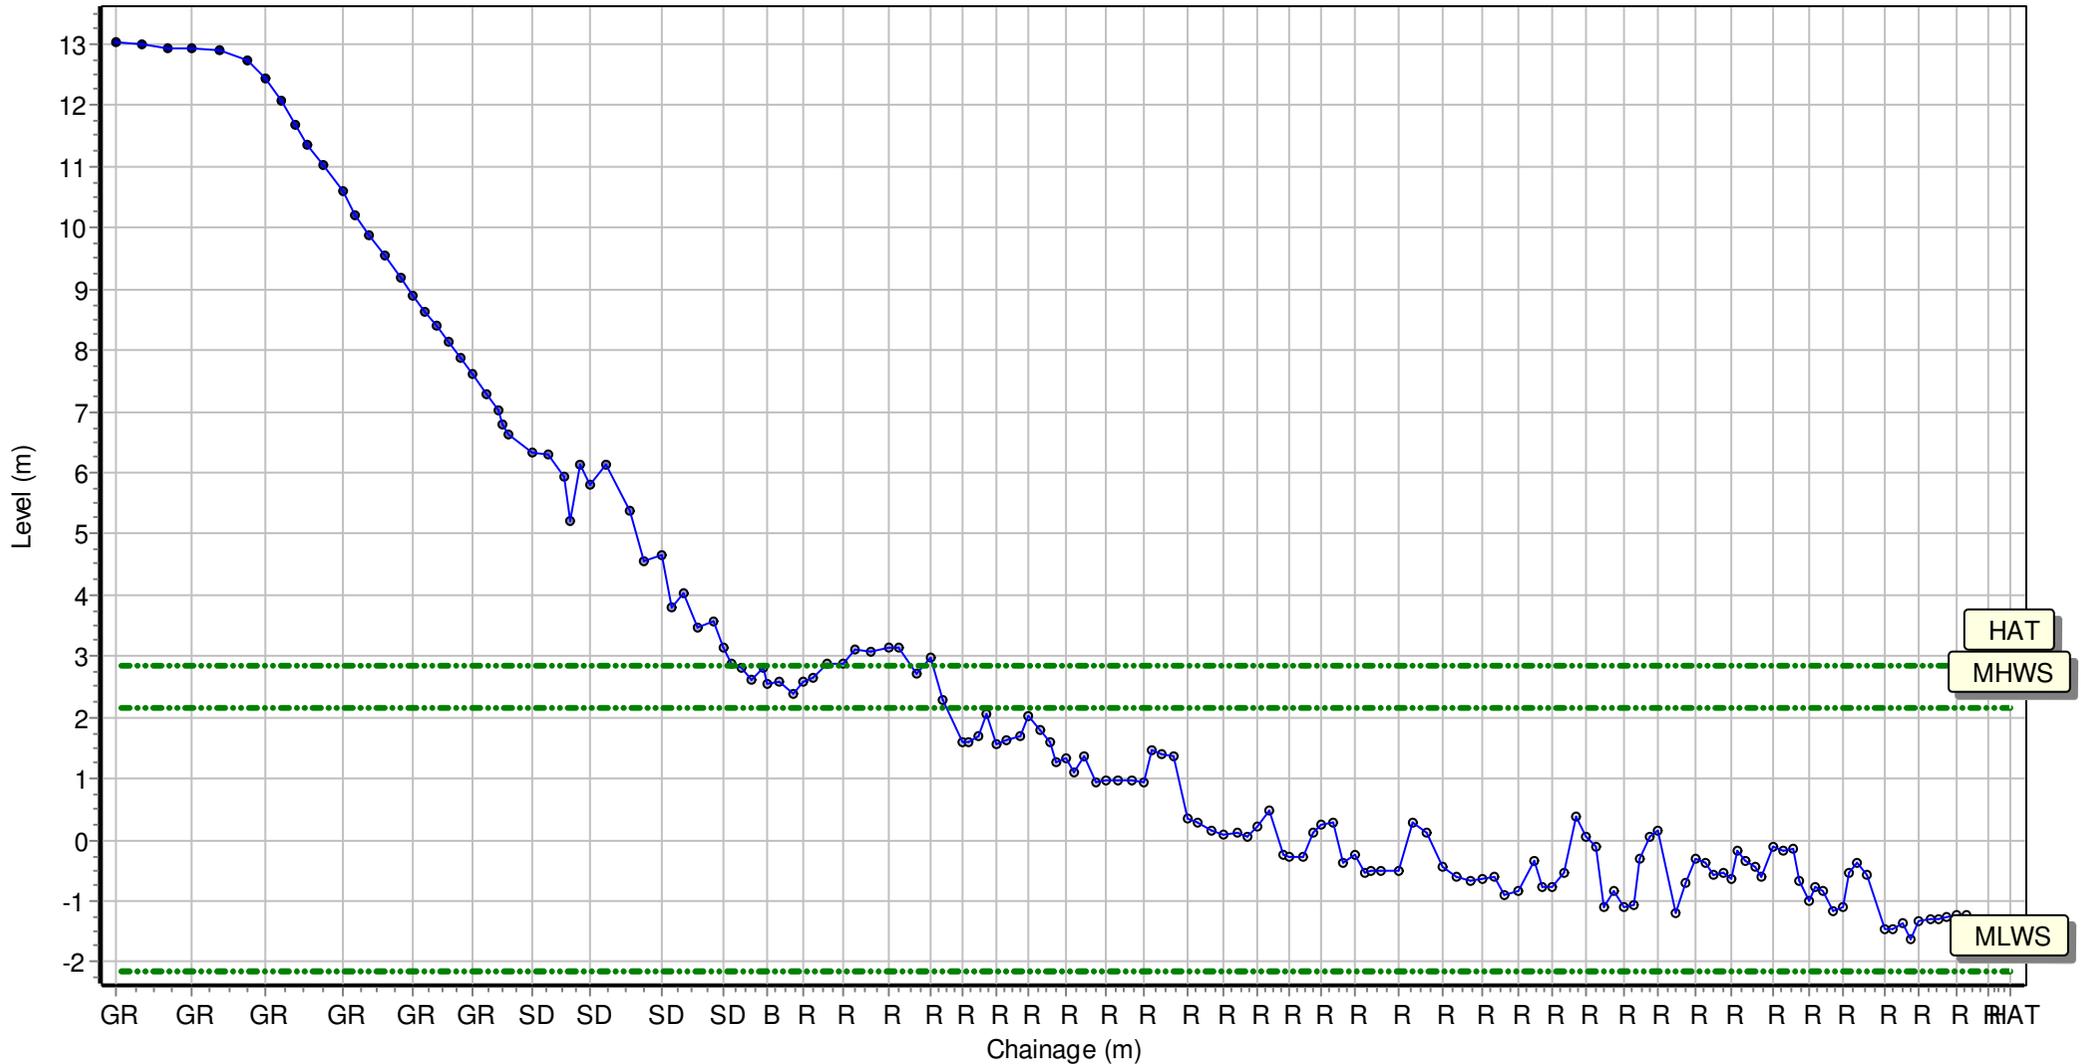
Location: 1bSS13

Summary: 2017 Full Measures Topo Survey

Easting: 438696.305 Northing: 566412.949 Profile Bearing: 26 ° from North

Beach Profile

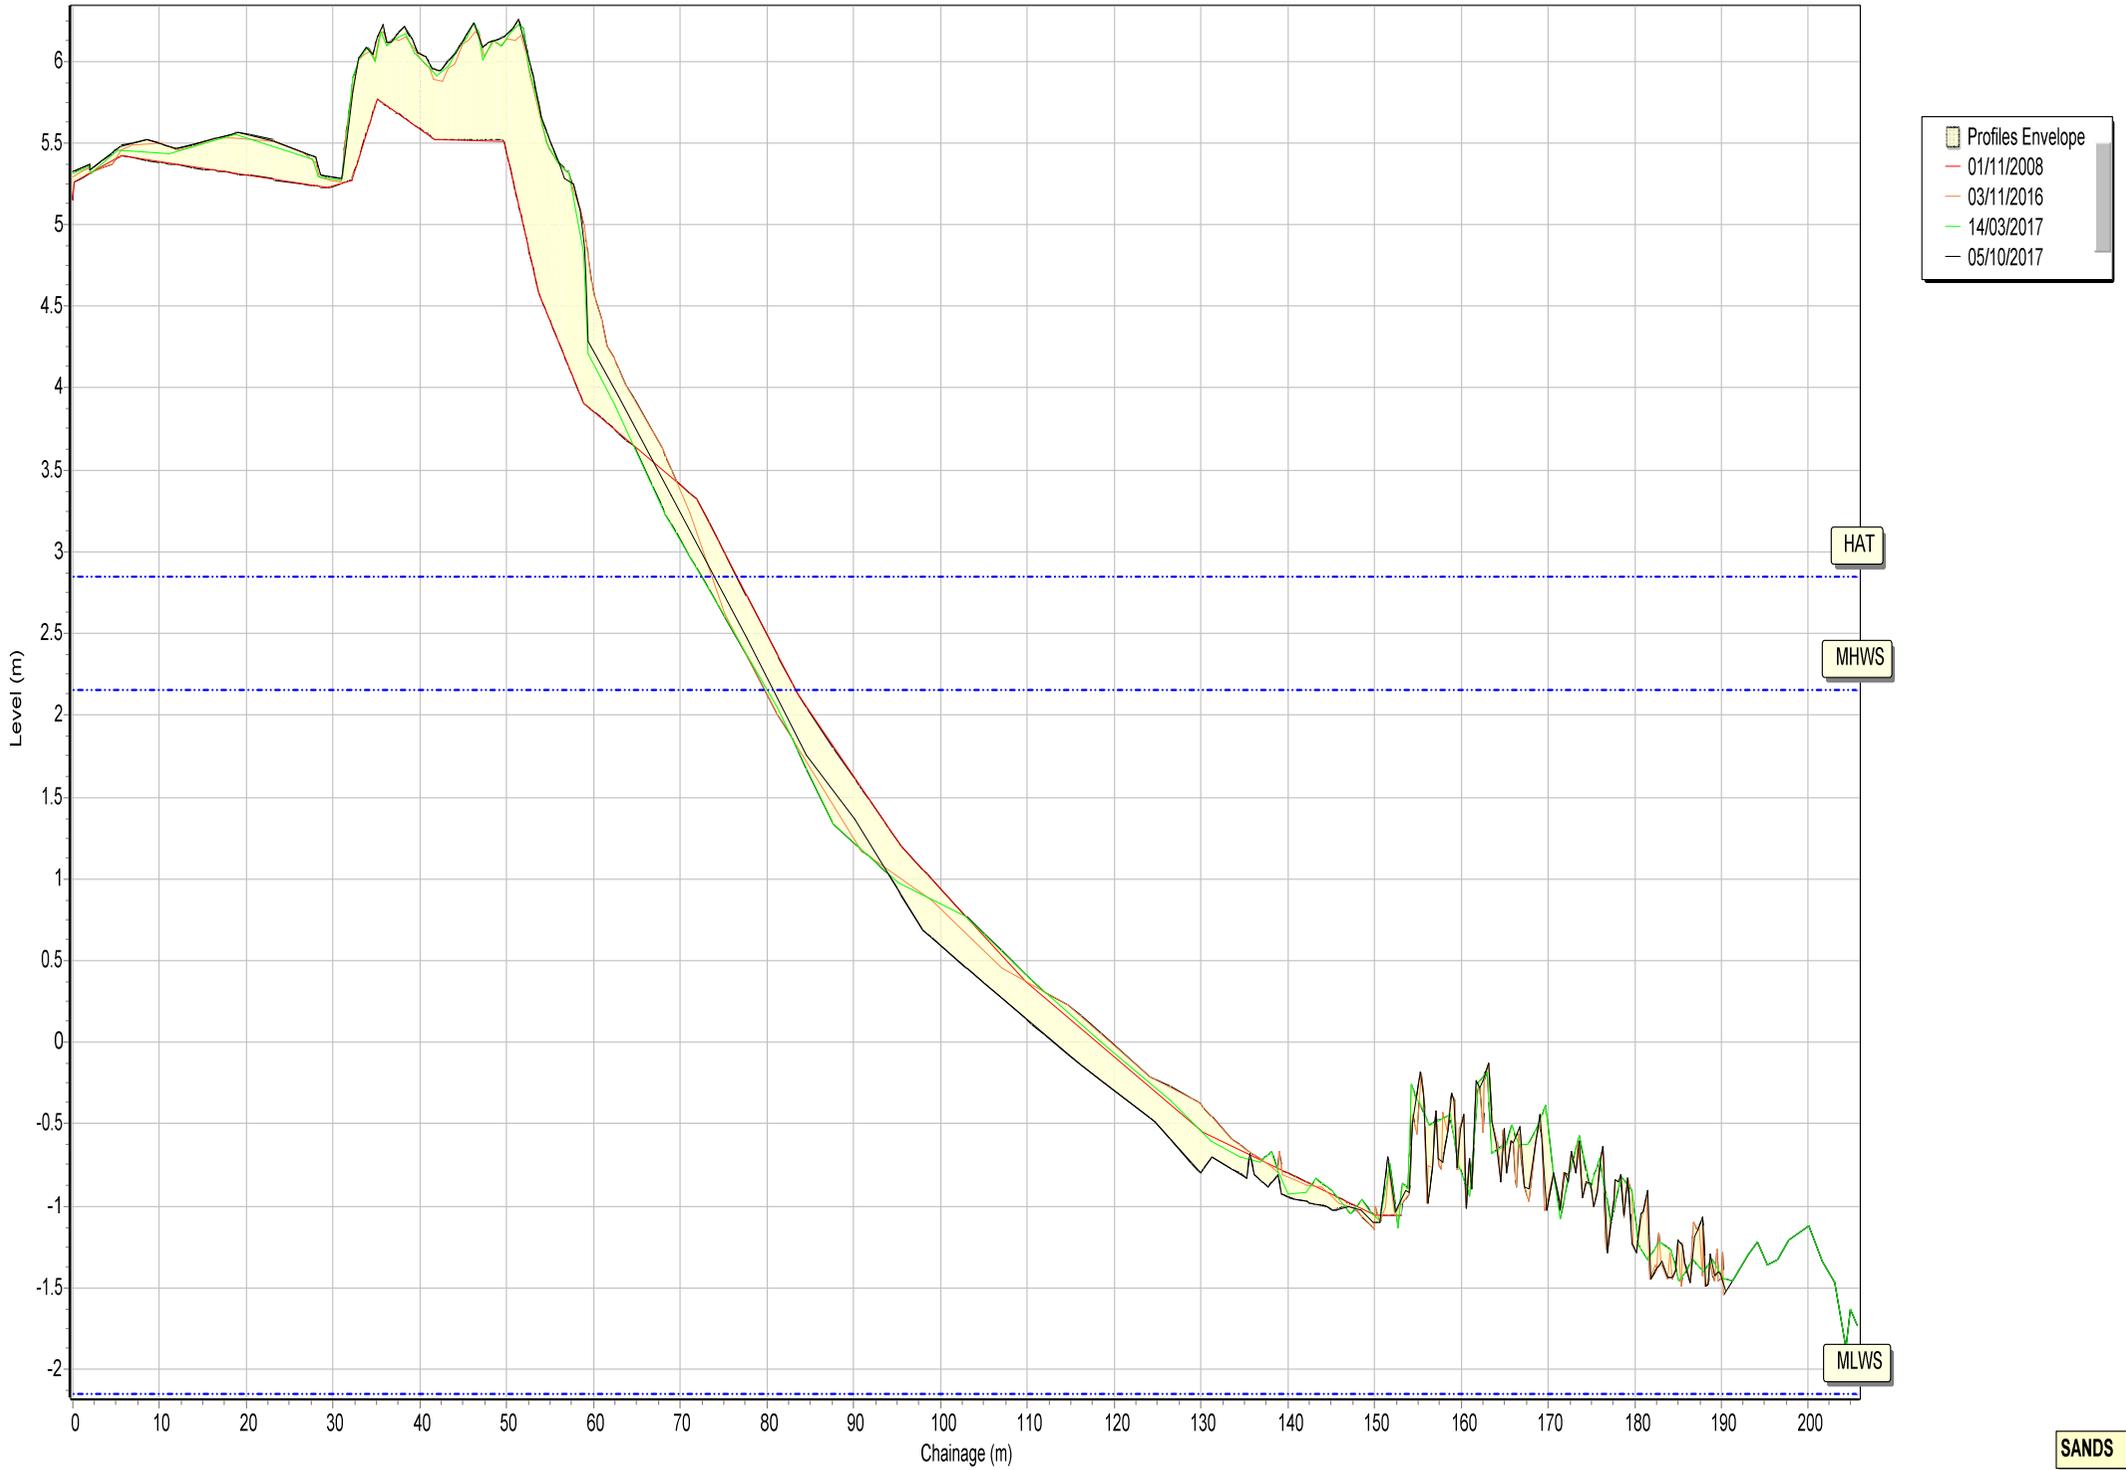
Beach Profiles: 1bSS1

Survey Date	Description of Changes Since Last Survey	Interpretation
5 th October 2017	<p>Beach Profiles:</p> <p>Littlehaven Beach is covered by four beach profile lines for the Full Measures survey, spaced between South Groyne and South Pier (Appendix A). The previous survey was the Partial Measures survey undertaken in March 2017 and the previous Full Measures survey was undertaken in November 2016. Profiles 1bSS1 and 1bSS3 were last surveyed during the Partial Measures spring survey, 2017. Profiles 1bSS2 and 1bSS4 were last surveyed during the Full Measures autumn survey, 2016.</p> <p>Profile 1bSS1 is located to the north of Littlehaven beach, in the lee of a rocky outcrop and South Groyne. The dunes have remained stable since the last survey. Beach levels on the upper beach (chainage 60m to 95m) have changed very little since the March 2017 survey, with small amounts of accretion <0.1m along the whole beach profile. From chainage 95m to 150m there has been erosion of up to 0.3m, with boulders exposed from chainage 130m. From chainage 150m seawards there has been no change to the exposed boulders. The profile is at a medium level through the upper beach compared to the range recorded from previous surveys, but at a relatively low level on the lower beach.</p> <p>Profiles 1bSS2 to 1bSS4 extend seawards from the new sea wall that was completed since the Full Measures survey in April 2014.</p> <p>At profile 1bSS2, beach levels have fallen by up to 0.7m at the toe of the seawall, exposing more of the seawall, however this is a regular occurrence in the autumn surveys. There has been accretion of up to 0.6m between chainage 3m and 65m flattening the upper beach, and forming a small berm at chainage 7m. The upper-mid beach has steepened due to the accretion. There is little change in the profile seawards of chainage 65m with erosion limited to less than 0.2m. Overall the profile is at a medium-high level compared to the range recorded from previous surveys.</p> <p>At profile 1bSS3, shows a very similar pattern to profile 1bSS2. There has been erosion at the seawall of up to 0.7m, exposing more of the seawall, however this is a regular occurrence in the autumn</p>	<p>The beach at Littlehaven has had some time to adjust since construction of the new seawall in April 2014. All of the profiles show little change since March 2017, with erosion at the toe of the seawall and small amounts of accretion being typical across the rest of the profile. All of the profiles are generally at medium level compared to the range recorded from previous surveys.</p> <p>Longer term trends: The beach profiles are at variable positions relative to past levels. In general they are within the boundaries of previous surveys indicating the new seawall has not adversely affected sediment movements. Profile 1bSS1 shows signs of progressive steepening, but is not currently a cause for concern.</p>

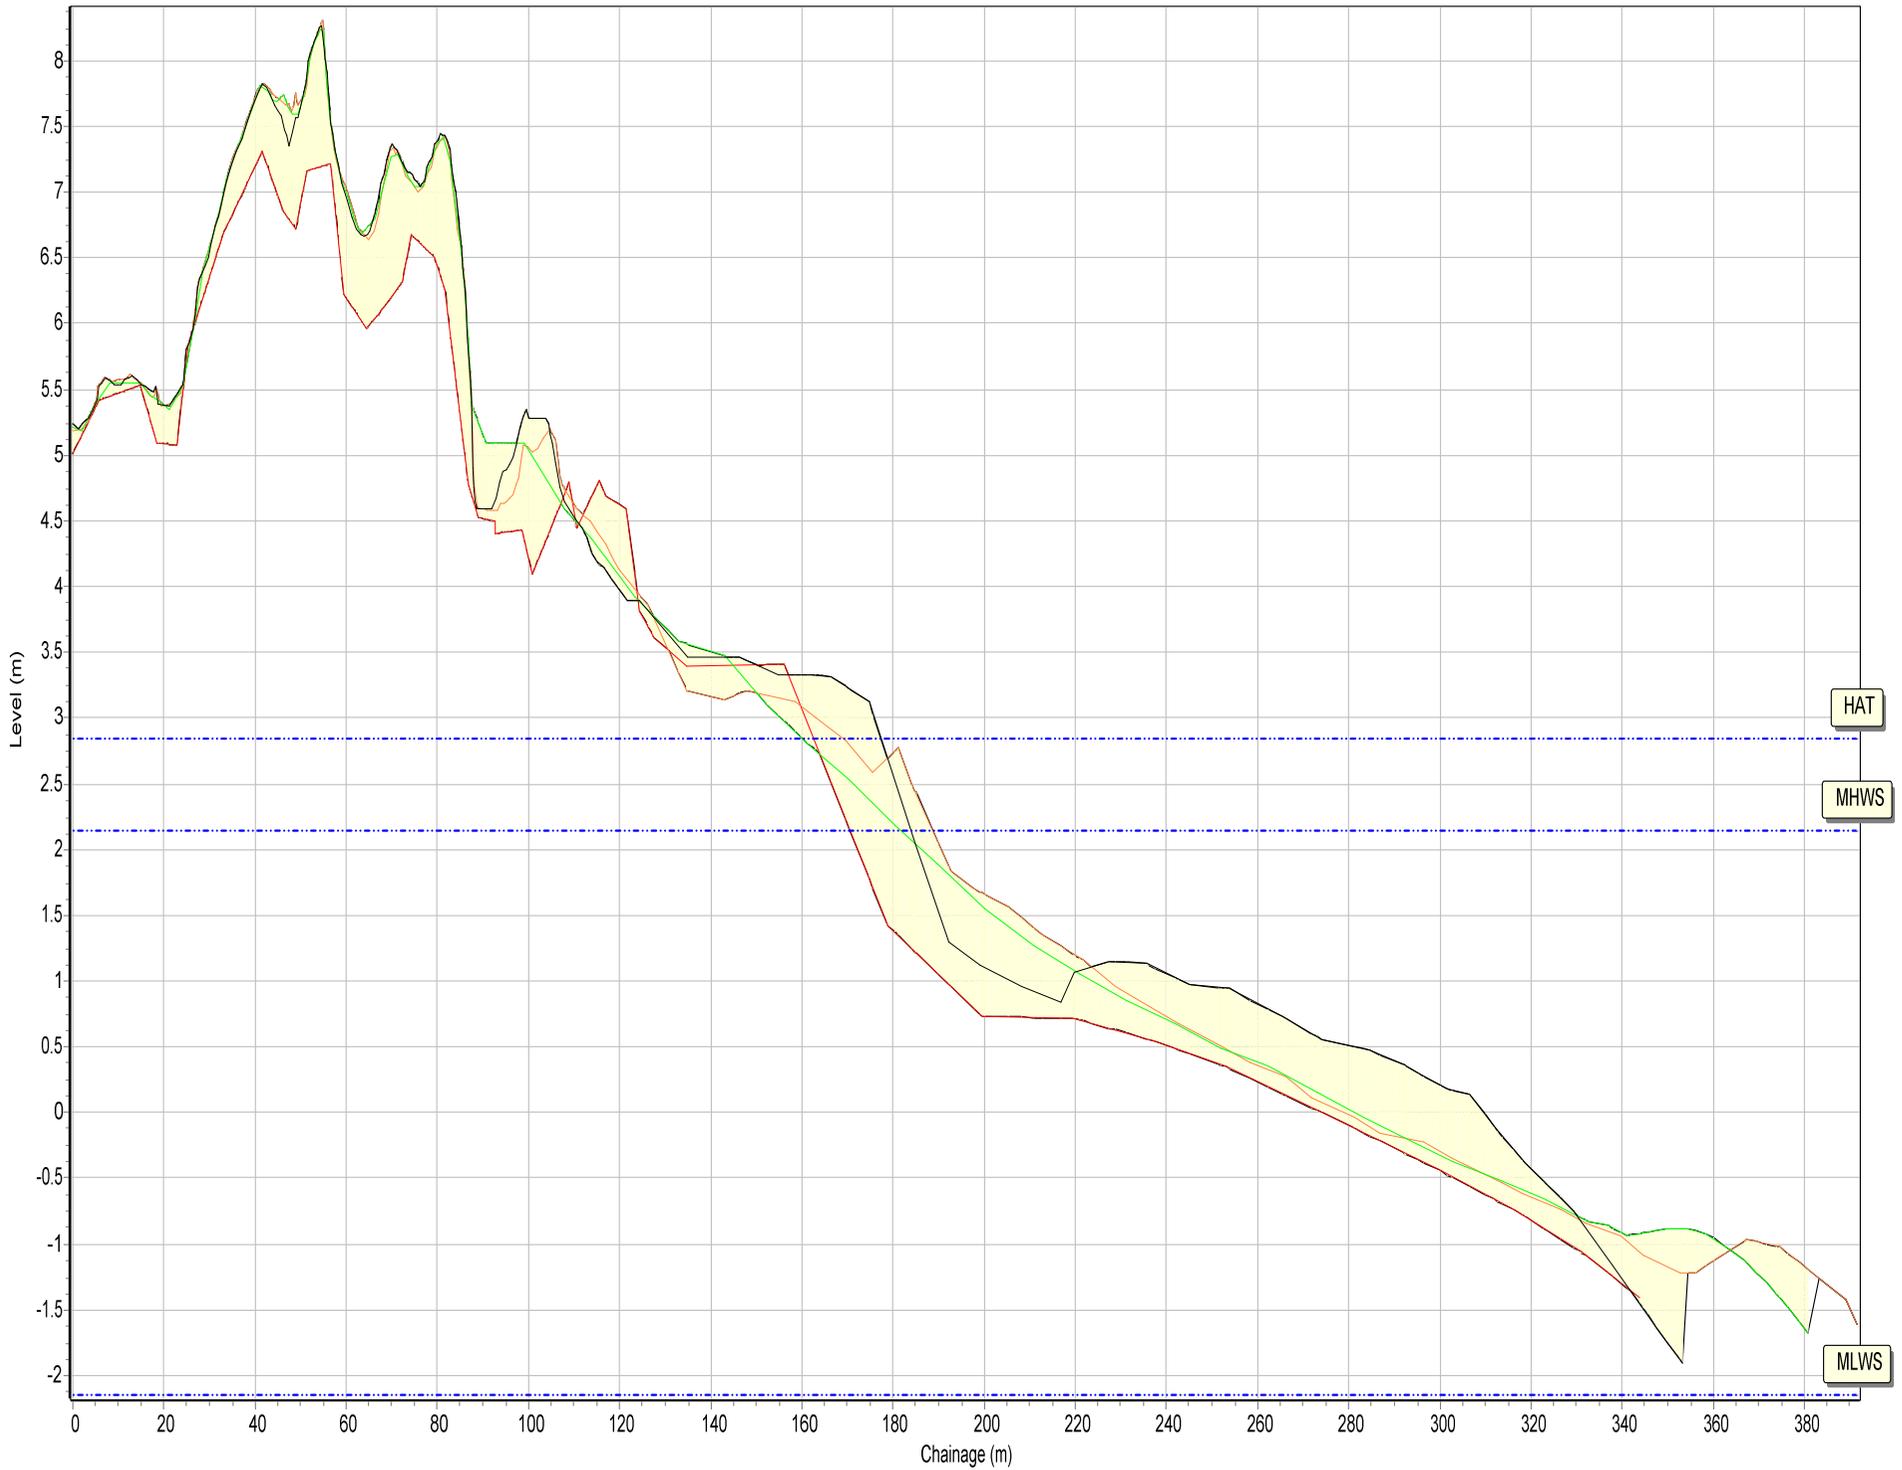
Beach Profiles: 1bSS5

Survey Date	Description of Changes Since Last Survey	Interpretation
5 th October 2017	<p>Beach Profiles:</p> <p>Herd Sands is covered by five beach profile lines for the Full Measures survey (Appendix A). Profiles 1bSS5, 1bSS8 to 1bSS9 were last surveyed during the Partial Measures spring survey, 2017. Profiles 1bSS6 and 1bSS7 were last surveyed during the Full Measures autumn survey 2016.</p> <p>Profile 1bSS5 is located to the north of Herd Sands and is in the lee of the breakwater. Sand fences were constructed on these dunes in 2012 to encourage accretion. The dunes have largely retained a similar form to the previous survey, showing that the defences are helping to stabilise the dunes on the landward of side of the path. The hollow between the dunes at chainages 40m and 55m has deepened by 0.3m. The largest change in the dunes is the formation of a hollow, 0.5m deep, between chainage 87m and 97m, with a corresponding dune formation between chainage 97m and 106m. This has created a similar profile to that seen in November 2016. There has been varying amounts of erosion and accretion across the beach profile seaward of the dunes, creating an irregular profile. The upper beach has remained largely the same up to chainage 140m. From chainage 140m to 185m there has been accretion of up to 0.6m creating a berm. From chainage 185m to 220m there has been erosion of up to 0.5m forming a depression. Between chainage 220m and 330m there has been accretion of up to 0.6m. The toe of the beach has been steepened, with erosion of up to 1.0m seawards of chainage 330m, and moved landwards by 35m. Overall, the beach is at a high-medium level compared to the range recorded from previous surveys, with the section between chainages 230m and 330m showing the highest recorded levels.</p> <p>At profile 1bSS6, the dunes have largely retained a similar form to the previous survey, with small amount of accretion, <0.2m, to the crest at chainage 85m. The upper beach has been flattened with the removal of the berm between chainages 125m and 180m (erosion of up to 1m). There is little change in the mid-beach between chainage 180m to 235m. The lower beach seawards of chainage 235m shows accretion of up to 0.7m, however the toe of the beach shows no change. Overall the profile is smoother with the beach at a medium-high level compared to the range recorded from previous surveys, with the section between chainages 250m and 310m being the highest on record.</p>	<p>The pattern of change at Herd Sands is complex. The profiles are dominated by accretion, with profiles 1bSS6 and 1bSS7 (the profiles which are not included in the Partial Measures survey) showing erosion on the upper beach.</p> <p>Longer term trends: Beach levels generally remain at medium to high levels compared to earlier surveys.</p>

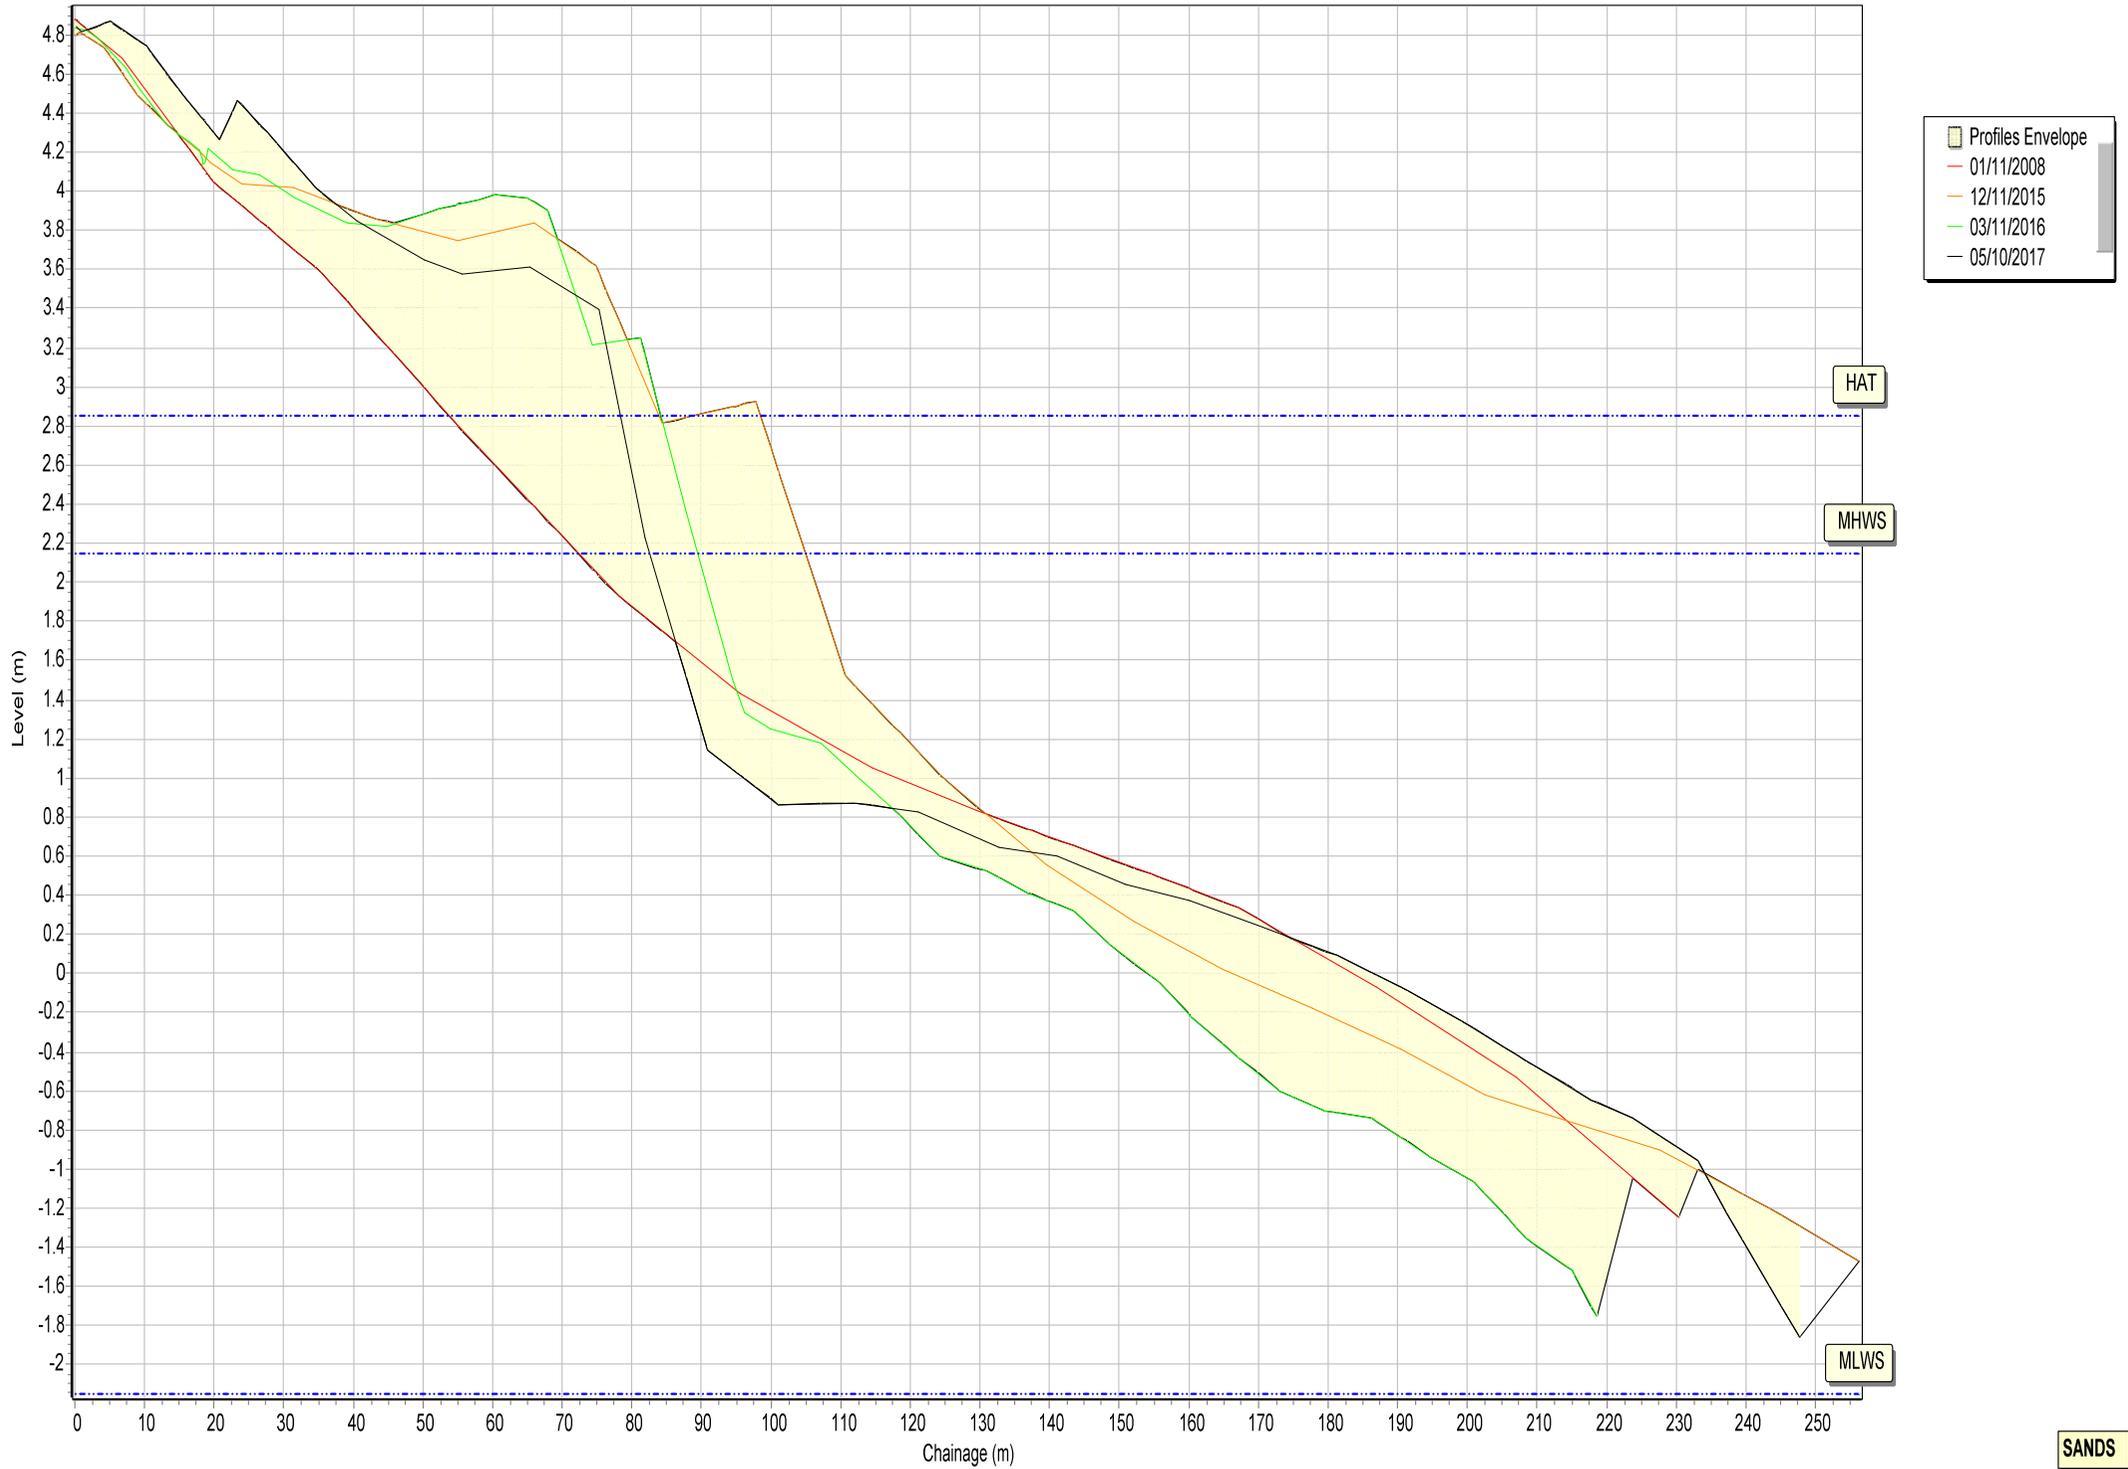
Beach Profiles: 1bSS7

Survey Date	Description of Changes Since Last Survey	Interpretation
	<p>At profile 1bSS7, located at the centre of Herd Sands, the upper beach to chainage 40m has accreted by 0.2m. Between chainage 40m and 120m there has been erosion of 0.4m removing the berms and retreating the face of the beach landwards by c.7m. Seawards of chainage 120m there has been accretion of up to 1.0m, extending the toe of the beach seawards by 30m. Overall, the beach is at a medium-high level compared to the range recorded from previous surveys.</p> <p>At profile 1bSS8, there has been variable erosion and accretion across the profile creating a steeper upper beach. At the toe of the seawall there has been erosion of 0.8m to chainage 18m. Between chainage 18m and 50m there has been accretion of up to 0.7m. Between chainage 50m and 75m there has been erosion of up to 0.4m. Between chainage 75m and 190m there has been accretion of up to 0.3m. The toe of the beach seawards of chainage 190m shows erosion of 0.2m. Overall, the beach is at a medium level compared to the range recorded from previous surveys, apart from the middle beach between chainage 130m and 175m, which is relatively high.</p> <p>Profile 1bSS9 is located at the southern end of Herd Sands. The dune profile fronting the car park remains unchanged. The profile is dominated by accretion of up to 0.7m, with the exception of between chainage 65m and 85m where there has been erosion of up to 0.4m. Overall the beach is at a medium-high level compared to the range recorded from previous surveys, with highest recorded levels between chainages 35m and 45m, and 135m and 155m.</p>

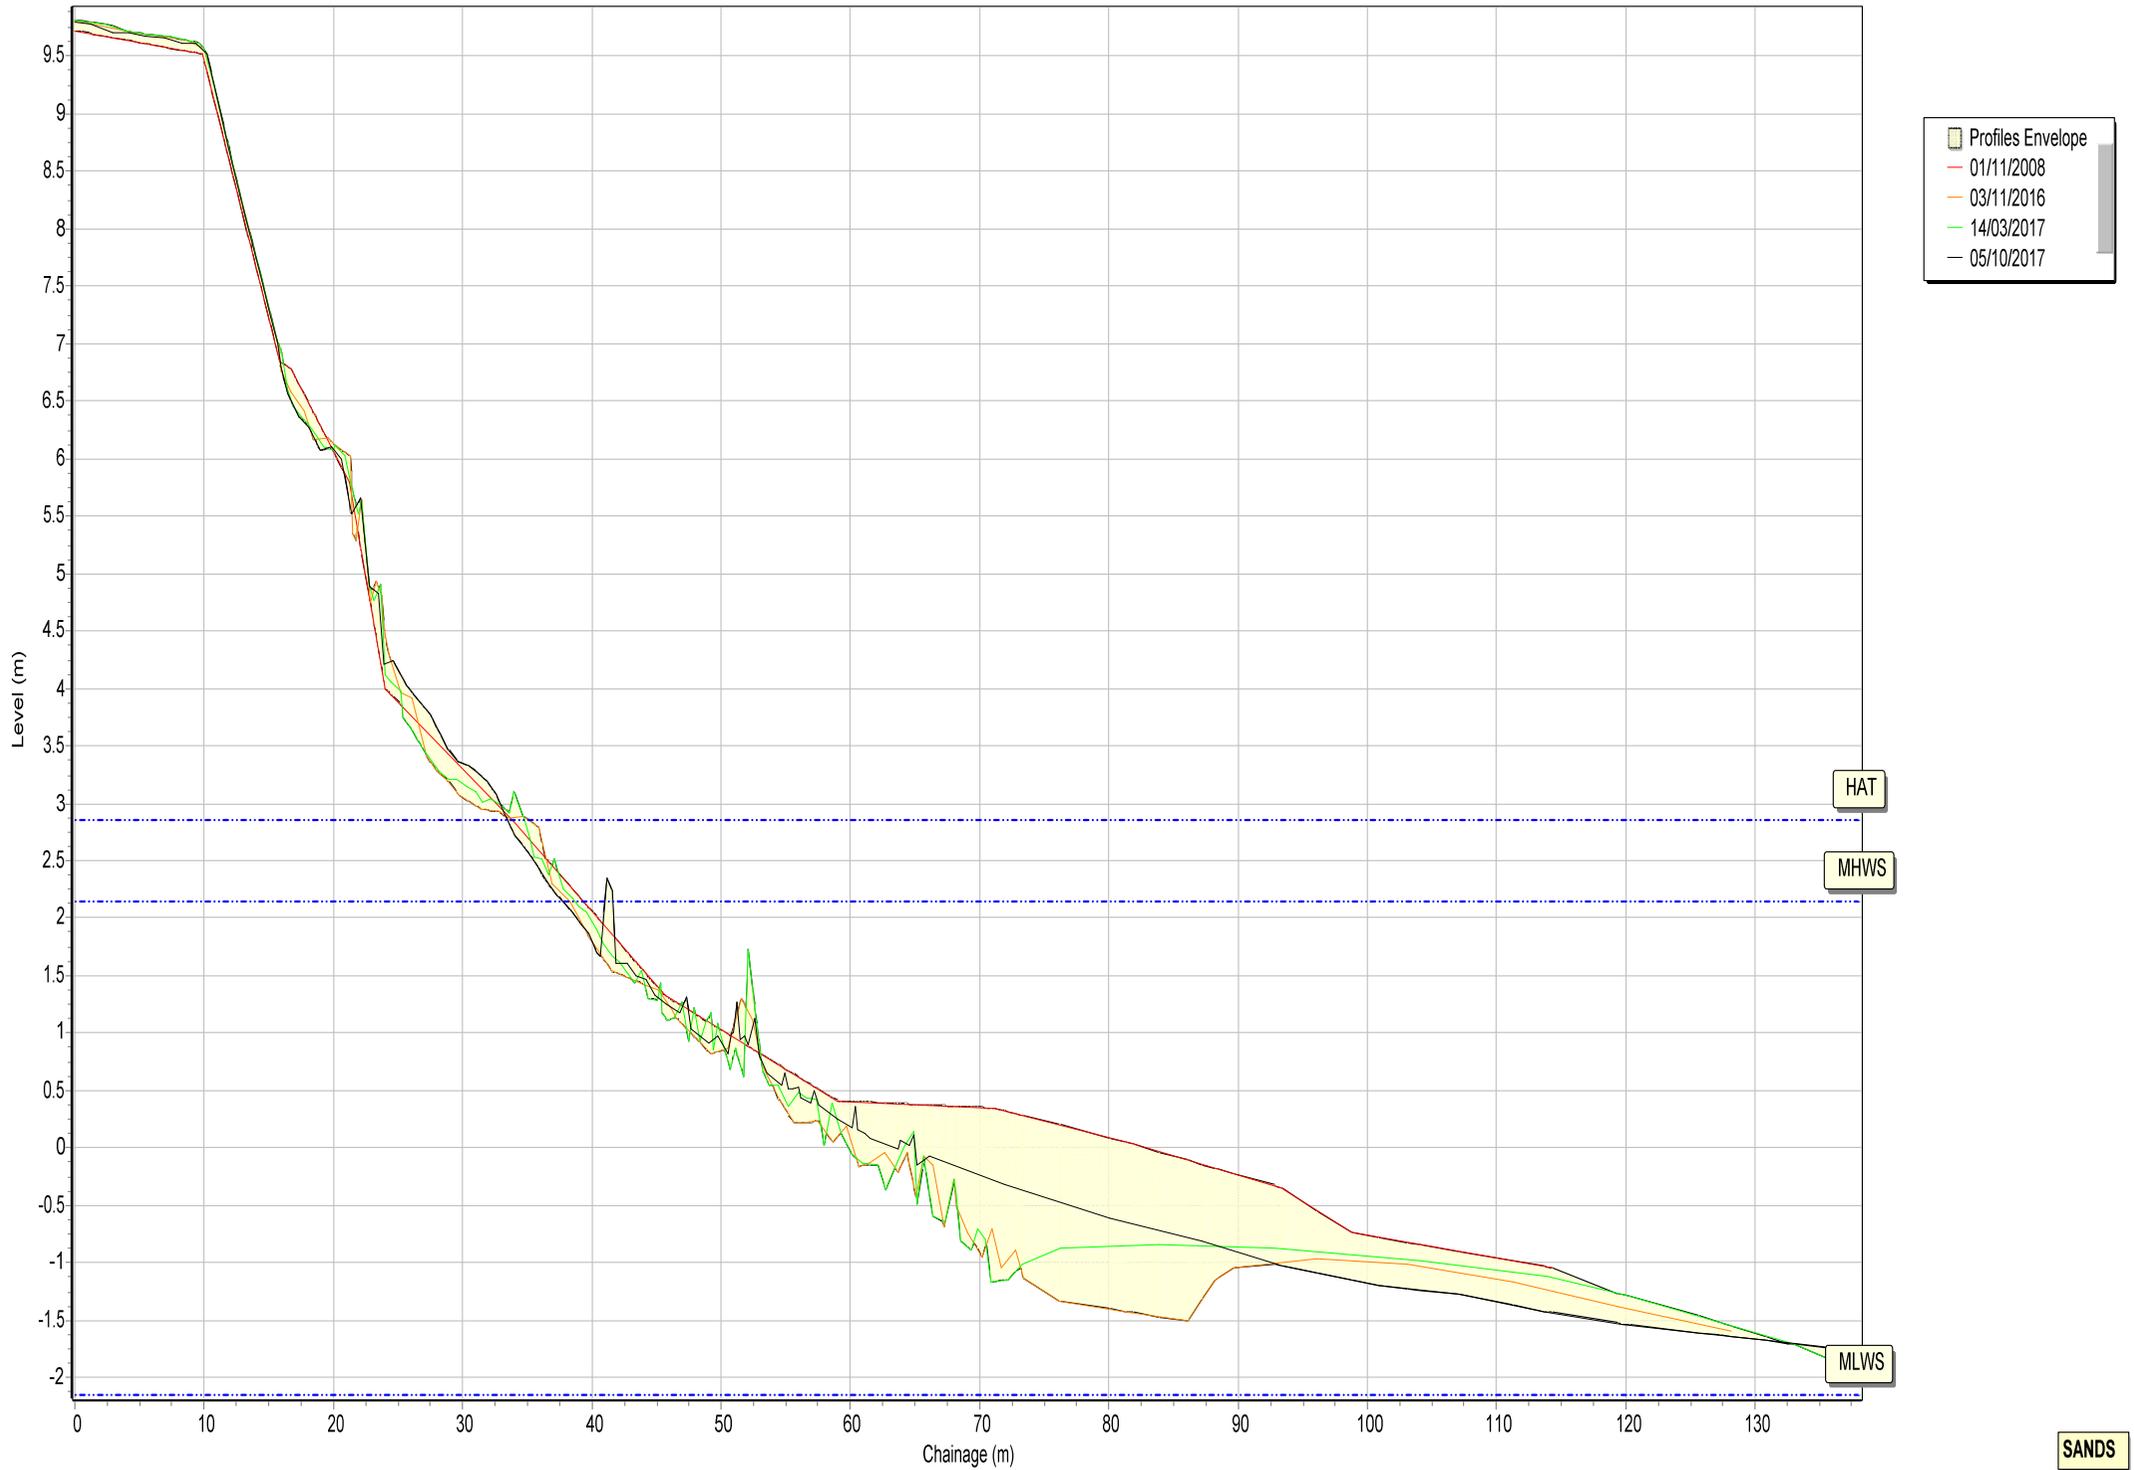
Beach Profiles: 1bSS10

Survey Date	Description of Changes Since Last Survey	Interpretation
5 th October 2017	<p>Beach Profiles:</p> <p>Trow Quarry is covered by four beach profile lines for the Full Measures survey (Appendix A), two in Graham's Sand and two in Southern Bay. The previous survey was the Partial Measures survey undertaken in March 2017.</p> <p>Profiles 1bSS10 and 1bSS11 are located in Graham's Bay.</p> <p>At profile 1bSS10 the backshore has remained stable. The gravel deposit noted on the March 2016 survey between chainage 24m and 33m has accreted by 0.3m, although there has been some erosion of gravel between 33m and 40m of up to 0.2m. There has been accretion of sand between chainage 55m and 90m covering c.15m of the previously exposed rocks. From chainage 90m seawards the broad berm previously recorded has been eroded by 0.3m creating a smoother concave profile. Overall, the profile is at a relatively medium level compared with the range recorded from previous surveys.</p> <p>At profile 1bSS11, the profile has remained stable. There has been accretion of up to 0.4m of sand at the toe of the beach from chainage 80m seawards, covering some of the rocks, and extending the toe seawards by c.15m.</p> <p>Profile 1bSS12 and 1bSS13 are located in Southern Bay. At both locations the beach profile has remained stable since the previous survey. Apparent changes in the profile likely derive from minor movement of cobbles or differences in the exact placement of survey points.</p>	<p>At both Graham's Bay and Southern Bay, the cliff and rock revetment have remained stable.</p> <p>At Graham's Bay, the northern part of the beach shows accretion in the upper and mid beach, with erosion on the lower foreshore, creating a smoother profile.</p> <p>At Southern Bay, the rocky foreshore has generally retained the same form and position.</p> <p>Longer term trends: Overall, the beach at Graham's Bay and Southern Bay has retained the same form and position since November 2008/March 2009 when surveys began. Movement in the north of Grahams Bay at profile 1bSS10 is within the bounds of previous surveys.</p>
