Cell 1 Regional Coastal Monitoring Programme Analytical Report 10: 'Full Measures' Survey 2017

South Tyneside Council

February 2018

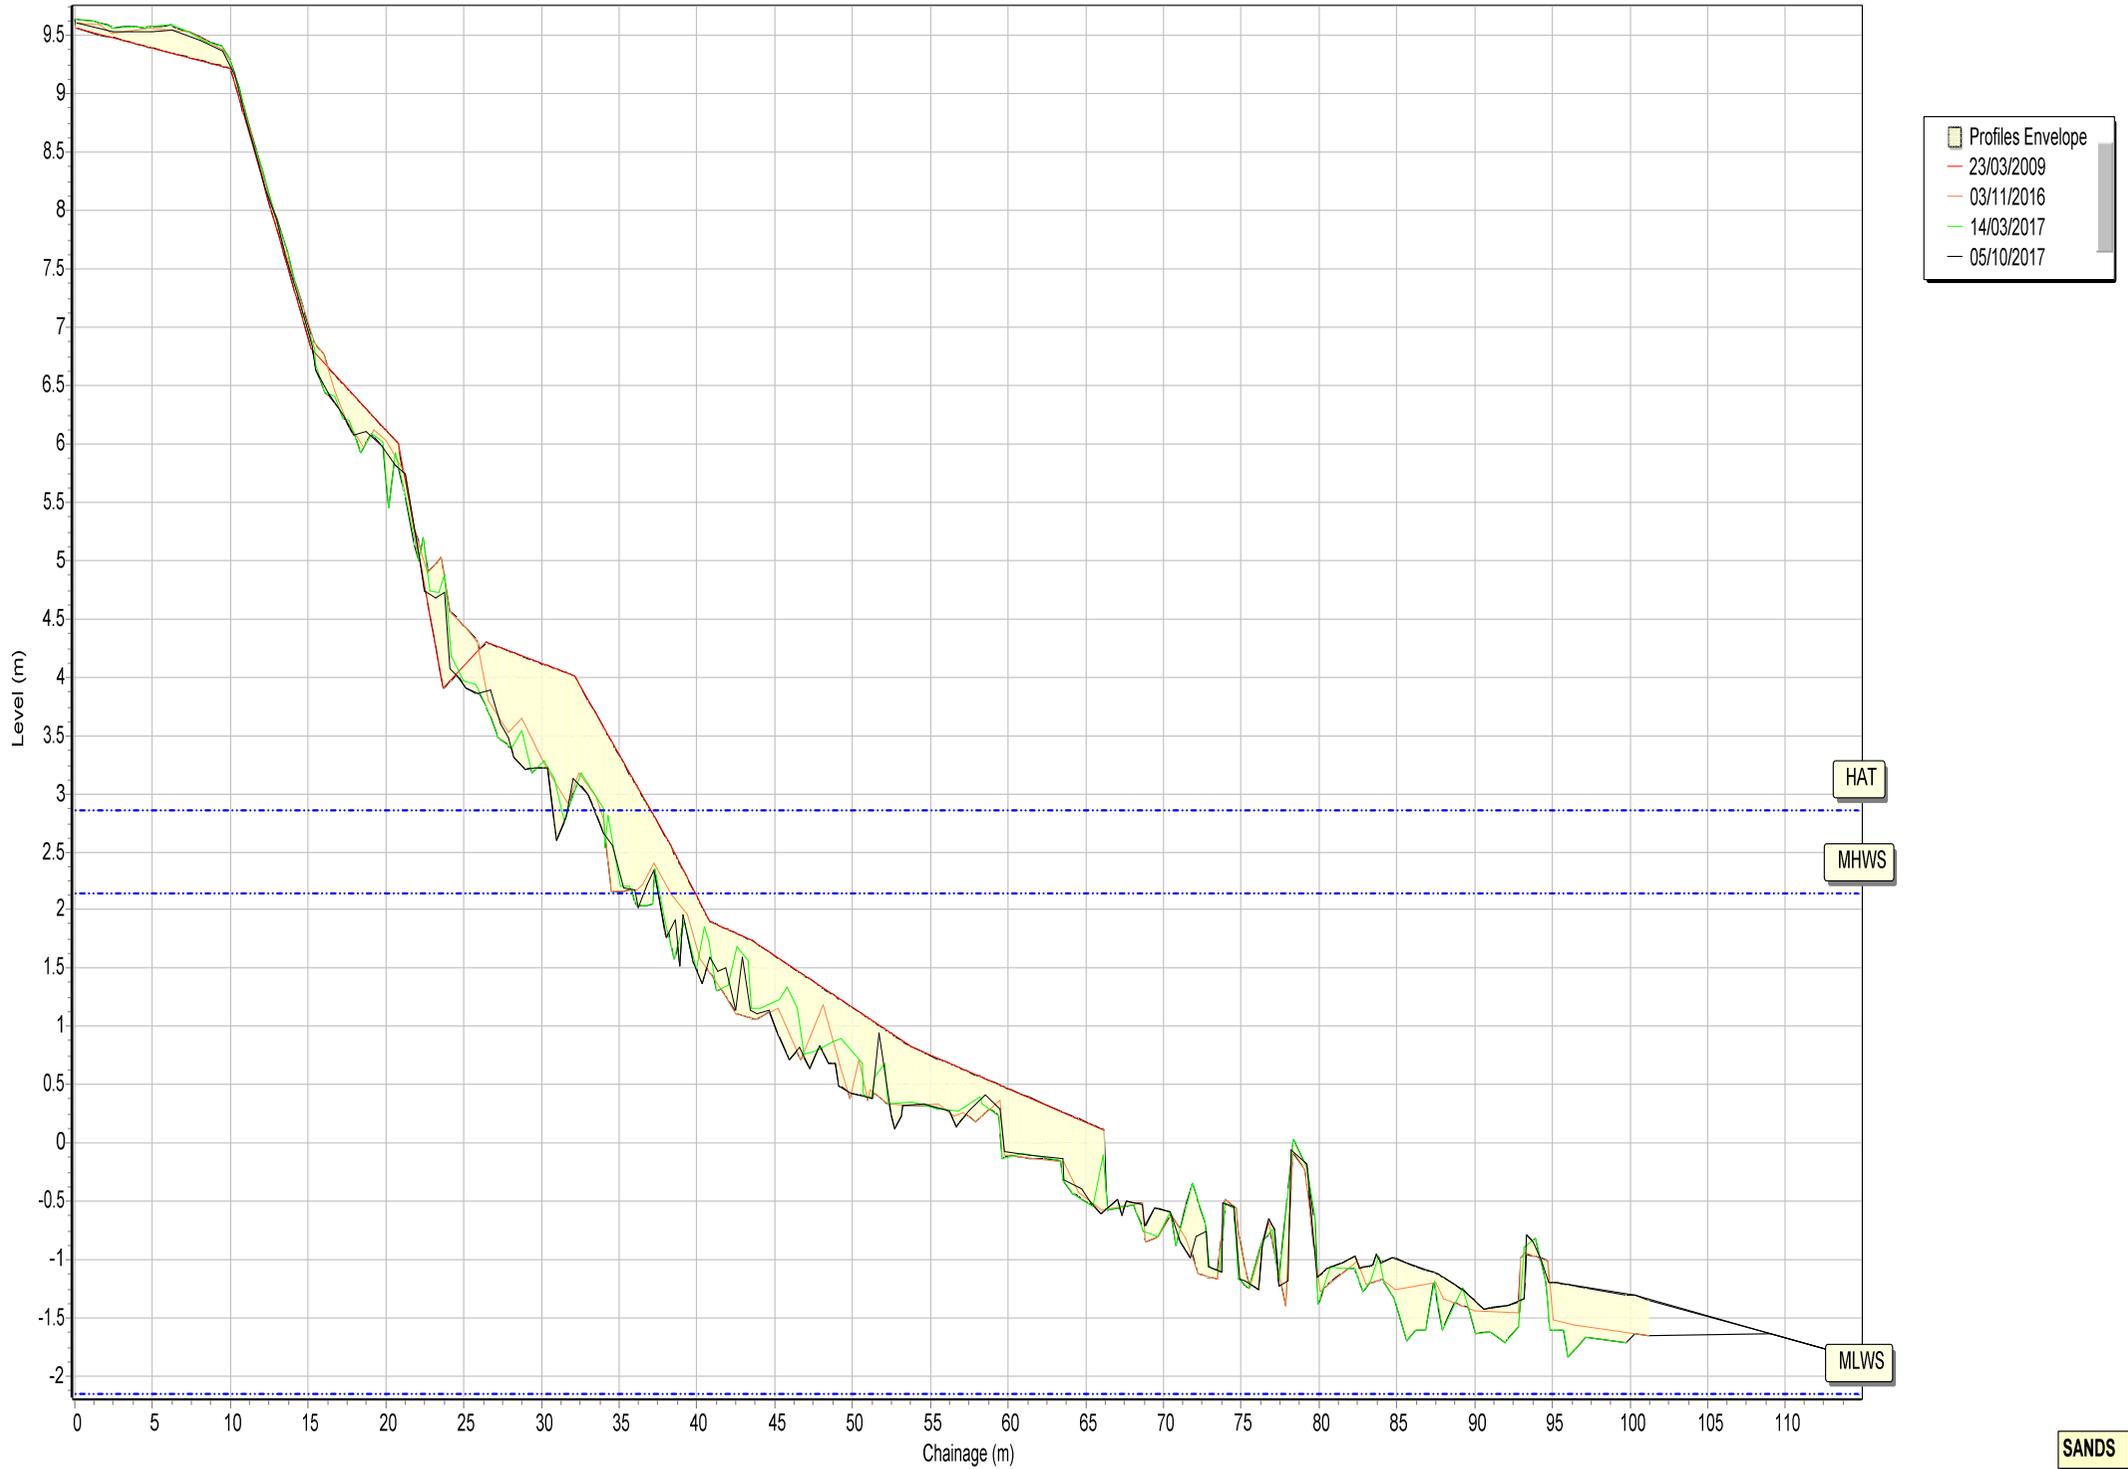
Beach Profiles: 1bSS11

Survey Date	Description of Changes Since Last Survey	Interpretation
5 th October 2017	<p>Beach Profiles:</p> <p>Trow Quarry is covered by four beach profile lines for the Full Measures survey (Appendix A), two in Graham's Sand and two in Southern Bay. The previous survey was the Partial Measures survey undertaken in March 2017.</p> <p>Profiles 1bSS10 and 1bSS11 are located in Graham's Bay.</p> <p>At profile 1bSS10 the backshore has remained stable. The gravel deposit noted on the March 2016 survey between chainage 24m and 33m has accreted by 0.3m, although there has been some erosion of gravel between 33m and 40m of up to 0.2m. There has been accretion of sand between chainage 55m and 90m covering c.15m of the previously exposed rocks. From chainage 90m seawards the broad berm previously recorded has been eroded by 0.3m creating a smoother concave profile. Overall, the profile is at a relatively medium level compared with the range recorded from previous surveys.</p> <p>At profile 1bSS11, the profile has remained stable. There has been accretion of up to 0.4m of sand at the toe of the beach from chainage 80m seawards, covering some of the rocks, and extending the toe seawards by c.15m.</p> <p>Profile 1bSS12 and 1bSS13 are located in Southern Bay. At both locations the beach profile has remained stable since the previous survey. Apparent changes in the profile likely derive from minor movement of cobbles or differences in the exact placement of survey points.</p>	<p>At both Graham's Bay and Southern Bay, the cliff and rock revetment have remained stable.</p> <p>At Graham's Bay, the northern part of the beach shows accretion in the upper and mid beach, with erosion on the lower foreshore, creating a smoother profile.</p> <p>At Southern Bay, the rocky foreshore has generally retained the same form and position.</p> <p>Longer term trends: Overall, the beach at Graham's Bay and Southern Bay has retained the same form and position since November 2008/March 2009 when surveys began. Movement in the north of Grahams Bay at profile 1bSS10 is within the bounds of previous surveys.</p>

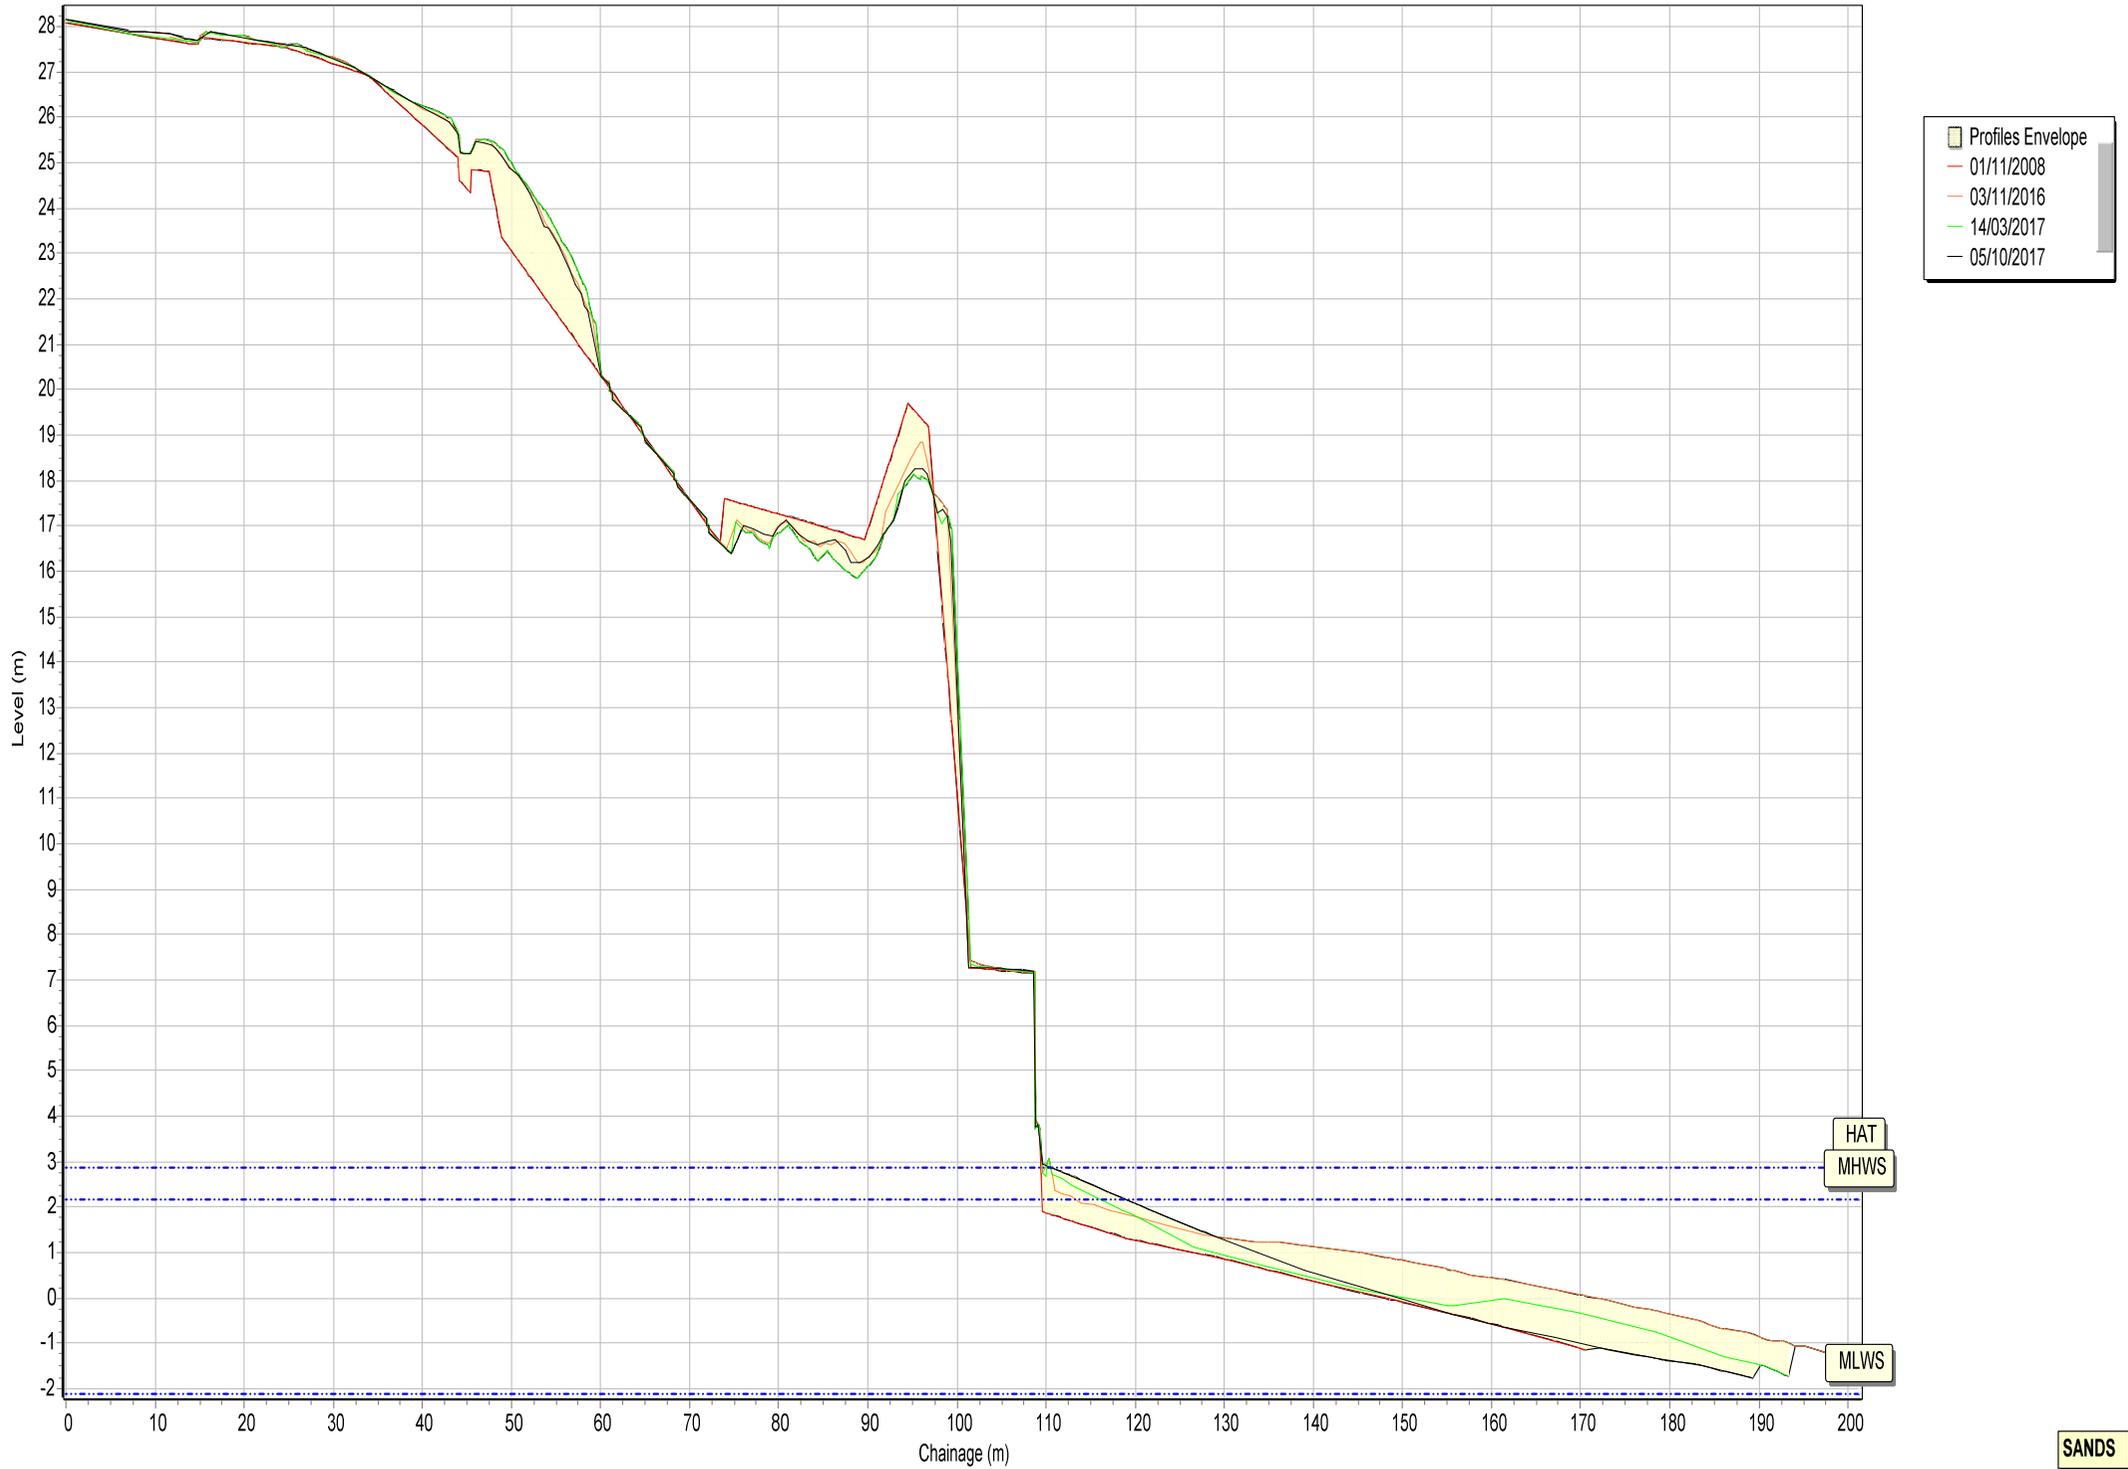
Beach Profiles: 1bSS14

Survey Date	Description of Changes Since Last Survey	Interpretation
5 th October 2017	<p>Beach Profiles:</p> <p>Marsden Sands is covered by four beach profile lines for the Full Measures survey (Appendix A). The previous survey was the Partial Measures survey in March 2016 and prior to that the Full Measures survey was completed in November 2015. Profiles 1bSS14 and 1bSS17 were last surveyed during the Partial Measures spring survey, 2017. Profiles 1bSS15 and 1bSS16 were last surveyed during the Full Measures autumn survey, 2016.</p> <p>Profile 1bSS14 is located to the north of the bay and covers the cliff and the former lifeguard station adjacent to the Redwell Steps. The cliff has retained the same form and position since the last survey. The upper beach has accreted by up to 0.4m between the steps and chainage 148m. From 148m seawards there has been accretion of up to 0.7m, forming a lower beach berm at chainage 160m. Overall, the profile is at a medium level compared to the range recorded by previous surveys.</p> <p>At profile 1bSS15, the profile suggests that the cliff has advanced by c.2m but this is likely due to difficulties in confirming the cliff edge. There has been up to 0.4m of erosion at the toe of the cliff to chainage 67m. From chainage 67m to the end of the profile at chainage 185m there has been accretion of up to 0.8. This has covered up the gravel in the upper beach and boulders in the mid beach which were exposed on the previous survey. Overall, the profile is at a medium-high level compared to the range recorded by previous surveys, with the section seawards of chainage 120m being the highest on record .</p> <p>At Profile 1bSS16, the profile suggests that the cliff has retreated by c.4m but this is likely due to difficulties in confirming the cliff edge. The profile suggests there has been some minor slumping of material at the toe of the cliff between chainages 68m and 76m. Apparent changes across the rest of the profile likely derive from minor movement of cobbles or differences in the exact placement of survey points. The profile is at a low level compared with the range recorded from previous surveys.</p> <p>Profile 1bSS17 is located to the south of the bay. The profile which crosses rocky platform and boulders with small pockets of sand remains relatively unchanged, with some changes in levels of <0.2m. Overall, the profile is at a medium level compared with the range recorded from previous surveys.</p>	<p>The more northerly part of Marsden Bay appears to have been dominated by accretion , whereas changes are minimal further south, where there is less mobile sediment available.</p> <p>Longer term trends: The sandier beaches in the north of the bay are medium-high compared to earlier surveys. Further south, there is little sand and therefore the underlying coarser sediment and the shore platform is exposed, indicating a general trend of movement of sediment towards the north.</p>

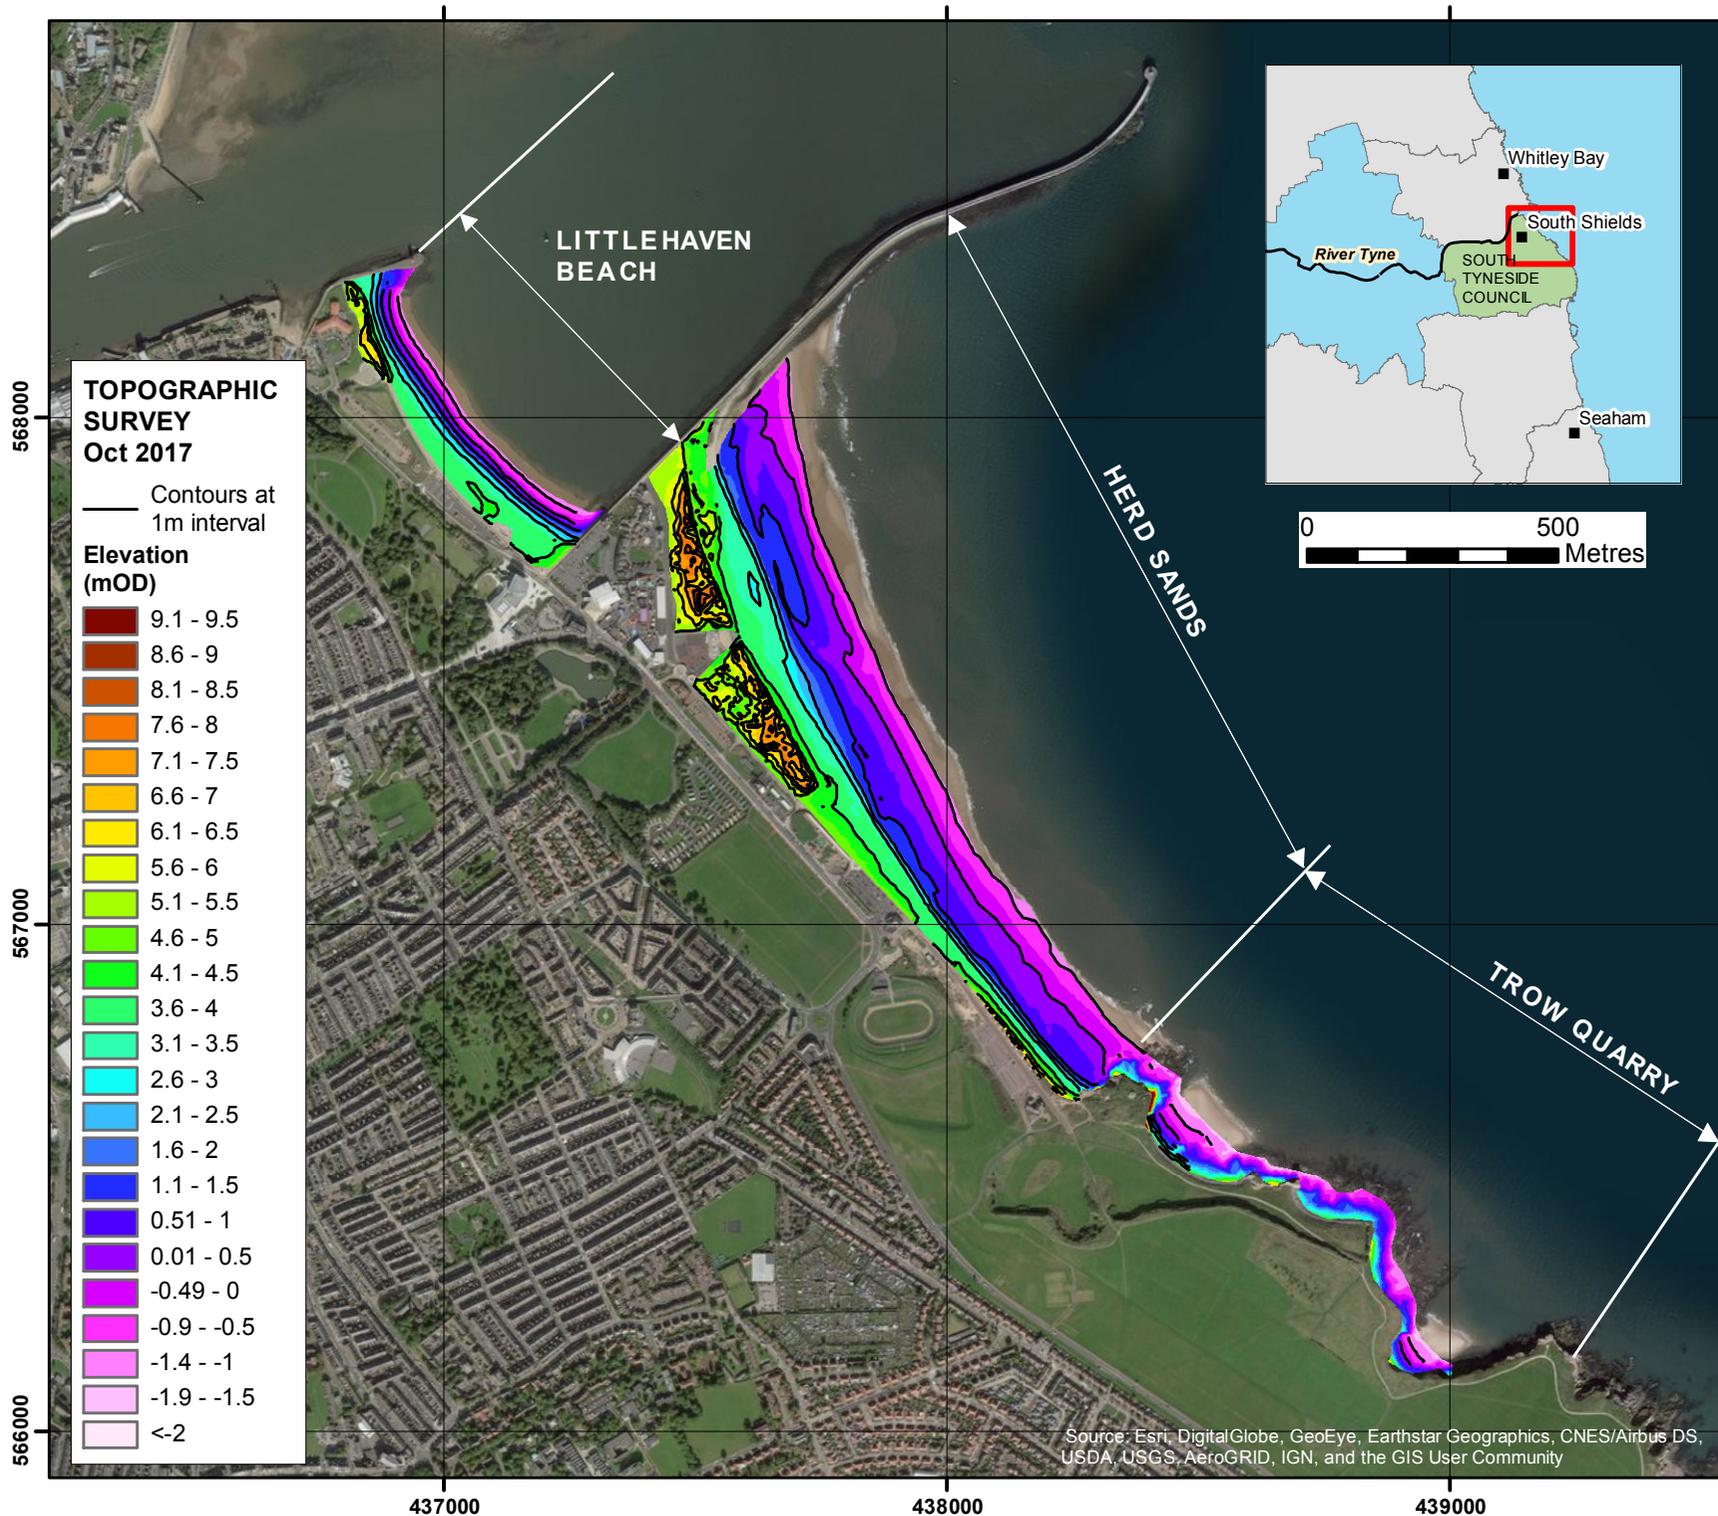
Appendix B - Map 1

<p>October 2017</p>	<p>Topographic Survey:</p> <p>Littlehaven Beach is covered by bi-annual topographic survey between the South Groyne and the South Pier, which commenced in March 2010.</p> <p>Data from the most recent topographic survey (Full Measures, autumn 2017) have been used to create a DGM (Appendix B – Map 1) using GIS. A difference plot has also been produced using the DGM (Appendix B – Map 3) produced from the last topographic survey (Partial Measures, spring 2017) and the present survey.</p> <p>The topographic survey shows a continuous narrow band of erosion at the toe of the seawall. There is a wide band of accretion covering most of the beach, with the lower foreshore showing little to no change. There are a couple of patches of erosion in the mid and lower beach at the southern end of the bay. North of the seawall the pattern is patchier; with the upper beach showing a mix of erosion and accretion. The middle of the beach shows a continuation of the wide band of accretion, whilst the lower beach shows erosion.</p>	<p>Comparison of the present topographic survey with the previous Partial Measures (spring, 2017) shows that the beach is generally stable with shore-parallel bands of elevation change which reflect seasonal redistributions of material throughout across the beach as bars.</p>

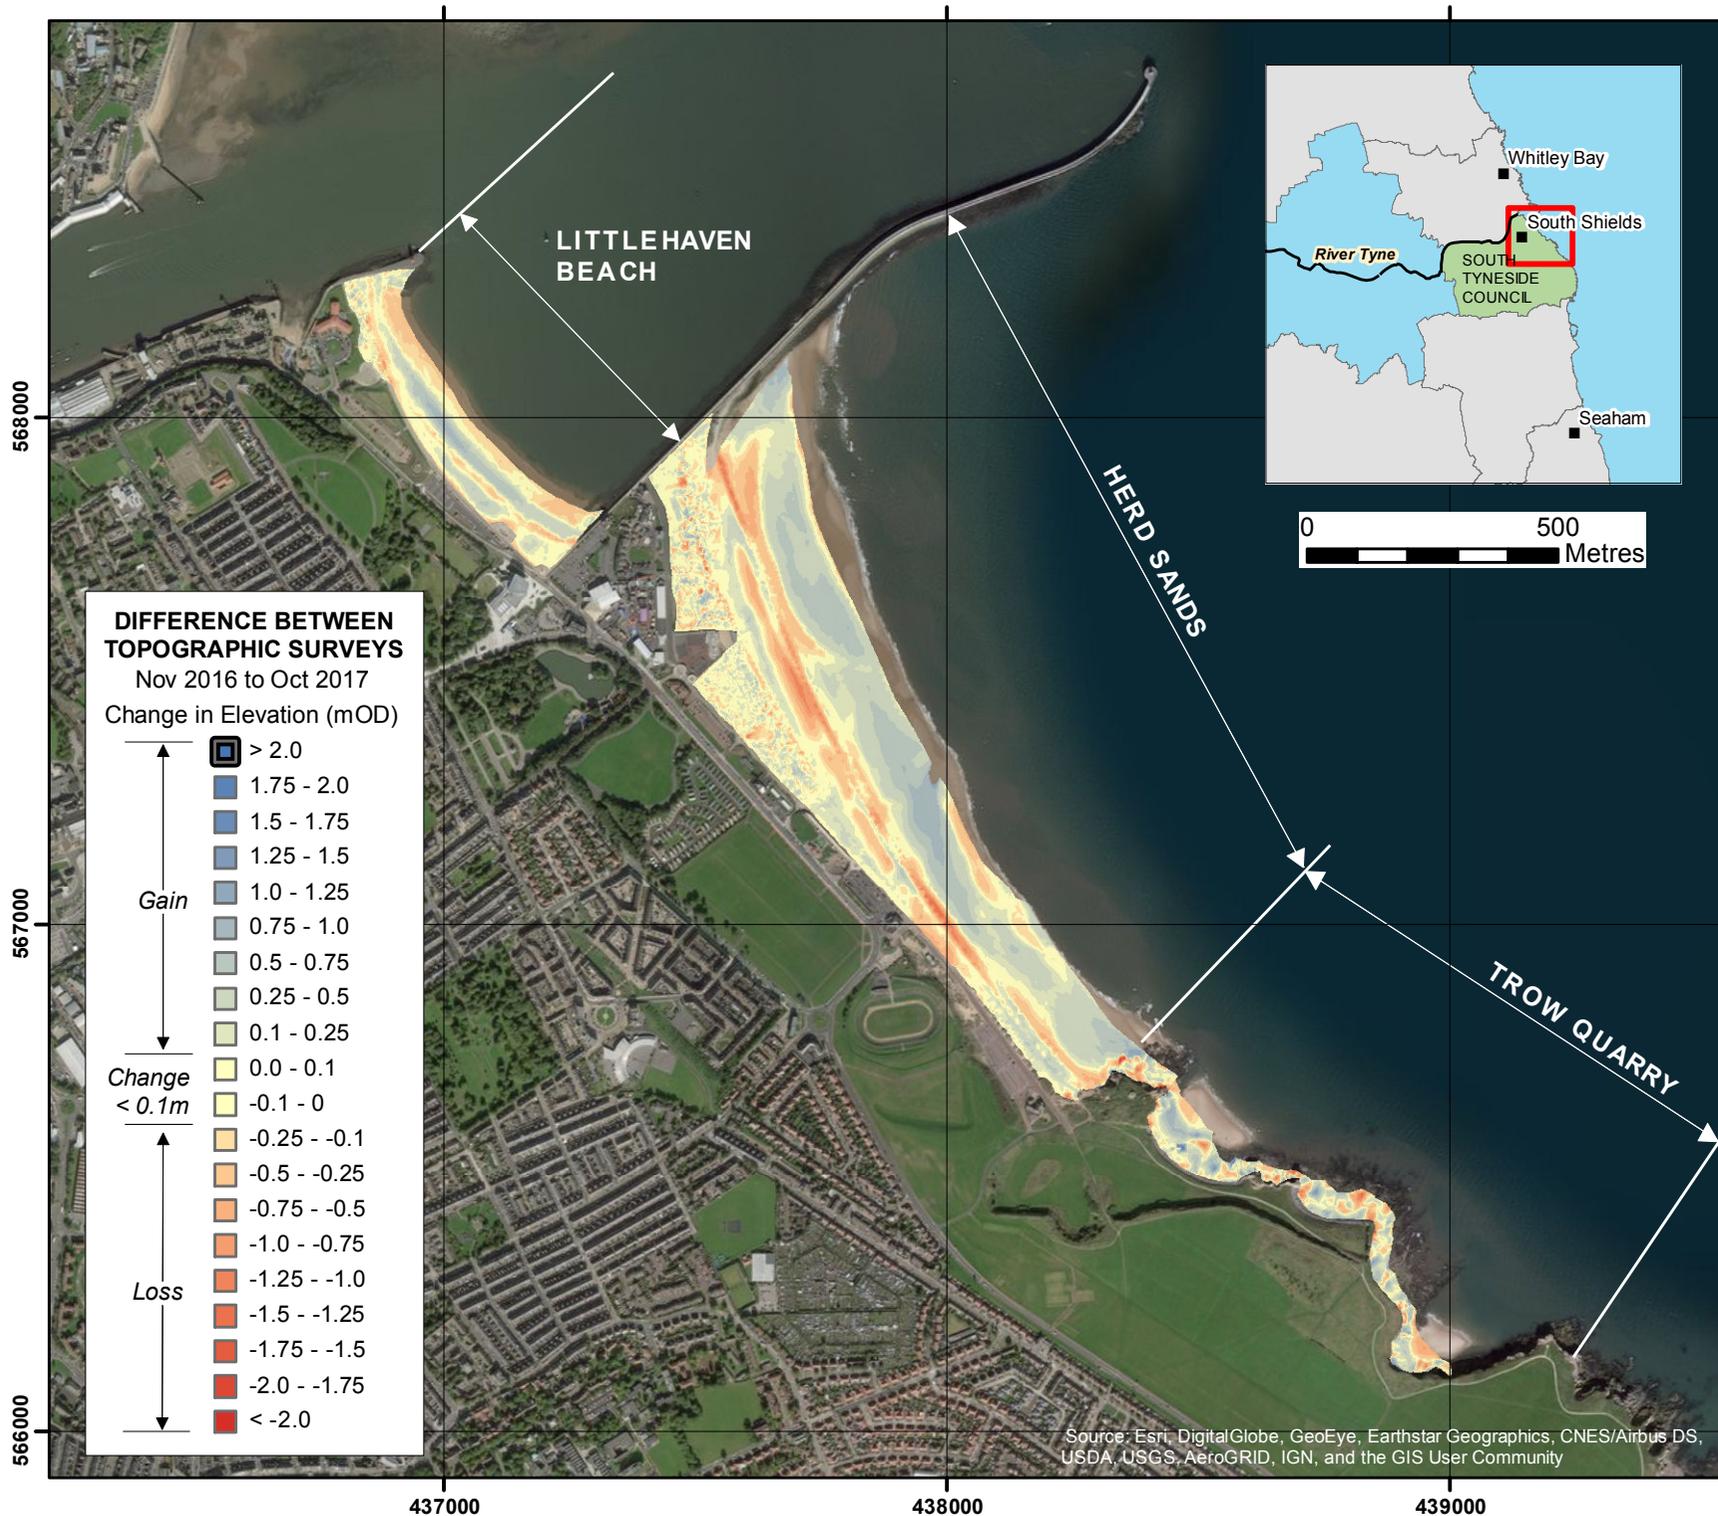
Appendix B - Map 2
LITTLEHAVEN BEACH, HERD SANDS, TROW QUARRY
North Tyneside Council Frontage
Analytical Report
'Full Measures' Survey 2017

<p>October 2017</p>	<p>Topographic Survey:</p> <p>Herd Sands is covered by an annual topographic survey between the South Pier and Trow Point, which commenced in November 2008.</p> <p>Data from the most recent topographic survey (Full Measures, autumn 2017) have been used to create a DGM (Appendix B – Map 1) using GIS. A difference plot has also been produced using the DGM (Appendix B – Map 2) produced from the last topographic survey (Full Measures, autumn 2016) and the present survey.</p> <p>The difference plot shows that change across the dunes is patchy but overall shows more areas of accretion than erosion. The beach itself shows shore parallel bands of erosion and accretion. The upper beach is dominated by erosion with some smaller areas of erosion at both ends of the bay. The</p>	<p>Comparison of the present topographic survey with the previous Full Measures (autumn, 2016) shows widespread accretion of limited intensity in the dunes and at the dune front, the mid to lower foreshore. This is mirrored by erosion in the upper foreshore and toe of the beach.</p> <p>The topographic survey matches the pattern shown in profiles 1bSS6 and 1bSS7, which are also surveyed on an annual basis. However, it does not match the pattern shown in profiles 1bSS5, 1bSS8, and 1bSS9, which are also included in the Partial Measures survey.</p>

Survey Date	Description of Changes Since Last Survey	Interpretation
	mid and lower beach is dominated by a wide continuous band of accretion. There are some small patches of erosion at the toe of the beach.
