Cell 1 Regional Coastal Monitoring Programme Analytical Report 12: 'Full Measures' Survey 2019

South Tyneside Council

November 2019

(*) The present report is **Analytical Report 12** and provides an analysis of the 2019 Full Measures survey for South Tyneside Council's frontage.

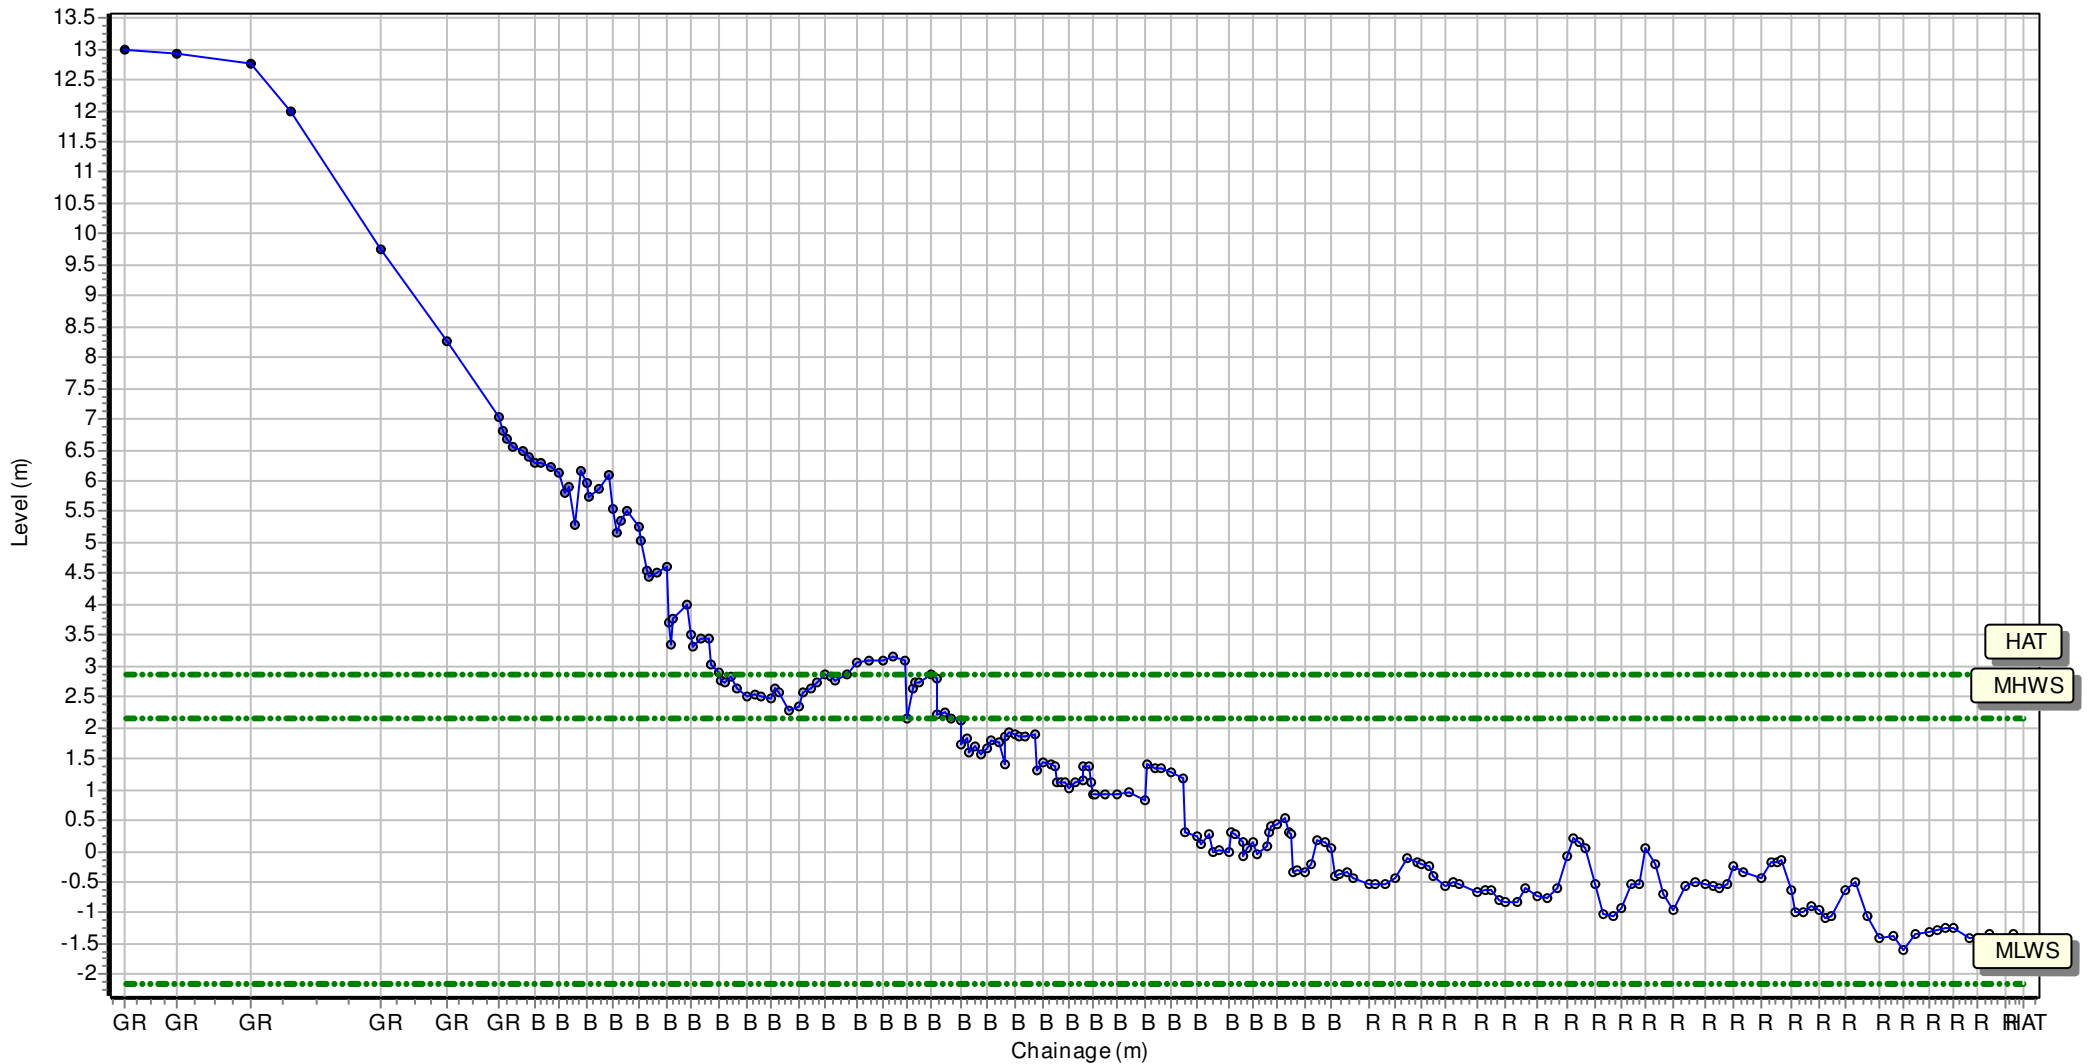
Location: 1bSS13

Summary: 2019 Full Measures Topo Survey

Easting: 438696.305 Northing: 566412.949 Profile Bearing: 26 ° from North

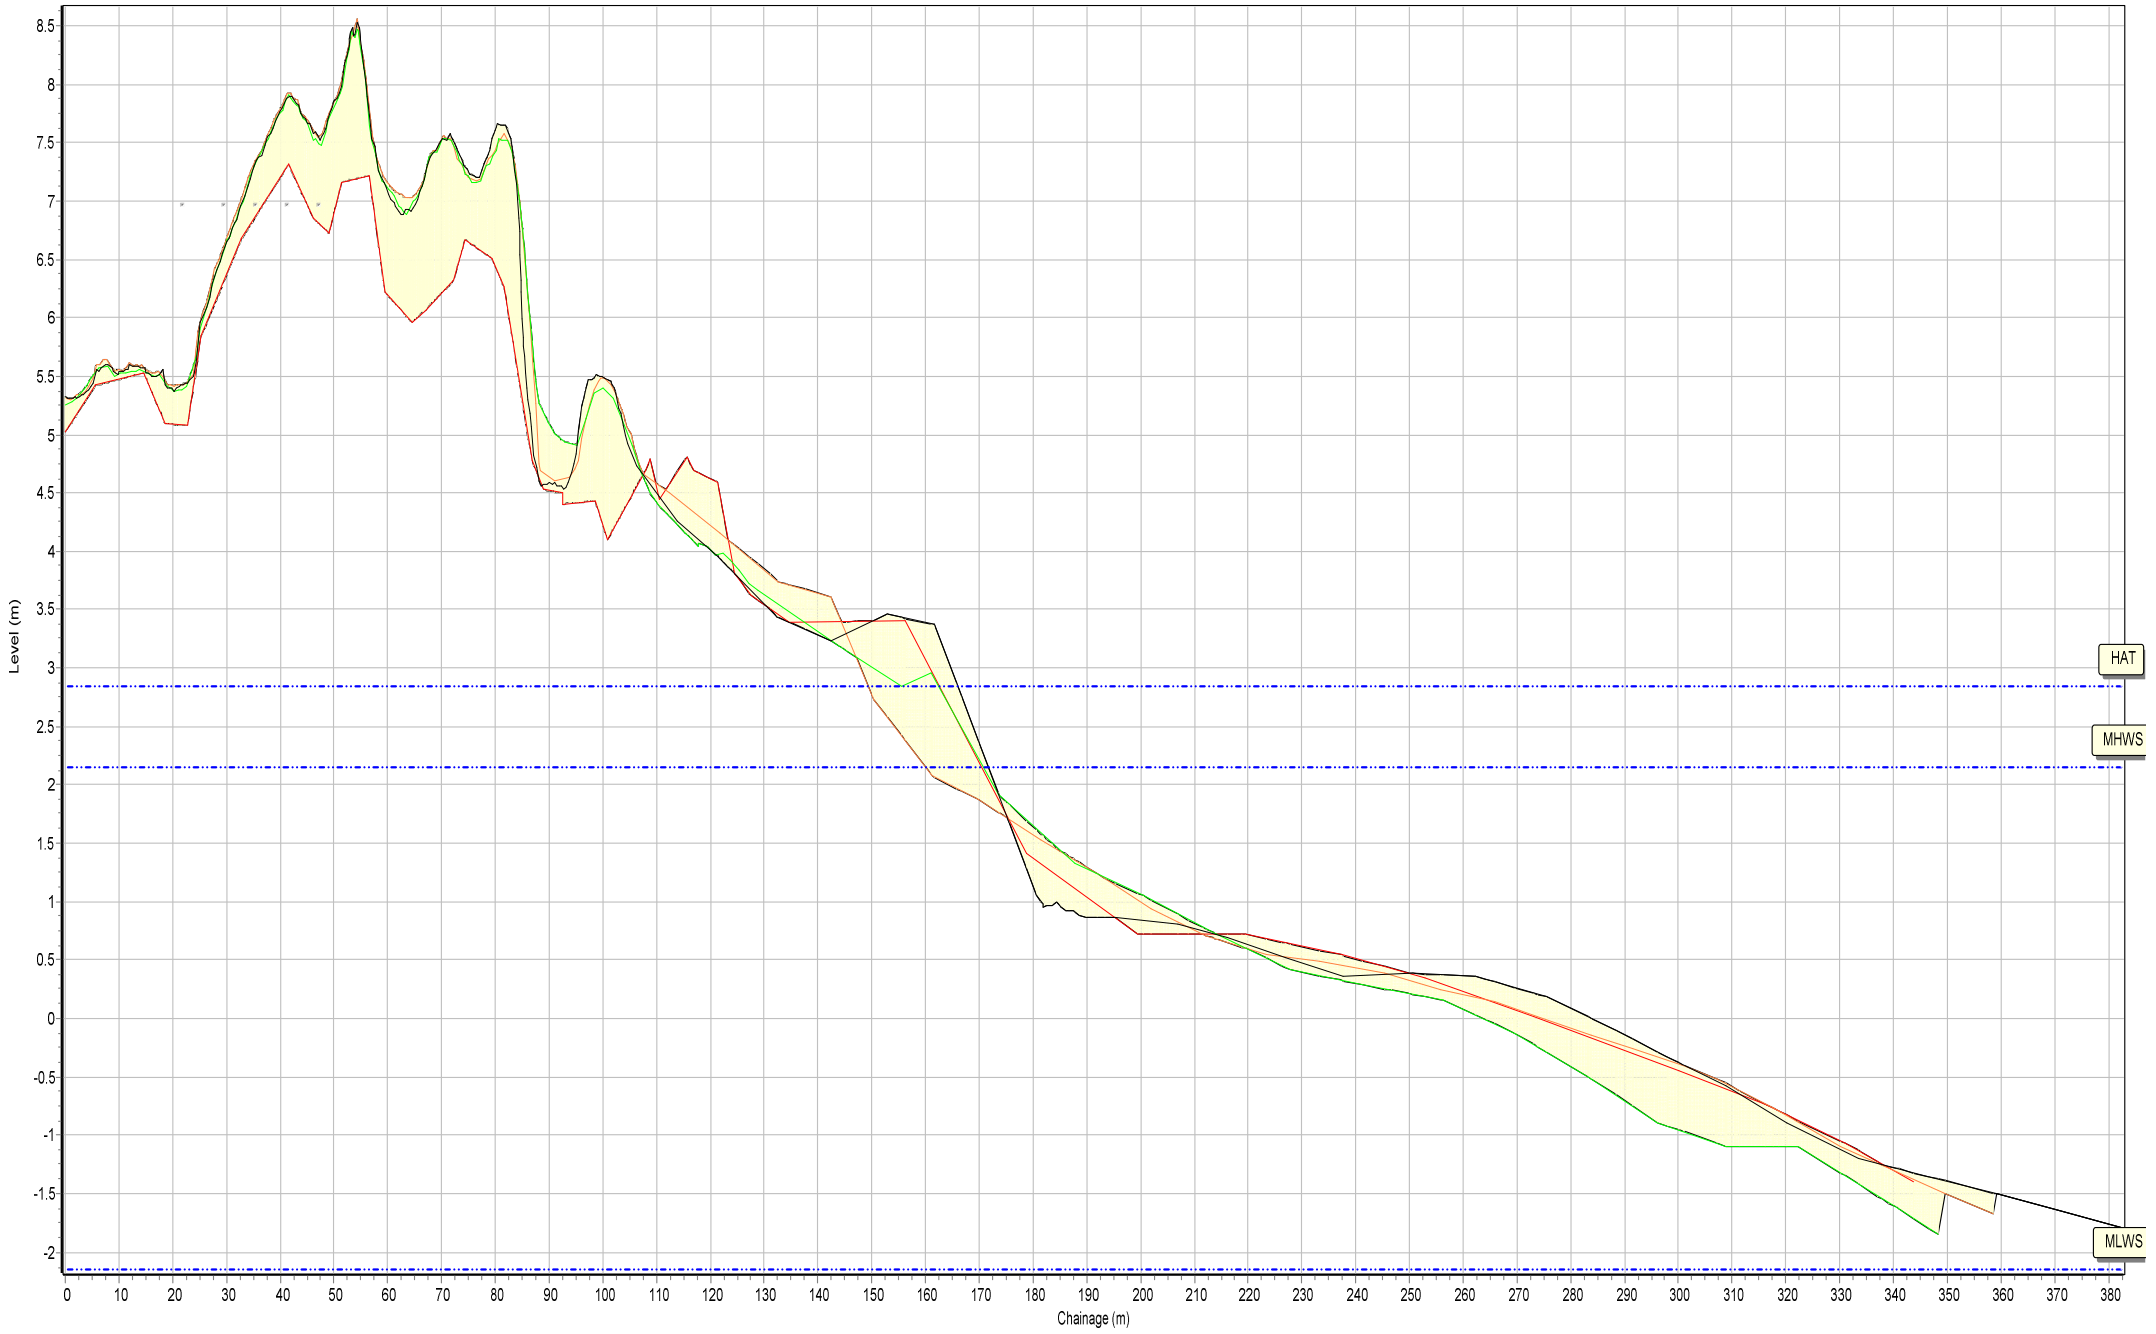
Beach Profiles: 1bSS5

Survey Date	Description of Changes Since Last Survey	Interpretation
<p>10th – 15th September 2019</p>	<p>Beach Profiles:</p> <p>Herd Sands is covered by five beach profile lines for the Full Measures survey (Appendix A). Profiles 1bSS5, 1bSS8 to 1bSS9 were last surveyed during the Partial Measures spring survey, 2019. Profiles 1bSS6 and 1bSS7 were last surveyed during the Full Measures autumn survey 2018.</p> <p>Profile 1bSS5 is located to the north of Herd Sands and is in the lee of the breakwater. Sand fences were constructed on these dunes in 2012 to encourage accretion. The dunes have largely retained a similar form to the previous survey, showing that the defences are helping to stabilise the dunes on the landward side of the path. The hollow between the dunes at chainages 87m and 97m has deepened by 0.4m, with accretion on the landward and seaward side of the hollow of up to 0.1m. This has created a similar profile to that seen in November 2018, however the dunes are now at their highest level recorded. There has been small amounts of accretion across the beach profile seaward of the dunes, by up to 0.5m in the upper beach creating a berm at chainage 155m. At the toe of the upper beach berm the beach has eroded by up to 0.6m. From chainage 214m the lower beach has accreted by up to 0.6m, extending the toe of the beach by 35m. Overall, the beach is at a high level on the upper beach compared to the range recorded from previous surveys, with the seaward facing dunes at their highest recorded levels. The middle and lower beach level are generally in the medium range compared to the range recorded from previous surveys.</p> <p>At profile 1bSS6, the dunes have accreted by up to 0.2m. From the toe of the dunes to chainage 145m, the upper beach has undergone varying levels of change by up to ±0.1m. From chainage 145m there has been an accretion of up to 1.1m, forming a berm at chainage 170m. There has been an erosion of the beach profile seaward of the berm by up to 0.3m to chainage 222m, reverting to accretion of up to 0.2m to chainage 261m. From chainage 261m to 305m there has been erosion by up to 0.2m, before reverting again to accretion at the toe of the beach by up to 0.3m. Overall the landward facing side of the dune profile is at a high level compared to the range recorded from previous surveys. The dune at chainage 82m is at its highest level recorded. Overall, the rest of the profile is a medium level compared to the range recorded from previous surveys.</p>	<p>The profiles generally show accretion on the upper beach, erosion across the middle and accretion on the lower foreshore. Generally, the profiles are at a medium level compared to the range recorded from previous surveys.</p> <p>Longer term trends: Beach levels generally remain at medium to high levels compared to earlier surveys. At profile 1bSS5, a similar profile has been formed to that seen in previous surveys, however parts of the dunes are now at their highest level recorded. Additionally, the s dune at chainage 82m at profile 1bSS6 is at its highest level recorded.</p>

- At Herd Sands the recorded profiles present no causes for concern, and beach profiles remain at medium levels. At profile 1bSS5, the dunes have progressively prograded and are now at their highest level recorded. The short term difference plot indicates that accretion has been dominant at Herd Sands relative to the previous survey.

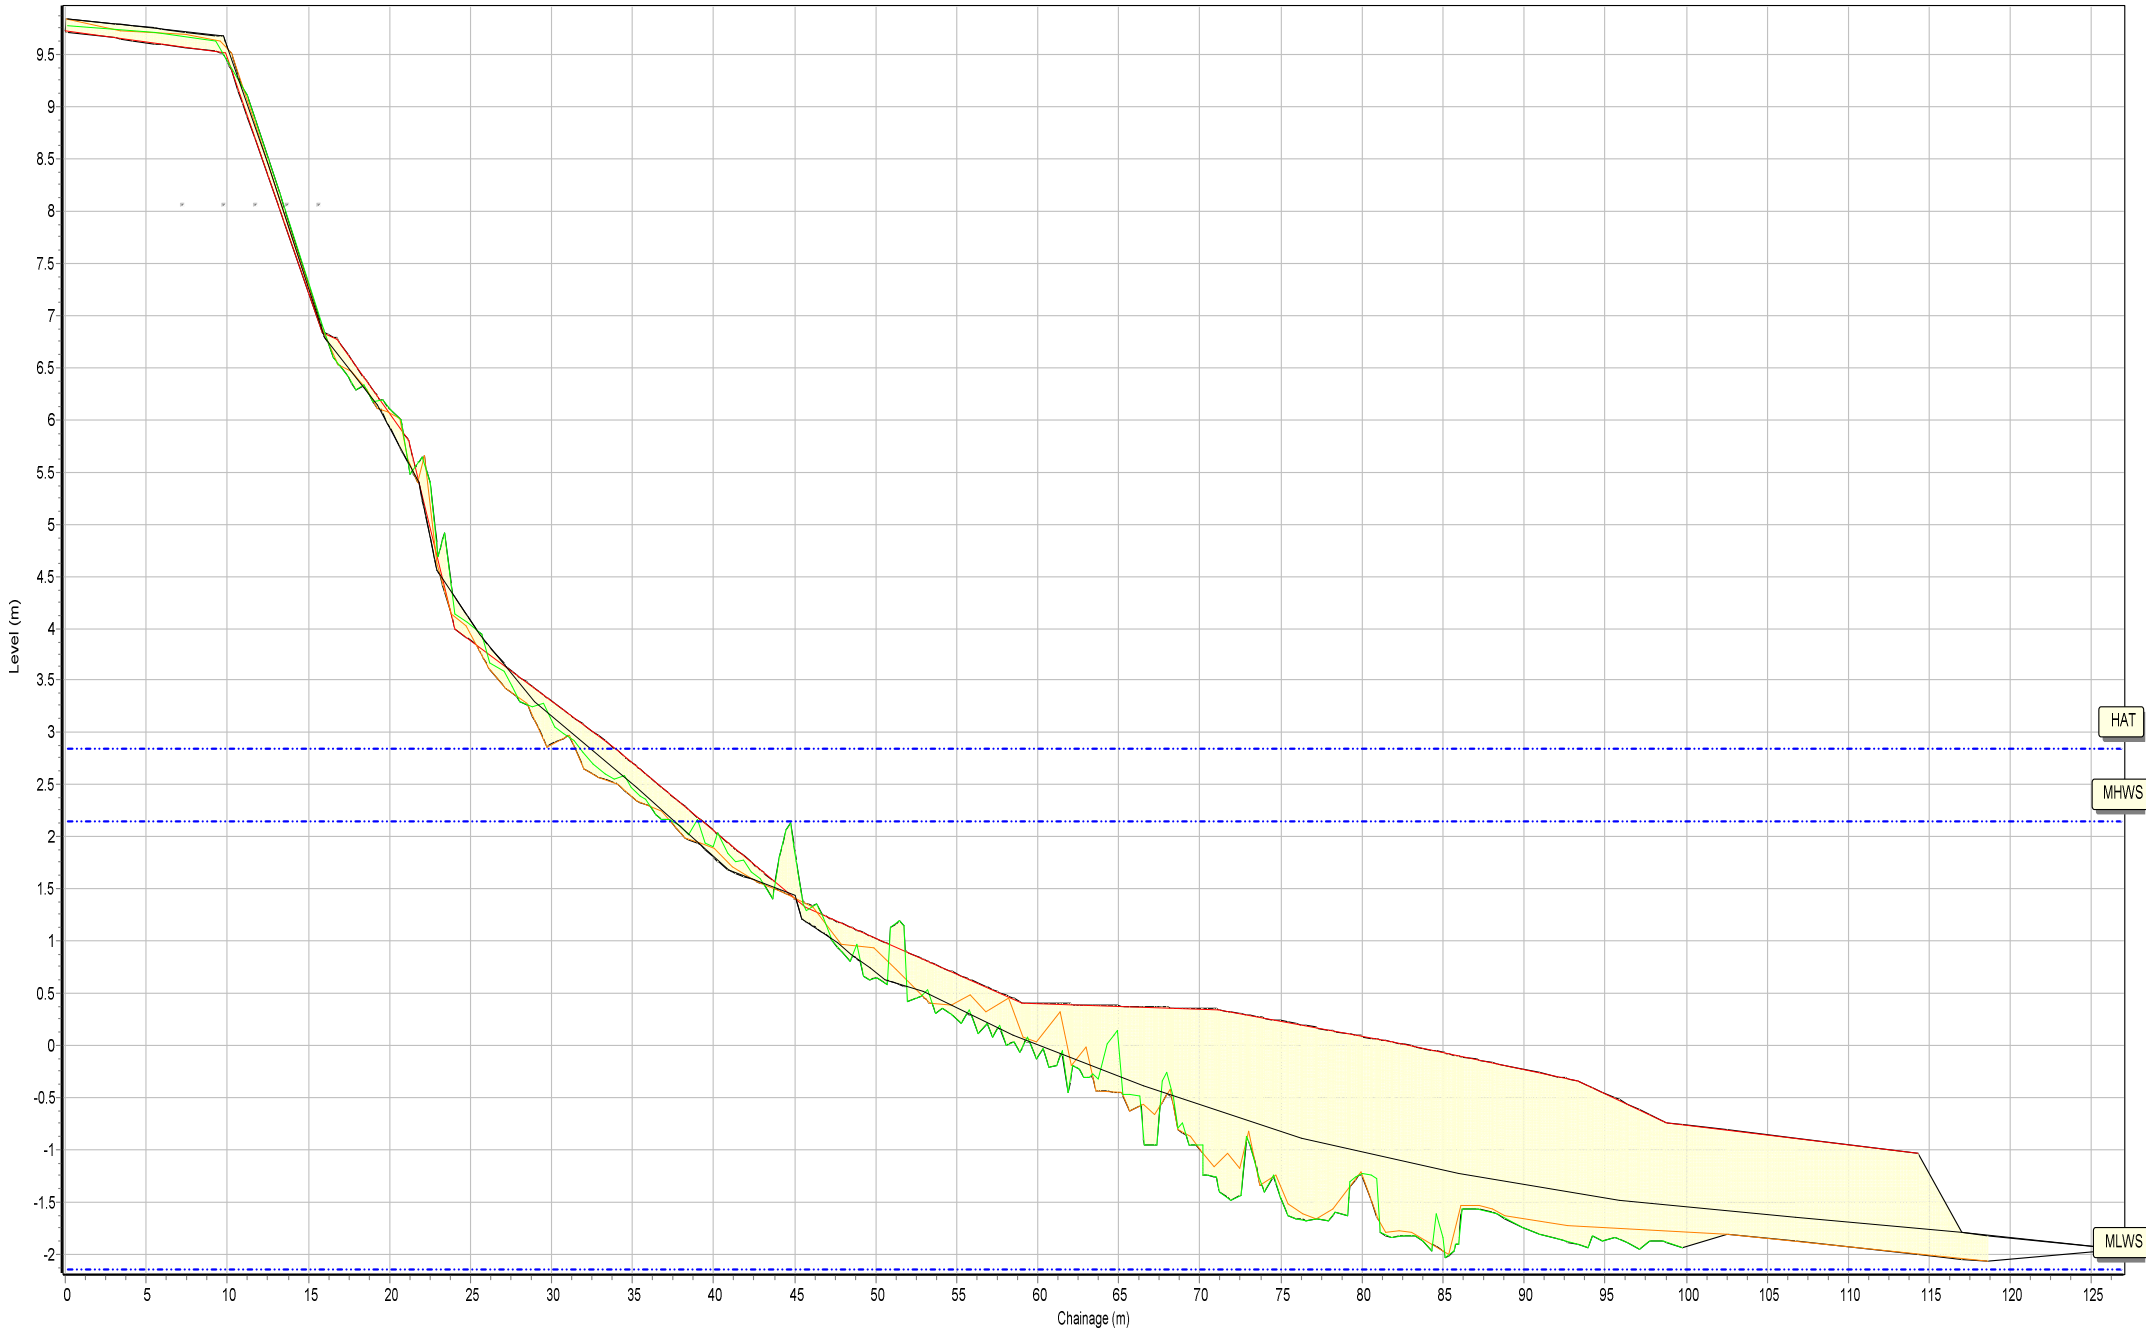
Beach Profiles: 1bSS10

Survey Date	Description of Changes Since Last Survey	Interpretation
<p>10th – 15th September 2019</p>	<p>Beach Profiles:</p> <p>Trow Quarry is covered by four beach profile lines for the Full Measures survey (Appendix A), two in Graham's Sand and two in Southern Bay. The previous survey was the Partial Measures survey undertaken in February 2019.</p> <p>Profiles 1bSS10 and 1bSS11 are located in Graham's Bay.</p> <p>At profile 1bSS10 the backshore has remained stable. Across the majority of the profile, there has been an accretion of sediment over previously exposed cobbles. Accretion ranges from 0.1m between chainages 16m and 66m, to 0.7m seaward of chainage 66m. Overall, the profile is at a relatively medium-low level compared with the range recorded from previous surveys.</p> <p>At profile 1bSS11, there has been very little change in the beach profile to chainage 27m. Between chainage 27m and 45m there has been erosion of up to 0.5m. Seaward of 45m there has been varying amounts of erosion of up to 1.0m of sand, exposing some of the rocks. Overall the profile is at a low level compared with the range recorded from previous surveys.</p> <p>Profile 1bSS12 and 1bSS13 are located in Southern Bay. At both locations the beach profile has remained stable since the previous survey. Apparent changes in the profile likely derive from minor movement of cobbles or differences in the exact placement of survey points.</p>	<p>At both Graham's Bay and Southern Bay, the cliff and rock revetment have remained stable.</p> <p>At Graham's Bay the beach shows small amounts of accretion in between rocks and cobbles at profile 1bSS10, creating a smoother profile. There has been erosion across profile 1bSS11.</p> <p>At Southern Bay, the rocky foreshore has generally retained the same form and position.</p> <p>Longer term trends: Overall, the beach at Graham's Bay and Southern Bay has generally retained the same form and position since November 2008/March 2009 when surveys began.</p>

- At Trow Quarry, the beach has generally maintained the same form since surveys began in 2009. There has been accretion at profile 1bSS10, creating a smoother profile and erosion across profile 1bSS11 which is now at a low level. The recorded profiles show no cause for concern. The cliffs at Trow Point appear to have been stable and the data does not indicate cause for concern.

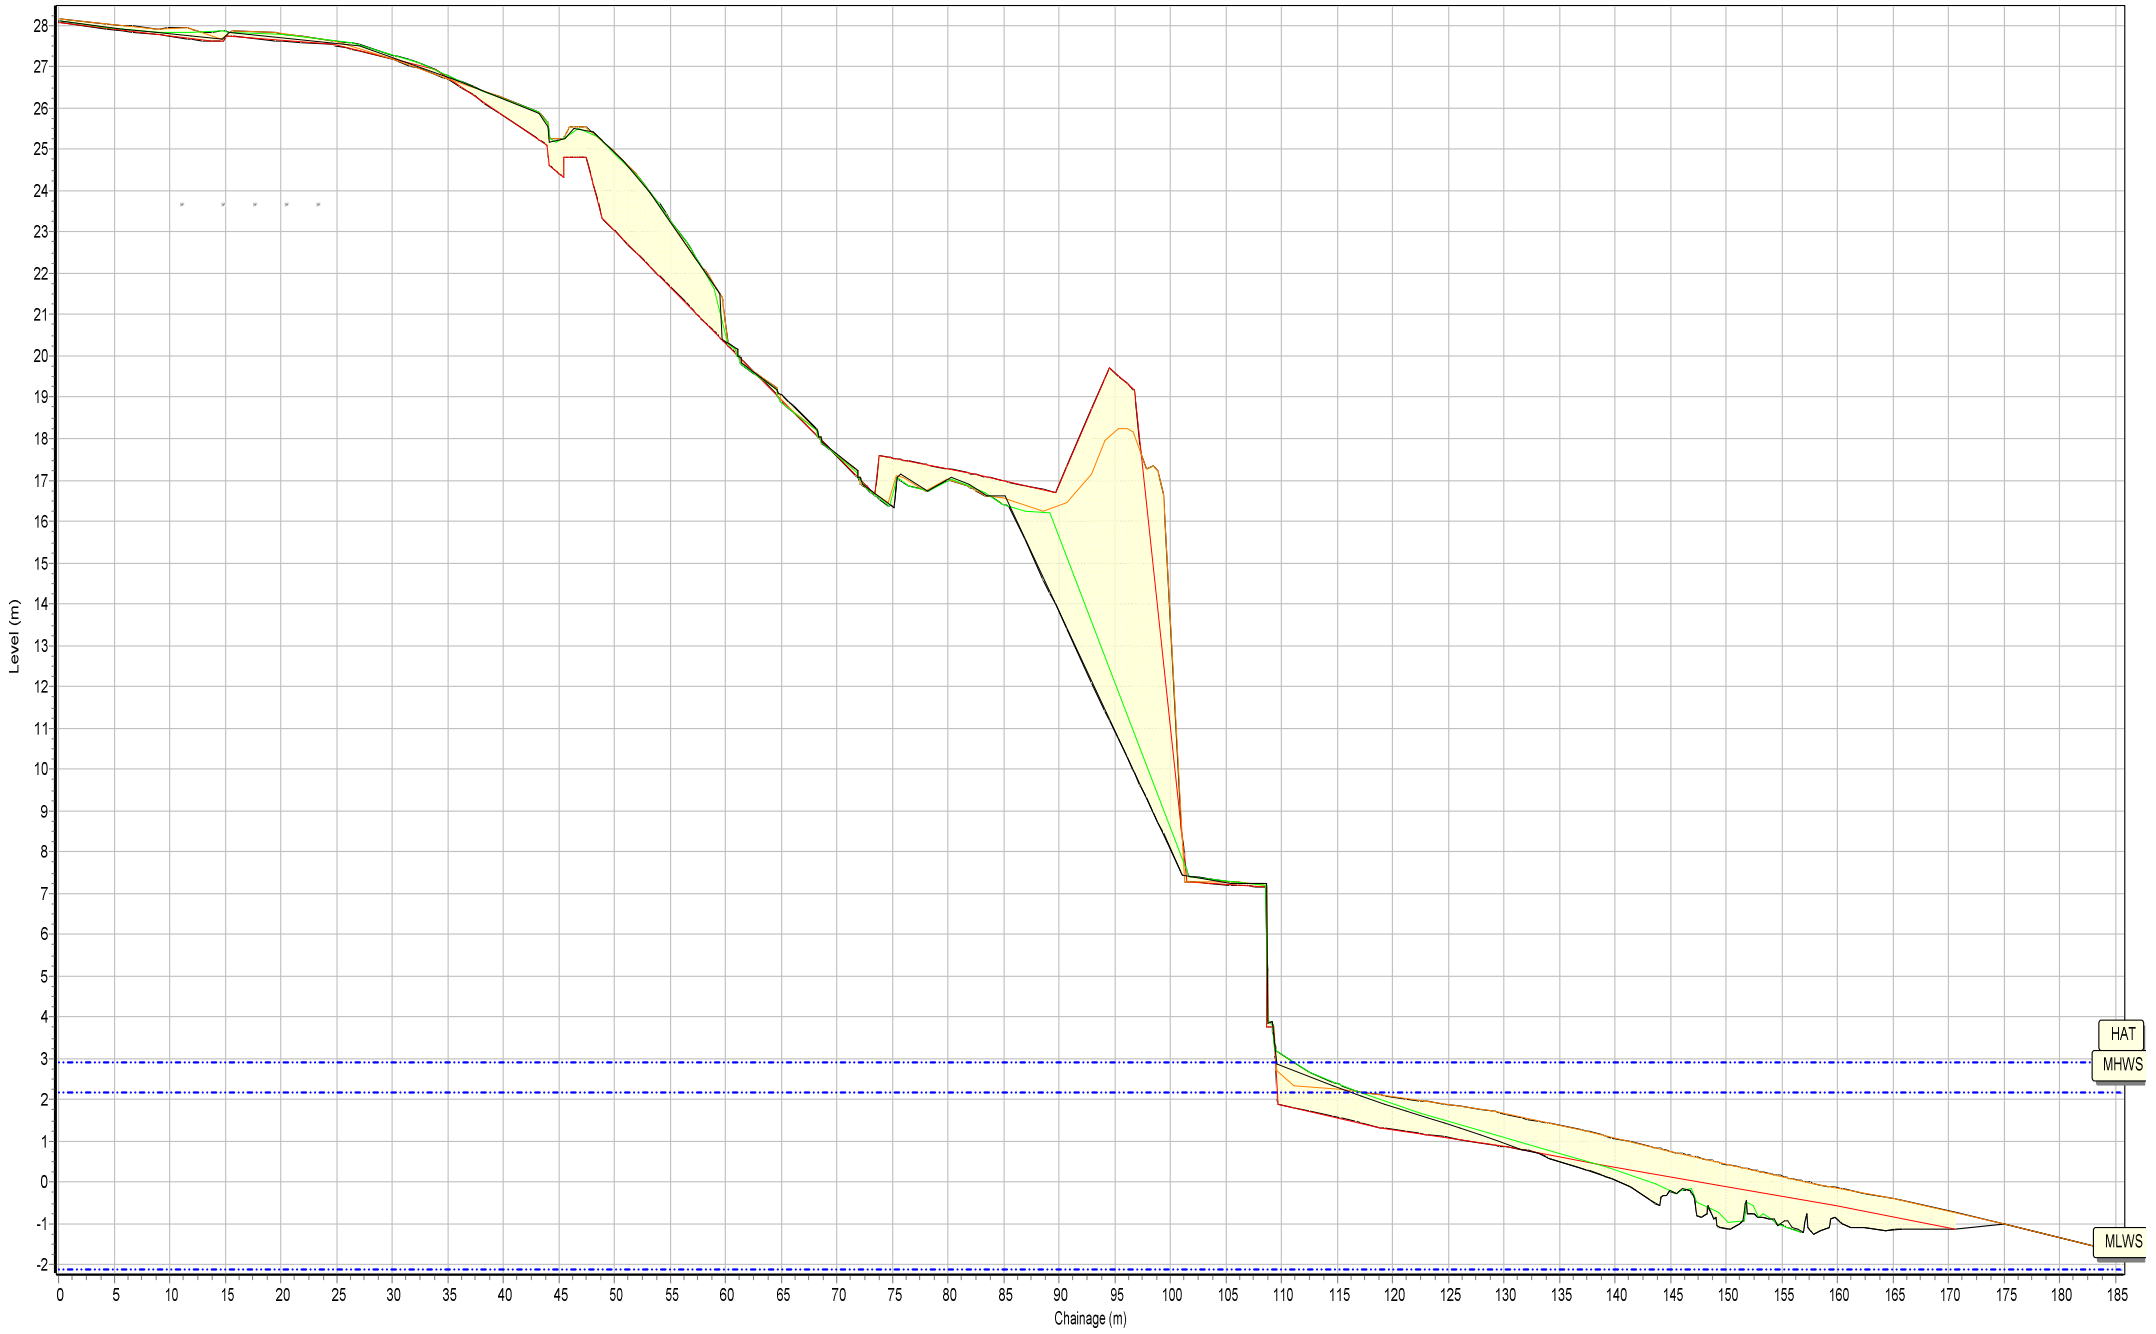
Beach Profiles: 1bSS14

Survey Date	Description of Changes Since Last Survey	Interpretation
10 th – 15 th September 2019	<p>Beach Profiles:</p> <p>Marsden Sands is covered by four beach profile lines for the Full Measures survey (Appendix A). The previous survey was the Partial Measures survey in February 2019 and prior to that the Full Measures survey was completed in November 2018. Profiles 1bSS14 and 1bSS17 were last surveyed during the Partial Measures spring survey, 2019. Profiles 1bSS15 and 1bSS16 were last surveyed during the Full Measures autumn survey, 2018.</p> <p>Profile 1bSS14 is located to the north of the bay and covers the cliff and the former lifeguard station adjacent to the Redwell Steps. The cliff top section shows a recession of c.3m, however this could be due to a change in position of surveying due to unsafe ground conditions, as per the spring 2019 survey report. There has been a uniform erosion of the beach profile from the cliff toe to the rocks at chainage 144m of up to 0.2m. The rocks are more exposed than the spring 2019 survey. Overall, the profile is at a medium level on the upper and middle beach and a low level on the lower beach compared to the range recorded by previous surveys.</p> <p>At profile 1bSS15, there has been a 4m recession in position of the cliff toe, however this could be a difference in surveying position at the base of the cliff. Across the beach profile there has been an accretion of up to 0.8m to chainage 105m. There is a small section of erosion between 113m and 118m of 0.3m. From chainage 105m to the end of the profile there has been accretion of up to 0.3m, covering the boulders at the beach toe. Overall, the profile is at a high level on the upper beach and a low level on the middle and lower beach compared to the range recorded by previous surveys.</p> <p>At Profile 1bSS16, the cliff profile has remained stable since the previous survey. There has been accretion of up to 1.2m of material to chainage 126m, covering up previously exposed cobbles. From 126m, apparent changes across the rest of the profile likely derive from minor movement of cobbles or differences in the exact placement of survey points. The profile is at a medium to high level compared with the range recorded from previous surveys.</p> <p>Profile 1bSS17 is located to the south of the bay. There has been erosion of sand at the toe of the cliff to chainage 67m of up to 0.2m, which is now at its lowest level recorded. The profile which crosses rocky platform and boulders with small pockets of sand remains relatively unchanged, with</p>	<p>The most northerly part of Marsden Bay at profile 1bSS14 appears to have been dominated by erosion across the upper to lower beach. At the centre of the bay, profiles 1bSS15 and 1bSS16 are dominated by accretion across almost the entire beach. Changes are minimal further south, where there is less mobile sediment available.</p> <p>Longer term trends: The sandier beaches in the north of the bay are at a medium to -high level across the profile, except the lower beach in the northern two profiles which is at a low level compared to earlier surveys. Further south, there is little sand and therefore the underlying coarser sediment and the shore platform is exposed, indicating a general trend of movement of sediment towards the north.</p>

- At Marsden Bay, profile 1bSS14 shows uniform erosion, whilst the central two profiles 1bSS15 and 1bSS16 show uniform accretion. The toe of the cliff at profile 1bSS17 is now at its lowest level recorded. The profiles present no causes for concern; with the majority of profiles in the medium bounds of previous surveys, except profile 1bSS17 which is at a low level.

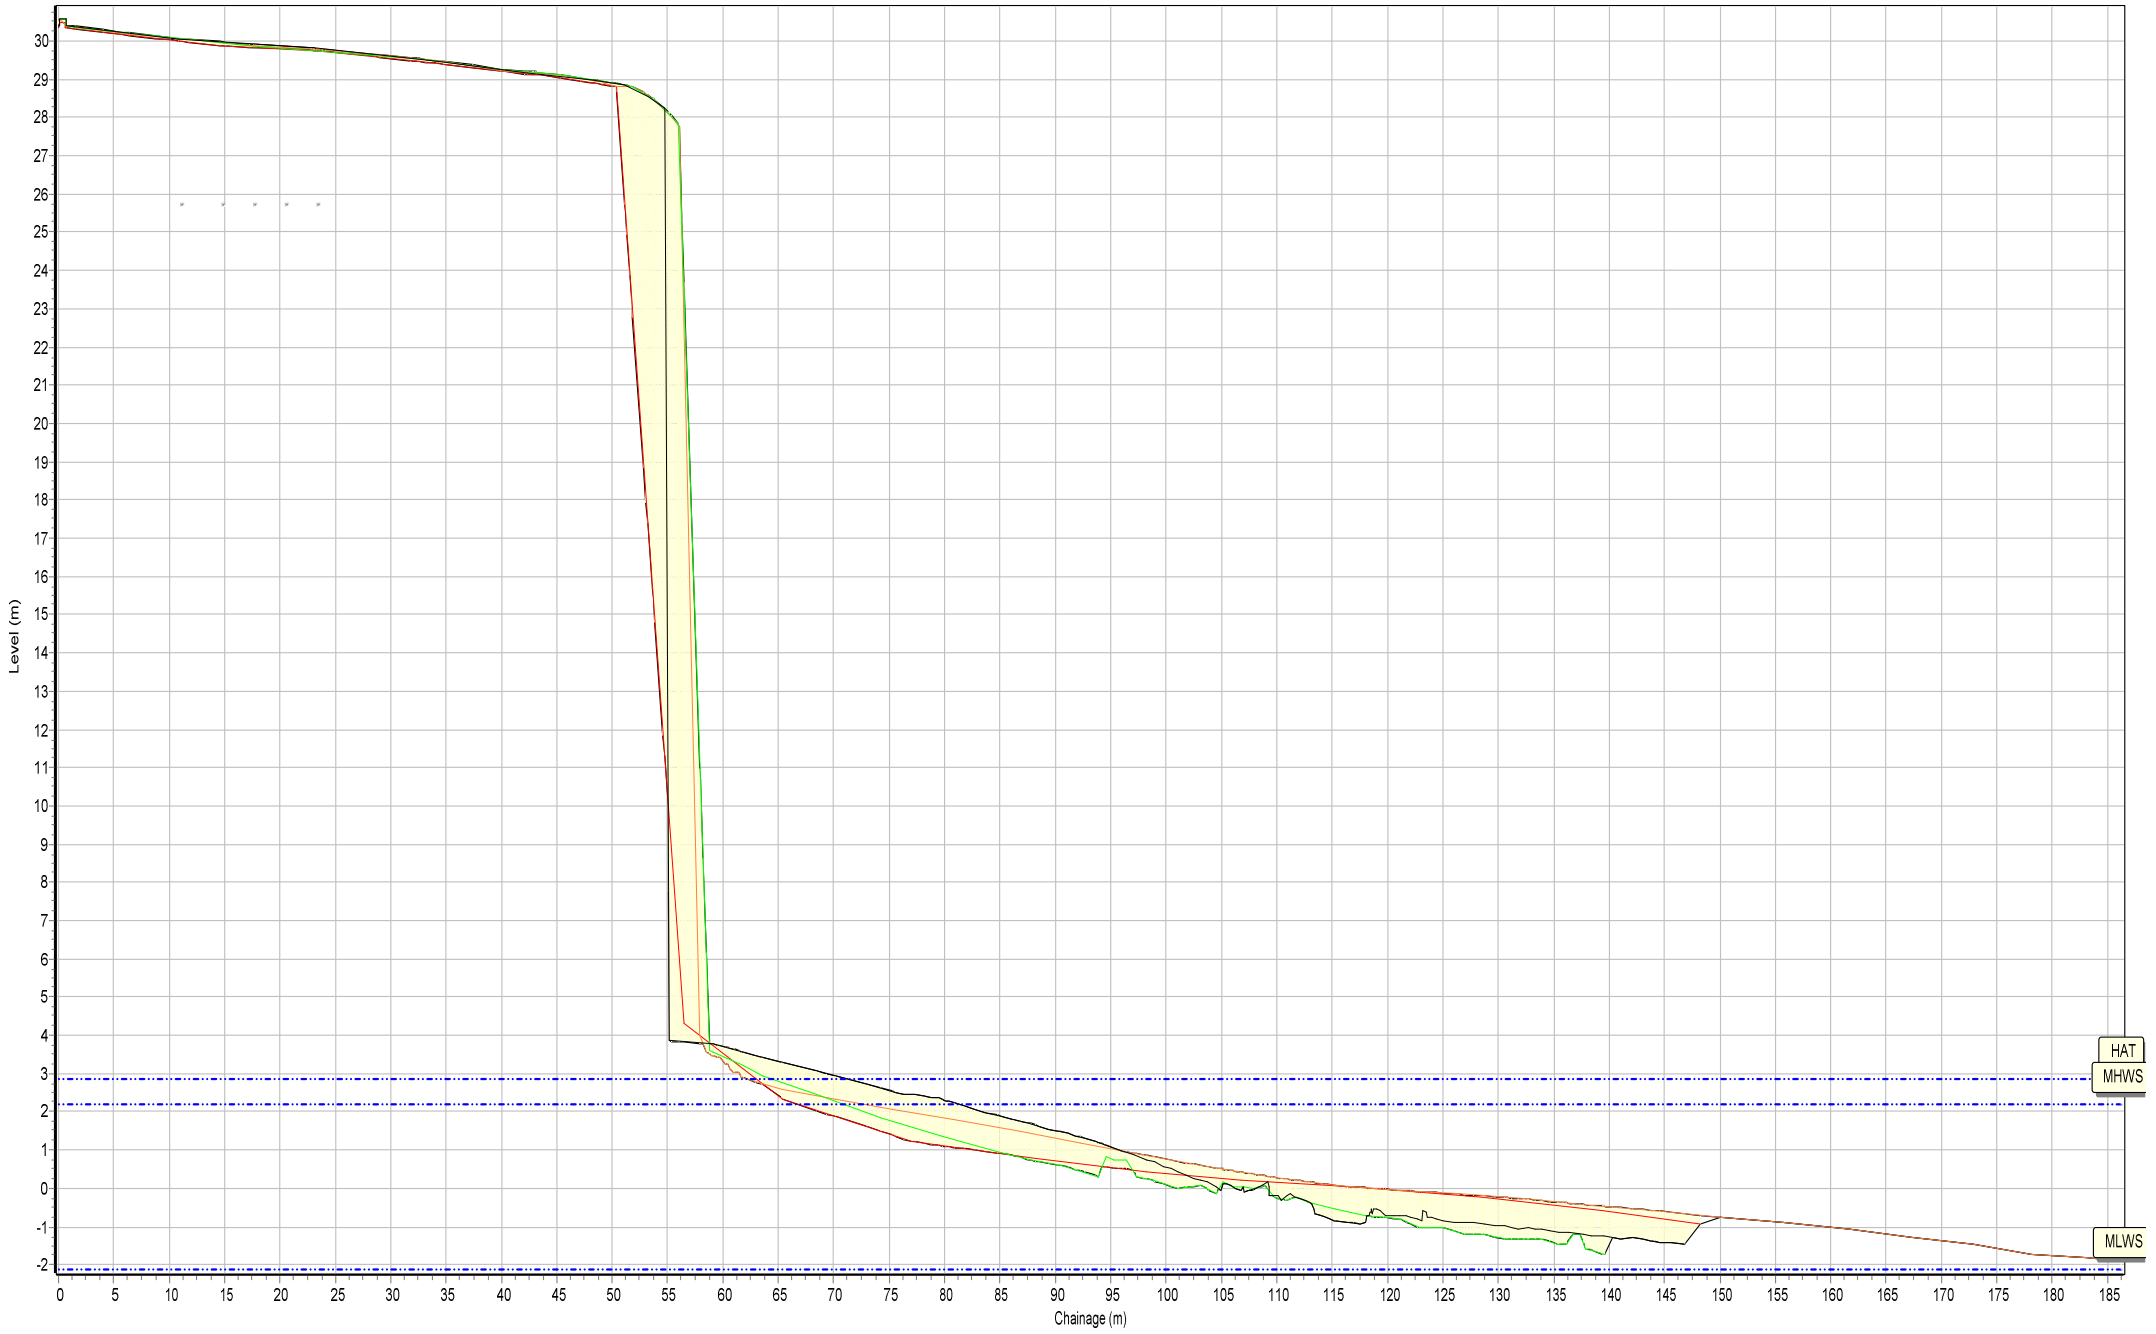
Beach Profiles: 1bSS15

Profiles Envelope 01/11/2008 05/10/2017 12/11/2018 15/09/2019

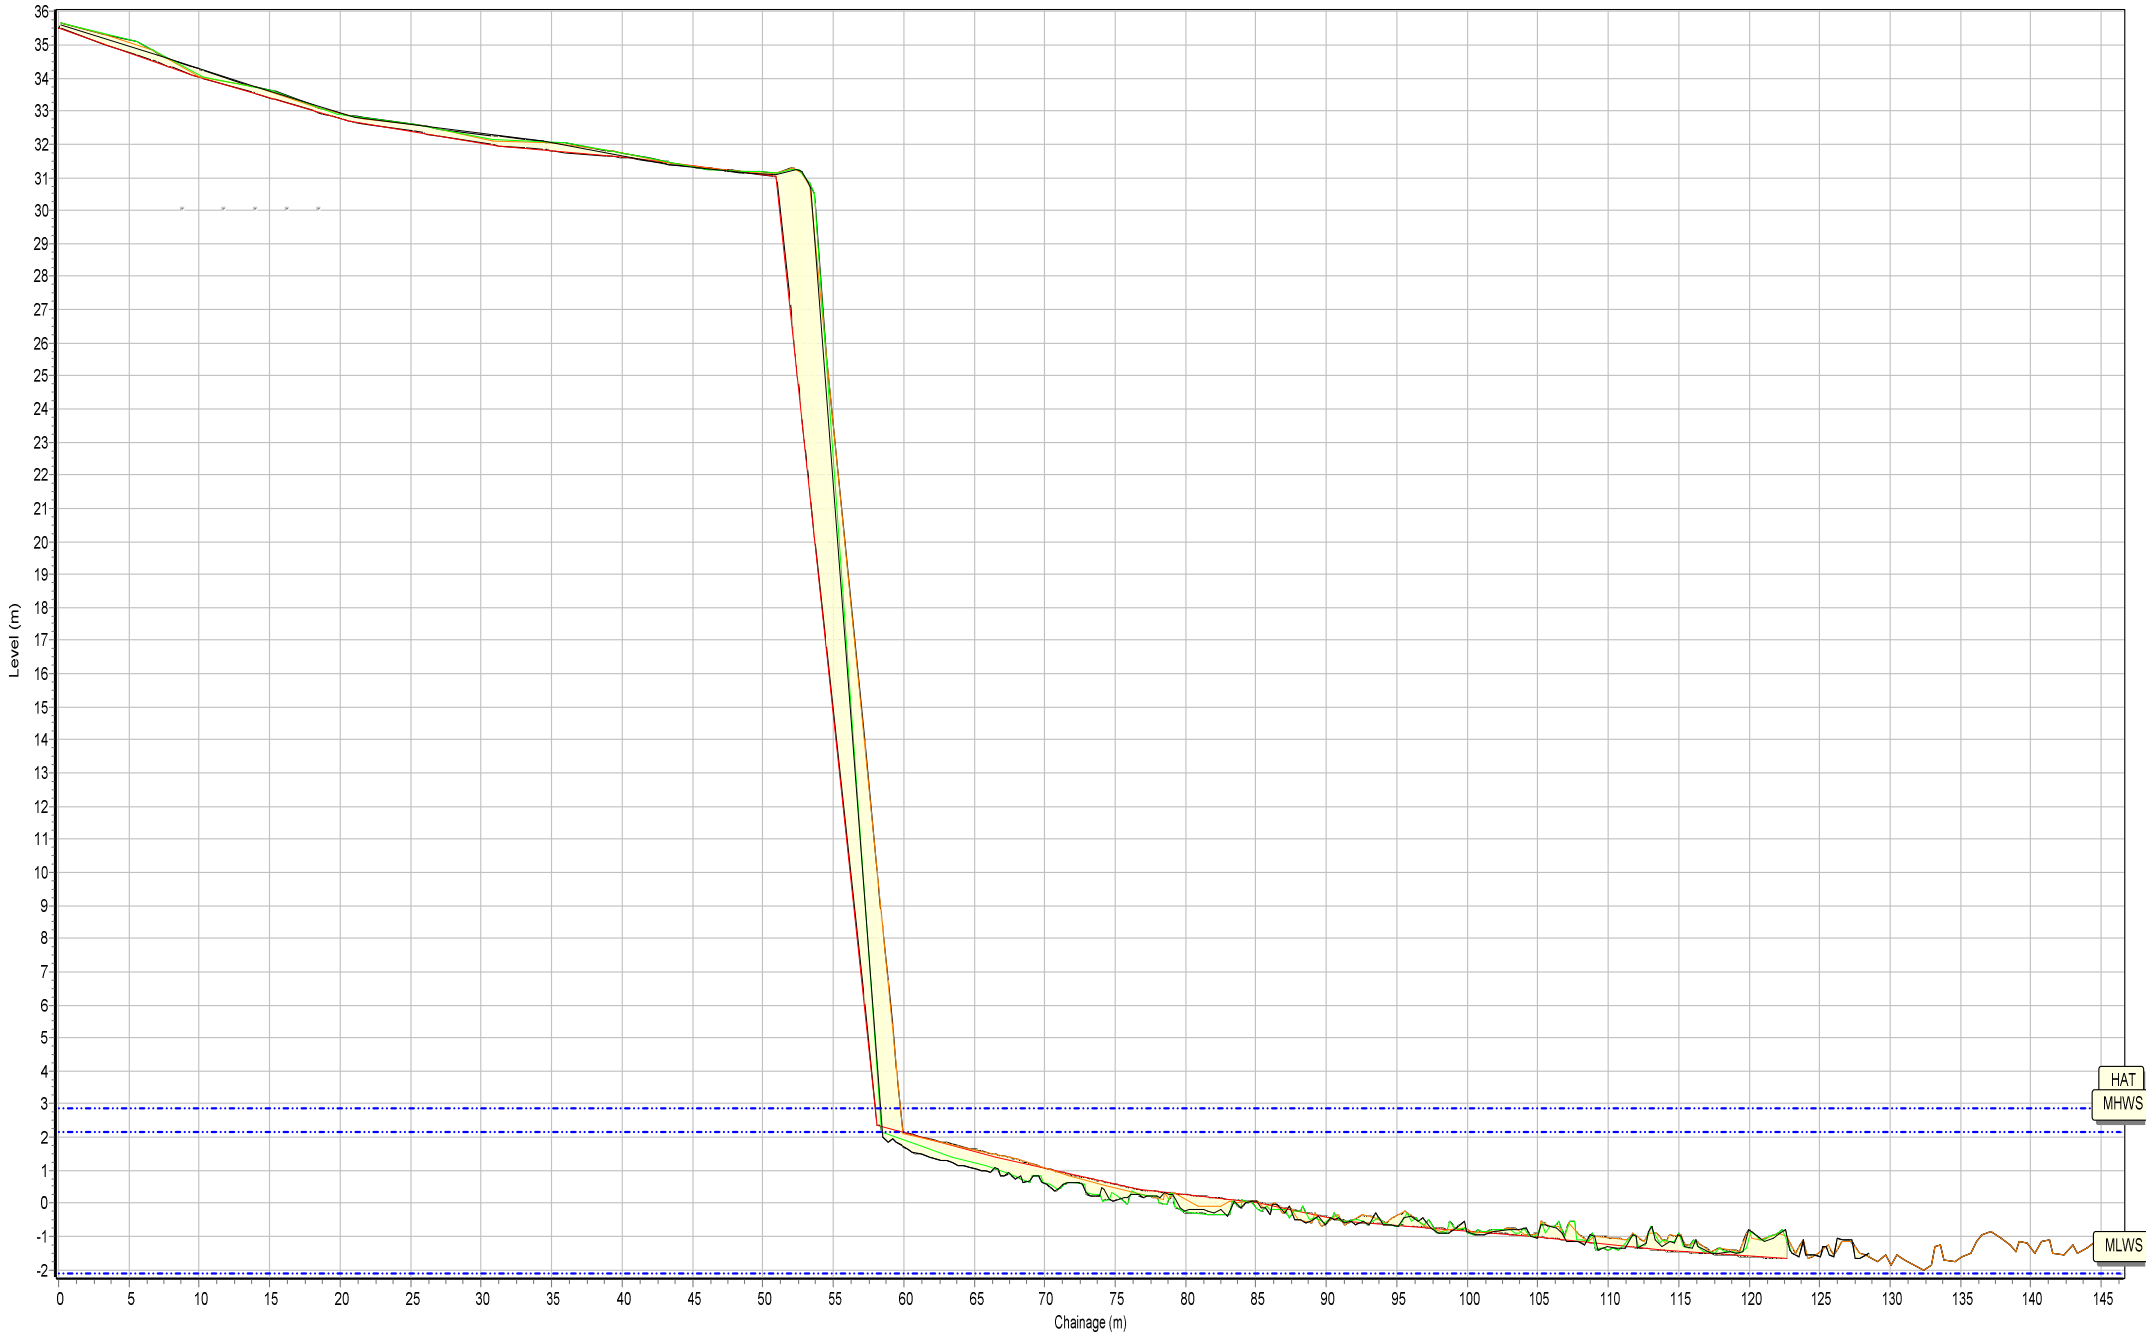
Beach Profiles: 1bSS17

Survey Date	Description of Changes Since Last Survey	Interpretation
	some changes in levels of <0.5m. Overall, the profile is at a low level compared with the range recorded from previous surveys, with the section between chainages 59m and 67m at its lowest level recorded since surveys began

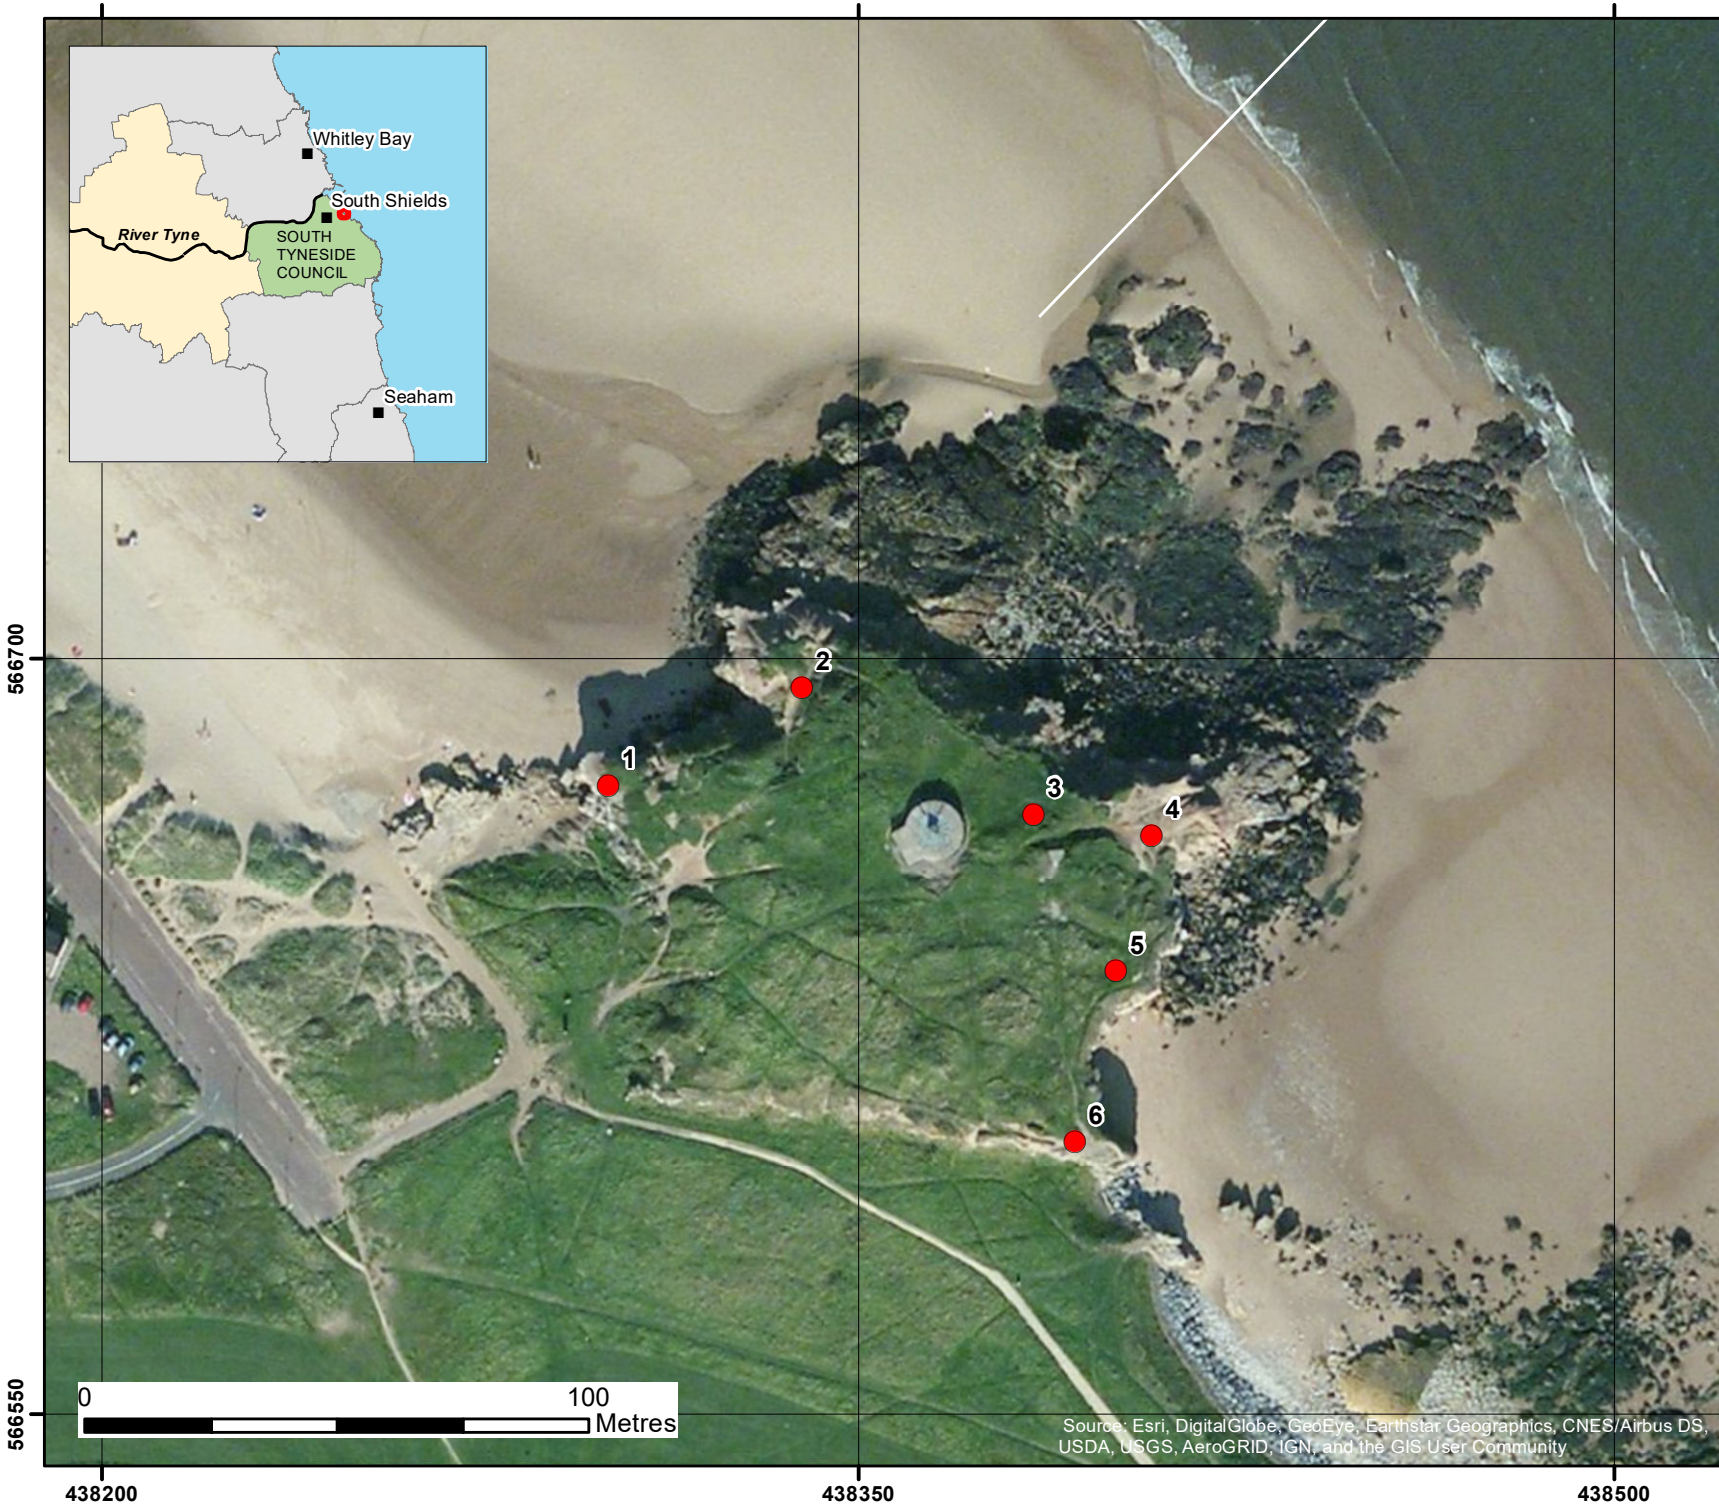
Survey Date	Description of Changes Since Last Survey	Interpretation
<p>10th – 15th September 2019</p>	<p>Cliff-top Survey:</p> <p>Cliff top survey data collected for baseline survey (autumn, 2011) and bi-annual surveys since then, including the present Full Measures survey (autumn, 2019) is presented in this report.</p> <p>Six ground control points (numbered points 1 to 6) were established along the cliff top at Trow Point in 2008 to monitor cliff erosion at the site of a former landfill. Note: the numbering of ground control points is not intended to correlate with that of the beach profile lines and reference should be made to Appendix C – Map 1 for the location of ground control points.</p> <p>Measurements are taken from each ground control point along a fixed bearing to the edge of the cliff top. The results from the cliff top monitoring are anticipated to have an accuracy of ± 0.1 m due to the technique used.</p> <p>The results from the cliff top survey are presented in Appendix C – Table C1, showing the position from the ground control point to the edge of the cliff top along a defined bearing.</p> <p>Results show no points experienced erosion greater than the anticipated survey error since the last survey.</p>	<p>Results show that since the last survey there has been no erosion greater than the anticipated survey error. Over the long term, minimal survey points have recorded recession greater than the survey accuracy. It can be concluded that minimal recession has taken place at the Trow Rocks headland over the survey period.</p>

Results from the cliff survey at Trow Quarry show that since the last survey, no erosion greater than the survey error has occurred. Therefore, it was concluded that minimal recession has taken place at the Trow Rocks headland over the survey period and there is no cause for concern.
