Cell 1 Regional Coastal Monitoring Programme Analytical Report 14: 'Full Measures' Survey 2021

South Tyneside Council

November 2021

(*) The present report is **Analytical Report 14** and provides an analysis of the 2021 Full Measures survey for South Tyneside Council's frontage.

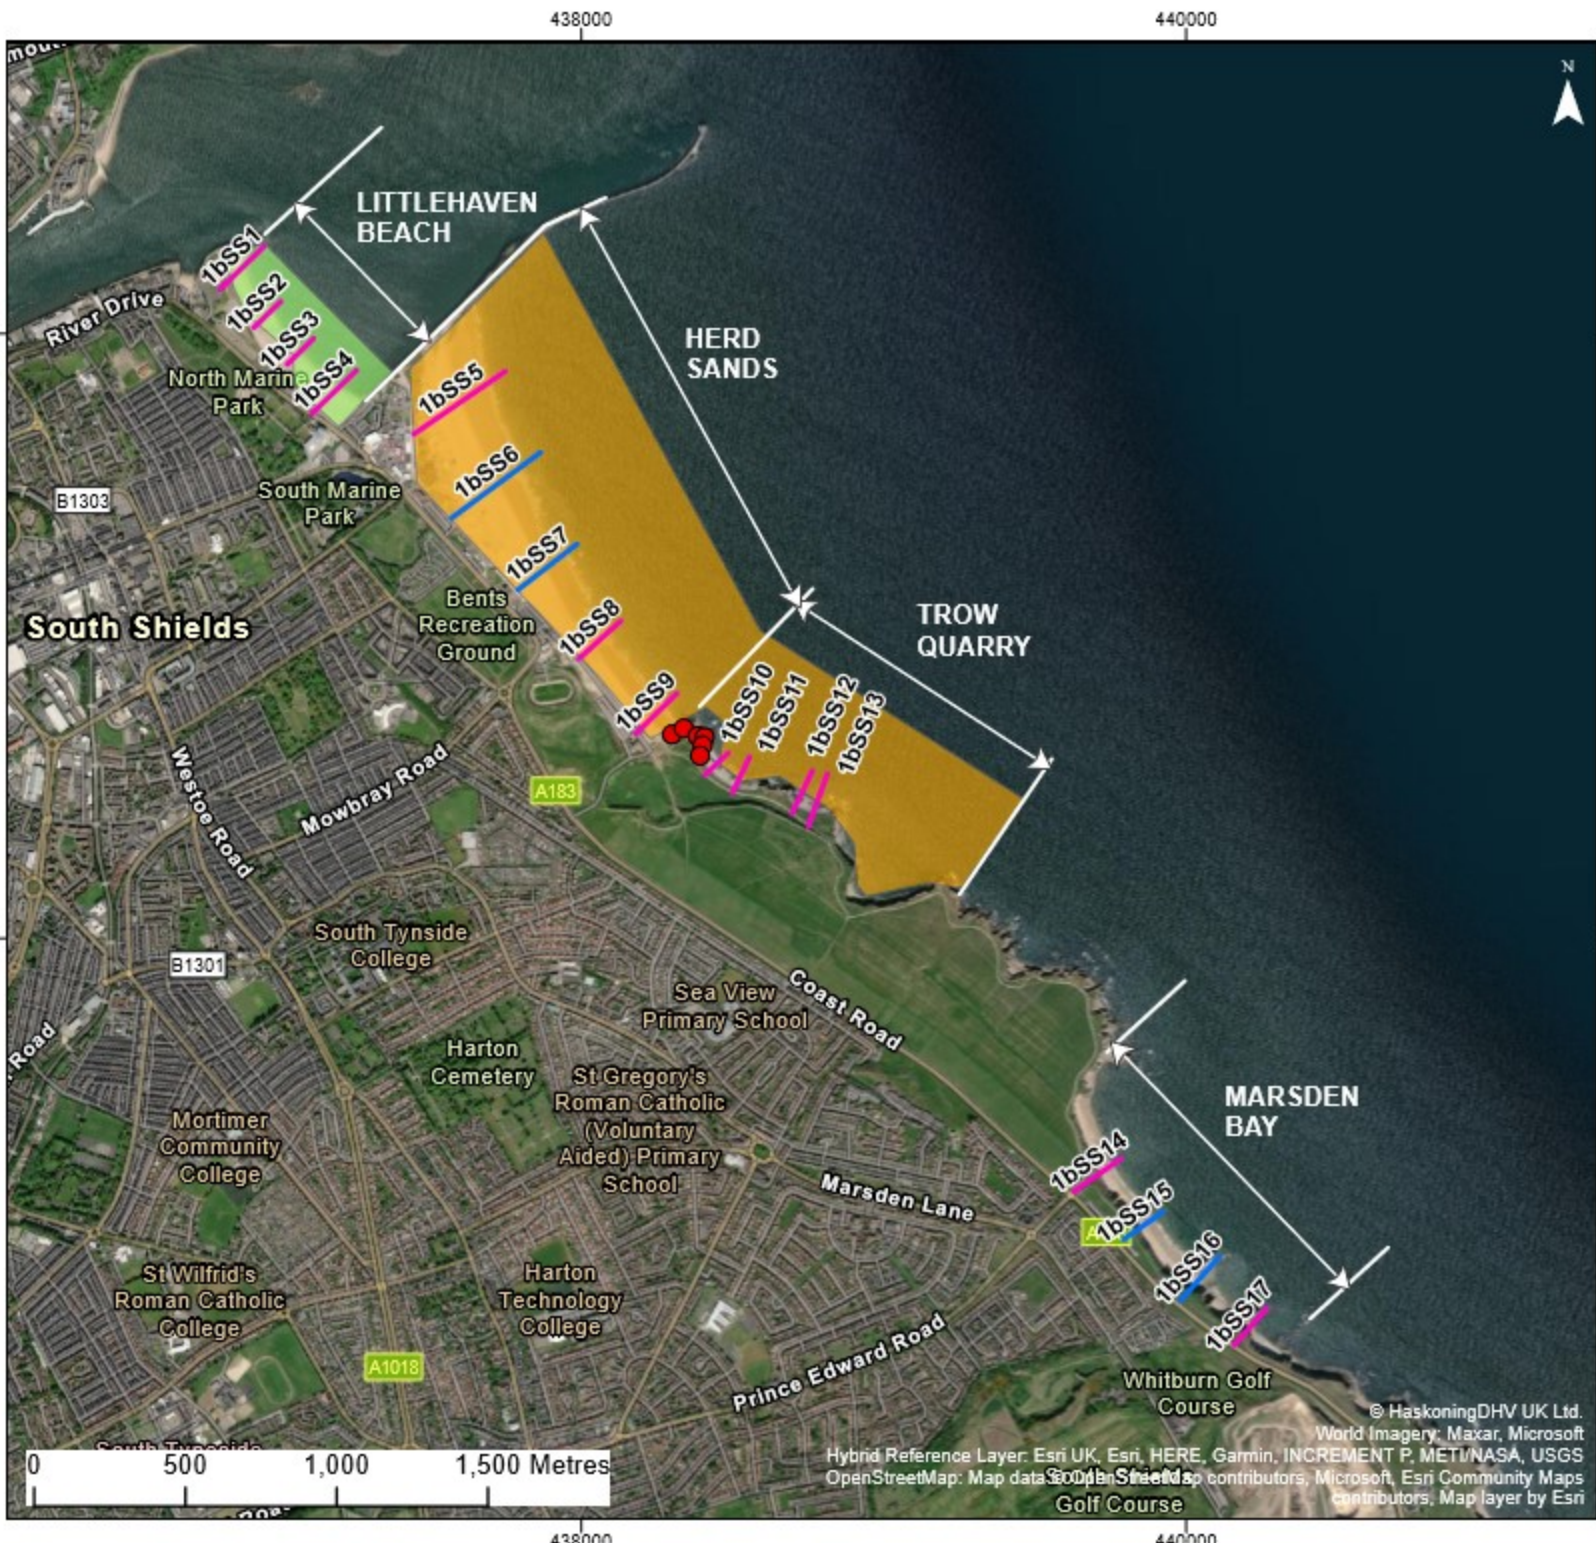
Title: **Figure 2 - Map 1**
LITTLEHAVEN BEACH TO MARSDEN BAY
South Tyneside Council Frontage

The location of these surveys is shown in Figure 2. The Full Measures survey was undertaken along this frontage between 7th September and 16th September 2021. During this time, the weather and sea state varied greatly, for details of the survey conditions refer to the Academy Geomatics survey report.

Topographic Profile

- Annual (Blue line)
- Bi-Annual (Pink line)

Topographic Area

- 6 monthly (Green)
- yearly (Orange)
- 5 yearly (Purple)

● Cliff Top Survey Points (refer to Figure 3 for details)

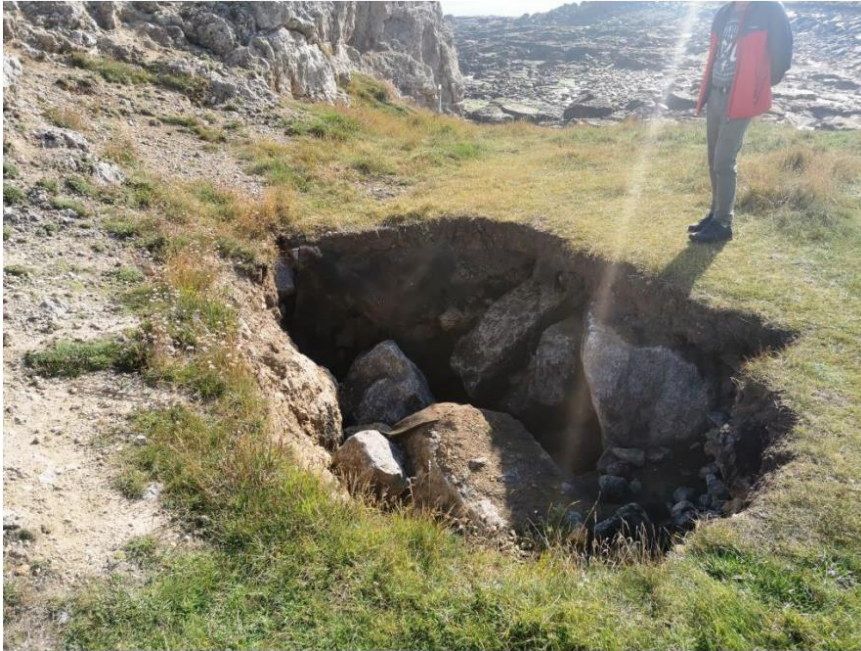
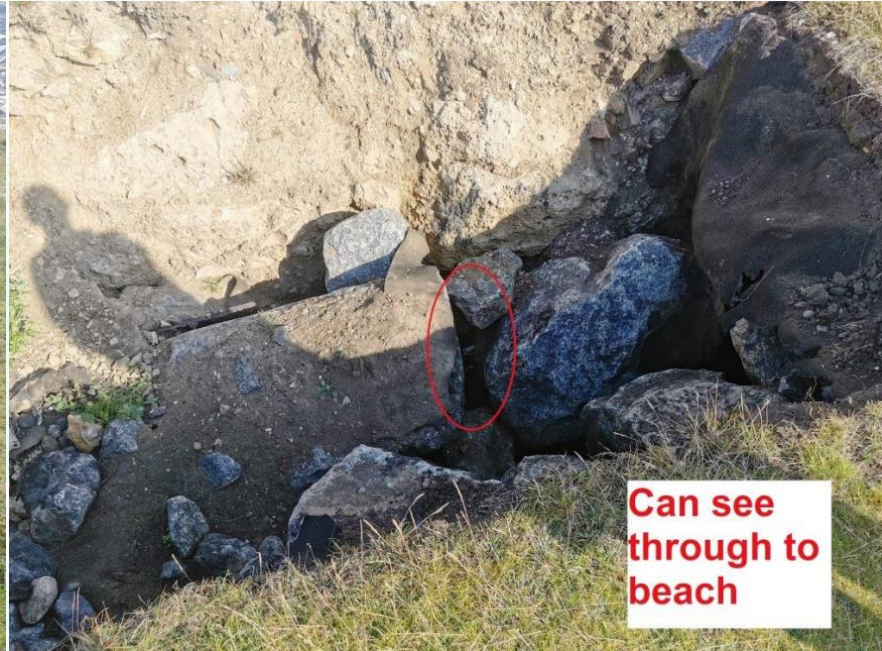
Plate 1 and 2 A sink hole between profiles 1bSS11 and 1bSS12

- At Trow Quarry, the surveyor's report notes that a previous small sinkhole has become enlarged between profiles 1bSS11 and 1bSS12 (see Plates 1 and 2). The foreshore has generally maintained the same form since surveys began in 2009. There has been accretion between cobbles on the upper beach at profile 1bSS10, and very little change has occurred at profile 1bSS11. The recorded profiles show no cause for concern. The cliffs at Trow Point appear to have been stable and the data does not indicate cause for concern.

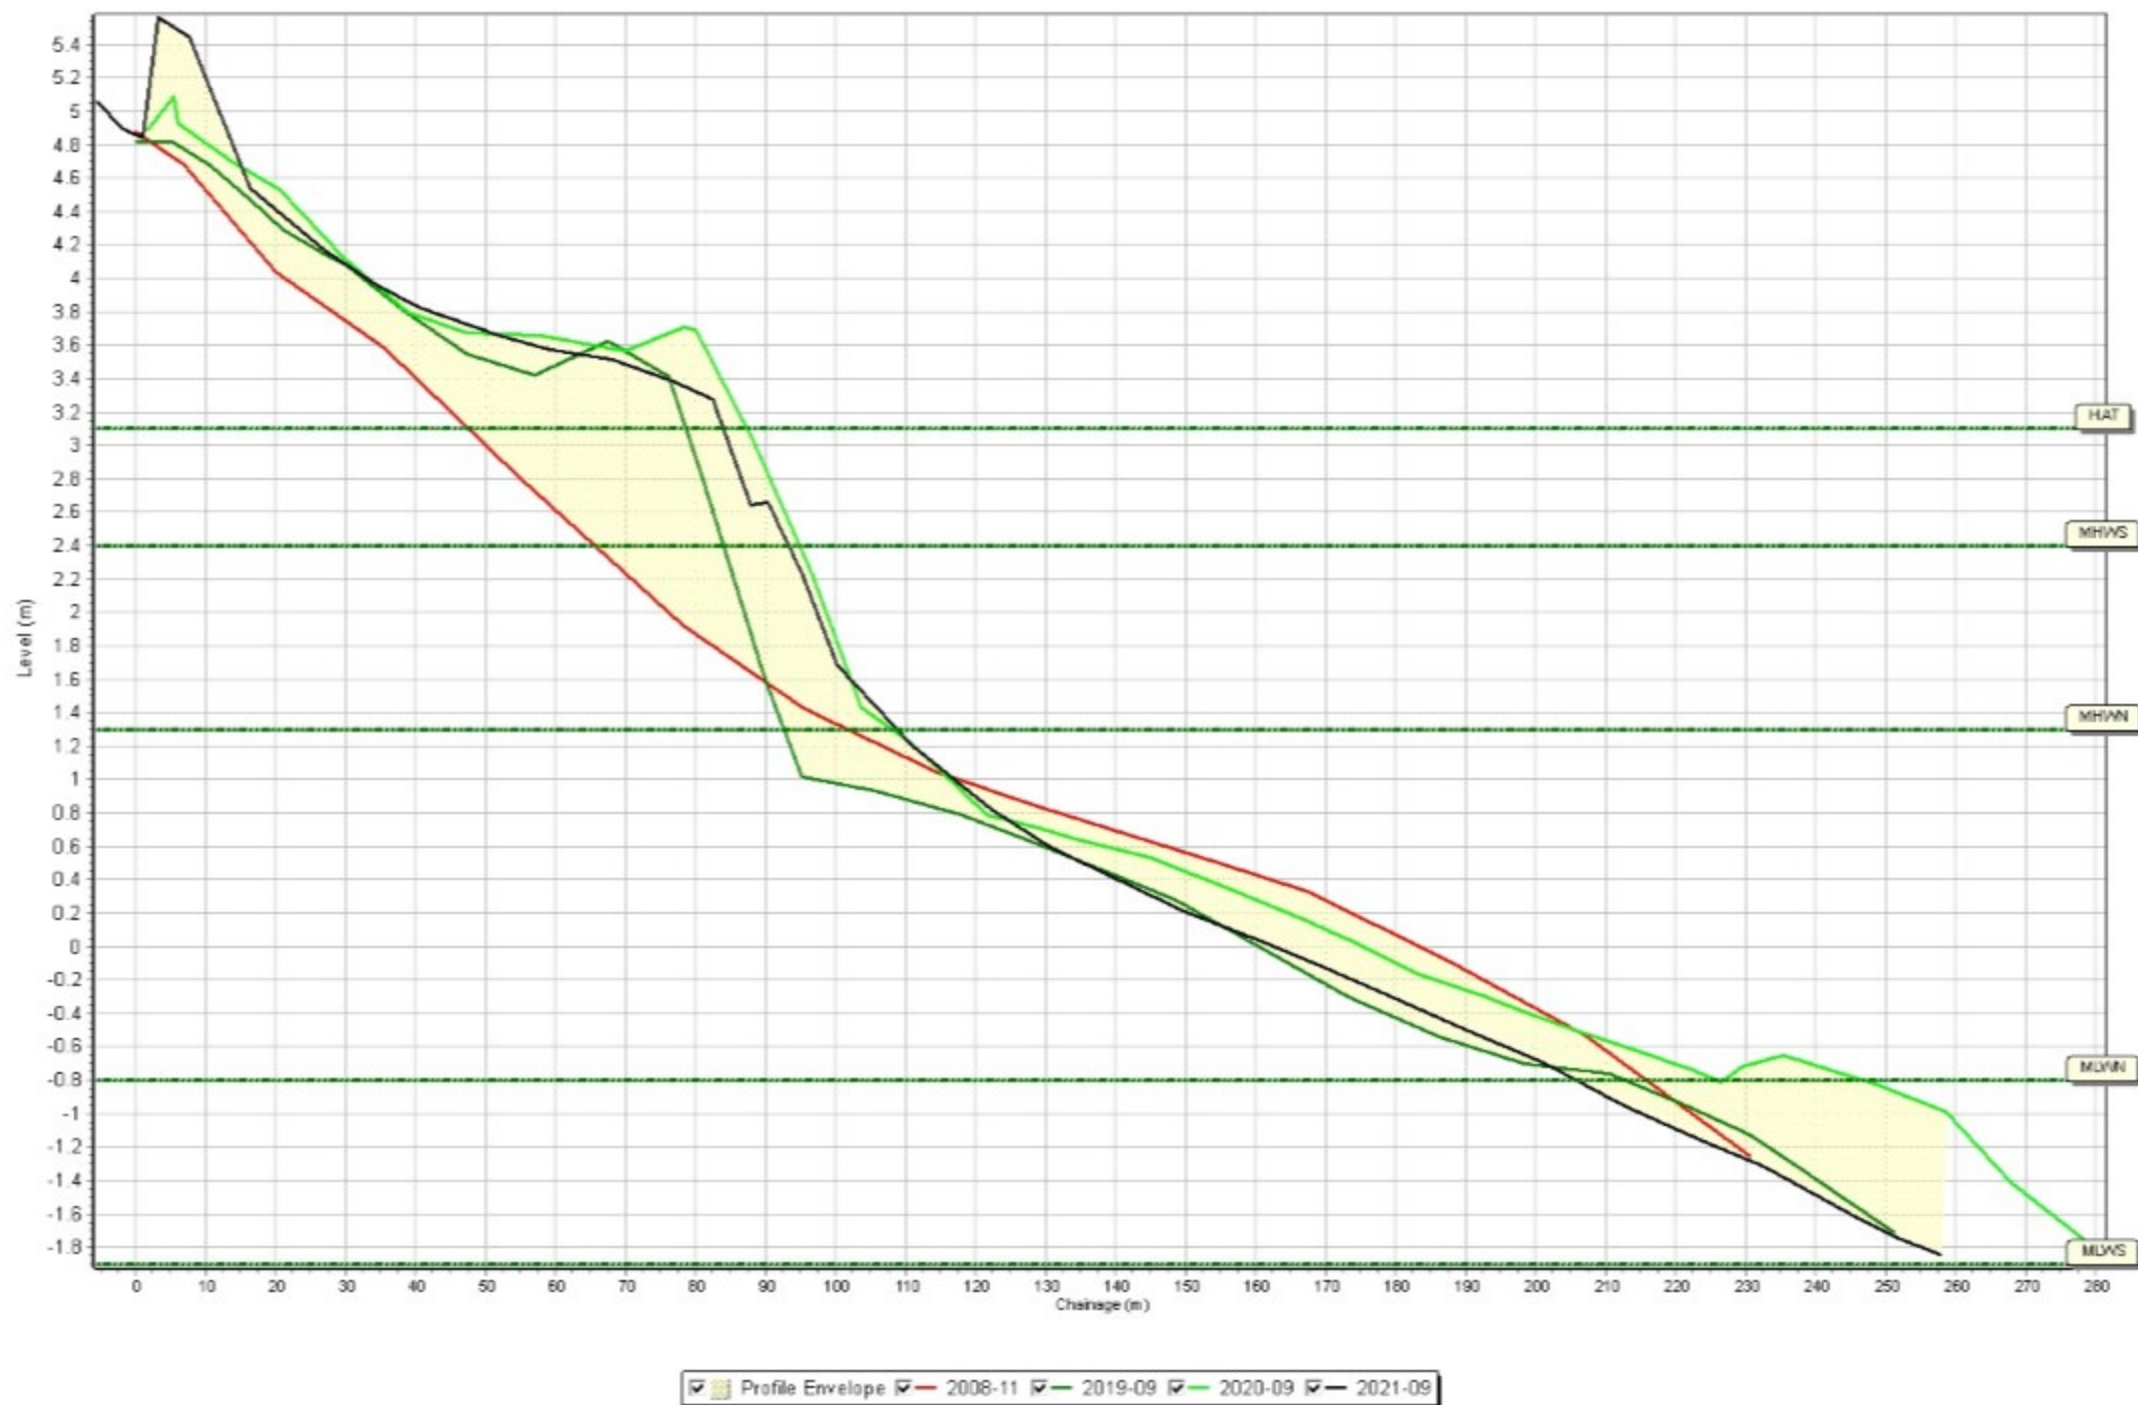
Profiles: 1bSS7

- At Herd Sands the recorded profiles present no causes for concern, and beach profiles remain at medium to high levels. At profile 1bSS7, the dunes have progressively prograded, however a hollow between chainage 87-97m has progressively deepened by a further 0.7m. The short-term difference plot indicates that the northern beach has been dominated by little change ($\pm 0.1\text{m}$) with patchy change within the dunes, and the southern beach has a band of accretion on the upper beach, erosion on the middle beach and little change on the lower beach relative to the previous survey.

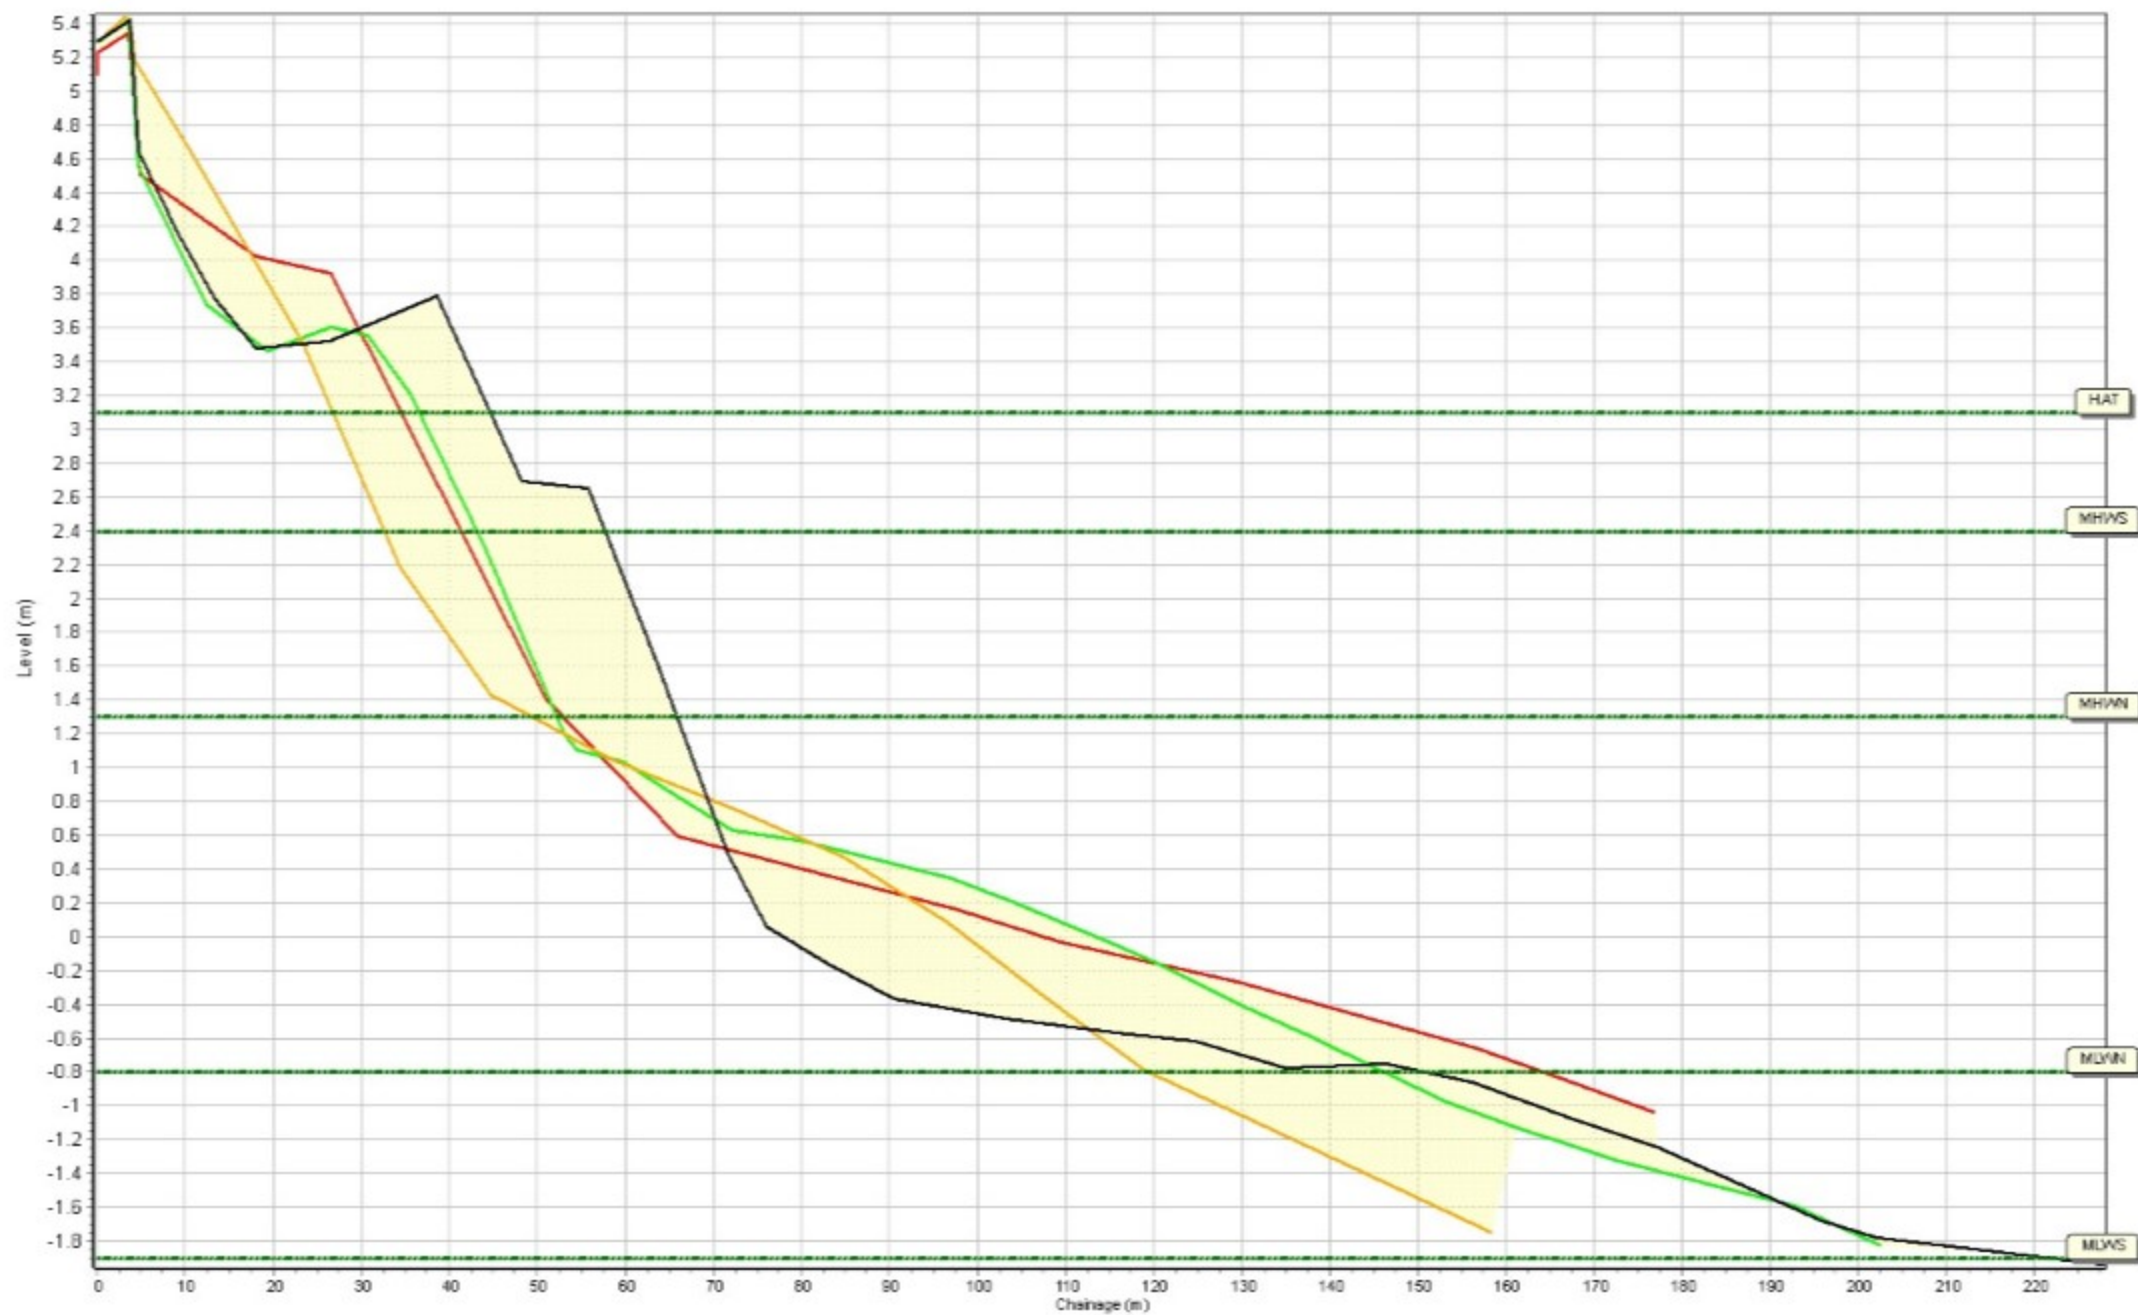
Profiles: 1bSS8

Survey Date	Description of Changes Since Last Survey	Interpretation
	<p>At profile 1bSS8, between the toe of the seawall and chainage 27m the beach has lowered by up to 0.6m. There has been accretion by up to 1.8m forming a berm on the upper beach at chainage 37m that was not present during the April 202 survey. The middle beach between chainage 70m and 112m there has been erosion by up to 0.7m, leading to a steeper upper beach profile. Seaward of chainage 112m there has been accretion of the beach profile by up to 0.8m. Overall, the upper and middle beach is at a high level, particularly the upper beach berm which is at its highest level recorded at chainage 38m. The lower beach is at a low level compared to the range recorded from previous surveys.</p> <p>Profile 1bSS9 is located at the southern end of Herd Sands. From the toe of the dunes at chainage 25m to the end of the survey, the beach profile has accreted by up to 1.2m (forming a berm at chainage 60m) on the upper beach, and up to 0.5m on the middle and lower beach Overall the dunes fronting the car park remain at a high level and the beach is at a medium level compared to the range recorded from previous surveys.</p>

Profile Envelope
 2008-11
 2020-09
 2021-04
 2021-09

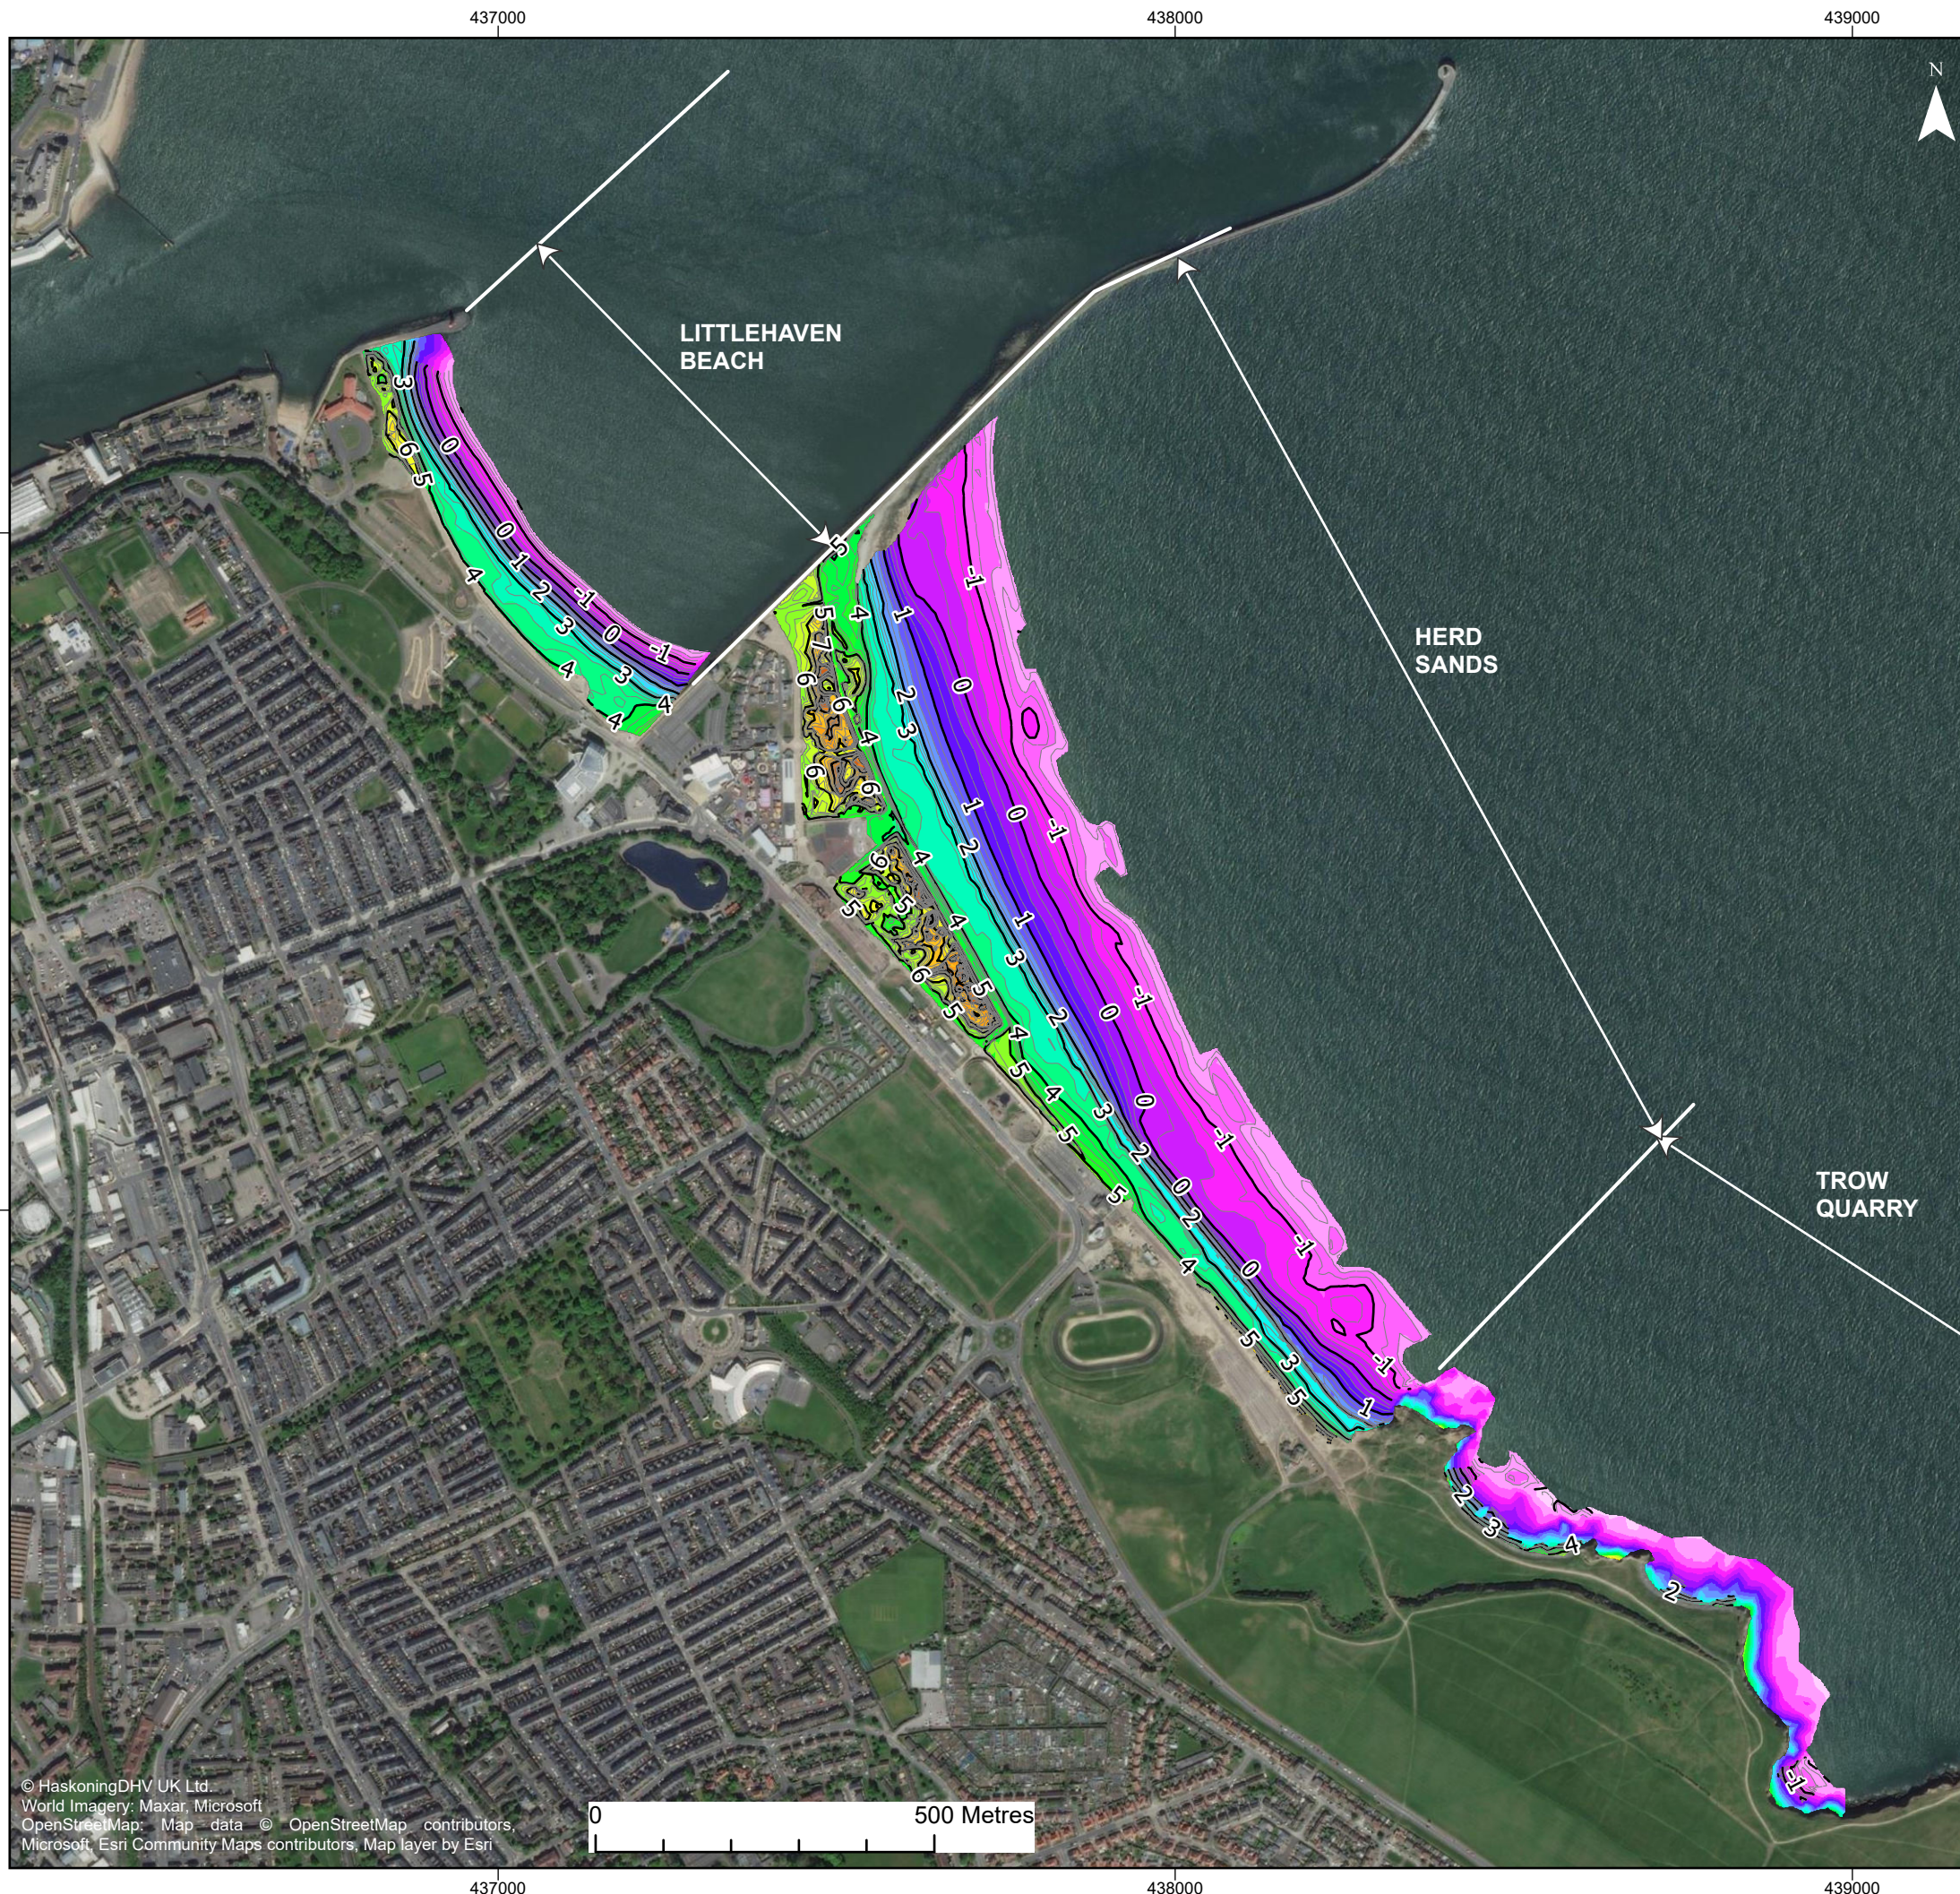
Appendix B - Map 1

LITTLEHAVEN BEACH, HERED SANDS, TROW QUARRY

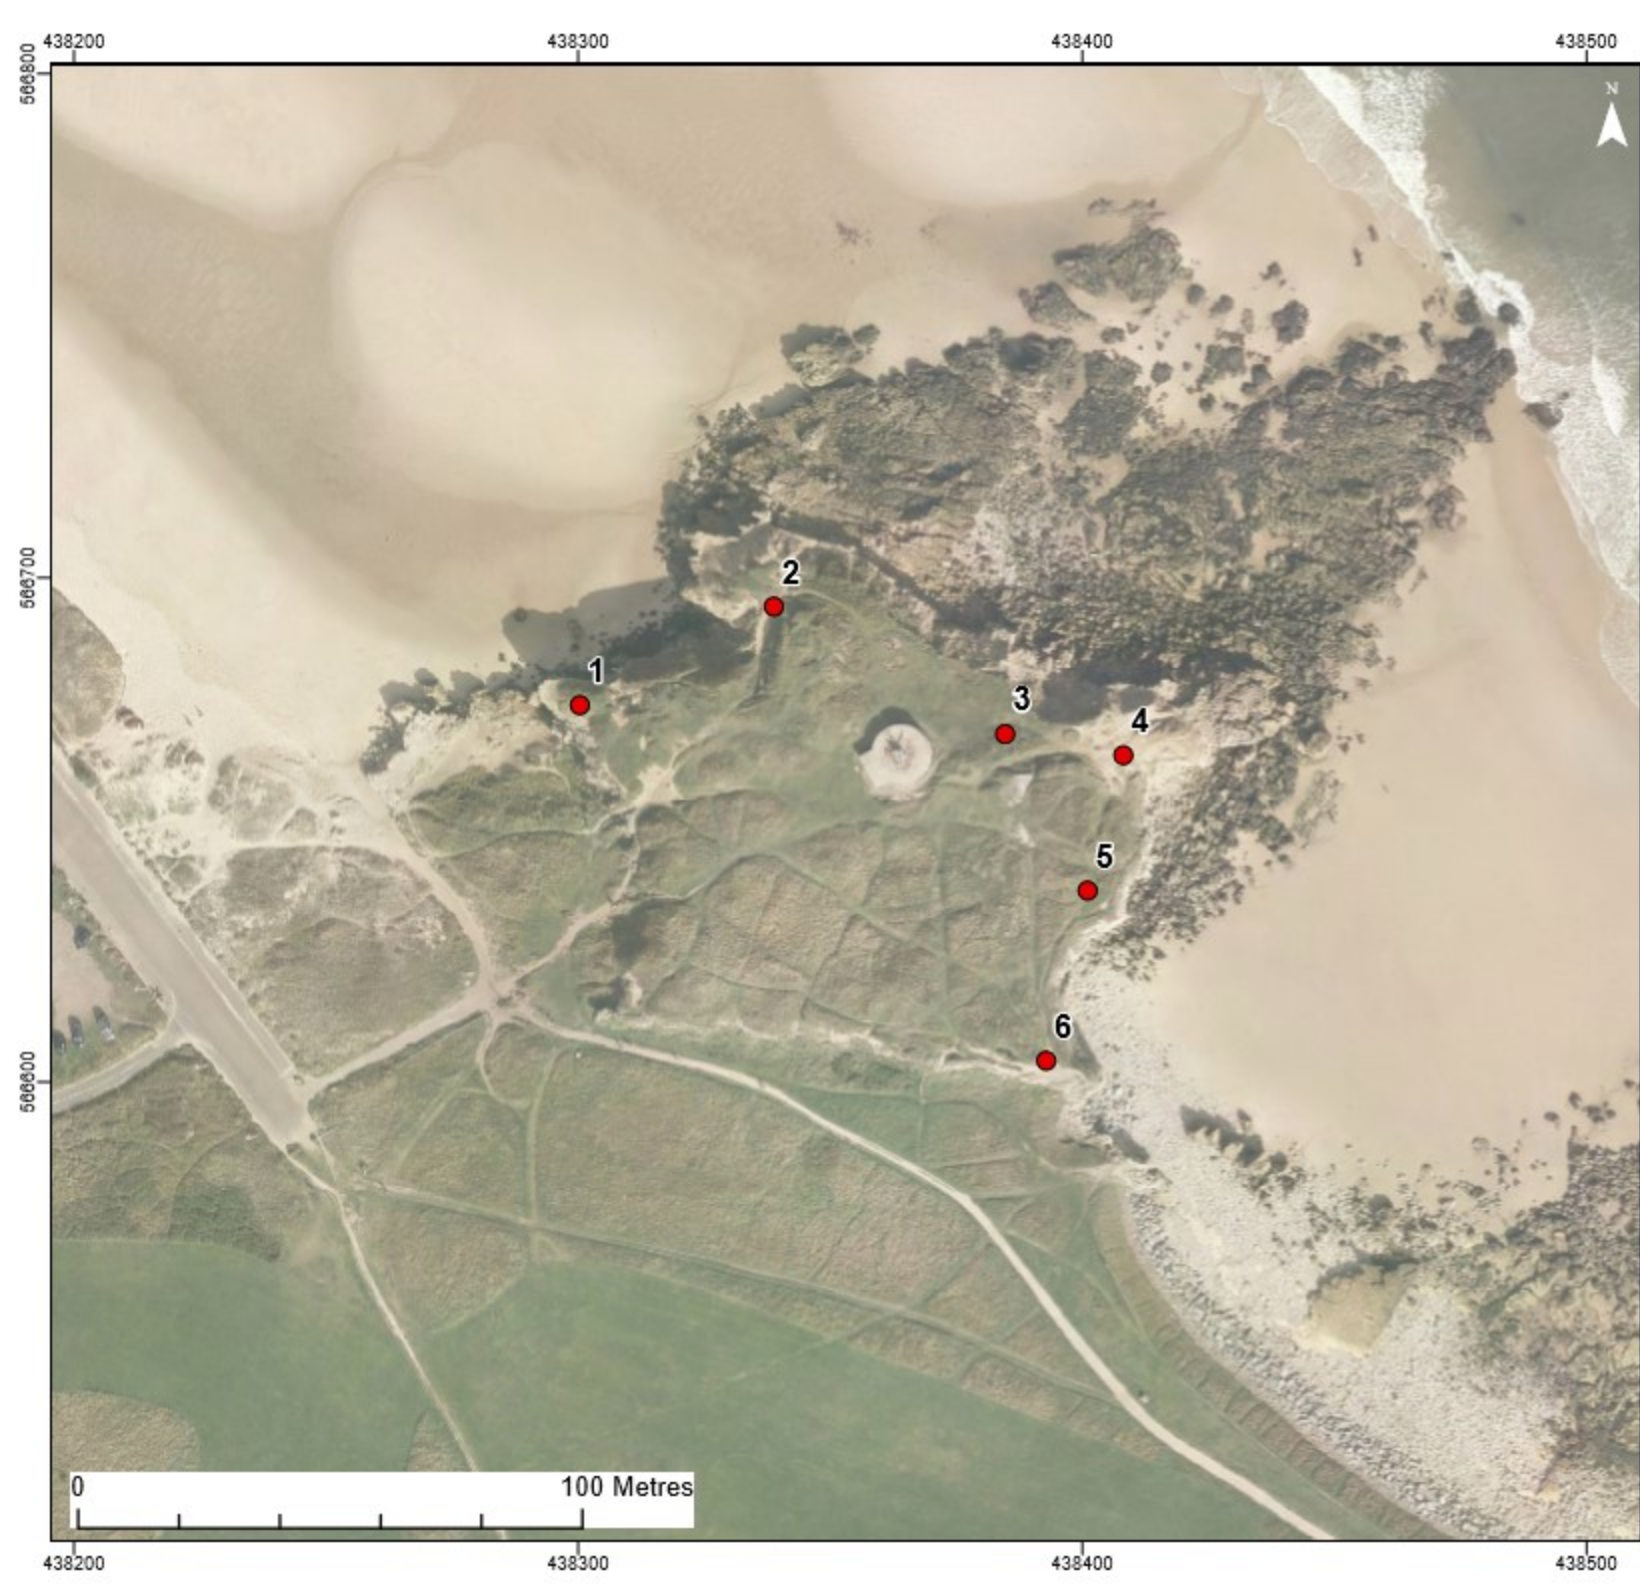
Title:
Figure 3 - Map 1
TROW QUARRY
South Tyneside Council Frontage

SURVEY LOCATIONS

- Cliff Top Survey Points
