Cell 1 Regional Coastal Monitoring Programme Analytical Report 15: 'Full Measures' Survey 2022

South Tyneside Council

January 2023

(*) The present report is **Analytical Report 15** and provides an analysis of the 2022 Full Measures survey for South Tyneside Council's frontage.

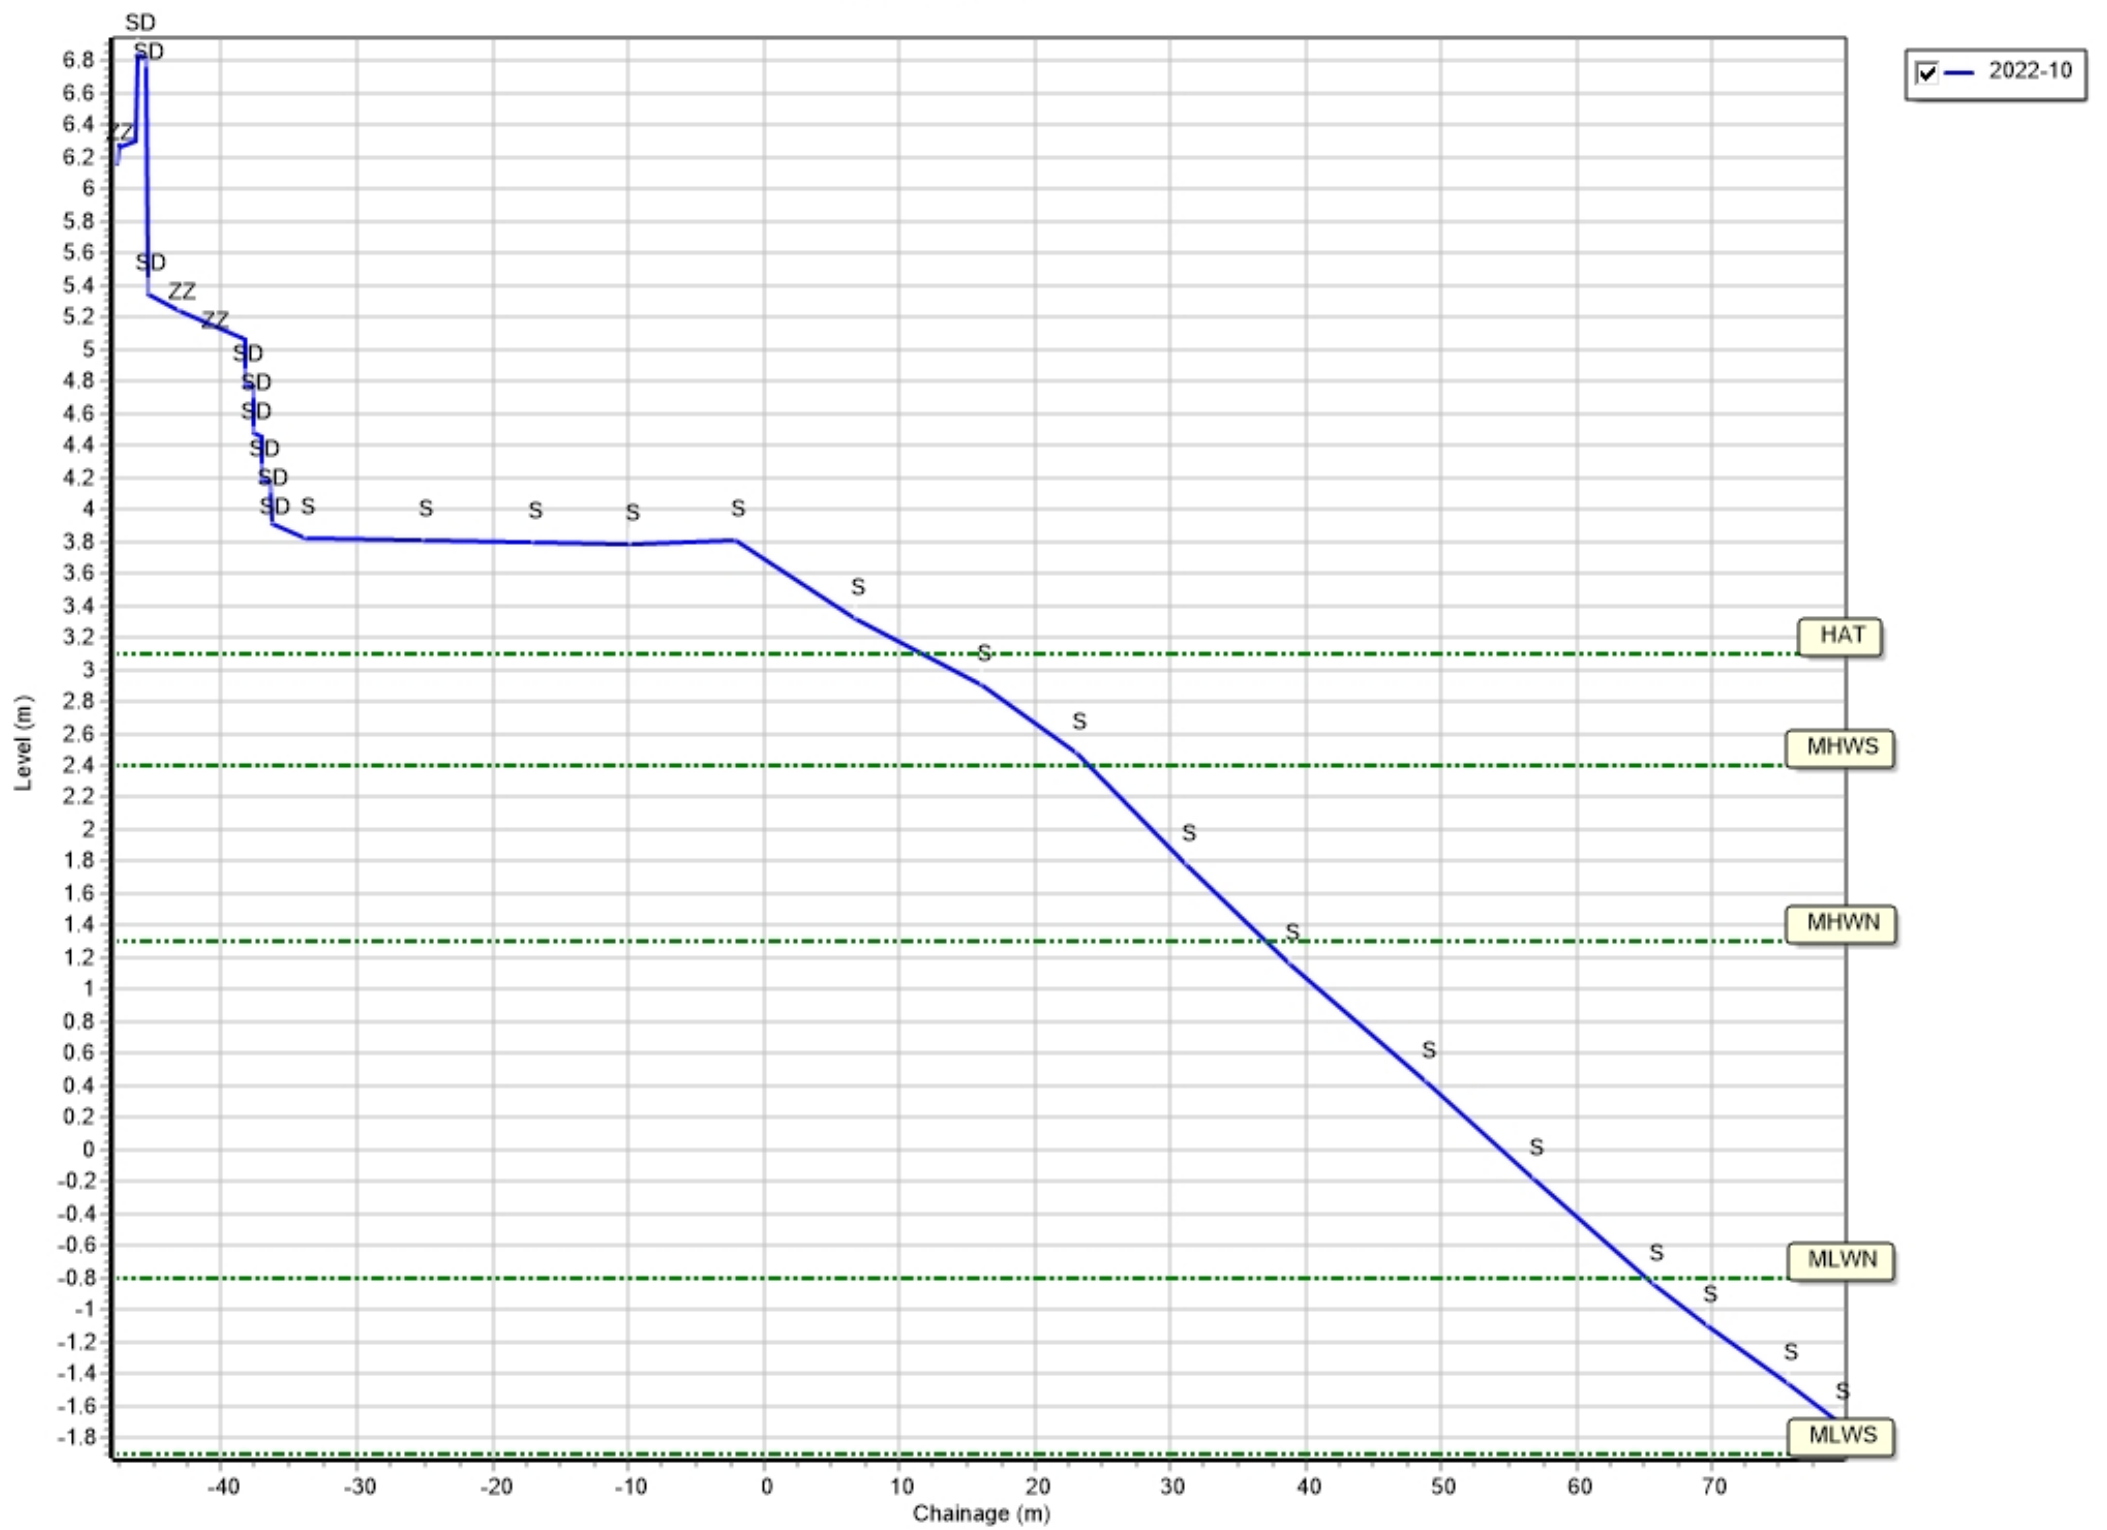
Profiles: 1bSS3

Survey Date	Description of Changes Since Last Survey	Interpretation
	<p>At profile 1bSS3, the sea wall is exposed compared to the previous survey, with the erosion of 0.4m of sediment to chainage -31m. The majority of the rest of the beach profile has risen by up to 0.2m on the upper beach and 0.2m on the lower beach. There is a small section of erosion between chainages 3-12m by up to 0.1m. Overall, the beach profile is at a low level at the toe of the seawall, a high level on the upper beach and a medium-high level on the middle-lower beach compared to the range recorded from previous surveys.</p> <p>At profile 1bSS4, the beach level has dropped by up to 0.15m at the toe of the seawall to chainage 34m. Between chainage 34-84m the upper-middle beach has risen by up to 0.3m. The middle beach has lowered by up to 0.2m between chainages 84-114m, switching back to accretion seaward of this point by up to 0.2m. Overall, the profile is generally at a medium level compared to the range recorded from previous surveys, except at the end of the survey seaward of chainage 142m which is at its lowest level recorded.</p>

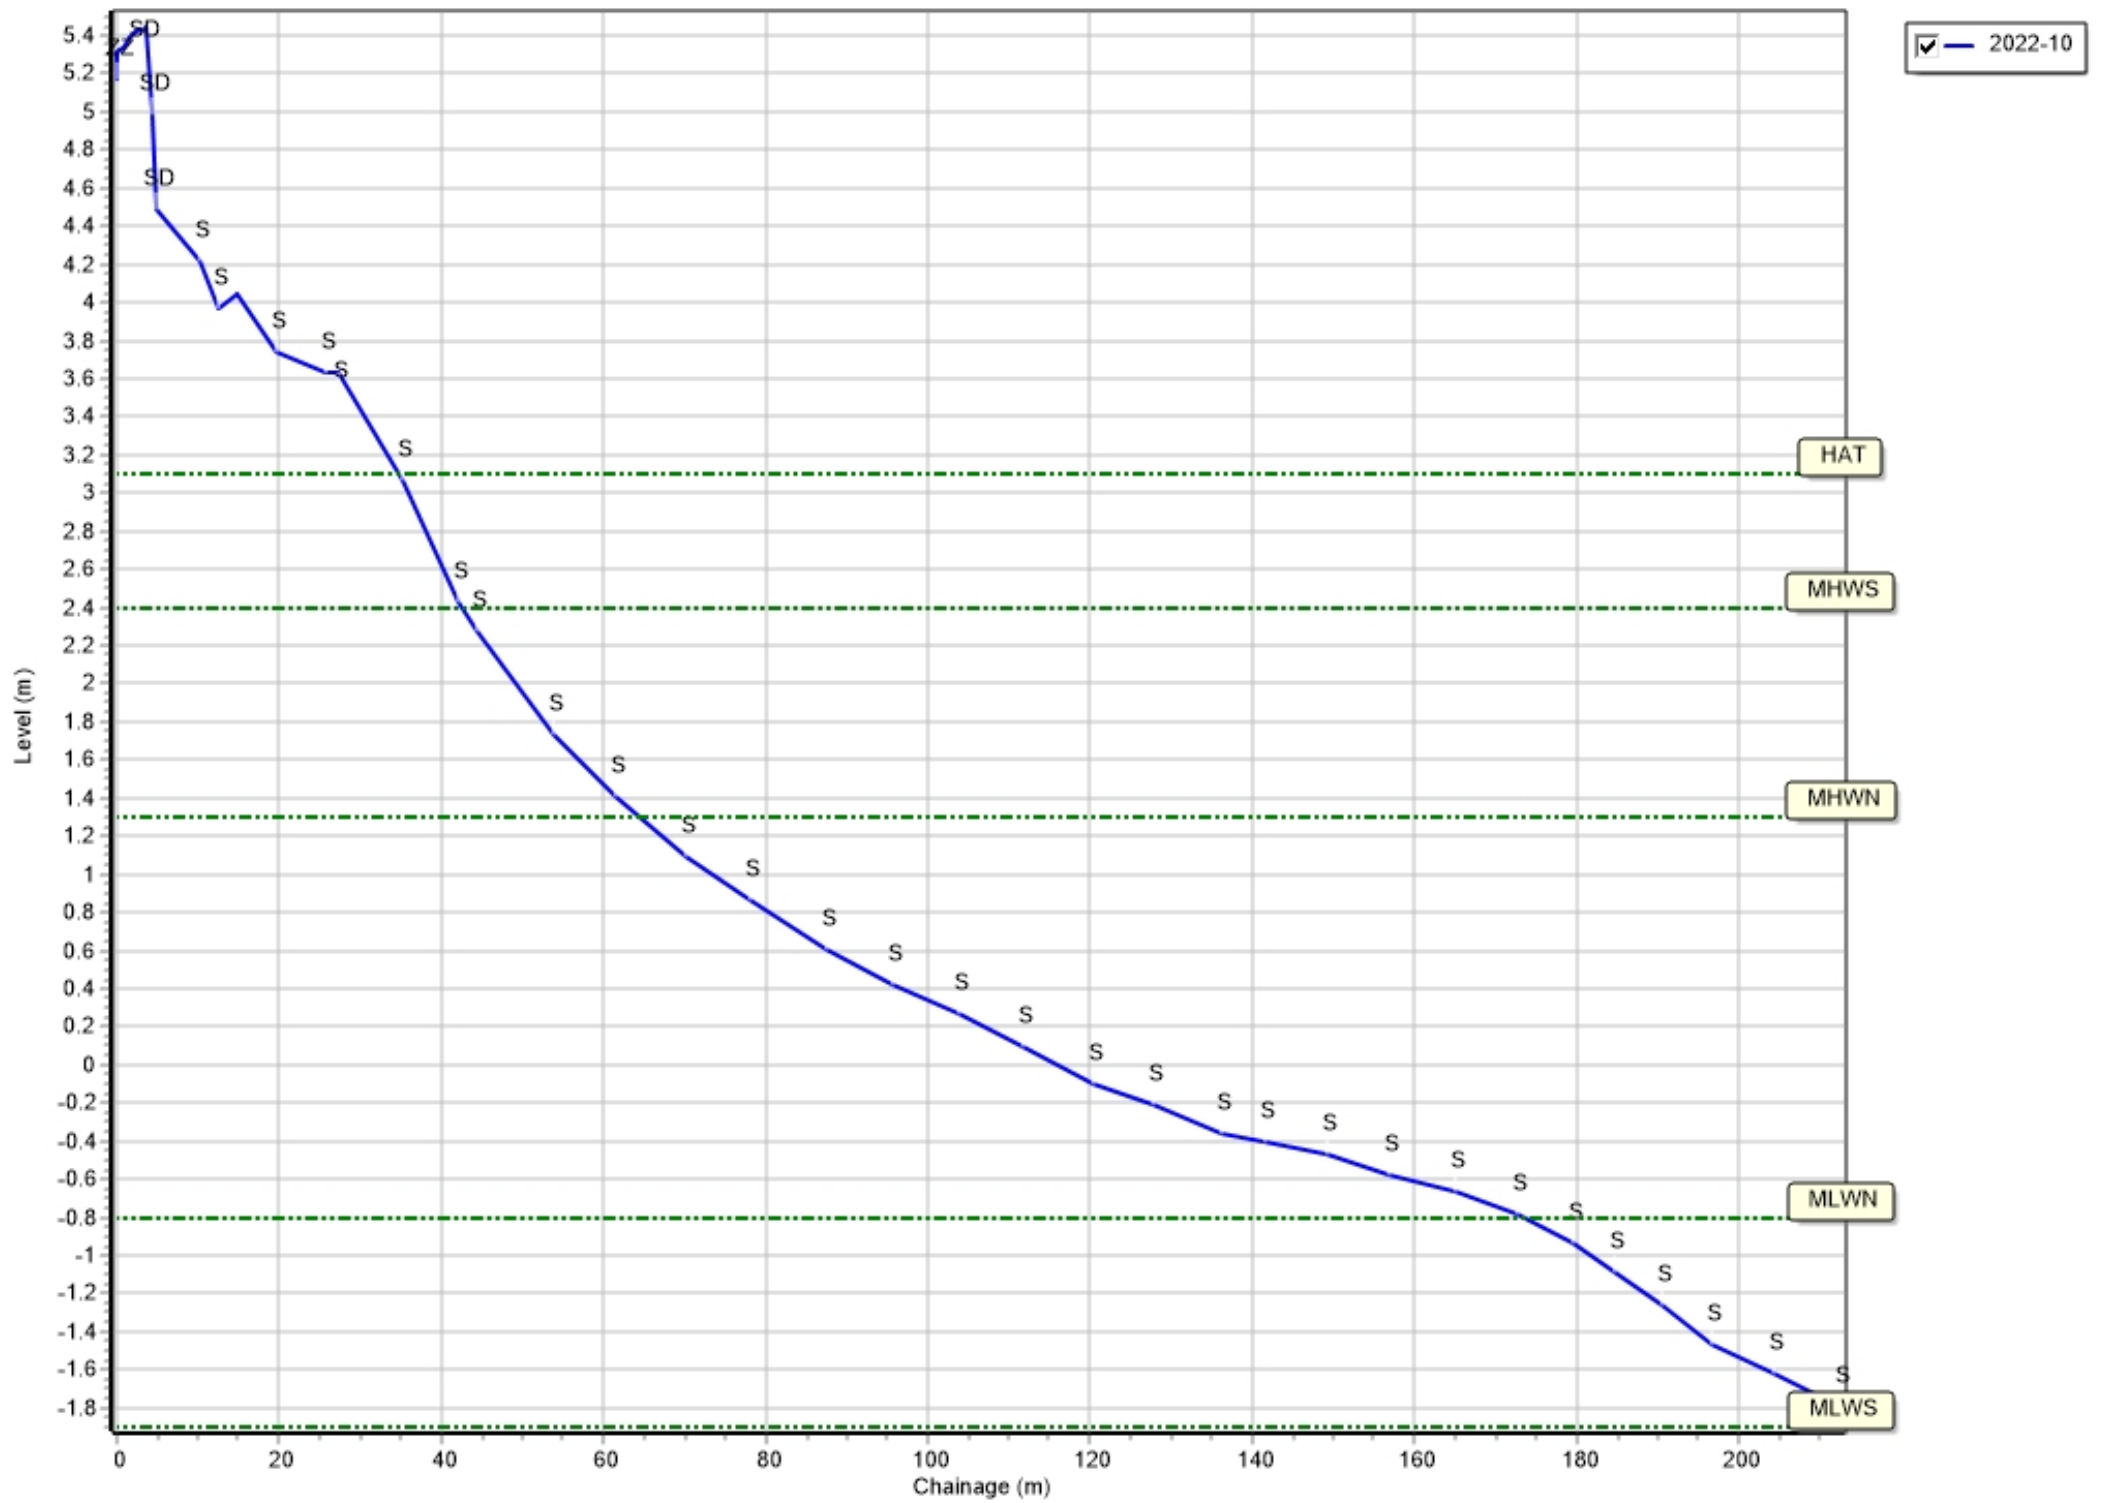
Profiles: 1bSS8

Survey Date	Description of Changes Since Last Survey	Interpretation
	<p>At profile 1bSS8, between the toe of the seawall and chainage 20m the beach has lowered by up to 0.9m. The upper beach between chainage 20-42m has risen by up to 0.4m, before switching to lowering across the middle beach by up to 0.3m to chainage 157m. The beach seaward of this point has risen by up to 0.3m. Overall, the upper and middle beach is at a medium level, whilst the lower beach is at a high level compared to the range recorded from previous surveys.</p> <p>Profile 1bSS9 is located at the southern end of Herd Sands. There has been a small amount of lowering at the toe of the dunes between chainages 22-28m by up to 0.2m. The upper beach between chainages 28-60m has risen by up to 0.3m, switching to erosion across the middle beach by up to 0.2m to chainage 160m. Seaward of this point the lower beach has risen by up to 0.2m. Overall the dunes fronting the car park remain at a high level and the beach is at a medium-high level compared to the range recorded from previous surveys.</p>

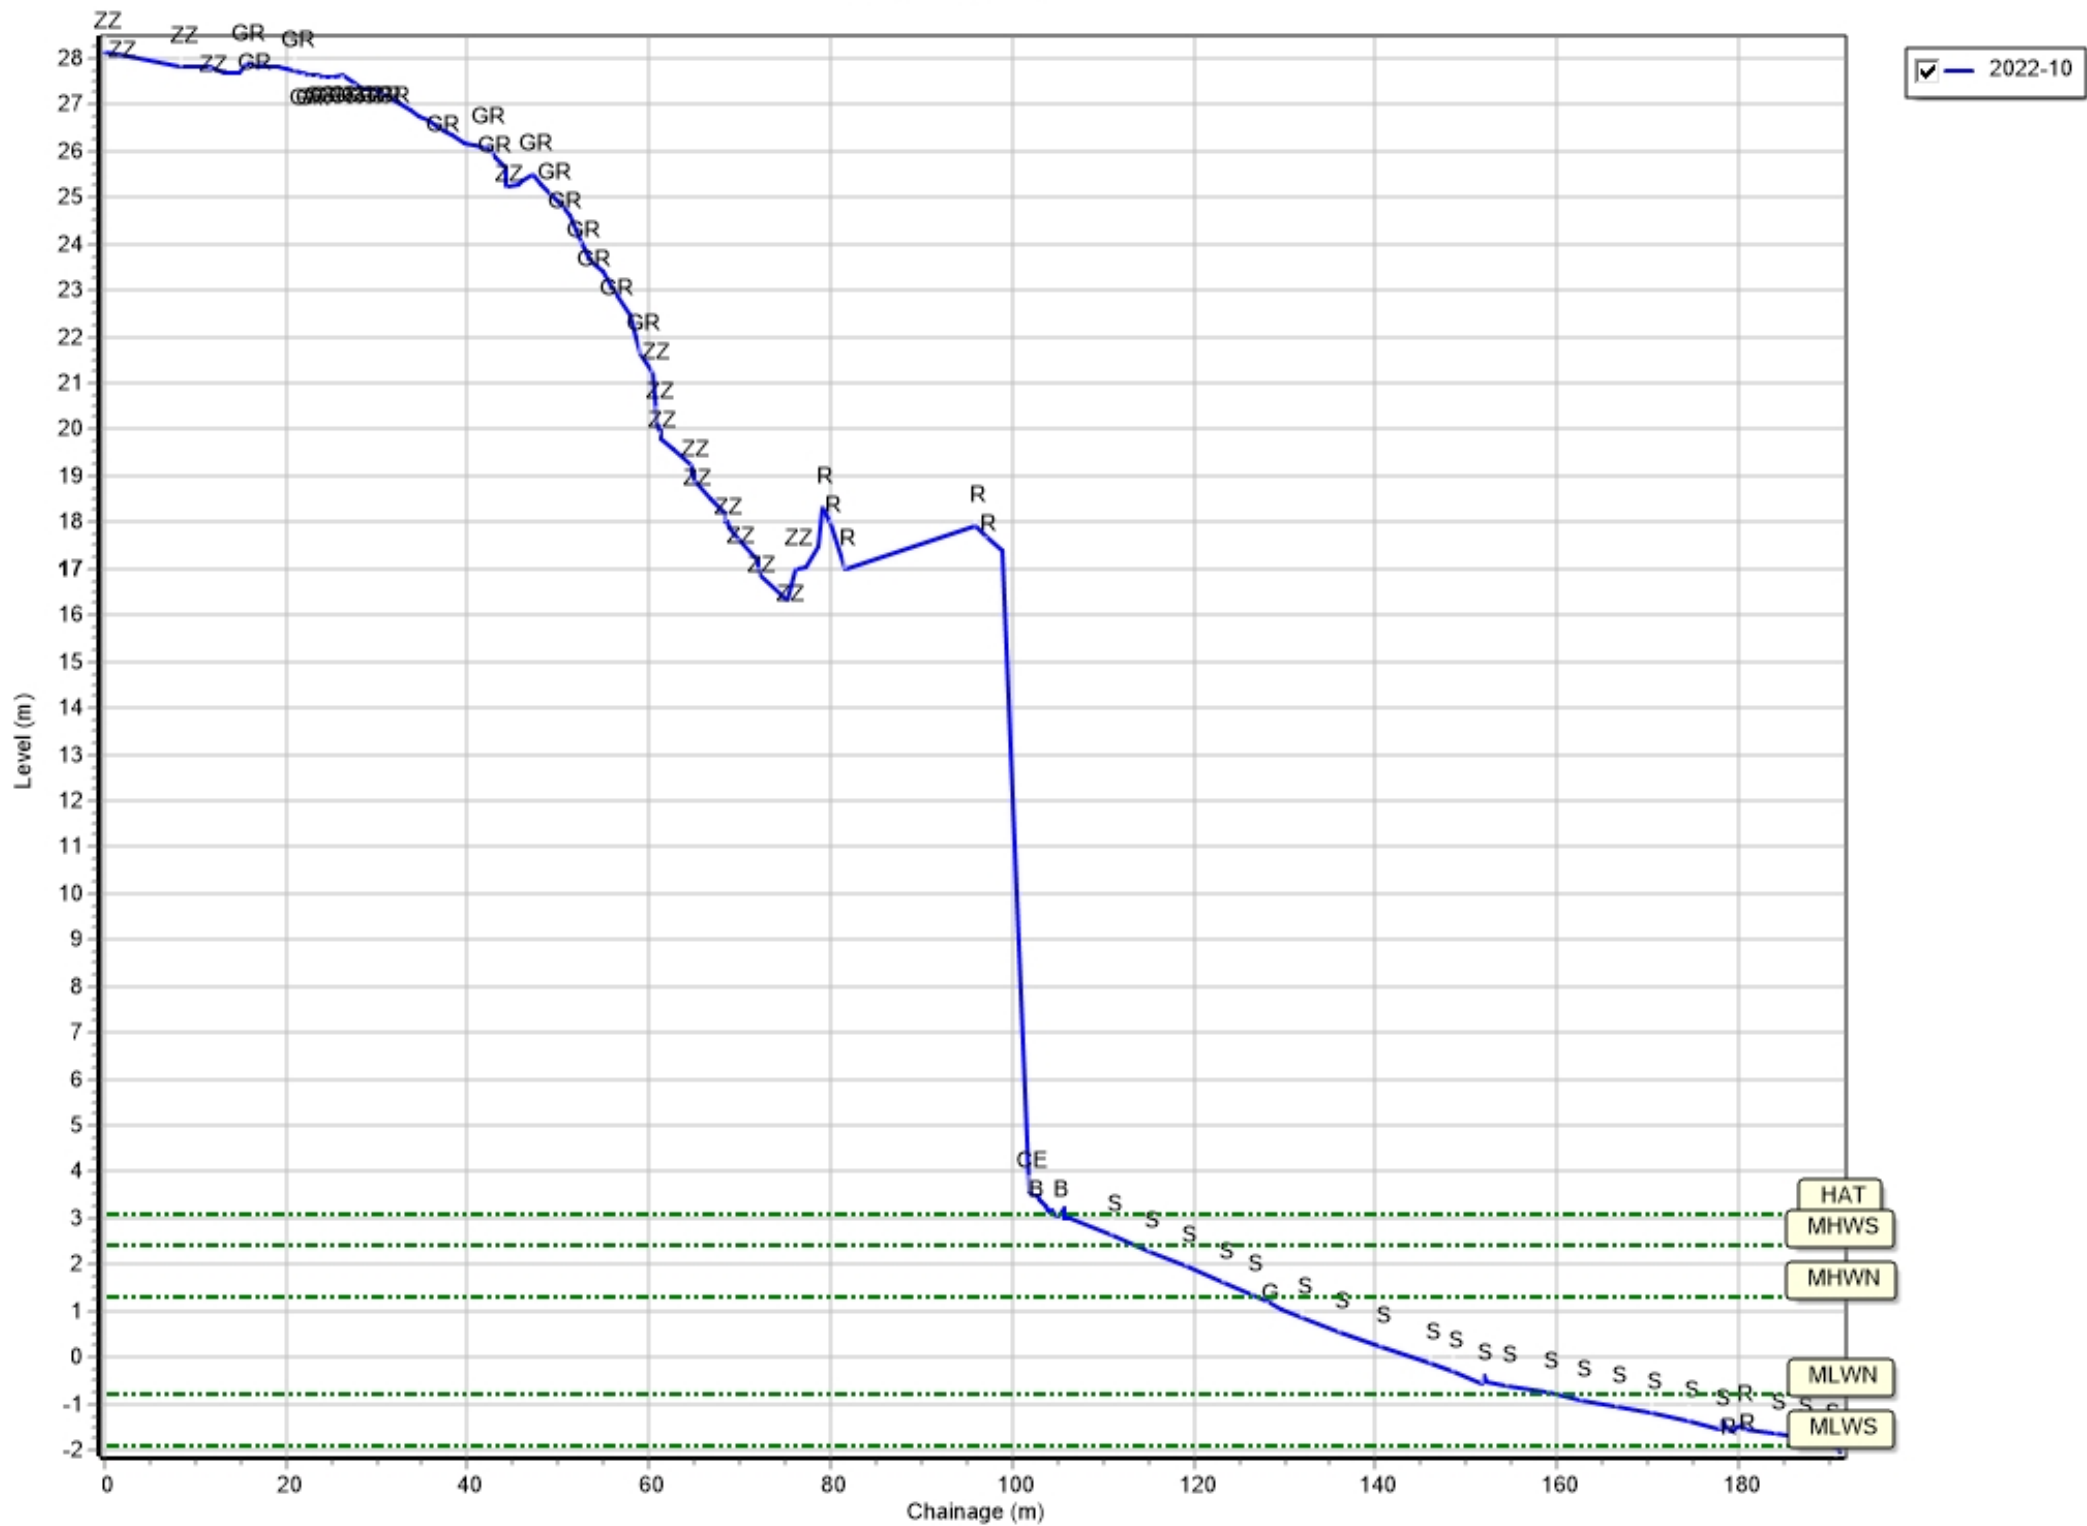
Profiles: 1bSS14

- The survey report notes that part of Profile **1bSS14** was inaccessible due to unsafe conditions (a former survey report noted the removal of former structures in the area).

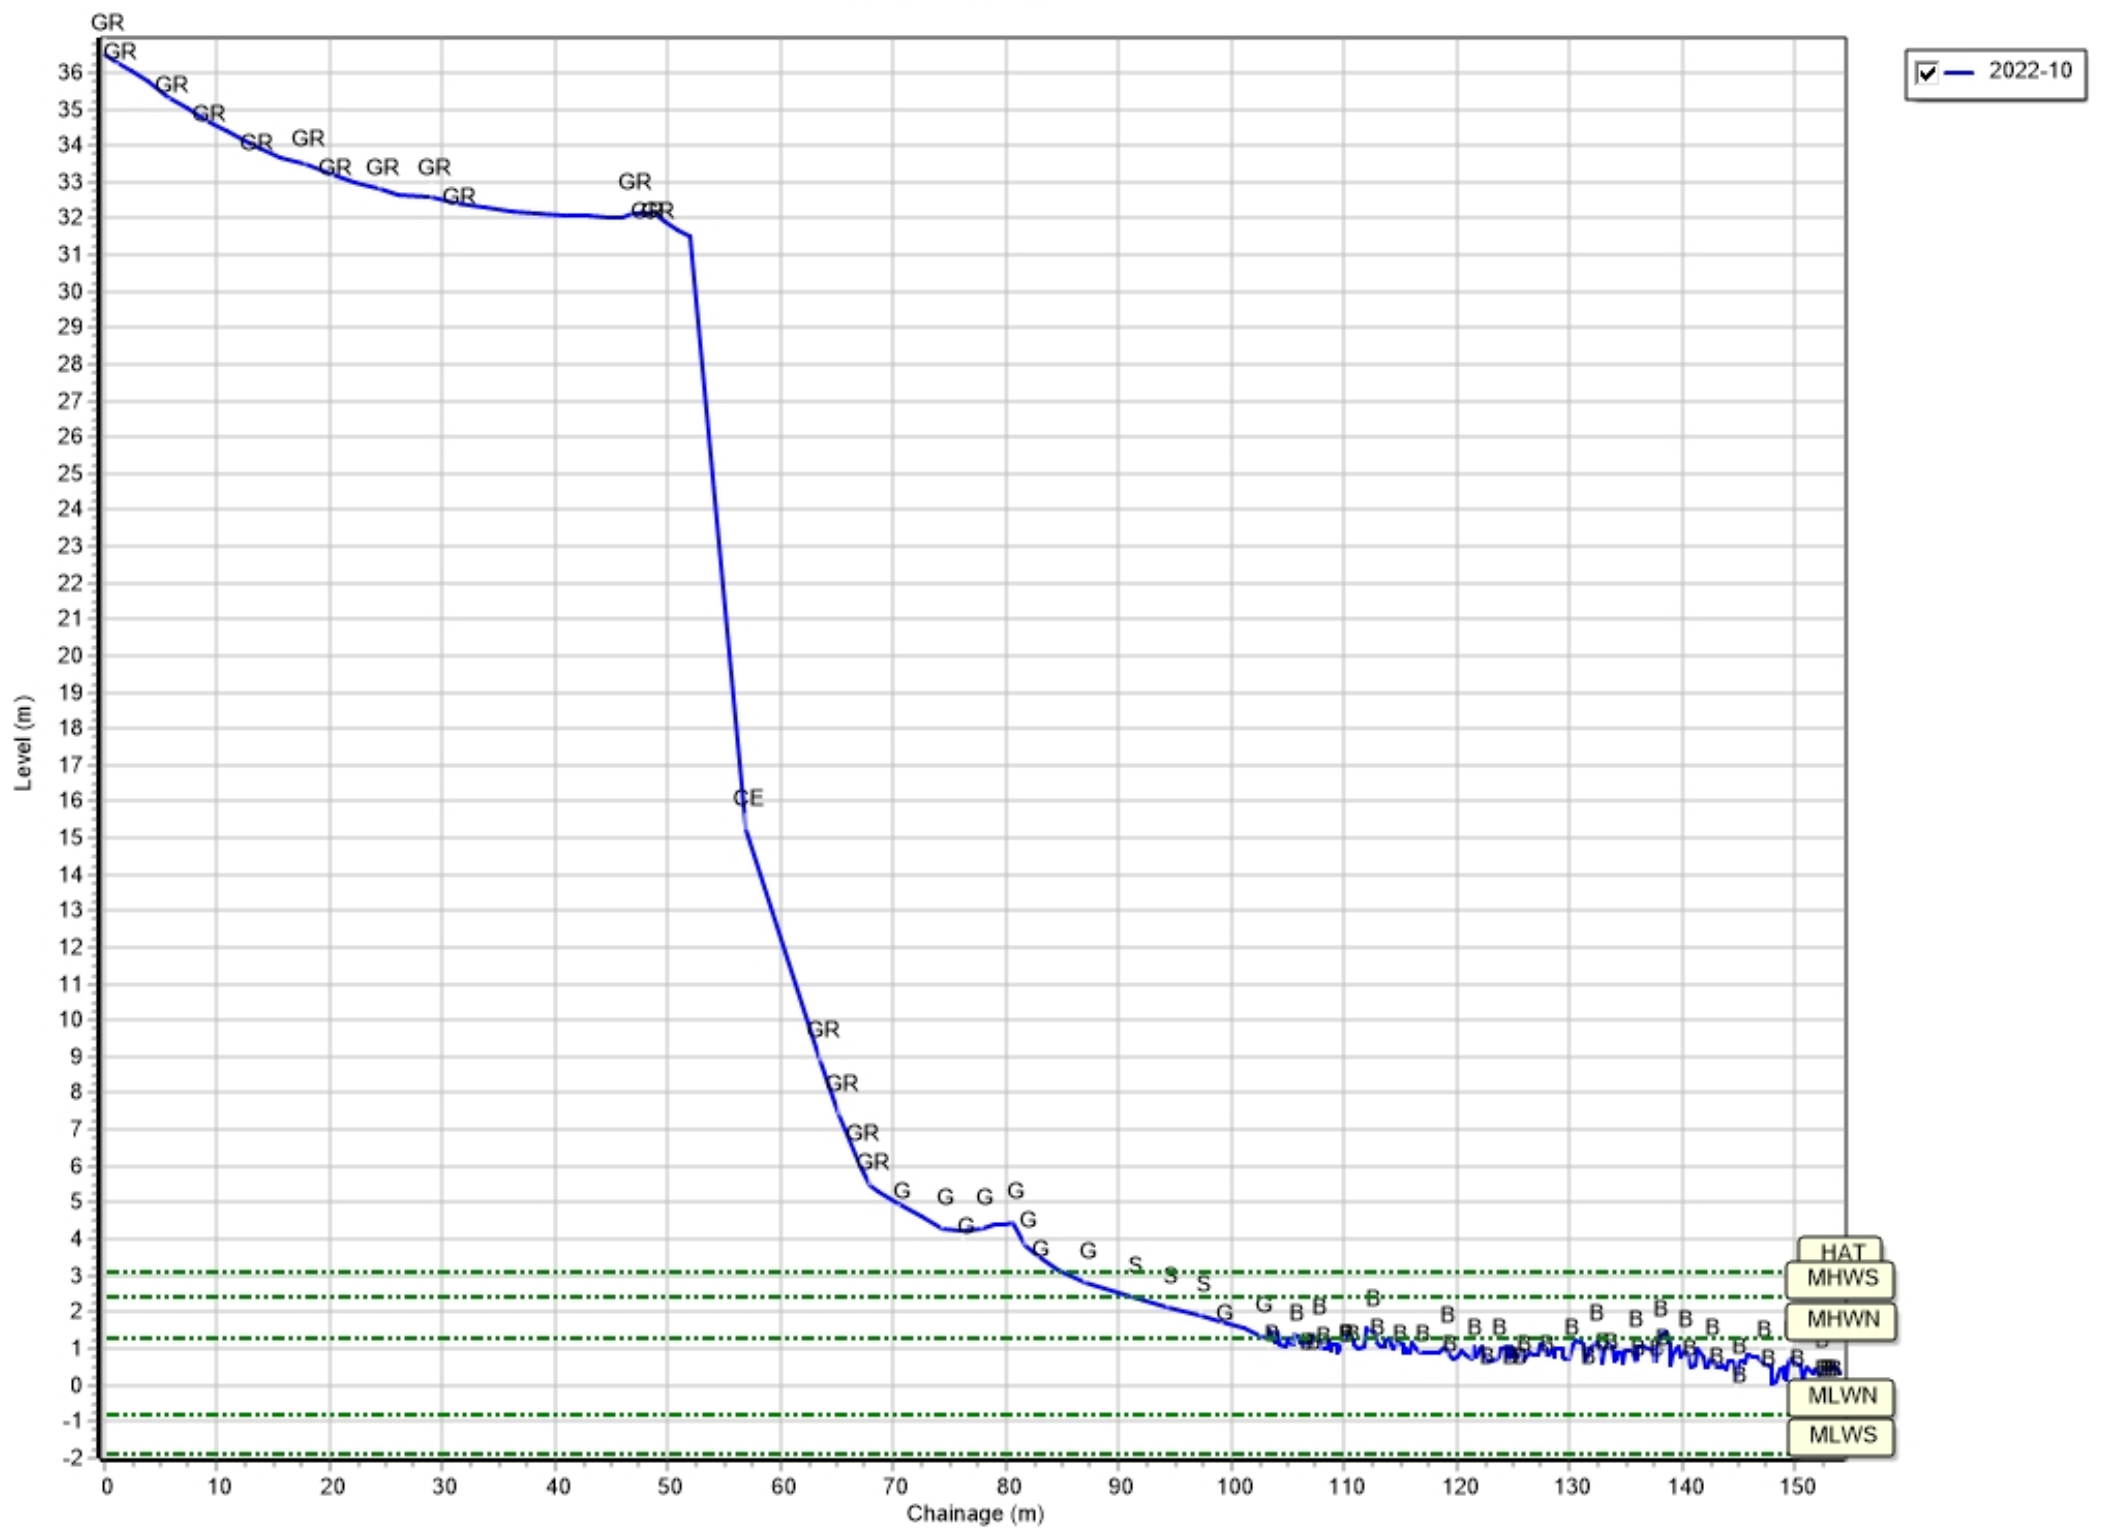
Profiles: 1bSS16

- At Marsden Bay, profiles have generally undergone little change, with only one area of significant change (1.0m of accretion on the upper beach at profile 1bSS16). The profiles present no causes for concern; with most profiles at a medium level compared to previous surveys.

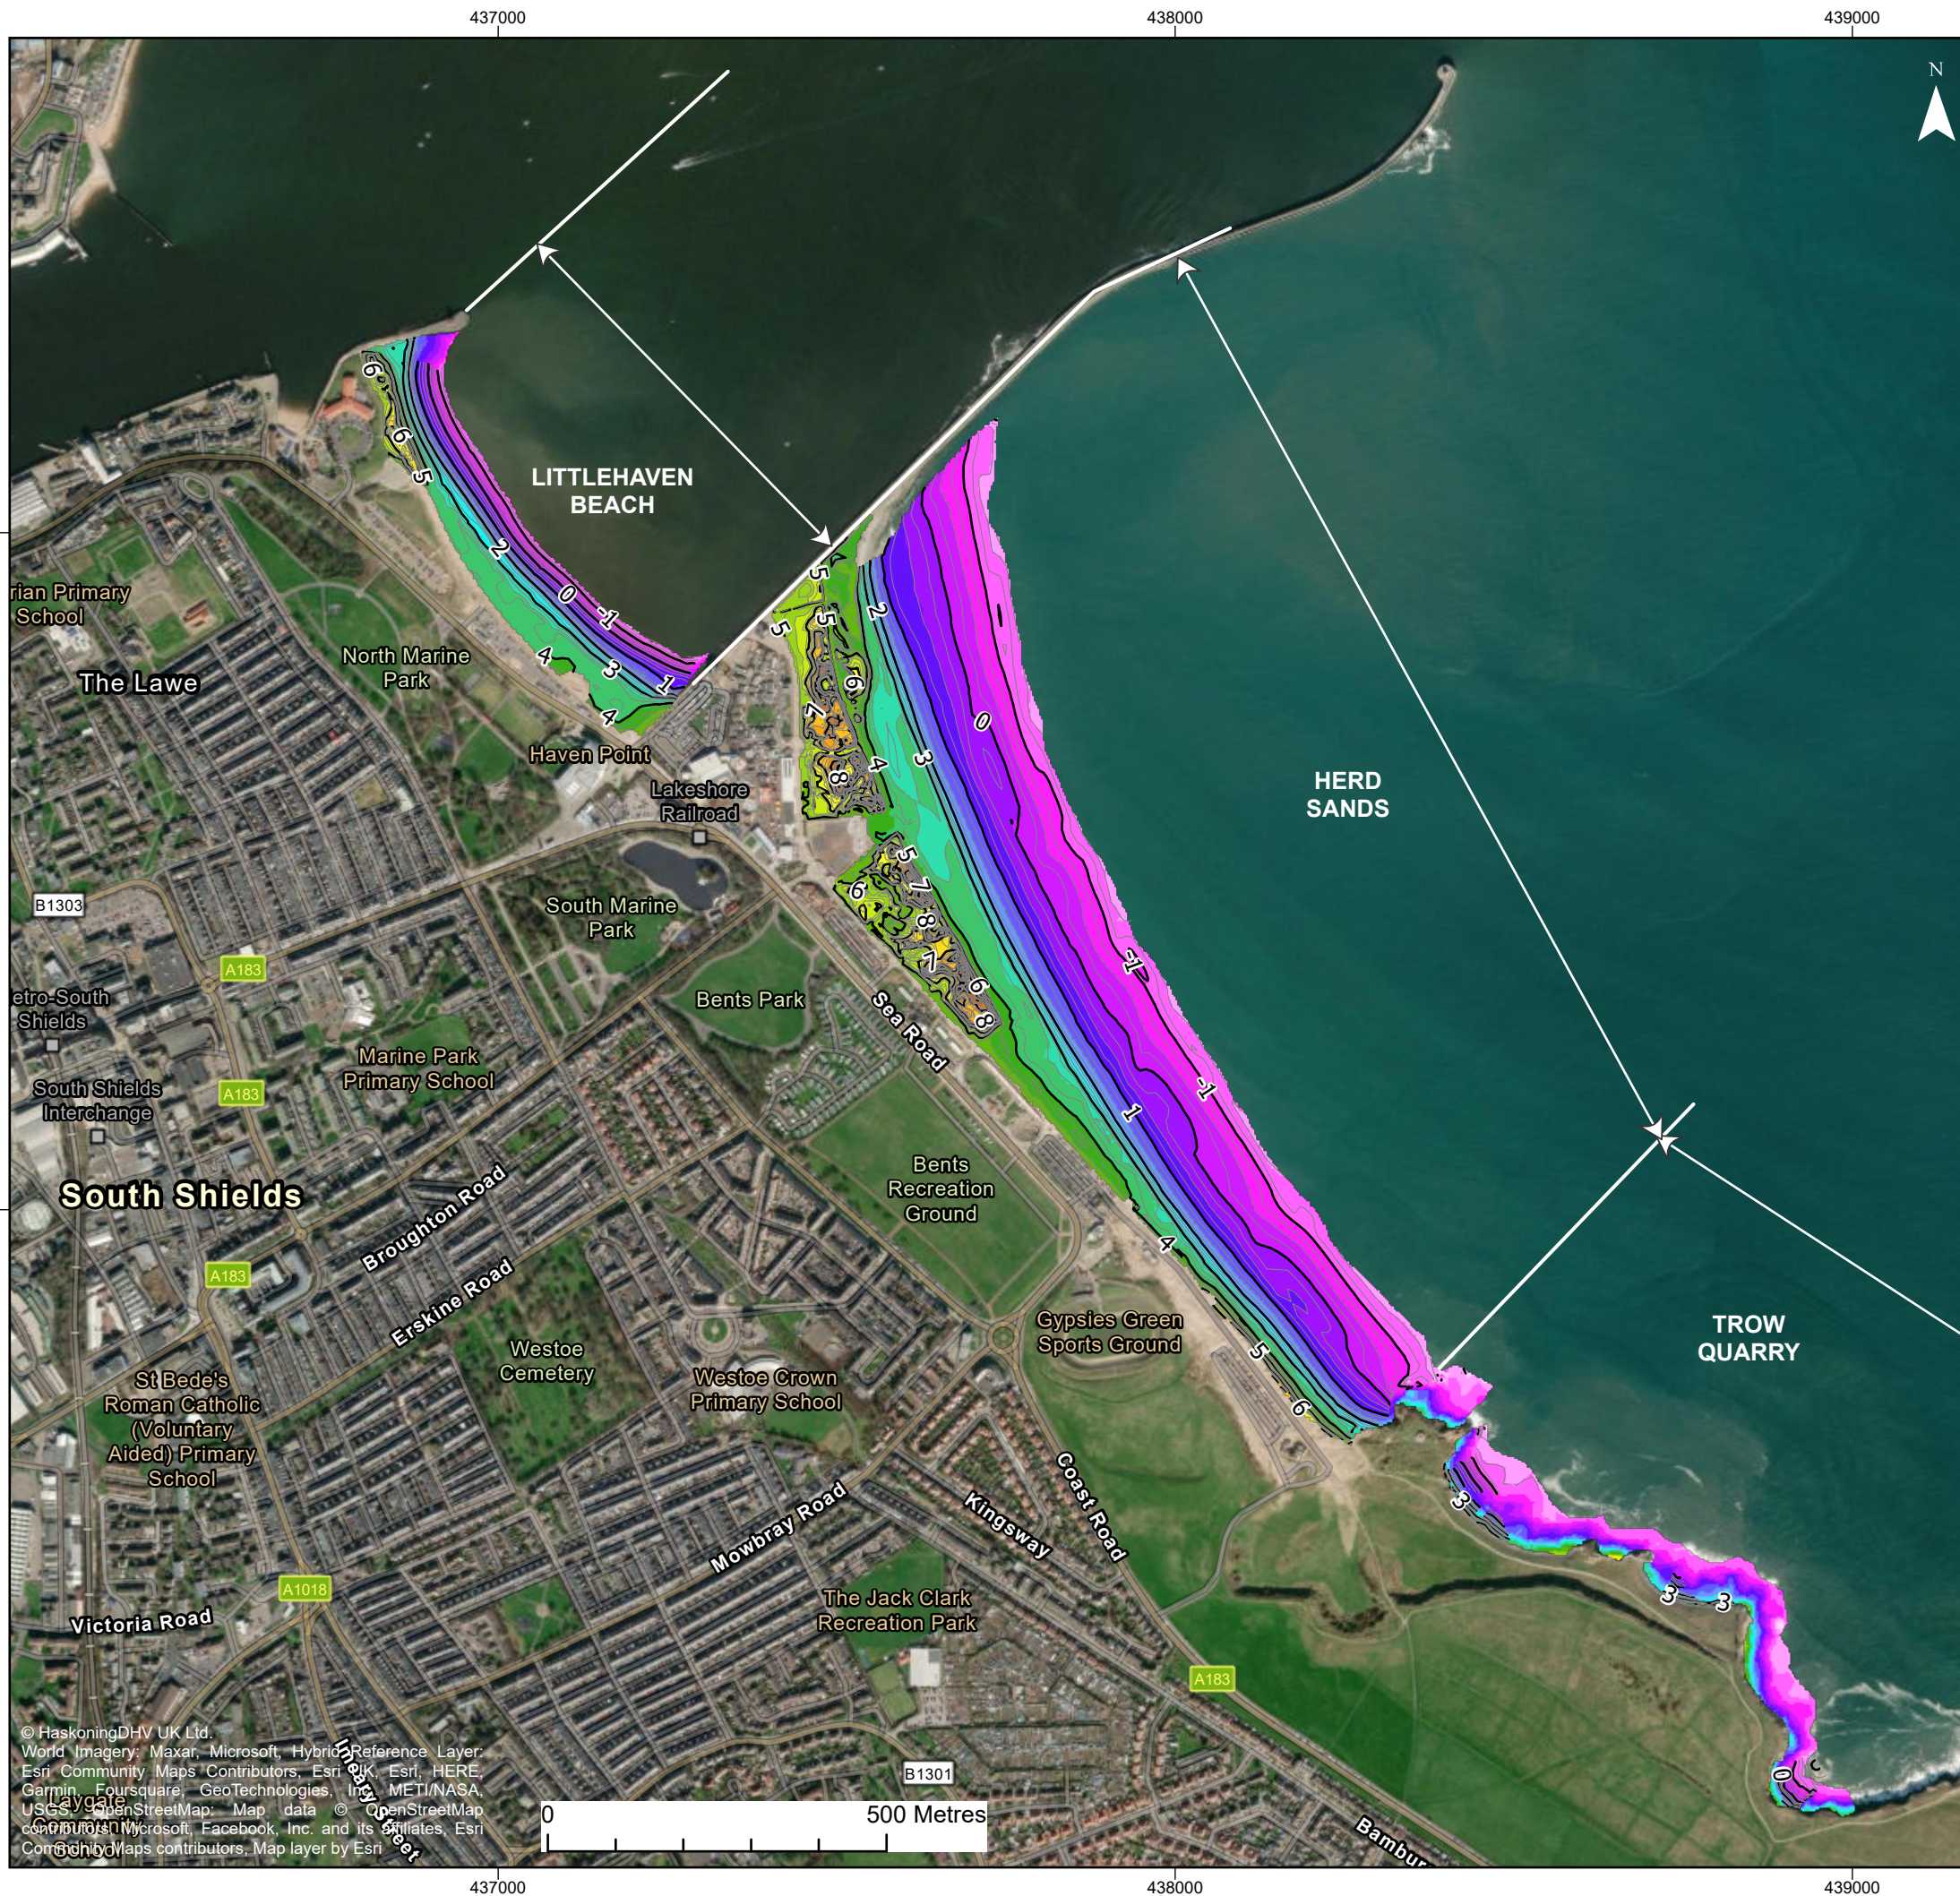
Appendix B - Map 1

TOPOGRAPHIC SURVEY (October 2021)

LITTLEHAVEN BEACH, HERED SANDS, TROW QUARRY

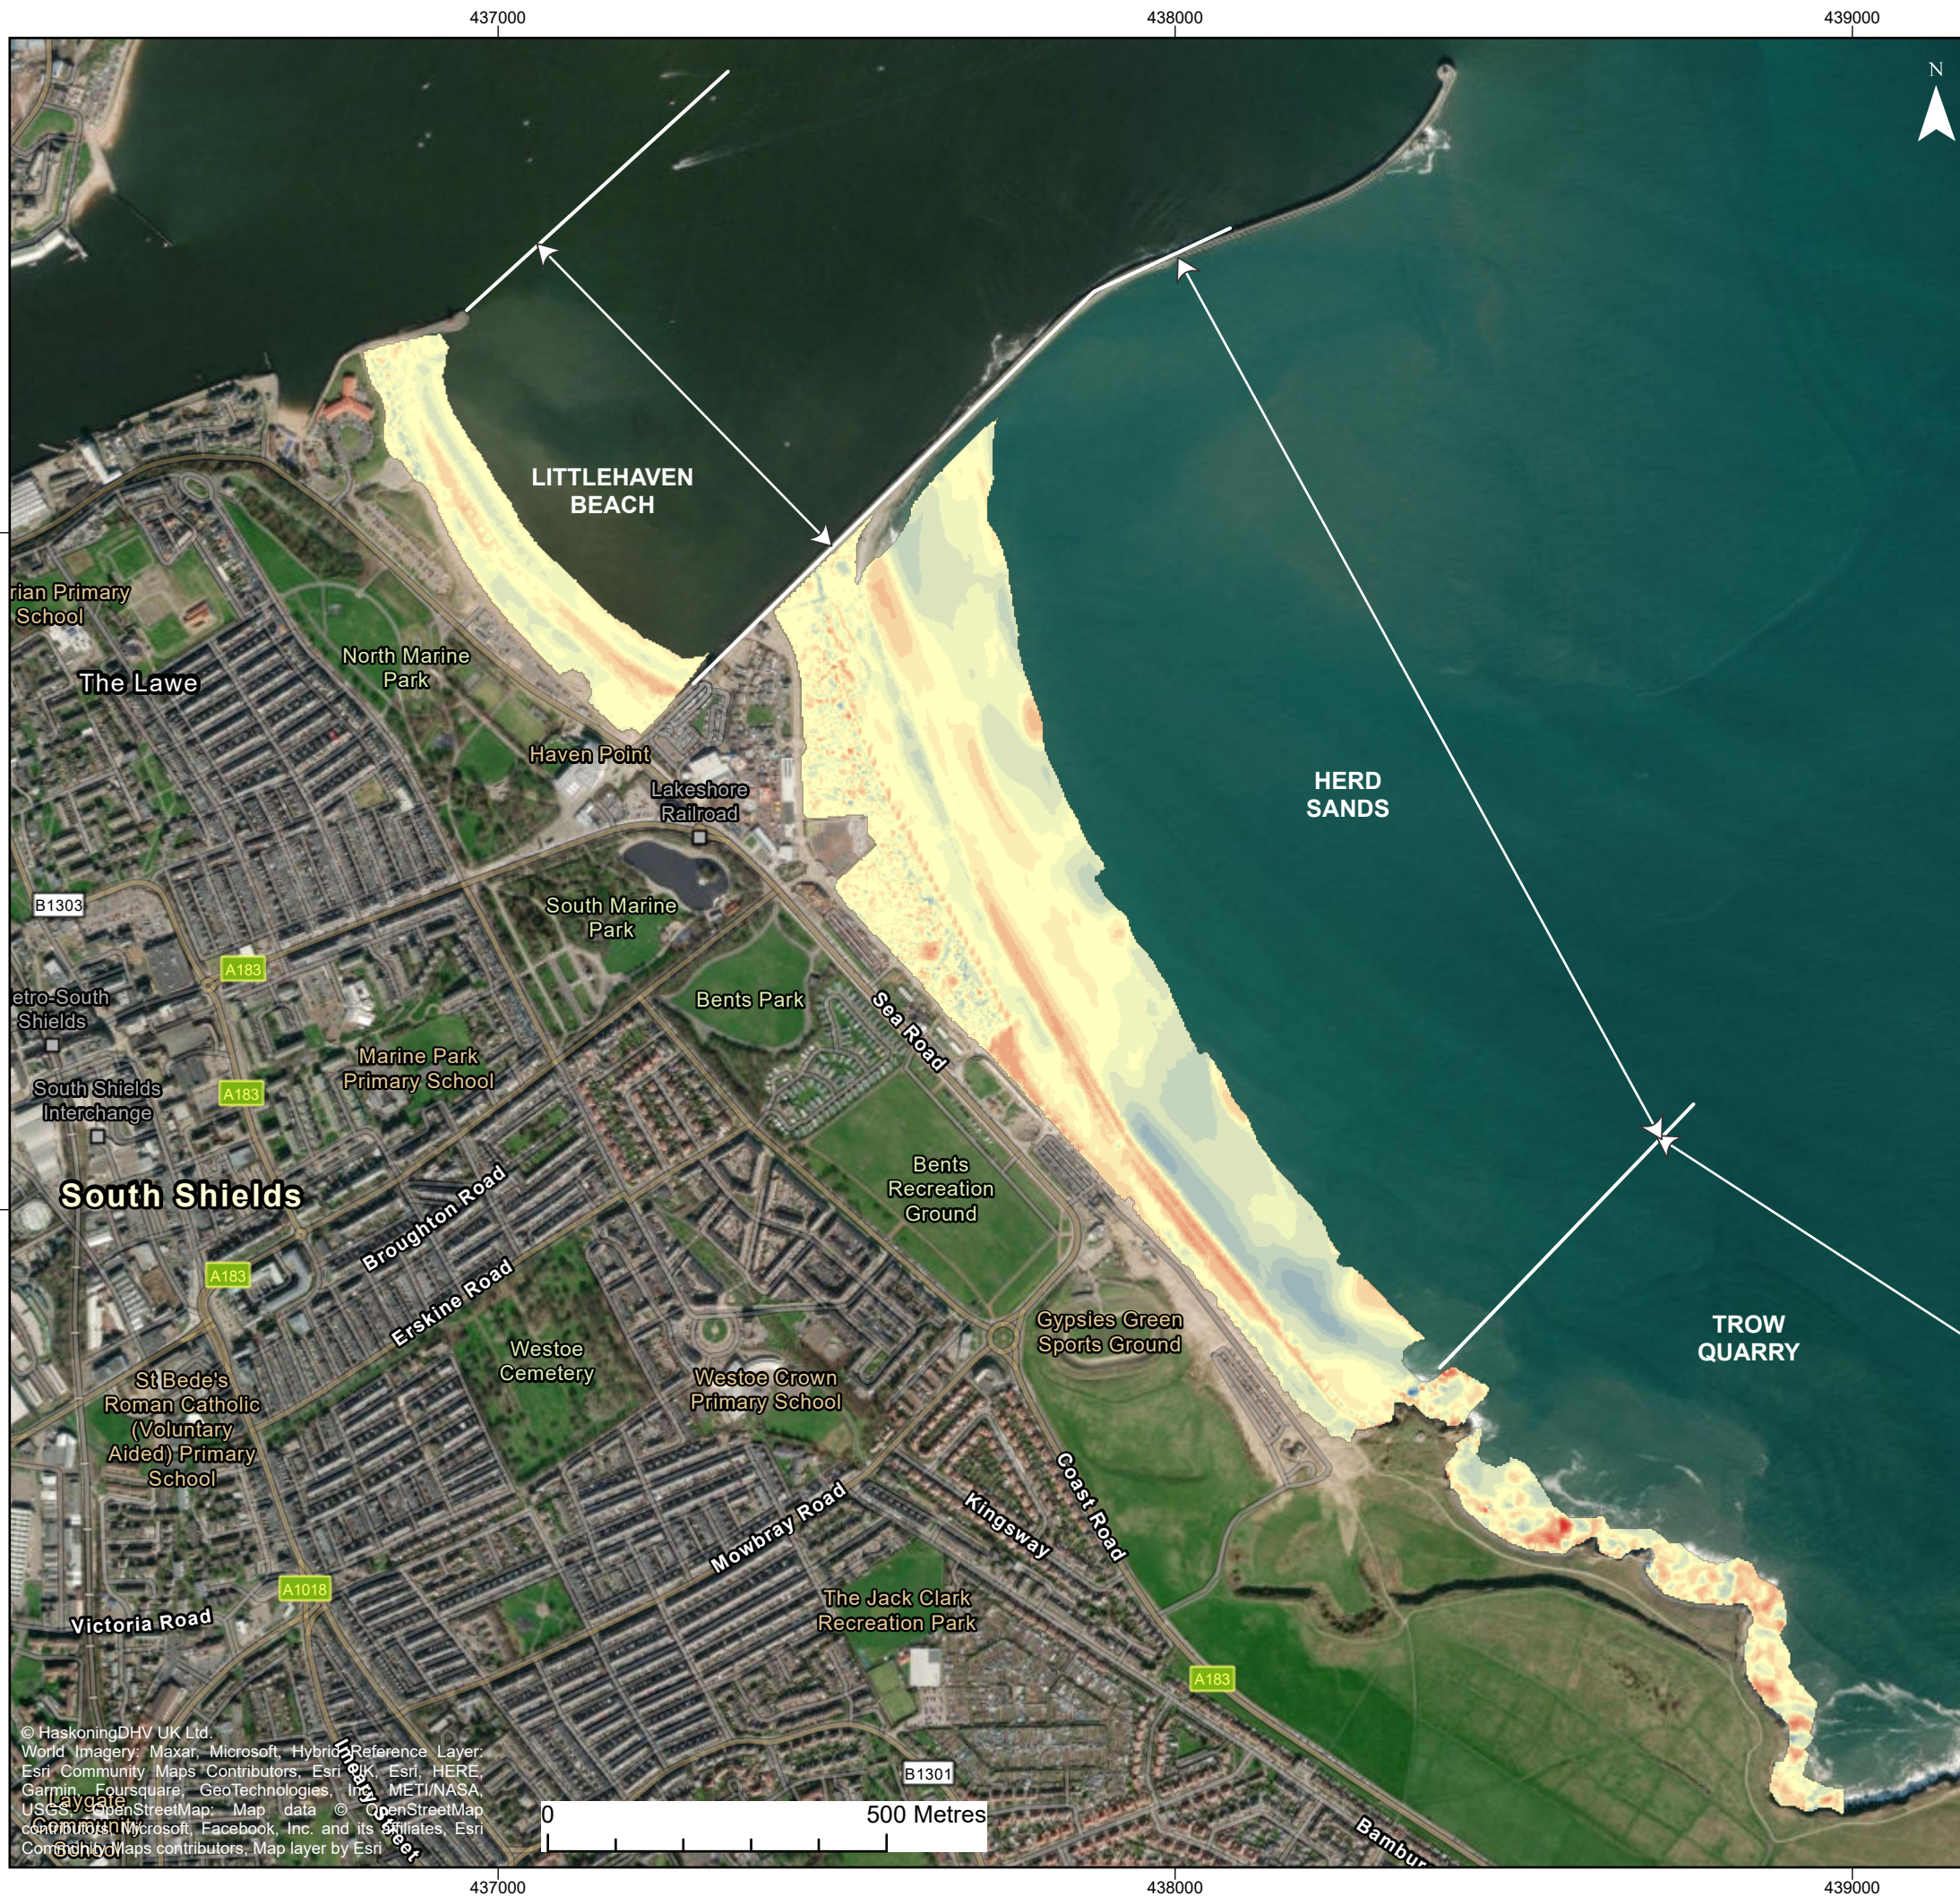
Title: **Appendix B - Map 2**
LITTLEHAVEN BEACH, HERD SANDS, TROW QUARRY
South Tyneside Council Frontage

<p>October 2022</p>	<p>Topographic Survey:</p> <p>Herd Sands is covered by an annual topographic survey between the South Pier and Trow Point, which commenced in November 2008.</p> <p>Data from the most recent topographic survey (Full Measures, autumn 2022) have been used to create a DGM (Appendix B – Map 1) using GIS. A difference plot has also been produced using the DGM (Appendix B – Map 2) produced from the last topographic survey (Full Measures, autumn 2021) and the present survey.</p> <p>The difference plot shows that change across the dunes is patchy but overall shows more areas of accretion within the back dunes, and lowering at the dune and seaward face of the dunes. The upper beach shows a band of lowering from the south to the centre of the bay, which switches to accretion in the north of the bay. The middle beach is dominated by little change in the north and centre of the bay, and lowering in the south of the bay. The lower beach generally exhibits accretion, particularly in the centre-south of the bay.</p>	<p>Comparison of the present topographic survey with the previous Full Measures (autumn, 2021) generally shows accretion / little change across the bay, with lowering limited to a narrow band on the upper beach in the south-centre of the bay and at the toe of the dunes.</p> <p>Accretion reaches 1.5-2.0m on the lower beach in the south of the bay, and erosion reaches 1.75m on the upper beach of the southern bay. Change in the middle and north part of the bay are limited to ± 0.75m.</p>
