Cell 1 Regional Coastal Monitoring Programme Analytical Report 15: 'Full Measures' Survey 2022

South Tyneside Council

January 2023

(*) The present report is **Analytical Report 15** and provides an analysis of the 2022 Full Measures survey for South Tyneside Council's frontage.

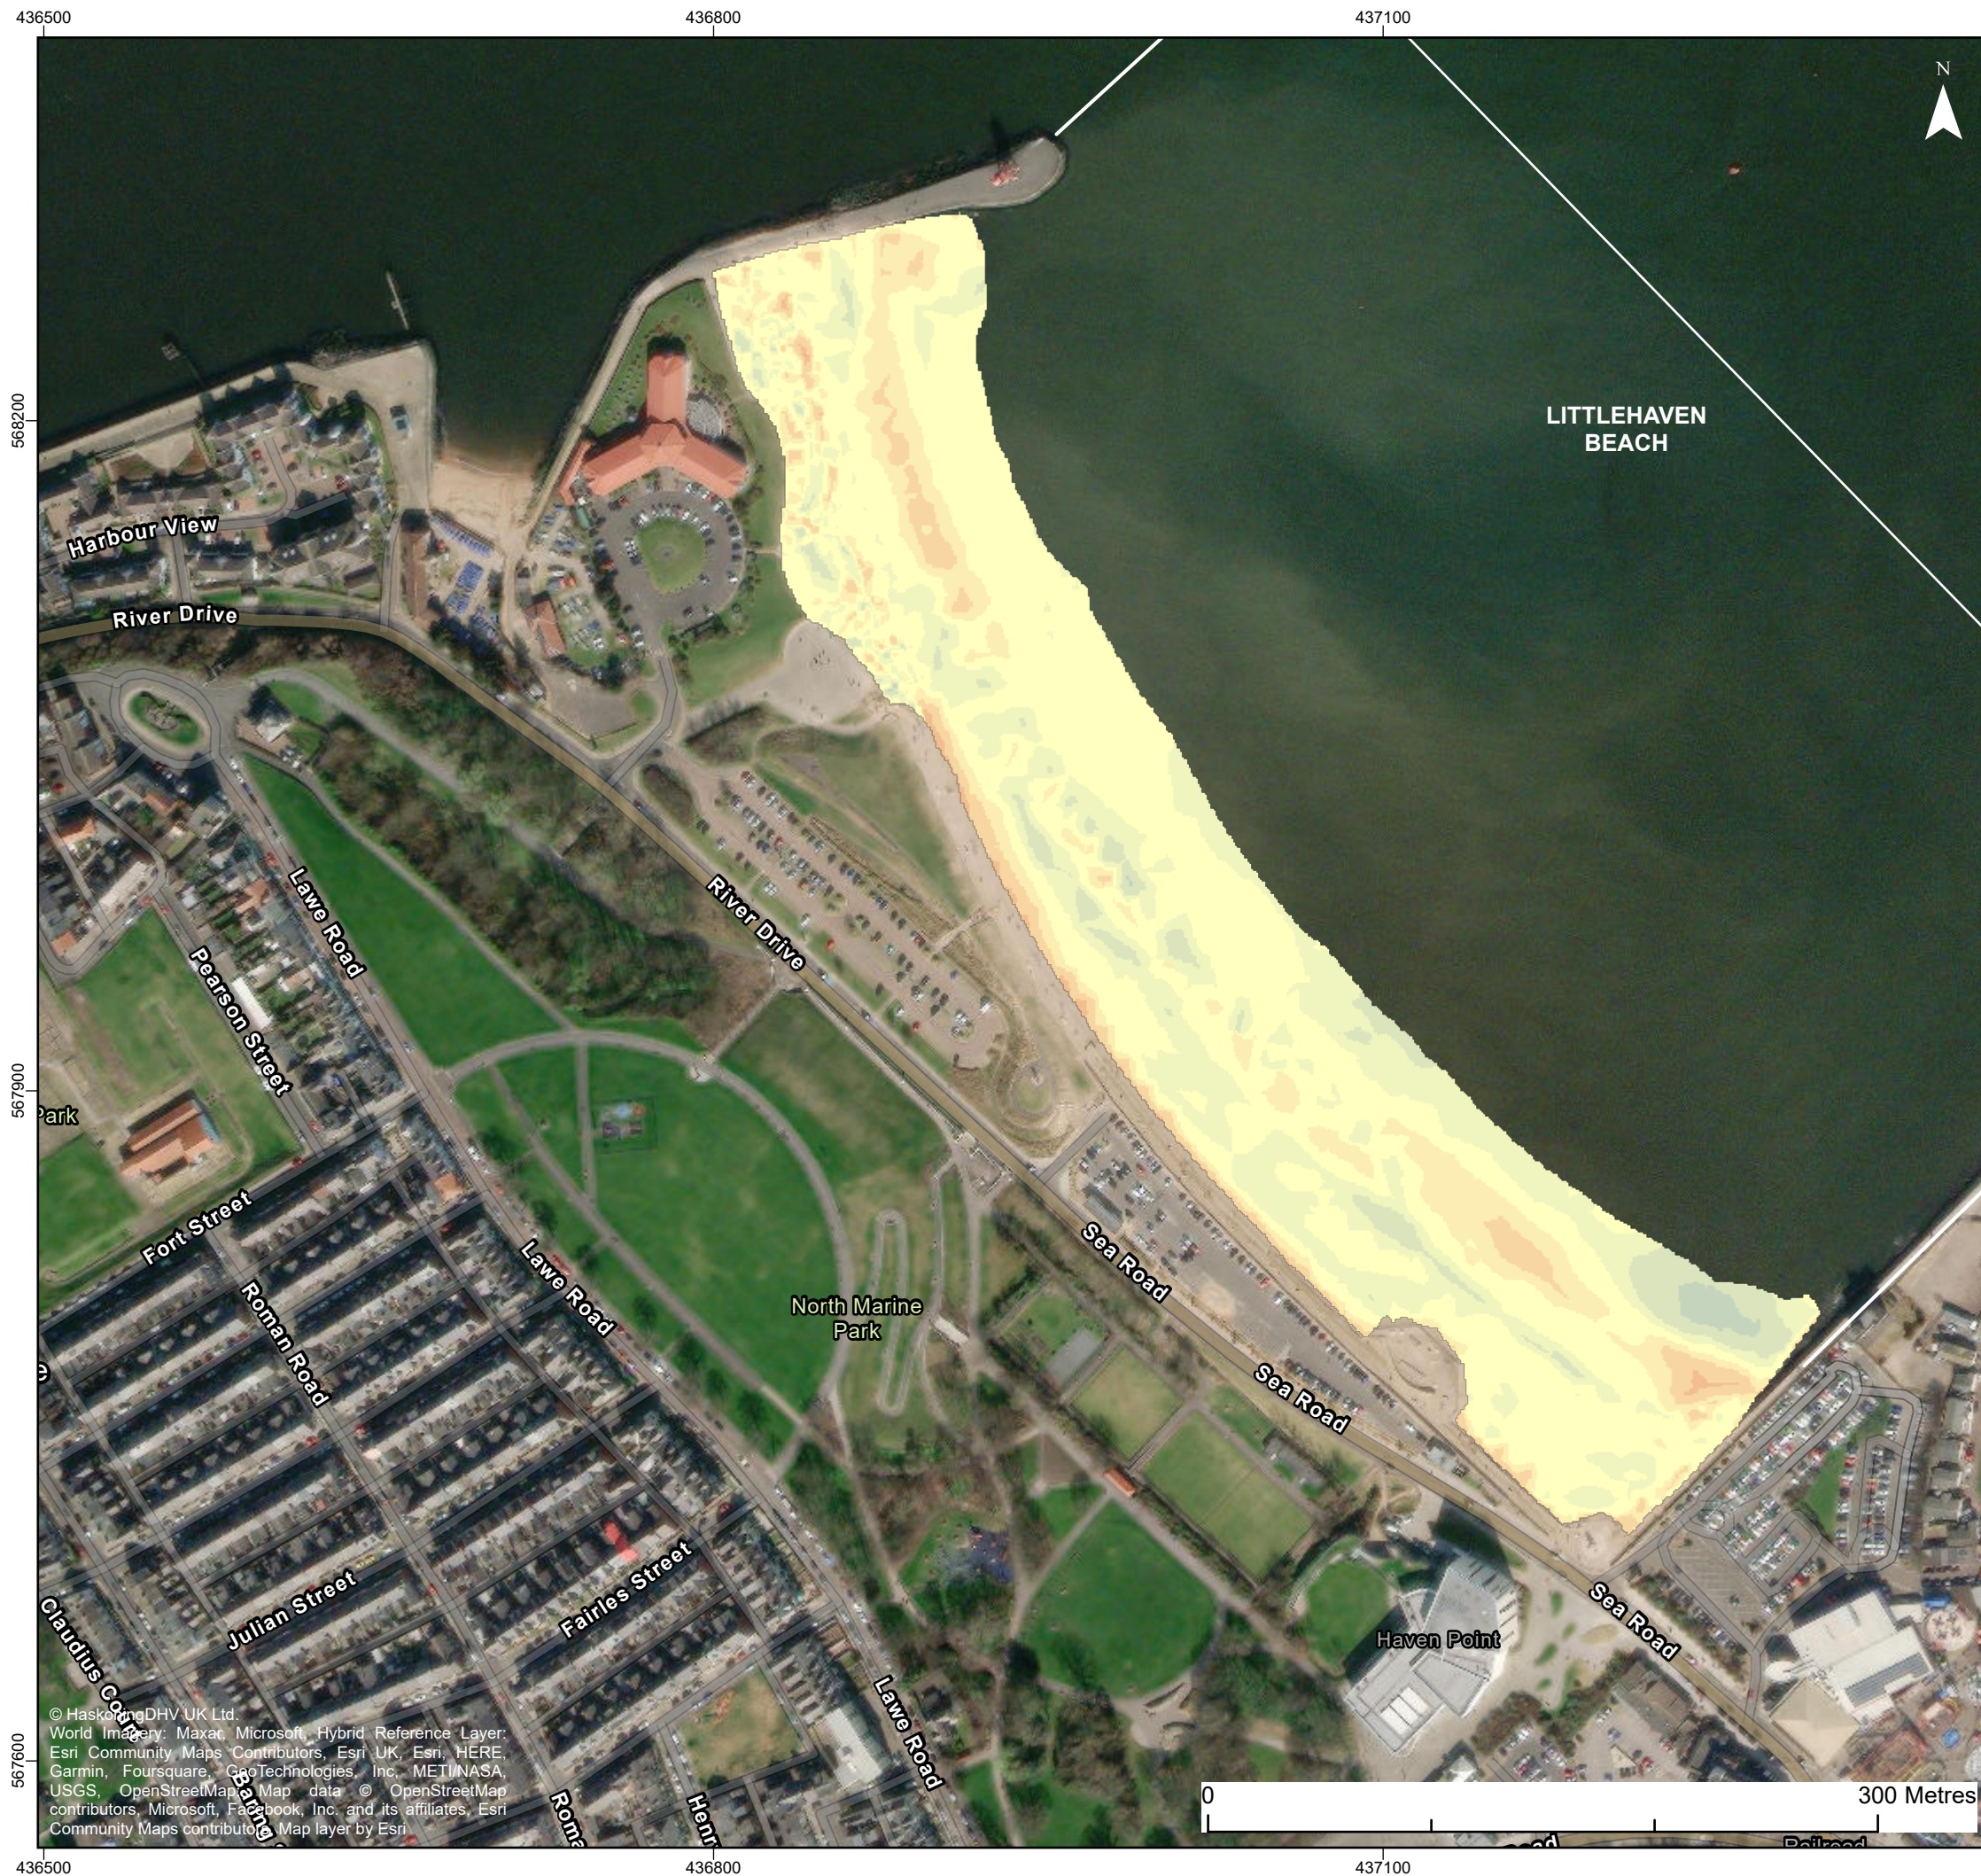
Title:
Appendix B - Map 3
LITTLEHAVEN BEACH
South Tyneside Council Frontage

<p>October 2022</p>	<p>Topographic Survey:</p> <p>Littlehaven Beach is covered by a bi-annual topographic survey between the South Groyne and the South Pier, which commenced in March 2010.</p> <p>Data from the most recent topographic survey (Full Measures, autumn 2022) have been used to create a DGM (Appendix B – Map 1) using GIS. A difference plot has also been produced using the DGM (Appendix B – Map 3) produced from the last topographic survey (Partial Measures, spring 2022) and the present survey.</p> <p>The topographic survey shows a continuous shore-parallel band of accretion across the upper-middle beach and middle-lower beach. A band of lowering is visible on the middle beach, except in the northern survey area which shows little change ($\pm 0.1\text{m}$). North of the seawall the pattern is patchy; with the upper beach showing a mix of accretion and little change ($\pm 0.1\text{m}$). Change across the whole bay is limited to $\pm 1.25\text{m}$.</p>	<p>Comparison of the present topographic survey with the previous Partial Measures (spring, 2022) shows that the beach is generally stable with shore-parallel bands of elevation change which reflect seasonal redistributions of material throughout across the beach as bars.</p>

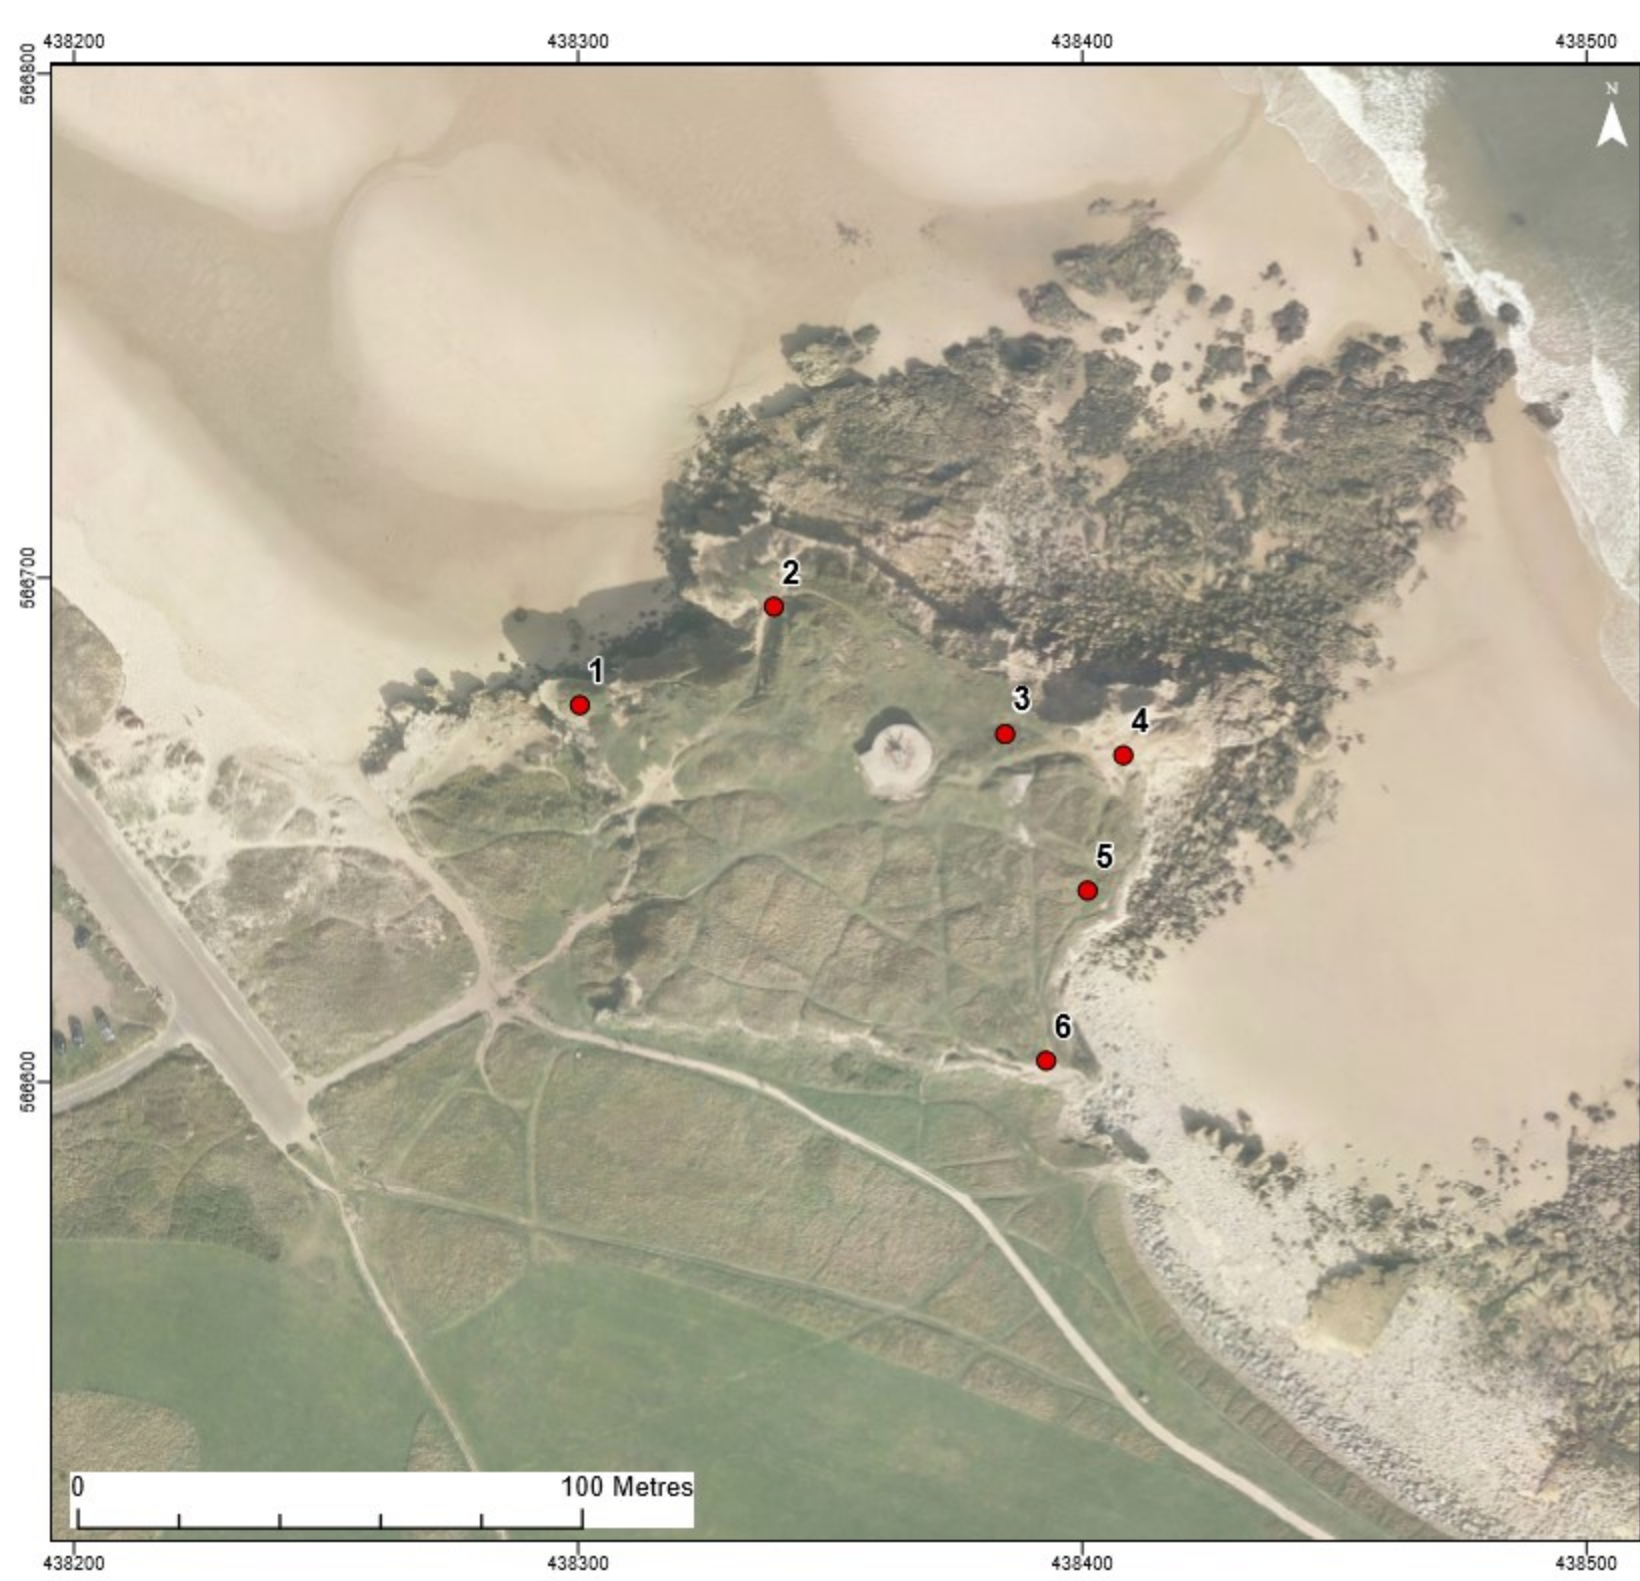
Title:
Figure 3 - Map 1
TROW QUARRY
South Tyneside Council Frontage

Six ground control points have been established at Trow Quarry (Figure 3 – Map 1). The maximum separation between any two points varies along the coast, reflecting the degree of risk from the erosion.

The cliff top surveys at Trow Quarry are undertaken bi-annually. Measurements are taken from a fixed ground control point along a fixed bearing to the edge of the cliff top.

Table C1 provides baseline information about these ground control points and results from the 2011 (baseline) survey showing the position from the ground control point to the edge of the cliff top along the defined bearing. Future reports will show results from subsequent surveys and provide a means of assessing erosion since the baseline survey.

Ground Control Points				Distance to Cliff Top (m)			Total Erosion (m)		Erosion Rate (m/year)
Ref	Easting	Northing	Bearing	Baseline Survey	Previous Survey	Present Survey	Baseline to Present	Previous to Present	Baseline to Present
			(°)	Sep 2011	March 2022	October 2022	Sep 2011 - Oct 22	Mar 2022 – Oct 2022	Sep 2011 - Oct 2022
1	438300.3	566674.7	309	7.00	6.52	6.53	-0.47	0.01	-0.04
2	438338.8	566694.3	312	9.40	9.39	9.24	-0.16	-0.15	-0.01
3	438384.7	566669	33	7.00	7	6.49	-0.51	-0.51	-0.05
4	438408.1	566664.8	71	10.50	11	10.92	0.42	-0.08	0.04
5	438401.1	566638	120	7.00	7.11	7.03	0.03	-0.08	0.00
6	438392.8	566604.2	110	10.20	9.88	9.77	-0.43	-0.11	-0.04
