# **Cell 1 Regional Coastal Monitoring Programme Analytical Report 16: 'Full Measures' Survey 2023**

**South Tyneside Council**

**November 2023**

(\*) The present report is **Analytical Report 16** and provides an analysis of the 2023 Full Measures survey for South Tyneside Council's frontage.

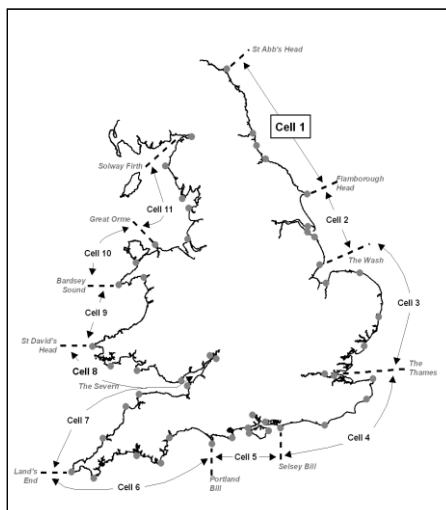
**Figure 1 Sediment Cells in England and Wales**

The Cell 1 Regional Coastal Monitoring Programme covers approximately 300km of the north east coastline, from the Scottish Border (just south of St. Abb's Head) to Flamborough Head in East Yorkshire. This coastline is often referred to as 'Coastal Sediment Cell 1' in England and Wales (Figure 1). Within this frontage the coastal landforms vary considerably, comprising low-lying tidal flats with fringing salt marshes, hard rock cliffs that are mantled with glacial sediment to varying thicknesses, softer rock cliffs and extensive landslide complexes.

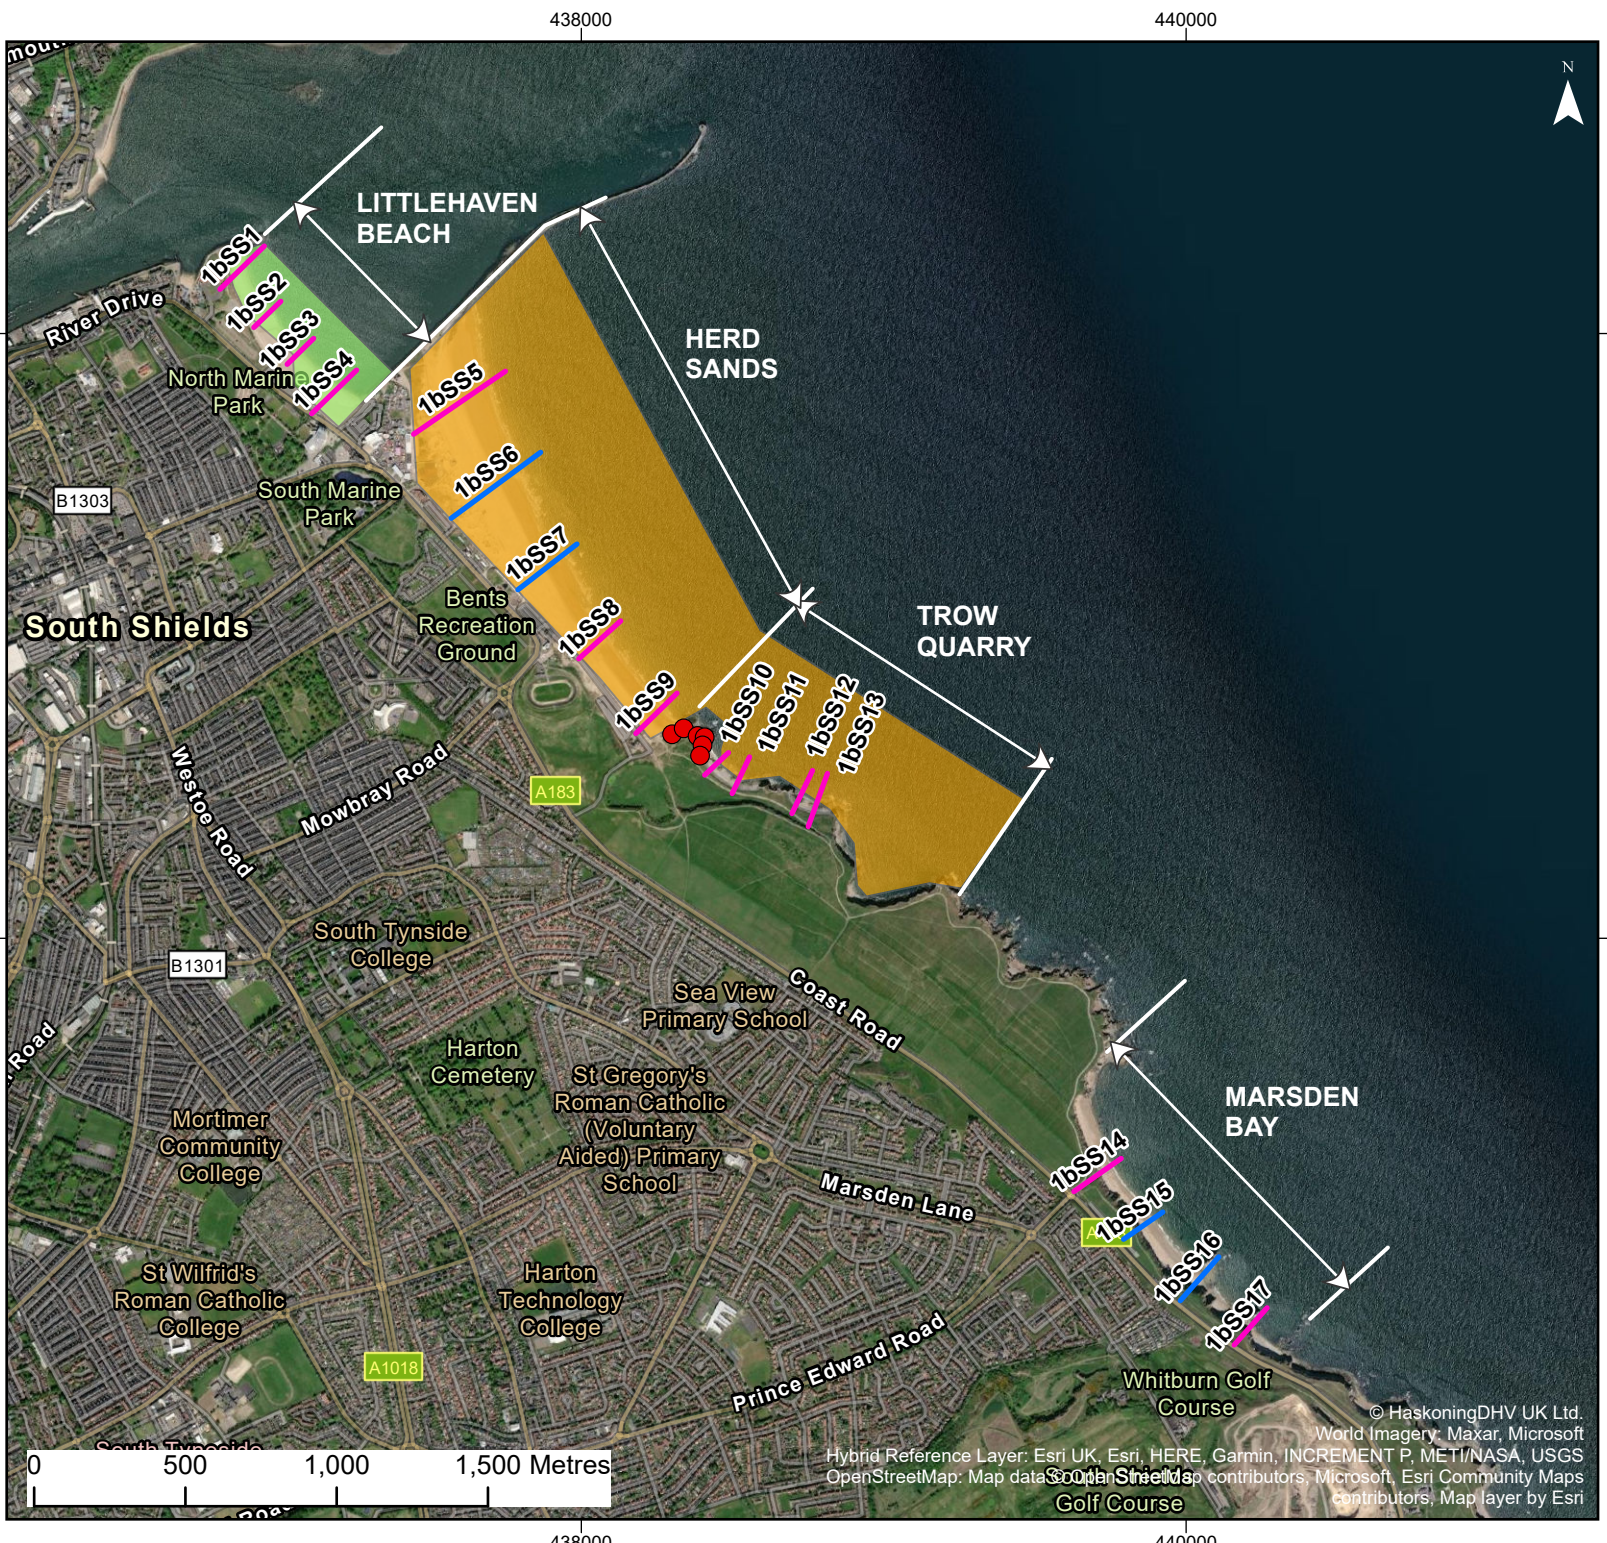
**Figure 2 - Map 1**

**SURVEY LOCATIONS**

**Topographic Profile**

- Annual (Blue line)
- Bi-Annual (Pink line)

**Topographic Area**

- 6 monthly (Green)
- yearly (Yellow)
- 5 yearly (Purple)

- Cliff Top Survey Points (Red dots)

**LITTLEHAVEN BEACH to MARSDEN BAY**

The location of these surveys is shown in Figure 2. The Full Measures survey was undertaken along this frontage between 6<sup>th</sup> September 2023 and 15<sup>th</sup> September 2023. During this time, the weather and sea state varied greatly, for details of the survey conditions refer to the Academy Geomatics survey report.

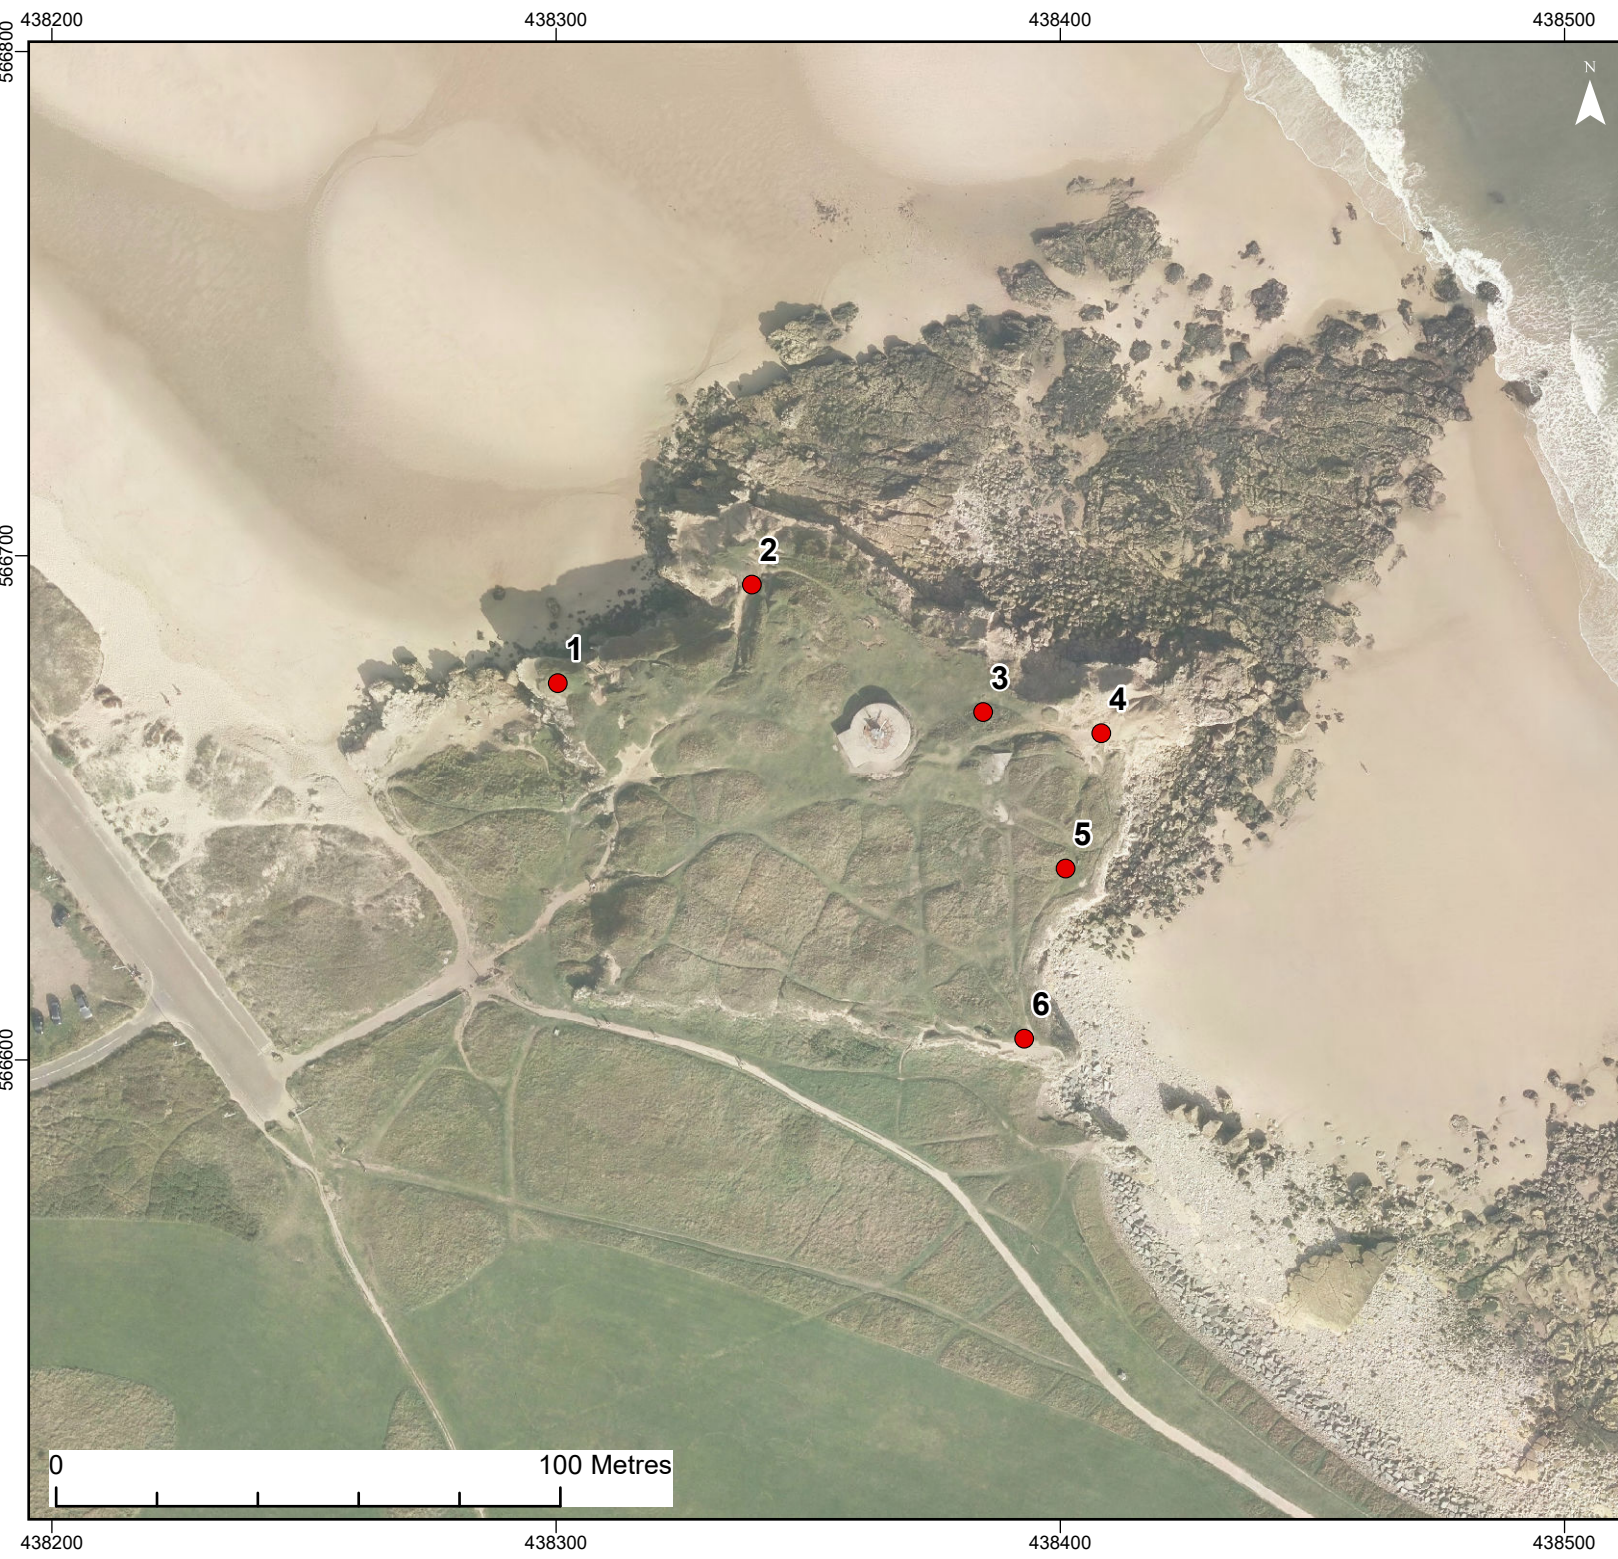
Title:  
**Figure 3 - Map 1**  
**TROW QUARRY**  
**South Tyneside Council Frontage**

**SURVEY LOCATIONS**  
 ● Cliff Top Survey Points

Six ground control points have been established at Trow Quarry (Figure 3 – Map 1). The maximum separation between any two points varies along the coast, reflecting the degree of risk from the erosion.

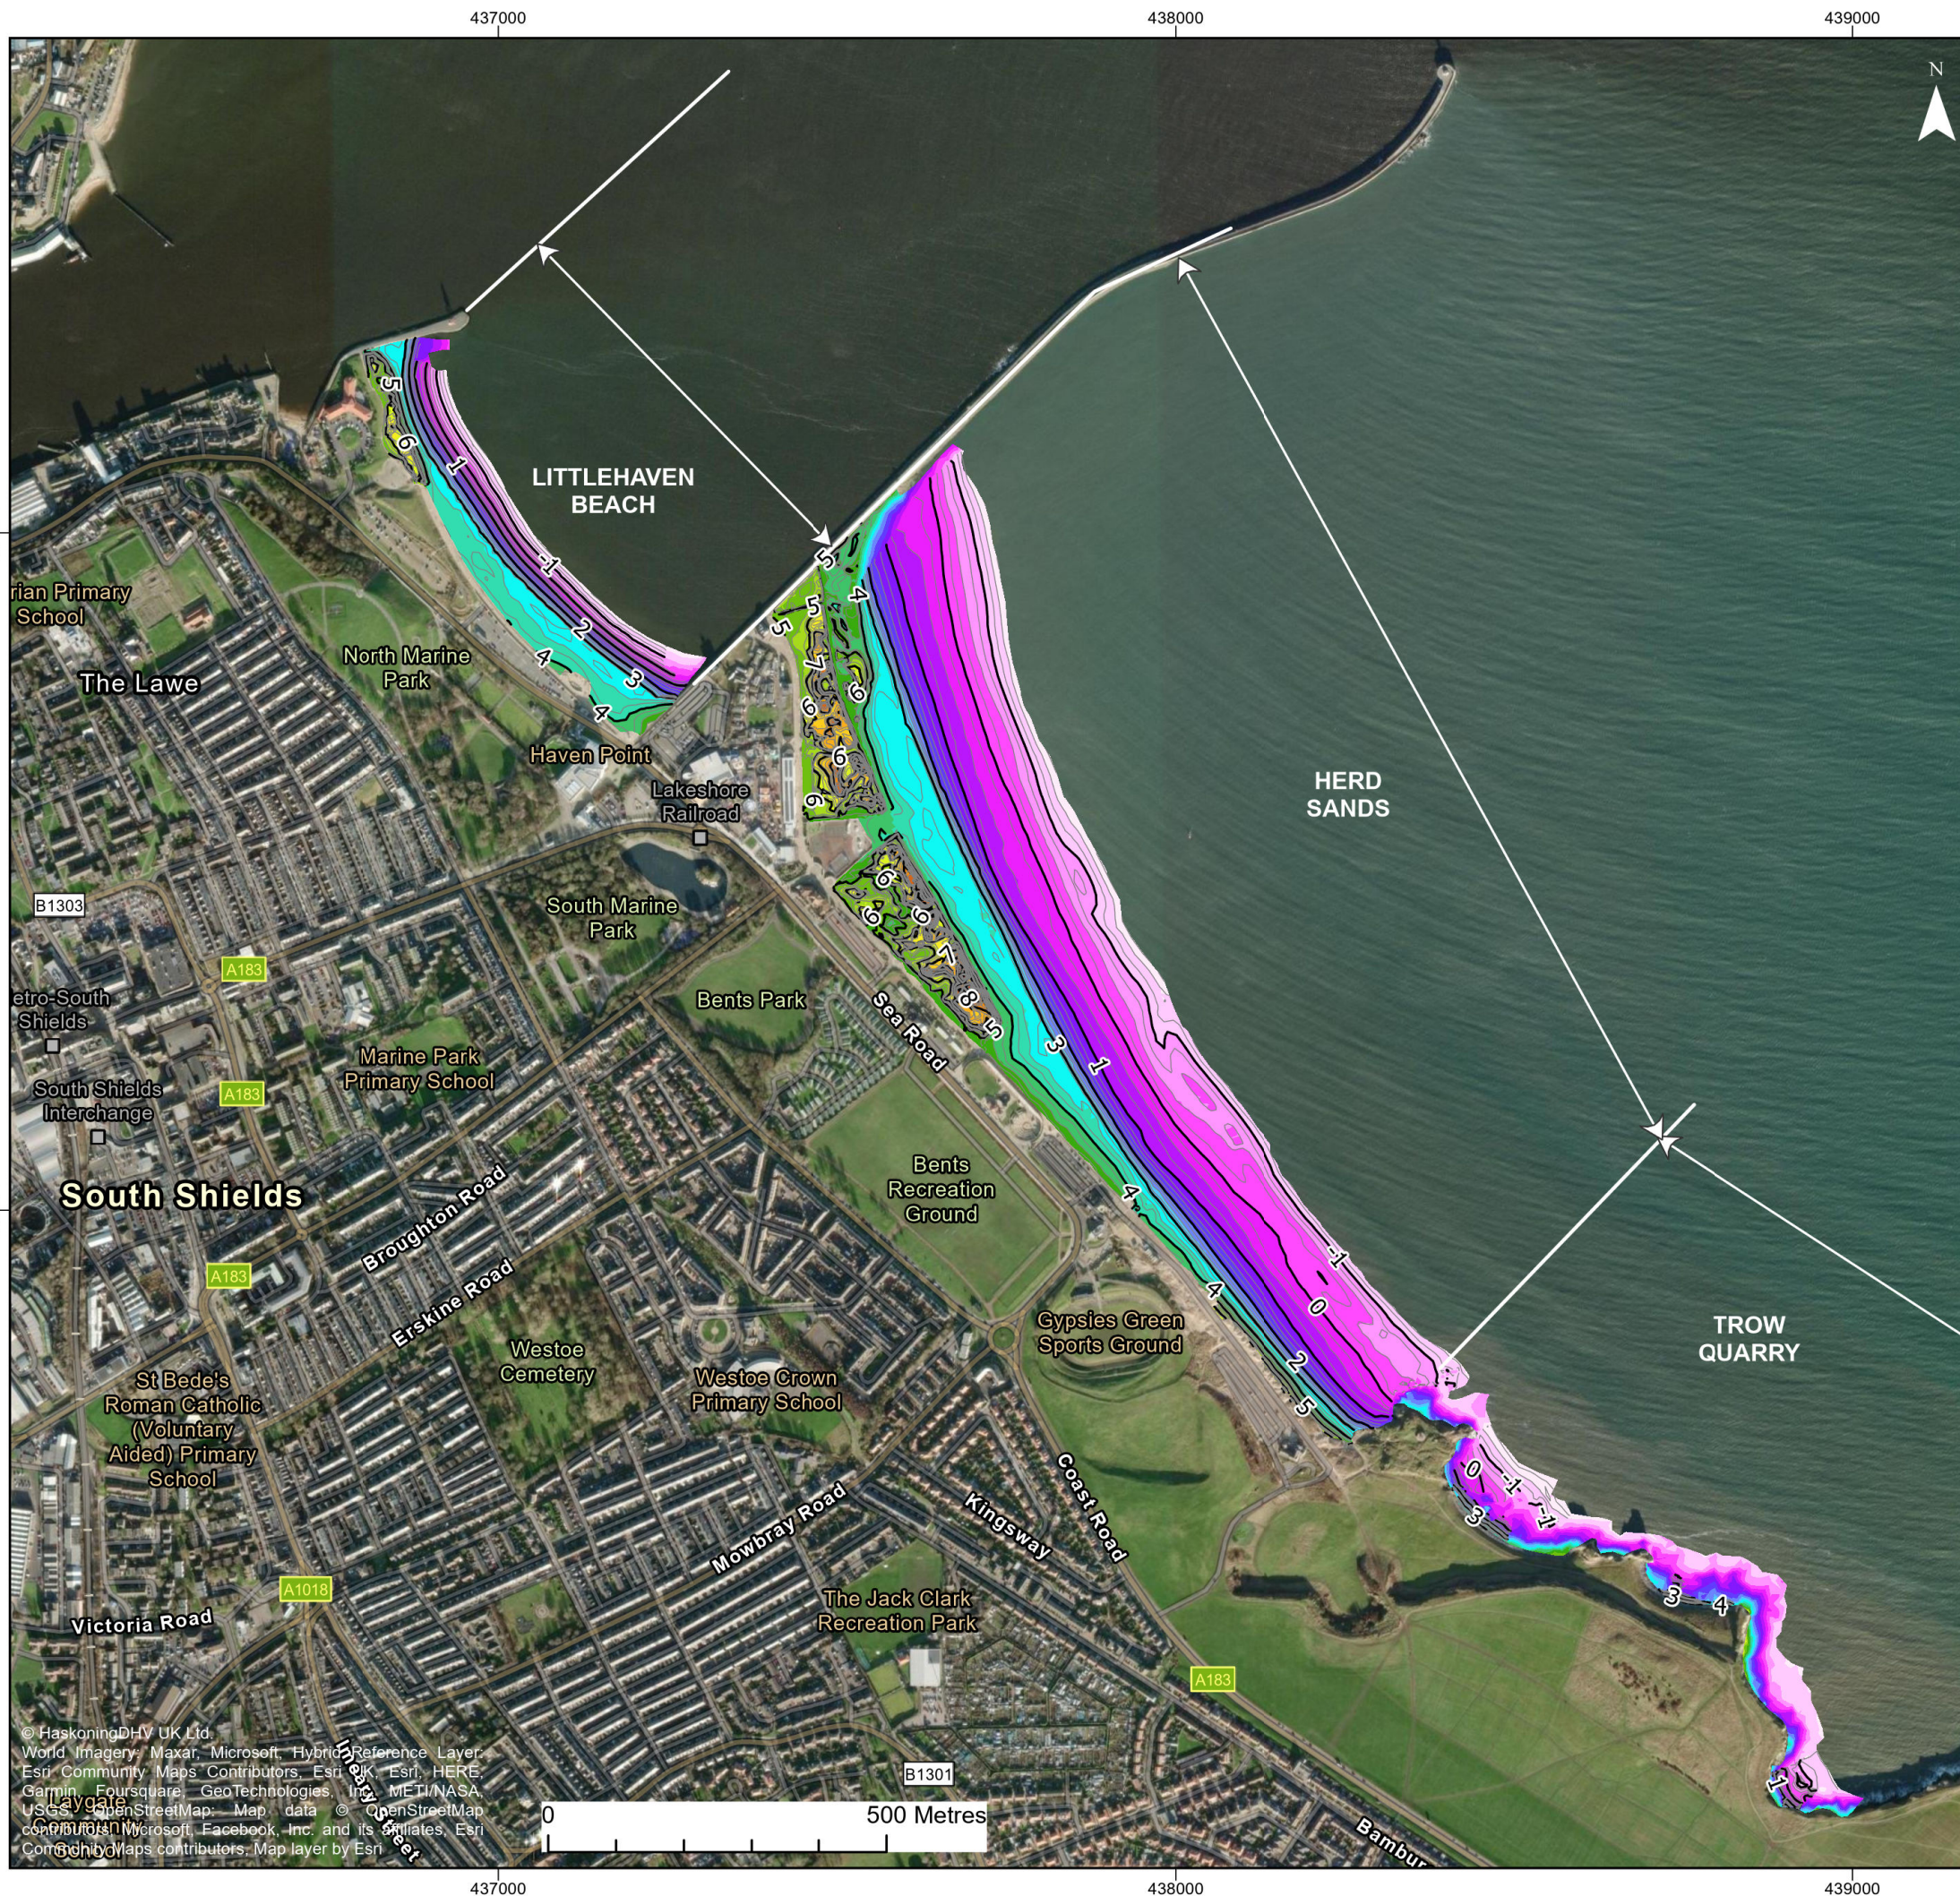
**Appendix B - Map 1**

**LITTLEHAVEN BEACH, HERD SANDS, TROW QUARRY**

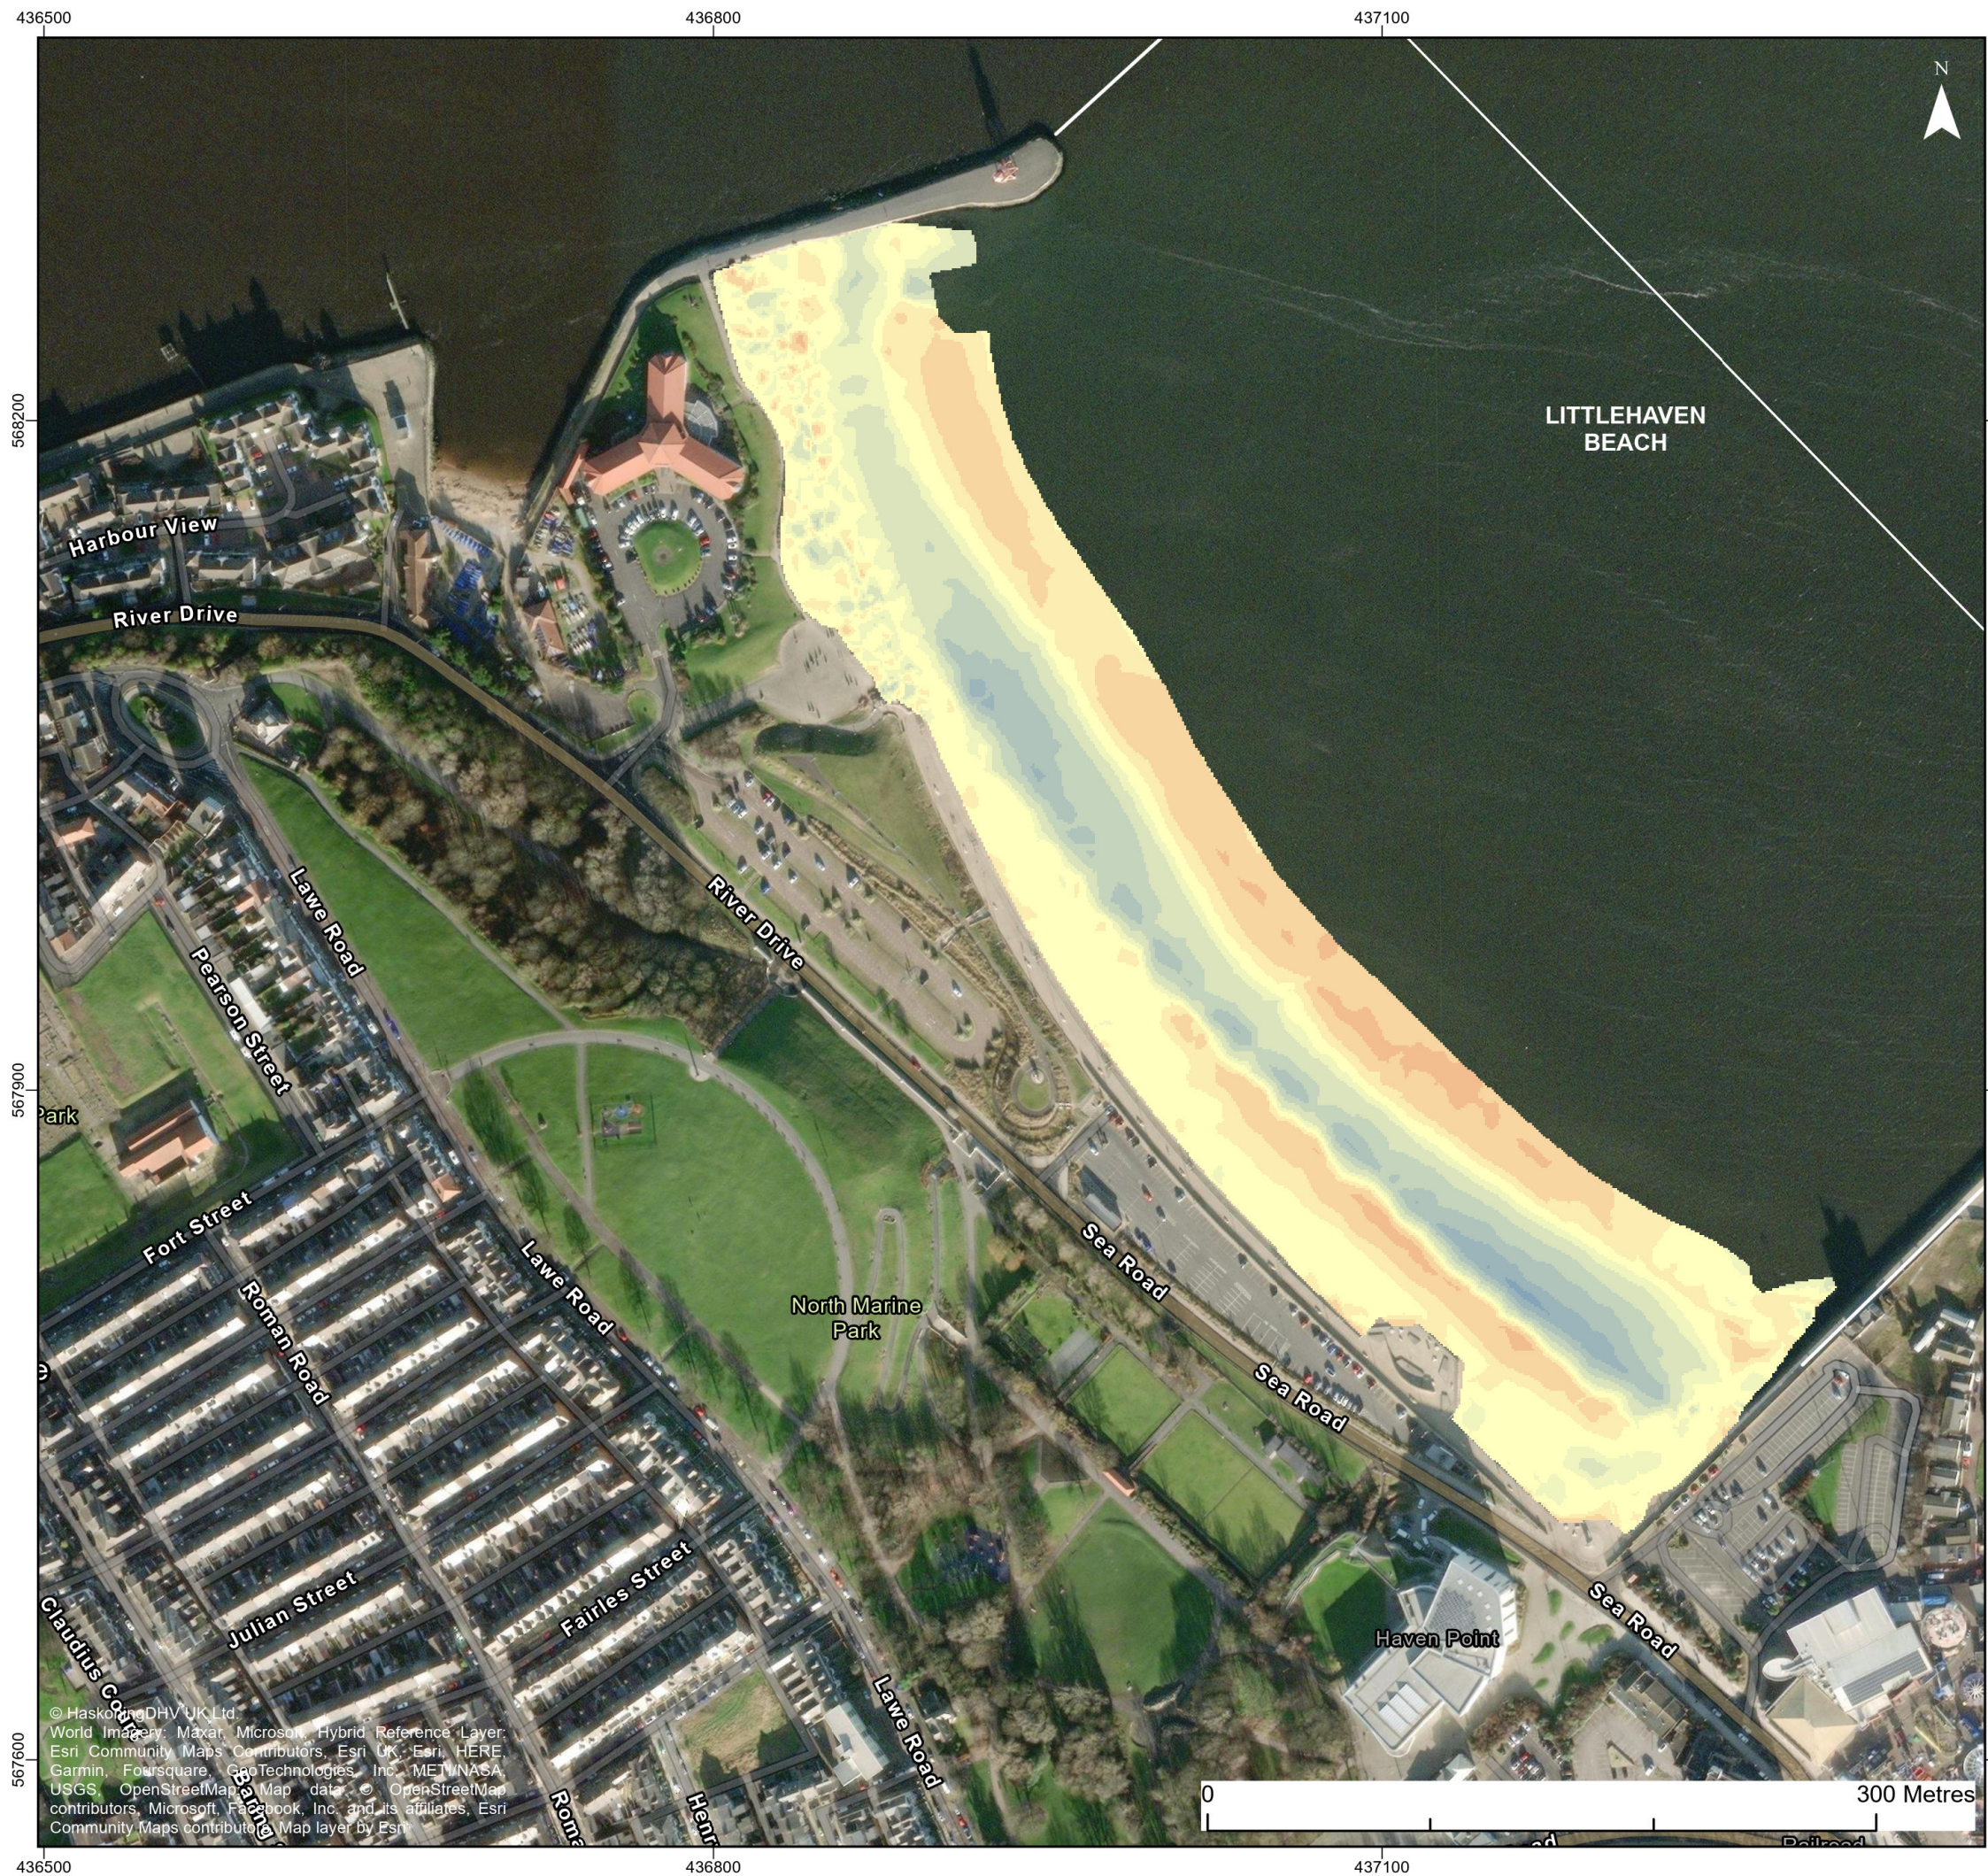
**Appendix B - Map 3**

**Difference between topographic surveys**  
(Mar 2023 to Sept 2023)

**Change in Elevation (mOD)**

**LITTLEHAVEN BEACH**

Survey Date	Description of Changes Since Last Survey	Interpretation
6 <sup>th</sup> – 15 <sup>th</sup> Sept 2023	<p><b>Beach Profiles:</b></p> <p>Littlehaven Beach is covered by four beach profile lines for the Full Measures survey, spaced between South Groyne and South Pier (Appendix A). The previous survey was the Partial Measures survey undertaken in March 2023 and the previous Full Measures survey was undertaken in October 2022. Profiles 1bSS1 and 1bSS3 were last surveyed during the Partial Measures spring survey, 2022. Profiles 1bSS2 and 1bSS4 were last surveyed during the Full Measures autumn survey, 2021. Profile <b>1bSS1</b> is located to the north of Littlehaven beach, in the lee of a rocky outcrop and South Groyne. The dunes have lowered by 0.1m since the last survey on the back dunes and dune face. Beach levels on the dune toe have lowered since the previous survey (between chainages 60-64m) by up to 0.2m. The upper and middle beach between chainages 64-96m has risen by up to 0.2m, switching to erosion on the lower beach by up to 0.5m to chainage 138m. The boulder patch seaward of chainage 144m remains exposed with slight changes in position of boulders since the previous survey. The profile is at a high level on the dunes and upper-middle beach, and at a low level on the lower beach compared to the range recorded from previous surveys.</p> <p>Profiles <b>1bSS2 to 1bSS4</b> extend seawards from the new sea wall that was completed since the Full Measures survey in April 2014.</p> <p>At profile <b>1bSS2</b>, beach levels have dropped at the toe of the seawall by up to 0.2m to chainage 15m. The upper to middle beach between chainages 15-66m has risen by up to 0.8m, switching to lowering on the lower beach between chainage 66m and 104m by 0.3m. Overall the beach profile is at a low level at the toe of the seawall, a high level on the upper and middle beach, dropping to a low level on the lower beach compared to the range recorded from previous surveys.</p> <p>At profile <b>1bSS3</b>, there has been minor erosion of less than 0.1m at the toe of the seawall to chainage -16m. An upper beach berm has lowered by up to 0.2m and moved seaward by up to 12m. The upper beach has risen by up to 0.6m, before switching to erosion on the lower beach at chainage 40m by up to 0.6m to the end of the survey. Overall, the beach profile is at a low level at the toe of the</p>	<p>The beach at Littlehaven has had some time to adjust since construction of the realigned seawall in April 2014. All profiles generally show a seaward movement of berms and have generally risen on the upper half and lowered on the lower half of the beach. The profiles range from a high-low level compared to the range recorded from previous surveys, with a small section on the upper beach at profile 1bSS4 at its lowest recorded level.</p> <p><b>Longer term trends:</b> The beach profiles are at variable positions relative to past levels. In general, they are within the boundaries of previous surveys indicating the new seawall has not adversely affected sediment movements.</p>

Survey Date	Description of Changes Since Last Survey	Interpretation
	<p>seawall, a high level on the upper beach and a medium-high level on the middle-lower beach compared to the range recorded from previous surveys.</p> <p>At profile <b>1bSS4</b>, the beach level at the toe of the seawall has risen by less than 0.1m to chainage 40m. The upper beach berm has lowered by up to 0.3m and moved seaward by up to 11m. The middle beach has risen by up to 0.6m to chainage 126m. The lower beach has lowered by up to 0.2m to the end of the survey. Overall, the profile is generally at a medium-low level compared to the range recorded from previous surveys, except between chainages 60-76m which is at its lowest level recorded.</p>	
September 2023	<p><b>Topographic Survey:</b></p> <p>Littlehaven Beach is covered by a bi-annual topographic survey between the South Groyne and the South Pier, which commenced in March 2010.</p> <p>Data from the most recent topographic survey (Full Measures, autumn 2023) have been used to create a DGM (Appendix B – Map 1) using GIS. A difference plot has also been produced using the DGM (Appendix B – Map 3) produced from the last topographic survey (Partial Measures, spring 2023) and the present survey.</p> <p>The topographic survey shows a wide, continuous shore-parallel band of accretion (+0.5-1.75m) across the upper-middle beach across Littlehaven. A continuous band of erosion (-1.0m) is present on the lower beach, and on the middle-upper beach in the southern part of the bay. Between these bands of erosion/accretion the beach has experienced little change (<math>\pm 0.1</math>m). North of the seawall, the pattern on the upper beach is patchy; showing a mix of accretion (up to +1.0m) and little change (<math>\pm 0.1</math>m) with isolated patches of erosion (-0.5m).</p>	<p>Comparison of the present topographic survey with the previous Partial Measures (spring, 2023) shows that the beach is generally stable with shore-parallel bands of elevation change which reflect seasonal redistributions of material throughout across the beach as bars.</p>
