**Cell 1 Regional Coastal Monitoring Programme
Update Report 3: 'Partial Measures' Survey 2011**

South Tyneside Council

June 2011

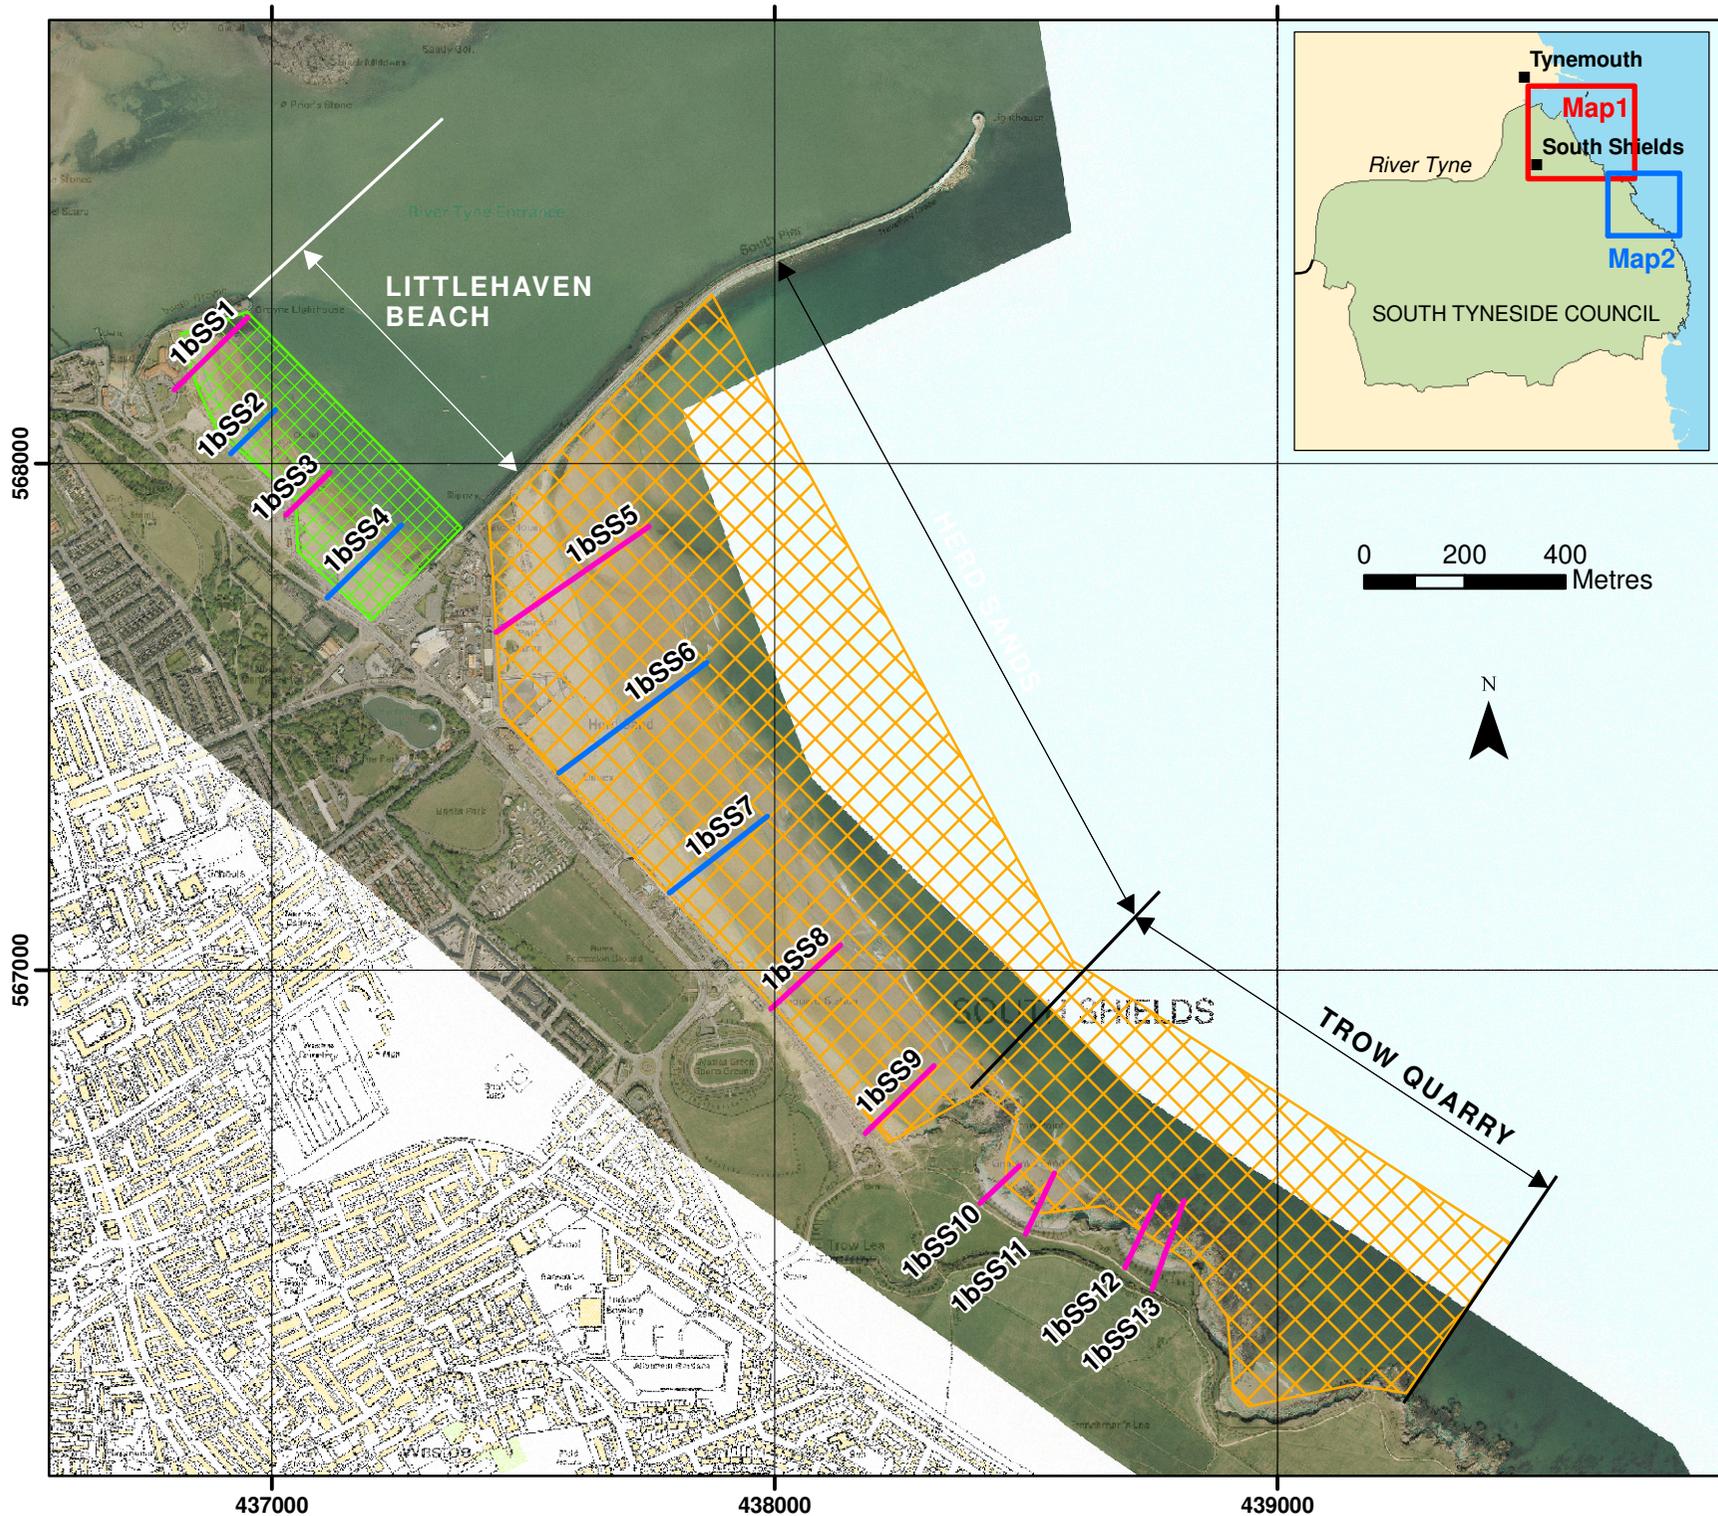
**Figure 2 - Map 1
 South Tyneside Council Frontage**

- SURVEY LOCATIONS**
- Topographic Profiles**
- Annual
 - Bi-Annual
- Topographic Surveys**
- 6 monthly
 - yearly
 - 5 yearly
- Cliff Top Monitoring Pegs**
- @ 50 centres
 - @ 100 centres
 - @ 300 centres
- (Indicative Survey Extents shown)*

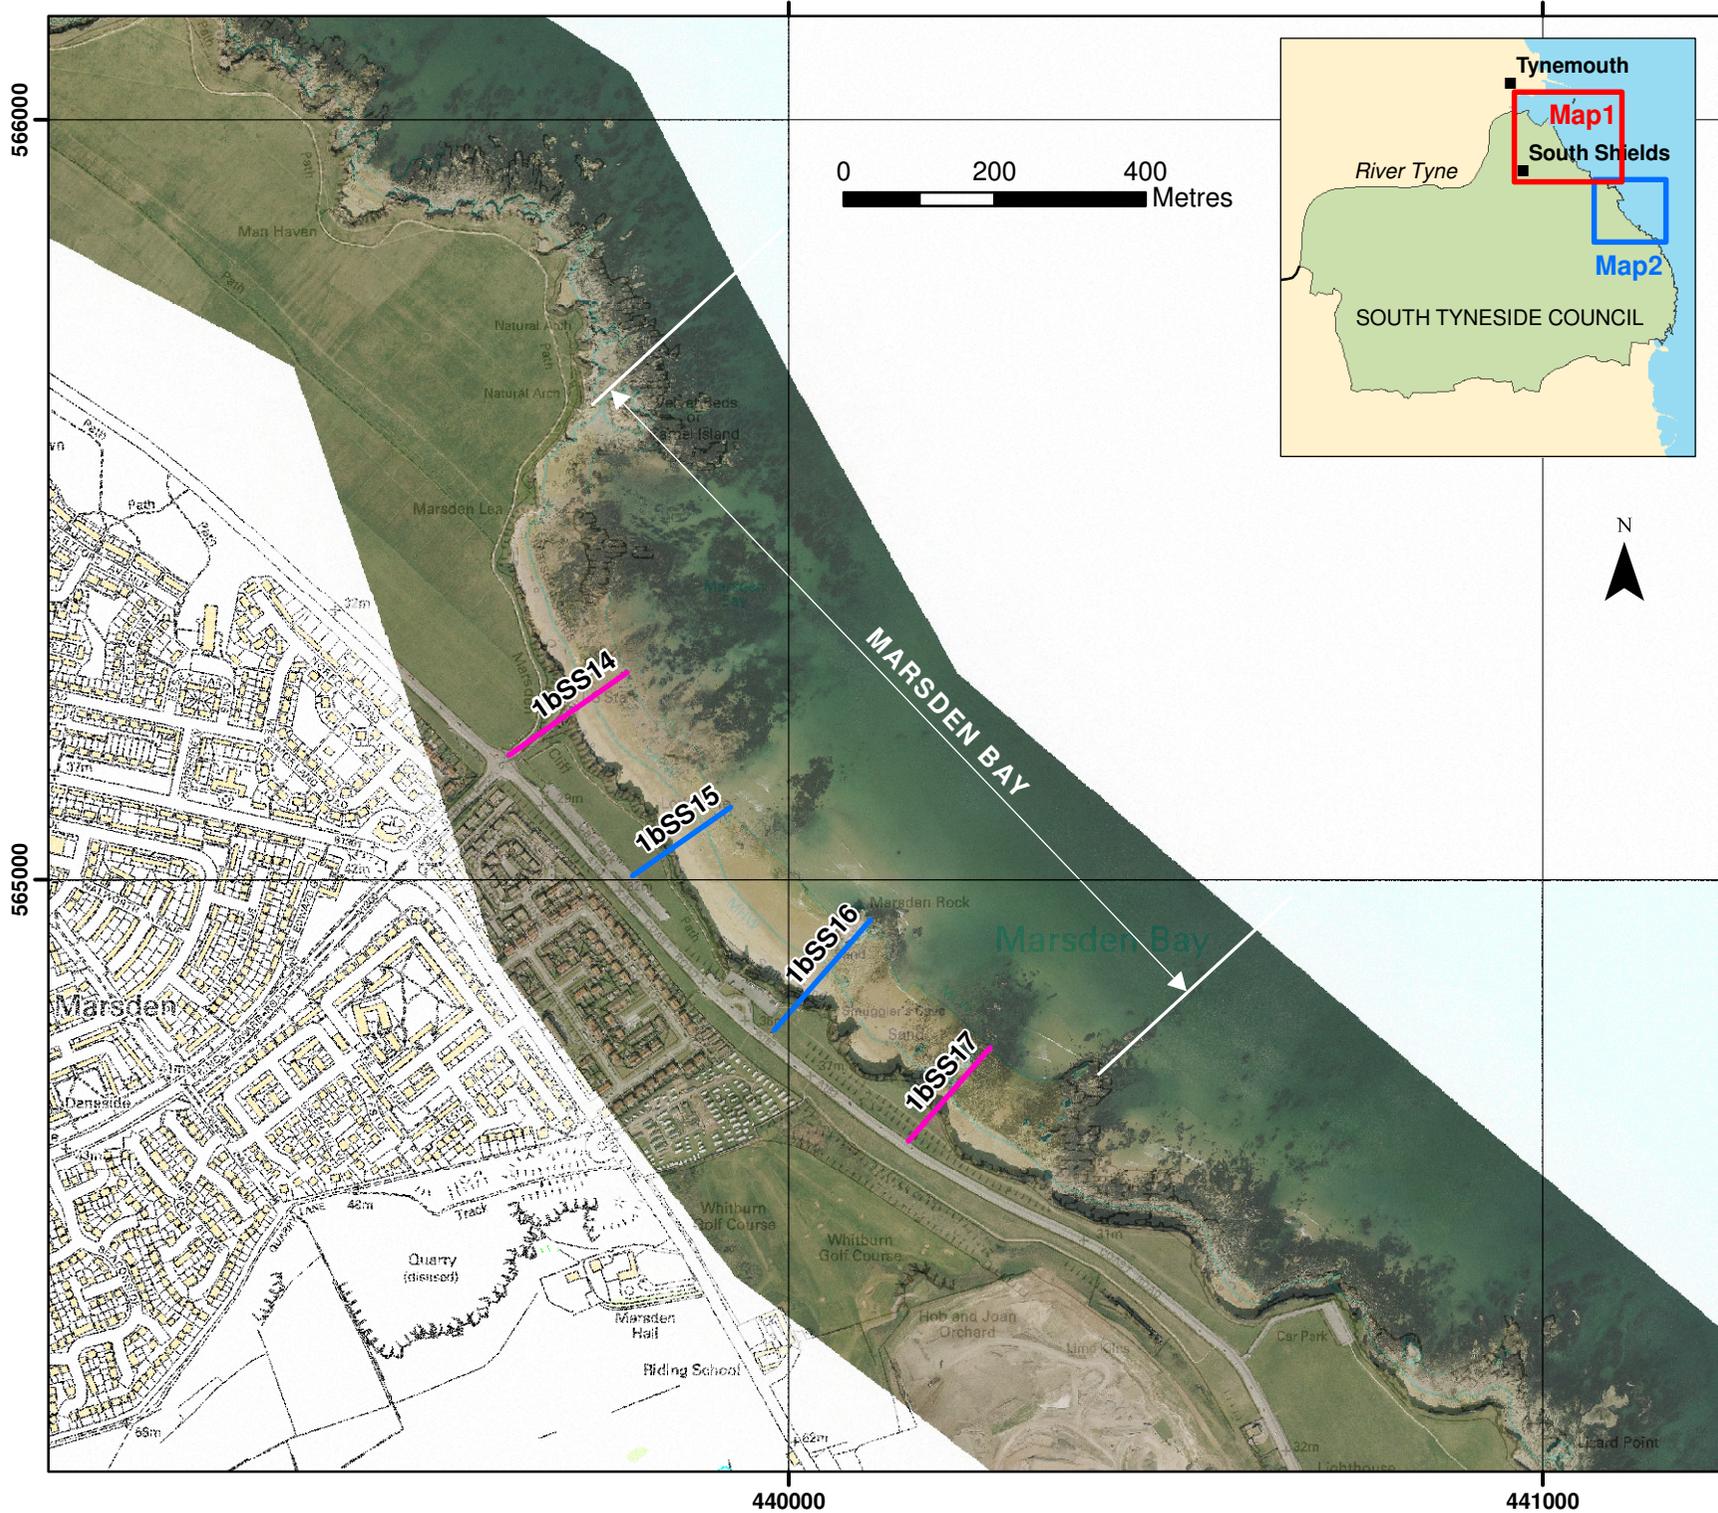
**Figure 1 - Map 2
South Tyneside
Council Frontage**

SURVEY LOCATIONS

The location of these surveys is shown in Figure 1. Previously supplied on a CD-rom was a file which can be opened in Google Earth showing the locations of the surveys.

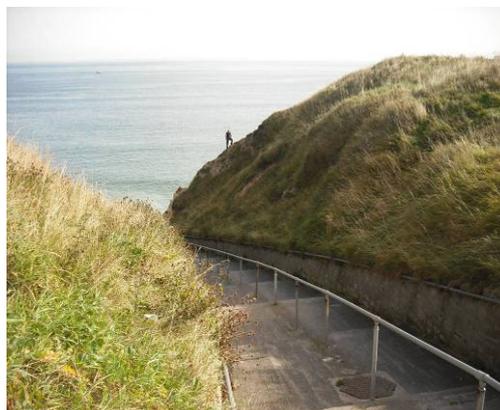
Beach Profile SS14 is located at the northern end of Marsden Bay, close to the Redwell Steps. Surveys of the beach and the concrete platform and steps at the base of the cliffs are accurately undertaken on each survey. Due to this, it has become clear that the changes in the cliff form above the structure are 'apparent' changes caused by survey difficulties on this steeply bevelled cliff face. In particular, the rock that outcrops at the seaward face of the cliff is showing apparent signs of change (see Appendix A - Beach Profile 1bSS14).

A slight change in alignment of the profile across the cliff section can result in an apparently large change in form simply due to different rock features being picked up on each survey.

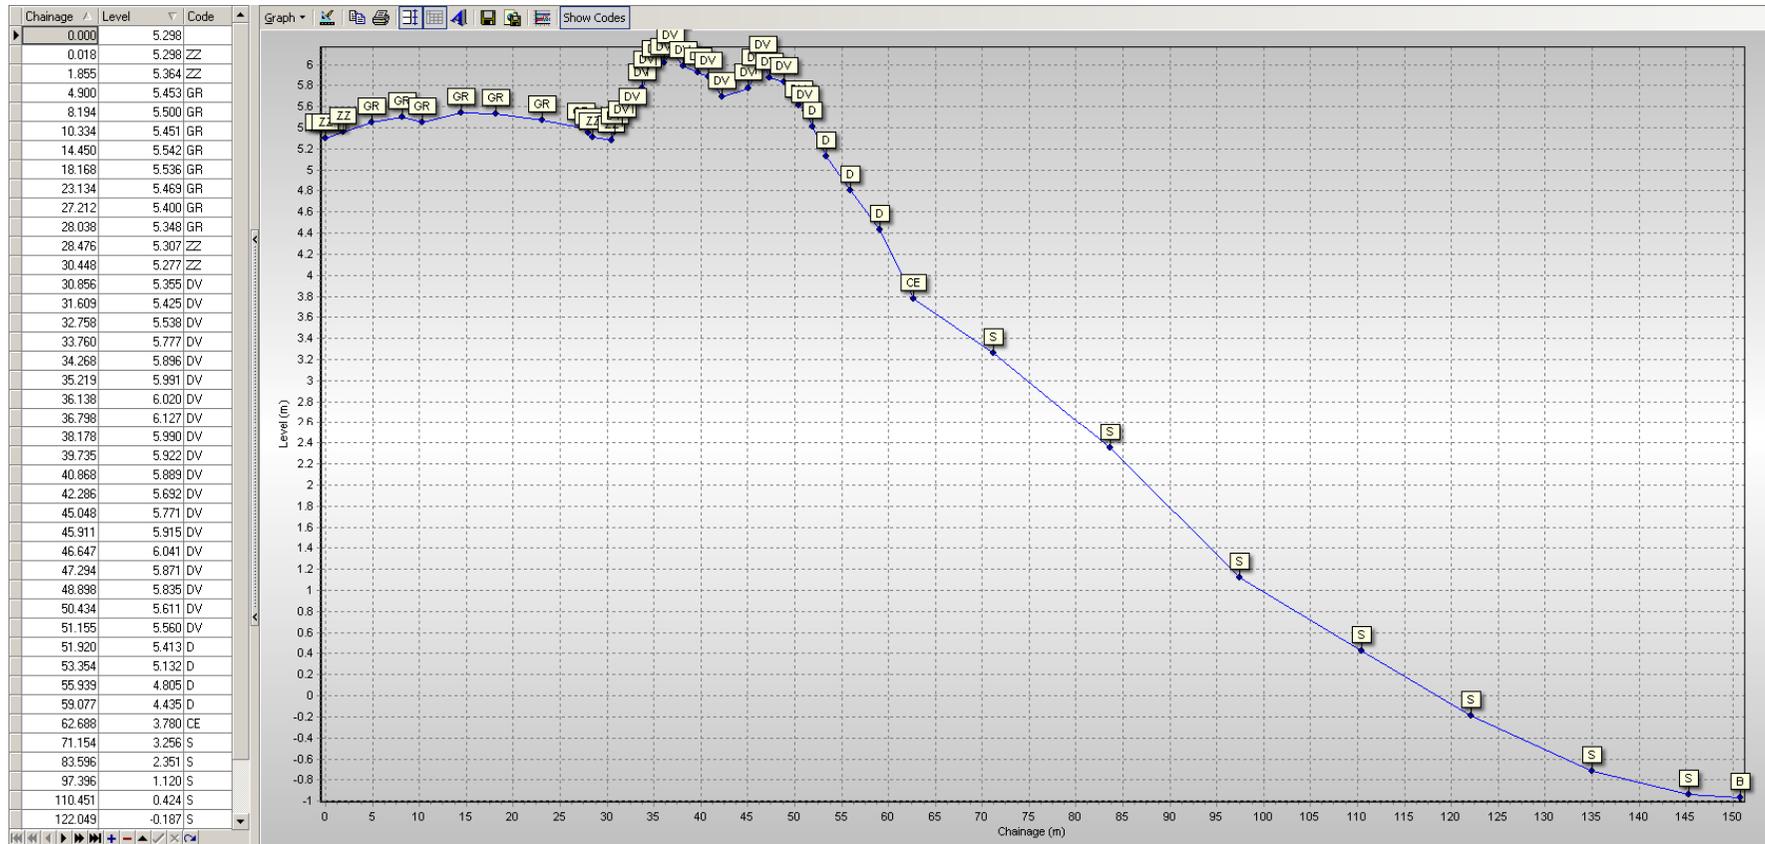
1bSS1 - 10/03/2011

Survey Date	Description of Changes Since Last Survey	Interpretation
03-2011	<p>Beach Profiles:</p> <p>Littlehaven Beach is covered by two beach profile lines during the Partial Measures survey (Appendix A). SS1 is located at the northern end of Littlehaven Beach, close to the South Groyne, and extends seawards across the foreshore from the undefended dunes which front the Little Haven Hotel. The foreshore, to a chainage of 115m, appears to have relatively high beach levels, with new record high values recorded along much of this length. A short length of foreshore at the toe of the dunes has slightly cut back, but sand appears to have been deposited on the dune face and landward of the dune crest.</p> <p>SS3 extends seawards from the protruding section of Littlehaven Sea Wall. Here beach levels remain healthy despite some minor flattening of the mid and upper profile, although levels at the toe of the sea wall are some 0.45m higher than those recorded in March 2010 when major overtopping occurred.</p>	<p>The undefended dunes and fronting foreshore along SS1 continue to remain healthy.</p> <p>Beach levels have recovered in front of Littlehaven Sea Wall since the record low values in March 2010, although there has been some minor flattening of the profile along the mid and upper beach sections since September 2010.</p>

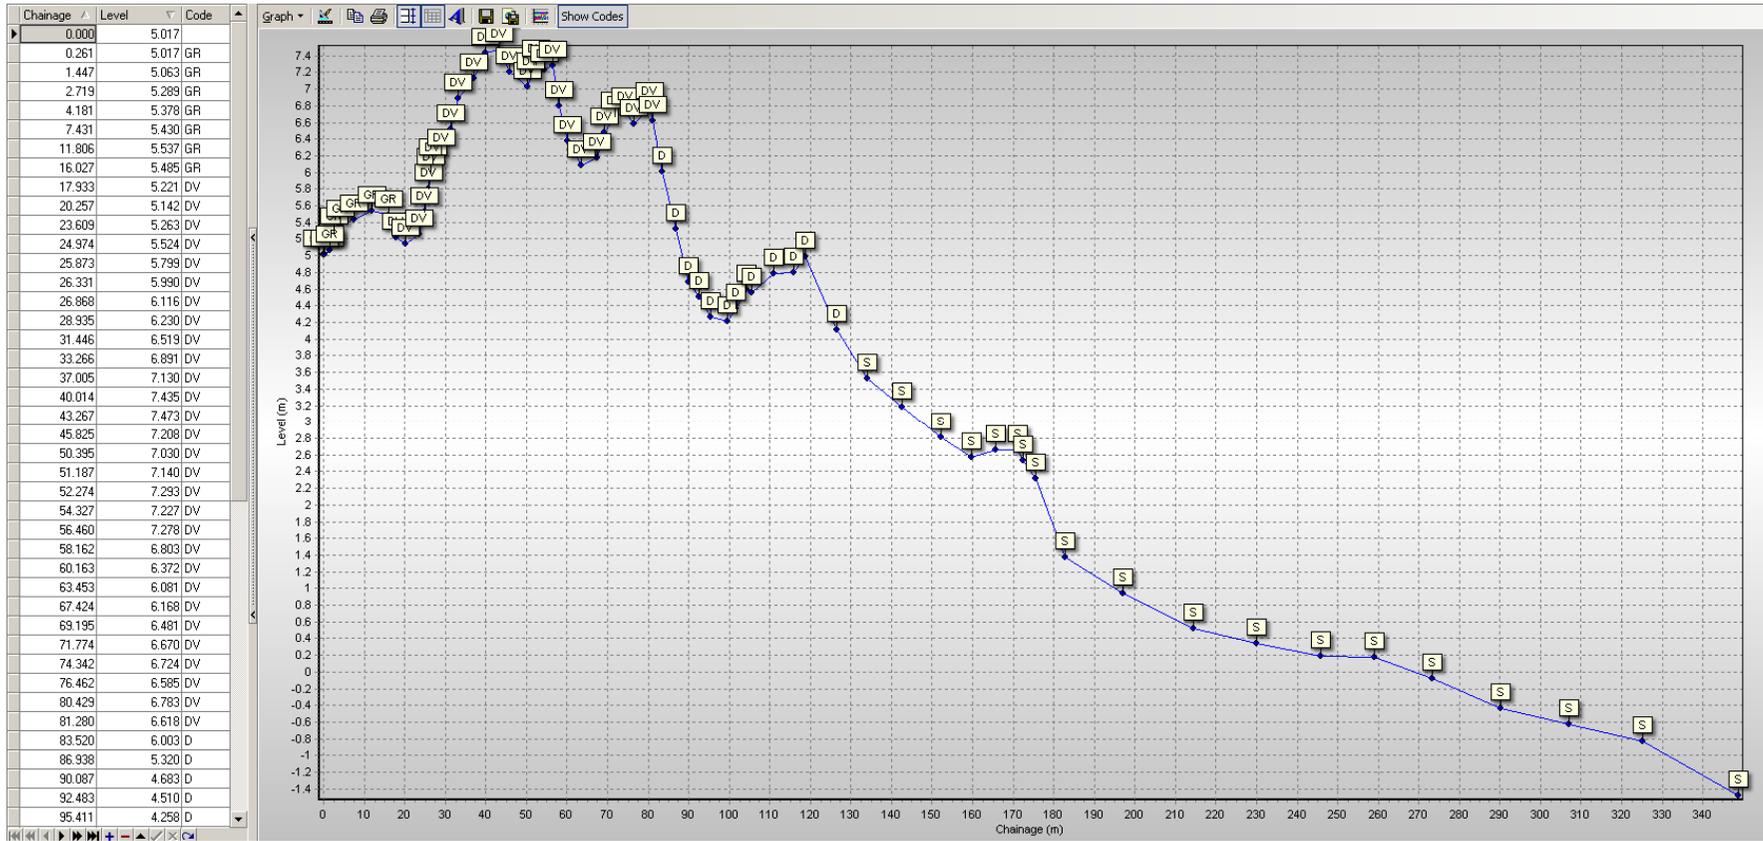
1bSS5 - 10/03/2011

Survey Date	Description of Changes Since Last Survey	Interpretation
03-2011	<p>Beach Profiles:</p> <p>Herd Sands is covered by three beach profile lines during the Partial Measures survey (Appendix A).</p> <p>SS5 showed little change along the dunes, although there was change in the level and chainage of the upper beach berm that is now located between MHWS and HAT (it was recorded above HAT in September 2010). Between a chainage of around 180m to around 320m, the foreshore levels were relatively low, caused mainly by the absence of the lower beach berm that was recorded in both March and September 2010.</p> <p>Profile SS8 shows a highly irregular beach form, with a series of berms separated by troughs. Notably, the beach levels between chainages of 45m to 90m are very low, setting new record low values. The gradient of the upper beach, between around MHWN and HAT, is very steep, matching the observations from March 2009. Another steep section, above HAT is in places near vertical and appears highly unnatural.</p> <p>SS9 showed low beach levels, especially between chainages of 65m and 135m. A small berm was apparent around HAT. The dunes appeared to have accreted slightly on their crest and seaward face.</p>	<p>Beach levels were relatively low along Herd Sands, although the dunes along the profiles in both the north and south of the bay were stable. Profile SS8, in front of Gypsies' Green, was highly irregular in appearance and along the upper beach an unnaturally steep gradient was recorded. This may have been affected by construction plant during the amenity enhancement works along the promenade.</p>

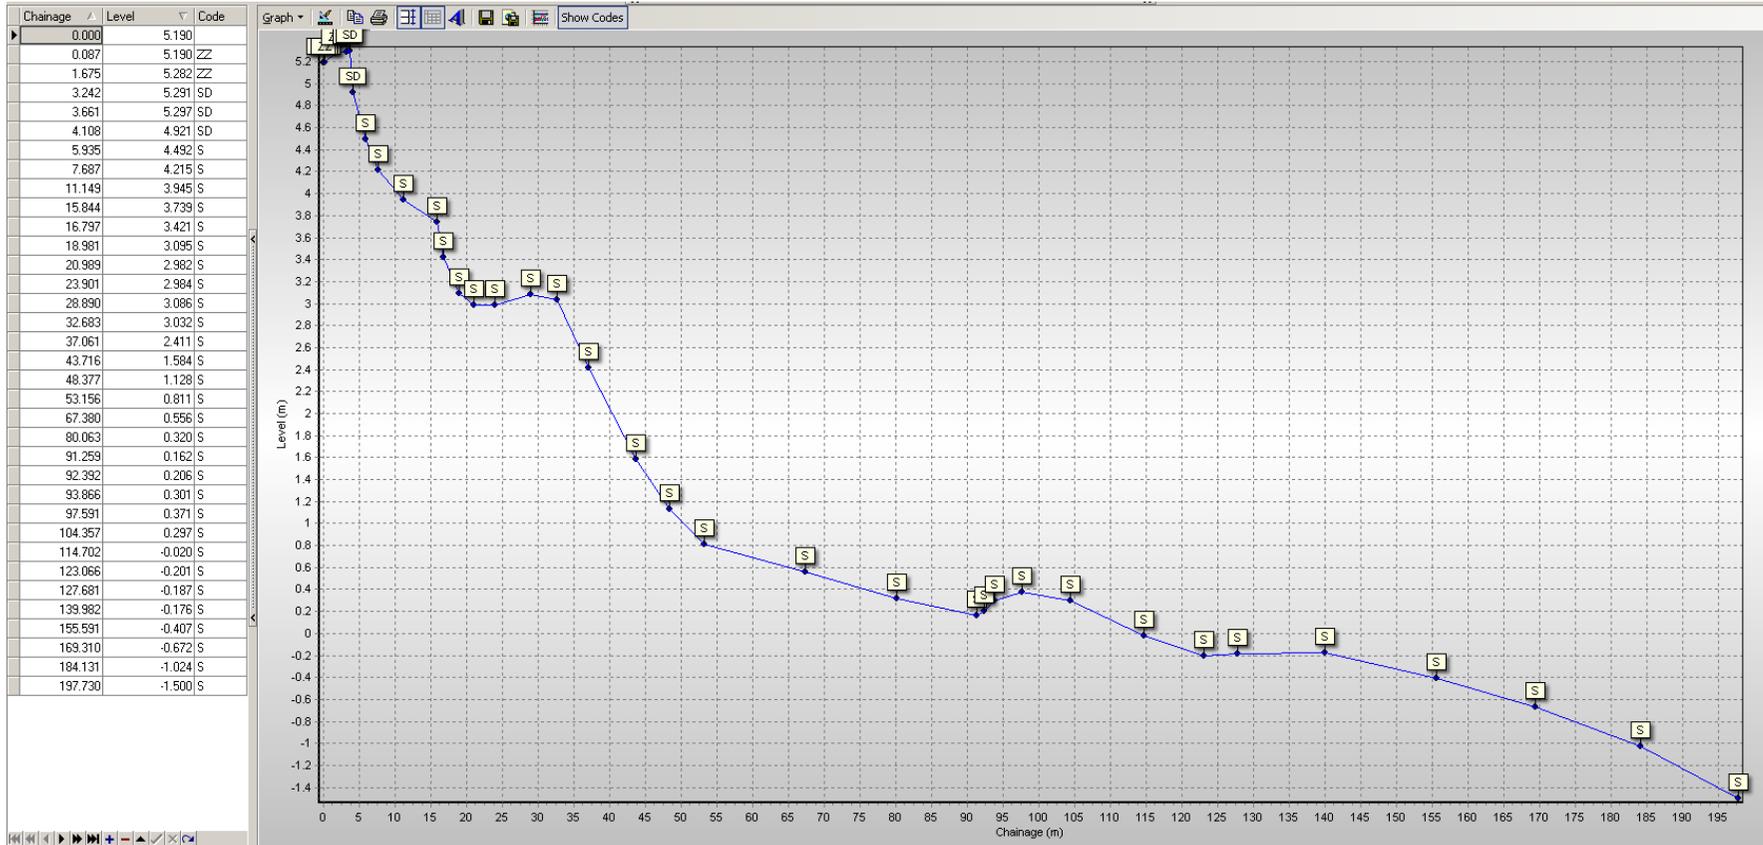
1bSS8 - 10/03/2011

It appears that the upper foreshore along SS8 may have been temporarily affected by construction plant during the amenity enhancement works along the promenade.

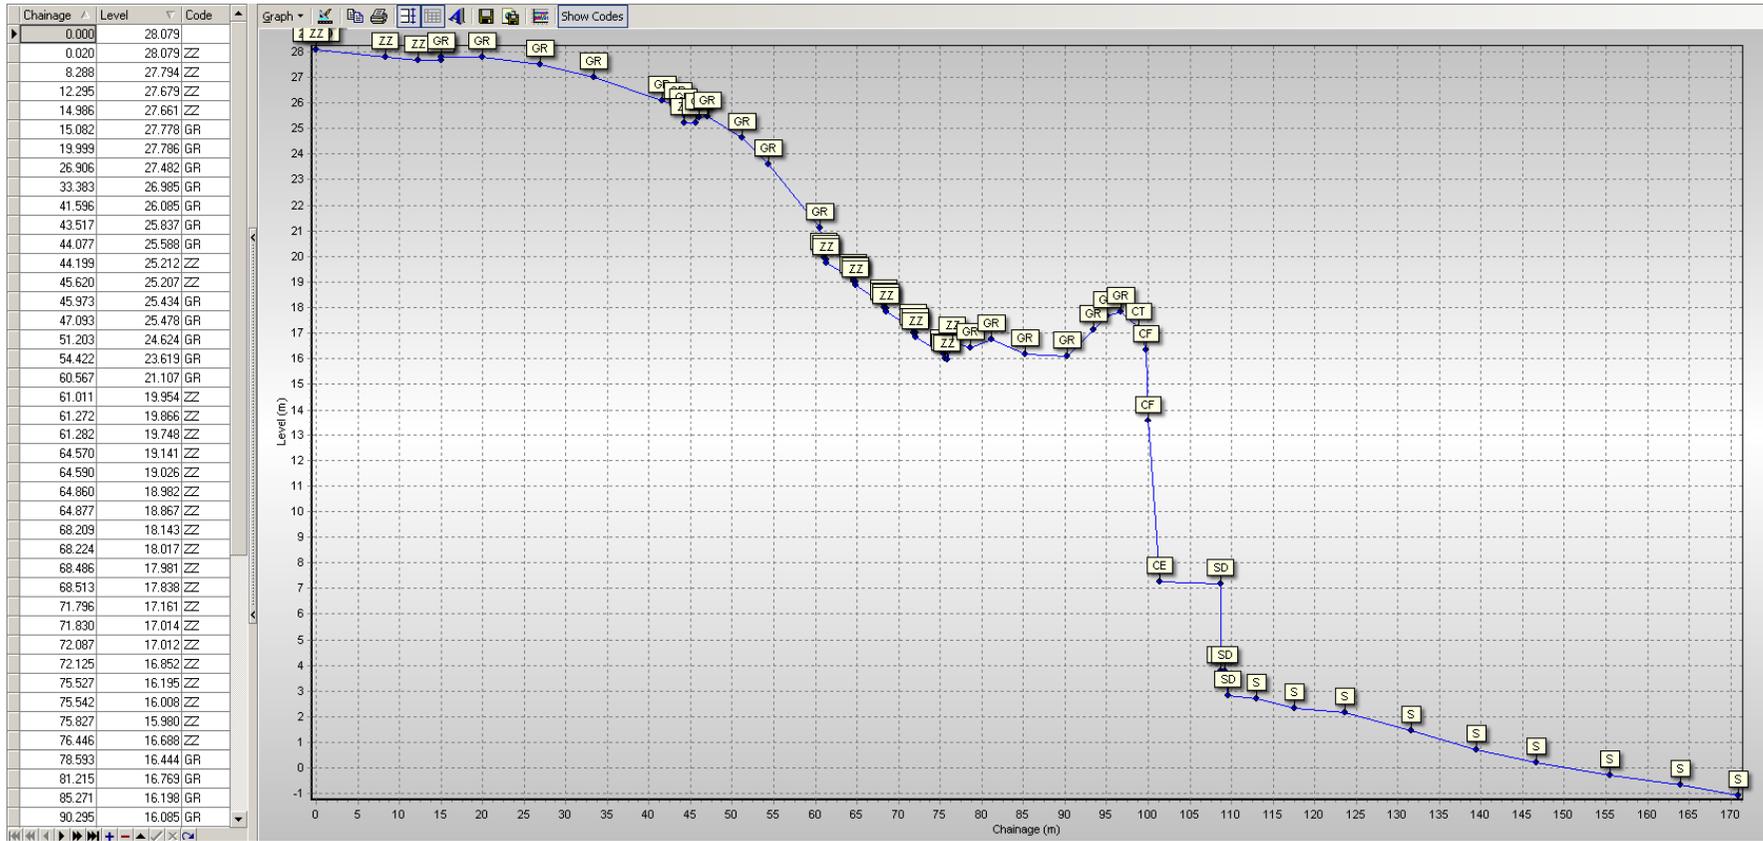
1bSS14 - 11/03/2011

Survey Date	Description of Changes Since Last Survey	Interpretation
03-2011	<p>Beach Profiles:</p> <p>Marsden Bay is covered by two beach profile lines during the Partial Measures survey (Appendix A).</p> <p>SS14 and SS15 both showed high foreshore levels and stability in the backing cliffs.</p>	<p>The cliffs along SS14 and SS15 remain stable and the foreshore levels were healthy.</p>

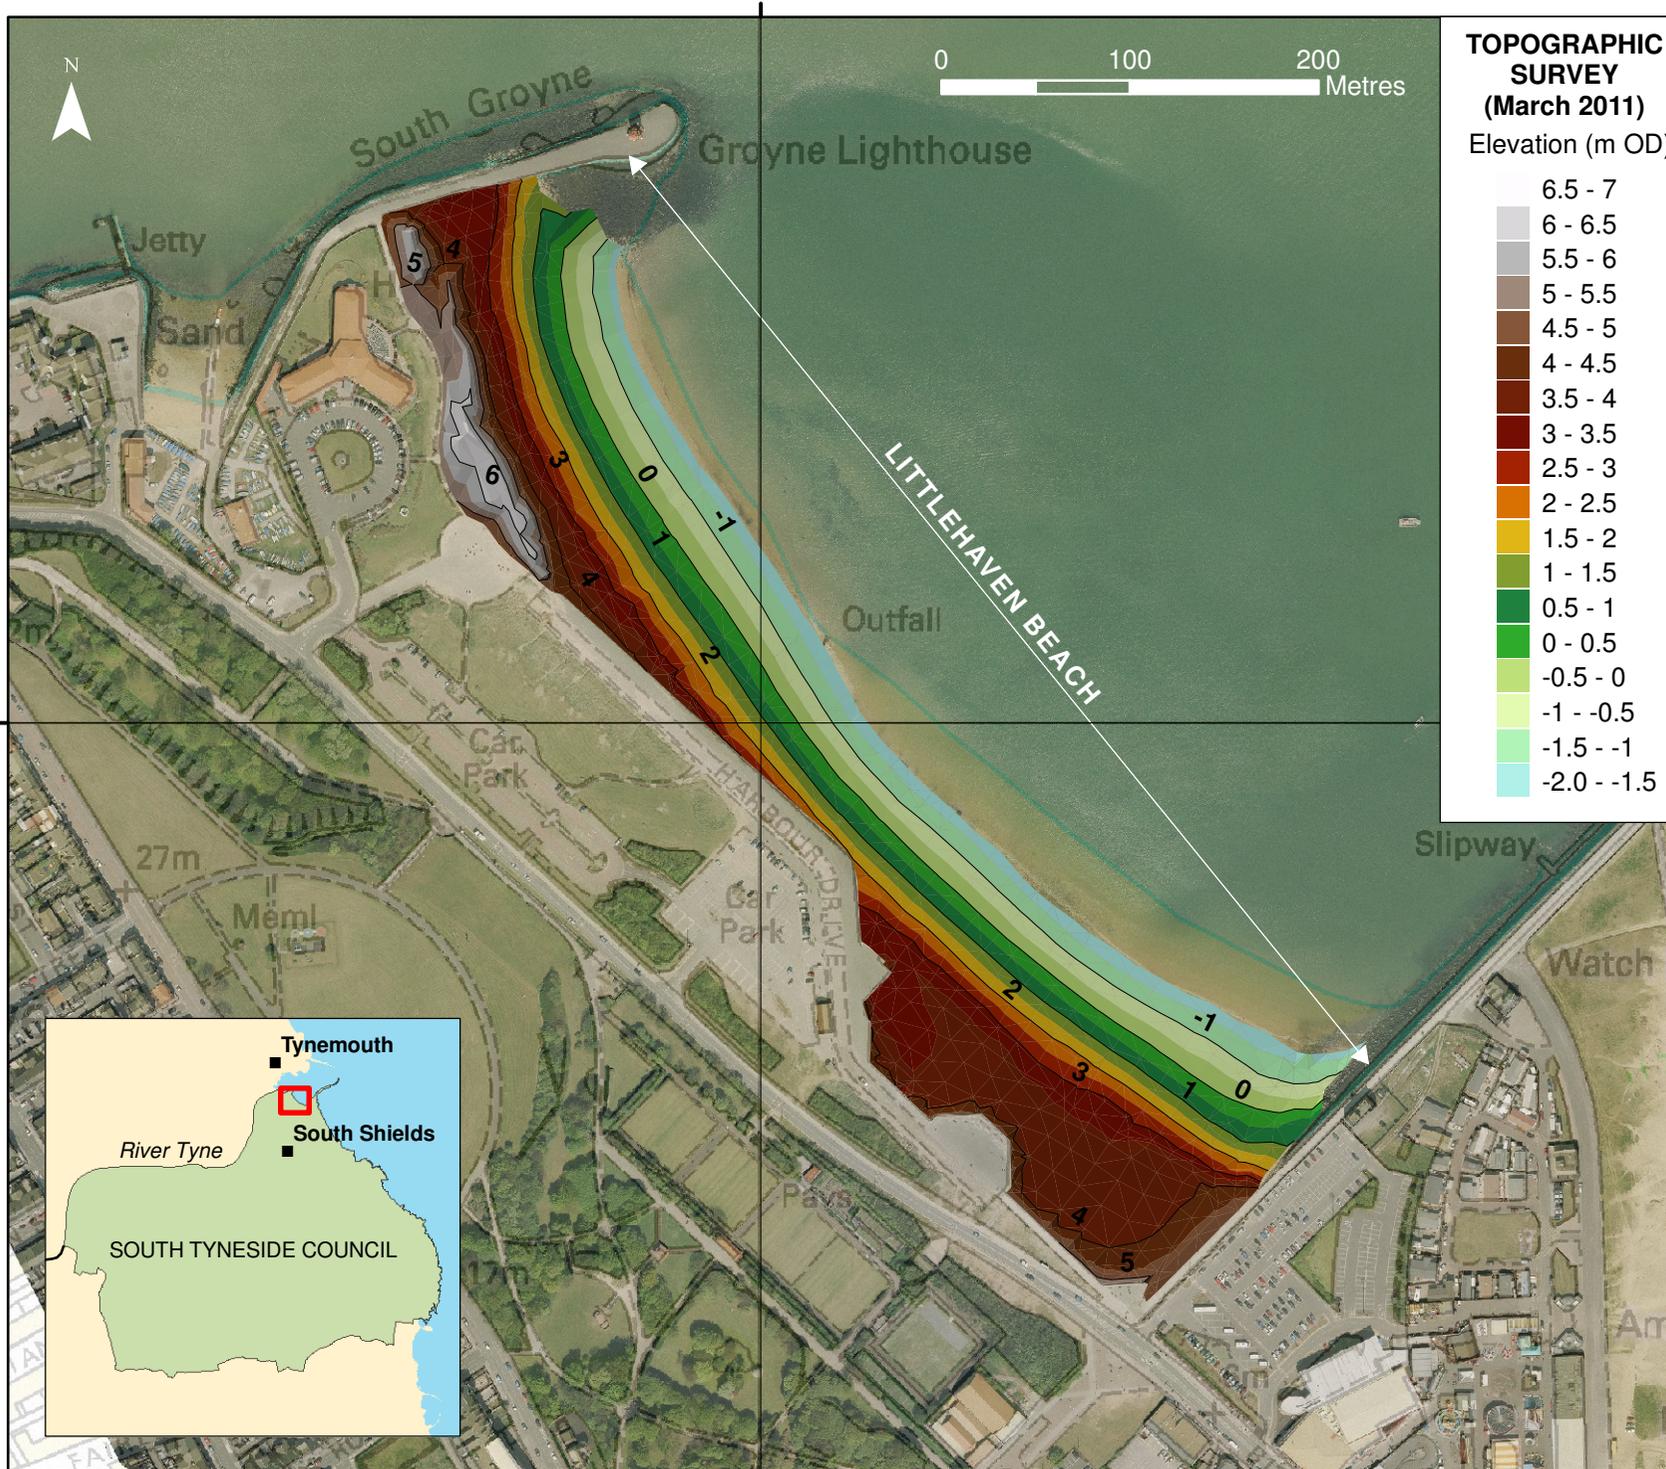
Appendix B - Map 1a
South Tyneside Council Frontage

03-2011	<p>Topographic Survey:</p> <p>Topographic surveys were introduced to the Cell 1 Regional Coastal Monitoring Programme along Littlehaven Beach in March 2010 and have been repeated at six-monthly intervals since. Data from the March 2011 survey have been used to create a DGM (Appendix B – Map 1a). This shows how the beach contours between 2.5 and 3.0mODN are interrupted by the protruding sea wall in the centre of the bay, with higher beach levels on the upper foreshore to both the north and south of this central section.</p> <p>Comparing the March 2011 survey against the earlier September 2010 data (Appendix B – Map 1b) it can be seen that along the central and southern frontages material has been flattened from the mid beach and deposited both along the upper and lower sections. In the north, the lower foreshore and dunes have accreted.</p>	<p>The northern section of frontage remains relatively well sheltered by the port structures and the dunes have shown some accretion since the last survey.</p> <p>Along Littlehaven Sea Wall the beach levels have adjusted slightly following the notable accretion recorded between march 2010 and September 2010, although they remain at healthy levels.</p> <p>The southern section continues to exhibit a wide healthy upper foreshore, with little change above the high water mark.</p>

— Topographic Contours at 1 metre interval

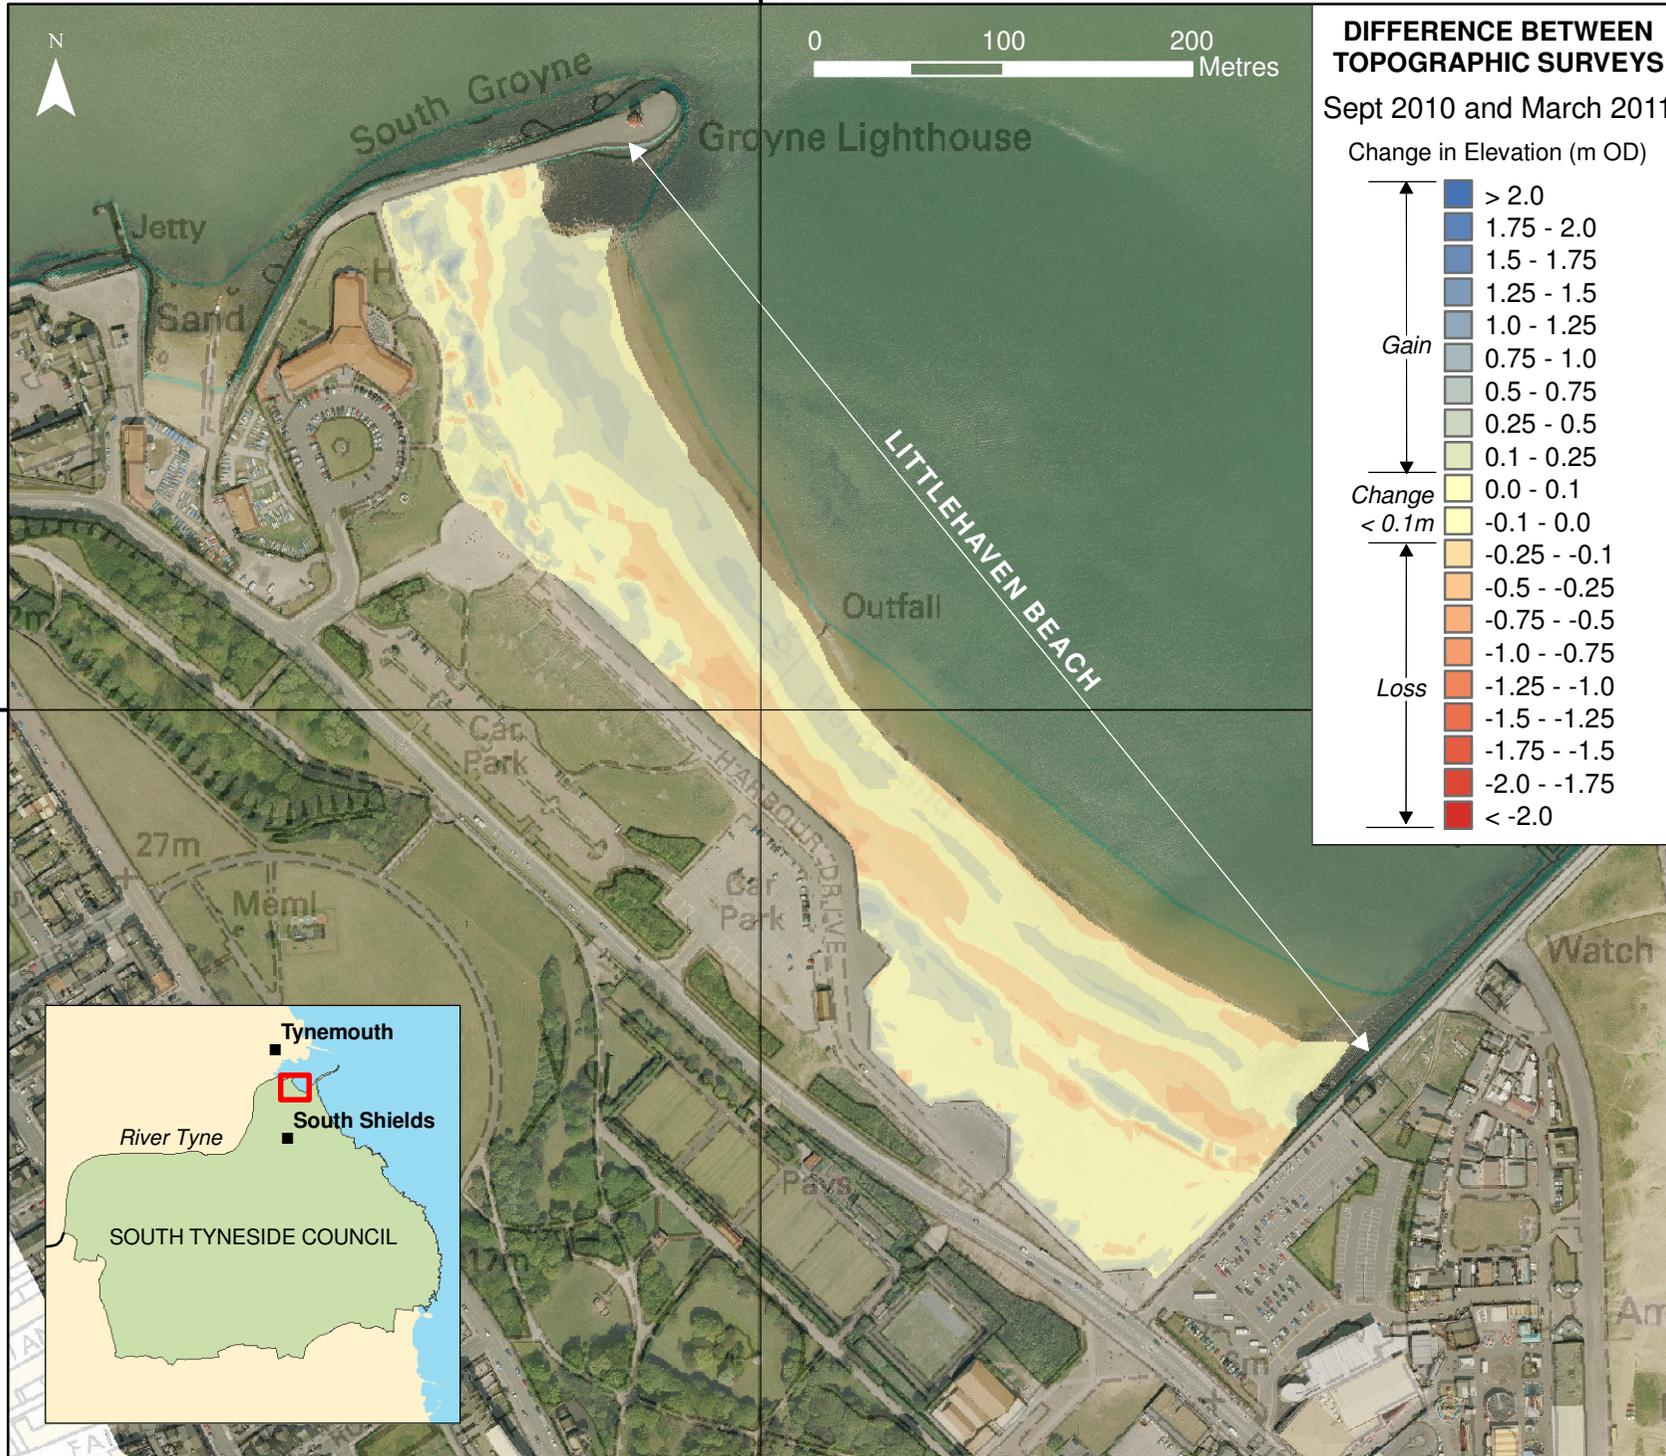
Appendix B - Map 1b
South Tyneside
Council Frontage

DIFFERENCE BETWEEN TOPOGRAPHIC SURVEYS
 Sept 2010 and March 2011

Change in Elevation (m OD)
