**Cell 1 Regional Coastal Monitoring Programme
Update Report 4: 'Partial Measures' Survey 2012**

**South Tyneside Council
Final Report**

(*) The present report is **Update Report 4** and provides an analysis of the 2012 Partial Measures survey for South Tyneside Council's frontage.

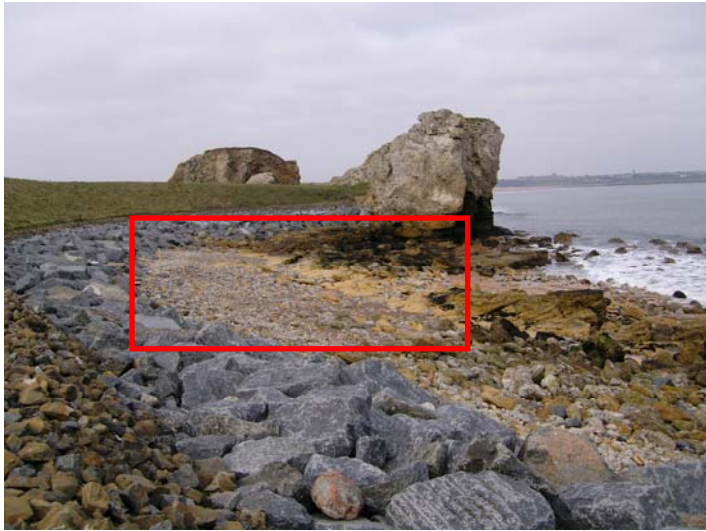
Plate 1 – Survey photograph 1bSS13_20120315_N5.JPG (PM 2012)

Survey Date	Description of Changes Since Last Survey	Interpretation
	<p>should be made to Appendix C – Map 1 for the location of ground control points.</p> <p>These cliff top surveys are undertaken bi-annually. Measurements are taken from each ground control point along a fixed bearing to the edge of the cliff top. The results from the cliff top monitoring are anticipated to have an accuracy of $\pm 0.2\text{m}$ due to the technique used.</p> <p>The results from the cliff top survey are presented in Appendix C – Table C1, showing the position from the ground control point to the edge of the cliff top along a defined bearing. Also shown is the change in measurement since the baseline (winter 2011) and current (spring 2012) cliff top surveys.</p> <p>Results show that erosion or an amount greater than the survey error has occurred 3 ground control points since the baseline survey in winter 2011. Other locations have not changed, or erosion is within the error band.</p> <p>Point 1, which is located on the north-west side of the headland, has eroded by up to 0.3m.</p> <p>Points 5 and 6, which are located on south-west side of the headland in Graham's Bay, have accreted up to 0.4m and 0.6m respectively. A beach profile has not been surveyed at this location so it is not possible to compare this to another dataset. The indicated cliff advance may result from survey of cliff fall debris, but is more likely to represent error in the survey, either due to misidentification of the cliff line, or error in the survey data. Review and analysis of the 2012 aerial photography will allow the nature of change to be better understood.</p>	<p>suggests that the south-west side is accreting, however, this is likely to represent survey error.</p>

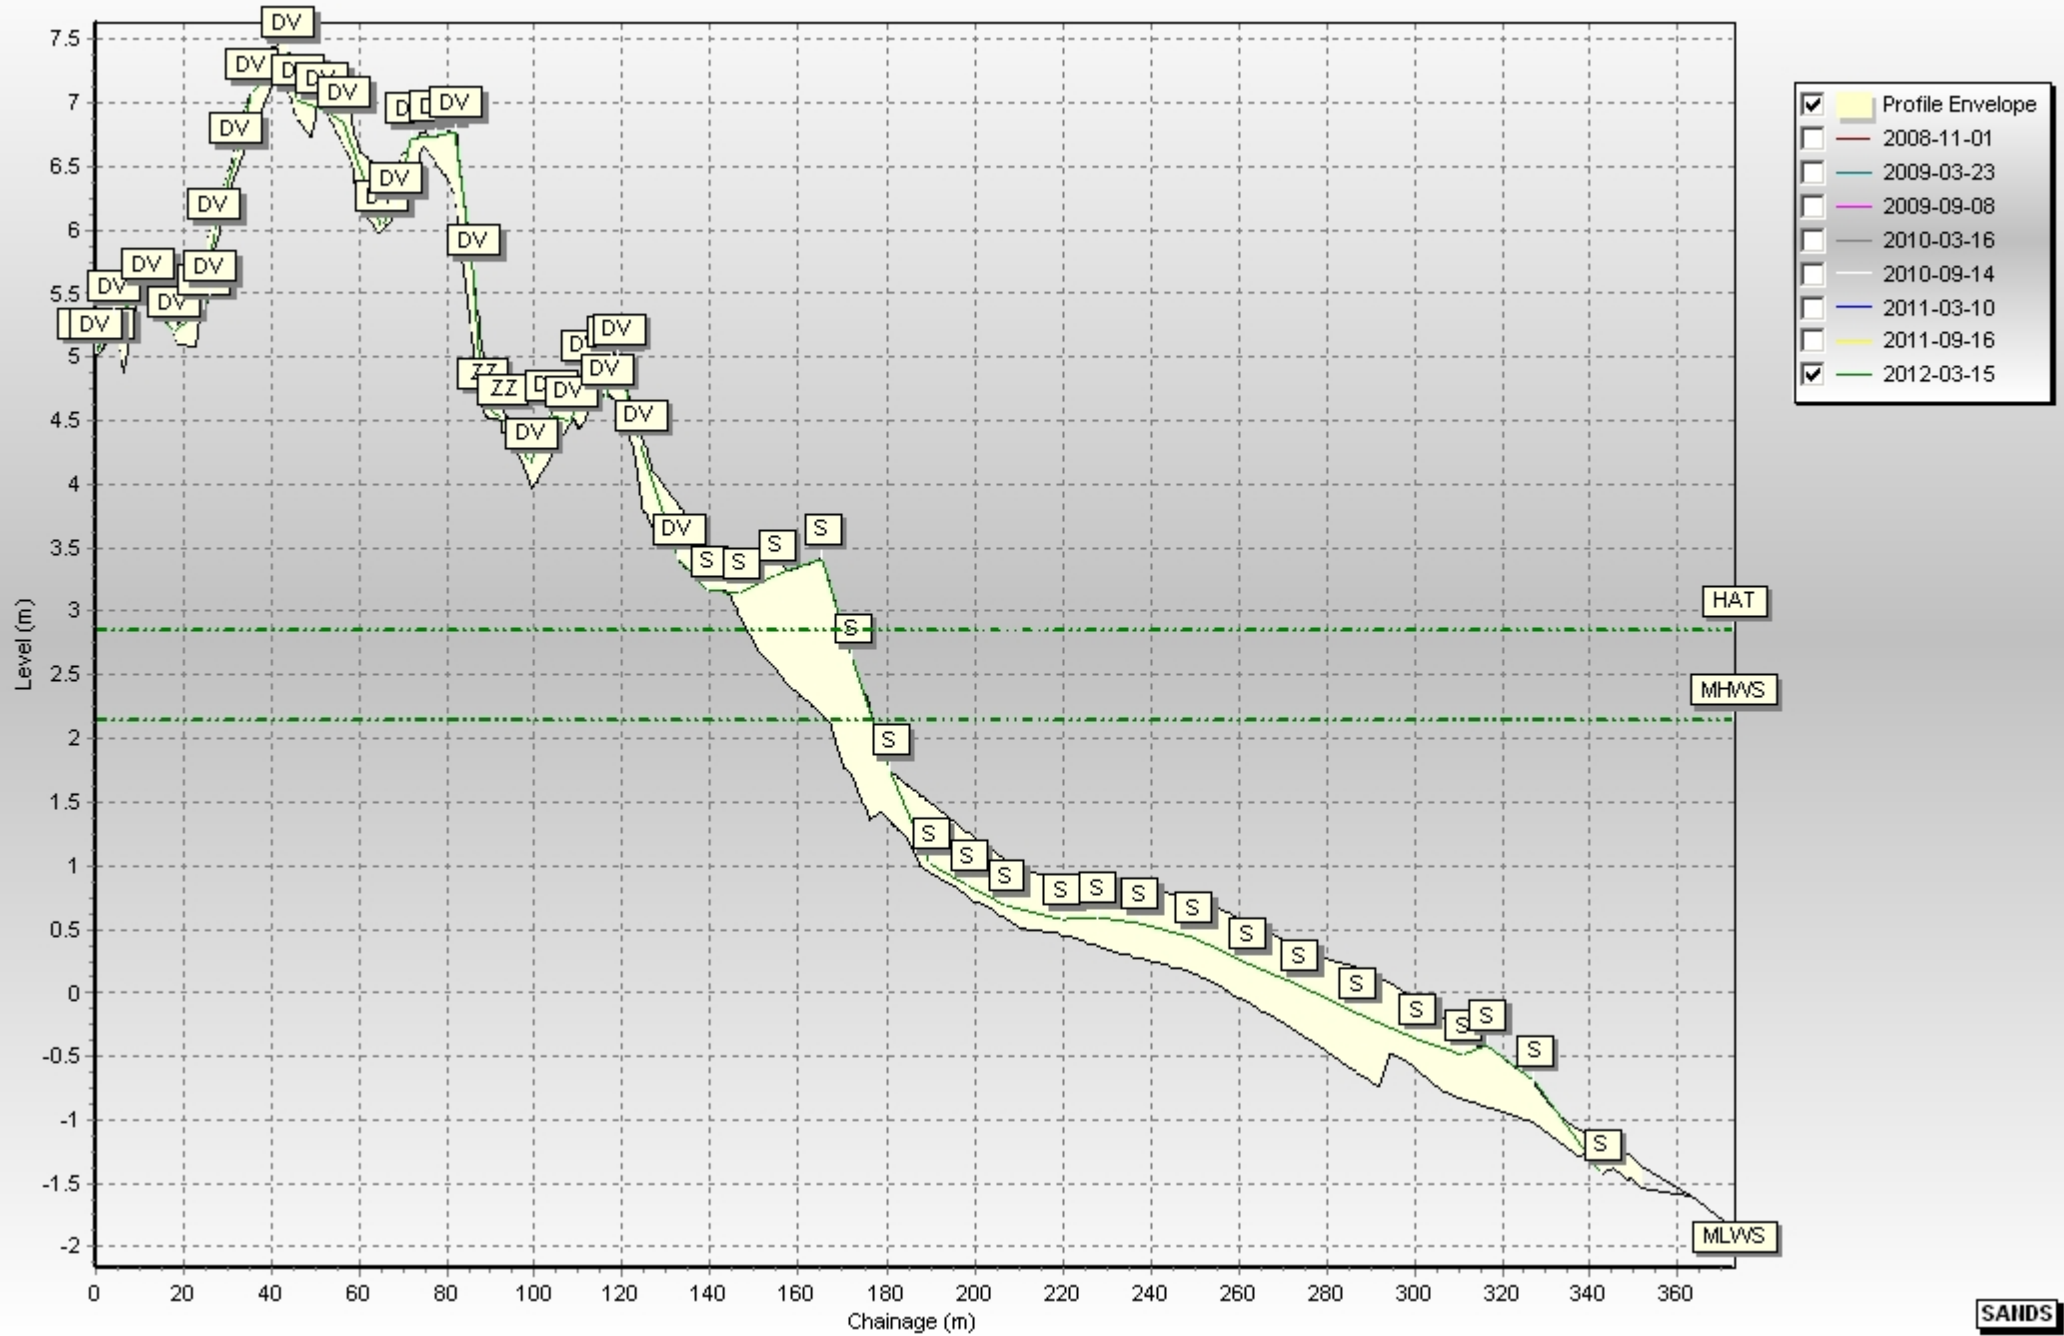
Beach Profiles: 1bSS5

Survey Date	Description of Changes Since Last Survey	Interpretation
Mar 2012	<p>Beach Profiles:</p> <p>Herd Sands is covered by three beach profile lines for the Partial Measures survey (Appendix A). The previous survey was the full measures survey undertaken in winter 2011.</p> <p>Profile 1bSS5 is located to the north of Herd Sands and is located in the lee of the breakwater. The dunes have largely retained a similar form since the last survey. Between a chainage of 130m and 180m, around a height 3.4m, the dunes have eroded, however, on the dune face and across the beach profile, levels have increased by approximately 0.2m.</p> <p>Profile 1bSS8 is located to south of Herd Sands. Since the last survey, beach levels above HAT have increased by up to 0.5m. From MHWS to the end of the profile, beach levels have oscillated, with an increase in the order of 0.2m between 65m and 110m chainage and a fall of the same magnitude seaward of 110m chainage.</p> <p>Profile 1bSS9 is located to south of Herd Sands. The dune face has retained the same form and position since the last survey. Beach levels have generally increased across the length of the profile, particularly at the toe of the dunes, between a chainage of 25m and 60m and 75m and 155m. The profile was last at this level in September 2009. The beach berm remains present, however seaward of there, the profile has flattened.</p>	<p>Since the last survey, the beach at Herd Sands has shown an accretionary trend. To the south, in particular, beach levels have increased above HAT and a level of 1m and -1m. As described in the previous survey report, this accretion is probably related to the transport of material across the beach by wind and wave activity.</p> <p>Longer term trends: Generally the changes observed since the last survey are within the bounds of previous surveys. To the north at 1bSS5, the berm at HAT is the highest observed since November 2008 (full measures, winter 2008) To the south, the changes observed are within the bounds of previous surveys.</p>

At profile 1bSS5, numerous sand fences have been installed in the dunes at start of the section. The next full measures survey (winter, 2012) should show the impact that they have had on sediment retention on the beach.

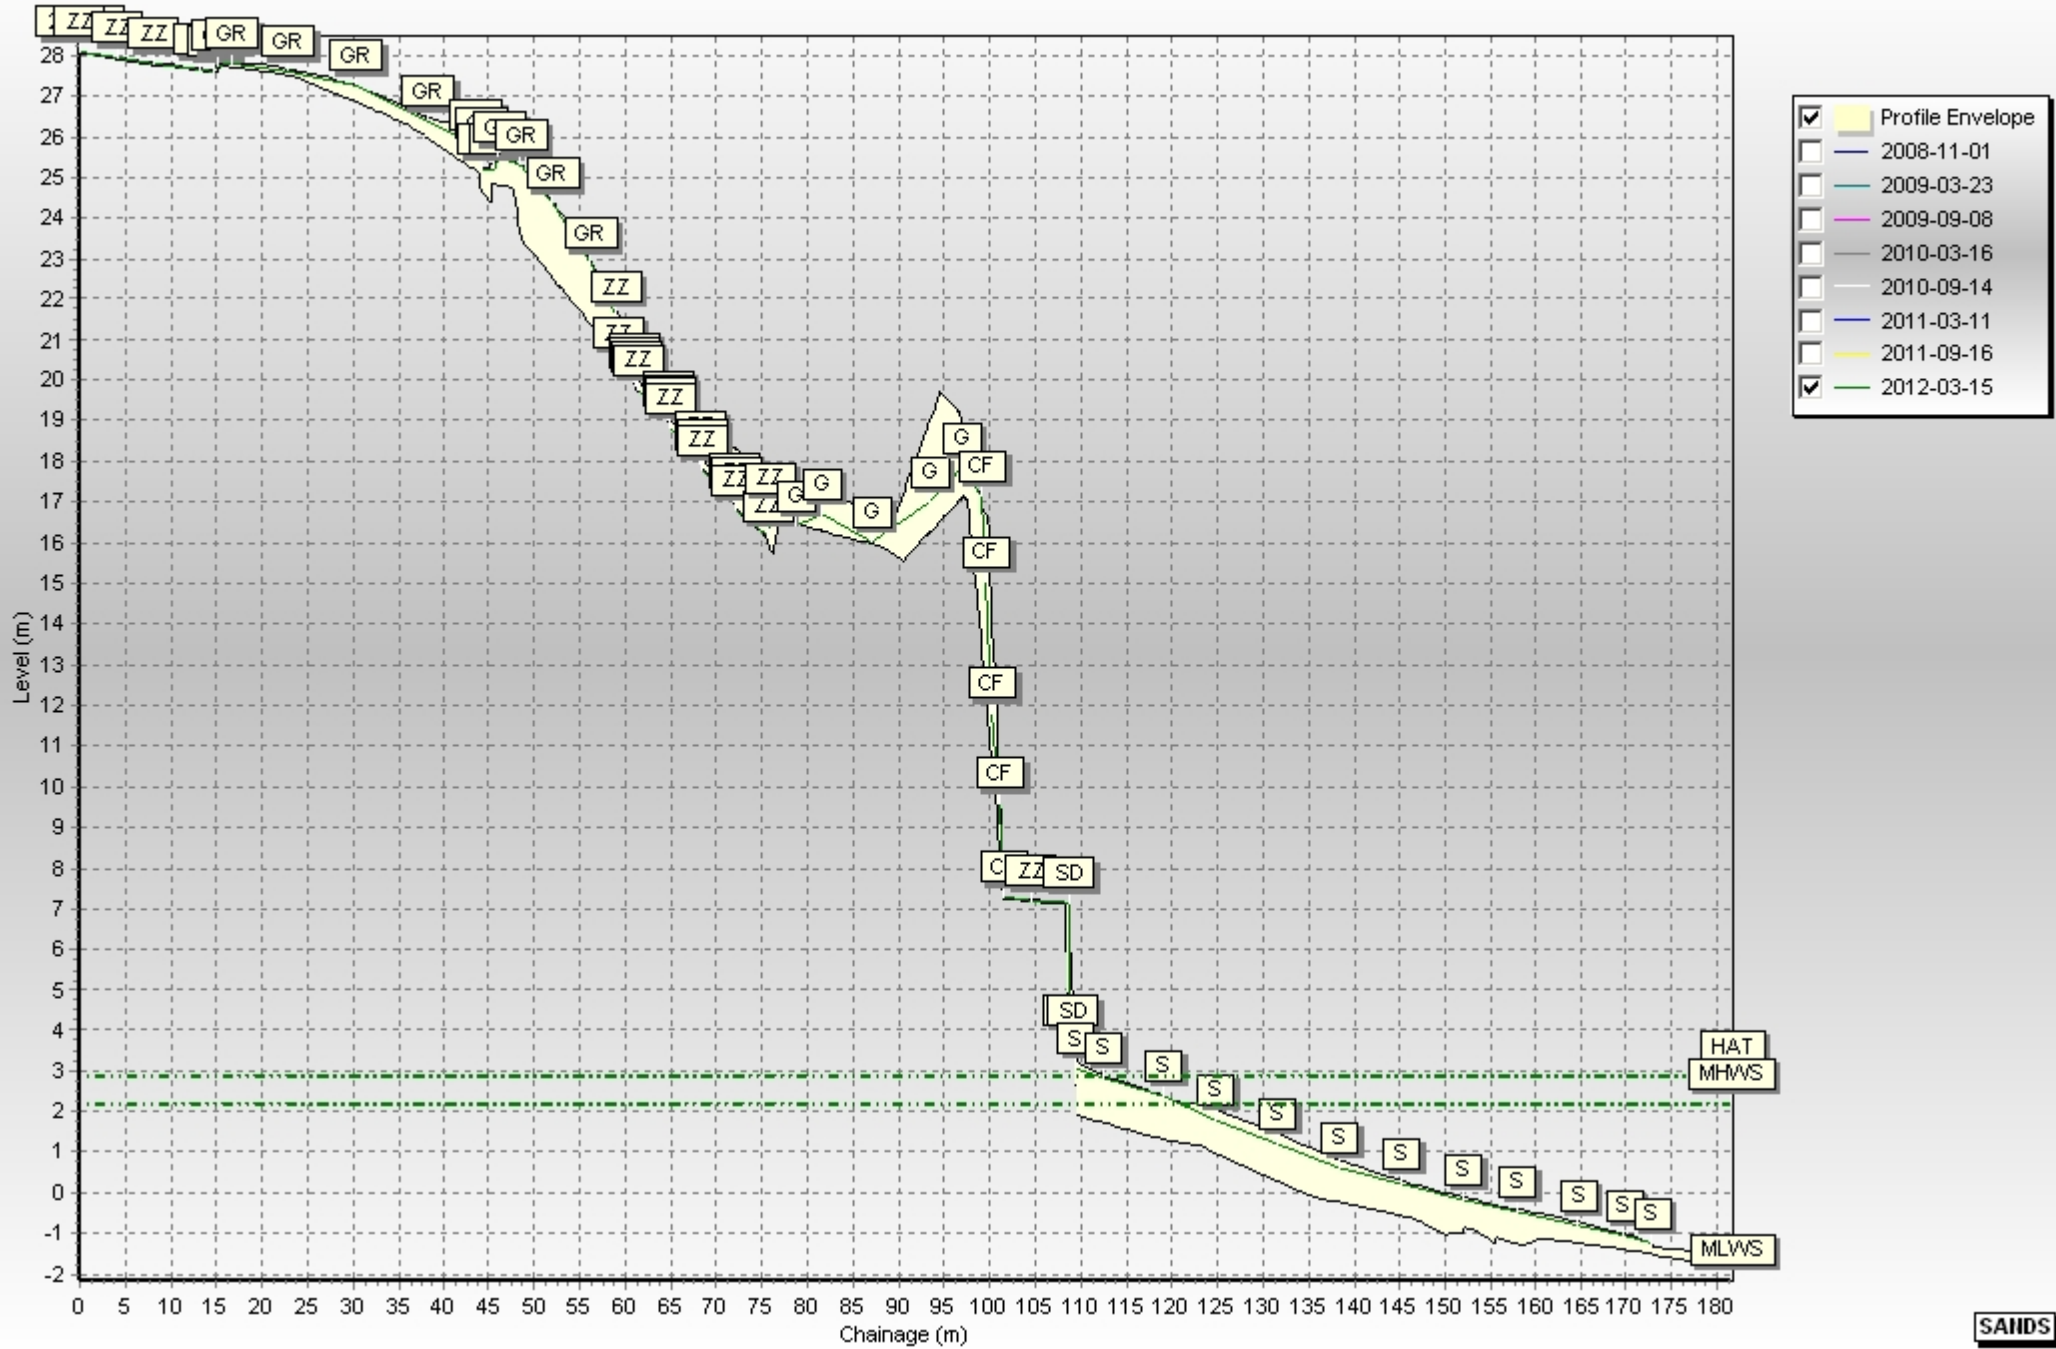
Beach Profiles: 1bSS14

Survey Date	Description of Changes Since Last Survey	Interpretation
Mar 2012	<p>Beach Profiles:</p> <p>Marsden Bay is covered by two beach profile lines for the Partial Measures survey (Appendix A). The previous survey was the full measures survey undertaken in winter 2011.</p> <p>Profile 1bSS14 is located to the north of the bay and covers the cliffs and former lifeguard station adjacent to the Redwell Steps. The cliff has retained the same form and position since the last survey. Beach levels seaward of HAT have increased by approximately 0.2m across the profile.</p> <p>Profile 1bSS17 is located to the south of the bay. Since the last survey, the cliff has retained the same form and position. Beach levels at the toe of the cliff to a chainage of 70m have remained stable since the last survey. From 75m to 95m chainage, beach levels have lowered by approximately 0.2m and between 95m and 115m, beach levels have increased by approximately 0.2m. This is likely to represent cross-shore transport of material and draw-down during winter storms.</p>	<p>The cliffs in Marsden Bay have retained the same form and position since the last survey (full measures, winter 2011).</p> <p>To the north of the Marsden Bay there has been a small level of beach accretion.</p> <p>To the south, the beach fronting the cliffs has remained stable with no change in form or position. Beach lowering on the middle beach has occurred alongside beach level increase on the lower beach suggesting draw-down of sediment during winter storms.</p> <p>Longer term trends: Although beach movements are observed since the last survey, the overall change is within the bounds of changes observed since the first survey in November 2008. The beach to the south of Marsden Bay is particularly stable with movements within a range of 0.3m since November 2008.</p>

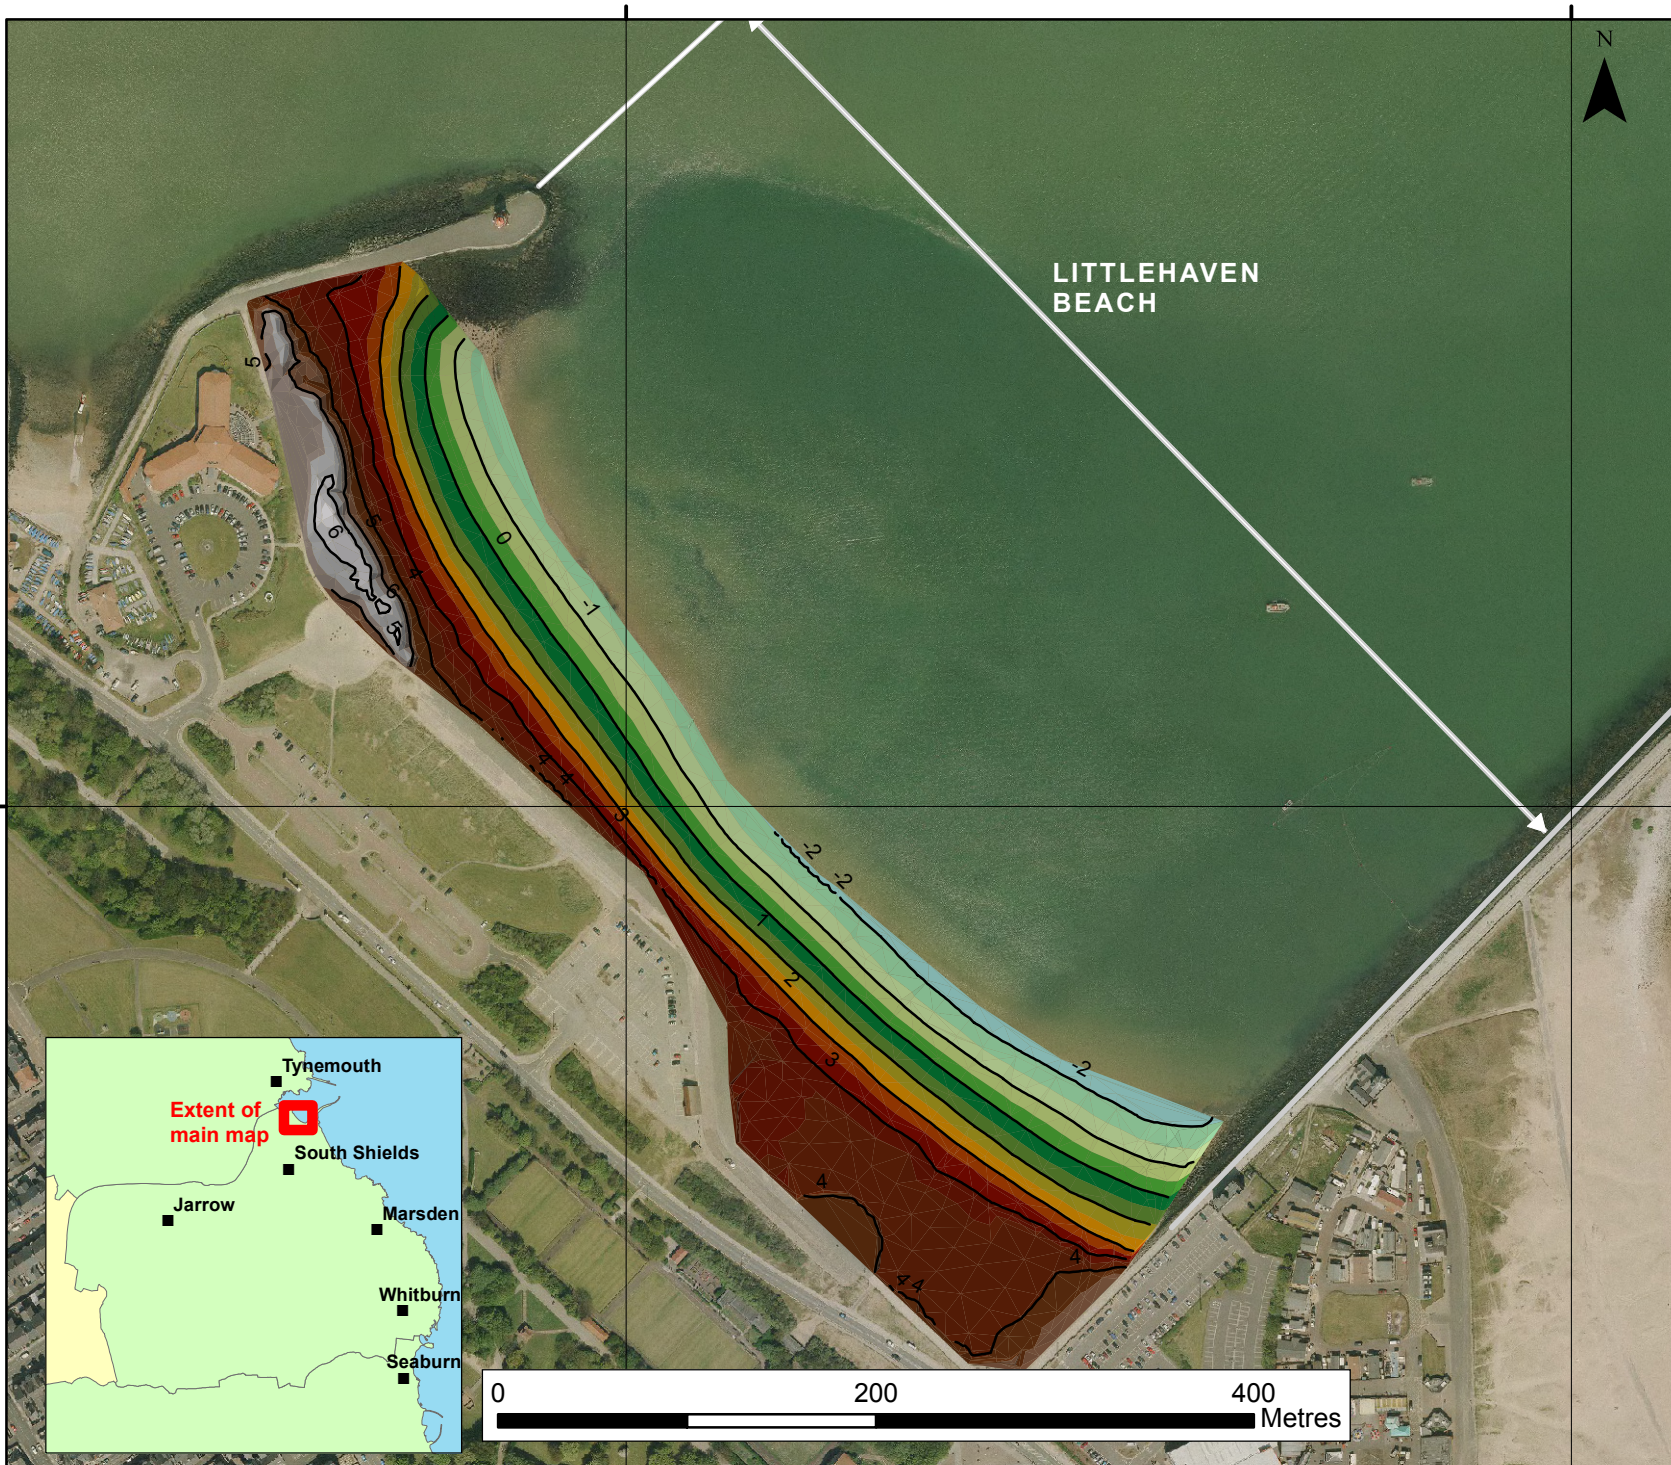
**Appendix B- Map 1a
Topographic Survey
Littlehaven Beach
South Tyneside Council**

Mar 2012	<p>Topographic Survey:</p> <p>Littlehaven Beach is covered by bi-annual topographic survey between the South Groyne and the South Pier, which commenced in March 2010. Data from the most recent topographic survey (full measures, winter 2011) have been used to create a DGM (Appendix B – Map 1a) using a Geographical Information System (GIS). A difference plot has also been produced using the DGM (Appendix B – Map 1b) produced from the last produced topographic survey (partial measures, spring 2011) and the present</p>	<p>Similarly to the previous survey, generally beach elevation changes are in the region of 0 to +/-0.5m. There has been some accretion along the backshore in small pockets. There has been a slight decrease in beach elevation to the north on the upper beach and to the south on the middle beach. Otherwise the beach has generally remained stable.</p>

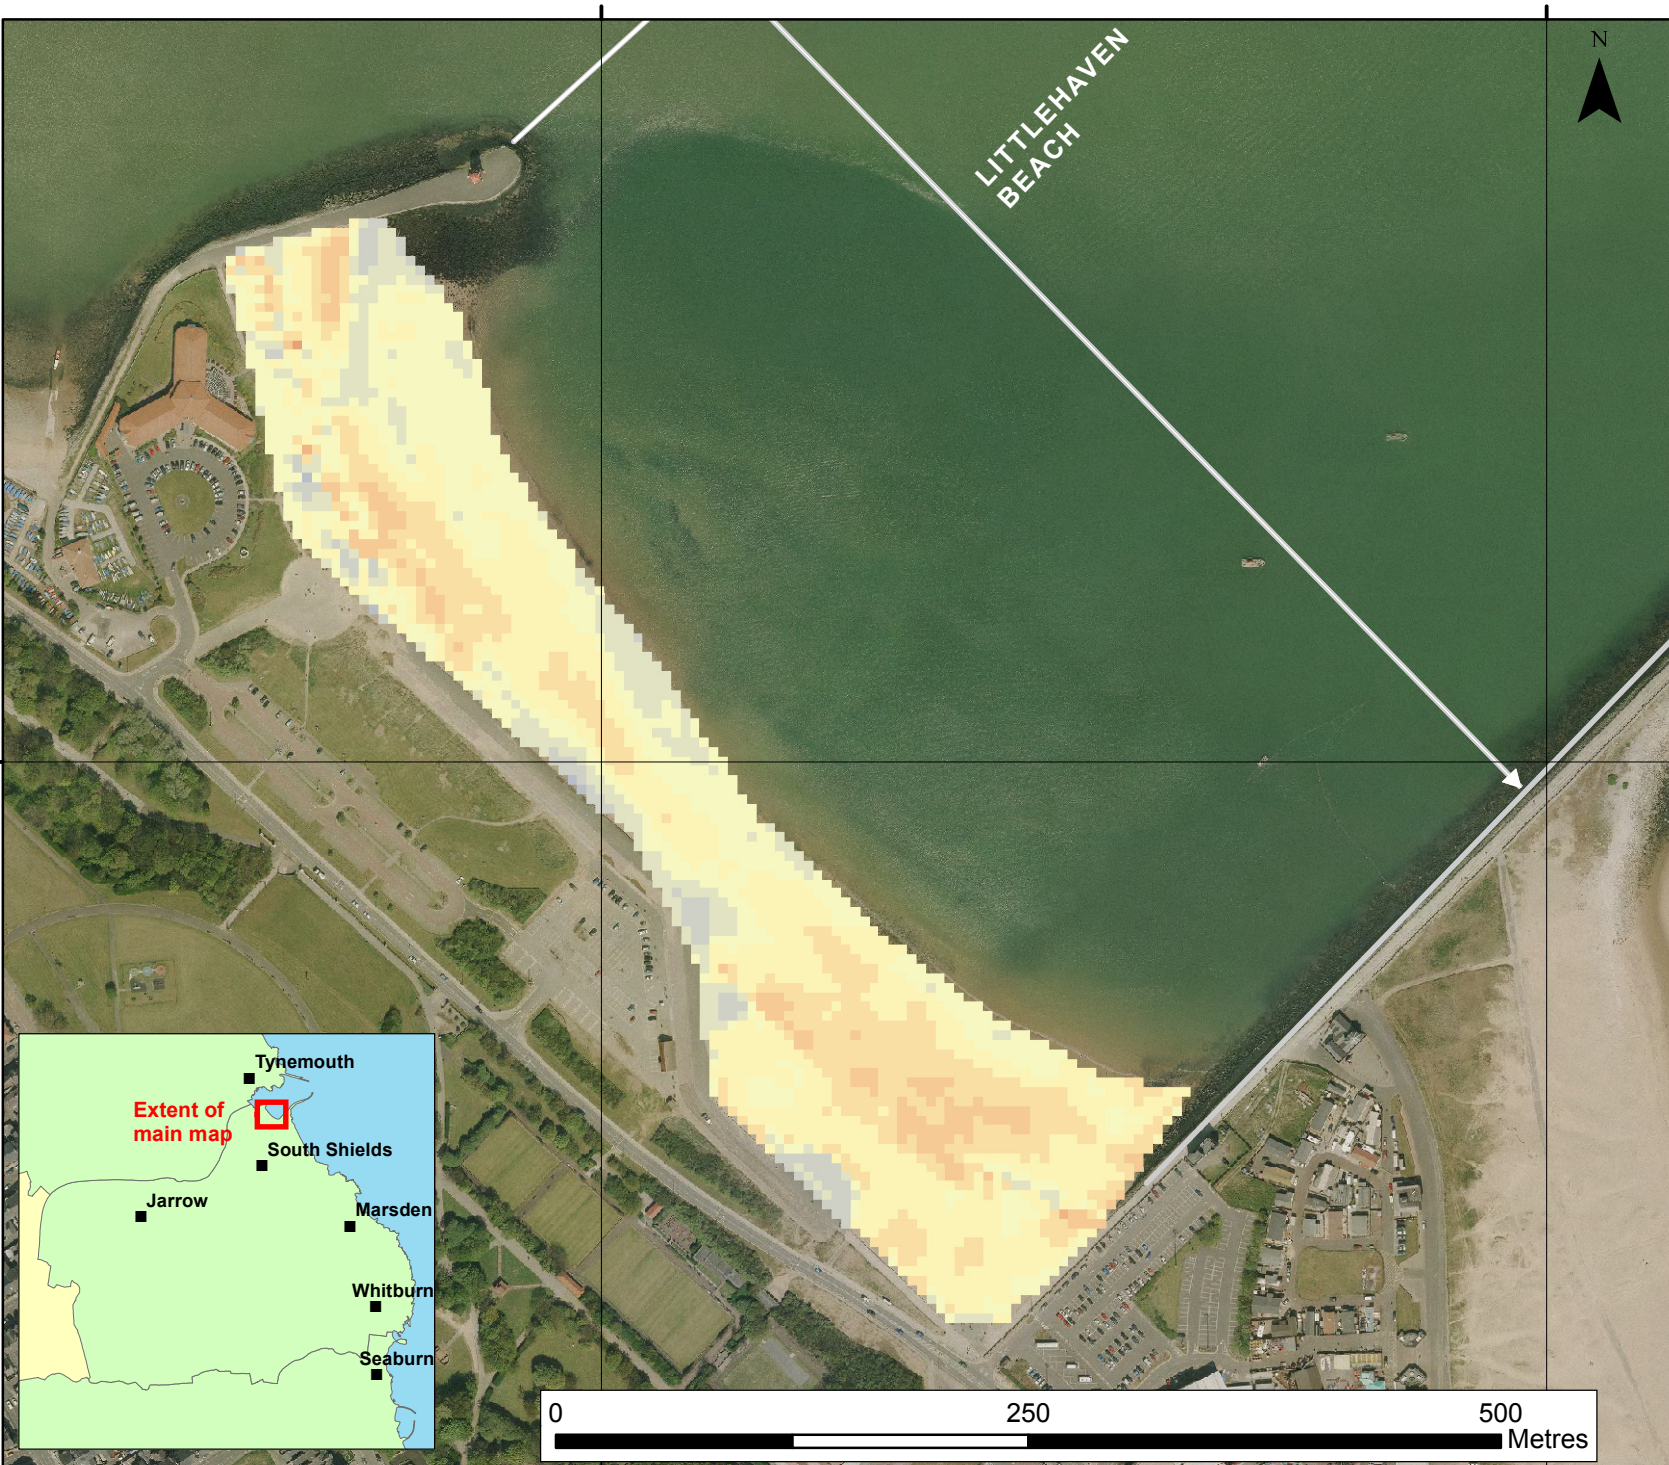
**Appendix B- Map 1b
Topographic Difference
Littlehaven Beach
South Tyneside Council**

Survey Date	Description of Changes Since Last Survey	Interpretation
	<p>survey.</p> <p>In particular, the difference plot shows: (i) a general pattern of change of less than 0.1m, with some small gain in the region of 0.1 to 0.25m; (ii) beach elevation loss to the north on the upper beach and to the south on the middle beach; and (ii) pockets of beach elevation gain along the backshore.</p>

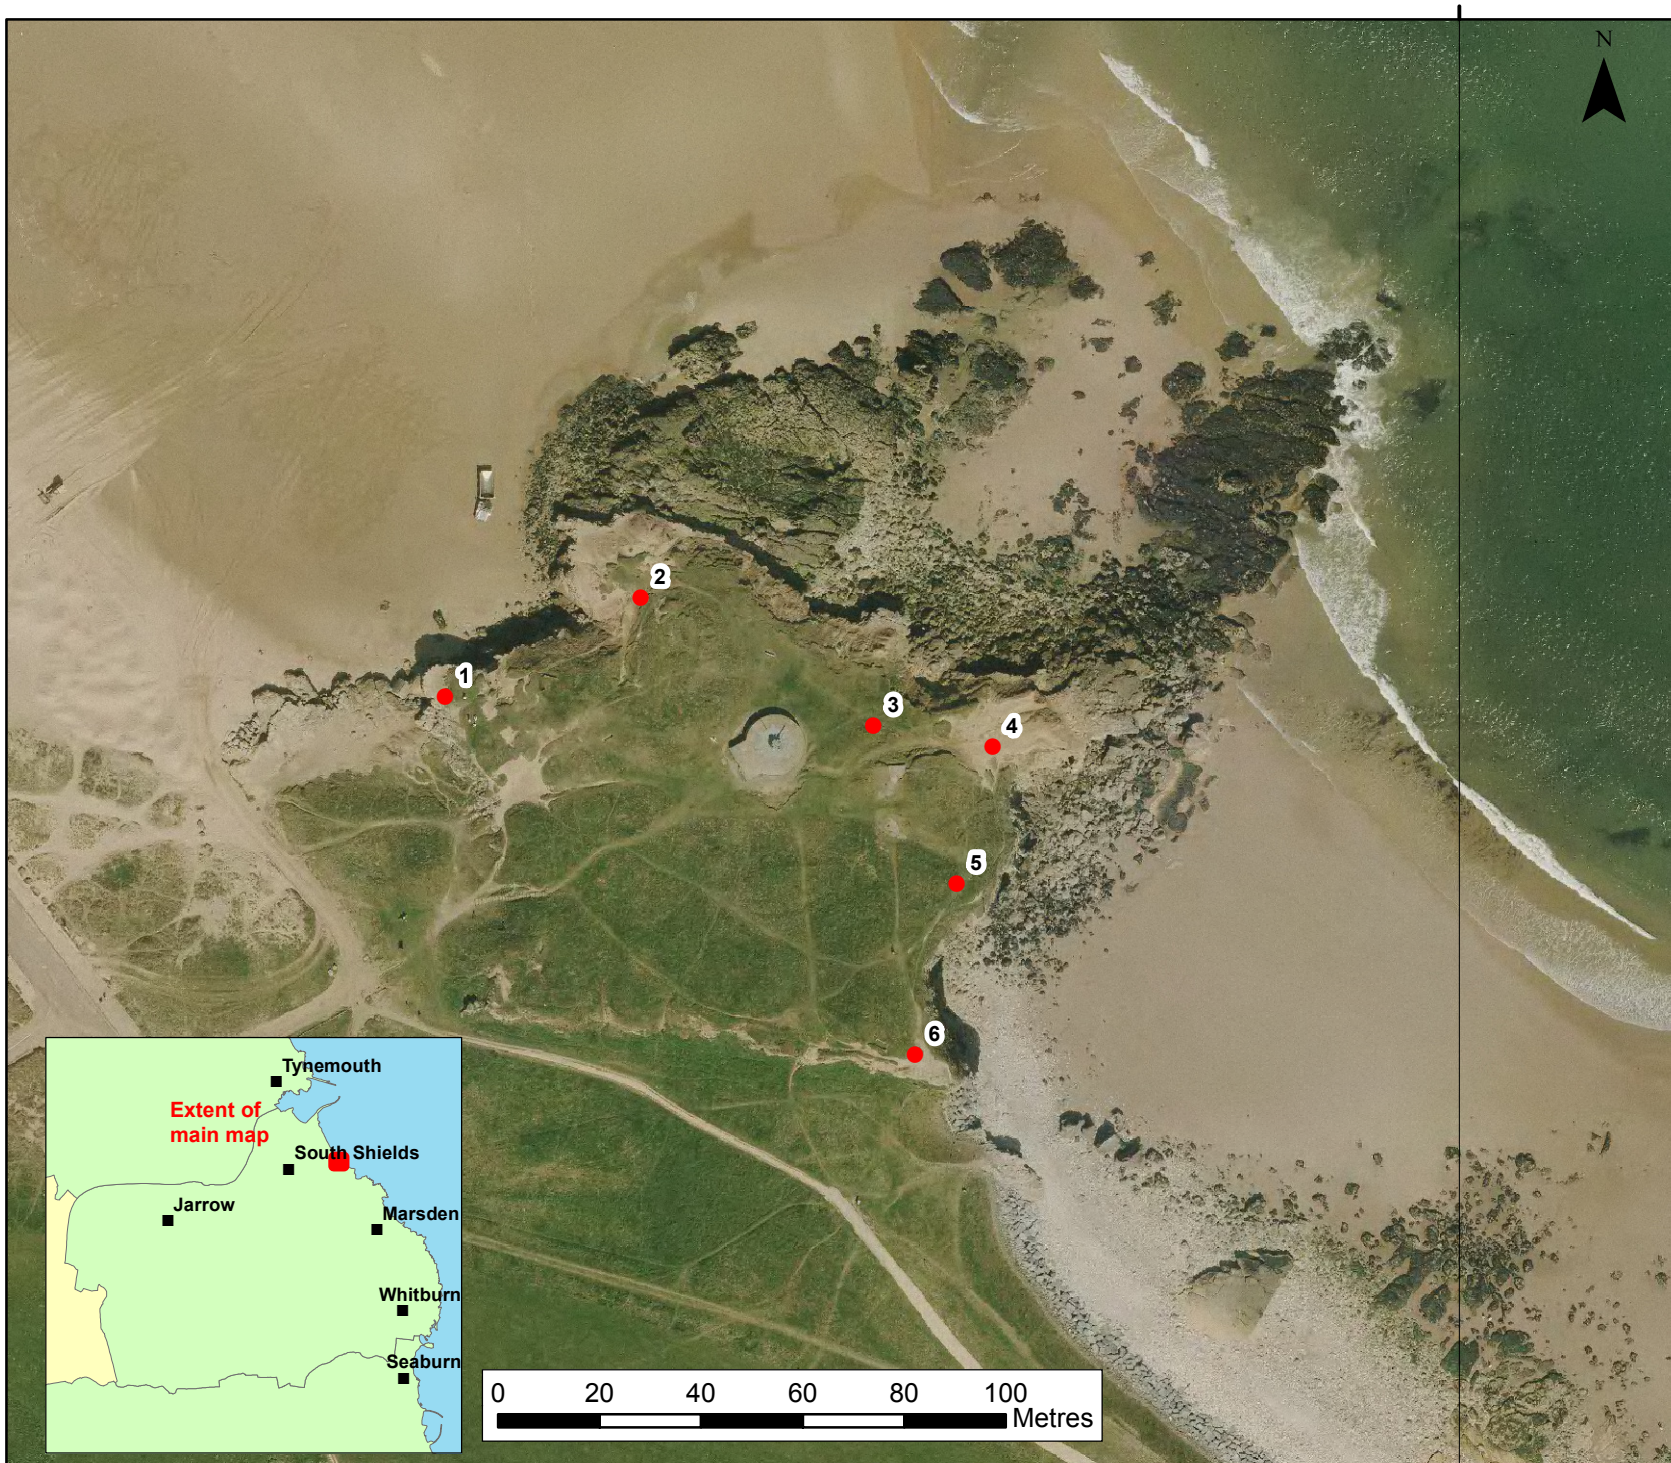
**Appendix C- Map 1
Cliff Top Survey
Trow Quarry
South Tyneside Council**

Mar 2012	<p>Cliff-top Survey:</p> <p>Cliff top survey data collected for the full measures survey (winter 2011) and the present partial measures survey (spring, 2012) is presented in this report. Since this is the first time the cliff top data has been presented in this way and the first time that a comparison with a previous survey has been completed, the full measures (winter, 2011) survey is the baseline survey.</p> <p>6 ground control points (numbered 1-6) were established along the cliff top at Trow Point in 2008 to monitor cliff erosion at the headland adjacent to the site of a former landfill. Note: the numbering of ground control points is not intended to correlate with that of the beach profile lines and reference</p>	<p>This is the second year that the cliff top survey data has been included within the survey report and the data presented in a table, so it is the first time that a comparison with previous data has been completed.</p> <p>Longer term trends: The limited data set does not allow long term trends to be established yet. From the data available the cliffs around Trow Headland have shown minimal change. There is a small degree of erosion around the north-west side. The survey data</p>

In addition, the cliff top measurements to the south-west of Trow Point appear to indicate accretion. This is more likely to be error resulting from mis-identification of the cliff top or error in the survey data. Further surveys will provide a longer data-set over which to make comparisons, and therefore provide more clarity to observed trends.

Six ground control points have been established at Trow Quarry (Figure C1). The maximum separation between any two points varies along the coast, reflecting the degree of risk from the erosion.

The cliff top surveys at Trow Quarry are undertaken bi-annually. Measurements are taken from a fixed ground control point along a fixed bearing to the edge of the cliff top.

For all cliff-top surveys prior to Full Measures 2011, data was reported separately in Trow Quarry Coastal Defence Scheme - Monitoring Plan Year 2 (available from South Tyneside Council). Although cliff top data is available for surveys prior to the Full Measures 2011, the accuracy of the data is such that no reliable interpretation can be made. For this reason, the 'kmz' files are not presented or analysed as part of the present report. Cliff top surveying needs to be undertaken with careful identification of the 'cliff top' to make the data useful in long-term assessment of erosion.

However, in the short term, more reliable assessments of cliff recession will be derived from analysis of time-series remote sensing data. A high quality baseline survey, comprising LiDAR and aerial photography, was collected in 2010, a repeat survey was completed in Sept/Oct 2012 and a second repeat survey is planned for 2014. These data will be analysed to give more accurate information on the behaviour of the cliffs in a separate report.
