**Cell 1 Regional Coastal Monitoring Programme
Update Report 6: 'Partial Measures' Survey 2014**

**South Tyneside Council
Final Report**

July 2014

(*) The present report is **Update Report 6** and provides an analysis of the 2014 Partial Measures survey for South Tyneside Council's frontage.

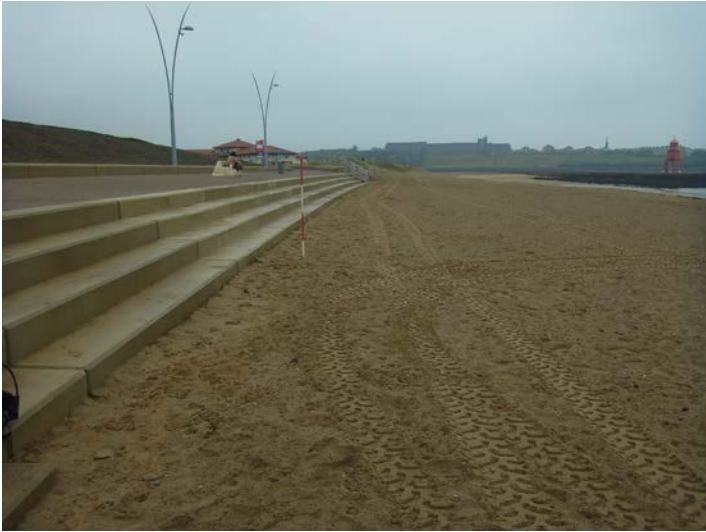
Plate 1 – Survey photograph 1bSS2_20140428_N2.JPG

Survey Date	Description of Changes Since Last Survey	Interpretation
	Profiles 1bSS1 to 1bSS4 now provide a post construction baseline for future beach profile surveys.	construction works.
April 2014	<p>Topographic Survey:</p> <p>Littlehaven Beach is covered by bi-annual topographic survey between the South Groyne and the South Pier, which commenced in March 2010. Data from the most recent topographic survey (Partial Measures, spring 2014) have been used to create a DGM (Appendix B – Map 1a) using a Geographical Information System (GIS). A difference plot has also been produced using the DGM (Appendix B – Map 1b) produced from the last produced topographic survey (Partial Measures, spring 2011) and the present survey.</p> <p>Sea defence works to realign the seawall have been carried out since the previous survey and were completed in early 2014. Most changes in the beach levels are likely to be the result of these works.</p> <p>In particular, the difference plot shows: (i) an increase in beach level across the upper beach, concentrated towards the middle of the bay in the proximity of the sea defence works; (ii) slight erosion towards the southern end of the bay, in particular along the lower beach. (ii) No significant changes across other areas of the bay.</p>	<p>Comparison of the present topographic survey with the previous partial measures (autumn, 2013) shows the impact of the recent sea defence works and the changes reflect the findings of the beach profile surveys.</p> <p>The current survey forms a new baseline against which future changes can be assessed. This will highlight the impacts of the sea wall on the beach</p>

Profiles 1bSS2 to 1bSS4 are all along the lower bounds of previous surveys. As this is the first survey to be carried out since the realignment of Littlehaven seawall it is not possible to determine whether this is the result of the storm surge or the construction works. This survey will provide a post-construction baseline for comparison with future surveys.

- At Littlehaven Beach, profiles 1bSS2 to 1bSS4 are all along the lower bounds of previously measured profiles. It is not possible to identify whether this is the result of storm conditions eroding the beach over the winter period or the result of the recent construction works. This should be monitored in future surveys.

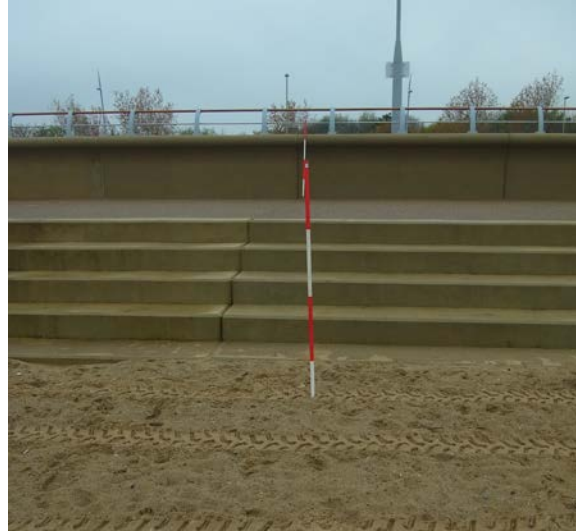
Plate 2 – Survey photograph 1bSS3_20140428_Up1_N2.JPG

Survey Date	Description of Changes Since Last Survey	Interpretation
April 2014	<p>Beach Profiles:</p> <p>Littlehaven Beach is covered by two beach profile lines for the Partial Measures surveys, spaced between South Groyne and South Pier (1bSS1 and 1bSS3). In this 2014 survey two additional profiles were also surveyed (1bSS2 and 1bSS4) to provide information on the impact of engineering works to realign the seawall that were completed in early 2014 (Plates 1 to 3). The previous survey was the Full Measures survey undertaken in autumn 2013.</p> <p>Profile 1bSS1 is located to the north of Littlehaven Beach, in the lee of a rocky outcrop and harbour wall. The dunes and beach profile have remained stable since the previous survey but there has been some small steepening of the upper beach and flattening of the lower beach.</p> <p>Profiles 1bSS2 to 1bSS4 extend seawards from the new sea wall that was completed since the last survey (Full Measures Autumn 2014). Plates 1 and 2 show the newly constructed sea wall and all 3 profiles show the seawall profile. At profile 1bSS2 the beach level has increased by up to 0.4m from the toe of the sea wall and across the upper beach to a chainage of about 65m (elevation 0.2m). Below this the beach level has remained stable. The increase in beach level is likely to be the result of the construction works. At profile 1bSS3 the beach level has also increased across the upper beach from the toe of the sea wall to a chainage of about 40m. A berm is present above HAT which may be the result of storm waves occurring since the construction works were completed. This cannot be confirmed, however, as there are no measured profiles from the post construction but pre storm time period for comparison. The beach has steepened as levels have dropped on the lower beach. At profile 1bSS4 the beach level has decreased since the previous survey, with the exception of chainage 72m to 86m where a distinct berm is present resulting in higher beach levels. On the flatter upper beach the sand levels have dropped by about 0.15m, and on the steeper lower beach the levels have fallen by up to 0.6m. It is likely that this is erosion is the result of storm waves since the construction works. This cannot be confirmed, however, as there are no measured profiles from the post construction but pre storm time period for comparison.</p>	<p>At Littlehaven Beach, the profile 1bSS1 has remained stable over the winter period.</p> <p>Profiles 1bSS2 to 1bSS4 have changed significantly due to the construction of a new sea wall, particularly around MHW. This is likely to be associated with beach works. The data from this survey will provide a baseline post construction works profile for comparison with future surveys.</p> <p>It was noted in the survey report that material was being cleaned from paths and roads behind the Littlehaven dunes and moved back onto the dunes. This indicates wind transport of material from the dunes onto the roads during the Winter period leading to maintenance requirements. It is important that the wind-blown sand is returned to the dunes to maintain the sediment budget..</p> <p>Longer term trends: When compared with previous profile surveys, profile 1aSS1 is generally within the bounds of previous surveys, although there appears to be steepening of the profile and a net transfer of sediment from the beach to the dunes.</p> <p>Profiles 1bSS2 to 1bSS4 are along the lower bounds of previous surveys. It is not possible to determine whether this is the result of storm conditions or recent</p>

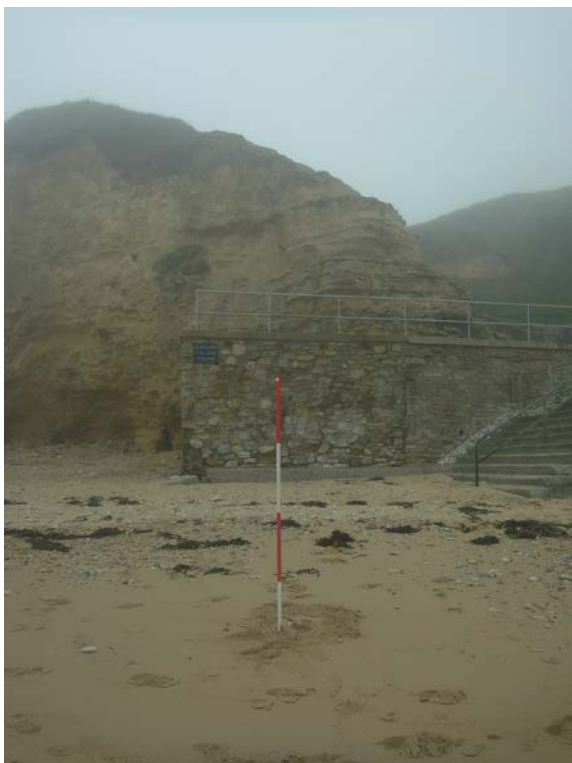
Plate 4 – Survey photograph 1bSS14_20140429_Up3.JPG

Survey Date	Description of Changes Since Last Survey	Interpretation
April 2014	<p>Beach Profiles:</p> <p>Marsden Bay is covered by two beach profile lines for the Partial Measures survey (Appendix A). The previous survey was the Full Measures survey undertaken in autumn 2013.</p> <p>Profile 1bSS14 is located to the north of the bay and covers the cliffs and former lifeguard station adjacent to the Redwell Steps. The cliff profile has remained stable since the previous survey (autumn 2013). Beach levels have increased by approximately 0.5m across the profile, from the toe of Redwell steps to a chainage of 170m, while the toe of the beach has remained stable (See Plate 4 and Plate 5).</p> <p>Profile 1bSS17 is located to the south of the bay. At profile 1bSS14 the cliff has remained stable while the beach levels across the upper beach have increased by approximately 0.5m and the beach toe has remained stable.</p> <p>The survey report noted large cliff falls in Marsden Bay. There is no evidence of cliff falls along profiles 1bSS14 and 1bSS17, indicating the falls were located between these profiles.</p>	<p>Along the length of Marsden Bay, the cliff has retained the same form and position since the last surveys.</p> <p>Along both profiles 1bSS14 and 1bSS17, the beach level has increased along much of the profile with the exception of the beach toe, which has remained stable.</p> <p>Longer term trends: At profile 1bSS14 and 1bSS17 the beach levels are within the bounds of previous changes, with the exception of parts of the upper beach along profile 1bSS14 which are the highest levels recorded since surveys began in 2008.</p>

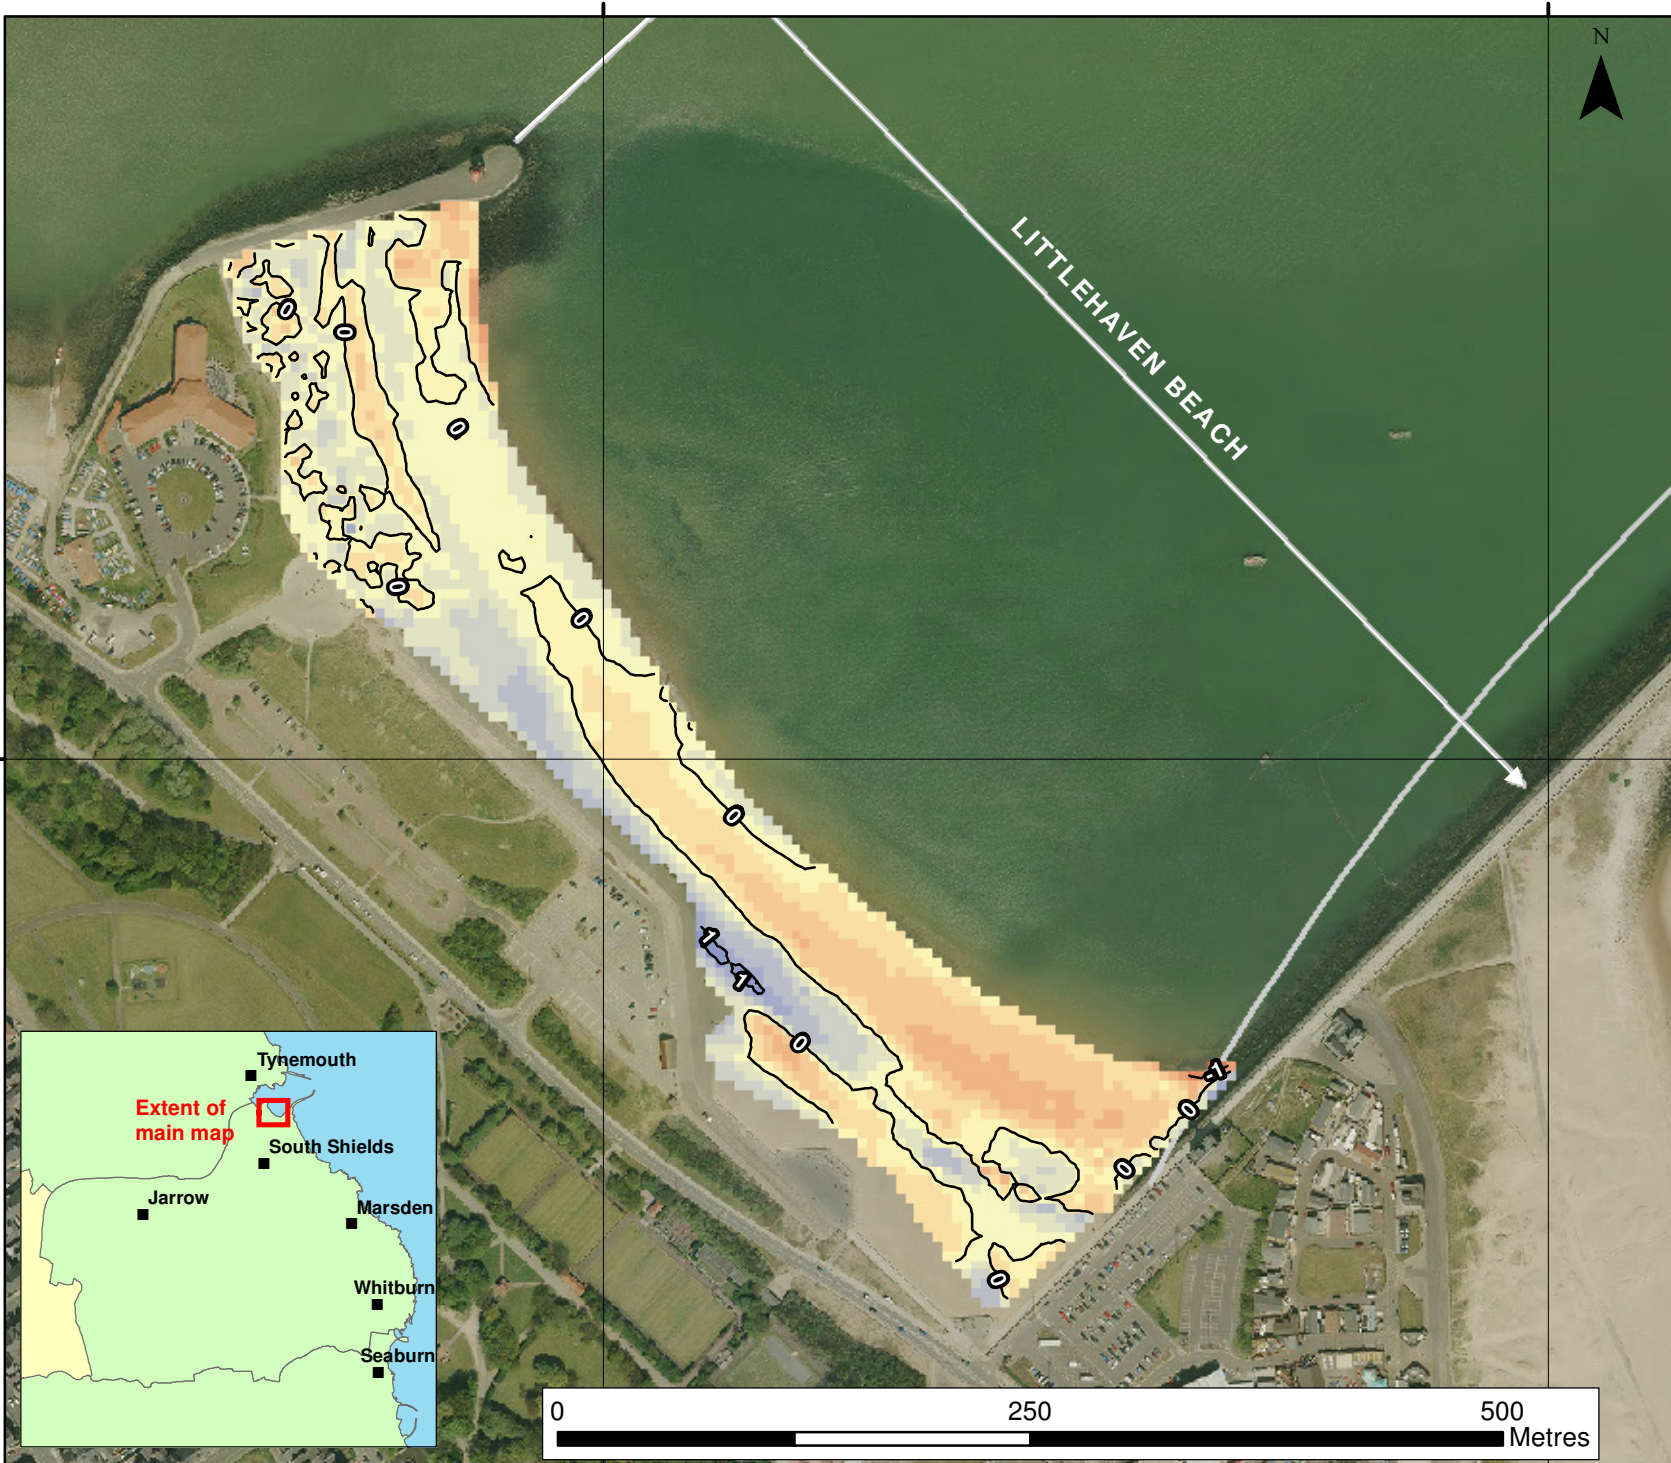
Appendix B- Map 1b
Short-term
Elevation Change
Littlehaven
SouthTyneside Council

KEY Autumn 2013 and Spring 2014
Change in elevation (m)

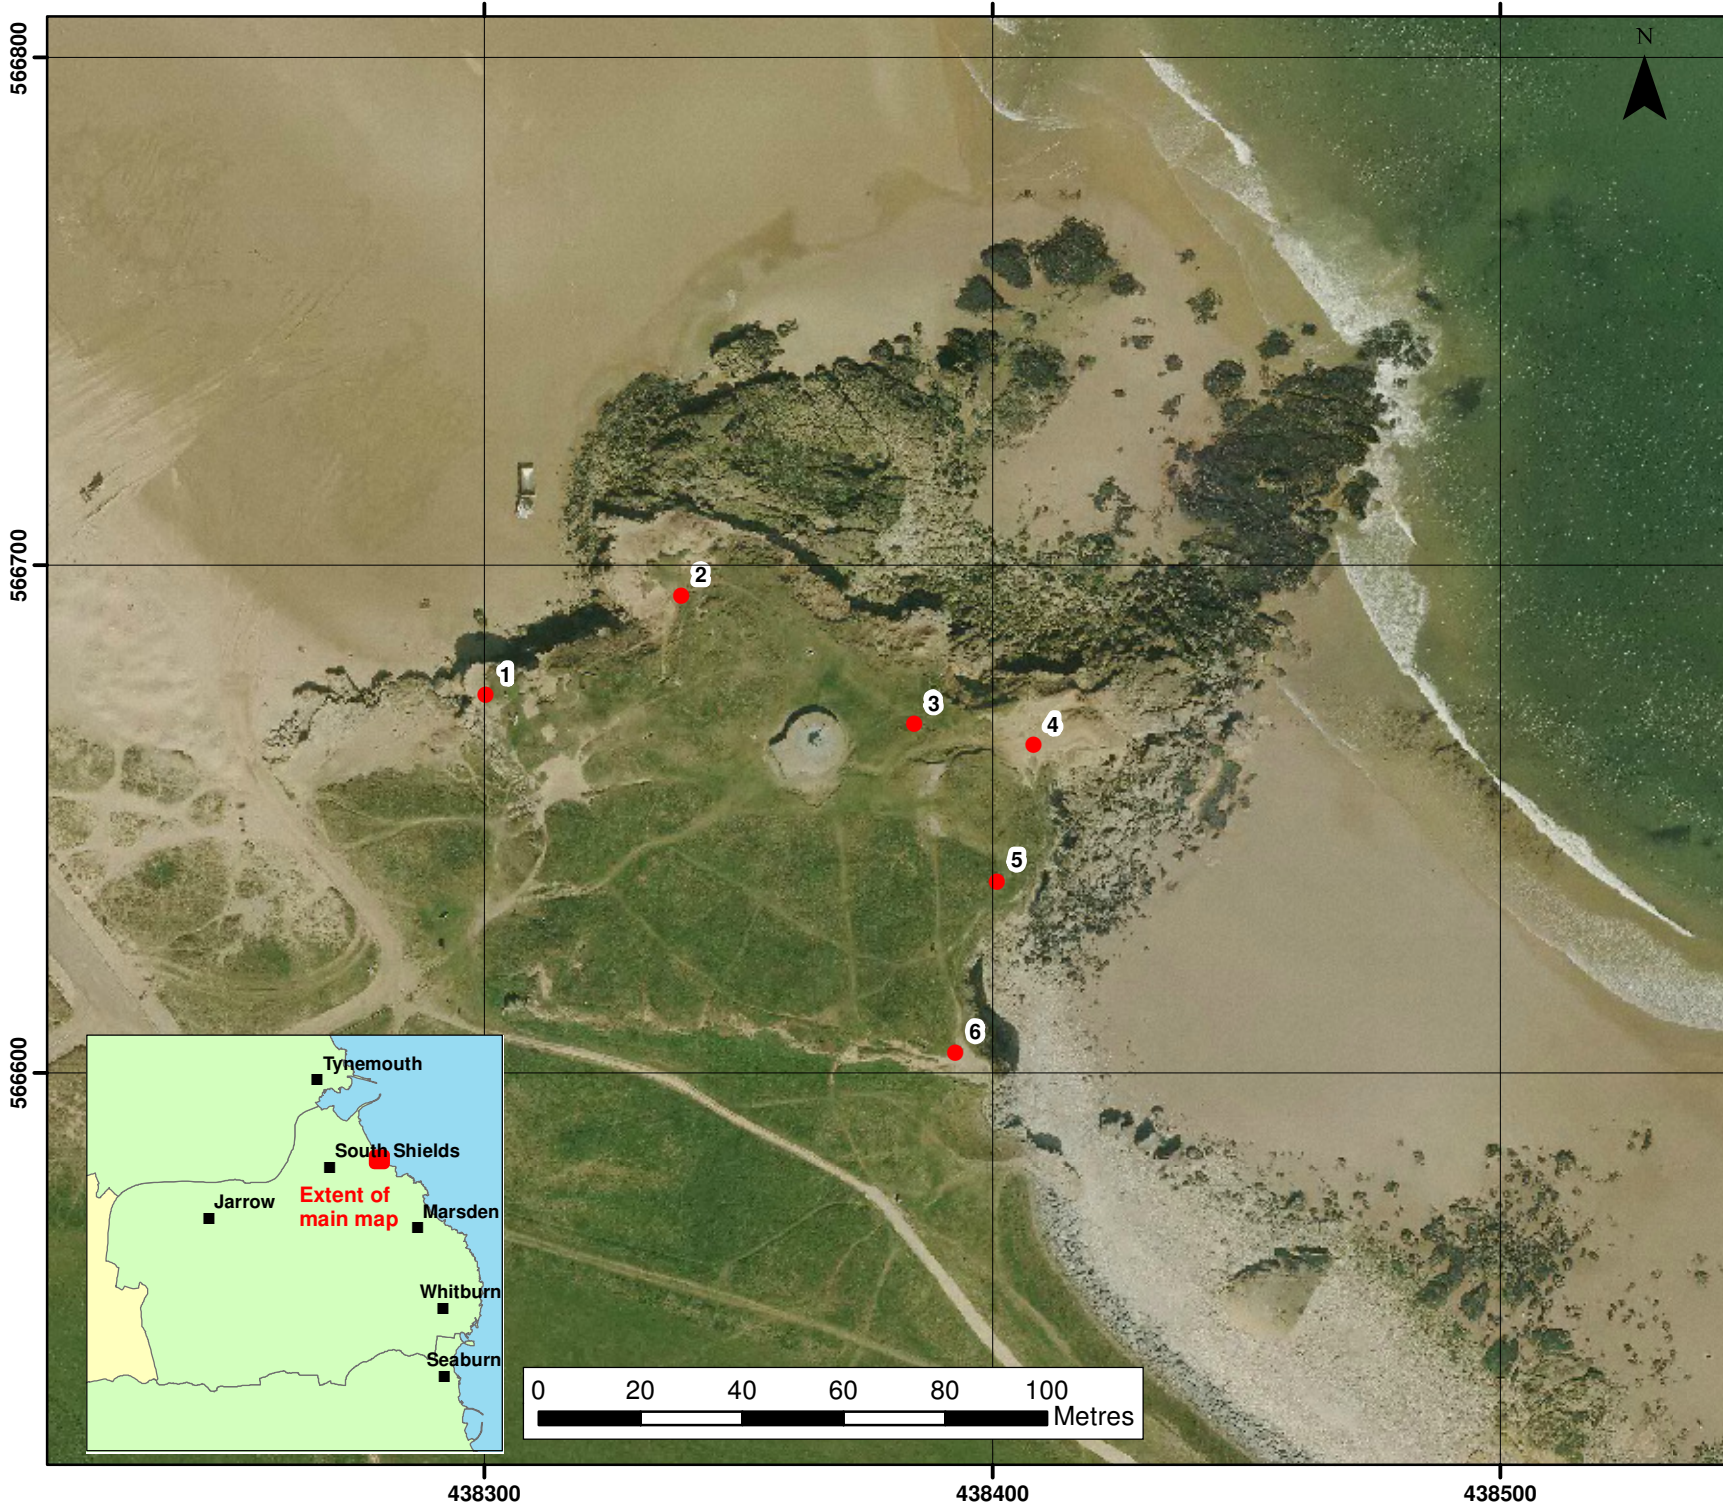
**Appendix C- Map 1
 Cliff Top Survey
 Trow Quarry
 South Tyneside Council**

Survey Date	Description of Changes Since Last Survey	Interpretation
	<p>should be made to Appendix C – Map 1 for the location of ground control points.</p> <p>These cliff top surveys are undertaken bi-annually. Measurements are taken from each ground control point along a fixed bearing to the edge of the cliff top. The results from the cliff top monitoring are anticipated to have an accuracy of $\pm 0.2\text{m}$ due to the technique used.</p> <p>The results from the cliff top survey are presented in Appendix C – Table C1, showing the position from the ground control point to the edge of the cliff top along a defined bearing. Also shown is the change in measurement since the baseline (autumn 2011) and current (spring 2013) cliff top surveys.</p> <p>Results show that erosion or an amount of movement greater than the survey error has occurred has not occurred at any control points since surveys began in September 2011. Since the last survey in November 2012, erosion greater than the survey error has not occurred at any locations and it has not been possible to identify any trends.</p>	<p>suggests that the cliff recession process in hard rock cliffs such as these is episodic, with rock falls occurring on a frequency of 5 to 10 years.</p>

Six ground control points have been established at Trow Quarry (Figure C1). The maximum separation between any two points varies along the coast, reflecting the degree of risk from the erosion.

The cliff top surveys at Trow Quarry are undertaken bi-annually. Measurements are taken from a fixed ground control point along a fixed bearing to the edge of the cliff top.

No cliff recession has been recorded at Trow Quarry since records began, but visual inspection indicates that small rock falls have occurred. The data reflects the episodic nature of rock falls through time and the uneven distribution of events along the cliff.
