**Cell 1 Regional Coastal Monitoring Programme
Update Report 7: 'Partial Measures' Survey 2015**

**South Tyneside Council
Final Report**

(*) The present report is **Update Report 7** and provides an analysis of the 2015 Partial Measures survey for South Tyneside Council's frontage.

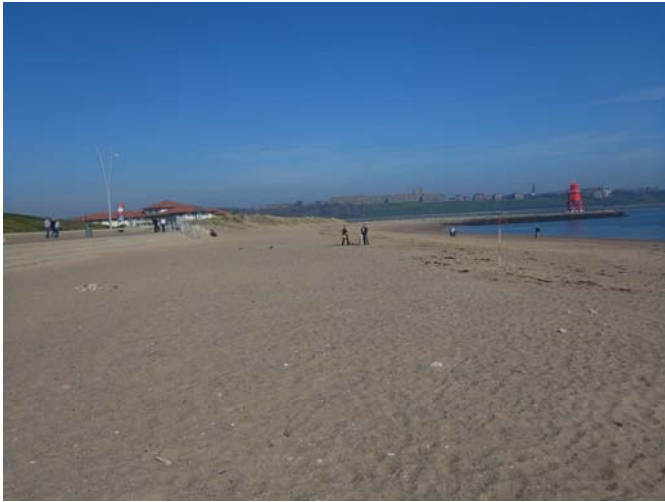
Plate 1 – Survey photograph 1bSS2_20150423_N3.JPG

Survey Date	Description of Changes Since Last Survey	Interpretation
Apr 2015	<p>Beach Profiles:</p> <p>Littlehaven Beach is covered by two beach profile lines for the Partial Measures surveys, distributed between South Groyne and South Pier (1bSS1 and 1bSS3). In this survey two additional profiles were re-surveyed (1bSS2 and 1bSS4) to provide information on the impact of engineering works to realign the seawall that were completed in early 2014. The previous survey was the Full Measures survey undertaken in autumn 2014.</p> <p>Profile 1bSS1 is located to the north of Littlehaven Beach, in the lee of a rocky outcrop and harbour wall. The dunes have remained mostly stable since the previous survey with up to 0.5m retreat of the dune face and a small advance at the dune toe suggesting redistribution of sand. Beach levels have fallen between the dunes and lower foreshore by approximately 0.3m, although the profile shape is unchanged.</p> <p>Profiles 1bSS2 to 1bSS4 extend seawards from the new sea wall that was completed since the last survey.</p> <p>At profile 1bSS2 beach levels have changed across the profile, decreasing on the upper beach in front of the seawall by approximately 0.5m to form a lower and flatter beach berm, increasing by up to 0.8m on the middle beach to form a more gently sloping profile, and decreasing by approximately 0.5m seaward of a chainage of 70m. Overall, the survey photograph (see Plate 1) shows the beach to be in good condition.</p> <p>At profile 1bSS3 the upper beach has lowered and beach berm is lower and narrower. As at profile 1bSS2, beach levels on the middle beach have increased by approximately 0.7m, while on the lower beach (seaward of a chainage of 65m), they have lowered by 0.7m to give a steeper profile.</p> <p>At profile 1bSS4 the beach level on the upper beach has lowered by up to 0.2m. On the middle beach, between a chainage of 90m and 140m, beach levels have increased by approximately 0.7m, which is similar to the two profiles to the north (1bSS2 and 1bSS3). As a result of the higher beach levels, the</p>	<p>At Littlehaven Beach, the dune profile 1bSS1 has remained mostly stable over the winter/spring period, with a small amount of re-distribution of material across the dune face. Beach levels have fallen however.</p> <p>Profiles 1bSS2 to 1bSS4 show a very similar pattern of change with narrowing and lowering of the upper beach, accretion of the middle beach and erosion on the lower beach. These changes are likely to represent the adjustment of the profile following construction works to the day to day conditions and winter/spring storms. Survey photos show health beach levels and no significant impact from the recent construction is noted to date.</p> <p>Longer term trends: When compared with previous profile surveys, profiles 1bSS1 to 1bSS4 are generally within the bounds of previous surveys, indicating generic behaviour with no clear trend.</p>

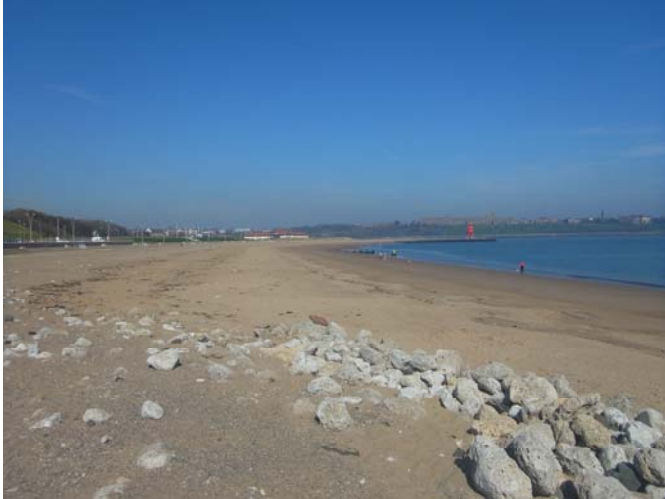
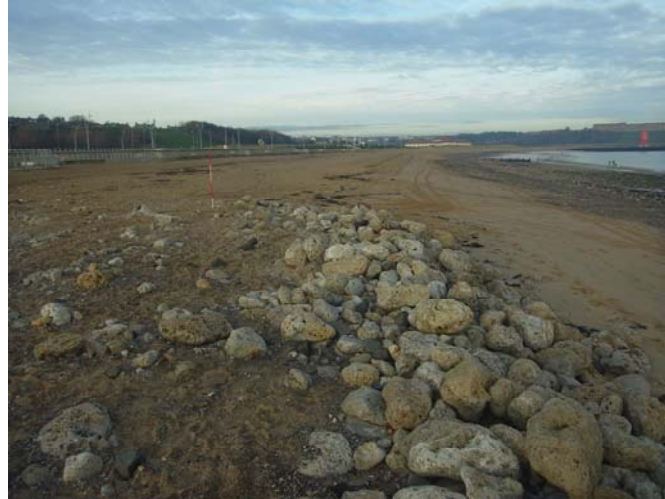
Survey Date	Description of Changes Since Last Survey	Interpretation
	boulders on the foreshore were covered by sand at the time of the survey when compared to the last survey (see Plates 2 and 3).	
Apr 2015	<p>Topographic Survey:</p> <p>Littlehaven Beach is covered by bi-annual topographic survey between the South Groyne and the South Pier, which commenced in March 2010.</p> <p>Data from the most recent topographic survey (Partial Measures, spring 2015) have been used to create a DGM (Appendix B – Map 1a) using a Geographical Information System (GIS). A difference plot has also been produced using the DGM (Appendix B – Map 1b) produced from the last produced topographic survey (Full Measures, autumn 2014) and the present survey.</p> <p>The difference plots shows a clear a pattern of change across the beach, which reflects the beach profile data. The plots shows three bands of change, which extend from north to south, and comprise: (i) a band of beach lowering along the upper beach; (ii) a band of beach accretion along the middle beach; and (iii) beach lowering along the lower beach. The pattern of erosion at the upper and lower beach and accretion in the middle beach suggests development of a convex form</p>	<p>The pattern of beach elevation change observed from the topographic difference plot distinct areas of erosion and accretion, which is likely to be due to the beach responding to post construction day-today conditions and winter/spring storms.</p> <p>Comparison of the present topographic survey with the previous Full Measures (autumn, 2014) survey shows a reversal in the pattern of beach change which is typical of seasonal beach responses to storms.</p>

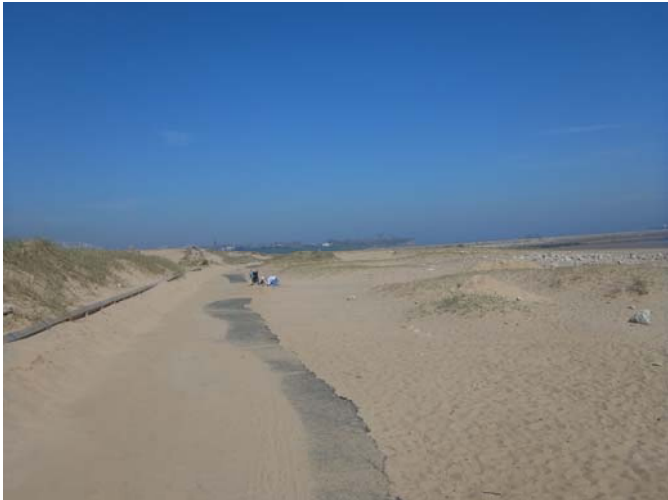
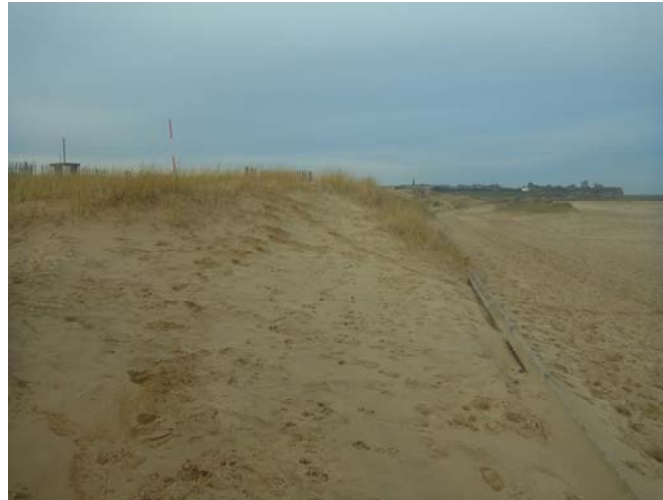
Survey Date	Description of Changes Since Last Survey	Interpretation
Apr 2015	<p>Beach Profiles:</p> <p>Herd Sands is covered by three beach profile lines for the Partial Measures survey (Appendix A). The previous survey was the Full Measures survey undertaken in autumn 2014.</p> <p>Profile 1bSS5 is located to the north of Herd Sands and is located in the lee of the breakwater. Sand fences were constructed on the dunes in 2012 to encourage accretion and stabilisation. The dunes are unchanged since the last survey but the dune toe and upper beach have decreased to expose the tarmac path (refer to Plates 4 and 5). At chainage of 170m, beach levels have increased to form a berm and an overall higher beach. As Plate 3 shows, the berm appears to have become vegetated with early dune plants, suggesting some stability and growth of the foreshore dune.</p> <p>Profile 1bSS8 is located to south of Herd Sands. The beach profile has changed in form since the previous survey. Beach levels on the upper beach, from the seawall to a chainage of approximately 50m, have fallen by approximately 0.5m to form a wider and more gently sloping beach profile. Between 50m and 70m chainage, beach levels have increased by 0.7m, but the slope and form have remained the same. The largest change is observed at a chainage of 80m, where beach levels have increased by 1.5m to form a berm and runnel, which steeply slopes to the sea. The topographic survey report notes '<i>contractors have removed sand from the beach in the area of sections 8 and 9 leaving a prominent berm</i>'. These observations are likely to be related to dune management practices undertaken at Herd Sands (which includes the movement of sand that has blown inland over the footpath back onto the beach) and not associated with the removal of sand from the beach.</p> <p>Profile 1bSS9 is located to south of Herd Sands where dunes have remained stable since the previous survey. The beach profile shows a similar trend to profiles 1bSS8 with accretion of up to 2.5m at the upper/middle beach. As the survey photograph shows (see Plate 6), the beach profile has a convex shape, with a runnel and ridge on the lower beach. An explanation for these changes is likely to reflect cross-shore movement of material and the influence of storm activity over the winter/spring months. The topographic survey report notes that '<i>contractors have removed sand from the beach in the area of sections 8 and 9 leaving a prominent berm</i>.' As noted above these observations are likely to be related to dune management practices undertaken at Herd Sands (which includes the movement of sand that</p>	<p>Since the last survey, the dunes at Herd Sands have remained stable.</p> <p>Along the length of the Herd Sands the beach fronting the dune has eroded, while the upper/middle beach has accreted significantly to form a higher and wider slope. There is a clear runnel and ridge formation on the lower section of the beach, which is likely to have formed in response to cross-shore movement of material under the influence of storm activity over the winter/spring months.</p> <p>Longer term trends: Although the beach has experienced significant accretion, beach levels at profile 1bSS5 are within the bounds of previous surveys, indicating fluctuating levels with no net trend. The observed berm existed previously and appears to migrate across the beach. At profile 1bSS8 beach levels along the upper and middle beach are the highest recorded, but lowest at the seaward end of the beach indicating the most substantial movement across the beach yet. The southernmost profile, Profile 1bSS9 has the highest level along the middle beach recorded since surveys began in 2008; given that they were the lowest since surveys began during the last full measures, it is likely that this change is response to beach recovery over the winter/spring months.</p>

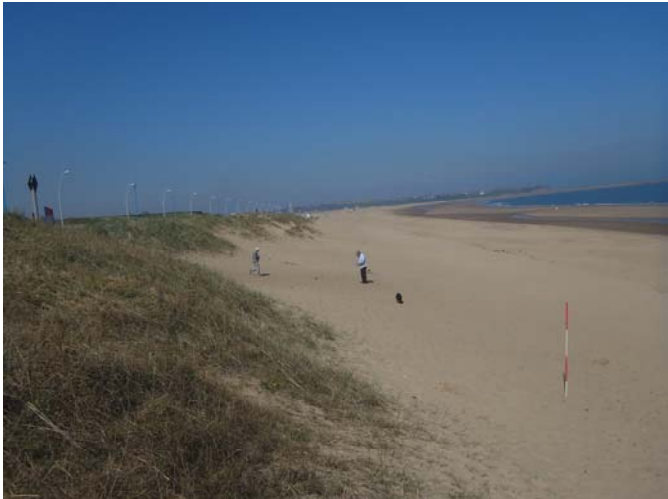
Plate 6 – Survey photograph 1bSS9_20150423_N3.JPG

Survey Date	Description of Changes Since Last Survey	Interpretation
	has blown inland over the footpath back onto the beach) and not associated with the removal of sand from the beach.

- At the southern end of Herd Sands, the survey report notes 'contractors have removed sand from the beach in the area of sections 8 and 9 leaving a prominent berm'. A number of beach and dune management activities are undertaken at Herd Sands to loss of wind-blown sand from the system, prevent build-up of blown sand on the footpath and to help prevent local dune erosion due to pedestrian access. One of those activities includes the movement of sand that has blown inland onto the beach to stop it being lost from the system. Observations made by the contractors are likely to be related to dune management and not associated with the removal of sand from the beach.

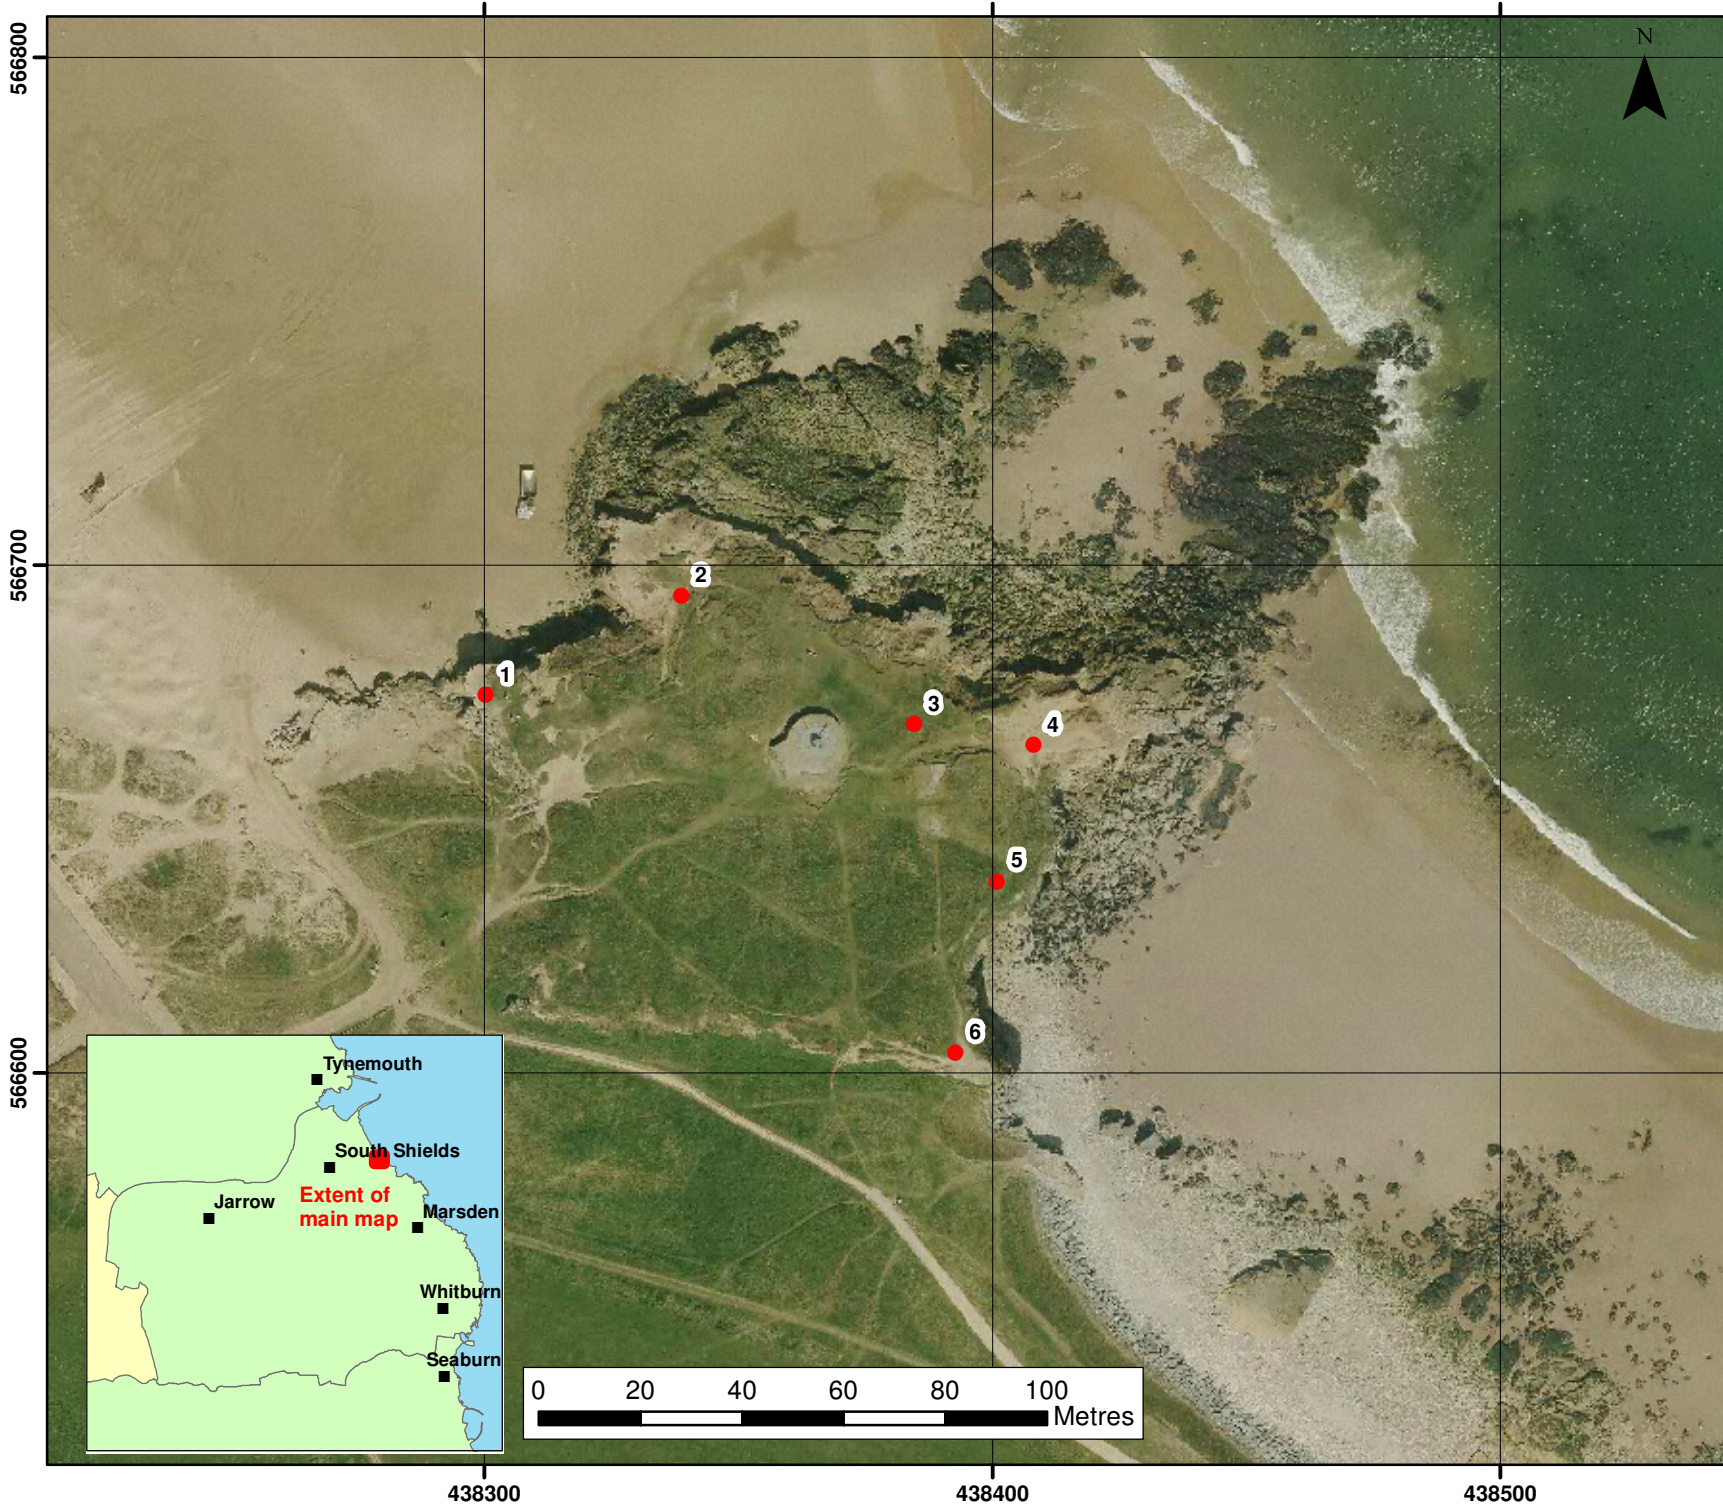
Appendix C- Map 1
Cliff Top Survey
Trow Quarry
South Tyneside Council

<p>April 2015</p>	<p>Cliff-top Survey:</p> <p>Cliff top survey data collected for the baseline survey (autumn, 2011), Full Measures survey (autumn, 2014) and the present Partial Measures survey (spring, 2015) is presented in this report.</p> <p>Six ground control points (numbered 1-6) were established along the cliff top at Trow Point in 2011 to monitor cliff erosion at the headland adjacent to the site of a former landfill. Note: the numbering of ground control points is not intended to correlate with that of the beach profile lines and reference should be made to Appendix C – Map 1 for the location of ground control points.</p> <p>These cliff top surveys are undertaken bi-annually. Measurements are taken from each ground control point along a fixed bearing to the edge of the cliff top. The results from the cliff top monitoring are anticipated to have an accuracy of $\pm 0.2\text{m}$ due to the technique used. The results from the cliff top survey are presented in Appendix C – Table C1, showing the position from the ground control point to the edge of the cliff top along a defined bearing.</p> <p>Results show that since the last survey in November 2014, cliff movement greater than the survey error occurred at ground control point 4 where retreat of 0.3m was recorded.</p>	<p>Since the last survey, erosion has occurred at one ground control point 4, where loss of 0.3m is recorded.</p> <p>Longer term trends: Very limited change has been detected since surveys began in November 2011.</p>

Six ground control points have been established at Trow Quarry (Figure C1). The maximum separation between any two points varies along the coast, reflecting the degree of risk from the erosion.

The cliff top surveys at Trow Quarry are undertaken bi-annually. Measurements are taken from a fixed ground control point along a fixed bearing to the edge of the cliff top.

- Surveying any cliff top is difficult due to the need for a consistent interpretation of the cliff edge in successive surveys, which can be challenging, especially when vegetation is thick. For these reasons, it has been assumed that any changes of $\pm 0.2\text{m}$ may be considered as being within the accuracy of the surveying technique and that any indication of an advancing cliff line is error.
- With the exception of the rock falls recorded during the last Partial Measures (spring 2014) report, no further cliff recession has been recorded at Trow Quarry since records began.
