Cell 1 Regional Coastal Monitoring Programme Update Report 9: 'Partial Measures' Survey 2017

(*) The present report is **Update Report 9** and provides an analysis of the 2017 Partial Measures survey for South Tyneside Council's frontage.

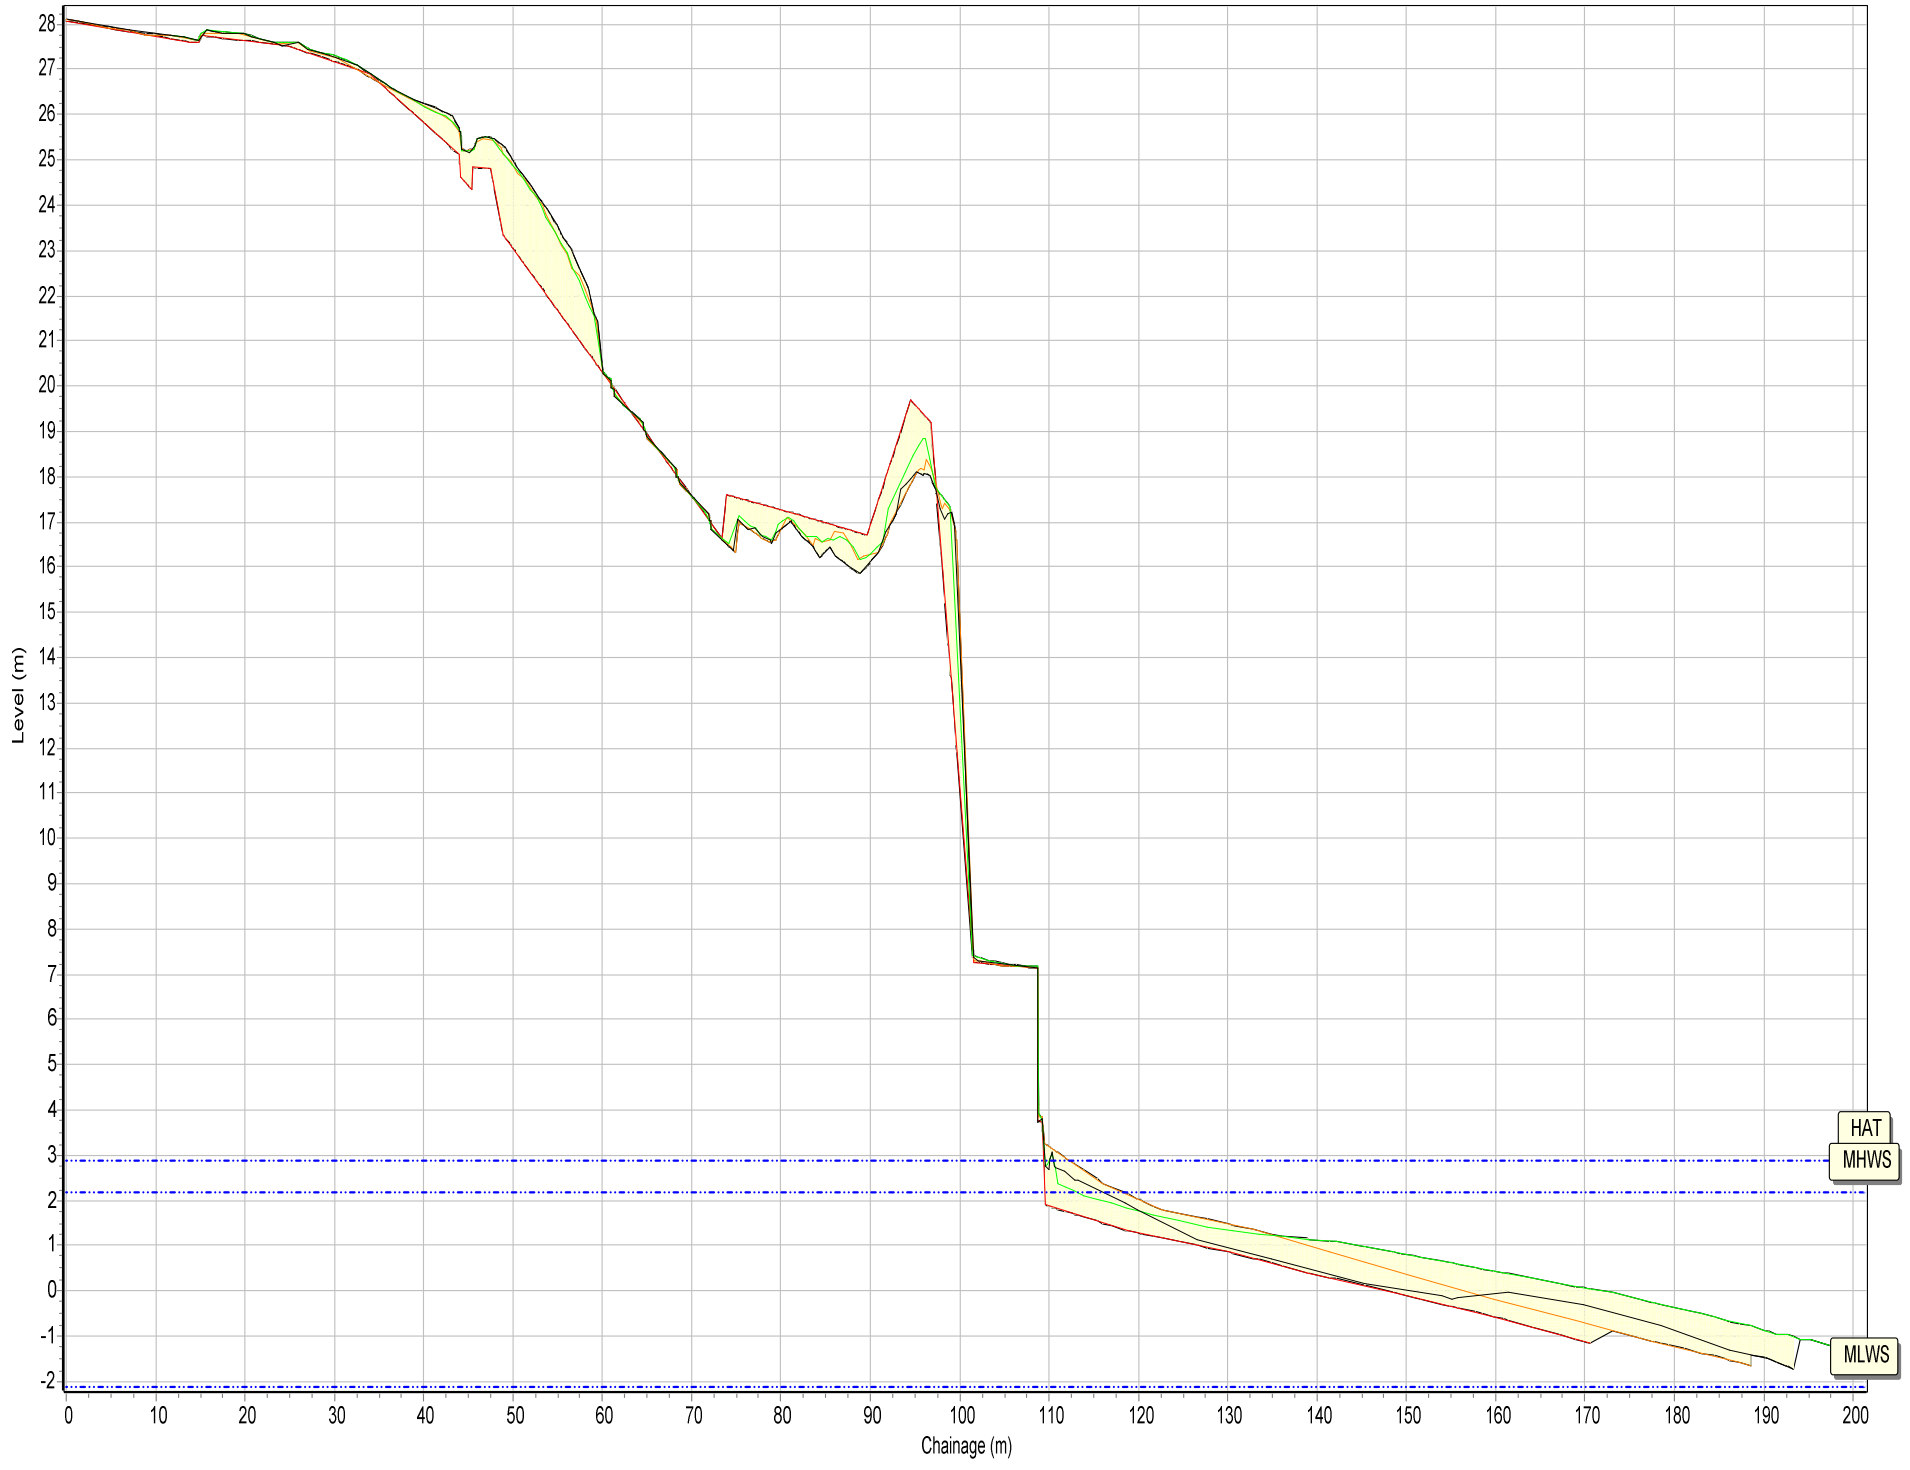
Beach Profiles: 1bSS14

Survey Date	Description of Changes Since Last Survey	Interpretation
14 th March 2017	<p>Beach Profiles:</p> <p>Marsden Bay is covered by two beach profile lines for the Partial Measures survey (Appendix A). The previous survey was the Full Measures survey undertaken in autumn 2016.</p> <p>Profile 1bSS14 is located to the north of the bay and covers the cliffs and former lifeguard station adjacent to the Redwell Steps. There has been no change in the cliff profile since the previous survey. Upper beach levels have risen between the steps and 120m chainage by up to 0.3m. The rest of the profile shows erosion of up to 0.8m, with a berm forming at chainage 162m. The overall effect is a steepening of the profile. Overall the profile is at a medium level compared to the range recorded from previous surveys.</p> <p>Profile 1bSS17 is located to the south of the bay. There has been apparent recession of 1.0m at the cliff toe where the cliff is undercut, although it is possible that this is an artefact of the survey techniques. The upper beach between the cliff toe and 78m chainage has reduced in elevation by up to 0.5m, but more typically <0.2m. Seaward of 78m chainage the rocky beach and shore platform has not changed. Overall the profile is at a medium level compared to the range recorded from previous surveys.</p>	<p>At profiles 1bSS14 the beach has steepened in response to winter/spring storm conditions. The beach at profile 1bSS17 shows 1.0m of recession at the cliff toe. However, this result should be treated with caution as it may relate to redistribution of sediment from the undercut cliff toe as it is accompanied by a lowering of the upper beach level of 0.5m. This change will be in response to winter storms</p> <p>Longer term trends: At profile 1bSS14 and 1bSS17 the beach levels are within the bounds of previous changes, indicating fluctuating seasonal or interannual behaviour with no particular trend.</p>
