**Cell 1 Regional Coastal Monitoring Programme  
Update Report 11: 'Partial Measures' Survey 2019**

(\*) The present report is **Update Report 11** and provides an analysis of the 2019 Partial Measures survey for South Tyneside Council's frontage.

**South Tyneside Council Frontage**

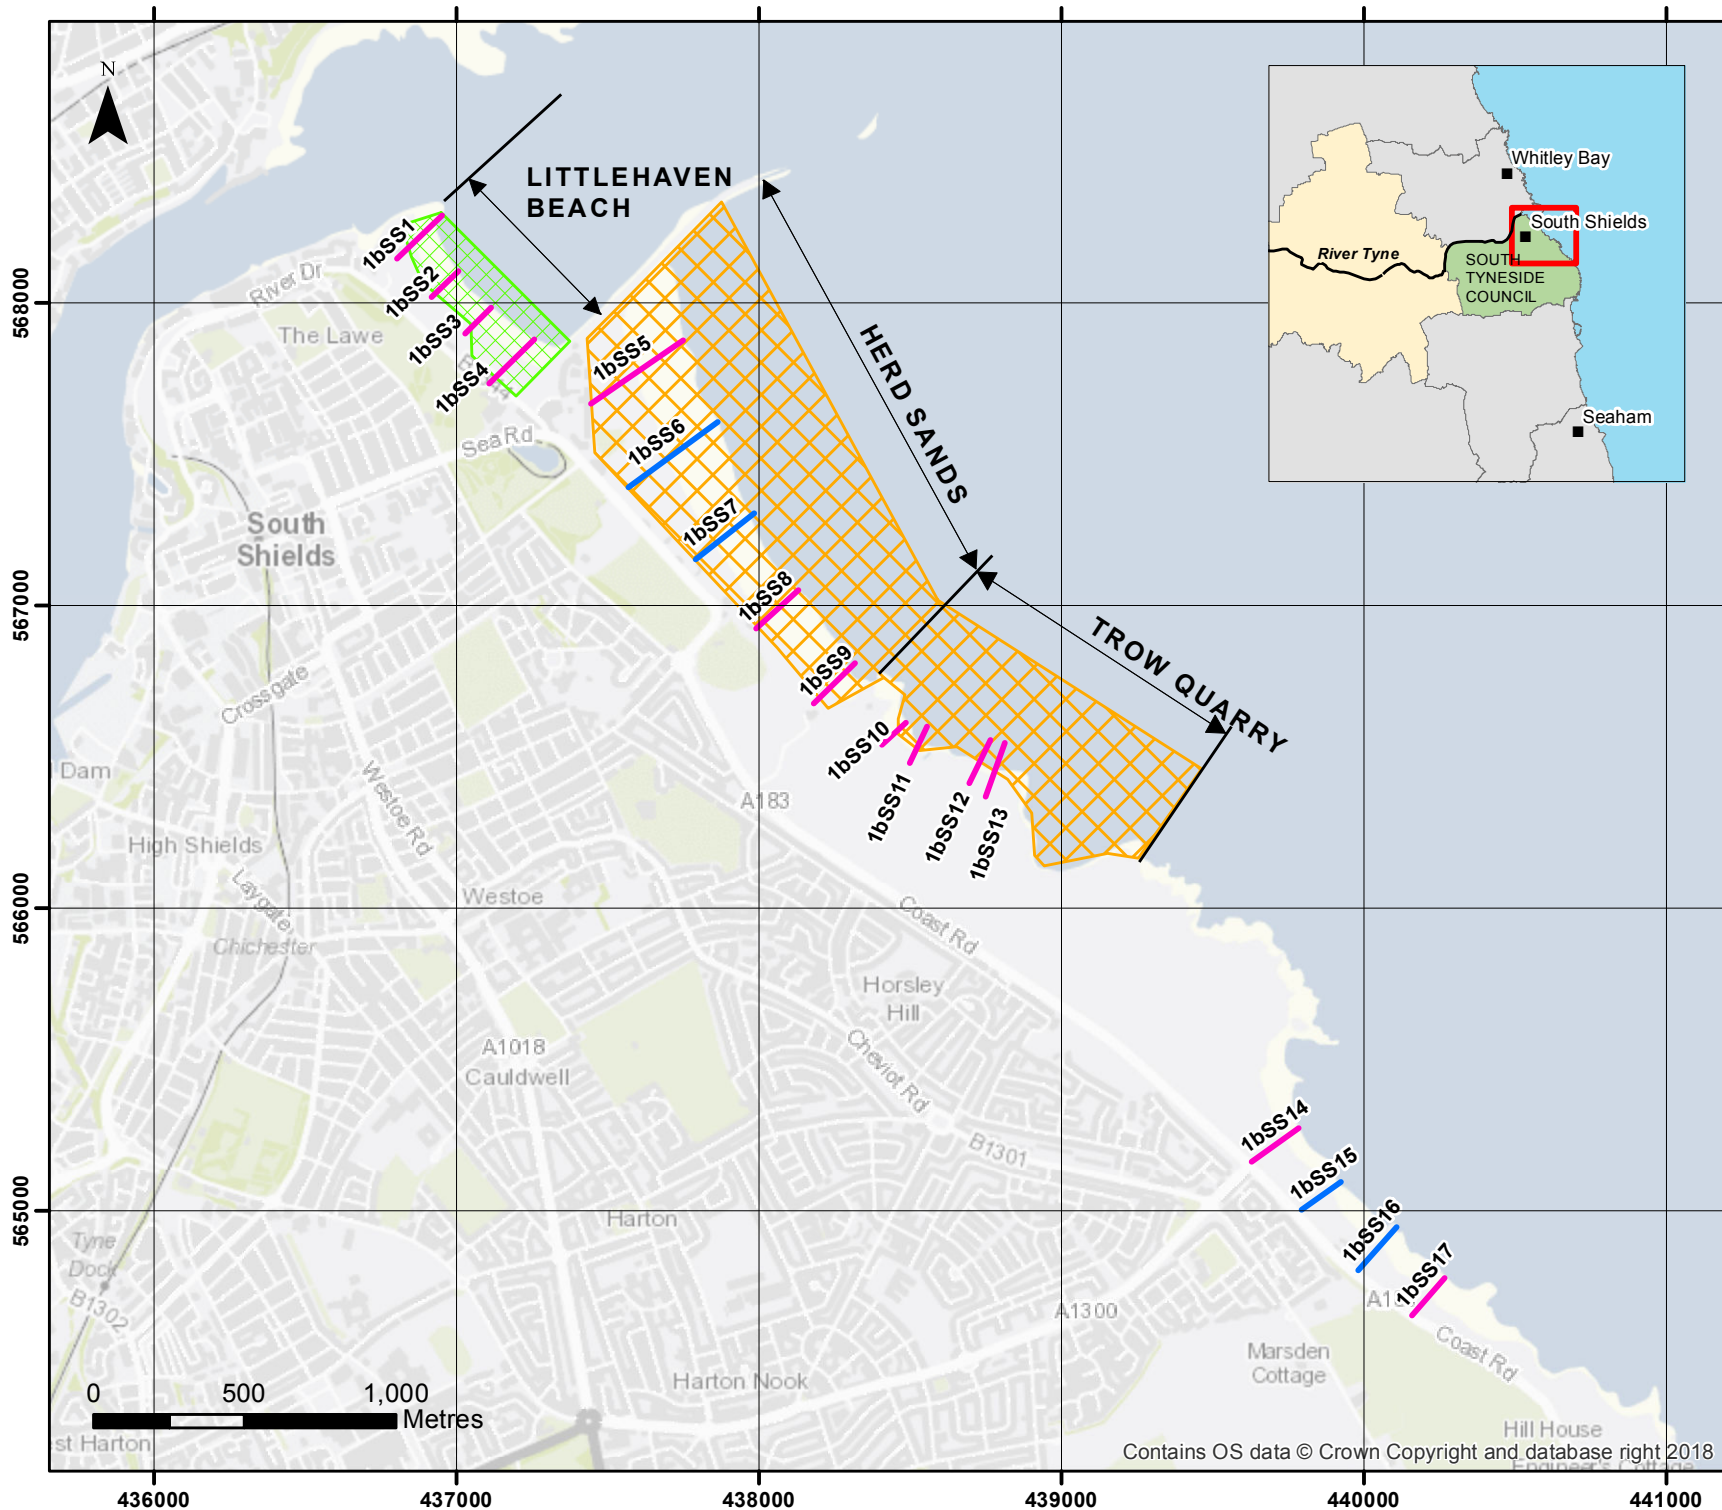
**Figure 2 - Map 1**

**SURVEY LOCATIONS**

For all cliff-top surveys prior to Full Measures 2011, data was reported separately in Trow Quarry Coastal Defence Scheme - Monitoring Plan Year 2 (available from South Tyneside Council). The data was saved in '.kmz' format for plotting and comparison in GoogleEarth. For the present survey report, this data has been visualised in GIS, which revealed the quality was variable and reliable interpretations of cliff change could not be made. For this reason, the 'kmz' files are not presented or analysed as part of the present report. Therefore, cliff top survey data collected from Full Measures survey (autumn 2011) going forward is presented in this report. The location of these surveys is shown in Figure 2.

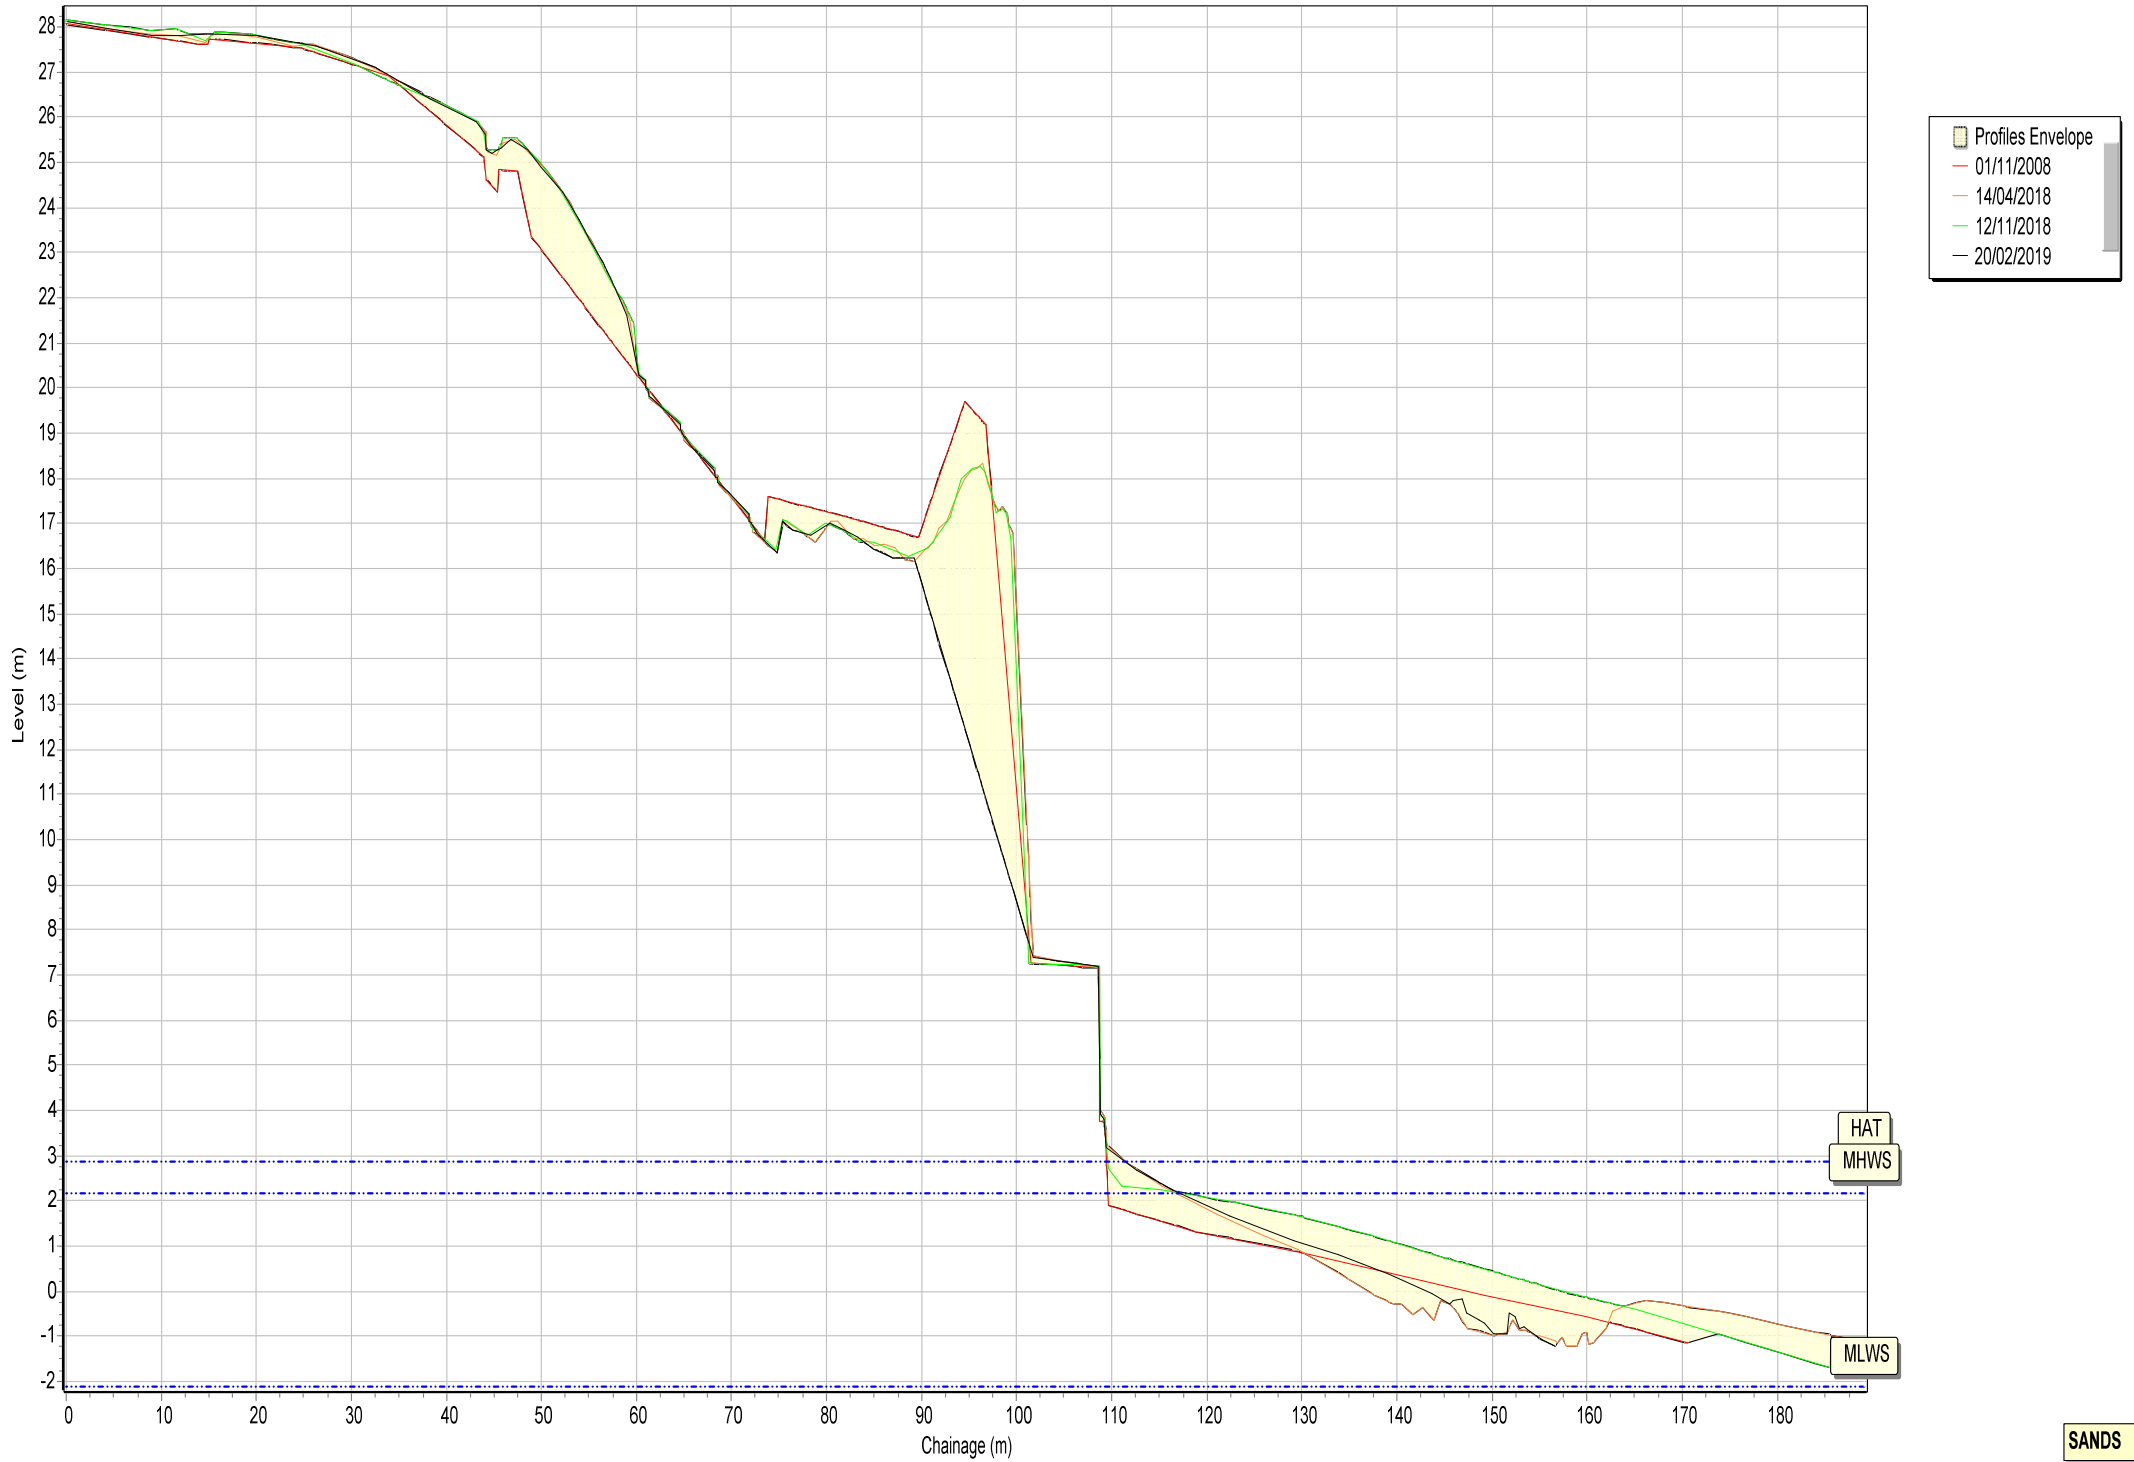
Beach Profiles: 1bSS14

- A section of cliff face could not be surveyed at profile 1bSS14 due to ground conditions being unsafe.

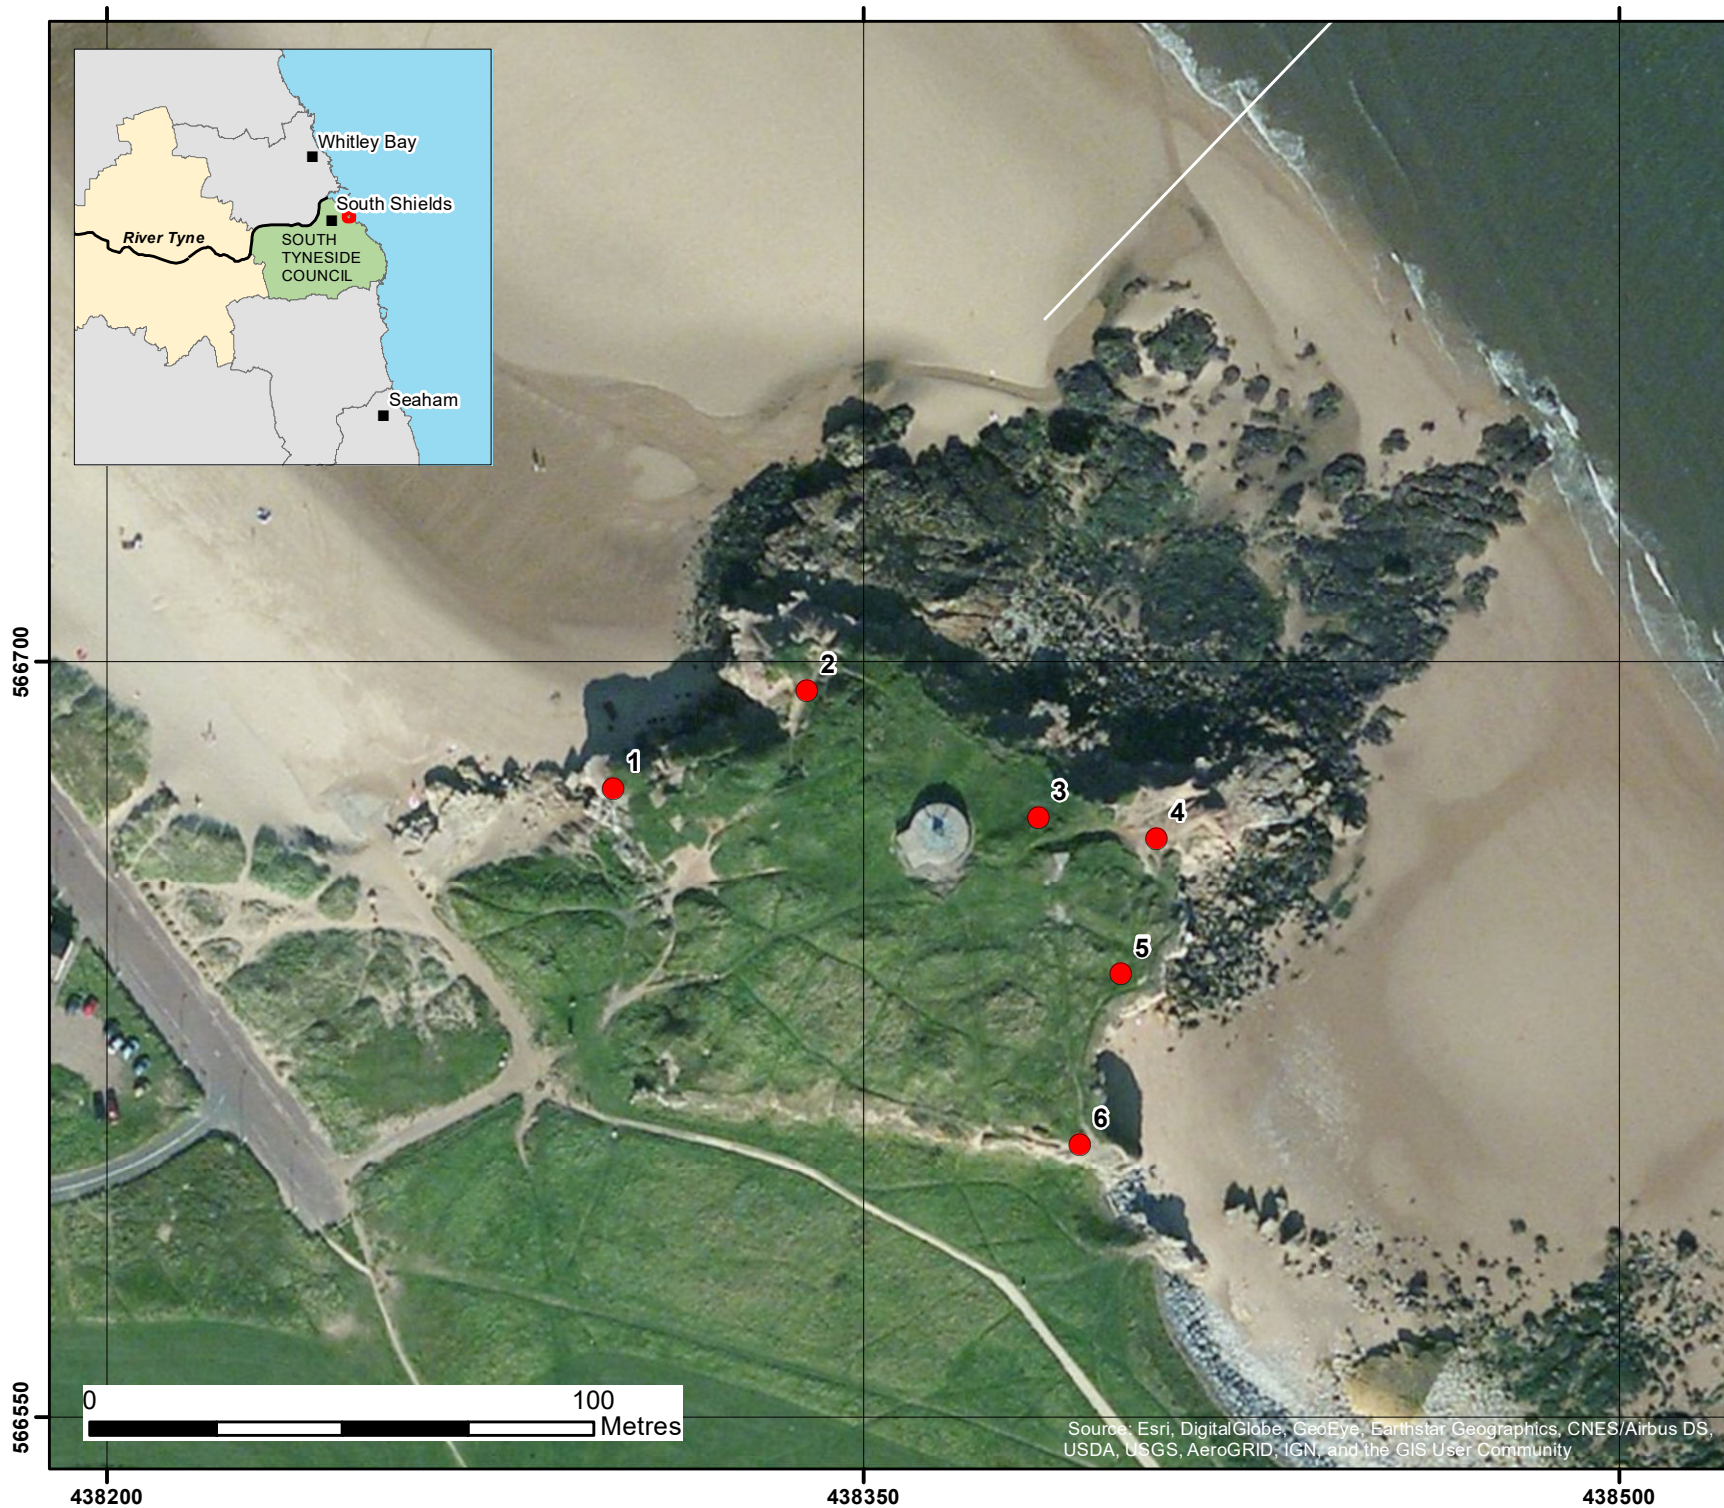
**Figure 3 - Map 1**

Cliff Top Survey Locations

Six ground control points have been established at Trow Quarry (Figure C1). The maximum separation between any two points varies along the coast, reflecting the degree of risk from the erosion.

The cliff top surveys at Trow Quarry are undertaken bi-annually. Measurements are taken from a fixed ground control point along a fixed bearing to the edge of the cliff top.

Feb 2019	<p><b>Cliff-top Survey:</b></p> <p>Cliff top survey data collected for the baseline survey (autumn, 2011), Full Measures survey (autumn, 2018) and the present Partial Measures survey (spring, 2019) is presented in this report.</p> <p>Six ground control points (numbered 1-6) were established along the cliff top at Trow Point in 2011 to monitor cliff erosion at the headland adjacent to the site of a former landfill. Note: the numbering of ground control points is not intended to correlate with that of the beach profile lines and reference should be made to Appendix C – Map 1 for the location of ground control points.</p> <p>These cliff top surveys are undertaken bi-annually. Measurements are taken from each ground control point along a fixed bearing to the edge of the cliff top. The results from the cliff top monitoring are anticipated to have an accuracy of <math>\pm 0.2\text{m}</math> due to the technique used. The results from the cliff top survey are presented in Appendix C – Table C1, showing the position from the ground control point to</p>	<p>Since the last survey, point 5 experienced erosion greater than the survey error, with 0.35m of erosion recorded.</p> <p><b>Longer term trends:</b> Very limited change has been detected since surveys began in November 2011.</p>

Survey Date	Description of Changes Since Last Survey	Interpretation
	<p>the edge of the cliff top along a defined bearing.</p> <p>Results show that since the last survey in November 2018, only one point (5) experienced erosion greater than the survey error (0.35m). No change greater than the survey error has been recorded over the long term.</p>

- At Trow Quarry, the recorded profiles present no causes for concern. The cliffs to the north west of Trow Headland appear to have been generally stable, however at point 5 there has been erosion greater than the survey error recorded (0.35m). The data does not indicate cause for concern.
