Cell 1 Regional Coastal Monitoring Programme Update Report 13: 'Partial Measures' Survey 2021

(*) The present report is **Update Report 13** and provides an analysis of the 2021 Partial Measures survey for South Tyneside Council's frontage.

South Tyneside Council Frontage

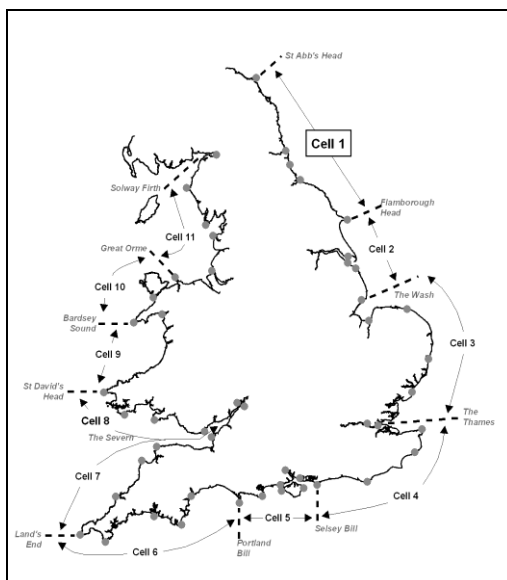
Figure 1 Sediment Cells in England and Wales

The Cell 1 Regional Coastal Monitoring Programme covers approximately 300km of the north east coastline, from the Scottish Border (just south of St. Abb's Head) to Flamborough Head in East Yorkshire. This coastline is often referred to as 'Coastal Sediment Cell 1' in England and Wales (Figure 1).

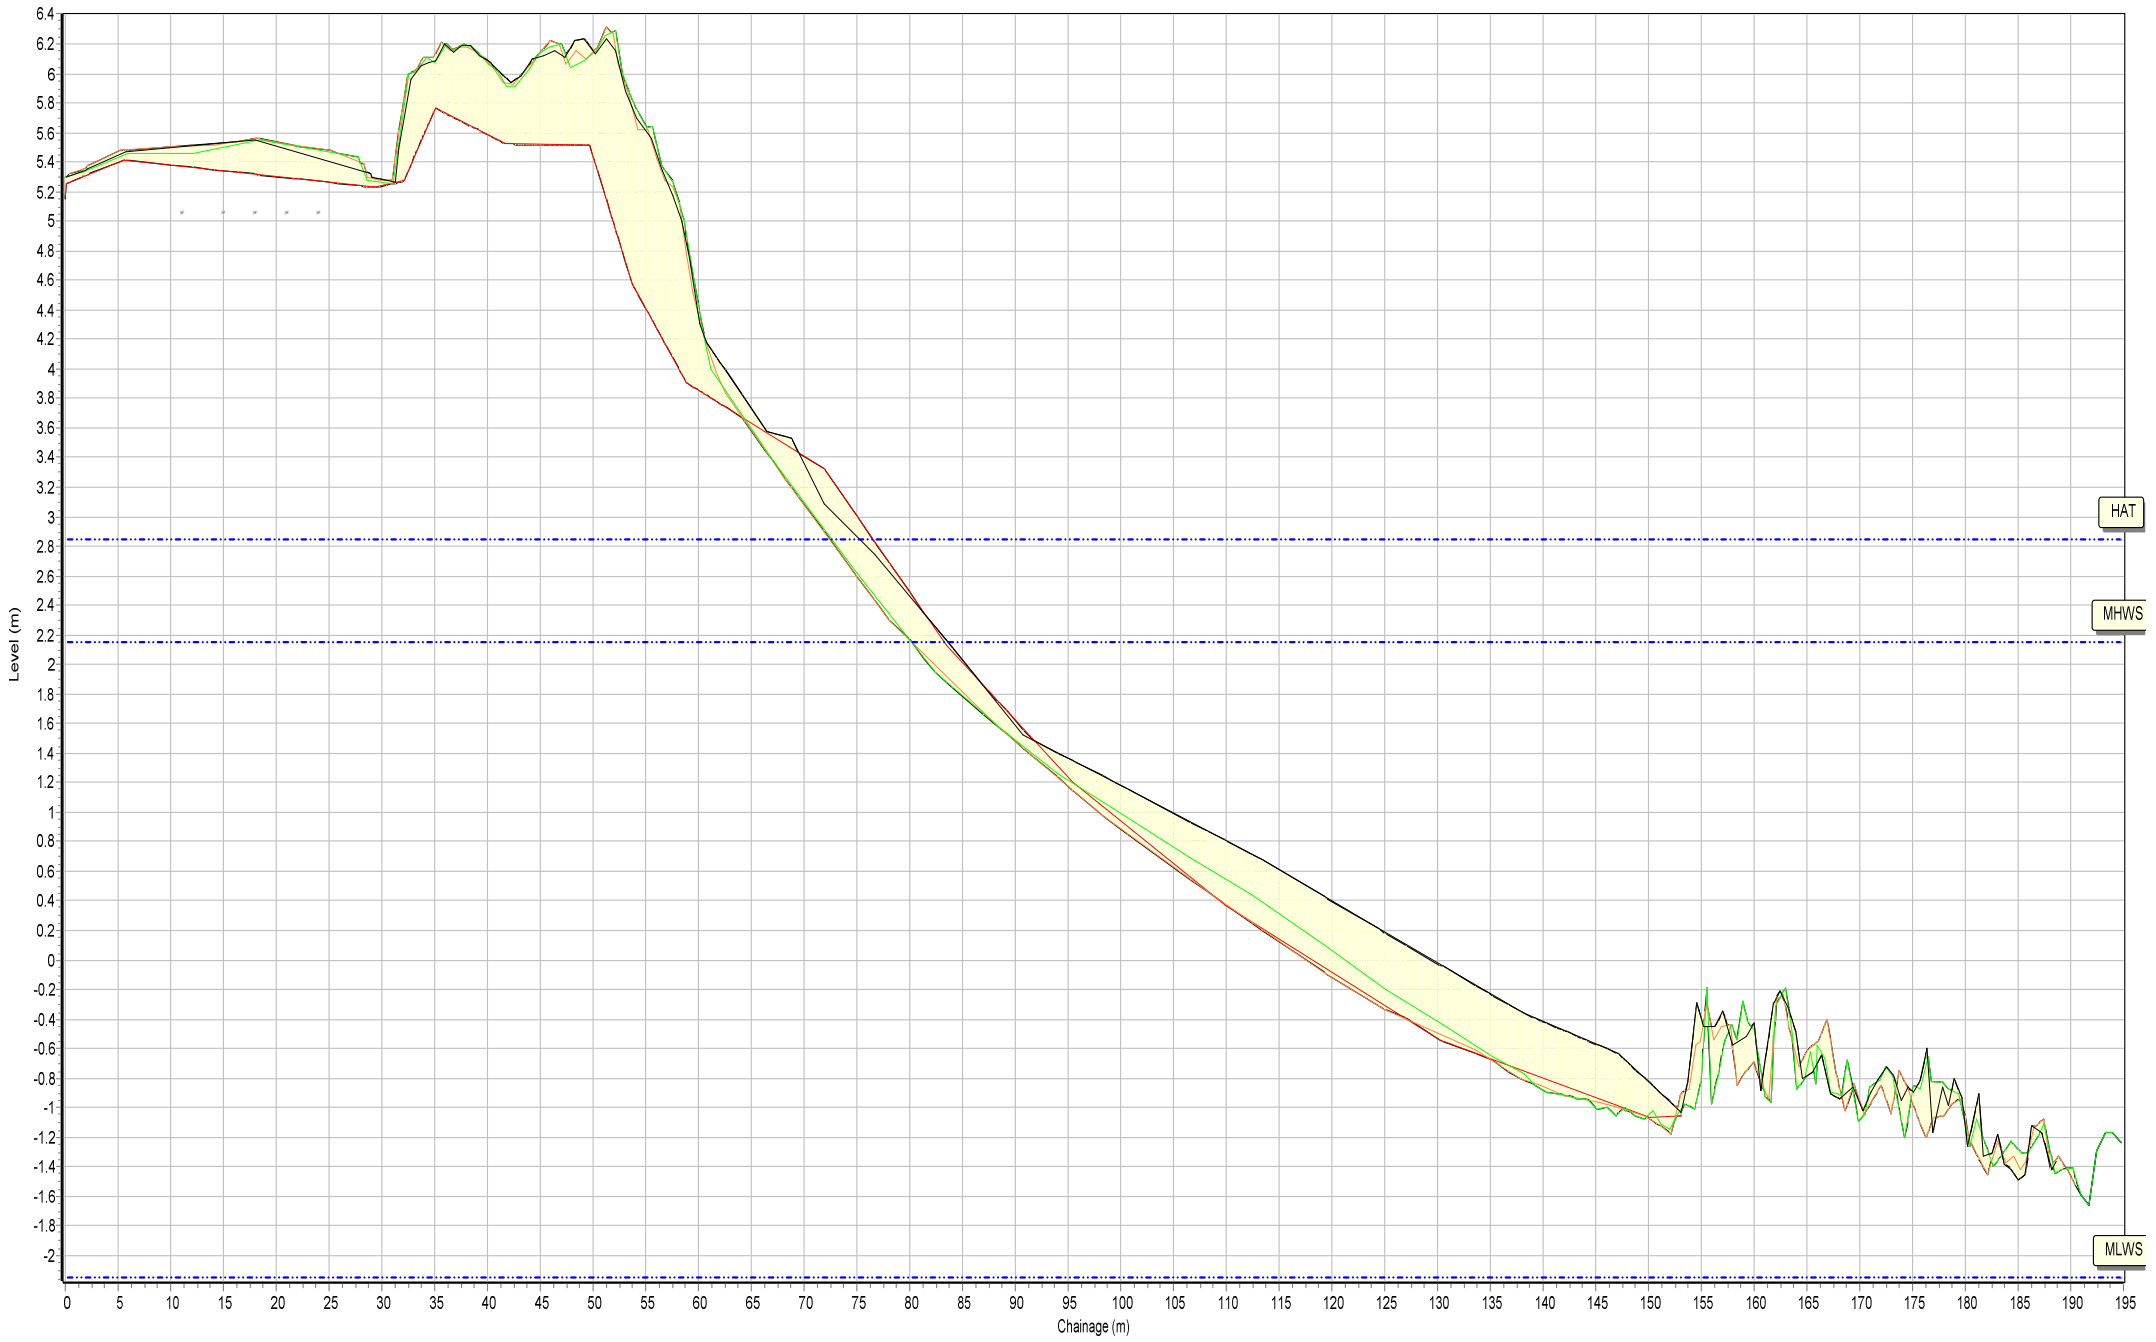
Beach Profiles: 1bSS1

Survey Date	Description of Changes Since Last Survey	Interpretation
12 th – 13 th April 2021	<p>Beach Profiles:</p> <p>Littlehaven Beach is covered by four beach profile lines for the Partial Measures surveys, distributed between South Groyne and South Pier (1bSS1, 1bSS2, 1bSS3 and 1bSS4). The previous survey was the Full Measures survey undertaken in September 2020 and the previous Partial Measures survey was undertaken in May 2020. Profiles 1bSS1 and 1bSS3 were last surveyed during the Partial Measures spring survey 2020. Profiles 1bSS2 and 1bSS4 were last surveyed during the Full Measures autumn survey 2020.</p> <p>Profile 1bSS1 is located towards the north of Littlehaven Beach, in the lee of a rocky outcrop and harbour wall. The dunes have changed little, with <0.1m accretion / erosion over the back dunes. Beach levels have risen from the toe of the dunes across the beach profile to the exposed rock patch at chainage 150m by up to 0.2m on the upper and middle beach, and 0.5m on the lower beach. Overall, the dunes and beach are at a high level compared to the range recorded from previous surveys, particularly across the lower beach between chainages 96-144m which is at its highest level recorded.</p> <p>Profiles 1bSS2 to 1bSS4 extend seawards from the new sea wall that was completed in 2014.</p> <p>At profile 1bSS2, beach levels at the toe of the seawall have risen by up to 0.6m to chainage 21m, forming a berm on the upper beach at chainage 16m. Between chainages 21m and 44m the beach has lowered by up to 0.6m, before switching to accretion across the middle and lower beach by up to 0.4m. Overall, the upper and middle beach profile are at a low level and the lower beach is at a high level compared to the range recorded from previous surveys, particularly between chainages 67m and the end of the survey at chainage 115m which is at its highest levels recorded.</p> <p>At profile 1bSS3 there has been varying sections of accretion and erosion across the upper beach by \pm 0.3m. The toe of the seawall has been covered by sediment. The middle and lower beach have lowered evenly by up to 0.5m. Overall, the upper beach profile is at a high level and the middle and lower beach are at a medium level compared with the range recorded from previous surveys.</p>	<p>Overall, there has been alternating bands of erosion and accretion across Littlehaven beach. Generally, the northern profiles (1bSS1 and 1bSS2) have accreted and the southern profiles (1bSS3 and 1bSS4) have lowered.</p> <p>Longer term trends: When compared with previous profile surveys, profiles 1bSS1 to 1bSS4 range between low to high levels, however two sections experienced their highest levels recorded (96-144m at 1bSS1 and 67-115m at 1bSS2). The profiles indicate normal seasonal behaviour with no clear trend.</p>

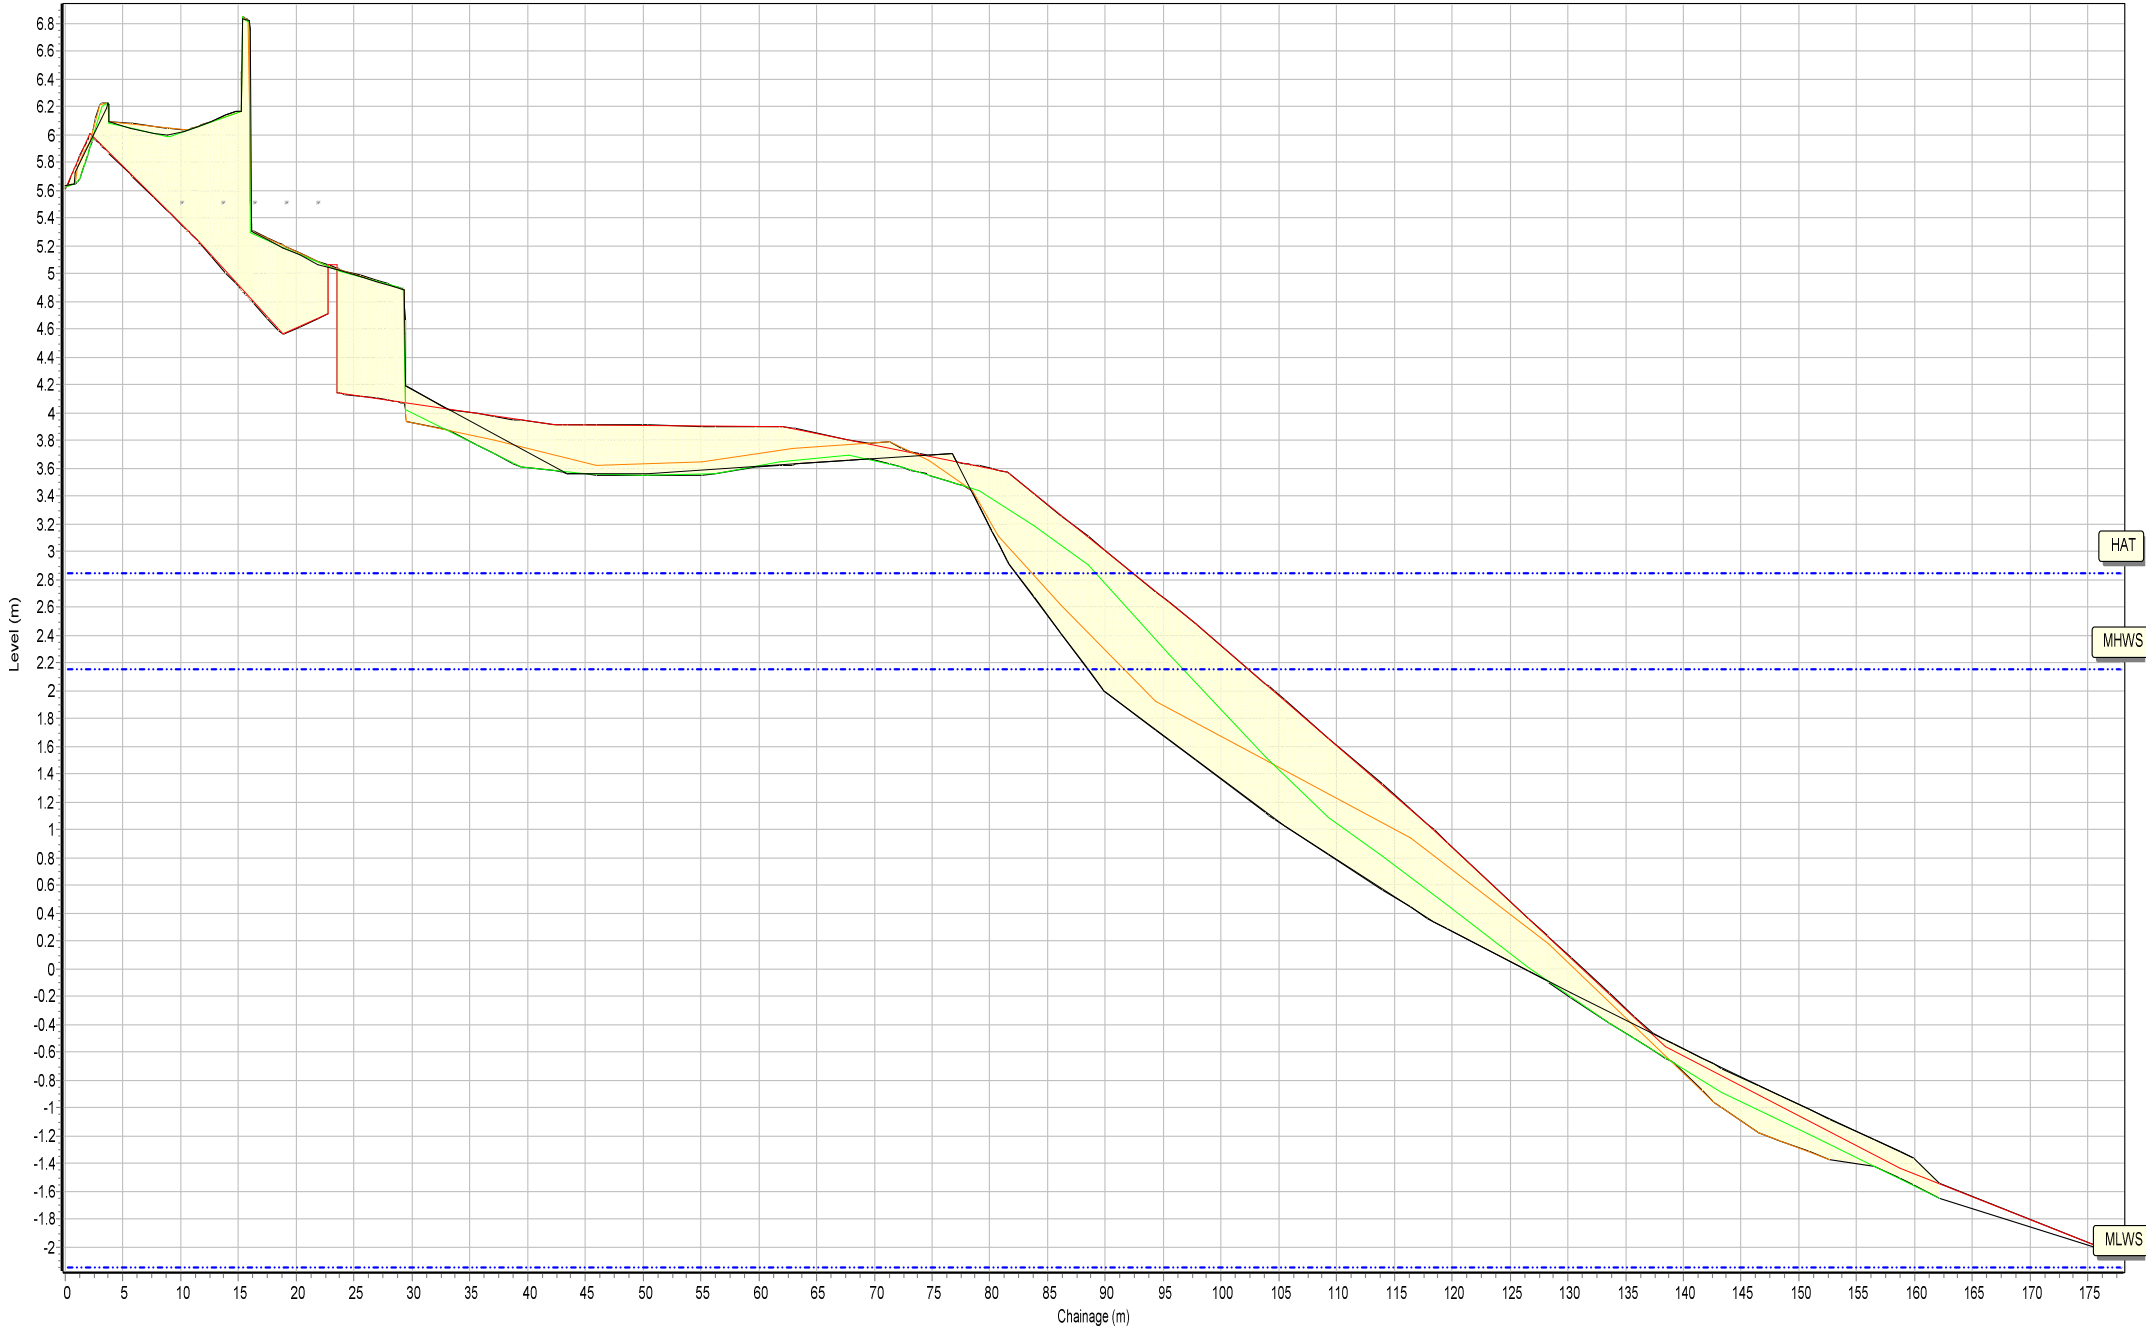
Beach Profiles: 1bSS4

Survey Date	Description of Changes Since Last Survey	Interpretation
	<p>At profile 1bSS4 there has been accretion on the upper beach between the seawall and chainage 78m of up to 0.2m. The middle beach has lowered by up to 0.7m to chainage 130m. The lower beach has accreted by up to 0.2m to the end of the survey at chainage 160m. Overall, the beach is at a low level on the upper and middle beach compared to the range recorded from previous surveys, whilst the lower beach is at a medium level.</p>	
<p>April 2021</p>	<p>Topographic Survey:</p> <p>Littlehaven Beach is covered by bi-annual topographic survey between the South Groyne and the South Pier, which commenced in March 2010.</p> <p>Data from the most recent topographic survey (Partial Measures, spring 2021) have been used to create a DGM (Appendix B – Map 1a) using a Geographical Information System (GIS). A difference plot has also been produced using the DGM (Appendix B – Map 1b) produced from the last produced topographic survey (Full Measures, autumn 2020) and the present survey.</p> <p>The difference plot shows a clear a pattern of change across the beach, which reflects the beach profile data. The plots show, in general terms, alternating bands of change, which extend from north to south, and comprise: (i) a band of patchy accretion / little change ($\pm 0.1\text{m}$) parallel to the new defences on the upper beach; (ii) a band of erosion on the middle beach which narrows from the south toward the central beach and disappears in the north; and (iii) a band of accretion / little change ($\pm 0.1\text{m}$) on the lower beach which is at its widest from the central beach to the north. Change is limited to $\pm 0.5\text{m}$. The pattern of alternating bands of erosion and accretion suggests cross-shore movements of sediment. The dunes at the northern end of the bay generally remained stable.</p>	<p>The pattern of beach elevation change observed from the topographic difference plot indicates distinct areas of erosion and accretion, associated with migration of sand bars across the beach face.</p>

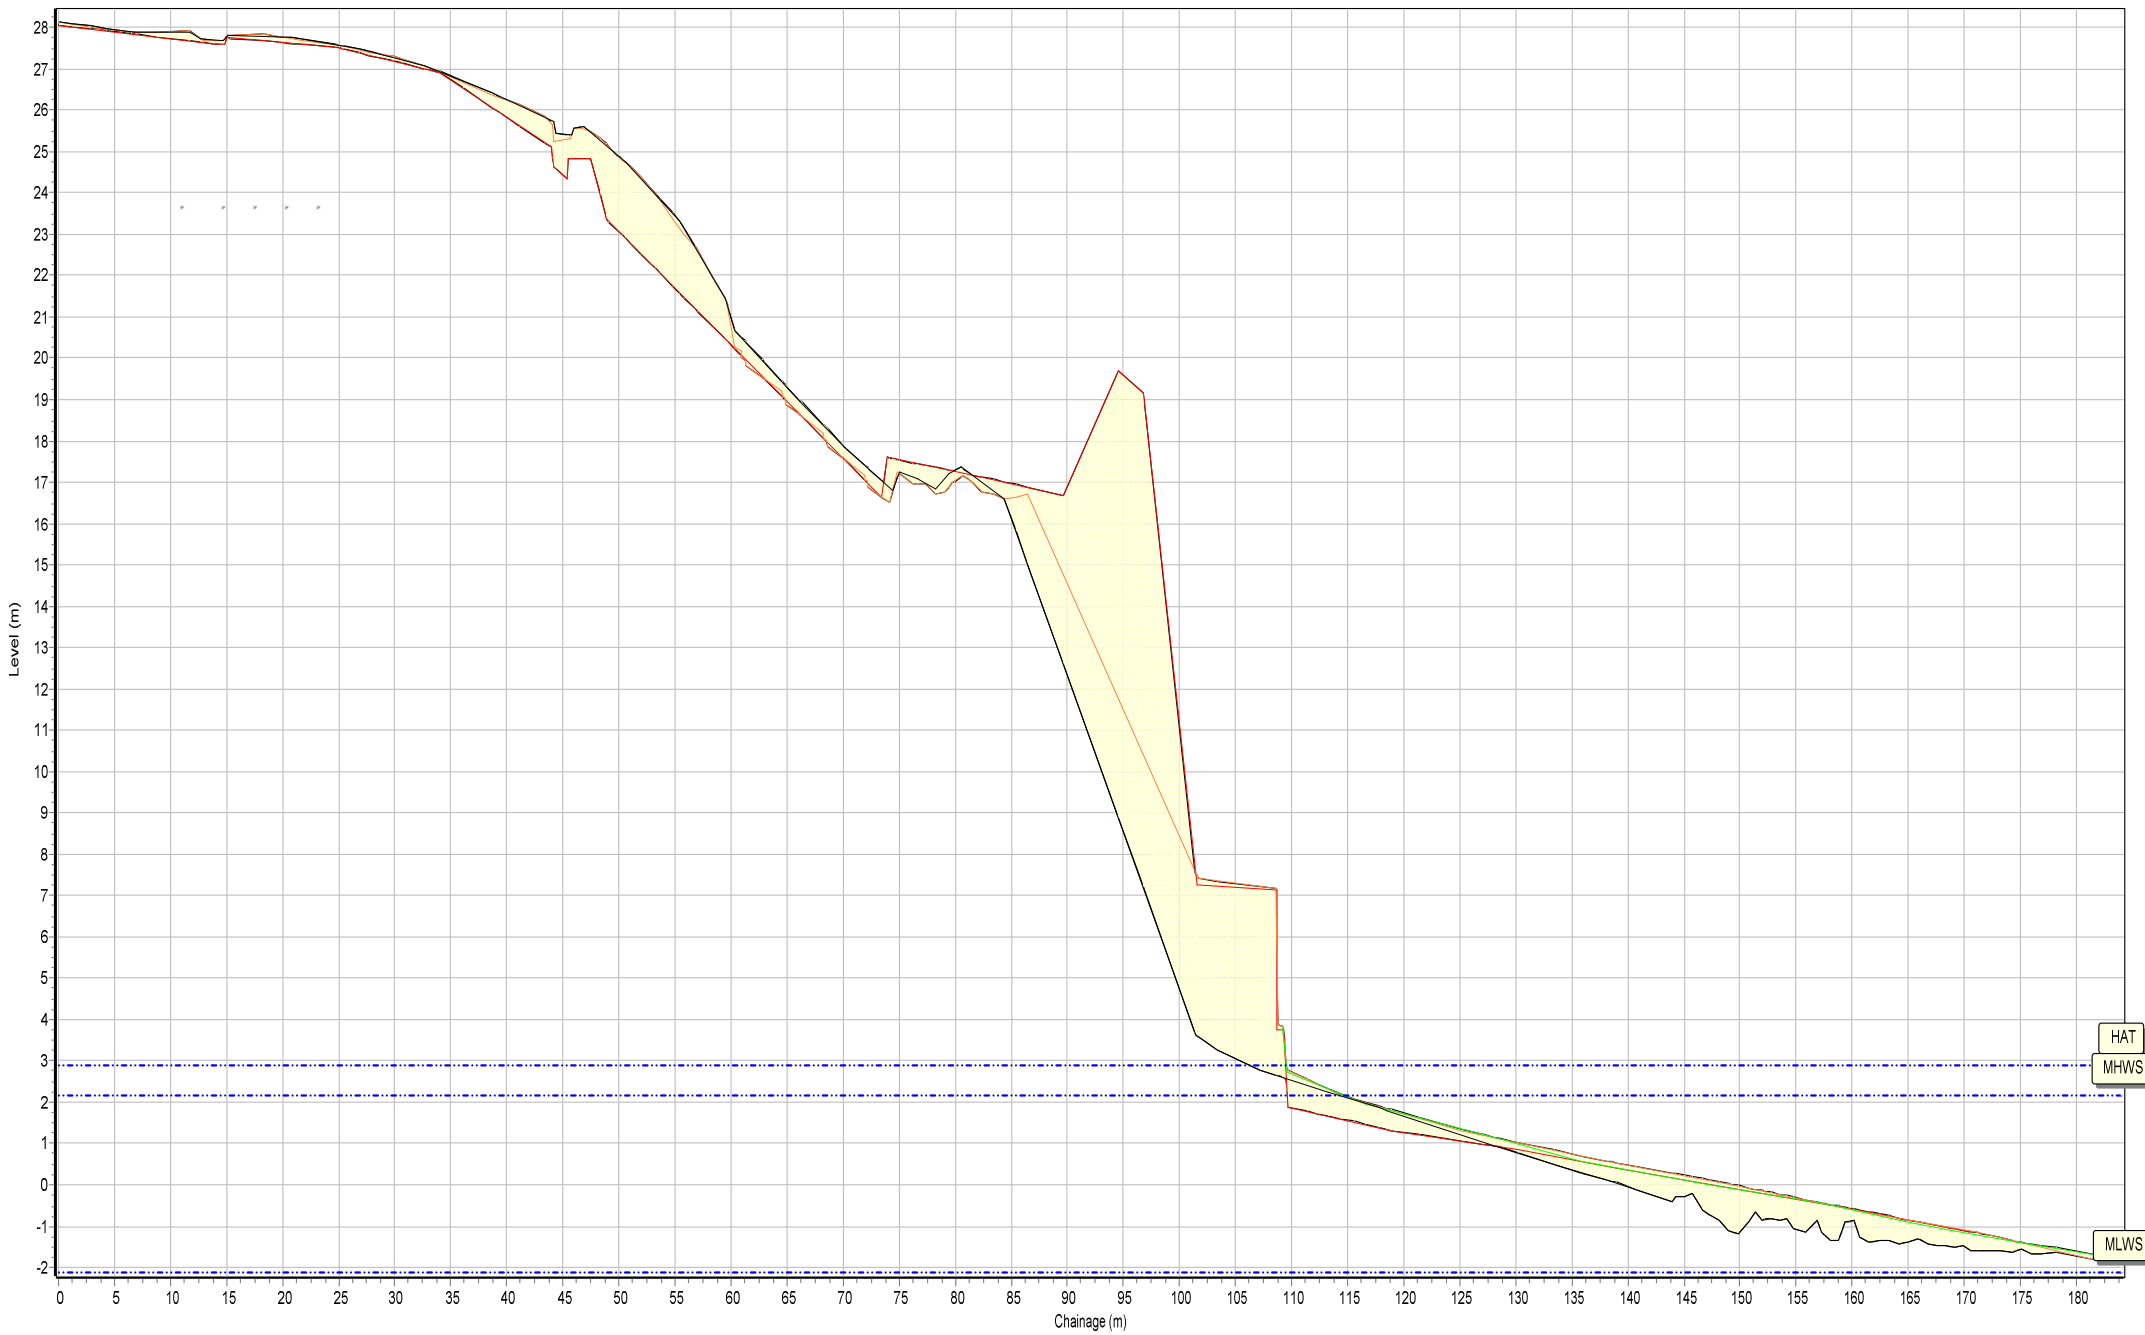
Beach Profiles: 1bSS14

- A section of cliff face could not be surveyed at profile 1bSS14 due to ground conditions being unsafe. This is an area where the lower section of the Redwell Steps have been removed (along with the adjacent canoe store and lifeguard station, which have both been demolished) and replacement access steps are not yet in place.
