Cell 1 Regional Coastal Monitoring Programme Update Report 15: 'Partial Measures' Survey 2023

South Tyneside Council
April 2023

(*) The present report is **Update Report 15** and provides an analysis of the 2023 Partial Measures survey for South Tyneside Council's frontage.

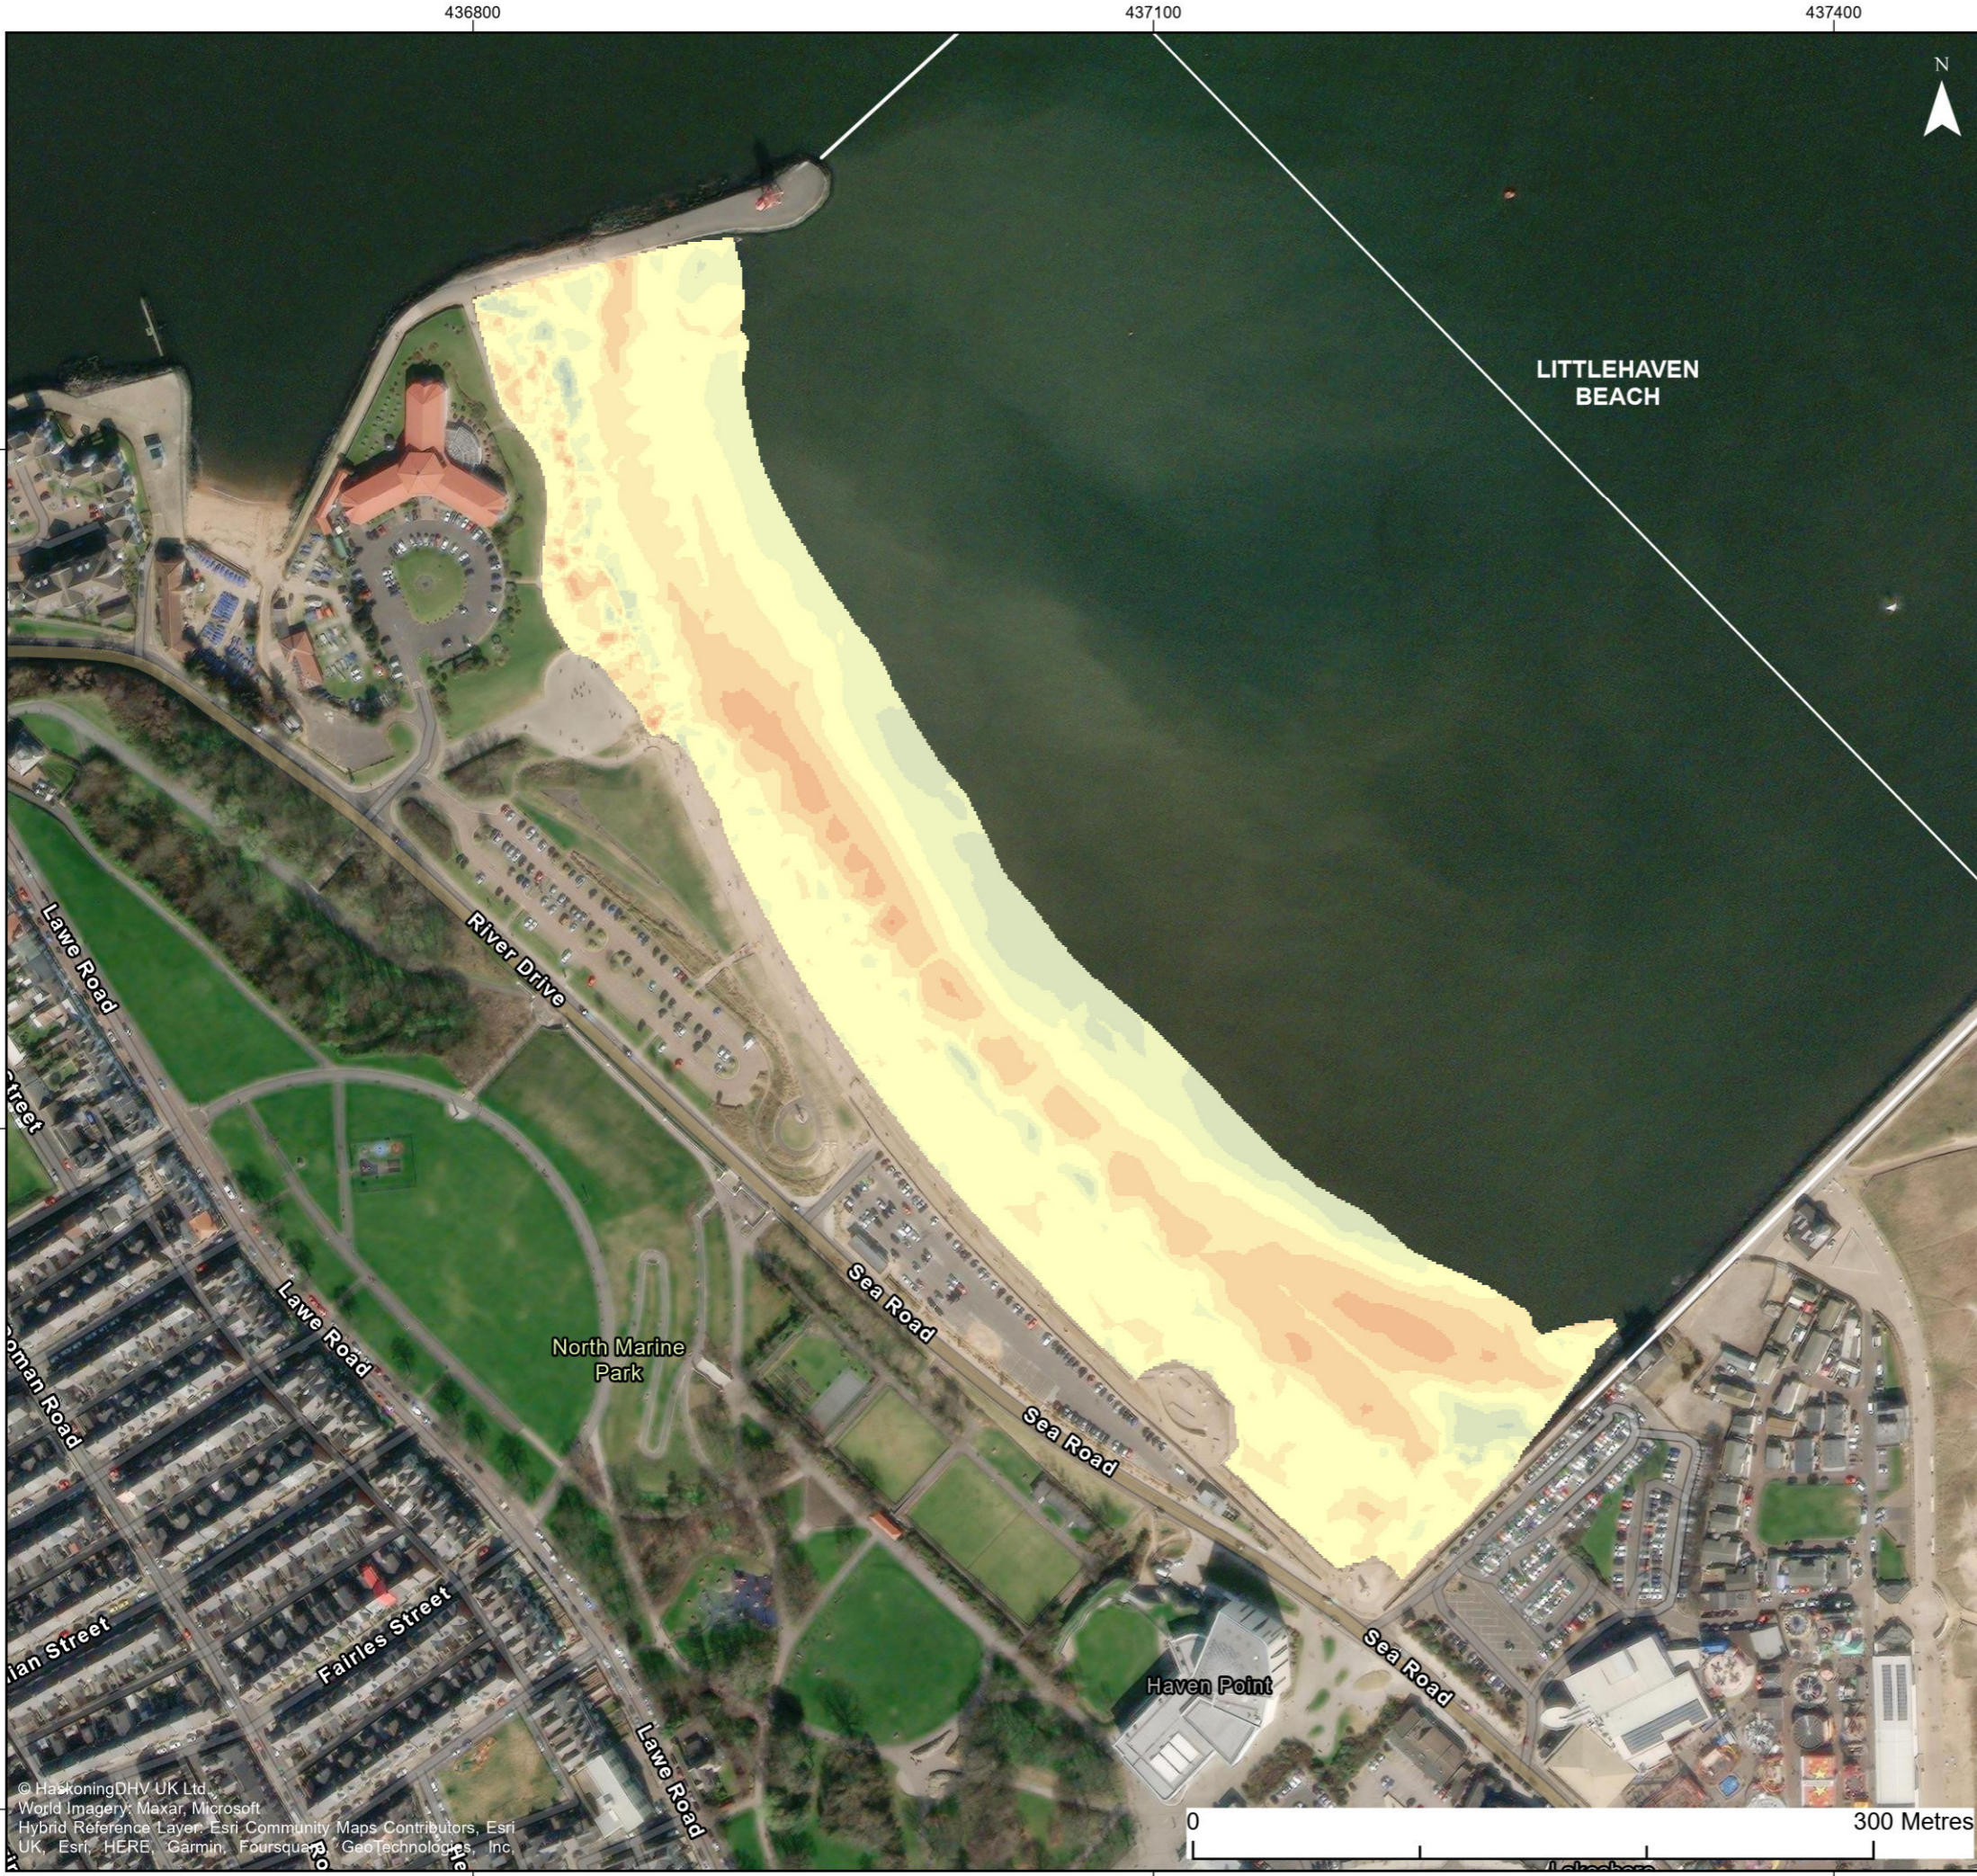
Appendix B - Map 2

<p>March 2023</p>	<p>Topographic Survey:</p> <p>Littlehaven Beach is covered by bi-annual topographic survey between the South Groyne and the South Pier, which commenced in March 2010.</p> <p>Data from the most recent topographic survey (Partial Measures, spring 2023) have been used to create a DGM (Appendix B – Map 1a) using a Geographical Information System (GIS). A difference plot has also been produced using the DGM (Appendix B – Map 1b) produced from the last produced topographic survey (Full Measures, autumn 2022) and the present survey.</p> <p>The difference plot shows a clear a pattern of change across the beach, which reflects the beach profile data. The plots show, in general terms, alternating bands of change, which extend from north to south, and comprise: (i) a band of patchy accretion / erosion ($\pm 1.0\text{m}$) on the upper beach in the north of the bay; (ii) a band of erosion on the middle beach which widens towards the south of the bay; and (iii) a band of accretion / little change ($\pm 0.1\text{m}$) on the lower beach which is at its widest on the central beach (except in the south which shows erosion on the lower beach). Change is limited to $\pm 0.5\text{-}0.75\text{m}$. The pattern of alternating bands of erosion and accretion suggests cross-shore movements of sediment. The dunes at the northern end of the bay generally remained stable.</p>	<p>The pattern of beach elevation change observed from the topographic difference plot indicates distinct areas of erosion and accretion, associated with migration of sand bars across the beach face. The plot is similar to previous years.</p>
