**Cell 1 Regional Coastal Monitoring Programme  
Analytical Report 2: 'Full Measures' Survey 2009**

<sup>(\*)</sup> The present report is **Analytical Report 2** and provides an analysis of the 2009 Full Measures survey for Sunderland City Council's frontage.

Sunderland City Council's frontage extends from The Bents to Ryhope Dene. For the purposes of this report, it has been sub-divided into three areas, namely:

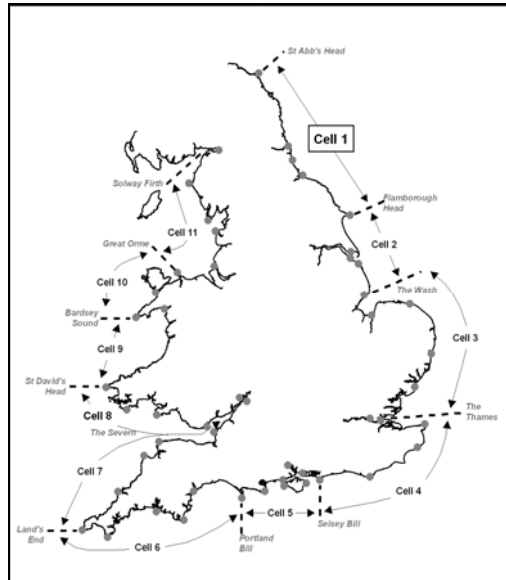
Figure 1 Sediment Cells in England and Wales

The Cell 1 Regional Coastal Monitoring Programme covers approximately 300km of the north east coastline, from the Scottish Border (just south of St. Abb's Head) to Flamborough Head in East Yorkshire. This coastline is often referred to as 'Coastal Sediment Cell 1' in England and Wales (Figure 1). Within this frontage the coastal landforms vary considerably, comprising low-lying tidal flats with fringing salt marshes, hard rock cliffs that are mantled with glacial till to varying thicknesses, softer rock cliffs, and extensive landslide complexes.

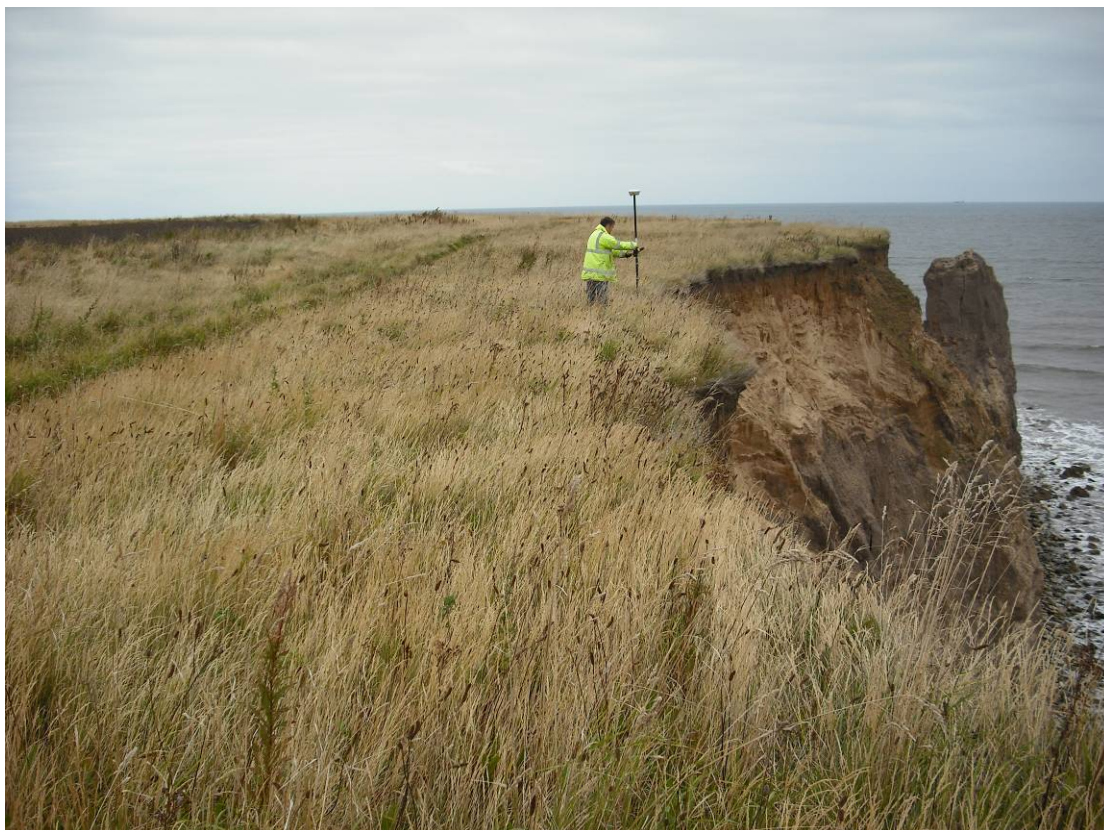
#### Plate 1 – Cliff Top Surveying

Surveying any cliff top is difficult due to the Health and Safety risks posed to surveyors, especially during adverse weather, and the 'apparent' changes that can arise due to surveyors interpreting different points as the cliff edge on successive surveys (Plate 1). This has been identified as affecting one beach profile (SNN9) and most of the cliff top surveys.

In addition to surveyor interpretation, the cliffs along this frontage have a characteristic tendency to heave seawards prior to a toppling failure, leading to apparent discrepancies in the data.

It is also known that along cliff top monitoring points 1 – 3 the cliff top has been re-landscaped behind the coastal defences, giving rise to the apparent massive increase in distance to the cliff edge.

It is recommended that further attempts at the cliff top surveys are made in spring 2010 during the Partial Measures surveys (as already scheduled) and if problems in interpretation persist then the cliff top surveys be removed from the programme, reduced in frequency of occurrence, or undertaken using alternative technology, such as terrestrial laser scanning.

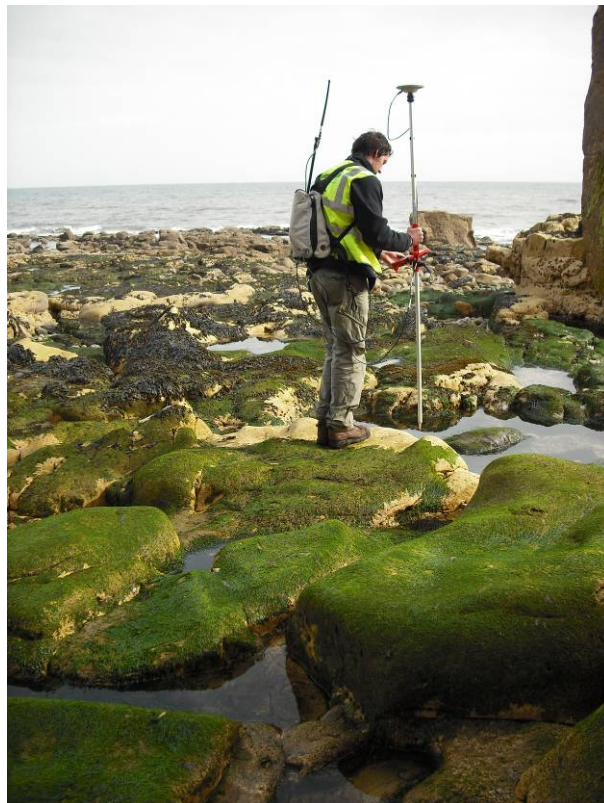
**Plate 2 - Survey of Rock Foreshore**

Surveys of foreshore areas that are covered by inter-tidal rock outcrops present some problems to our surveyors (Plate 2). It is logistically difficult for staff to access across the foreshore but more importantly it is very difficult to ensure that identical rock features are re-surveyed on each occasion. Due to the fragmented, creviced and 'rocky' nature of the foreshore it is extremely likely that different features will be recorded on successive surveys due to this. We would expect that the rock foreshore would not experience significant down-weathering over short timescales and therefore any apparent changes between successive surveys are likely to be due to surveying different features rather than erosion.

Notwithstanding this, the rock foreshore areas may periodically be covered with a thin veneer of beach sand, which due to its mobility, can be absent on subsequent surveys. Such changes are identified through inspection of the photographs that are taken by the surveyors along each transect line and analysis of the sediment coding that is included in the raw data file, depicting areas of 'sand' or 'rock'.

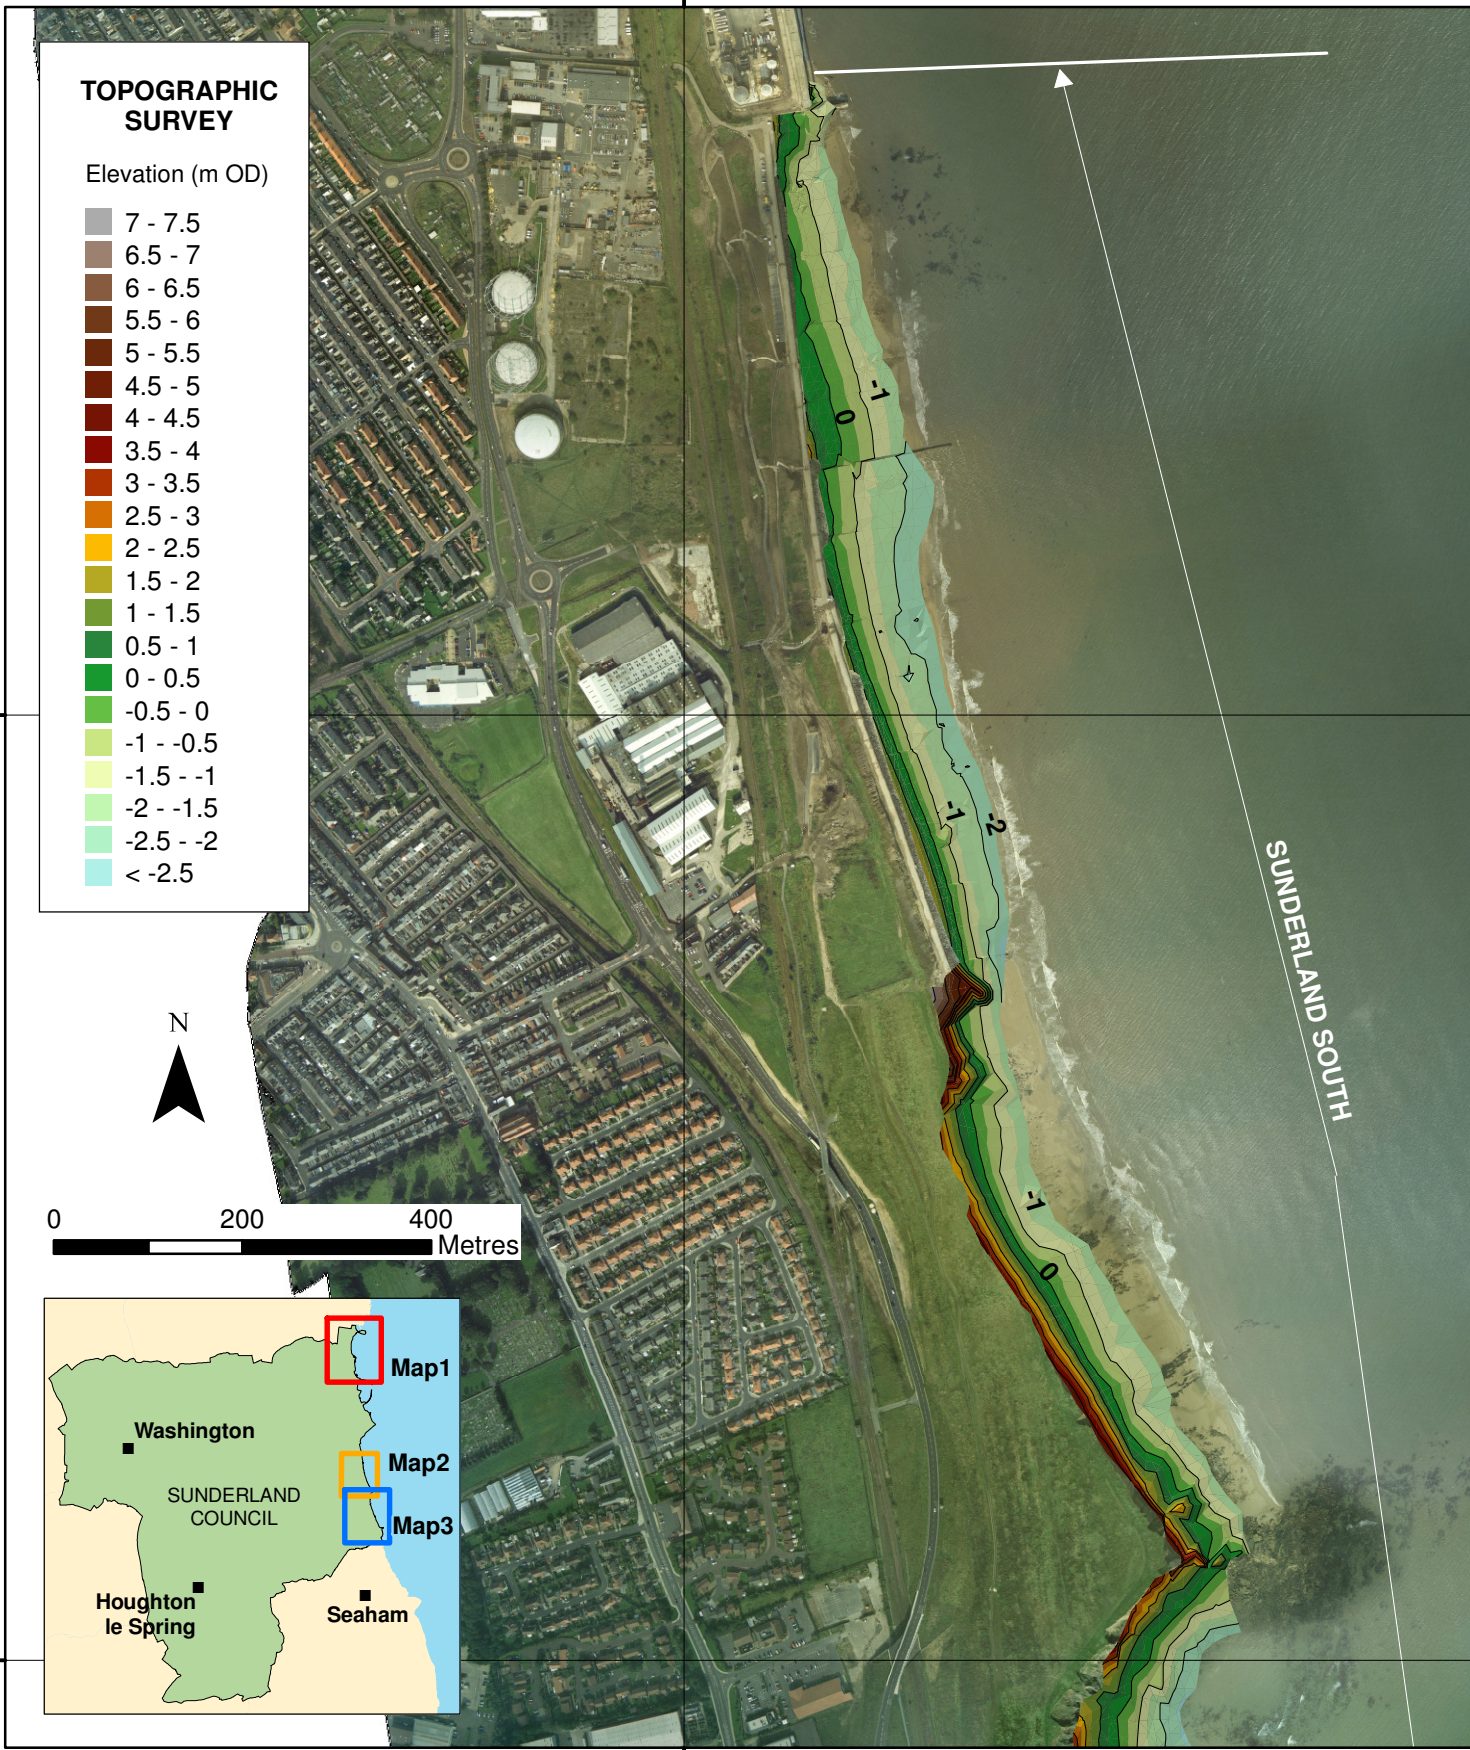
### Appendix B - Map 2 Sunderland Council Frontage

— Topographic Contours at 1 metre interval

### TOPOGRAPHIC SURVEY

Elevation (m OD)

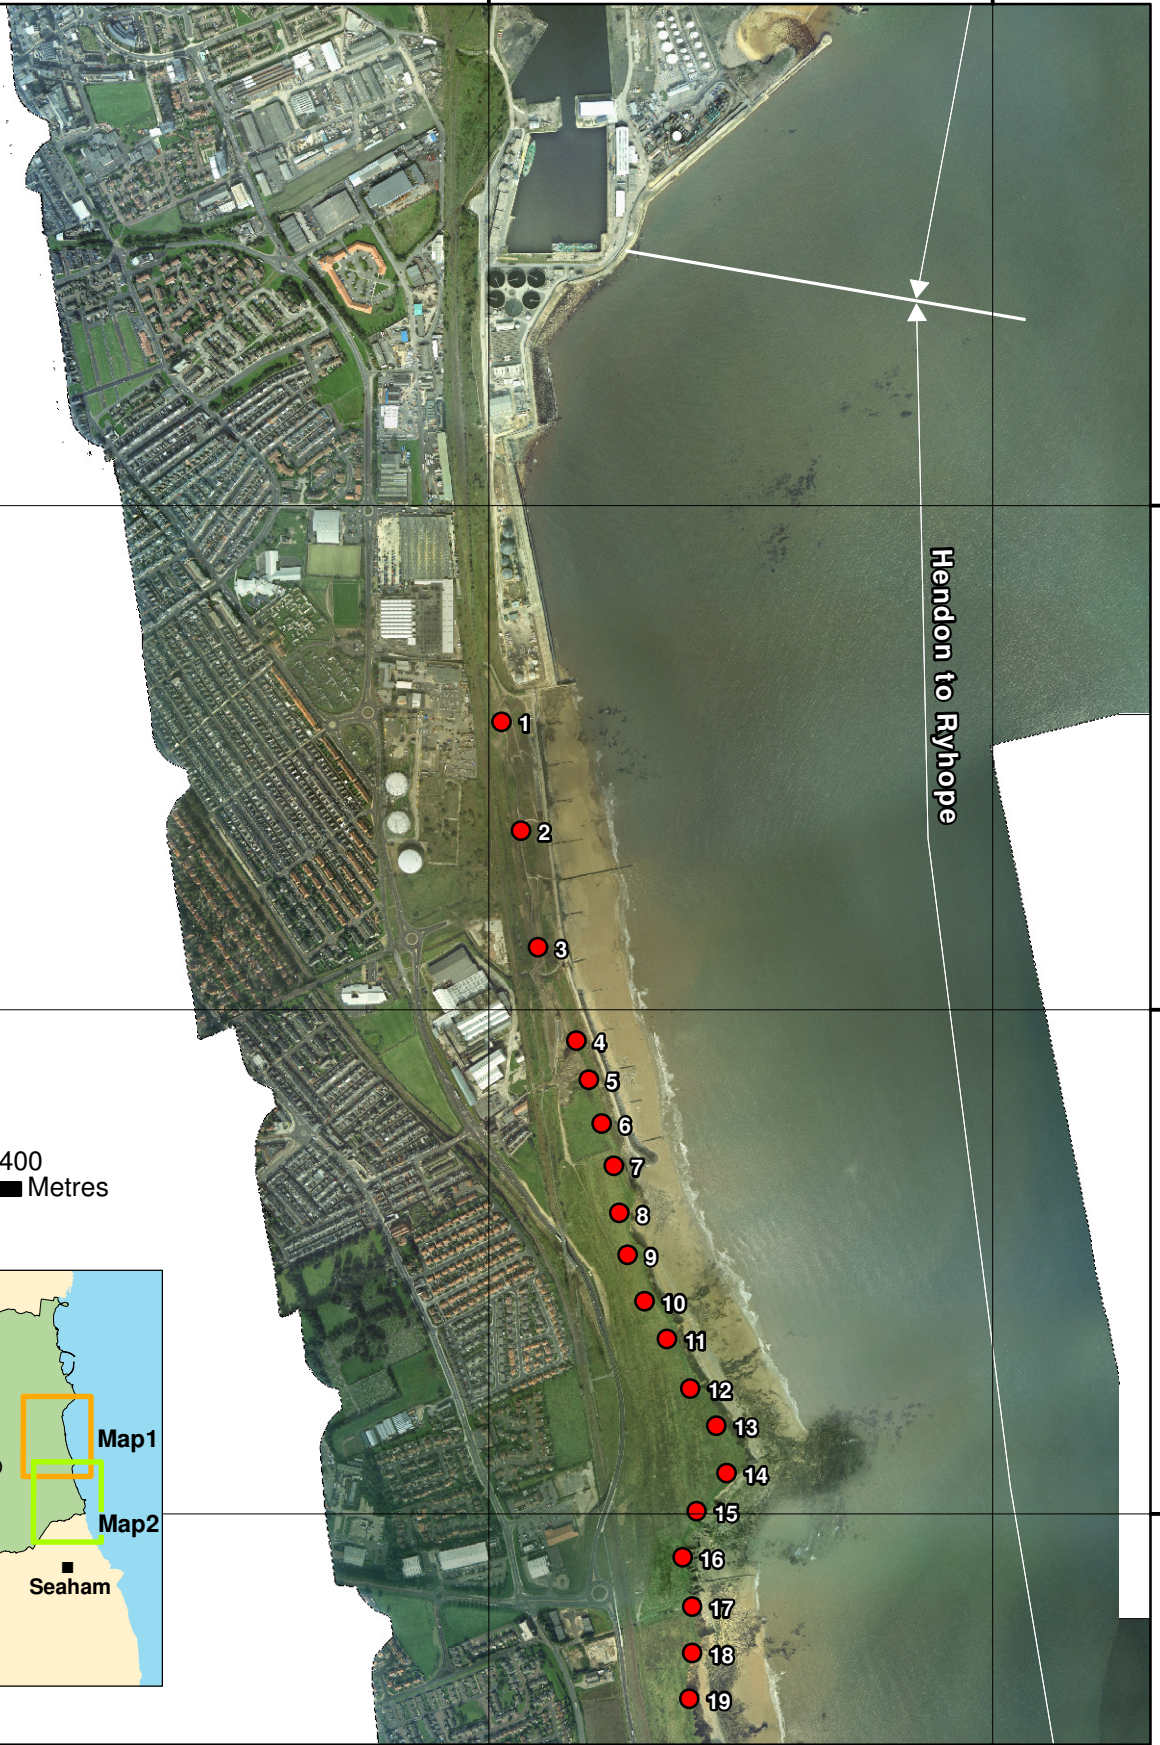
### Appendix C - Map 1 Sunderland Council Frontage

Thirty-two ground control points have been established between Hendon and Ryhope (Figure C1). The maximum separation between any two points varies along the coast, reflecting the degree of risk from the erosion.

The cliff top surveys between Hendon and Ryhope are undertaken bi-annually. Measurements are taken from a fixed ground control point along a fixed bearing to the edge of the cliff top.

● Cliff Top Monitoring Points

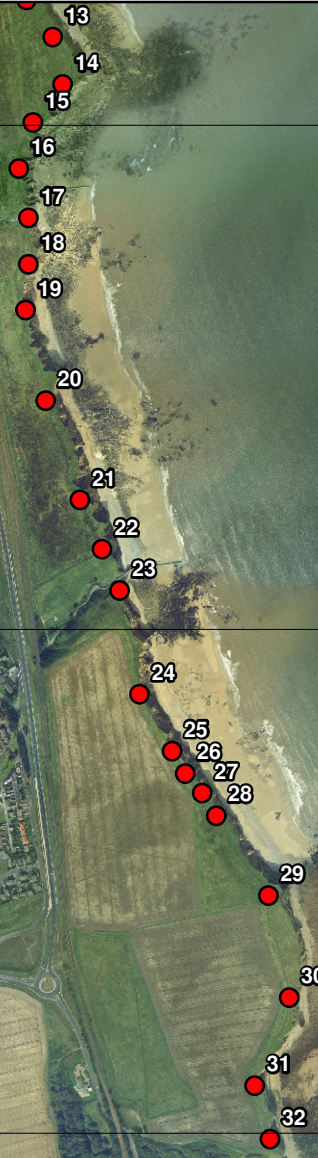
**Appendix C - Map 2  
 Sunderland  
 Council Frontage**

Hendon to Ryhope

Cliff Top Monitoring Points
