**Cell 1 Regional Coastal Monitoring Programme
Analytical Report 3: 'Full Measures' Survey 2010**

(*) The present report is **Analytical Report 3** and provides an analysis of the 2010 Full Measures survey for Sunderland City Council's frontage.

Analytical Report 3
 'Full Measures' Survey 2010

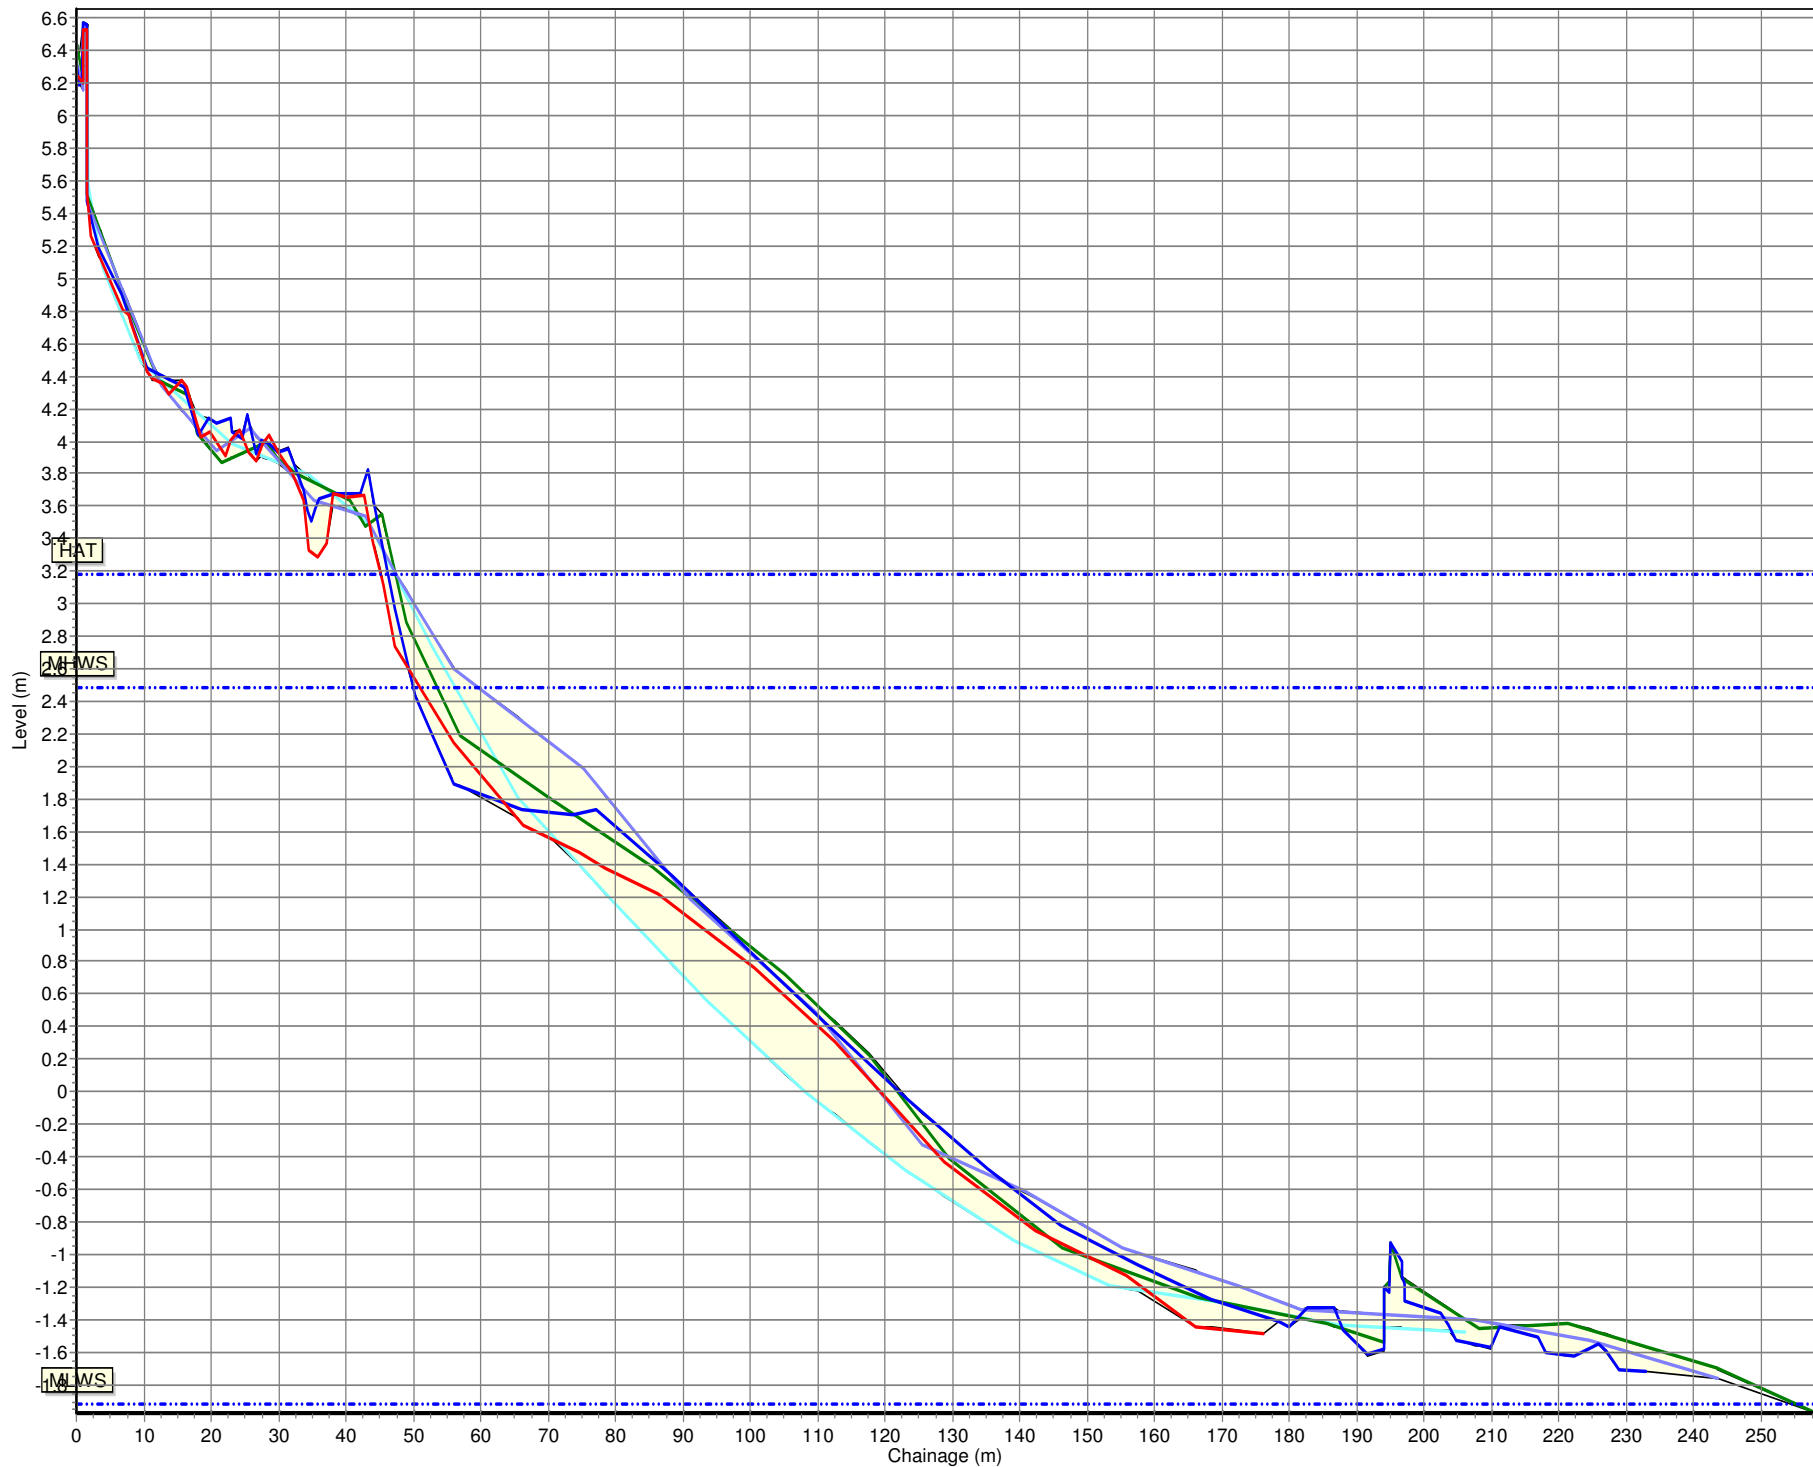
Beach Profiles: 1bSNN1

- Profiles Envelope
- 10/11/2006
- 27/04/2009
- 07/09/2009
- 18/03/2010
- 28/09/2010

- Beach levels are particularly low along Seaburn, where the high water contour intercepts the sea wall. This places the structure at high exposure, leaving it vulnerable to damage and toe undermining.

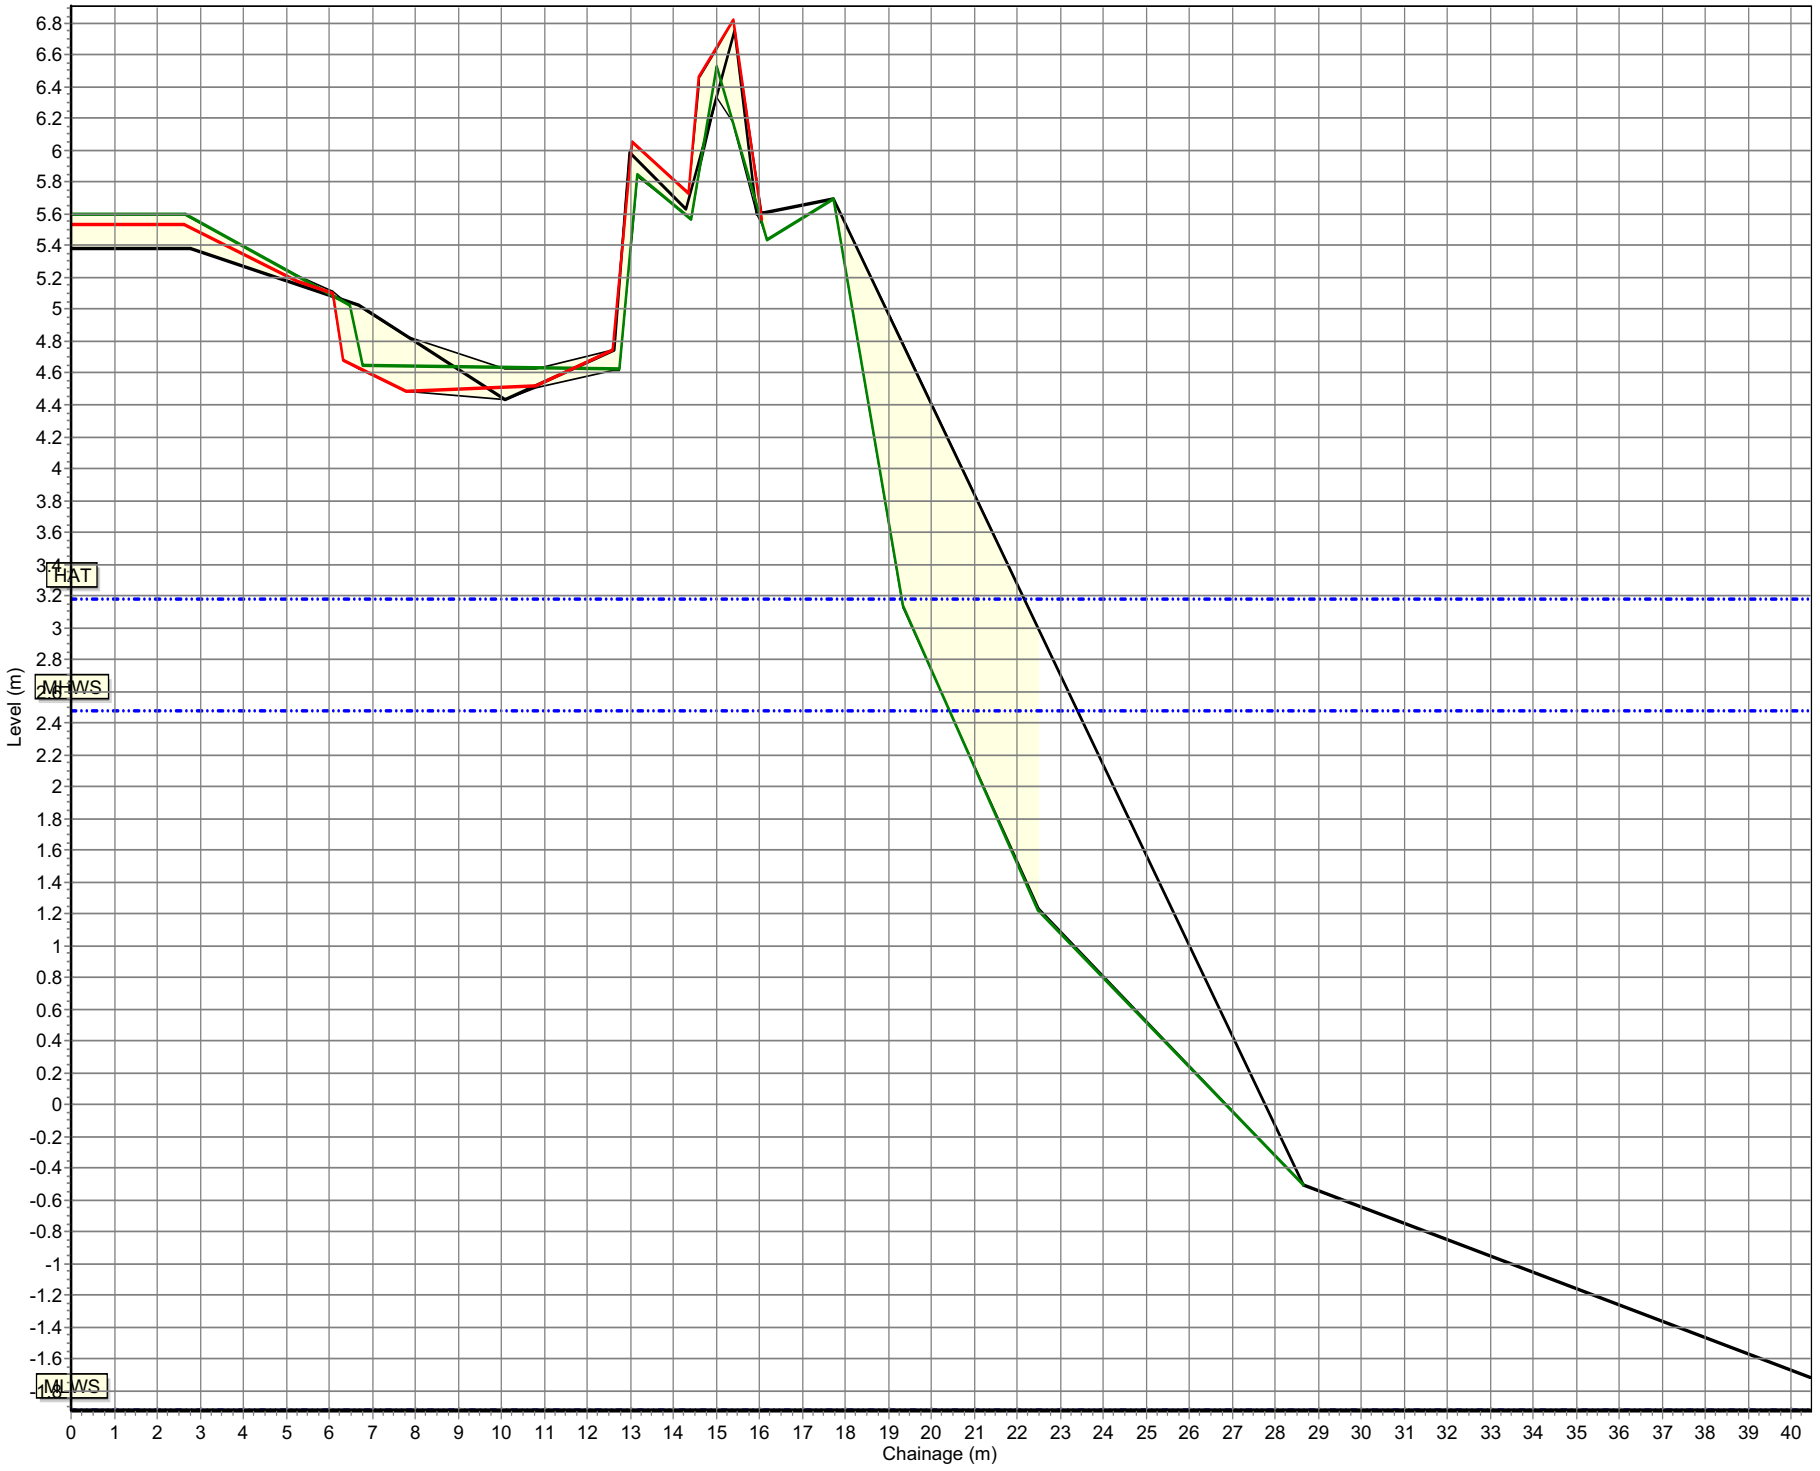
Beach Profiles: 1bSNS1

| Survey Date | Description of Changes Since Last Survey | Interpretation |
|---|---|---|
| | <p>SNS1 to SNS6 are located along the sea wall protecting the Hendon Sewage Treatment Works. The profiles typically include a section along the concrete deck, wall crest (which varies in elevation between around 7.0mODN in the north and 7.6mODN in the south after the dog-leg in the wall position), near-vertical seaward face of the wall, and sloping rock armour revetment. The foreshore across SNS1, SNS2 and SNS3 was not surveyed because of difficult access and dangerous conditions whilst the profile of SNS5 and SNS6 drops directly from the structure into deep water. Along SNS4 a short patch of foreshore is surveyed at the toe of the revetment, and this showed minor redistribution of sediment.</p> | <p>SNS1 to SNS6 generally record the Hendon Sea Wall and not the foreshore.</p> |

- Profiles Envelope
- 10/11/2006
- 16/09/2009
- 06/10/2010

The foreshore across SNS1, SNS2 and SNS3 was not surveyed because of difficult access conditions and dangerous conditions at the time of the survey.

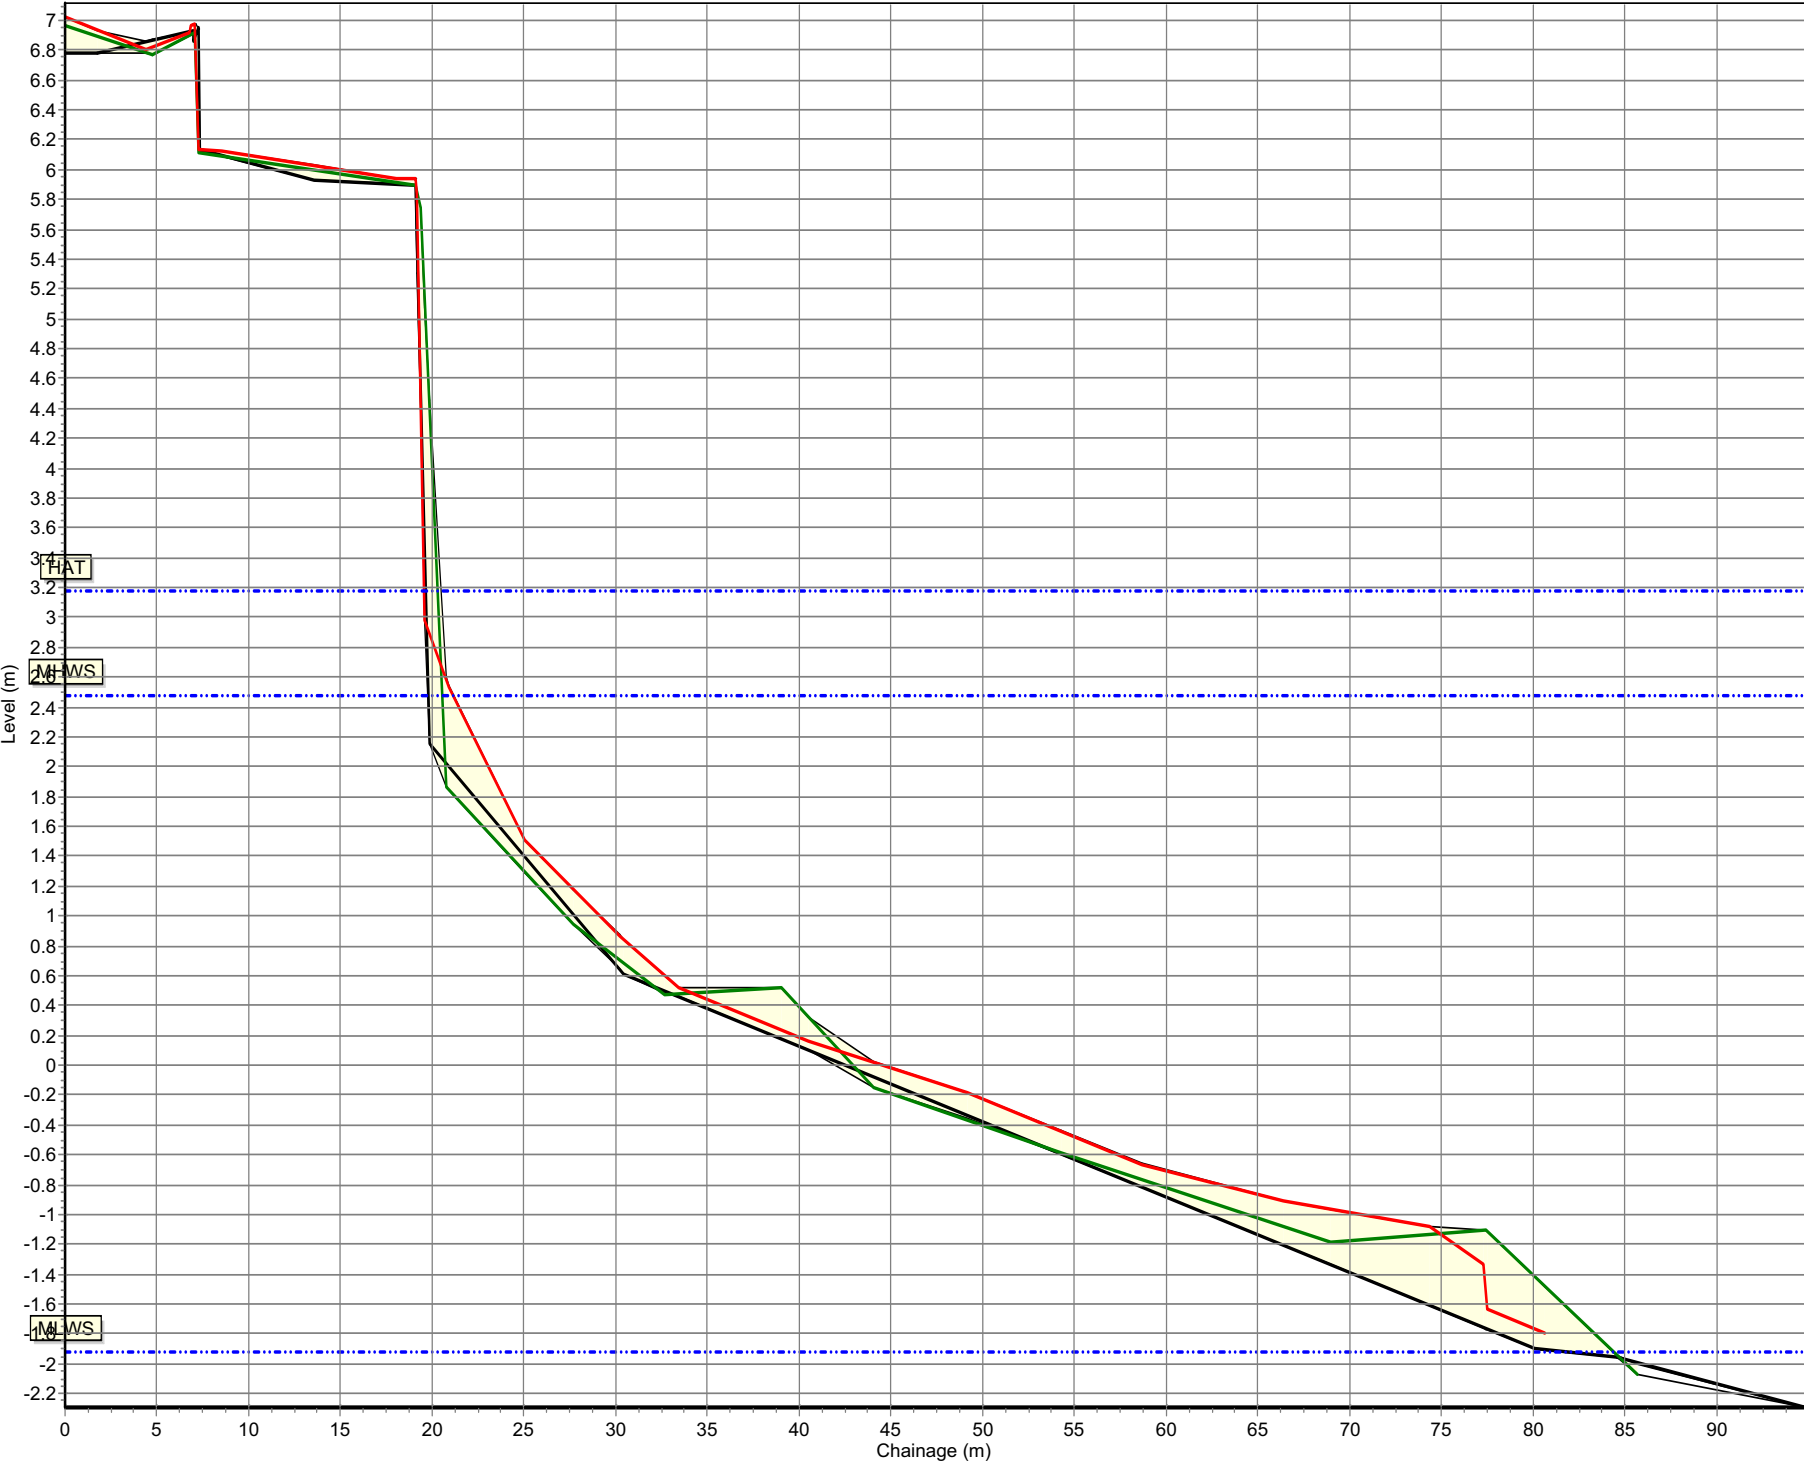
Beach Profiles: 1bSNS7

| Survey Date | Description of Changes Since Last Survey | Interpretation |
|---|---|---|
| <p>Along SNS7, beach levels increased compared to the September 2009 surveys, resulting in an increase in level directly at the toe of the sea wall of around 1m. Along SNS8 and SNS9 foreshore levels experienced modest change, remaining mid-way between the envelope of previous recorded changes. Along SNS10 and SNS11 record low values were observed along the mid and lower profiles.</p> | | |

- Profiles Envelope
- 10/11/2006
- 16/09/2009
- 06/10/2010

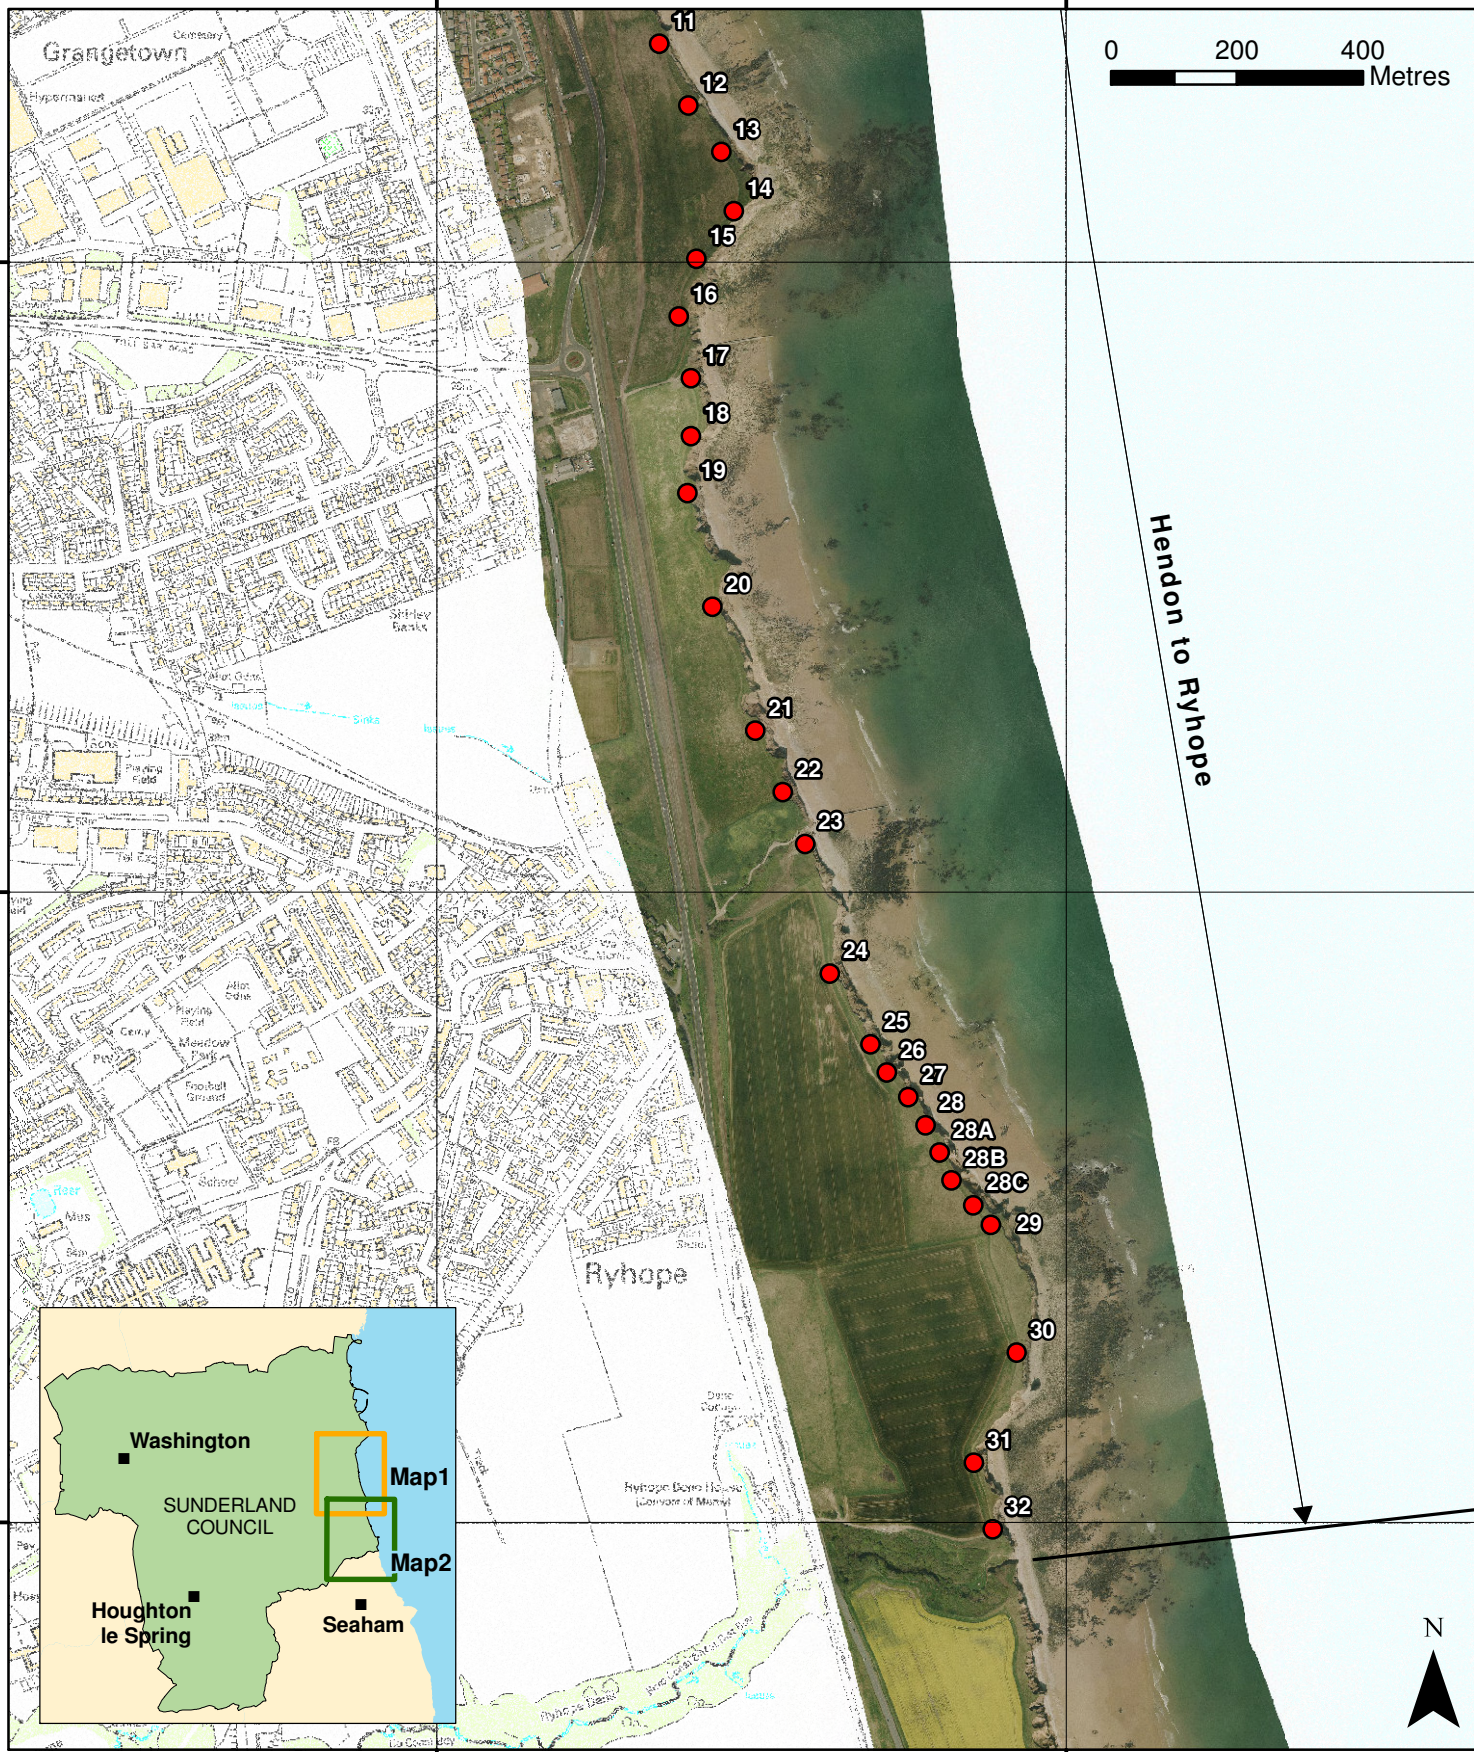
However, in addition to surveyor interpretation, the cliffs along this frontage have a characteristic tendency to heave seawards prior to a toppling failure, leading to apparent discrepancies in the data where the cliff edge can appear to 'grow' seawards.

● Cliff Top Monitoring Points
