**Cell 1 Regional Coastal Monitoring Programme  
Analytical Report 7: 'Full Measures' Survey 2014**

**Sunderland City Council  
Final Report**

**February 2014**

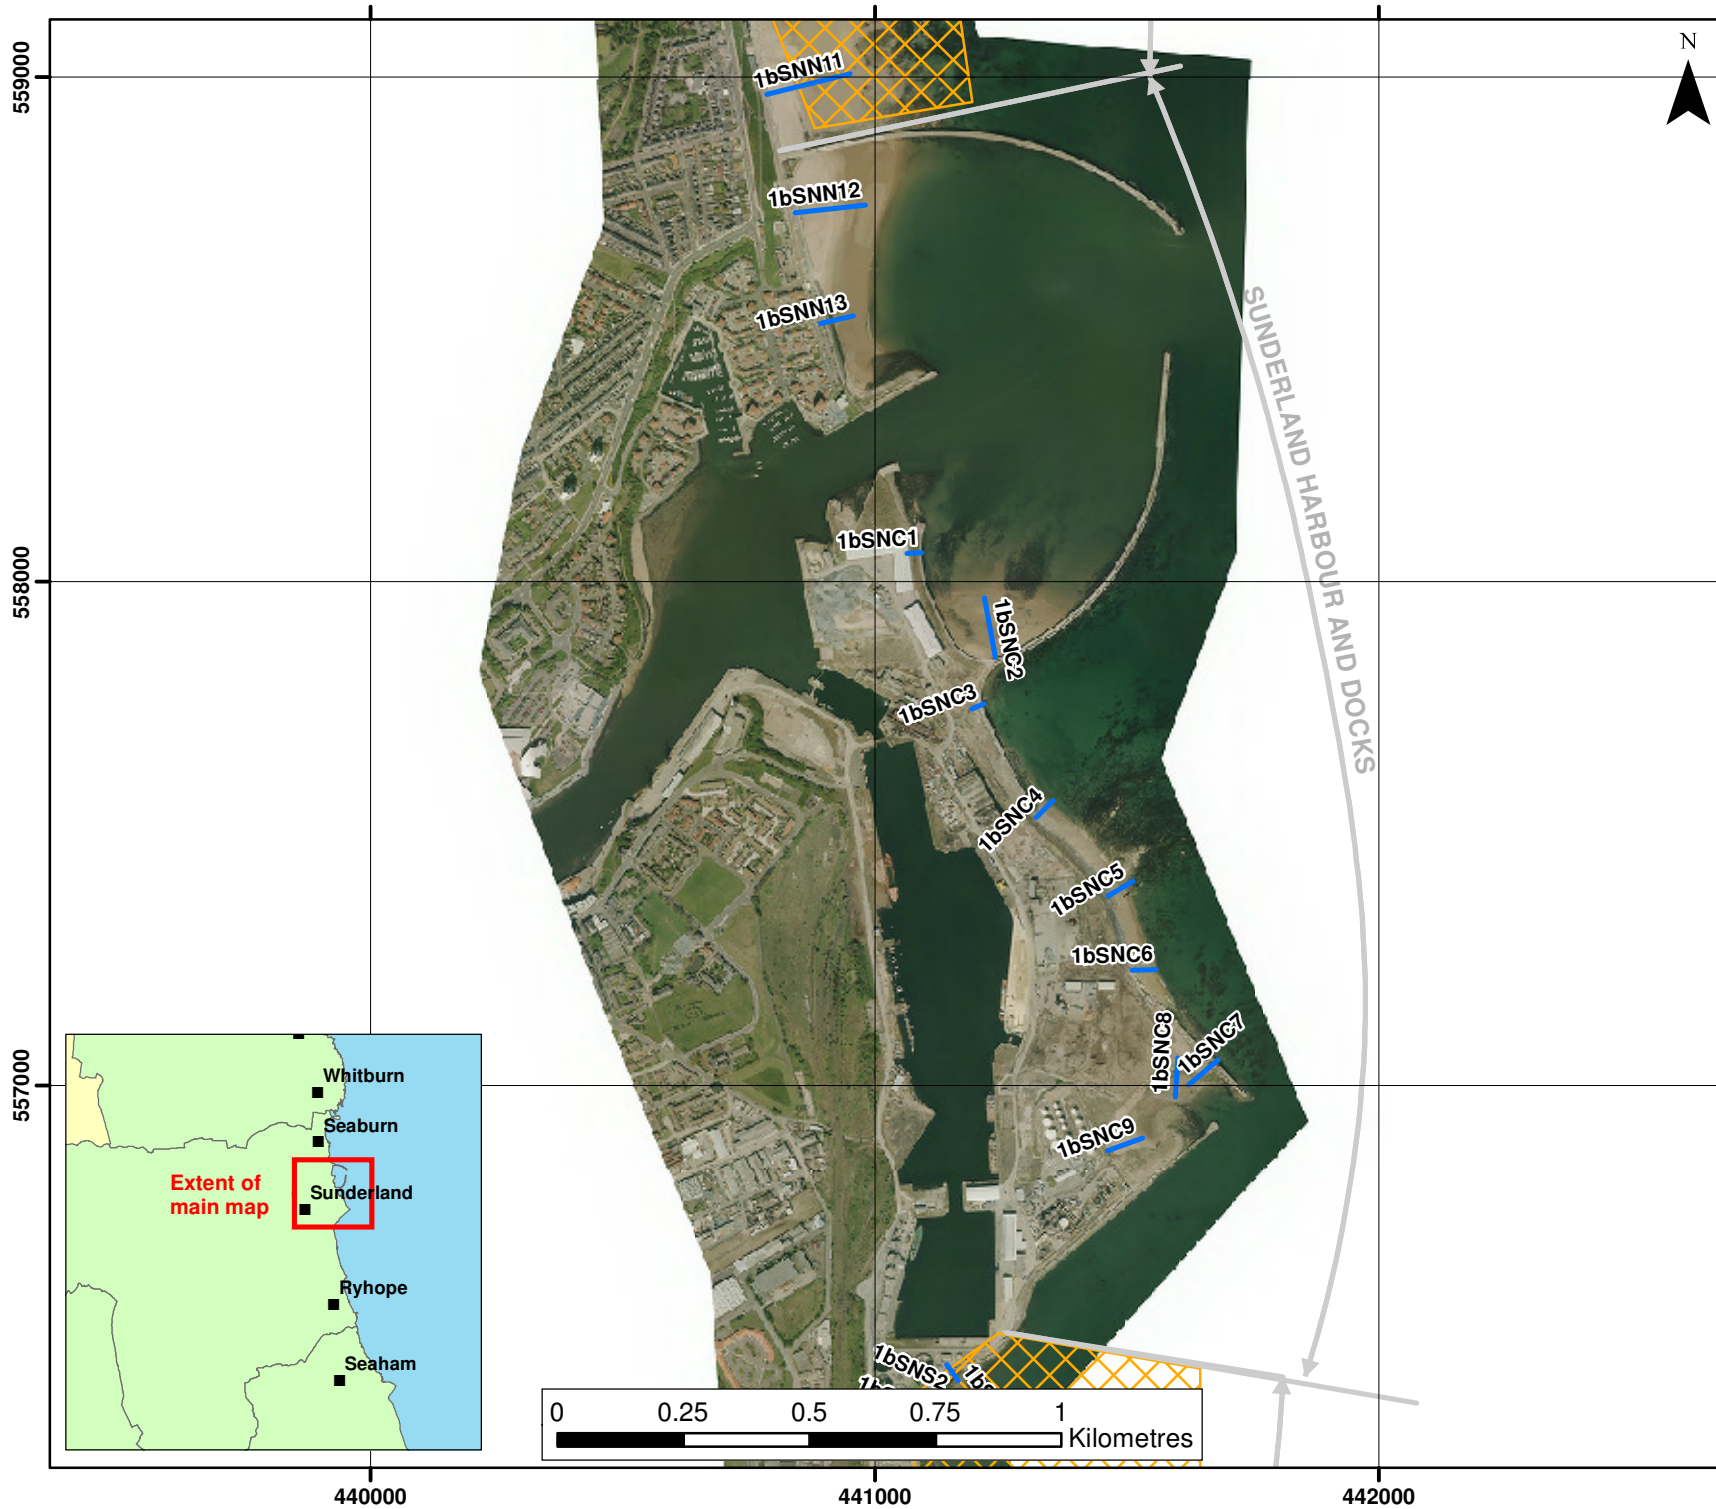
**Figure 2- Map 1  
 Survey Locations  
 Whitburn Bay  
 Sunderland City Council**

The location of these surveys is shown in Figure 2. The Full Measures survey was undertaken along this frontage between the 5<sup>th</sup> and 6<sup>th</sup> November 2014 (Whitburn Bay), 26<sup>th</sup> November 2014 (Sunderland Harbour and Docks) and 8<sup>th</sup> and 13<sup>th</sup> September 2014 (Hendon to Ryhope (incl. Halliwell Banks)). During this time weather conditions varied considerably. Refer to the survey reports for details of the weather conditions over this survey period.

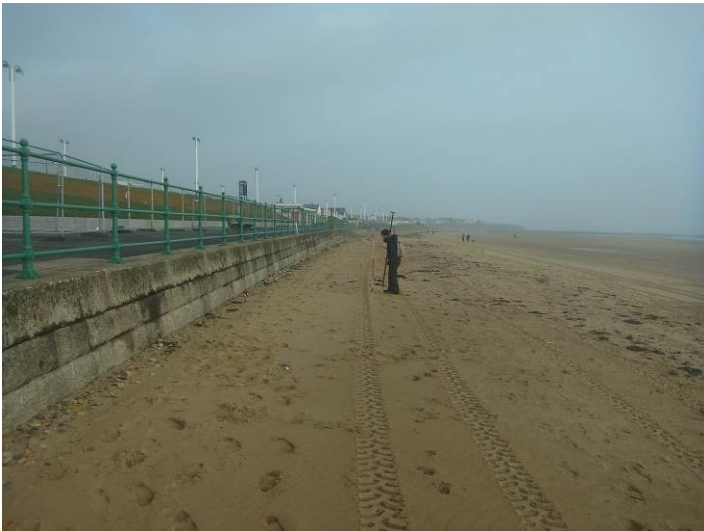
Plate 2 – Survey photograph 1bSNN5\_20131003\_N7

Survey Date	Description of Changes Since Last Survey	Interpretation
	<p>approximately 0.5m at the toe of the seawall. As also observed from the survey photographs (refer to Plates 2 and 3), the sand veneer has been removed from the beach to leave a band of shingle along the toe of the seawall. Between a chainage of 100m and 200m, beach levels have increased and it is likely that this veneer of sand has been moved down the beach during the past 12 months. At profile <b>1bSNN6</b>, beach levels have increased across the profile by up to 1m in places to form a more gently sloping beach. There has been a small drop in beach levels at the toe of the steps since the last survey, as shown by the survey photographs in Plates 4 and 5 and is likely to be due to erosion caused by the interaction of waves with the steps/seawall.</p> <p><b>1bSNN7</b> is at Seaburn, just to the north of Parson's Rock. Beach levels have increased across the profile by over 0.5m around the existing berm to form an overall flatter beach.</p> <p>Profile <b>1bSNN8</b> extends across Parsons Rock. There are no discernible changes in this profile since the previous Full Measures survey.</p> <p>Profile <b>1bSNN9</b> drops from the cliff top to the foreshore at Roker. Beach levels have increased by approximately 0.3m across most of the profile, the exception being at the toe of the seawall where levels have fallen by 0.5m.</p> <p><b>1bSNN10</b> is located approximately mid-way between Parson's Rock and Roker Pier. Beach levels have fallen by approximately 0.2m across the beach, to form a slightly steeper upper beach between the seawall and a chainage of 30m. Seaward of a chainage of 110m, beach levels have increased by marginally. Material is likely to have been drawn-down from the upper/middle beach to the lower beach during the recent autumn months.</p> <p><b>1bSNN11</b> is located to the south of Whitburn. Beach levels from the toe of the seawall to a chainage of 70m have fluctuated with no distinct trend in level. Between a chainage of 70m and the exposed rock platform on the lower beach, there has been a substantial change in beach levels with an increase of over 1.5m to form a large berm.</p>	<p>respectively are the lowest since surveys began in September 2009. For profile 1bSNN11, this is a trend continued from the past 2 surveys.</p>

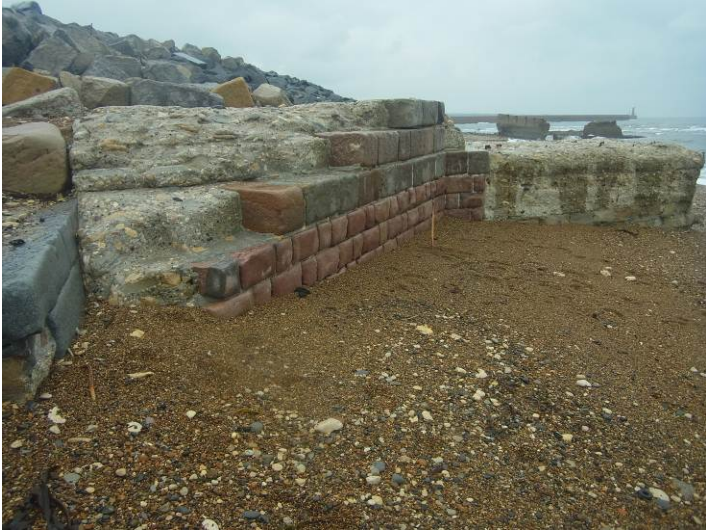
**Plate 6 – Survey photograph 1bSNC6\_20130911\_N2**

Survey Date	Description of Changes Since Last Survey	Interpretation
	<p>to 1.5m, exposing the boulder revetment (refer to Plates 6 and 7).</p> <p><b>1bSNC7</b> to <b>1bSNC9</b> are within the shelter of North East Pier and South West Breakwater in the former South Outlet, parts of which have been in-filled with tipped rubble. <b>1bSNC7</b> is a section across North East Pier and shows the terraced nature of the landward face of the pier wall, extending across rock to the small sheltered bay between the two structures. For this reason, profile 1bSNC7 has not been analysed. Profile <b>1bSNC8</b> crosses the boulders and rubble, which reaches a level of around 6.2mODN, and then extends across the sand and boulder foreshore. Beach levels have fluctuated slightly over the profile with no discernible net trend.</p> <p>Profile <b>1bSNC9</b> extends from the dock facilities and crosses a short length of concrete wall before extending across the sand foreshore to reach and cross a boulder mound that is towards the seaward end of the south west breakwater. The profile generally remains unchanged since the last survey, with the exception of a section of the beach between a chainage of 20m and 50m, which shows beach levels to have increased by 0.5m to form a small berm.</p>	<p>Within the breakwaters to the south of the River Wear, at profile 1bSNC2, the profile is mostly within the bounds of previous surveys. The exception is beach levels at the toe of the seawall, where they are the highest recorded since surveys began in October 2009.</p> <p>Outside of the harbour breakwaters, to the north, beach levels at profile 1bSNC3 and 1bSNC4 are the highest recorded since surveys began in October 2009. At profile 1bSNC5, they are within the bounds of previous surveys.</p> <p>Outside of the harbour breakwaters, to the south, at profiles 1bSNC6 to 1bSNC9, the profiles are generally within the bounds of previous surveys. Although levels at profile 1bSNC6 are low, they were lower in November 2011. At profile 1bSNC9, beach levels at the location of the berm are the highest recorded since surveys began in October 2009.</p>

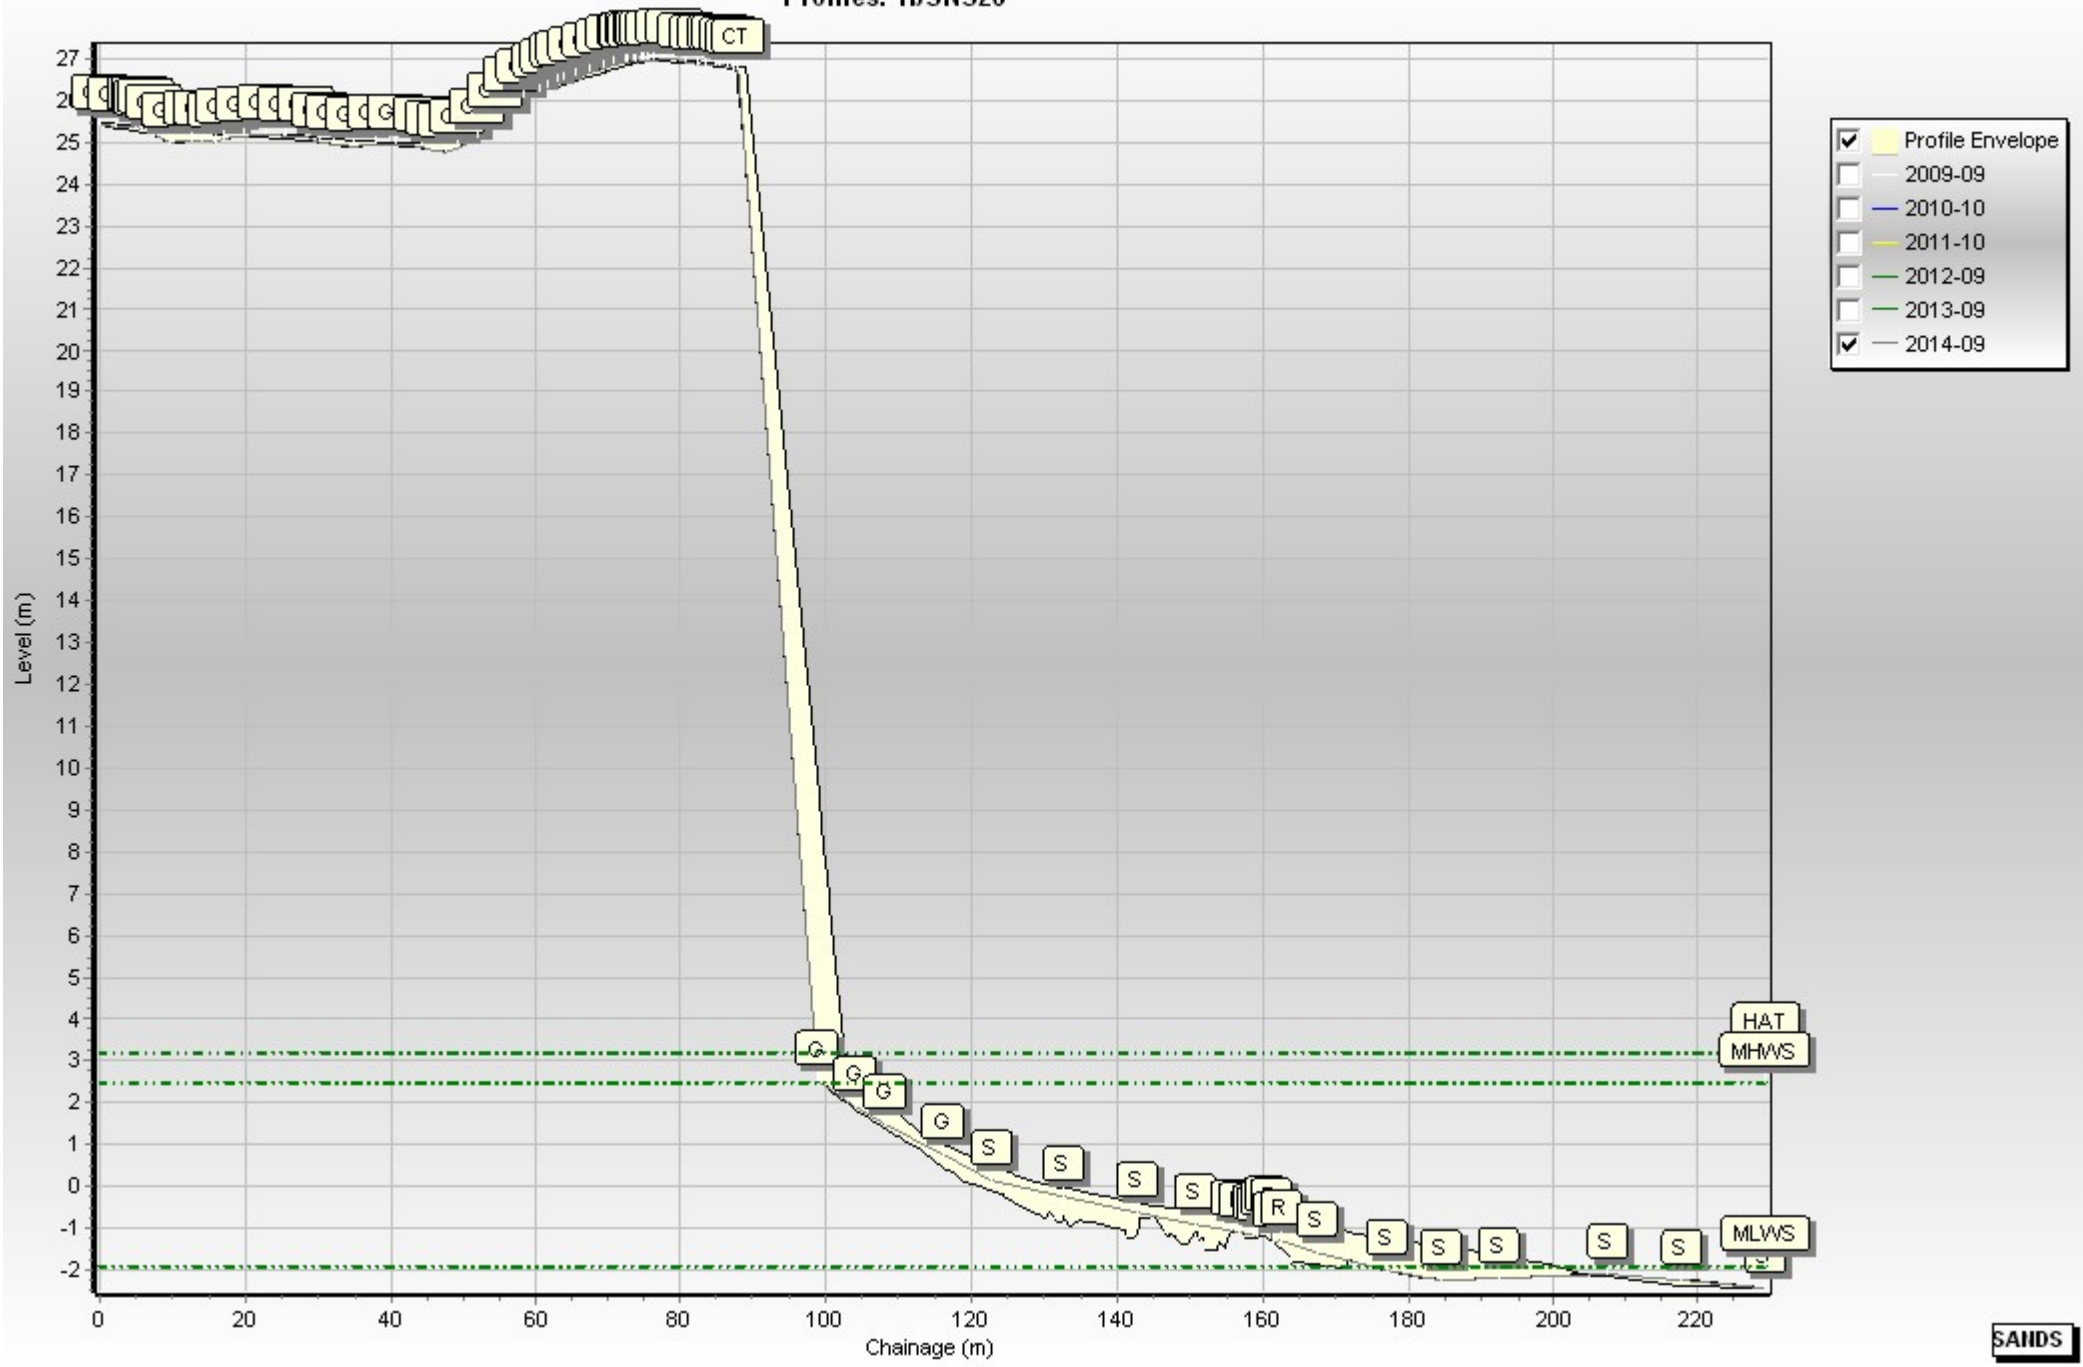
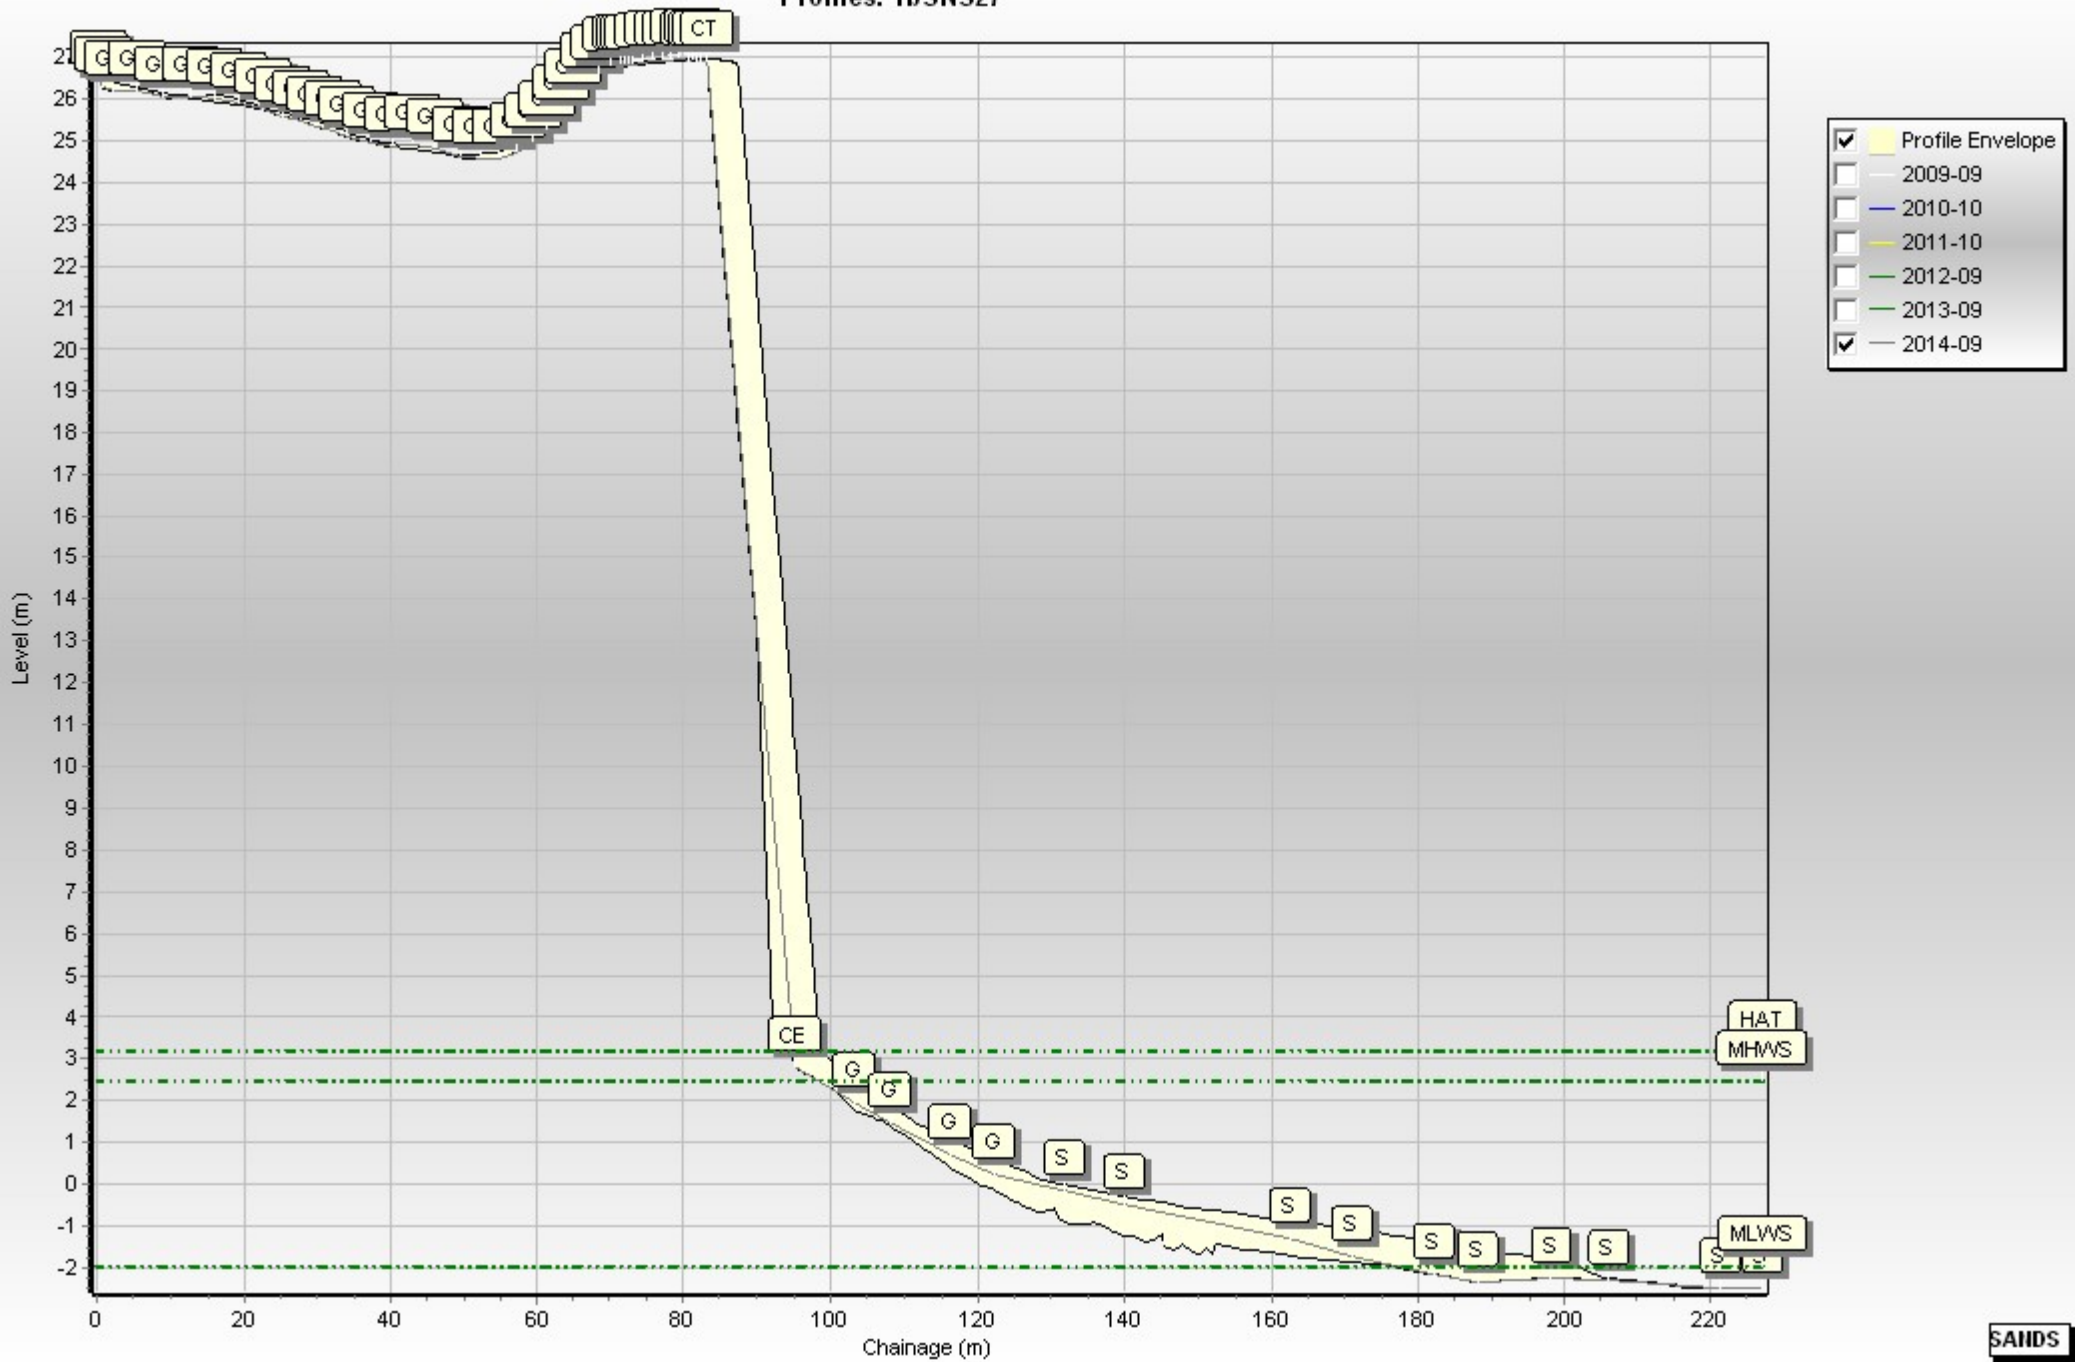
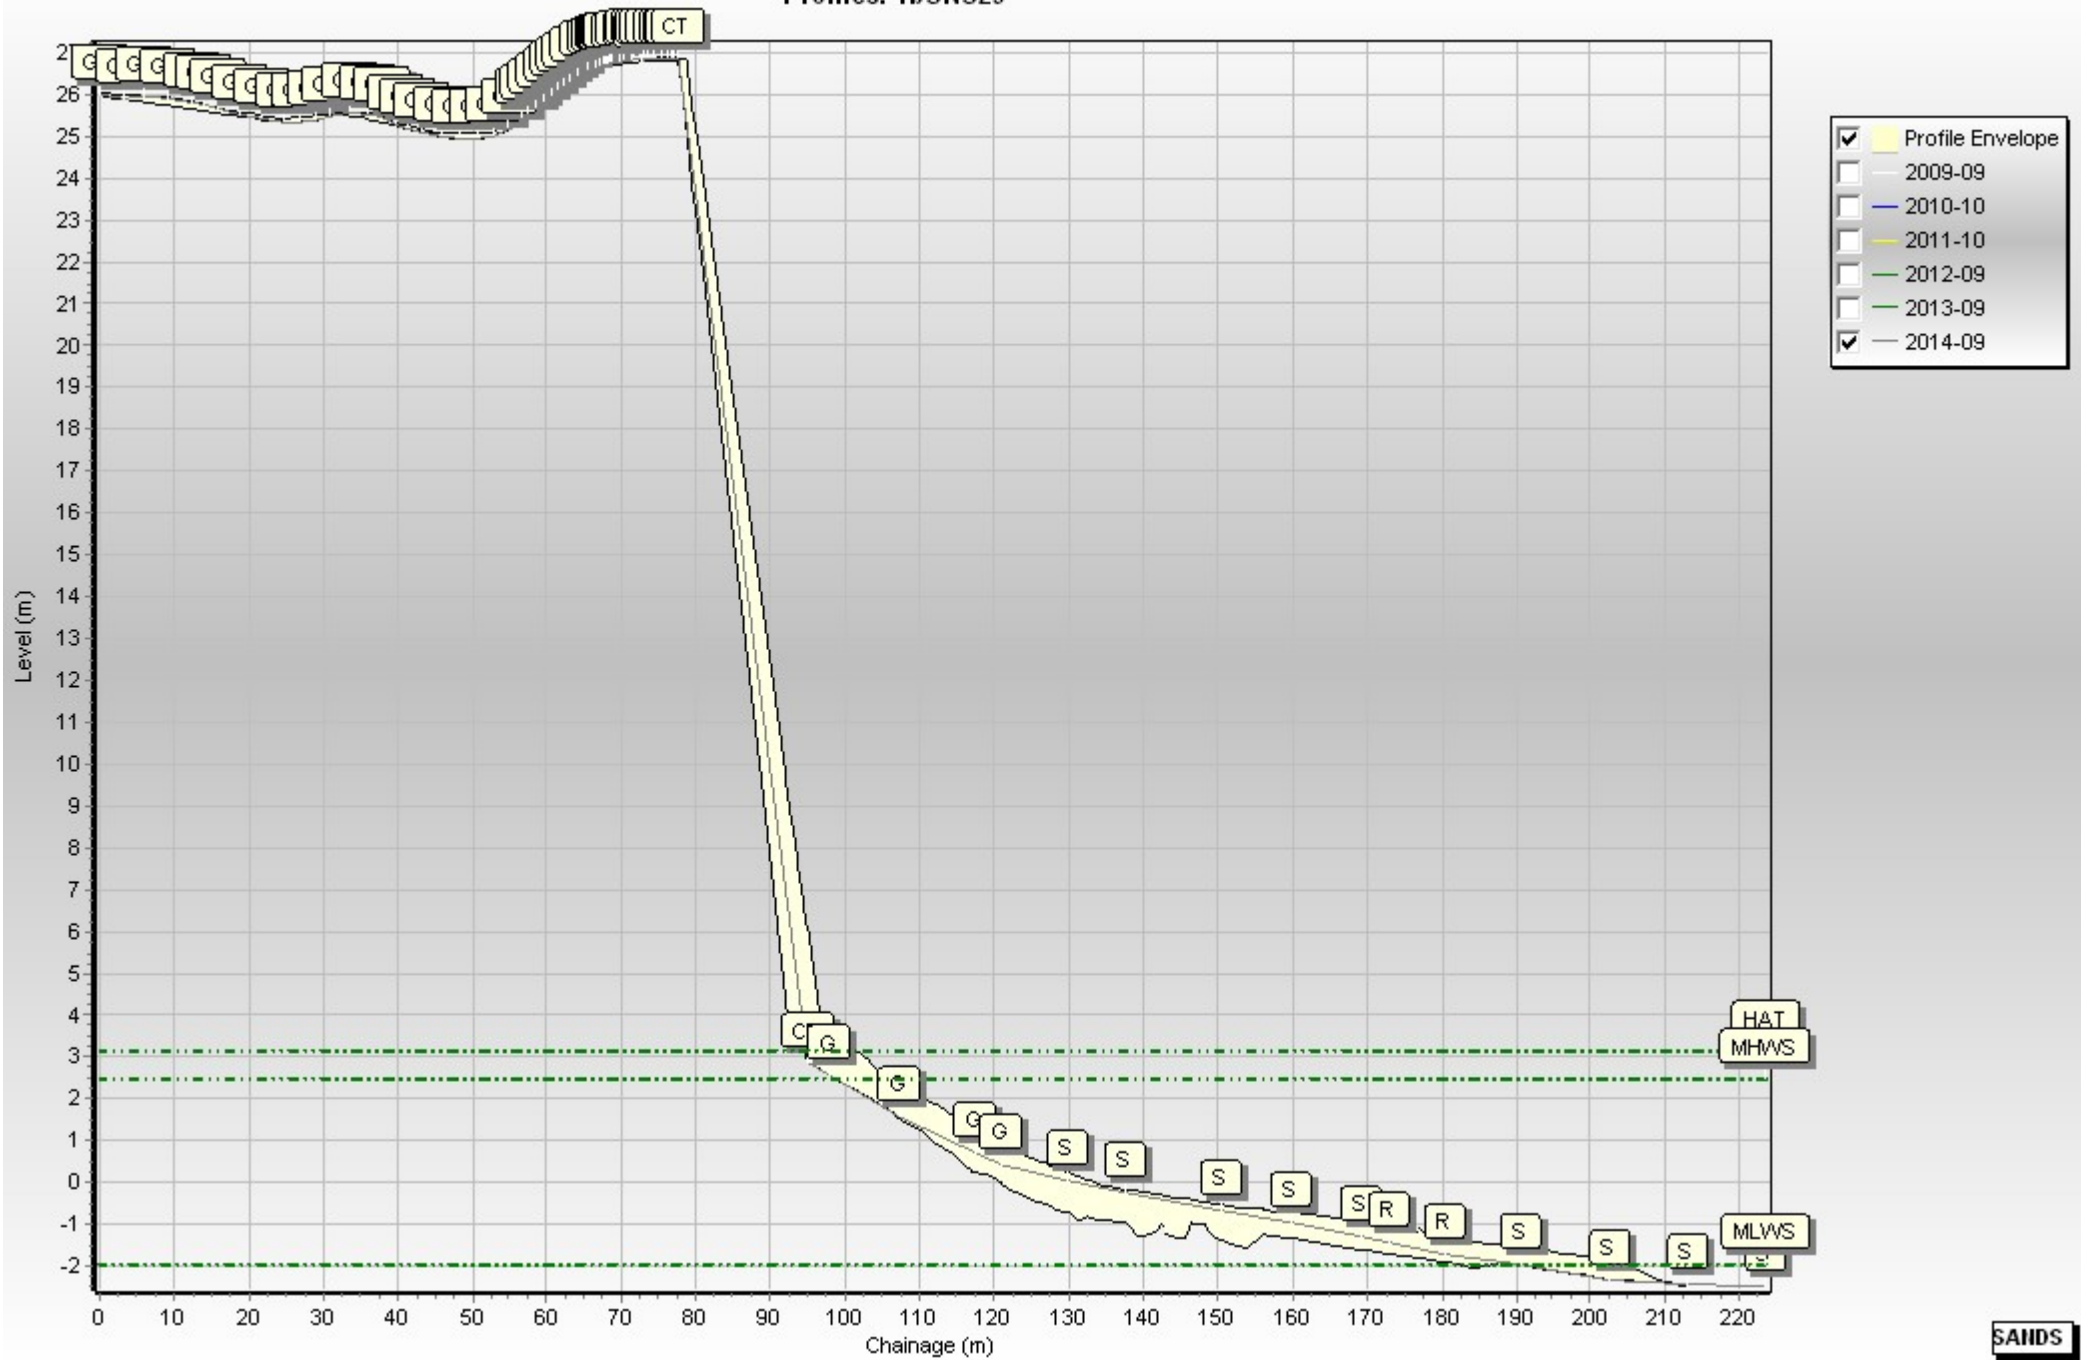
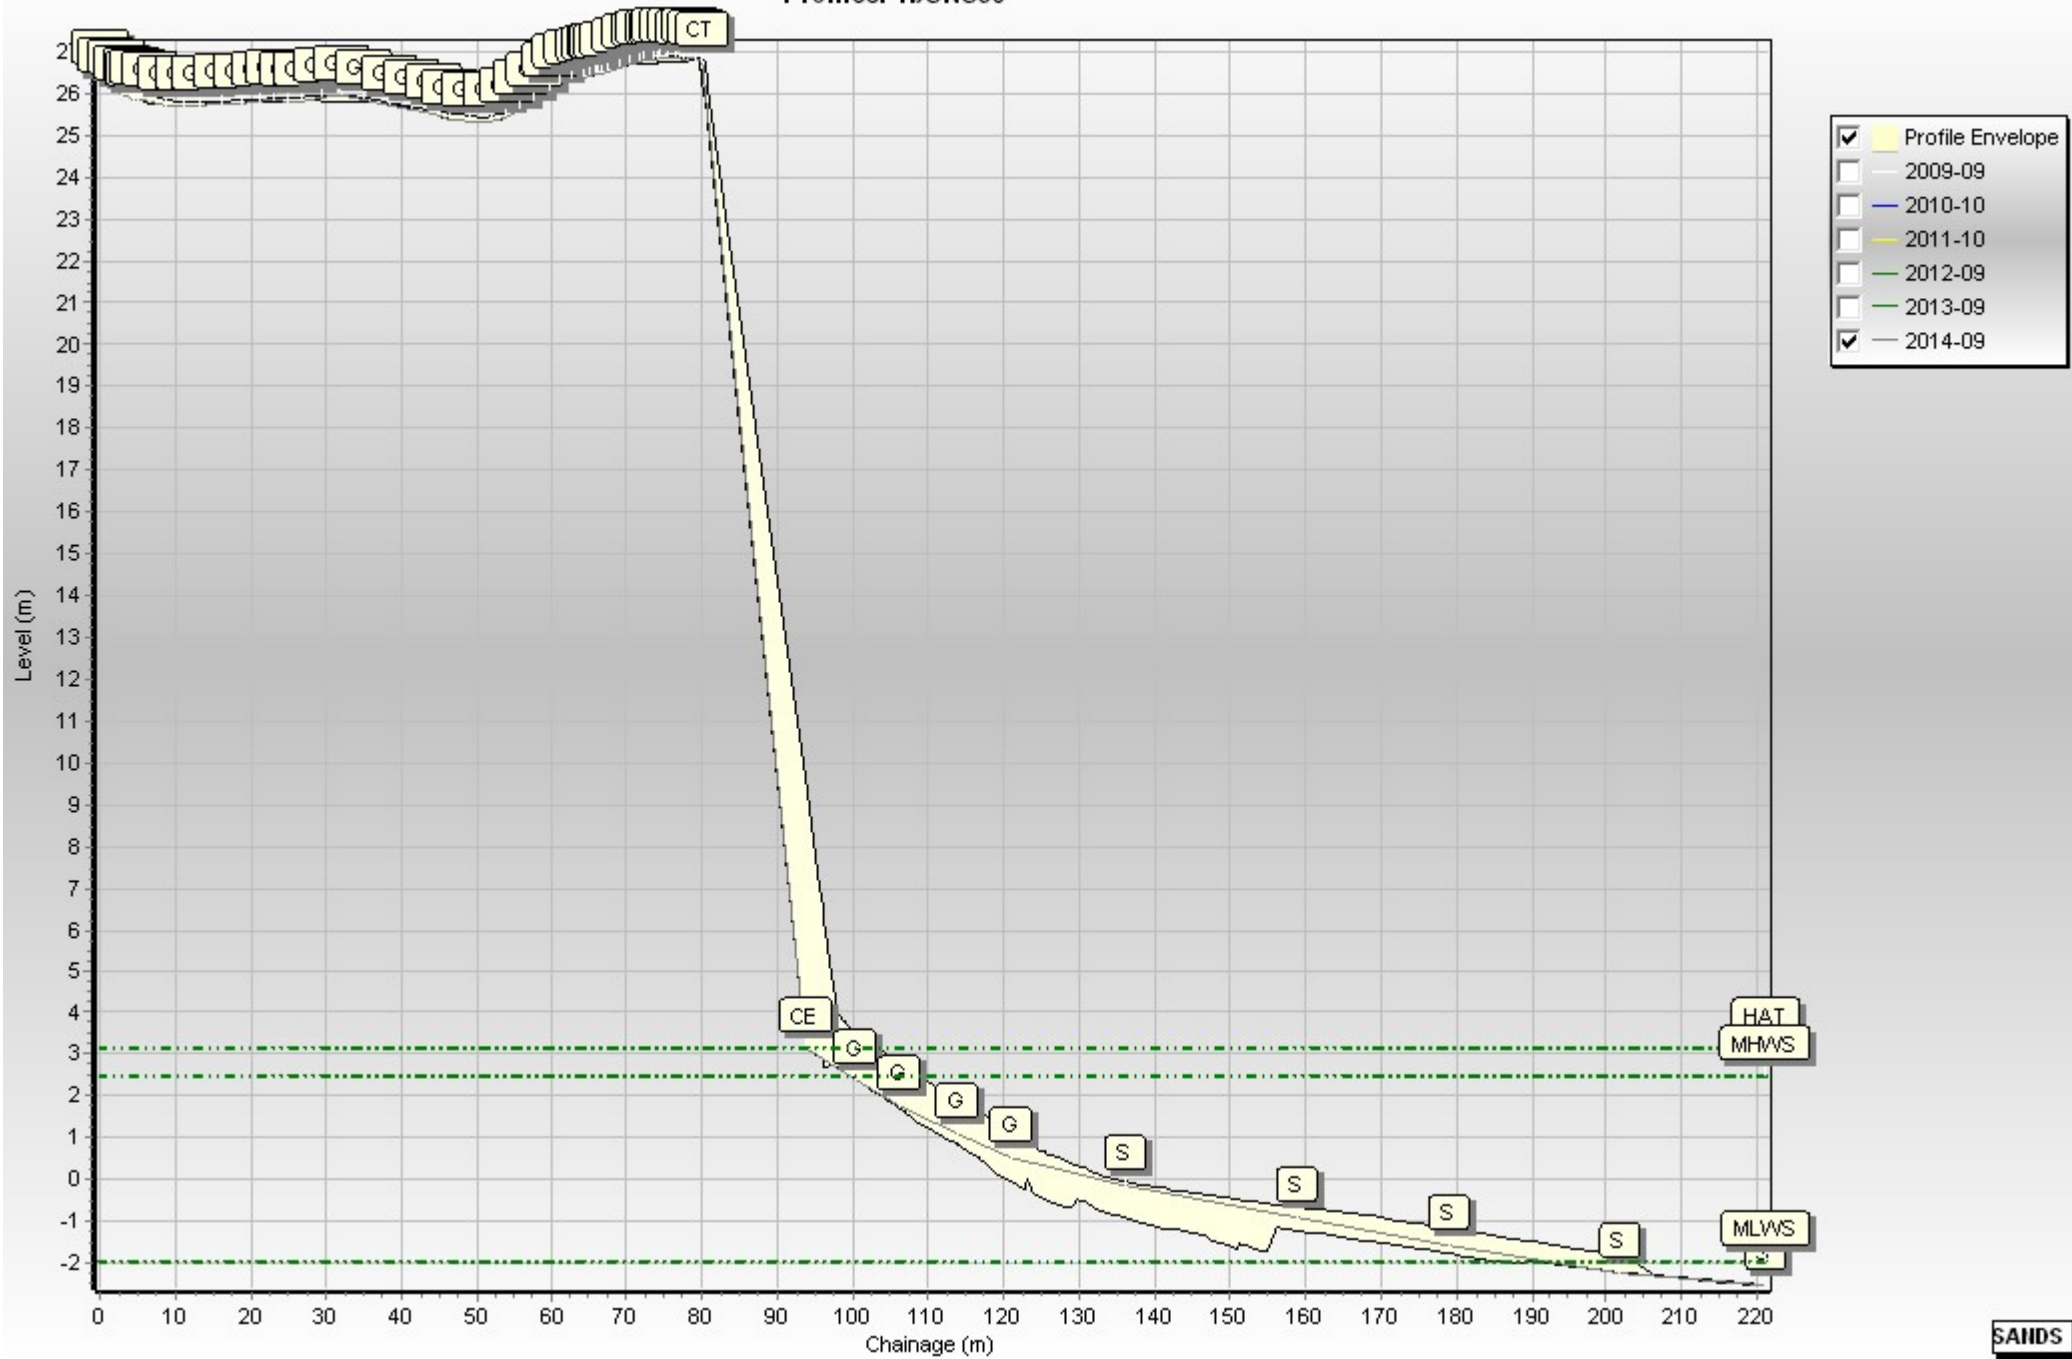
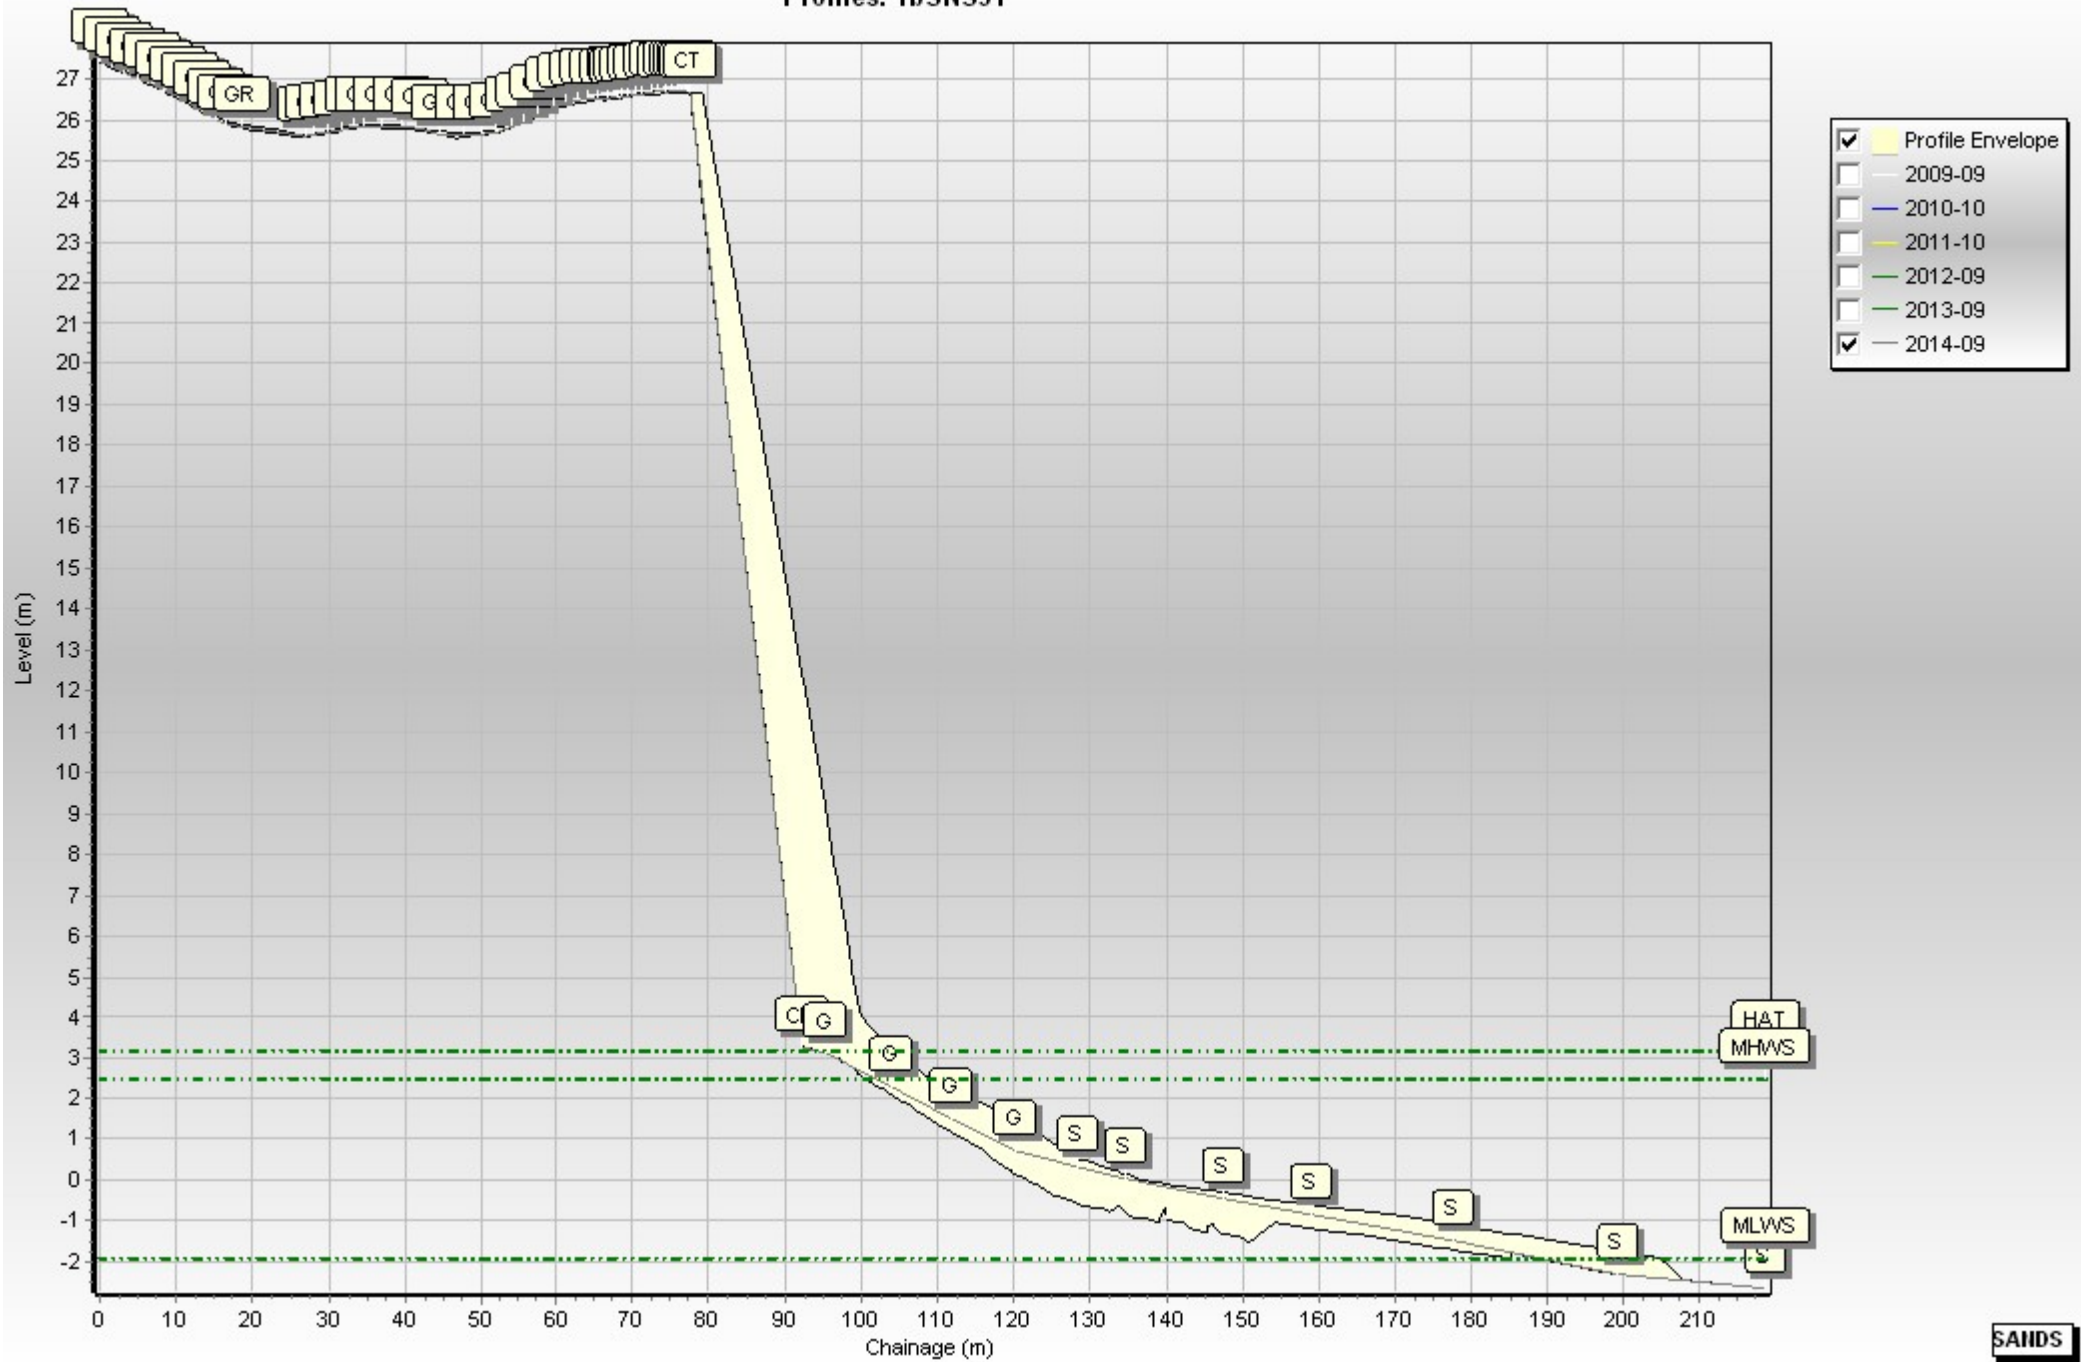
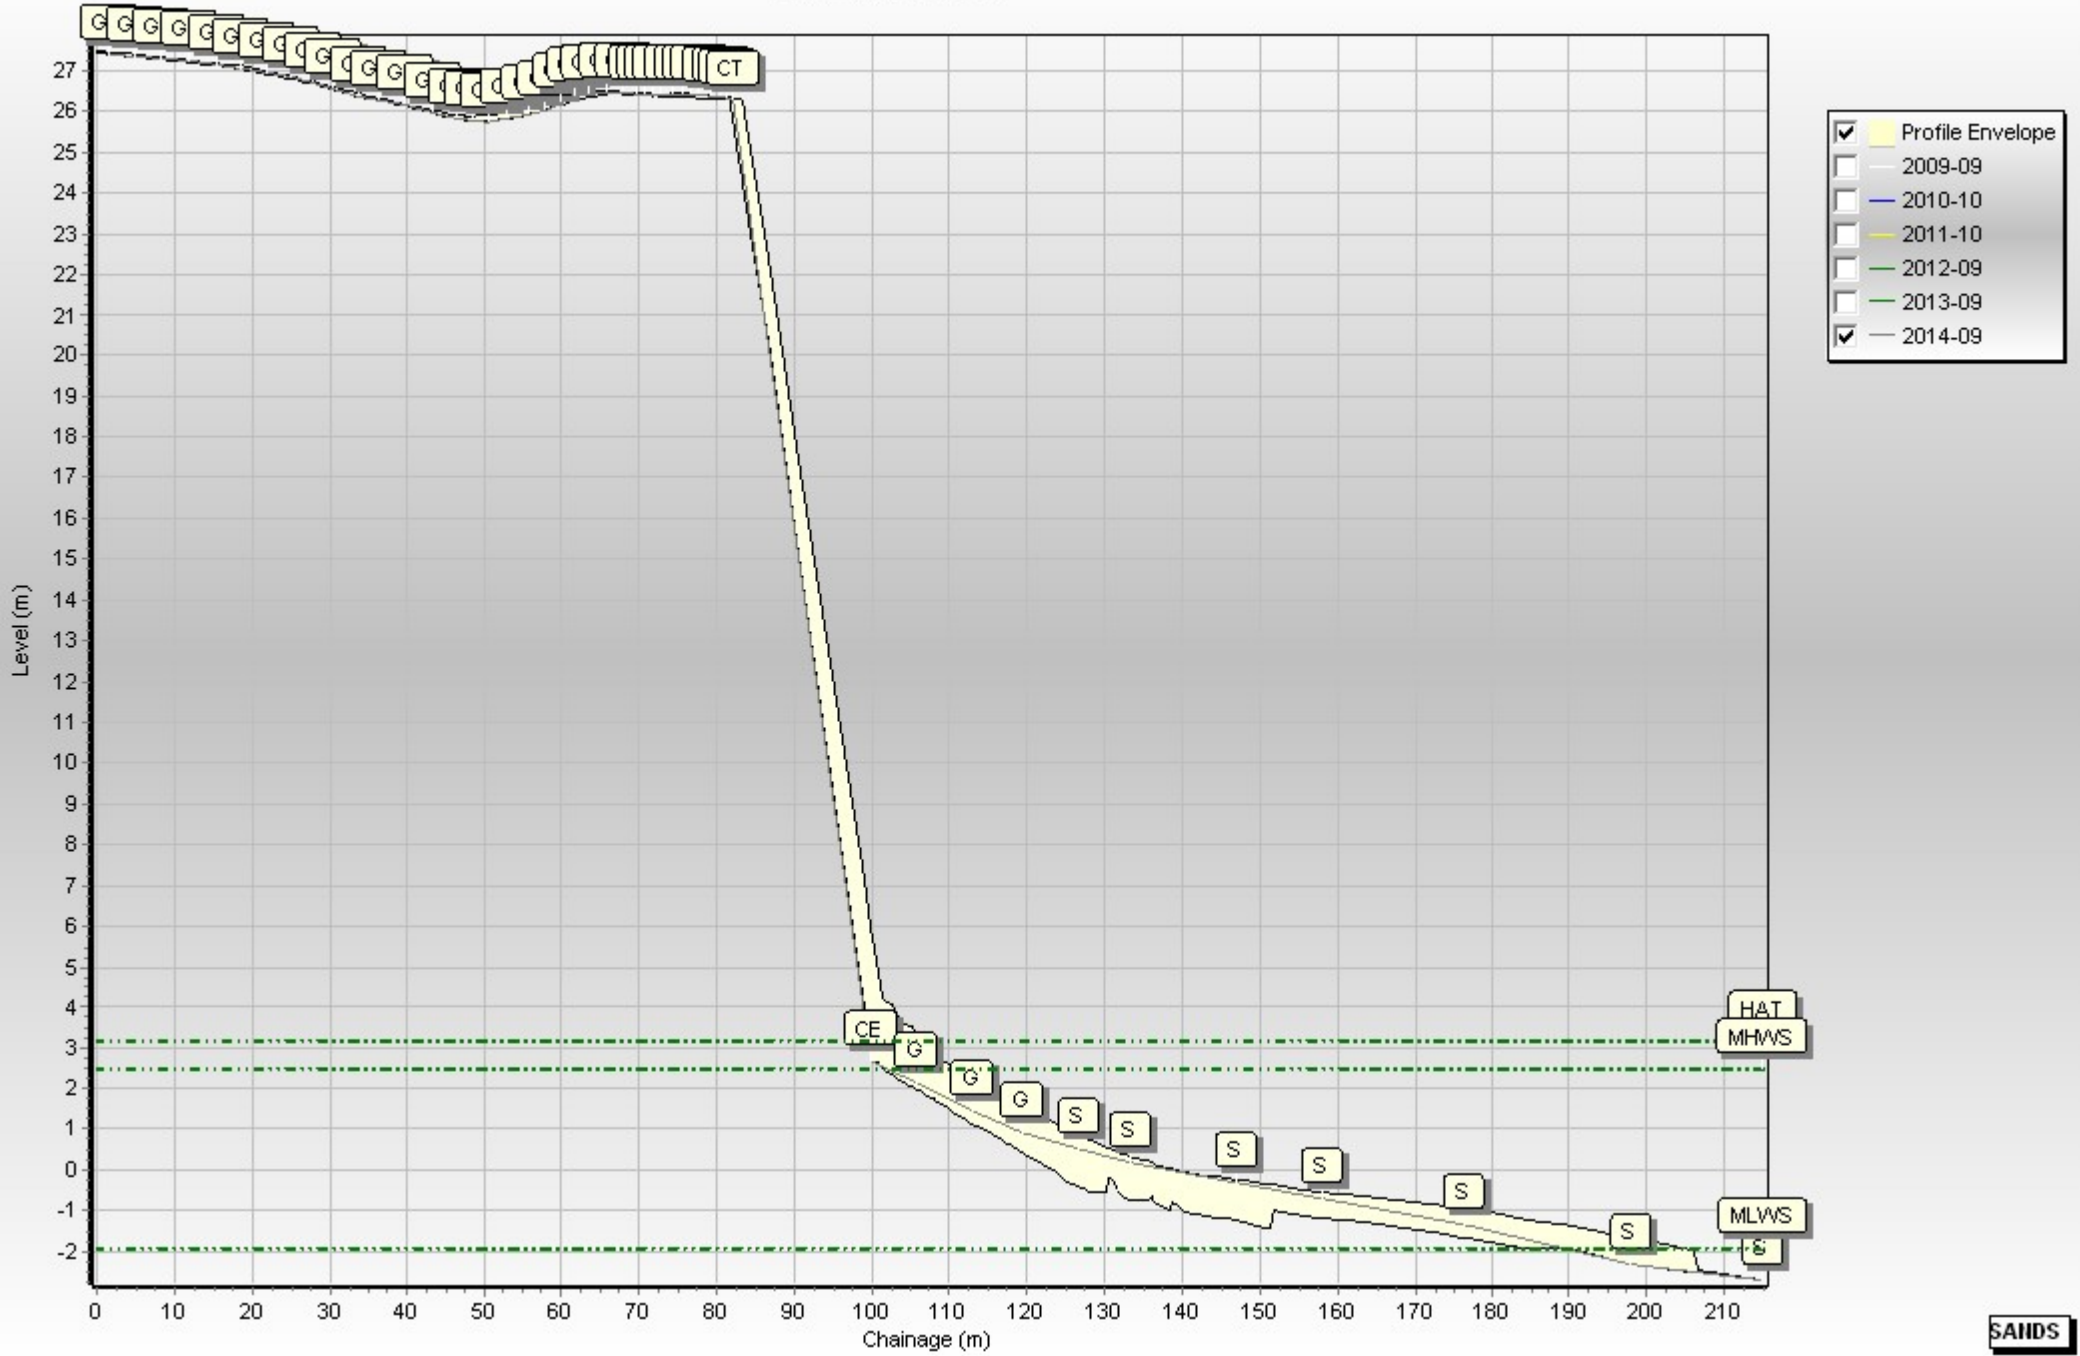
Survey Date	Description of Changes Since Last Survey	Interpretation
	<p>Profiles <b>1bSNS26</b> to <b>1bSNS32</b> are located at Halliwell Banks specifically to assess risks from erosion at a former land fill. Cliff height is between 26m and 27mOD, with beaches at the toe typically at levels between 3.3m and 3.9mODN. Profiles <b>1bSNS26</b> to <b>1bSNS32</b>, have changed little since the last survey. Profile 1bSNS27 shows some erosion at the cliff toe, associated with erosion of a debris lobe from a previous cliff failure. Beach levels have increased along the length of this section of coastline by 0.5m to 1m, to form a more gently sloping and sandier beach.</p> <p>Profiles <b>1bSNS33</b> to <b>1bSNS36</b> are located around the Pincushion Headland. The cliffs have generally retained the same form and position since the last survey, with the exception of profile 1bSNS36, where the cliff has retreated by c. 2m. This erosion is evident in the survey photographs (see Plates 16 and 17).</p> <p>At locations <b>1bSNS33</b> to <b>1bSNS35</b> the cliff face has retained the same form and position since the last surveys. At locations <b>1bSNS35</b> to <b>1bSNS36</b> the cliff top shows a up to 0.5m of retreat. Beach levels have increased across the profile at all locations, particularly 1bSNS33, where they have increased by 1m to form a more gently sloping and flatter beach.</p>
