**Cell 1 Regional Coastal Monitoring Programme  
Analytical Report 12: 'Full Measures' Survey 2019**

**Sunderland City Council**

(\*) The present report is **Analytical Report 12** and provides an analysis of the 2019 Full Measures survey for Sunderland City Council's frontage.

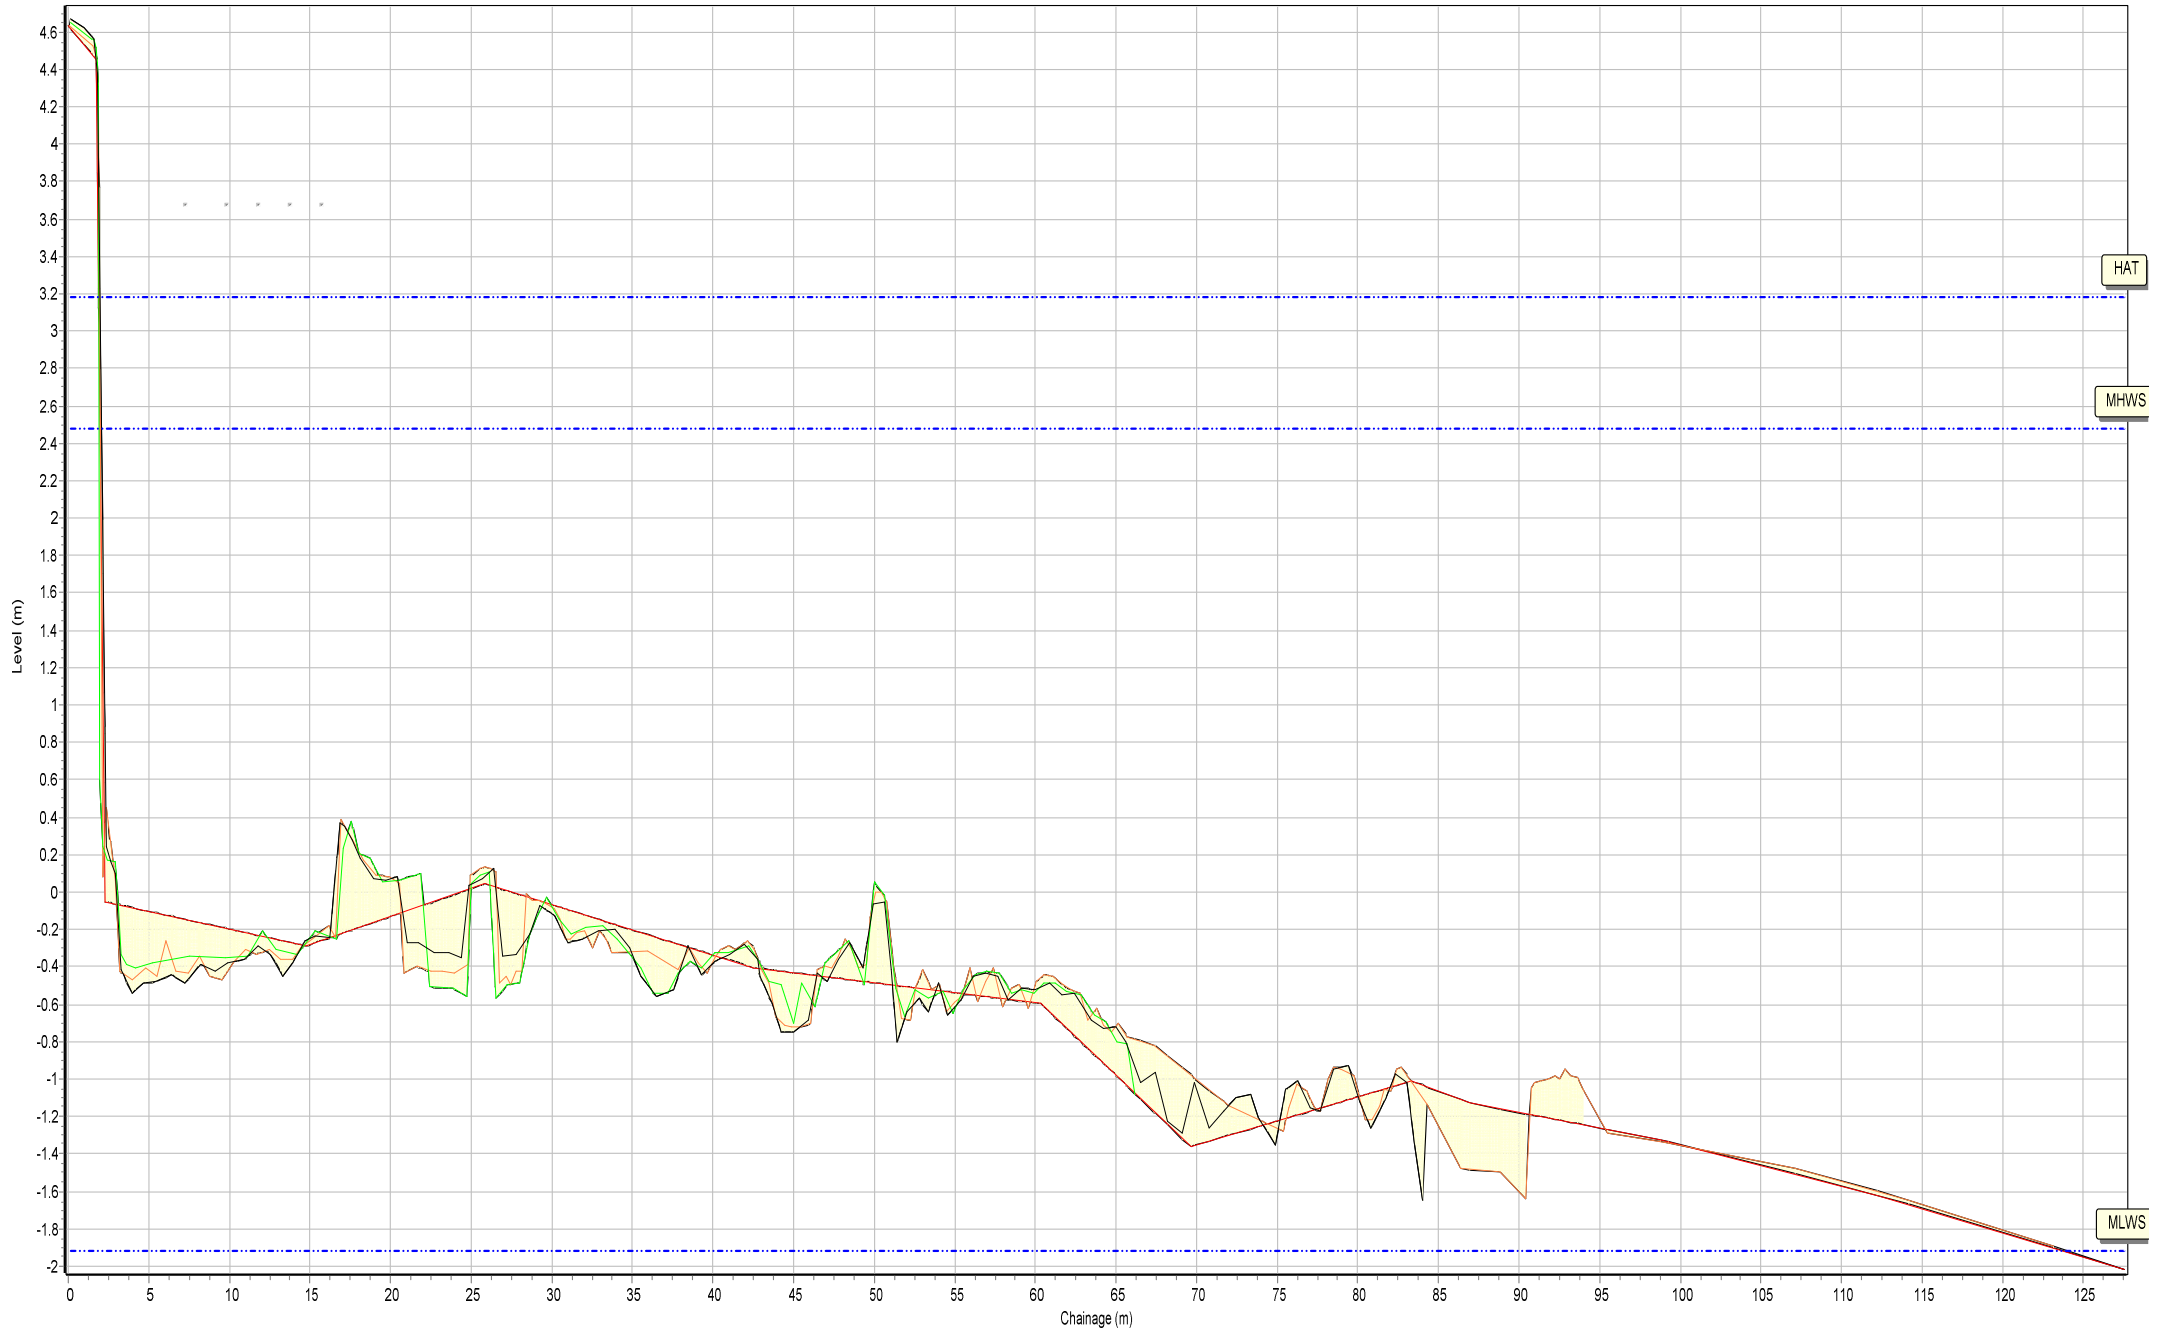
# Beach Profiles: 1bSNN8

Survey Date	Description of Changes Since Last Survey	Interpretation
	<p>Profile <b>1bSNN8</b> extends across Parsons Rocks. There are no discernible changes across most of the profile since the previous Full Measures survey in 2018.</p> <p>Profile <b>1bSNN9</b> drops from the cliff top to the foreshore at Roker. The survey report notes that the start of this profile was not measured due to unsafe access. The upper beach from the toe of the cliff to chainage 69m has accreted by up to 0.1m. From chainage 69m to 128m there has been minor accretion of 0.2m across the middle beach. The toe of the beach has accreted by 1.2m. The profile is at a medium-low level compared to the range recorded from previous surveys.</p> <p>Profile <b>1bSNN10</b> is located approximately mid-way between Parson's Rocks and Roker Pier. There has been erosion of 0.8m at the toe of the seawall. Between chainage 38m and the end of the profile there has been accretion by up to 0.4m across the middle beach and 1.1m on the lower beach. Overall, the beach is at a low level on the upper beach, and a medium-low level on the middle and lower beach compared to the range recorded in previous surveys.</p> <p>Profile <b>1bSNN11</b> is located to the south of Whitburn. There has been varying amounts of accretion by up to 0.3m across the beach profile. Overall the beach is at a high level on the upper beach and medium-low level on the middle and lower beach compared to the range recorded from the previous surveys.</p>

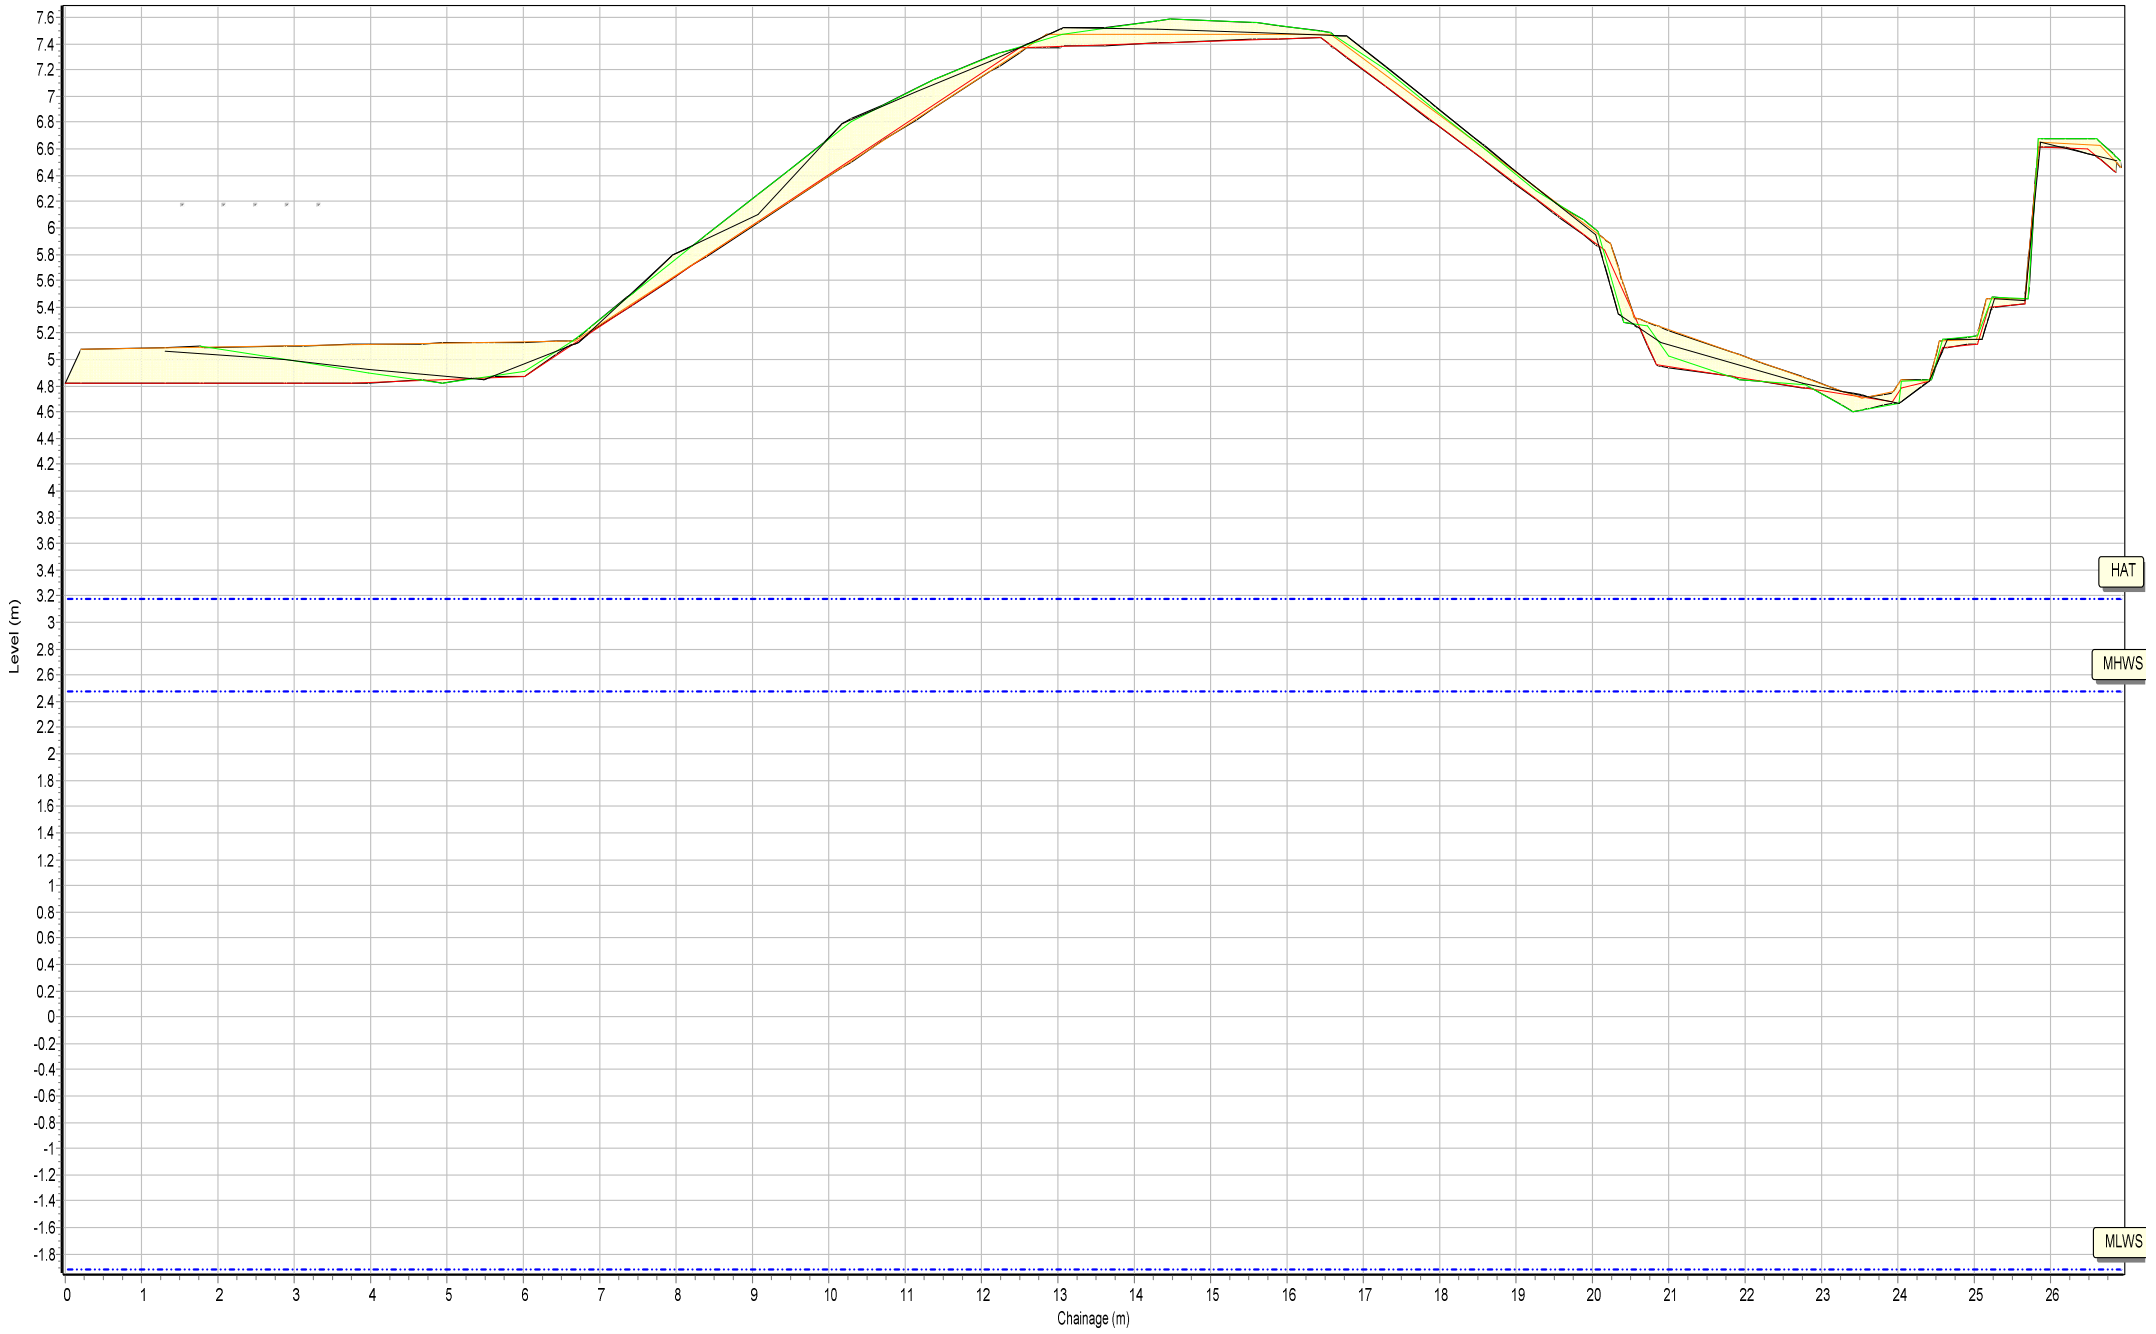
# Beach Profiles: 1bSNC1

Based upon recommendations made by the surveyors in 2017, profiles 1bSNC1 and 1bSNC3 have been removed from the programme. These profiles did not cover any beach and were difficult and dangerous for the surveyors to access.
