**Cell 1 Regional Coastal Monitoring Programme
Analytical Report 13: 'Full Measures' Survey 2020**

(*) The present report is **Analytical Report 13** and provides an analysis of the 2020 Full Measures survey for Sunderland City Council's frontage.

Sunderland City Council's frontage extends from The Bents to Ryhope. For the purposes of this report and for consistency with previous reporting, it has been sub-divided into three areas, namely:

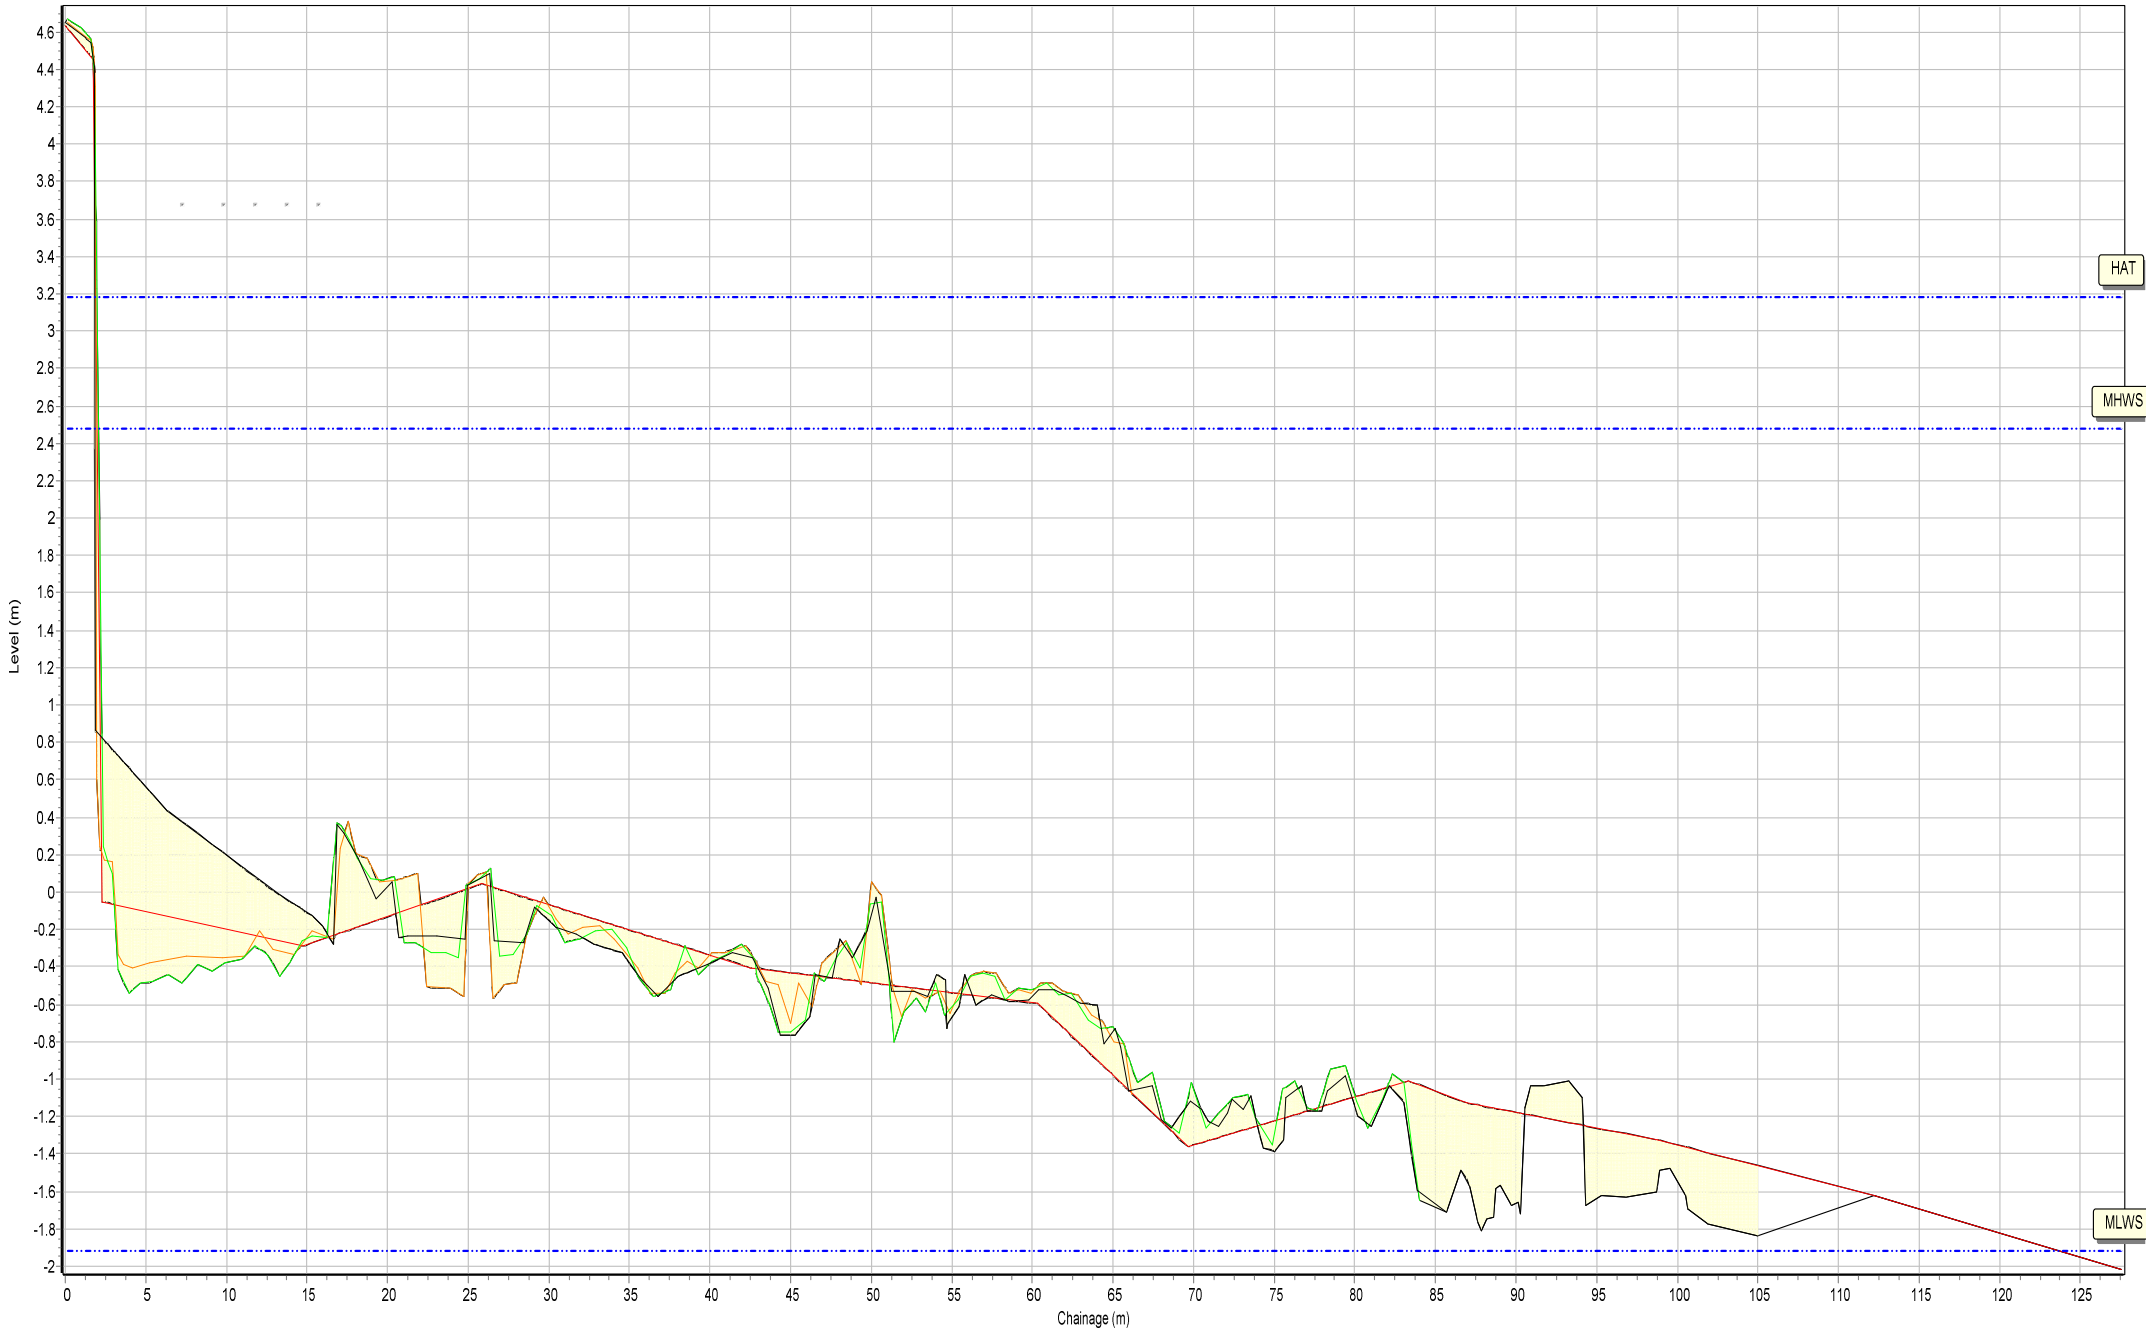
Beach Profiles: 1bSNN8

Survey Date	Description of Changes Since Last Survey	Interpretation
	<p>Profile 1bSNN8 extends across Parsons Rocks. There has been up to 1.1m of accretion at the toe of the seawall to chainage 16m, where the rest of the profile is similar to that of the previous Full Measures survey (autumn 2019). There are no discernible changes across the rock patch, however the survey has extended by 20m to expose more rocks. Overall, the profile is at a medium level compared to the range recorded from previous surveys, except the upper beach which is at its highest level recorded.</p> <p>Profile 1bSNN9 drops from the cliff top to the foreshore at Roker. The survey report notes that the start of this profile was not measured due to unsafe access. The upper beach from the toe of the cliff to chainage 38m has accreted by up to 0.5m. From chainage 38m to 76m there has been minor erosion of <0.1m across the upper beach. The middle beach has accreted by up to 0.2m to chainage 140m, smoothing out the profile from the previous Full Measures survey (autumn 2019). Between chainages 140-175m the beach has eroded by up to 0.2m, switching to accretion at the beach toe by up to 0.2m. The profile is at a medium-low level compared to the range recorded from previous surveys.</p> <p>Profile 1bSNN10 is located approximately mid-way between Parson's Rocks and Roker Pier. There has been accretion across the entire beach profile. Between the toe of the seawall and chainage 126m the upper and middle beach has accreted by between 0.1-0.3m. A berm has formed on the lower beach with an accretion of up to 0.8m from chainage 126m to the end of the survey. The beach toe has extended by 30m. Overall, the upper and middle beach is at a medium level and the lower beach is at a high level compared to the range recorded in previous surveys.</p> <p>Profile 1bSNN11 is located to the south of Whitburn. The beach level has mostly accreted, except between the toe of the sea wall and chainage 38m which has eroded by up to 0.2m. Seaward of this point, the middle beach has accreted by 0.2m, whilst the lower beach has accreted by up to 0.9m with the extension of the beach toe by up to 60m and an overall smoothing of the beach profile. The upper beach is at a medium level, while the middle and lower beach are at a high level particularly between chainages 54-65m which is at its highest level recorded.</p>

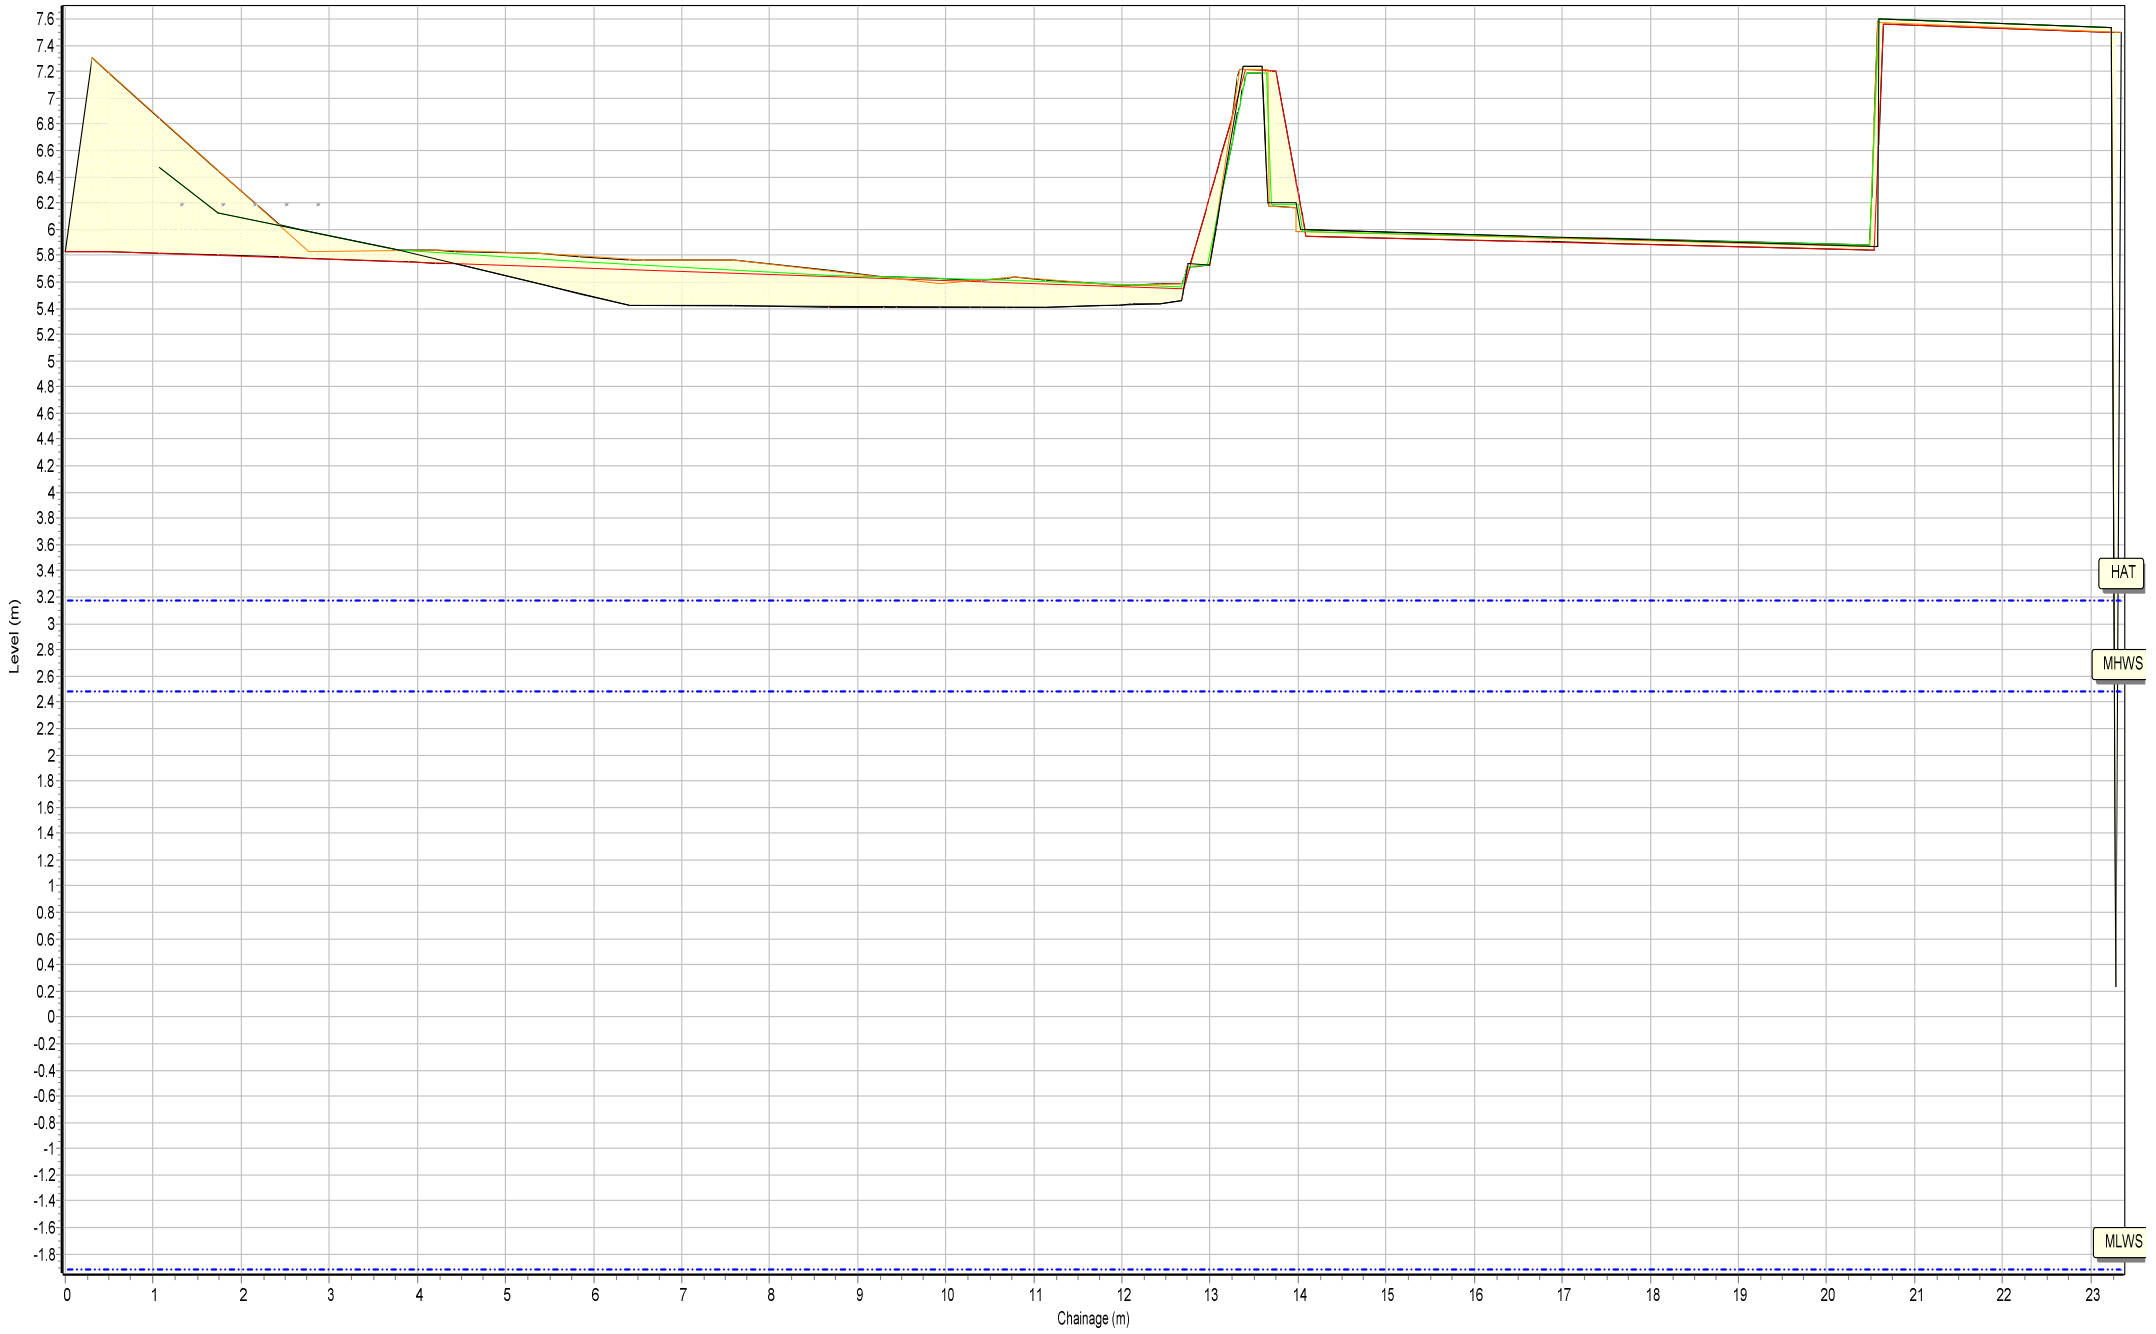
Beach Profiles: 1bSNC3

Survey Date	Description of Changes Since Last Survey	Interpretation
	<p>Profile 1bSNC3 extends from the dockyard across a back flood wall, which has a crest level of around 7.2mOD, and promenade to the main seaward dock wall, which has a crest level of 7.55mOD. The profile then extends down the seaward face of the wall into deep water. As there is no beach present, this profile has not been analysed.</p> <p>Profiles 1bSNC4 and 1bSNC5 extend from the rock armoured revetment across the short width of foreshore down to low water.</p> <p>At profile 1bSNC4, the beach levels show erosion across the beach profile by up to 0.8m on the upper beach, tapering to 0.4m on the middle and lower beach. The beach is at a medium to low level compared to the range recorded from previous surveys.</p> <p>At profile 1bSNC5, beach levels have lowered across the survey by up to 0.4m on the upper beach and 0.6m at the beach toe, exposing the toe of the rock revetment further seaward than the previous survey (at chainage 11m). The beach is at a low level compared to the range recorded from previous surveys and the beach toe is at its most landward position recorded.</p> <p>Profile 1bSNC6 extends across the revetment and seawall. The beach level has accreted across the entire profile by up to 0.6m from the toe of the sea wall to the end of the survey. The beach levels are at a high level compared to the range recorded from previous surveys.</p> <p>Profiles 1bSNC7 to 1bSNC9 are within the shelter of North East Pier and South West Breakwater in the former South Outlet, parts of which have been in-filled with tipped rubble.</p> <p>Profile 1bSNC7 is a section across North East Pier. There has been no discernible change in the overall profile. Small apparent changes will be artefacts of the placement of survey points along the profile.</p> <p>Profile 1bSNC8 crosses the boulders and rubble. The survey report notes that there was a “noticeable amount of sand at the bottom of section 8”. From chainage 35m seaward of the boulders and rubble, the beach level has accreted by 0.3m, although it has not recovered to the levels seen between 2009 – 2012. Overall the profile is now at a medium to low level.</p> <p>Profile 1bSNC9 extends from the dock facilities and crosses a short length of concrete wall and sheetpiling before extending across the sand and gravel backshore and foreshore to reach and cross a boulder mound that is towards the seaward end of the south west breakwater. The profile shows a</p>	<p>previous survey. Profile 1bSNC3 was not analysed as it does not cover any beach.</p> <p>Within the breakwaters either side of the former South Outlet of the docks, long term change is small at 1bSNC7 and 1bSNC9. At profile 1bSNC8, the long-term trend has been lowering beach levels since surveys began in October 2009, however the most recent survey in autumn 2020 has shown accretion since the previous survey (albeit not to the level seen in 2009).</p>

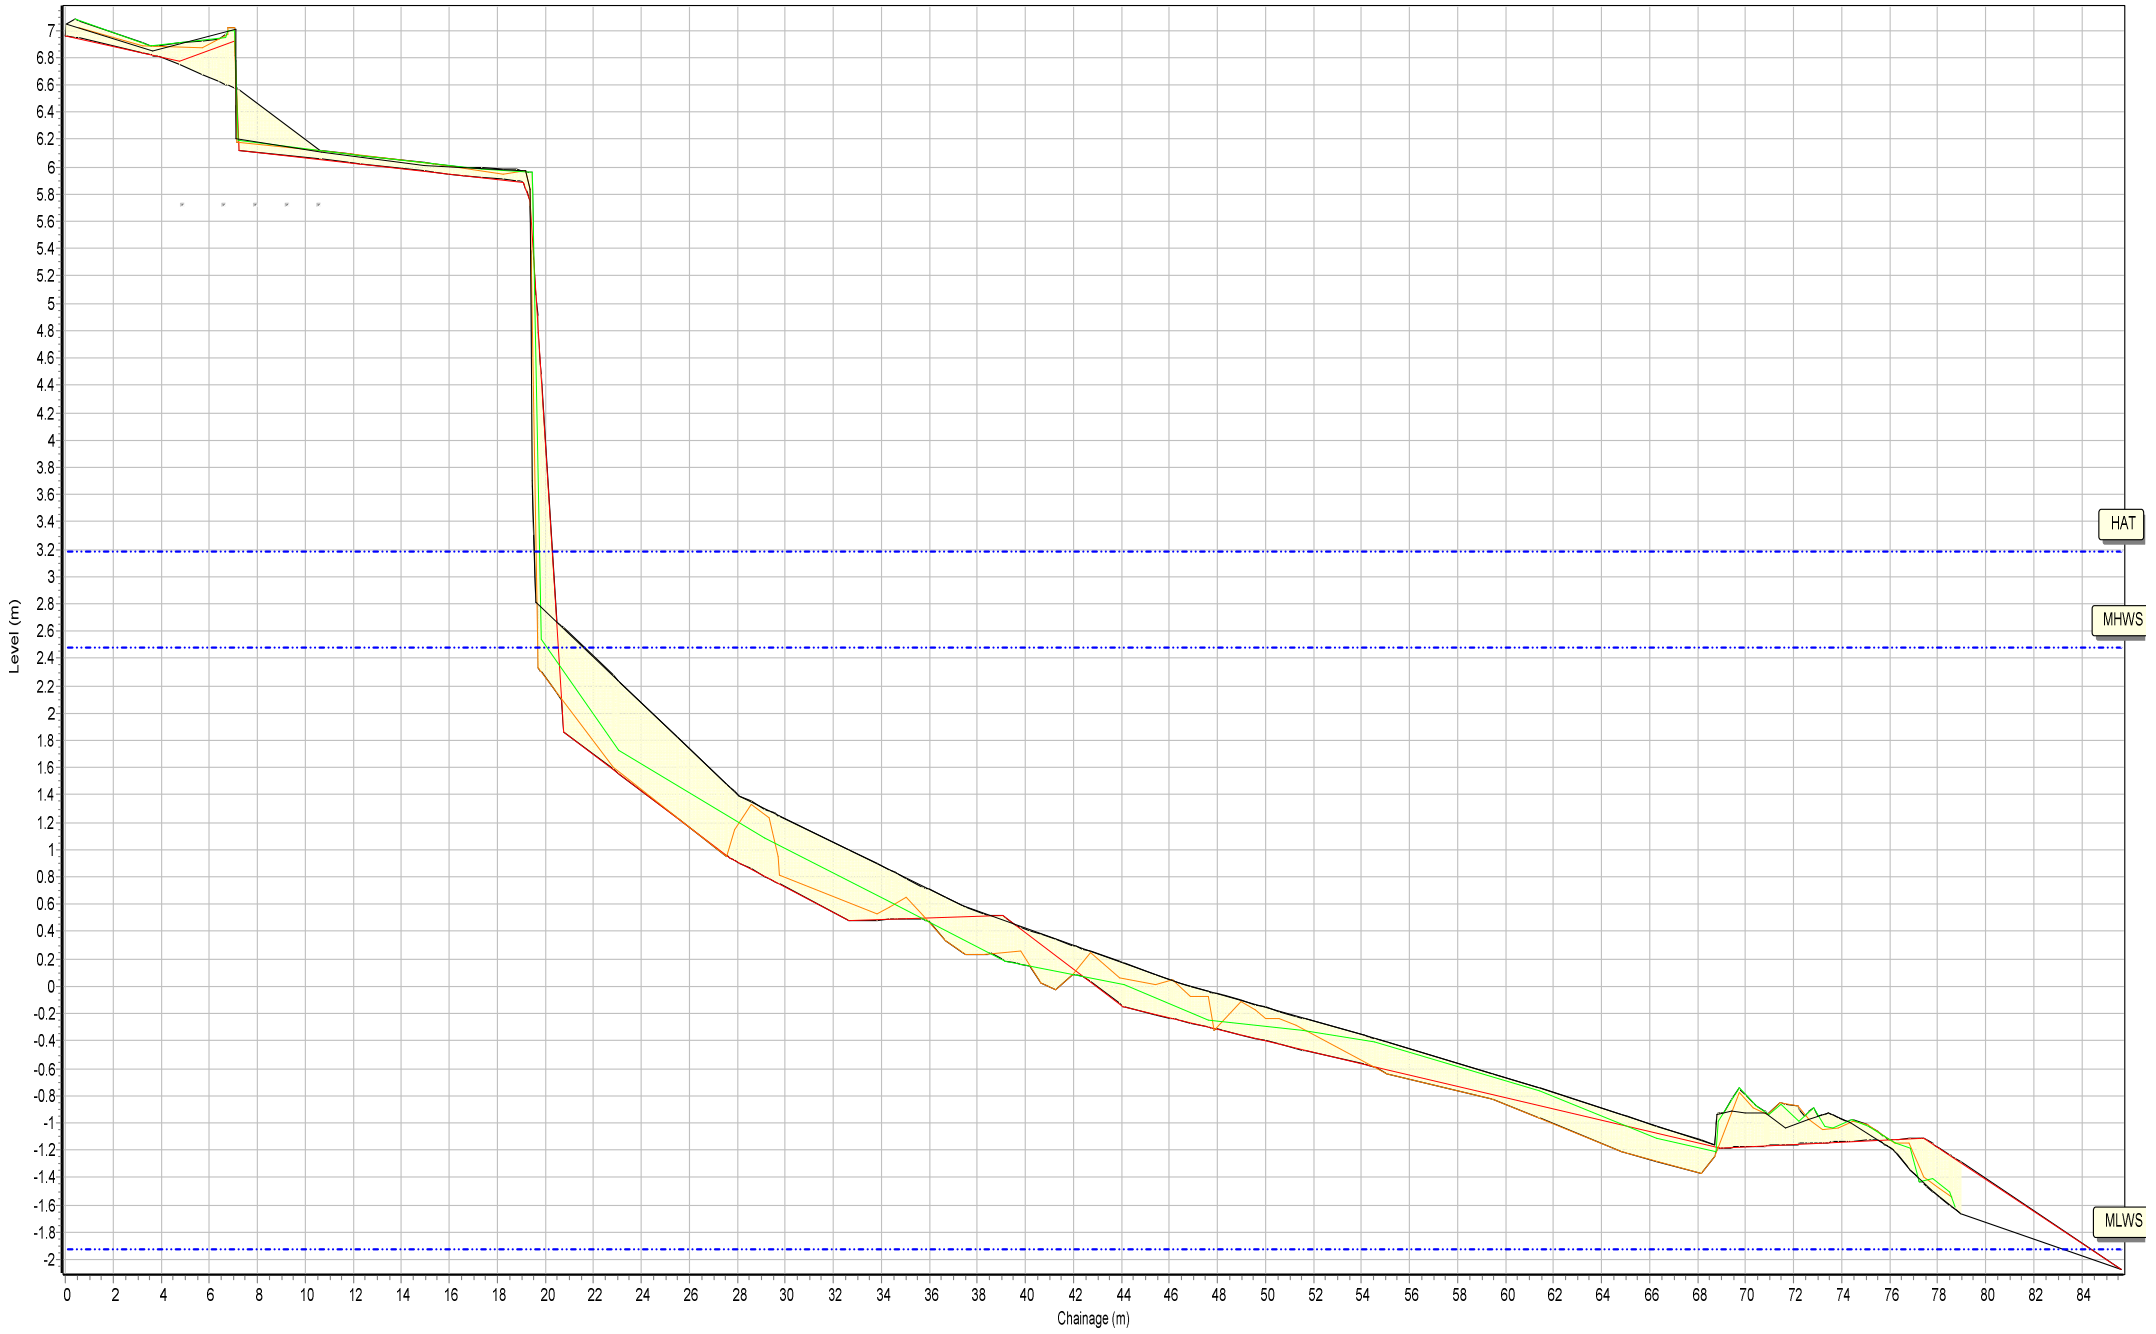
Beach Profiles: 1bSNS7

- At Sunderland Harbour and Docks, the recorded profiles present no causes for concern.
- At Hendon to Ryhope (incl. Halliwell Banks), several sections reached their highest (between the toe wall and chainage 49m at 1bSNS7, seaward of chainage 80m at 1bSNS9 and between the toe of the sea defences and 53m chainage at 1bSNS11) and lowest (between chainages 41-49m at 1bSNS8 and the beach toe at 1bSNS10) levels recorded since autumn 2009. However, the recorded profiles, topographic survey and cliff top survey present no causes for specific concern. Ongoing cliff erosion is of a similar magnitude to previous surveys.
