**Cell 1 Regional Coastal Monitoring Programme
Update Report 3: 'Partial Measures' Survey 2011**

Sunderland City Council

^(*) The present report is **Update Report 3** and provides an analysis of the 2011 Partial Measures survey for Sunderland City Council's frontage. It is intended as a brief update of the key findings from this survey to maintain an understanding of ongoing changes.

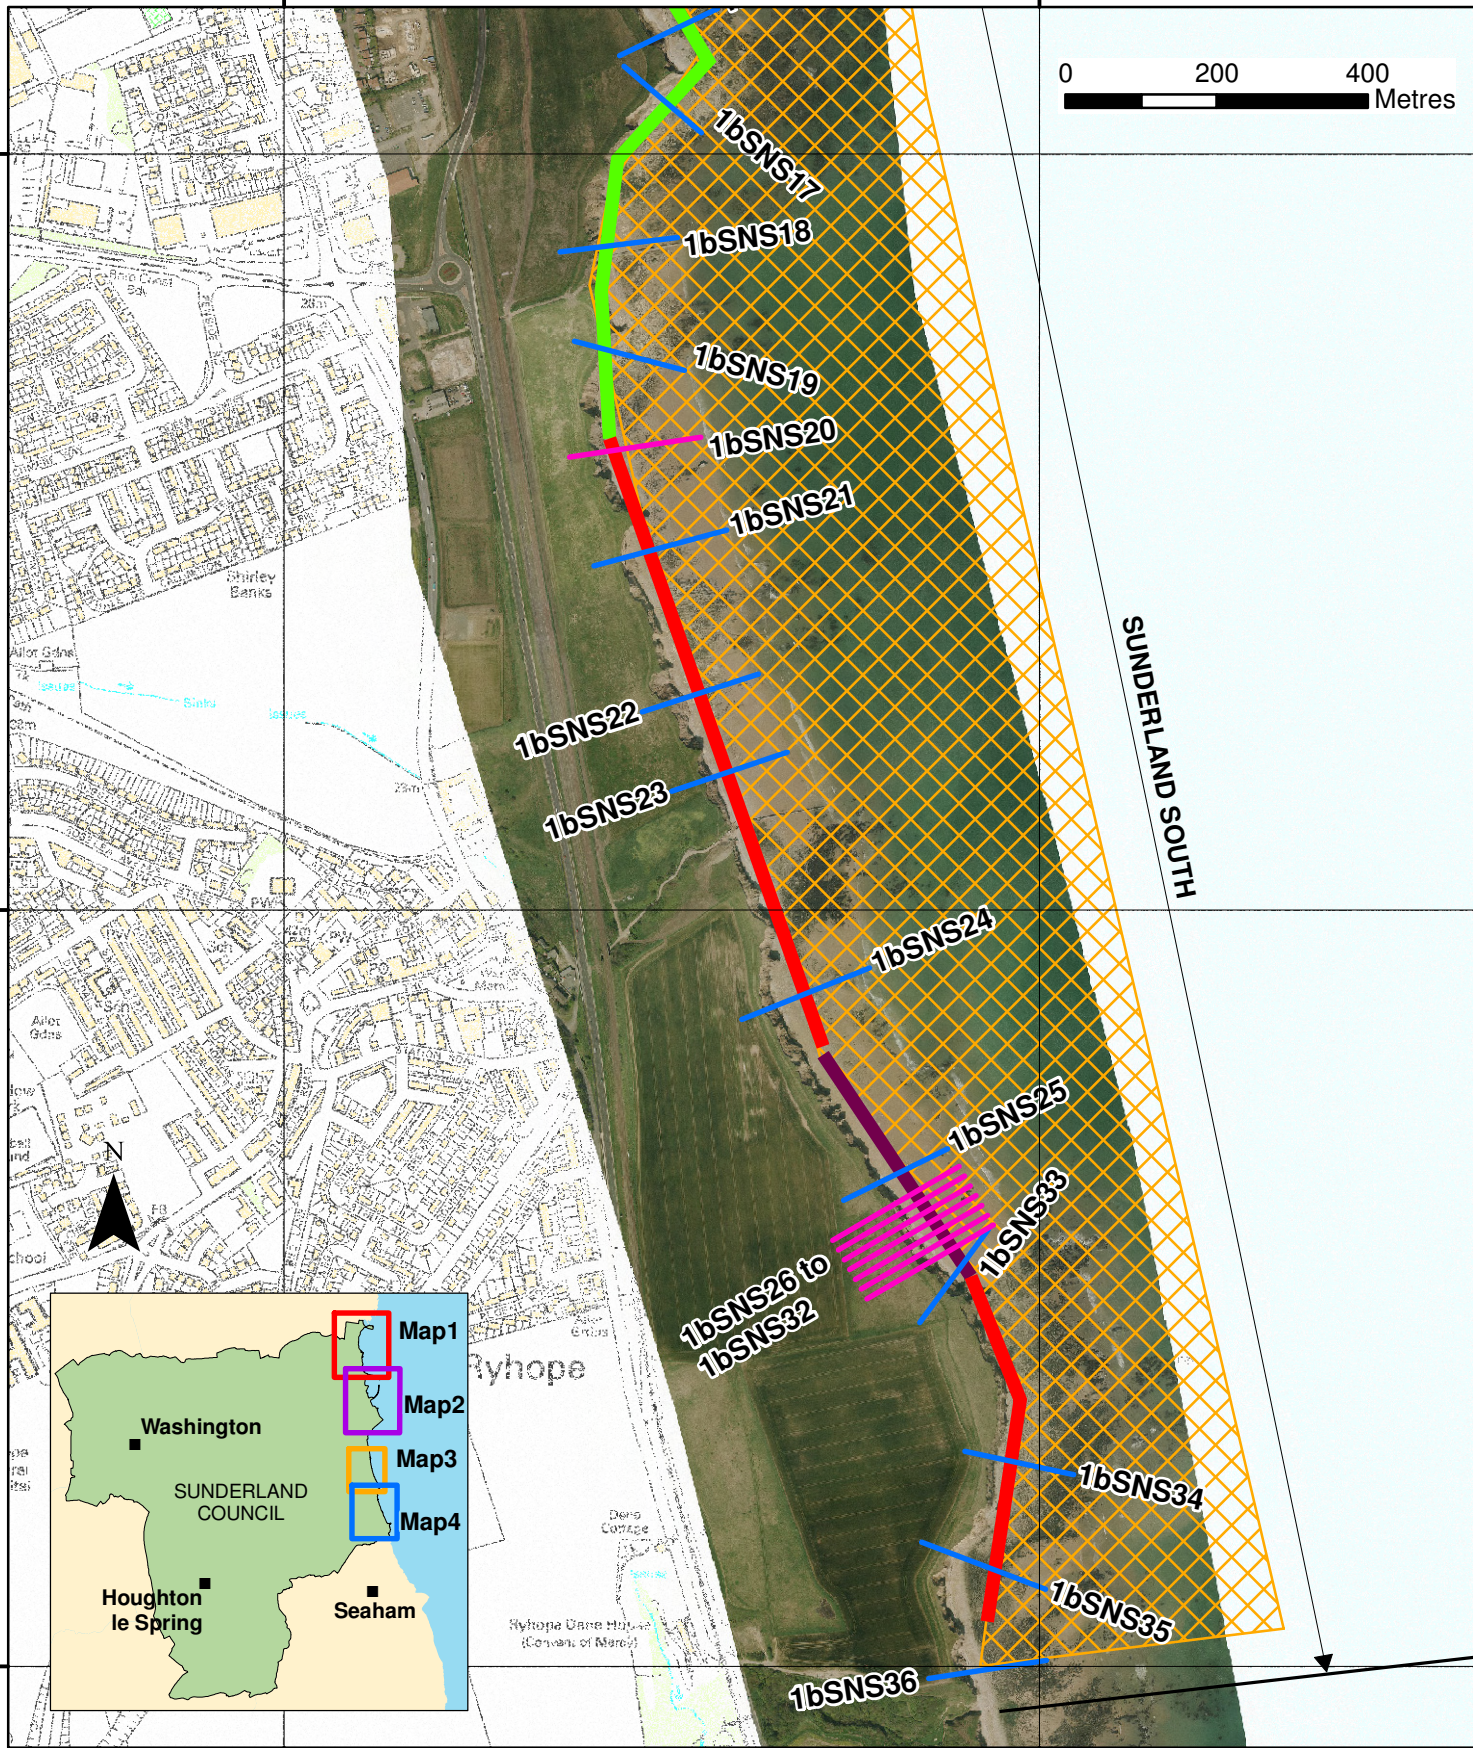
**Figure 1 - Map 4
 Sunderland
 Council Frontage**

- Annual Profile
 - Bi-Annual Profile
 - ▨ 6 monthly Survey
 - ▨ Yearly Survey
 - ▨ 5 yearly Survey
 - Cliff Top Survey @ 50 centres
 - Cliff Top Survey @ 100 centres
 - Cliff Top Survey @ 300 centres
- (Indicative Survey Extents shown)*

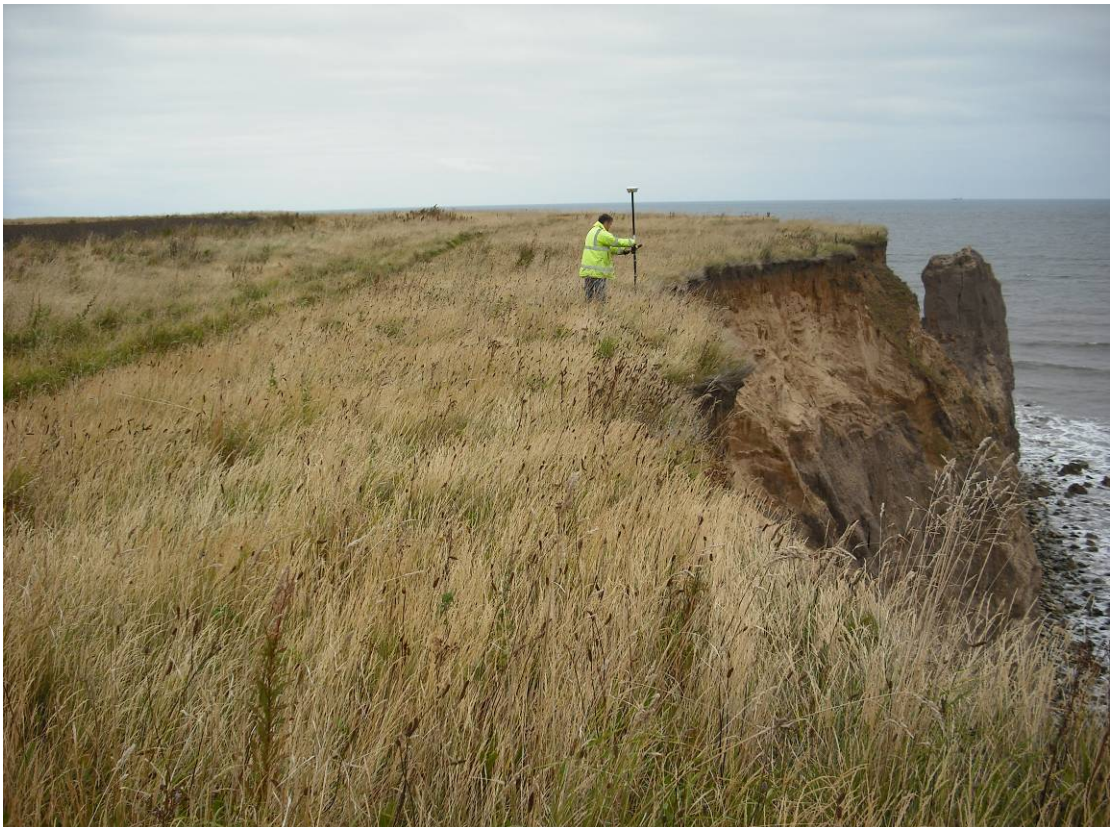
Plate 1 – Cliff Top Surveying

Surveying any cliff top is difficult due to the safety risks posed to surveyors, especially during adverse weather, and the 'apparent' changes that can arise due to surveyors interpreting different points as the cliff edge on successive surveys (Plate 1). This has previously been identified as affecting most of the cliff top surveys and demonstrates the importance of a long term record.

In addition to surveyor interpretation, cliffs along this frontage have a characteristic tendency to heave seawards prior to a toppling failure, leading to apparent discrepancies in the data.

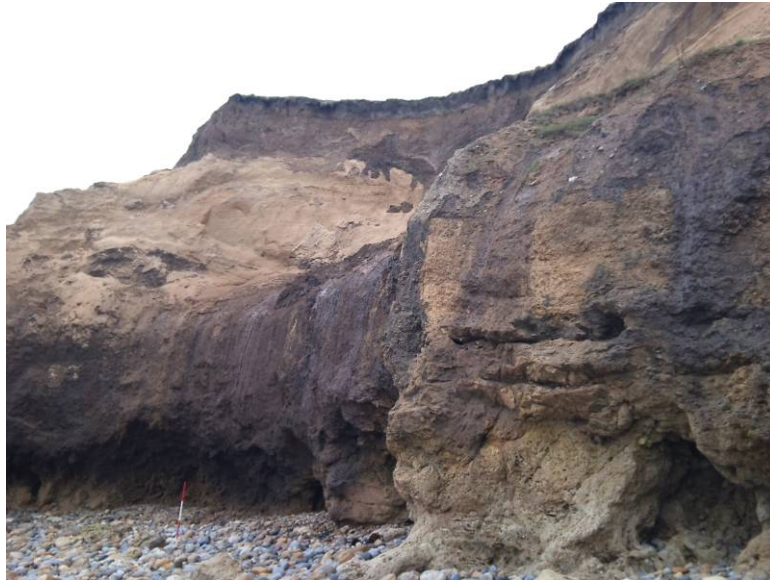
- Whitburn Bay had high beach levels at the time of the March 2011 surveys, with a berm recorded at a chainage of around 85-100m.
- There appear to be alternating patterns of erosion and accretion, typically within bounds of previous observations, along the Hendon frontage.
- Shirley Banks (as measured by profile SNS20) remained stable since the previous survey.
- The sections of undefended cliff along Halliwell Banks appear to be eroding quite rapidly, with several sections remaining active. There are numerous areas where the cliffs are undercut at their toe (see below), which is likely to lead to further collapses.

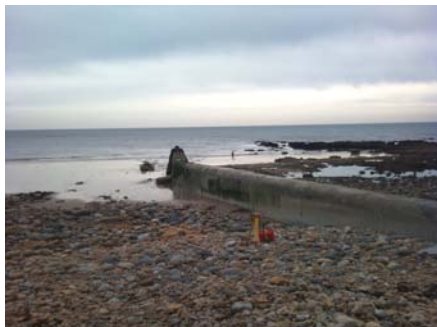
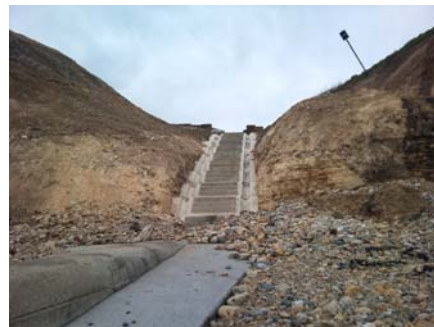
- A concerning feature from the March 2011 survey, was the very low foreshore levels fronting the Halliwell Banks cliffs. This, together with the current condition of some cliff sections, is likely to result in yet further erosion along this frontage.
- It was noted that work on beach access and a new outfall at Ryhope is complete.

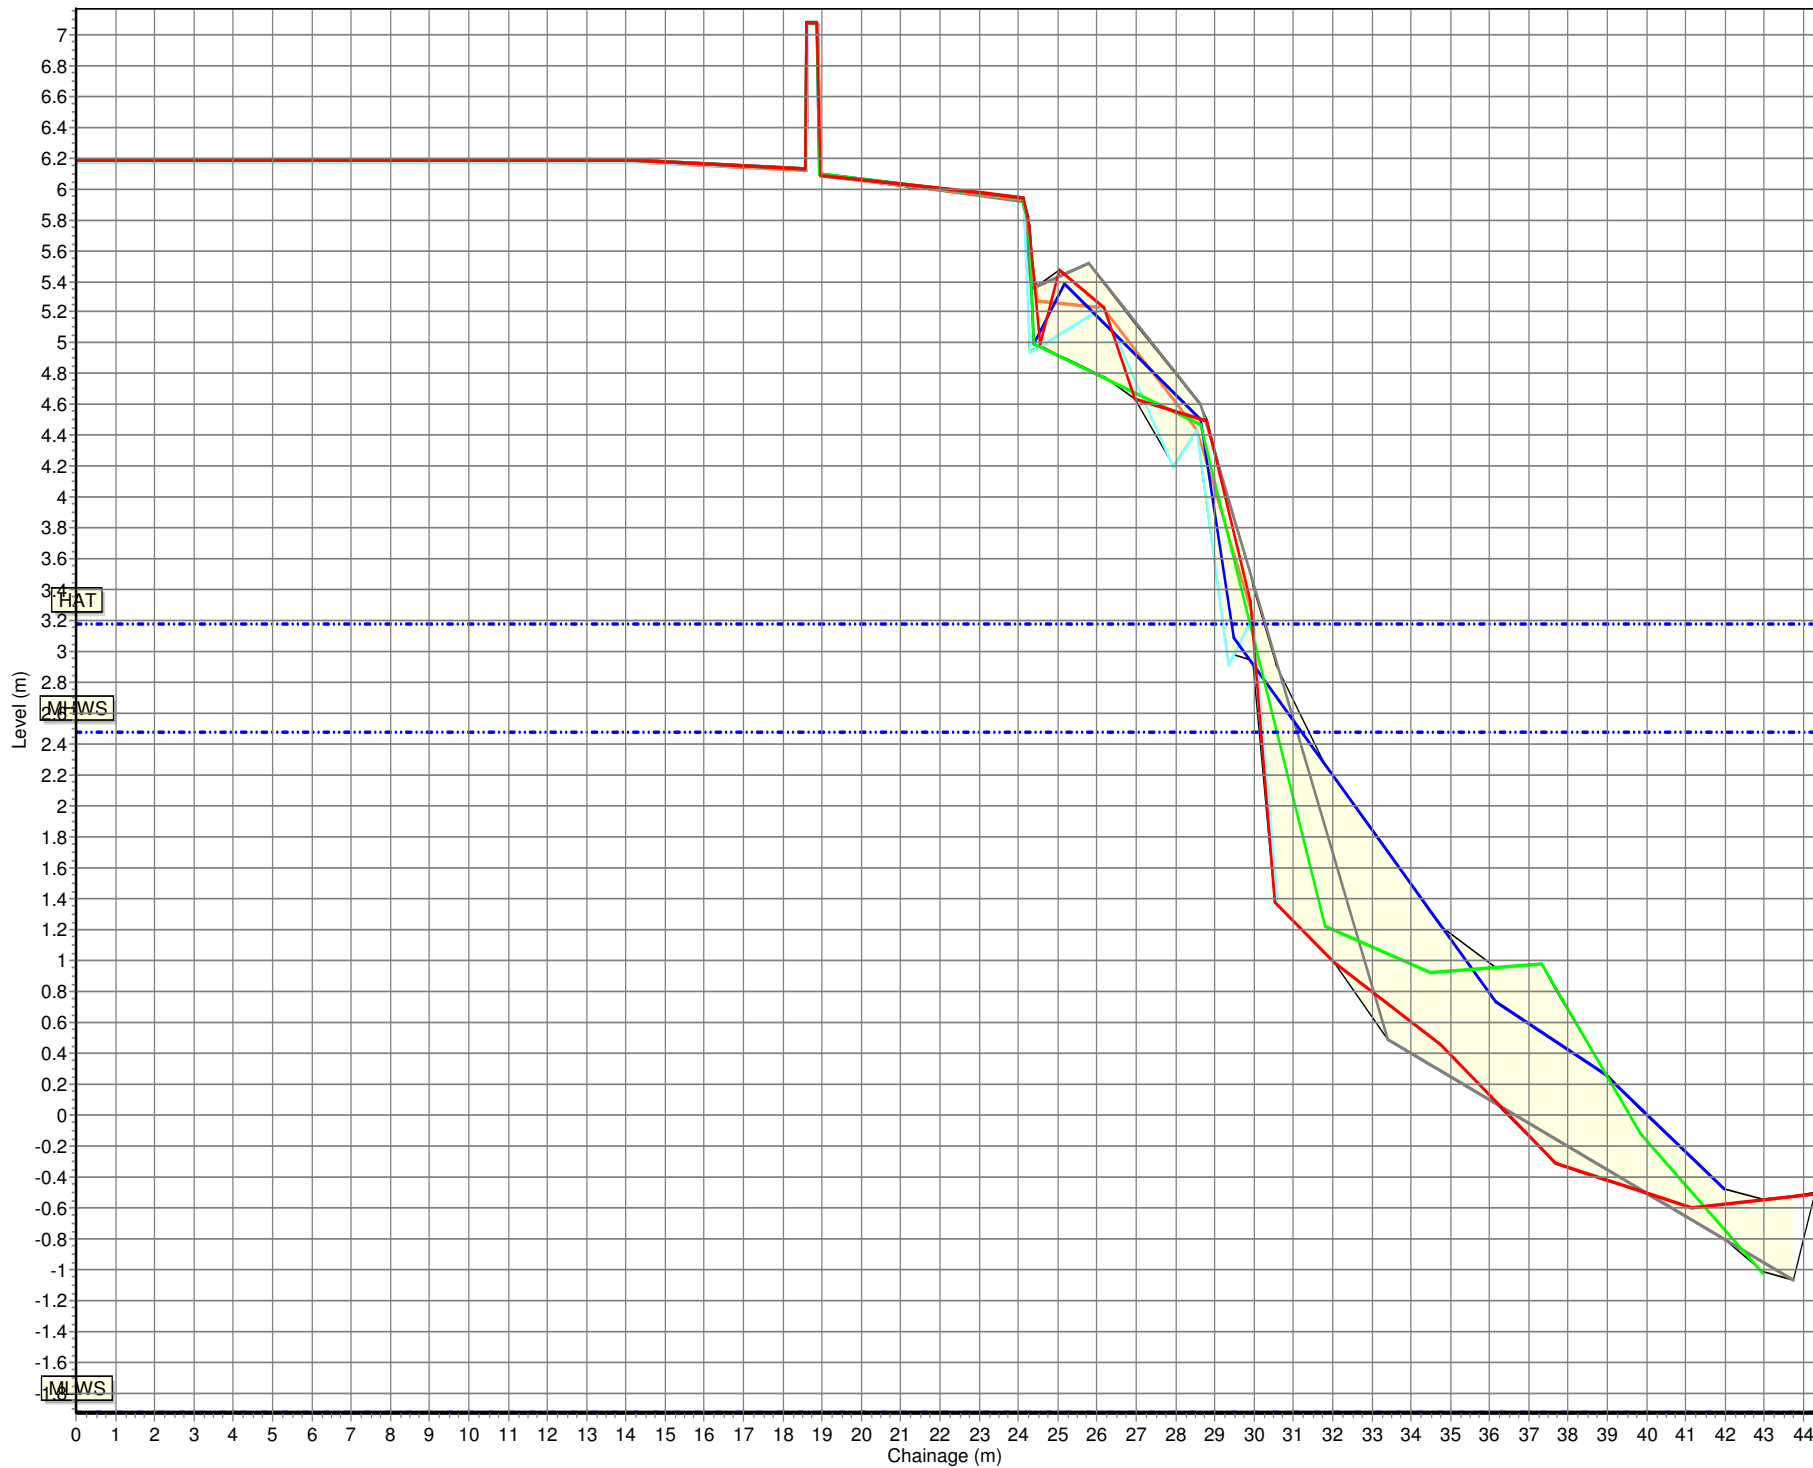
1bSNS4 - 04/04/2011

Survey Date	Description of Changes Since Last Survey	Interpretation
03-2011	<p>Beach Profiles:</p> <p>Hendon to Ryhope is covered by twelve beach profile lines during the Partial Measures survey (Appendix A). Eight of these are closely spaced and located at Halliwell Banks to specifically monitor erosion rates along the cliffs fronting the former landfill area.</p> <p>SNS4 crosses the concrete boundary wall of the Hendon Sewage Treatment Works, which has an elevation in excess of 7.0mODN, and extends a further 5m across the concrete deck to the edge of the near vertical wall face. The profile then crosses the fronting rock revetment until it intercepts water. There is very little foreshore exposed along the frontage as the profile soon extends into deeper water, but the short length of foreshore that is present at the toe of the revetment did exhibit erosion between September 2010 and March 2011 to reach quite low values.</p> <p>SNS8 and SNS11 both start at the coastal slope/cliff backing the Hendon Sea Wall and extend across the wall and fronting rock armour before reaching sand levels and then extending down to low water. SNS8 experienced accretion of the beach profile between the toe of the revetment and a chainage of around 75m. SNS11 also experienced accretion since September 2010 but levels remained moderate.</p> <p>SNS20 is located at Shirley Banks. The profile extends across the cliff top, which is at an elevation in excess of 25mODN, and drops over 21m in height down the steeply-sloping cliff face to the toe. The profile then extends across the foreshore down to low water, with some rock outcrops captured towards the landward end. There was no significant change in position of the cliff top, face or toe along this profile, and the foreshore levels remained stable.</p>	<p>There seems to be alternating patterns of erosion and accretion, typically within bounds of previous observations, along SNS4, SNS8 and SNS11.</p>

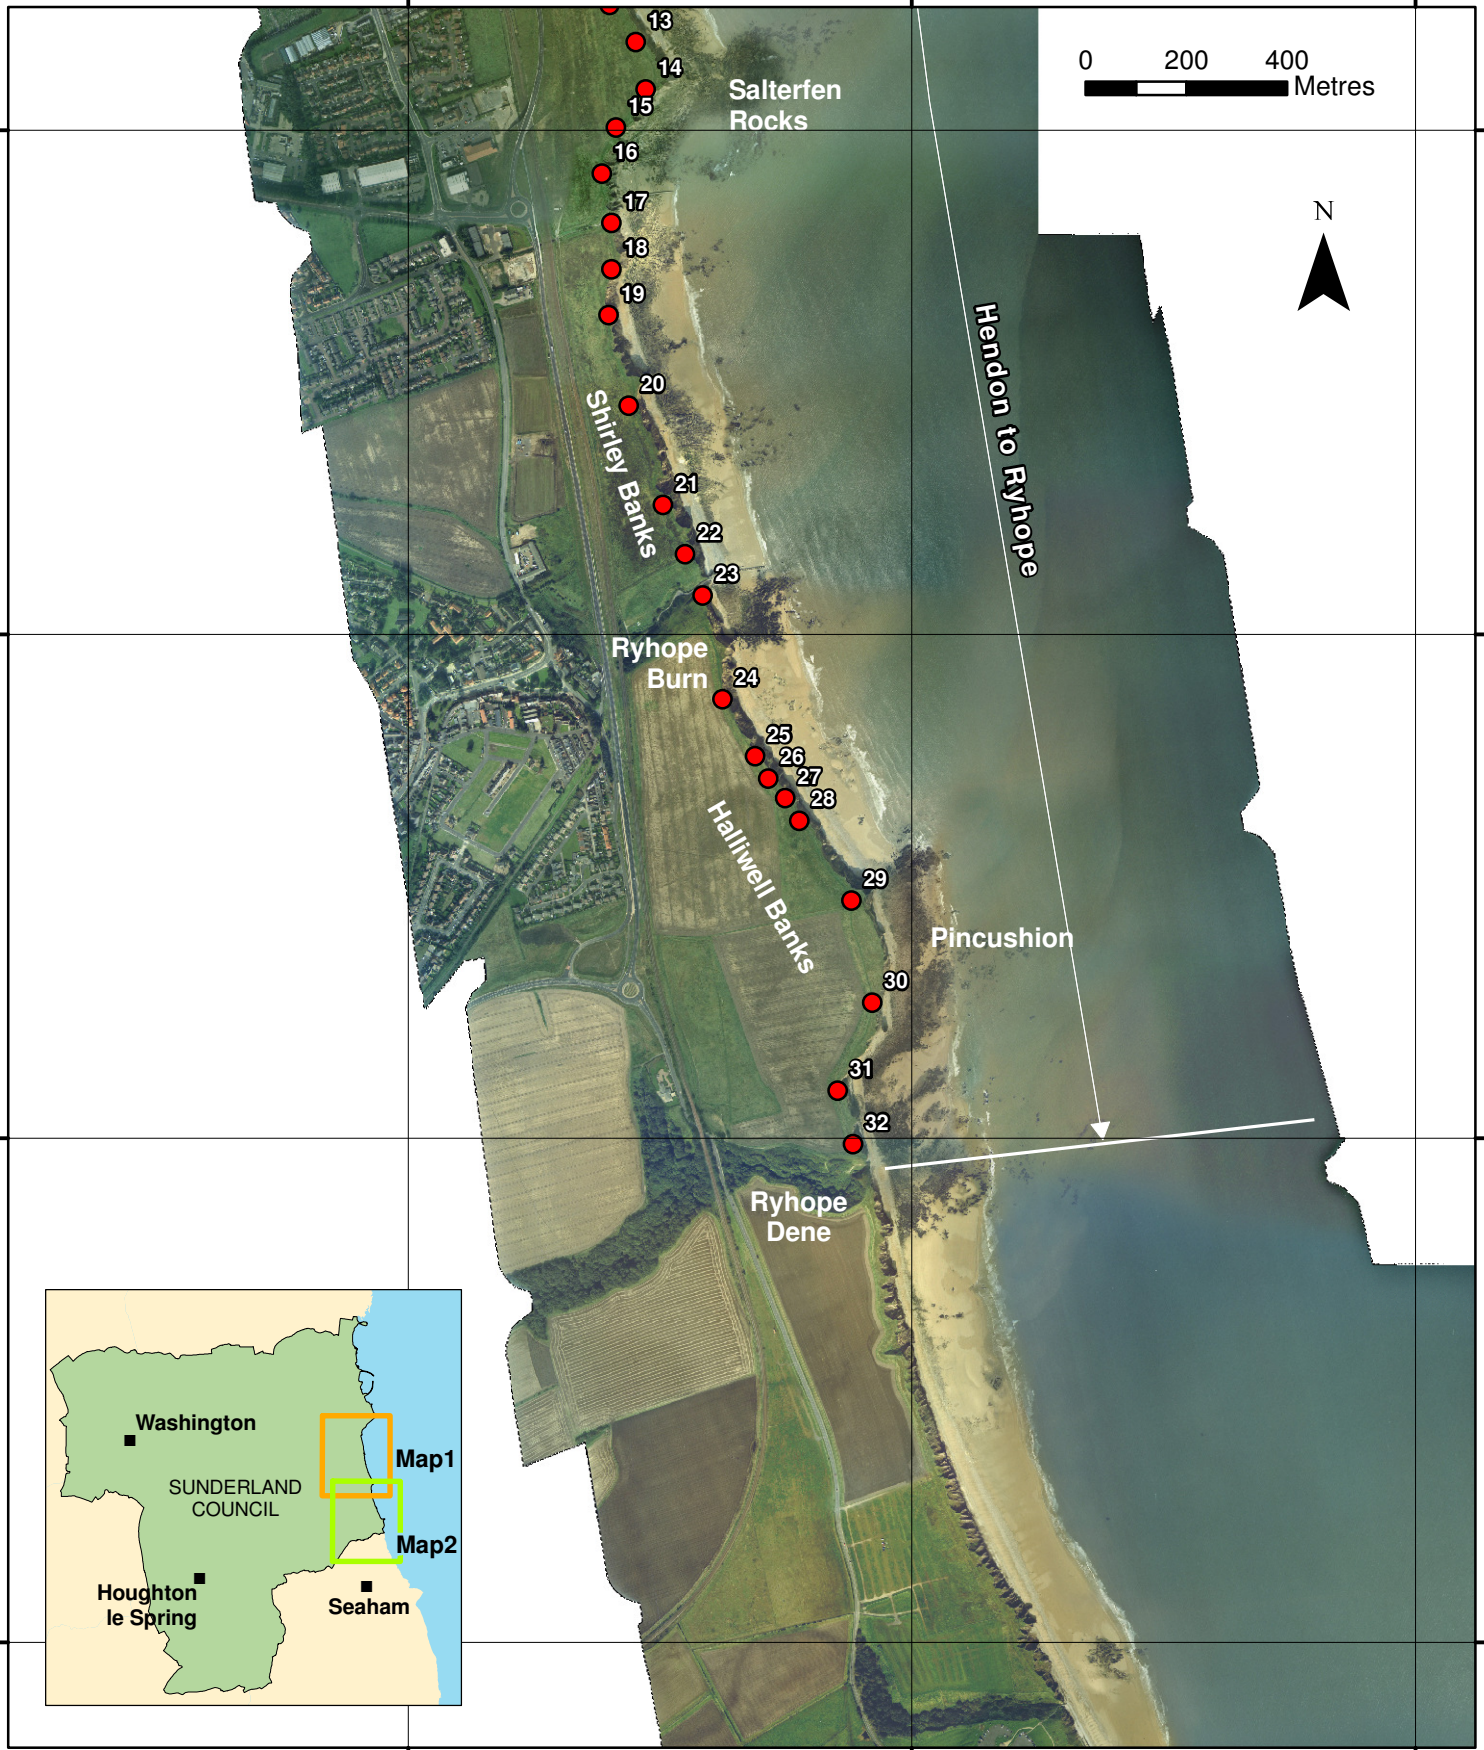
**Appendix B - Map 2
 Sunderland
 Council Frontage**

03-2011	<p>Cliff Top Survey:</p> <p>Thirty-five ground control points have been established along the cliff top between Hendon and Ryhope (Appendix B, Figure B1). [Note: the numbering of control points is <u>not</u> intended to correlate with that of the beach profile lines and reference should be made to Figure B1 for locations of control points].</p> <p>Measurements are taken from each ground control point along a fixed bearing to the edge of the cliff top. These cliff top surveys are undertaken bi-annually and are intended to inform on erosion rates of the sea cliffs extending from the defended industrial areas at Hendon southwards along the undefended cliffs to Ryhope Dene.</p> <p>Points 1 to 3 have been affected by cliff landscaping works that were undertaken in 2009 and early 2010. With a baseline re-established in October 2010, all three points have seen a degree of change since.</p> <p>Points 4 to 23 are located along the undefended sea cliffs extending from the end of the Hendon Seawall south to Ryhope Burn (sometimes known as Ryhope Beach Road), which separates Shirley Banks from Halliwell Banks. Here, the changes recorded to date have generally been within the bands of accuracy of the surveying technique, so no net trends have been identified along most of the frontage. However, there do appear to be two sections where erosion has occurred. Between points 9 and 11 and between points 19 and 21 the cliffs have cut back measurably. At some of these points, the erosion occurred between October 2010 and March 2011, although the process seems to have been initiated earlier.</p>	<p>The changes along the re-landscaped area covered by points 1-3 may be due to settlement rather than erosion.</p> <p>There are two sections of cliff along the undefended frontage between the end of the Hendon Seawall and Ryhope Burn where measurable erosion has occurred.</p>

<p>03-2011</p>	<p>Points 24 to 32, which extend along Halliwell Banks to Ryhope Dene, have generally experienced changes greater than the accuracy of the surveying technique and therefore must be considered as true records of recession. In some cases, such as at points 24, 25, 27, 28, 31 and 32, the recession has been of the order of metres since the first survey in March 2009. The recession is also approaching 1m along two of the additional points introduced in September 2009 (namely 28A and 28B).</p>	<p>Recession rates along the undefended cliffs at Halliwell Banks (which fronts the former land fill) and immediately south of Pincushion appear high. At the most extreme (point 25), the cliff top has eroded 5.7m between March 2009 and March 2011, giving rise to concern about the integrity of the rock barrier which retains the waste within the land fill.</p>
-----------------------	--	--

Thirty-five ground control points have been established between Hendon and Ryhope (Figure C1). The maximum separation between any two points varies along the coast, reflecting the degree of risk from the erosion.

The cliff top surveys between Hendon and Ryhope are undertaken bi-annually. Measurements are taken from a fixed ground control point along a fixed bearing to the edge of the cliff top. It is assumed that the accuracy of cliff top monitoring using this technique is $\pm 0.2\text{m}$. Therefore this should be taken into account when considering the calculated erosion rates in the table below.
