**Cell 1 Regional Coastal Monitoring Programme
Update Report 10: 'Partial Measures' Survey 2018**

(*) The present report is **Update Report 10** and provides an analysis of the 2018 Partial Measures survey for Sunderland City Council's frontage.

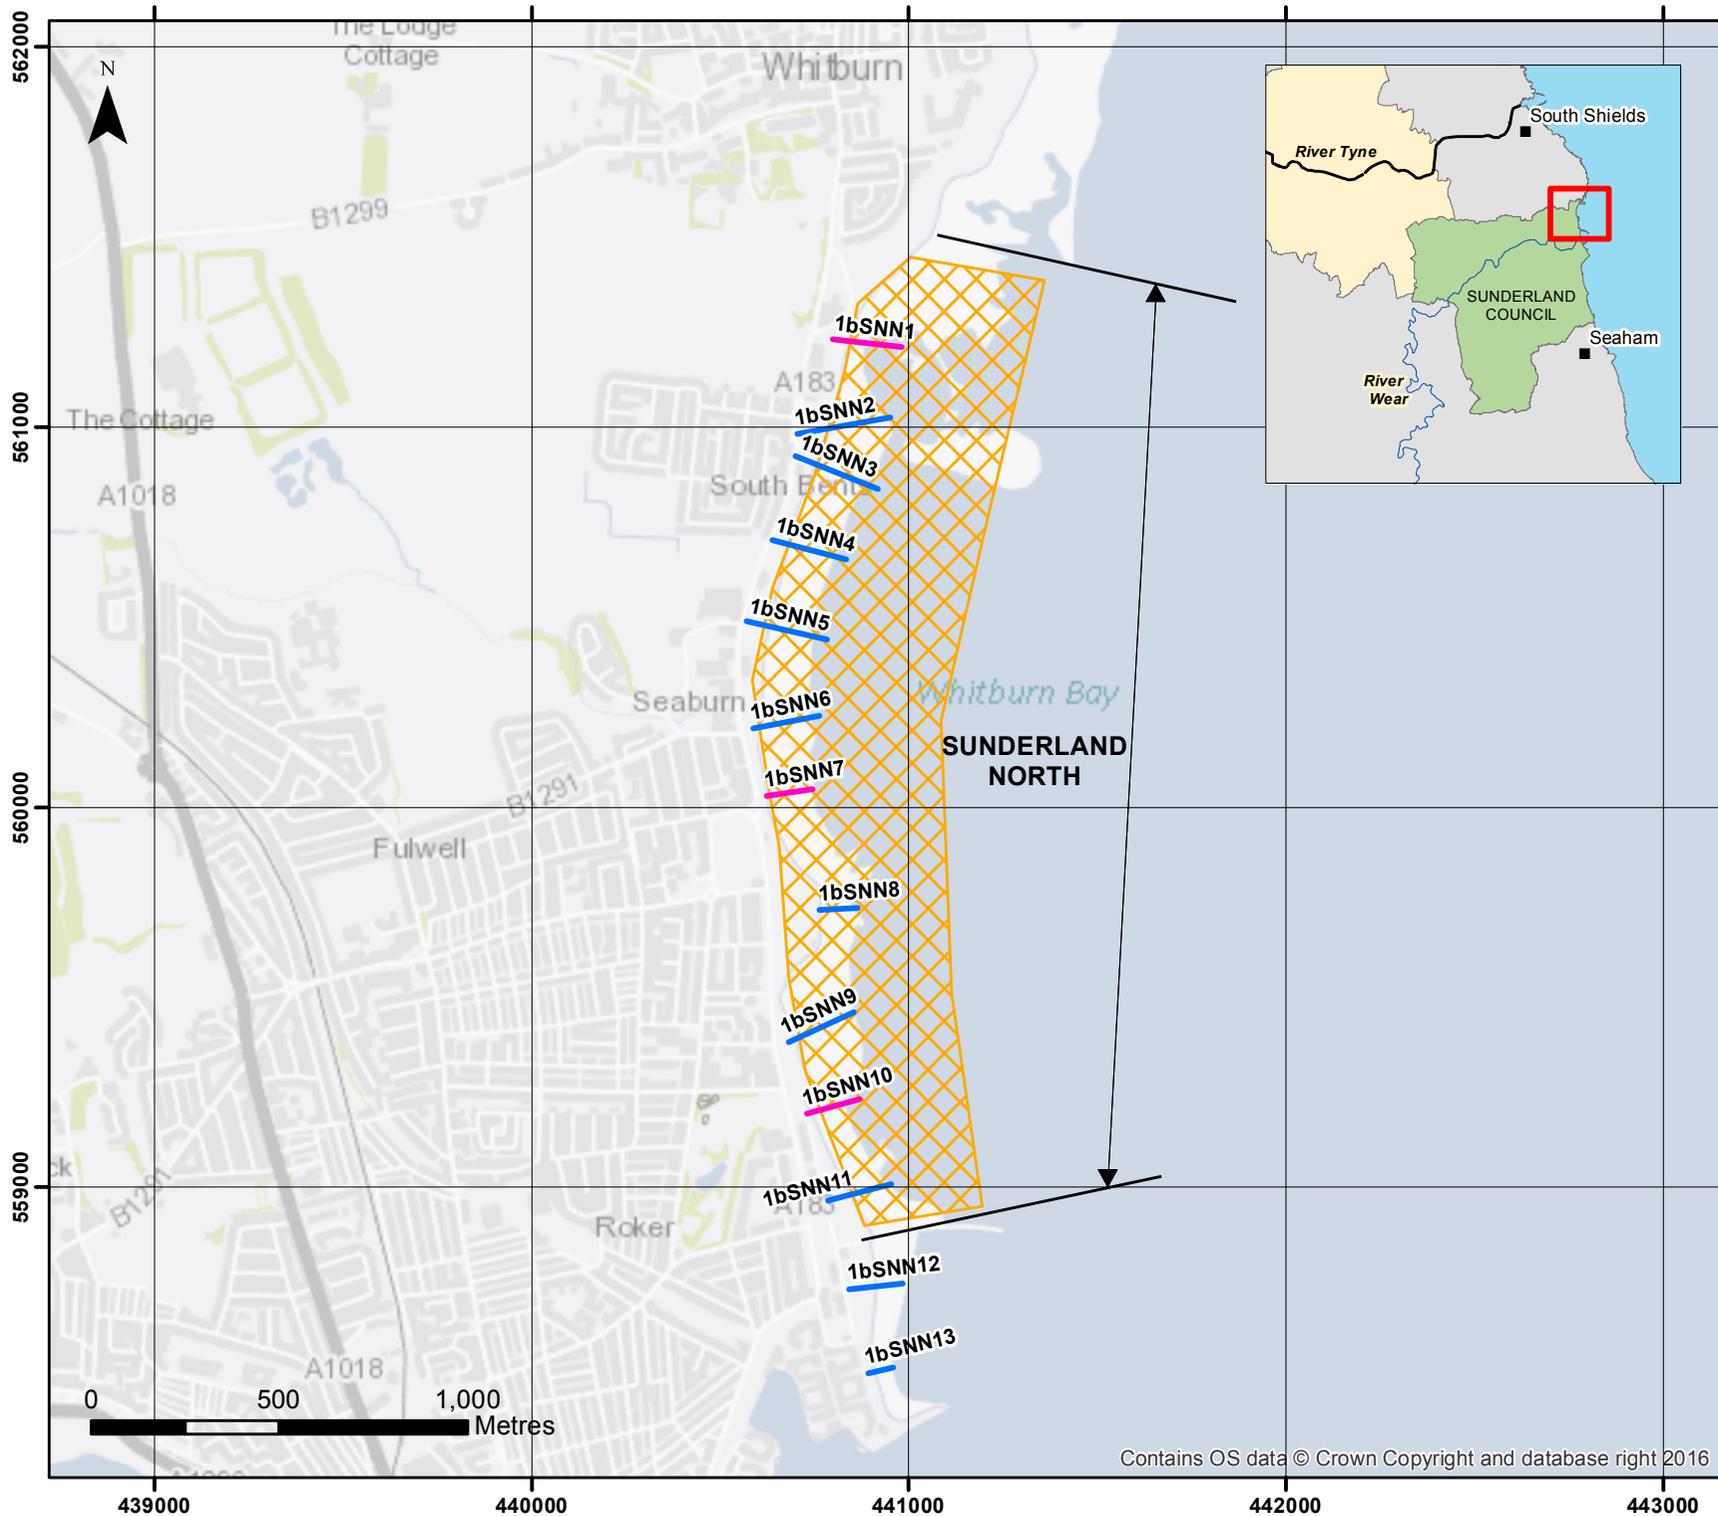
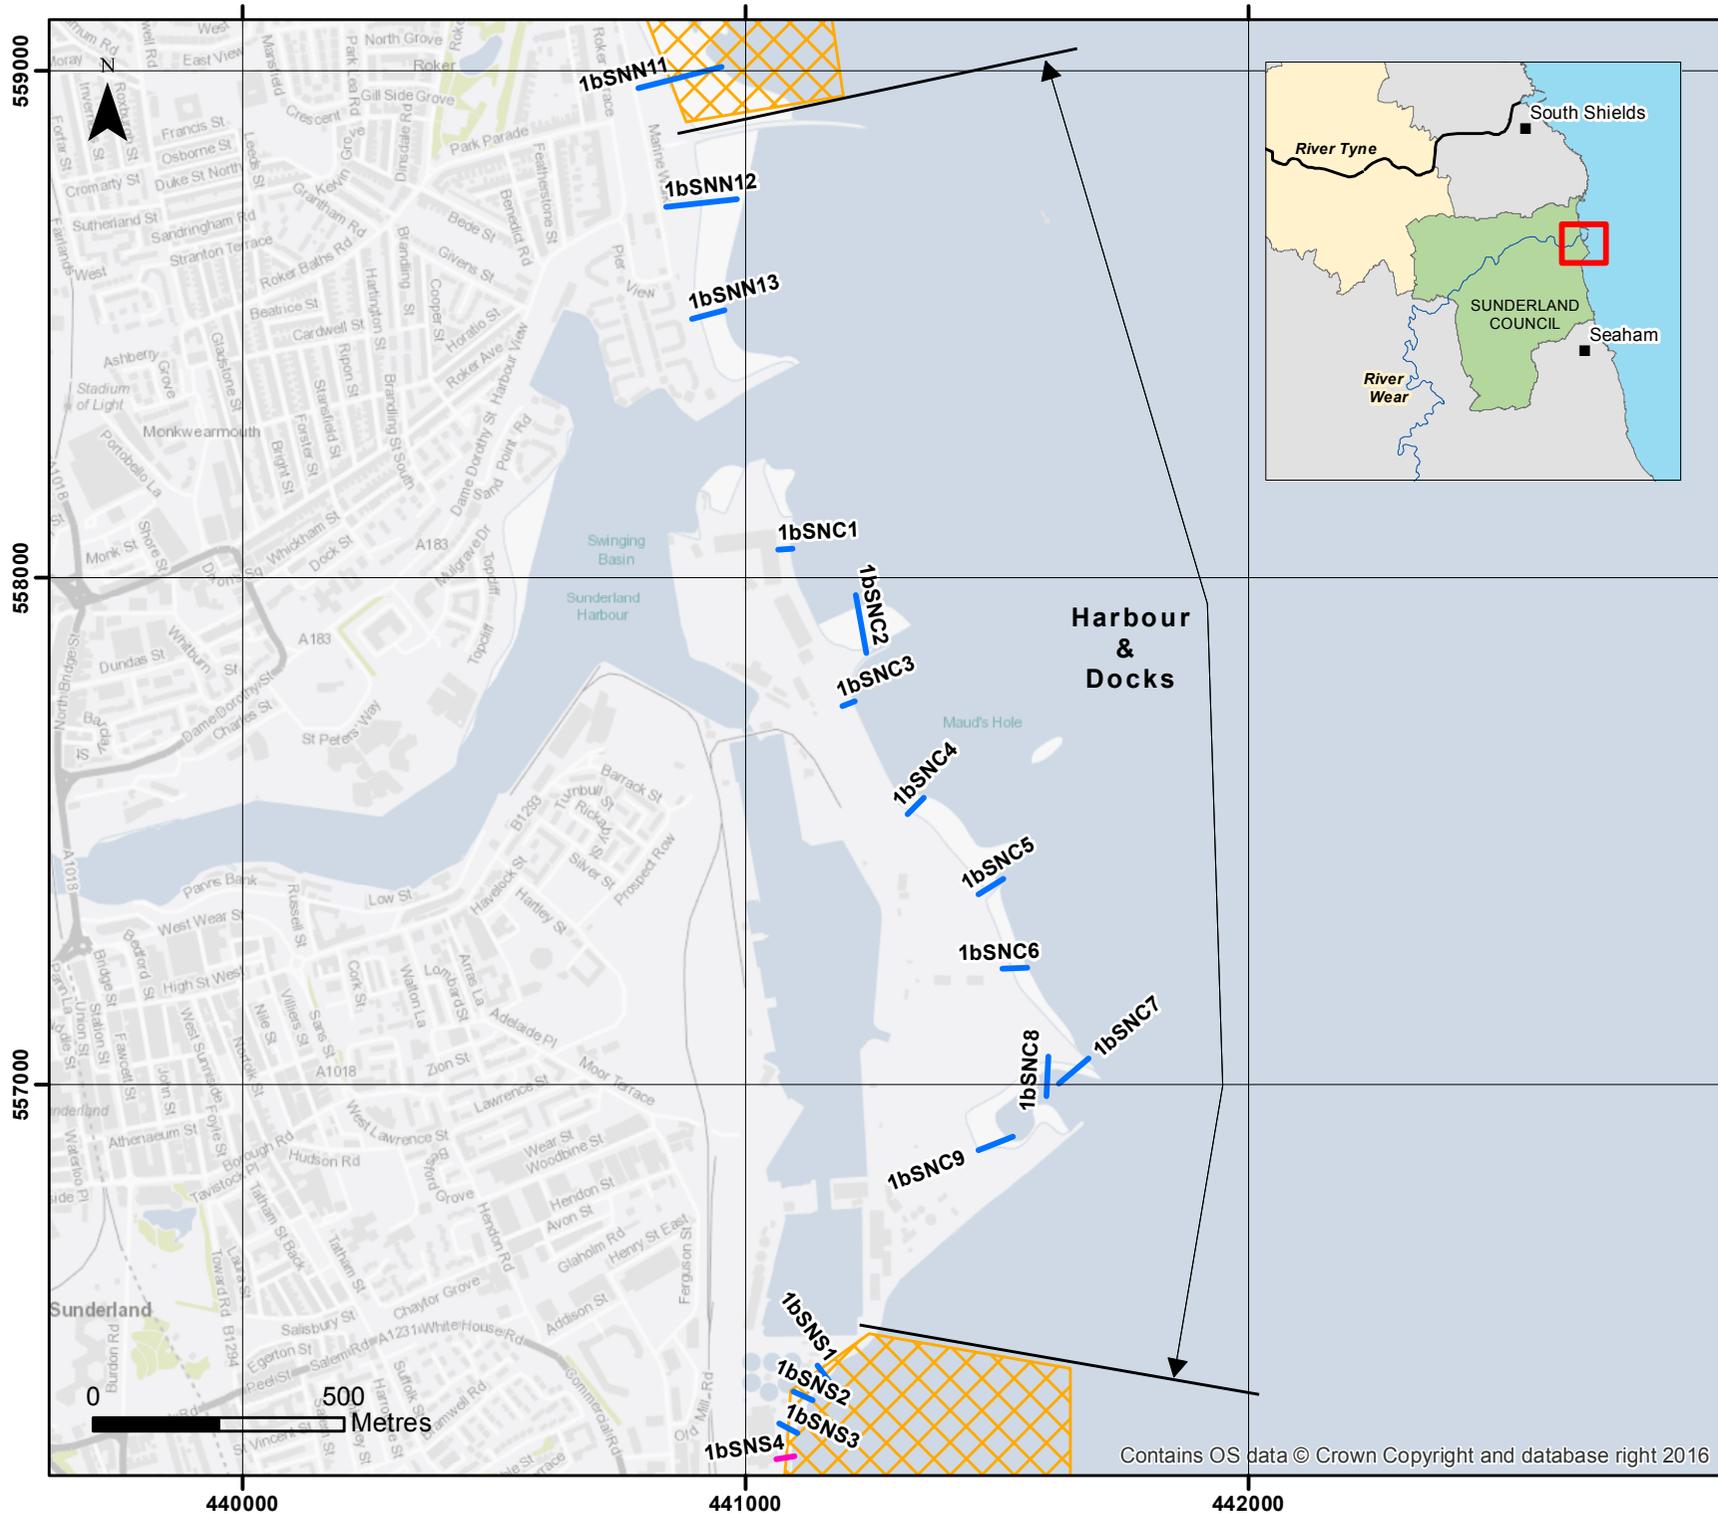
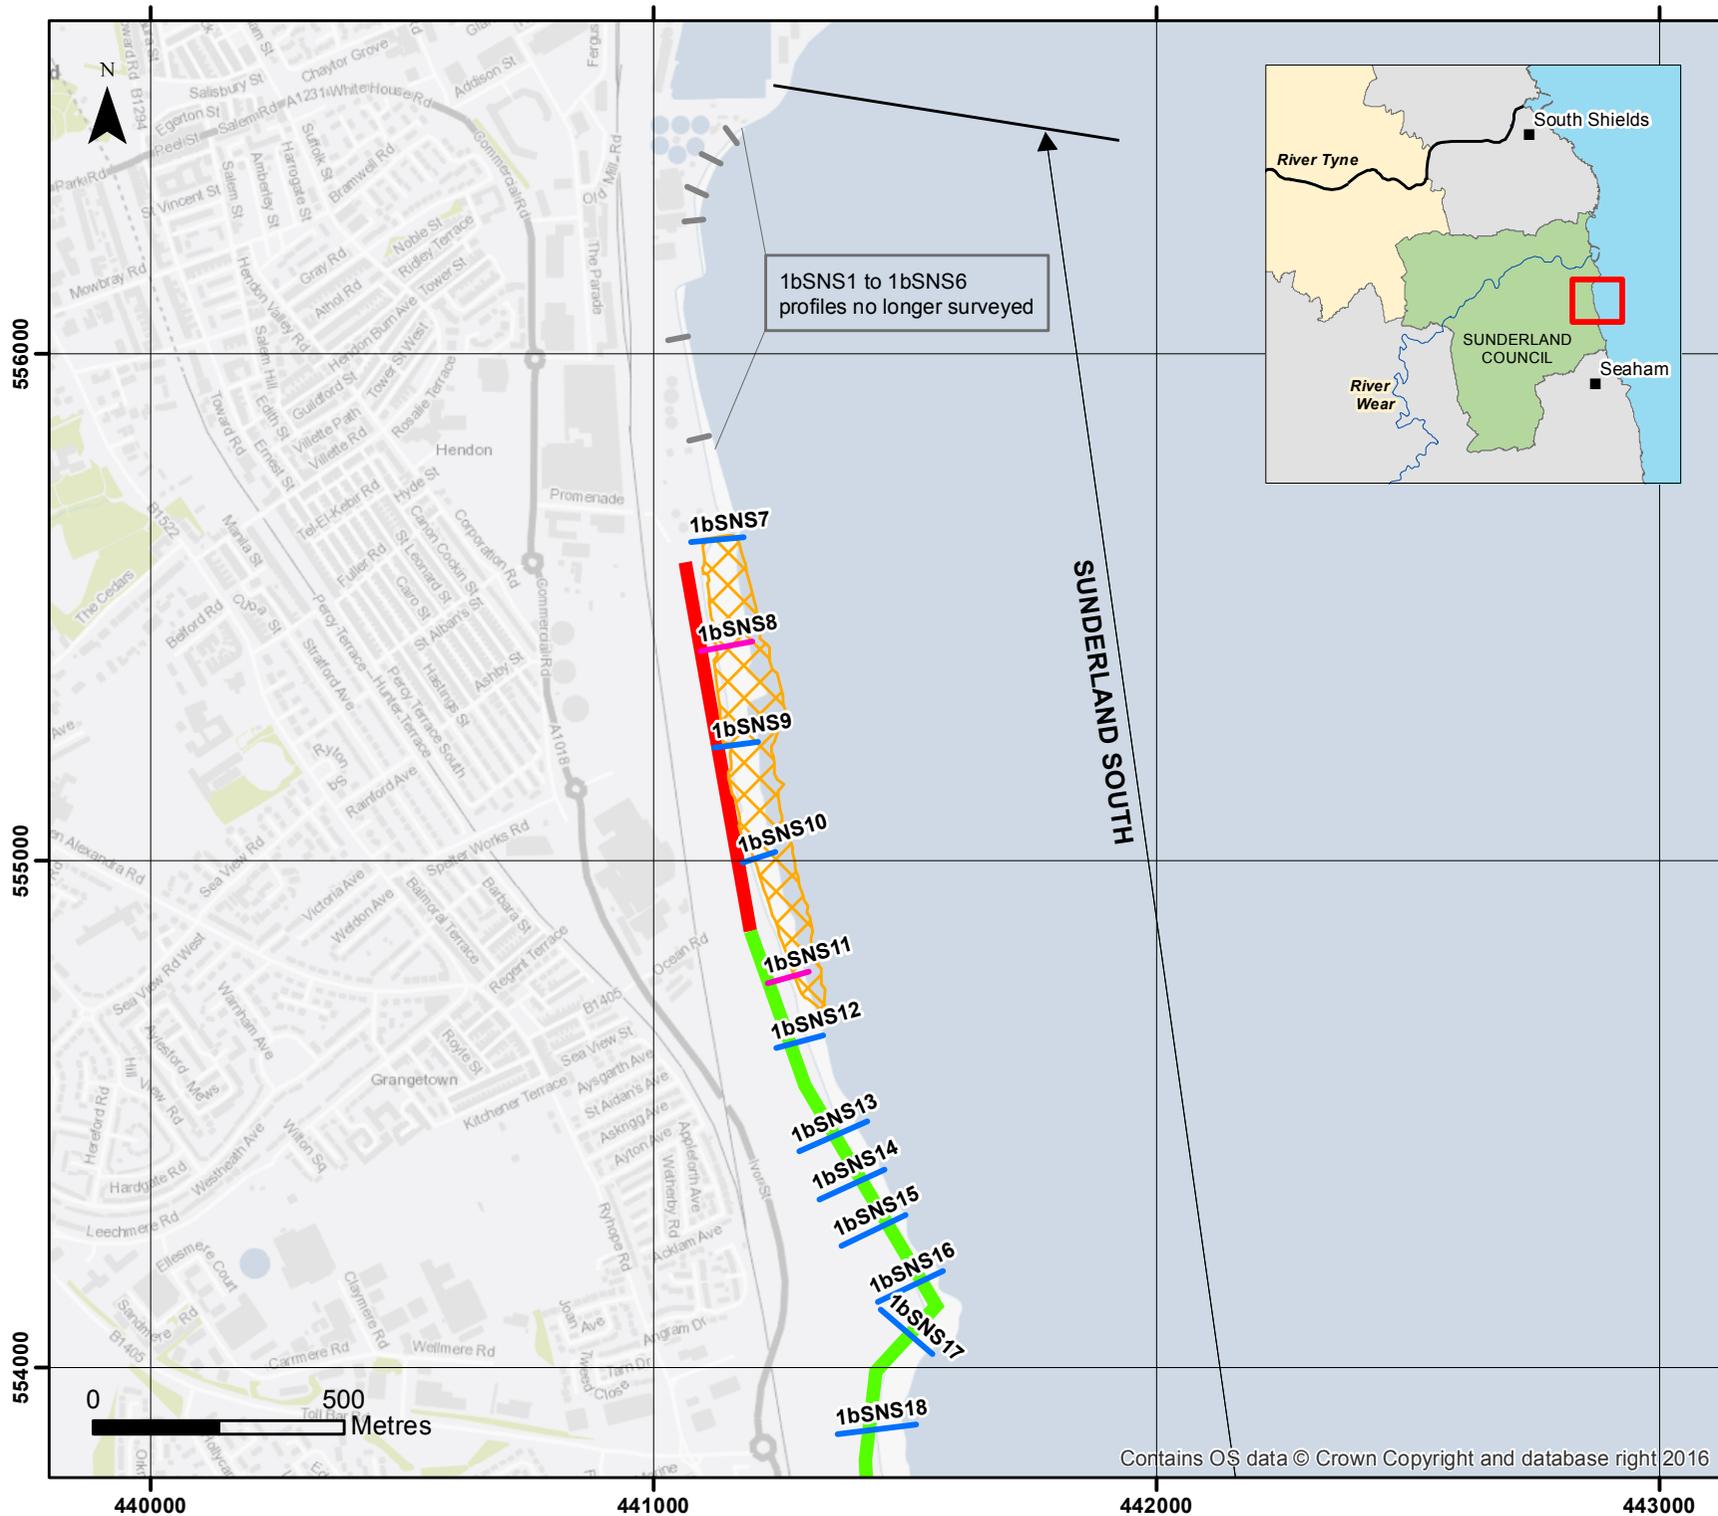
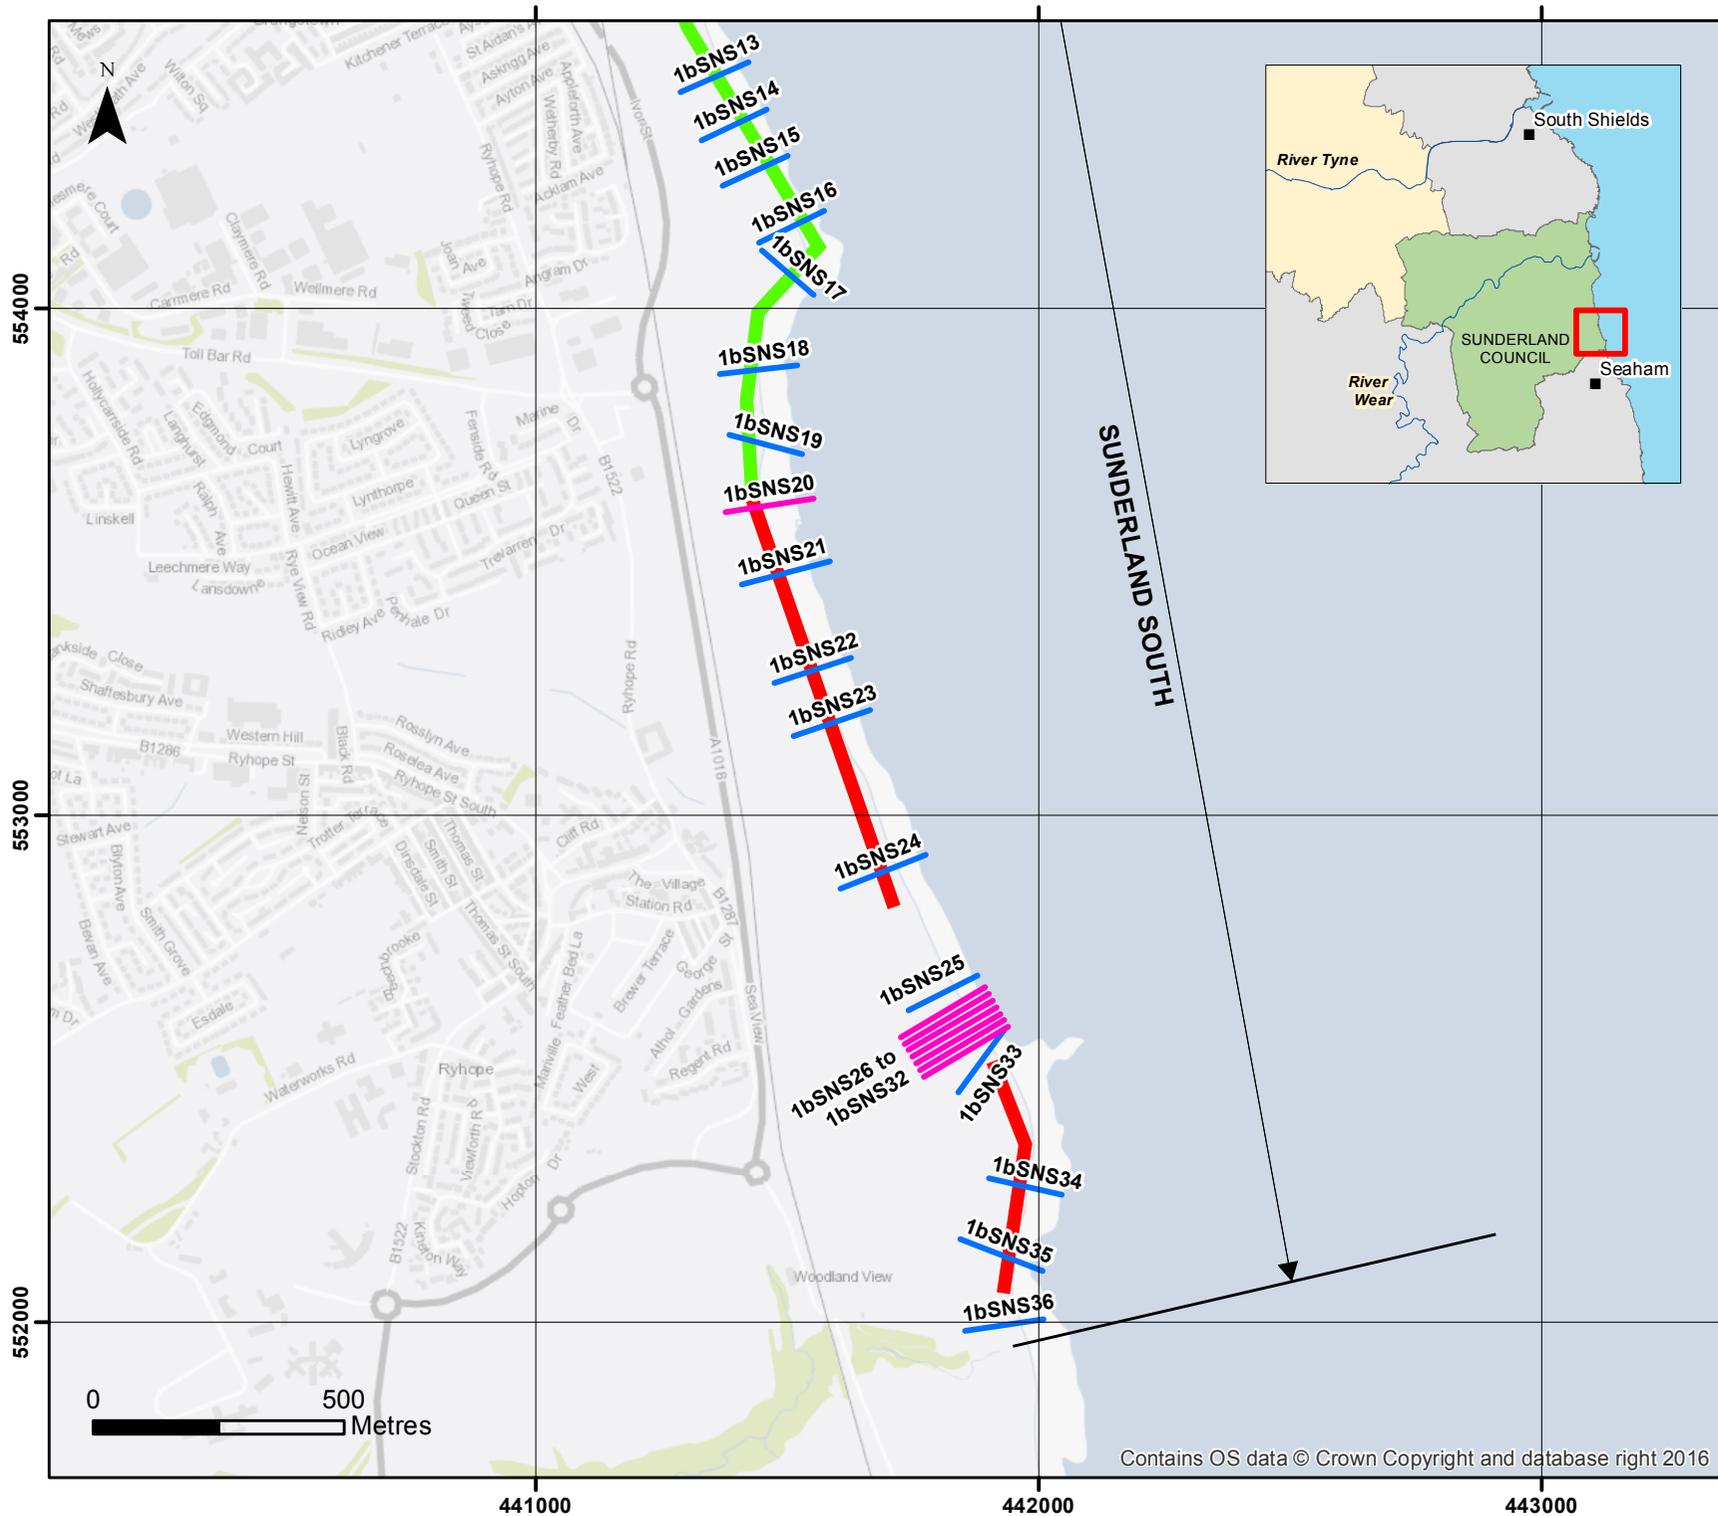
Figure 2 - Map 1

The location of these surveys is shown in Figure 2. The Partial Measures survey was undertaken along this frontage on 7th March 2018 (Whitburn Bay), and between 13th and 17th March 2018 (Hendon to Ryhope, including Halliwell Bank). During this time weather conditions varied, see surveyors reports for details.

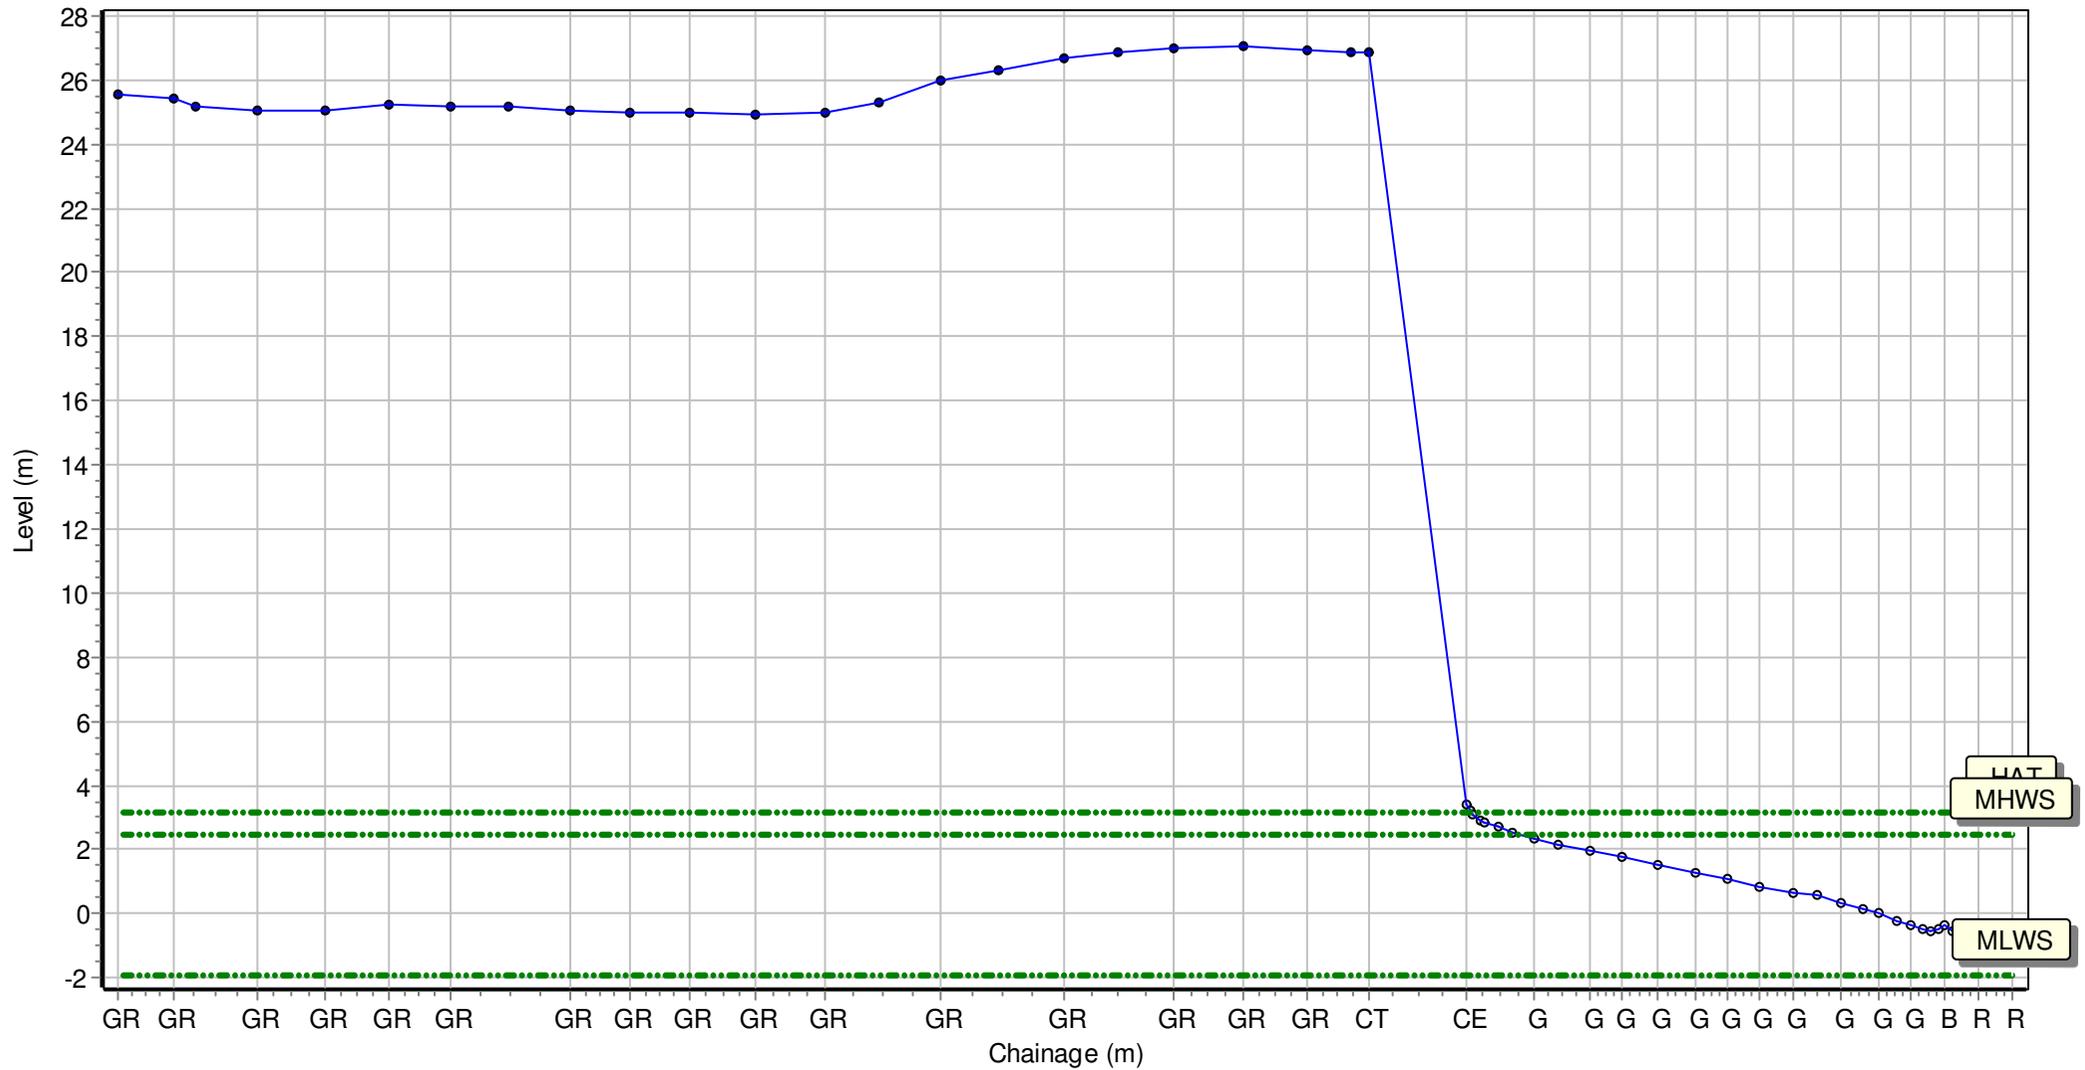
Location: 1bSNS26

Survey Date	Description of Changes Since Last Survey	Interpretation
	<p>At profiles 1bSNS26, there has been apparent recession of the cliff face by c.1.0m, but no change in position of the toe of the cliff. There has been erosion of up to 0.3m from the cliff toe to chainage 103m. Between chainage 103m and 122m there has been accretion of 0.2m. Seawards of chainage 122m there has been erosion of 0.4m exposing rock. Overall the profile is at a medium level in the compared to the range recorded from previous surveys.</p> <p>At 1bSNS27 there has been a small accumulation of material at the foot of the cliff, which is supported by the survey photographs. From chainage 94m to 102m there has been erosion of up to 0.3m. Between chainage 102m to 121m there has been accretion of up to 0.2m. Seawards of chainage 121m the lower beach has dropped by 0.3m exposing rock. Overall the profile is at a low-medium level compared to the range recorded from previous surveys.</p> <p>At 1bSNS28, the toe of the cliff appears to have retreated by c.1m. The beach has behaved in a similar way as at 1bSNS26 and 1bSNS27, with erosion of 0.2m from the cliff to chainage 106m accretion of 0.2m between chainage 106m to 121m, and erosion of up to 0.4m seawards of chainage 121m exposing rock. Overall the profile is at a low-medium level compared to the range recorded from previous surveys.</p> <p>At profiles 1bSNS29, the toe of the cliff appears to have retreated by c.0.5m. Between the cliff and chainage 108m there has been erosion of up to 0.2m. Between chainage 108m and 119m there has been accretion of up to 0.2m. Seawards of chainage 119m there has been erosion of up to 0.4m. Overall the profile is at a low level compared to the range recorded from previous surveys.</p> <p>At 1bSNS30, there has been an accumulation of 0.4m of material at the toe of the cliff. Between chainage 91m and 111m there has been erosion of up to 0.2m. Between chainage 111m and 118m there has been minor accretion of 0.1m. Seawards of chainage 118m there has been erosion of up to 0.4m exposing rock. Overall the profile is at a low-medium level compared to the range recorded from previous surveys.</p> <p>Profile 1bSNS31 shows erosion across the whole beach profile of up to 0.6m. Overall the profile is at a low-medium level compared to the range recorded from previous surveys.</p> <p>At 1bSNS32 the cliff shows apparent recession of 0.5m at the top and 1.5m at the toe. There has been a drop in levels across the whole beach profile of up to 0.4m, exposing rock at the toe of the beach. Overall the profile is at a low- medium level compared to the range recorded from previous surveys.</p>

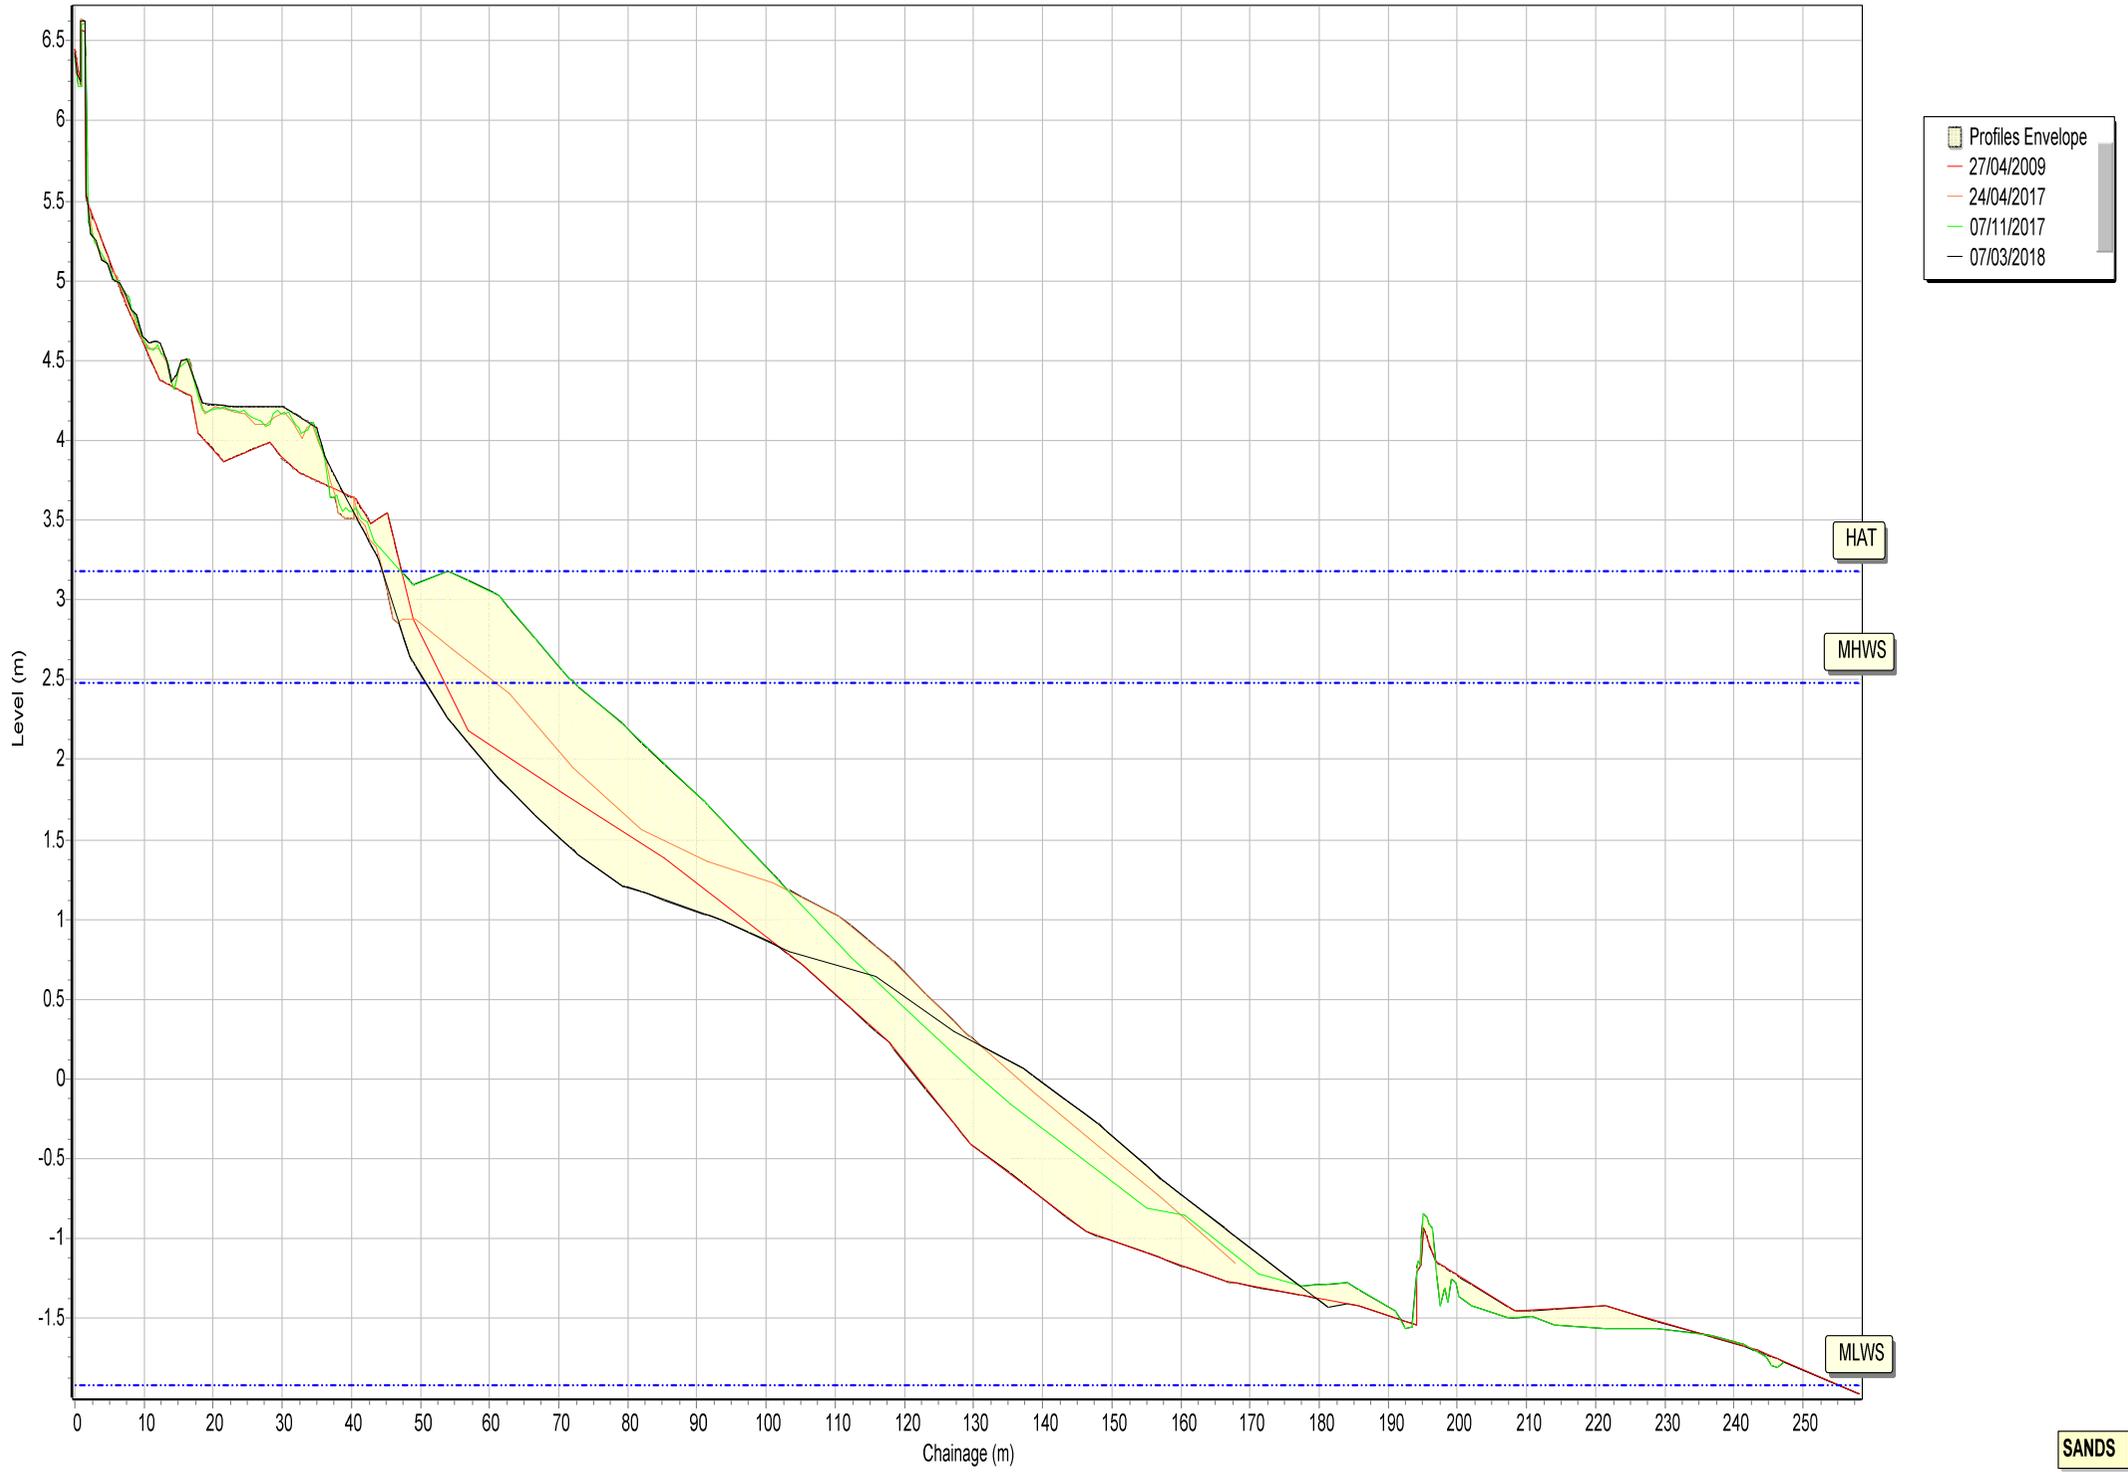
Beach Profiles: 1bSNN1

Survey Date	Description of Changes Since Last Survey	Interpretation
7 th March 2018	<p>Beach Profiles:</p> <p>Whitburn Bay is covered by three beach profile lines for the Partial Measures survey (Appendix A). The last survey was Full Measures, undertaken in November 2017.</p> <p>1bSNN1 is just to the south of Sunderland City Council's northern boundary. Since the last survey the backshore above HAT has changed little. From chainage 45m to 115m the beach shows a drop in levels of up to 1.0m. Seawards of chainage 115m there has been accretion of up to 0.3m. The upper beach is at a relatively low level compared to the range recorded from previous surveys, whilst the lower beach is at a more medium level.</p> <p>1bSNN7 is at Seaburn, north of Parson's Rock. Beach levels in front of the seawall have fallen by up to 0.9m. The rest of the profile shows erosion more typically of 0.3m to 0.6m.. Overall this profile is at a medium-low level compared to the range recorded from previous surveys.</p> <p>1bSNN10 is located mid-way between Parson's Rock and Roker Pier. There has been erosion on the upper beach from the seawall to chainage 80m of up to 0.4m. The middle beach shows very little change. Seawards of chainage 120m there has been accretion on the lower beach of up to 0.6m. The overall effect has been to flatten the profile. The upper beach at the toe of the seawall is the lowest on record from chainage 15m to 30m. From chainage 30m to 120m the beach is at a medium level relative to the range recorded from previous surveys, whilst the lower beach seawards of chainage 120m is relatively high.</p>	<p>Along the length of Whitburn Bay beaches have been dynamic, generally showing reductions in upper beach level, with corresponding increases on the lower beach.</p> <p>Longer term trends: Profiles in Whitburn Bay are within the bounds of previous surveys, with all being at medium to low levels.</p>

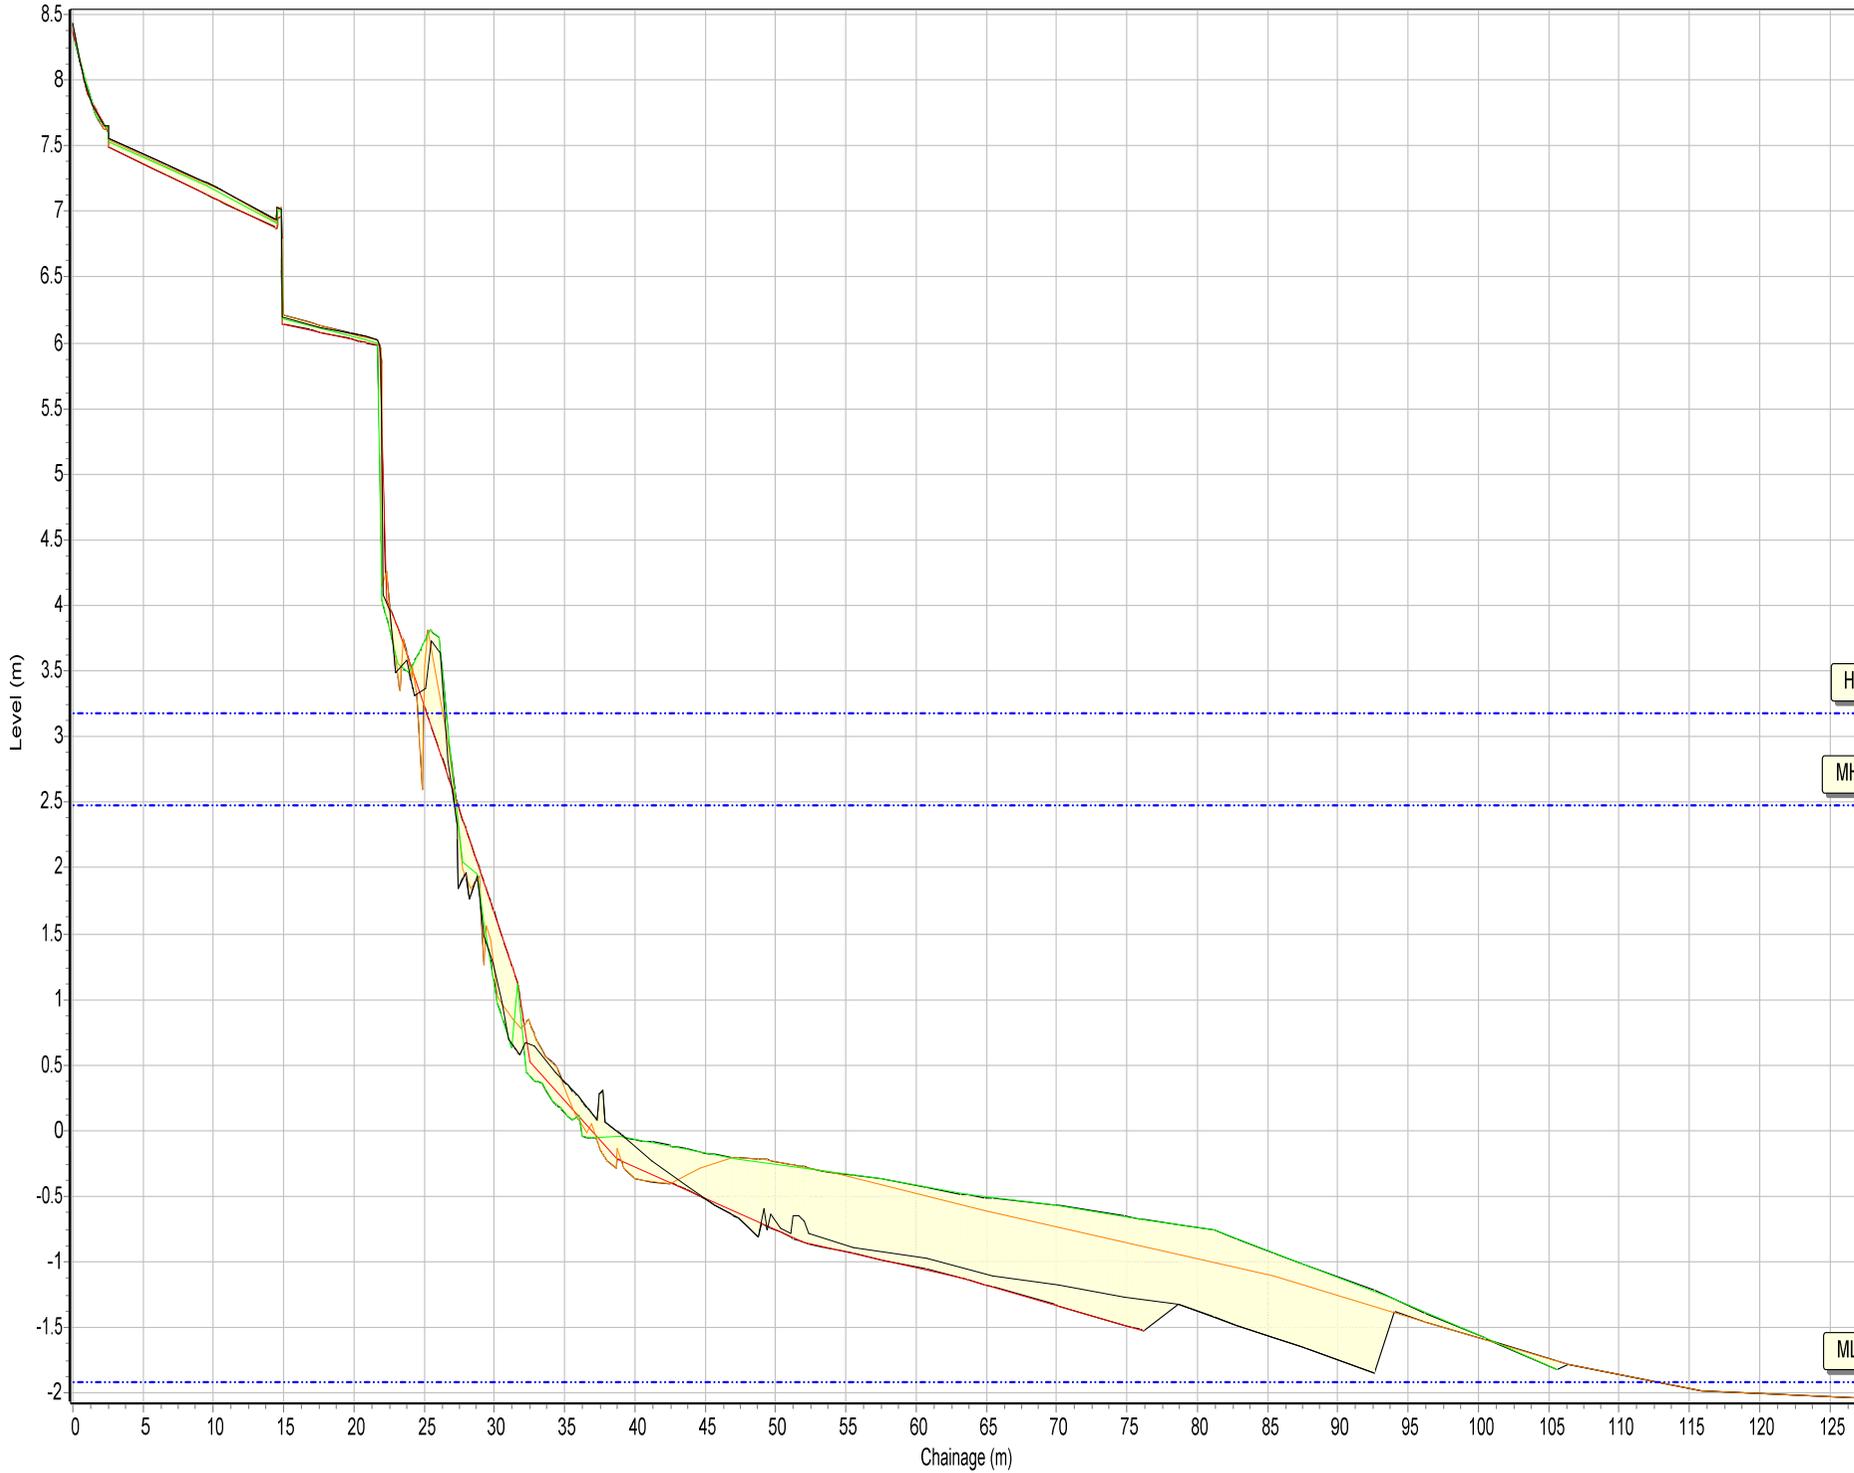
Beach Profiles: 1bSNS8

Survey Date	Description of Changes Since Last Survey	Interpretation
17 th March 2018	<p>Beach Profiles:</p> <p>Hendon to Ryhope is covered by twelve beach profile lines for the Partial Measures survey (Appendix A). The last survey was Full Measures, undertaken in November 2017.</p> <p>Profile 1bSNS8 extends across the seawall, rock revetment, and sandy beach. Beach levels between the toe of the rock revetment and 40m chainage have increased by 0.2m. Seaward of 40m chainage, the elevation of the beach has reduced by 0.6m. The toe of the beach has moved landwards by around 30m. The combined effect has been to steepen the upper beach. The upper beach is at a medium level compared to the range recorded from previous surveys, whilst the mid and lower beach are at a relatively low level.</p> <p>Profile 1bSNS11 starts at the coastal slope backing the sea wall and extends over the rock armour and beach. Beach levels have decreased across the profile by up to 1.4m, exposing more of the rock armour toe. From chainage 65m the rock platform is exposed, where there was sand present on the previous survey in November 2017. Overall the profile is at a relatively low level compared to the range recorded from previous surveys.</p> <p>Profile 1bSNS20 is located at Shirley Banks. The profile shows the cliff toe extending across the beach by around 3m, with upper beach levels increasing by up to 0.6m from the cliff toe at chainage 43m to chainage 55m. The survey photos show there has been slumping at the toe of the cliff. There has been very little change over the rest of the profile, ± 0.1m, with rock exposed along much of the profile length. Overall the profile is at a medium level compared to the range recorded from previous surveys.</p> <p>Profile 1bSNS25 is located at Halliwell Banks. The top of the cliffs, cliff face and cliff toe have not changed since the last survey. There has been erosion of up to 0.4m from the toe of the cliff to chainage 62m. Between chainage 62m and the rock exposure at chainage 85m there has been accretion of up to 0.2m. The upper beach is at a relatively medium level compared to the range recorded from previous surveys.</p> <p>Profiles 1bSNS26 to 1bSNS33 are located on Halliwell Banks to assess erosion of a former land fill site. Cliff tops are between 26m and 27mOD.</p>	<p>At South Hendon (1bSNS8 and 1bSNS11), sand levels have increased in the upper beach but fallen in the lower beach.</p> <p>At Profile 1bSNS20 only minor changes have occurred since the previous survey.</p> <p>At profile 1bSNS25, has experienced a general fall in beach level there has been small amounts of both erosion and accretion since the previous survey.</p> <p>At the landfill site (profiles 1bSSN26 to 1bSSN33) the cliff there has seen some apparent erosion of the cliff toe and a more limited amount at the cliff top. There appears to have been quite a consistent reduction in the elevation of the upper beach and at the toe of the beach, with little change/slight accretion in the middle beach.</p> <p>Longer term trends: In general, the profile change along the Hendon to Ryhope frontage is within the bounds of previous surveys.</p> <p>At the landfill site (profiles 1bSSN25 to 1bSSN33), continue to show recession of the cliff toe and a more limited amount of cliff top change. Overall the beach levels are low-medium compared to past surveys.</p>
