**Cell 1 Regional Coastal Monitoring Programme
Update Report 10: 'Partial Measures' Survey 2018**

(*) The present report is **Update Report 10** and provides an analysis of the 2018 Partial Measures survey for Sunderland City Council's frontage.

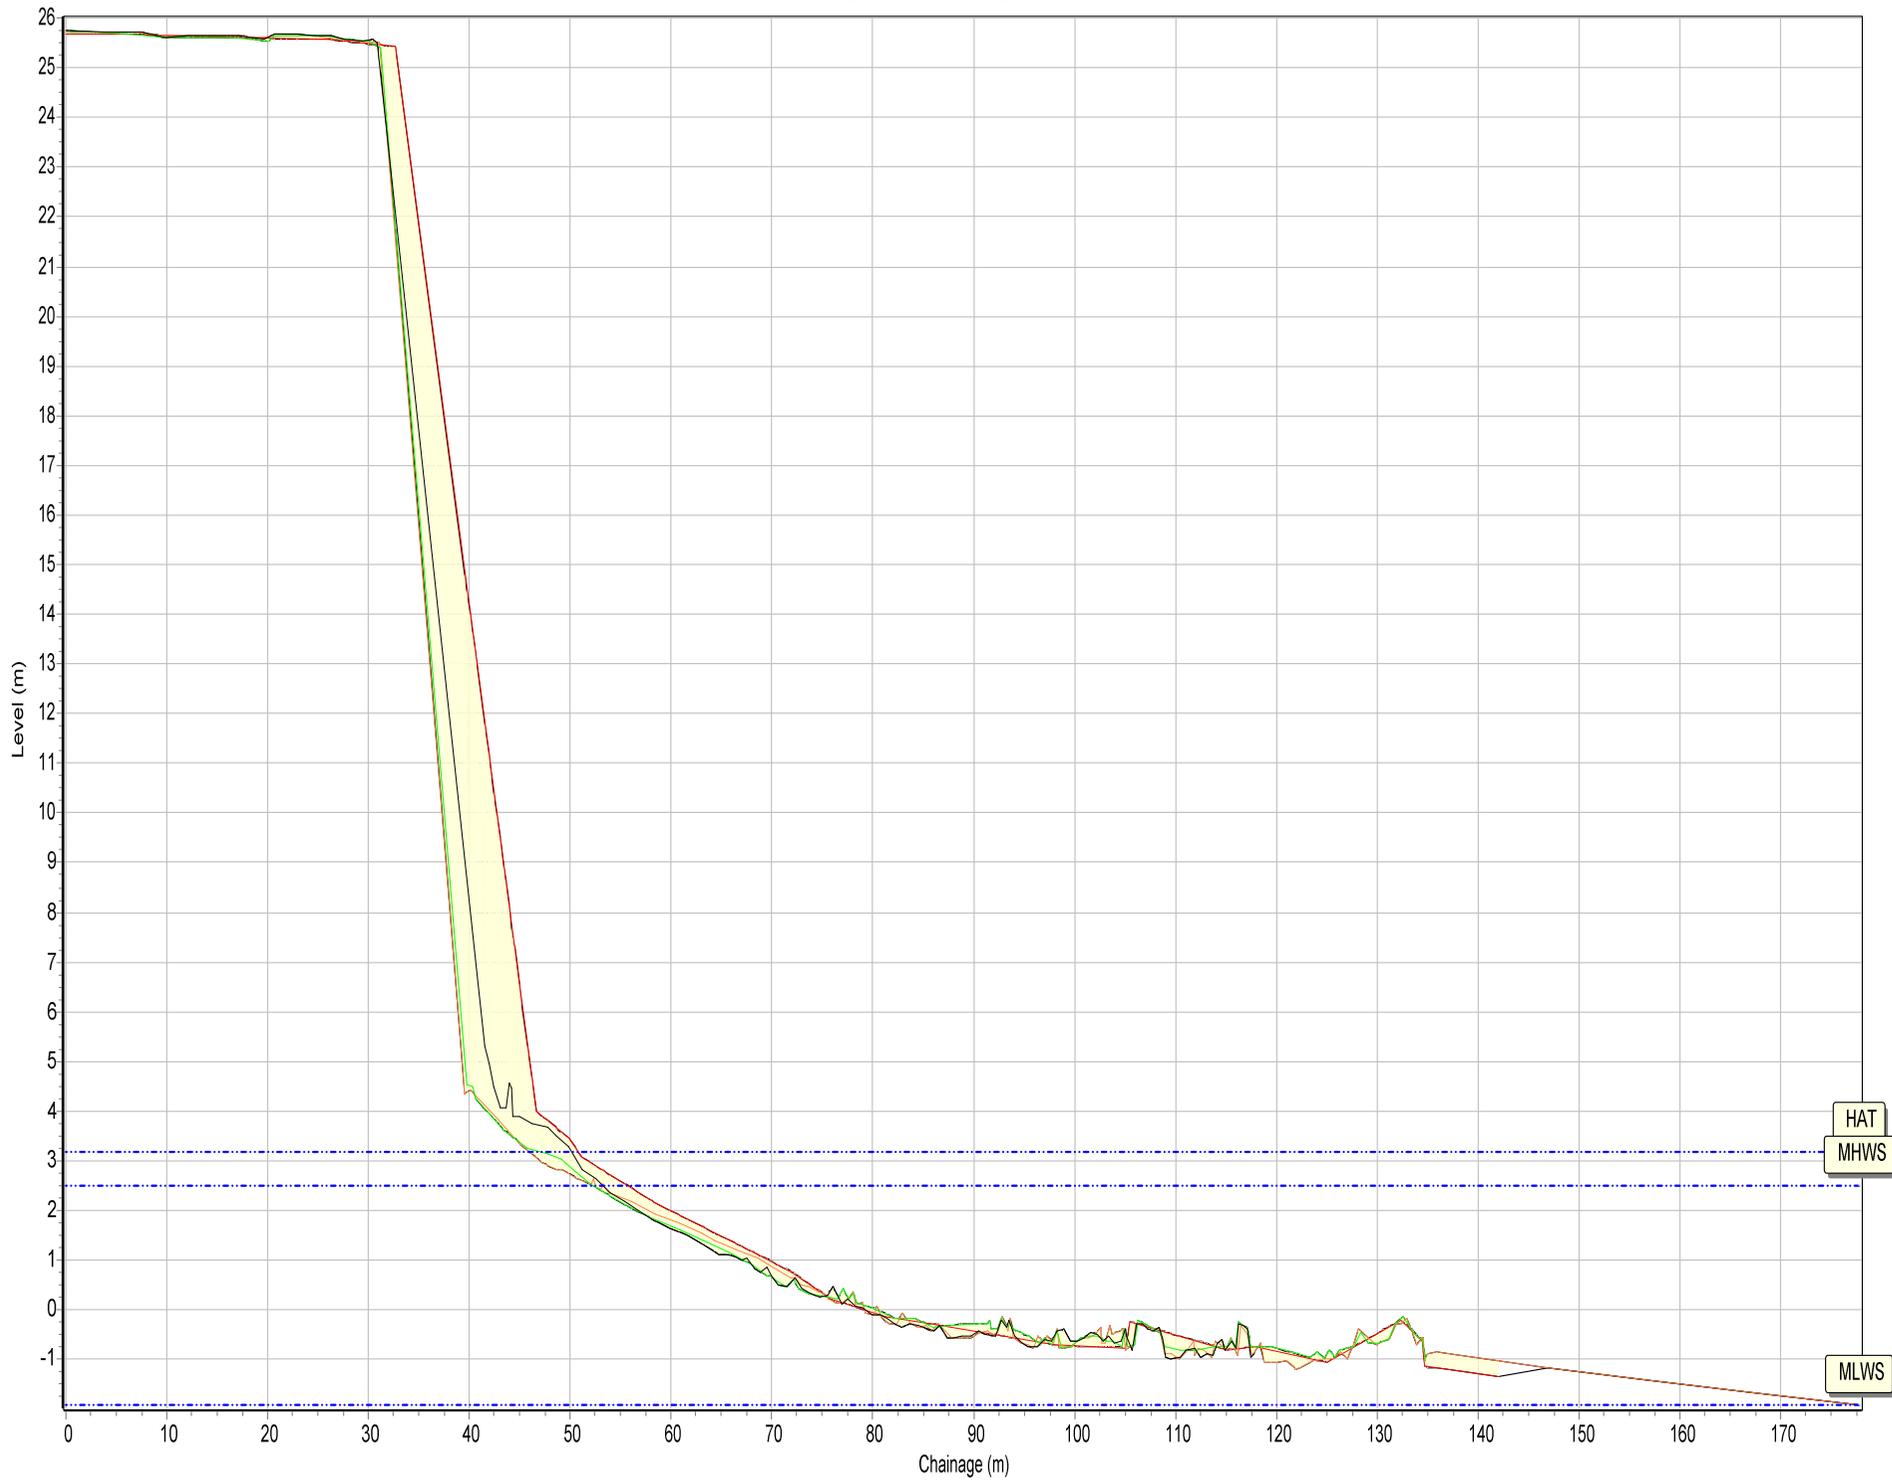
Beach Profiles: 1bSNS20

- Heavy easterly winds resulted in higher tide levels than expected, resulting in cross-sections 1bSNS20 and 1bSNS25 to 1bSNS33 being shorter than anticipated

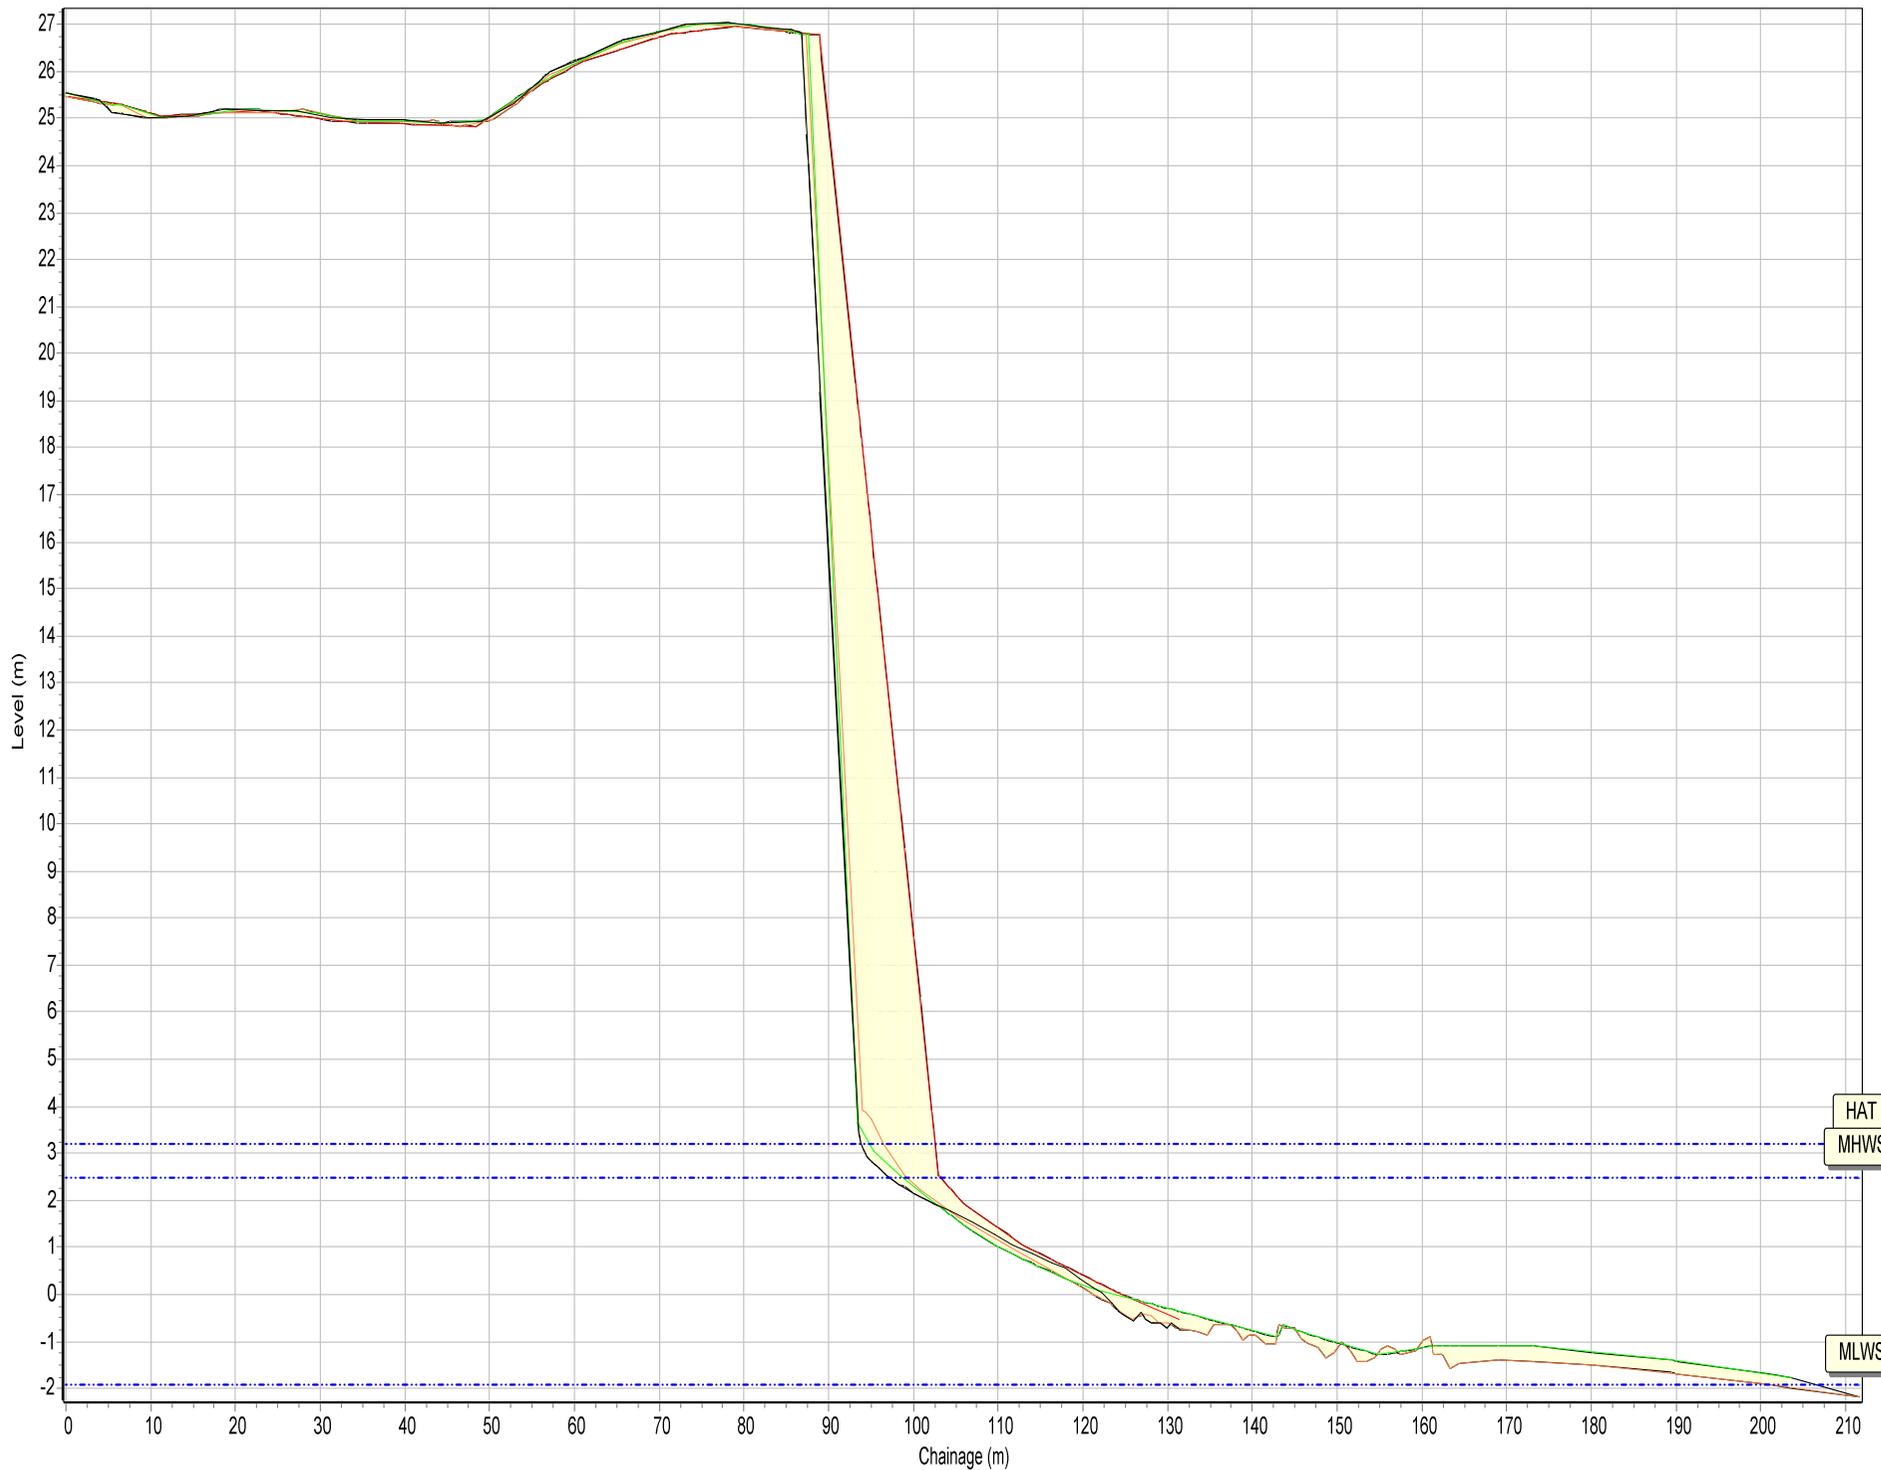
Beach Profiles: 1bSNS26

Survey Date	Description of Changes Since Last Survey	Interpretation
	<p>At profiles 1bSNS26, there has been apparent recession of the cliff face by c.1.0m, but no change in position of the toe of the cliff. There has been erosion of up to 0.3m from the cliff toe to chainage 103m. Between chainage 103m and 122m there has been accretion of 0.2m. Seawards of chainage 122m there has been erosion of 0.4m exposing rock. Overall the profile is at a medium level in the compared to the range recorded from previous surveys.</p> <p>At 1bSNS27 there has been a small accumulation of material at the foot of the cliff, which is supported by the survey photographs. From chainage 94m to 102m there has been erosion of up to 0.3m. Between chainage 102m to 121m there has been accretion of up to 0.2m. Seawards of chainage 121m the lower beach has dropped by 0.3m exposing rock. Overall the profile is at a low-medium level compared to the range recorded from previous surveys.</p> <p>At 1bSNS28, the toe of the cliff appears to have retreated by c.1m. The beach has behaved in a similar way as at 1bSNS26 and 1bSNS27, with erosion of 0.2m from the cliff to chainage 106m accretion of 0.2m between chainage 106m to 121m, and erosion of up to 0.4m seawards of chainage 121m exposing rock. Overall the profile is at a low-medium level compared to the range recorded from previous surveys.</p> <p>At profiles 1bSNS29, the toe of the cliff appears to have retreated by c.0.5m. Between the cliff and chainage 108m there has been erosion of up to 0.2m. Between chainage 108m and 119m there has been accretion of up to 0.2m. Seawards of chainage 119m there has been erosion of up to 0.4m. Overall the profile is at a low level compared to the range recorded from previous surveys.</p> <p>At 1bSNS30, there has been an accumulation of 0.4m of material at the toe of the cliff. Between chainage 91m and 111m there has been erosion of up to 0.2m. Between chainage 111m and 118m there has been minor accretion of 0.1m. Seawards of chainage 118m there has been erosion of up to 0.4m exposing rock. Overall the profile is at a low-medium level compared to the range recorded from previous surveys.</p> <p>Profile 1bSNS31 shows erosion across the whole beach profile of up to 0.6m. Overall the profile is at a low-medium level compared to the range recorded from previous surveys.</p> <p>At 1bSNS32 the cliff shows apparent recession of 0.5m at the top and 1.5m at the toe. There has been a drop in levels across the whole beach profile of up to 0.4m, exposing rock at the toe of the beach. Overall the profile is at a low- medium level compared to the range recorded from previous surveys.</p>
