**Cell 1 Regional Coastal Monitoring Programme
Update Report 11: 'Partial Measures' Survey 2019**

(*) The present report is **Update Report 11** and provides an analysis of the 2019 Partial Measures survey for Sunderland City Council's frontage.

Sunderland Council Frontage

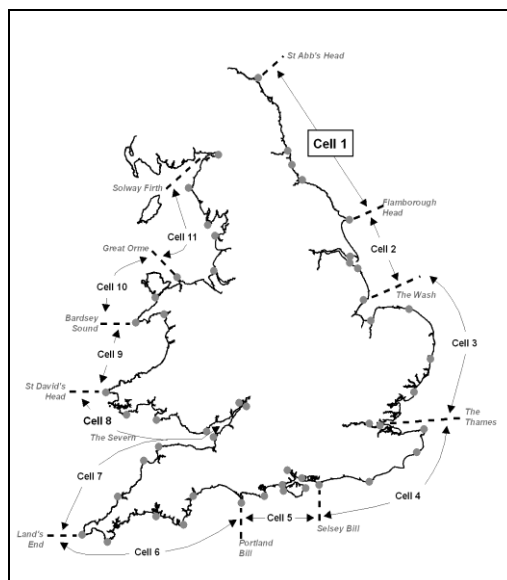
Figure 1 Sediment Cells in England and Wales

The Cell 1 Regional Coastal Monitoring Programme covers approximately 300km of the north east coastline, from the Scottish Border (just south of St. Abb's Head) to Flamborough Head in East Yorkshire. This coastline is often referred to as 'Coastal Sediment Cell 1' in England and Wales (Figure 1).

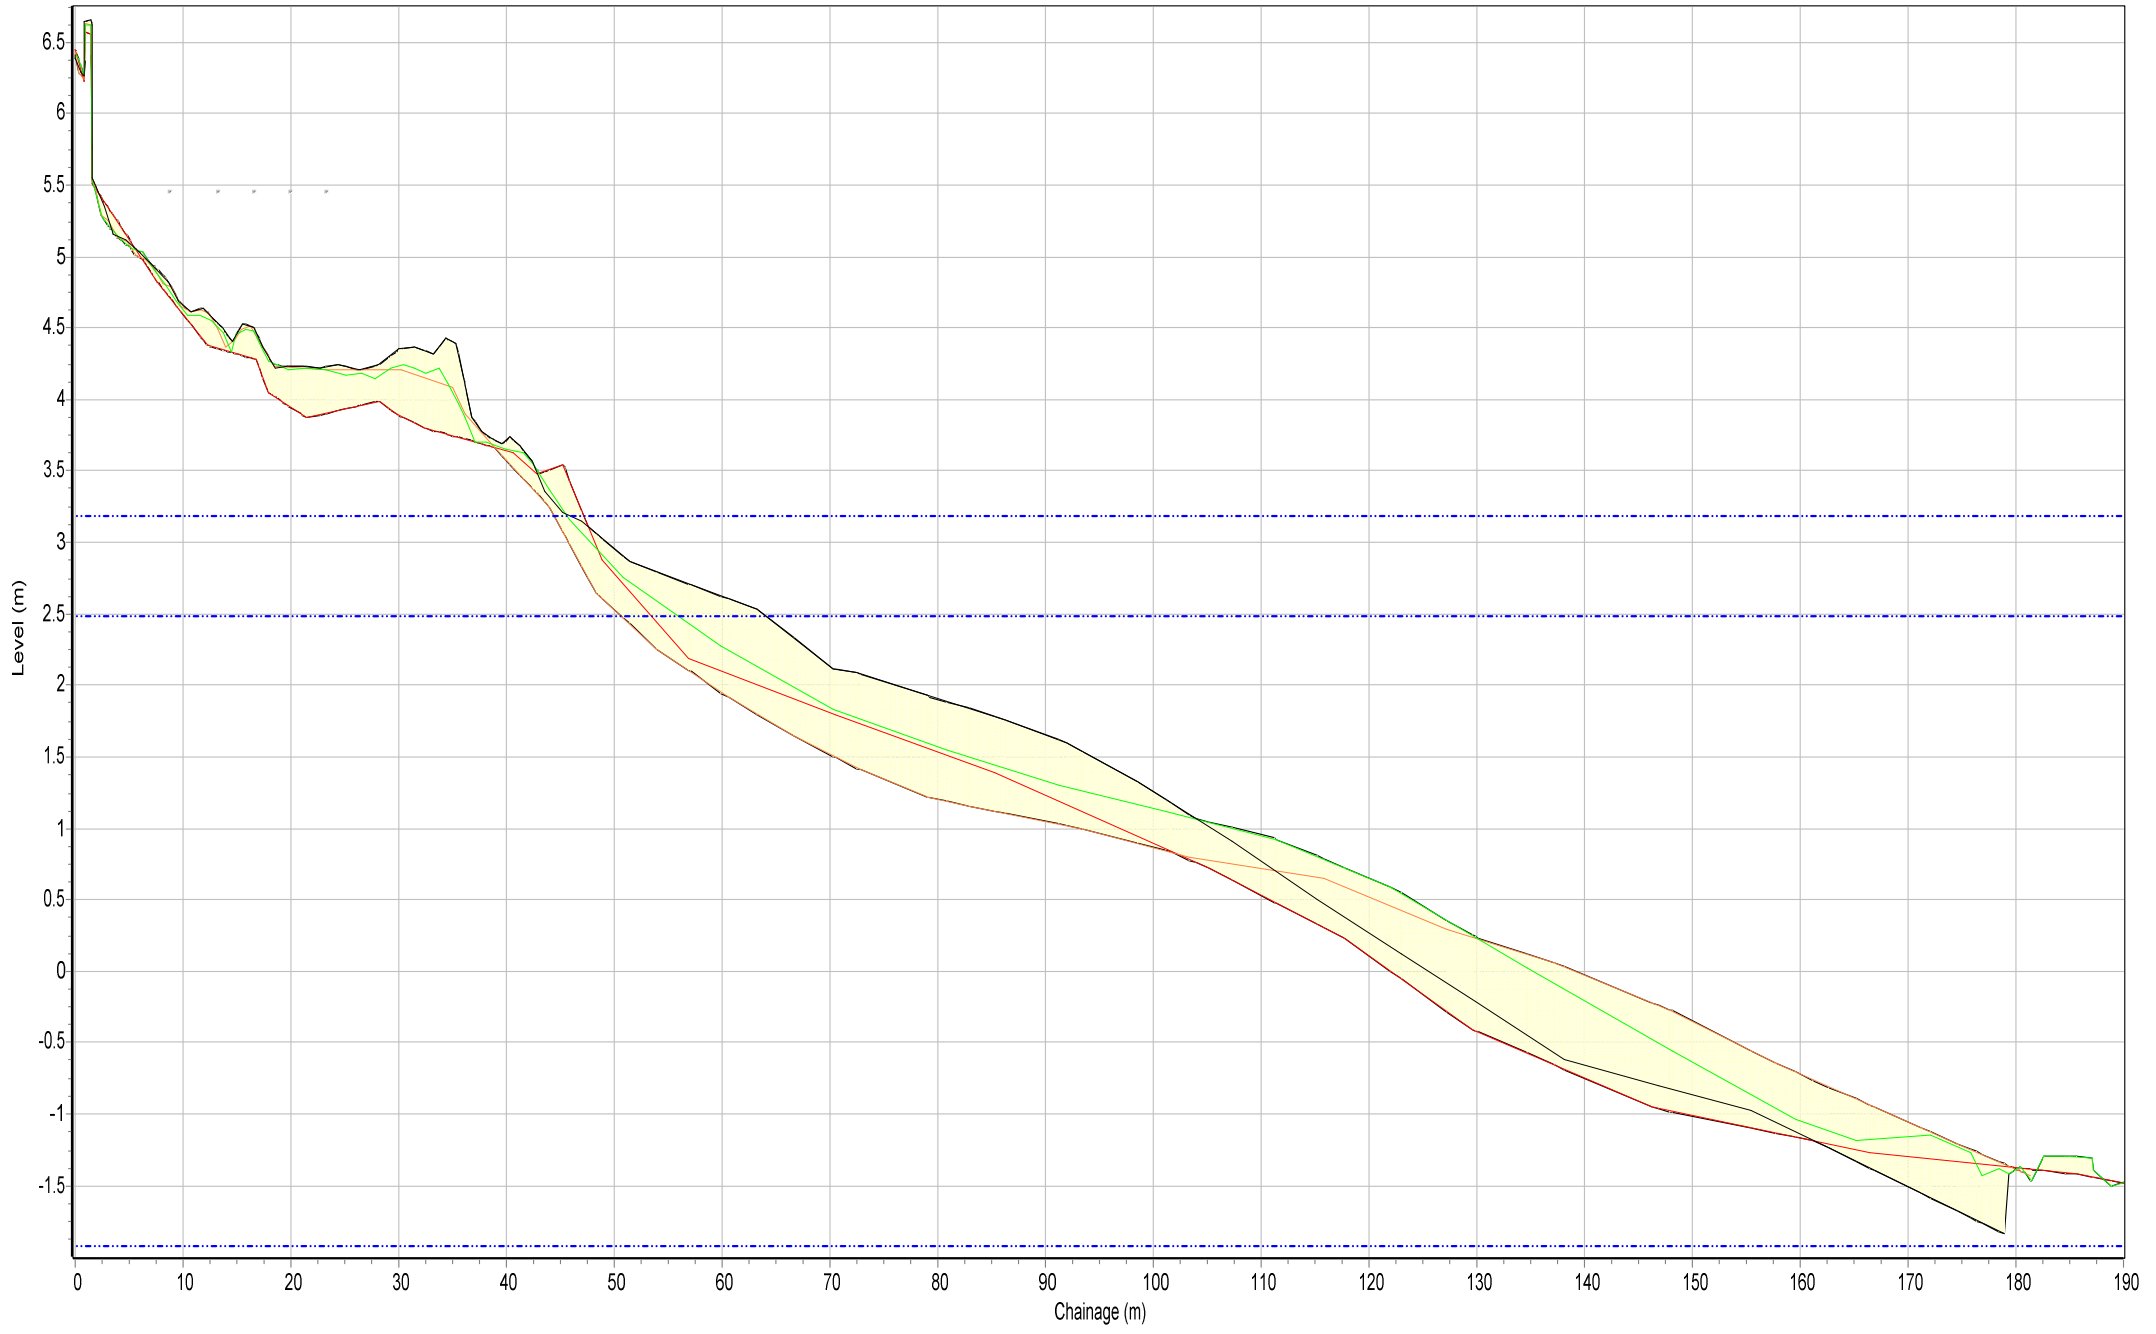
Beach Profiles: 1bSNN1

Survey Date	Description of Changes Since Last Survey	Interpretation
<p>18th February 2019</p>	<p>Beach Profiles:</p> <p>Whitburn Bay is covered by three beach profile lines for the Partial Measures survey (Appendix A). The last survey was Full Measures, undertaken in November 2018.</p> <p>1bSNN1 is just to the south of Sunderland City Council's northern boundary. Since the last survey the backshore above HAT has changed little, with small sections of accretion of up to 0.1m. From chainage 45m to 104m the beach shows an increase in levels of up to 0.3m. Seawards of chainage 115m there has been erosion of up to 0.45m. The upper beach is at a relatively high level on the upper beach compared to the range recorded from previous surveys, particularly between chainages 19m and 41m which is at its highest level recorded. The lower beach is at a more medium level, however the beach toe is recorded at its most landward position since records began,</p> <p>1bSNN7 is at Seaburn, north of Parson's Rock. Beach levels in front of the seawall have risen by up to 0.3m. The profile from chainage 29m to 85m shows little change, with a small of accretion of up to 0.05m. Seaward of chainage 85m there is an accretion of the lower beach by up to 0.4m and a seaward extension of the beach toe by 36m. Overall this profile is at a medium-low level on the upper and middle beach compared to the range recorded from previous surveys, whilst the lower beach is at a high level.</p> <p>1bSNN10 is located mid-way between Parson's Rock and Roker Pier. There has been accretion on the upper beach from the seawall to chainage 29m of up to 0.3m. Between chainages 29m and 118m there has been erosion of up to 0.4m, switching to accretion at the toe of the beach of up to 0.3m. The upper beach to chainage 50m is at a medium level, however the rest of the beach is at a low level compared to the range recorded from previous surveys, particularly between chainages 52m to 72m which is at its lowest level on record.</p>	<p>Along the length of Whitburn Bay beaches have been dynamic, generally showing the greatest accretion on the central profile (1bSNN7) and upper beach of the northern profile (1bSNN1), with erosion dominating the southern (1bSNN10) profile.</p> <p>Longer term trends: Profiles in Whitburn Bay are generally within the bounds of previous surveys, however small sections are now at their highest (19-41m chainage at profile 1bSNN1) and lowest levels (52-72m chainage at profile 1bSNN10) recorded.</p>

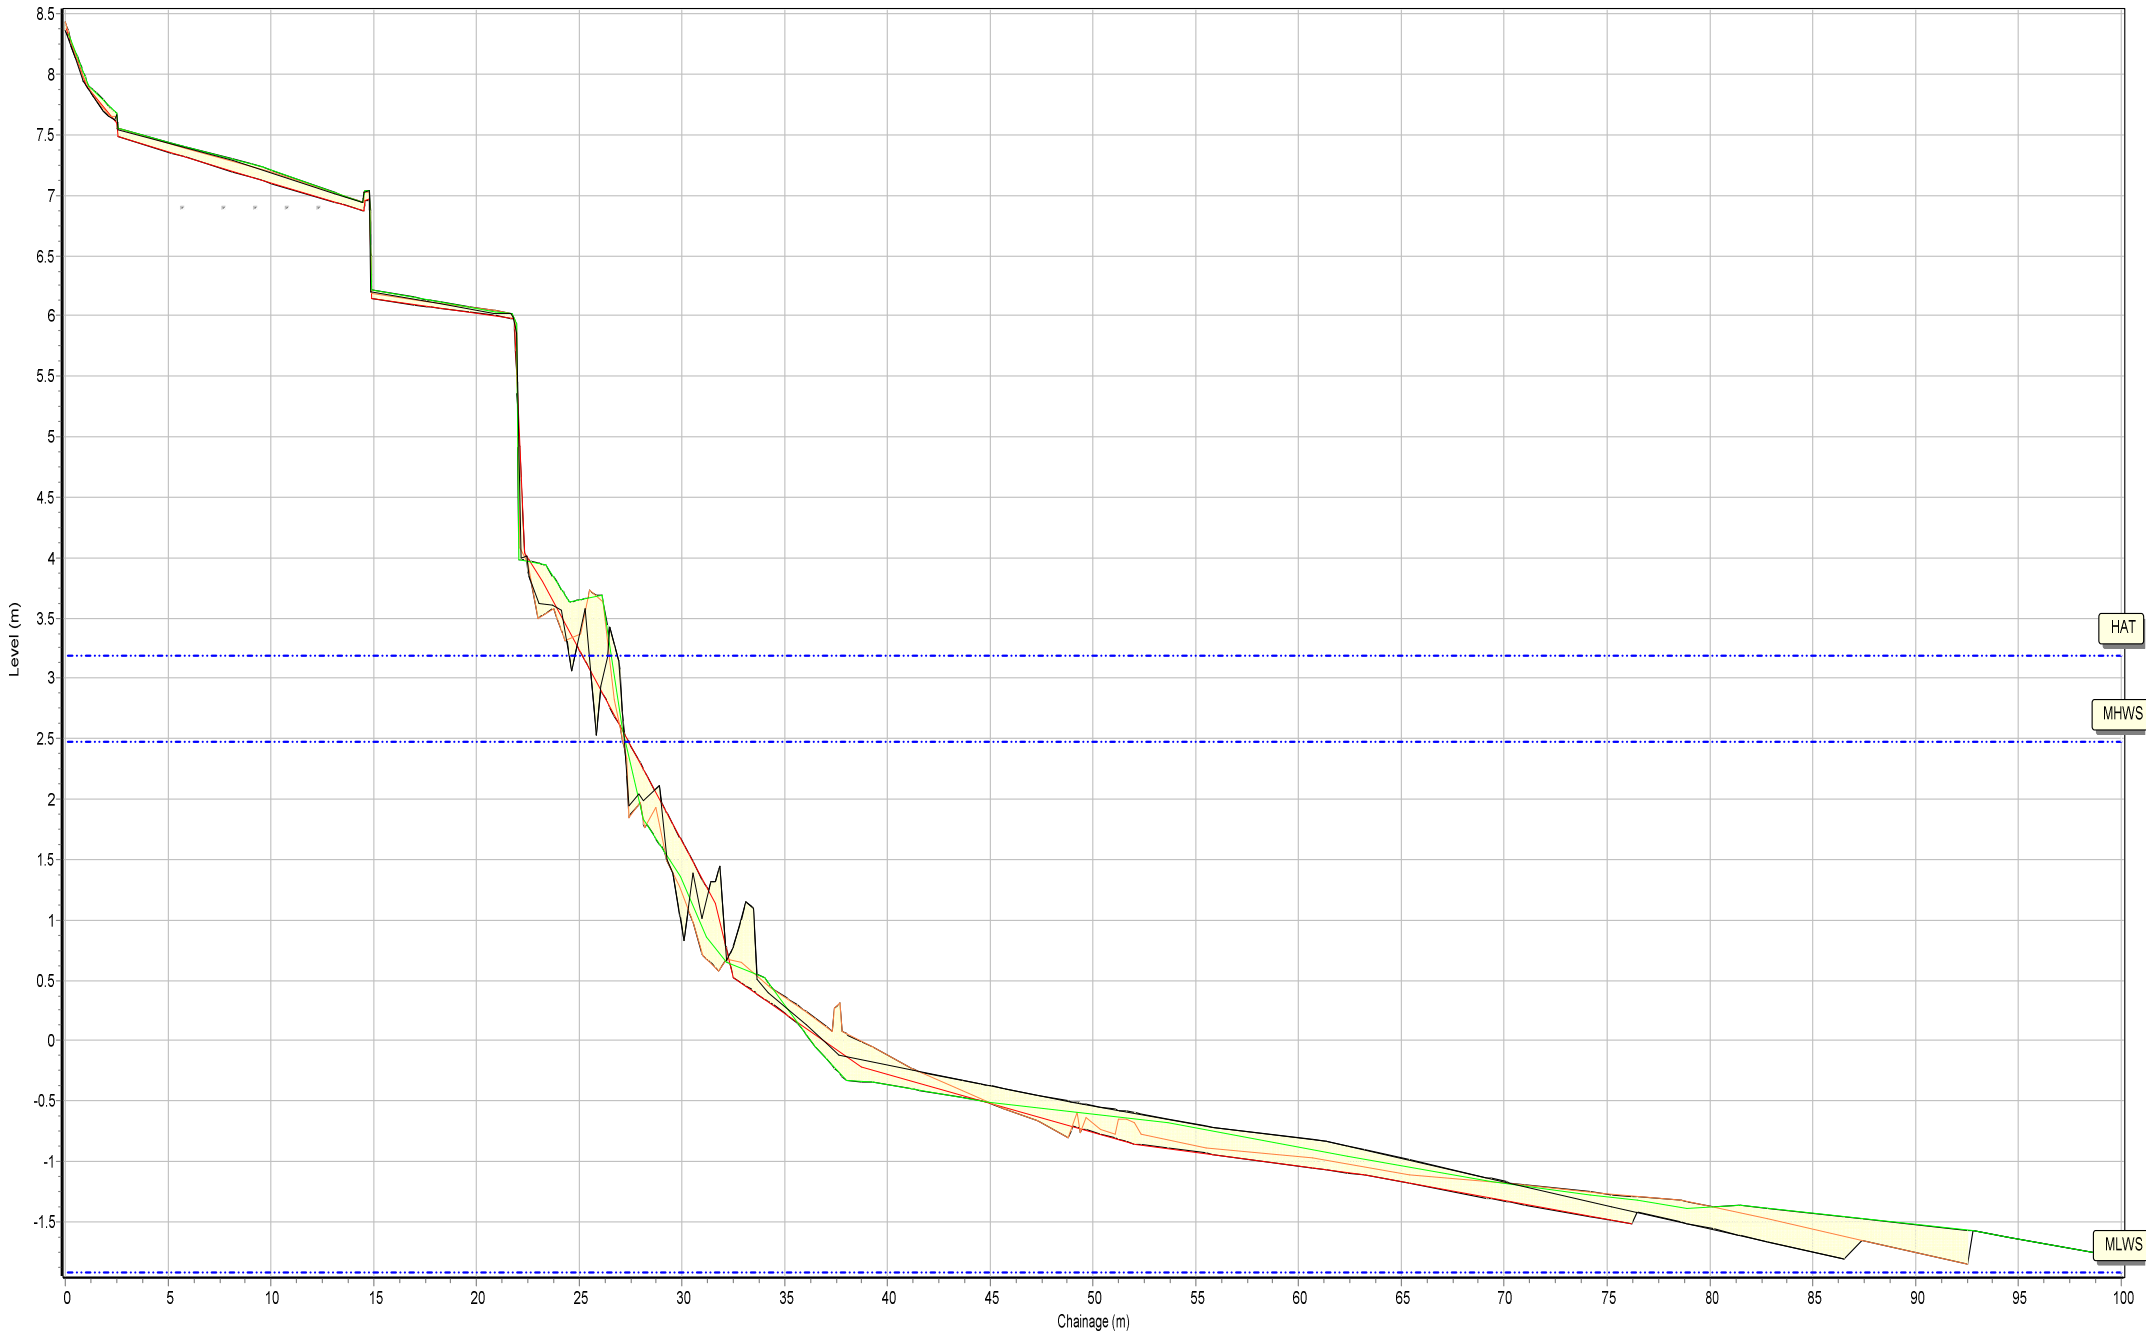
Beach Profiles: 1bSNS8

Survey Date	Description of Changes Since Last Survey	Interpretation
5 th -6 th March 2019	<p>Beach Profiles:</p> <p>Hendon to Ryhope is covered by twelve beach profile lines for the Partial Measures survey (Appendix A). The last survey was Full Measures, undertaken in November 2018.</p> <p>Profile 1bSNS8 extends across the seawall, rock revetment, and sandy beach. Beach levels between the toe of the rock revetment and 74m chainage have changed very little, with accretion/erosion limited to 0.15m. Seaward of 74m chainage, the elevation of the beach has reduced by 0.3m. The toe of the beach has moved landwards by around 12m. The combined effect has been to steepen the beach profile. The beach profile is at a medium low level compared to the range recorded from previous surveys. Profile 1bSNS11 starts at the coastal slope backing the sea wall and extends over the rock armour and beach. Beach levels have increased across the profile by up to 1.2m, covering up the rock armour toe which was previously exposed. Overall the profile is at a high level compared to the range recorded from previous surveys, with the section between the toe of the seawall and chainage 92m at its highest level recorded</p> <p>Profile 1bSNS20 is located at Shirley Banks. The profile shows the cliff toe receding landward by around 3m, with upper beach levels decreasing by up to 0.2m from the cliff toe at chainage 42m to chainage 69m. The survey photos show there has been slumping at the toe of the cliff. There has been very little change over the rest of the profile, ± 0.1m, with rock exposed along much of the profile length. Overall the profile is at a medium low level compared to the range recorded from previous surveys.</p> <p>Profile 1bSNS25 is located at Halliwell Banks. The top of the cliffs, cliff face and cliff toe have not changed since the last survey. There has been accretion of up to 0.2m from the toe of the cliff to the rock exposure at chainage 86m. The upper beach is at a relatively medium level compared to the range recorded from previous surveys.</p> <p>Profiles 1bSNS26 to 1bSNS33 are located on Halliwell Banks to assess erosion of a former land fill site. Cliff tops are between 26m and 27mOD.</p> <p>At profiles 1bSNS26, there has been apparent recession of the cliff toe by c.1.0m. Between the cliff toe and chainage 126m there has been very little change in the beach profile, with erosion / accretion of up to 0.1m. Overall the profile is at a relatively low level compared to the range recorded from previous</p>	<p>At South Hendon (1bSNS8 and 1bSNS11), there has been erosion of the lower beach in the northernmost profile (1bSNS8), with an increase in beach level across profile 1bSNS11 to the south. At profile 1bSNS20 only minor changes have occurred since the previous survey.</p> <p>Profile 1bSNS25 has experienced an increase in beach since the previous survey.</p> <p>At the landfill site (profiles 1bSSN26 to 1bSSN33) the cliff there has seen some apparent erosion of the cliff toe. Generally, the profiles are dominated by erosion of between 0.1-0.4m, with some low levels of accretion of up to 0.1m.</p> <p>Longer term trends: In general, the profile change along the Hendon to Ryhope frontage is within the bounds of previous surveys.</p> <p>At the landfill site, profiles 1bSSN25 to 1bSSN33 continue to show recession of the cliff toe, with some profiles showing accumulation of sediment slumped from the cliff face. Overall the beach levels are low-medium compared to past surveys.</p>

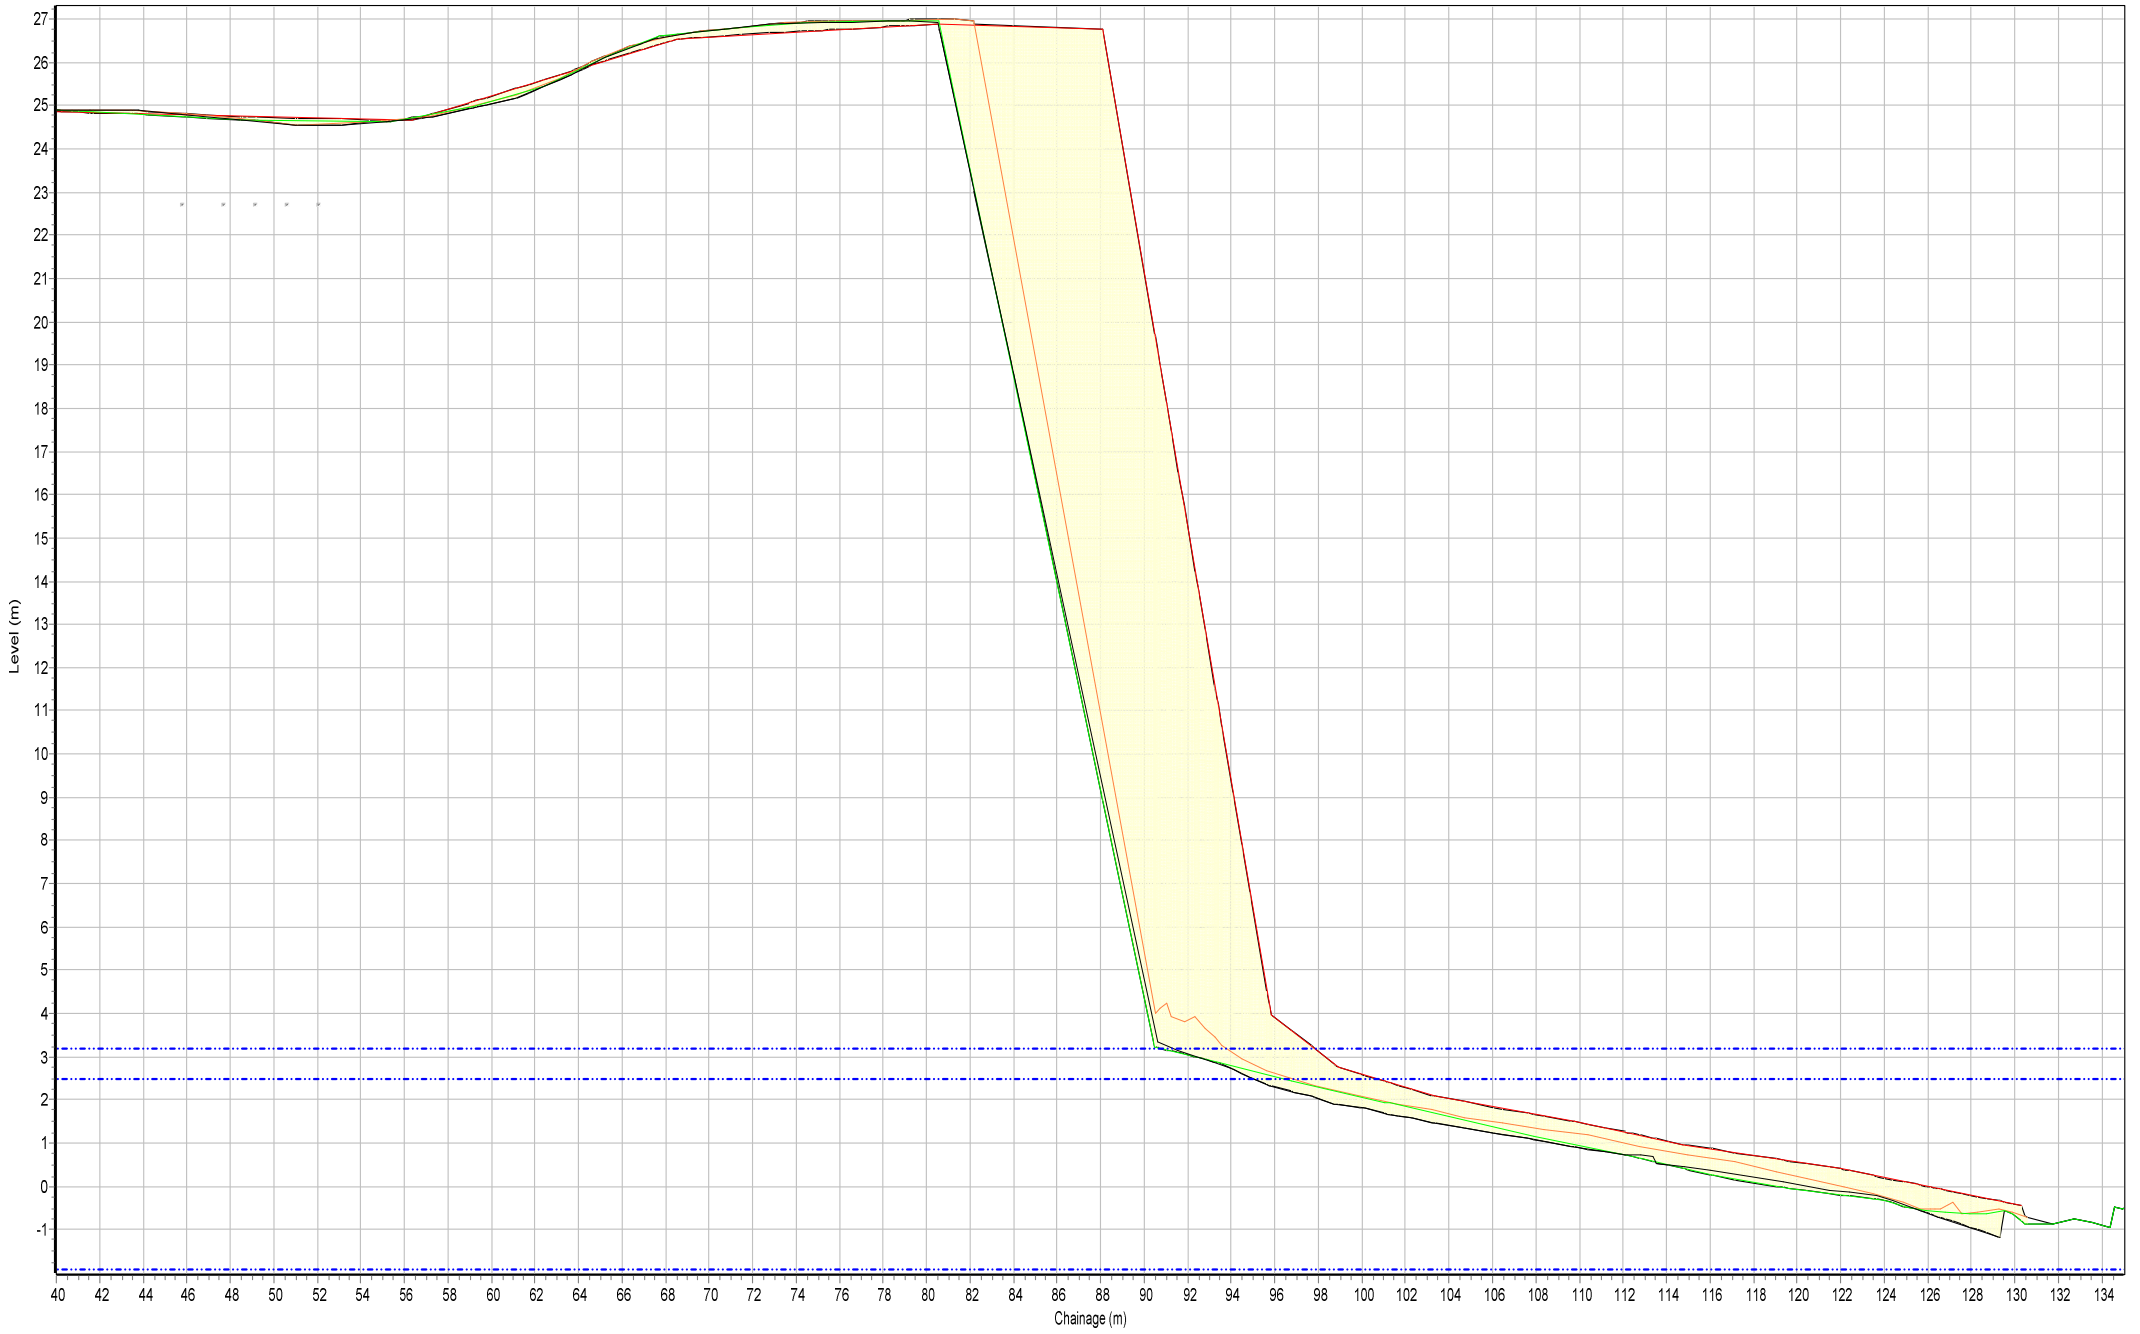
Beach Profiles: 1bSNS27

Survey Date	Description of Changes Since Last Survey	Interpretation
	<p>surveys.</p> <p>At 1bSNS27 there has been no change in the position of the top of the cliff, cliff face or cliff toe since the last survey. From chainage 90m to 112m there has been erosion of up to 0.3m. Between chainage 112m to 125m there has been accretion of up to 0.1m. Seawards of chainage 125m the lower beach has dropped by 0.5m. Overall the profile is at a low-medium level compared to the range recorded from previous surveys, particularly between chainages 94m to 104m which is at its lowest level and the beach toe is at its most landward position since records began.</p> <p>At 1bSSN28, the toe of the cliff appears to have retreated by c.0.5m. There has been very little change across the beach profile, with erosion limited to 0.2m on the upper beach and accretion limited to 0.1m on the lower beach. Sediment has been removed (0.2m) infilling exposed rocks seaward of chainage 120m. Overall the profile is at a low-medium level compared to the range recorded from previous surveys.</p> <p>At profiles 1bSNS29, the toe of the cliff appears to have retreated by c.1.0m. Between the cliff toe and chainage 92m there has been accretion of up to 0.4m. Between chainage 92m and 119m there has been erosion of up to 0.4m. Overall the profile is at a low level compared to the range recorded from previous surveys, particularly between chainages 92m and 110m which is at its lowest level recorded.</p> <p>At 1bSNS30, there has been an accumulation of 0.6m of material at the toe of the cliff. Between chainage 98m and 127m there has been erosion of up to 0.2m, exposing rocks at chainage 123m. Overall the profile is at a low-medium level compared to the range recorded from previous surveys.</p> <p>Profile 1bSNS31 shows an apparent erosion of the cliff face and toe by c.3.5m. The rest of the beach profile shows erosion of up to 0.3m, exposing rocks at chainage 130m. Overall the profile is at a low-medium level compared to the range recorded from previous surveys.</p> <p>At 1BSNS32 the cliff shows apparent recession of 0.5m at the toe. There has been a drop in levels across the whole beach profile, ranging from 0.4m on the upper beach to less than 0.1m on the middle and lower beach. The rocks are still exposed seaward of chainage 124m. Overall the profile is at a low-medium level compared to the range recorded from previous surveys.</p> <p>At 1bSNS33, the cliff shows apparent recession of the cliff toe of 1.5m. There is limited accretion of up to 0.1m across the rest of the beach profile. Overall the profile is at a low-medium level compared to the</p>

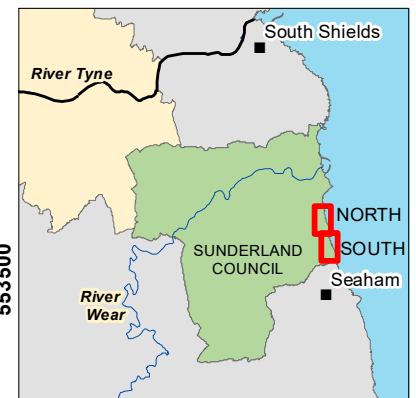
Figure 3 - Map 1
HENDON TO RYHOPE SOUTH
Sunderland City Council
Council Frontage
 Cliff Top Survey Locations

Survey Date	Description of Changes Since Last Survey	Interpretation
	range recorded from previous surveys.	
6 th March 2019	<p>Cliff-top Survey:</p> <p>32 ground control points (numbered 1-32) were established along the cliff top between Hendon and Ryhope in March 2009, with a further three (28A, 28B and 28C) added in September 2009 (Figure 3). Note: the numbering of ground control points is not intended to correlate with that of the beach profile lines.</p> <p>Measurements are taken from each ground control point along a fixed bearing to the edge of the cliff top. These cliff top surveys are undertaken bi-annually and are intended to inform on erosion rates of the sea cliffs extending from the defended industrial areas at Hendon southwards along the undefended cliffs to Ryhope Dene.</p> <p>The results from the cliff top monitoring are anticipated to have an accuracy of $\pm 0.2\text{m}$ due to the technique used. These cliff top surveys are undertaken bi-annually and are intended to inform on erosion rates of the sea cliffs extending from the defended industrial areas at Hendon southwards along the undefended cliffs to Ryhope Dene. Appendix B – Table B1 provides results from the March 2009 cliff top survey, showing the position from the ground control point to the edge of the cliff top along a defined bearing. Also shown is the change in measurement since the original (March 2009) and previous (November 2018) cliff top surveys.</p> <p>Results show that since the last survey, six locations have shown erosion greater than the anticipated survey error; Point 5 by 0.23m, Point 11 by 0.27m, Point 27 by 0.59m, Point 28B by 0.27m, Point 31 by 0.89m and Point 32 by 0.32m.</p> <p>Since surveys began in March 2009 (or September 2009 for 28A, 28B, and 28C) erosion greater than the survey error has occurred at around 80% of the ground control points, where total losses are 11.53m (at location 27) at their greatest, and more typically less than 5m. The long-term erosion rates are up to 1.15m/yr (location 27), with up to 0.5m/yr being more typical.</p>	<p>Since the last survey, the cliffs at Points 5, 11, 27, 28B, 31 and 32 have eroded, with very little change elsewhere. Point 31 shows the greatest amount of erosion of 0.89m.</p> <p>Longer term trends: Since 2009, the majority of the points south of the sea defences have eroded. The greatest erosion has occurred at points 10, 21, 25, 27, 31 and 32 where between 7.03m and 11.53m have been lost.</p>

Thirty-two ground control points have been established between Hendon and Ryhope. The maximum separation between any two points varies along the coast, reflecting the degree of risk from the erosion.

The cliff top surveys between Hendon and Ryhope are undertaken bi-annually. Measurements are taken from a fixed ground control point along a fixed bearing to the edge of the cliff top.
