**Cell 1 Regional Coastal Monitoring Programme  
Update Report 15: 'Partial Measures' Survey 2023**

**Sunderland City Council  
May 2023**

(\*) The present report is **Update Report 15** and provides an analysis of the 2023 Partial Measures survey for Sunderland City Council's frontage.

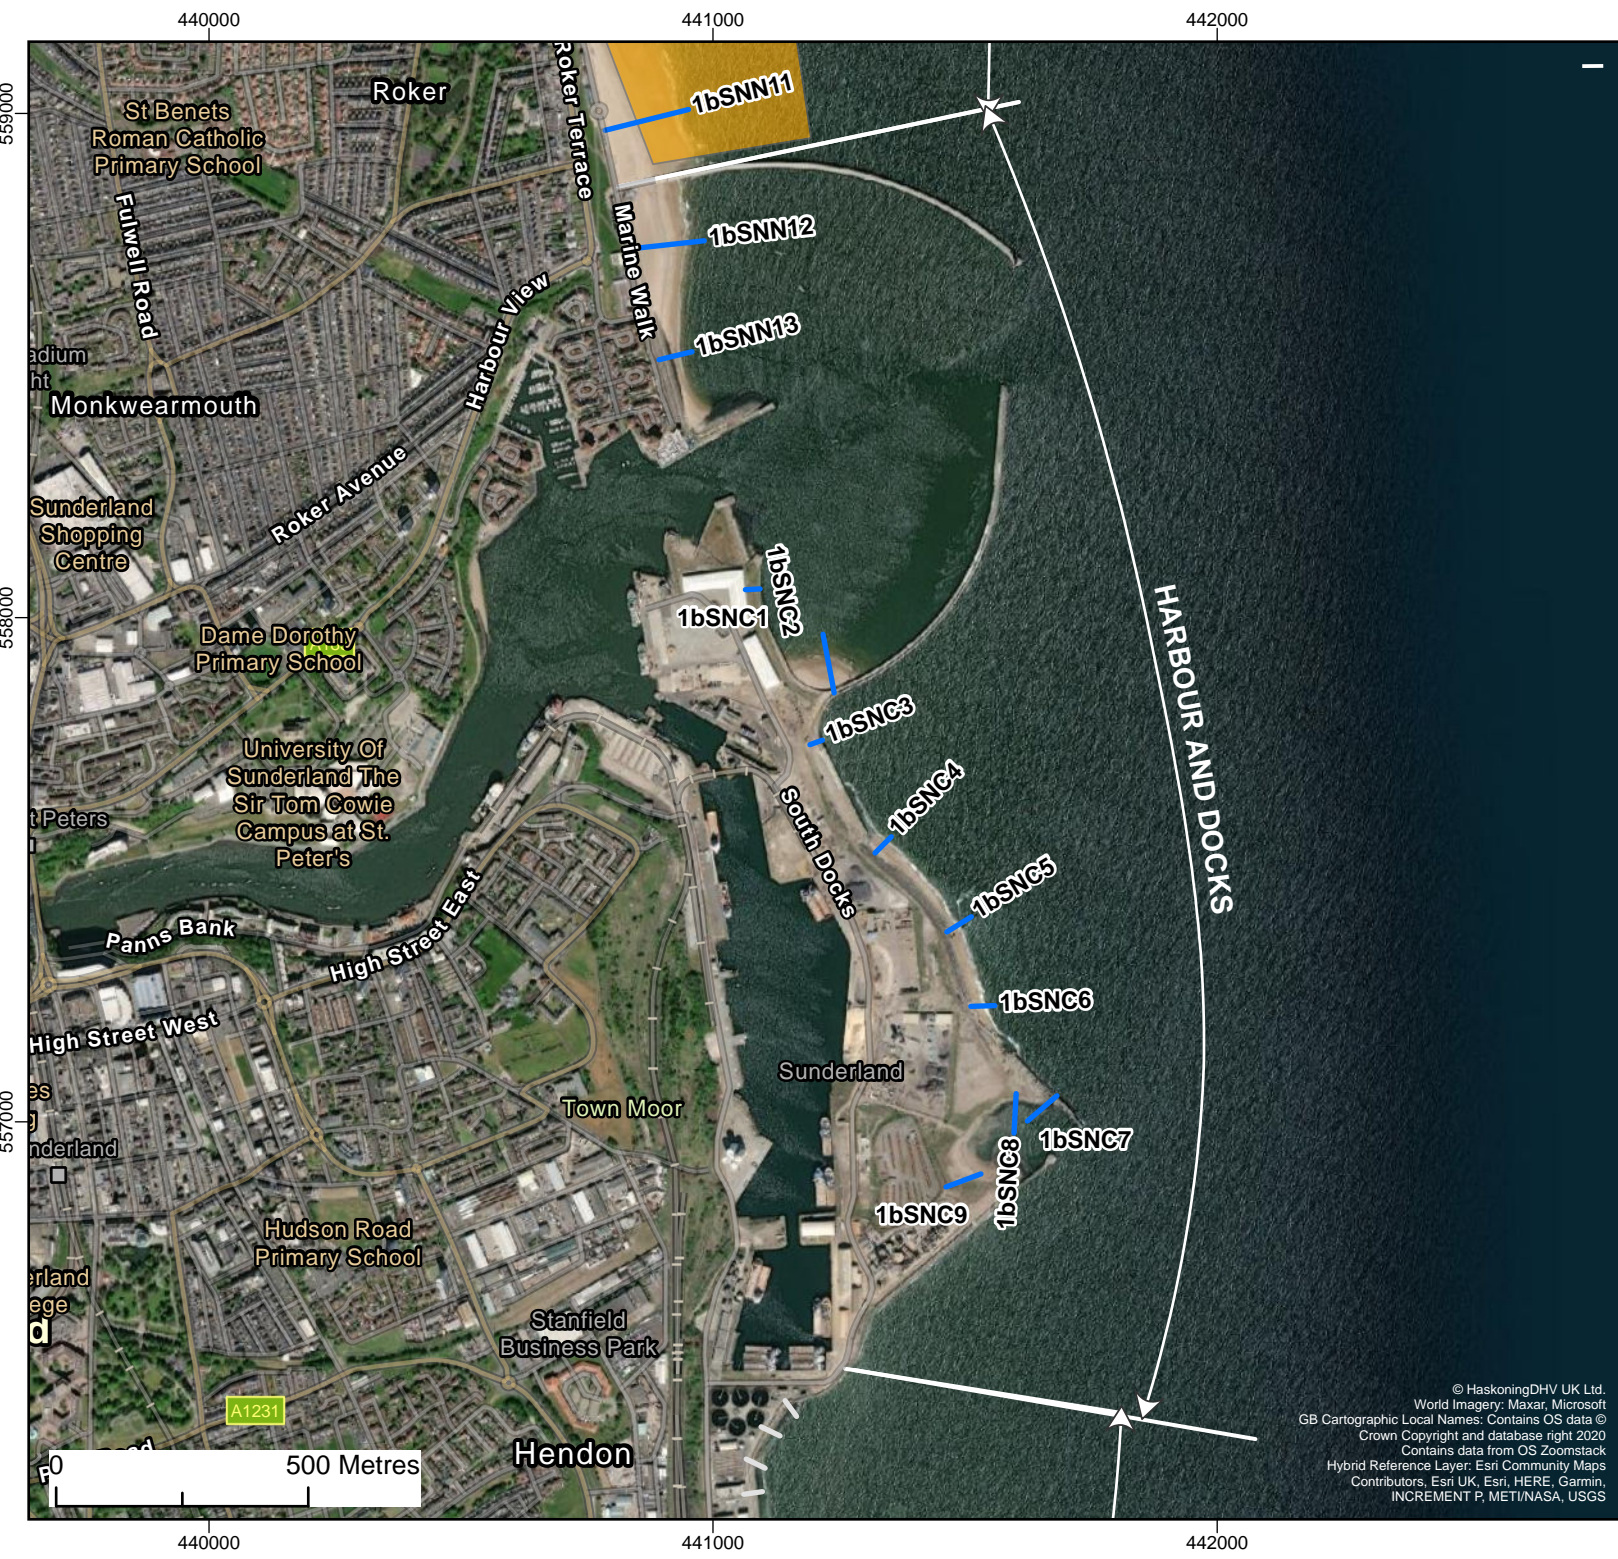
**Figure 2 - Map 2**

**HARBOUR AND DOCKS**

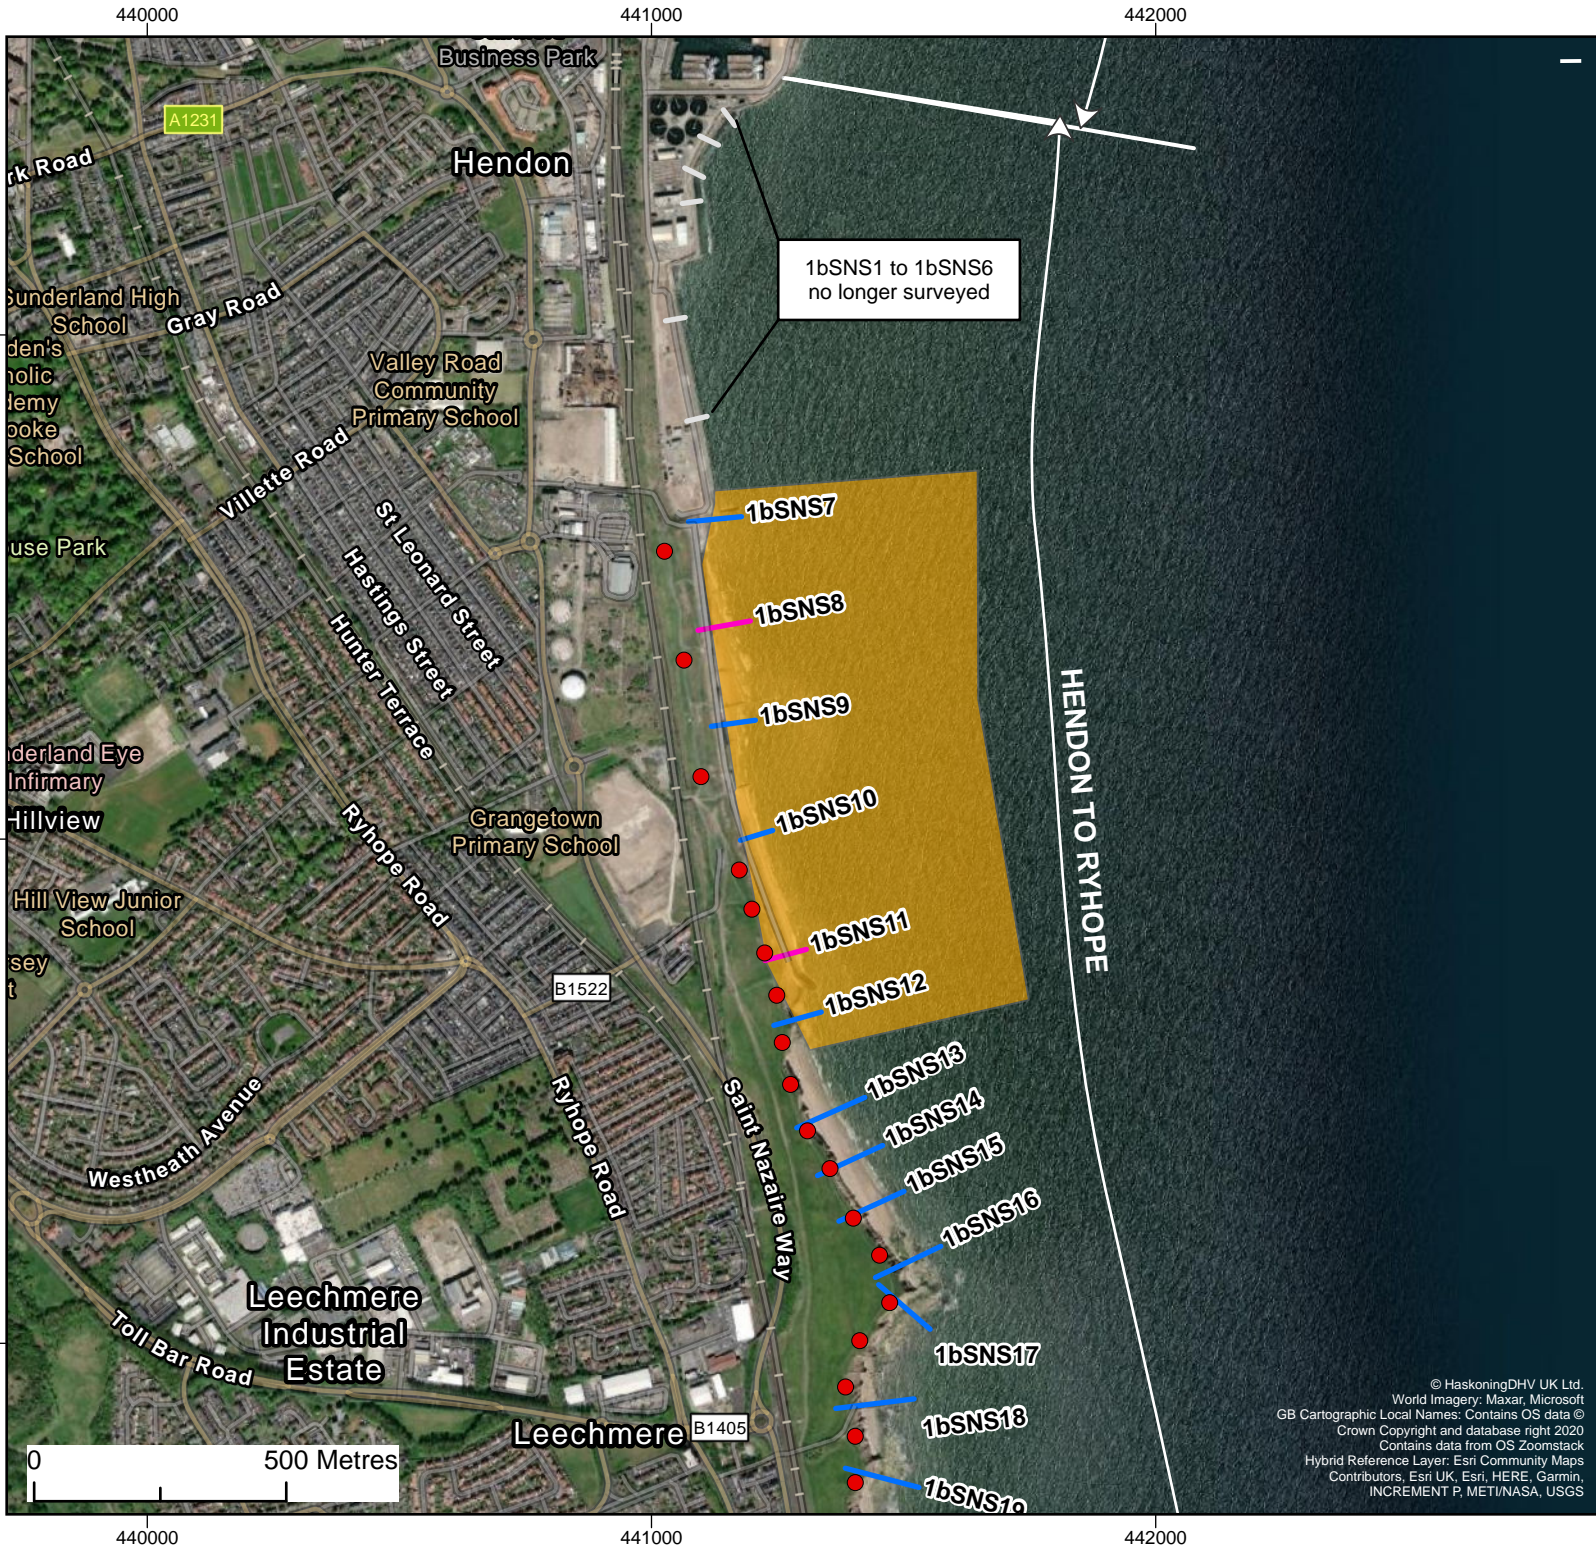
**Figure 2 - Map 3**

**HENDON TO RYHOPE (NORTH)**

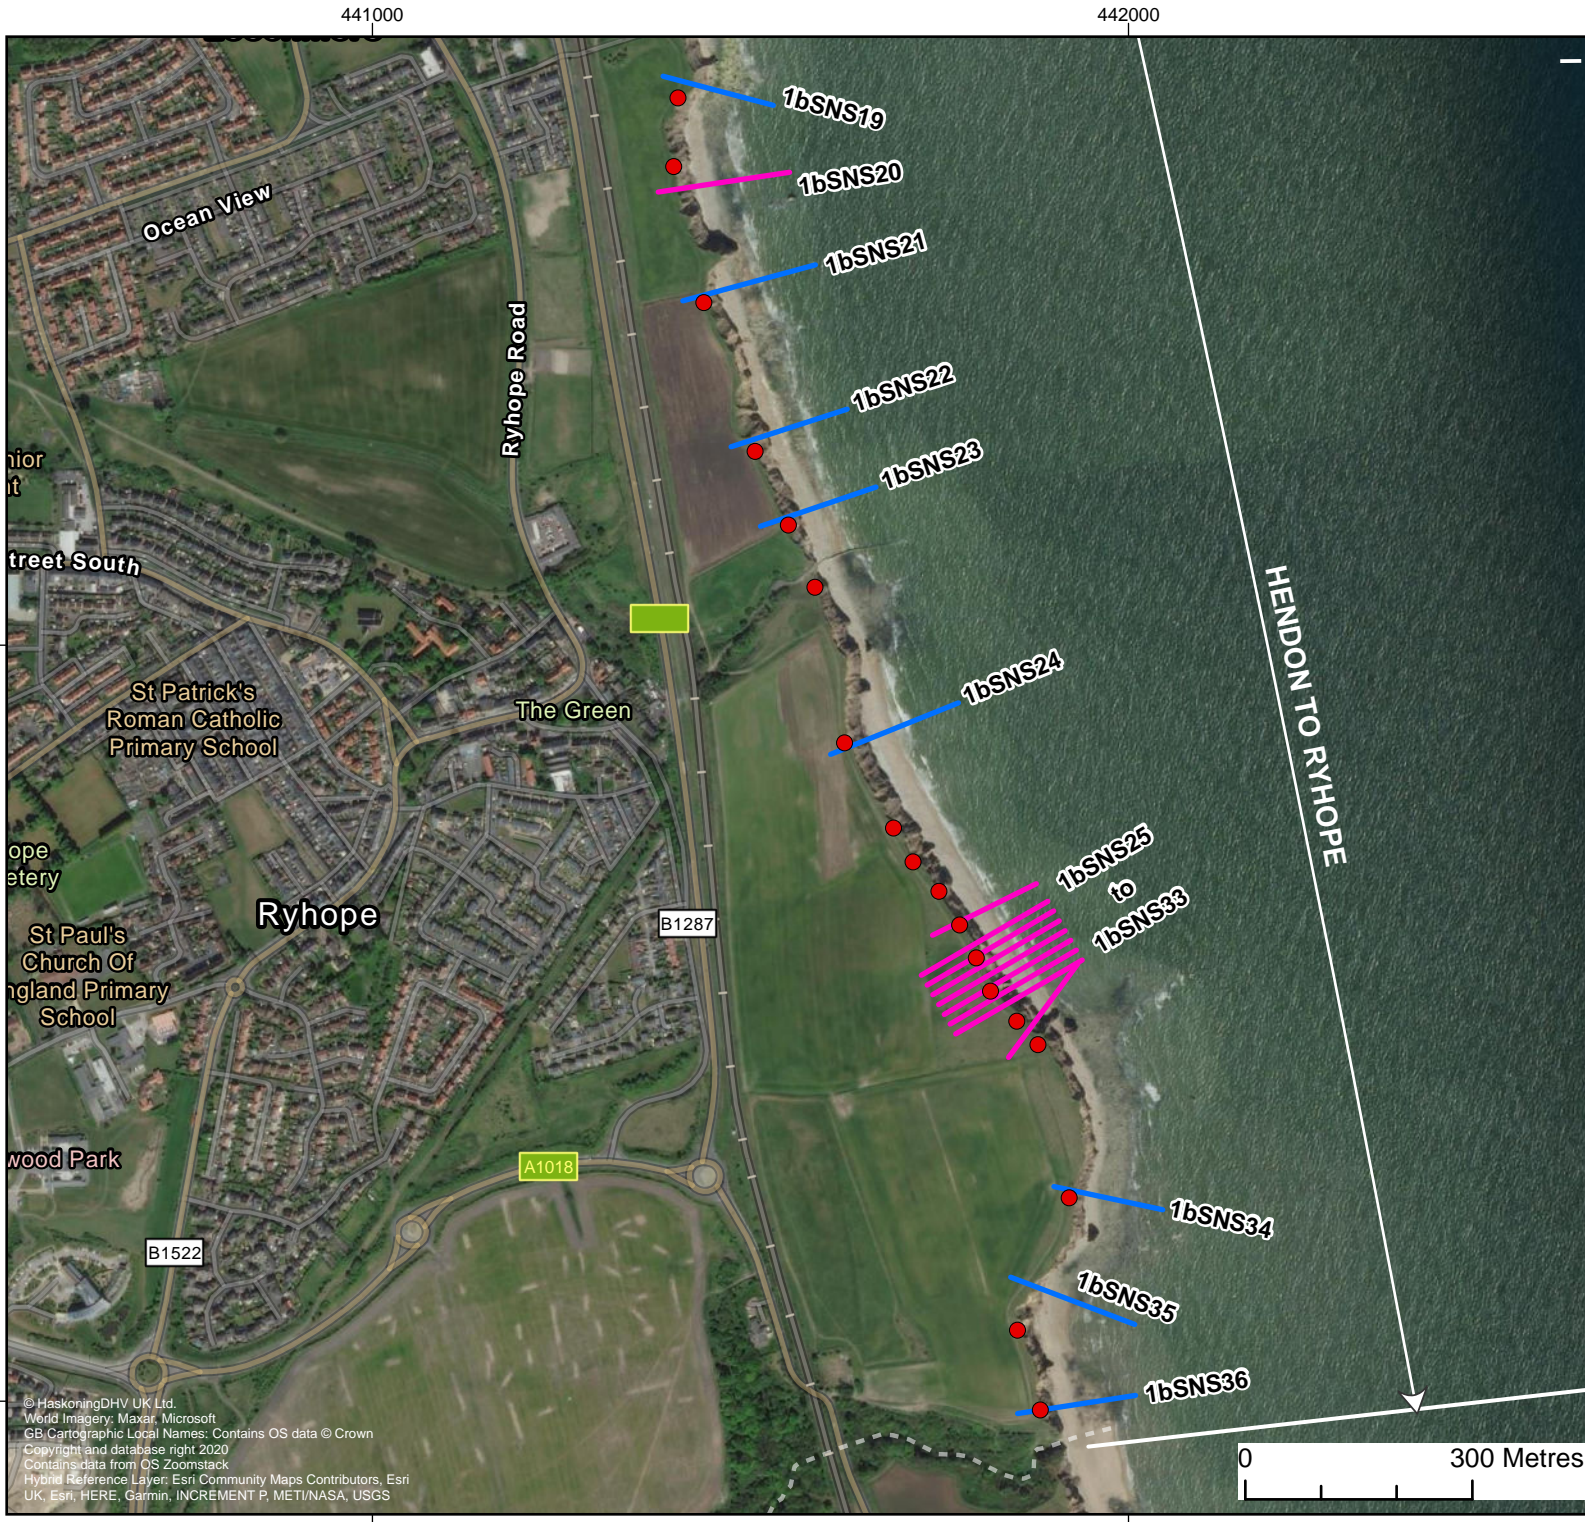
**Figure 2 - Map 4**

**HENDON TO RYHOPE (SOUTH)**

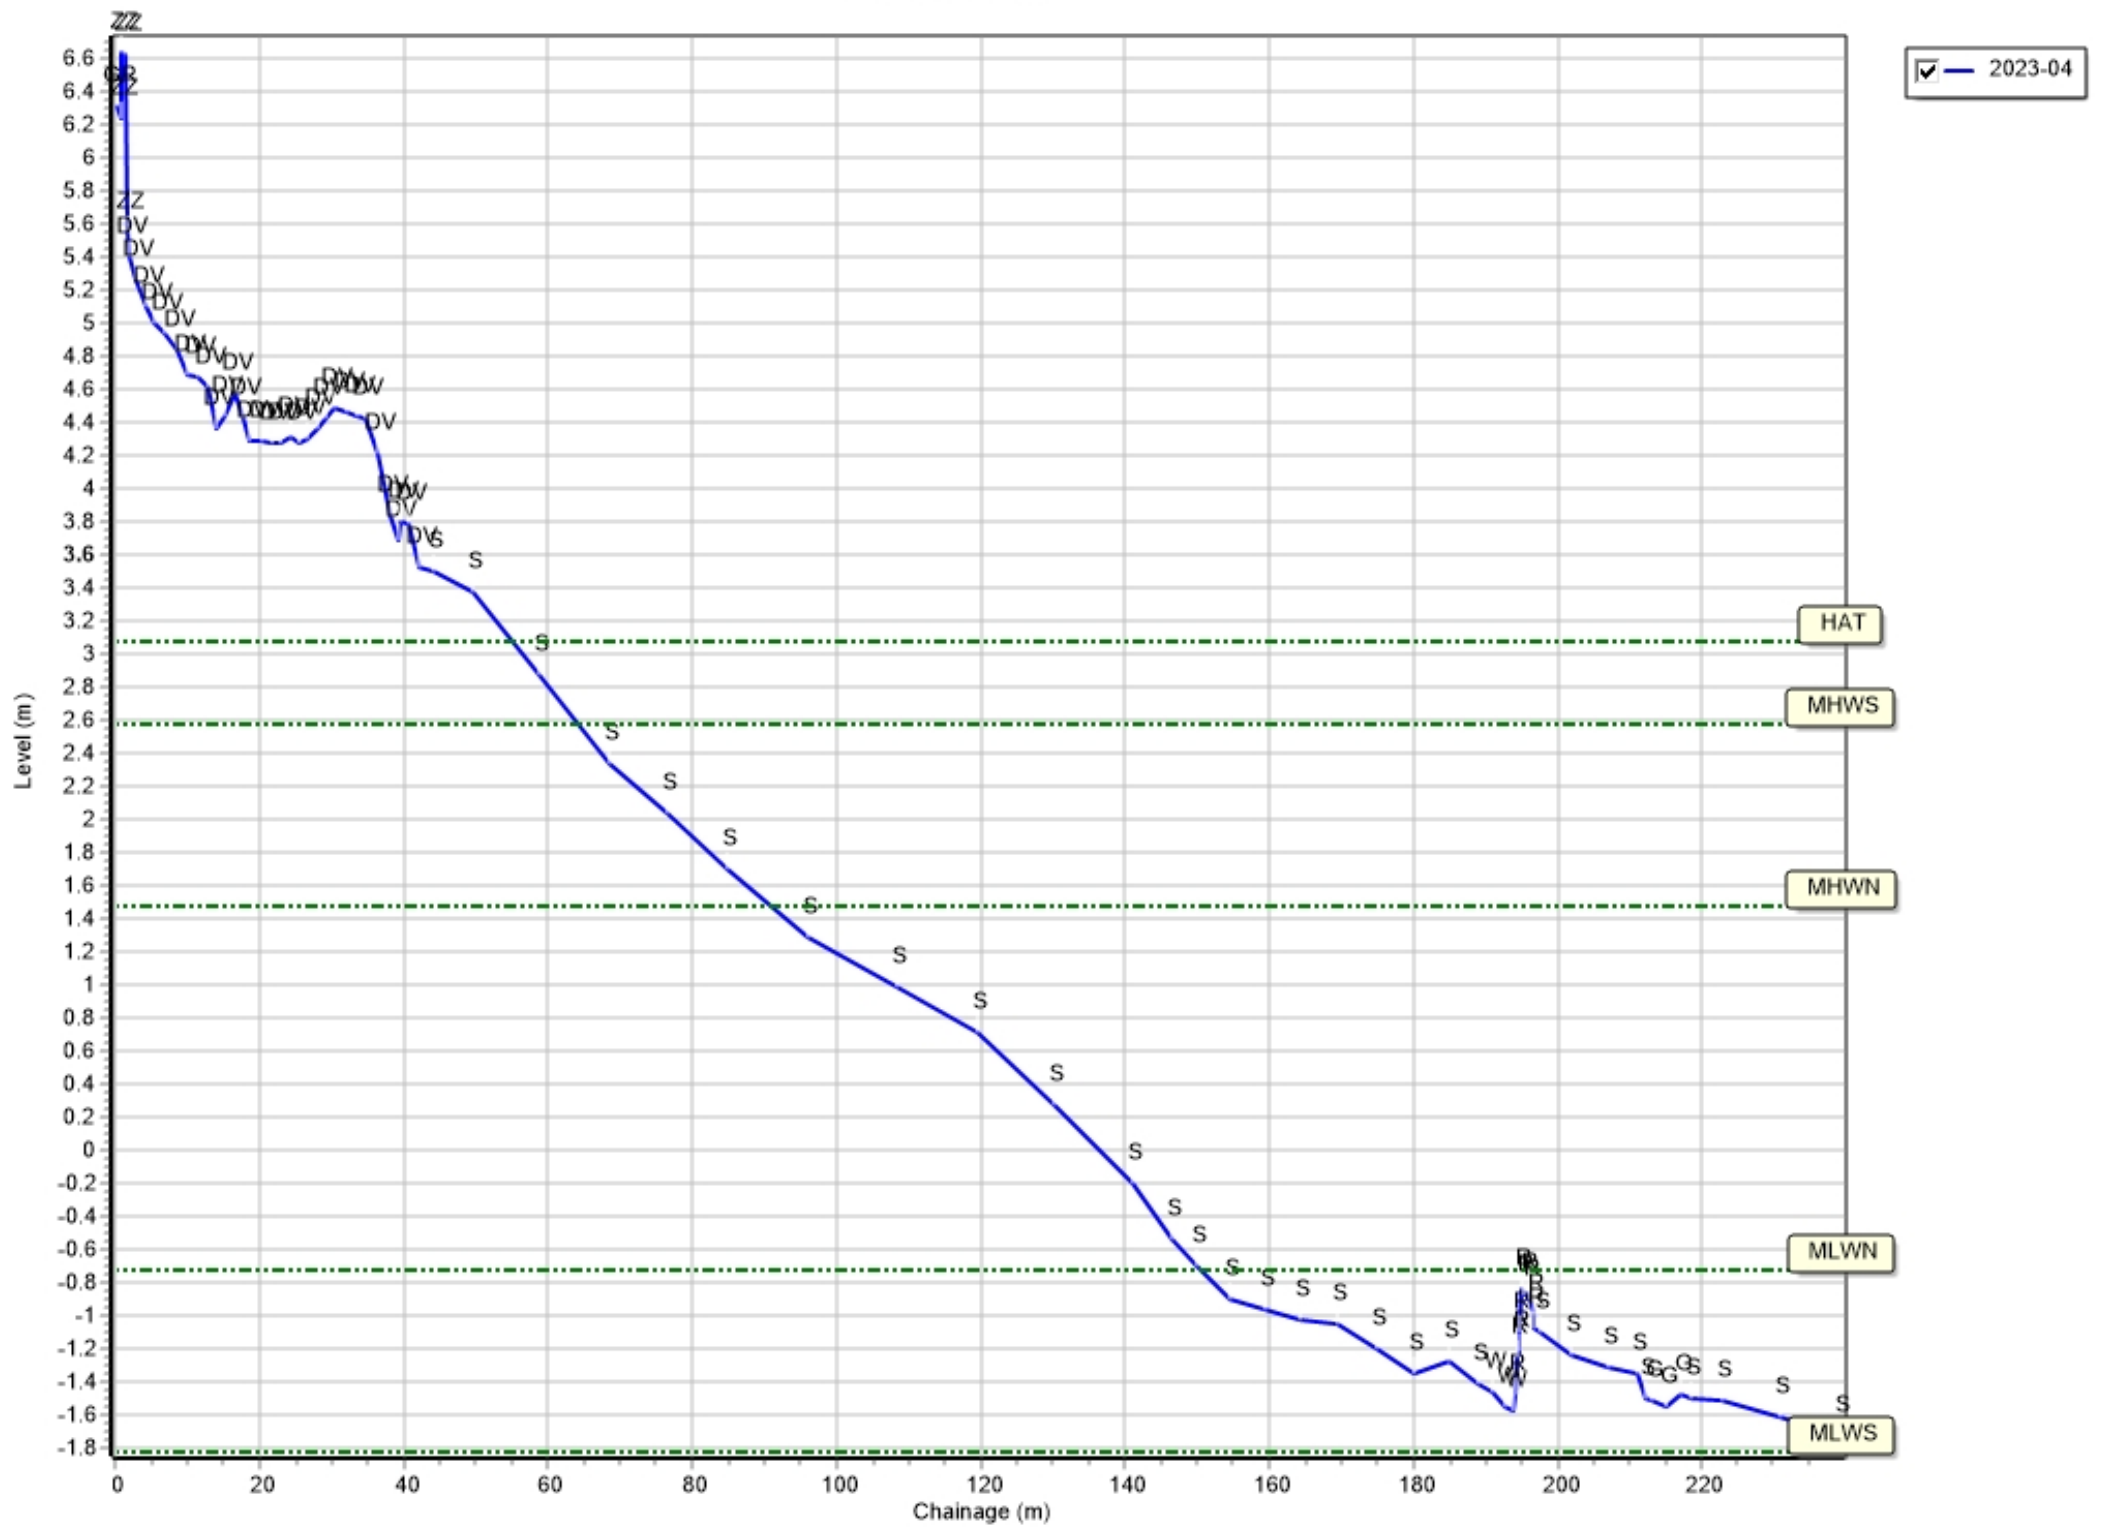
# Profiles: 1bSNN1

Survey Date	Description of Changes Since Last Survey	Interpretation
4 <sup>th</sup> April 2023	<p><b>Beach Profiles:</b></p> <p>Whitburn Bay is covered by three beach profile lines for the Partial Measures survey (Appendix A). The last survey was Full Measures, undertaken in Autumn 2022.</p> <p><b>1bSNN1</b> is just to the south of Sunderland City Council's northern boundary. Since the last survey, the backshore landward of chainage 43m has remained stable and not changed. The upper beach between chainage 43-51m has risen by up to less than 0.1m. The majority of the rest of the profile between chainage 51m and 190m has lowered by up to 0.3m on the upper beach, 0.4m on the middle beach and less than 0.1m on the lower beach. The rock at chainage 190m is still present, and the beach profile terminates at chainage 239m. Overall, the beach profile is at a medium level compared to the range recorded from previous surveys.</p> <p><b>1bSNN7</b> is at Seaburn, north of Parson's Rock. Beach levels have risen on the upper beach between chainages 6-56m by up to 0.4m. The middle beach has risen by less than 0.1m and the lower beach has risen by up to 0.3m. Overall, the upper beach profile is at a medium level and the middle and lower beach is at a high level compared to the range recorded from previous surveys.</p> <p><b>1bSNN10</b> is located mid-way between Parson's Rock and Roker Pier. The beach profile from the toe of the seawall across the upper and middle beach has lowered by up to 0.4m. The lower beach seaward of chainage 166m has risen by up to 0.5m. The profile across the upper and middle beach is at a medium level compared to the range recorded from previous surveys, whilst the lower beach is at a high level.</p>	<p>Beach levels across Whitburn Bay have generally lowered, except on the lower beach of 1bSNN10 and middle and lower beach of 1bSNN7.</p> <p><b>Longer term trends:</b> Profiles in Whitburn Bay are within the bounds of previous surveys, with most profiles at a medium-high level.</p>

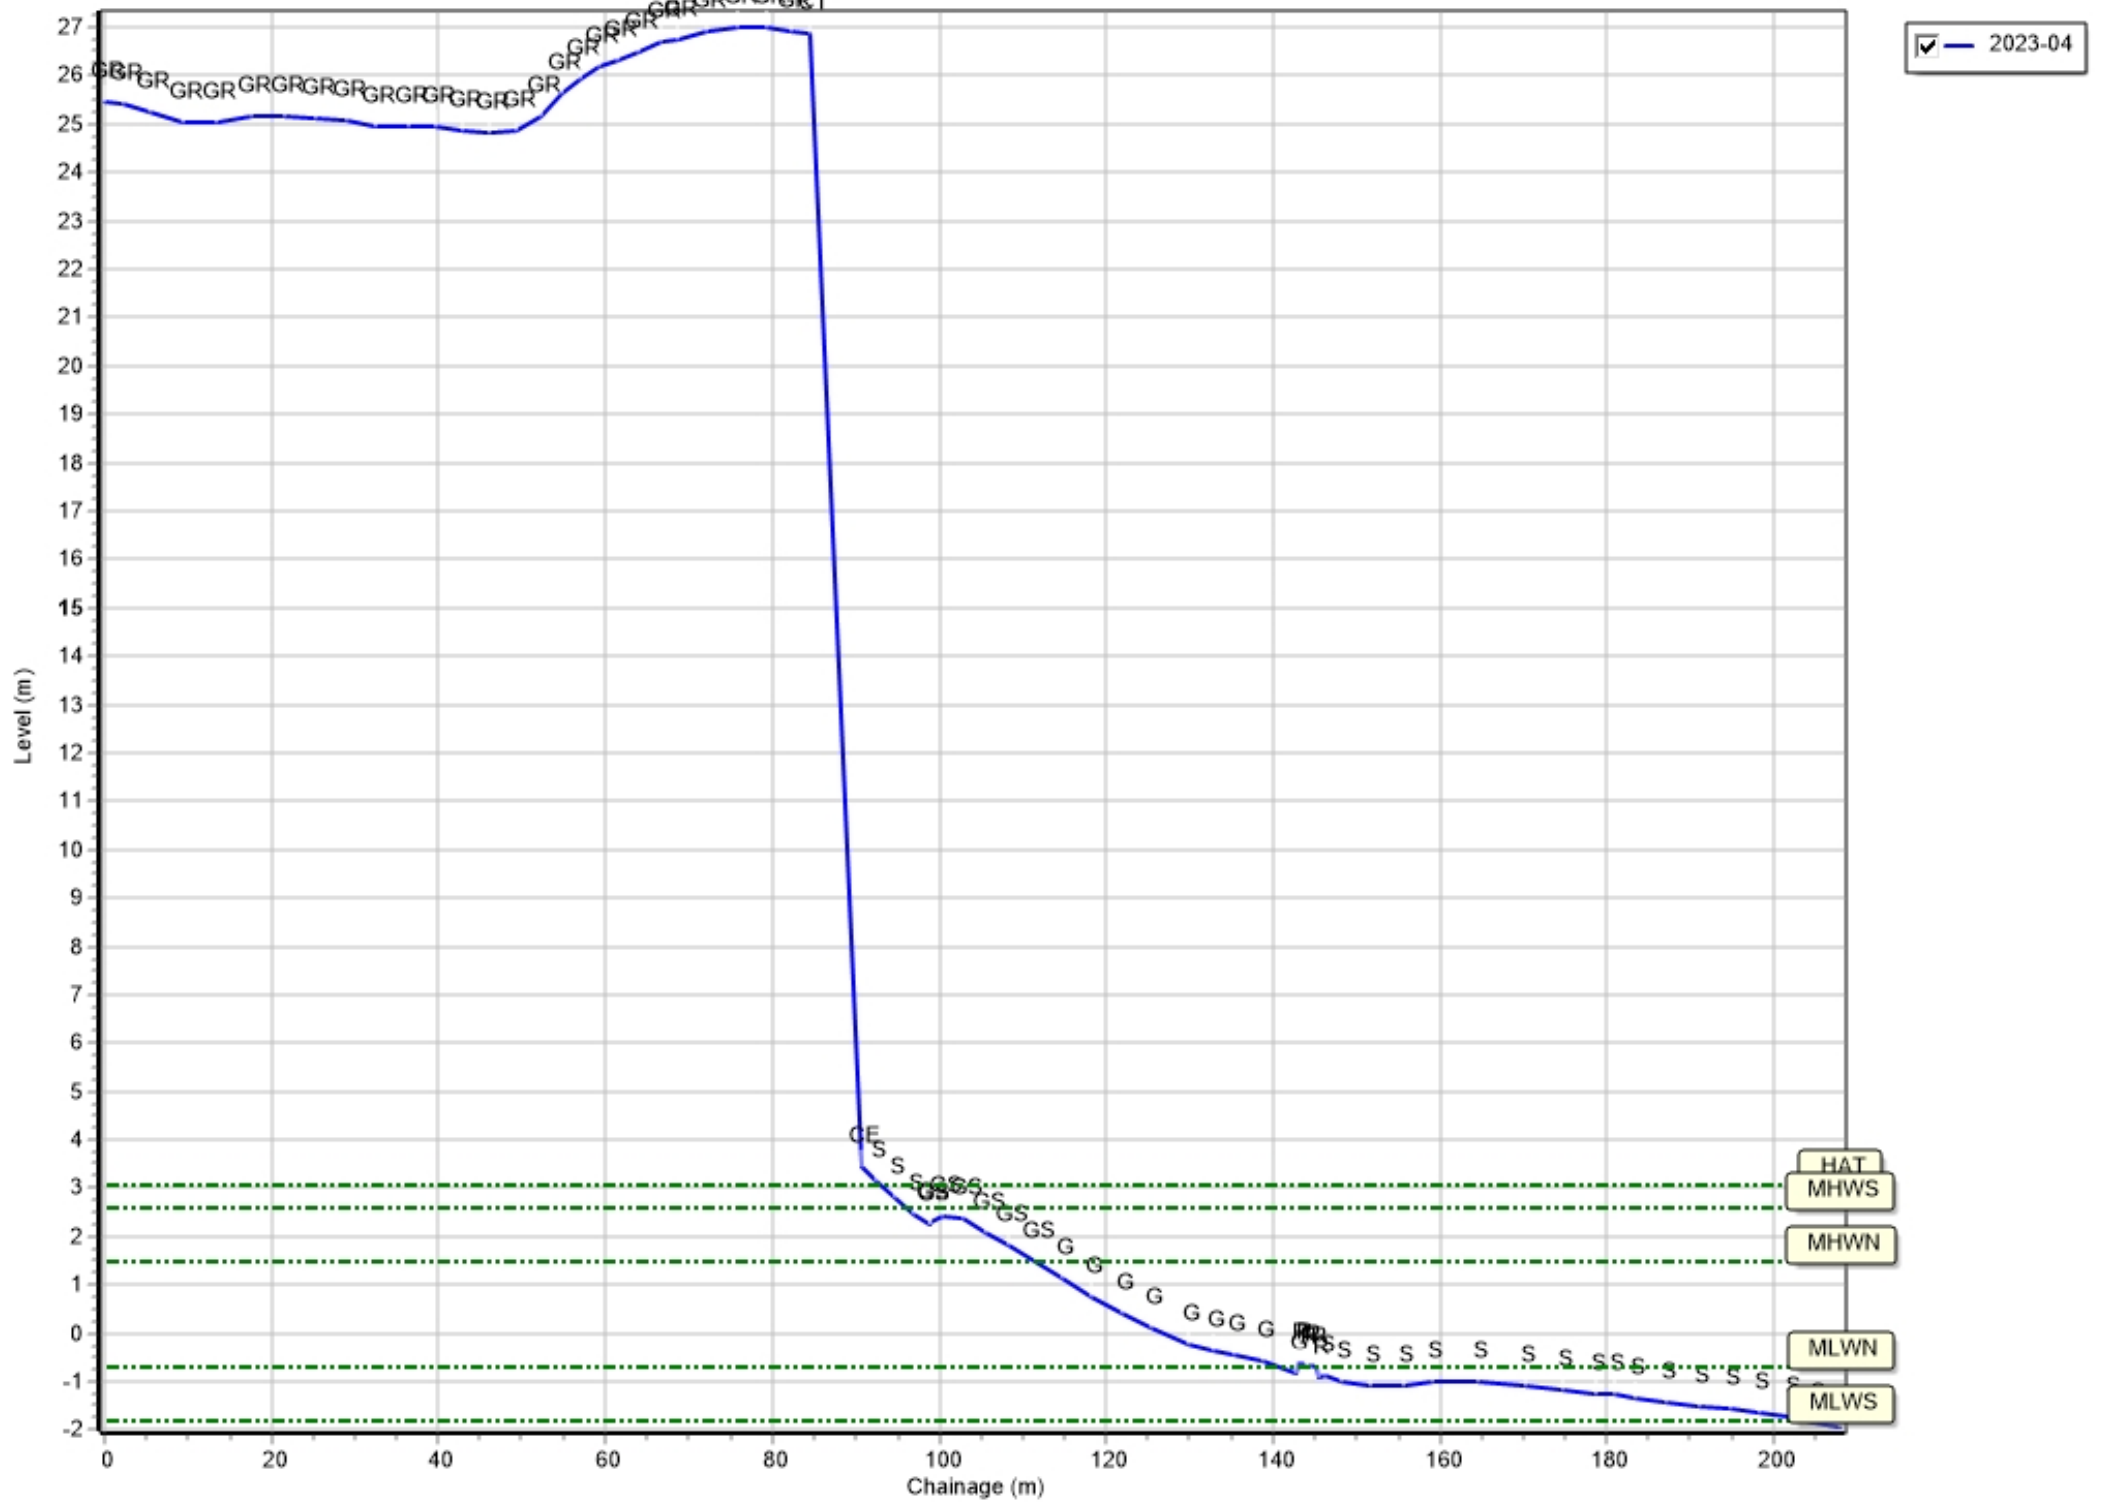
Profiles: 1bSNS26

Survey Date	Description of Changes Since Last Survey	Interpretation
	<p>At profiles <b>1bSNS26</b>, the toe of the cliff has retreated landward by approximately 0.5m. The beach level has generally risen by up to 0.6m on the upper beach and 0.4m on the lower beach. The profile between chainages 130-155m has not changed since the previous survey. Overall, the profile is at a relatively medium-high level compared to the range recorded from previous surveys.</p> <p>At <b>1bSNS27</b> there has been a recession in the cliff top by up to 0.5m. The beach level at the toe of the cliff has lowered by up to 1.4m. Similar to previous surveys, the beach has generally risen by up to 0.8m on the upper beach and 0.5m on the lower beach. The middle beach between chainages 130-140m has not changed since the previous survey. Overall, the beach at the toe of the cliff is at one of its lowest levels and the rest of the profile is at a high level compared to the range recorded from previous surveys.</p> <p>At <b>1bSNS28</b>, there has been very little change in the position of the cliff face. The beach profile has risen across the whole profile by up to 0.6m on the upper beach, less than 0.1m on the middle beach and 0.2m on the lower beach. Overall, the beach profile is at a high level compared to the range recorded from previous surveys.</p> <p>At profile <b>1bSNS29</b>, there has been very little change in the position of the cliff face. The beach profile at the toe of the cliff has lowered by up to 0.6m to chainage 102m. Seaward of this point, the beach has generally risen by up to 0.8m on the upper beach, less than 0.1m on the middle beach and 0.2m on the lower beach. The rock at chainage 147m remains exposed, however the rocks at chainage 175m are now covered by sediment. Overall, the beach is at a medium-high level compared to the range recorded from previous surveys.</p> <p>At profile <b>1bSNS30</b>, there has been a retreat of the cliff toe by up to 1.0m. The beach has undergone very little change from the toe of the cliff to chainage 103m. The beach profile seaward of this point has risen by up to 1.0m on the upper beach, less than 0.1m on the middle beach and up to 0.4m on the lower beach. Overall, the upper and middle beach profile is at a medium level compared to the range recorded from previous surveys, whilst the lower level is at a high level.</p> <p>The cliff top at profile <b>1bSNS31</b> shows a retreat by up to 4.0m. The beach has risen across the rest of the survey by up to 1.5m on the upper beach, 1.0m on the middle beach and 0.5m on the lower beach. Overall, the profile is at a medium-high level compared to the range recorded from previous surveys.</p>

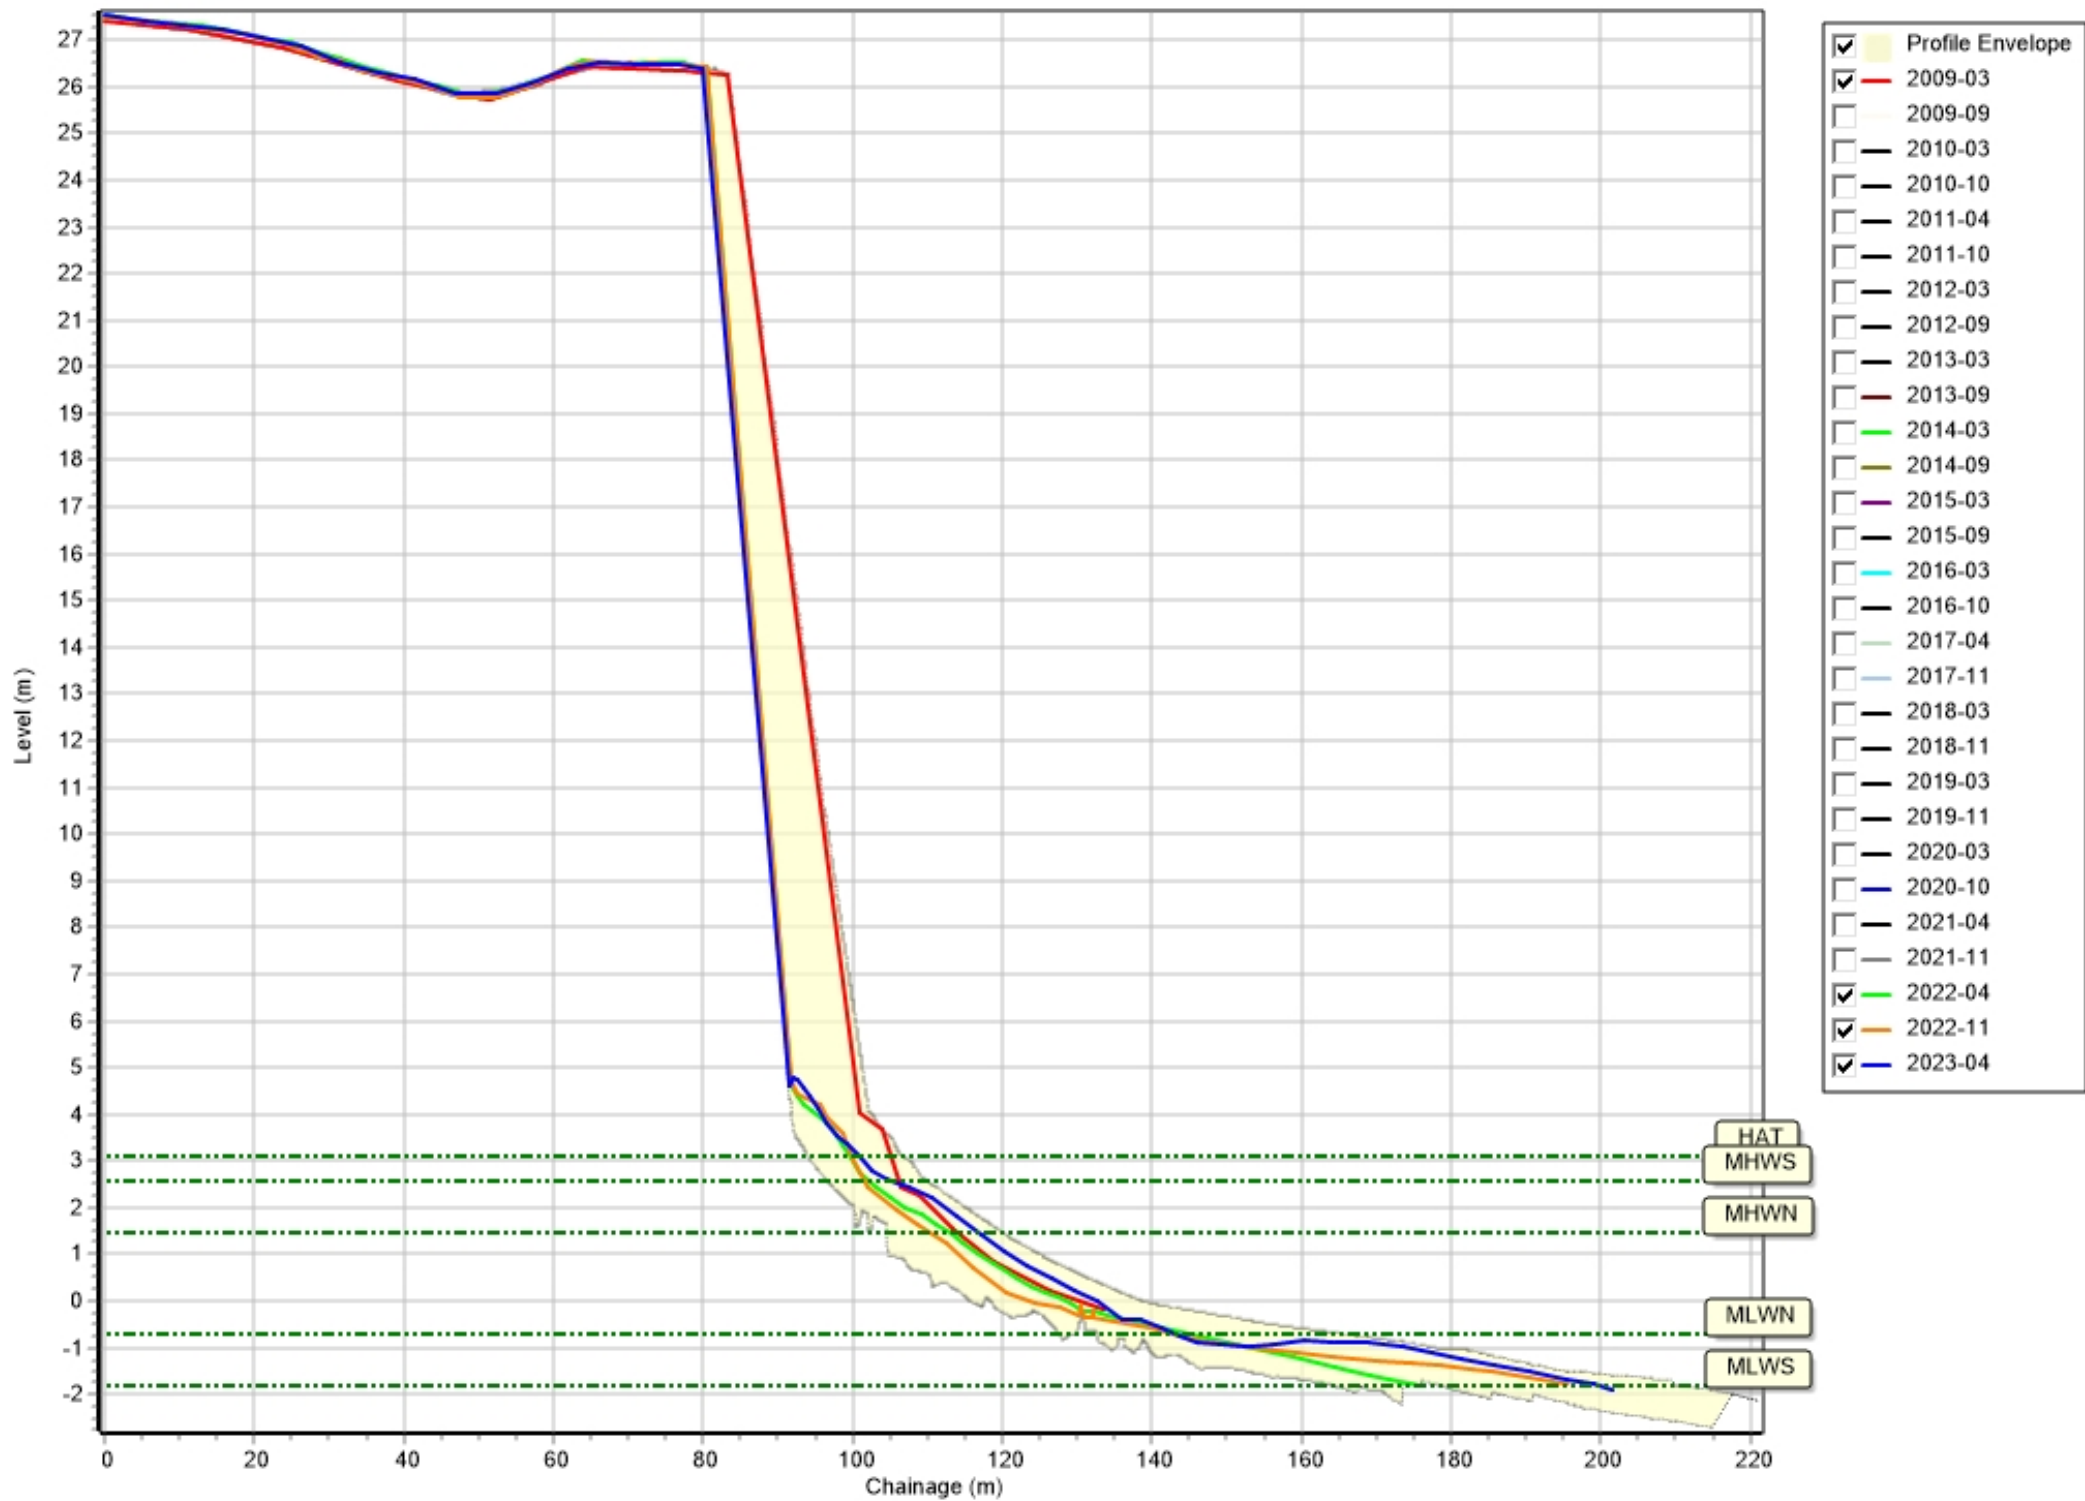
Profiles: 1bSNS32

Survey Date	Description of Changes Since Last Survey	Interpretation
	<p>At profile <b>1bSNS32</b>, the cliff top shows a minor retreat of 0.1-0.2m. Similar to previous profiles, the beach has risen across the beach by up to 0.7m on the upper beach, less than 0.1m on the middle beach and 0.5m on the lower beach. Overall, the beach profile is at a medium level on the middle beach and a high level on the upper and lower beach compared to the range recorded from previous surveys.</p> <p>At profile <b>1bSNS33</b>, the cliff has not changed position since the previous survey. The beach profile has risen on the upper beach by up to 1.4m and the lower beach by up to 0.2m. The middle beach between chainages 105-127m has lowered by 0.2m. Overall, the upper and lower beach profile is at a high level compared to the range recorded from previous surveys, whilst the middle beach is at a medium level.</p>
