**Cell 1 Regional Coastal Monitoring Programme
Analytical Report 1: 'Full Measures' Survey 2008**

**Hartlepool Borough Council
Final Report**

Analytical Report 1
 'Full Measures' Survey 2008

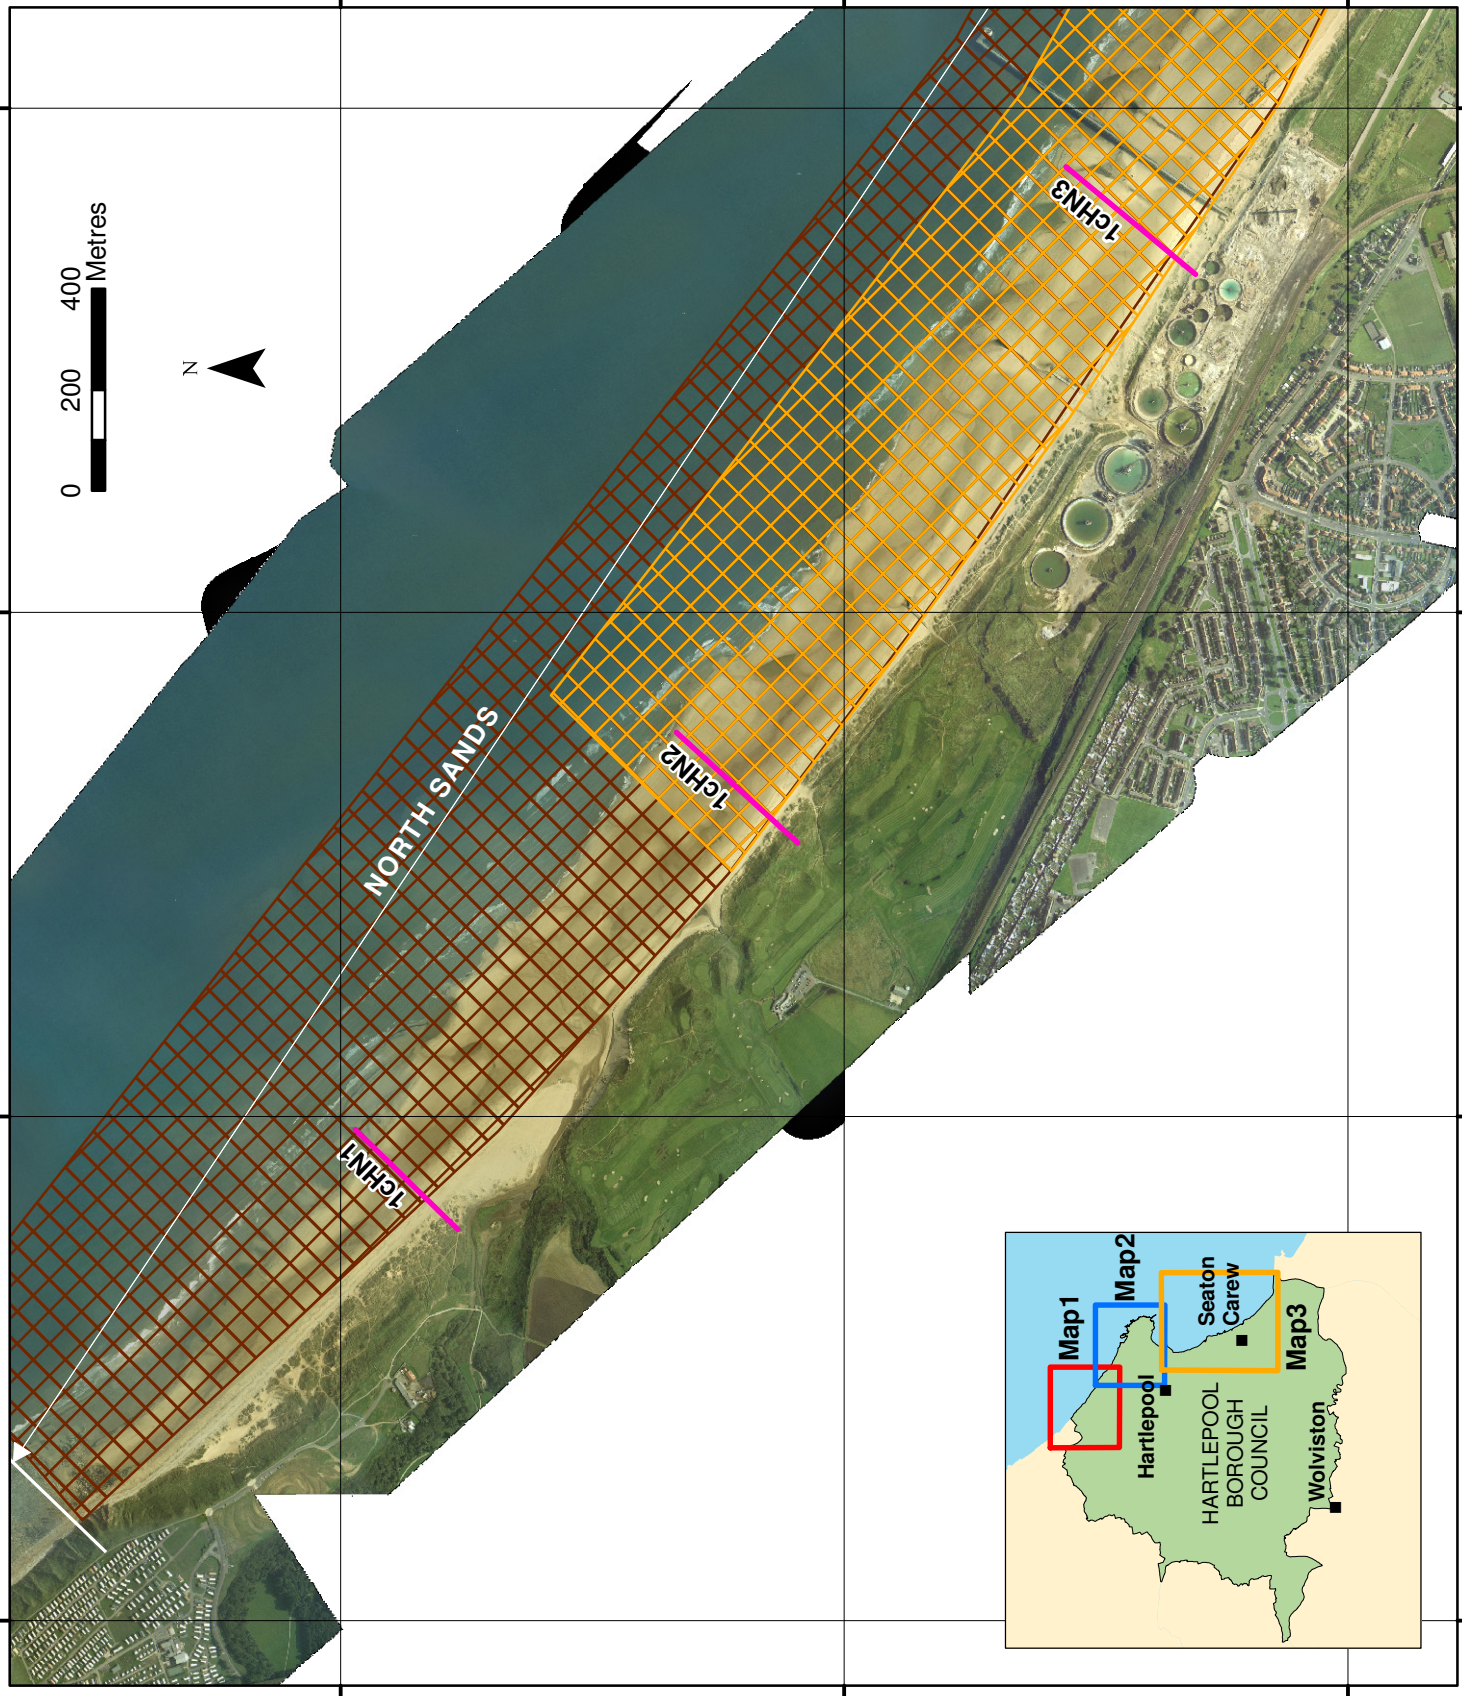
**Figure 2 - Map 1
 Hartlepool Borough
 Council Frontage**

SURVEY LOCATIONS

Topographic Profiles

- Annual
- Bi-Annual

Topographic Surveys

- 6 monthly
- yearly
- 5 yearly

Cliff Top Monitoring Pegs

- @ 50 centres
- @ 100 centres
- @ 300 centres

(Indicative Survey Extents shown)

The location of these surveys is shown in Figure 2. Also enclosed on the accompanying CD-rom is a file which can be opened in Google Earth showing the locations of the surveys.

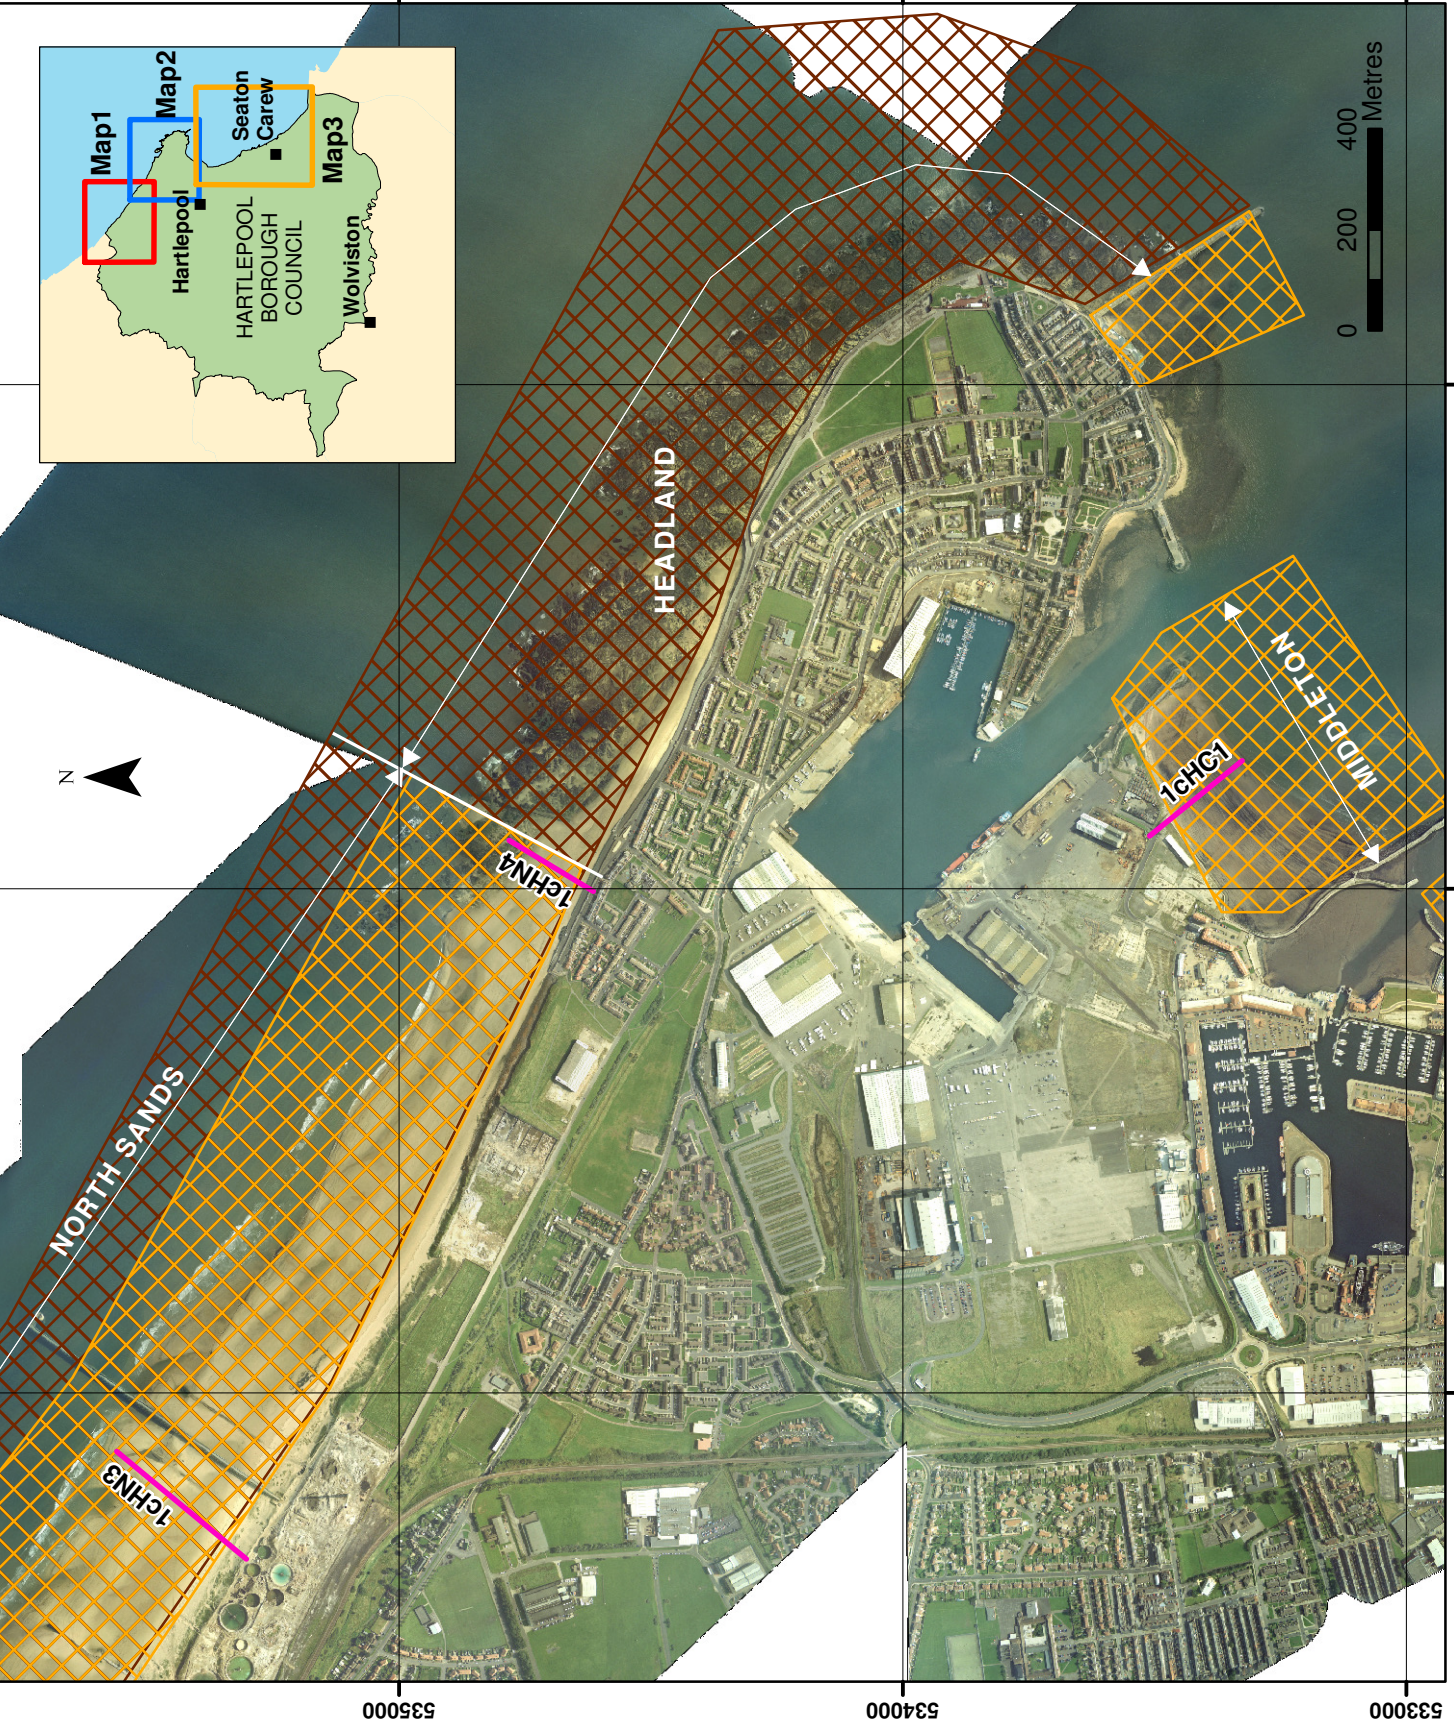
**Figure 2 - Map 2
 Hartlepool Borough
 Council Frontage**

SURVEY LOCATIONS

Topographic Profiles

- Annual
- Bi-Annual

Topographic Surveys

- 6 monthly
- yearly
- 5 yearly

Cliff Top Monitoring Pegs

- @ 50 centres
- @ 100 centres
- @ 300 centres

(Indicative Survey Extents shown)

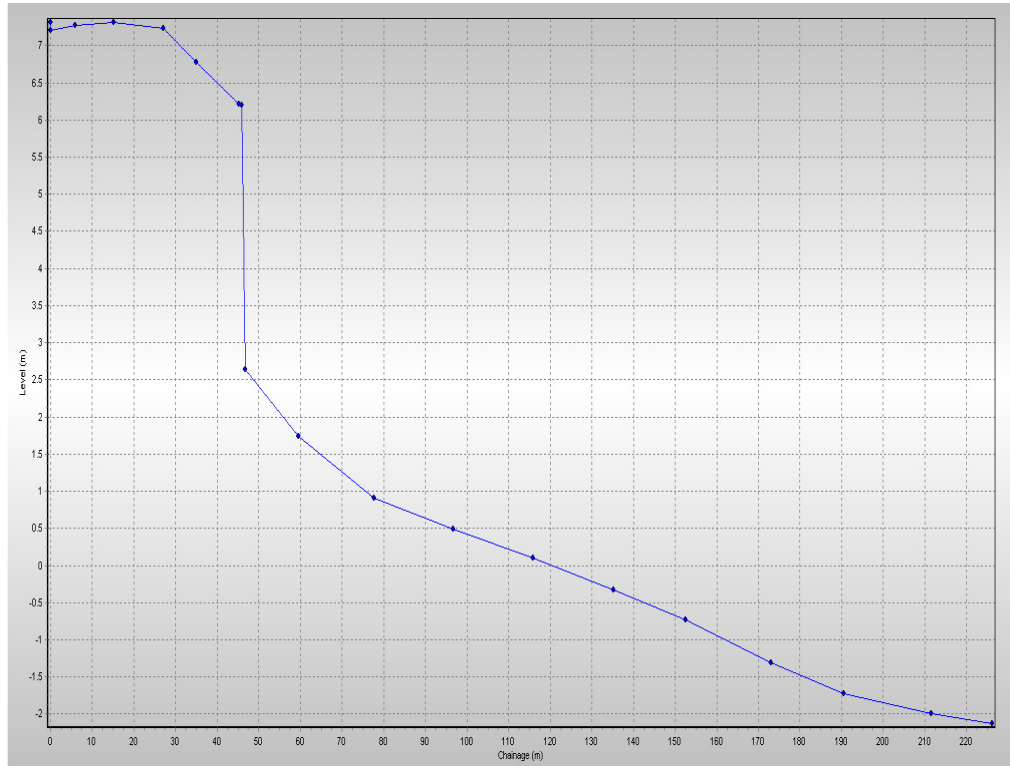
1cHC1

Date 25/11/2008 **Inspector** RH
Wind Light **Sea State**
Summary

Easting 452108.080 **Northing** 533506.120 **Bearing** 141

Chainage	Level
0.000	7.311
0.083	7.199
5.891	7.266
15.071	7.313
27.052	7.227
35.036	6.773
45.216	6.211
45.880	6.197
46.733	2.641
59.505	1.735
77.720	0.909
96.710	0.491
115.915	0.096
135.222	-0.322
152.593	-0.733
173.111	-1.312
190.548	-1.728
211.528	-1.997
226.165	-2.128

Survey Date	Description of Changes Since Last Survey	Interpretation
11-2008 (Baseline)	<p>Beach Profiles:</p> <p>Middleton is covered by one beach profile line (Appendix A). HC1 extends from the access road, across the vertical wall down to beach level, where the foreshore drops gradually down to low water level at the time of the survey.</p>	<p>It is envisaged that beach material will be relatively well contained within the shelter of the Middleton Jetty and the North Pier.</p>
	<p>Topographic Survey:</p> <p>Middleton is covered by an annual topographic survey between Middleton Jetty and North Pier. Data from the 2008 baseline have been used to create a DGM (Appendix B – Map 2a). This shows a small pocket of sand accumulation against the landward end of Middleton Jetty, but in general beach levels are greater in the south of the frontage than in the north.</p>

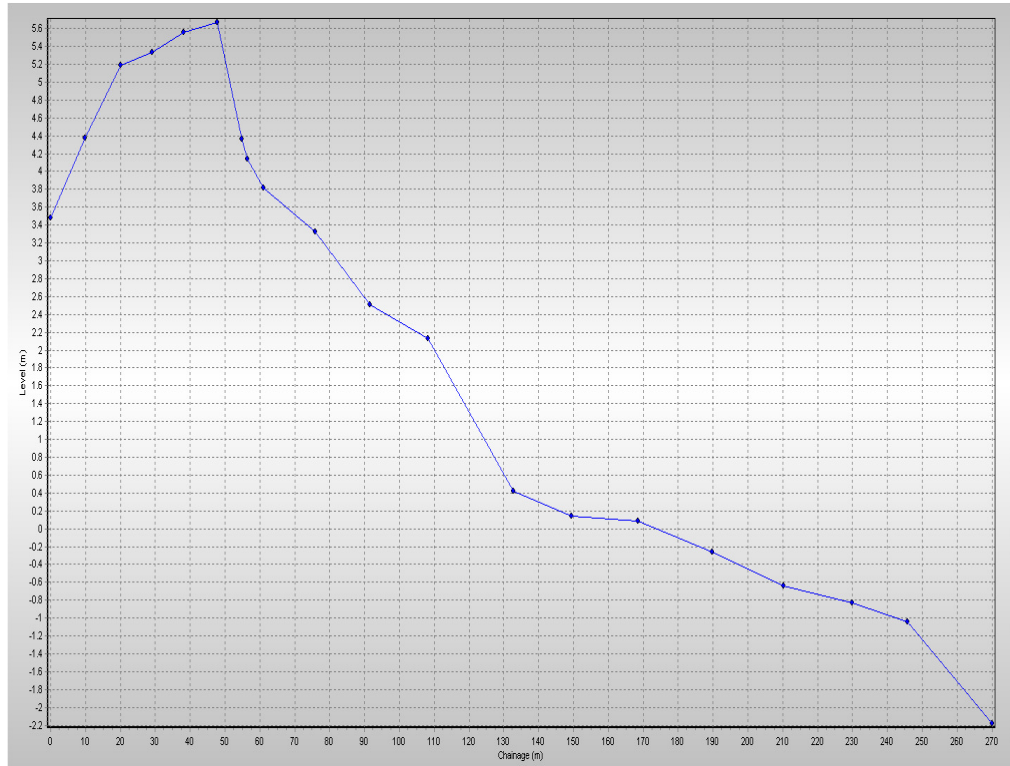
1cHN1

Date 10/11/2008 **Inspector** RH
Wind Light **Sea State**
Summary

Easting 448779.620 **Northing** 536767.420 **Bearing** 44

Chainage	Level
0.000	3.479
9.886	4.372
20.048	5.185
29.107	5.334
38.177	5.553
47.799	5.669
54.842	4.361
56.520	4.139
61.088	3.819
75.895	3.323
91.474	2.504
108.208	2.127
132.818	0.416
149.386	0.144
168.409	0.081
189.704	-0.263
210.143	-0.643
229.945	-0.830
245.677	-1.040
270.065	-2.182

Survey Date	Description of Changes Since Last Survey	Interpretation
<p>11-2008 (Baseline)</p>	<p>Beach Profiles:</p> <p>North Sands is covered by four beach profile lines (Appendix A).</p> <p>HN1 is at the northern end, about 400m north of the outfall channel of Crimdon Beck. The profile line extends from the landward side of the dune crest, which reaches a peak level of 5.7mODN, before dropping down to beach level. There is a good width of beach between the level of MHWS and the main dune ridge.</p> <p>HN2 is about 550m south of the outfall channel of Crimdon Beck. Here the dunes are much greater in height, peaking at about 18mODN. There is a width of about 15m between the level of MHWS and the dune toe.</p> <p>HN3 lies about 100m north of the timber pier which carries the pipeline to sea. The beach is backed by slag banks which are high and steep. There is a narrow berm at the toe of the slag bank presently protecting it from marine action.</p> <p>HN4 is about 180m south of the Marine Drive sea wall. The profile line starts at the wall to the rear of the promenade, just seaward of the road, which is at an elevation of around 9.2mODN. It then extends across the promenade, which is around 10m wide, and down the vertical face of the sea wall. The wall crest level is at 6.2mODN with upper beach levels some 2.6m lower than the wall crest. The foreshore then adopts a classic curve down to low water at the time of the survey.</p>	<p>HN1 and HN2 are profiles where we may expect to see interactions between the beaches and dunes, and changes in profile form due to storm action. In the immediate vicinity of the outfall channel of Crimdon Beck, we may expect to see changes in the backing dunes due to changing exposure associated with migration in the channel alignment. Any such changes will be recorded by the 5-yearly topographic surveys and the 2-yearly walk-over inspections.</p> <p>Along HN3 and neighbouring frontages, the beach is backed by high and steep slag banks from the former industrial practices along the shoreline. At present, there remains a narrow width preventing marine action from impacting the toe of the slag banks, but they are known to be suffering from slumping in places. Future surveys will reveal whether the beach width in front of the banks is changing, thus altering the risk of these areas to marine-induced erosion and the release of industrial waste material to the foreshore.</p>

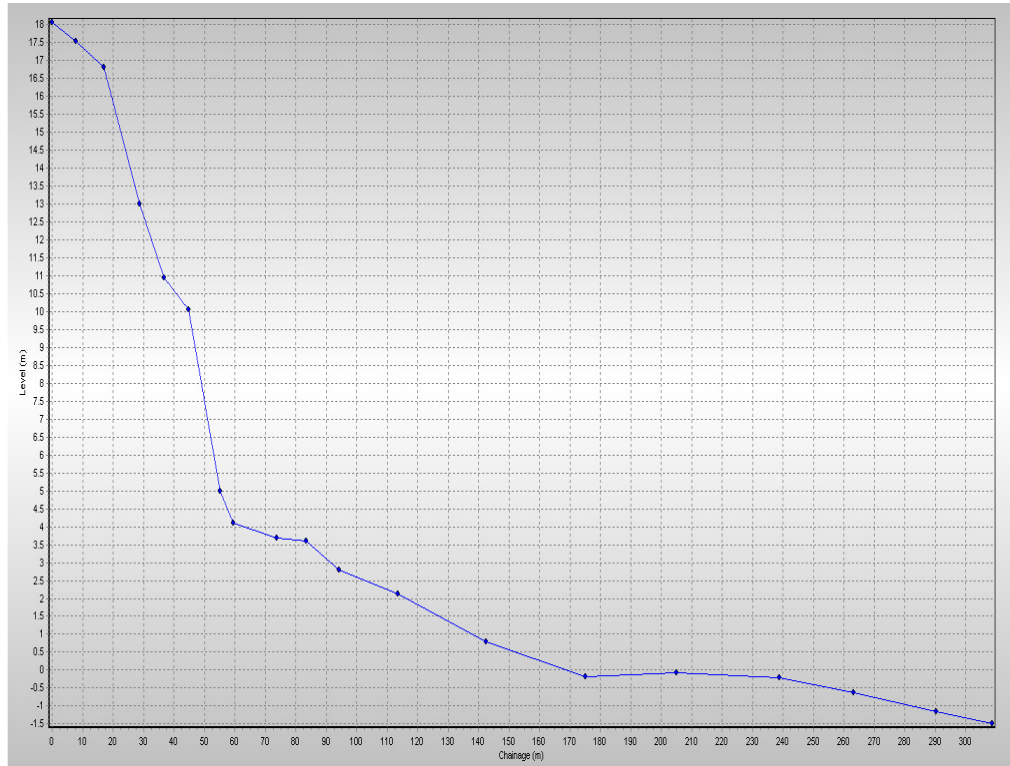
1cHN2

Date 10/11/2008 **Inspector** RH
Wind Light **Sea State**
Summary

Easting 449547.220 **Northing** 536095.460 **Bearing** 42

Chainage	Level
0.000	18.069
7.716	17.546
17.065	16.815
28.698	12.999
36.873	10.935
44.873	10.064
55.089	5.005
59.617	4.095
73.712	3.675
83.495	3.601
94.326	2.805
113.456	2.113
142.588	0.787
175.070	-0.188
205.002	-0.070
238.788	-0.210
263.118	-0.617
290.255	-1.145
308.629	-1.492

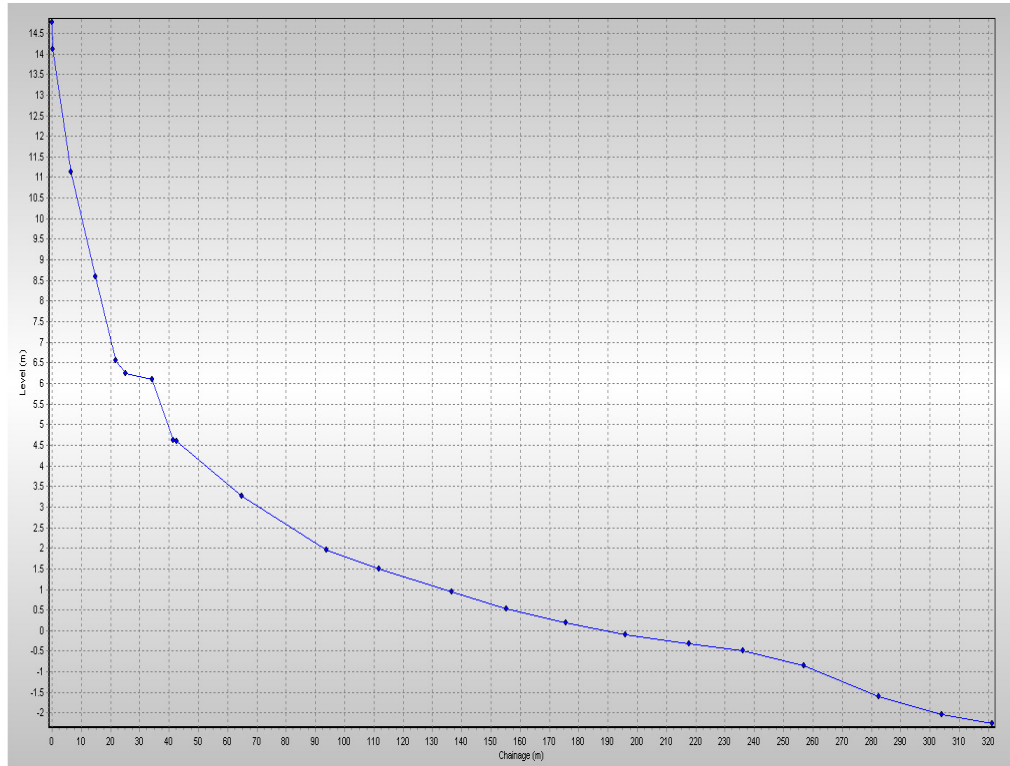
1cHN3

Date 10/11/2008 **Inspector** RH
Wind Light **Sea State**
Summary

Easting 450674.420 **Northing** 535305.140 **Bearing** 40

Chainage	Level
0.000	14.764
0.203	14.111
6.449	11.141
14.788	8.584
21.654	6.553
25.072	6.254
34.322	6.095
41.310	4.631
42.521	4.605
64.914	3.270
93.750	1.947
111.649	1.492
136.517	0.947
155.239	0.533
175.593	0.188
195.988	-0.096
217.584	-0.314
236.041	-0.495
256.916	-0.855
282.574	-1.602
304.088	-2.032
321.260	-2.256

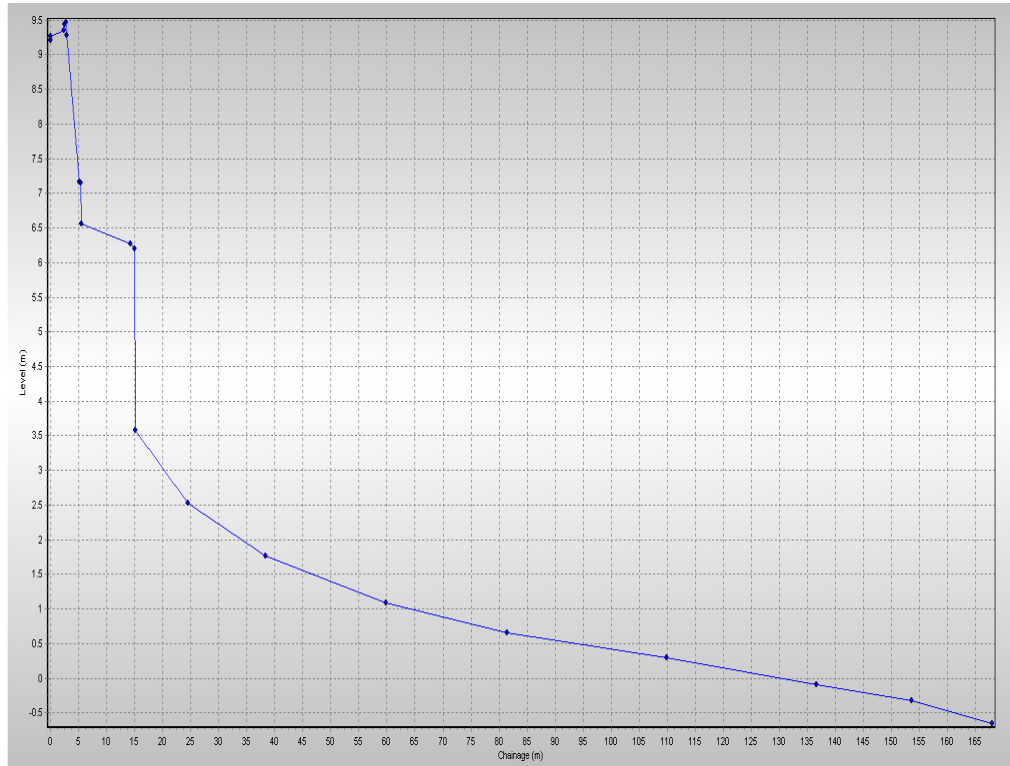
1cHN4

Date 10/11/2008 **Inspector** RH
Wind Light **Sea State**
Summary

Easting 451997.110 **Northing** 534616.630 **Bearing** 31

Chainage	Level
0.000	9.215
0.012	9.263
2.426	9.351
2.501	9.441
2.778	9.467
2.909	9.273
5.144	7.157
5.382	7.144
5.461	6.558
14.234	6.267
14.969	6.204
15.164	3.577
24.507	2.532
38.332	1.763
59.812	1.081
81.380	0.652
109.935	0.295
136.592	-0.087
153.569	-0.326
167.965	-0.654

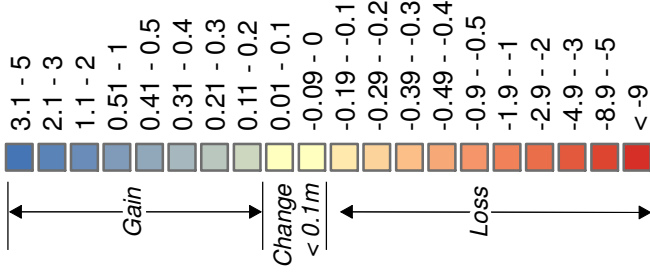
DIFFERENCE BETWEEN TOPOGRAPHIC SURVEYS
March 2000 and Nov 2008

Change in Elevation (m OD)

<p>Topographic Survey:</p> <p>North Sands is covered by an annual topographic survey. Every five years, including this baseline survey, coverage is extended further north along North Sands and further south around Hartlepool Headland. Data from the 2008 baseline have been used to create a DGM (Appendix B – Map 1a and</p>	<p>Along Marine Drive, profile HN4 will record any fluctuations that may occur in foreshore level in front of the sea wall. The lower foreshore levels here suggest that during storm events wave action will impact directly on the structure, causing a degree of</p>

Survey Date	Description of Changes Since Last Survey	Interpretation
	<p>part of Map 2a).</p> <p>This shows the generally high beach levels fronting the dunes around Crimdon, the outfall channel of the Beck, and the narrower width of protective berm at the upper beach along the disused industrial frontage. Also notable is how the foreshore levels fronting the Marine Drive sea wall are lower.</p> <p>This DGM has been compared against a similar DGM that was created using survey data collected in March 2000 between North Sands and Newburn Bridge (Appendix B – Map 1b and part of Map 2b). This was collected as a series of 57 beach profiles along this wider frontage at nominally 100m spacings. From these figures, it can be seen that much of the foreshore along North Sands gained material between these dates. A particular concern, however, is the loss of material from the upper beach along a 600m frontage extending north from the end of the Marine Drive sea wall, and a similar distance southwards along this structure.</p>	<p>wave reflection. The changes observed here in upper beach levels between 2000 and 2008 give an indication of the amount of variability already occurring.</p>

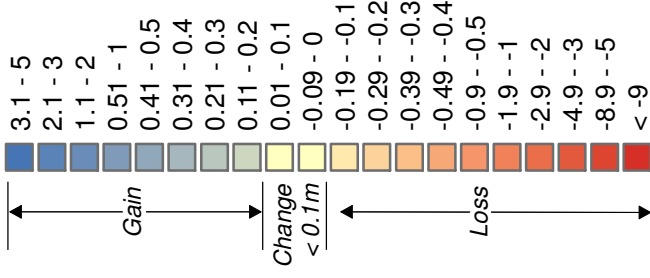
DIFFERENCE BETWEEN TOPOGRAPHIC SURVEYS
March 2000 and Nov 2008

Change in Elevation (m OD)

Survey Date	Description of Changes Since Last Survey	Interpretation
<p>11-2008 (Baseline)</p>	<p>Topographic Survey:</p> <p>Hartlepool Headland is covered by a topographic survey every five years. Data from the 2008 baseline have been used to create a DGM (Appendix B – Map 2a).</p> <p>This shows low foreshore levels fronting the Marine Drive sea wall and even lower foreshore levels around the Headland itself.</p> <p>This DGM has been compared against a similar DGM that was created using survey data collected in March 2000 between North Sands and Newburn Bridge (Appendix B – Map 2b). This was collected as a series of 57 beach profiles along this wider frontage at nominally 100m spacings. From these figures, it can be seen that foreshore levels around the entire headland were notable lower in 2008 than they were in 2000.</p>	<p>Due to low foreshore levels, it is anticipated that the sea walls extending around Hartlepool Headland would be subject to quite severe wave attack. The 2-yearly visual inspections will need to look for evidence of structural damage to the face of the walls and undermining at the toe due to lowering foreshore levels.</p>
