Cell 1 Regional Coastal Monitoring Programme Analytical Report 14: 'Full Measures' Survey 2021

Hartlepool Borough Council

November 2021

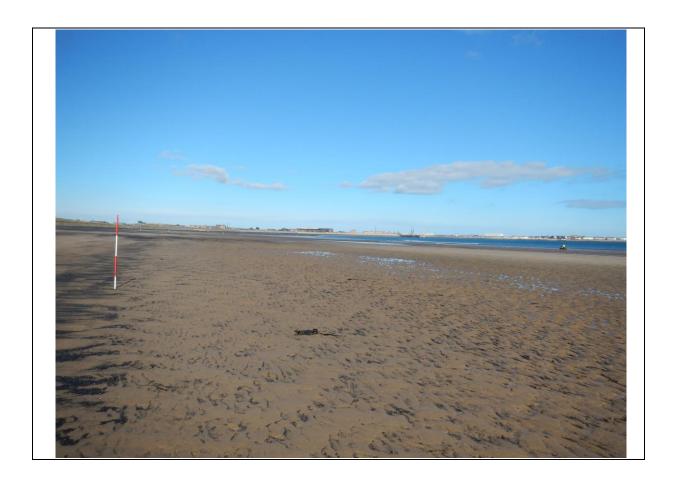
Figure 1 Sediment Cells in England and Wales

The Cell 1 Regional Coastal Monitoring Programme covers approximately 300km of the north east coastline, from the Scottish Border (just south of St. Abb's Head) to Flamborough Head in East Yorkshire. This coastline is often referred to as 'Coastal Sediment Cell 1' in England and Wales (Figure 1). Within this frontage the coastal landforms vary considerably, comprising low-lying tidal flats with fringing salt marshes, hard rock cliffs that are mantled with glacial sediment to varying thicknesses, softer rock cliffs and extensive landslide complexes.

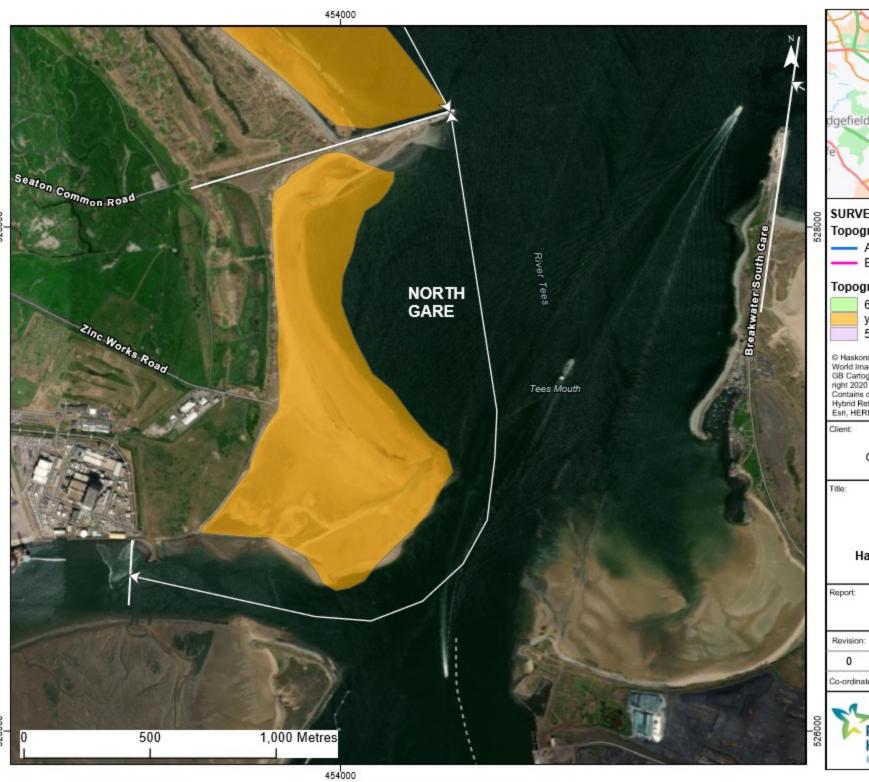
Figure 2 - Map 3

The location of these surveys is shown in Figure 2. The 2021 Full Measures survey was undertaken along this frontage between 19th September and 23rd September 2021. During this time, the weather was generally dry and sunny with force 2 to 5 breezes from variable directions. The sea state at all sites was either calm or moderate. The survey reports from Academy Geomatics document details of the weather conditions over this survey period.

SURVEY LOCATIONS

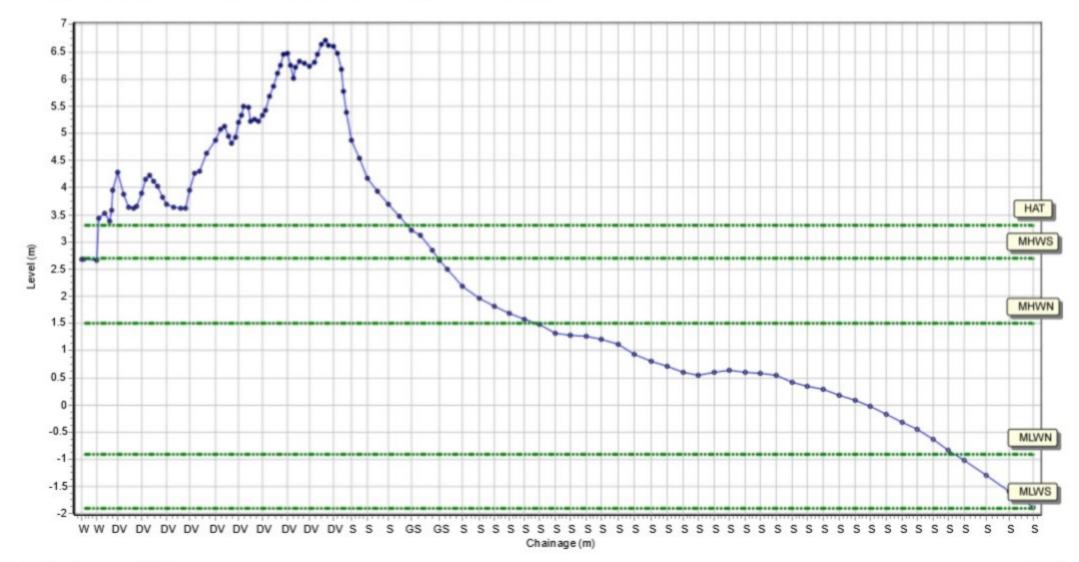
Location: 1cHN1

Survey Date	Description of Changes Since Last Survey	Interpretation
Date	Beach Profiles: North Sands is covered by four beach profile lines during the Full Measures survey (Appendix A). They were last surveyed in April 2021 Profile 1cHN1 is located within Durham County Council's area of responsibility, about 400m north of the outfall of Crimdon Beck, but is reported here so changes can be interpreted in association with those observed elsewhere along North Sands at HN2, HN3 and HN4. The beginning of profile 1cHN1, between 0m and 70m chainage, covers dunes and has remained largely unchanged. The crest of the foredune has accreted 0.1m in level and is at the highest level recorded. The seaward face of this dune remains unchanged. The upper beach has eroded by up to 0.2m in level between chainage 70m and 90m. Between chainage 100m and 260m the beach has accreted, with the most significant accretion occurring between chainage 180m and 200m where an	The dunes at North Sands have generally remained stable since the previous survey, whilst beach levels have predominantly eroded on the upper beach and lower beach and accreted across the middle beach. Longer term trends: The 2021 Full Measures survey is roughly in line with the longer term trends with a a general stability in the middle and east of the survey area. A larger magnitude of change is observed to the west.

20 th -21 th Sep 2021	increase by 1.0m in level is observed. This is the highest level recorded at this chainage. The profile is at a high level across the dunes compared to previous surveys, particularly at the foredune. The upper and middle beach are at a relatively medium level compared to previous surveys, whilst the lower beach is at a high level compared to the range recorded from previous surveys	
	At profile 1cHN2 , the dunes show very little change. Whilst the toe and crest of the foreshore dune are the same, the face of the dune has eroded by 1.0m resulting in the steepening of the upper face. Erosion, up to 0.5m, between chainage 90m and 120m has resulted in the steepening of the upper the beach and the plateauing of the middle beach. The lower beach, seaward of chainage 170m, has eroded by up to 0.5m in level.	
	Profile 1cHN2A was established in October 2011 and runs through the dunes close to North Sands. The dunes, between chainage 0m and 70m have remained stable, experiencing minor accretion and erosion limited to 0.1m. The upper beach has accreted by up to 0.2m between chainage 90m and 120m. The middle and lower beach has alternated between accretion and erosion. Overall, the profile shows a medium level compared with previously recorded surveys, except the face of the foredune

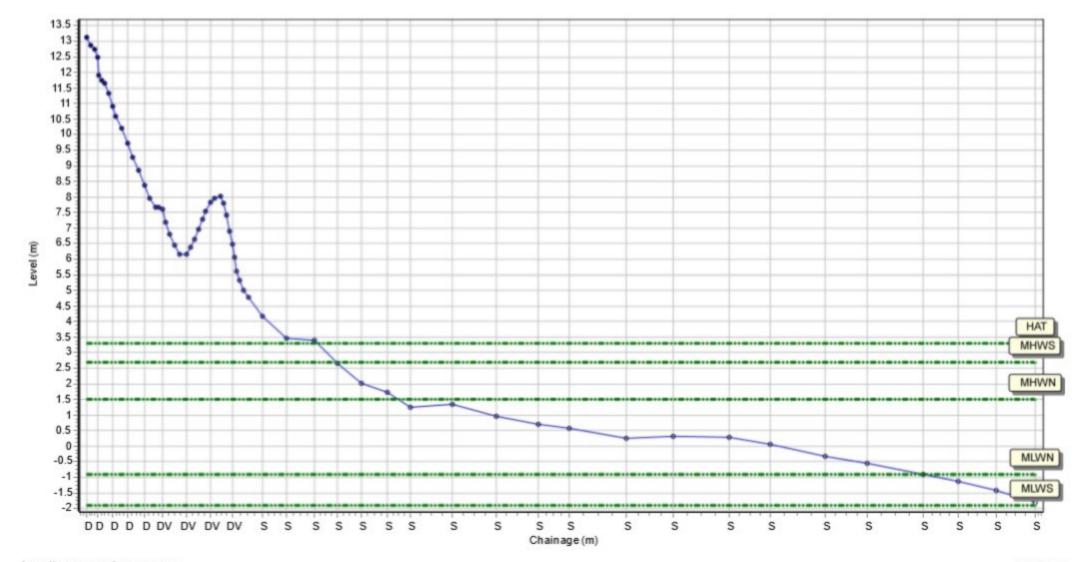
Location: 1cHN3

Survey Date	Description of Changes Since Last Survey	Interpretation
	which remains at its most landward position.	
	At profile 1cHN3 the foredune has accreted by 0.1m in level on the seaward face and by 0.2m on the landward face, making it the largest it has been on record. The toe of the rear dune has been eroded by 0.2m. From chainage 50m to 150m, the upper and middle beach has alternated between accretion and erosion by up to 0.4m. There has been significant accretion on the lower beach by up to 0.8m from chainage 150m to 245m. The dunes are at a high level, whilst the rest of the beach profile is at a medium level compared to the range recorded from previous surveys.	
	At profile 1cHN3A the dune face at 20m chainage has remained unchanged, with the toe of the dune experiencing an accretion of 0.3m. The upper beach has accreted slightly by 0.1m. The beach profile from chainage 65m to 110m has experienced little change. From chainage 110m, the lower beach has accreted by up to 1.0mOverall the level is in the medium range of the previous profiles.

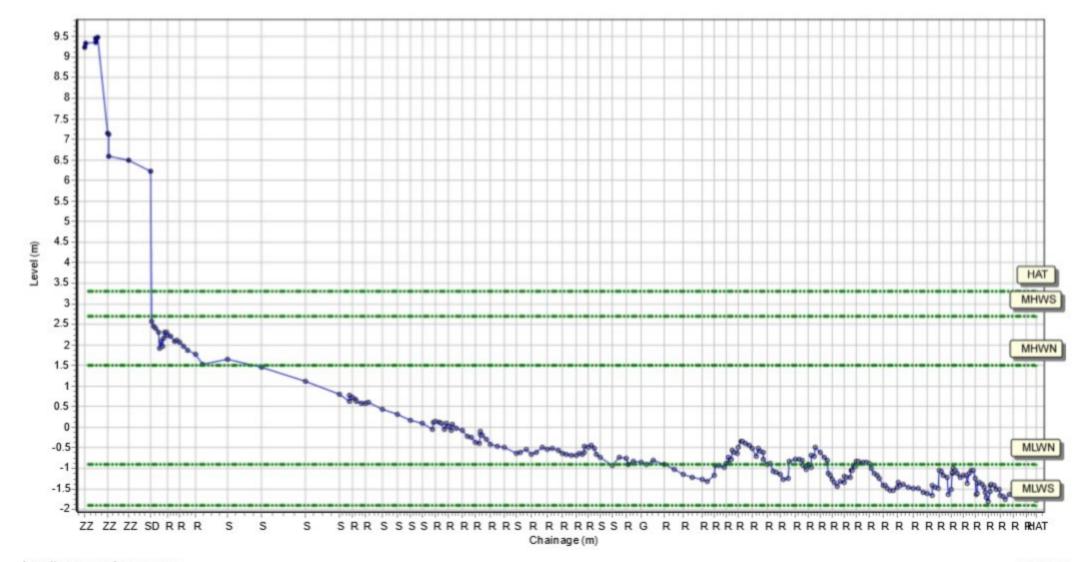
Location: 1cHN4

At profile 1cHN4 there has been an erosion of sediment across the majority of the beach, with the levels dropping between chainage 60m and 140m by up to 0.35m exposing the rocky foreshore in this location, for which is remains exposed until the end of the section at chainage 220m. There has been a slight accretion in sediment between chainage 30m and 60m by 0.2m. Overall, the profile is at a low level compared to the range recorded from previous surveys.	
	At profile 1cHN4a , there has been an accumulation of up to 0.7m of sediment on the upper beach between chainages 10m and 48m, covering up previously exposed rocks. There has been a similar accretion on a section of the middle beach between chainages 56m and 68m. Seaward of this point, there has been little change across the beach profile compared to previous surveys, with apparent minor changes in positions of rocks, although these are likely to be due to the survey techniques. Overall, the profile is at a medium level on the upper beach, and a low level on the middle and lower beach compared to the previous recorded surveys.

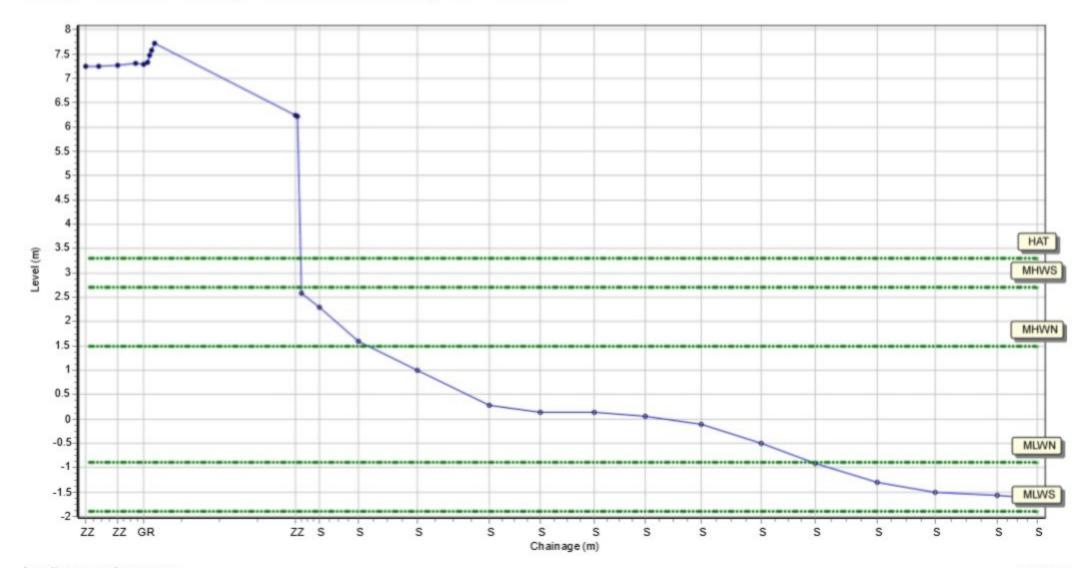
Location: 1cHC1

Survey Date	Description of Changes Since Last Survey	Interpretation
19 th September 2021	Beach Profiles: Middleton is covered by one beach profile line, 1cHC1, during the Full Measures 2020 survey (Appendix A). The survey report again notes that there was no access to the upper section of the profile. At the toe of the seawall, chainage 48m, there has been accretion by 0.65m. This accretion gradually reduced until chainage 85m, where for the next 20m there has been slight erosion of up to 0.2m. Accretion of the middle beach, between chainage 115m and 155m, by 0.25m and erosion of the lower beach, between 155m and 210m, by similar amounts has resulted in the steepening of the lower sections of the beach profile. Overall, the beach is at a medium level, with the exception between chainage 120m and 140m where it is at the highest level on record.	The beach profile showed an accumulation of material at the toe of the sea wall and on the middle beach. The lower beach has eroded. Longer term trends: The beach level at this location tends to fluctuate through the year, with the most variable area being adjacent to the sea wall where wave energy is reflected. There is a pattern of seasonal variation, with lower levels typically recorded in the spring, following the period of winter storms. Recovery tends to occur by the autumn.

At Middleton, there was no access to the upper section of profile 1cHC1.
