**Cell 1 Regional Coastal Monitoring Programme
Update Report 5: 'Partial Measures' Survey 2013**

**Hartlepool Council
Final Report**

June 2013

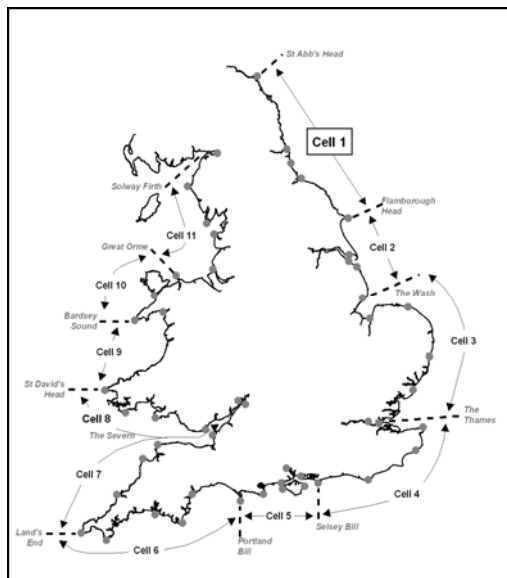
Figure 1 Sediment Cells in England and Wales

The Cell 1 Regional Coastal Monitoring Programme covers approximately 300km of the north east coastline, from the Scottish Border (just south of St. Abb's Head) to Flamborough Head in East Yorkshire. This coastline is often referred to as 'Coastal Sediment Cell 1' in England and Wales (Figure 1).

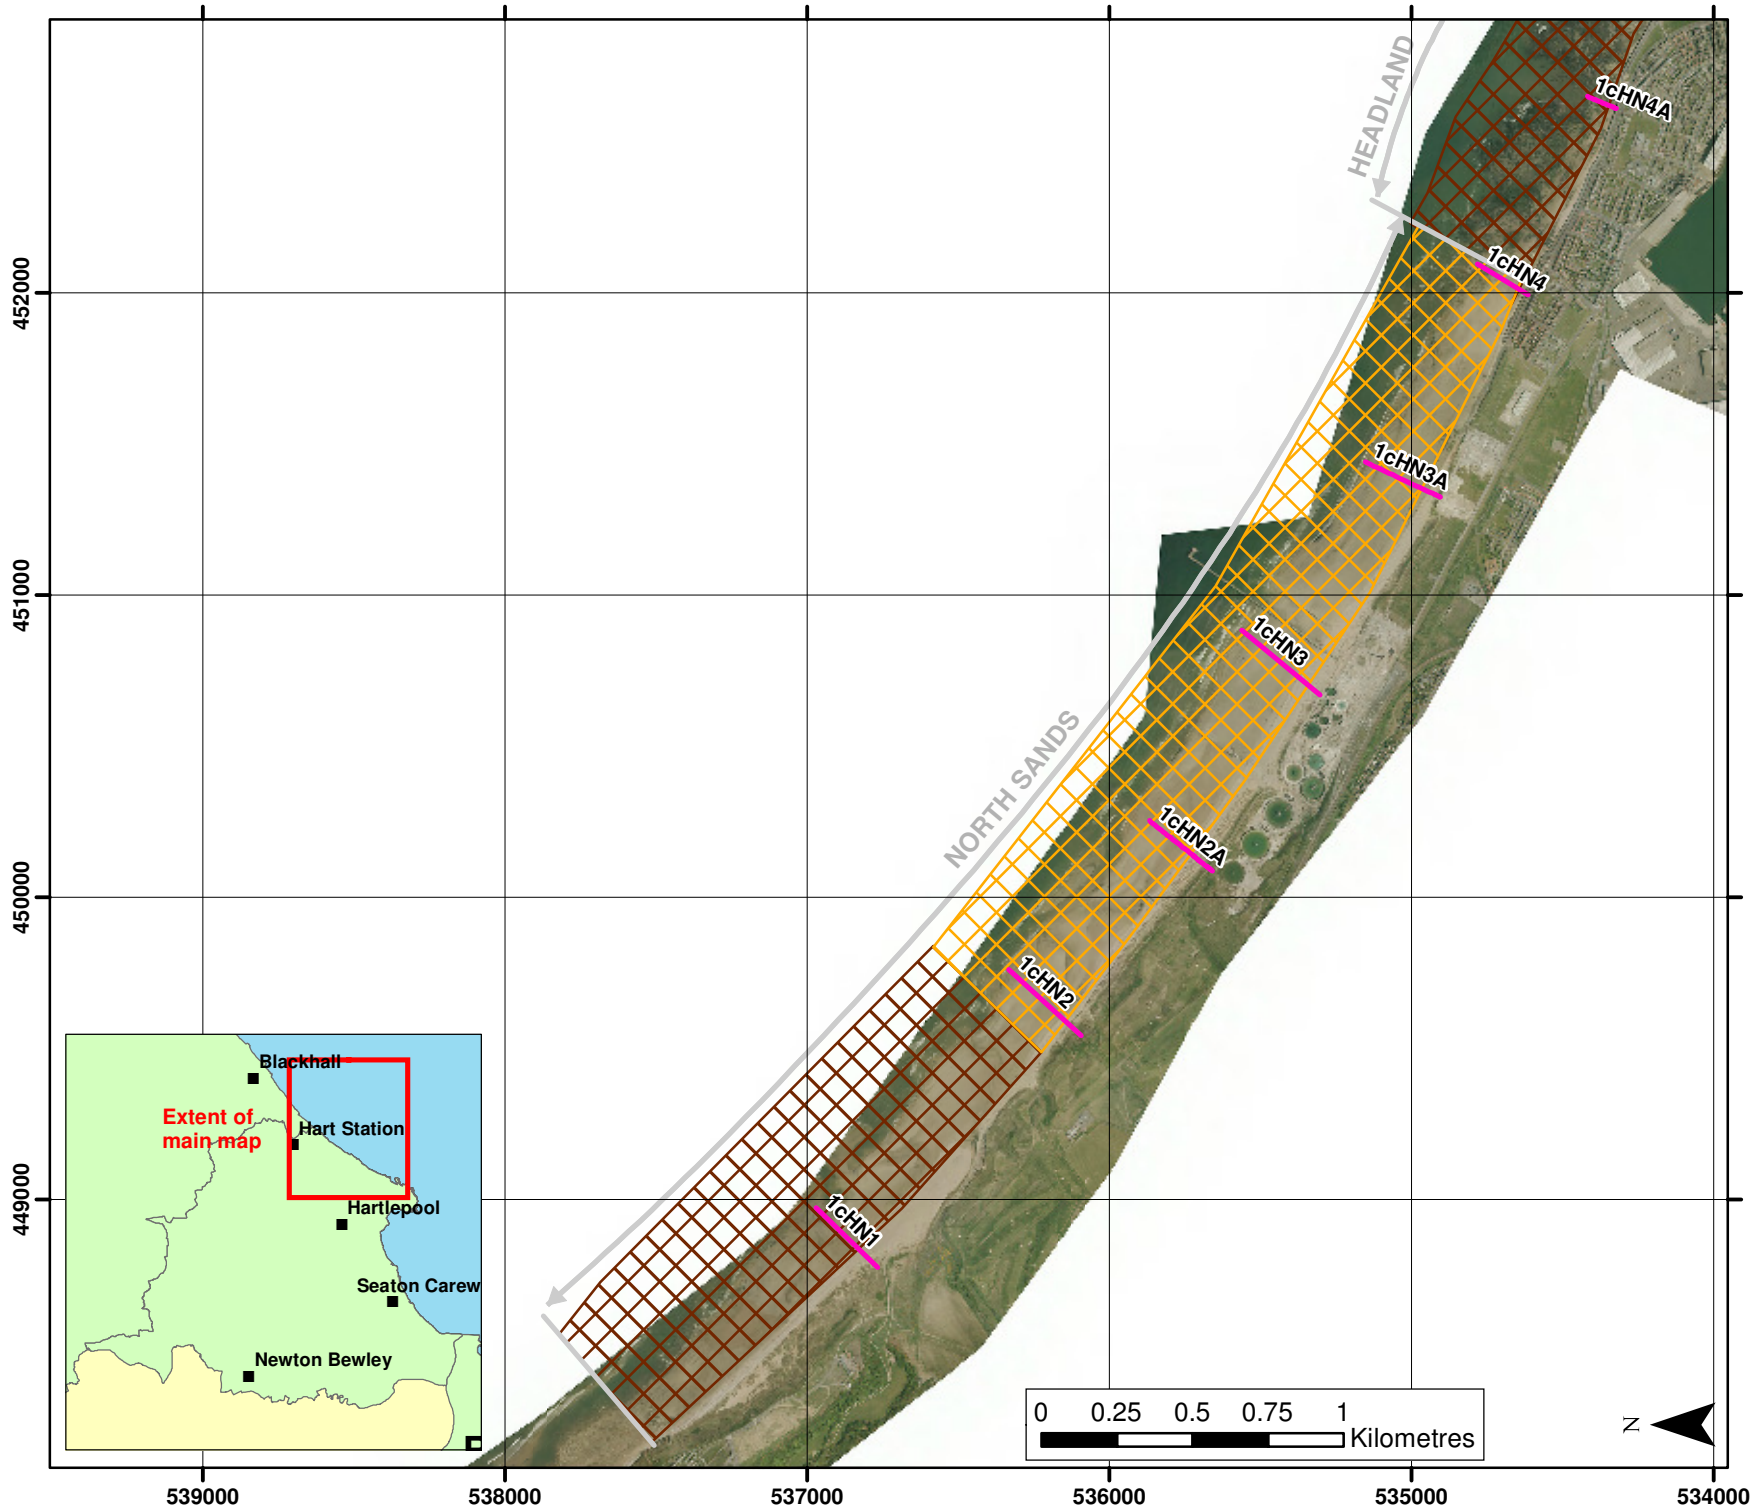
Figure 2 - Map 1
Survey Locations
North Sands
Hartlepool Borough Council

The location of these surveys is shown in Figure 2. The Partial Measures survey was undertaken along this frontage between 9th and 19th April 2013. During this time weather conditions cloudy with sunny spells the sea state was rough for the central and southern surveys, and calm for the northern survey.

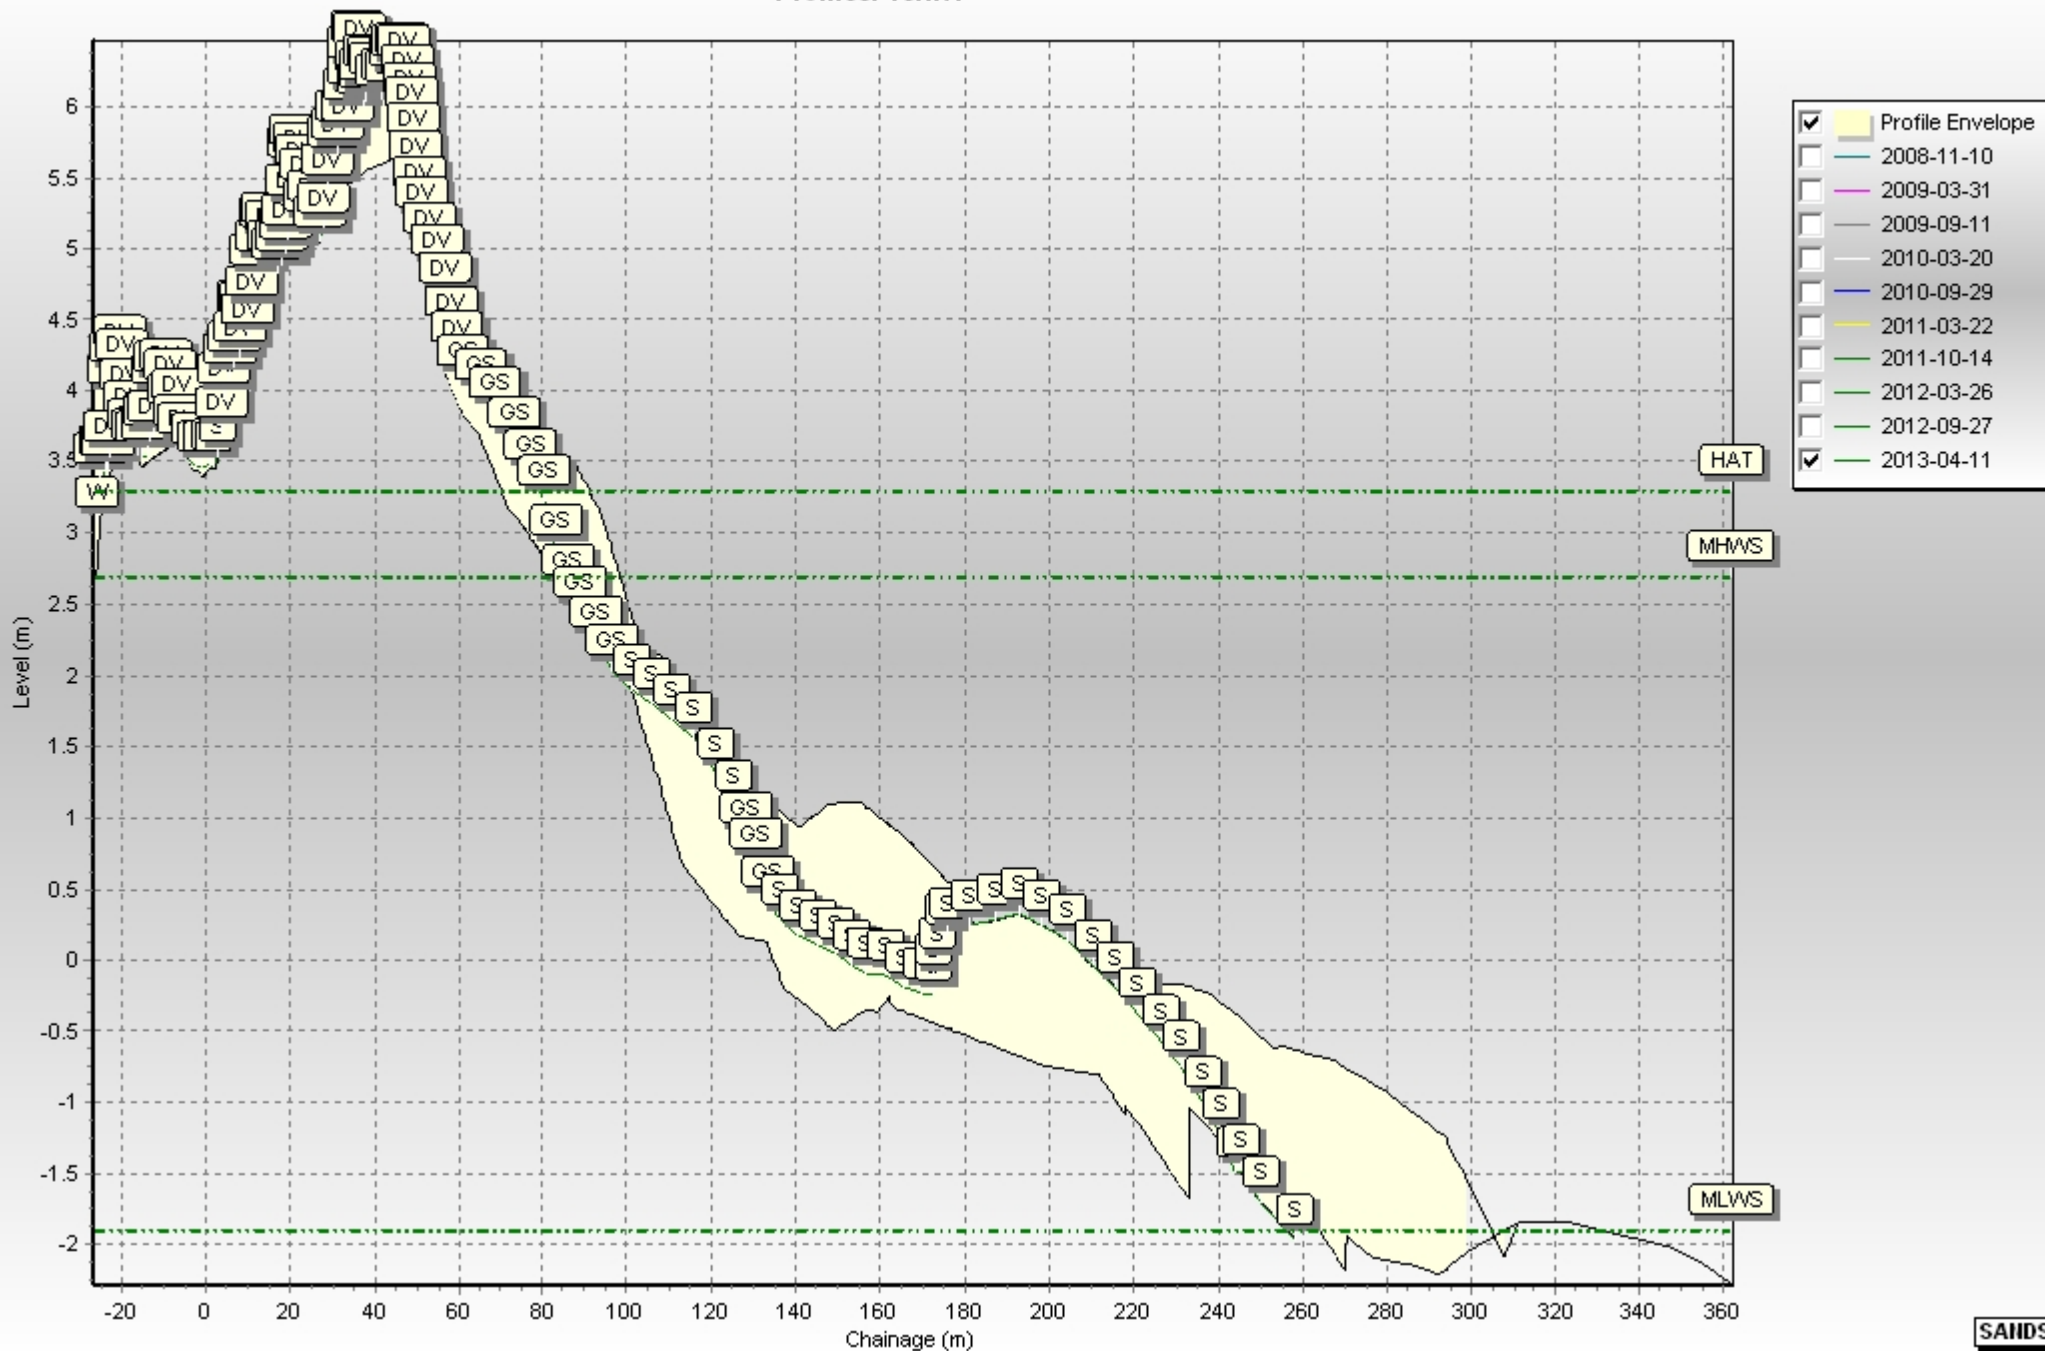
Profiles: 1cHN1

Survey Date	Description of Changes Since Last Survey	Interpretation
11 th April 2013	<p>Beach Profiles:</p> <p>North Sands is covered by four beach profile lines during the Partial Measures survey (Appendix A) that were last surveyed in September 2012.</p> <p>Profile HN1 is located within Durham County Council's jurisdiction, about 400m north of the outfall of Crimdon Beck, but has been reported here so changes can be interpreted in association with those observed elsewhere along North Sands at HN2, HN3 and HN4.</p> <p>The April 2013 profile for HN1 is very similar to the September 2012 profile to the HAT level. Below HAT (80m chainage) the September 2012 and April 2013 profiles are similar, but with some slight erosion around the level of MHWS. From 120m chainage to 175m chainage the beach level has dropped and is 0.5m below the level of the April 2013 profile. Between 175m to 230m the beach has accreted a sand bar and is 0.5m higher than the profile from September 2012. At the base of the profile close to MLWS the beach level in April 2013 was the lowest since 2010.</p> <p>Profile HN2 shows stability from 0m to 60m chainage. Between 60m and 110m chainage up to 1m has been eroded from the beach between September 2012 and April 2013. At 120m and 180m chainage the sand bars in the April 2013 profile mean that the beach level is similar to the level in September 2012. Between these two sand bars there is a depression where the profile is 0.5m lower than in September 2012. At its base the April 2013 profile records the lowest beach level seen since 2008.</p> <p>Profile HN2a was established in October 2011 and runs through the dunes close North Sands. The part of the survey over the dunes to 70m chainage has remained stable since October 2011. Between 70 and 80m chainage a small sand bar directly in front of the dune has grown by 0.5m. From 80m chainage to the end of the survey at 250m the beach level has dropped to its lowest level, which is 0.5m below the September 2012 level.</p> <p>At Profile HN3 the peak in the profile at 35m chainage, which has been progressively accreting since 2008, has grown in March 2013. From 65m to 145m chainage the beach has eroded and is 0.5m lower</p>	<p>The profiles are low for much of intertidal zone when compared to others surveyed following winter storms, which suggests the winter of 2012/13 was particularly severe. The profiles have developed sand bars on the lower beach, which are likely to be formed from material drawn down from the upper beach in storms. Many of the profiles are very low at the landward extent of the survey and HN4 was so low that the underlying rock shore platform was exposed.</p> <p>Longer term trends:</p> <p>All the profiles appear to be stable above the HAT line with variation of the beach below. At HN1 and HN2 the beach levels were reasonably similar to the range of beach levels observed since 2008.</p> <p>The beach levels at profiles HN2a HN3a and HN4a are the lowest since the surveys began in October 2011. At HN3 and HN4 the beaches are low compared to the profiles since 2008, to the point where the rocks are exposed on HN4. However, the peak at HN3 still continues to progressively accrete. Although the beach levels are low it is anticipated that they will recover over the summer months.</p>

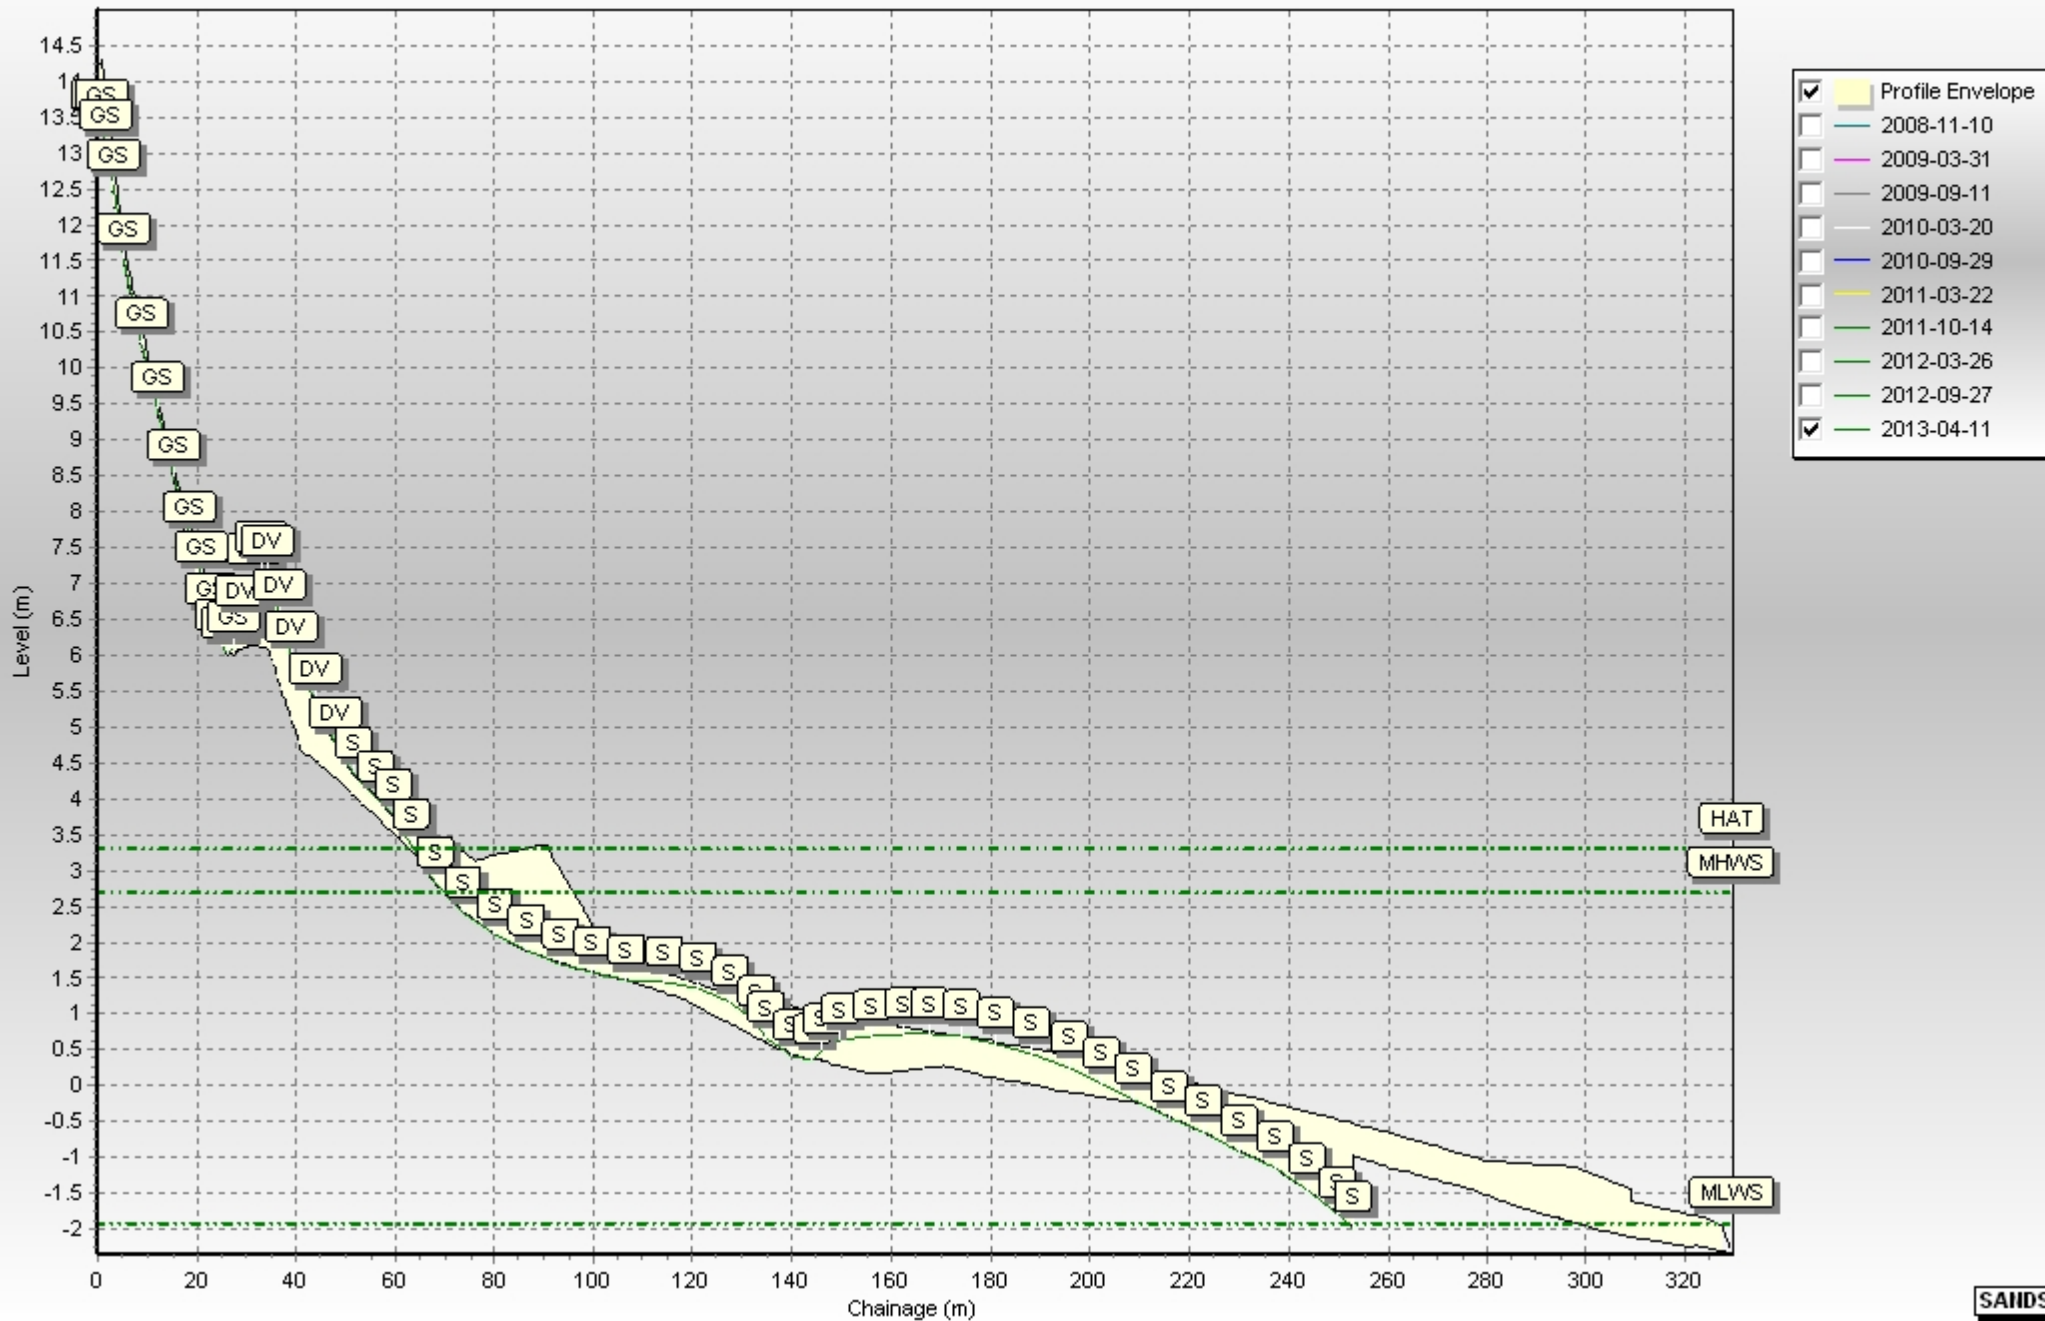
Profiles: 1cHN3

Survey Date	Description of Changes Since Last Survey	Interpretation
	<p>than in September 2012. Below 145m there is a mound in the profile followed by a rapid drop in level at the end of the profile.</p> <p>At Profile HN3a the part of the frontage above HAT has changed little since the profile was established in October 2011. From 25m chainage to the end of the survey at 250m the beach level has dropped by around 0.5m and a bar has formed in the mid-beach.</p> <p>Profile HN4 has not changed down to the HAT level. At the base of the sea wall near MHWS the beach has eroded. From the base of the seawall at 15m chainage to 40m chainage the beach and the level has dropped by 0.3m. Between 40m and 90m chainage the beach had accreted by 0.3m. From 90m chainage to the end of the survey at 210m the beach level has dropped by 0.5m. The uneven section of profile is interpreted as rocks on the lower beach that are usually covered by sediment.</p> <p>Profile HN4a was established in October 2011. The defended part of the profile to 10m chainage has not changed since October 2011. The shore platform is exposed for much of the survey, which is due to a 0.8m drop in beach level since September 2012.</p>

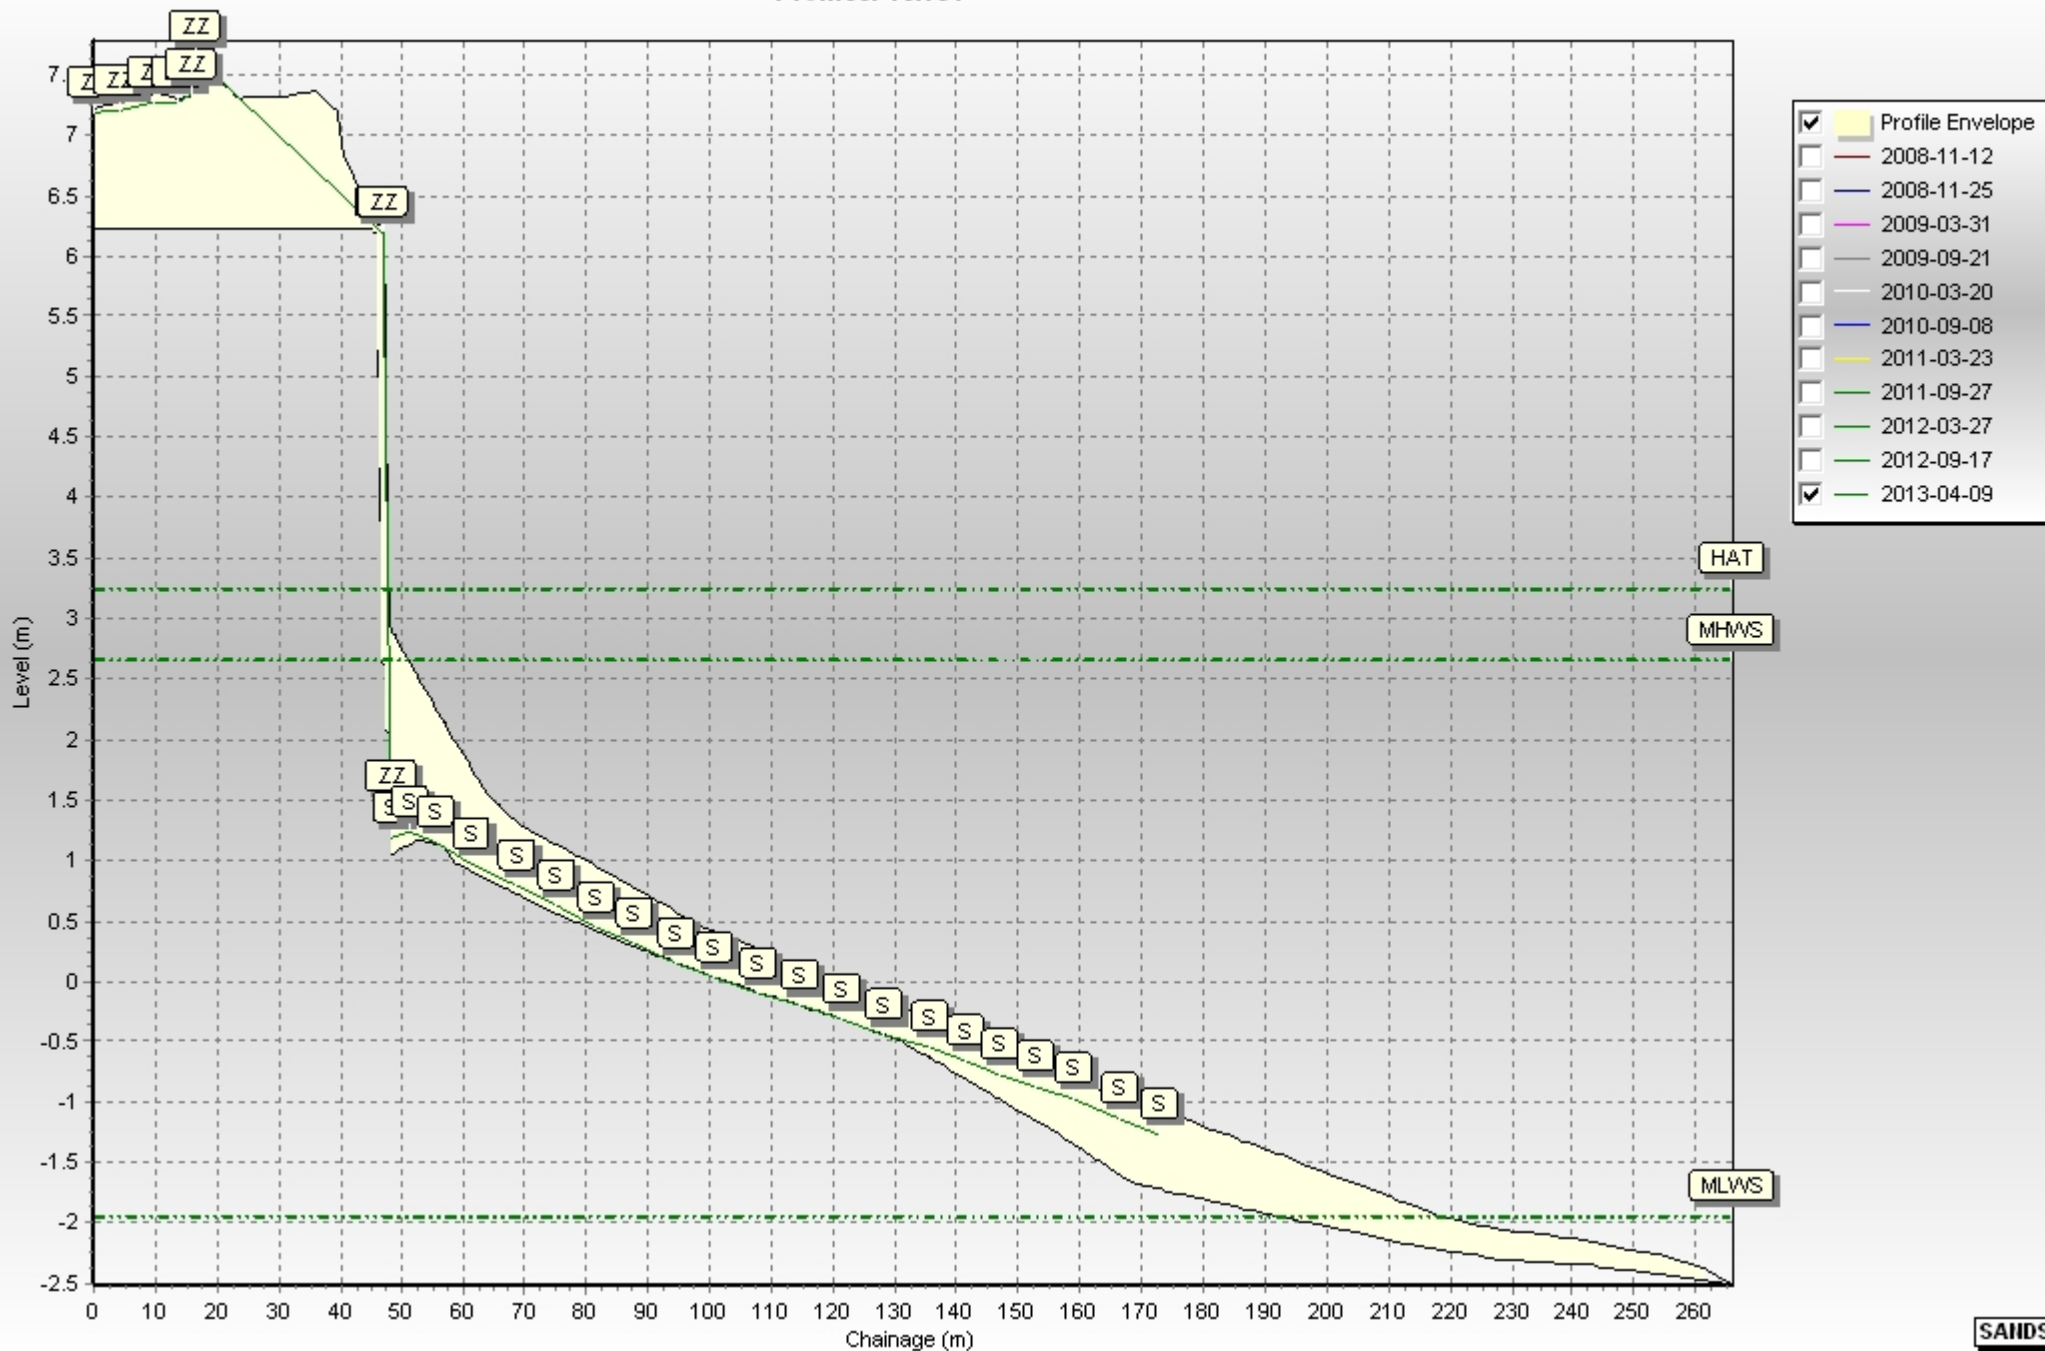
Profiles: 1cHC1

Survey Date	Description of Changes Since Last Survey	Interpretation
9 th April 2013	<p>Beach Profiles:</p> <p>Middleton is covered by one beach profile line during the Partial Measures survey (Appendix A). The profile was last surveyed in September 2012.</p> <p>Profile HC1 is a gentler slope than the September 2012 survey. The upper beach between the sea wall at 45m chainage and 130m chainage has eroded by up to 0.8m. From 130m chainage to the end of the survey near MLWS the beach has accreted by around 0.5m.</p>	<p>The beach was at a low level compared to the previous surveys, as can be expected following winter storms.</p> <p>Longer term trends: The beach level at this location tends to fluctuate through the year, with the most variable area being adjacent to the sea wall where wave energy is reflected. There a seasonality to the variability, with lower levels typically recorded in the spring, following winter storms.</p>

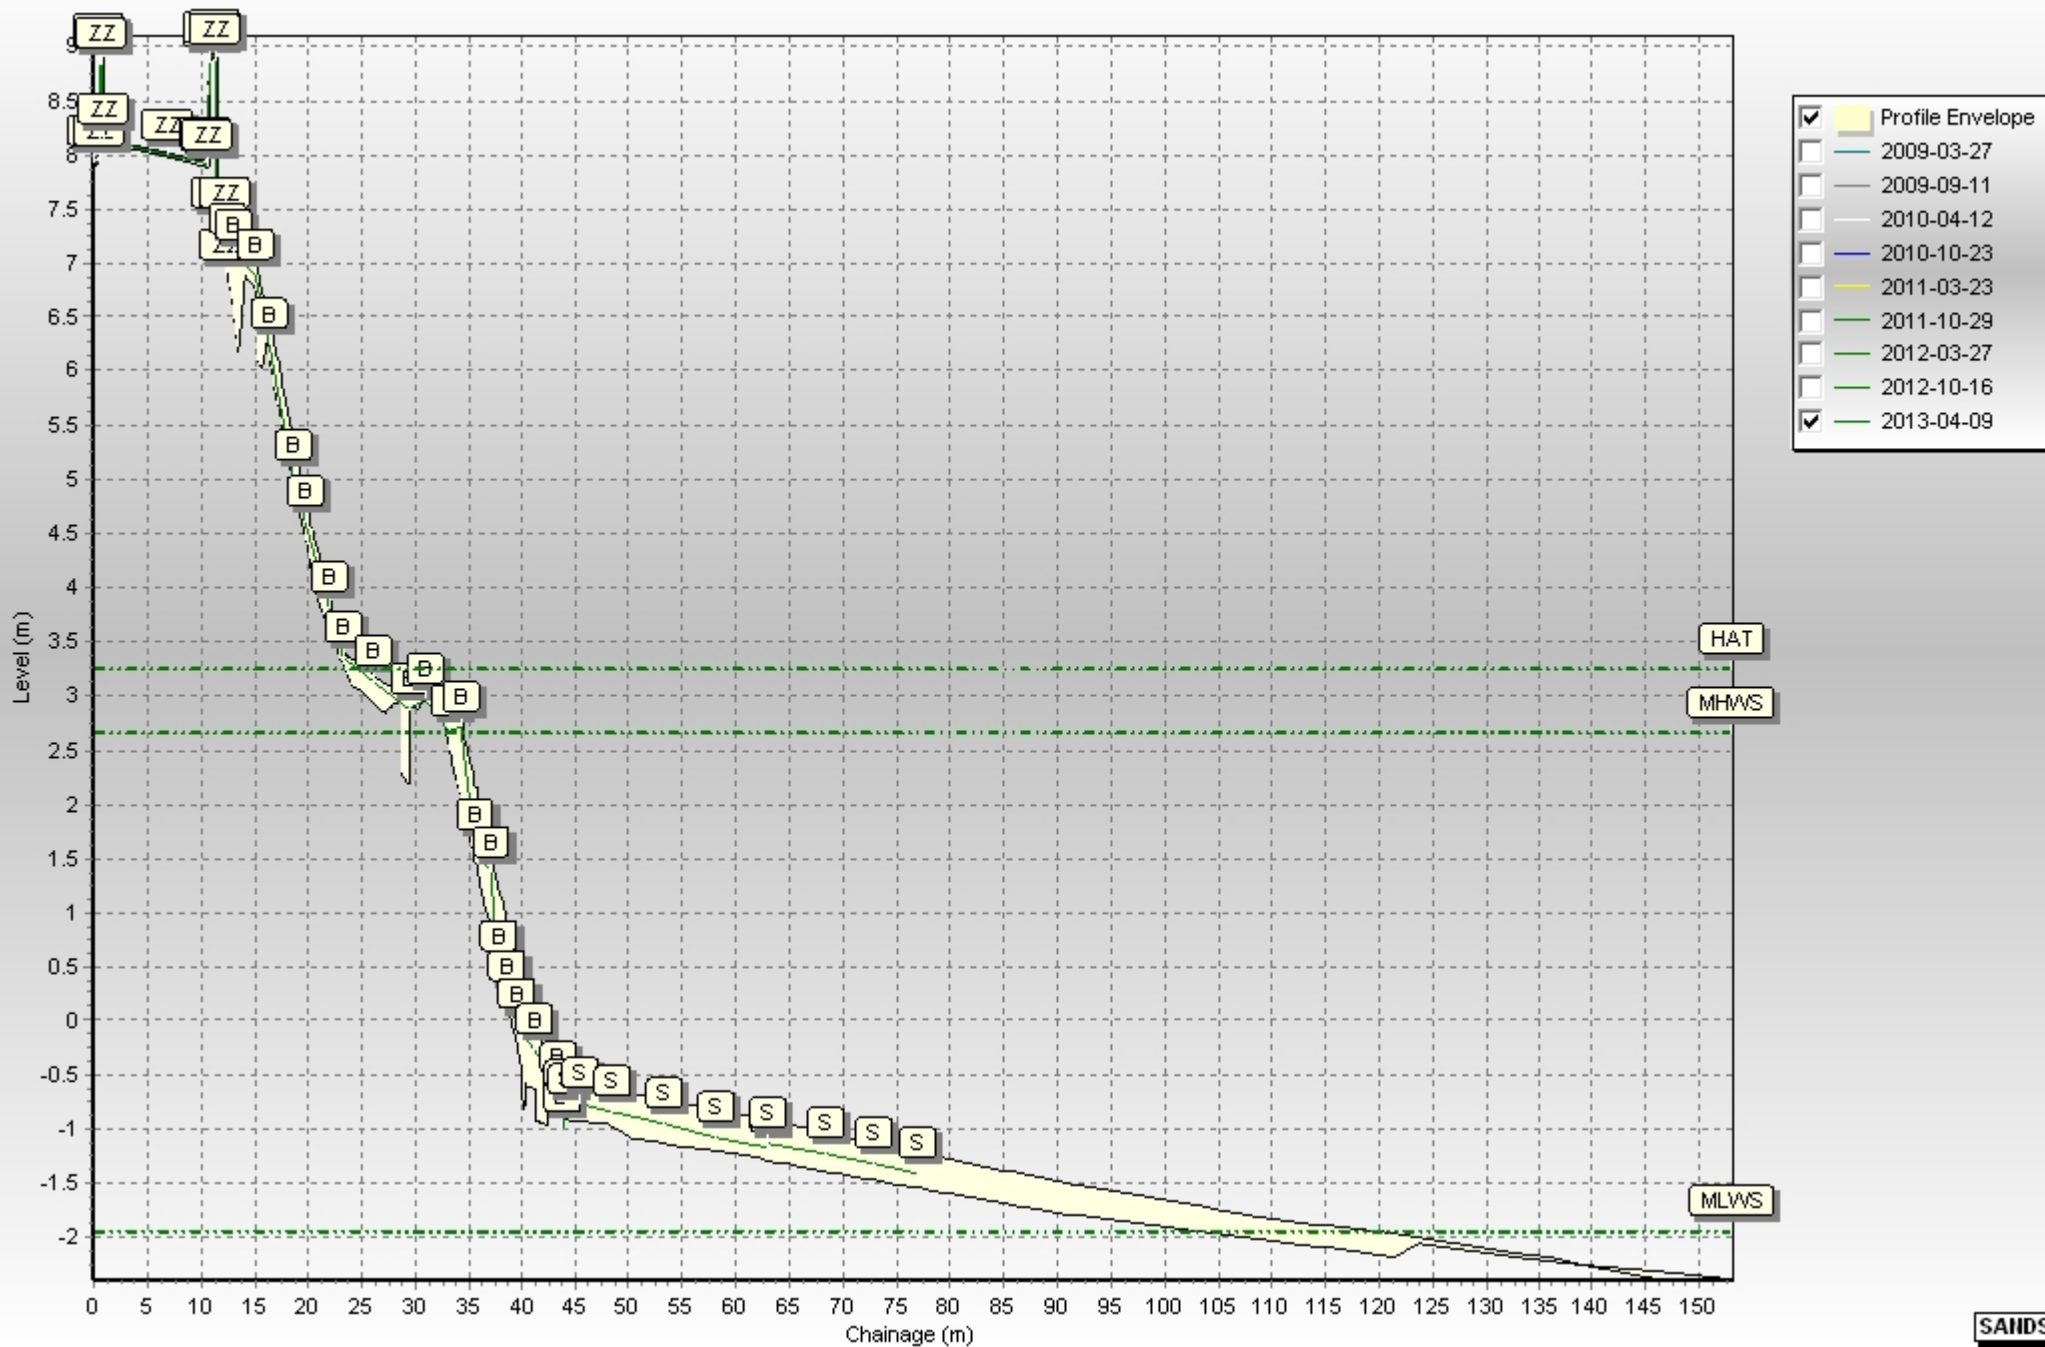
Profiles: 1cHS1

Survey Date	Description of Changes Since Last Survey	Interpretation
9 th April 2013	<p>Beach Profiles:</p> <p>Hartlepool Bay is covered by four beach profile lines during the Partial Measures survey (Appendix A). The profiles were last surveyed in October 2012.</p> <p>Profile HS1 is located approximately 150m south of the root of the South Pier. The profile starts at the wall to the rear of the promenade and extends over the fronting concrete splash wall and down the sloping face of the rock armour revetment before reaching the beach. The majority of changes in the profile occur beyond 40m chainage. The April 2013 profile stops in the mid-beach at 75m chainage because sea defence construction works inhibited safe access.</p> <p>Profile HS2 shows very little difference between the April 2013 and October 2012 profiles above the MHWS level at 20m chainage. Between 30 and 190m chainage the April 2013 profile is 0.2-0.5m lower than the October 2012 profile. Below 190m chainage the beach is 0.2m higher than the October 2012 profile.</p> <p>At profile HS3 the April 2013 and October 2012 profiles are very similar to the MLWS level at 30m chainage. From 30m to 205m chainage the beach has eroded by up to 0.3m. From 203m chainage to the end of the survey a mound of material has been formed and the beach has accreted by 0.6m.</p> <p>Profile HS4 is located around 1km north of the North Gare Breakwater, within the area of undefended dunes at Seaton Carew. The main dune ridge has remained very stable over time. However, there was a fore dune developing on the seaward face in October 2010, which was reduced in crest height and moved seaward by October 2012 and April 2013. Between the MHWS level at 360m chainage and 400m chainage around 0.4m of material has been lost. From 400m to 460m change the beach has accreted by 0.5m and a mound has formed. From 460m onwards the beach level in the April 2013 profile drops quickly and is up to 1m lower than in October 2012.</p>	<p>The beach level at HS1 is low at the toe of the defence but then recovers and is in the middle of the previous recorded values down to the mid-beach and the end of the profile.</p> <p>HS2 and HS3 show that the upper beach levels have dropped since October 2012 and a sand bar has formed on the lower beach.</p> <p>The mounds of material on HS2 and HS3 are likely to be due to the sea defence construction works on beach. The surveyors noted “deep excavations with corresponding spoil heaps”. The mound and very low beach on HS4 are therefore likely to be related to construction works.</p> <p>Longer term trends: The April 2013 profiles cannot be put into the wider context of the previous beach profiles because they are incomplete or altered by beach management. Response of the beaches to this engineering can be monitored in coming years.</p>

Academy Geomatics note that the Hartlepool Bay profiles were affected by the sea defence construction works taking place on beach. There were deep excavations and corresponding spoil heaps. The new sea wall was finished at profile HS3.
