Cell 1 Regional Coastal Monitoring Programme Update Report 15: 'Partial Measures' Survey 2023

Hartlepool Borough Council

June 2023

(*) The present report is **Update Report 15** and provides an analysis of the 2023 Partial Measures survey for Hartlepool Council's frontage.

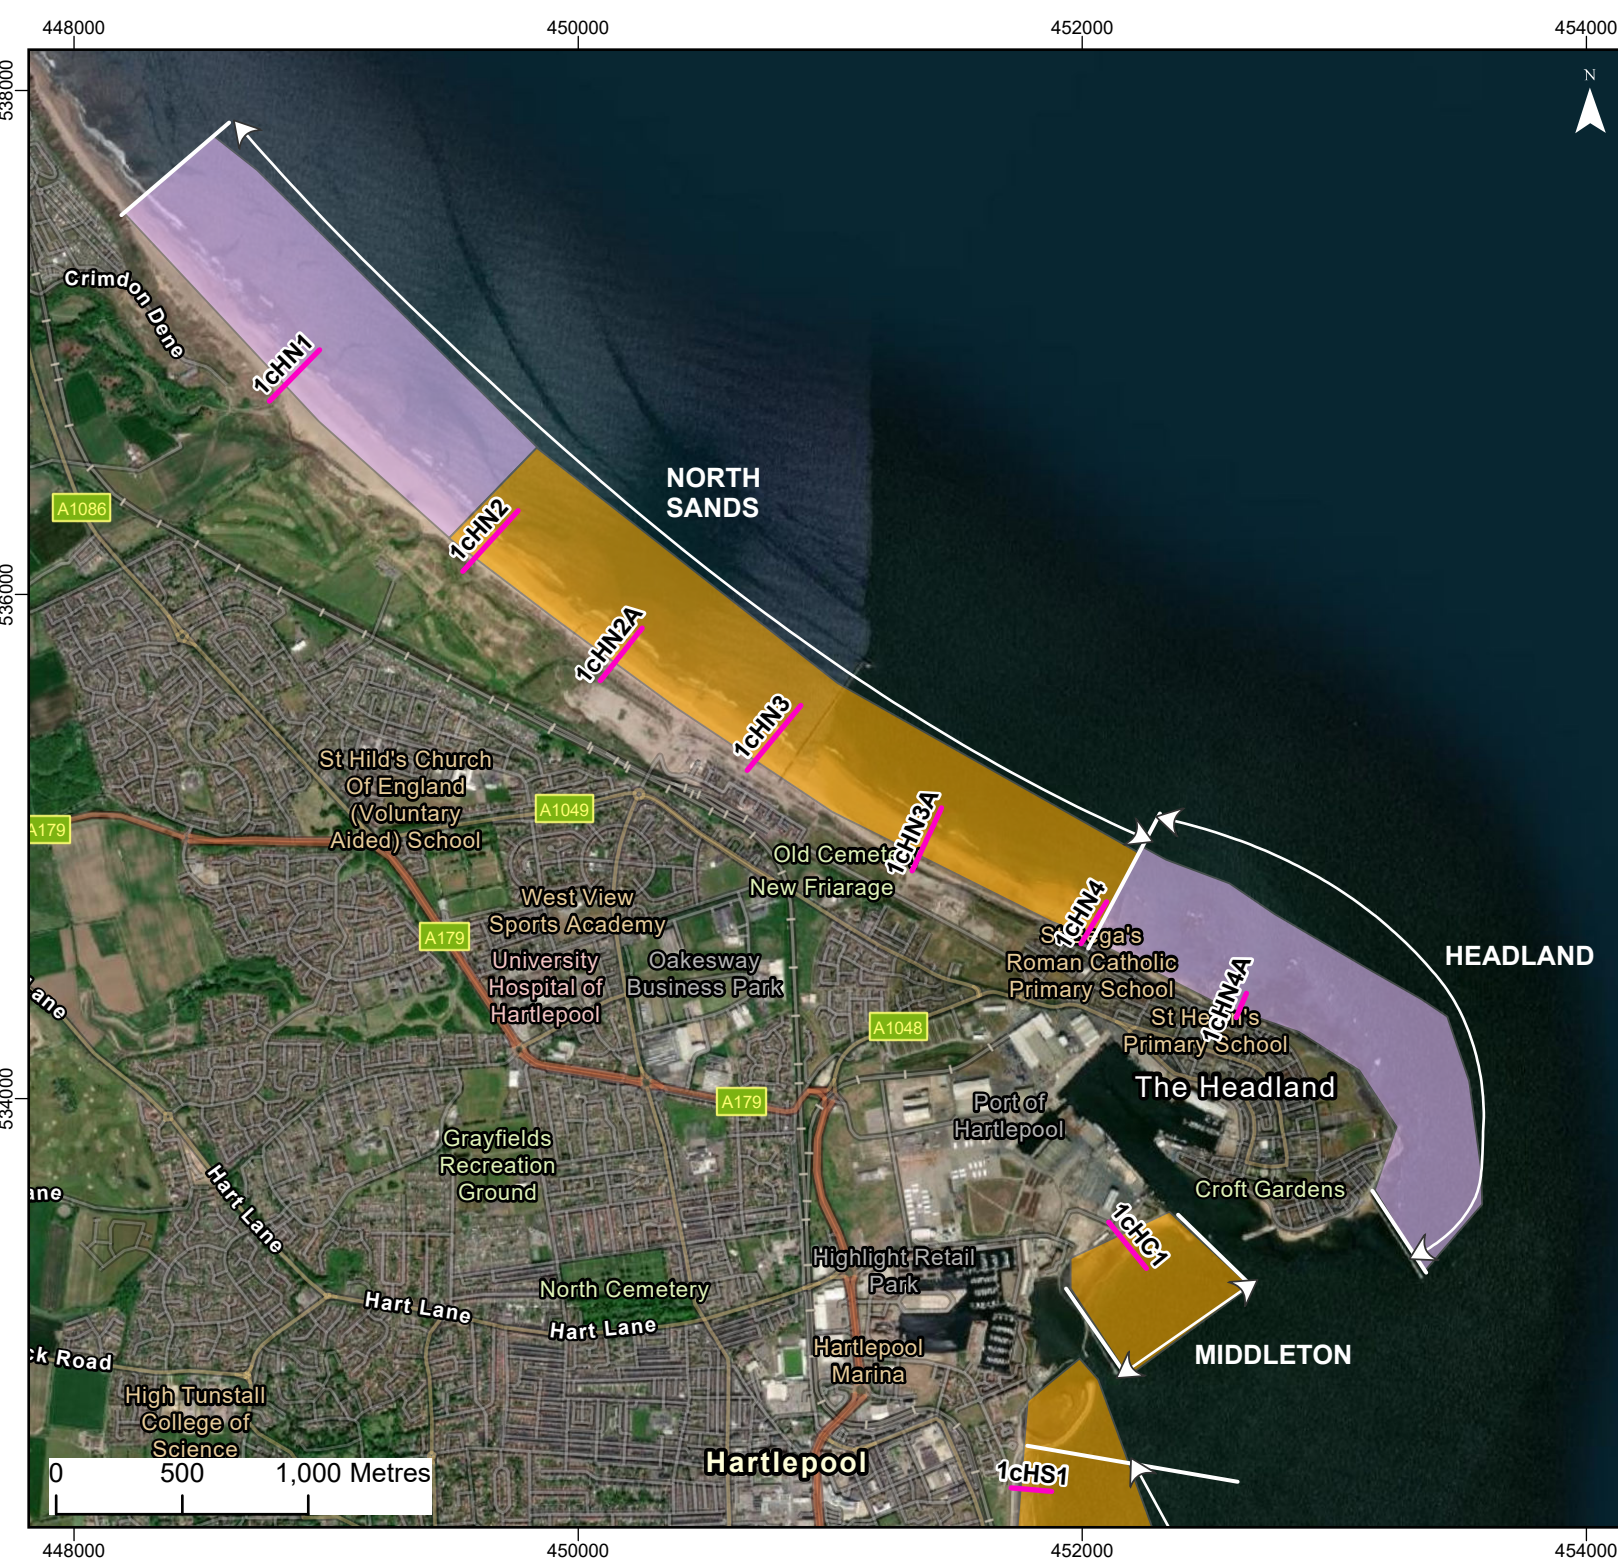
Figure 2 - Map 1

SURVEY LOCATIONS

Topographic Profile

- Annual (Blue line)
- Bi-Annual (Pink line)

Topographic Area

- 6 monthly (Light Green)
- yearly (Yellow)
- 5 yearly (Purple)

NORTH SANDS, HEADLAND, MIDDLETON

The location of these surveys is shown in Figure 2. The Partial Measures survey was undertaken along this frontage on the 24th and 25th April 2023. During this time, the weather conditions varied. Full details of the weather conditions can be found in the surveyor's reports.

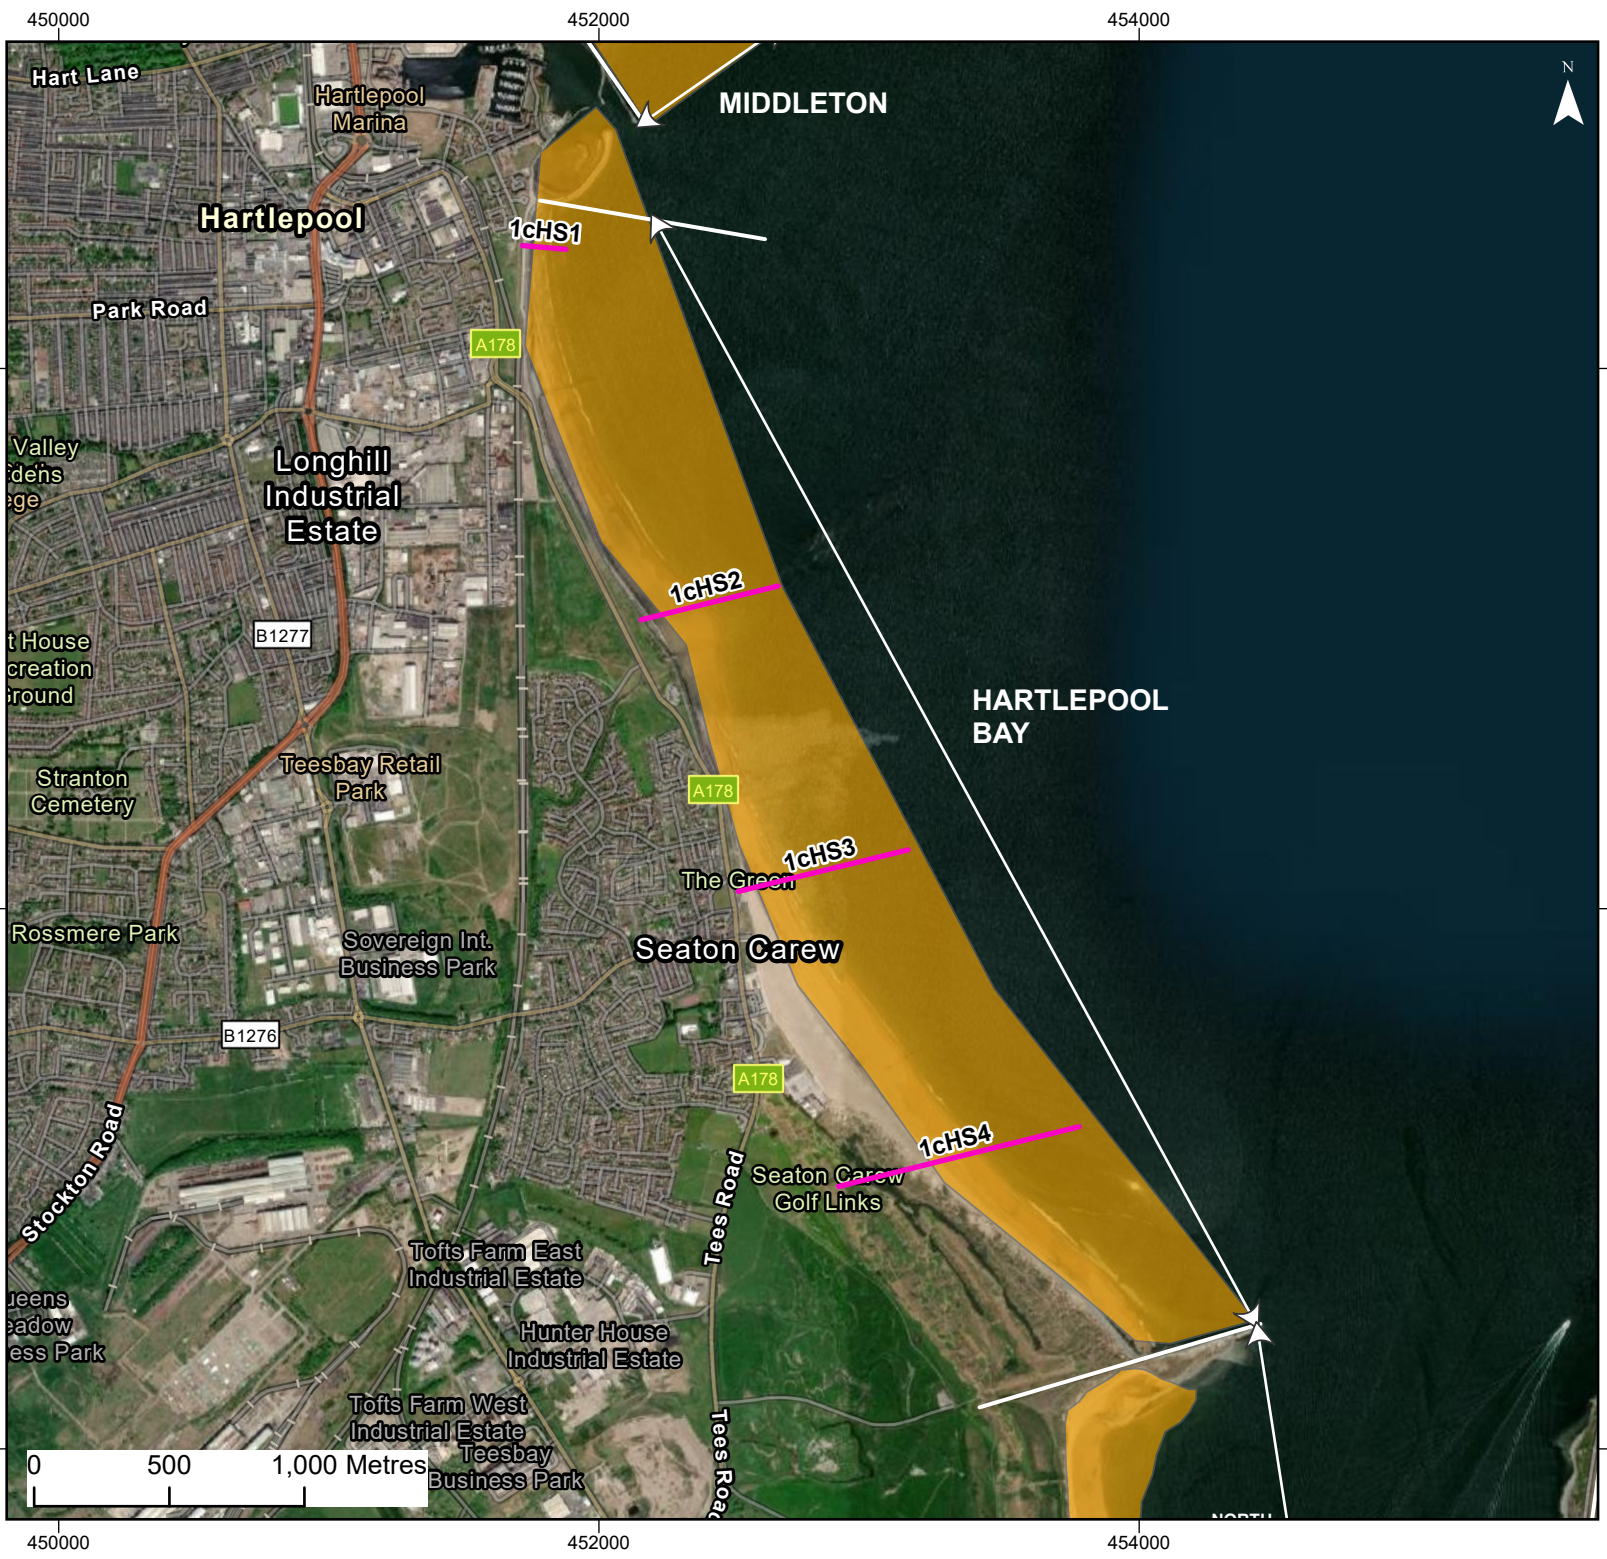
Figure 2 - Map 2

SURVEY LOCATIONS

Topographic Profile

- Annual (Blue line)
- Bi-Annual (Pink line)

Topographic Area

- 6 monthly (Light Green)
- yearly (Yellow)
- 5 yearly (Light Purple)

HARTLEPOOL BAY

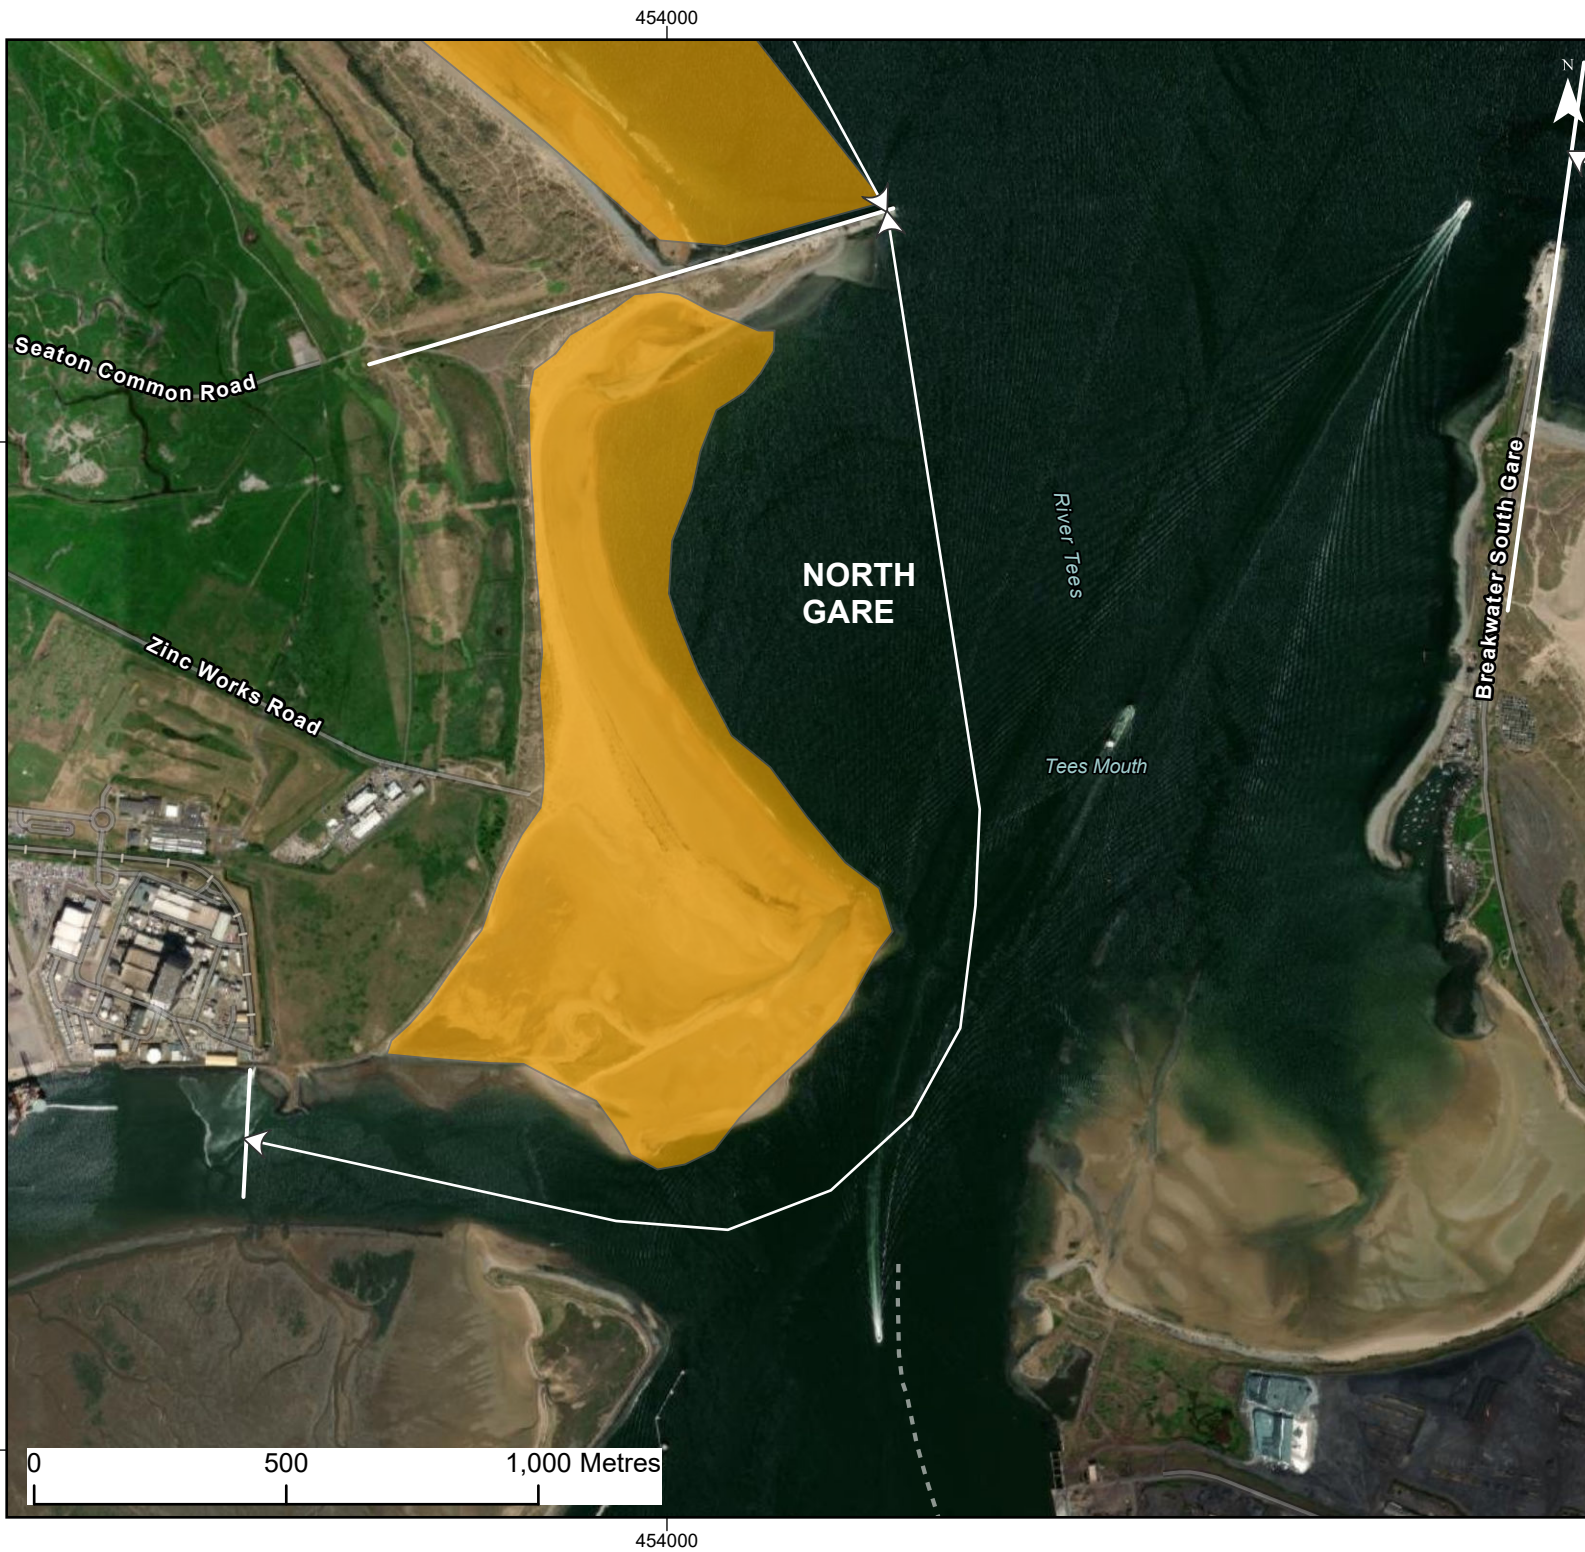
Title: **Figure 2 - Map 3**
NORTH GARE
Hartlepool Borough Council Frontage

SURVEY LOCATIONS

Topographic Profile

- Annual
- Bi-Annual

Topographic Area

- 6 monthly
- yearly
- 5 yearly

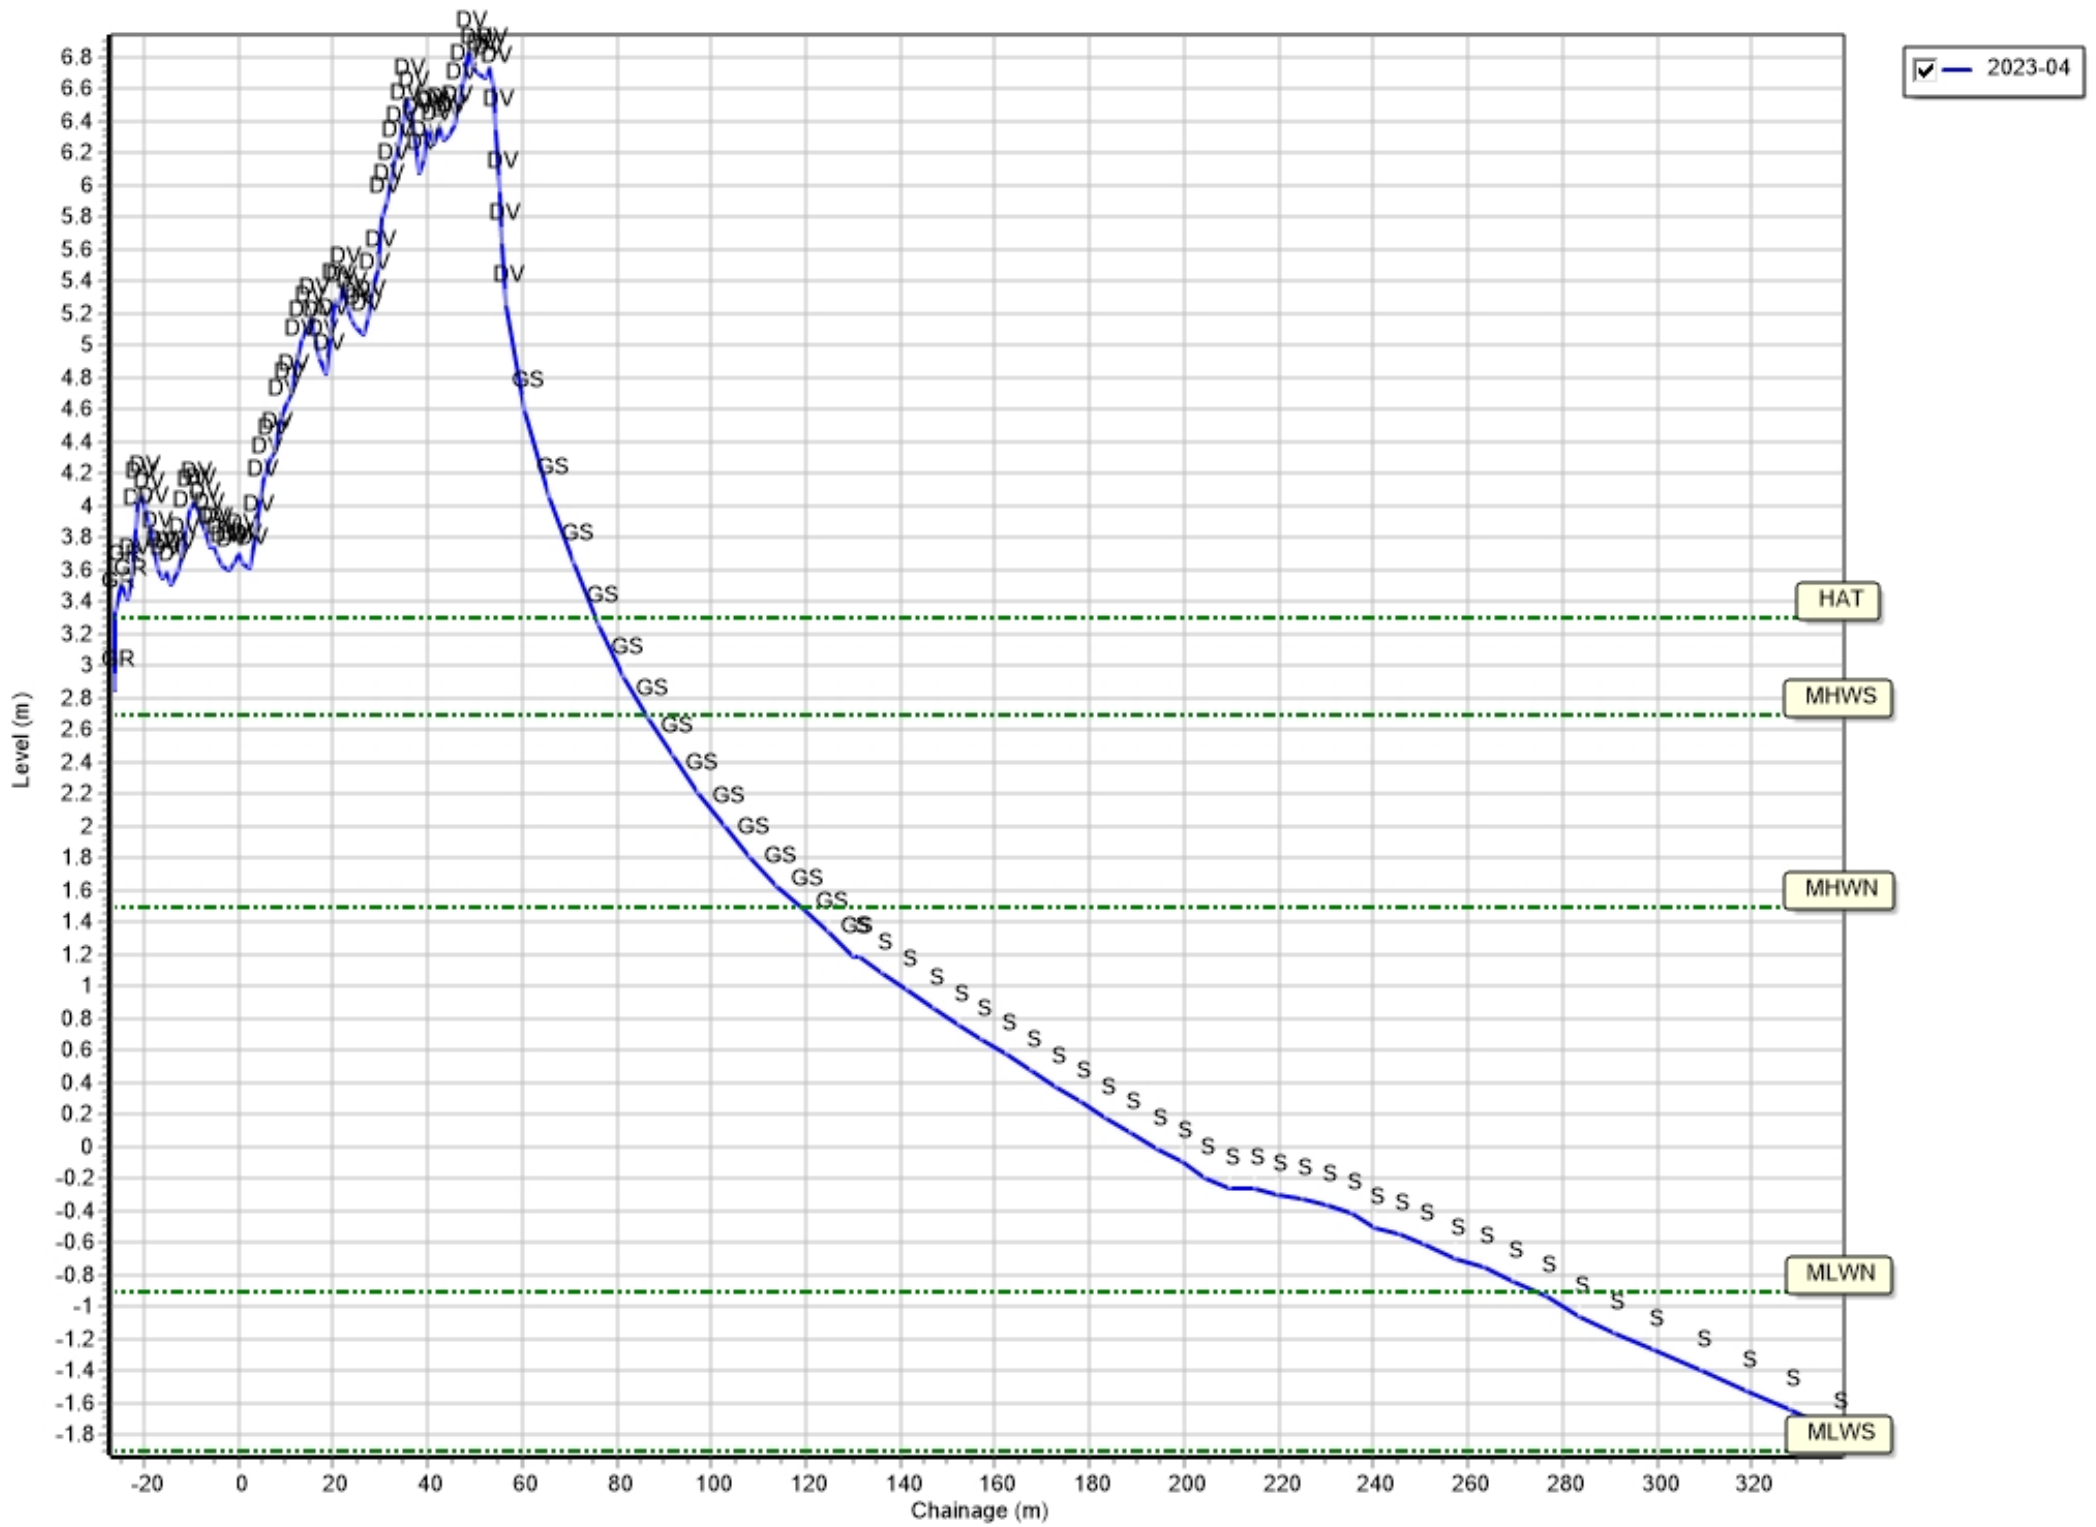
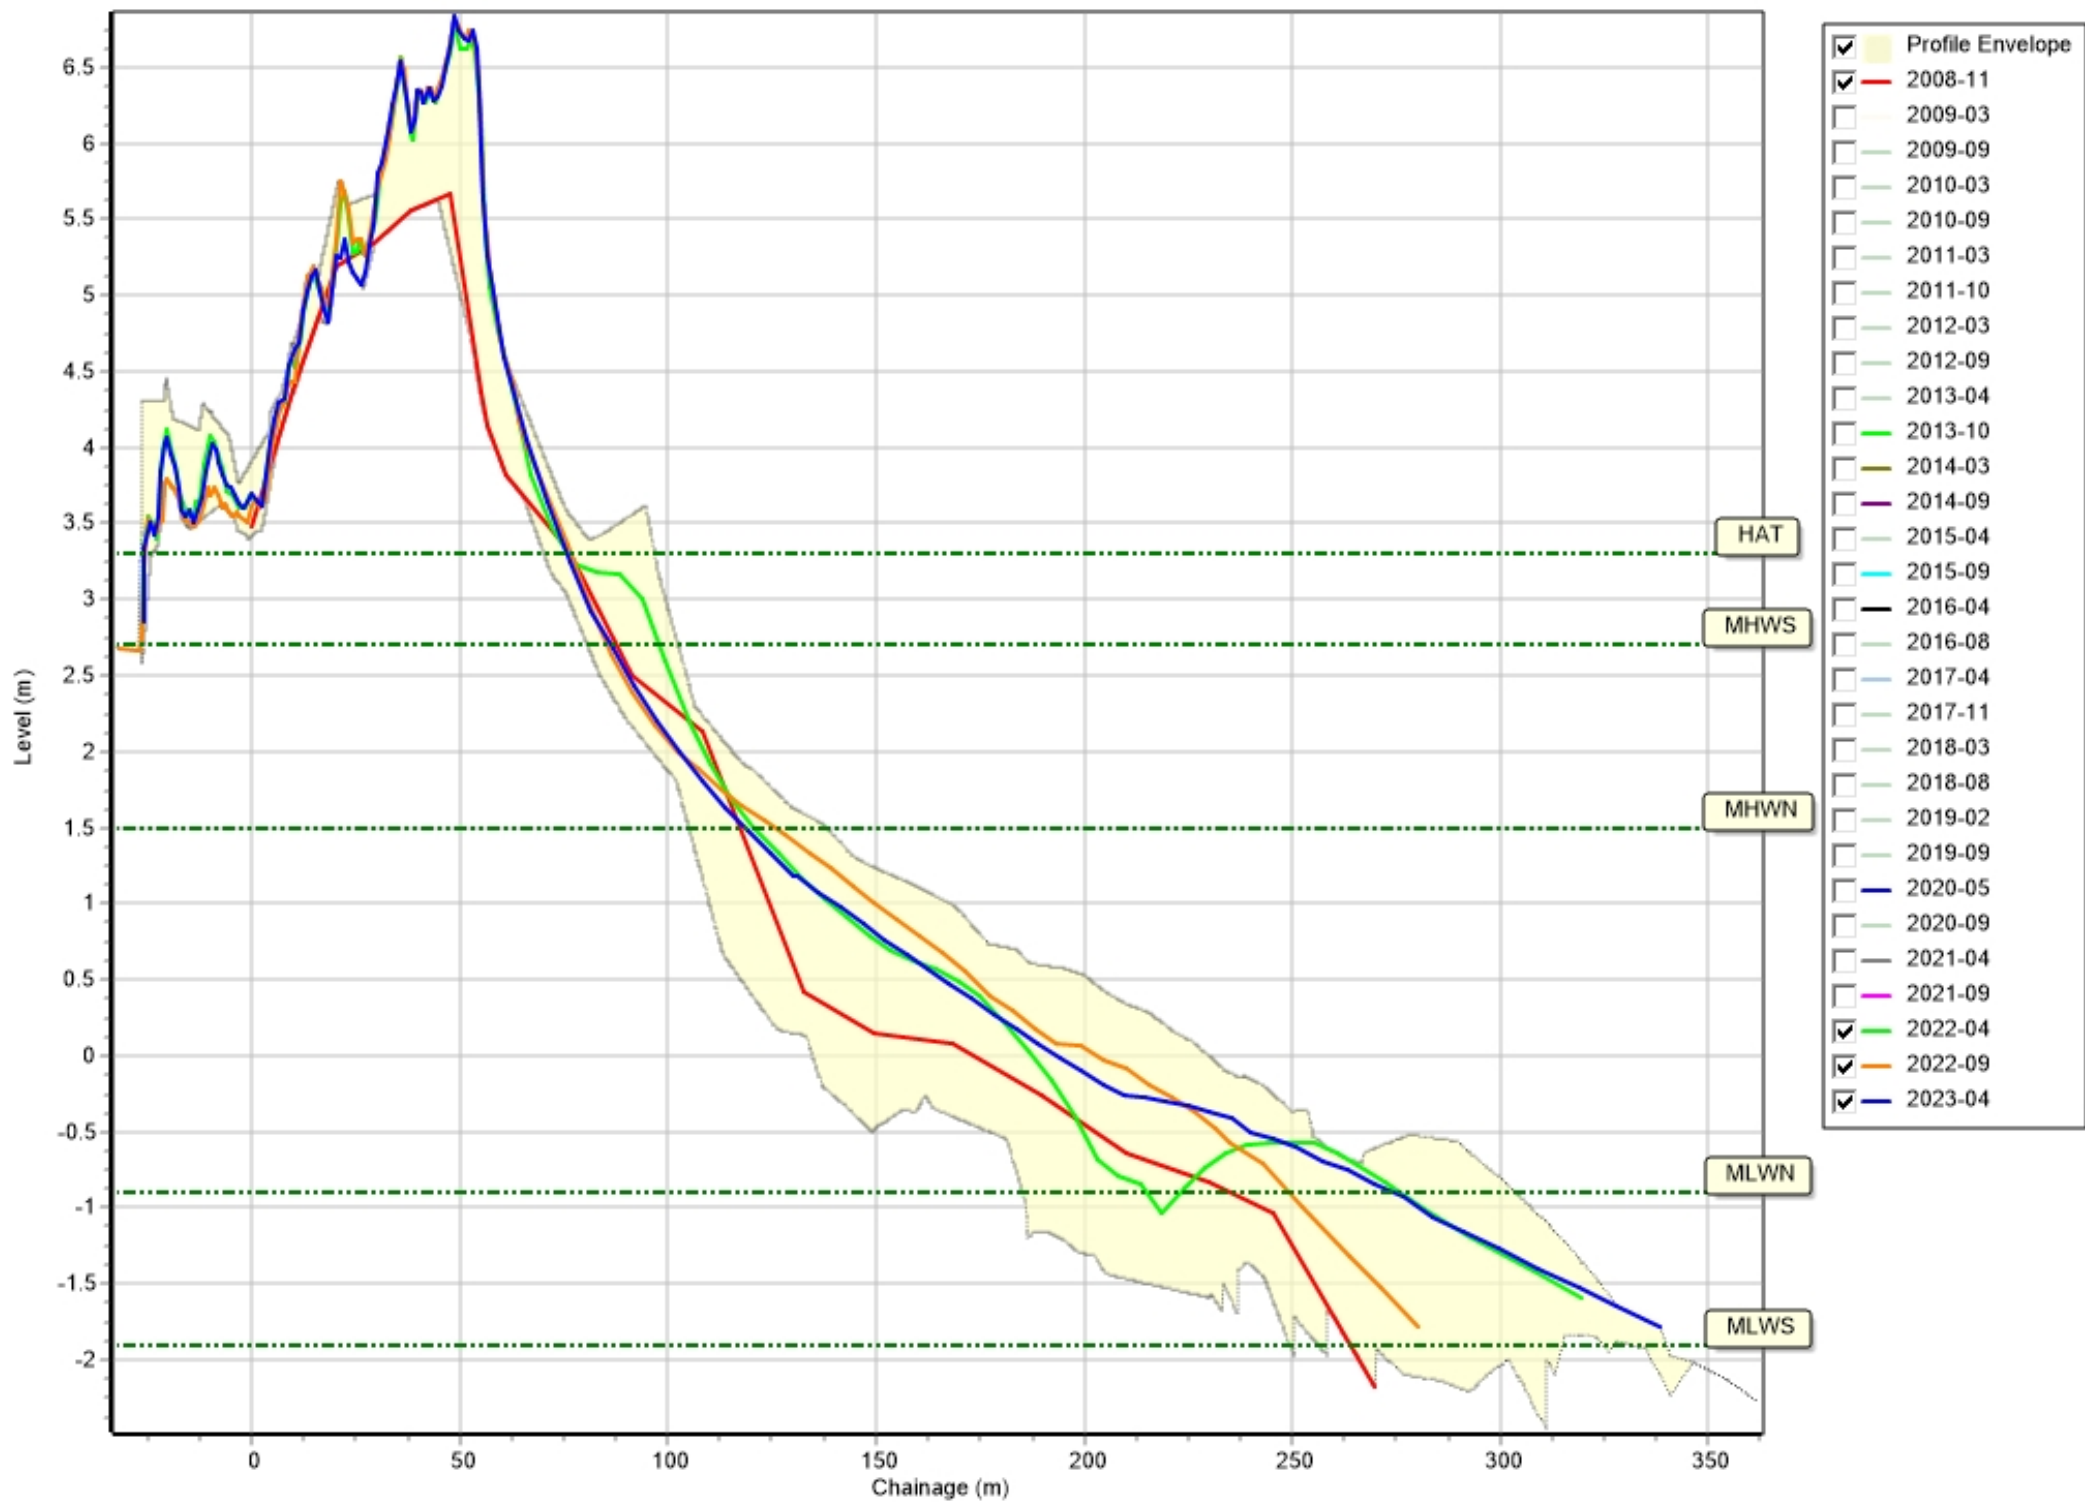
Profiles: 1cHN1

Survey Date	Description of Changes Since Last Survey	Interpretation
24 th April 2023	<p>Beach Profiles:</p> <p>North Sands is covered by seven beach profile lines during the Partial Measures survey (Appendix A) that were last surveyed in September 2022.</p> <p>Profile 1cHN1 is located within Durham County Council's jurisdiction, c. 400m north of the outfall of Crimdon Beck. It is reported here so changes can be interpreted in association with those observed elsewhere along North Sands. The beginning of profile 1cHN1, between chainages 0m and 70m, covers the dune system that generally have remained stable. Minor erosion of up to 0.3m in level is observed to the crests of the rear dunes. The upper beach up until chainage 105m is unchanged. Between chainage 105m and 224m the beach has dropped in level by 0.2m. Seawards of 224m, the lower beach profile has slackened significant resulting in an increase in level at the end of the previous profile of 0.8m in level. Overall, the beach is at a medium level compared to the range recorded in previous surveys.</p> <p>At profile 1cHN2, the dunes between chainage 0 and 48m, have remained stable since the previous survey. At the toe of the foredune until chainage 52m, accretion of up to 0.3m in level has occurred. Seawards of chainage 100m the undulating profile observed previously has become more uniform resulting in alternating lengths of erosion and accretion. The magnitude of change is limited to ± 0.6m. Overall, the beach is at a medium level compared to the range recorded in previous surveys.</p> <p>Profile 1cHN2A was established in October 2011 and runs through the dunes close to North Sands. The dunes themselves, from chainage 0m to chainage 72m, have remained stable with the exception of a localised drop in level of 0.3m between chainage 53m and chainage 57m. Seawards of chainage 72m, the previously undulating profile has again become more uniform resulting in alternating lengths of erosion and accretion, limited to ± 0.3m in level. The lower beach profile has slackened, extending the profile seaward. Overall, the beach is at a medium level compared to the range recorded in previous surveys, with the lower beach at high level.</p> <p>At Profile 1cHN3, the dune system covering chainage 0m to 42m has remained stabled. At the toe of</p>	<p>The pattern of change across the profiles on North Sands over winter 2022/23 is irregular. However, the magnitude of change is modest, and the profiles remain within the envelope of the previous surveys,</p> <p>Longer term trends:</p> <p>Following measurable dune erosion over the winter of 2013/14 the areas with dunes have remained stable, with several dune sections currently at their highest recorded levels.</p> <p>The fluctuation in the veneer beach continues so that parts of the shore platform in the south of the bay have become exposed.</p>

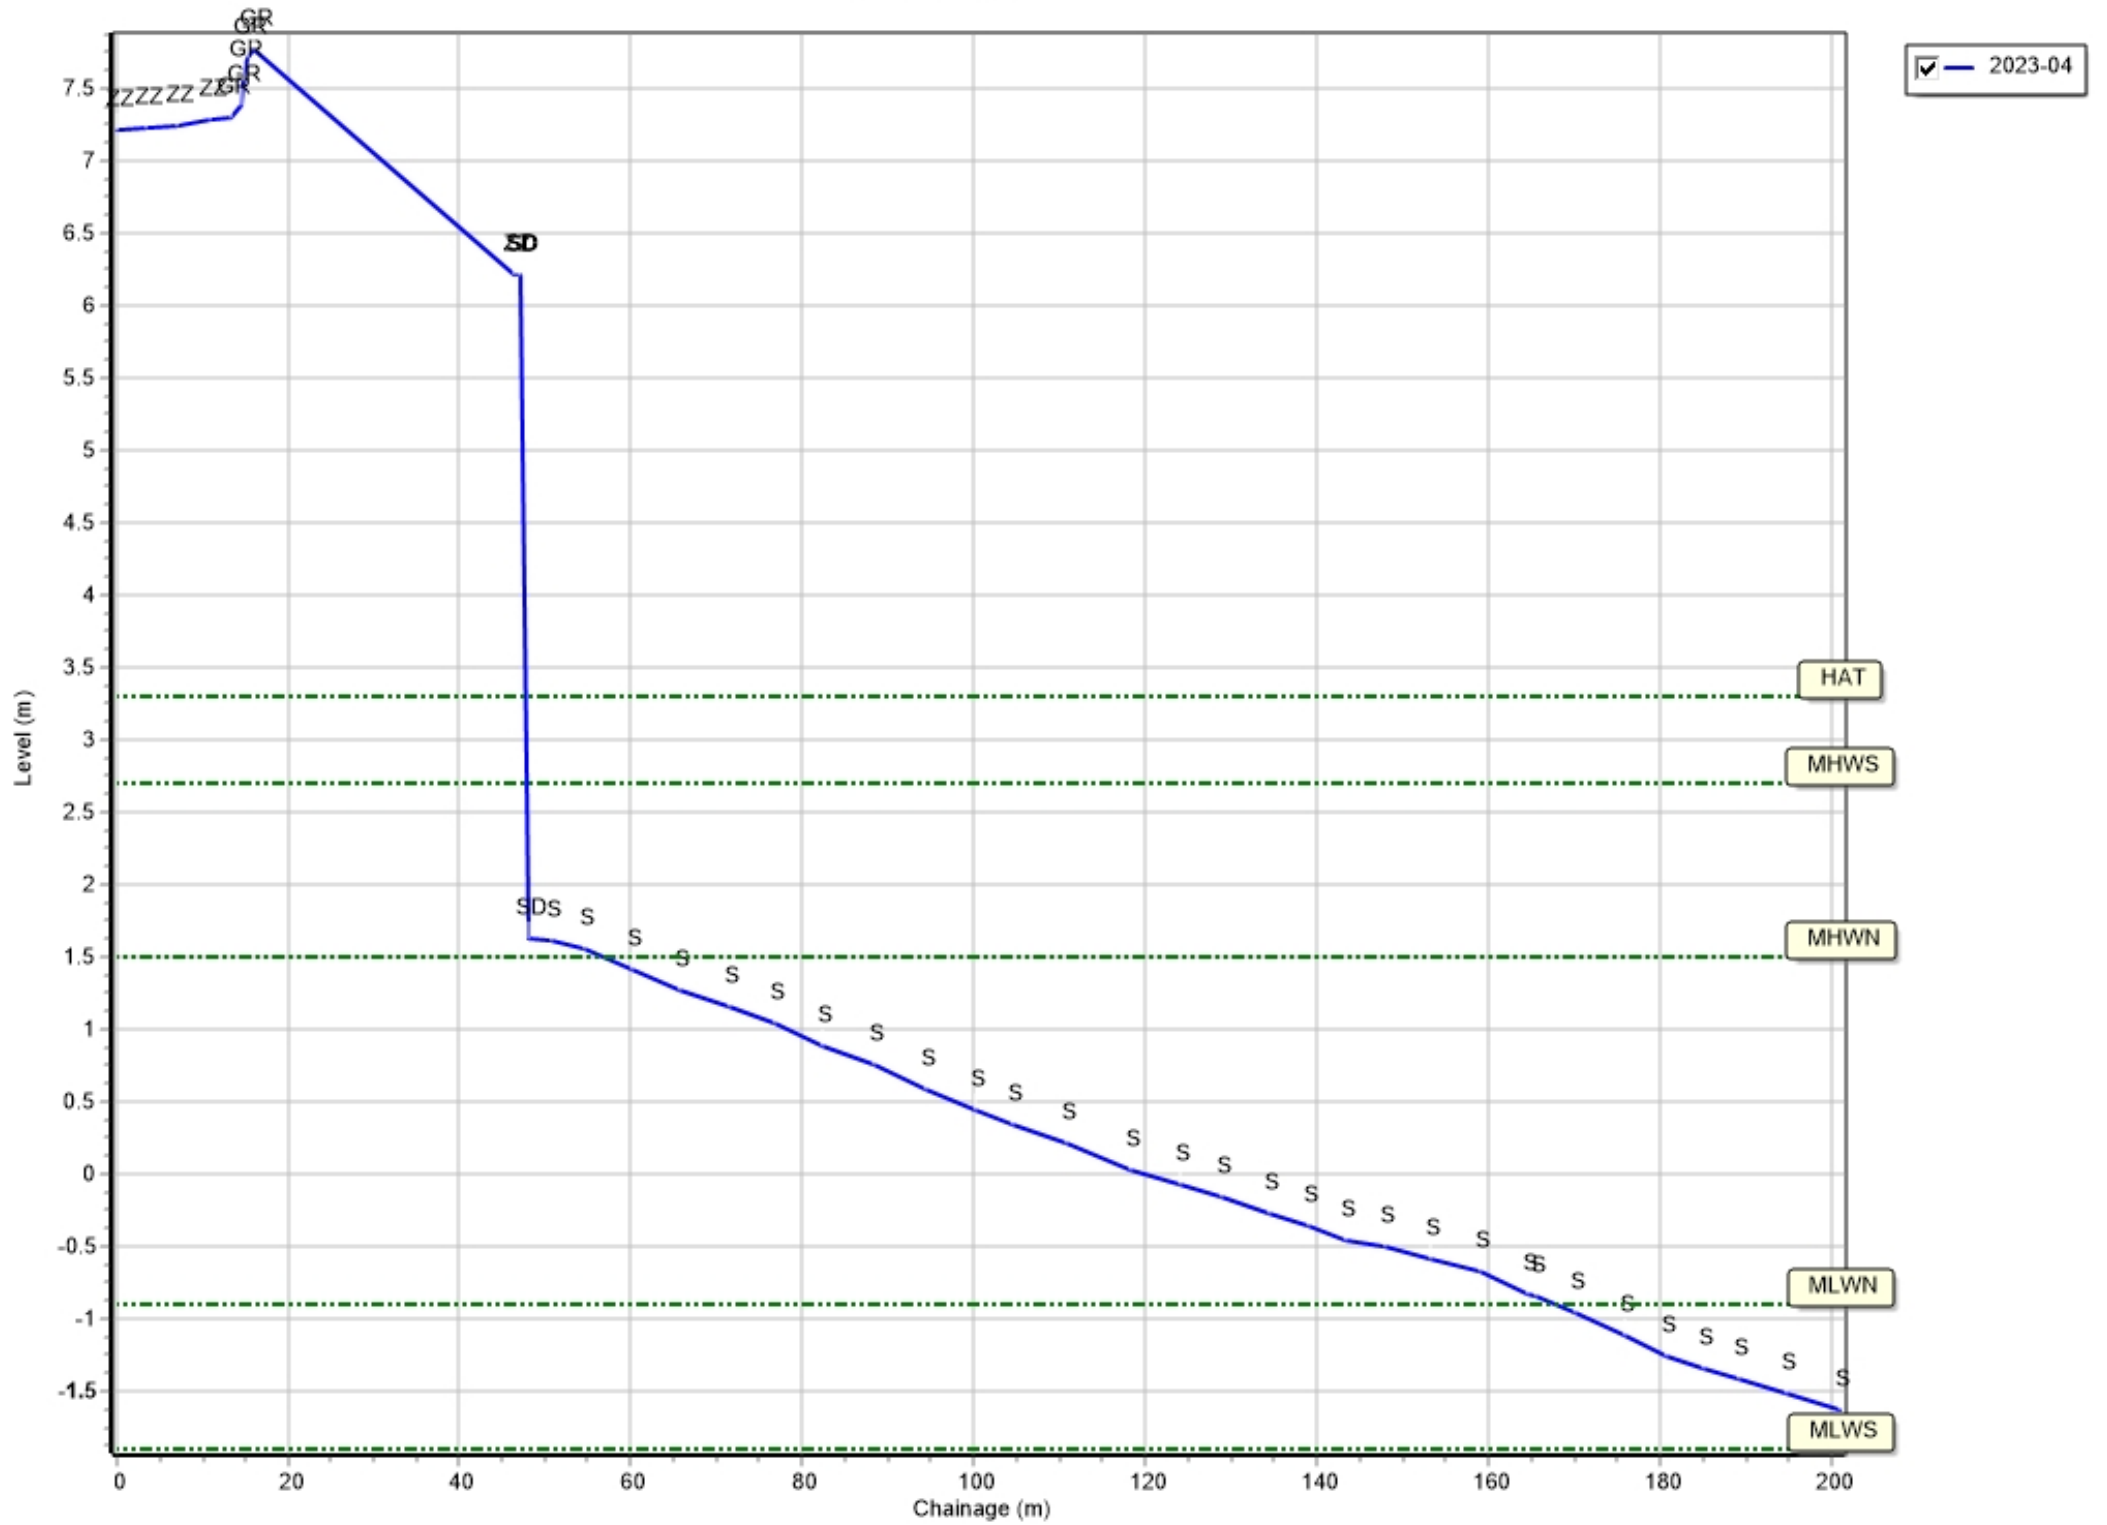
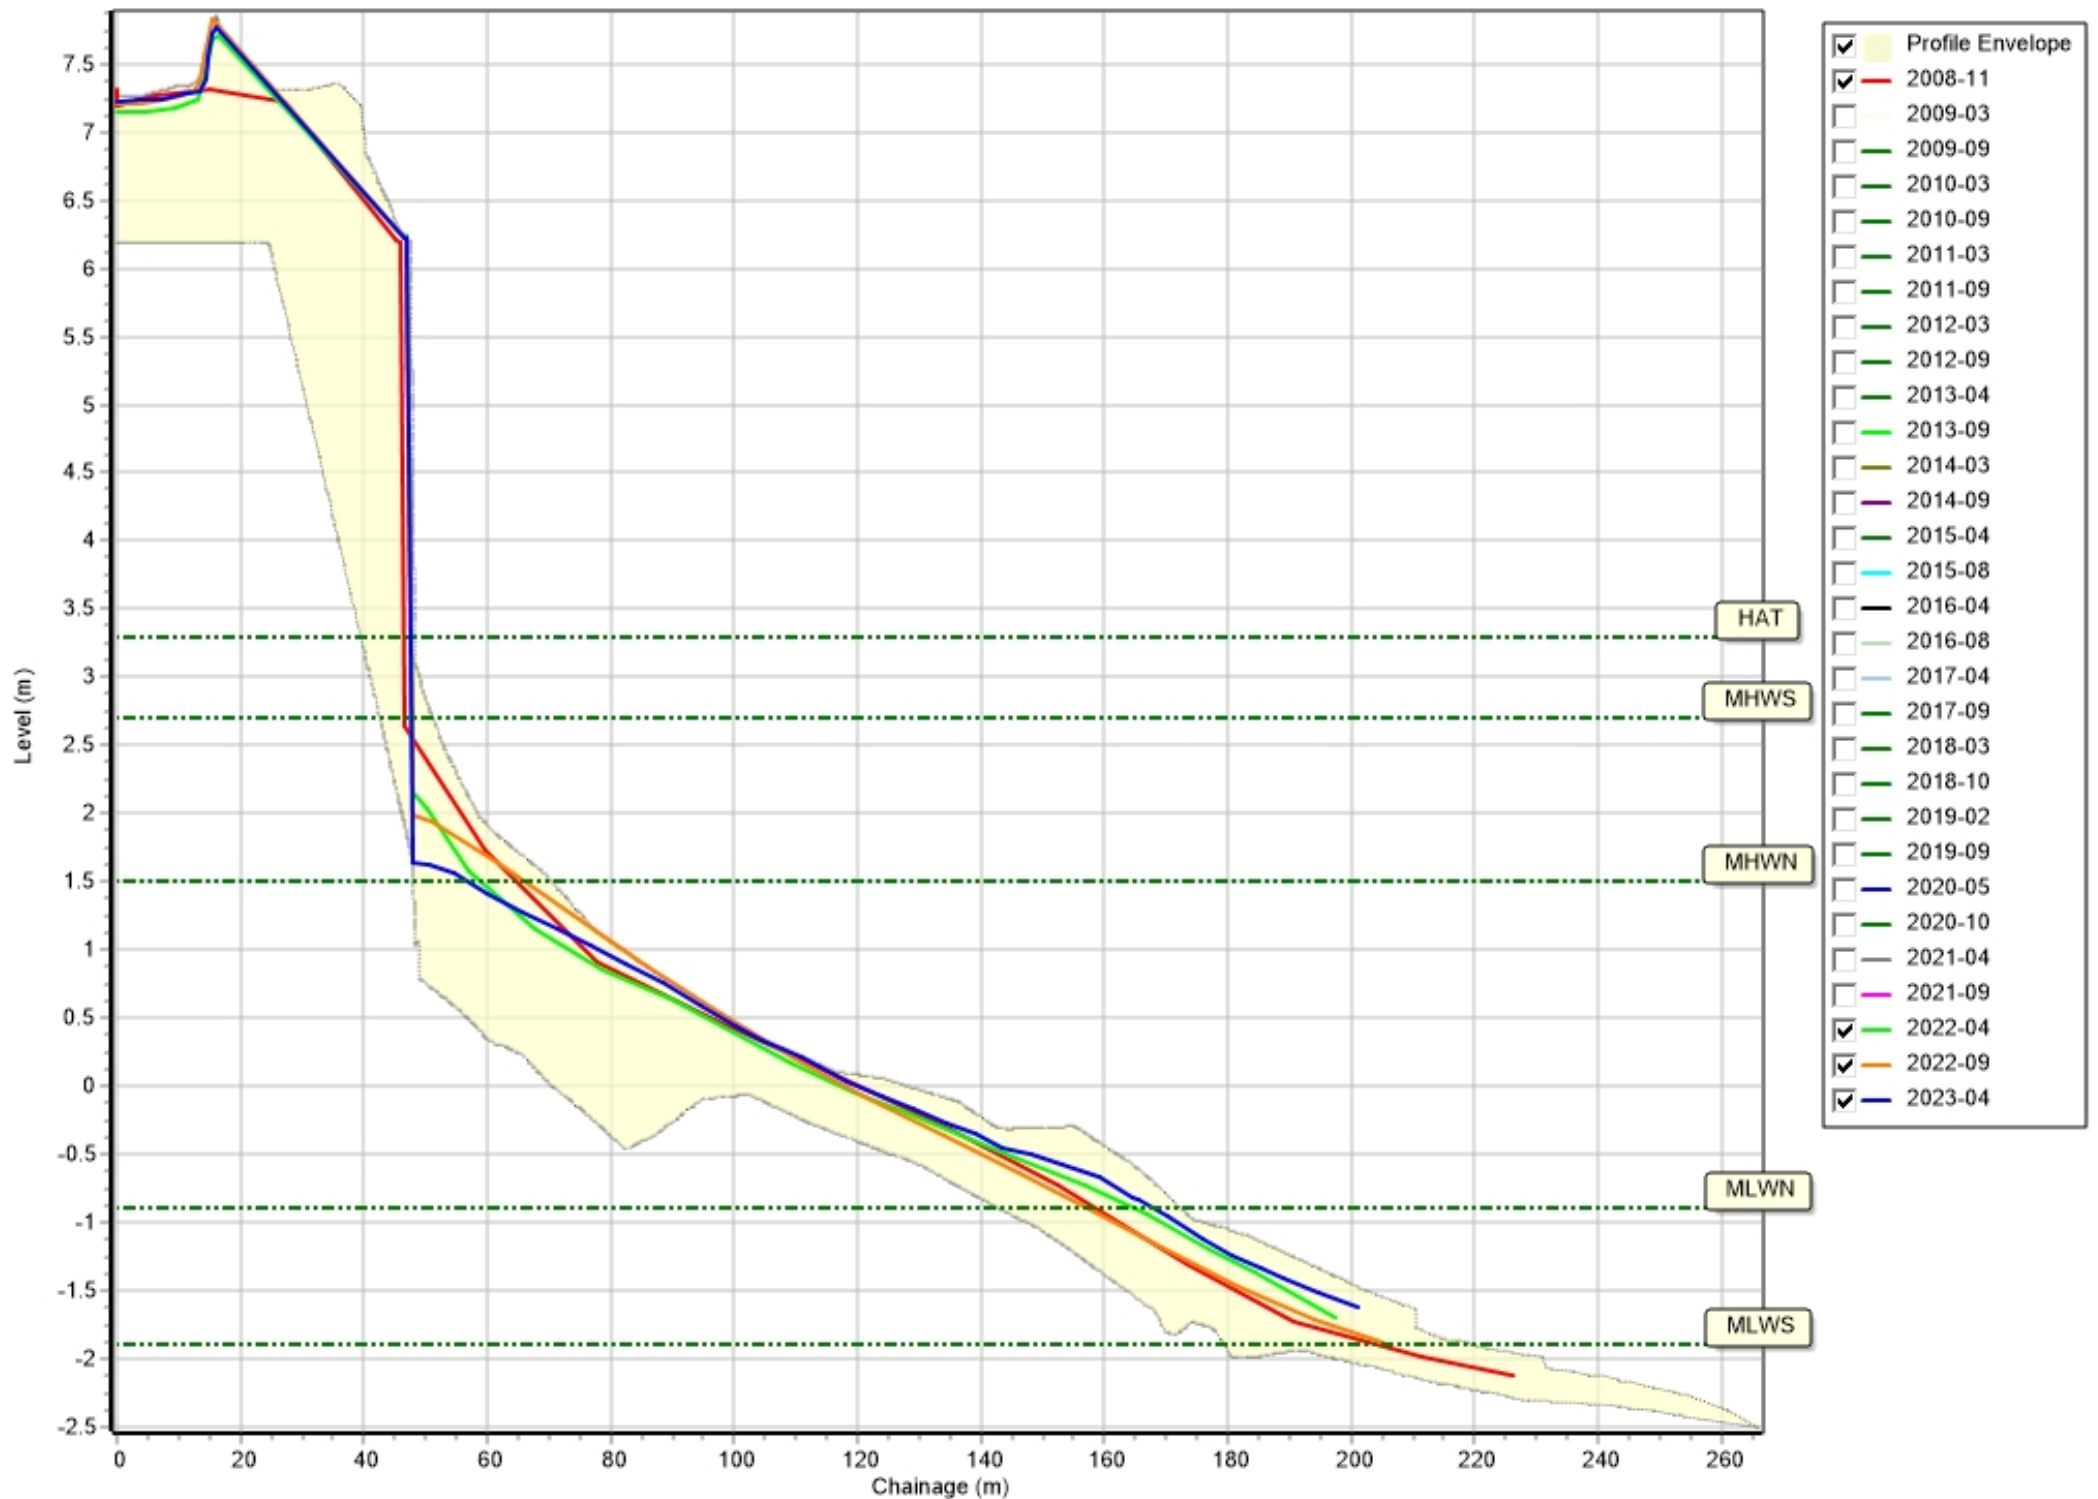
Profiles: 1cHC1

Survey Date	Description of Changes Since Last Survey	Interpretation
25 th April 2023	<p>Beach Profiles:</p> <p>Middleton is covered by one beach profile line, 1cHC1, during the Partial Measures survey (Appendix A). The profile was last surveyed in September 2022. The survey report again notes 'no access to upper section on HC1 within the factory area'. At the toe of the seawall (chainage 48m) the beach has lowered by 0.4m in level, gradually reducing to no change at chainage 105m. Seawards of chainage 105m, to the end of the profile, the beach has accreted by up to 0.2m in level. Overall, the beach profile remains at a high level compared to the range recorded from previous surveys.</p>	<p>At Middleton, erosion of the upper beach and accretion of the lower beach indicates the winter draw down of material, typical of seasonal fluctuations.</p> <p>Longer term trends: The beach level at this location tends to fluctuate through the year, with the most variable area being adjacent to the sea wall where wave energy is reflected. There is a pattern of seasonal variation, with lower levels typically recorded in the spring, following the period of winter storms. Recovery tends to occur by the autumn.</p>

- At Hartlepool Central a damaged fence along the crest of the brickwork seawall means that access was restricted to the upper reaches of profile 1cHC1.
