Cell 1 Regional Coastal Monitoring Programme Update Report 15: 'Partial Measures' Survey 2023

Hartlepool Borough Council

June 2023

(*) The present report is **Update Report 15** and provides an analysis of the 2023 Partial Measures survey for Hartlepool Council's frontage.

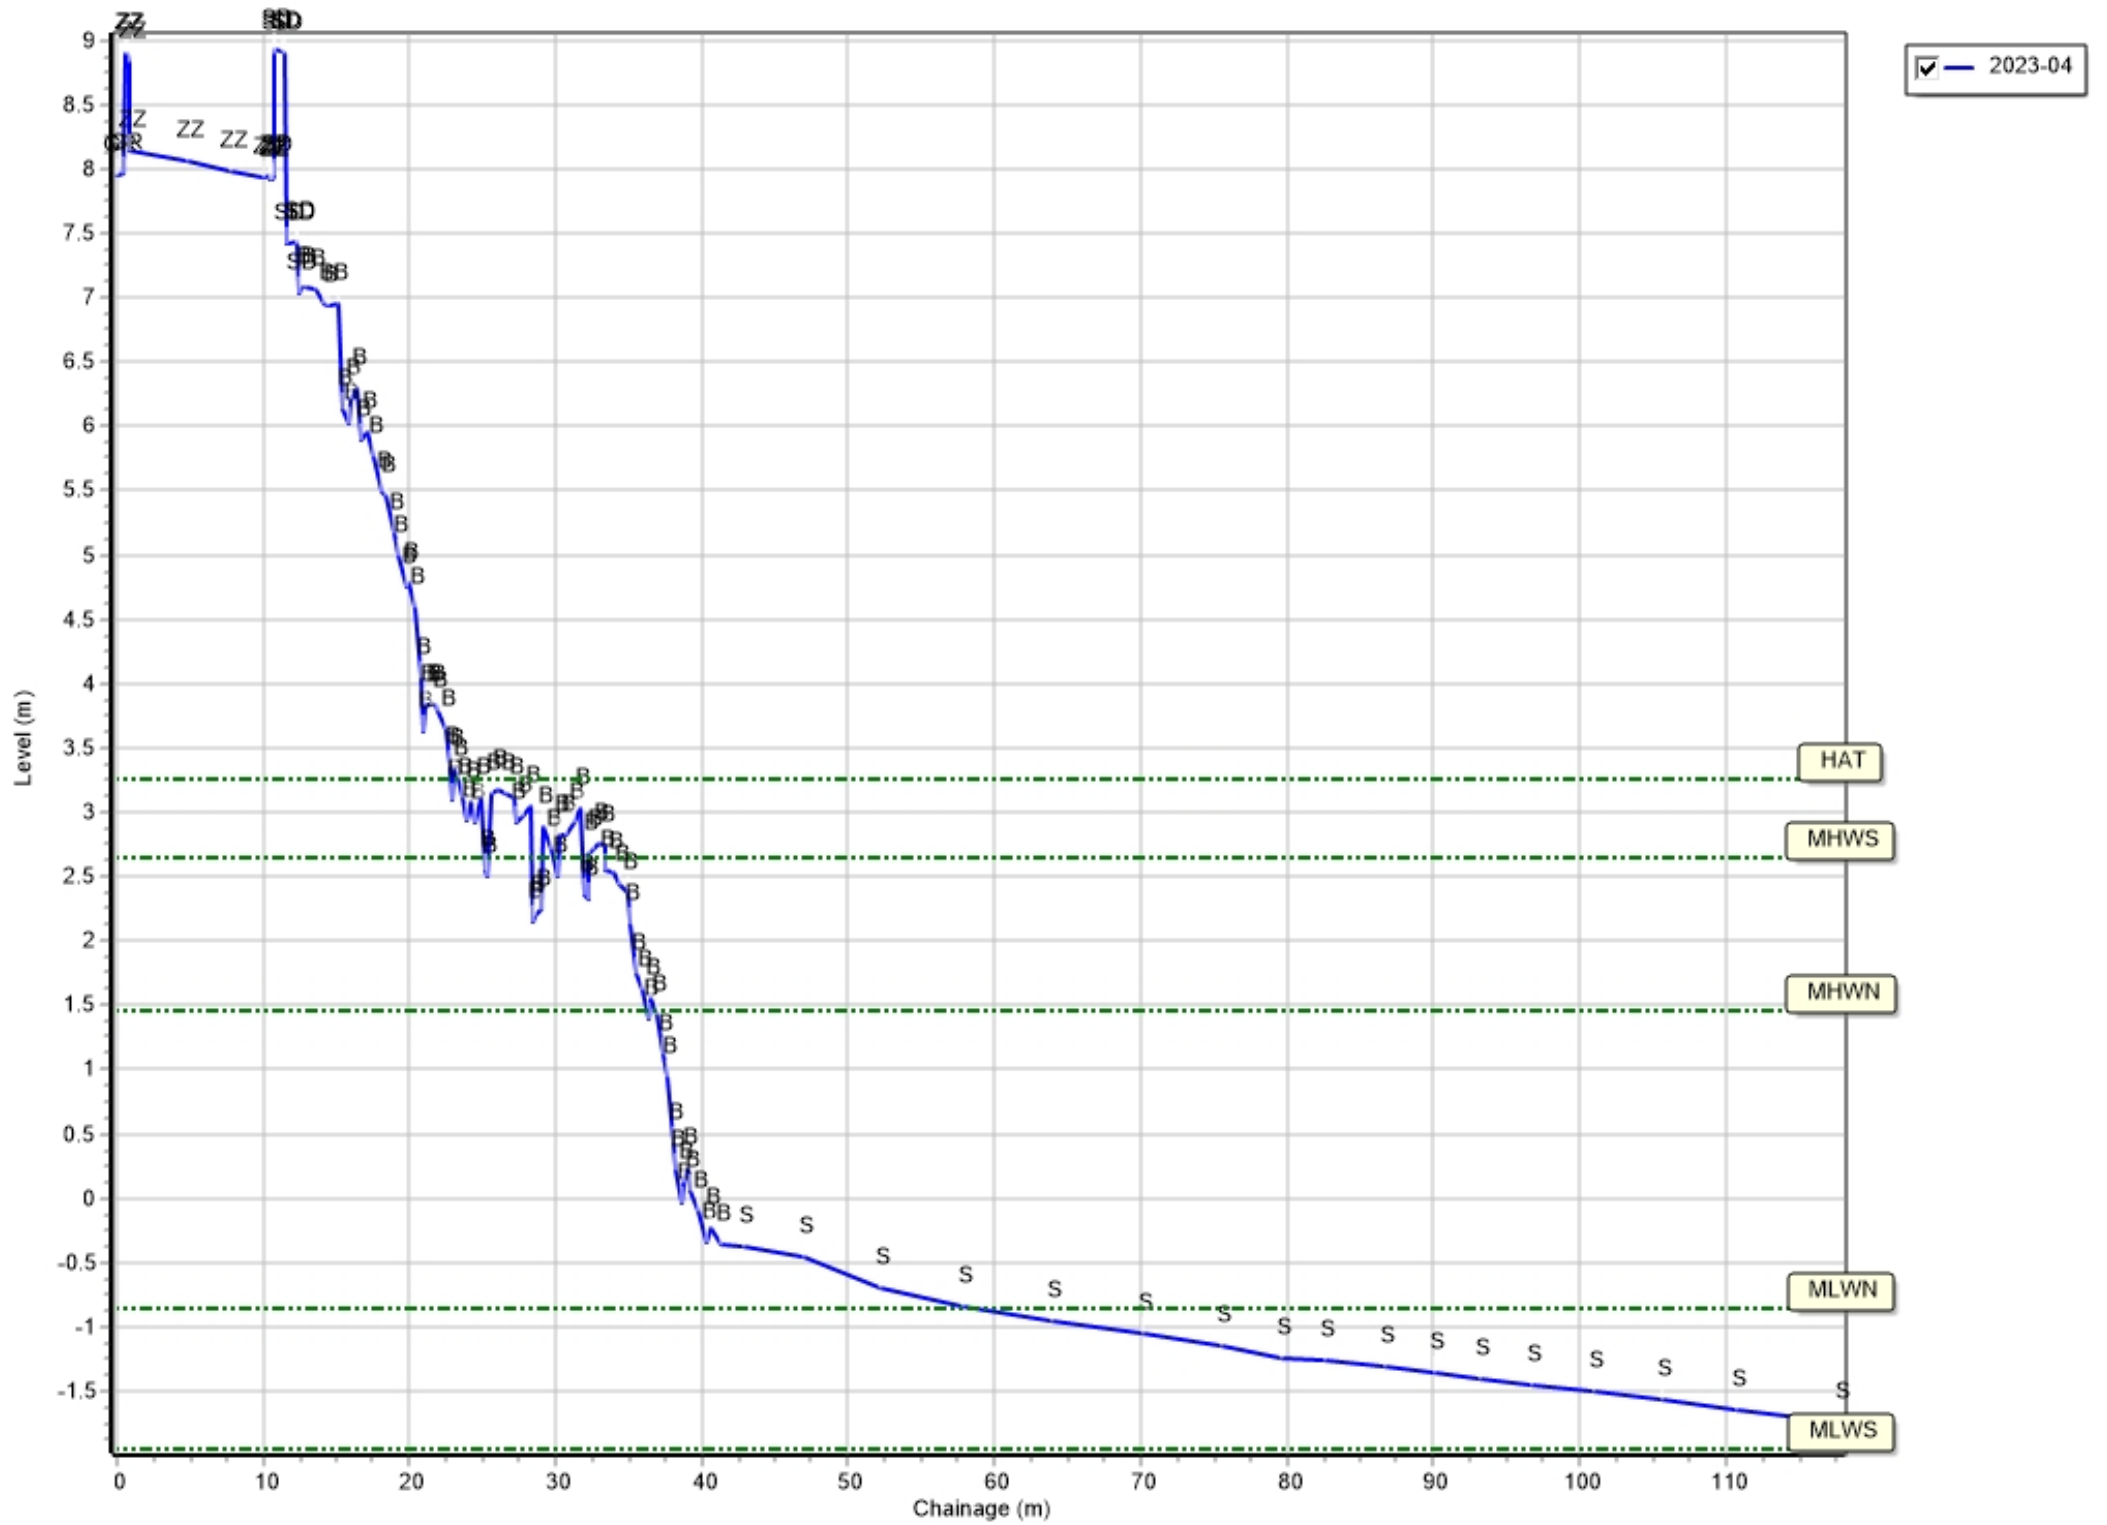
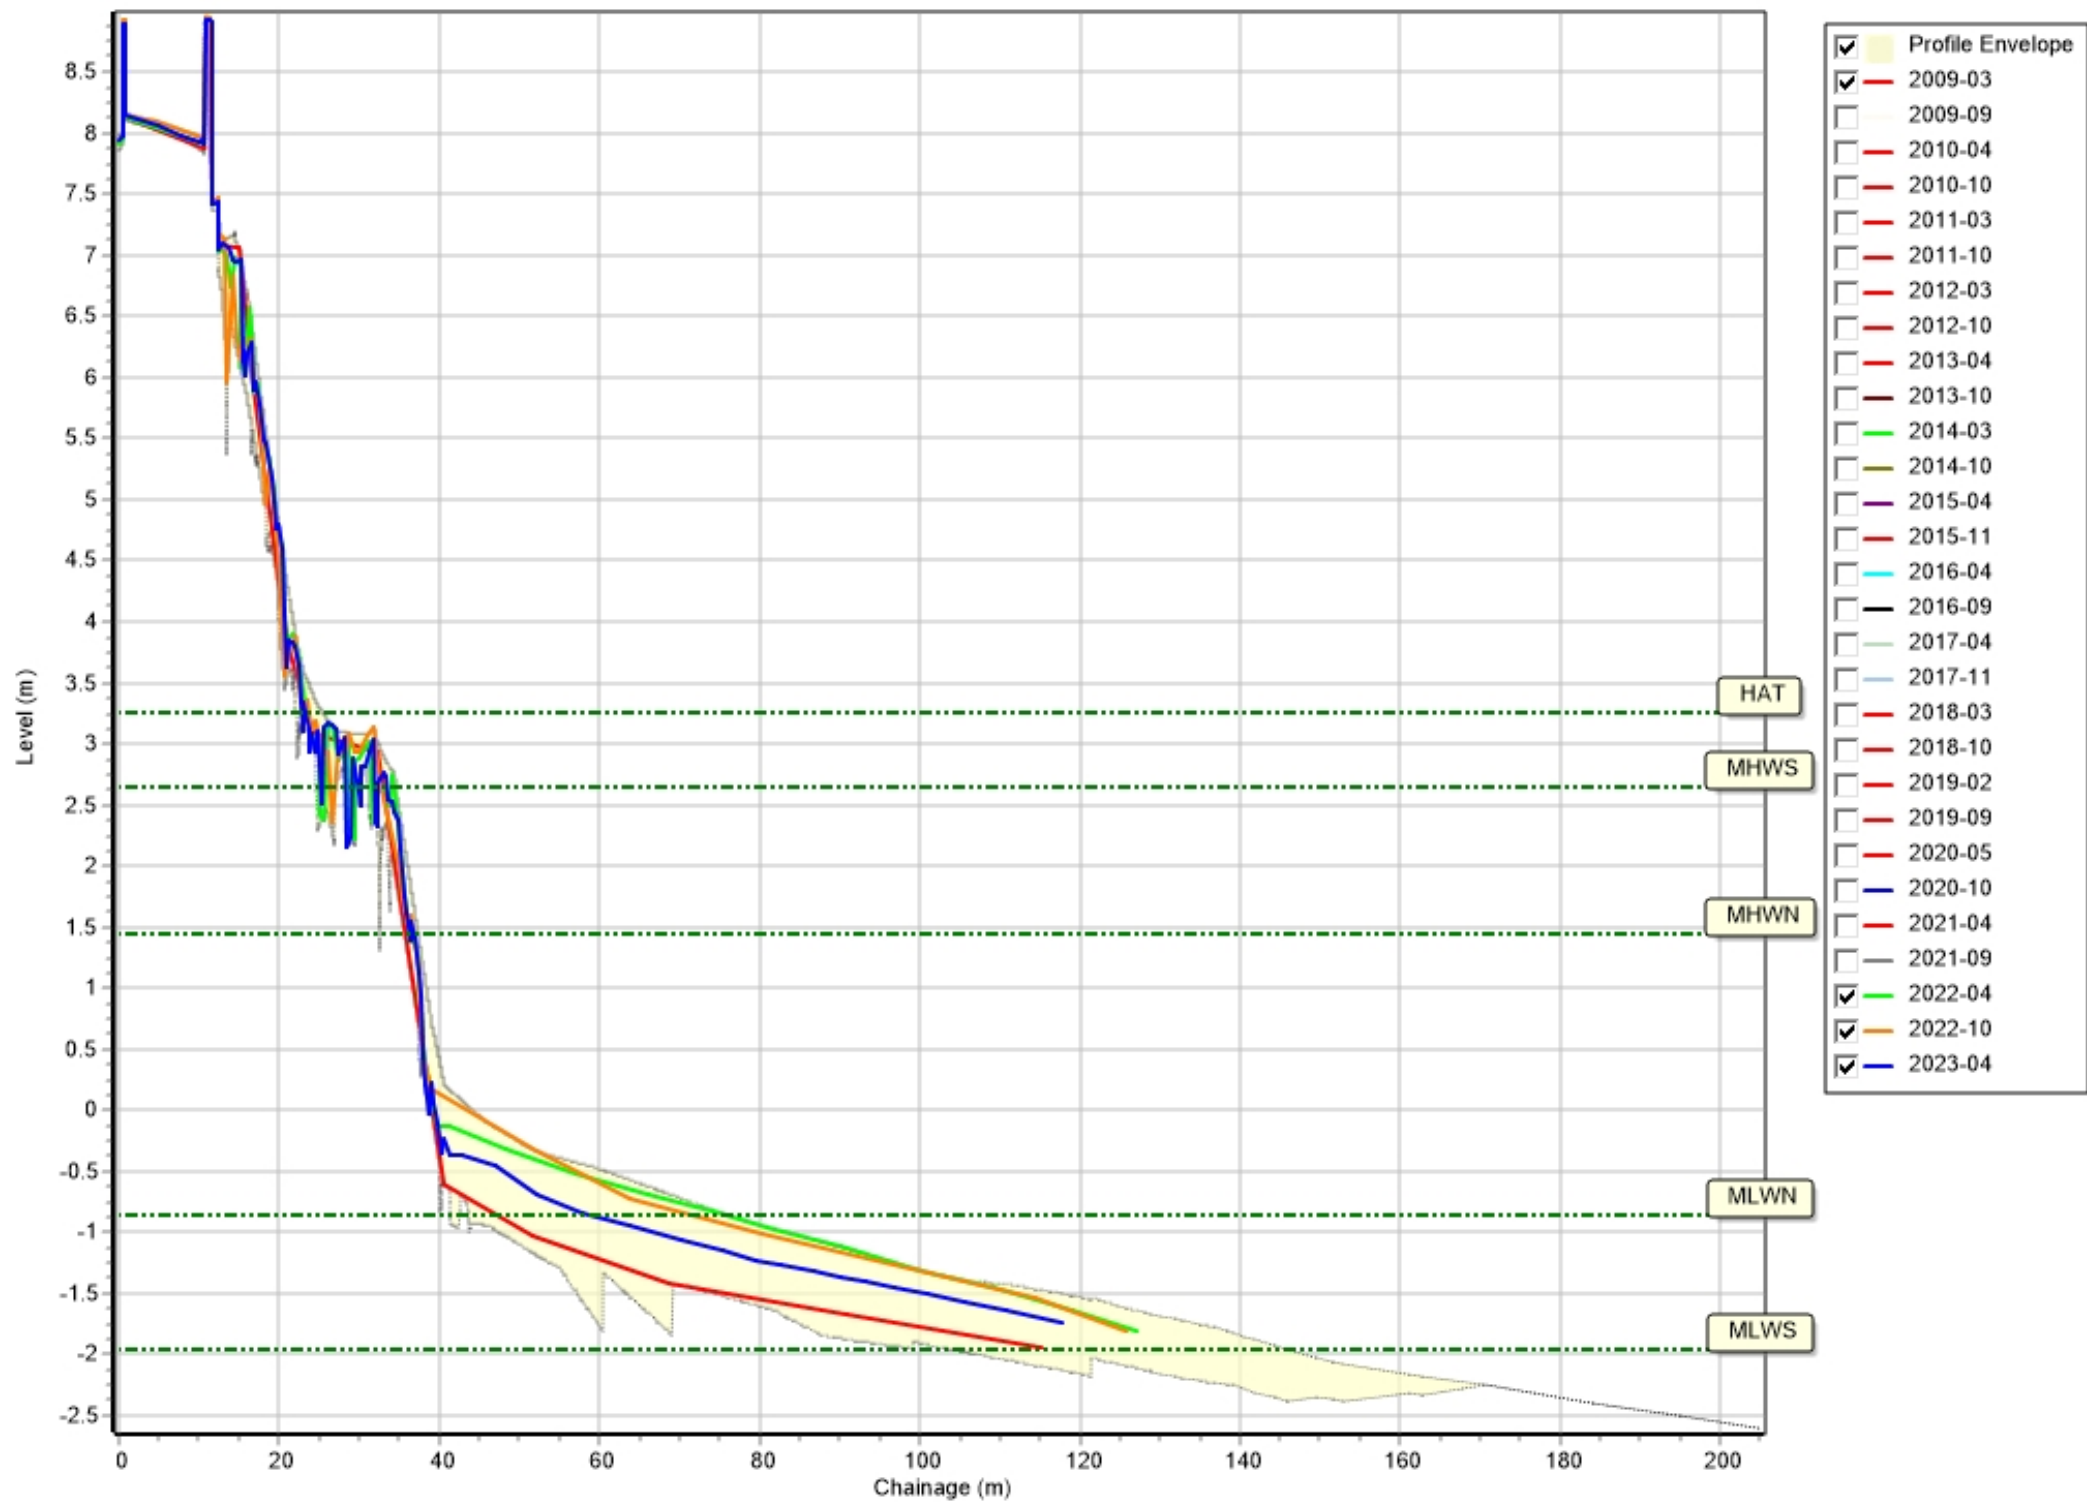
Profiles: 1cHS1

Survey Date	Description of Changes Since Last Survey	Interpretation
25 th April 2023	<p>Beach Profiles:</p> <p>Hartlepool Bay is covered by four beach profile lines during the Partial Measures survey (Appendix A). Profile 1cHS1 is located approximately 150m south of the root of the South Pier. The profile starts at the wall to the rear of the promenade and extends across the promenade, over the fronting concrete splash wall and down the sloping face of the rock armour revetment before reaching the beach. No significant change has occurred until 40m chainage, which is the toe of the sea defences. The beach itself has experienced consistent erosion along the whole profile since the previous survey. At the toe of the rock armour, the beach has dropped by 0.4m in level tapering slightly to a drop 0.3m in level at the end of the profile. The beach is now at a medium level when compared to the range of the previous surveys.</p> <p>Profile 1cHS2 encompasses the rock armour defence up until chainage 28m which has remained stable since the previous survey. The upper beach (between chainage 33m and chainage 78m) and the lower beach (between chainage 206m and chainage 295m) have both eroded by up to 0.2m in level. The middle section of the beach has remained stable. Overall, the profile is at a medium level compared to the range of previous surveys.</p> <p>Profile 1cHS3 shows no changes over the defended part of the profile up to 30m chainage. The beach profile seawards of chainage 30m displays a similar pattern to profile 1cHS2 with the upper beach (between chainage 44m and 102m) and lower beach (between chainage 164m and 220m) has eroded by up to 0.3m in level. The middle section of the beach has remained stable. Overall, the profile is at a medium level compared to the range of previous surveys.</p> <p>Profile 1cHS4 is located 1km north of the North Gare Breakwater, within the area of undefended dunes at Seaton Carew. Localised pockets of change have occurred across the dunes limited to $\pm 0.3\text{m}$, but generally have remained stable. The most significant change is to the rear of the foredune that accreted by up to 0.3m in level over 10m. From the toe of the dunes at chainage 340m, to chainage 375m, the upper beach remains unchanged. Seawards of chainage 375m the beach profile has dropped by 0.25m in level. The upper beach is at a low level when compared to previous surveys and the lower beach at a medium level.</p>	<p>The 2023 partial measures surveys highlights that Hartlepool Bay has been dominated by erosion over winter 2022/23 with all four profiles displaying a net loss of material. This said, the profiles remain largely within the middle of the range envelope of the previous surveys indicating that that is not a cause for a concern currently. Where present, the dunes have remained stable.</p> <p>Longer term trends: Since the start of the surveys, beach levels appear to have been progressively increasing towards the north of the bay.</p>
