**Cell 1 Regional Coastal Monitoring Programme
Hartlepool Headland 'Post Storm' Beach Monitoring
Survey Report 2023**

Hartlepool Borough Council

December 2023

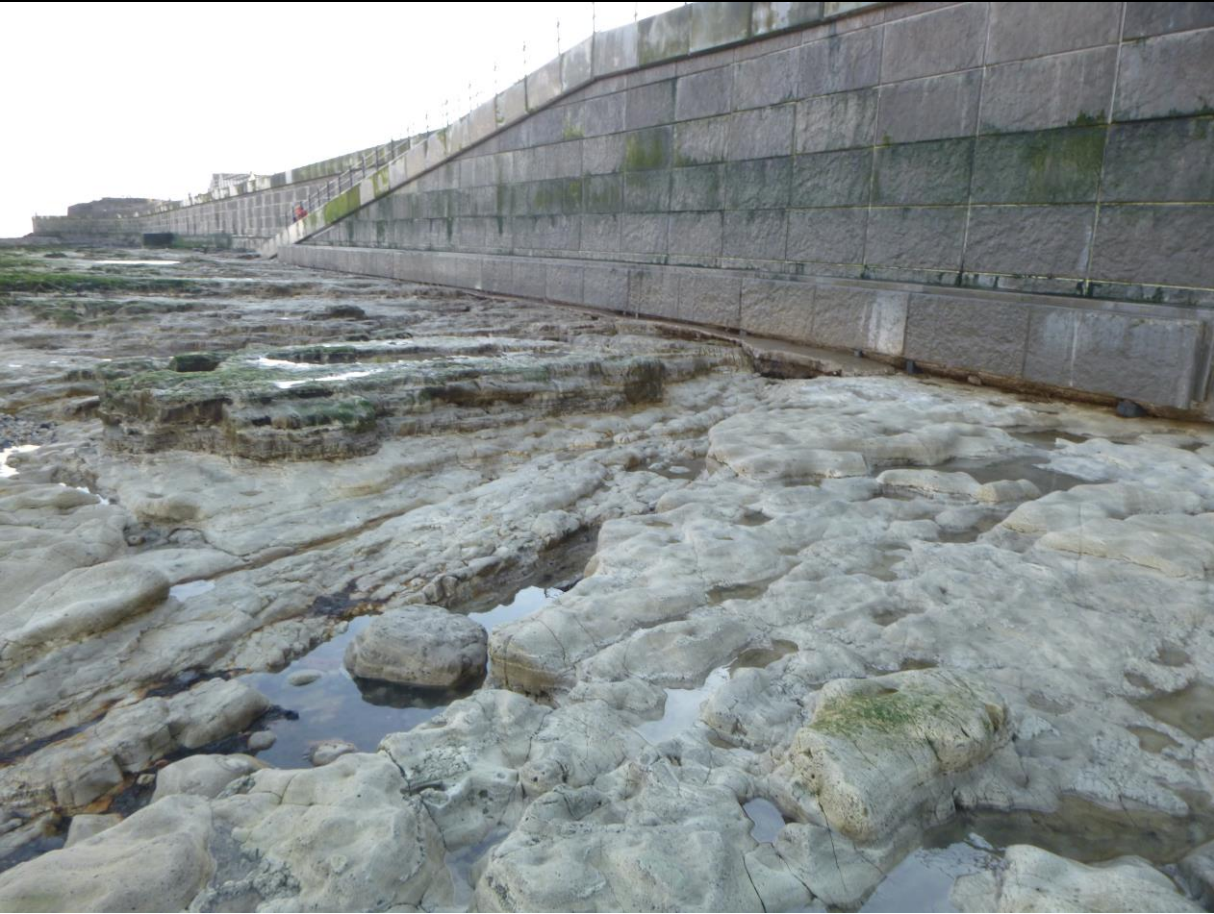
<p data-bbox="338 1198 1272 1230">Figure 3 Exposed rocky foreshore at Throston Scar November 2023</p>

The topographic survey difference plot shows that the most significant change has occurred at Throston Scar where up to 1.75m depth of sediment has been draw down and moved away from the toe of the seawall over an approximate 450m length. This length of erosion also corresponds with the damage to the precast concrete seawall observed both in the walkover inspection and by the topographic surveyors.

It is thought this frontage was particularly vulnerable due to being perpendicular to the direction of the largest Storm (Babet) which hit the coast from a North Eastly direction.

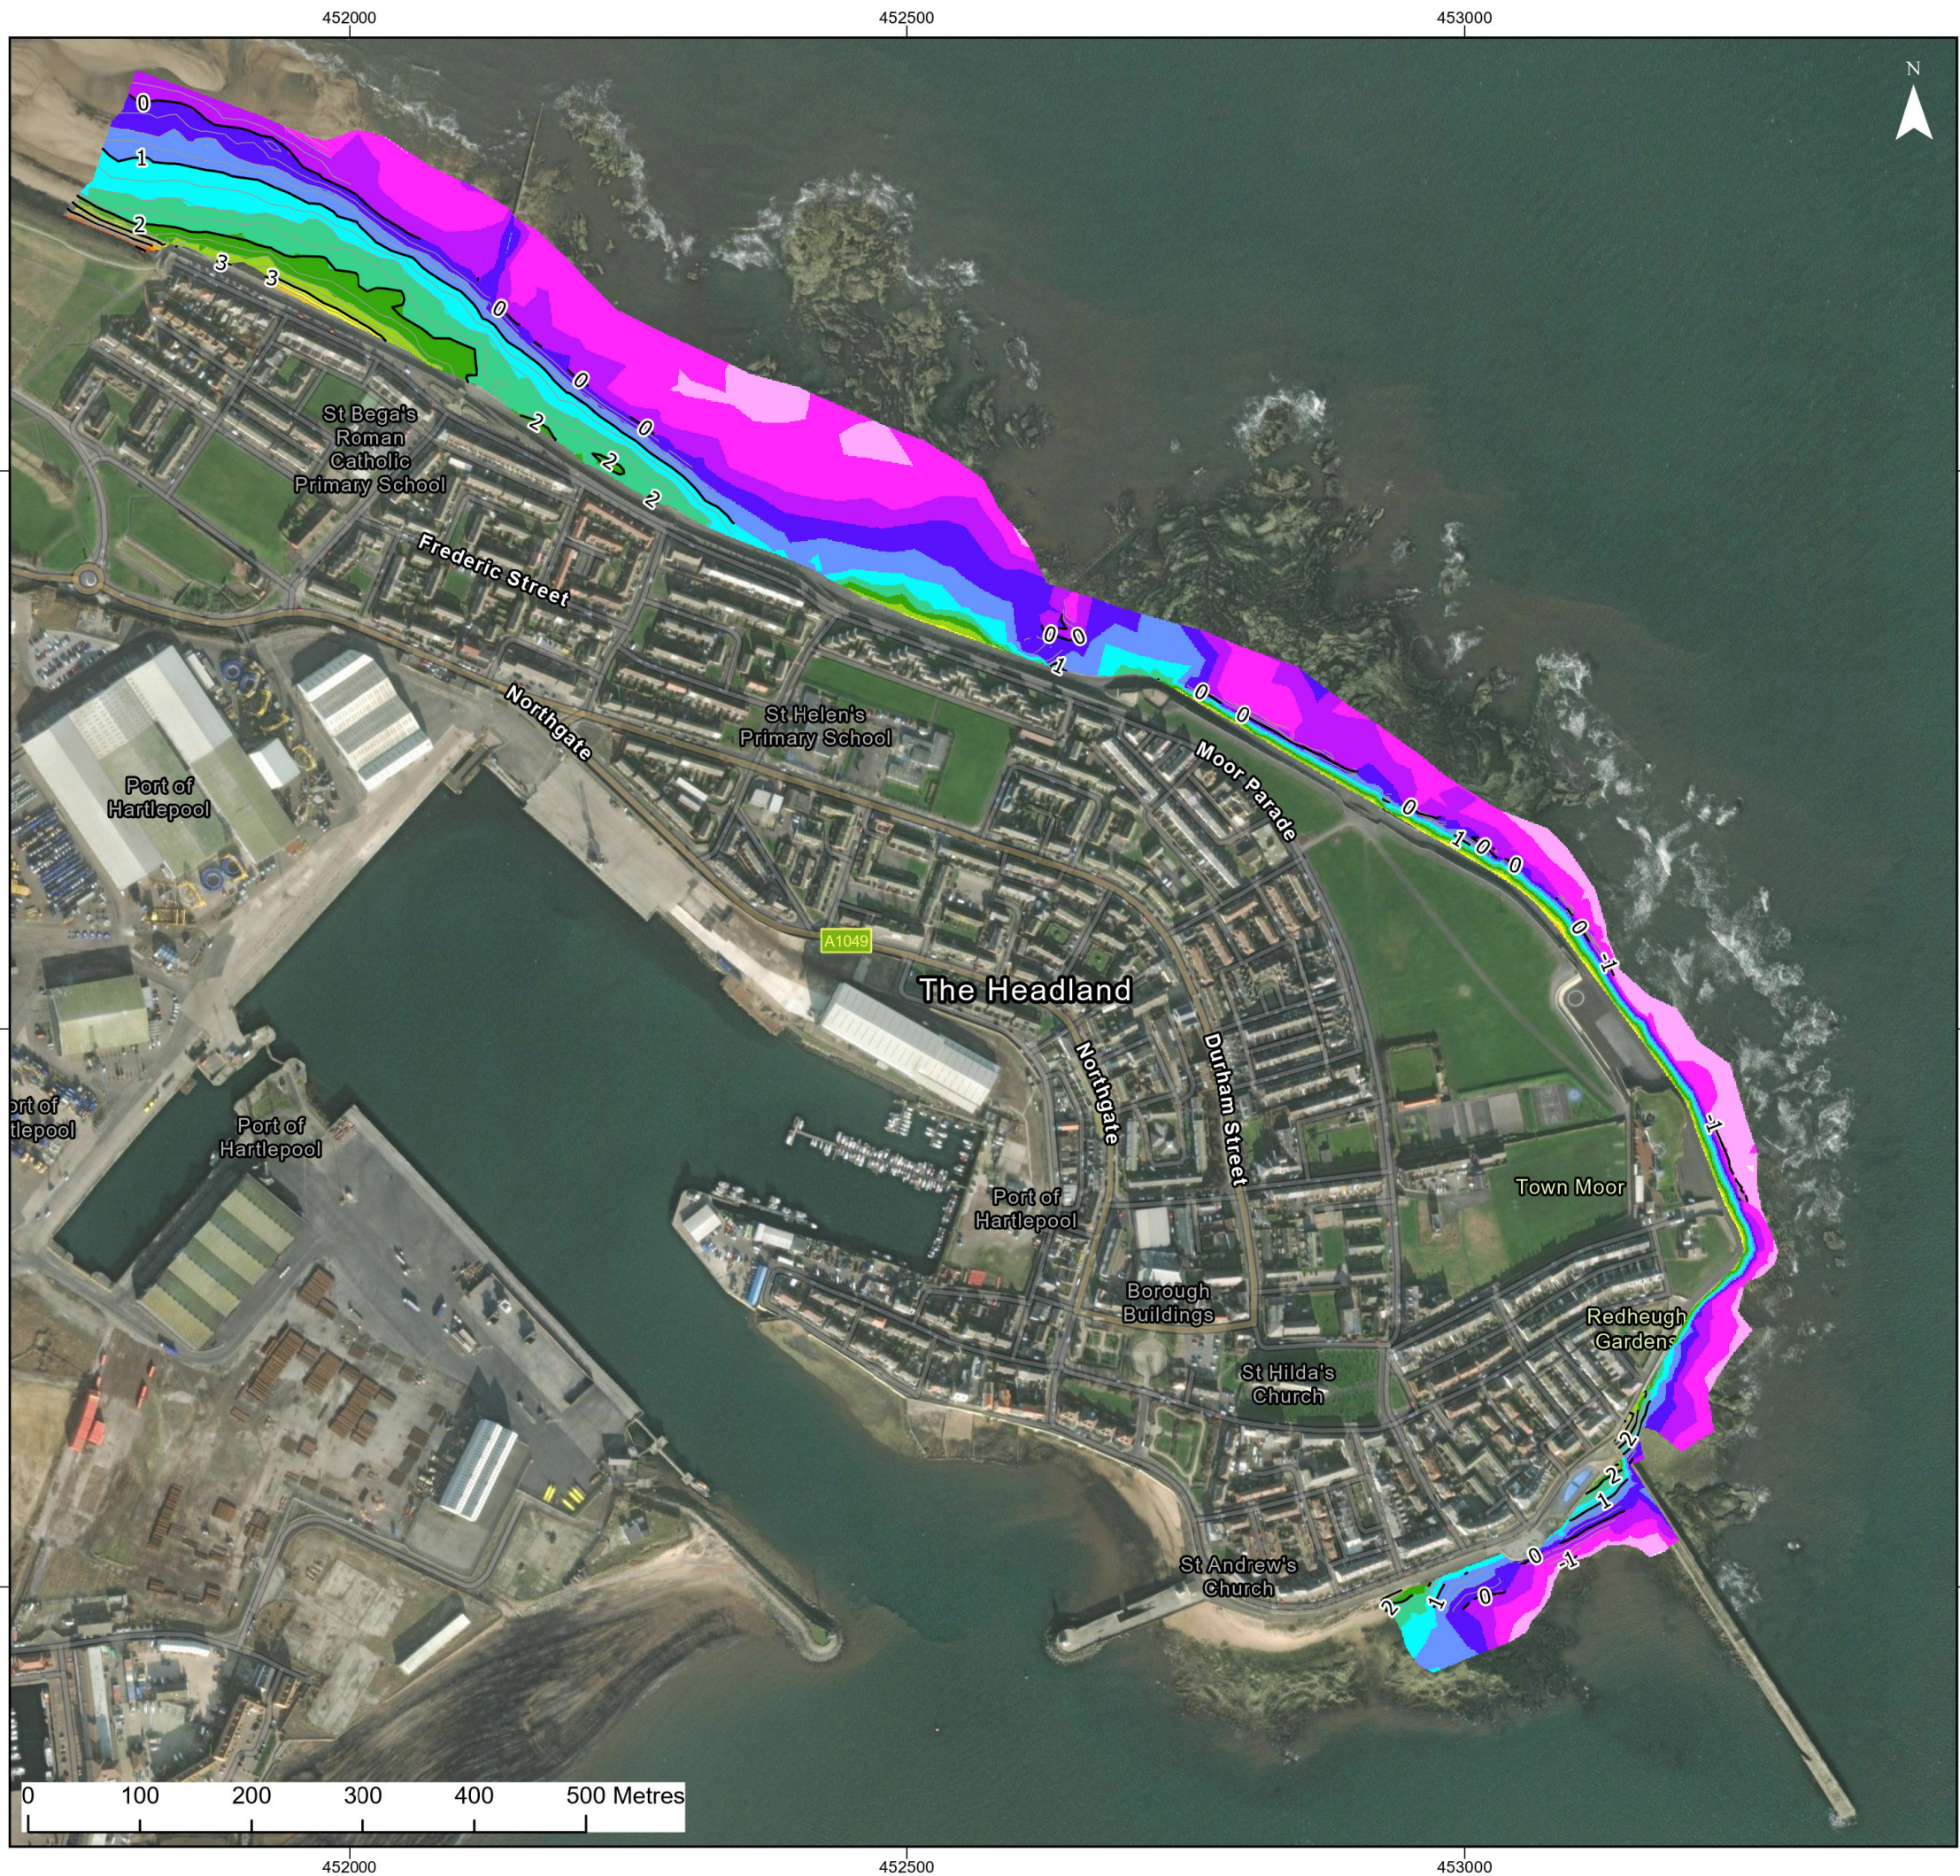
Appendix A - Map 1

TOPOGRAPHIC SURVEY (1st November 2023)

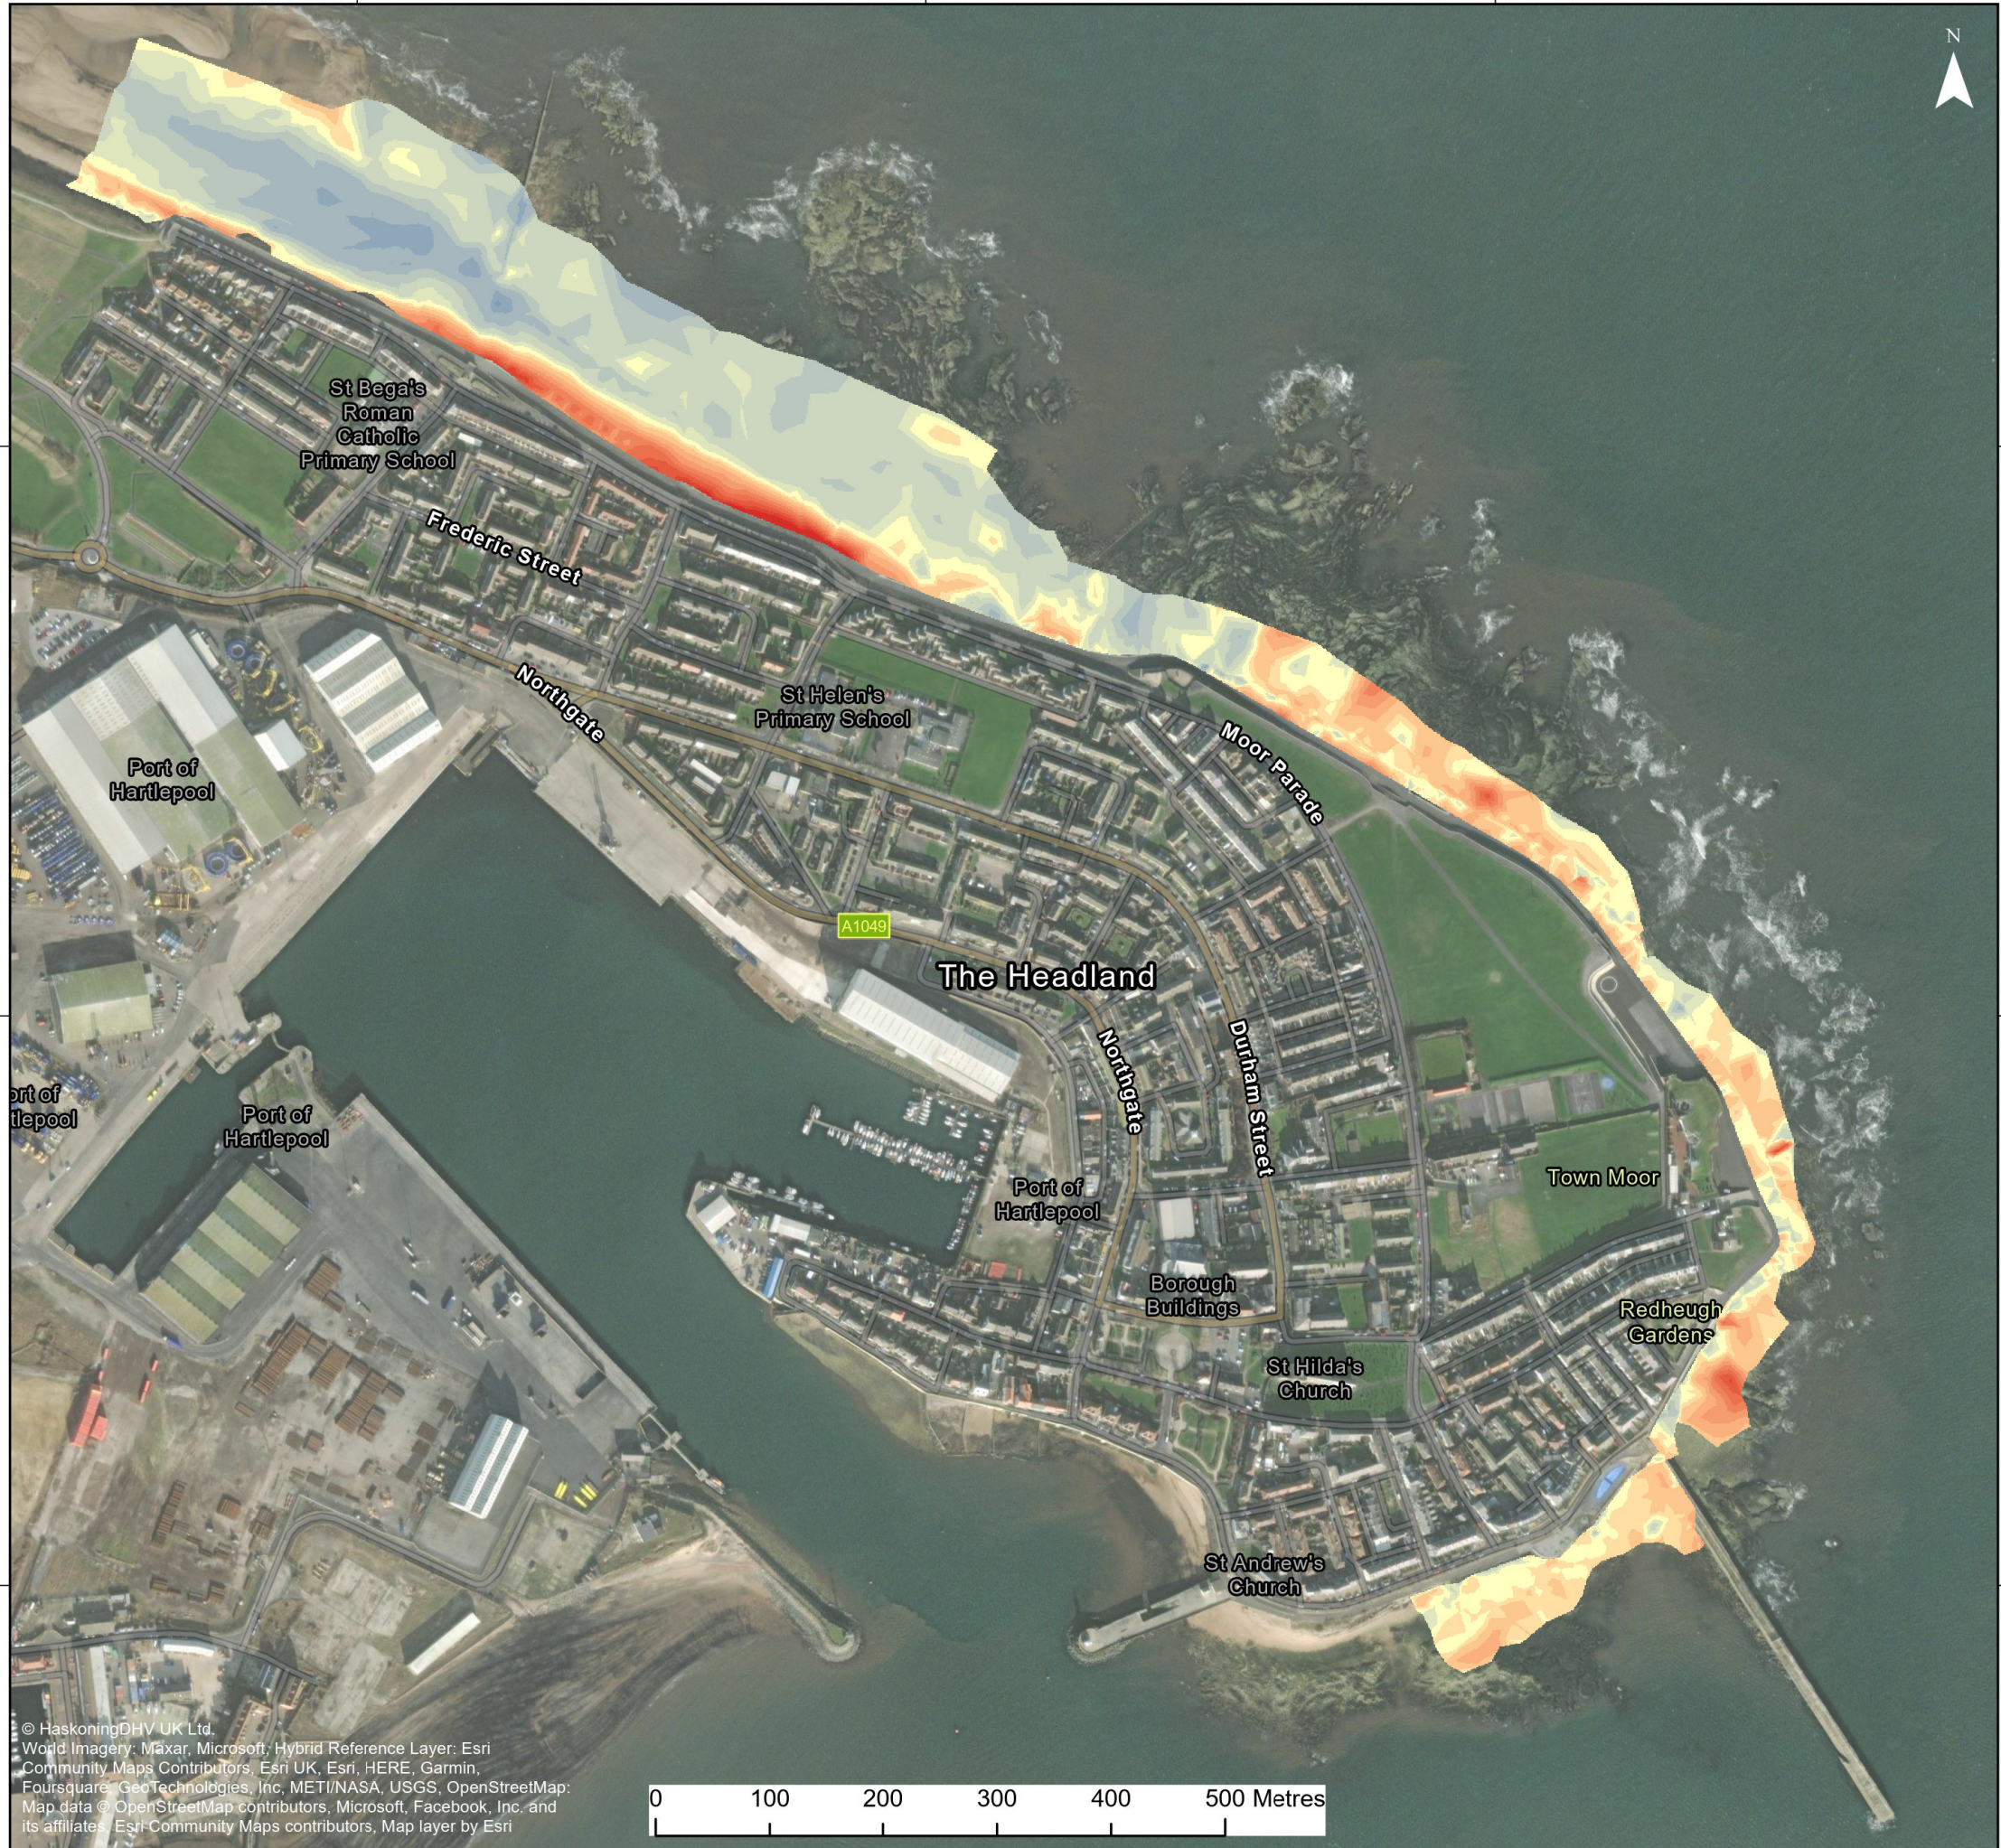
Title:
Appendix A - Map 2
Hartlepool Headland
Hartlepool Borough Council Frontage

Difference between topographic surveys
(October 2023 to November 2023)
Change in Elevation (mOD)
