Additional Note

To : Stewart Rowe
From : Nick Cooper
Date : 29 March 2011
Copy : Paul Knight, Emma Hick
Our reference : 9T6403 – Additional Note

Subject : Additional Beach Topographic Surveys

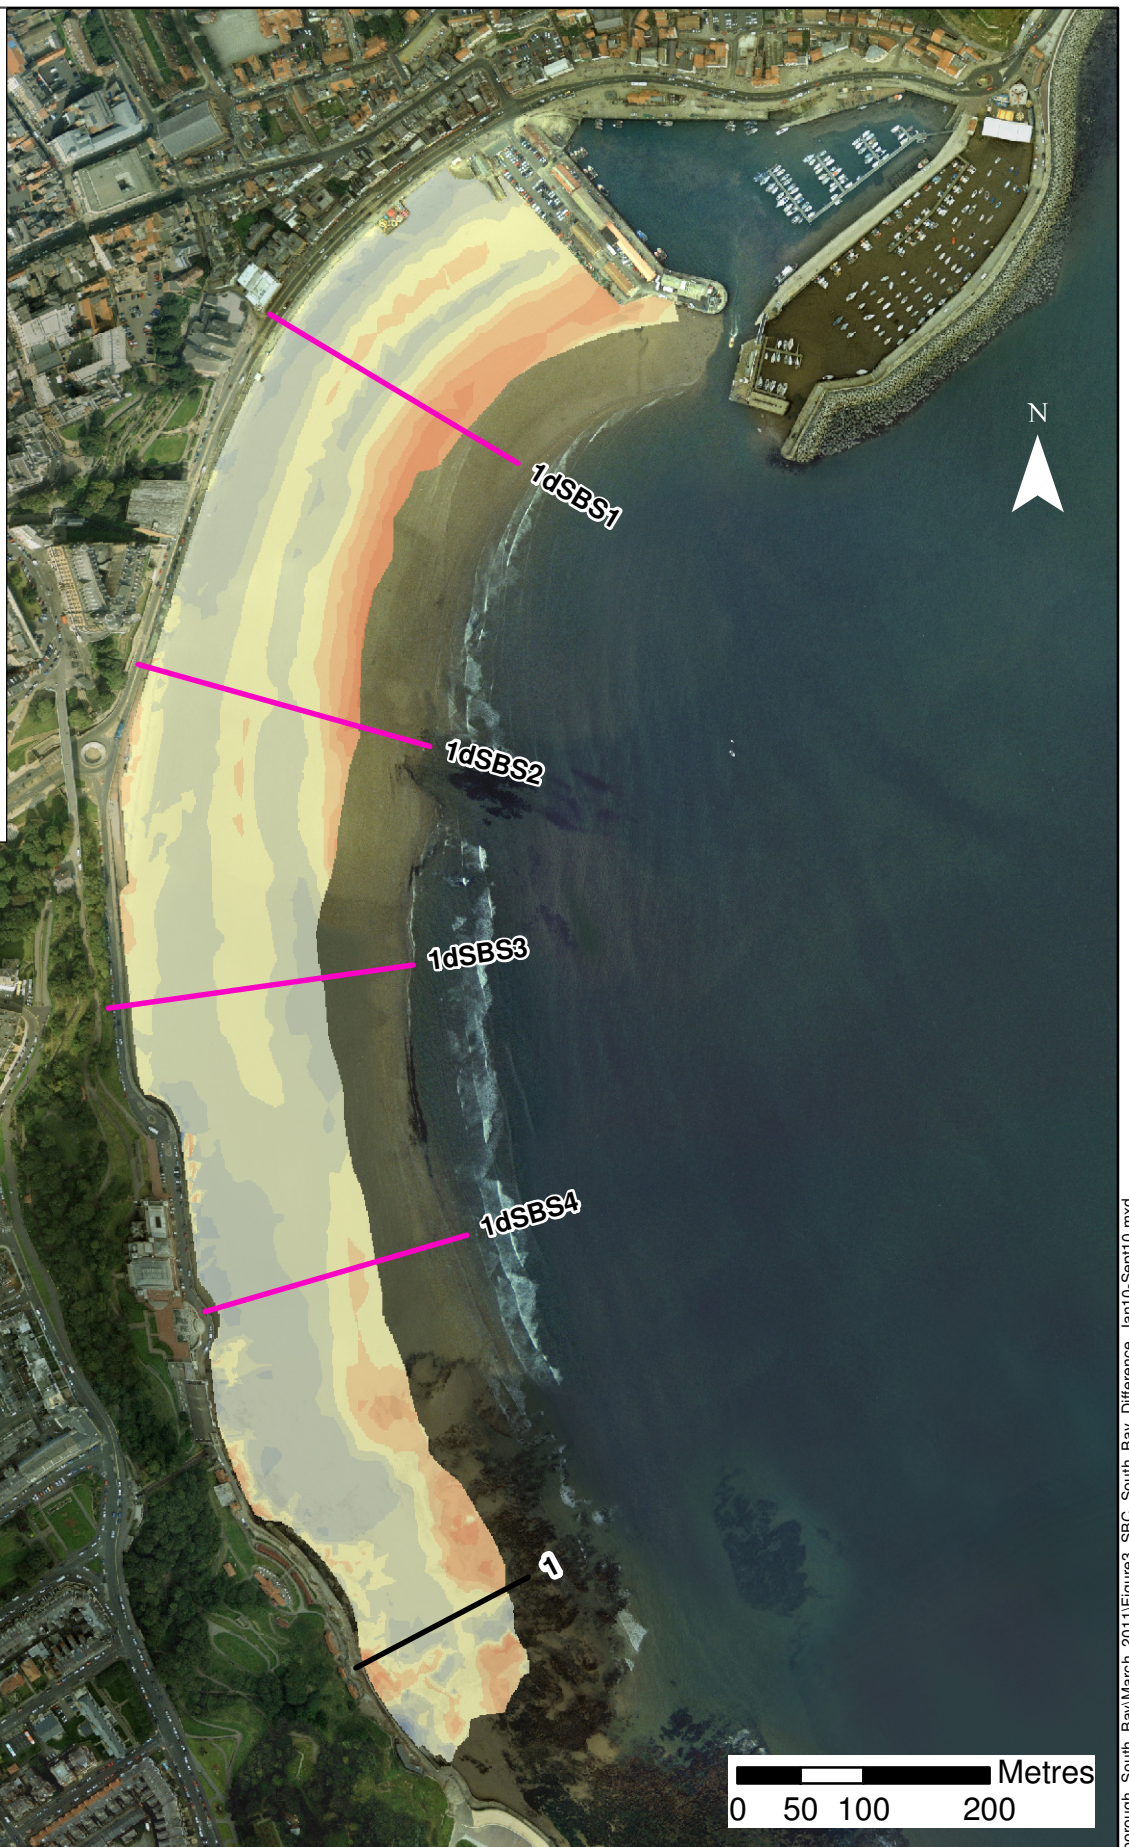
Figure:
 3

The subsequent September 2010 survey and the difference between the January 2010 and September 2010 surveys are shown in **Appendix A**. There was a general tendency for modest accretion throughout much of the Bay, showing no long-lasting detrimental effects of the sand mining (and subsequent substantial replacement) with a zone of erosion of the lower foreshore just south of the harbour, and another zone of erosion of the lower foreshore south of the Spa.

In the vicinity of profile line SBS1, the upper foreshore accretion was of the order of 0.35m at the toe of the sea wall, peaking at 0.6m at a chainage of around 18m from the wall. Accretion occurred along the profile across a width of upper beach of about 50m in total. A berm was then formed around mid beach level before the lower foreshore started to reduce in level compared to the previous survey, by up to 0.8m in places. This suggests that material was removed from the lower profile and driven up the beach, forming a berm around mid beach level. A similar trend was observed along profile line SBS2, but the upper beach accretion was less. Along profile line SBS3 no lowering was recorded, and accretion of up to 0.35m occurred along the width of the foreshore. Immediately offshore of the Spa, profile line SBS4 experienced accretion over much of its length (across a beach width of around 100m), with slight lowering at the very seaward end of the transect.

Title:
 Changes between Jan 2010 and Sept 2010 Topographic Surveys

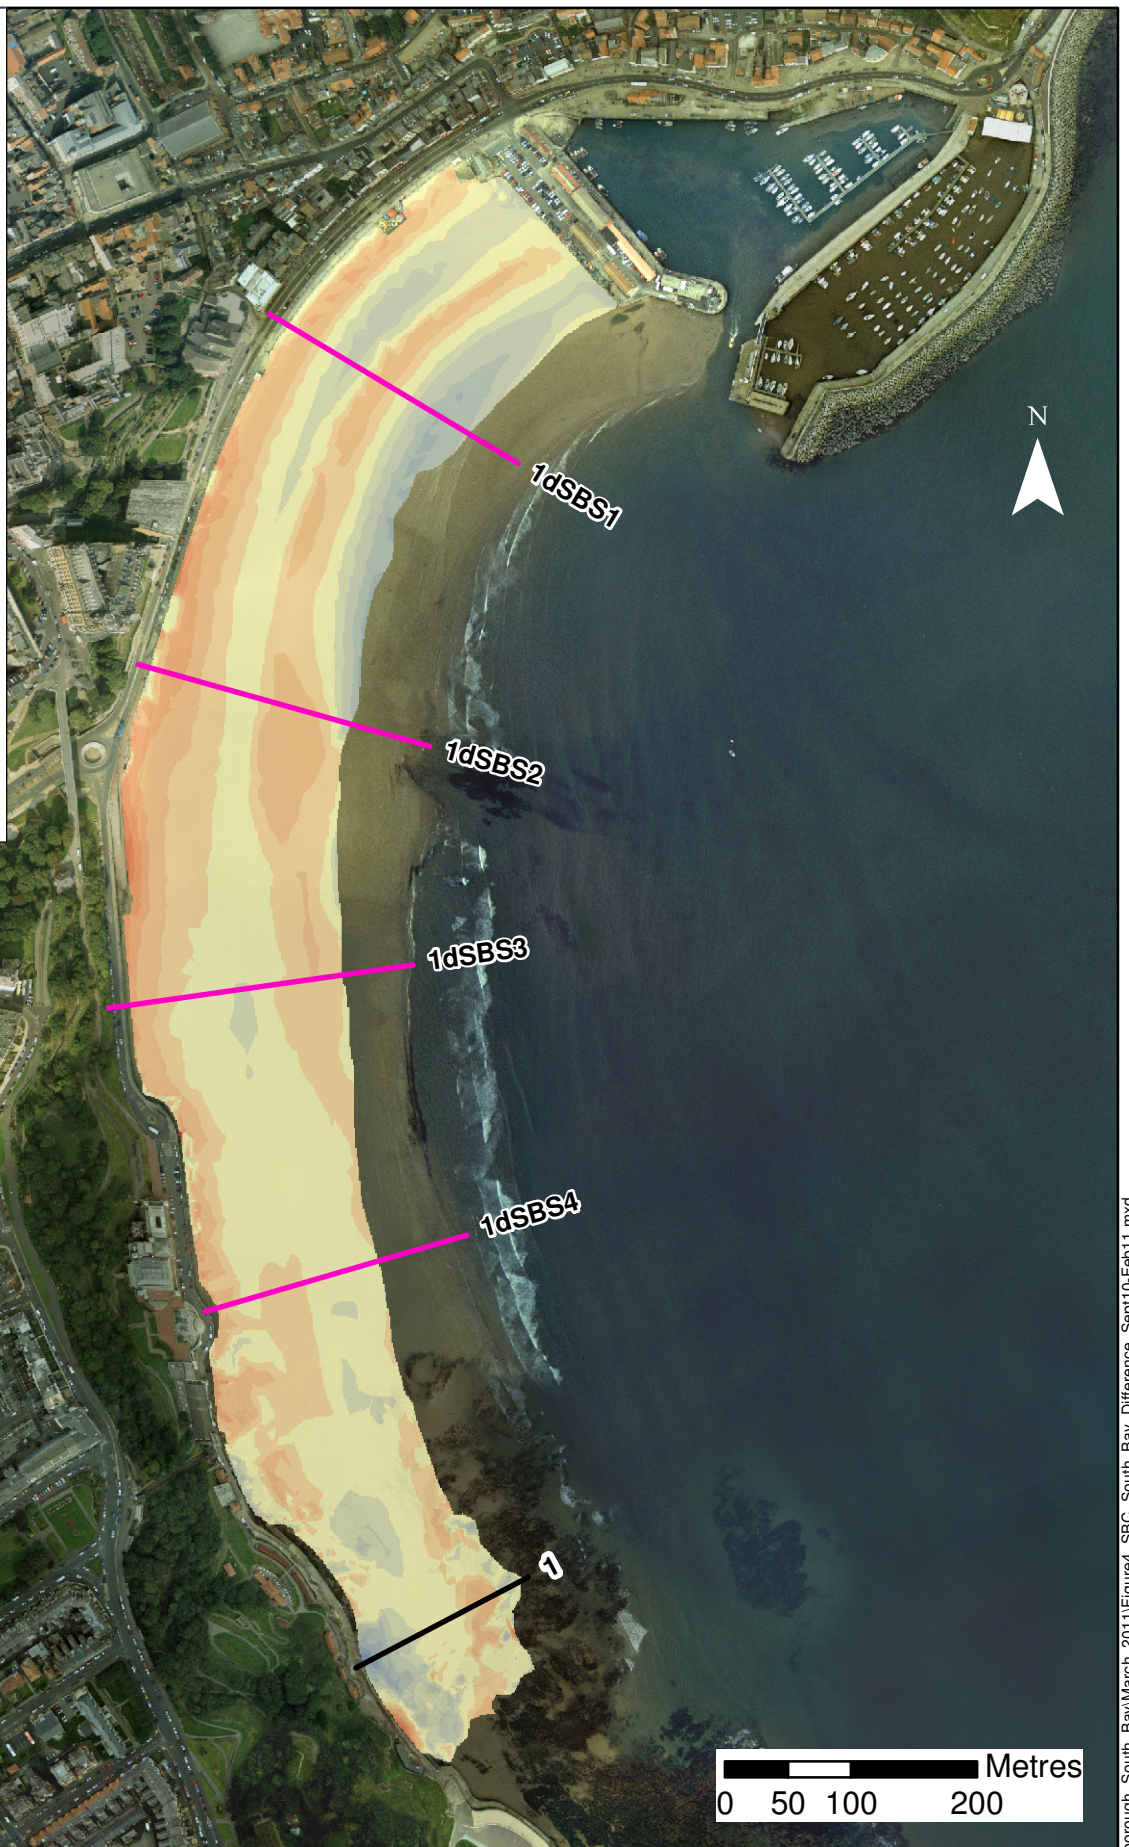
Date: March 2011	Scale on A4: 1:6,000		
Figure: 4	<table border="1"> <tr> <td>Drawn: TC</td> <td>Checked: NC</td> </tr> </table>	Drawn: TC	Checked: NC
Drawn: TC	Checked: NC

The February 2011 survey is also shown in **Appendix A**, together with a figure showing difference between the September 2010 and February 2011 surveys. In contrast to the preceding analysis, South Bay generally experienced a loss of material between these dates, with the upper beach levels notably reduced through much of the Bay and mid beach levels also reduced from north of the Spa northwards to the harbour. Some accretion occurred on the lower foreshore in the north of the Bay.

These changes were most marked at profile lines SBS2 and SBS3, where the drop in level of the upper beach was of the order of 0.6m. At the Spa, the drop in levels at the toe of the sea wall was less, being of the order of 0.35m.

Title:
 Changes between Sept 2010 and Feb 2011 Topographic Surveys

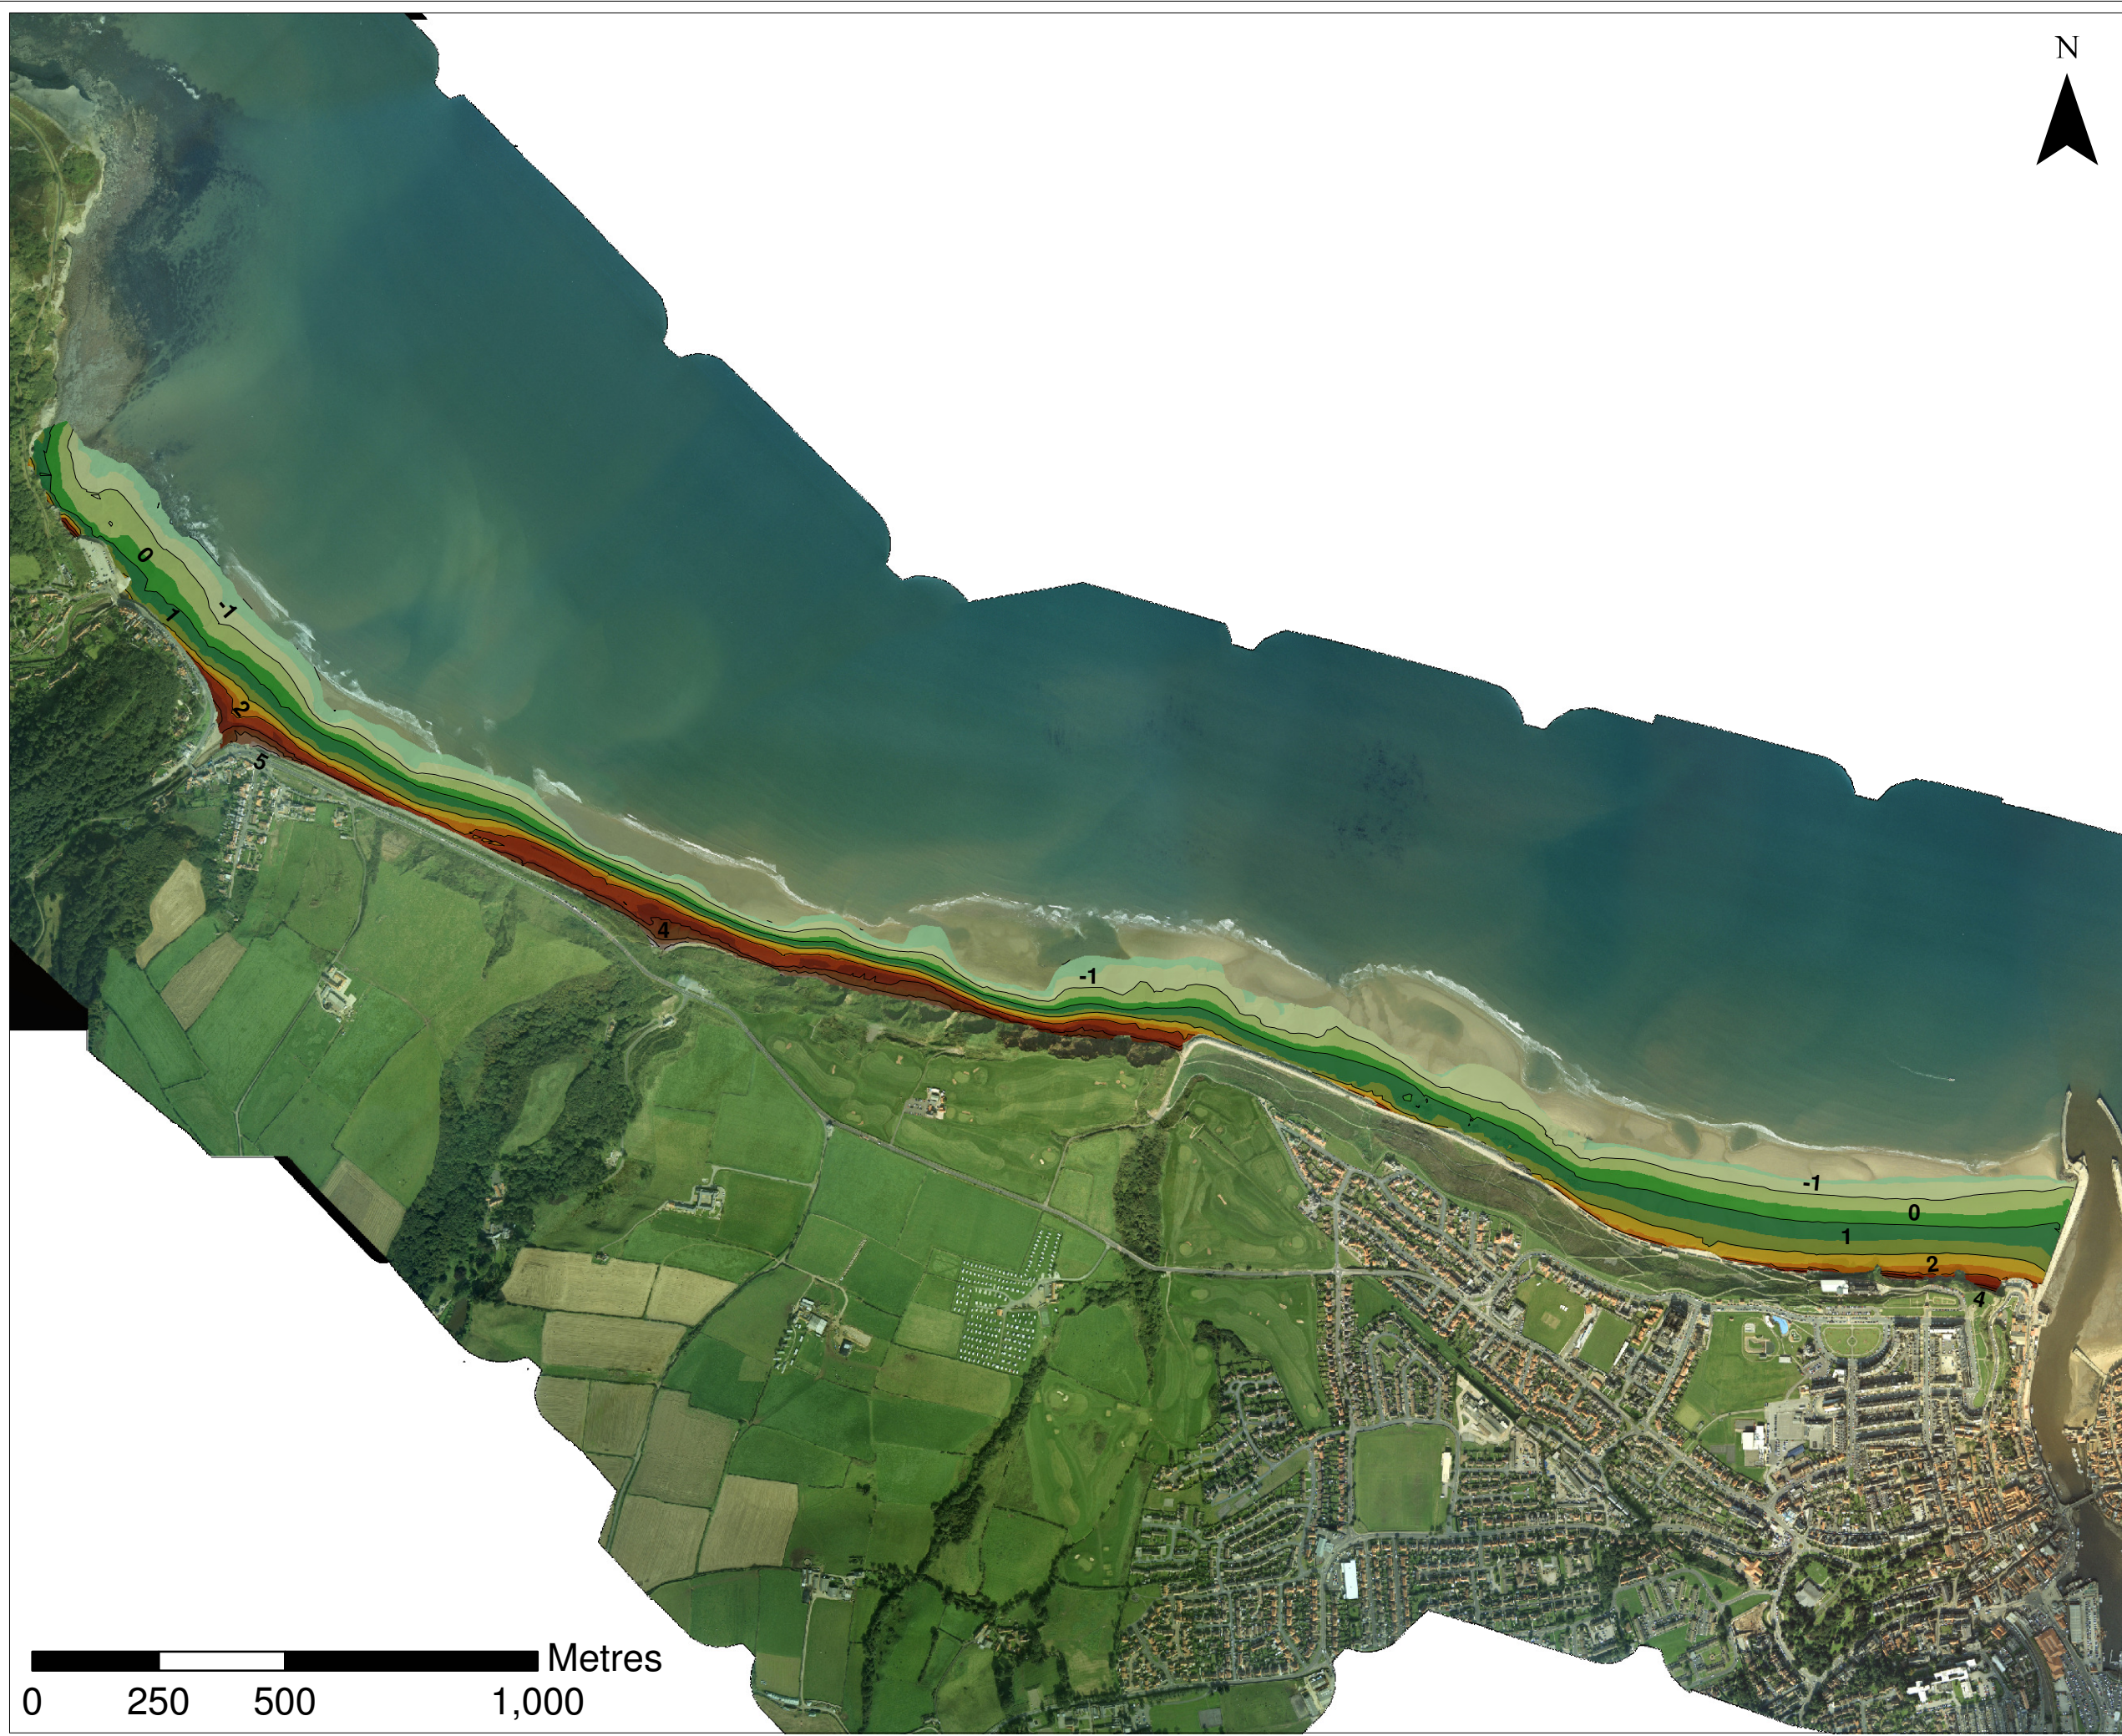
Figure: 1	Drawn: TC	Checked: NC
--------------	--------------	----------------

The March 2011 survey is shown in **Appendix C**, together with a figure showing difference between the November 2010 and March 2011 surveys. Between these dates there was a section of frontage along Sandsend Beach, extending eastwards of East Row Beck for a distance of approximately 625m where the road runs close to the coastline, where beach lowering occurred. Along Upgang Beach, deposition occurred across the mid and upper profile, with lowering of the lower foreshore. This trend was also noticed at Whitby Sands, although the magnitude of the changes was less than at Upgang Beach. It is envisaged that the upper foreshore lowering at the toe of the cliffs along Sandsend Road is within the natural bounds of behaviour and will recover due to natural variations in level over forthcoming months.

Title:
Topographic Survey
(March 2011)

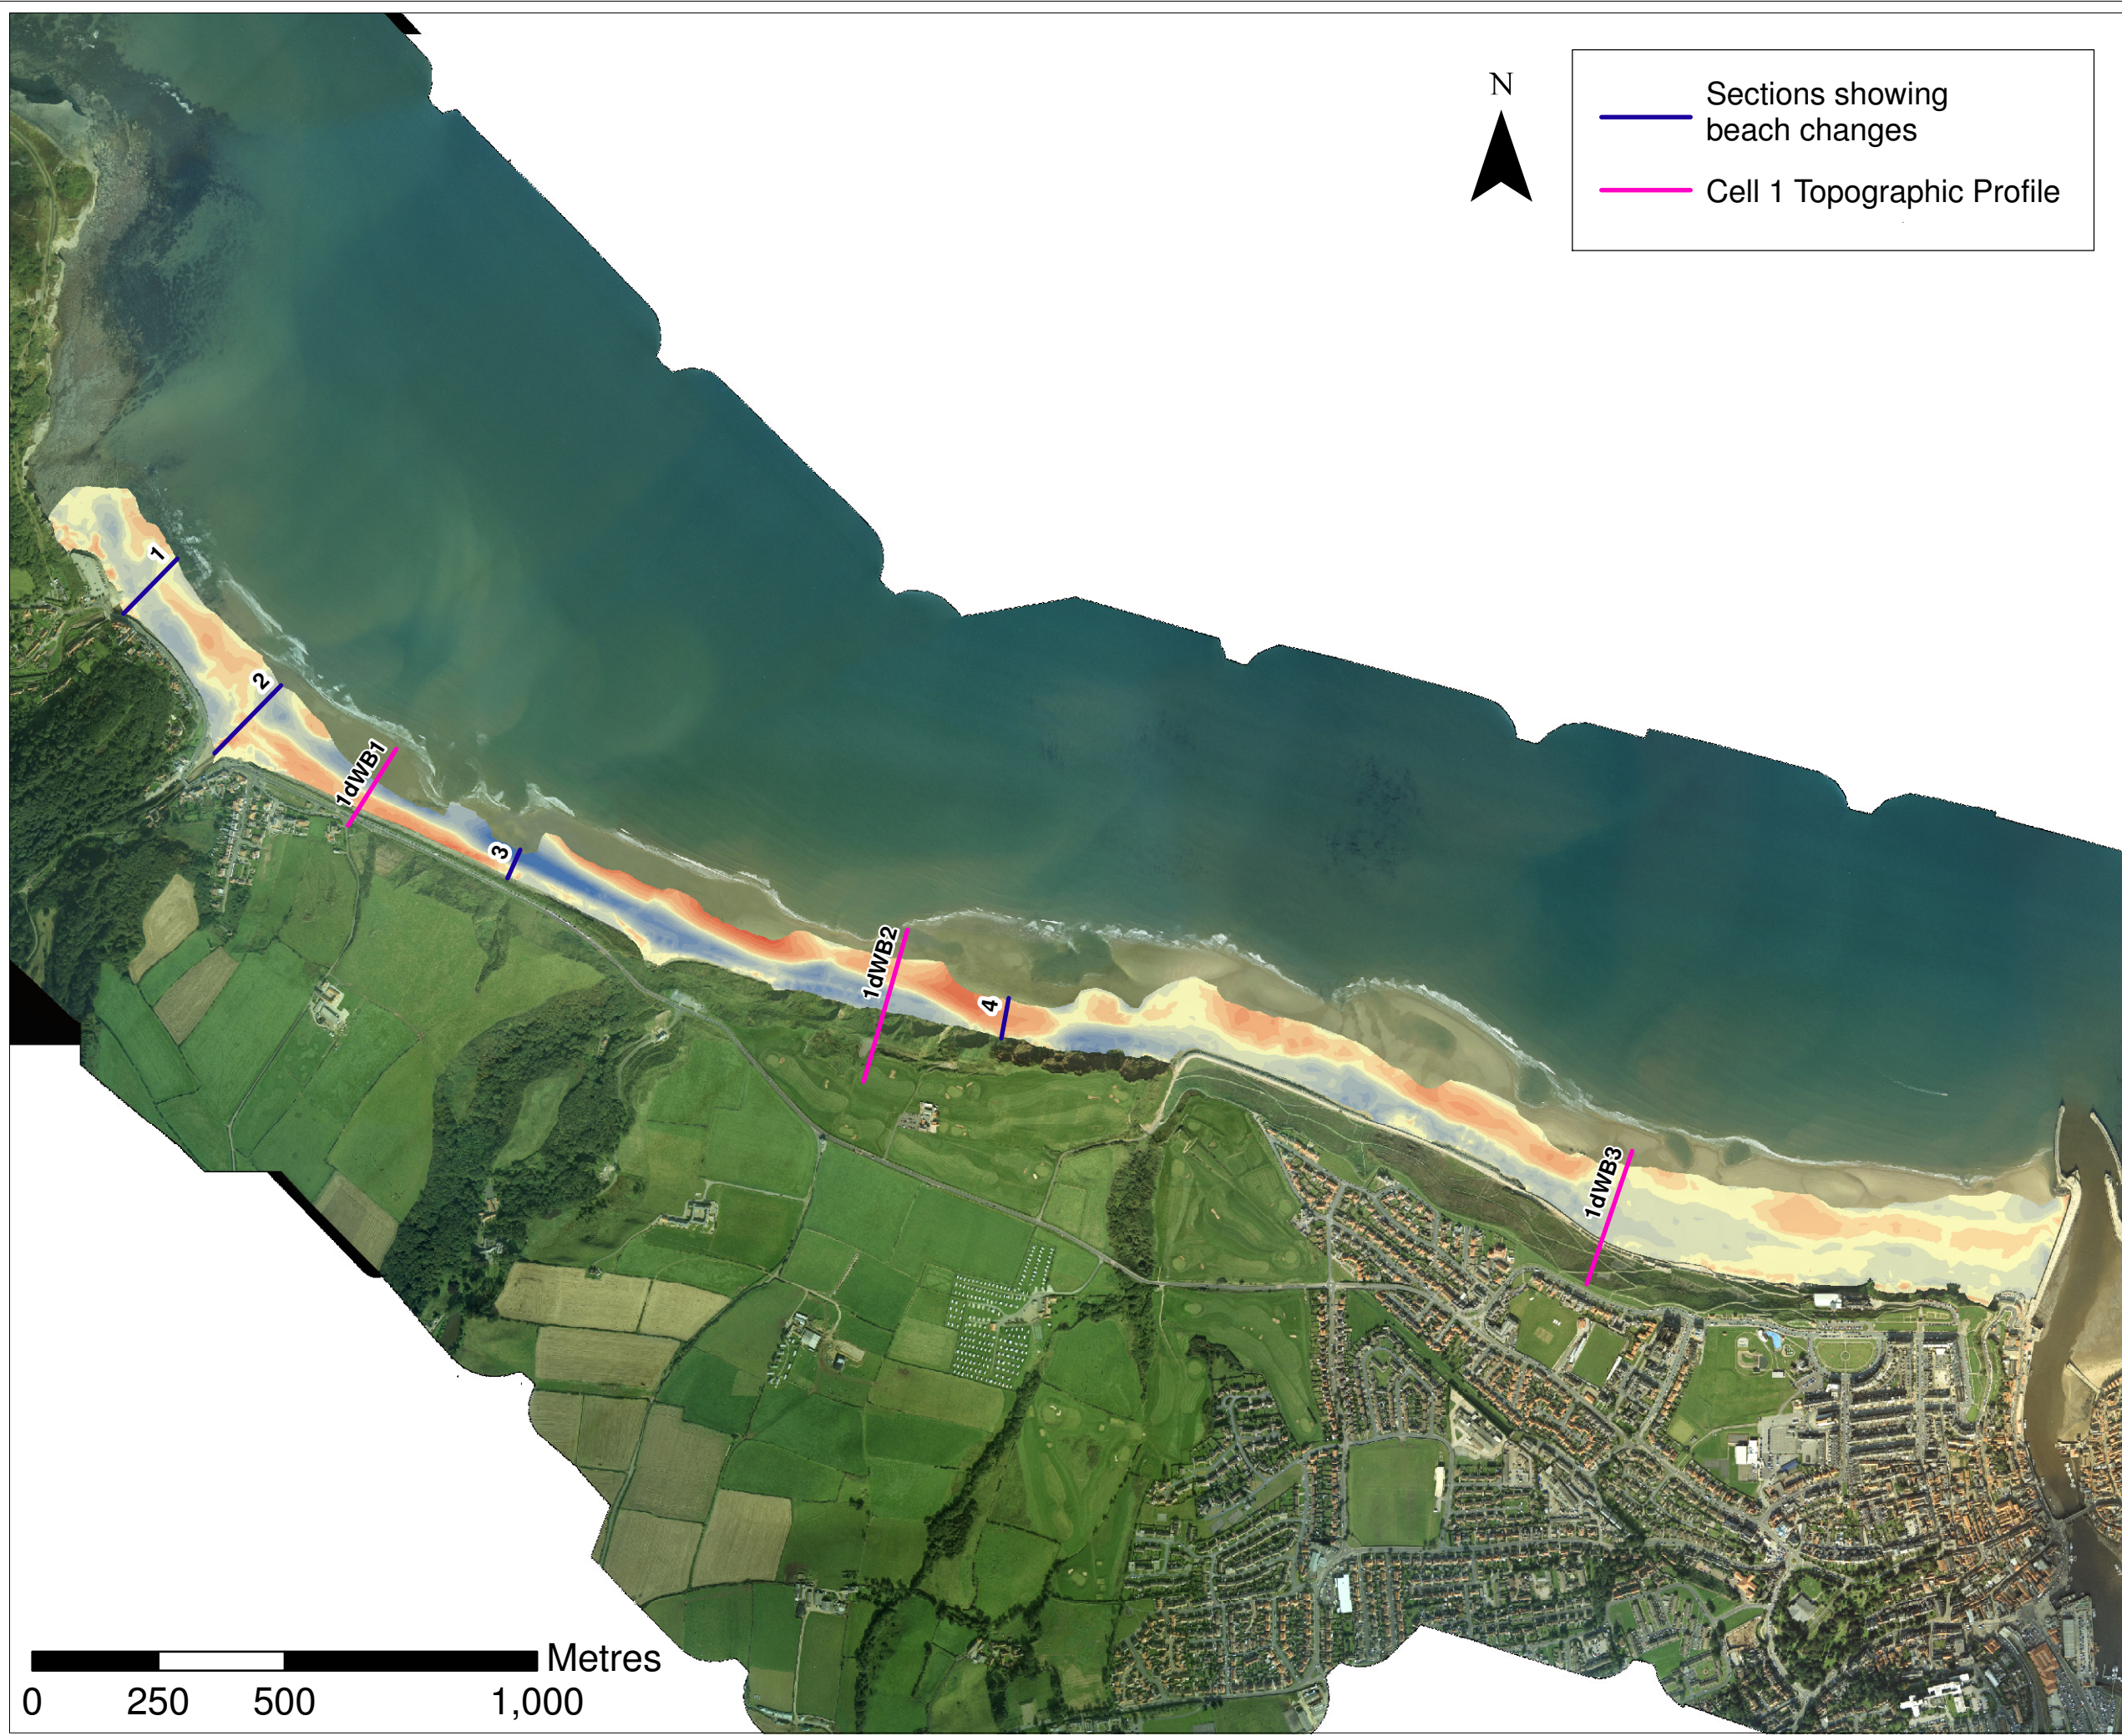
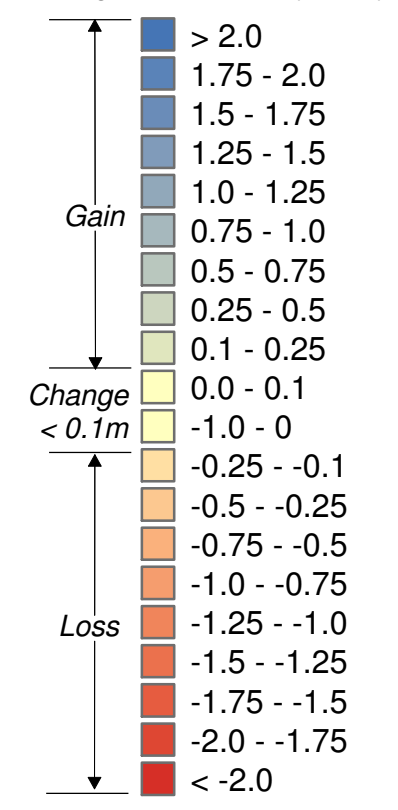
Figure: 1	Drawn: TC	Checked: NC
--------------	--------------	----------------

Title:
Changes between Nov 2010 and Mar 2011 Topographic Surveys

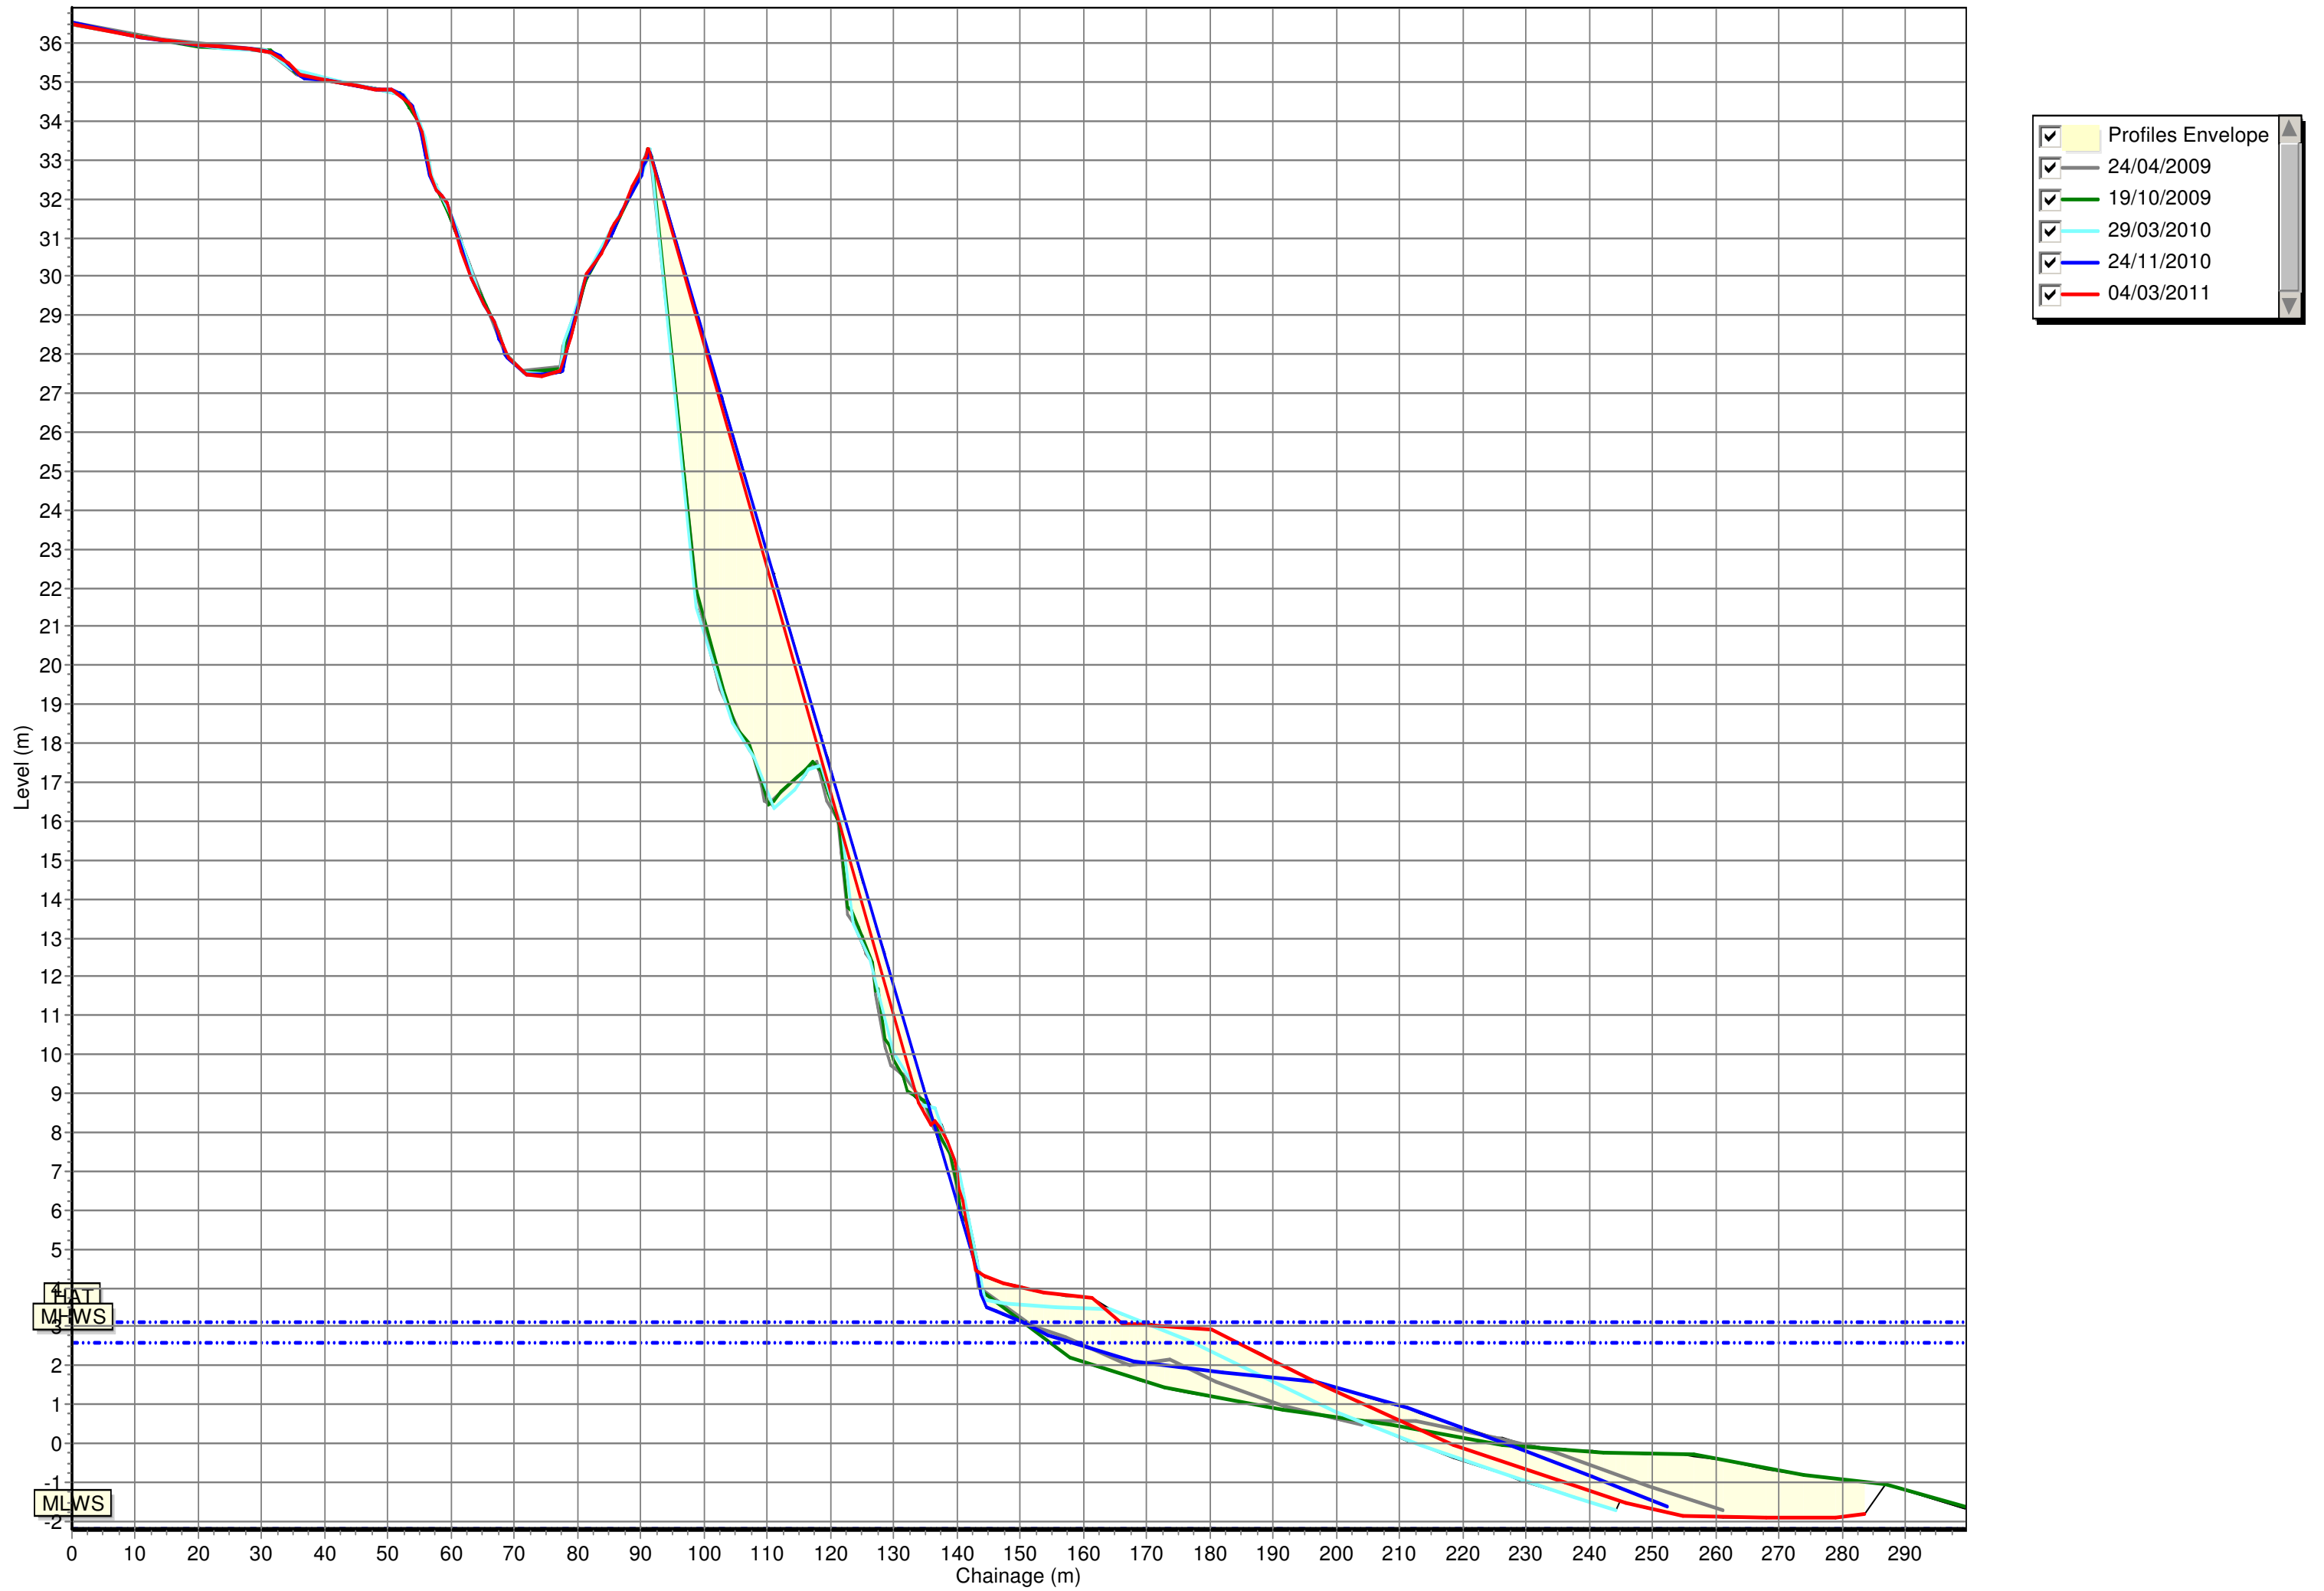
Beach Profiles: 1dWB2

Along profile WB2, extending from the undefended cliffs at Upgang, beach levels are also quite volatile, with changes of the order of 1m not uncommon between successive surveys along certain lengths of the profile. During the March 2011 survey, levels were relatively high on the upper beach, but dropped notably at the seaward end of the section.

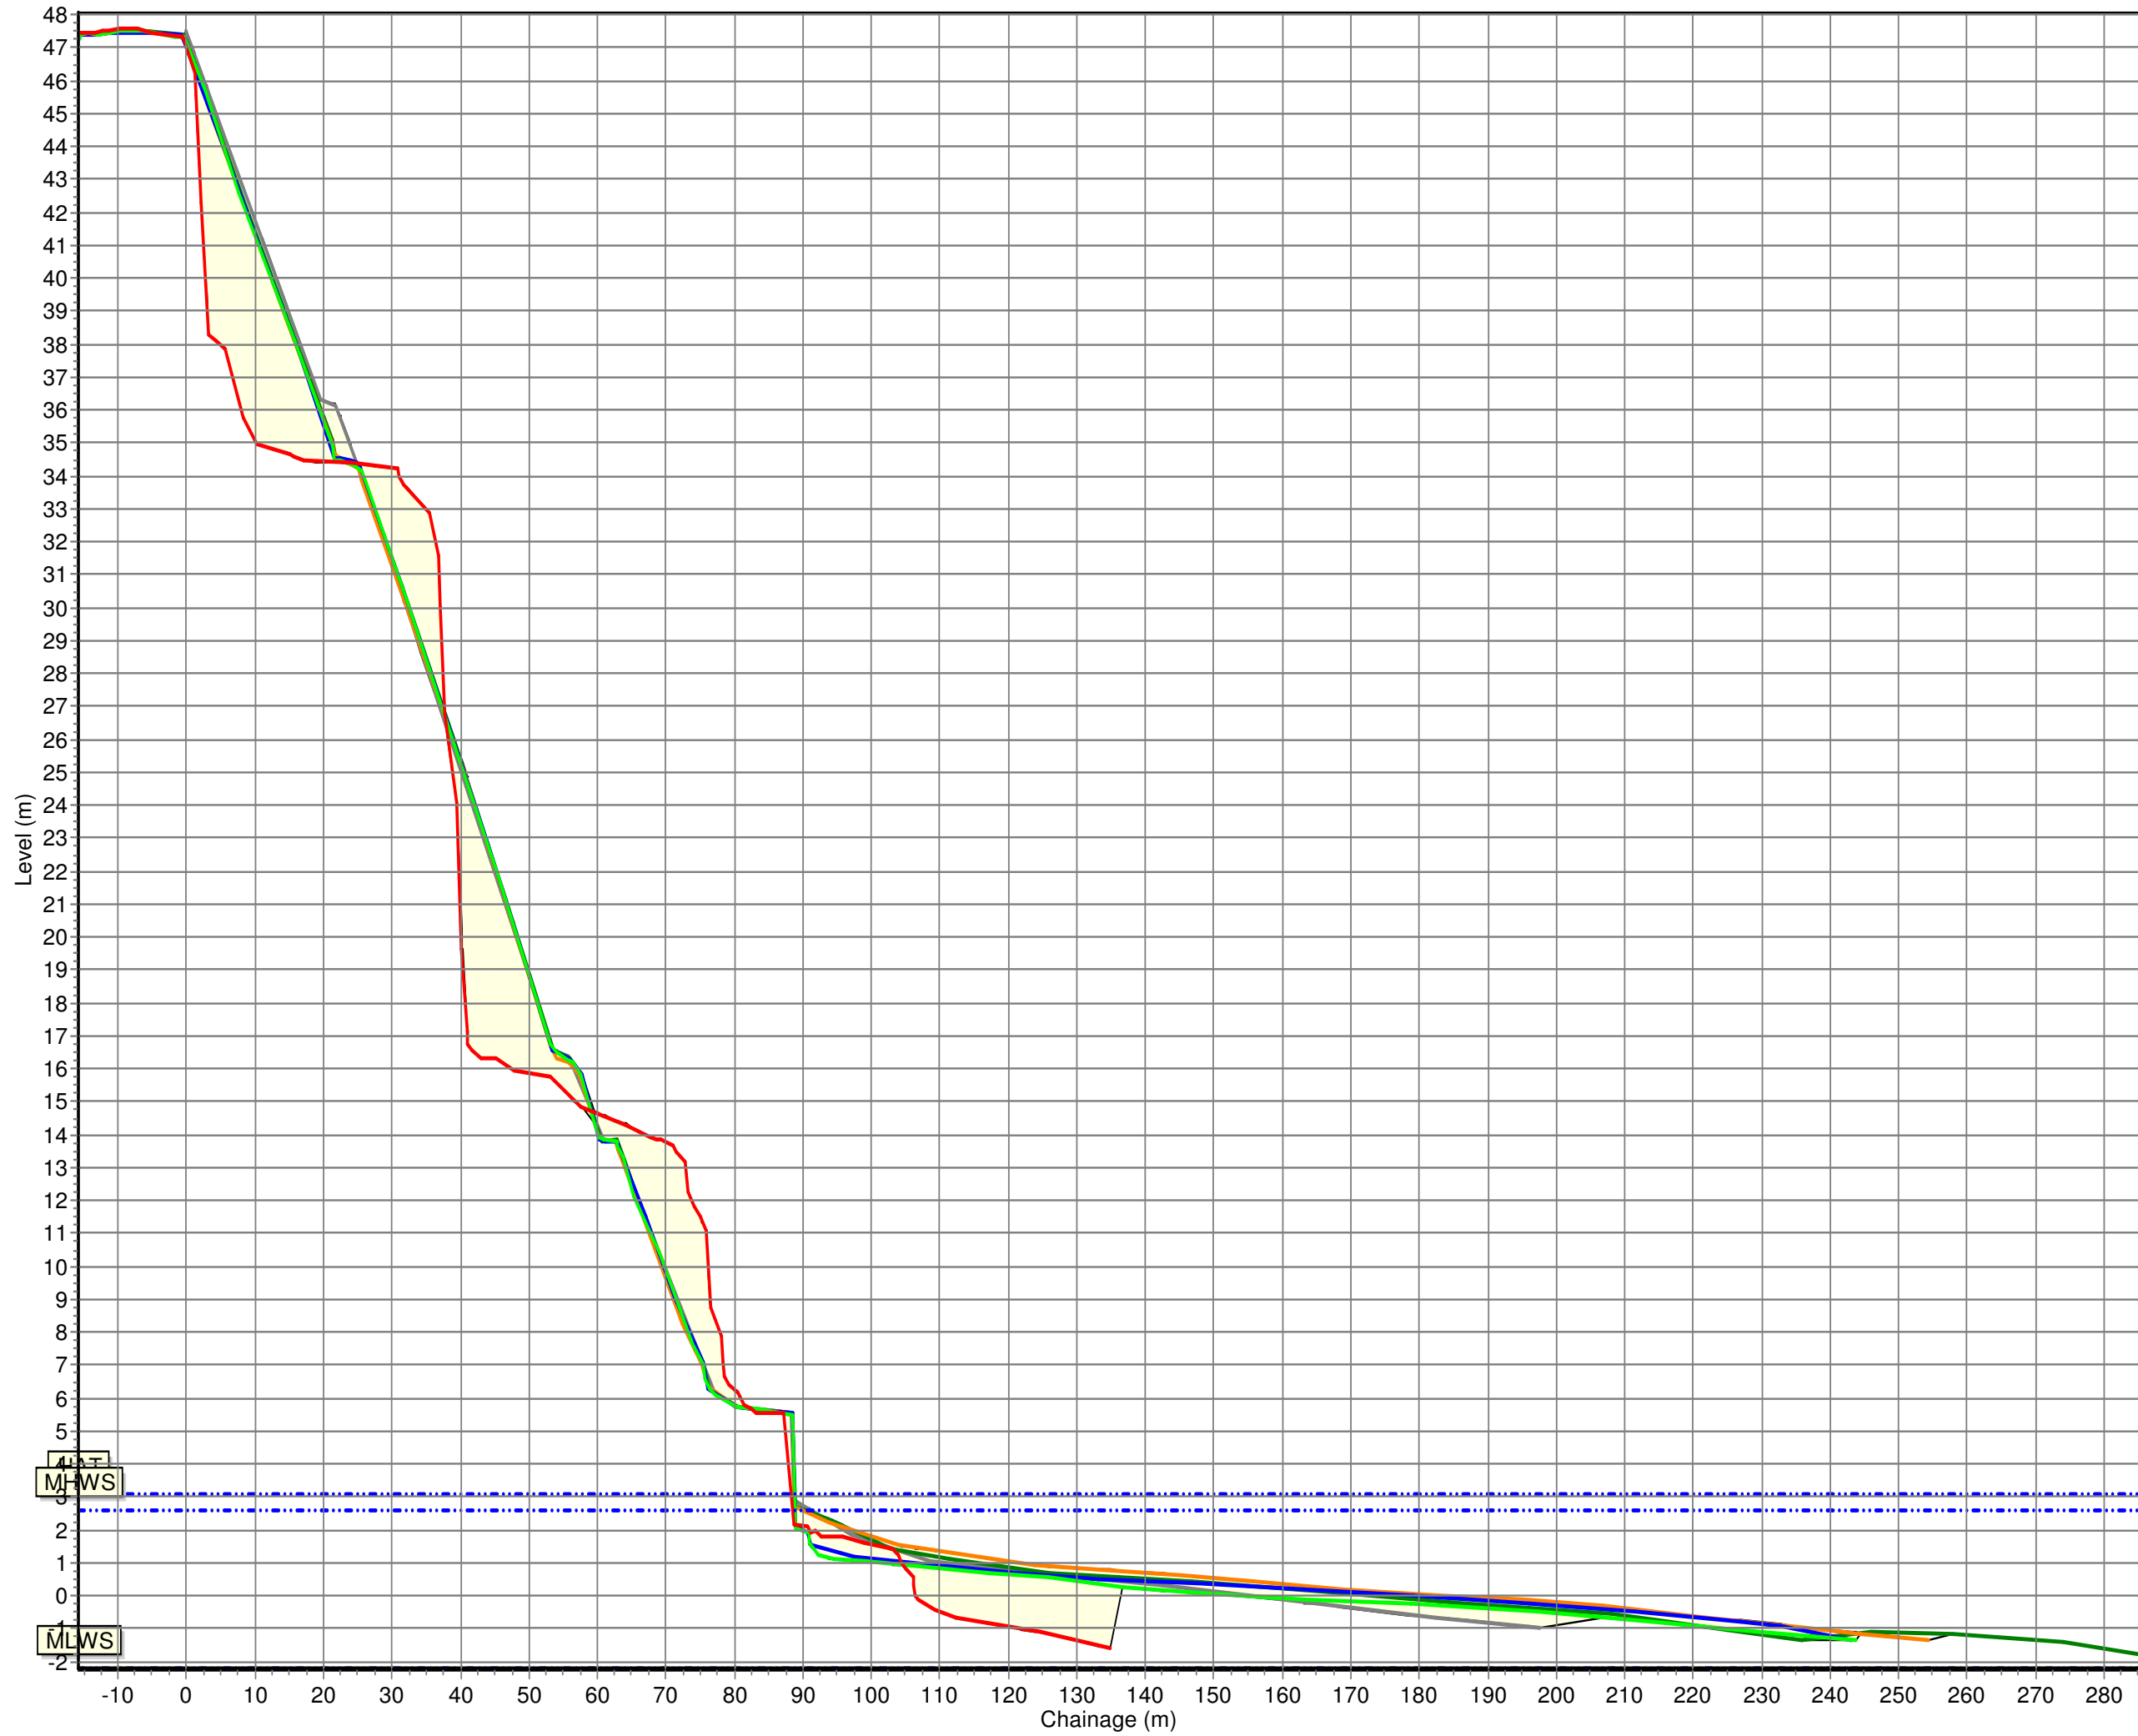
Beach Profiles: 1dWB3

WB3, which extends from the defended Whitby West Cliff, is generally more stable in beach levels, although the last survey showed a significant drop in level a short distance from the seawall.
