**Cell 1 Regional Coastal Monitoring Programme
Update Report 3: 'Partial Measures' Survey 2012**

**North Tyneside Council
Final Report**

February 2013

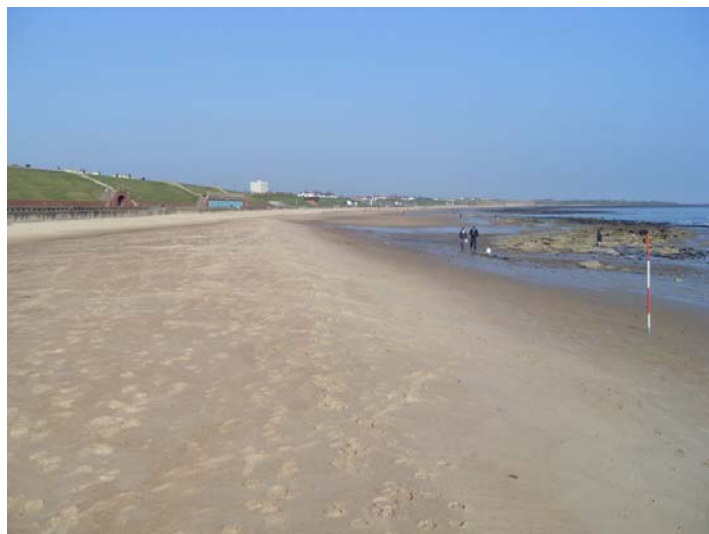
Plate 1 – Survey photograph 1aNTDC04_20120322_N5.JPG

Survey Date	Description of Changes Since Last Survey	Interpretation
	Profile 1aNTDC04a is located to the south of Whitley Sands. Since the last survey, beach levels at the toe of the seawall to a chainage of 40m (level of 1.2m) have increased by up to 1.5m. Seaward of 60m chainage to the rocky foreshore, beach levels have fallen by up to 1.2m.	To the south of Whitley Sand the increases are the largest observed. This suggests particularly significant storms over the winter have transported sediment into the system.
