**Cell 1 Regional Coastal Monitoring Programme  
Update Report 6: 'Partial Measures' Survey 2014**

**North Tyneside Council  
Final Report**

**July 2014**

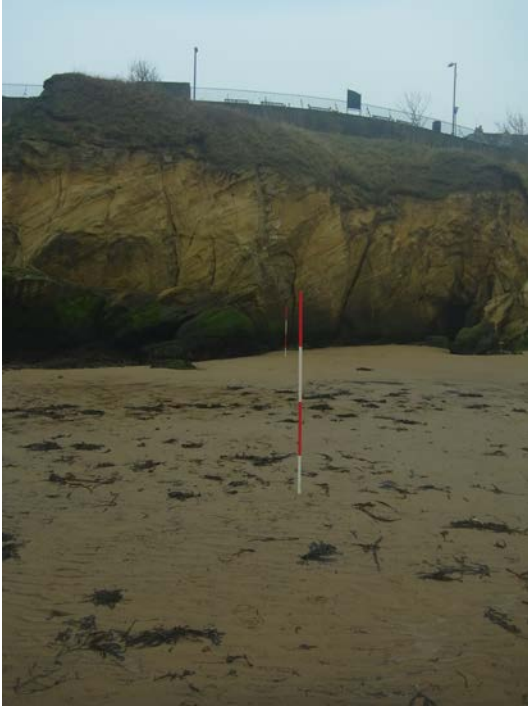
Plate 3 – Survey photograph 1aNTDC05\_20140403\_Up3.JPG

Survey Date	Description of Changes Since Last Survey	Interpretation
<p><b>Apr 2014</b></p>	<p><b>Beach Profiles:</b></p> <p>Cullercoats Bay is covered by one beach profile line for the Partial Measures survey (Appendix A). This was surveyed annually each autumn between 2002 and 2009. From spring 2010 onwards, it has been surveyed bi-annually. The last survey was the autumn 2013 Full Measures survey.</p> <p>The cliff top position along <b>1aNTDC05</b> has remained constant since surveys began in April 2002, but there have been apparent changes along the cliff face. The survey report notes '<i>cliff not measured at section 5 due to dangerous access</i>'. It is therefore likely that the changes observed are related to the survey technique used rather than actual change.</p> <p>From the cliff toe to a chainage of 48m beach levels have increased by almost 0.5m and the rock previously exposed (Full Measures 2013) now has a covering of sand (Plate 3 and Plate 4). Seaward of 48m chainage, beach levels have remained stable down to 95m chainage. Seawards of this the large toe berm observed in the previous survey (Full Measures, autumn 2013) is no longer present and the profile is now flatter with a drop in beach level of approximately 1.4m. Although the upper beach levels have increased slightly, visual observations indicate that the increase in area is likely to be smaller than the area of material lost from the toe berm. This suggests that storm waves may have moved this store of material further offshore. The berm was a new feature in the Full Measures 2013 survey and has not been observed in any other surveys. The profile has therefore returned to a similar form to those measured in spring 2013 and earlier.</p>	<p>As in previous surveys, the surveyors report that access to the cliff has not been possible.</p> <p>The upper beach has accreted to cover the underlying rock exposed in the previous survey. The berm previously observed at the toe of the beach is no longer present resulting in a significant reduction in level at the beach toe (up to 1.4m).</p> <p>Although the upper beach levels have increased slightly, visual observations indicate that the increase in area is likely to be smaller than the area of material lost from the toe berm. This suggests that storm waves may have moved this store of material further offshore.</p> <p><b>Longer term trends:</b> The beach levels observed are within the bounds of previous surveys.</p>

At profile 1aNTDC05 the cliff was not measured due to dangerous access. Access to this profile is noted to have been dangerous in the previous partial measures and full measures reports, and therefore consideration should be given to changing the location of this survey.
