## Cell 1 Regional Coastal Monitoring Programme Overview Report (2008 - 2011)

**Final Report**

**October 2011**

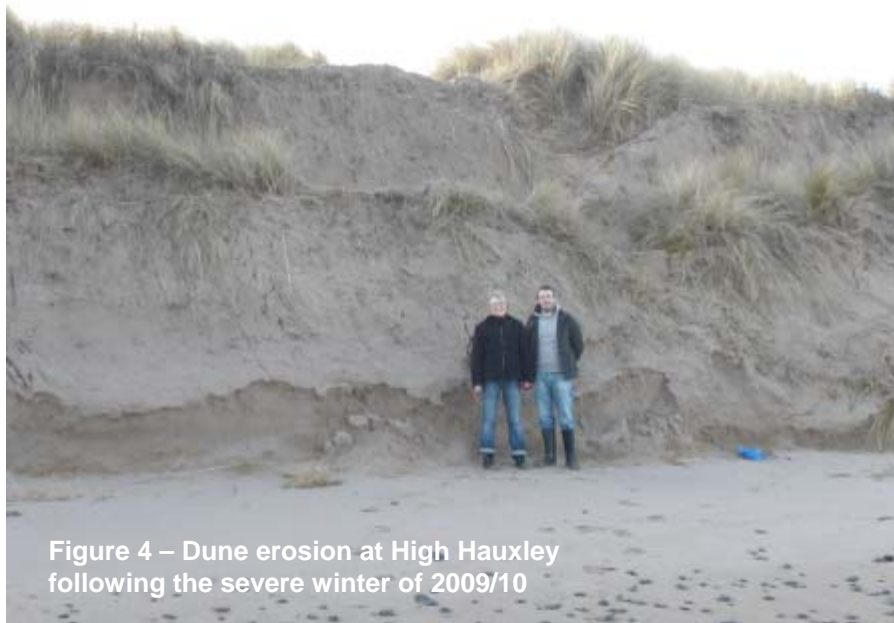
Figure 4 – Dune erosion at High Hauxley following the severe winter of 2009/10

- Hauxley has suffered from winter storm damage (as discussed previously) and erosion of rubble-strewn land behind a block revetment wall north of the Nature Reserve has occurred. Fossilised tree stumps have become exposed on the foreshore and within a peat layer at the base of the dunes as foreshore and dune erosion has occurred. A broader pattern of recession has been observed from comparison of aerial photographs from 1999 and 2010.

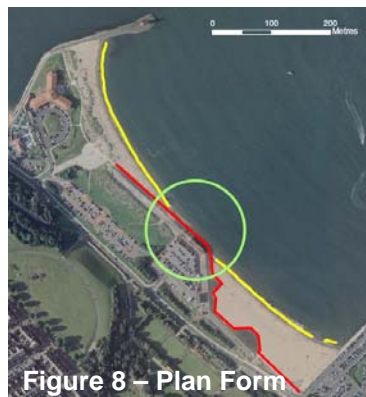
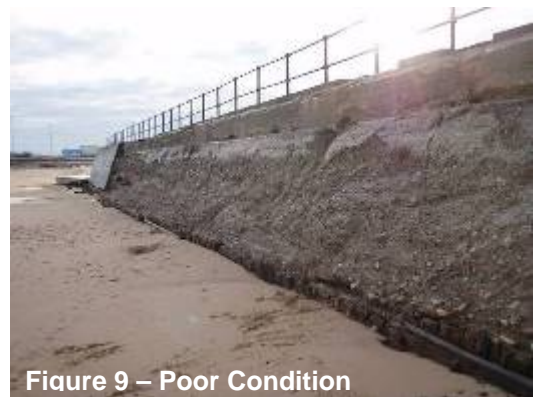
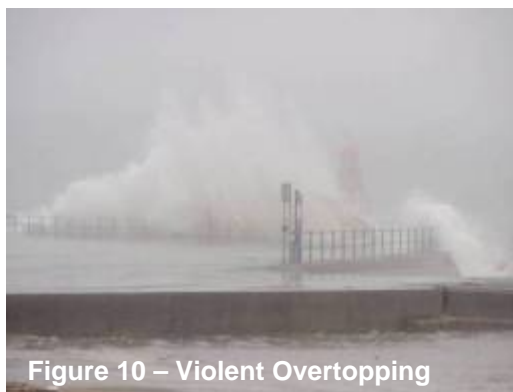
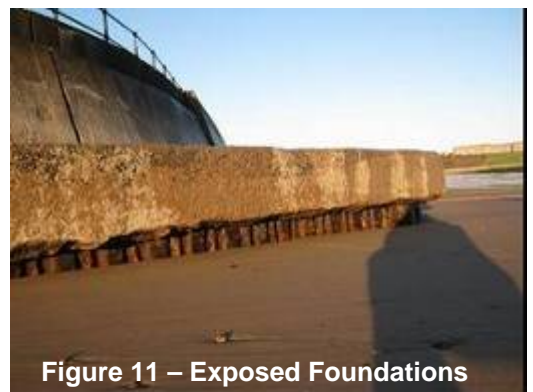
- The dunes along the northern section and the wide foreshore along the southern section of Littlehaven beach remain relatively stable, but in the central section, where the sea wall protrudes seawards (Figure 8), the foreshore levels can vary significantly. This, in part, is likely to be caused by reflection off the wall itself causing local mobilisation of beach material. The consequences of low beach levels at this location are: (i) greater wave forces act directly on the seawall, further worsening its already poor and deteriorating condition (Figure 9); (ii) wave overtopping is more likely to occur, leading the flooding and closure of the backing car park (Figure 10); and (iii) undermining of the foundations of the seawall starts to occur (Figure 11), leading to wash-out of the backing made ground and the creation of voids and, ultimately, local collapses.

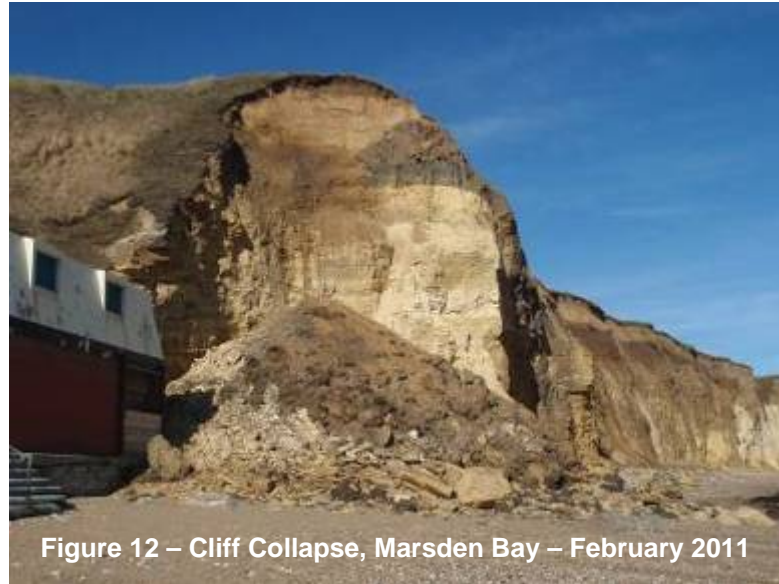
- Frenchman's Bay and Man Haven Bay have both suffered from notable cliff collapses following severe winters of 2009/10 and 2010/11, respectively. Other sections of cliff along this frontage remain unstable due to cracks in the rock structure, overhanging rocks and caves formed at the base of the cliffs.
- There is only a relatively narrow width of foreshore at the northern end of Marsden Bay and this has led to progressive damage to the Redwell Steps, which are now partially closed to public access due to safety reasons, and to collapse in February 2011 of a section of cliff adjacent to the disused Lifeguard Station adjacent to these steps (Fig. 12).

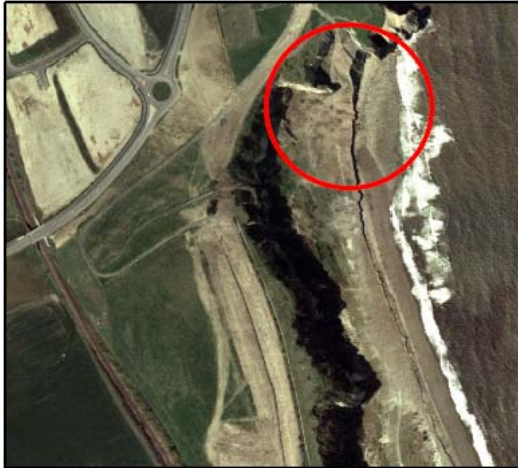
**Figure 14 – Blast Beach, 1999**

- There was substantial cliff top recession at parts of the Dawdon cliffs during two specific events.
- The colliery spoil beaches along many parts of County Durham remain wide and protect the backing relict cliffs from exposure to marine action. However, the colliery spoil is eroding along parts of Nose's Point, parts of Blast Beach and parts of Blackhall Colliery during specific storm events. Figures 14 and 15 show how erosion has occurred at the northern end of Blast Beach between 1999 and 2010.

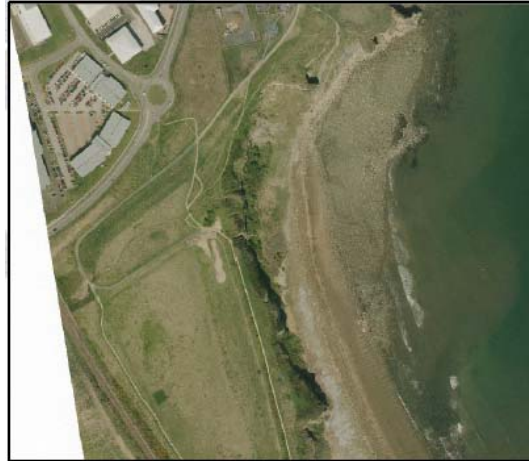
**Figure 15 – Blast Beach, 2010**

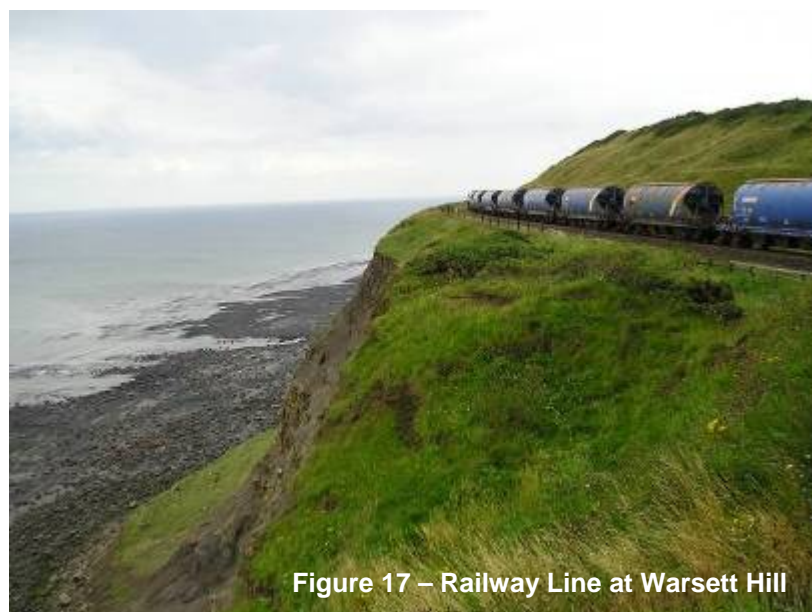
Figure 17 – Railway Line at Warsett Hill

- The walkover survey of summer 2010 identified high levels of cliff activity at Hunt Cliff and Warsett Hill, to the south of Saltburn Sands. A railway line runs very close to the cliff edge at this location.

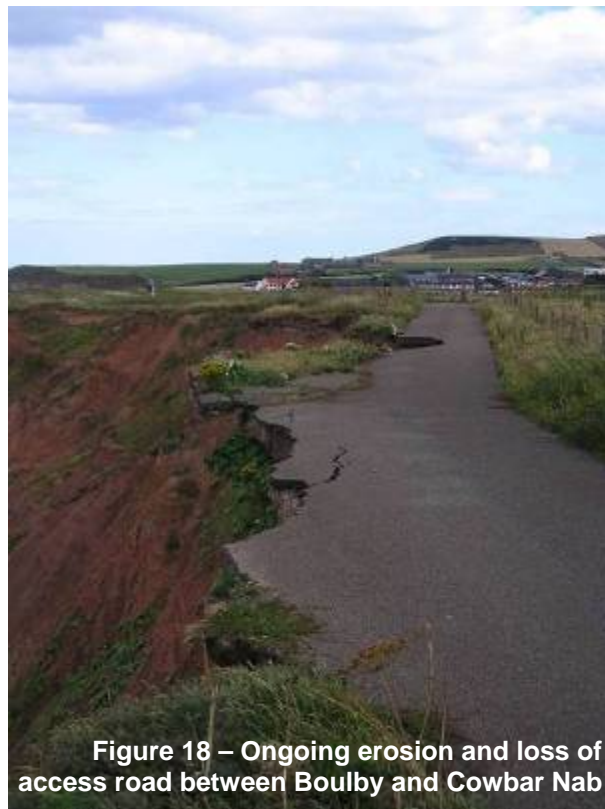
**Figure 18 – Ongoing erosion and loss of access road between Boulby and Cowbar Nab**

- The beach topographic data suggests during summer periods, Cattersty Sands often exhibits behaviour typical of a summer swell-dominated marine system. In the east, the influence of Skinningrove Beck on beach morphology is also observed. The Skinningrove bathymetric survey shows two main zones. The nearshore zone is predominantly sandy and smooth with some areas of rough bedrock. Further offshore, the sea bed features outcrops of jointed bedrock with patchy cover of sand where it has accumulated in hollows.
- The 2008 and 2010 walkover inspections noted the frontage between Boulby and Cowbar as an area of intense cliff erosion. Setback of the road has been necessary and a significant risk is posed to local traffic as this is the only access onto Cowbar Nab.

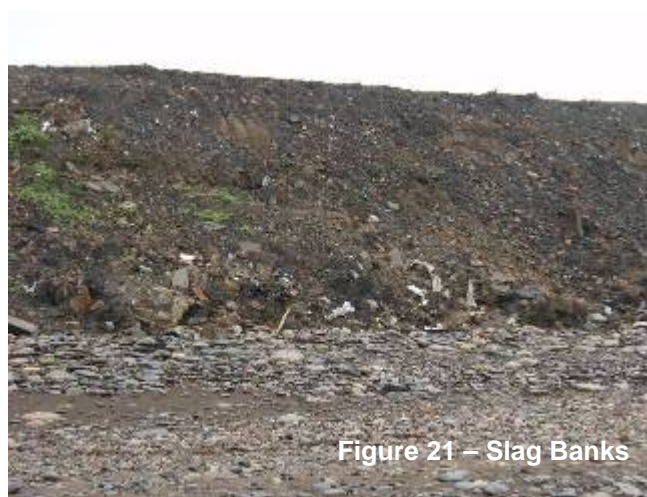
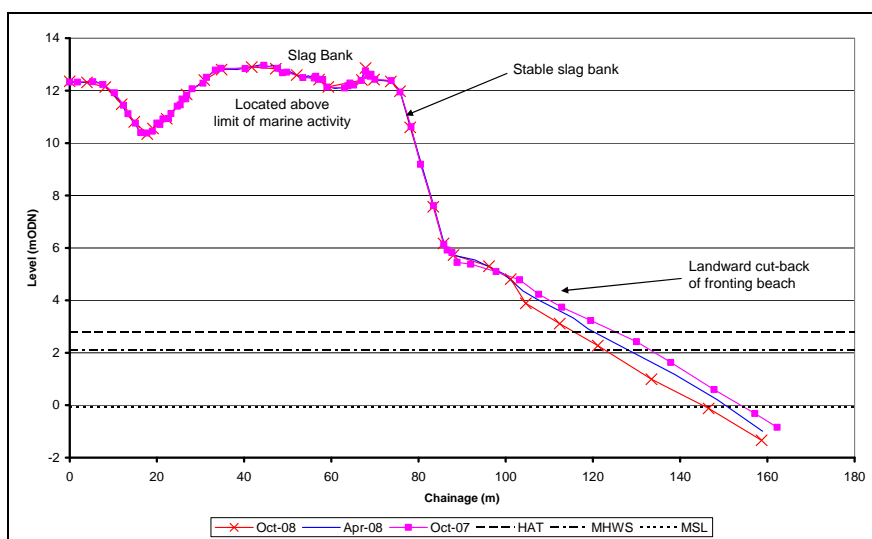
Figure 22 - Profile changes in northern Lynemouth Bay

Where the slag banks remain located above the limit of marine activity, such as towards the north of Lynemouth Bay, they are presently stable, but the fronting beach changes are quite rapid, causing lowering of levels and reductions in beach width (Figure 22). If these processes continue, the presently stable slag banks will become subject to marine conditions in the mid term.

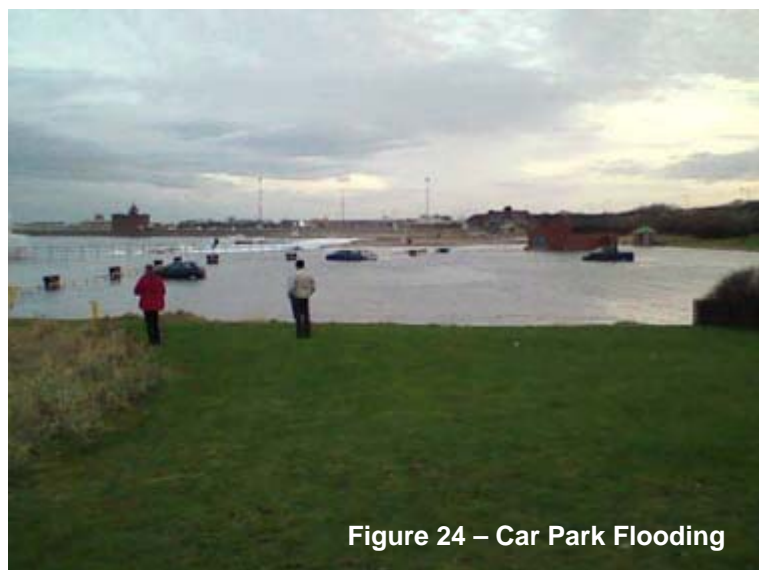
**Figure 24 – Car Park Flooding**

The beach profile surveys along this frontage showed particularly low levels at the toe of the wall in March 2010. Shortly after this survey was completed violent wave overtopping of the wall occurred, leading to substantial flooding of the backing car park. While this mechanism was previously hypothesised, the beach profile surveys give tangible evidence of the link between low beach levels and overtopping events, and support the case for landward re-alignment of the wall to reduce this risk.

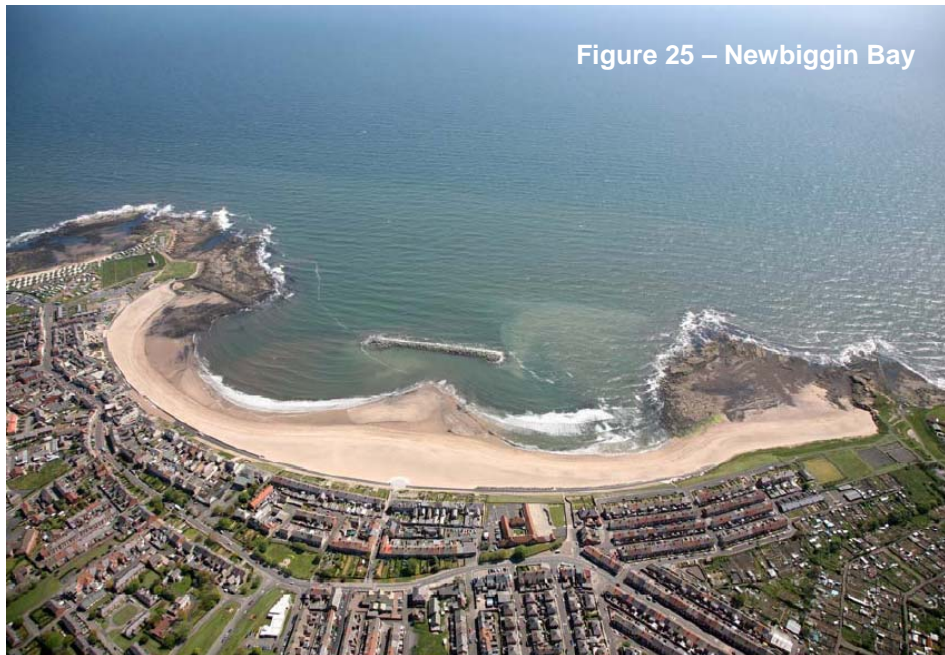
A succession of topographic surveys at Newbiggin Bay has helped to identify and quantify changes that have occurred following beach replenishment as part of a capital scheme in 2007. The changes have been much influenced by the presence of an offshore breakwater built as part of that scheme, which has segmented Newbiggin Bay into two small embayments, encouraging the build up of sediment immediately in its lee on the lower foreshore, creating a tombolo feature.

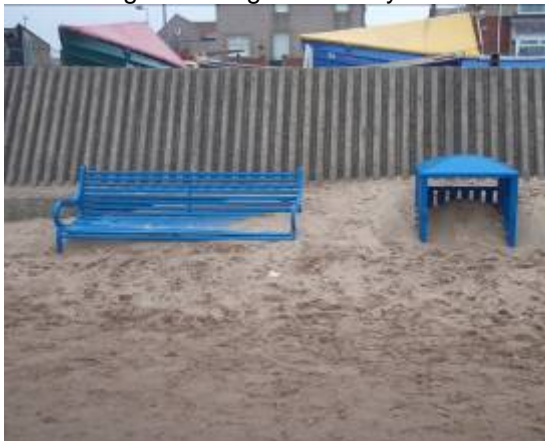
Figure 27 – Wind Blown Sand

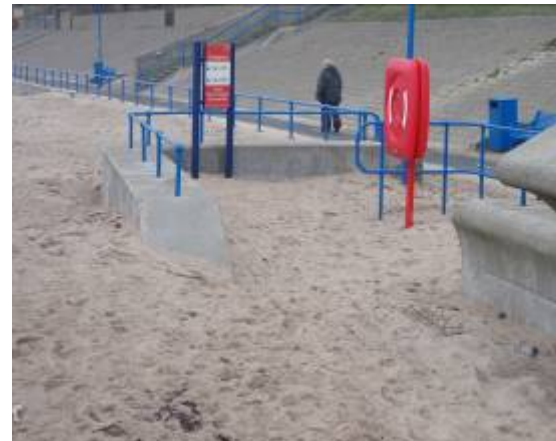
Figure 28 – Wind Blown Sand

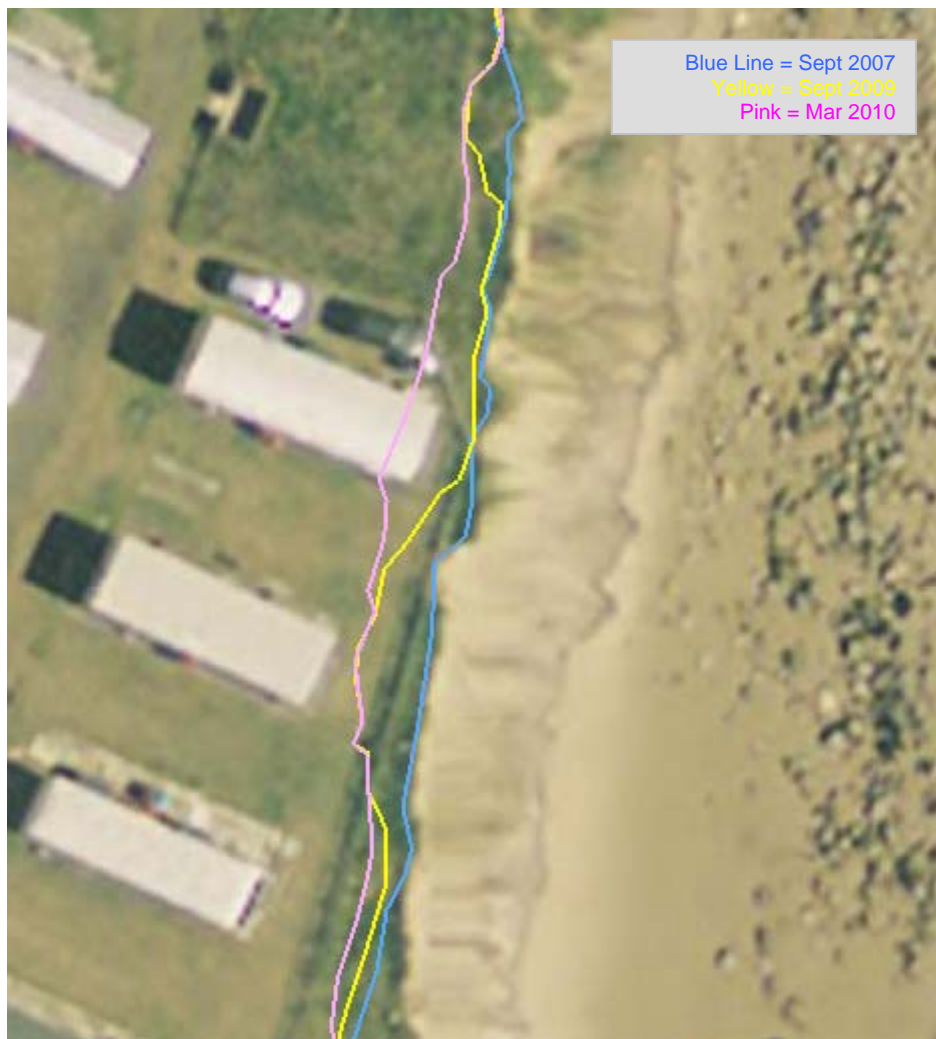
Figure 30 - Cliff Top Recession at Sandy Bay Caravan Park

Cliff top monitoring has been undertaken at Sandy Bay Caravan Park since Full Measures 2007 as a continuous cliff top survey line. Recession has been greatest at the southern end of Caravan Park and in places exceeded 3m between September 2009 and March 2010. As can be seen from Figure 30, the site owners have had to re-locate some caravans to accommodate the ongoing change.

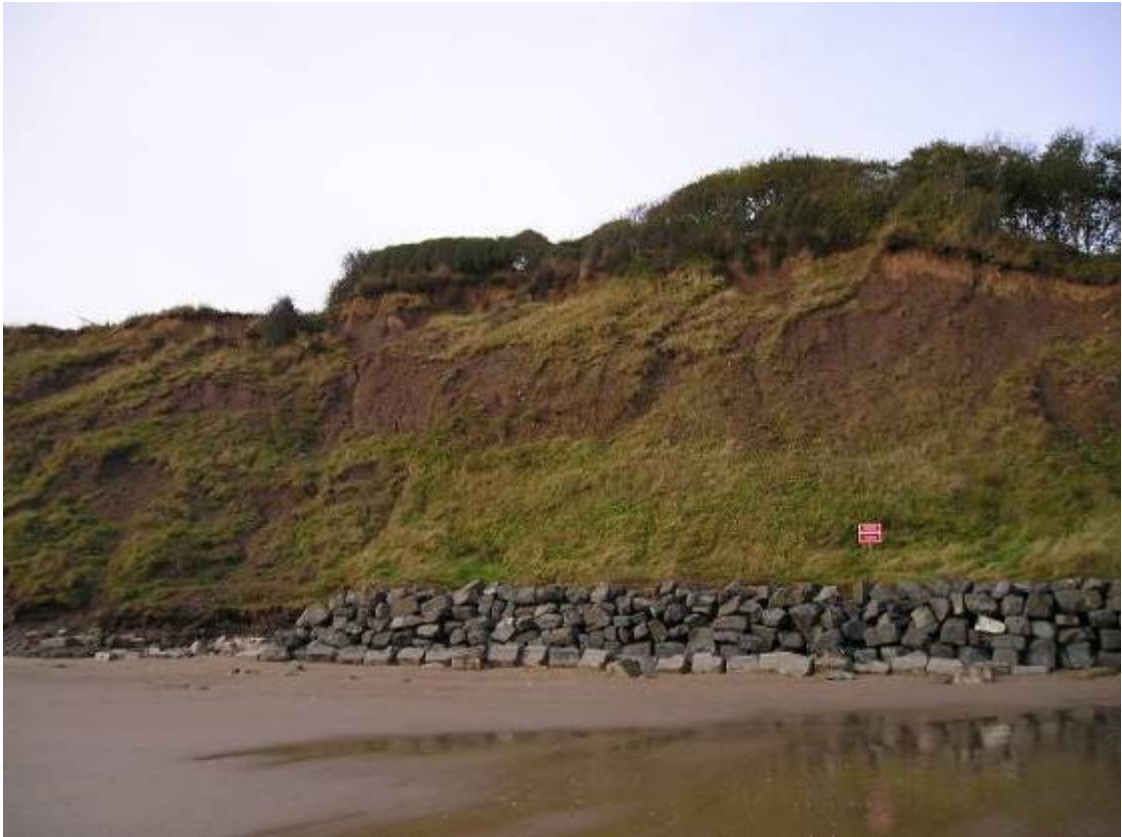
**Figure 32 – Cliff Erosion in Filey Bay  
(Marker 5 is located to the left, beyond the extent of the rock armour)**

Within Filey Bay there are 27 cliff top monitoring positions. Of these, the most notable cliff recession is recorded at marker 5, immediately south of the seawall and rock armour at Filey town. Since the marker was installed in November 2008 it has shown a consistent trend of cliff top retreat so that by March 2011 there has been a total of 5.5m of recession. This information suggests that outflanking of the Filey seawall is occurring which may require attention in terms of coastal management. Such activity is currently being examined by the Filey Coastal Stability and Outflanking Study.

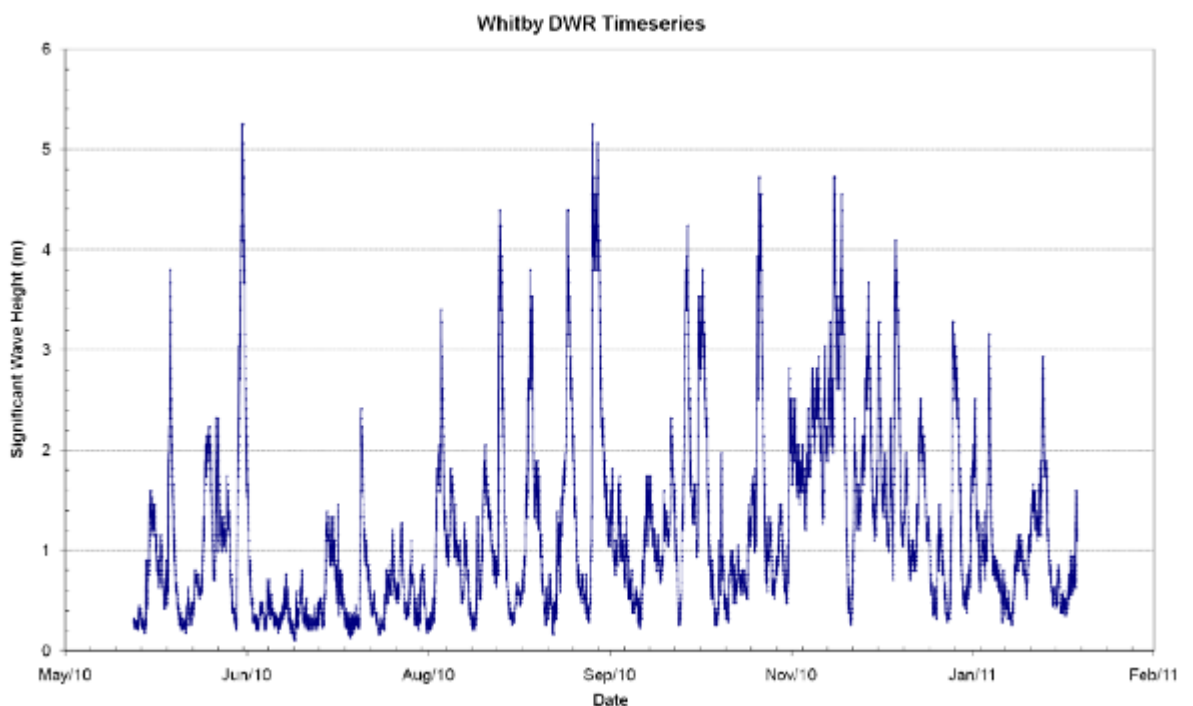
Figure 35 – Sample of Wave Heights Recorded at Whitby Waverider Buoy

To help determine the favourable time to start in 2011, the wave heights for the preceding year were reviewed and these indicated calmer conditions between May to Sept 2010. This period exhibited markedly lower wave heights and longer periods between storms. To estimate the anticipated number of days lost due to excessive wave heights, the days actually worked on site between August through to December 2010 were plotted against the wave heights derived from the buoy for the same time period. This identified a wave height threshold of 1.2m measured at the buoy. The 14 weeks of works planned in 2011 to complete the works had the potential for 65 days where the wave heights were well below this threshold (based on the previous year's data) and so could be taken as a possible working day.

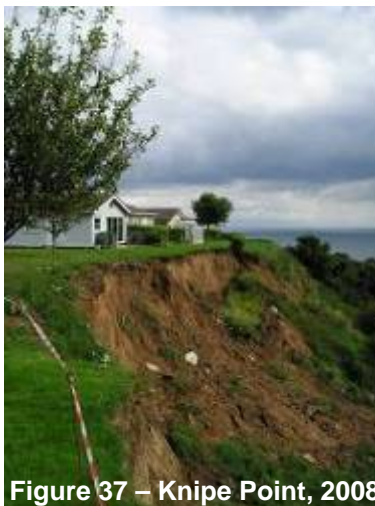
Figure 37 – Knipe Point, 2008

The walkover inspections at Knipe Point (Cayton Bay) were undertaken in 2008 and again in 2009. The inspection in 2008 was undertaken a few months following the re-activation of a major landslide, the effects of which were observed, as shown in Figure 37. By 2009, the activity at this site had reduced somewhat but ongoing changes were still noted. For example, Figure 38, taken in the same location demonstrates that the tree in the foreground has moved from the cliff top to somewhat down slope. Whilst a separate investigation was launched here in 2008/9, the walkover surveys provided an update concerning activity at the site, thereby contributing to the understanding of cliff behaviour. It is anticipated that future walkover surveys will highlight any further changes at sites such as this.

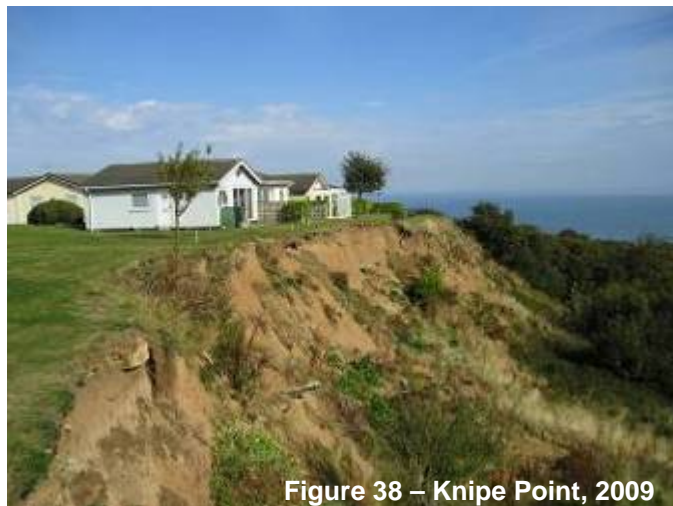
Figure 38 – Knipe Point, 2009

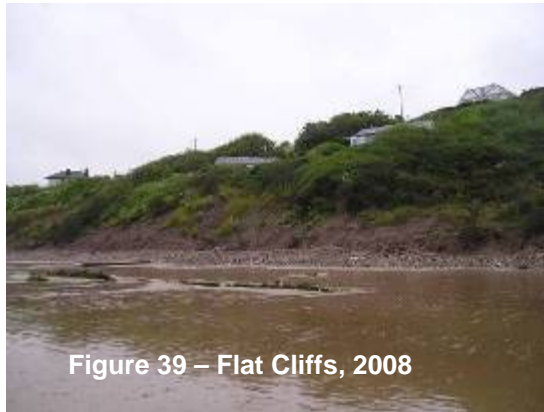
Figure 39 – Flat Cliffs, 2008

Flat Cliffs comprises a small community of properties located about 1.5km south of Filey. Concerns about the stability of the cliffs in this area have been suggested in recent years. The Cell 1 walkover inspections have provided an opportunity to capture any evidence of recent activity including changes in the cliff and beach morphology and damage to property and infrastructure. Figures 39 and 40 show the beach and cliff toe at Flat Cliffs in 2008 and 2009, respectively. In the later photograph, there appears to have been erosion of storm beach gravels from the back of the beach.

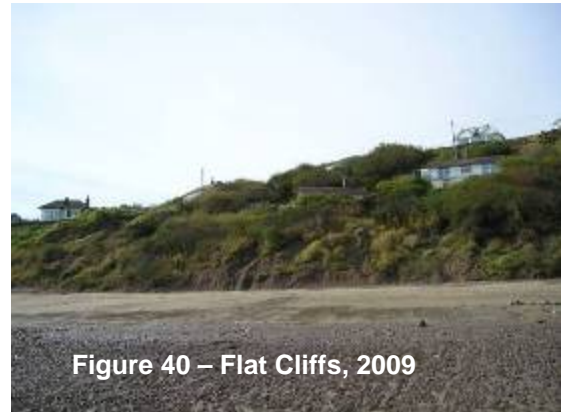
Figure 40 – Flat Cliffs, 2009
