## **Cell 1 Regional Coastal Monitoring Programme Overview Report (2016 – 2021)**

# North East Coastal Observatory

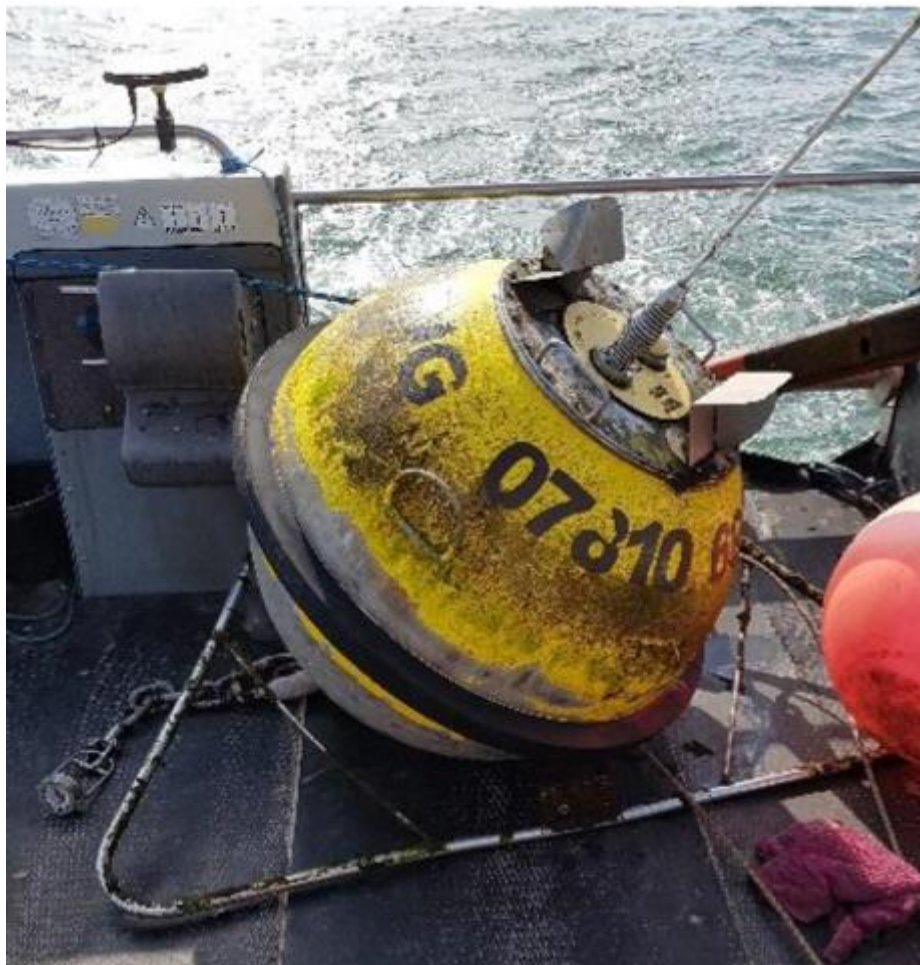
Plate 1-1 - Wave rider buoy (image courtesy FugroEMU)

Throughout the current phase of the Cell 1 Regional Coastal Monitoring Programme, wave rider buoys (Plate 1-1) have been deployed off the coast of Newbiggin (Northumberland) and Whitby and Scarborough (both North Yorkshire). In addition, wave data have been derived from Cefas' WaveNet buoy further offshore at Tyne-Tees and water level data have been collected from tide gauges at North Shields (North Tyneside), Whitby and Scarborough (both North Yorkshire). Whilst each of the three Cell 1 waverider buoys has been out of action for some periods of time, the overall data record is of excellent quality.

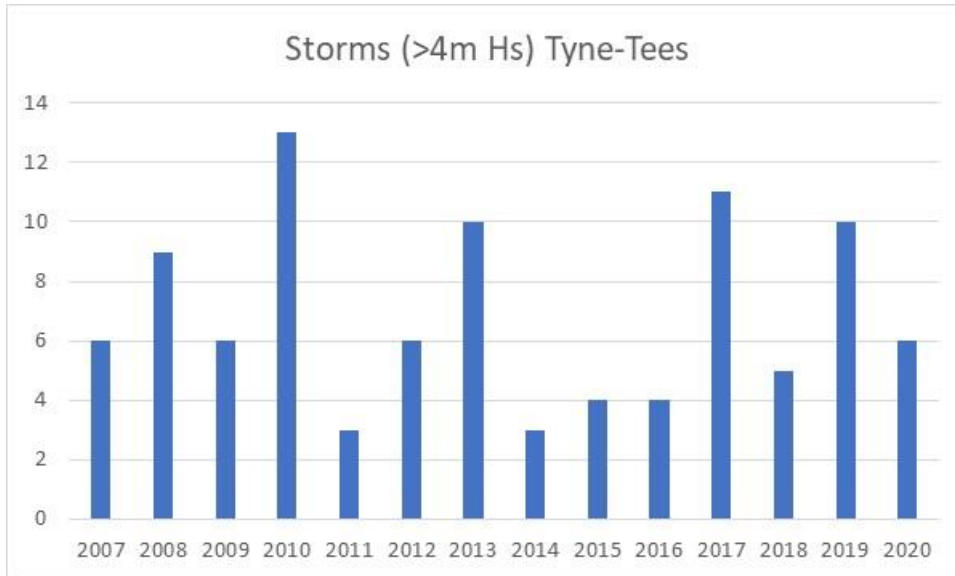
**Figure 1-1 – Storms (>4m H<sub>s</sub>) at Tyne-Tees Wave Buoy**

The longest running dataset is from the Cefas Tyne-Tees waverider buoy that forms part of WaveNet. Analysis of the December 2006 to March 2021 data from the Tyne-Tees buoy (Figure 1-1) against a storm threshold of 4m significant wave height ( $H_s$ ) indicates that the stormiest year over this period was 2010 (thirteen storms above the threshold) whilst the years with the fewest number of storms were 2011 and 2014 (three storms in each year above the threshold). The average number of storms over the fourteen full years between 2007 and 2020 is 6.9 storms per year above the 4m  $H_s$  threshold. The average over the five year period 2016 – 2021 was 7.2 storms per year, with 2017 and 2019 being particularly notable for the number of storms recorded above the threshold.

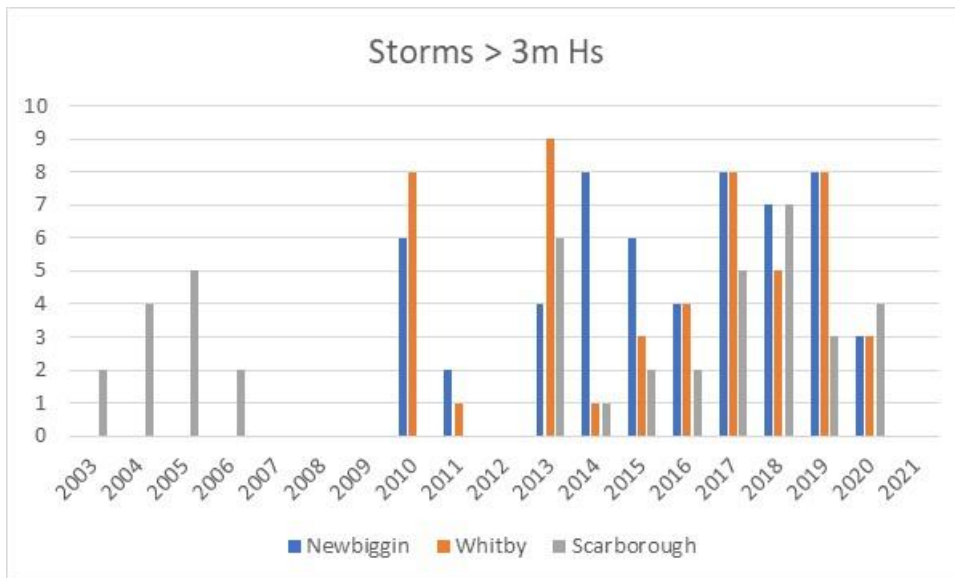
**Figure 1-2 – Storms (>3m H<sub>s</sub>) at Newbiggin, Whitby and Scarborough Wave Buoys**

Similar analysis of data from the Newbiggin, Whitby and Scarborough wave buoys against a storm threshold of 3m significant wave height (H<sub>s</sub>) is shown below. Considering full years of data records, over the eight years from 2013 to 2020, on average Newbiggin experiences 6 storms per year above the 3m H<sub>s</sub> threshold, with Whitby experiencing 5.1 storms per year and Scarborough 3.8 storms per year. For the most recent five full years, between 2016 and 2020, Newbiggin experienced average conditions, whilst Whitby and Scarborough experienced slightly more storms than average. The years 2017, 2018 and 2019 were noted to be particularly stormy, with 2020 lower than average in terms of number of storms.

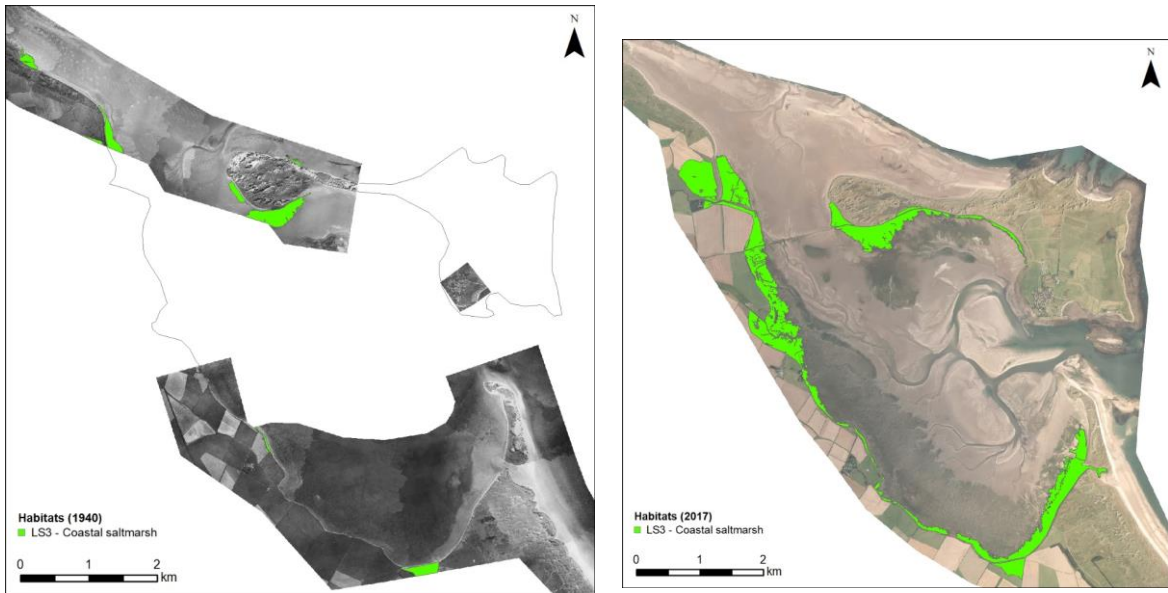
Figure 3-4 – Saltmarsh extent in 1940s (left) and 2017 (right)

The areas of saltmarsh that was mapped in 2017 can be compared against those mapped from the 1940s aerial photography in Figure 3-4. It can be seen that there has been an expansion in saltmarsh area over the past decades. However, monitoring the topography of the tidal flats either side of the causeway between 2004 and 2020 has identified no trend in sedimentation that can specifically be attributed to the causeway itself (example shown in Figure 3-5). Furthermore, a comparison of LiDAR data from 2010 and 2020 (Figure 3-6) shows that the deposition rates across Lindisfarne NNR are relatively consistent and there is no tendency for greater sedimentation in the vicinity of the causeway.

This demonstrates that sedimentation rates across the NNR are driven by landscape-scale geomorphological change, strongly influenced by the prograding barrier beach at Goswick Sands and the prograding dunes at Ross Links and Old Law. As sedimentation occurs, currently at a rate that outpaces sea level rise, so the tidal flats become more conducive to colonisation by saltmarsh species, initially the pioneering *Spartina anglica* and then a succession of other species. This, coupled with cessation of management of the *Spartina anglica* by roto-burying in 2002, has led to the observed increase in saltmarsh habitat in Lindisfarne NNR over recent decades.

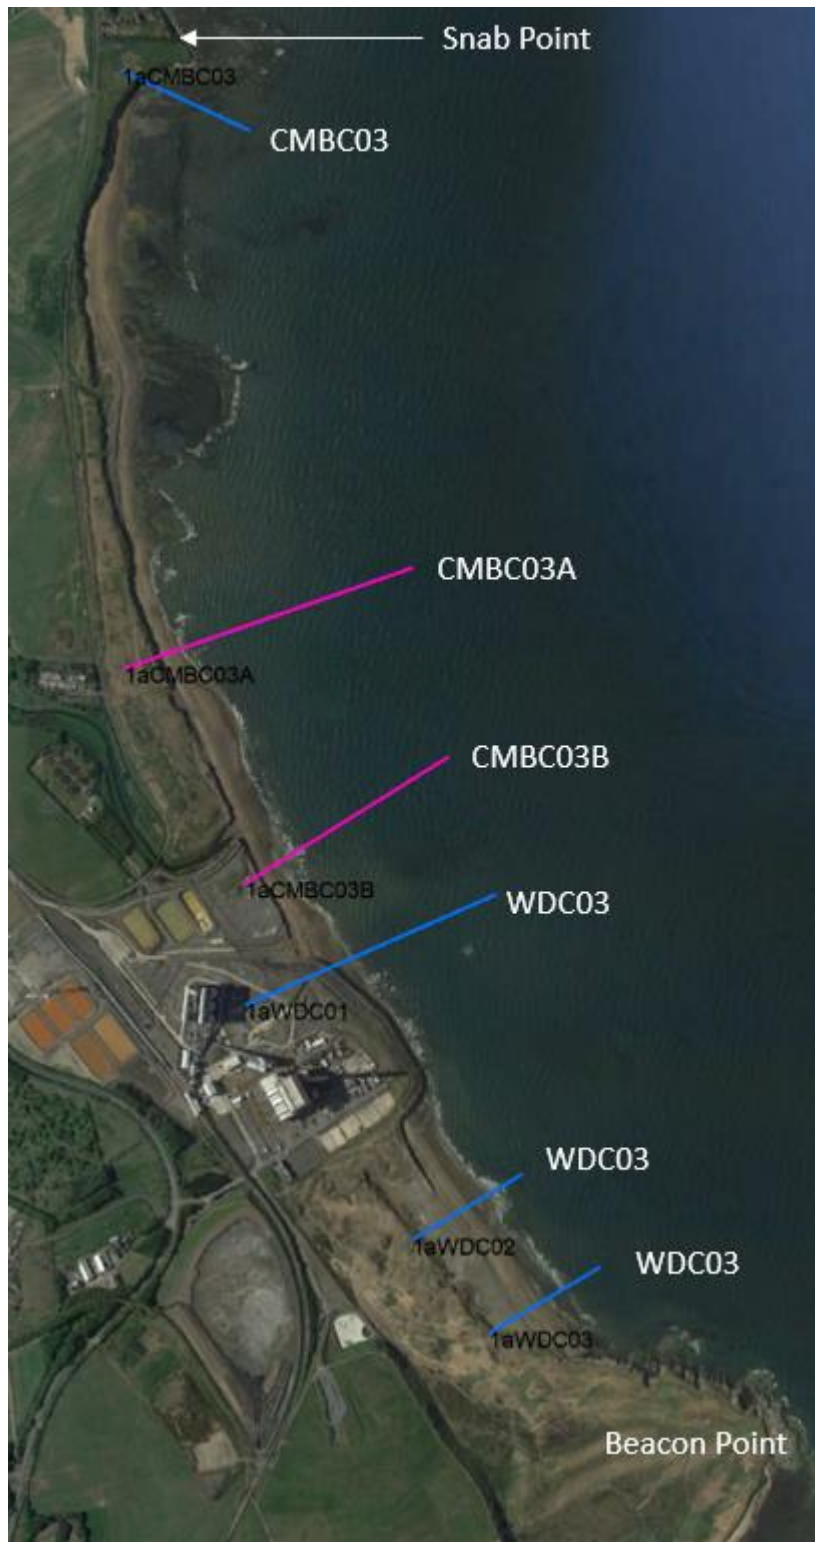
**Figure 3-7 – Beach Profile Survey Locations in Lynemouth Bay**

Monitoring of coastal change in Lynemouth Bay has been undertaken as part of the Cell 1 Regional Coastal Monitoring Programme (or its predecessor programme across Northumberland) since 2002, with aerial photography and beach profile surveys. Various profiles have been added or removed over time in accordance with Table 3-1 and the location of these profiles is shown in Figure 3-7. Annual average erosion rates, based upon the most up to date data, are also shown in the table.

Profile	Location	First Survey	Latest Survey (at the time of writing)	Landward recession of MHWS over period stated		Comments
				Total recession (m)	Average annual rate (m/year)	
1aCMBC03	Northern end of Lynemouth Bay, near Snab Point	02/05/2002	28/11/2019	2	0.1	Stable cliffs
1aCMBC03A	Northumberland County Council land	01/10/2007	21/04/2020	29	2.3	Profiles CMBC03A and CMBC03B were added to the programme in October 2007
1aCMBC03B	Coal Authority land	01/10/2007	21/04/2020	58	4.6	
1aWDC01	Power Station Revetment	03/05/2002	22/04/2016	67	4.8	No longer surveyed as the fronting spoil beach has eroded back to the revetment
1aWDC02	Lyne Sands	03/05/2002	28/11/2019	54	3.1	Recession based on seaward berm
1aWDC03	Southern end of Lynemouth Bay	03/05/2002	28/11/2019	55	3.1

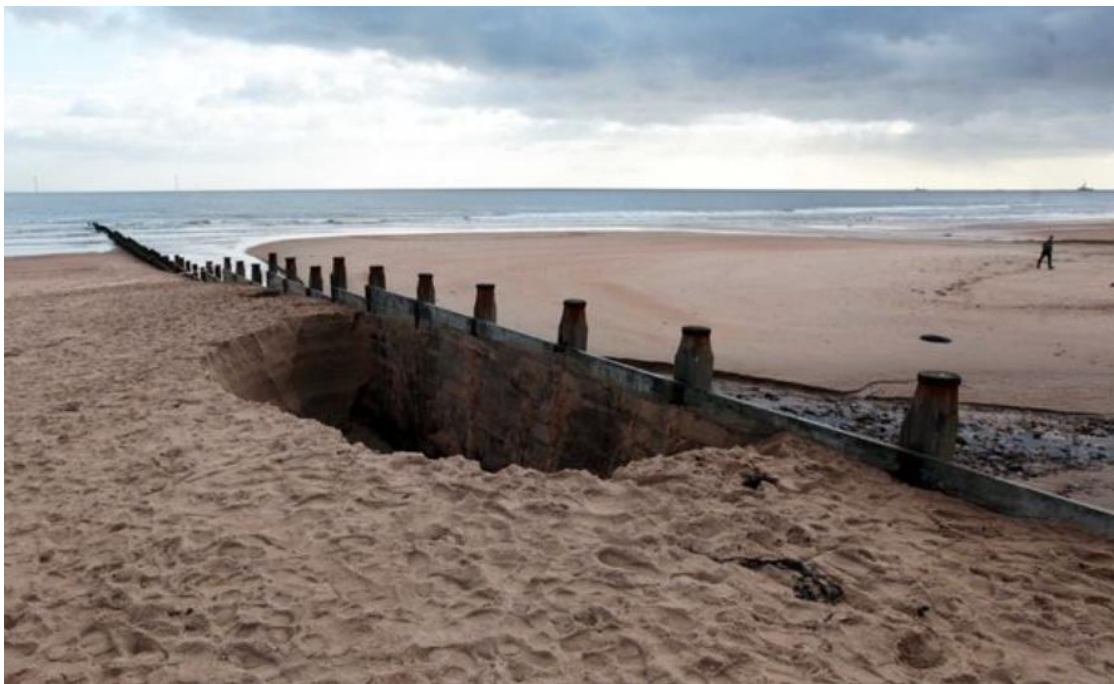
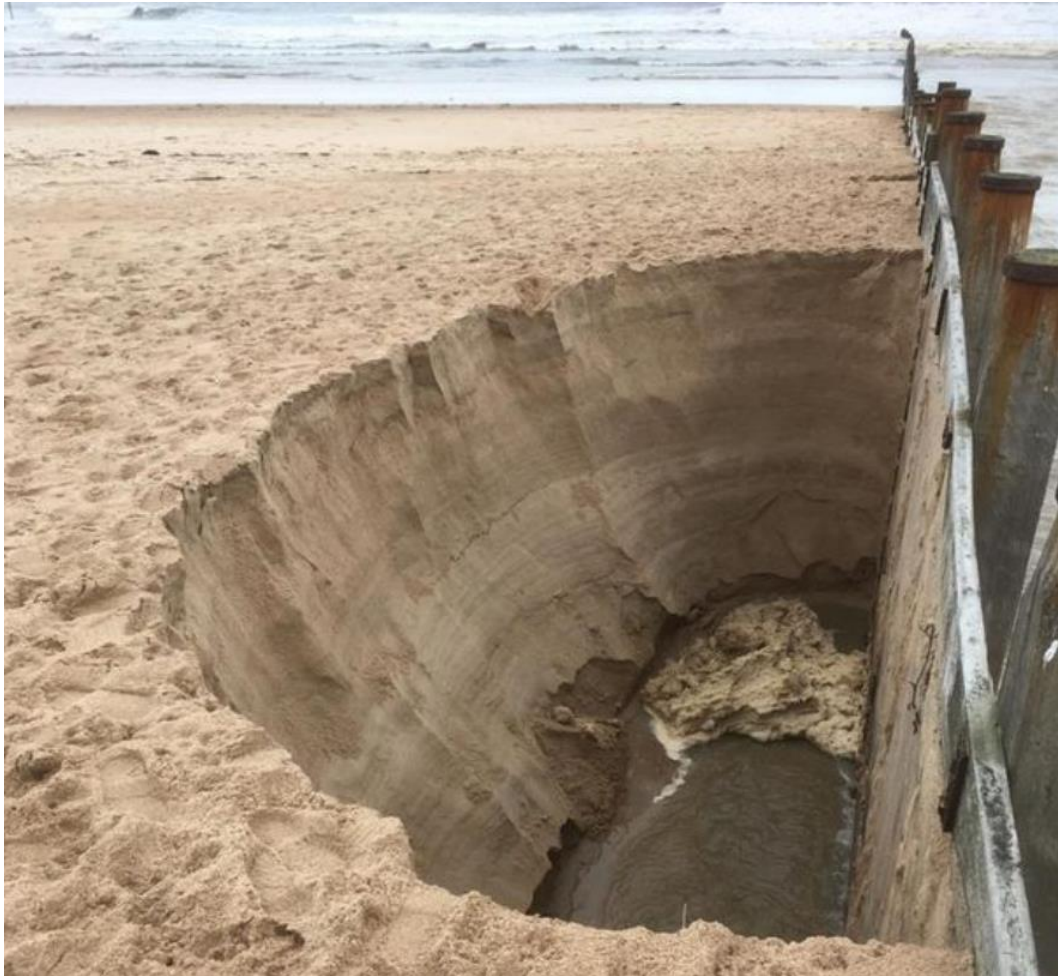
**Figure 3-15 – Sink hole in the beach due to changes in the channel alignment of Meggies Burn, October 2019**

On 7<sup>th</sup> October 2019, the channel of the burn had moved north along the toe of the dunes to reach the last timber groyne, causing a large sink hole to be created in the beach as the channel meandered beneath it (Figures 3-15 & 3-16). The sinkhole developed following a period of very heavy rainfall over a few days which caused the burn to be in spate. When coupled with high equinox tides, the channel flow diverted northwards until reaching the groyne. The sand level was higher on the north side of the groyne, so the force of water from the burn washed away the sand underneath the groyne causing the hole to form. The hole was cordoned off and then infilled with adjacent beach sand using mechanical plant (Figure 3-17). After the spate abated, and the newly formed channel bed dried, it left exposed former anti-tank defences that were installed along Blyth South during World War II as a military measure against armed invasion, but which had subsequently become buried by beach sand and had not previously been observed for at least a decade (Figure 3-18).

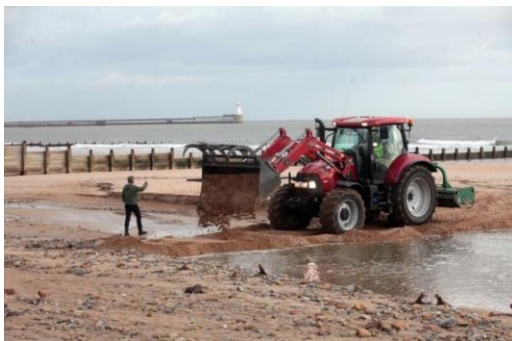
**Figure 3-17 – Infilling of sink hole**

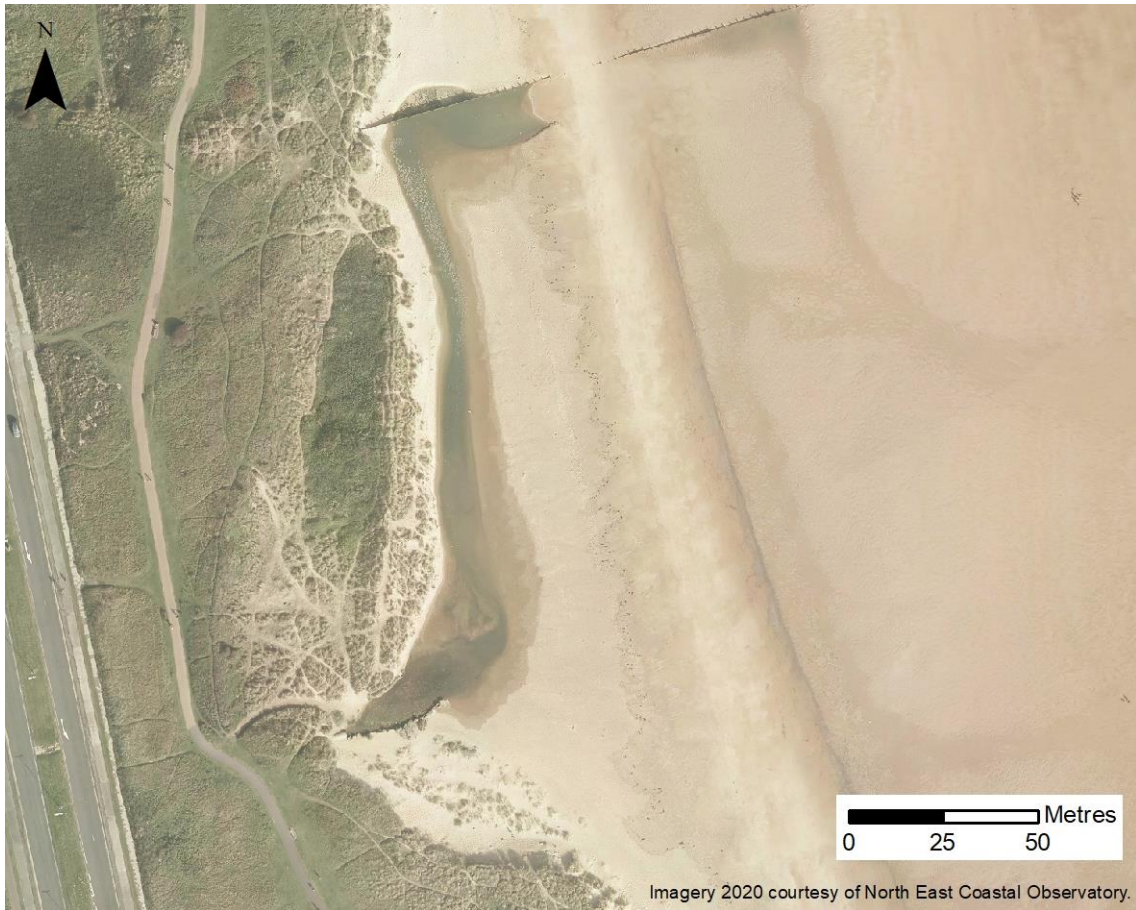
This situation has been captured by the most recent aerial photography available from the Cell 1 Regional Coastal Monitoring programme from the year 2000, as shown in Figure 3-19.

**Figure 3-19 – Meggies Burn in 2020**

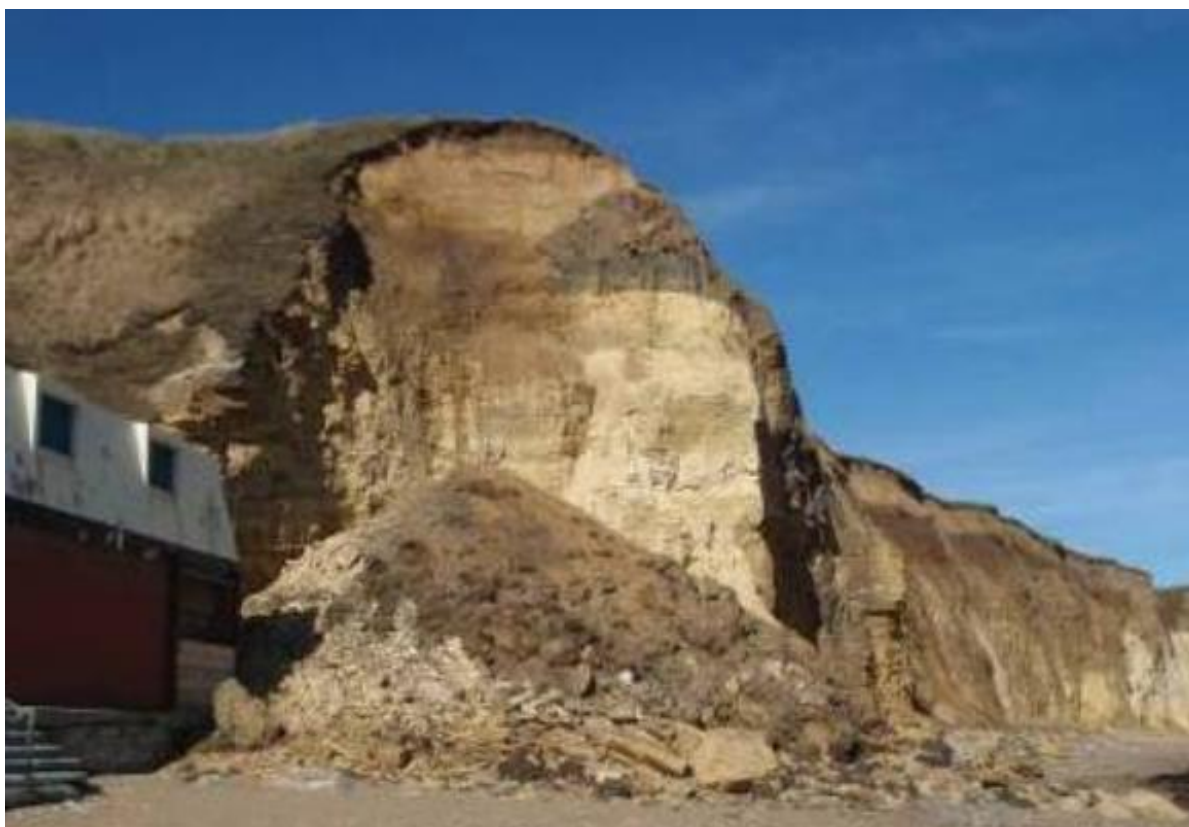
Figure 3-20 – Marsden Bay rockfall, 2010

There have been a number of notable rockfalls along the South Tyneside frontage in recent years, particularly at Frenchman's Bay and Lizard Point in 2010 and in Marsden Bay adjacent to the (now demolished) Lifeguard Station by the Redwell Steps (Figure 3-20). In fact, the history of rockfalls in these cliffs has left a series of rock stacks, arches and caves along the frontage and is representative of the characteristic behaviour of cliffs of this type.

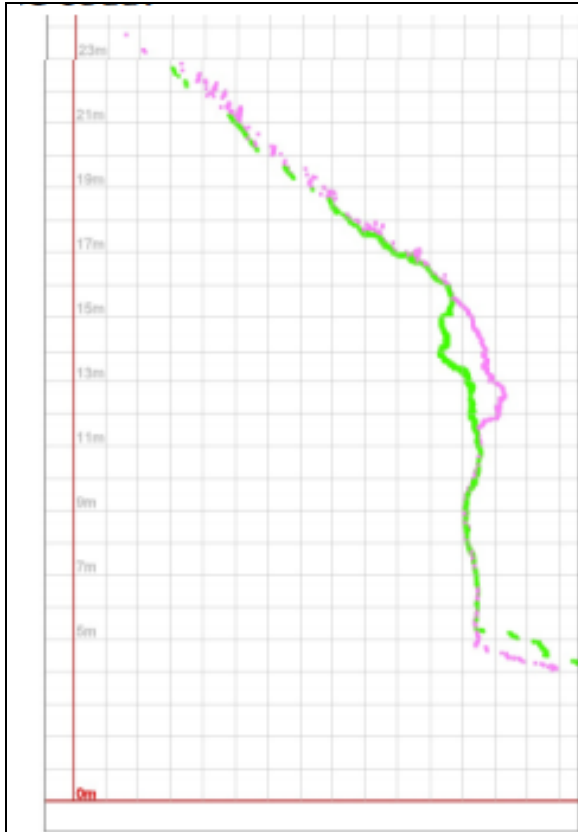
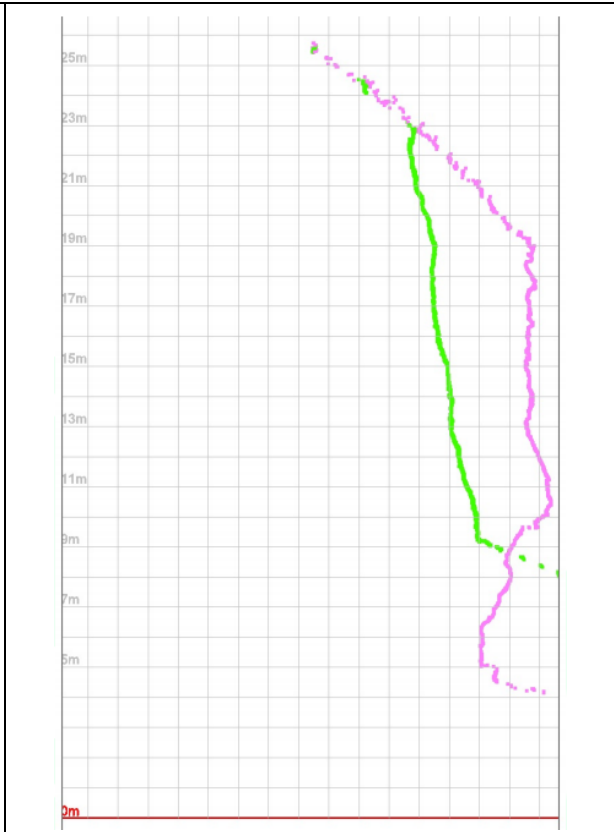
**Figure 3-24 – Small rockfall of overhanging cliff face**

During the larger rockfall around 311m<sup>3</sup> of material dropped suddenly from the cliff face to the cliff toe, with the greatest depth of incision into the cliff face being 3.6m. This rockfall occurred in an area where two small caves were observed in the November 2020 laserscan data, which have now become blocked by the toe debris. This rockfall involved the shearing of a larger section of cliff face from directly above the caves, with failure movement along a near-vertical plane (Figure 3-25).
