# **Cell 1 Regional Coastal Monitoring Programme Cambois Bay 'Post Storm' Cliff-Top Monitoring Survey Report 2023**

**Northumberland County  
Council**

**December 2023**

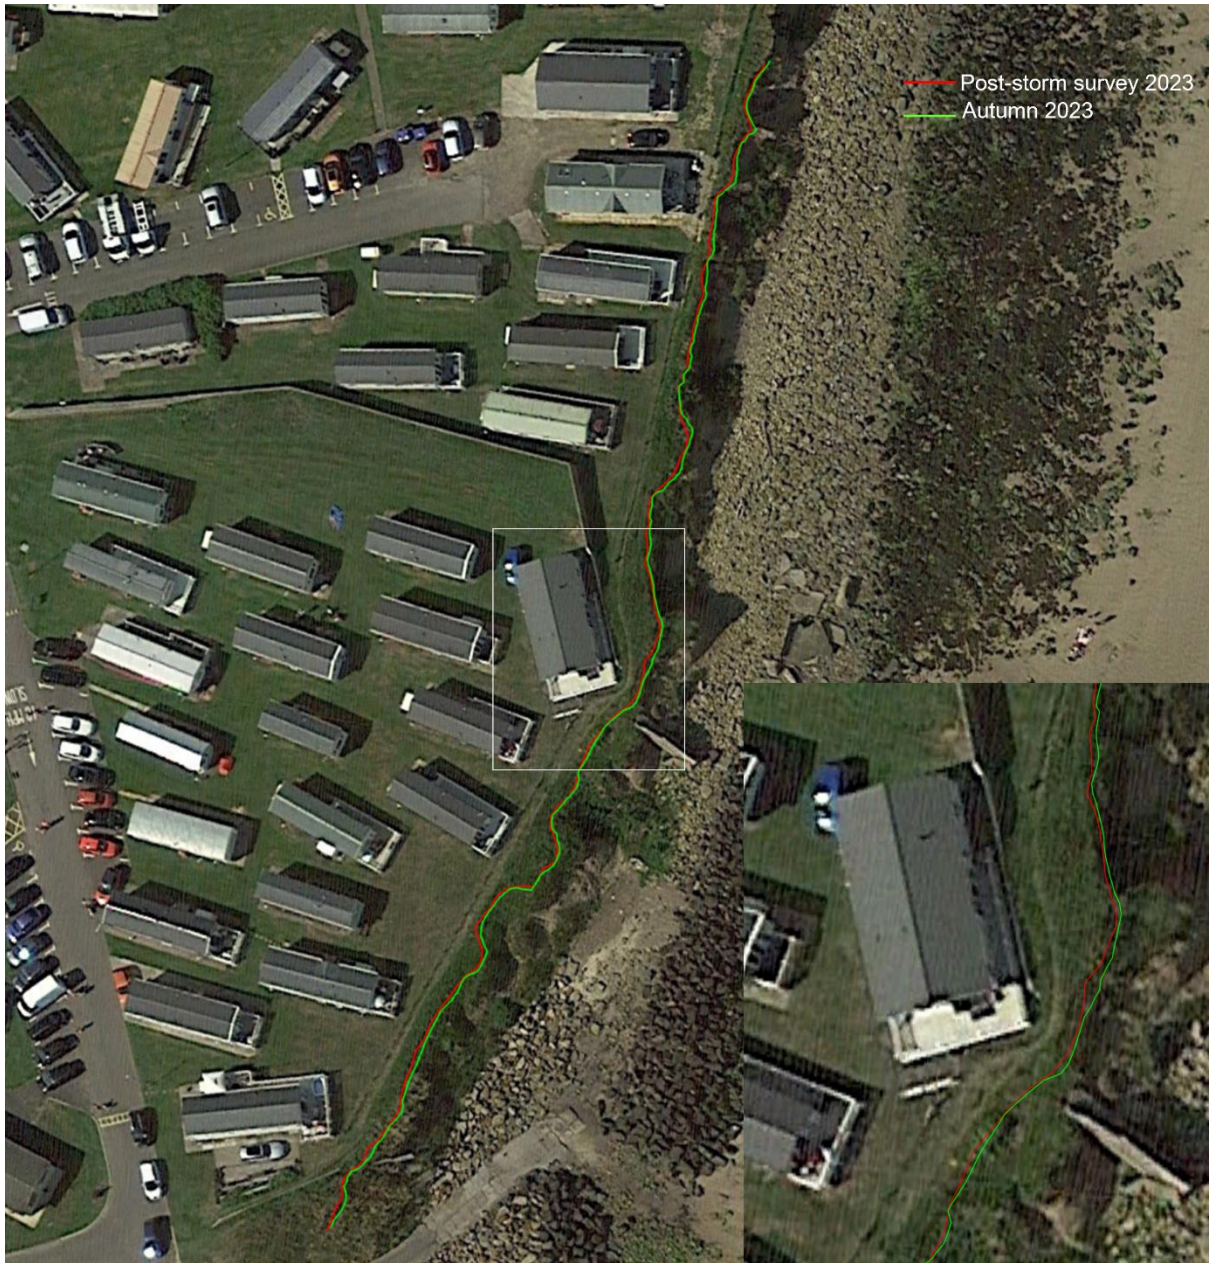
Survey Date	Description of Changes Since Last Survey	Interpretation
<p><b>November 2023</b></p>	<p><b>Cliff-top Survey:</b> Cliff top survey data was last collected for the Full Measures survey in autumn 2023 and supplemented by a post-storm survey in November 2023.</p> <p>The cliff top survey is carried out as a continuous cliff edge line survey in two locations within Cambois Bay; at Sandy Bay Caravan Park to the north of the River Wansbeck estuary, and Cambois Bay from south of the River Wansbeck to the breakwater at the southern end of the bay. The results from the cliff top monitoring are anticipated to have an accuracy of <math>\pm 0.2\text{m}</math> due to the technique used. Furthermore, problems in precisely locating the cliff top, due to vegetation growth or the indistinct form of the cliff top, have also affected the data quality.</p> <p>There has been a uniform retreat of the cliff line adjacent to Sandy Bay caravan park by up to 0.5m between the autumn 2023 survey and the post-storm survey in November 2023 (<b>Figure 2</b>).</p> <p>There has been relatively little change along the defended coastline to the south of Wansbeck Estuary to the cross-shore outfall adjacent to the 'northern' car park between the autumn 2023 and post-storm survey in November 2023 (<b>Figure 3</b>). The coastline to the south of the cross-shore outfall, where the rock armour no longer protects the coastline, has retreated in some sections by between 1m and 3m (<b>Figure 3</b>). This is corroborated by the survey report which notes 'up to 3m of cliff has eroded as result of storm Babet on the main stretch of cliff top at Cambois'.</p> <p>South of the cross-shore outfall towards North Blyth, the greatest change occurs at the most 'southern' car park close to North Blyth terminal, where the cliff top (or vegetation line at this point) has retreated by up to 4.7m (<b>Figure 3</b>). The coastline adjacent to the rock revetment at Blyth terminal has not significantly changed since the previous survey in autumn 2023 (<b>Figure 4</b>).</p>	<p>Since the last survey in autumn 2023, there has been a retreat in cliff top position recorded at Sandy Bay Caravan Park, with a maximum retreat of up to 0.5m. Cambois Bay appears to have been relatively stable along much of its frontage with isolated areas of significant retreat of up to 1-3m in the north and centre of the bay, and up to 4.7m in the south of the bay.</p> <p><b>Longer term trends:</b> The coastline adjacent to Sandy Bay Caravan Park has undergone significant cliff top retreat since 2008, particularly in the north of the survey area (up to 11.0m) whilst the southern part of the survey area has eroded by c.1.0-5.0m. Some caravans are now within 2-3m of the cliff top.</p> <p>In Cambois Bay, the area of greatest cliff top retreat since the surveys began in 2009 is the centre of the bay opposite Ridley Terrace, Cambois, where up to 16.0m of erosion has occurred. The north and south of the bay have retreat more typically c.1.0-5.0m.</p>

**Figure 2** Cambois Bay (Sandy Park) cliff top surveys in Autumn 2023 (pre-storm survey) and November 2023 (post-storm survey)

Cliff top surveys have shown a gradual retreat of the cliff top adjacent to the Sandy Bay caravan park and a small number of caravans are now very close to the cliff edge. It is likely that the cliff top will continue to retreat, accelerating following stormy periods and eventually undermining the closest caravans. This is continuing to be monitored but there should be proactive measures taken by caravan park owners (advised by Northumberland County Council) to relocate the closest caravans further inland as a matter of health and safety.

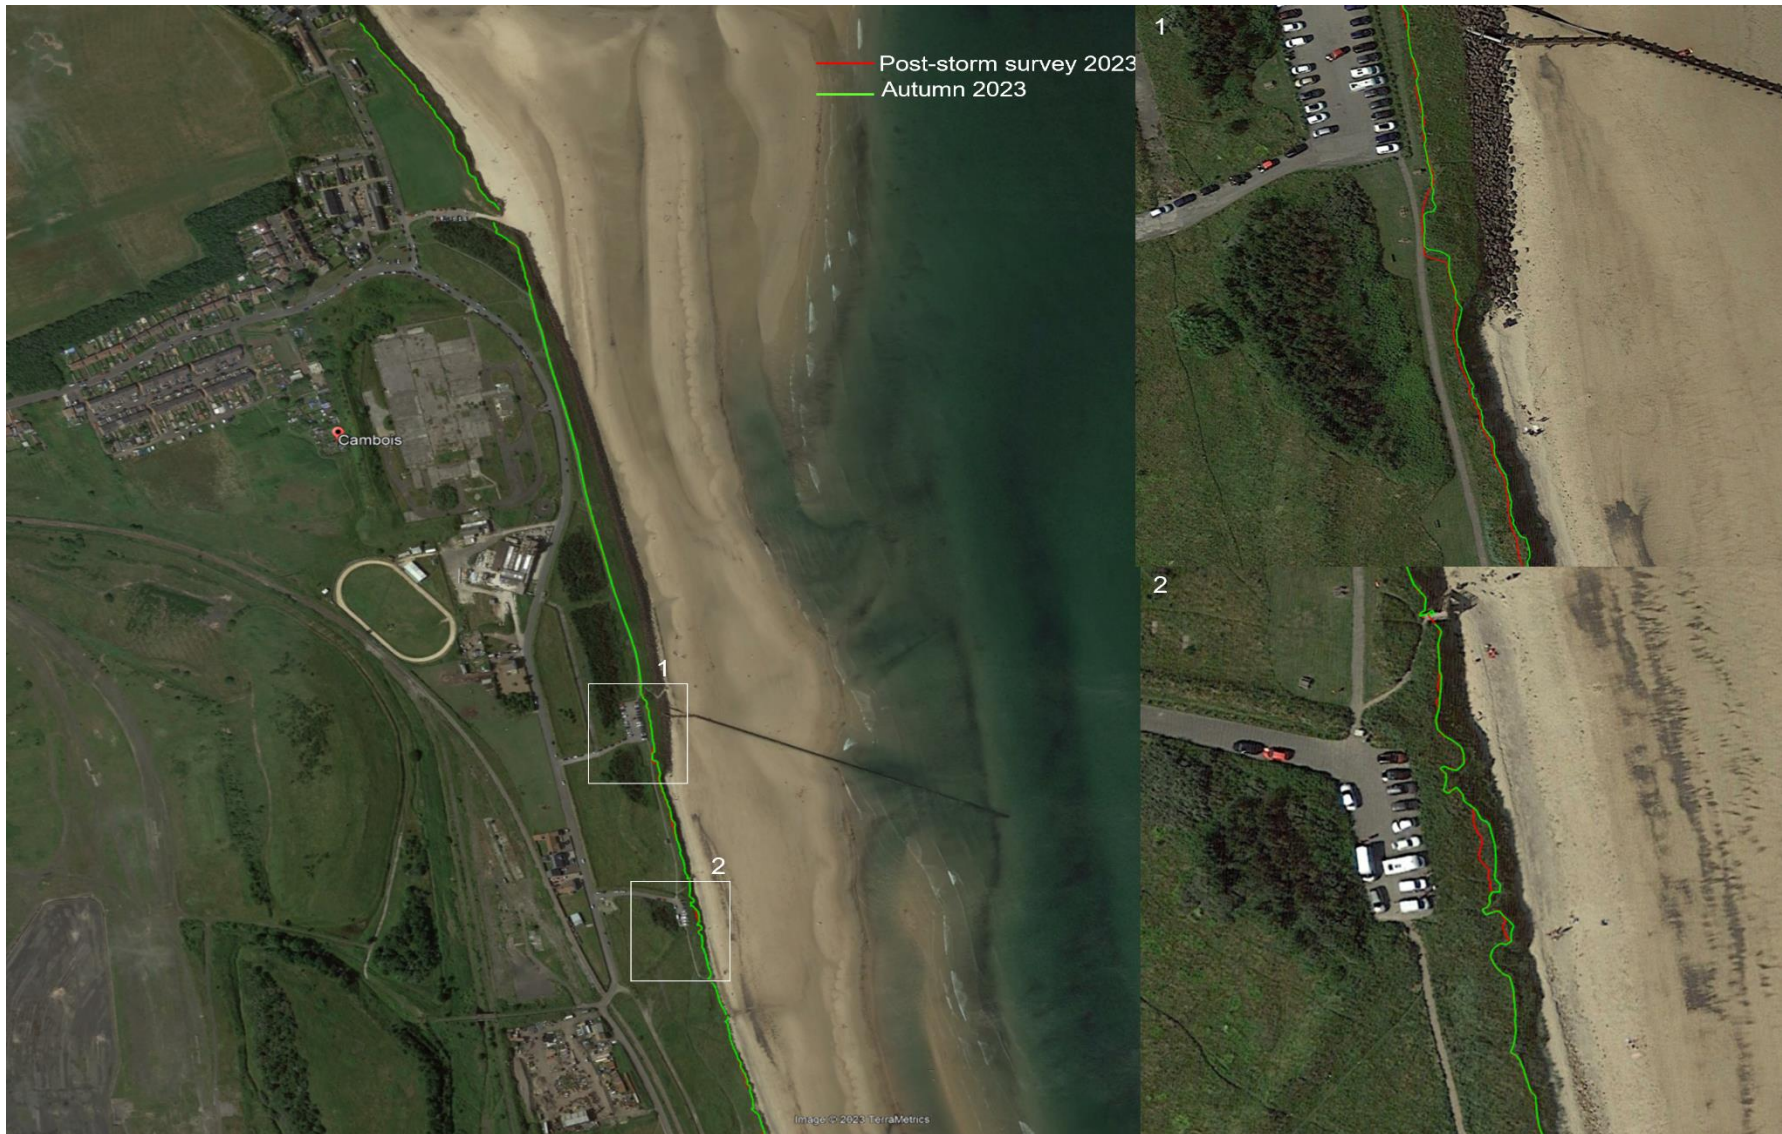
Figure 3 Cambois Bay cliff top surveys in Autumn 2023 (pre-storm survey) and November 2023 (post-storm survey) – North of bay

The cliff top surveys show a significant retreat of the cliff top has occurred at some sections in the north of the survey area (adjacent to Sandy Bay Caravan Park), south of Wansbeck Estuary (south of the rock revetment) and adjacent to Ridley Terrace, Cambois.

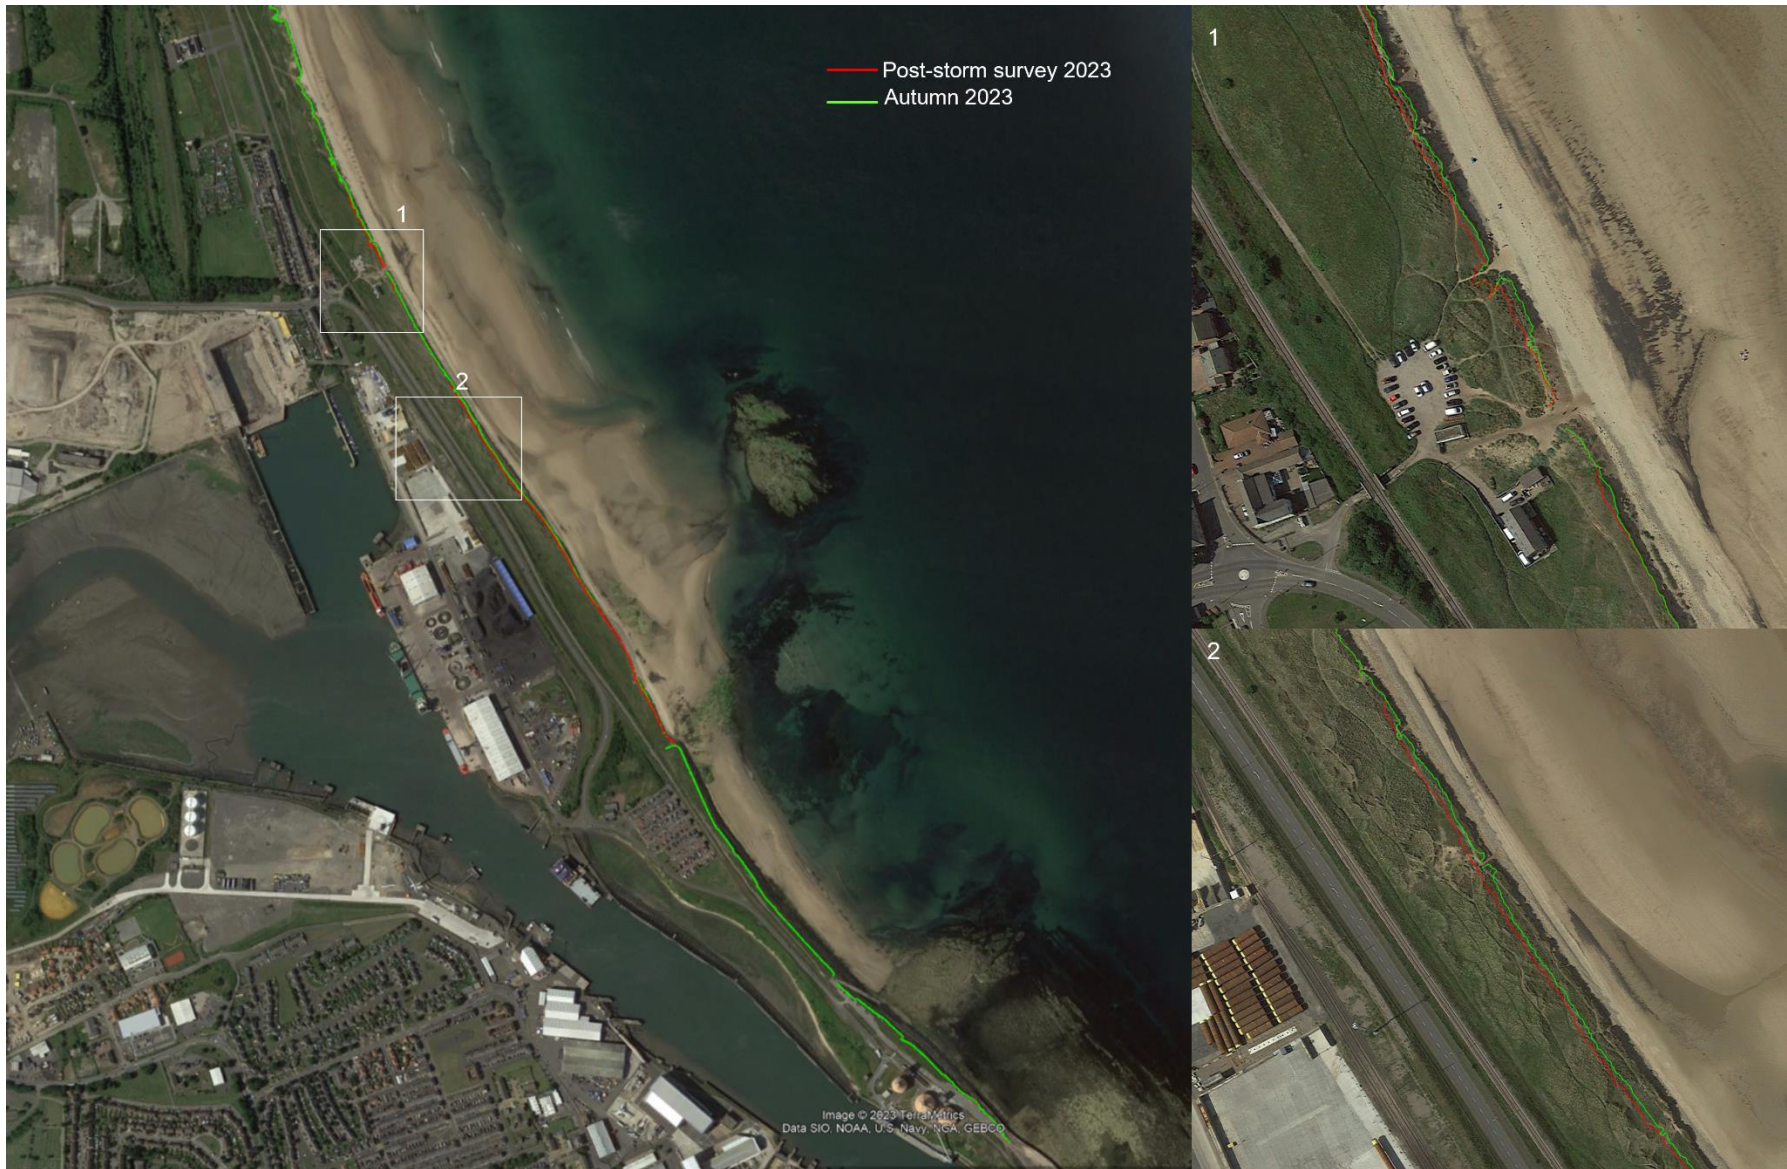
**Figure 4** Cambois Bay cliff top surveys in Autumn 2023 (pre-storm survey) and November 2023 (post-storm survey) - South of bay
